**EXPERIMENTAL INVESTIGATION OF
ASR/DEF-INDUCED REINFORCING BAR FRACTURE**

Thesis

The University of Texas at Austin
December 2011

A two-part experimental program was conducted at The University of Texas at Austin relating to ASR/DEF-induced reinforcing bar fracture. Work conducted under TxDOT Project 0-6491 included the fabrication and monitoring of four concrete specimens. Methods were employed to simulate a fracture of the transverse reinforcement within the time frame of the study and the applicability of various NDT monitoring techniques to detect bar fracture was evaluated. Furthermore, a number of reinforcing bar samples were tested and analyzed to investigate (1) the development of reinforcing bar cracking due to the bending operation and (2) the progression of cracks after application of an expansive opening force on bars with 90° bends. Research findings and conclusions form a preliminary assessment on the potential for reinforcing bar fracture within affected infrastructure in Texas.

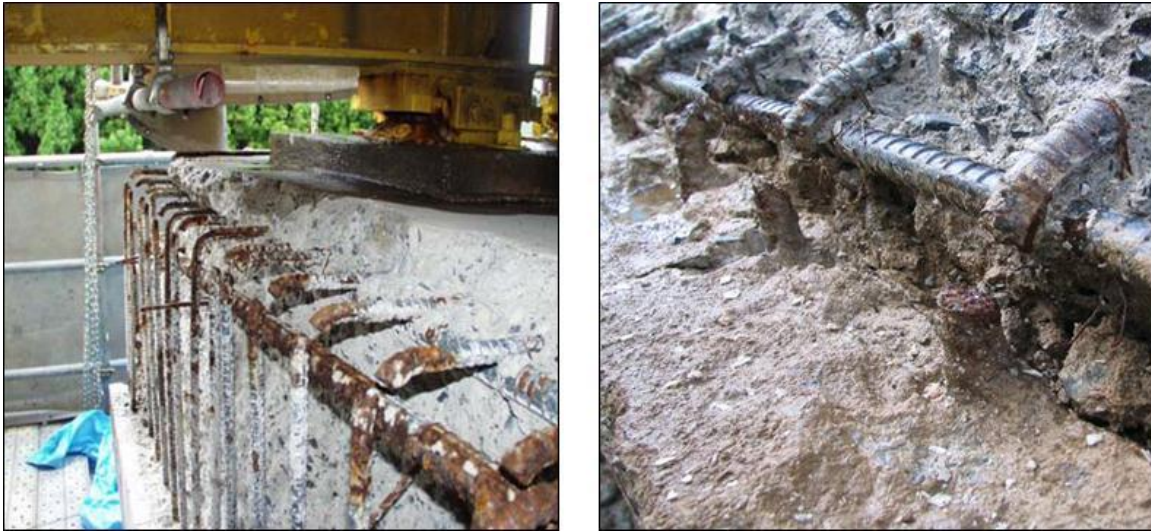
*Figure 1-1: Examples of ASR-Induced Reinforcing Bar Fracture in Japan
(Torii et al. 2008)*

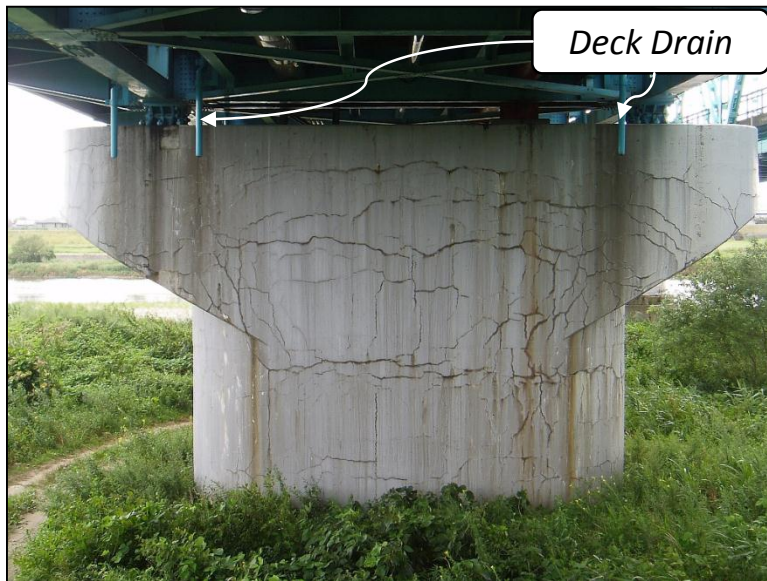
Daidai and Torii investigated heavily deteriorated concrete piers of a seven span bridge to determine the degree of reinforcing bar fracture and develop an appropriate repair procedure. The piers, constructed in 1972, were repaired in 1989 using epoxy crack injection and waterproofing coating. Within five years the surface coating was cracked on two piers at locations where the deck drained directly onto the concrete piers, providing for a supply of water required for continuous ASR deterioration. Figure 2-7 shows the condition of one heavily damaged pier, with confirmed bar fractures, before the concrete cover was removed for the investigation.

***Figure 2-7: Heavily Damaged Bridge Pier with Confirmed Reinforcing Bar Fractures
(Daidai and Torii 2008)***

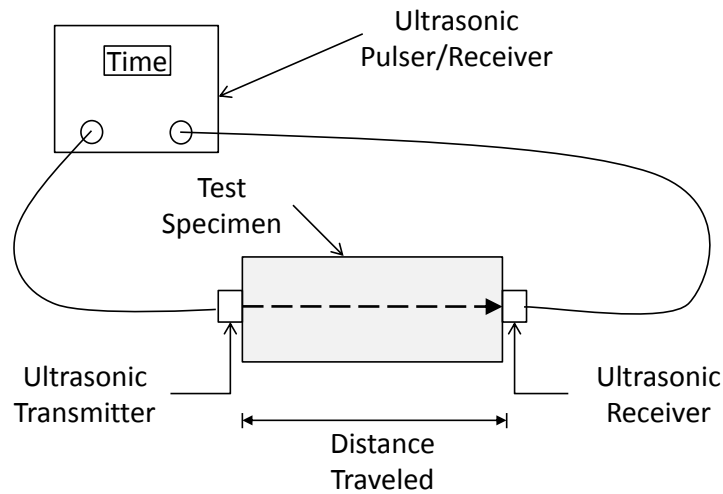
The UPV method is a technique that is commonly used to evaluate concrete properties and assess the uniformity of concrete within a structural element. The testing setup, illustrated in Figure 2-12, consists of an ultrasonic pulser/receiver and two transducers. The pulse travel time is measured and the velocity of the compression wave (travel time \div distance traveled) is computed.

Figure 2-12: Ultrasonic Pulse Velocity Test Setup (Kreitman 2011)

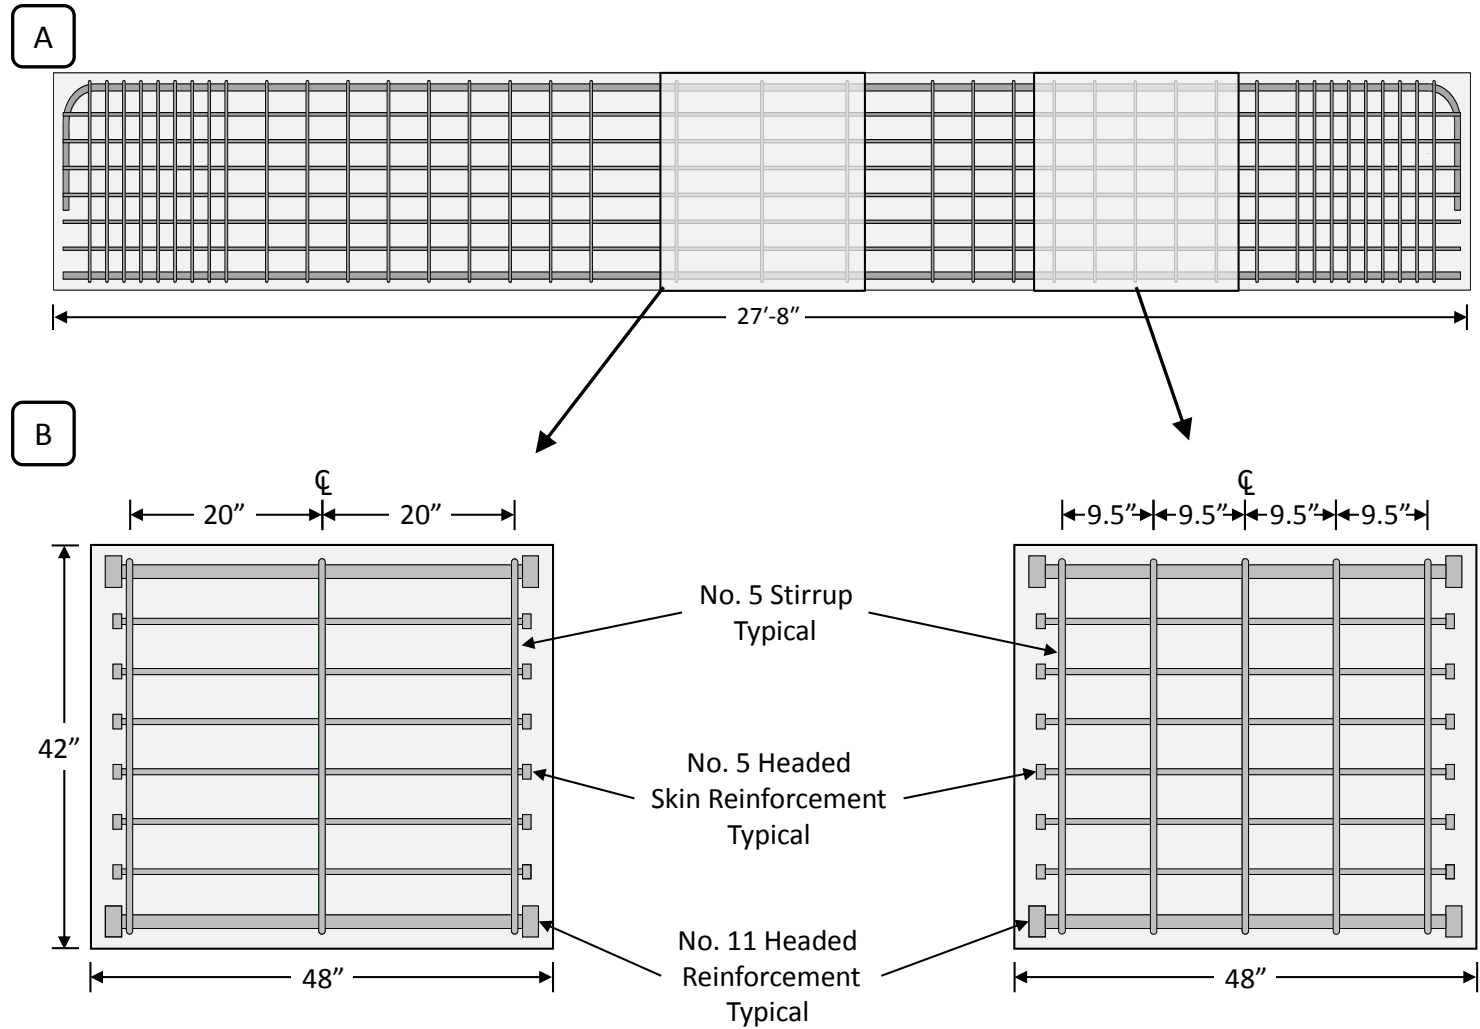
Figure 3-2: (A) Large Scale Flexural Test Specimen(s) (B) Related Beam Segments - Elevation

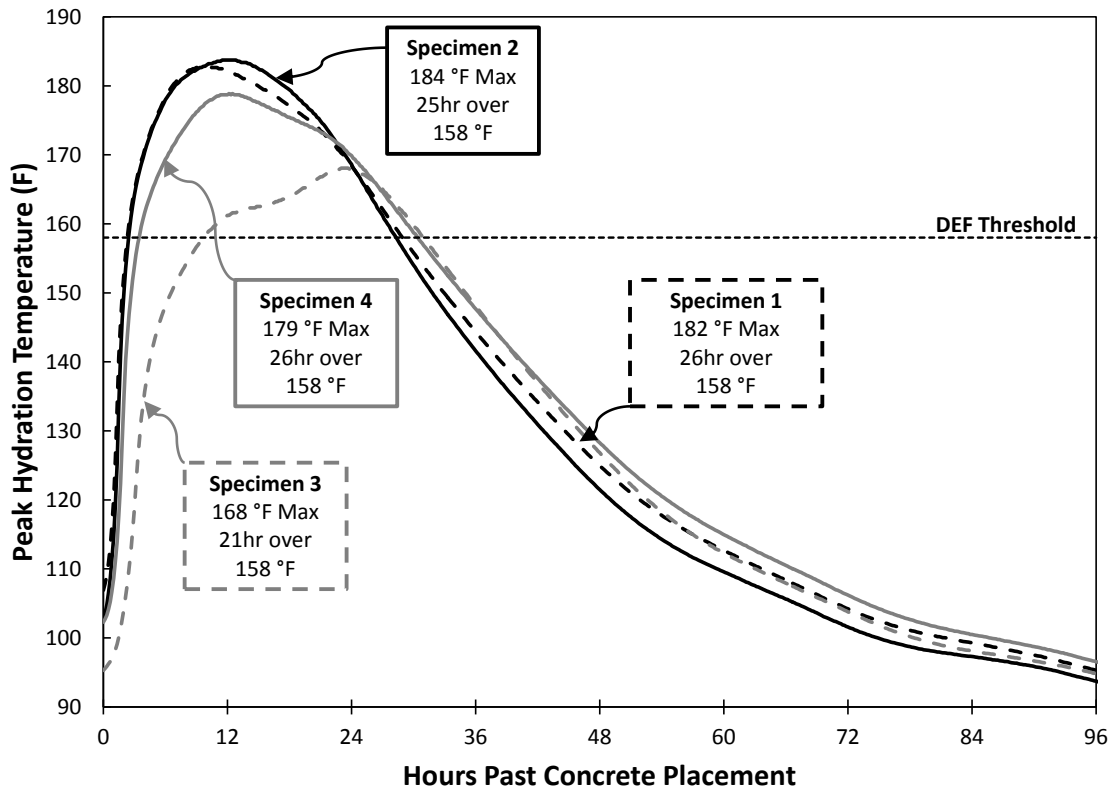
Hydration curves from each beam segment can be found in Appendix A. The maximum variation of hydration temperature across the cross section was approximately 10°F; therefore, only the peak temperature hydration curves for the four beam segments are compared in Figure 3-8. With the exception of Specimen 3, the peak temperatures were achieved within about twelve hours after concrete was placed. For Specimen 3, hydration temperature leveled off at twelve hours before picking up again at approximately fifteen hours and peaking around twenty-four hours after initial hydration. The partial replacement of cement with fly ash resulted in the uniqueness of the curve for Specimen 3 and is likely a result of the delayed hydration of the fly ash after the initial hydration of the cement. Regardless, peak curing temperatures ranged from 168°F to 184°F and were sustained for a minimum of twenty-one hours. Consequently, the potential to develop deleterious DEF was established for all specimens.

Figure 3-8: Peak Hydration Temperature Curves

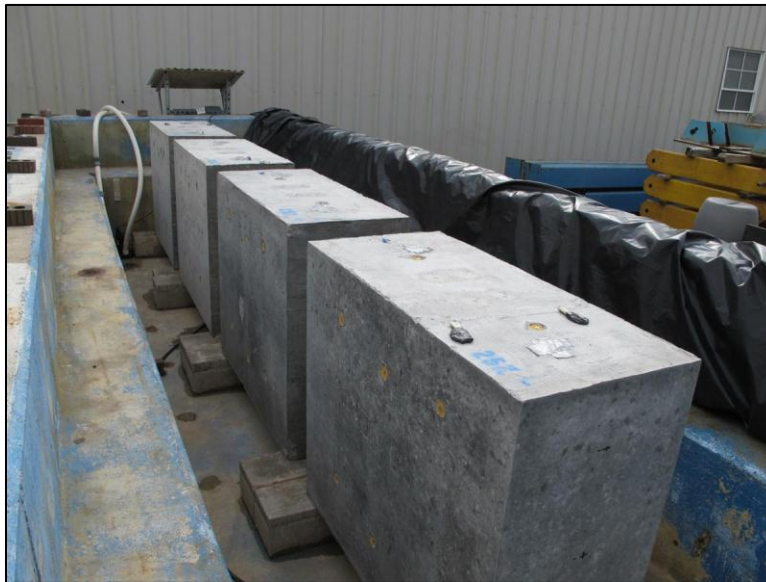
The beam segments were moved to a large concrete storage tank outside of the laboratory within two weeks of construction (Figure 3-9). Lifting inserts embedded into the concrete allowed for easy maneuverability and transport using a small forklift. Within the tank, the specimens were supported on eight inch tall concrete curbs over four to six inches of water. A black plastic tarp was placed over the beam segments to minimize water evaporation and keep the reactive concrete moist. Humidity was measured directly with a combination thermometer/hygrometer mounted inside the tank and was consistently maintained between 90 and 100 percent. Additionally, a black, weather-resistant coated vinyl tarp was placed over the entire length of the tank to act as a solar heater during the daylight hours. The addition of the heavy tarp allowed for a ten to fifteen degree temperature increase inside the tank relative to the ambient air temperature.

Figure 3-9: Specimens in Concrete Storage Tank

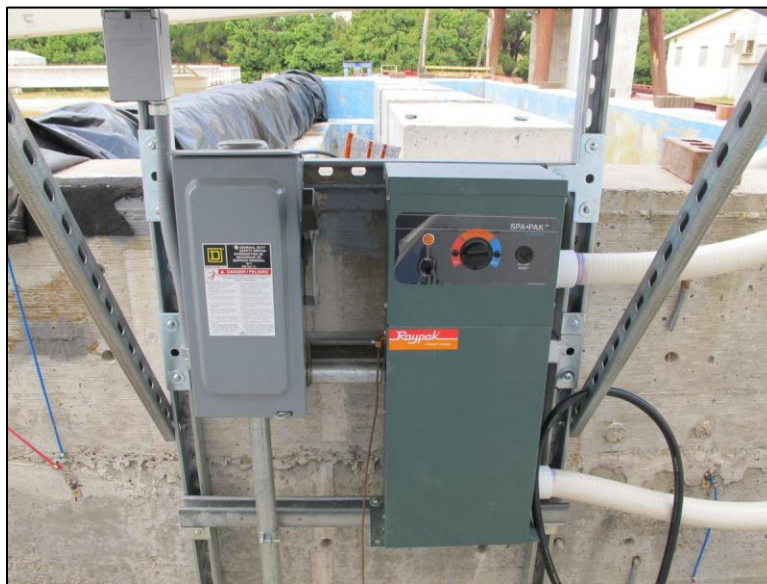
A unique method of heating the water inside the tank was established during the winter months in order to sustain the rapid development of ASR/DEF deterioration when the outside air temperature in Austin began to decrease. Water inside the tank was circulated via a submersible pump through an 11kW electric spa heater mounted to the exterior of the tank (Figure 3-10). The addition of the heater increased the water temperature to a constant 100°F and the relative humidity within the tank to 100 percent; thereby, subjecting the specimens to the “worst case” conditions for accelerated deterioration.

Figure 3-10: Electric Water Heater for High Temperature Conditioning

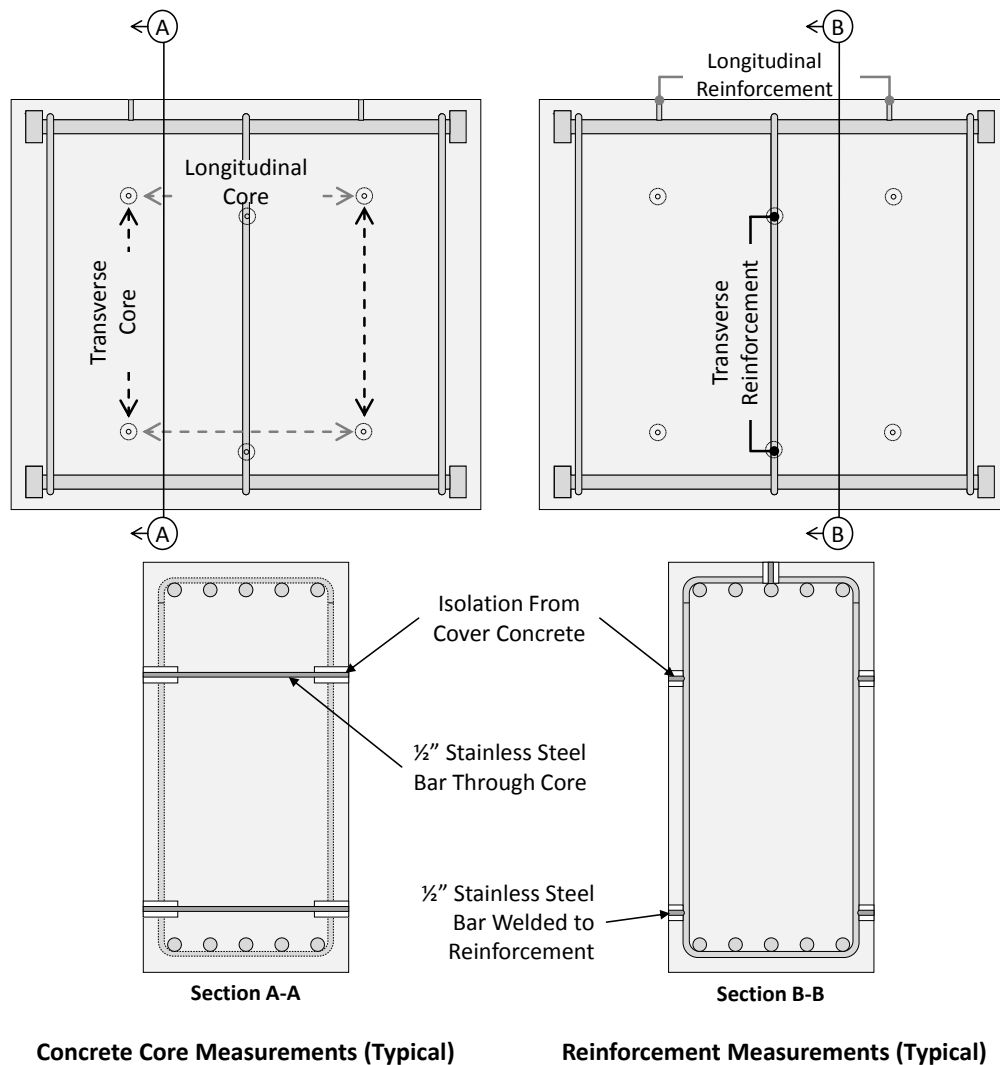
Instrumentation consisted of a grid of targets, spaced at twenty-four inches and centered on both faces of the beam segments, to directly measure the steel and concrete strains. The layout of the grid is shown in elevation and within the cross section in Figure 3-11. Both steel and concrete core measurements were taken longitudinally (horizontal) and transversely (vertical) on both faces of the specimens. In total, eleven individual strain/expansion measurements were recorded per beam segment.

Figure 3-11: Typical Layout of Instrumentation for Expansion Measurements

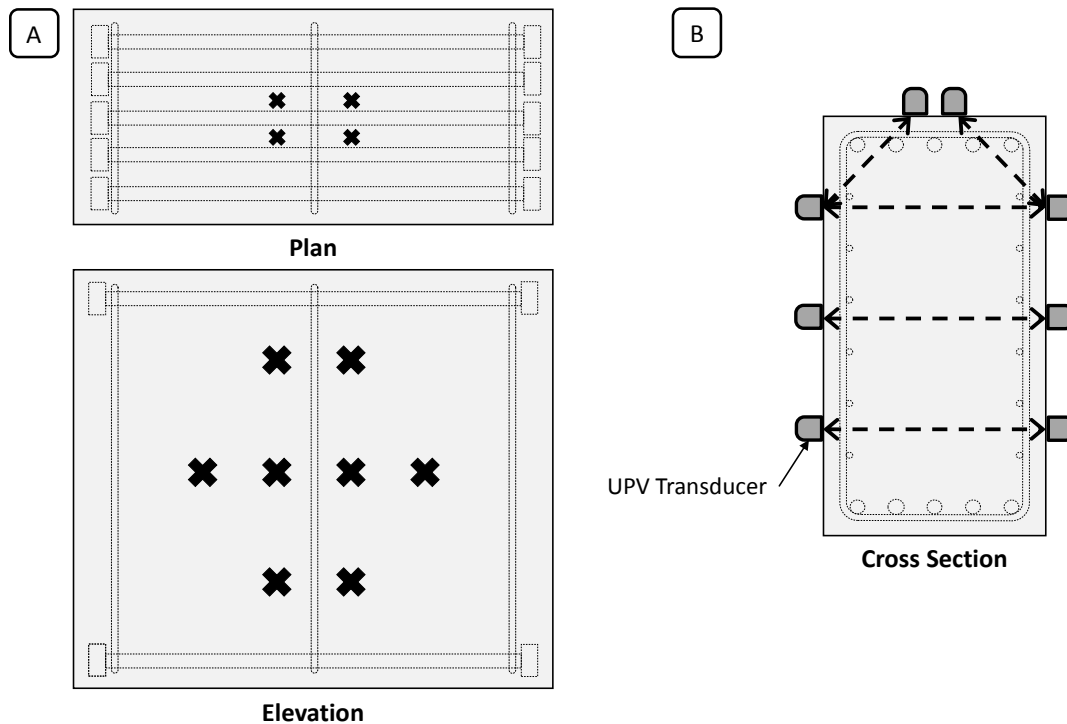
UPV testing was performed using the through-transmission technique following the procedures of ASTM C597 (2009). Travel times were measured via a PUNDIT 7 UPV test instrument. Figure 3-15A shows the grid layout for ultrasonic testing. Twelve individual velocities were computed for each beam segment both through the width of the cross section and across the diagonal of the top corners (Figure 3-15B). Testing required a minimum of two operators. Transducers were placed firmly against the concrete surface at the correct grid point, and the minimum travel time of the ultrasonic pulse was recorded. Frequent re-application of a water-based couplant was applied to the transducers to ensure a correct reading. Velocities were computed from the recorded travel time and known distance in a computer spreadsheet.

Figure 3-15: (A) UPV Testing Grid Layout (B) Associated Measurements

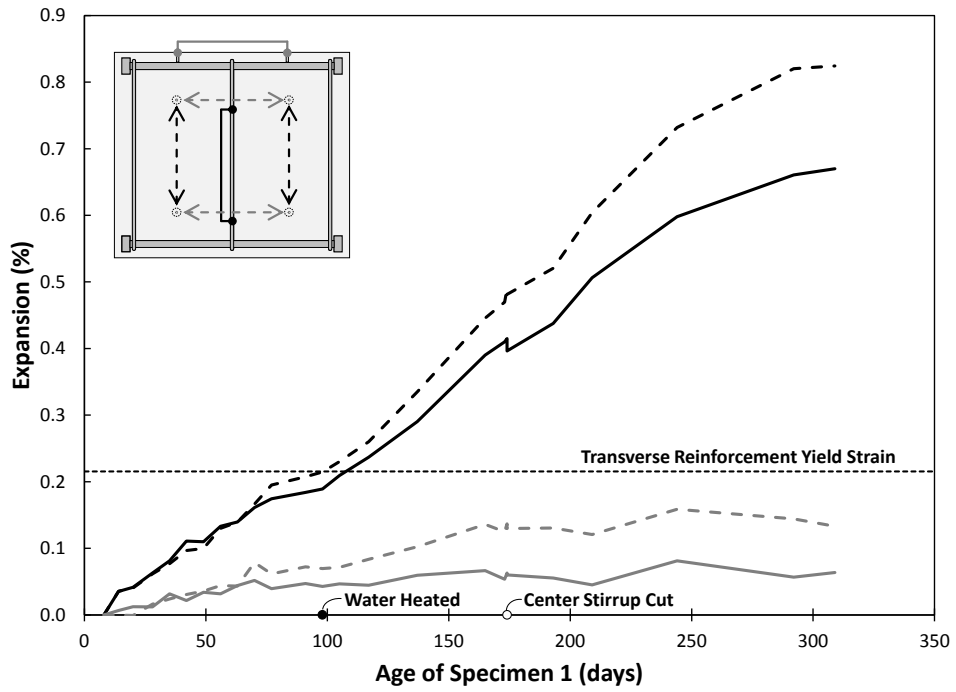
Figure 4-2: Specimen 1 Measured Expansions

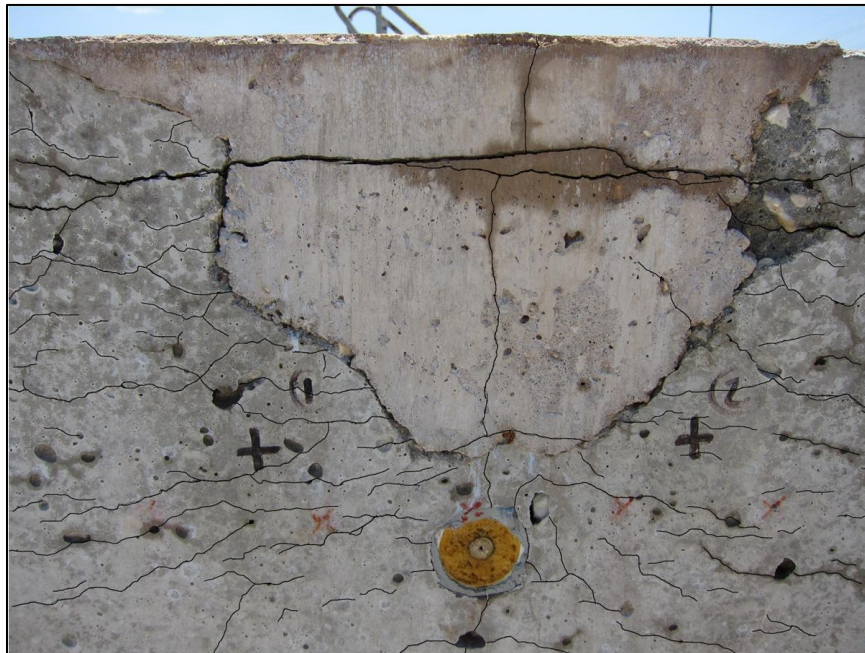
Figure 4-9: Surface Cracking at Location of Fractured Stirrup

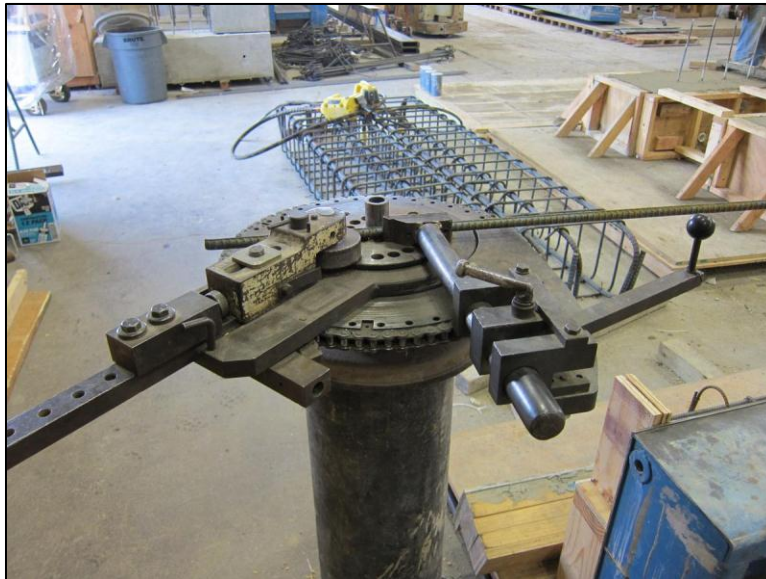
Figure 5-4: Reinforcing Bar Bender Used for Bend Tests

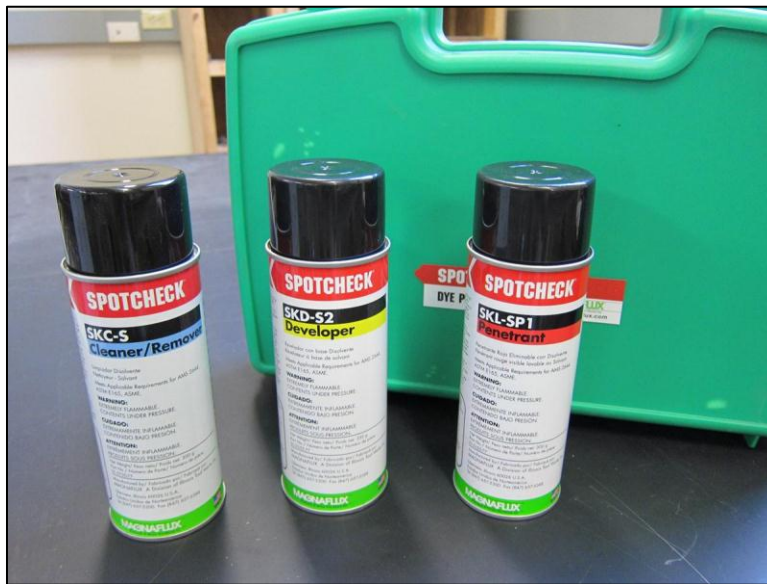
Figure 5-8: Liquid Penetrant Inspection

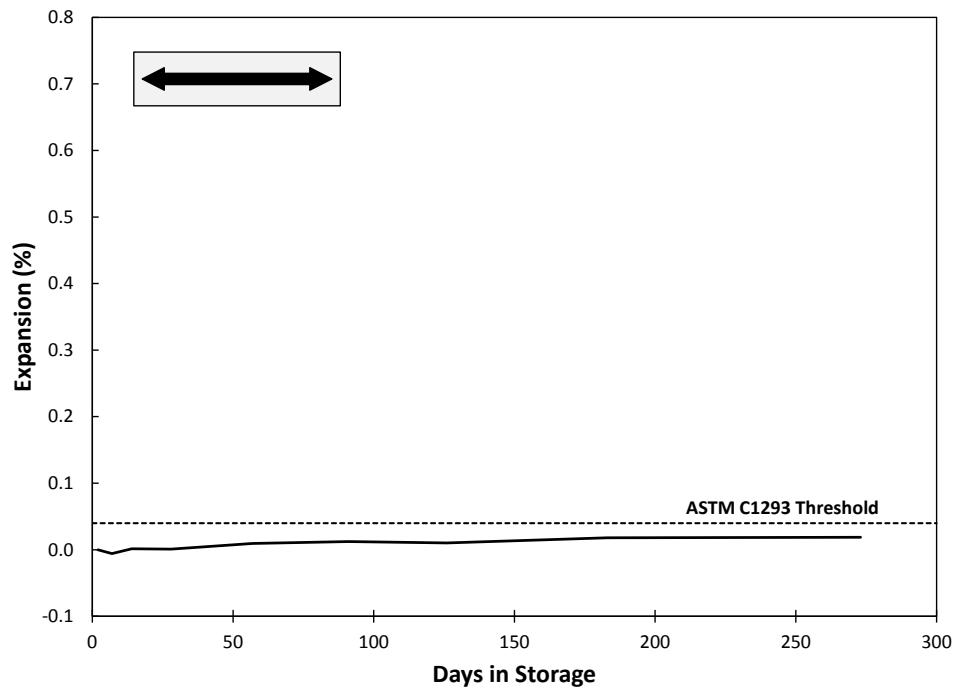
Figure A-6: Free Expansion of ASTM C1293 Prisms – Specimen 4
