**Durability Design of
Post-Tensioned Bridge Substructures**

Dissertation

The University of Texas at Austin

May 1999

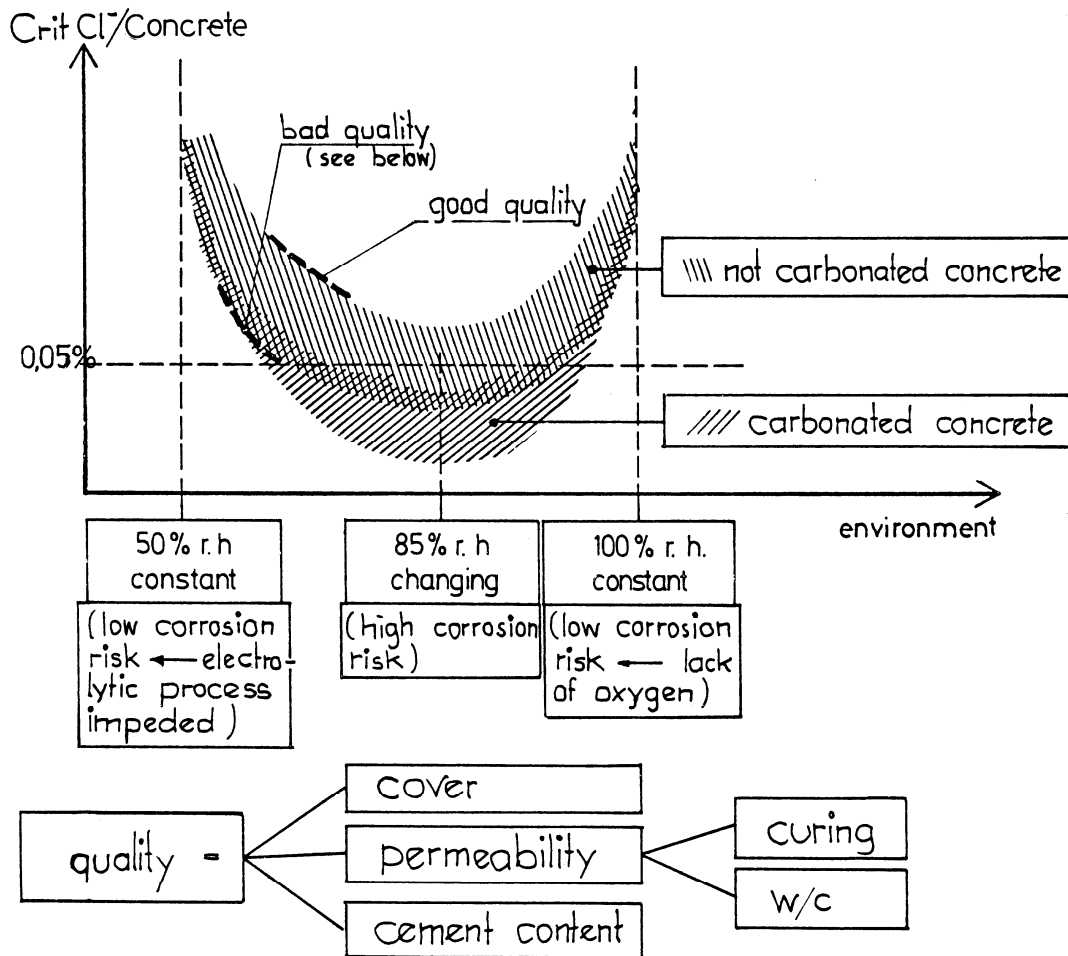
Figure 2.12 - CEB Critical Chloride Ion Content for Corrosion^{2.1}

- **pH of concrete pore solution:** Since the pH influences the passive film on the steel, some suggest that instead of a chloride threshold, the corrosion threshold should be in terms of the ratio of chloride ions to hydroxyl ions (Cl⁻/OH⁻).^{2.9,2.23,2.27,2.28}

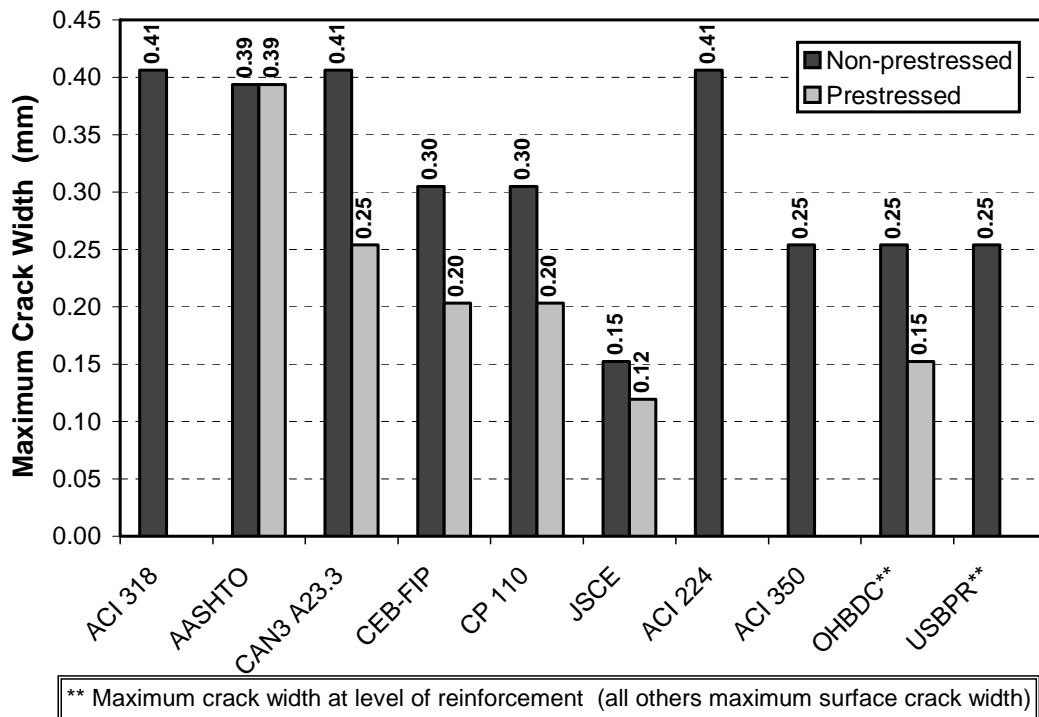
Figure 2.16 - Comparison of Allowable Crack Widths: Mild Exposure

For comparison purposes, the maximum allowable crack widths specified or implied by the reviewed design codes and technical committees are presented in Figure 2.16 and Figure 2.17 for the most mild and most severe environment specified by each document. In some cases, intermediate environmental conditions were also specified but have not been shown here. The majority of the crack widths presented in the figure are specified as surface crack widths, with the exception of the Ontario Highway Bridge Design Code (OHBDC)^{A.6} and the U.S. Bureau of Public Roads (USBPR)^{A.19} which use maximum allowable crack widths at the level of the reinforcement. These values will be less than crack widths at the concrete surface.

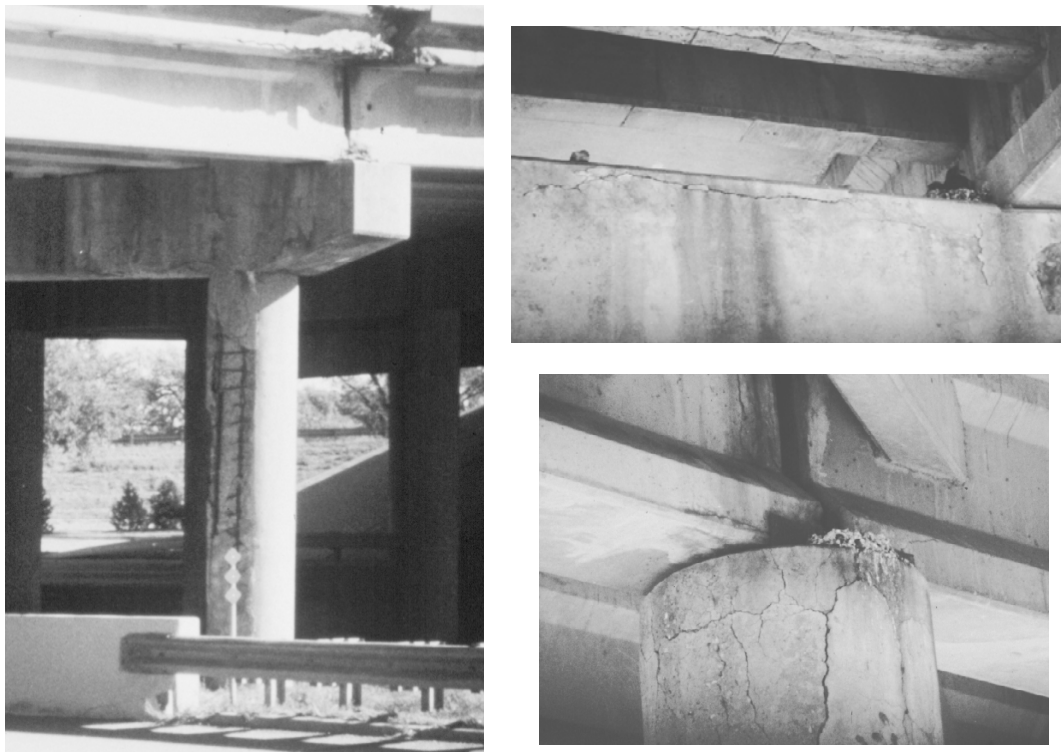
Figure 2.23 - Severe Substructure Corrosion Damage Due to Defective Expansion Joint

A very common source of substructure corrosion problems is moisture and chlorides dripping onto substructure components through leaking deck joints, as shown in Figure 2.23. Corrosion damage can occur on bent caps and columns or piers. Sloping of the top surface of the bent cap as shown in Figure 2.24 could reduce the severity of corrosion damage. However, proper joint design and maintenance are better solutions when the severe conditions shown in Figure 2.23 are encountered. Another option is to reduce the number of expansion joints by making the bridge deck continuous for several spans.^{2,36}

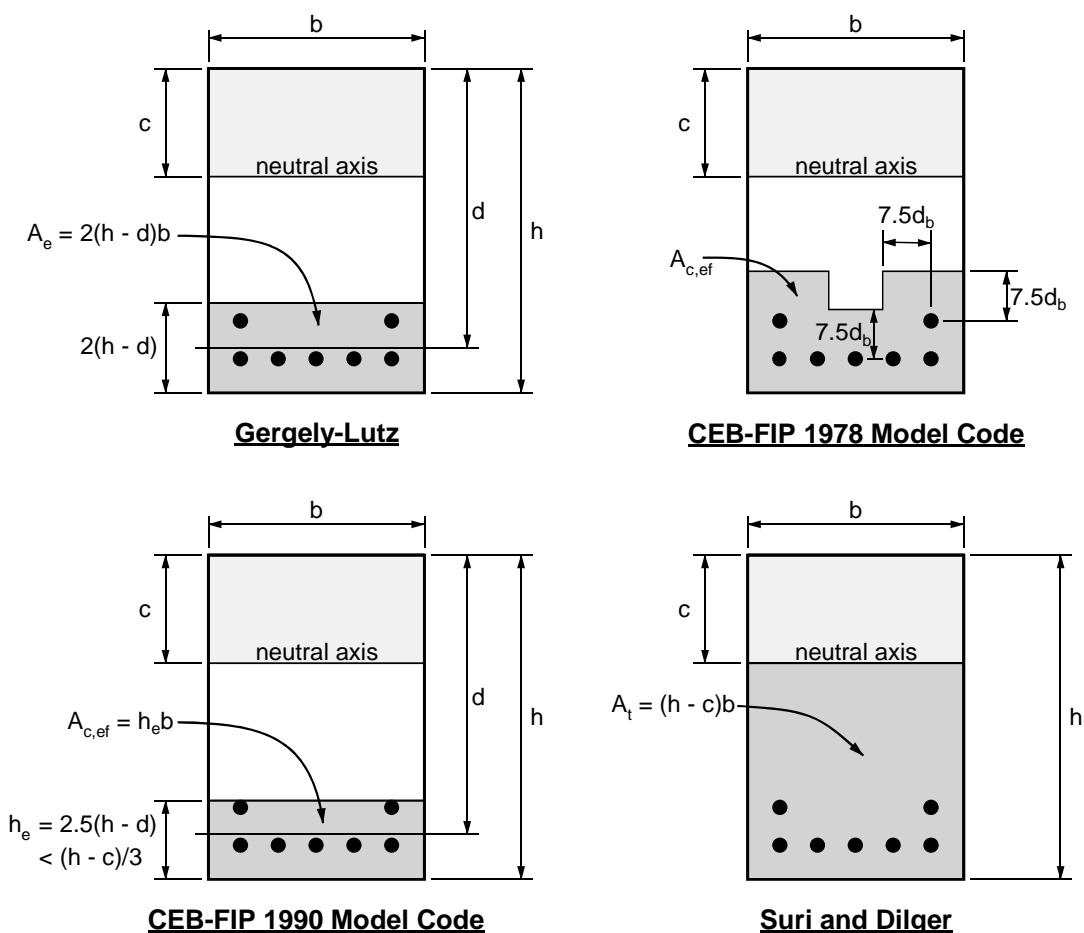
Figure 2.36 - Calculation of Effective Concrete Area in Tension for Various Models

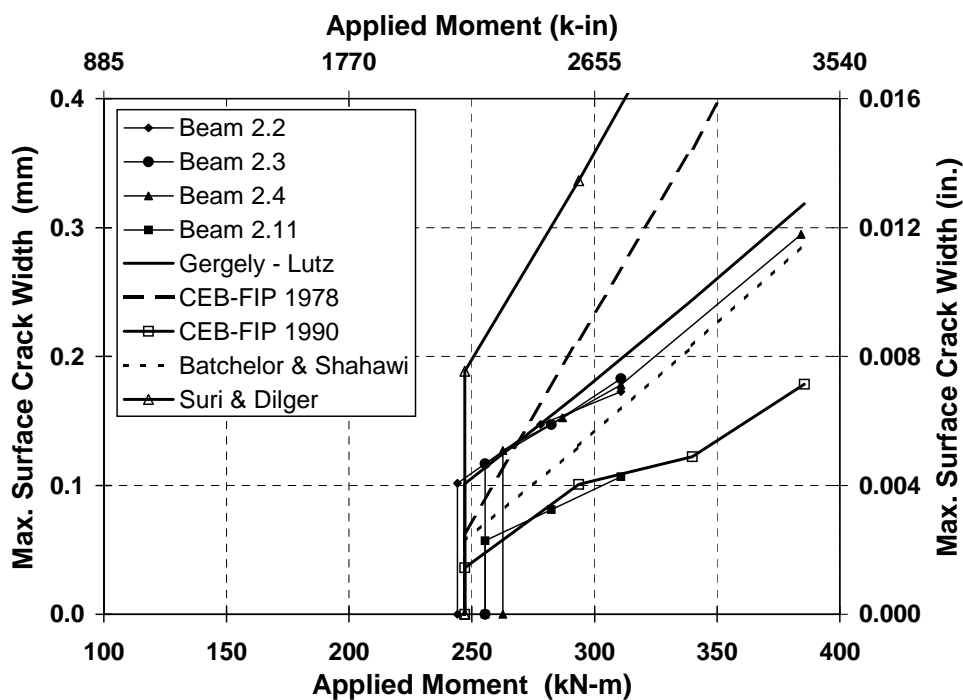
Figure 3.58 - Moment - Crack Width Relationship for 2/3 PS Beams

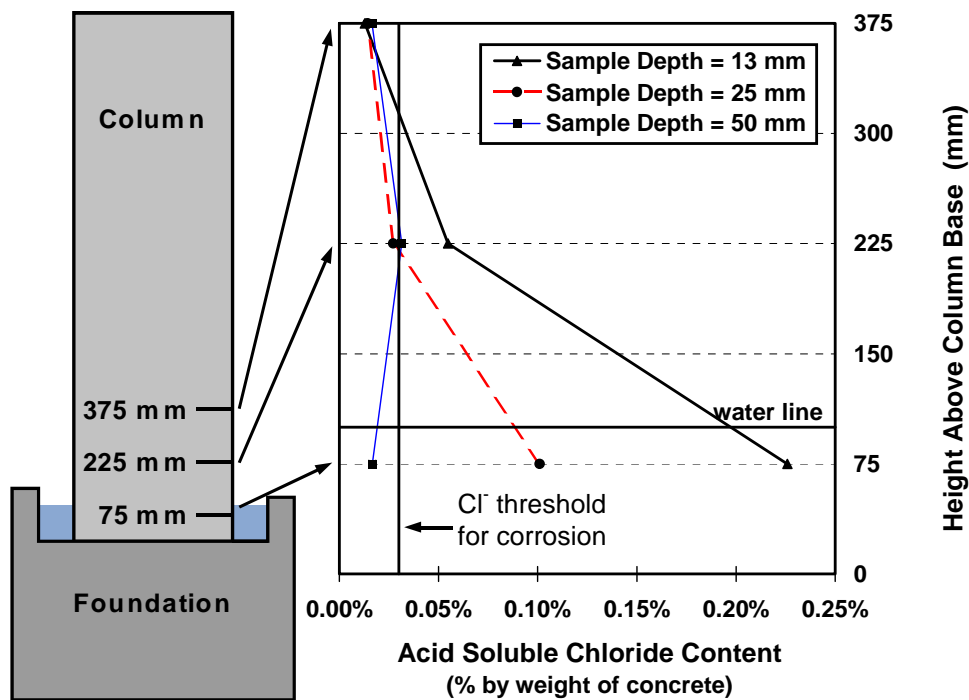
Figure 4.29 - Column NJ-TC-S Chloride Profiles

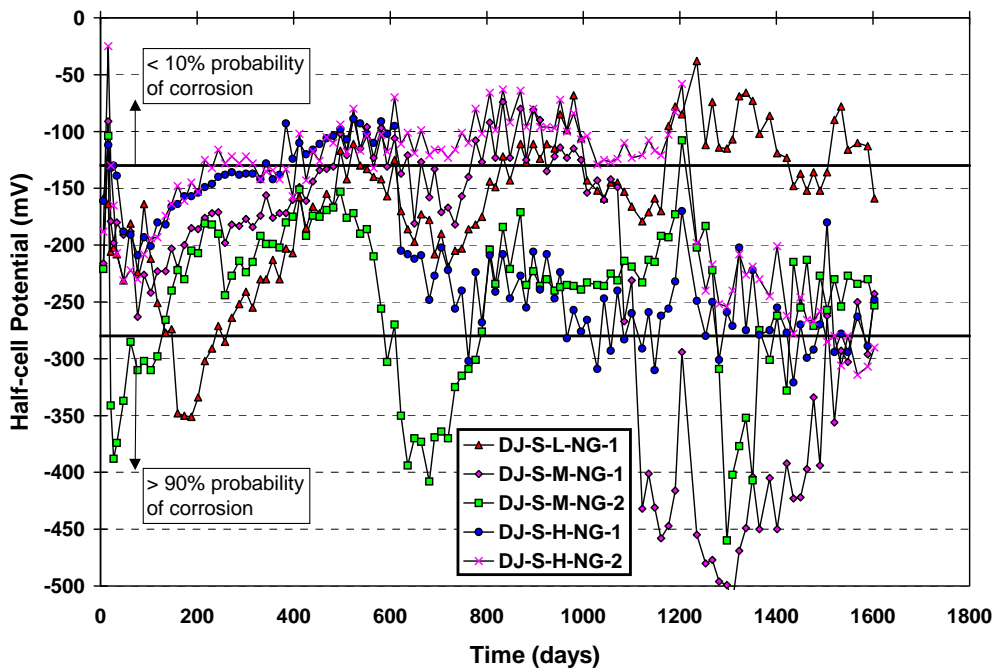
Figure 5.10 - Half-Cell Potentials: Dry Joint, Steel Duct and Normal Grout
