**Rehabilitation of Reinforced Concrete Slab-column Connections
for Two-way Shear**

Widianto, B.Sc., M.S.E.

Dissertation

The University of Texas at Austin

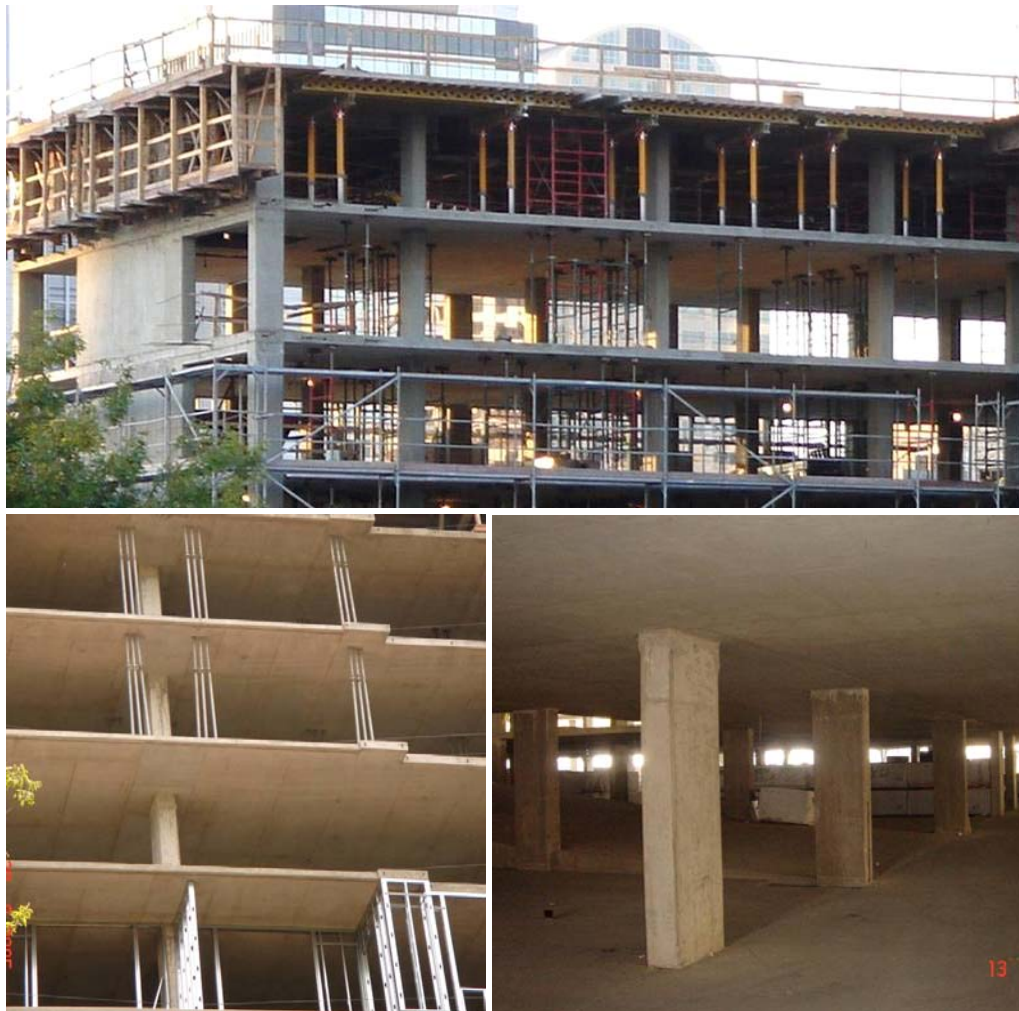
Figure 1.1 Flat-plate structures

Flat-plate structural systems consist of slabs with a uniform thickness that are supported directly on columns without any beams, drop panels, or column capitals (Figure 1.1). The use of flat-plate structural systems was common for office and residential construction up to substantial heights in the period around 1950-1960 (FEMA 1997). Durrani et al. (1995) indicated that in the central and eastern regions of the United States (US), there are many older flat-slab buildings designed and detailed to resist gravity loads only. They further stated that these buildings are typically 5 to 15 stories high and do not have shear walls except for the elevator shafts and stairwells. The floor slabs in these buildings can be categorized as lightly reinforced and the slab-column connections do not have the appropriate reinforcement details for seismic resistance. Sherif and Dilger (1996) reported that most slabs in flat plate structures have a flexural reinforcement ratio of less than 1%. Moehle (1996) indicated that in western US, gravity load carrying system is commonly ignored for resisting seismic forces. However, the gravity load carrying system must be designed to carry the gravity loads under the design lateral deformations. Structural drawings of several flat-plate structures located in western US, examined as part of this research, show that those structures have roughly about 0.5% flexural reinforcement ratio in the column strip and do not have shear reinforcement.

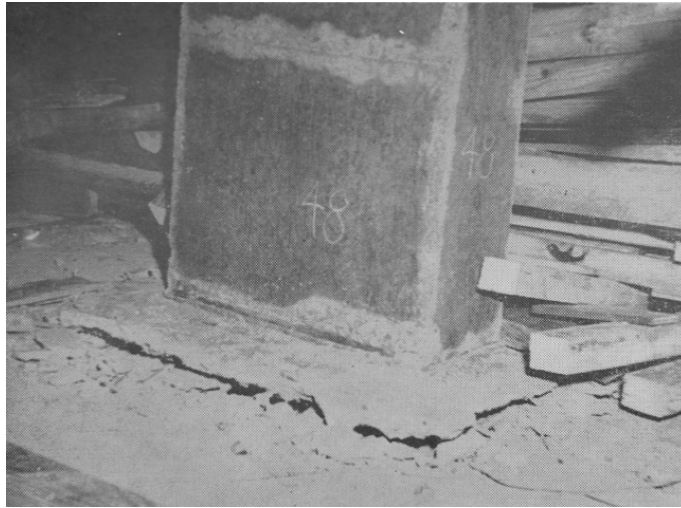
Figure 1.2 Punching shear failure at an interior connection (Feld 1964)

A typical punching shear failure surface on the top side of an interior slab-column connection is shown in Figure 1.2. The failure surface intersects the bottom side of the slab right at the slab-column intersection, as shown in Figure 1.3. It should be noted that the opening adjacent to the column (Figure 1.3), interrupts continuity of reinforcement and reduces the concrete contribution to shear strength.

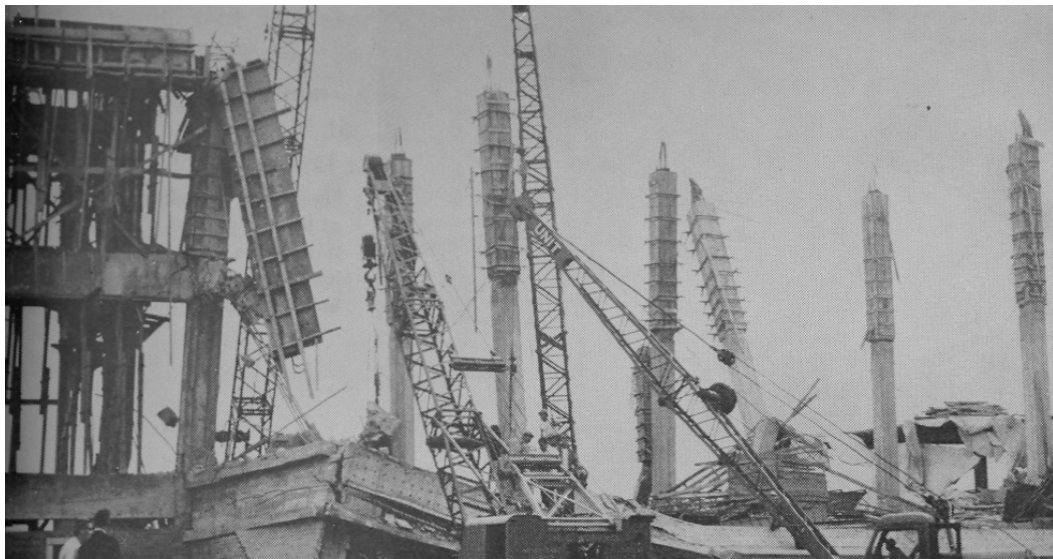
Figure 1.4 Columns remained standing after the progressive collapse (Feld 1964)

On October 3, 1956, the progressive collapse of a flat-plate office building in Jackson, Michigan occurred when concrete had been placed in the fourth floor that was shored to the second floor (Feld 1964). At failure, the second floor was only several weeks old. Almost all columns remained standing full height after the collapse (Figure 1.4). It can also be seen from Figure 1.4 that there were only very few reinforcing bars projecting from the free-standing columns at the floor levels.

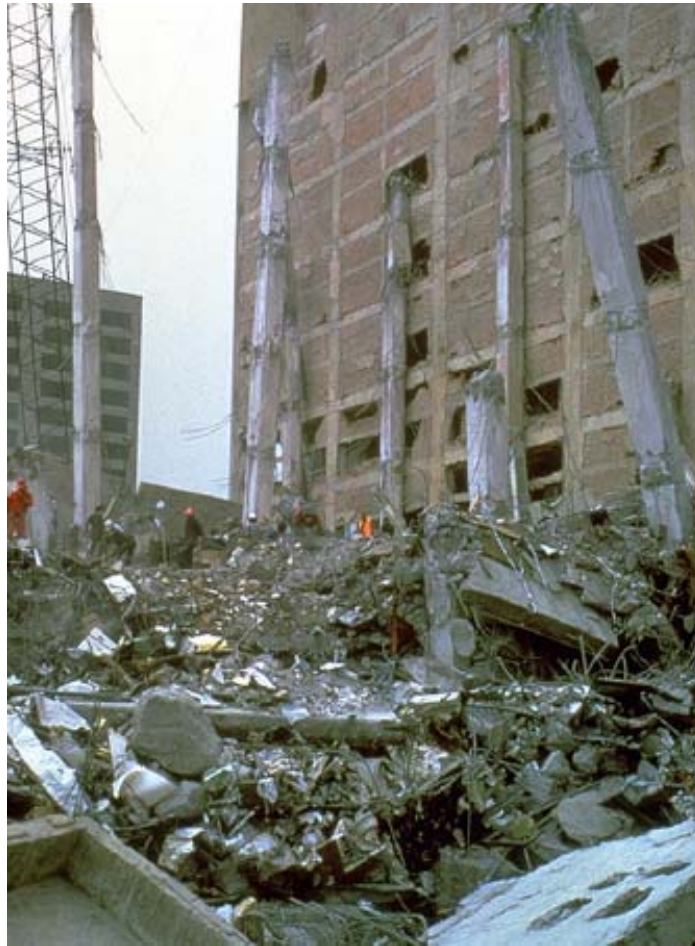
Figure 1.6 Complete collapse of a waffle-flat-plate structure (EERI 1997)

complete collapse of a waffle-flat-plate structure, respectively, after the 1985 Mexico City Earthquake. It is interesting to note that there were only very few flexural reinforcing bars passing through the column (Figure 1.6) and that these bars could not provide secondary resistance once punching failure occurred.

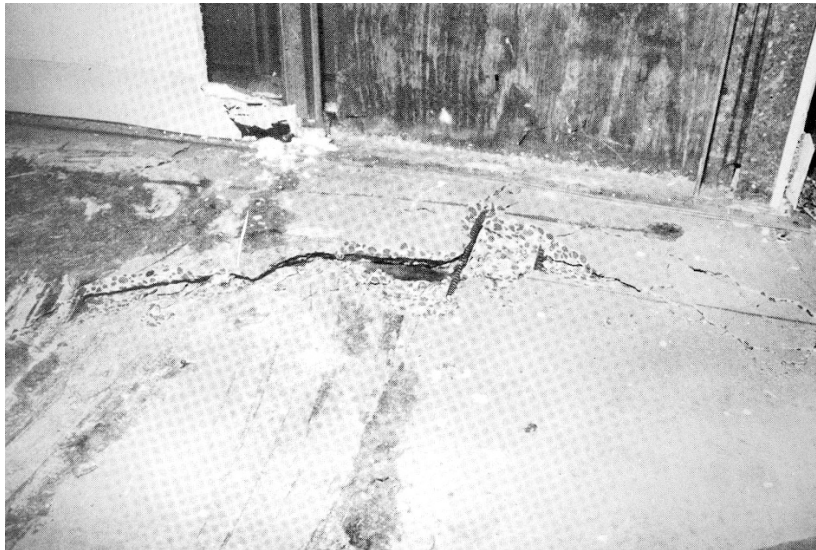
Figure 1.7 Punching shear failure in post-tensioned slab (Mitchell et al. 1990)

Figure 1.7 shows the incipient punching shear failure in one of the interior slab-column connections in Baybridge Office Plaza, Emeryville, after the 1989 Loma Prieta Earthquake. The floor slabs were two-way post-tensioned flat-plates with post-tensioned beams only around the perimeter of the building.

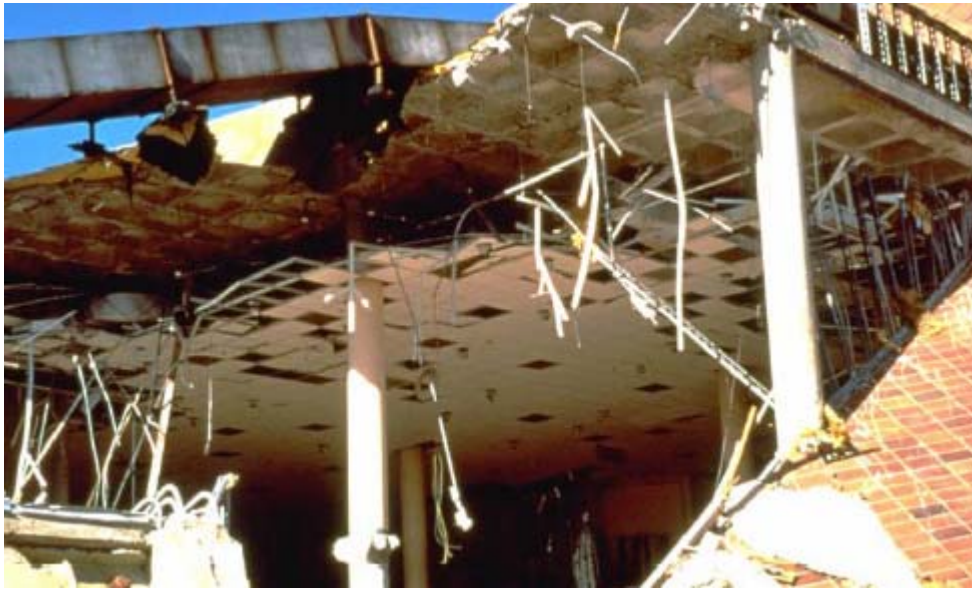
Figure 1.8 Collapse of Bullock's Department Store (EERI 1997)

In the 1994 Northridge Earthquake, punching shear failure caused the progressive collapse of Bullock's Department Store in the Northridge Fashion Center (Figure 1.8). The close-up view of one of the connections at a lower level after the collapse is shown in Figure 1.9. As can be observed in Figure 1.9, only the top reinforcing bars in one direction passed through the column. These top bars were not effective in preventing progressive collapse after punching shear failure because the top bars ripped out of the top surface of the slab (Mitchell et al. 1995). Figure 1.10 shows interior connection damages in a flat-slab building structure that was “red-tagged” following the 1994 Northridge Earthquake (Sabol 1994). The damage followed the outline of the drop panel and exposed flexural rebars in many locations. Vertical offsets of the slab on the order of 0.5 to 0.75 inches were observed in severely damaged connections.

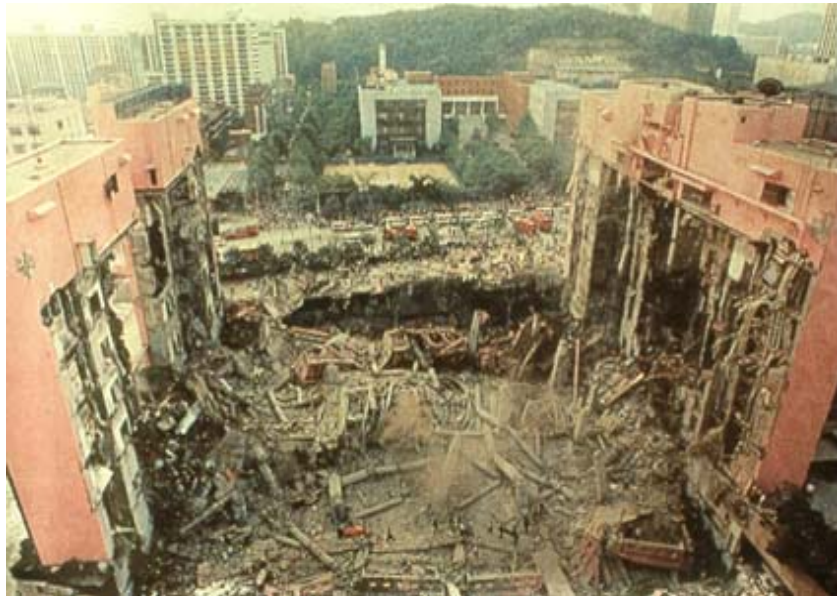
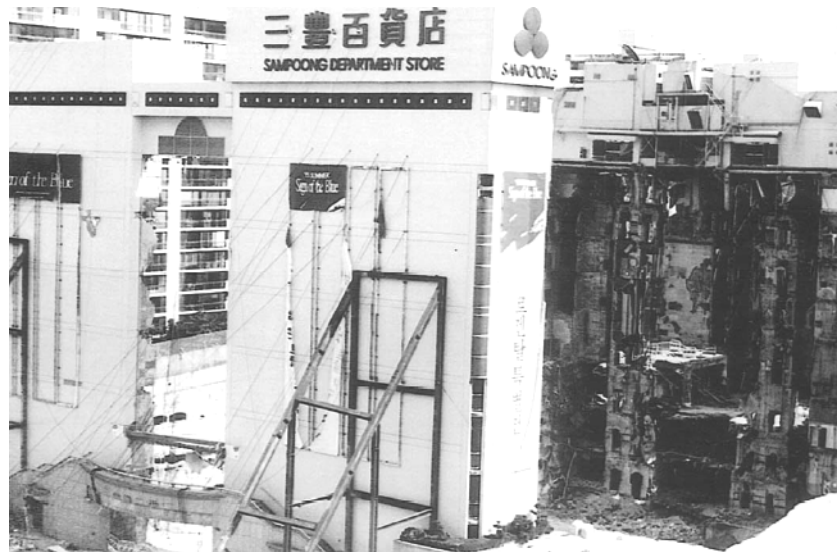
Figure 1.11 Sampoong Department Store collapse

Punching shear failure has also occurred under gravity loads. On June 29 1995, the north wing of the Sampoong Department Store, Seoul, South Korea collapsed (Figure 1.11) due to punching shear failure of an interior connection on the fifth floor (Gardner et al. 2002). The building was a 5-story flat-plate building with 0.47% flexural reinforcement ratio in slab-column connections. The most important causes of the collapse were the reduced slab depth and the excessive loads applied to the building due to change of use of the fifth floor from a roller

skating rink to a restaurant, which increased the dead loads by 35% (Gardner et al. 2002).

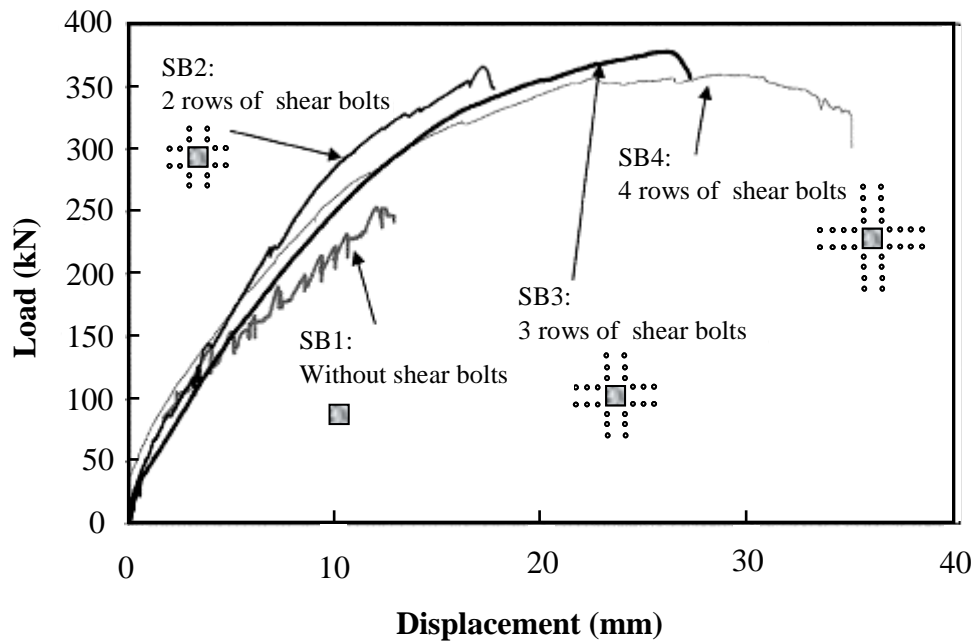
Figure 2.22 Effectiveness of shear bolts (Adetifa and Polak 2005)

Adetifa and Polak's specimens were designed to ensure their punching failure, before the application of the shear bolts. Figure 2.22 shows that the presence of shear bolts increased the ultimate capacity and the deformation capacity of the connection. The deformation capacity of the connection also increased with the number of peripheral rows of shear bolts. In all strengthened connections, the punching cone formed outside the shear reinforced zone. The connection strengthened with two rows of bolts failed in a mixed punching/flexural mode, whereas connections reinforced with three or more rows of bolts failed in flexure.

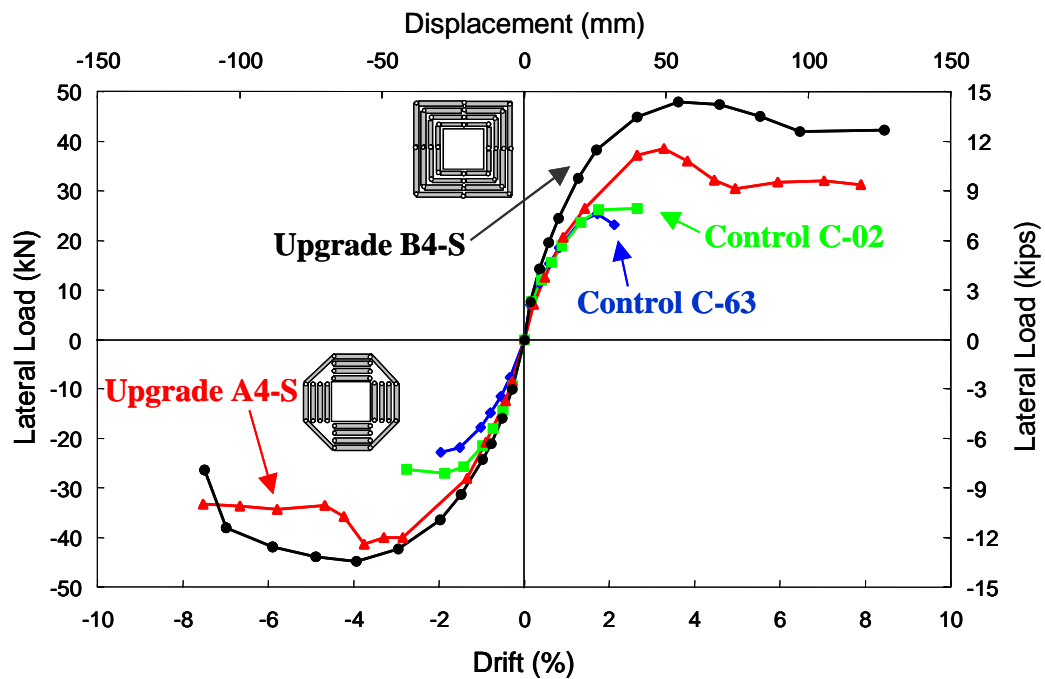
Figure 2.31 Backbone curves (Stark 2003)

Figure 2.31 shows the lateral load versus inter-story drift backbone curves for the test specimens. Both control specimens C-63 and C-02 failed in punching shear. The poor inelastic behavior displayed by specimens C-63 and C-02 was eliminated in upgraded specimens A4-S and B4-S. Strengthening the region adjacent to the column faces shifted the critical perimeter of the upgraded specimens, which also increased the lateral load capacity. The upgrade method also significantly increased the deformation capacity by eliminating punching shear failures without significantly affecting the stiffness of the connection. Moreover, as the lateral load excursions increased, the stiffness of the upgraded specimens did not degrade rapidly because the CFRP stirrups helped mitigate damage within the connection region. Of the upgraded specimens, specimen A4-S showed the least amount of damage in the connection area (Stark 2003).

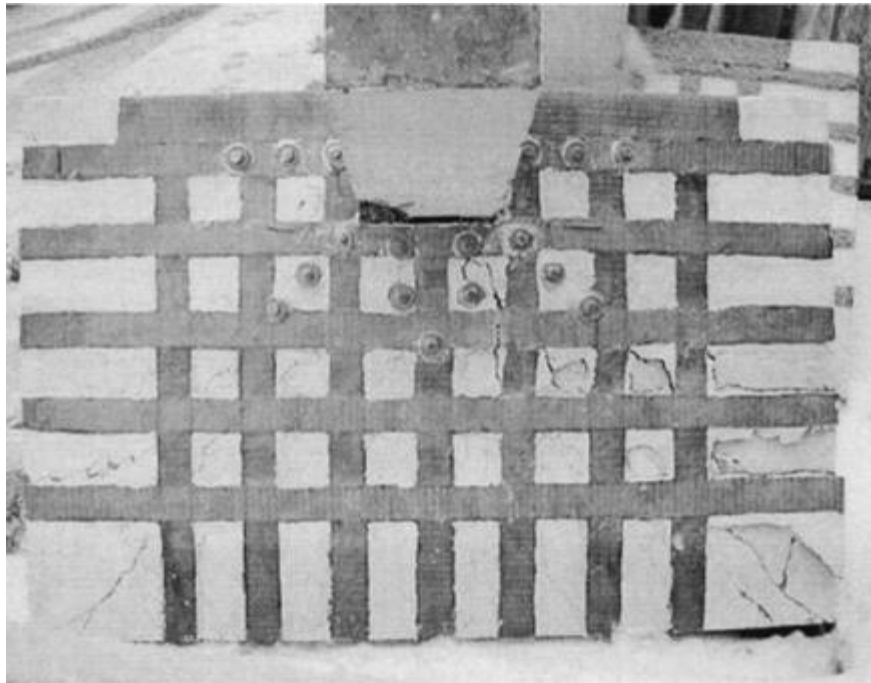
Figure 2.43 Combination of FRP sheets and steel bolts (El-Salakawy et al. 2004)

El-Salakawy et al. (2004) also combined the FRP sheets with steel bolts to strengthen edge connections (Figure 2.43). The presence of the shear bolts increased the ductility of the connections and changed the failure mode from punching to flexure. The combination of CFRP sheets and steel bolts increased the ultimate strength between 23% and 30% (as opposed to between 2% and 23% for the strengthening with CFRP sheets only).

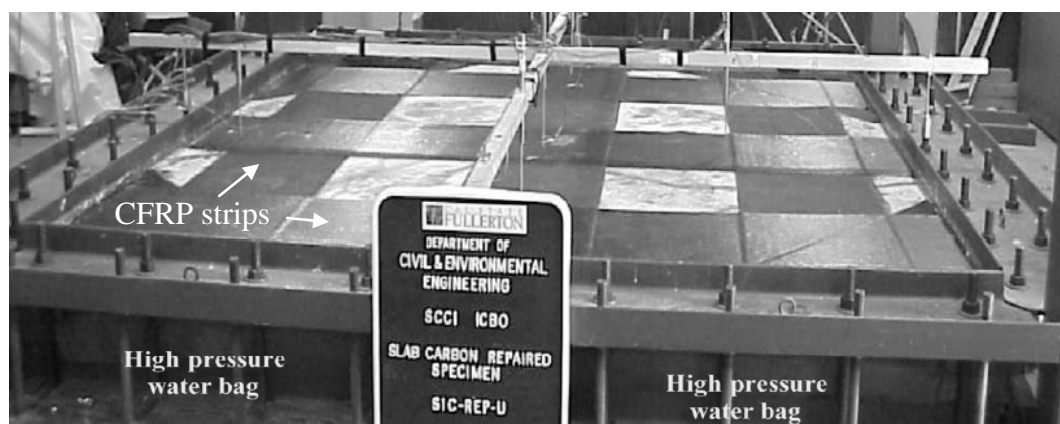
Figure 2.52 Repair using CFRP strips (Mosallam and Mosalam 2003)

Mosallam and Mosalam (2003) investigated the ultimate capacity of two-way slabs repaired with CFRP strips (Figure 2.52). Before the repair, the slabs

were loaded up to 85% of their ultimate capacity. The ultimate capacity of the repaired slabs was approximately 198% higher than that of the control slab and the failure was preceded by relatively large deformations (more than 1/45 of the clear span length). The maximum strain in CFRP strips at ultimate load was 0.0078 (65% of the rupture strain). The common failure mode was a localized compression failure of the concrete with some localized debonding near the ultimate.

Slab: 104" × 104" × 3"
 $\rho = 0.43\%$

CFRP strips:
 "FiberBond" FRP composite
 wet/hand lay-up system
 Thickness: 0.023"
 $f_u = 180.7$ ksi
 $\epsilon_u = 0.012$

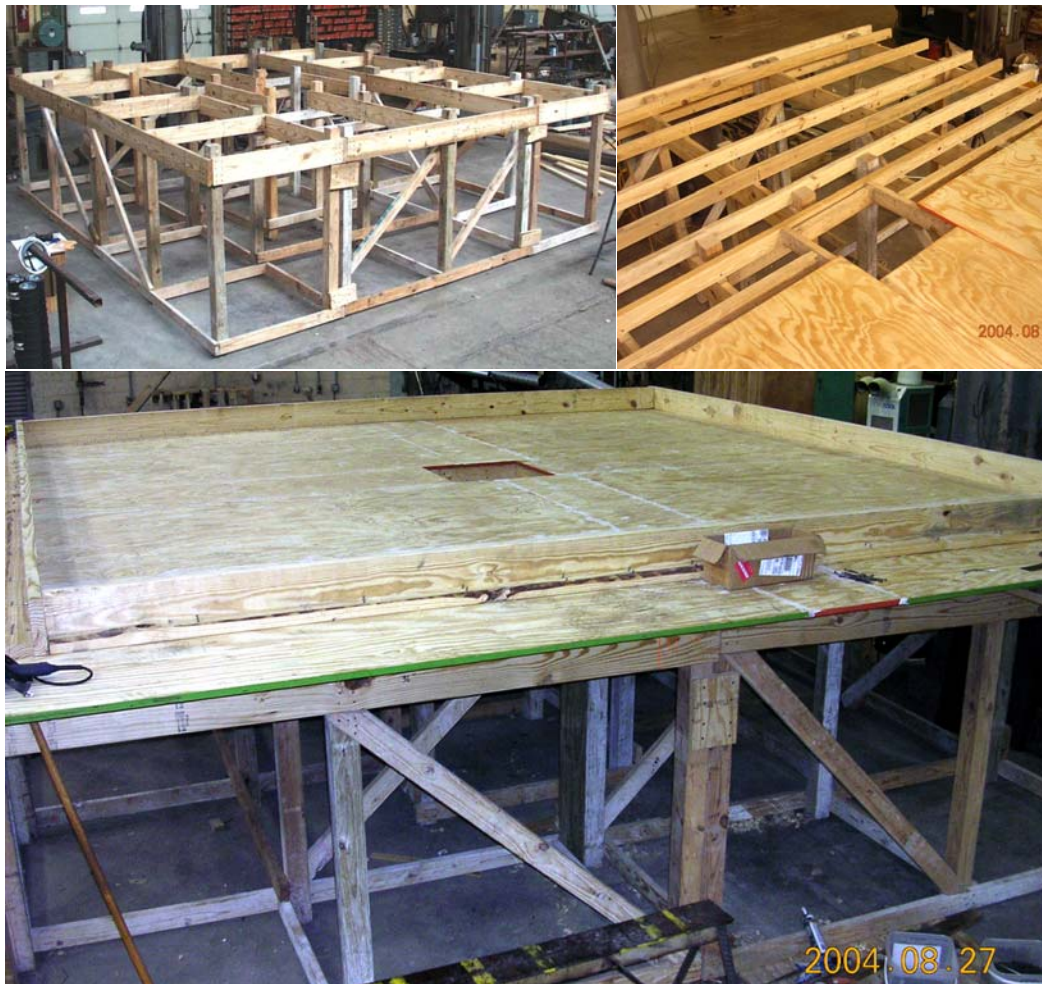
Figure 3.7 Formwork

Formwork (Figure 3.7), was built using $\frac{3}{4}$ -in thick plywood as a slab platform and as part of the column forms. 4×4 stud grade wood was used to support the elevated slab platform. 2×4, 2×6, 2×8 stud grade lumbers were used for bracings, joists, stringers, and sides of slab formwork. Joist and stringer spacings were selected to satisfy the maximum tolerable deflection of $\frac{1}{8}$ inches. A laser level was used to check the level of the slab platform. 1.5-in diameter PVC pipes were used for creating the connection holes for the vertical struts to support the specimen during testing.

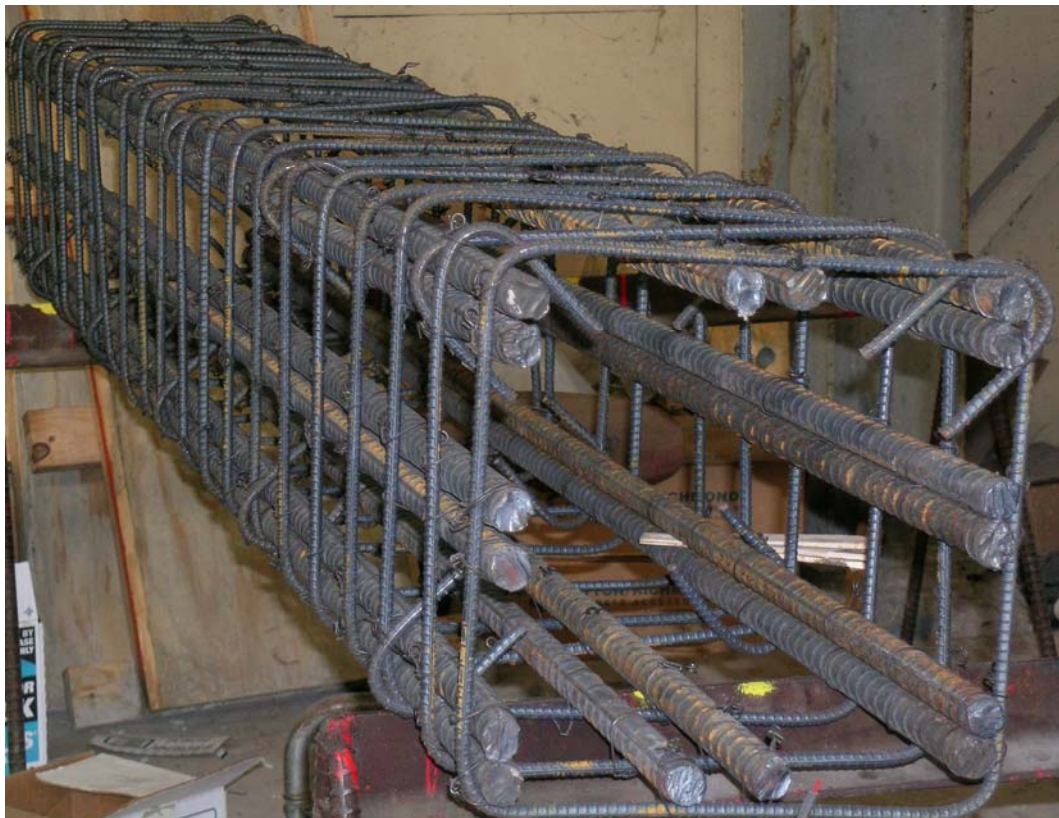
Figure 3.8 Column reinforcing cage

After the formwork was constructed, form oil was sprayed, the column reinforcing cage (Figure 3.8) was placed, and slab flexural reinforcement was then installed. Electrical strain gages were attached to the slab bars before the bars were placed on the formwork. Strain gage placement is further discussed in Section 3.7.1. Slab flexural reinforcement was placed in two mats consisting of bars running in North-South (N-S) and East-West (E-W) directions, tied together in a single mat. Top and bottom bars running in N-S direction (lateral loading direction) were placed in outer layers to give the maximum effective depth in this

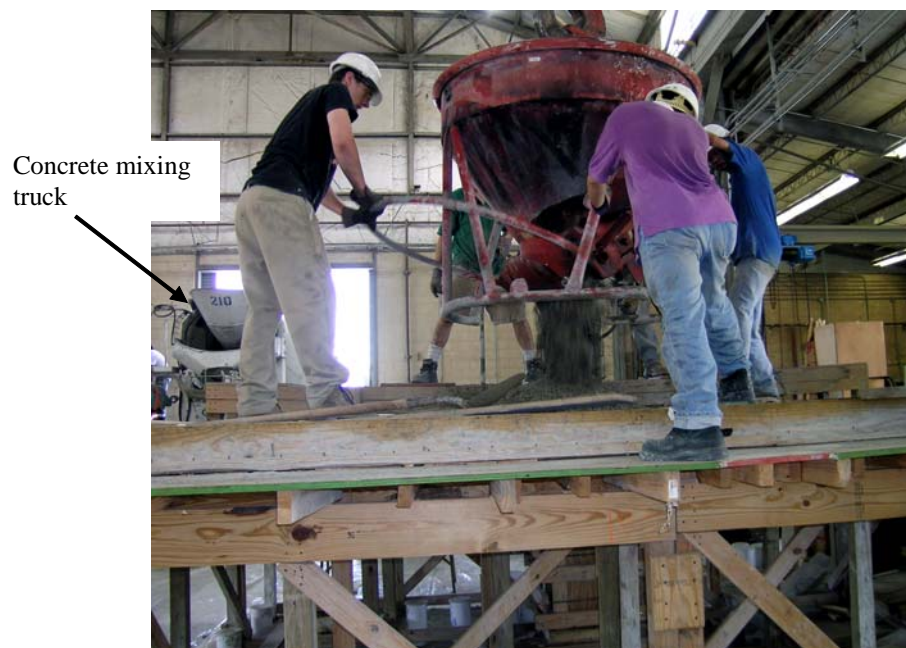
Figure 3.12 Concrete placement: slab and lower column

Ready-mix concrete was used in the specimen construction. Upon arrival, slump was checked according to ASTM C143 procedures. In order to increase the workability of concrete, super plasticizers were used. Concrete was placed using a bucket suspended from an overhead crane and compacted with electric hand vibrators as shown in Figures 3.12 and 3.13. The slab and the lower column stub were cast monolithically. Slab surfaces were finished using hand and bull floats. Figure 3.14 shows the construction joint. Five days after the first cast, the formwork for the upper column was installed and concrete was placed, as shown in Figure 3.15.

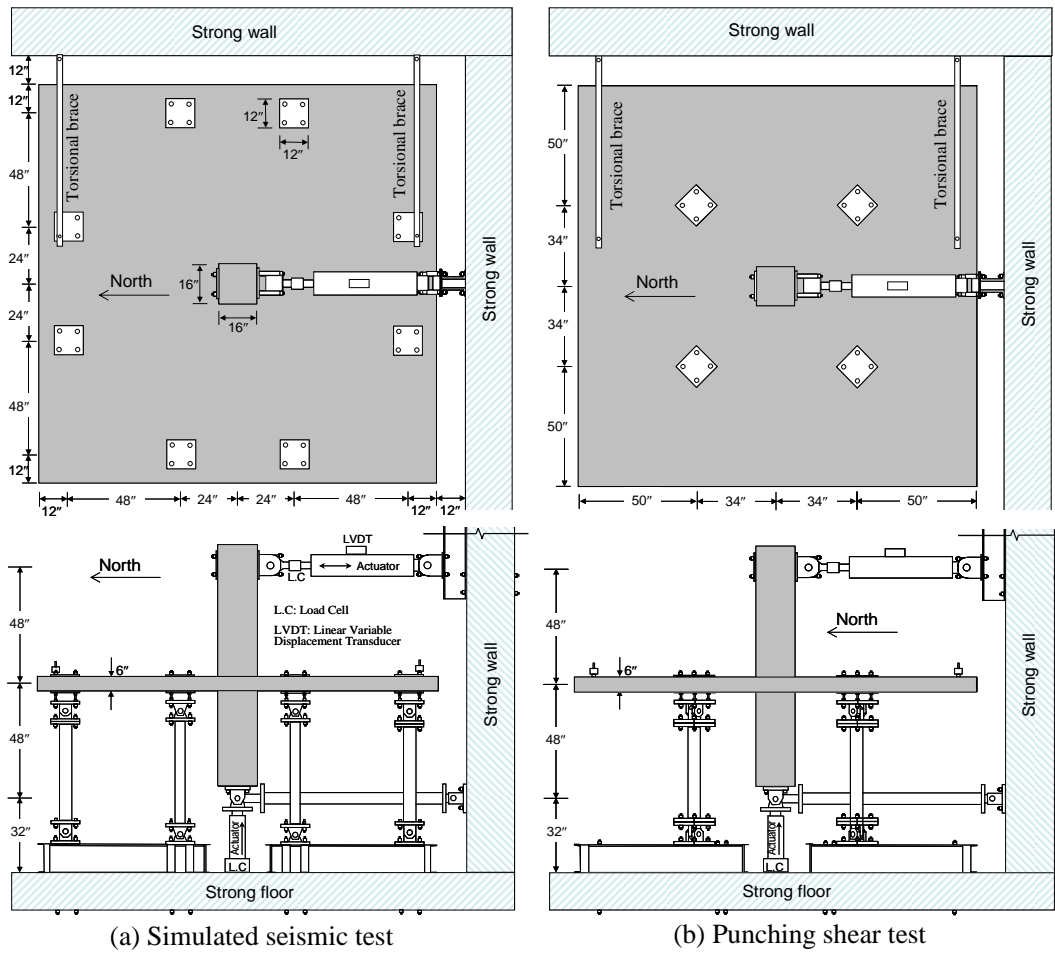
Figure 3.17 Schematic of the test setup

Gravity loads were applied using a hydraulic jack and resisted by vertical struts fixed to the laboratory strong floor. All vertical struts had pin-connections at both ends. Vertical load was maintained manually by using a hand-pump (Power Team model P460) during the application of reversed cyclic lateral displacements. The gravity loads were simulated by applying a concentric upward load on the column instead of placing heavy blocks on the top surface of the slab. This approach was chosen to allow for the observation of the seismic-damage on the slab surface and the evaluation of damage using non-destructive methods (Argudo 2006).

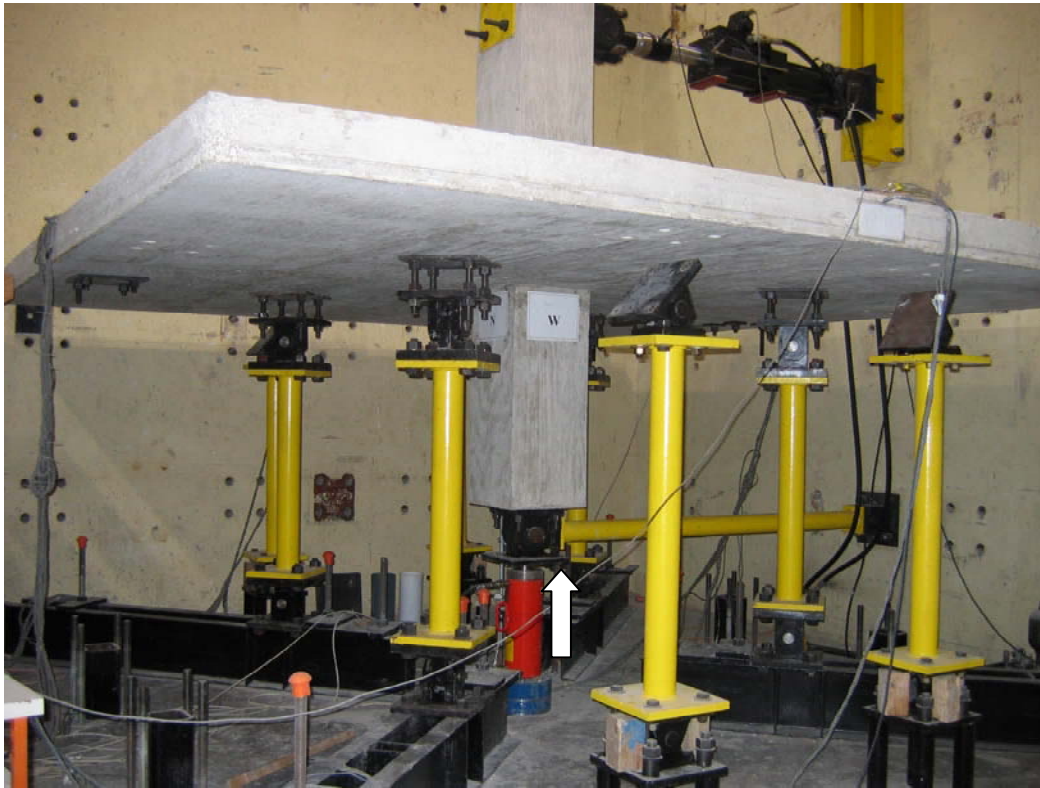
Figure 3.19 Test setup: Punching shear test

In order to study the two-way shear capacity of earthquake-damaged connections, two different test setups must be used. The first test setup was designed to simulate seismic loading (combination of reversed cyclic lateral displacements simulating the effects of a ground motion and a constant vertical load simulating the effects of gravity loads acting on the connection during an earthquake). The second test setup is for punching shear tests (monotonically increasing concentric vertical loads). Figure 3.17 shows a schematic of the two test setups (plan and elevation views). Figures 3.18 and 3.19 show perspective views of the test setup for simulated seismic tests and for punching shear tests, respectively.

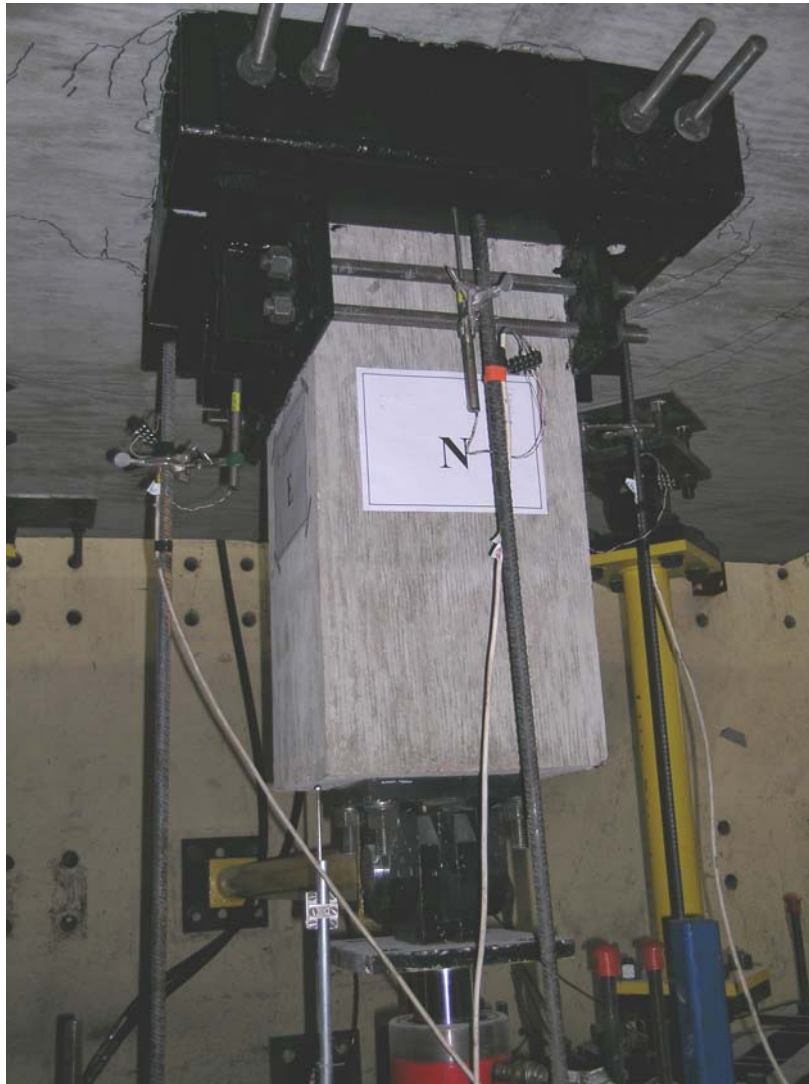
Figure 3.23 Linear potentiometers

Linear variable displacement transducers (LVDT) and linear potentiometers were used to monitor displacements. The displacement of horizontal actuator was monitored by an LVDT integrated within the horizontal actuator. Vertical displacement of the column was measured by a 6-in potentiometer installed underneath the column (Figure 3.22). In the punching shear test performed on the specimen strengthened using steel collars, four 6-in potentiometers were also used to measure vertical displacement of the steel collars at each column face (Figure 3.23).

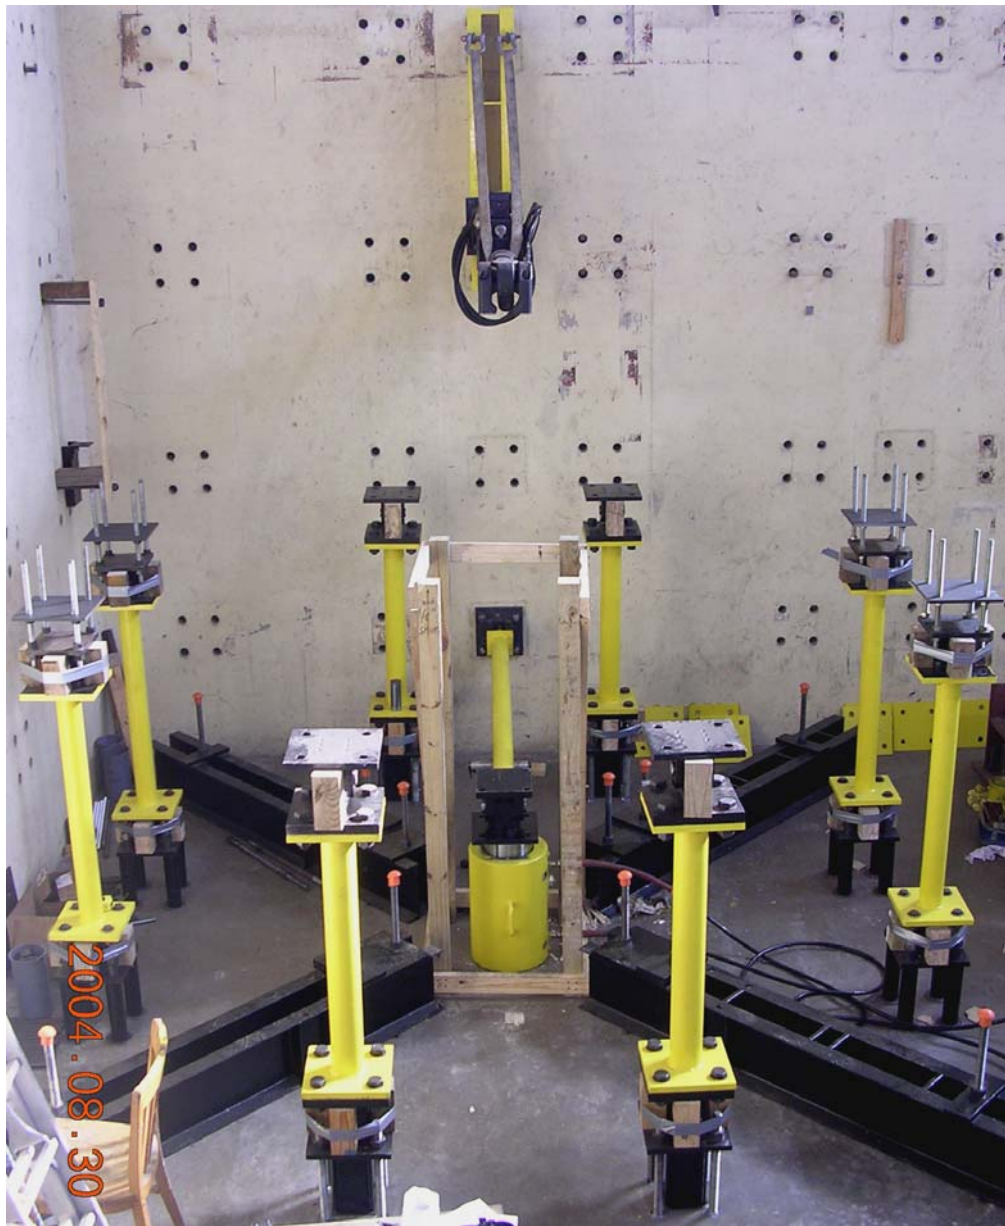
Figure 3.24 Position of vertical struts: simulated seismic test

Figure 3.24 shows the position of vertical struts used in simulated seismic tests. Prior to specimen installation, all vertical struts were locked into place using wooden blocks. Specimens were moved from the formwork to the testing area using an overhead crane and they were placed on the wood shoring (Figure 3.25). They were then connected to the clevises at the end of the vertical struts and underneath the lower column. The horizontal actuator was connected to the upper column and torsional bracings were attached to the slab. The linear potentiometers were mounted in their proper position underneath the lower column stub, and between the slab and the strong wall in the lateral loading direction.

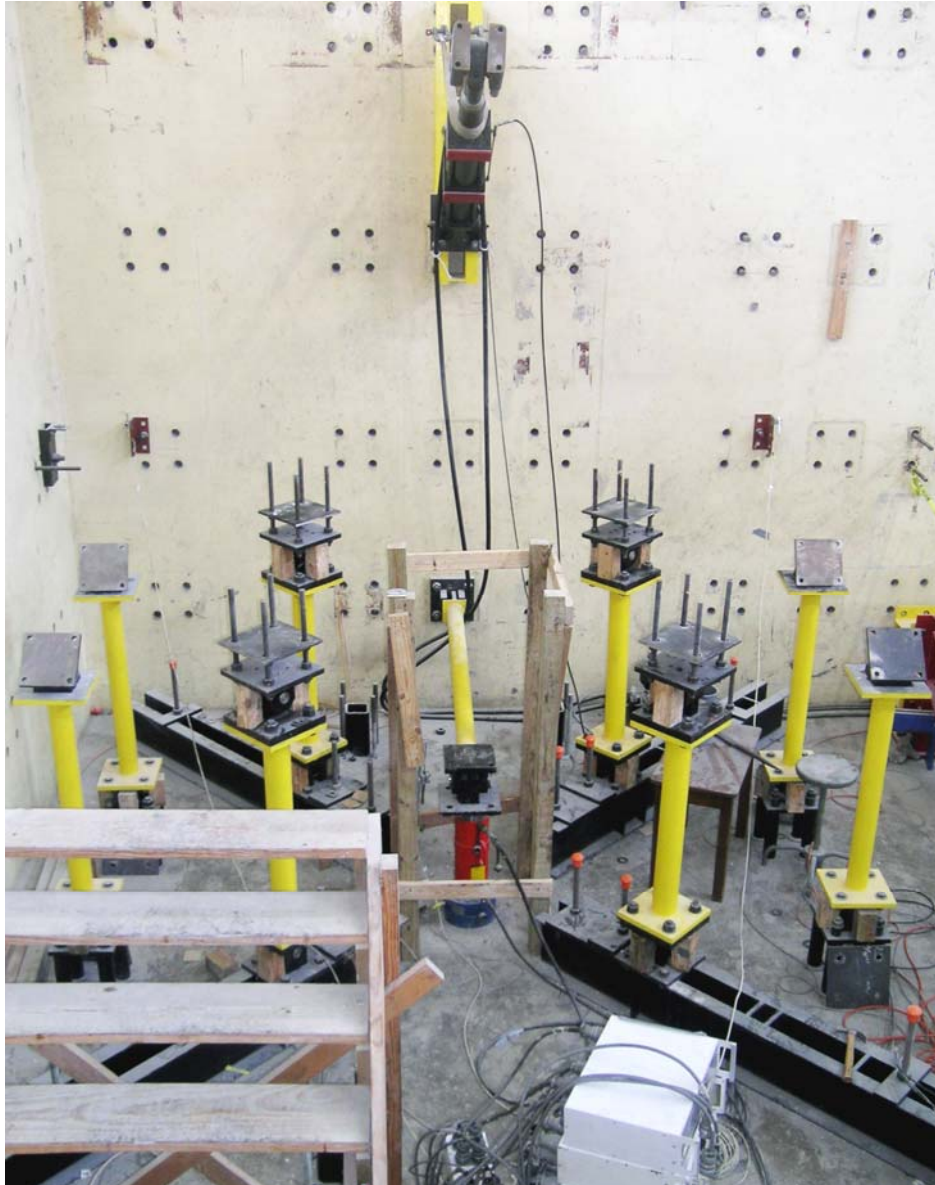
Figure 3.26 Position of vertical struts: punching shear test

For the specimens G0.5 and G1.0, which were not subjected to lateral loading, the vertical struts were positioned for a punching shear test (Figure 3.26), before the specimens were moved to the testing area.

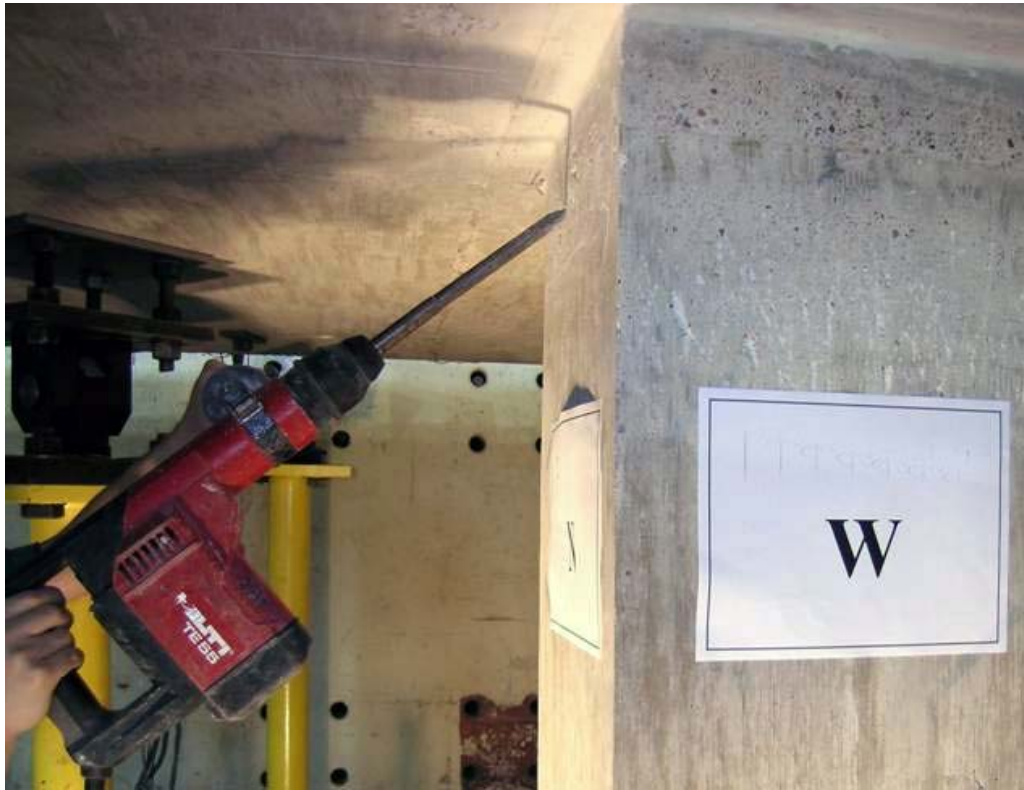
Figure 4.6 Roughening the column surface

After punching shear failure of specimens G0.5 and G1.0, both specimens were unloaded completely. Then, cracks on the bottom of slab-column intersection were sealed with silicone (Figure 4.5) and the uneven surfaces of the column and the bottom surface of the slab, where the steel collars were installed, were ground to be flat. The column surface where the steel collars were clamped was then roughened using a rotary hammer drill (Hilti TE 55 shown in Figure 4.6). Figure 4.5 shows the concrete surfaces before and after they had been ground and roughened.

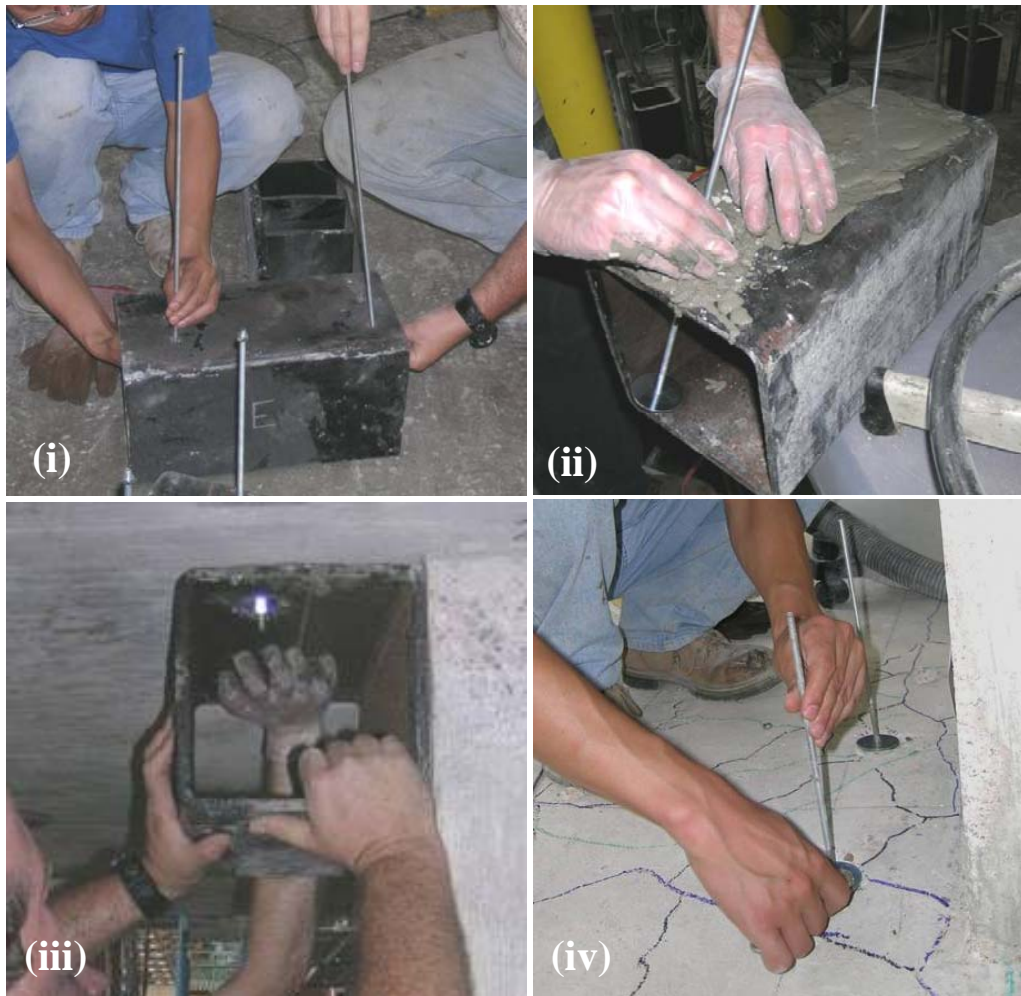
Figure 4.7 Installation of the shorter steel tubes

Installation of the collars (Figure 4.7) began by (i) hanging the shorter square tubes from the slab with threaded rods, (ii) applying a high consistency grout on the top surface of the tube, (iii) pressing the tube against the slab and against the column, and (iv) tightening the threaded rods from the top to fix the tube in position. After the two shorter tubes were installed (Figure 4.8), the longer tubes were installed in a similar manner. After one of the longer tubes was placed, two high-strength 1-in diameter threaded rods were inserted and the other longer tube was installed (Figure 4.9). After all square tubes were installed, the four high-strength threaded rods connecting the longer tubes were torqued to produce the shear-friction capacity needed. Then the angles supporting the shorter tubes were installed. The installation of the angles (Figure 4.10) involved (i) hanging

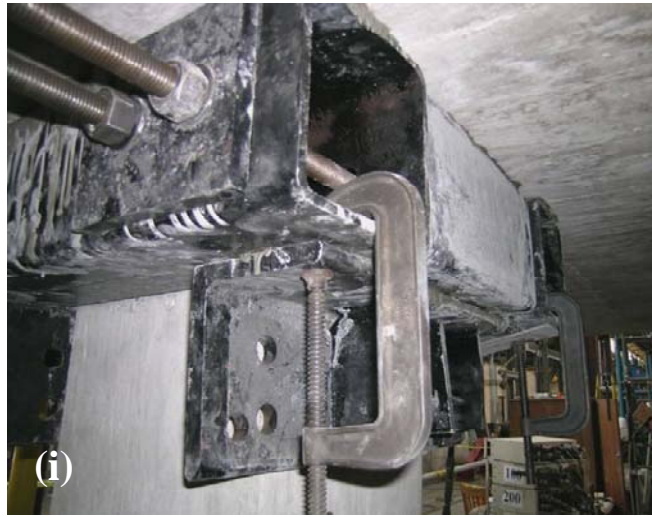
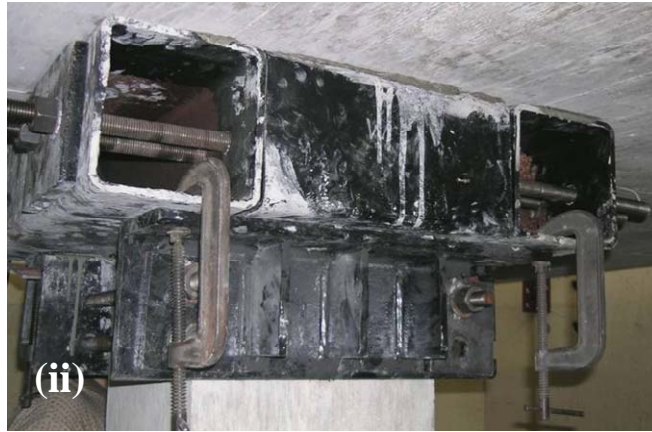
Figure 4.10 Installation of the angles

both angles by clamping them on the longer tubes and (ii) inserting the high-strength threaded rods and tightening them so that the two angles were fixed in their position. The steel shims and grout were then placed to fill gaps between the angles and the tubes or between the tubes and the slab (Figure 4.11). After installation of the collars was completed, the nuts on the $\frac{1}{4}$ -in threaded rods to hang the steel tubes during installation were loosened so that the rods did not act as shear reinforcement during the test.

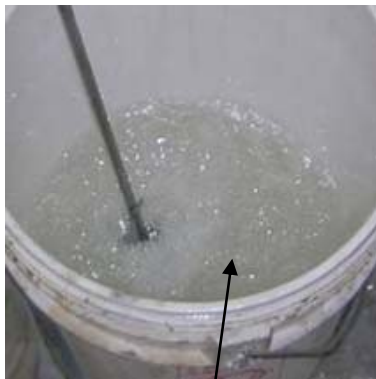
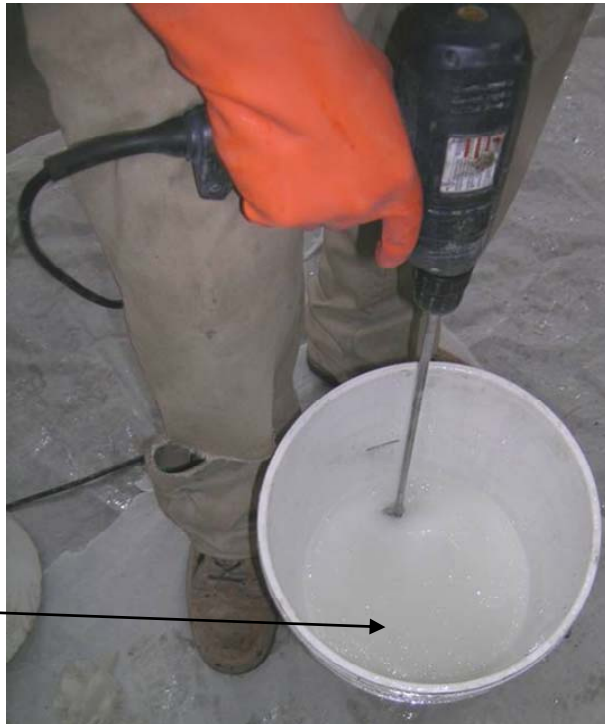
Figure 4.12 Mixing epoxy

Finally, the two-component of Tyfo S epoxy was prepared. 42.0 parts of component B was poured to 100 parts of component A (by volume). Both components were mixed thoroughly for five minutes with 600 RPM mixer (Figure 4.12). When both components were just mixed, the color was clear. After they had been mixed for a while, the color became whitish. Epoxy was then poured to fill cracks of the punching shear cone (due to a previous failure from the punching shear test) from the top surface (Figure 4.13). In room temperature, the epoxy could be poured within 15 minutes after both components had been mixed. Within that period, the epoxy was not viscous and its consistency was not different than that of water. After 15 minutes, the epoxy started to become more viscous and it could not be used to fill cracks.

Both components were just mixed (clear color)

Both components have been mixed for a while (whitish color)
