**Rehabilitation of Reinforced Concrete Slab-column Connections
for Two-way Shear**

Widianto, B.Sc., M.S.E.

Dissertation

The University of Texas at Austin

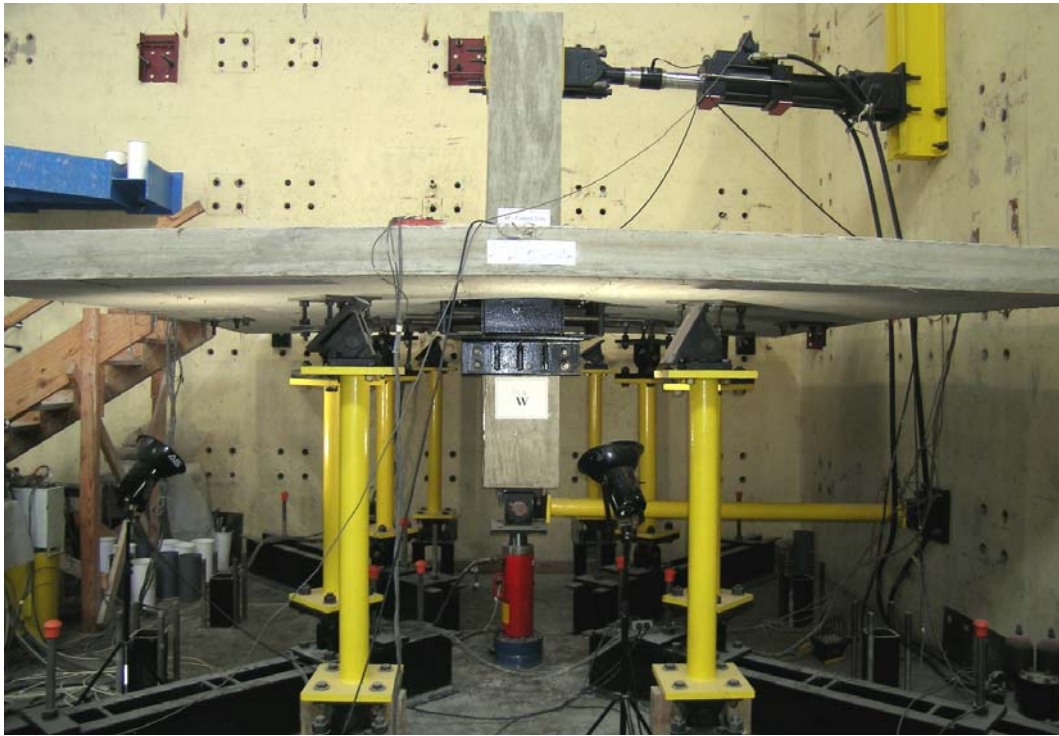
Figure 4.14 Significant vertical deflection at failure of RcG0.5

Figure 4.14 shows a significant vertical deflection after the punching shear failure of specimen RcG0.5. Figure 4.15 shows the punching shear failure surface before and after removal of delaminated concrete. The distance between the failure surface of RcG0.5 and the edges of the collars underneath the slab was about the same as the distance between the failure surface of G0.5 and the column face. Figure 4.16 shows that steel collars were effective in enlarging the critical shear perimeter because the punching cone intersected the bottom slab surface at the edges of steel collars. There was a circular cracking pattern away from the steel collars. Figure 4.17 shows that the angles of diagonal cracks of the punching cone with and without steel collars (RcG0.5 and G0.5) were about the same. Unlike a typical angle of punching cone that varies between 22° and 35° (Binici 2003), the angles of punching cone of RcG0.5 and G0.5 varied between 50° and 83° . These steep angles were quite similar to those of flexural-shear cracks in a beam. Figure 4.17 also shows that the punching cone intersected the top slab surface at the flexural reinforcement locations.

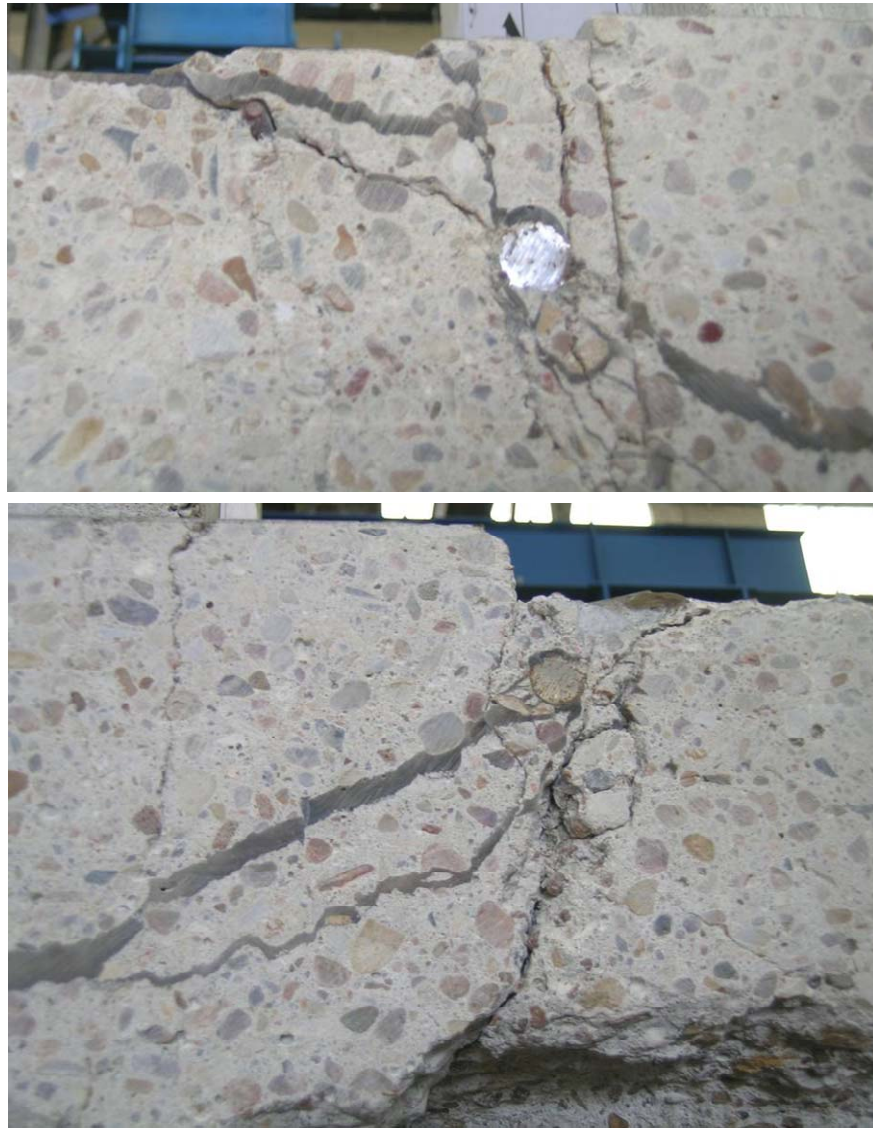
Figure 4.18 Cracks filled with epoxy

Figure 4.18 shows a close-up picture of the cracks filled with epoxy. The gravity driven (without a special injection method) epoxy filled the cracks effectively, with insignificant amounts of air voids.

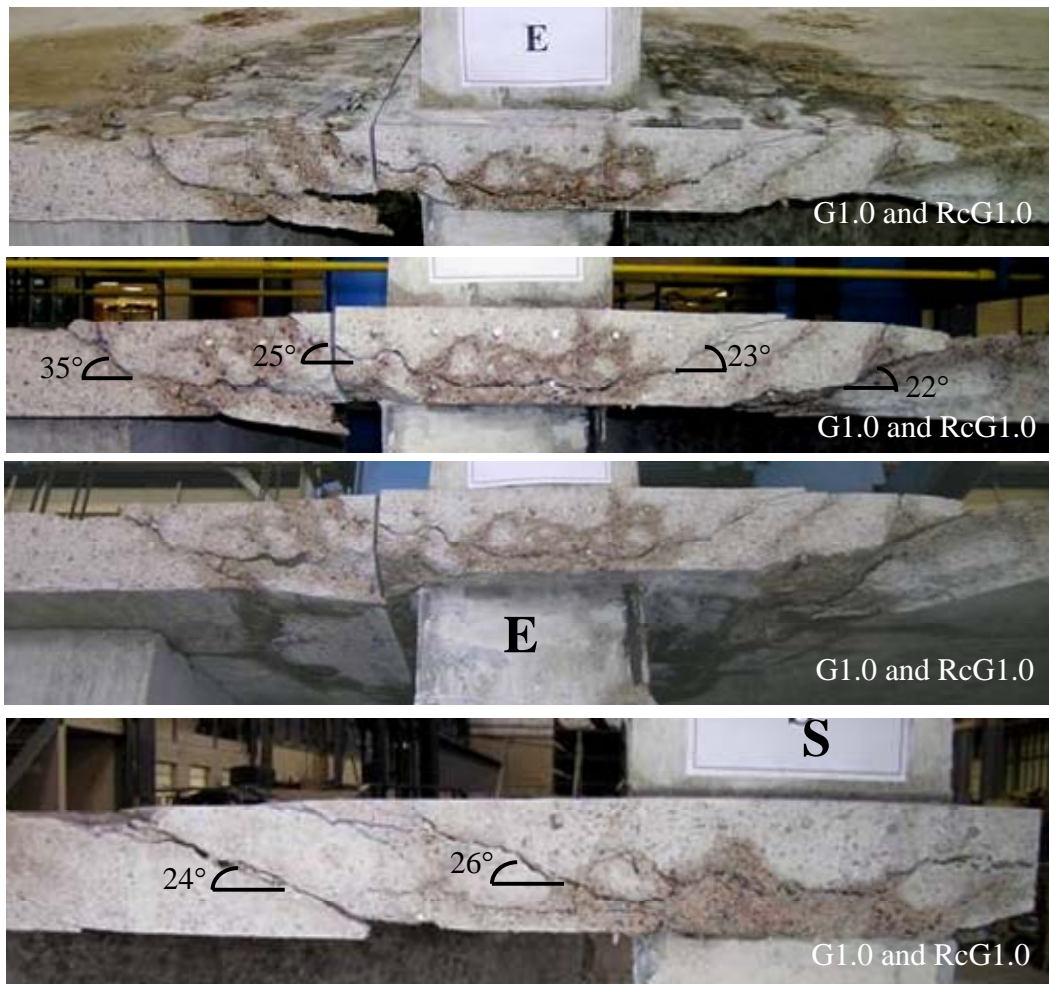
Figure 4.21 Angles of punching cones of G1.0 and RcG1.0

Figure 4.21 shows that the angles of diagonal cracks of the punching cone with and without the collars (RcG1.0 and G1.0) were about the same, as was the case in RcG0.5. This suggests that the formation of the inclined cracks leading to a punching failure was the same for both the strengthened and the unstrengthened specimens (regardless of the percentage of top flexural reinforcement). The only difference was the location of the failure surface. The collars only shifted the failure surface away from the column and did not change the failure mechanism. Unlike in RcG0.5 and G0.5, the angles of punching cones of RcG1.0 and G1.0 (varied between 22° and 35°) were quite similar to Binici's observation (2003). It should be noted that Binici's specimens had 1.76% flexural reinforcement. These relatively small angles were quite similar to those in a typical punching shear failure.

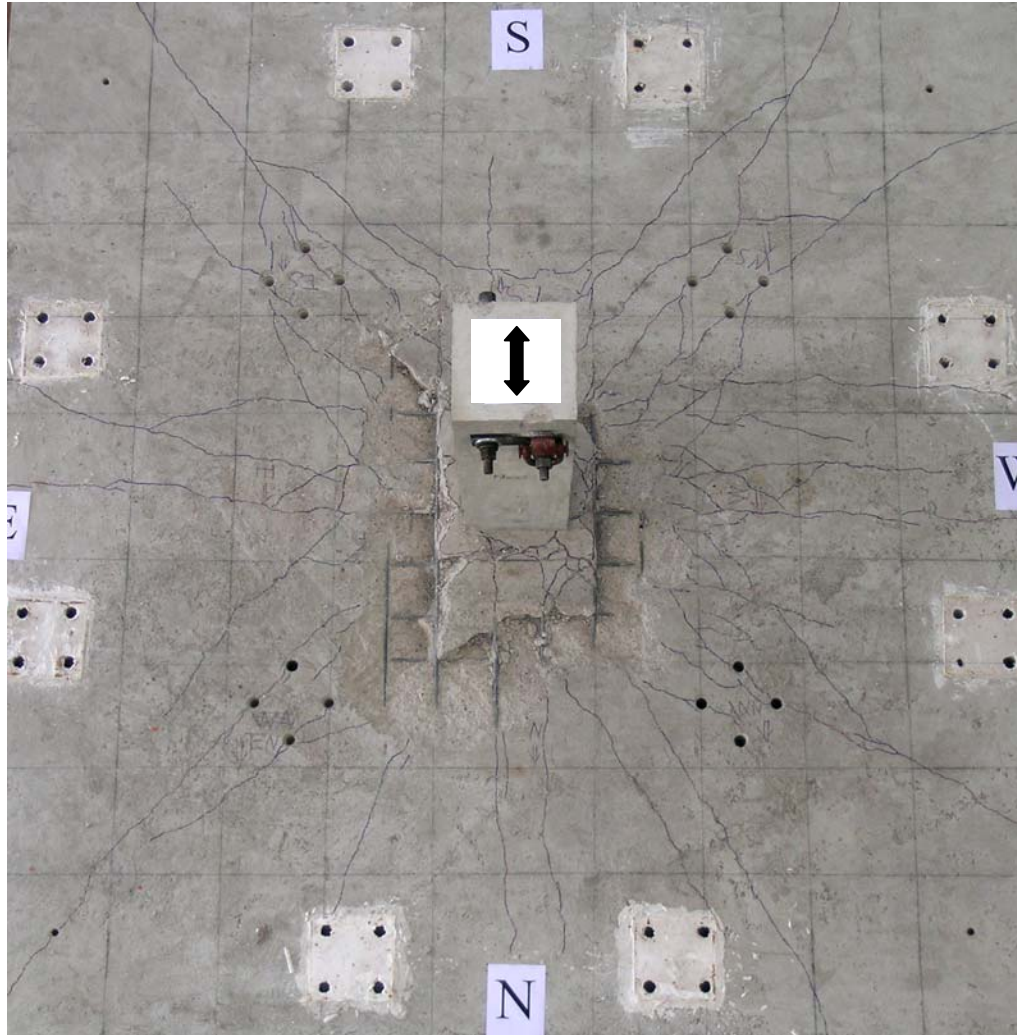
Figure 4.24 Top failure surface of L0.5

Figures 4.24 and 4.25 show the top and the bottom failure surfaces at the end of the simulated seismic test. Significant torsional cracks and concrete spalling around the connection were observed. The observation of concrete spalling and exposure of reinforcing bars around the column were consistent with the failure surfaces observed in flat-plate structures after strong ground motions (Figures 1.7 and 1.10). Figure 4.26 shows the inclination of failure surface. Unlike a typical punching shear failure surface with the angle of punching cone varies between 22° and 35° (Binici 2003), the angle of punching cone of specimen L05 was very steep near the top surface. This suggests that the punching cone originated from flexural cracks that occurred at the location of reinforcing bars. As the punching shear failure surface propagated to the bottom surface of the slab, it turned toward the slab-column intersection. As those in specimens G0.5 and G1.0, the punching cone intersected the bottom slab surface at the slab-column intersection.

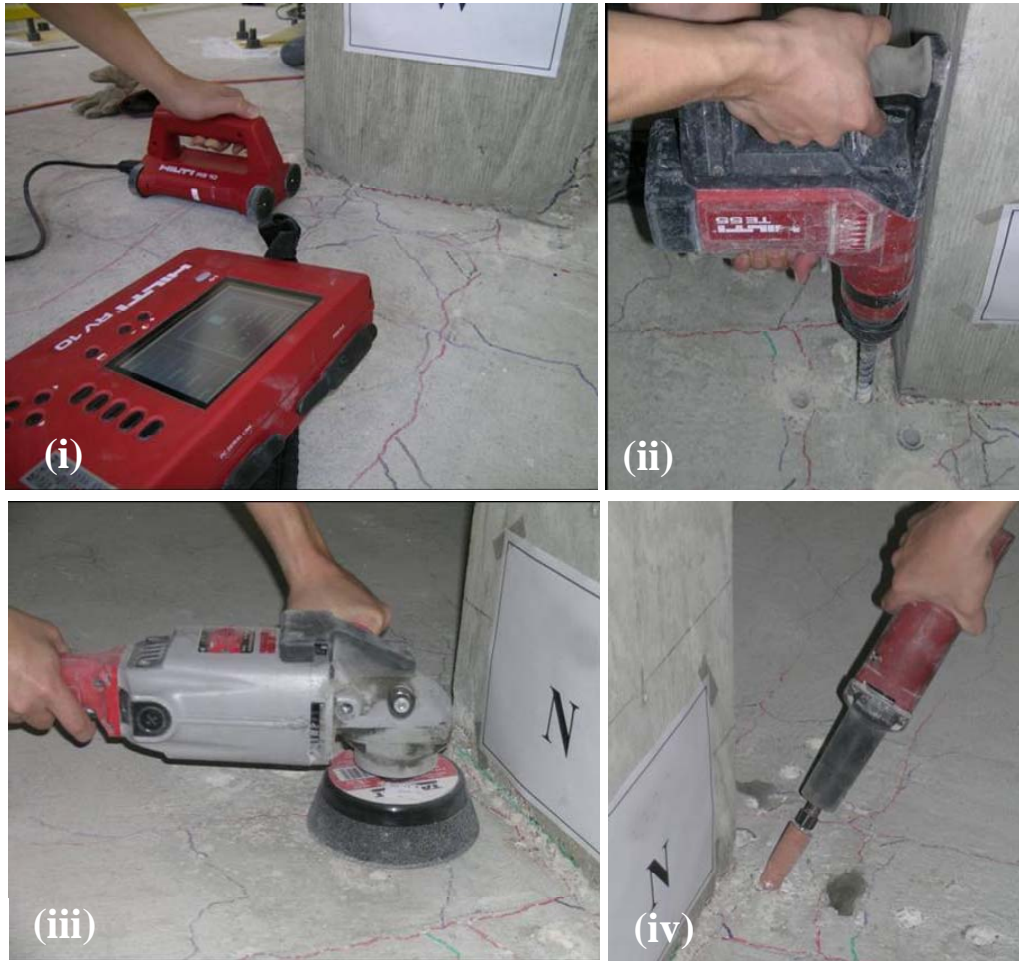
Figure 4.30 Surface preparation

Figure 4.30 shows the surface preparation, which involved (i) locating the slab reinforcement using non-destructive testing, (ii) drilling 3/4–inch holes, (iii) grinding the slab surface, and (iv) chamfering the edge of the holes to minimize

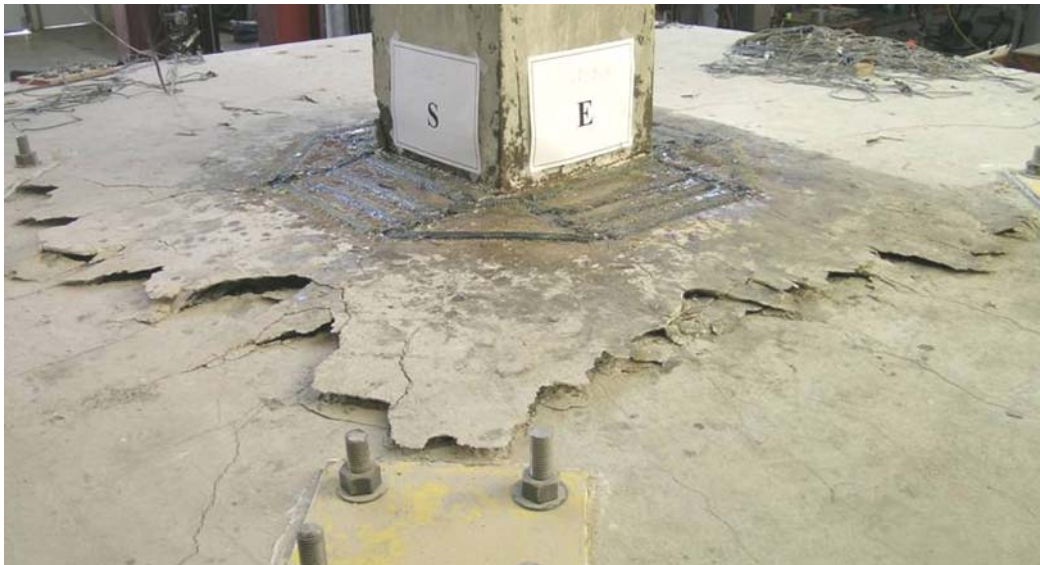
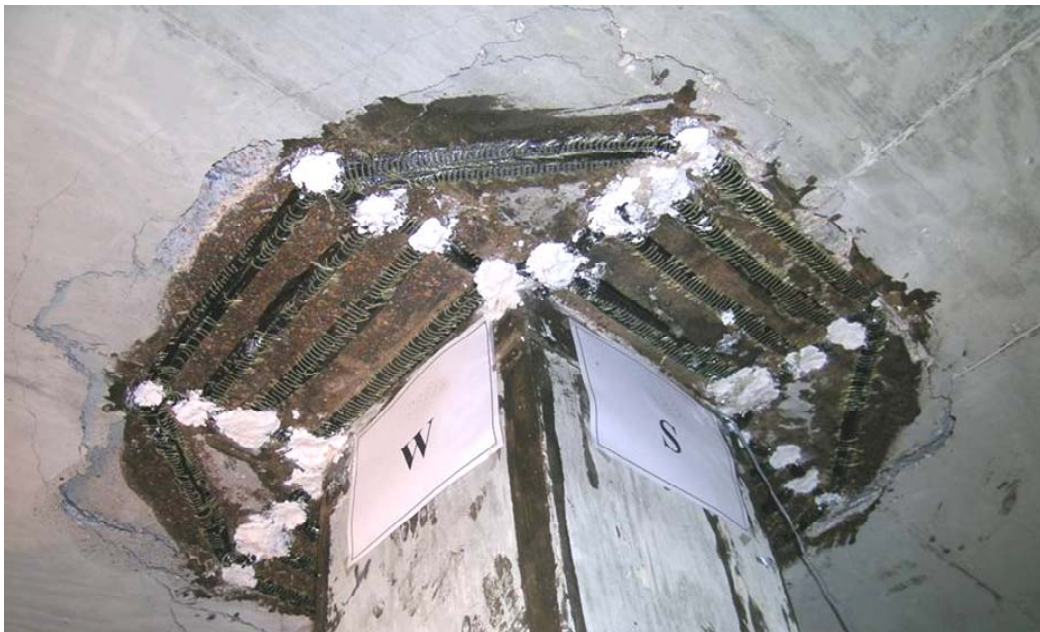
Figure 4.34 Failure surfaces of LRstG0.5

Figure 4.33 shows that specimen LRstG0.5 exhibited a significant vertical displacement at failure. This indicates that the externally installed CFRP stirrups increased ductility of the connection. Figure 4.34 shows the top and bottom failure surfaces. It can be seen that the tightly knit array of CFRP stirrups was effective in shifting the failure surface away from the shear reinforced zone and thus, increasing the critical shear perimeter. Figure 4.35 shows the failure surface after the specimen LRstG0.5 was saw-cut. Even though there were many flexural cracks within the shear reinforced zone due to the simulated seismic test, the punching cone formed outside the shear reinforced zone. This indicates that the tightly knit array of CFRP stirrups was also effective to restore the continuity of

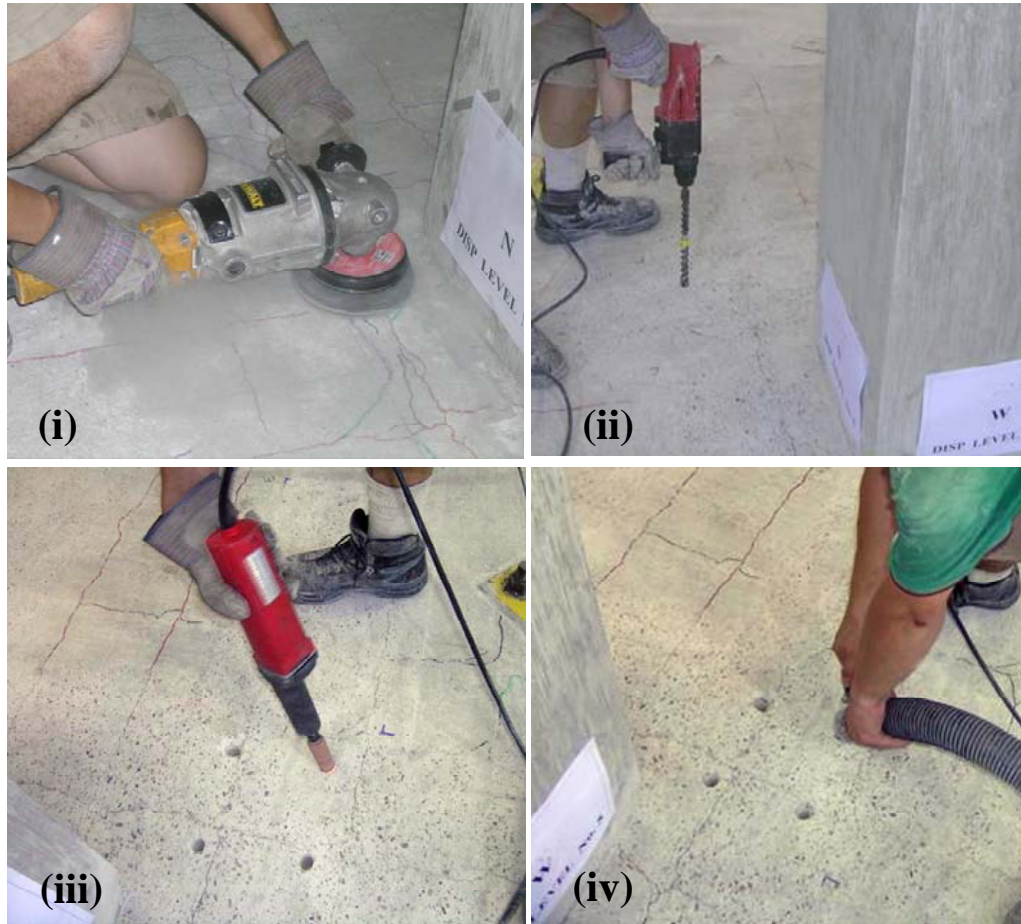
Figure 4.36 Surface preparation before the application of CFRP sheets

Figure 4.36 shows the surface preparation before CFRP sheet installation, which involved (i) grinding the concrete surface where the CFRP sheets were placed, (ii) drilling four holes ($\frac{3}{4}$ -inch diameter and $4\frac{1}{2}$ -inch deep) at each corner of the column so that CFRP anchors could be inserted, (iii) chamfering the edges of the holes to minimize stress concentrations, and (iv) cleaning the concrete surface. Concrete surface before and after the surface preparation are shown in Figure 4.37. Since the cracks around the column (due to reversed cyclic lateral displacements up to 1.25%) penetrated through the entire slab depth, the bottom surface of the slab was sealed with silicone as shown in Figure 4.38. The rehabilitation was then continued (Figure 4.39) with (v) pouring epoxy into cracks and holes, (vi) coating the concrete surface with the epoxy using a paint roller, (vii) inserting the epoxy-impregnated CFRP sheet into a saturator to remove excessive epoxy, (viii) placing the sheets on the concrete surface and rolling the sheets with a paint roller to avoid any wrinkles and to remove air pockets below the sheets.

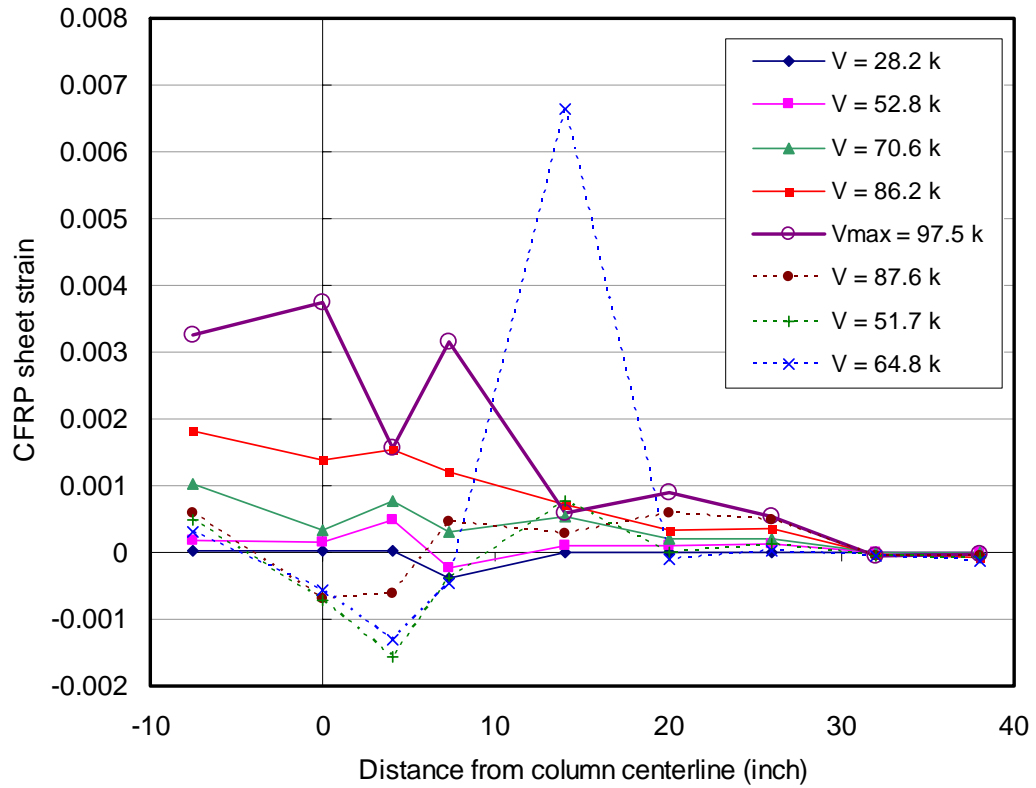
Figure 4.42 CFRP strain profile along the West-East sheet

Figure 4.42 shows that the strain of CFRP sheets in the region beyond the location of the anchors were generally low (less than 0.001) for all levels of gravity loads. This indicates that extending the sheets 36 inches away from the column face was not necessary. The CFRP sheets may be terminated about 12 inches beyond the location of the last anchors. At the maximum load, the strains were generally less than 0.004. Since CFRP sheets ruptured at failure, it is believed that the earthquake-damage caused stress concentration on CFRP sheets. After the maximum load was reached and punching cone formed (punching shear failure occurred), the well-anchored CFRP sheets started to act as tension bands (catenary action) and allowed the slab to carry substantial loads through larger deformations. For this reason, the strain of CFRP sheet in the middle of four anchors increased significantly after punching shear failure. Figure 4.43 shows that the strain was generally uniform across the width of CFRP sheets prior to punching shear failure. This indicates that the 12-in wide sheet was fully effective in resisting the load.

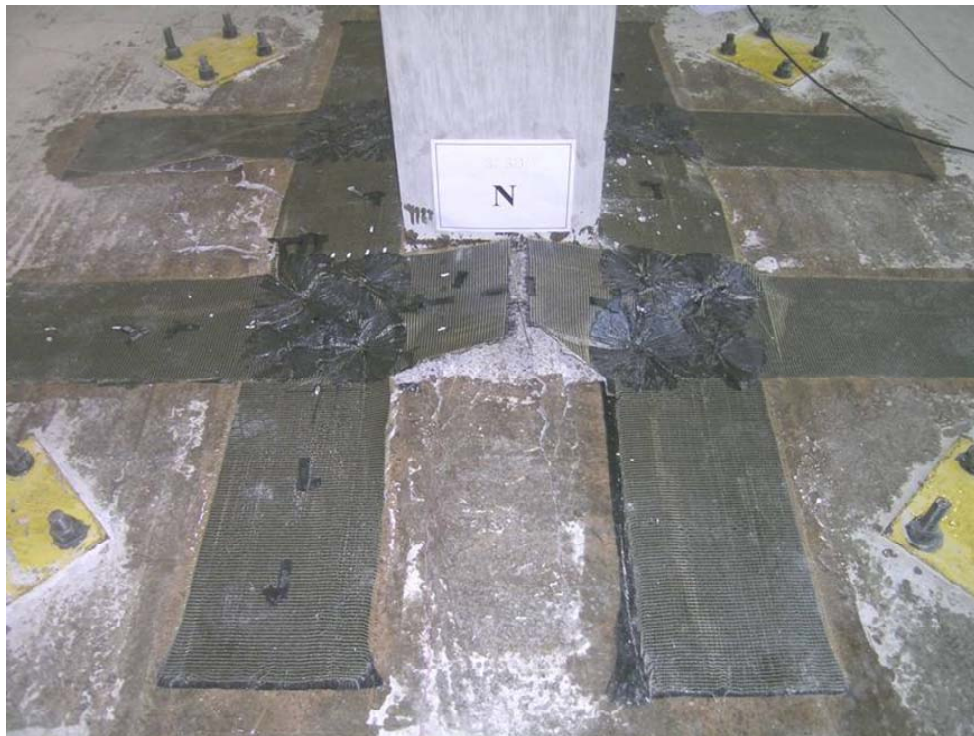
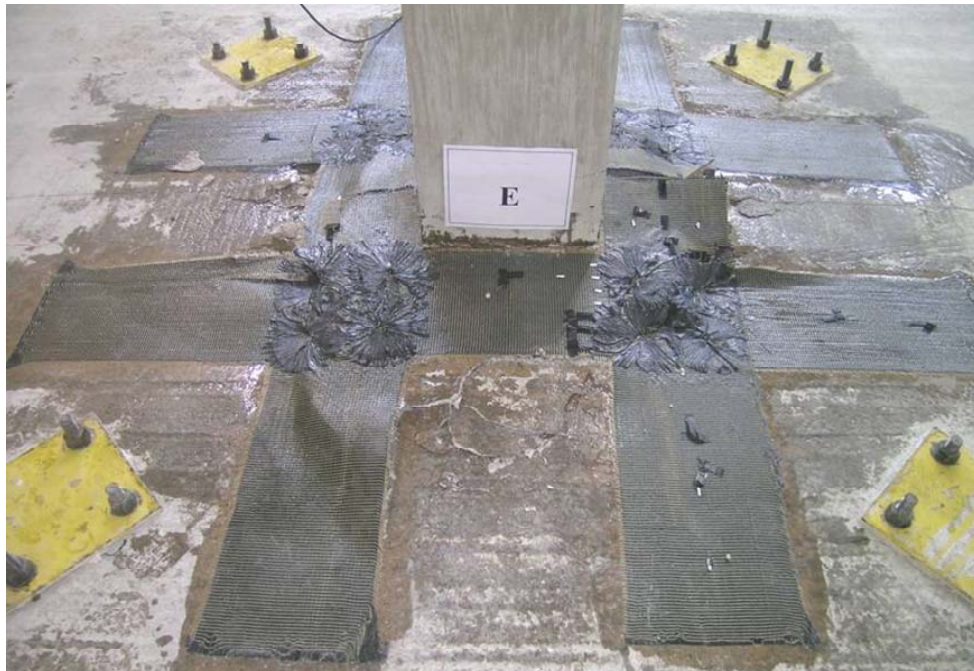
Figure 4.44 Top view of failure surface of LRshG0.5

quite similar to those of the specimen LG0.5 (Figure 4.28) supports the opinion that the external CFRP sheets did not change the location of the failure surface. Figure 4.48 shows the anchor after it was removed from the slab. The anchor was relatively undamaged, indicating that it did not act as shear reinforcement (it did not intersect punching shear cracks).

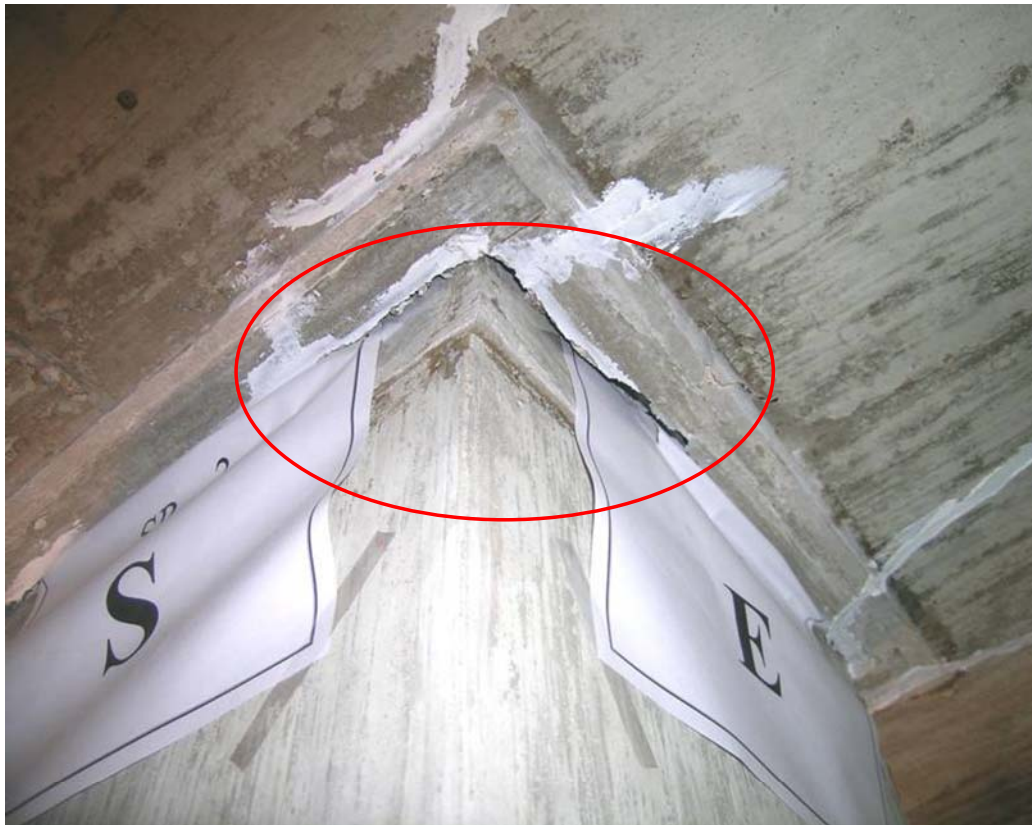
Figure 4.46 Bottom view of failure surface of LRshG0.5

Figure 4.46 shows the bottom failure surface. The diagonal shear cracks intersected the bottom slab surface right at the slab-column intersection, indicating that the presence of CFRP sheets did not change the location of failure surface. This observation was consistent with previous findings (Harajli and Soudki 2003).
