**NONDESTRUCTIVE EVALUATION OF REINFORCED CONCRETE
STRUCTURES AFFECTED BY ALKALI-SILICA REACTION AND
DELAYED ETTRINGITE FORMATION**

Thesis

The University of Texas at Austin
August 2011

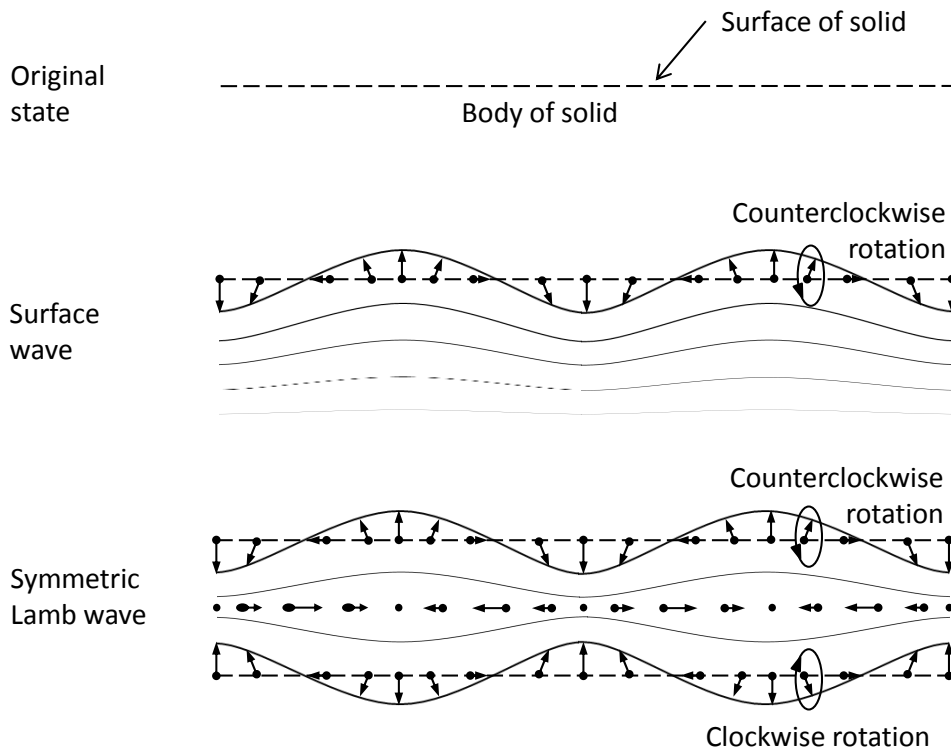
Surface waves propagate along the surface of the medium, rather than in the body. As depicted in Figure 3-2, the particles experience both longitudinal and transverse motion while traveling along elliptical paths. The energy diminishes exponentially with depth, reaching about one-tenth of the surface amplitude at a depth of around 1.5 wavelengths (Malhotra & Carino 2004).

Figure 3-2: Surface and Lamb Wave Propagation

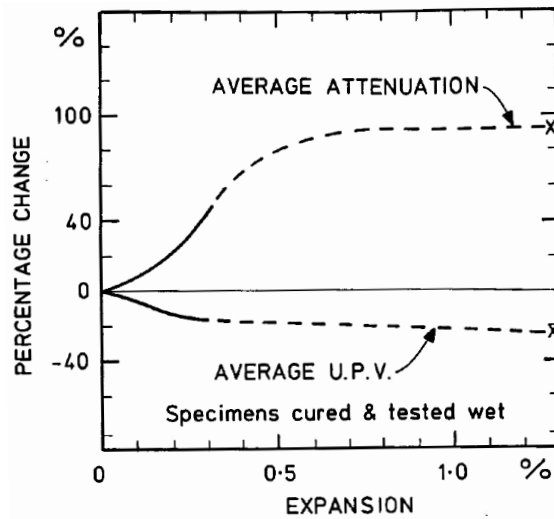
Results from two studies investigating ultrasonic attenuation are shown in Figure 3-7 and Figure 3-8. Both studies were performed on small unreinforced concrete cylinders and prisms. Details about the testing parameters can be found in Table 3-1. In both cases, the attenuation shows about a 90% increase while the velocity decreases only 10-20% (note the difference in scale of the horizontal axes in Figure 3-7). This is an indication that attenuation may be a better assessment technique than velocity. However, unlike UPV testing, attenuation measurements can be affected greatly by the coupling of the transducers to the concrete.

Figure 3-8: Comparison of Ultrasonic Velocity and Attenuation Results (Bungey 1991)

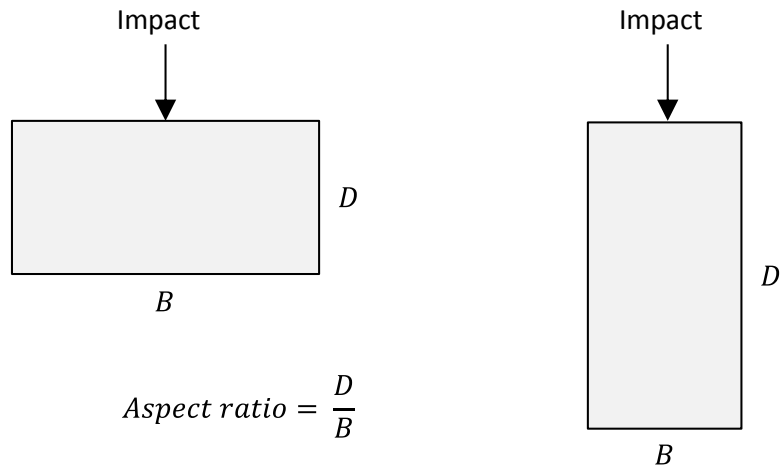
β varies between 0.75 and 0.96 for rectangular cross sections, depending on the aspect ratio. As depicted in Figure 3-10, the aspect ratio is defined as the depth-to-width ratio of the cross section, where the depth is measured parallel to the direction of the impact (Sansalone & Streett 1997). For an element to be classified as a plate, the aspect ratio must be less than 0.2. Schubert and Köhler (2008) argue that along with dependence on the cross sectional geometry, the correction factor is also a function of the time duration of the signal collected. Longer collection times allow for multiple reflections off of several boundaries, complicating the signal.

Figure 3-10: Definition of the Aspect Ratio in Impact Echo Testing

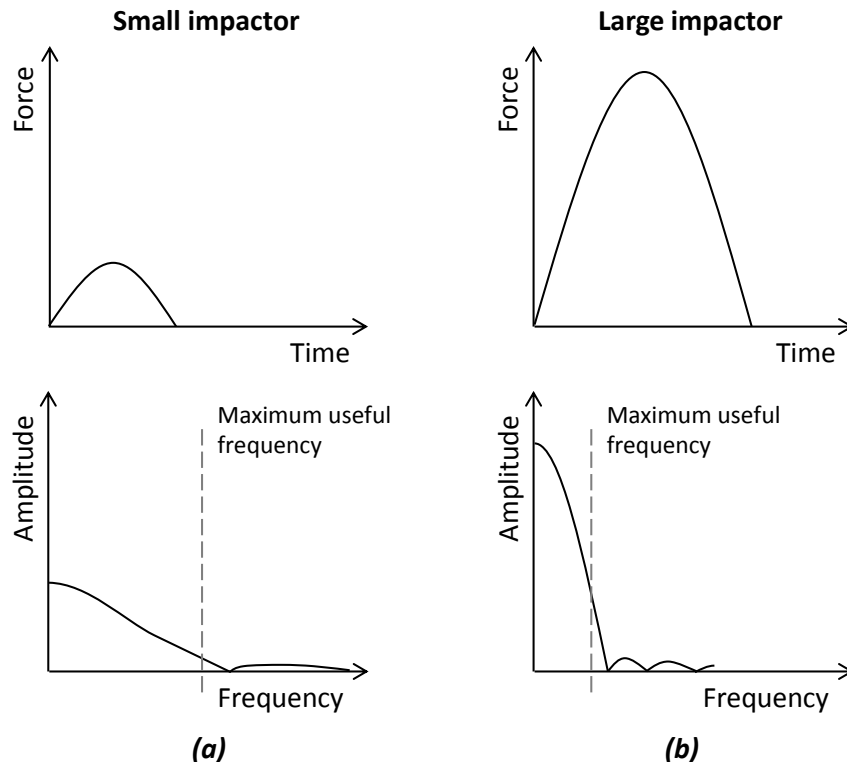
to the contact time and inversely related to the maximum frequency that can be detected. Because the frequency, in turn, is inversely related to the thickness of the element or depth of the defect, larger impactors are used to detect deeper defects or the back surfaces of thicker elements. Conversely, smaller impactors can detect defects that are closer to the surface which reflect the wave at a higher frequency. These relationships are shown in Figure 3-11.

Figure 3-11: Impact Force Functions and Induced Frequency Ranges for (a) Small and (b) Large Impactor Diameters (Adapted from Sansalone and Streett (1997))

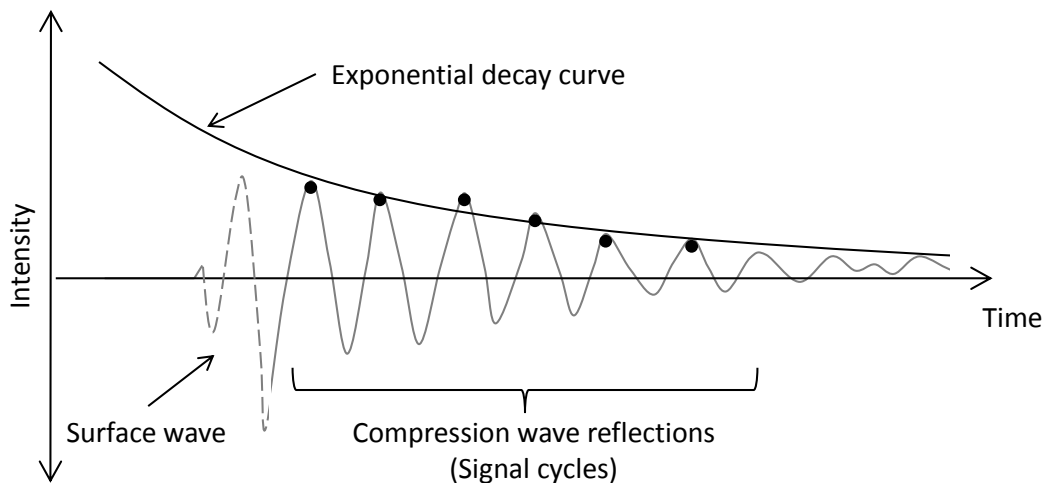
where I is the stress wave intensity at time t , I_0 is the initial stress wave intensity and α is the decay constant. A typical idealized impact echo waveform is shown in Figure 3-12. The first portion is the surface wave, shown as a dotted line, followed by consecutive reflections of the compression wave, or signal cycles. For this analysis, the surface wave is ignored, and an exponential decay curve is fit through the peaks of the cycles. The decay constant, α , is determined from the best fit curve. Larger values of α indicate faster attenuation and more damage.

Figure 3-12: Impact Echo Attenuation Method (Adapted from Tinkey et al. (2000))

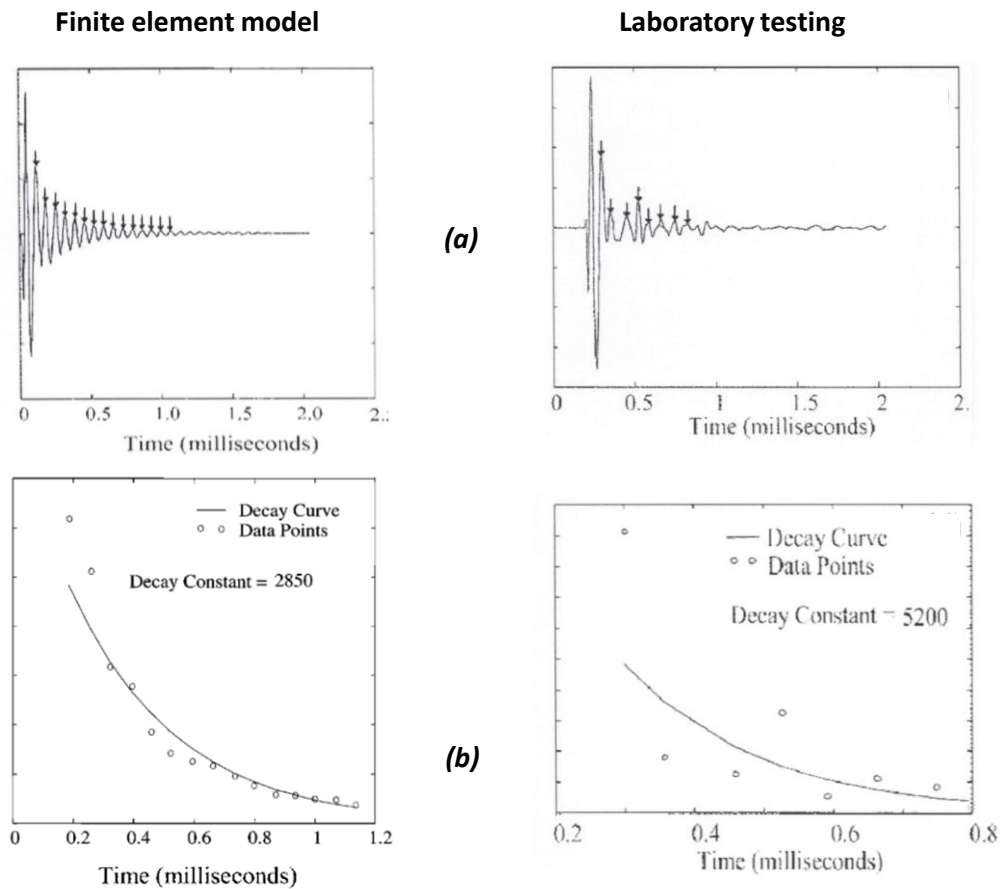
the microcracking worsened, Kesner et al. detected a trend of decreasing decay constants, although the relationship is not linear. Damage estimation recommendations, summarized in Table 3-2, were made based on the decay constants and the number of discernable compression wave peaks. Although no results were presented, Kesner stated that the field tests “were consistent with” the laboratory and finite element testing.

Figure 3-13: Typical Results from Kesner et al. (2004) (a) Waveforms and (b) Attenuation Analysis

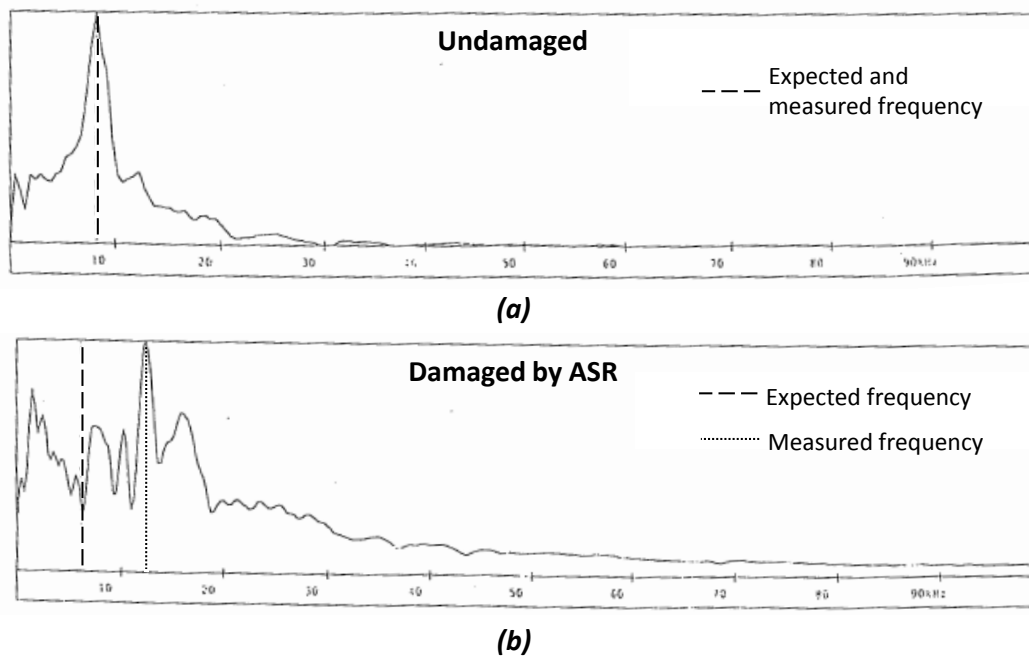
The ability to apply this method in the field is uncertain. It can often be difficult to determine which frequency peak to choose from a noisy spectrum for velocity calculation. This is exhibited in the spectrum in Figure 3-14, in which there are several peaks of similar amplitude, and it is not clear which frequency to use for computing the velocity. Petersen (2000) actually detected an increase in the dominant frequency in a railroad tunnel exhibiting ASR deterioration, indicating that the compression wave velocity is faster than in undamaged portions of the tunnel. However, the frequency spectrum (see Figure 3-15) has a significant amount of noise, and it is possible that the peak corresponding to the back surface is one with lower amplitude.

Figure 3-15: Typical Frequency Spectra from Petersen (2000) (a) Undamaged and (b) Damaged by ASR

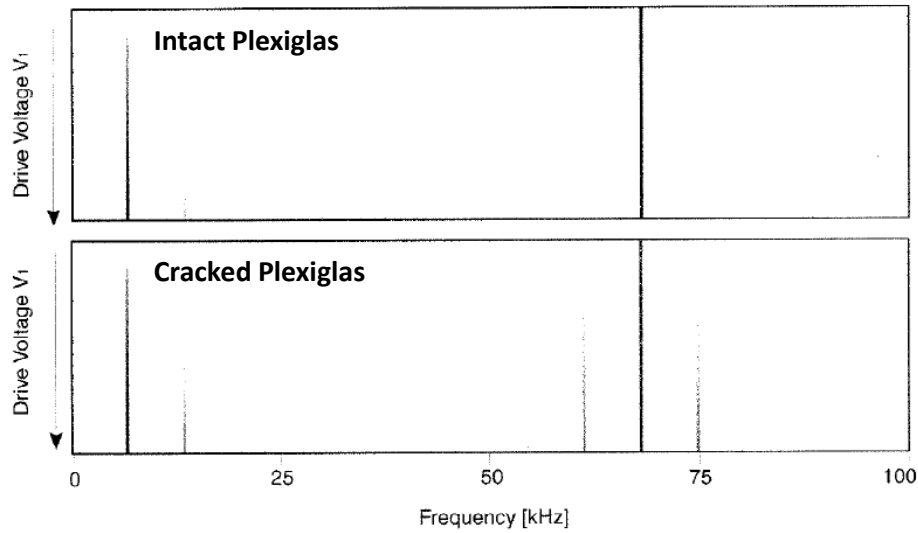
If a high frequency signal (f_{high}) is modulated by a low frequency vibration (f_{low}) in a damaged material, frequencies of $f_{high} \pm f_{low}$ will also be present in the received signal. This is evident in Figure 3-23, which shows the results of a high frequency ultrasonic signal modulated by a discrete low frequency in both a damaged and an undamaged Plexiglas sample.

Figure 3-23: Results of a Frequency Modulation Test with Discrete Low Frequency (Van Den Abeele et al. 2000)

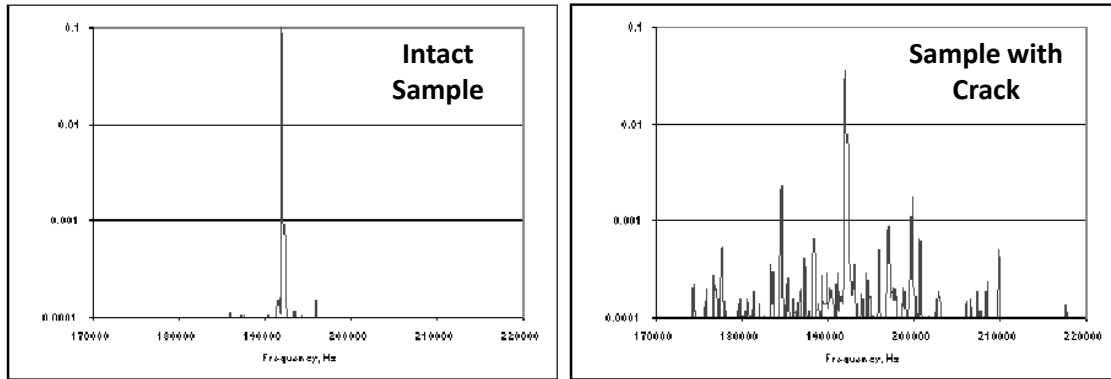
Figure 3-24: Results of a Frequency Modulation Test with Impact-Generated Low Frequency (A. M. Sutin & P. A. Johnson 2004)

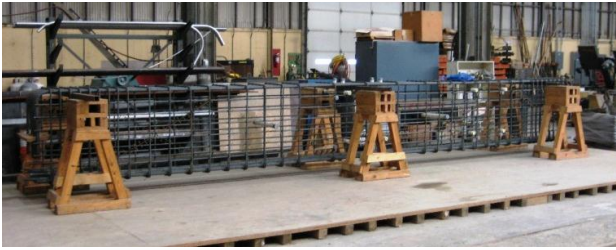
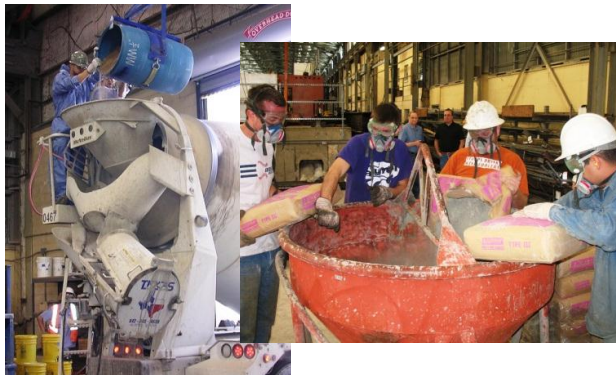
(a) Construct reinforcement cage

(b) Erect formwork, place cage inside

(c) Mix concrete

Figure 4-3: Specimen Fabrication Process

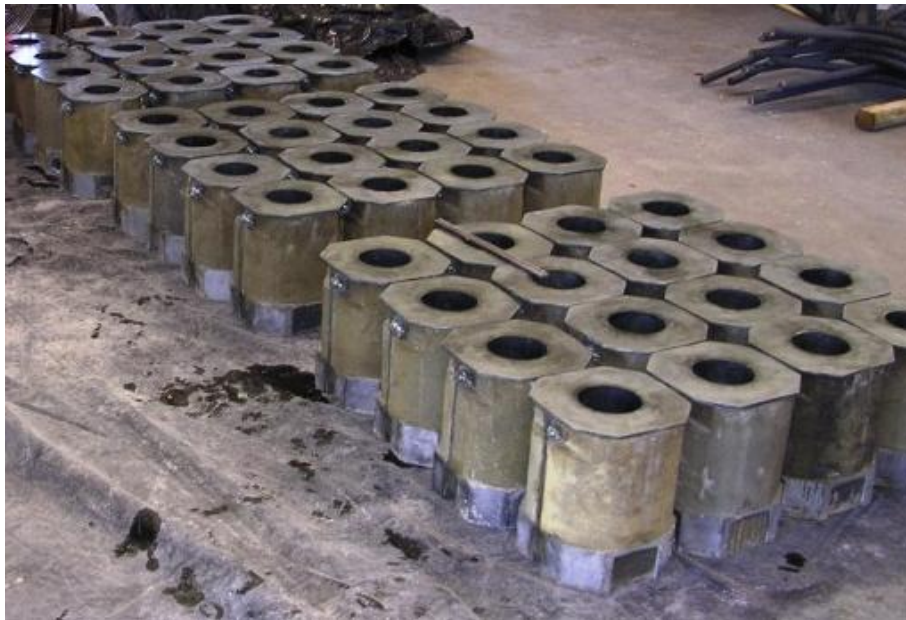
Figure 4-8: Match-Curing Cylinder Molds

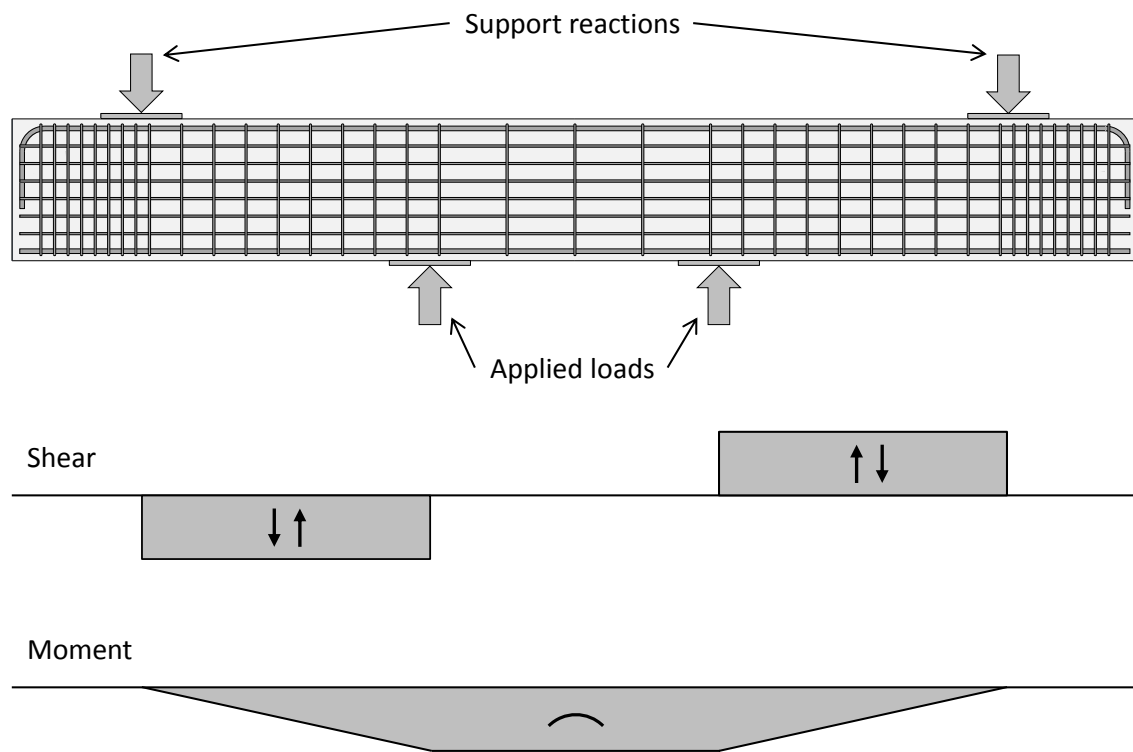
Figure 5-2: Load Conditioning of the Bent Cap Specimens

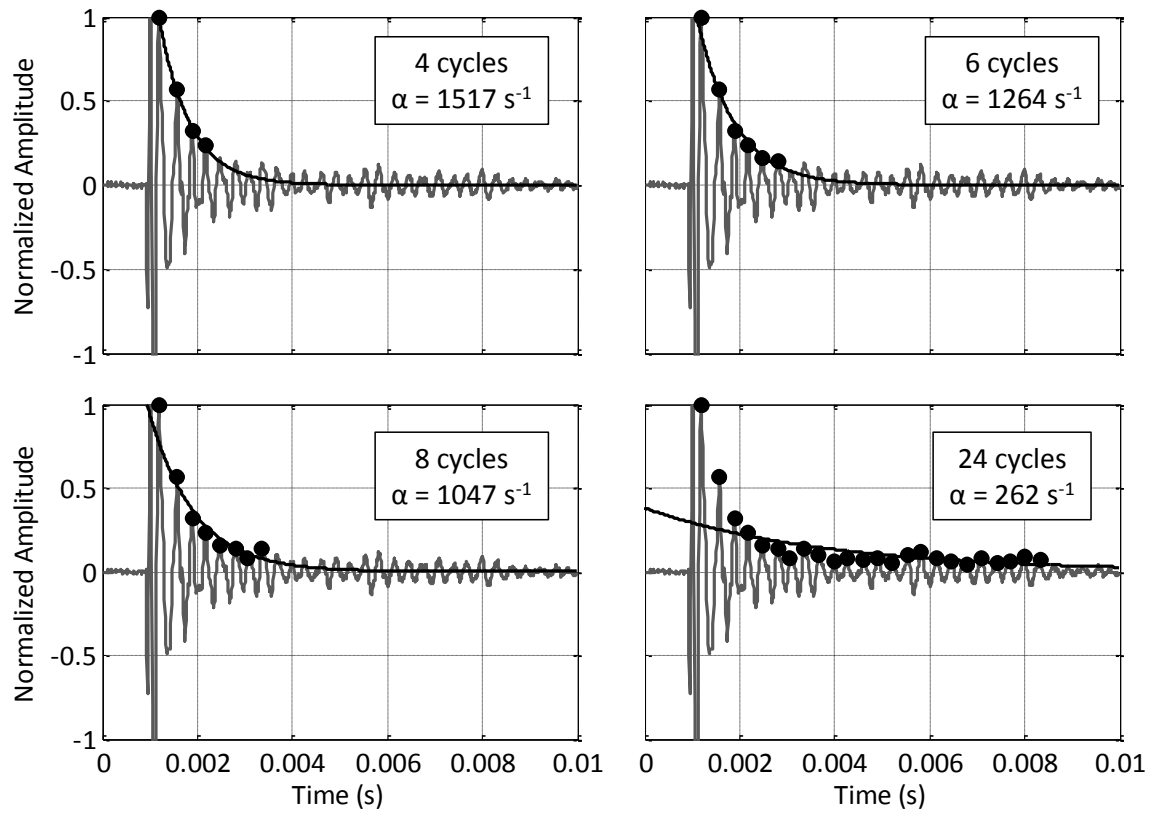
Figure 6-6: Influence of Number of Signal Cycles on Decay Constant
