**Design and Fabrication of a Compact Specimen for Evaluation of  
Corrosion Resistance of New Post-Tensioning Systems**

**Thesis**

The University of Texas at Austin

**May 2005**

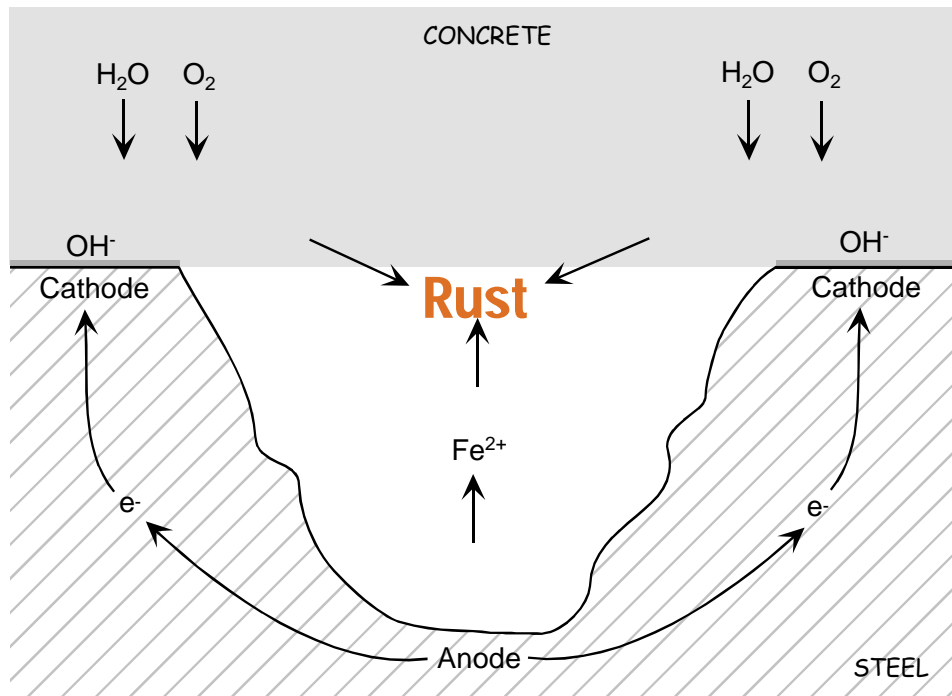
**Figure 1.3: Corrosion of Steel in Concrete (Schokker 1999)**

In the case of corrosion of steel in concrete, the anodes and cathodes are formed on the steel surface with the cement paste pore solution acting as an electrolyte. Figure 1.3 shows the basic corrosion process for steel in concrete. The rust product occupies a much larger volume than the products that go into its formation which can cause splitting tensile stresses in the concrete.

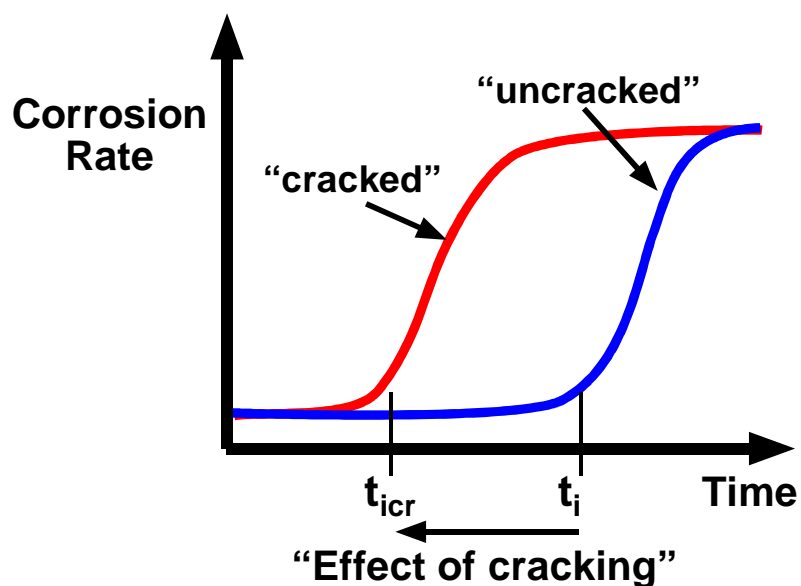
*Figure 1.5: Point of View 2: Cracking Accelerates Onset of Corrosion, But Over Time Corrosion is Similar in Cracked and Uncracked Concrete (West 1999)*

- 1.) Cracks reduce the service life of the structure by permitting a more rapid means of access for moisture, chloride ions and oxygen to reach the reinforcement, thus accelerating the onset of corrosion (i.e., cracking has a significant effect on corrosion).
- 2.) Cracks may accelerate the onset of corrosion, but such corrosion will be localized to the region of the crack. It is suggested that over time, chloride ions will eventually penetrate even uncracked concrete, initiating more widespread corrosion. Thus, after a long service life, the difference between the amount of corrosion in cracked and uncracked concrete will be minor (i.e., cracking does not have a significant effect on corrosion).

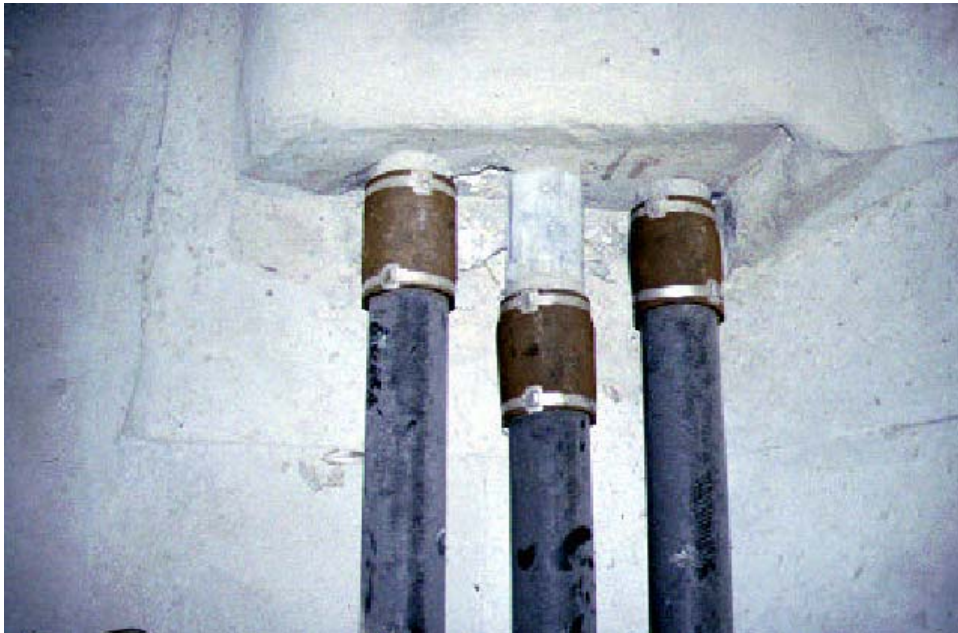
*Figure 1.6: Plan View of Slipped Tendon at Deviation Saddle Niles Channel Bridge (FLDOT 2002)*

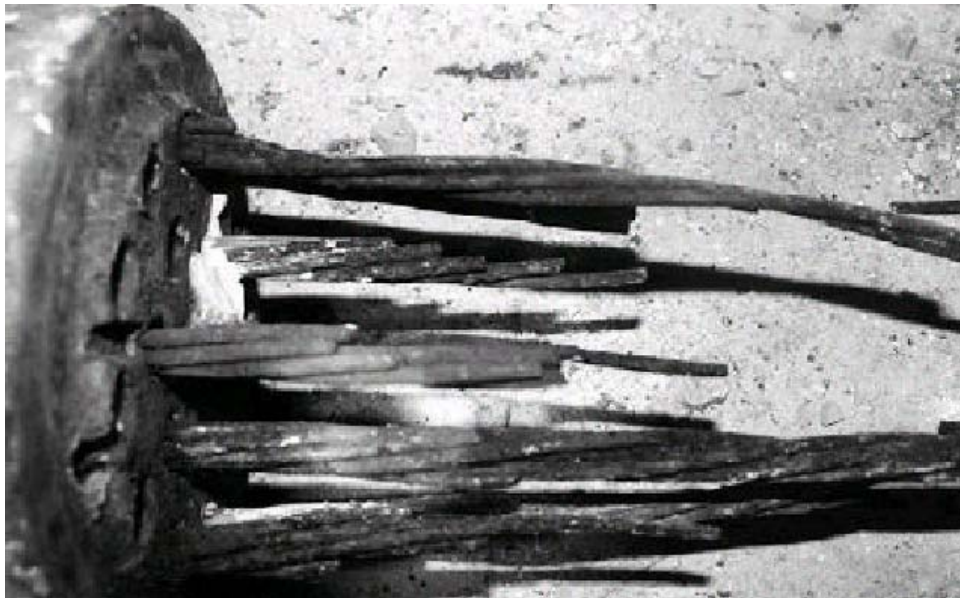
*Figure 1.7: Advanced Corrosion of Strands within Anchorage Niles Channel Bridge (FLDOT 2002)*

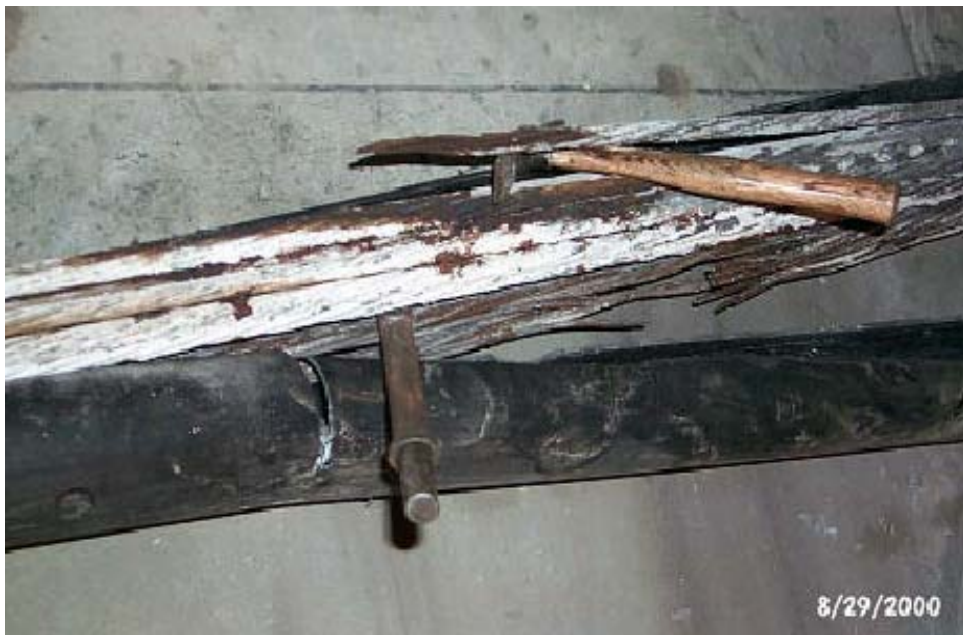
*Figure 1.9: Failure of Tendon 28-6 on the Mid-Bay Bridge (FLDOT 2002)*

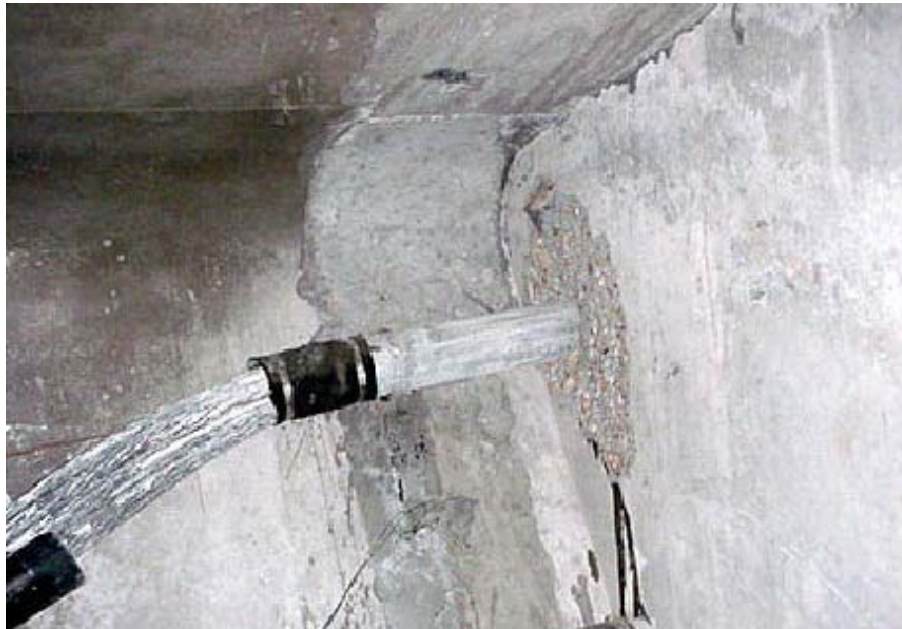
*Figure 1.10: Failure of Tendon 57-1 on the Mid-Bay Bridge at Expansion Joint Diaphragm (FLDOT 2002)*

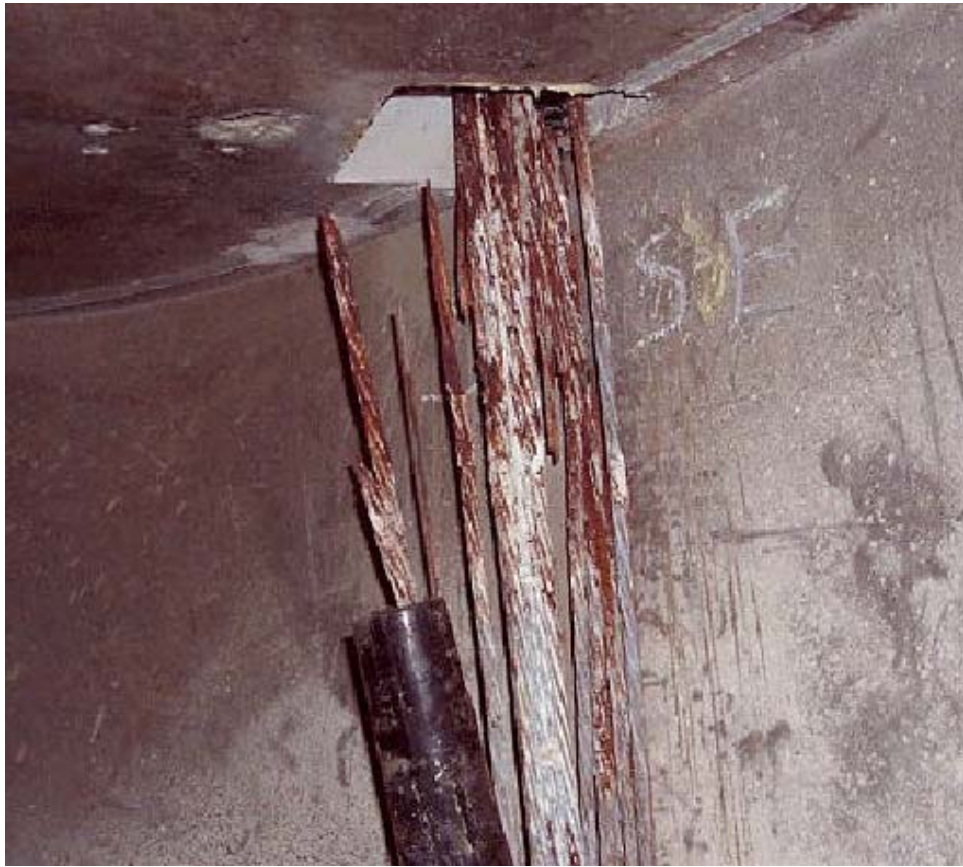
***Figure 1.12: Tendon Corrosion inside the Sunshine Skyway Bridge Piers  
(FLDOT 2002)***

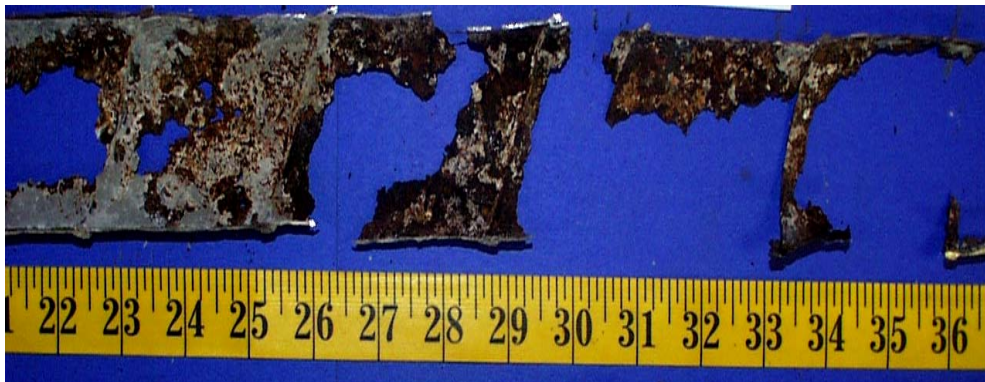
*Figure 2.1: Corroded Galvanized Steel Duct (Breen and Kreger 2003)*

Galvanized steel ducts were corroded in all cases. Duct corrosion led to concrete cracking along the line of the tendon in many specimens. Ducts were corroded through in nearly two-thirds of the specimens, eliminating the duct as corrosion protection for the prestressing tendon. Test results indicate the potential for durability problems when using galvanized ducts in aggressive exposures.

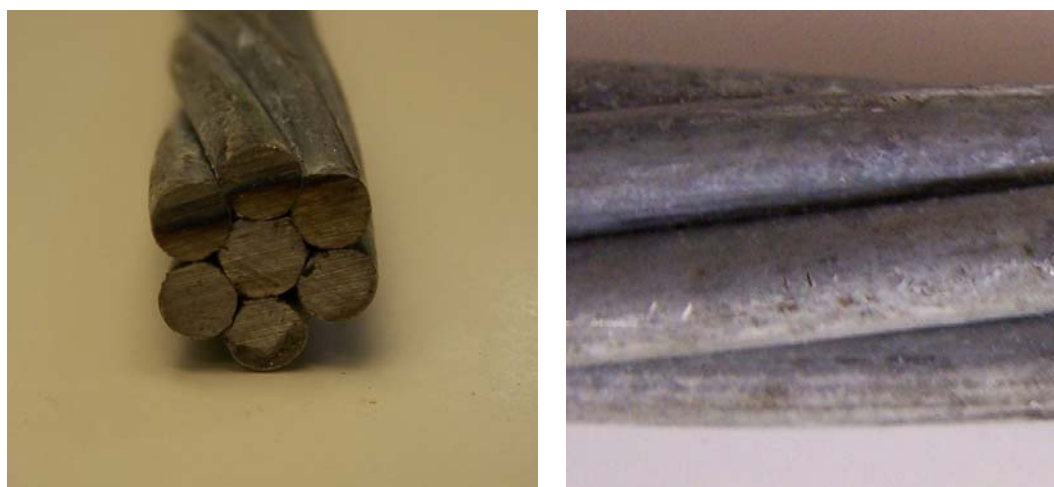
*a) Cross Section*

*b) Surface*

Although the zinc coating is beneficial to the strand's corrosive performance, the strand strength is affected by the galvanization process. Heating during galvanizing reduces the tensile strength to approximately 240 ksi (FHWA 2004). In addition to decreasing strength, the hot dip coating process also does not allow for uniform zinc coating. The zinc coating could block the grooves on the inside surface of the wedge and cause the stand to slip during anchoring.

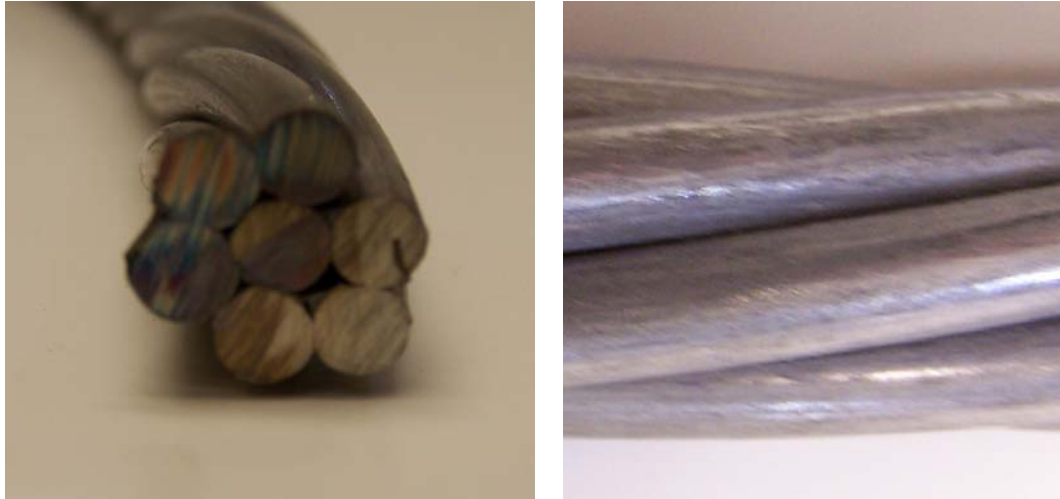
***Figure 2.4: 0.6" Stainless Steel Strand***

*a) Cross Section*

*b) Surface*

The stainless steel strand shown in Figure 2.4 was provided by Techalloy Company, Inc. The stainless strand was originally produced for a bridge project in California. The strand became available to the research project when the

bridge project switched to conventional strand. The stainless strand provided was 0.6" strand, but the post-tensioning hardware was designed for 0.5" strand. Because the stainless strand was rare and donated, special anchor heads were machined by VSL to accommodate the three 0.6" strands in the 0.5" bearing plate.

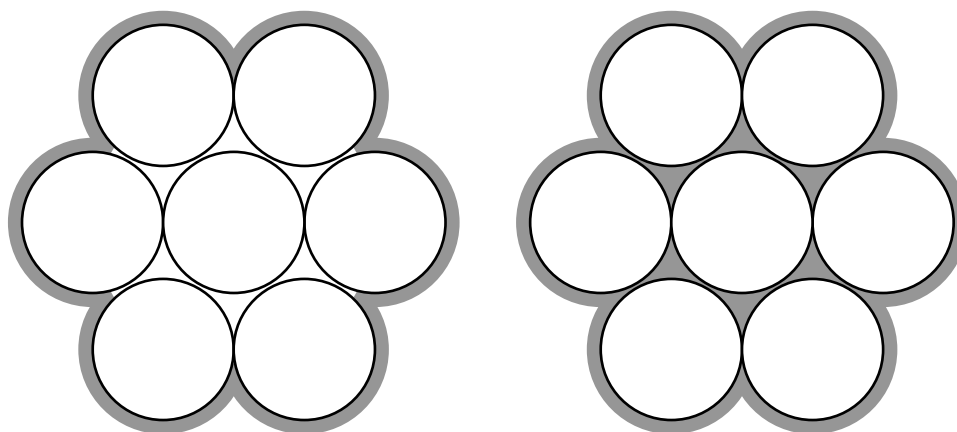
***Figure 2.7: Unfilled (left) vs. Filled (right) Epoxy Coated Strand Cross Sections***

core wires, the wires then corroded and the bond with the coating reduced (FIB Bulletin 11 2001). As the strand-coating bond is reduced, the bond between strand and structure for bonded post-tensioning response may be affected. Today, the seven-wire strand is opened during coating and closed again. Therefore, all wires are completely coated and there no voids in the cross-section. The unfilled and filled epoxy strand cross sections are shown in Figure 2.7.

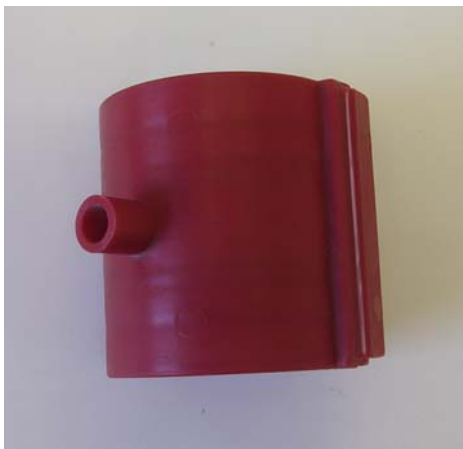
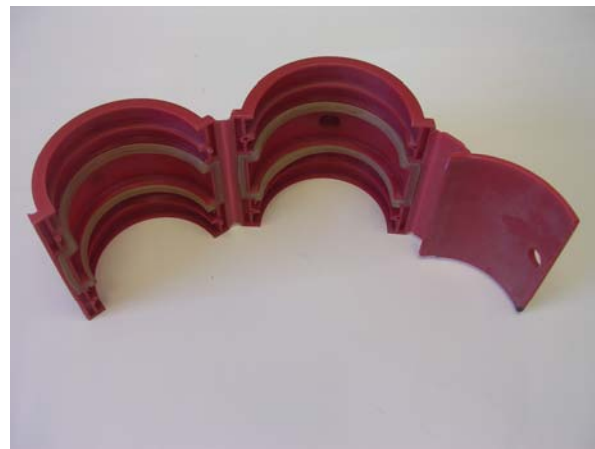
**Figure 2.11: GTI 76mm Plastic Duct Snap-On Coupler**

*a) Assembled*

*b) Unassembled*

The snap-on couplers provided by GTI are designed for the one-way ribbed duct and can not accommodate the two-way ribbed duct due to the additional ribbing. Plastic hinges connect the three segment of the snap-on coupler: two half-shells and a rigid fold-over section that holds the coupler together. Rubber rings inside the half-shells seal the splice; therefore, it is not necessary to seal the edges of the coupler using heat-shrink sleeves or any other means. Grouting vents were built into the snap-on couplers. The GTI snap-on coupler is shown in Figure 2.11.

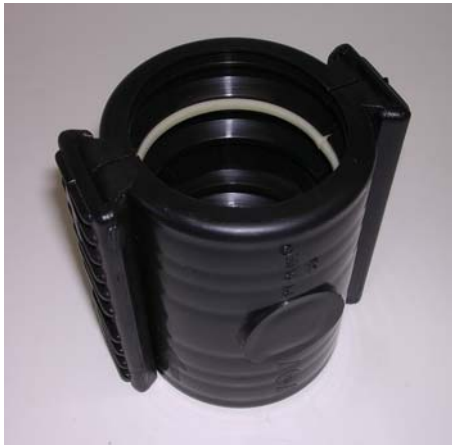
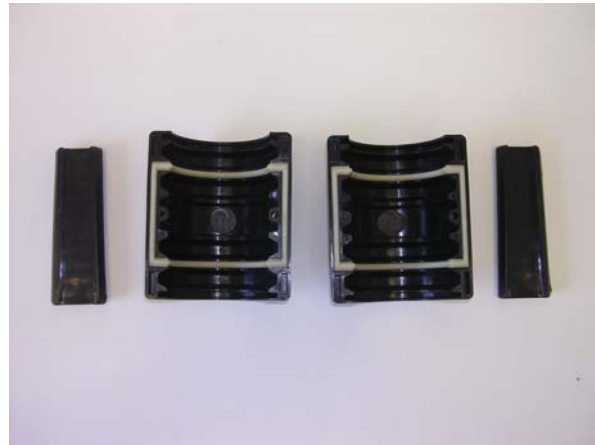
**Figure 2.13: VSL PT-Plus Plastic Duct Coupler**

*a) Assembled*

*b) Unassembled*

VSL produces the PT Plus plastic duct (59 mm) utilized for current research specimens and is shown in Figure 2.12. The duct is ribbed circumferentially and can be coupled with a robust four-part system: two half shells and two locking tabs along the sides. The VSL coupler is shown in Figure

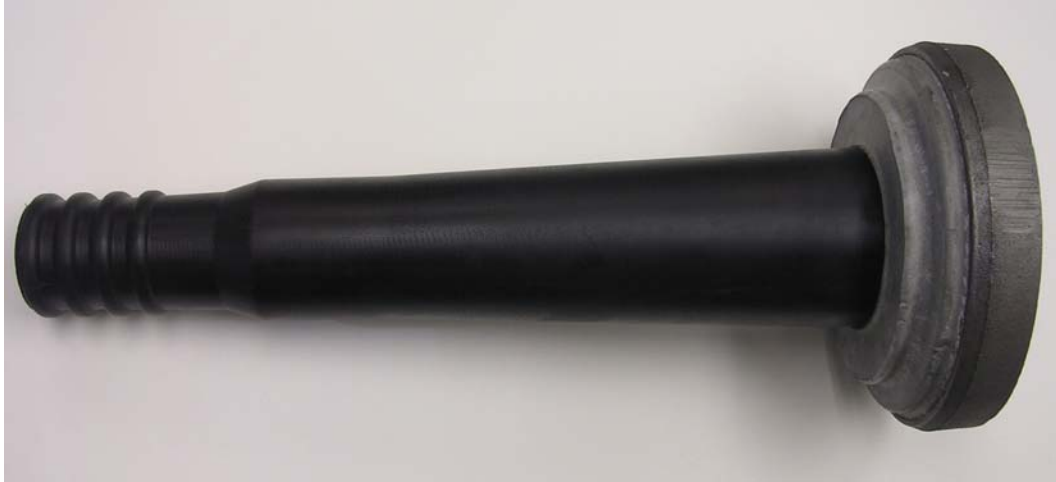
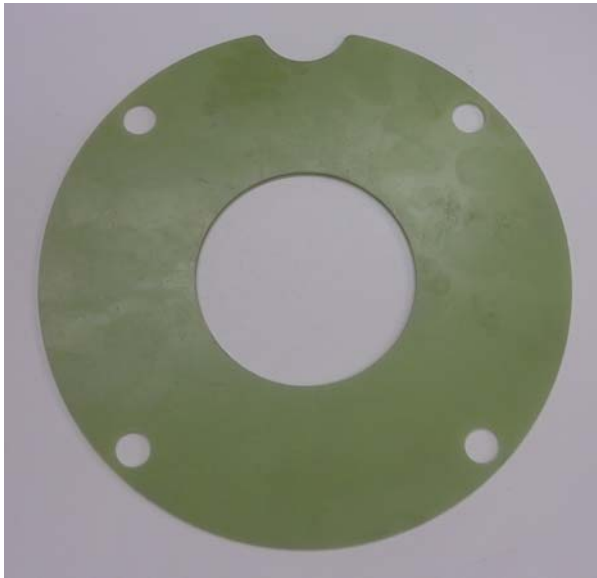
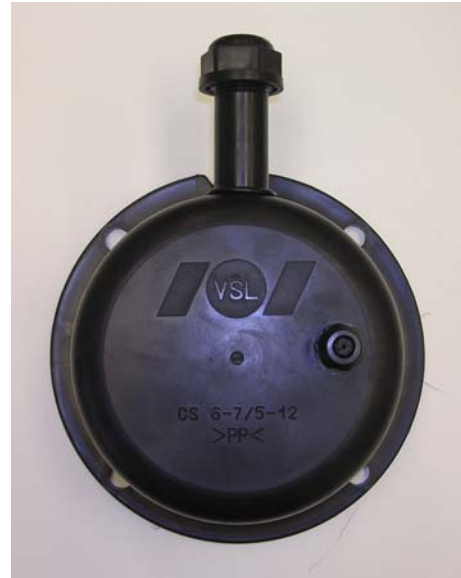
*Figure 2.18: VSL Electrically Isolated Tendon Materials*

*a) CS2000 6-7 Bearing Plate*

*b) Insulation Plate*

*c) Protection Cap*

Electrically isolated tendon (EIT) systems employ several levels of active corrosion protection. The tendon is electrically isolated from the rest of the post-tensioning hardware by means of an isolating insert between the anchor head and bearing plate. Plastic duct is standard and is connected to the plastic bearing plate trumpet by a rigid plastic coupler. A permanent plastic isolation protection cap seals the anchorage during grouting of the tendons and backfilling of the anchorage pocket with grout. See Figure 2.17 for an example detail of an EIT system from FIB Commission 5 (2004). The materials for the EIT specimens provided by VSL Switzerland are shown in Figure 2.18.

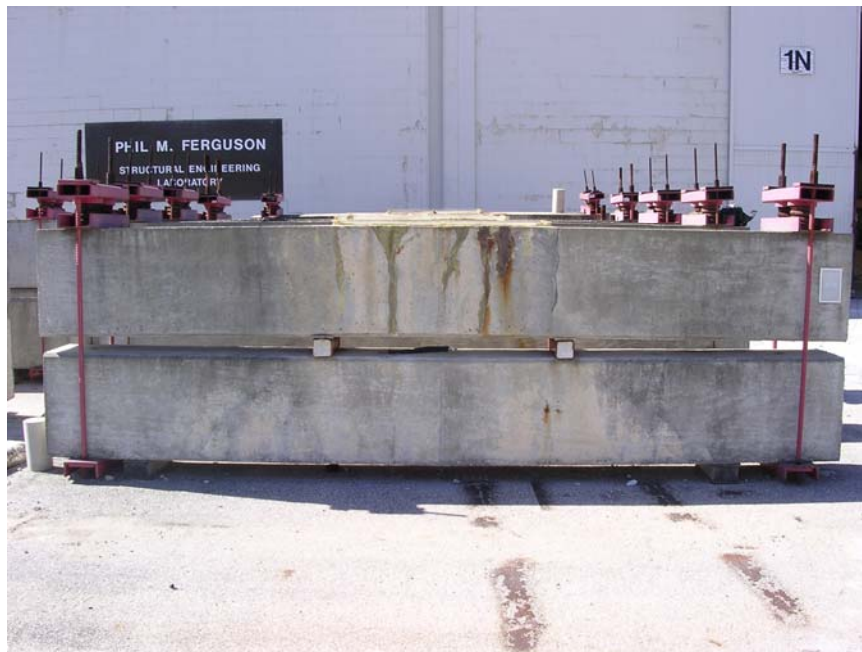
*a) In-Service Project 1405 Research Specimen*

**Figure 3.1: Project 1405 Research Specimen**

Large beam specimens from Project 1405 were still under load at the north end of FSEL during the design of the new specimens. The 1405 specimen consists of double-stacked beams with identical dimensions, but different content. The lower beam is heavily reinforced and serves as a reaction beam to load against. The upper beam was post-tensioned to various levels and the focus of the research. In each prestressed upper beam, there were two draped ducts with three strands per tendon. On the top surface of the upper beam, thin plastic walls sealed with silicon form a pool in order to pond saltwater. The region of research interest was directly beneath the pool. The saltwater exposure region is approximately the width of the beam and 4 ft. long, centered along the 15 ft.-2 in.

length. Therefore, only a small portion of the beam was being exposed and monitored. In addition to the exposure on the top surface, saltwater was also sprayed over the dead end anchorage zones on Beams 2.7, 2.9 and 2.12. The double-stacked research specimen from Project 1405 is shown in Figure 3.1a and detailed in Figure 3.1b.

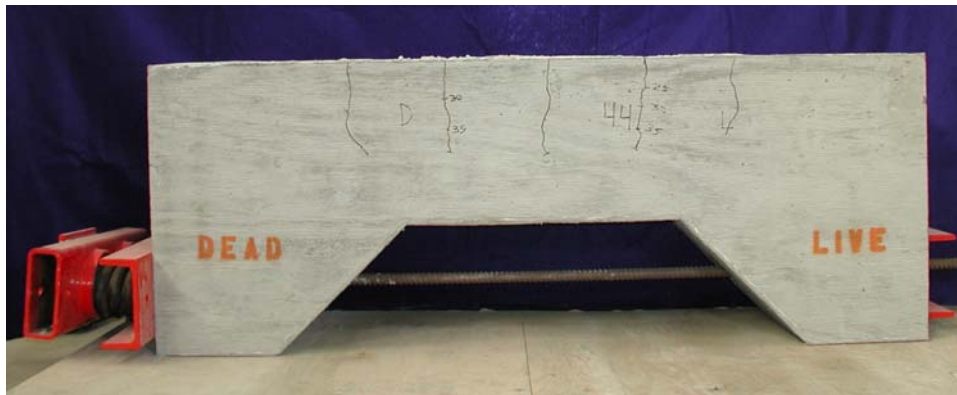
*a) Completed Project 4562 Research Specimen*

The new research specimens were designed to provide the same type and quantity of results using much less materials in a more efficient approach than the previous specimens. As in Project 1405, the new specimens each have two ducts with three strands per tendon. While the new specimen is over 9 ft. shorter than the old specimens, the saltwater exposure region is only 1 ft. shorter than old specimens. Therefore, the quantity of durability exposed post-tensioning duct and strand in each specimen is quite comparable for the current and past research specimens. Saltwater will also be sprayed on the anchorage zones of the new beams similarly to the 1405 beams. All loads in the new specimens are self-contained. Therefore, there is no need for a reaction beam. The new research specimens are shown in Figure 3.2a and detailed in Figure 3.2b. The same steel sections in contact with the 1405 and 4562 test specimens in Figures 3.1a and 3.2b provide a means of comparing the size of the specimens.

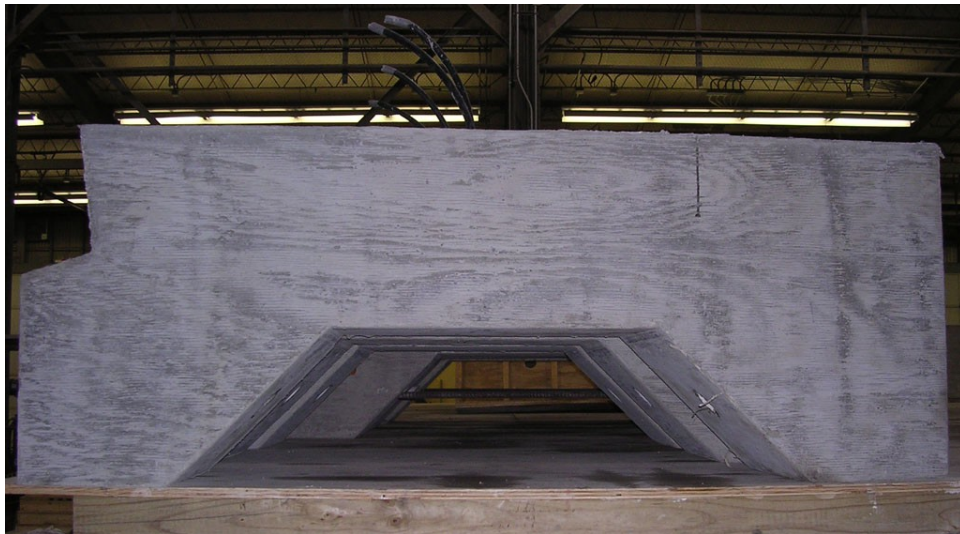
*Figure 4.1: Research Specimen Profile*

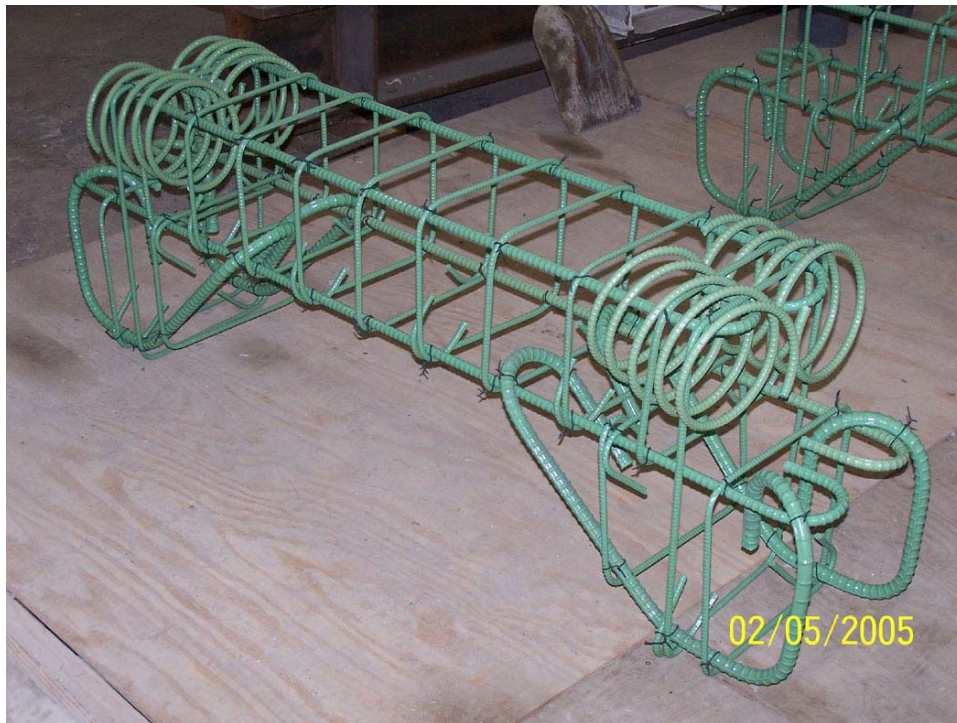
***Figure 4.4: Completed Passive Reinforcement Cage***

The reinforcing steel was delivered to FSEL bent and epoxy-coated as specified. As specified by the supplier, cages were tied together using coated wire provided by the supplier. Conventional wire ties could not be used because the bare wire might damage the epoxy coating. A completed steel reinforcement cage is shown in Figures 4.4.

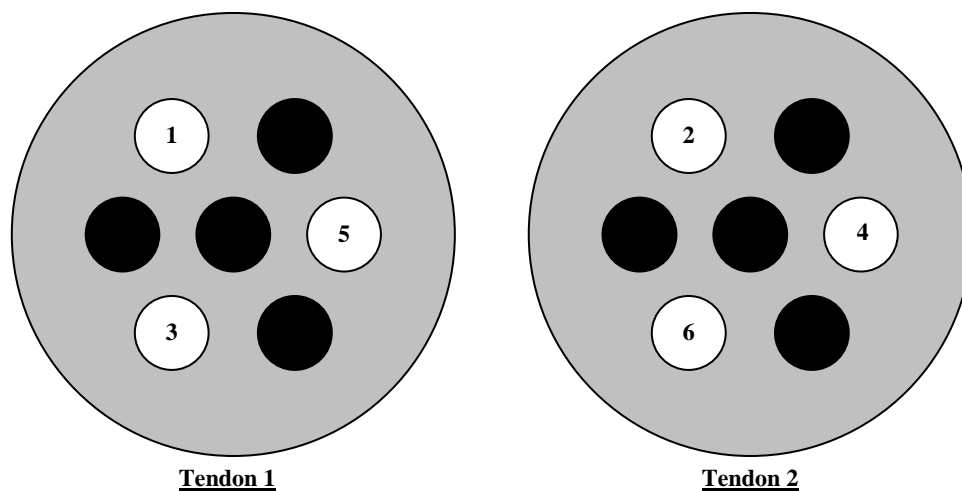
***Figure 4.7: Stressing Sequence (Live End Shown)***

When stressing is completed sequentially instead of all at once, induced tensile forces in elements stressed early in the stressing process can be reduced as compressive strain from subsequent stressed elements allow already stressed elements to relax. Due to equipment limitations caused by material availability, individual strands, not full tendons, were stressed sequentially. Although the shortening losses were assumed to be negligible due to the low levels of prestress (15% GUTS), steps were taken to minimize potential effects. Stressing of individual strands was alternated between the two tendons. The stressing sequence is detailed in Figure 4.7.

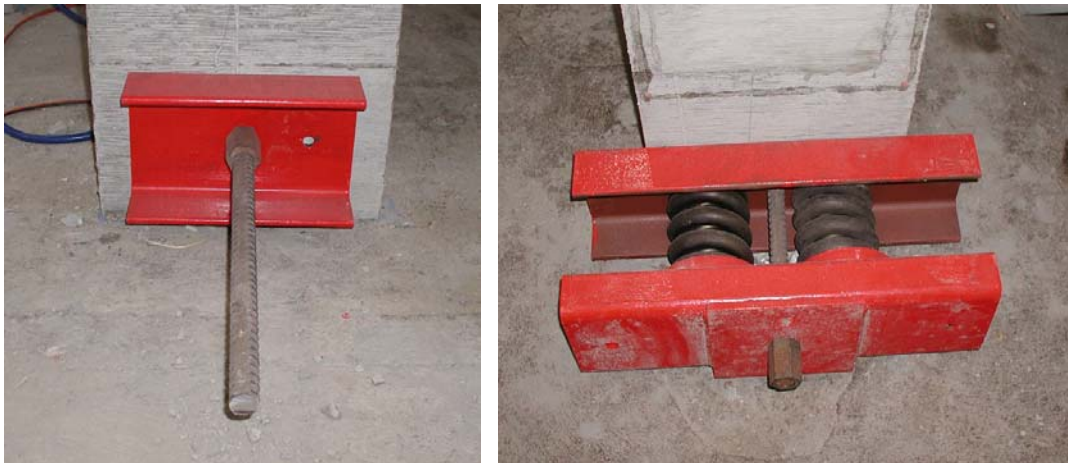
***Figure 4.9: Dywidag Assembly, Live End (Left) and Dead End (Right)***

4. Incrementally stress Dywidag bar and check for cracks between loading; if cracks are present, trace crack with a marker and record crack width and corresponding load.
5. Once acceptable cracking according to Section 3.1.2 has taken place, tighten the Dywidag nut at the live end to maintain level of force and then release ram pressure.

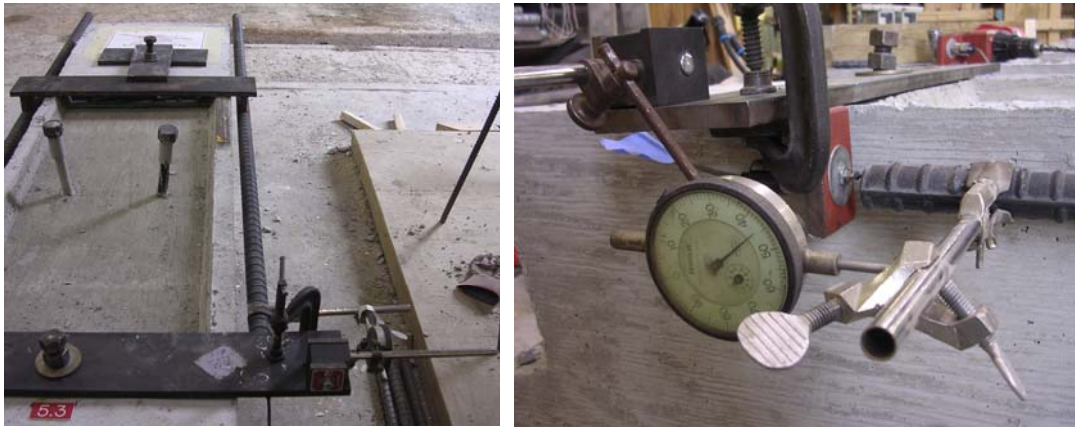
**Figure 4.10: Data Acquisition Hardware**

*a) overview*

*b) close-up*

During the stressing processes, a data acquisition system was used to record strain along the top of the beam and applied force. The change in length along the top surface was measured using two LVDTs – one on each side of the beam – and a rigid assembly attached to the beam using the lifting anchor inserts; therefore, LVDTs measured total change in length in the region between the lifting anchors which includes the reduced section of interest. The hardware for measuring elongation and compression along the top of the beam is shown in Figure 4.10 while the data collection equipment is shown in Figure 4.11.

Force was measured using a pressure transducer attached to the pump. The applied force is the pump pressure multiplied by the effective area of the ram. Redundant mechanical systems were in place to check the electronic output before and during stressing. A dial gauge assembly was attached parallel to the LVDTs and a pressure gauge was placed inline with the pressure transducer.

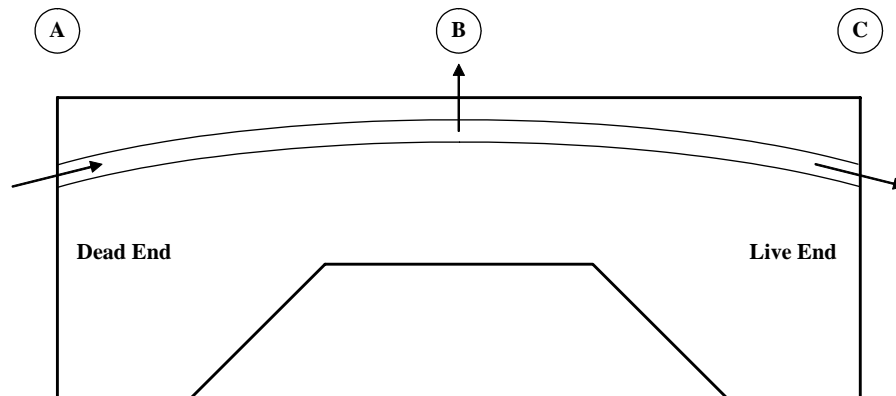
**Figure 4.12: Grouting Procedure**

1. Pump grout into ducts at A.
2. Cap grout vent at B once consistent flow is observed from the vent.
3. Cap grout vent at C once consistent flow is observed from the vent.
4. Maintain grout pressure with vents closed for approximately 1 minute and then open vent at B to allow any trapped air to escape. Recap vent at B once even flow resumes.
5. Cap grout vent at A.

Grouting was completed within 48 hours of stressing as required in Section 426.9 of Texas Standard Specifications. Sika Grout 300 PT was used to grout the ducts. Sika is a non-bleed, high flow and sand free grout. The grout was proportioned according to bag instructions and mixed in a bucket using an electric hand drill and paddle. A hand pump was used to place the grout into the ducts. There were three openings along the length of the duct: two grouting ports in the bearing plates and a grouting vent at the apex of the drape. Plastic hose provided by VSL was threaded into the grout ports. The hose for the vent at the apex was already in place. Plastic caps were placed at the end of all hoses to stop grout and seal the duct. The grouting procedure adopted from VSL (2002) is listed in Figure 4.12 and is shown in progress in Figure 4.13.

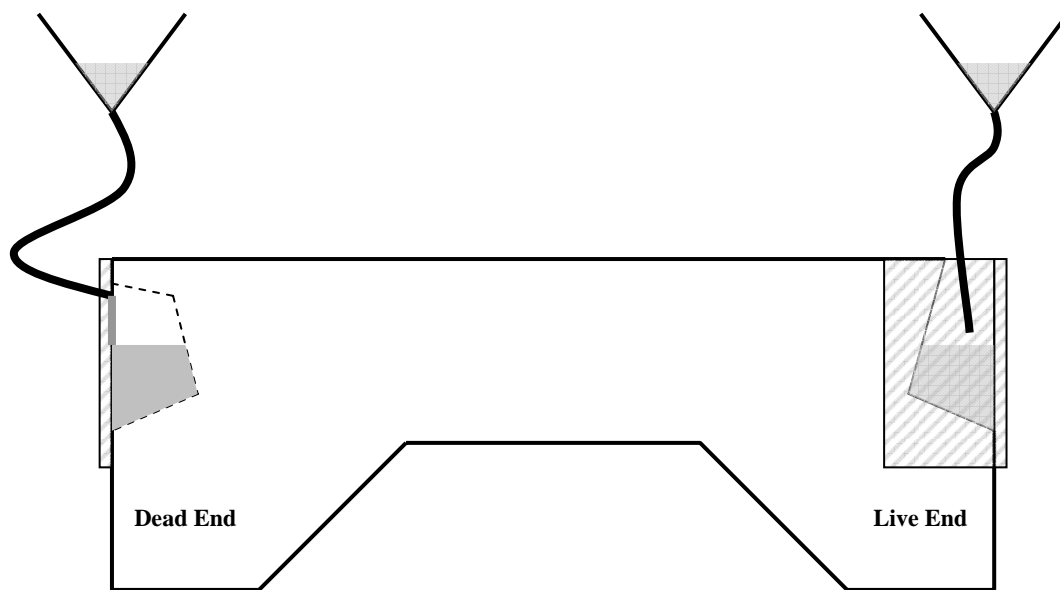
*Figure 4.15: Pour Back Process*

Forms were built to fit the dead end and live end anchorage pockets. The dead end form was attached to the specimen using plastic anchors in concrete and sealed with silicone. The live end was attached with bar clamps and sealed with silicon. Plastic buckets, funnels and plastic hoses were used to fill the anchorage pockets with Masterflow 928. The pour back process is shown in Figure 4.15.

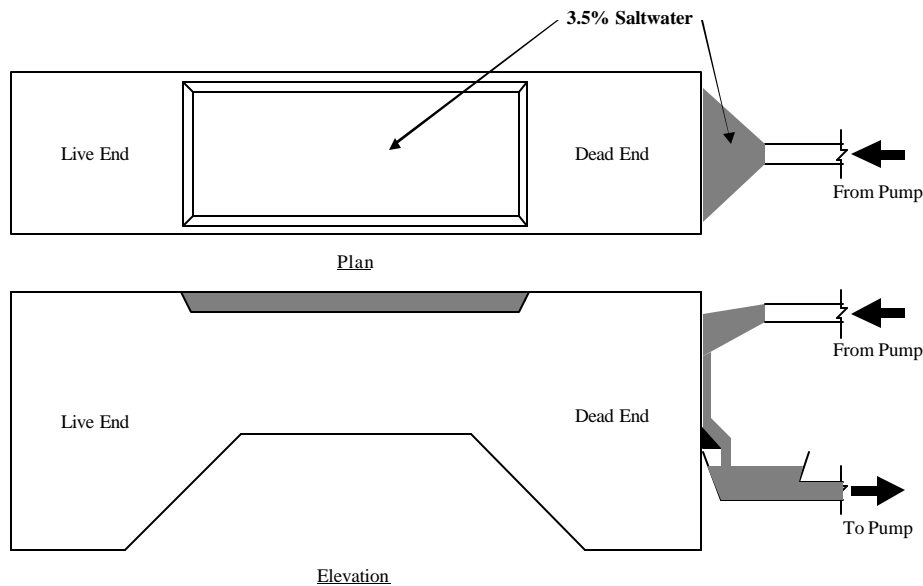
**Figure 5.4: Saltwater Exposure Detail**

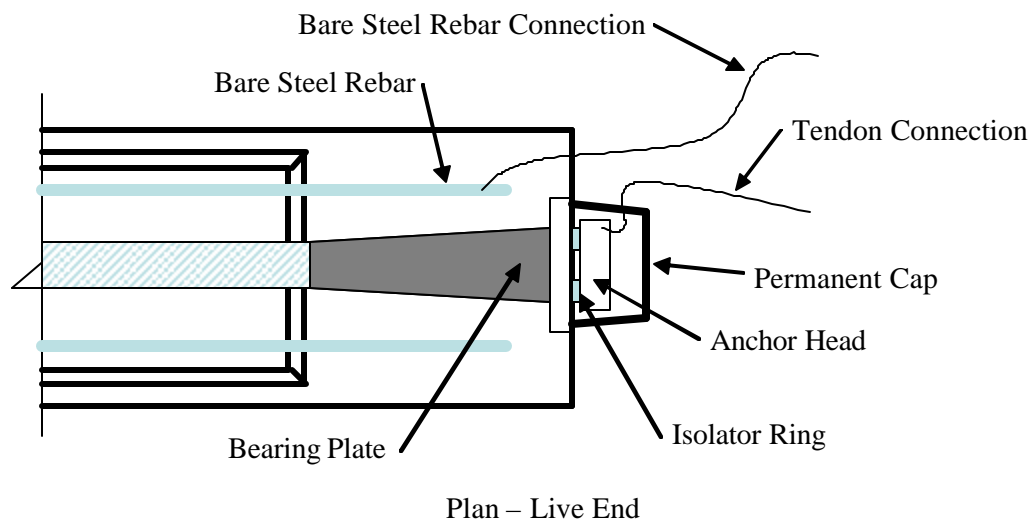
**Figure 5.7: EIT Monitoring Connections Detail**

AC impedance measurements are used to monitor the condition of electrically isolated tendons during service life. The measurements require a sound electrical connection to each individual tendon and another connection to the rebars (VSL 2003). The tendon connection is a wire attached to the anchor head that goes through the protection cap and out the concrete surface at the live end of the specimen. The rebar connection could not be made directly to the main reinforcement cage due to the epoxy coating. Therefore, two additional bare steel rebars with connection wires were placed on each side and parallel to the post-tensioning duct with similar concrete cover to conduct the AC impedance measurements. The additional bare steel reinforcement and monitoring connections are shown in Figure 5.7. Monitoring of the electrically isolated tendons is performed with AC impedance measurements at frequency of 1 kHz. From laboratory studies the limiting values for a sound encapsulation was found to be 500 kW\*m (VSL 2003).

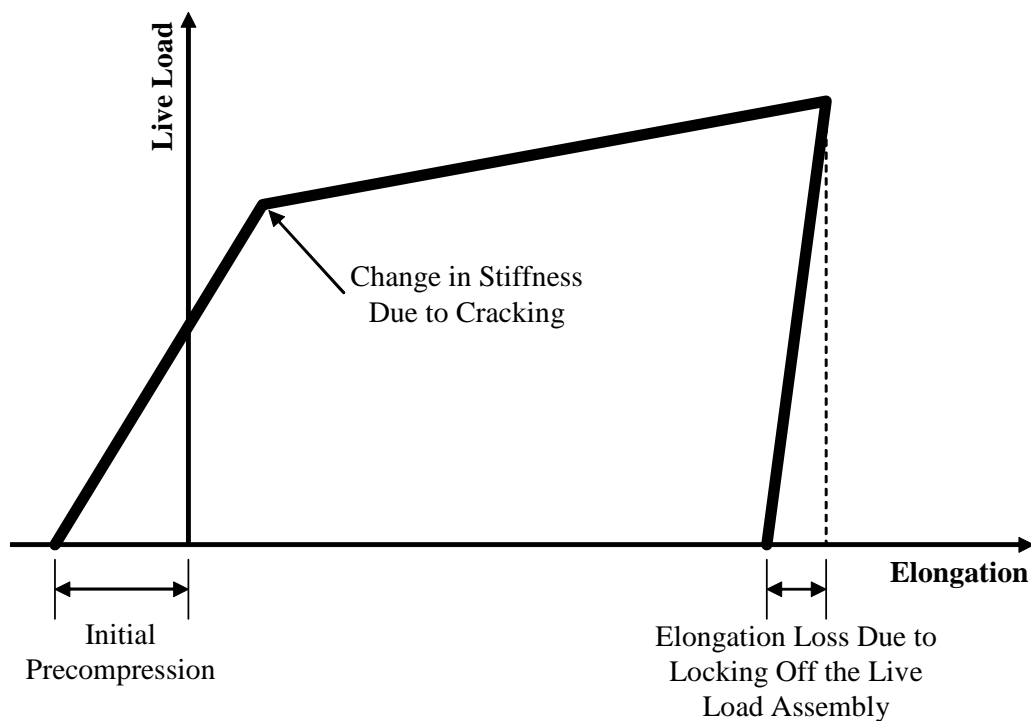
*Figure 6.2: Characteristic Load-Deformation Plot*

Cracks in the concrete were traced with a marker as they formed. The crack widths were determined using an optical crack microscope. Magnified cracks were compared to a scale with 0.001 in. increments seen through the lens to determine width.

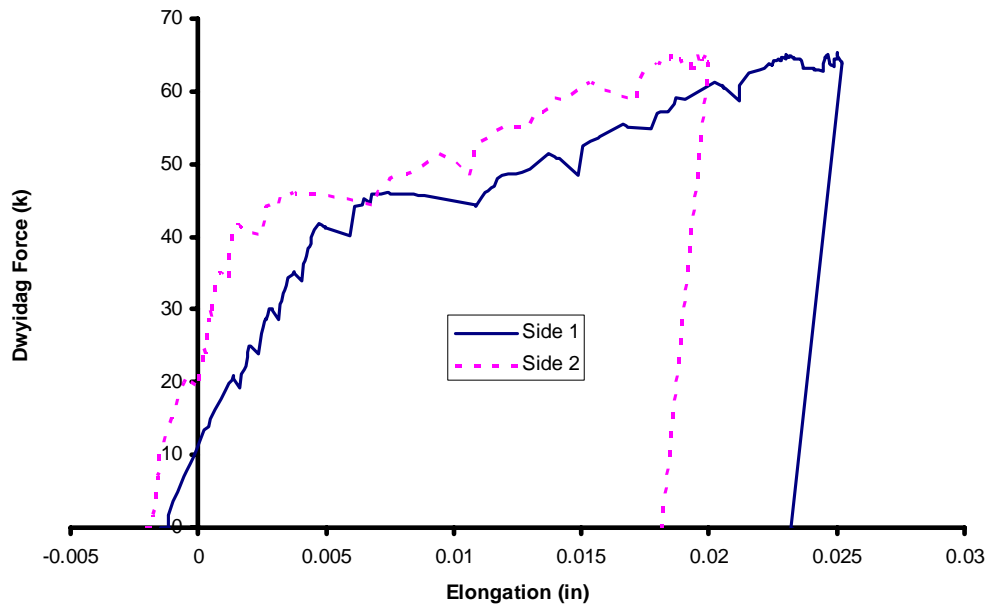
**Figure 6.3: Beam 1.1 Live Load Application Plot**

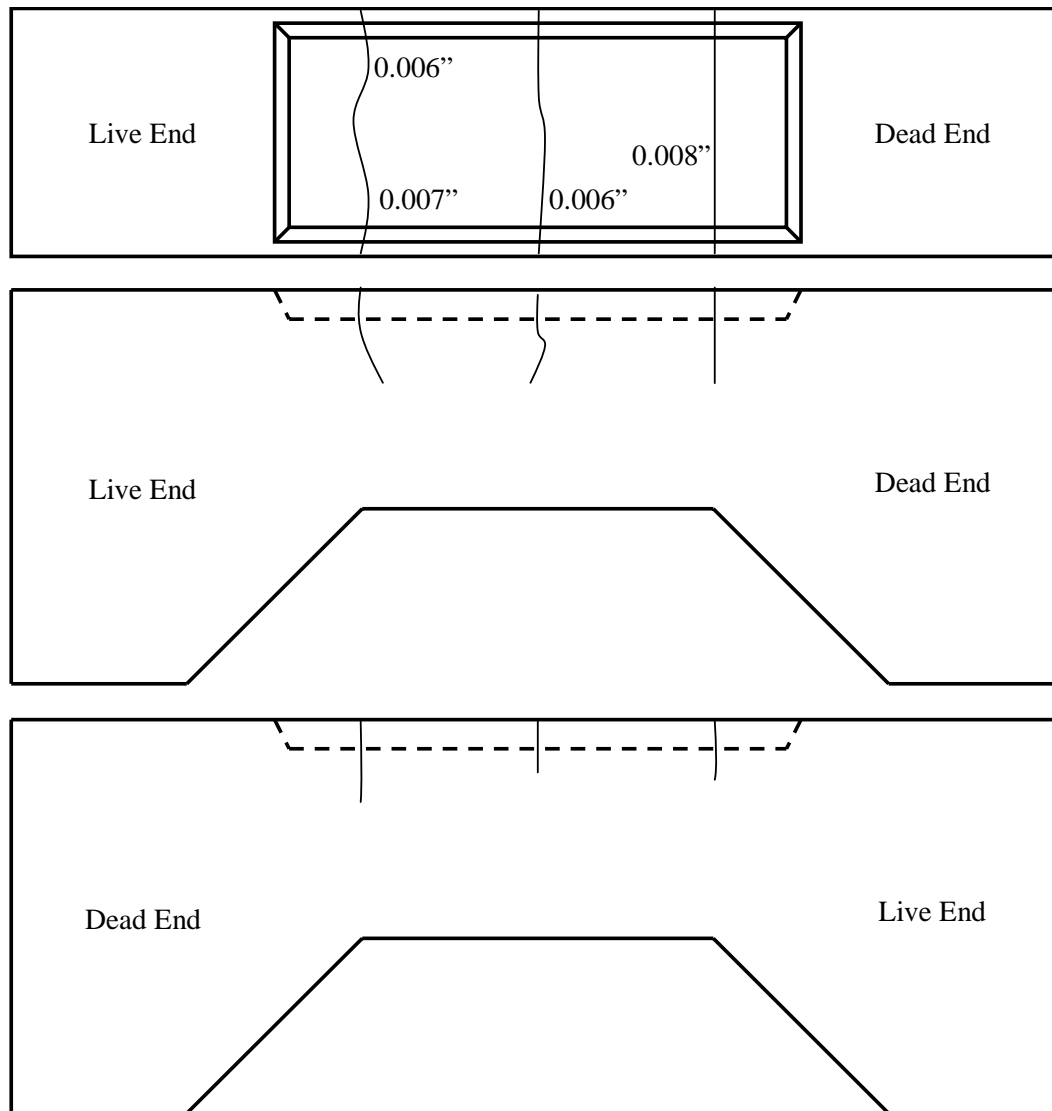
*Figure 6.4: Beam 1.1 Crack Map*

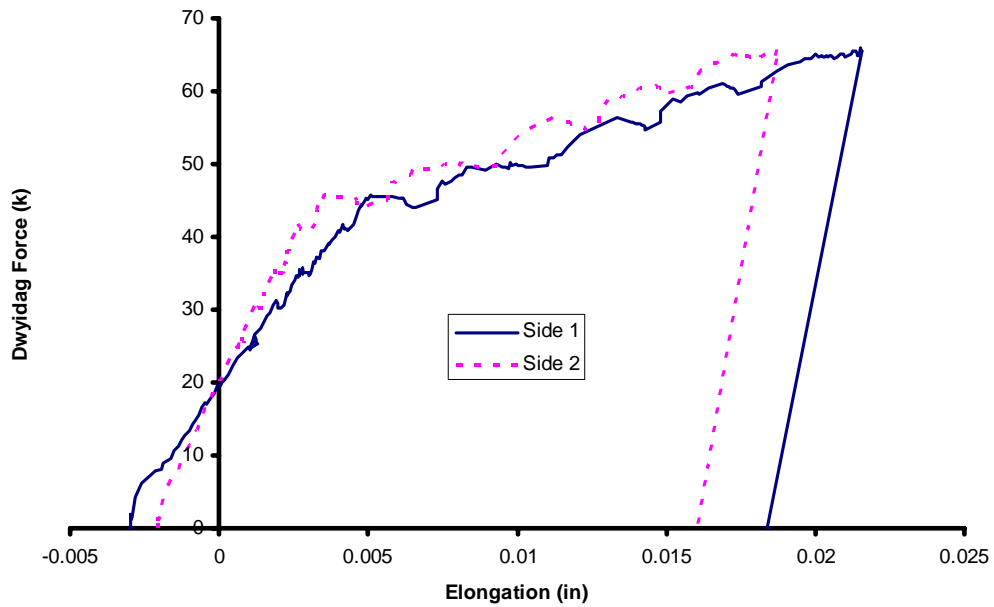
**Figure 6.5: Beam 2.2 Live Load Application Plot**

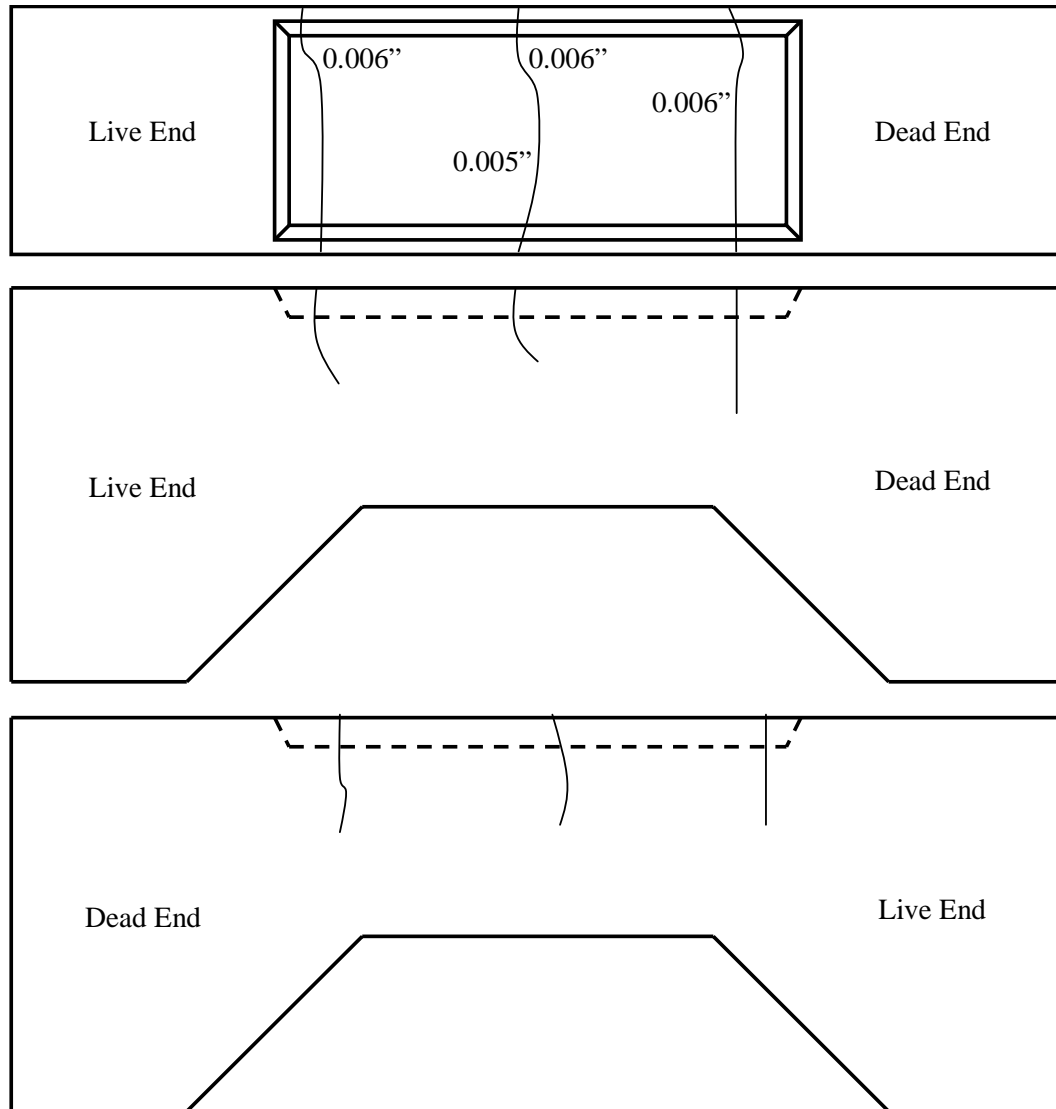
**Figure 6.6: Beam 2.2 Crack Map**

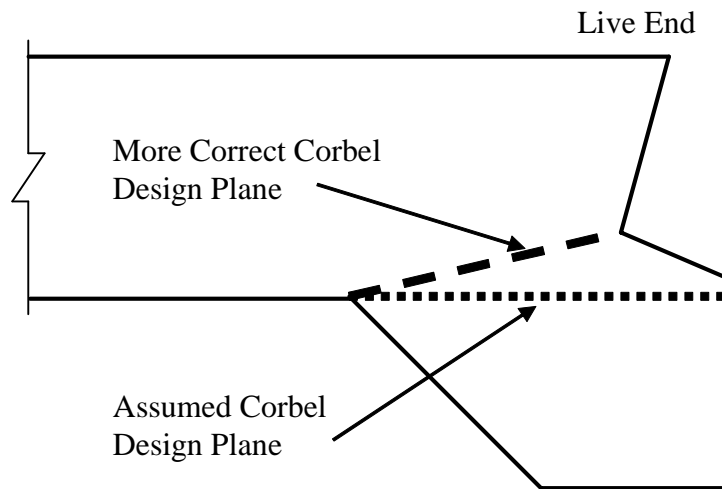
**Figure 7.2: Corbel Design Planes**

- *Exclude Reentrant Corner:* Cracks in the corbels formed during the live load application propagating from the reentrant corner at the live end of the specimen. The open live end was included to provide access for the equipment that was originally intended to prestress the specimens. Due to changes in the type of anchor heads after specimen production began, the original stressing equipment was not used. A monostrand ram was used to prestress the specimens. Because of the narrow nose of the monostrand ram, it did not require an open live end.
