**Design and Fabrication of a Compact Specimen for Evaluation of  
Corrosion Resistance of New Post-Tensioning Systems**

**Thesis**

The University of Texas at Austin

**May 2005**

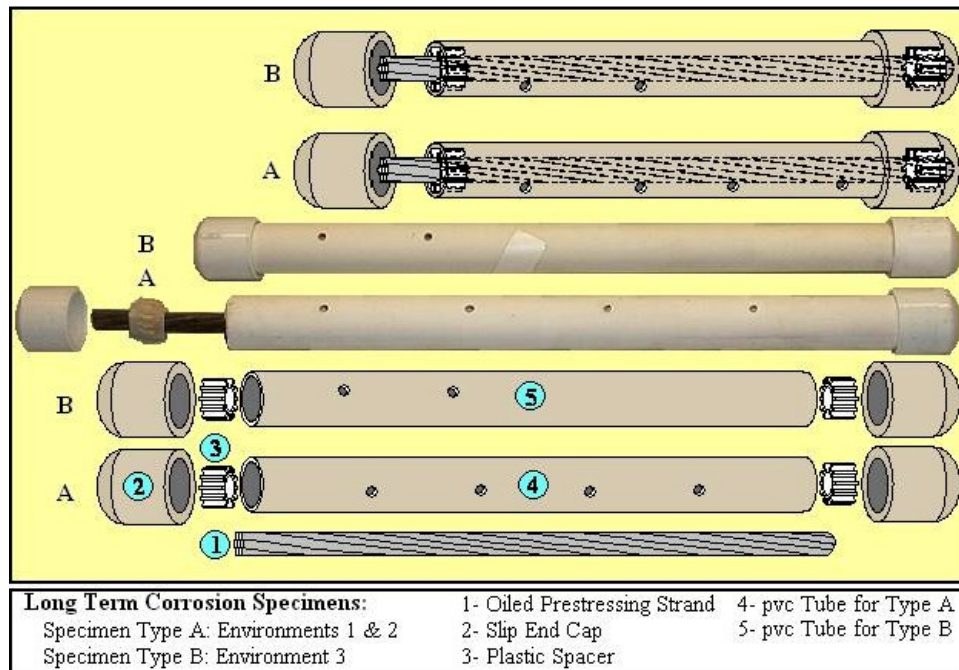
**Figure 7.3: PSU Strand Accelerated Corrosion Test Specimen (Salcedo 2003)**
