**Computation of Vehicular-Induced Vibrations and Long-Term
Instrumentation Reliability for Structural Health Monitoring of
Highway Bridges**

Dissertation

The University of Texas at Austin

August 2013

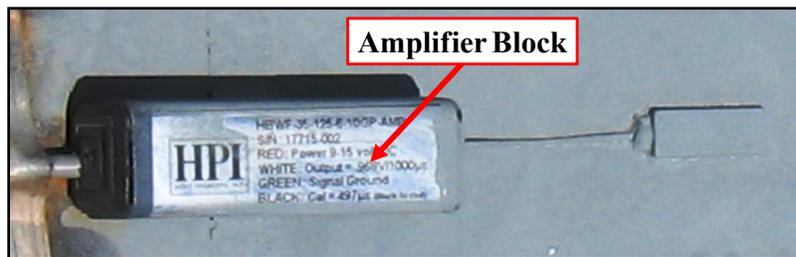
Figure 6-6: Amplifier block of amplified weldable gage

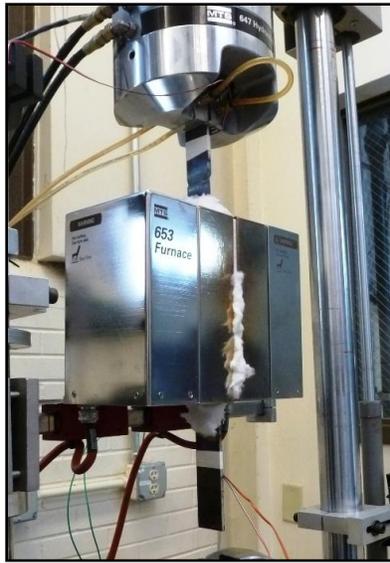
Figure 6-18: Steel bar placed inside a MTS furnace
