**Acoustic Emission Monitoring of Prestressed Bridge Girders  
with Premature Concrete Deterioration**

**Thesis**

**The University of Texas at Austin**

**May 2001**

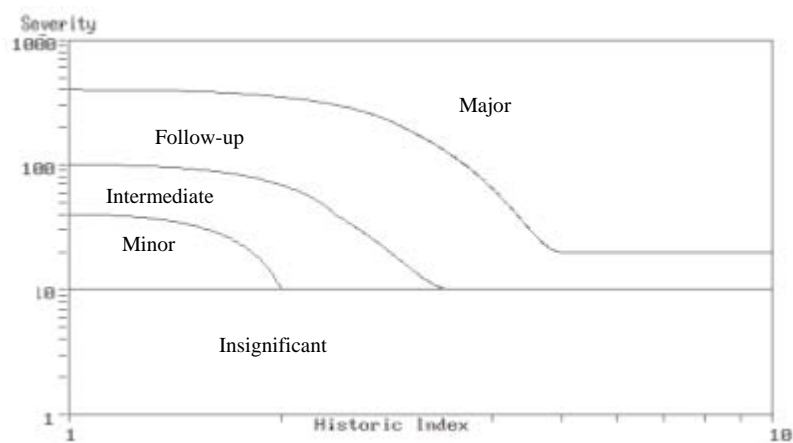
The results of historic index and severity for each channel are plotted on an intensity chart which uses a log scale for both historic index and severity. Figure 2.2 shows the intensity chart for FRP vessels monitored with 150 kHz sensors. The chart is divided into zones of defect intensity marked as: “Insignificant”, “Minor”, “Intermediate”, “Follow-up” and “Major”.

**Figure 2.2 – Intensity Chart for FRP Vessels Monitored with 150 kHz Sensors (CARP)**

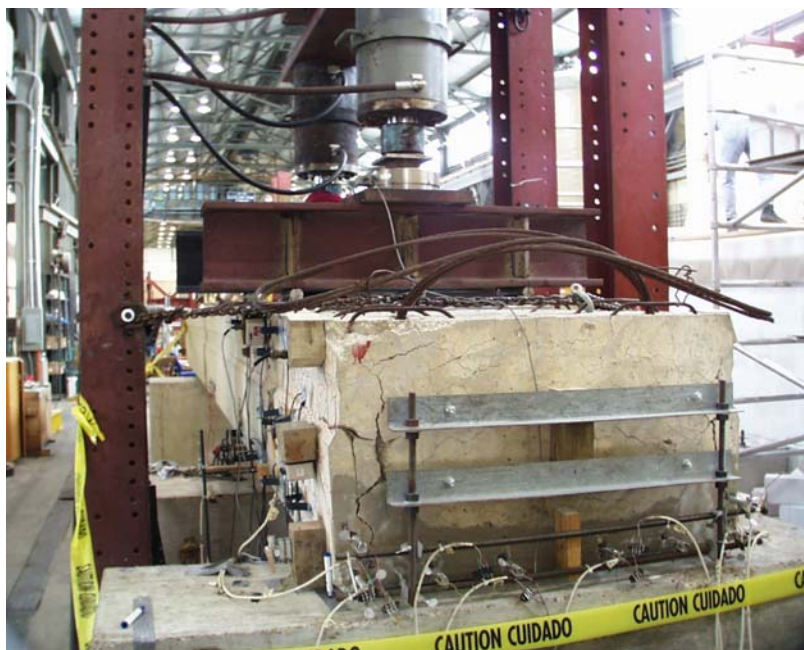
were oriented in the longitudinal direction and placed above the beam webs in order to prevent a punching shear failure of the top flange. The same grade of 1/8 inch thick neoprene pad was placed between the rollers and the girder in order to prevent background noise from the rams contaminating the acoustic emission data during cyclic loading. The test setup is shown in Figure 3.2.

**Figure 3.2 – Test Setup of Shear-Dominated Fatigue Test**

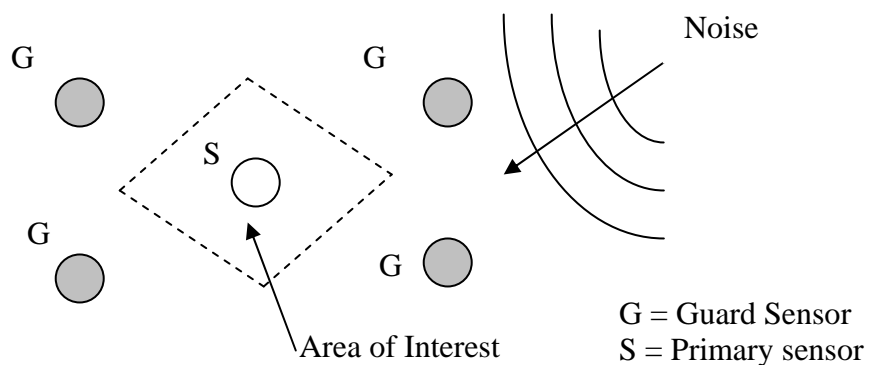
The second way is through post-test analysis. During the test, all hits detected by both primary sensors and guard sensors are recorded. Post-test software is used to identify which sensors were hit first by an event, and which acoustic emission originates in the region of interest and which comes from outside. This type of analysis is sometimes referred to as “first hit” analysis. The post-test analysis method retains all data and allows for manual inspection of the data. Accordingly, there is less chance of discarding genuine data. On the other hand, the post-test method does not permit a real-time assessment of the significance of the acoustic emission data, and requires the instrument to store several orders of magnitude more data.

**Figure 5.1 - Typical Guard Sensor Setup**

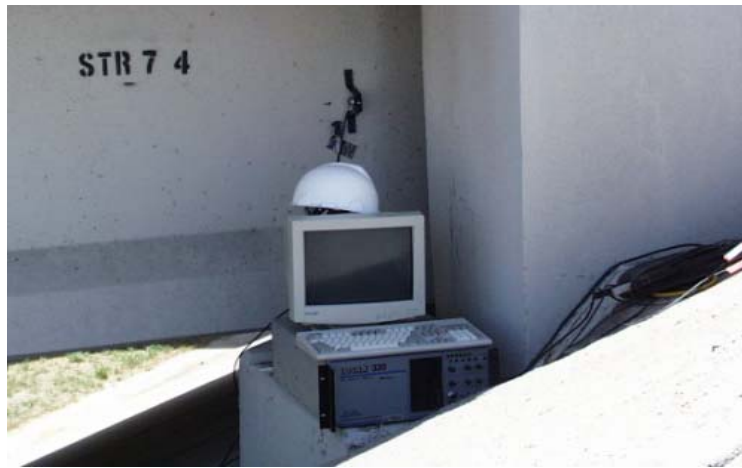
Three acoustic emission instruments were used to acquire data. The first, shown in Figure 5.2, is a six-channel LOCAN AT instrument, manufactured by PAC. It is an analog instrument, with an Intel 8 MHz 8086 CPU.

**Figure 5.2 – LOCAN AT Analog Acoustic Emission Instrument**

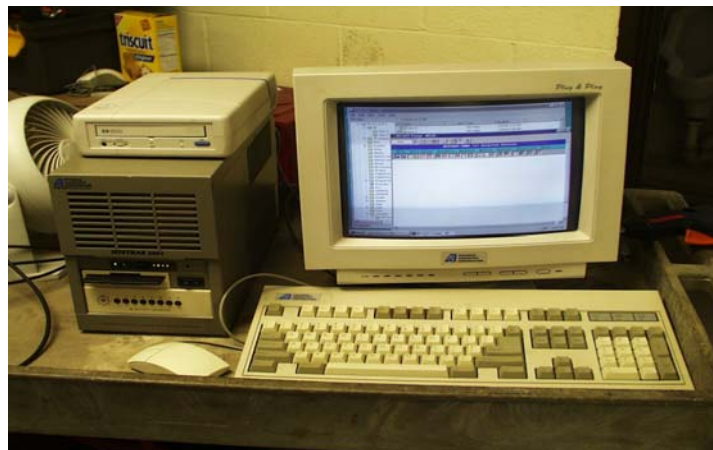
A six-channel MISTRAS 2001, also manufactured by PAC, is the second instrument used in the tests. The MISTRAS, shown in Figure 5.3, is a digital instrument with an Intel Pentium 166 MHz processor. This instrument has the ability to record a signal wave form and operate guard sensors.

**Figure 5.3 – MISTRAS 2001 Digital Acoustic Emission Instrument**

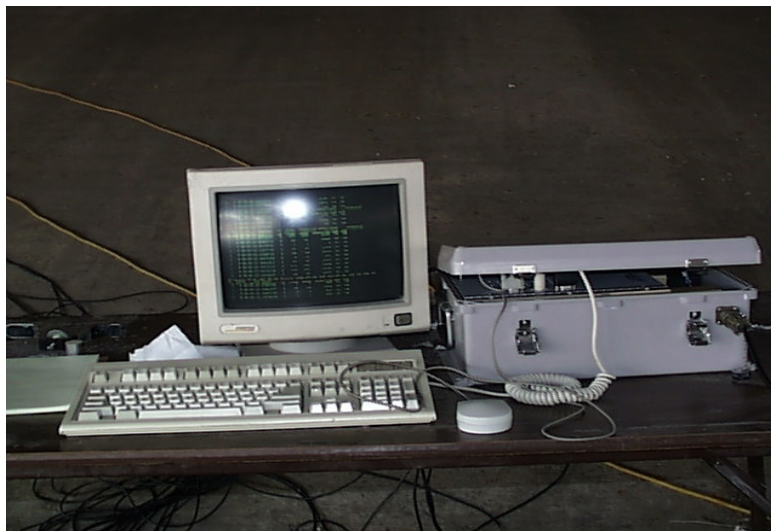
The third instrument used for the background noise tests is a Local Area Monitor (LAM), shown in Figure 5.4, also manufactured by PAC. The LAM is a digital instrument with a PC-104 CPU board, and a PC-104 modem. The system was specifically designed under a Federal Highway Administration project for remote monitoring. Setting up the instrument, downloading the acoustic emission data and controlling the machine can be done remotely. An internal battery can run the instrument up to 12 hours without recharging. The LAM can capture and store digitized wave forms and operate guard sensors.

**Figure 5.4 – LAM Digital Acoustic Emission Instrument**

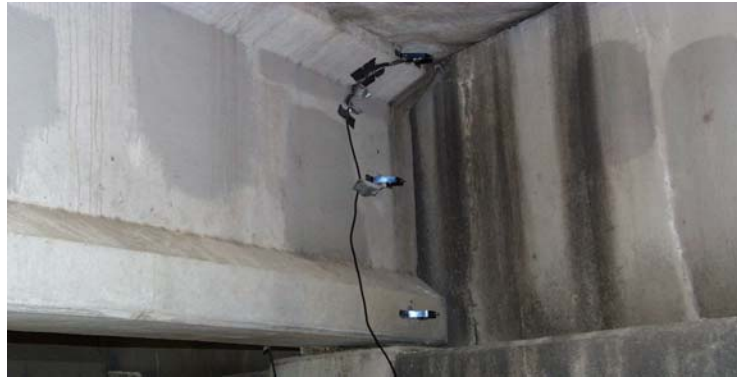
**Figure 5.5 – Attached Sensor Location**

At this site, background noise due to traffic was monitored. Data were collected using the LOCAN 320 data acquisition instrument. 60 kHz and 150 kHz resonant sensors with integral preamplifiers were used to monitor the characteristics of the background noise. A threshold of 40 dB was set for all channels. The outside (west) and the third from outside I-shape prestressed concrete girders were monitored. The outside girder supported the exit lane, while the third girder supported the middle and inside lanes going in the southbound direction. Data were recorded on the top flange, at mid-depth, and on the bottom flange. Two similar sensors were attached on both sides of the girder for each test. Figure 5.5 shows a sensor attached to the top flange and connected to the instrument. Sensor holders are mounted at the mid-height and on the bottom flange. Sensors were attached on the girder one foot from

the end. Background noise on the top flange was recorded first for 15 minutes and then these two sensors were moved in turn to the mid-depth and the bottom flange. During monitoring, the traffic flow was recorded.

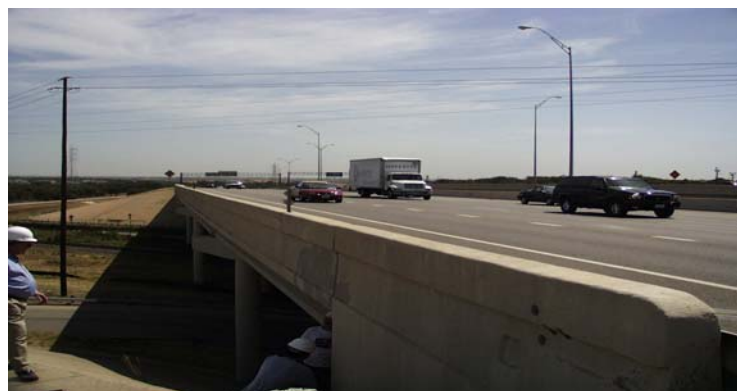
**Figure 5.6 – Southbound Mopac Railroad Overpass between Braker and Burnet, Austic, Tx**

Plots of amplitude versus time for each hit and traffic flow are shown in Figures 5.7 through 5.9. Lane 1 is the exit lane. Lane 2 and Lane 3 are the middle and inside lanes going the southbound direction.

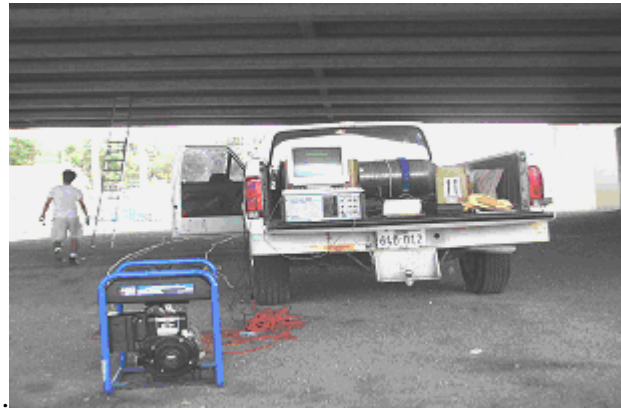
**Figure 5.10 – I-35 Overpass of U-Turn Lane near 41<sup>st</sup> Street**

The LOCAN 320 data acquisition instrument was used to record emission. As shown in Figure 5.10, a portable generator provided electricity to the instrument. The Mopac test showed that an R15I sensor reduces background noise compared to an R6I. In order to confirm this result, R6I and R15I sensors were used with two different levels of threshold setting. The outside girder supporting the exit lane (Exit 236B) and the third girder supporting the middle and inside lanes going in the southbound direction were selected to be monitored. Two sensors were attached on each side of the beam at the top flange, mid-depth, and bottom flange. The sensors were attached at mid-span of the I-shaped prestressed concrete girders. This is shown in Figure 5.11

The Mopac site discussed in Section 5.2.2 had a low amount of traffic passing over the bridge, and may not be typical. The site at the I-35 overpass U-turn lane near 41<sup>st</sup> Street was selected because it had heavy traffic passing over the bridge.

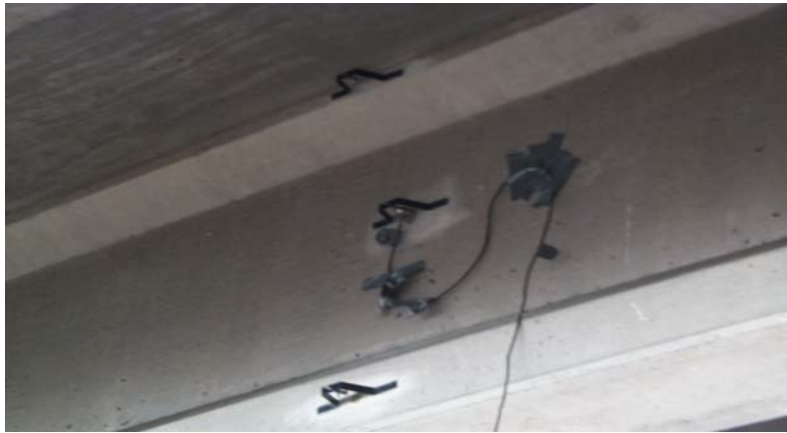
**Figure 5.11 – Arrangement of Acoustic Emission Sensors**

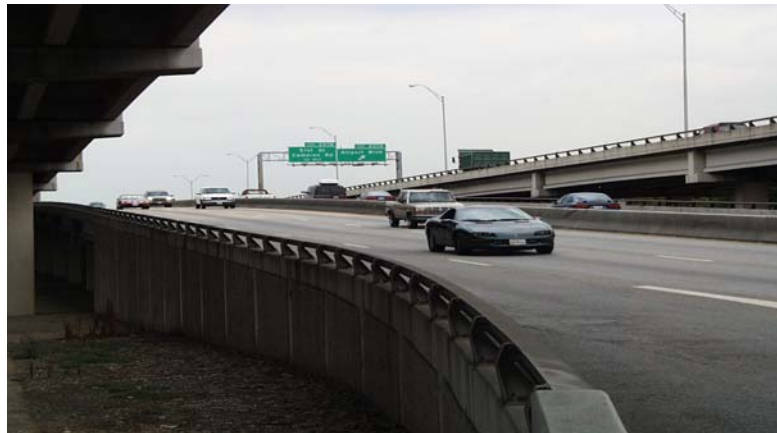
**Figure 5.12 – I-35 Overpass U-Turn Lane near 41<sup>st</sup> Street,  
Austin, TX**

The outside girder was monitored first. Thresholds equal to 50 and 40 dB were used for the R6I and R15I, respectively. The background noise was monitored for 15 minutes in each test. The plots of amplitude versus time are shown in Figures 5.13, 5.14 and 5.15. Lane 1 is the exit lane. Lane 2 and lane 3 are the middle and inside lanes going the southbound direction.

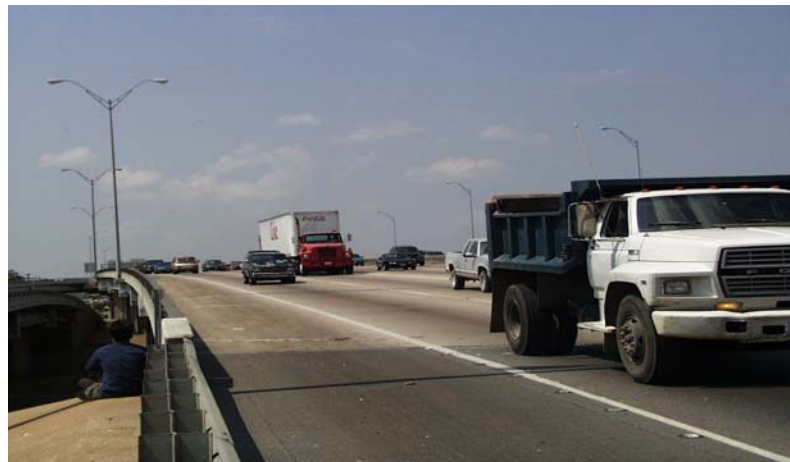
**Figure 5.19 – Northbound I-35 Overpass at Airport Blvd.,  
Austin, TX**

In the first phase, R6I and R15I sensors were used. The outside girder supporting the exit lane and the fourth girder supporting the inside lane going in the northbound direction were chosen to be the representative of other girders (Figure 5.19). The top flange, mid-depth and bottom flange were examined. Two similar sensors were mounted on opposite sides of the girder at each test location. Sensors were attached to the girder one foot from the end. Background noise on the top flange was recorded first for 15 minutes and then these two sensors were moved in turn to the mid-depth and bottom flange. A LOCAN 320 data acquisition instrument was used. The threshold was set to 40 dB. Other setting details were as shown in Table 5.1. The plots of amplitude versus time are shown in Figures 5.20, 5.21, and 5.22. Lane 1 is the exit lane. Lanes 2 and 3 are the middle lanes and Lane 4 is the inside lane going the northbound direction.

Two phases of background noise monitoring were carried out at this site. The purpose of the first phase was to investigate the background noise from the northbound lanes at the support near an abutment. This area was expected to have the most severe background noise. In the second phase, guard sensors were set up in order to evaluate the guard technique. Tests were conducted using several different sensor arrangements.

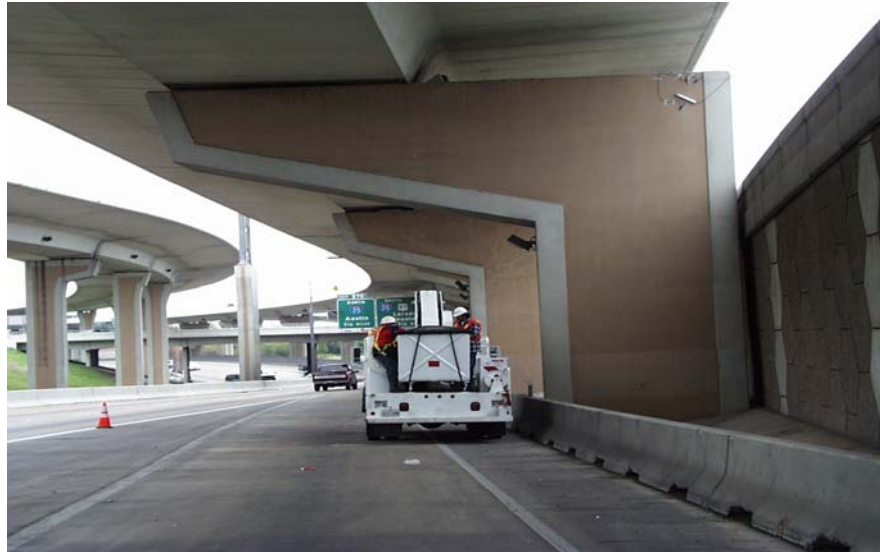
**Figure 5.29 – Monitored Column in San Antonio, TX**

A continuous monitoring test was carried out on Pier D35C near the Fredericksburg Road exit of I-35 in San Antonio, Texas. This pier has premature concrete deterioration at the corner on the top. The maximum crack size is 0.020 inch. On the east side, an epoxy repair material has been put into the cracks to prevent moisture penetrating into the structure. Continuous

acoustic emission monitoring was performed during the period 11/15/2000 to 11/20/2000.

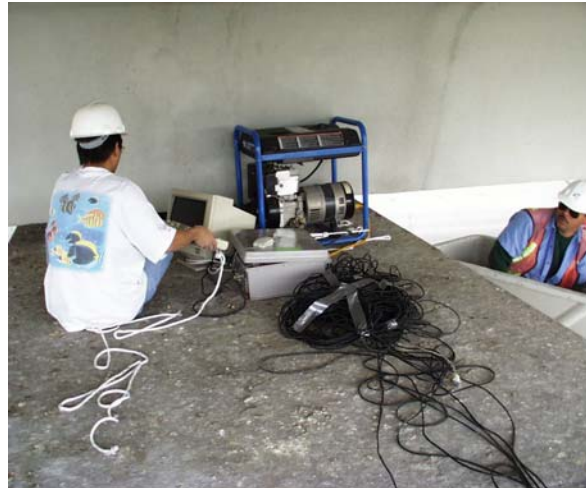
**Figure 5.31 – Location of LAM and Generator**

The acoustic emission instrument and generator were placed on the top of the pier during the test period (Figure 5.31). The instrument settings used for the test are shown in Table 5.5.
