**Development of an Embedded Wireless Corrosion Sensor for
Monitoring Corrosion in Reinforced Concrete Members**

Thesis

The University of Texas at Austin

May 2004

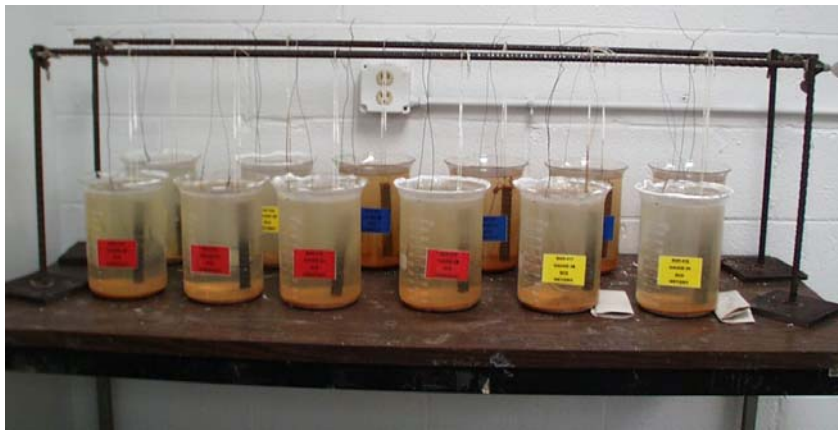
Figure 3-1. Accelerated corrosion test setup

Accelerated corrosion tests were conducted to relate the corrosion thresholds for each wire size to the progression of corrosion in rebar. Short sections of #5 reinforcing bars and wire (Figure 3-1) were suspended in a saturated calcium hydroxide solution, which simulates the pore water in concrete.

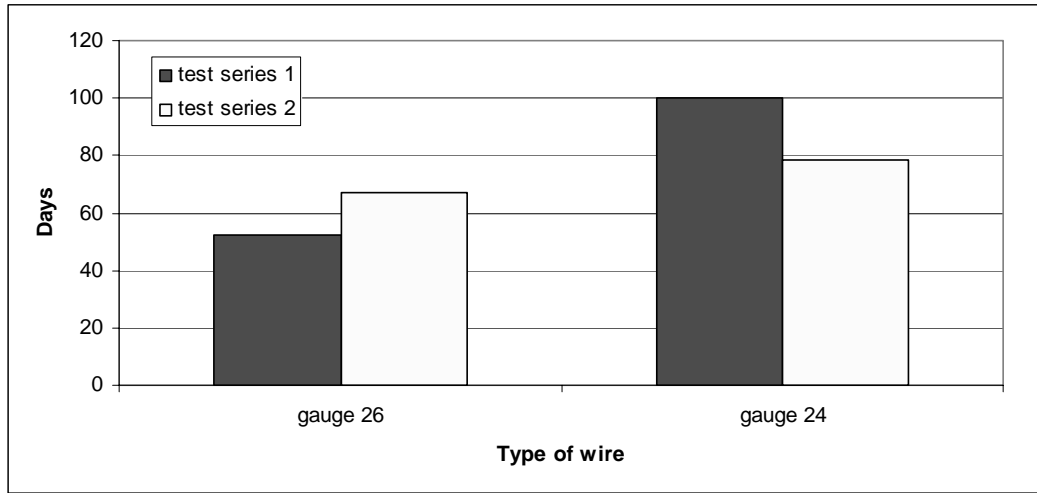
Figure 3-4. Average time to wire break for accelerated corrosion tests 1 and 2

These tests were run under the assumption that wires with smaller diameters will corrode and break in less time than wires with larger diameters. Therefore, different wire sizes could be used to detect different levels of corrosion. These times are represented in Figure 3-2 for the first set of accelerated corrosion tests and Figure 3.3 for the second set. The time to wire break for each gauge of wire was averaged and the results plotted (Figure 3.4).

The difference in the average time can be attributed to a slightly different solution mix. The results from both test series are consistent with the assumption that the smaller the wire diameter, the shorter the time required to corrode through the entire diameter. These results indicate that different diameter wires can be used to indicate different amounts of corrosion occurring in the concrete.

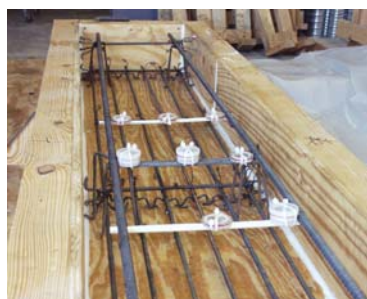
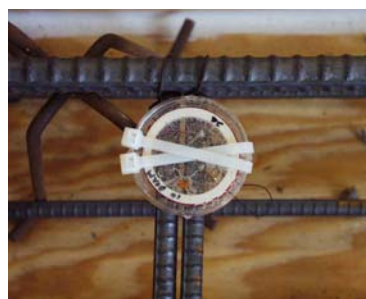
Figure 4-3. Typical sensor placement

Thirty two sensors were placed in the slabs; 16 basic sensors and 16 improved sensors. The sensors were placed in the middle of the beam where the concrete would experience the most cracking and therefore the fastest penetration of chlorides (Figure 4-3). The sensors were embedded with 1-in. cover corresponding to the level of the reinforcement. Each beam included eight sensors, four of each type. Also, two different arrangements of external switches were used for the sensors: a circumferential loop and an elongated loop (Figure 4-4). Installation of the sensors was executed by attaching the sensor to the adjacent rebar using two zip ties (Figure 4-3b). Attaching the sensors to the rebar ensured that they would be exposed to the same environment as the reinforcing steel.

a) Layout of sensors

b) Positioning of sensor

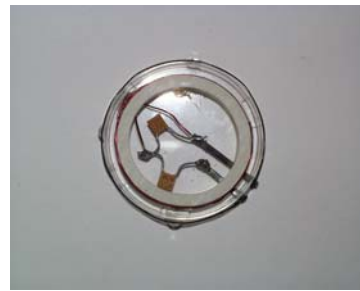
Figure 4-4. Switch configurations

(b) Basic sensor with circumferential loop

The slabs were allowed to cure for four weeks before they were transported outside and subjected to sustained loads. Before the slabs were cracked, the sensors were interrogated for the first time after being embedded in to the concrete. Of the thirty two sensors, two sensors responded at their final frequency indicating that the external switch had broken during the construction process. Both of the damaged sensors were constructed using the elongated loop configuration (Figure 4-4a). From this data, it was concluded that the elongated loop configuration was too fragile to be investigated further. Since the loop

extends about an inch beyond the sealed environment, it is vulnerable to being broken by a vibrator, a worker's boot, or a piece of sharp aggregate. However, the circumferential loop layout proved to be durable. Since the external wire of the circumferential loop is wrapped around the circumference of the sensors, it is better protected from being damaged. The durability of the circumferential loop was proven during construction of the slab. Overall durability of the sensors was found to be acceptable.

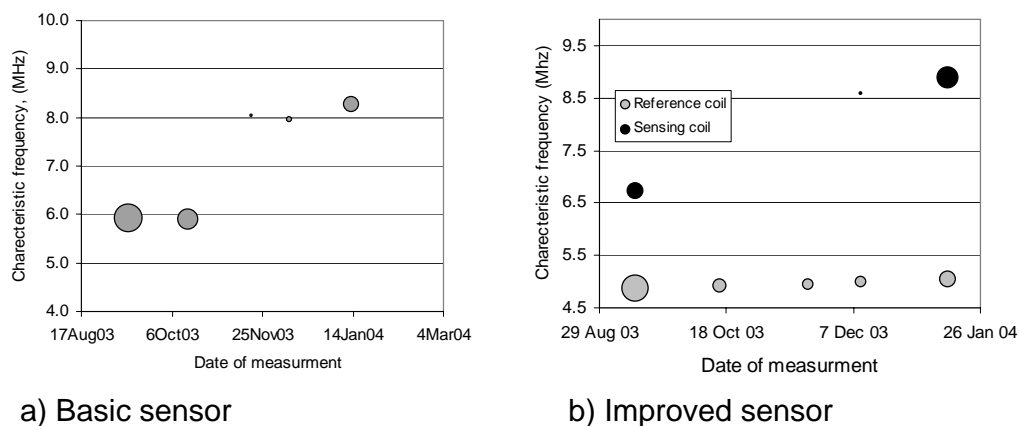
Figure 4-7. Characteristic frequency with time

After 5 months of exposure, few of the sensors started showing a large amplitude dip corresponding to a fractured wire. The variation of the characteristic frequencies with time is shown in Figure 4-7 for a typical basic sensor and a improved sensor that demonstrated a dip corresponding to a fractured wire. The frequency response of the improved sensor showed that the sensing coil could not be detected in the readings one, two, and three months after the initial interrogation (Figure 4-7). This same behavior was also observed in the basic sensor during the third and fourth months. However, after several months, the signal from the sensing coils reappeared for the sensors, and the characteristic frequencies corresponded to the final state, indicating that the external switch had fractured (Figure 4-7).

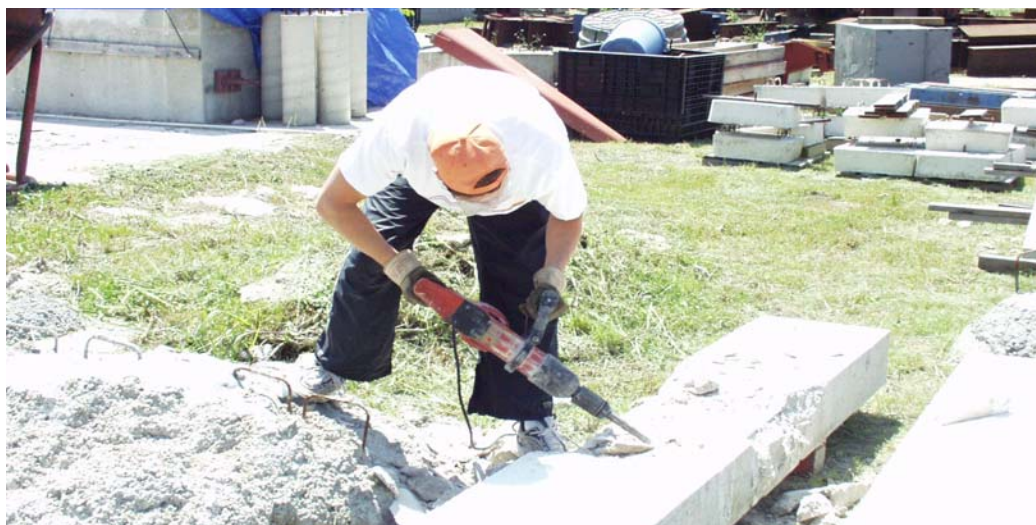
Figure 4-8. Concrete removal

To determine if corrosion was actually occurring in the slabs, the sensors and reinforcing bars had to be visually inspected. The visual inspection of the slabs was conducted by removing the concrete cover around the rebar and the sensors. This concrete removal was performed using both a 30-lb impact hammer and a hand chisel Figure 4-8. Most of the cover was removed using the impact hammer. The remainder of the concrete around the rebar and the sensors was removed using the chisel. This method was used to minimize the damage to the sensors during the concrete removal process. However, some of the sensors were damaged during the concrete removal process. Removing the concrete around the external wire proved to be especially difficult. Because the wire had bonded to the concrete, removing it from the concrete required some force and usually the wire broke during this process. Due to these accidental wire breaks, differentiating between breaks caused by corrosion and breaks caused by concrete removal was almost impossible.

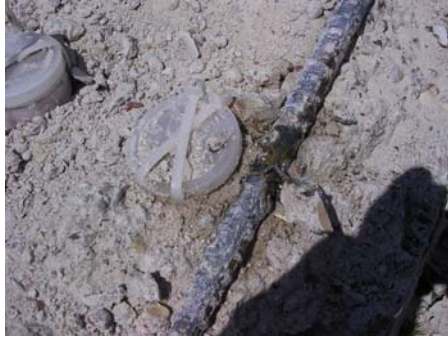
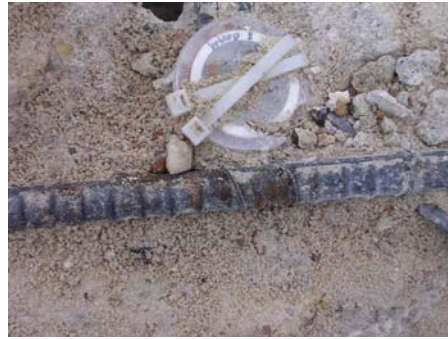
Figure 4-9. Corrosion around reinforcement

(a) Observed corrosion of reinforcement in the vicinity of improved sensor

(b) Observed corrosion of reinforcement in vicinity of basic sensor

From the visual inspections of the rebar and the sensors, it was evident that corrosion had initiated in the slabs. Corrosion on the rebar was always found near sensors where the frequency had shifted (Figure 4-9). But, corrosion was also found around sensors that were responding in transition zone. This was most evident in the last slab to be autopsied. This slab had the least leaks and had been moist for most of the time. Only one sensor in this beam indicated that its wire had fractured. During the autopsy it was discovered that the slab was still saturated even after being allowed to dry for two weeks. The corrosion in the slab was excessive and some areas of the bars showed significant corrosion damage (Figure 4-10). It was also evident from the autopsies that areas of the rebar that crossed cracks showed more corrosion than locations that were surrounded by uncracked concrete (Figure 4-11). From the autopsies it was concluded that the sensors do detect corrosion but their response was not as simple as originally assumed. It was hypothesized that moisture and chlorides in the beam affect the response of the sensors. This hypothesis is discussed in more detail in Chapter 5.

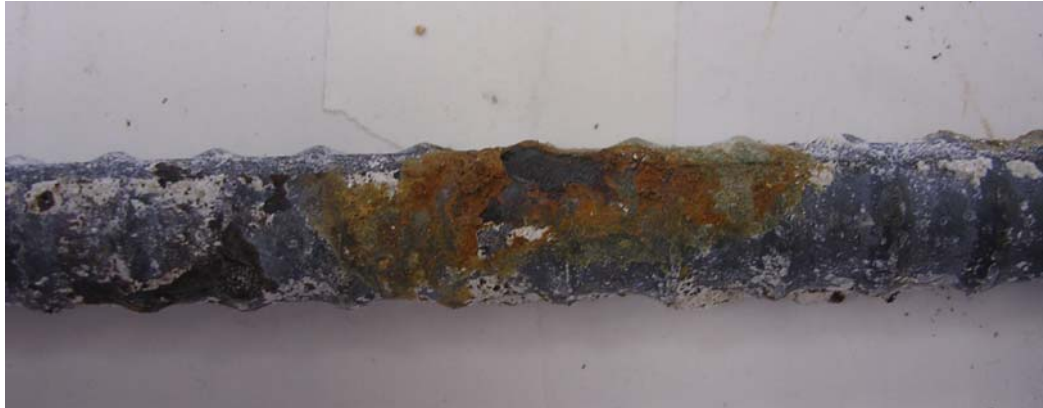
Figure 4-10. Heavy reinforcement degradation caused by corrosion

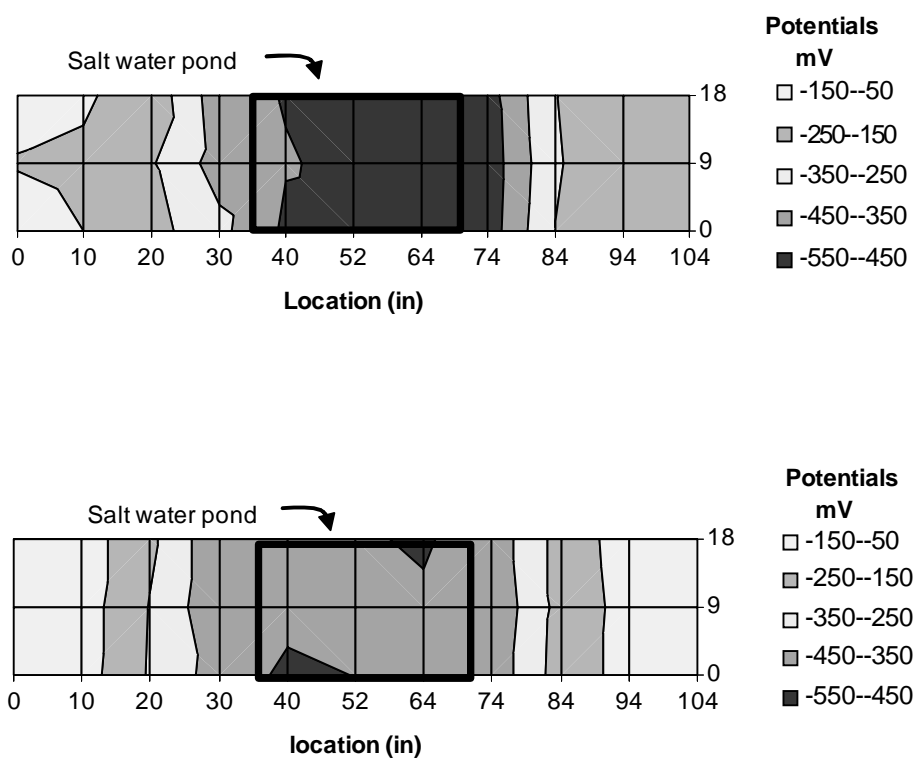
Figure 4-12. Half cell potential measurements

area, and (b) measurements more positive than -200 mV indicate that there is a 90 percent probability that corrosion is not occurring. As can be seen in Figure 4-12, the center of the slab, under the salt water pond, has a 90 percent probability that corrosion is occurring.

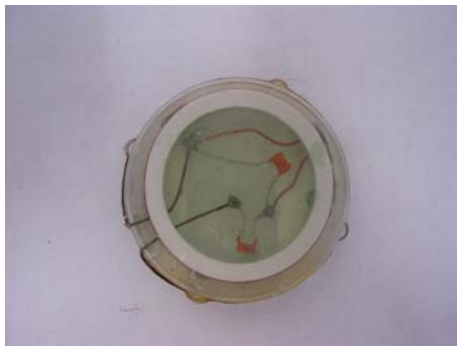
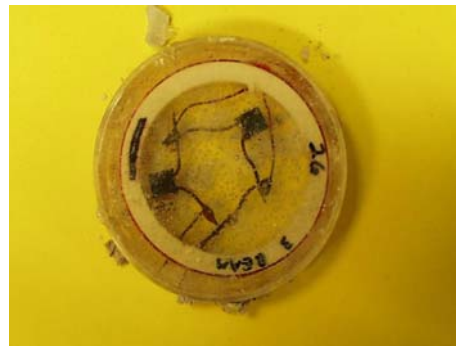
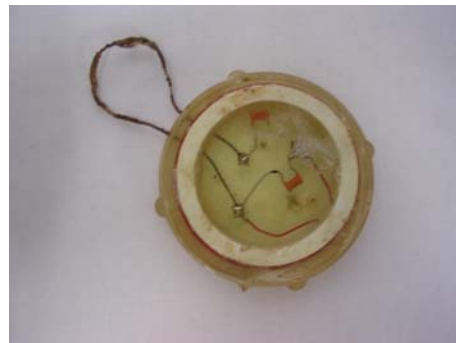
Figure 5-1. Different types of potting compounds

The ability of the compound to protect against corrosion was tested by creating sensors using all of the compounds and testing the sensors using the accelerated corrosion tests. The sensors were placed into beakers containing the same solution as used in the accelerated corrosion tests in Chapter 3. The sensors were also subjected to wetting and drying cycles as described in Chapter 3. The performance of the potting compounds was evaluated by visually inspecting the interior components. These inspections were conducted once a week. From the inspections it was evident that the RTV615A and the EnvirogelTM did not protect against corrosion (Figure 5-1a, 5-1b). These sensors showed evidence of corrosion within the first week and this level increased during subsequent inspections. The hot glue and the marine epoxy performed well in keeping the corrosion from occurring inside the Petri dish. The marine epoxy did not show any evidence of corrosion while the hot glue had a minimal amount of corrosion present inside of the sensor (Figure 5-1c, 5-1d).

a) RTV615A

b) Envirogel™

b) Marine epoxy

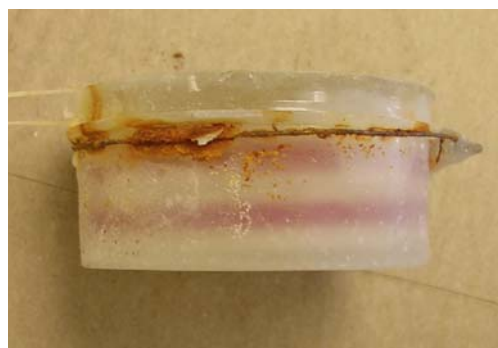
Figure 5-2. Sensors after being exposed to accelerated corrosion tests

a) Basic sensor heavily

a) Improved sensor heavily

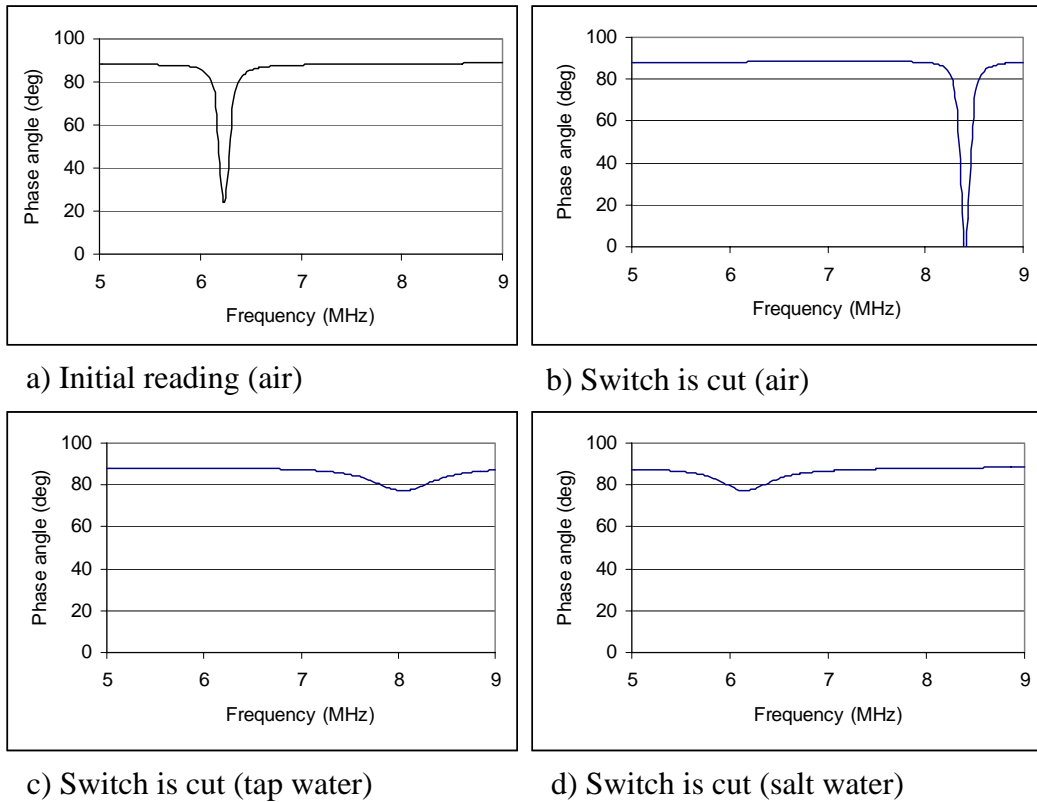
Figure 5-5. Sensor response in different environments

This hypothesis was tested by interrogating a sensor in several different conditions. The sensor was first interrogated with the external switch intact and a typical initial frequency was observed (Figure 5-5(a)). The switch was then cut using wire cutters and again the sensor was interrogated and a frequency corresponding to a broken wire was observed (Figure 5-5(b)). These results were expected and proved that the sensor was working properly. The sensor was then placed in a cup of tap water and the response was recorded (Figure 5-5(c)). Results of this behavior show that the frequency had shifted slightly toward the initial value and the strength of the signal had decreased. This behavior resembles the behavior observed in the full-scale slabs. To test the hypothesis further, salt was added to the tap water and the sensor was interrogated again. Once the salt was added the sensor's signal had shifted back to the initial value indicating that the wire was intact (Figure 5-5(d)). The distance between the sensor and the transmitter was kept constant through the test.

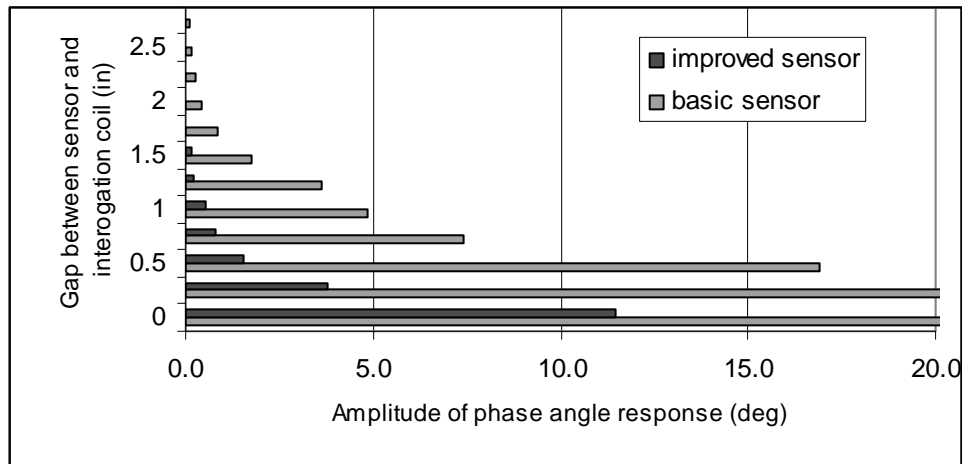
Figure 5-6. Variation of sensor response with distance to interrogation coil in air

The signal from the basic sensor was still identified at a gap of 2.75 in., which is nearly twice the range of the improved sensor. This range is considered to be satisfactory for the proposed application.
