**Evaluation of a Procedure for Encapsulation and Epoxy Injection
of Corroding Reinforced Concrete Structures**

Thesis

The University of Texas at Austin

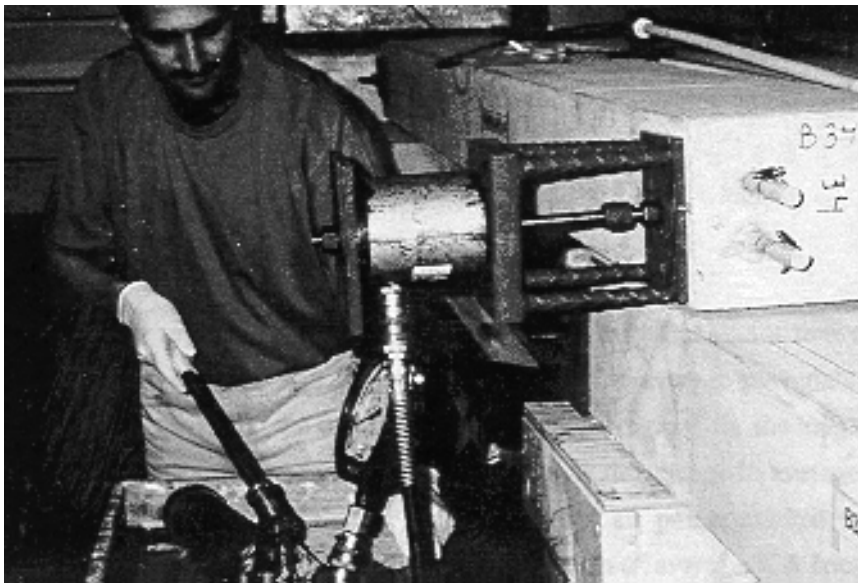
Figure 2.8. Loading Process.

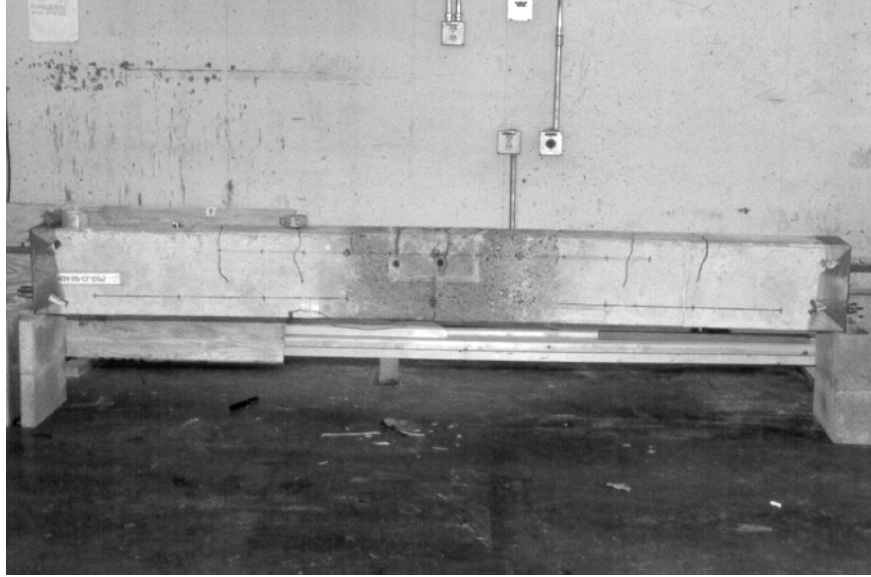
Figure 3.2. Beams Cleaned and Distribution Media Placed at Ends.

The concrete surface was prepared by pressure washing or grit blasting in order to provide a suitable surface for the adhesive system (Figure 3.2). The new material will not bond to the existing concrete surface unless the laitance produced by fine particles which may be carried to the surface by bleed water is removed to create a sound concrete surface.

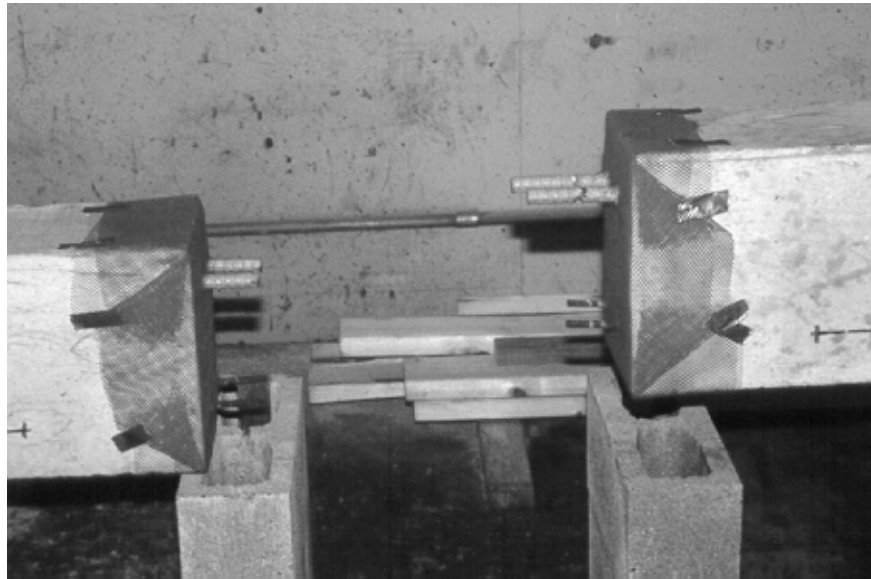
Figure 3.3. Application of Distribution Media.

A distribution media was applied at the ends of the beams in order to provide uniform epoxy flow (Figure 3.3).

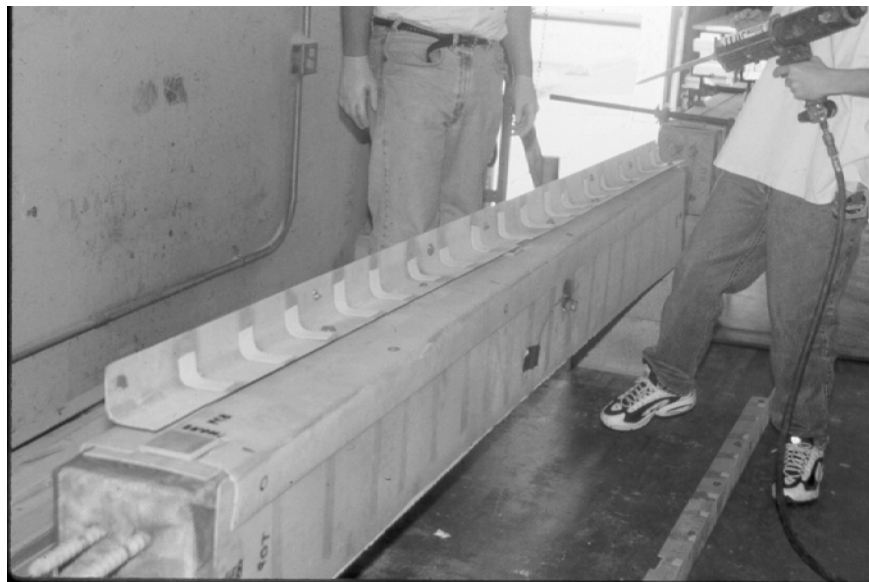
Figure 3.6. Installation of Angles.

Plates were erected in groups of opposing pairs (Figure 3.4) using quick dry adhesive and then held in place using prefabricated wood jigs and pipe clamps (Figure 3.5). Angles, because of their shape were more easily installed using the quick dry adhesive (Figure 3.6).

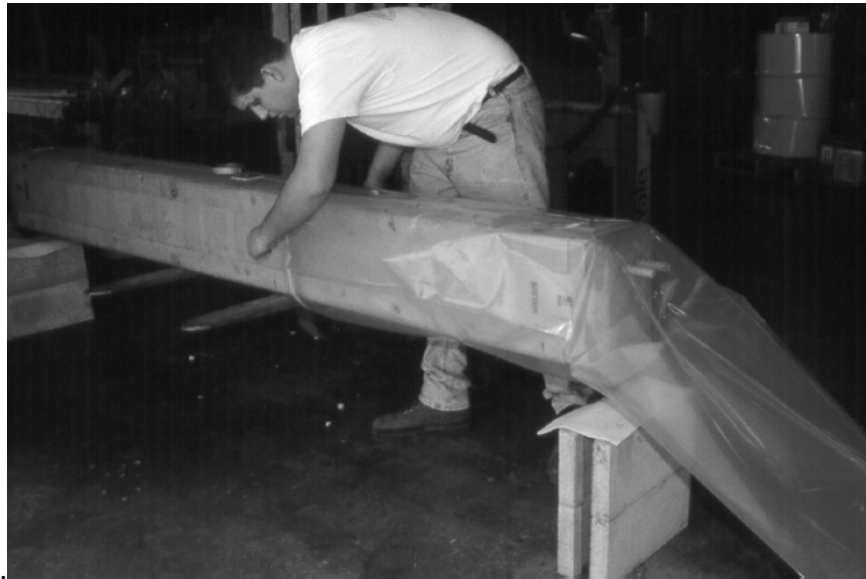
Figure 3.9. Application of Plastic Bags.

In order to evacuate the volume inside the shell, an airtight seal must be provided over the plate and angle system. In the laboratory, plastic bags were used to provide a seal (Figure 3.9). The ends of the bags were sealed using tackey tape which was also used as a temporary patching material if a leak was found after evacuation has started.

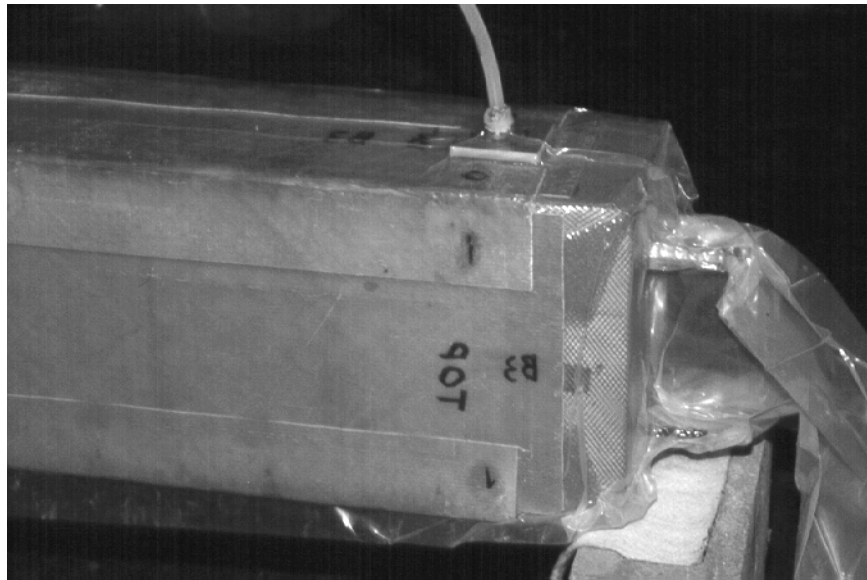
Figure 3.11. Evacuation Process.

The composite encased concrete was fitted with feeder inlets (Figure 3.10). The inlets were placed strategically to ensure quick and complete infusion. The encapsulated element was then evacuated and a leak test was performed to check the integrity of the seal (Figure 3.11). Perfect vacuum was rarely achieved immediately after the vacuum was drawn. Leak checks were performed and leaks were sealed with temporary patching materials such as tackey tape (Figure 3.12). These patches were removed following the infusion. The structure remained in a vacuum of 27 inches of mercury to remove excessive moisture in concrete. The system was then ready for infusion.

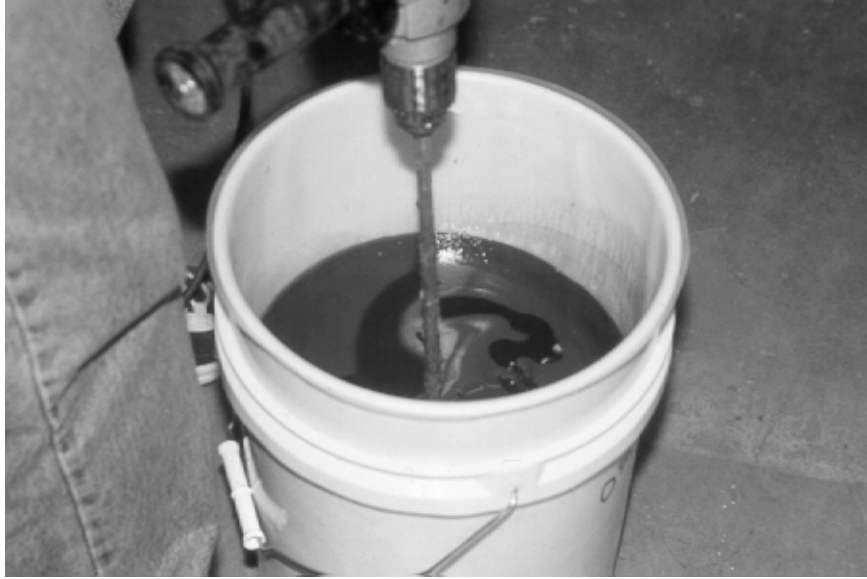
Figure 3.13. Mixing the Resin.

Once the system was ready for infusion the resin was mixed (Figure 3.13). Dow Derakena 8084 epoxy vinyl ester resin was used for this application. Cobalt Napthenate 6% was added to the resin at 0.4% by volume. After Cobalt Napthenate was fully mixed with the resin, Trigonox 239A was added at 2% by volume and mixed. These concentrations were related to give the desired gel time for infusion.

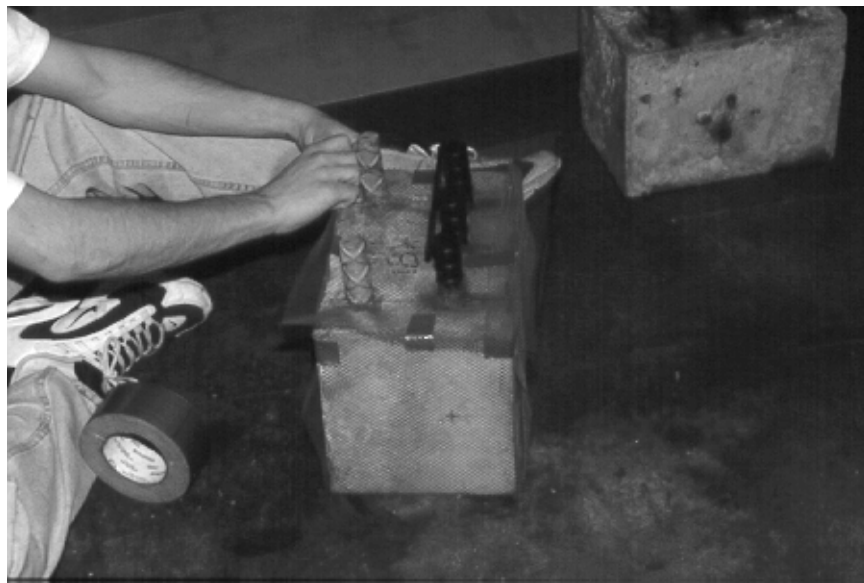
Figure 3.16. Application of Distribution Media.

The encapsulation and epoxy injection process for the macro-cells was performed simultaneously with the beams. Since the macro-cells were small, no hardshell encapsulation was provided after the surface of the macro-cells was prepared as described in Section 3.1.2. The same distribution media used for the beams was applied all around the macro-cells in order to provide a uniform resin flow (Figure 3.16).

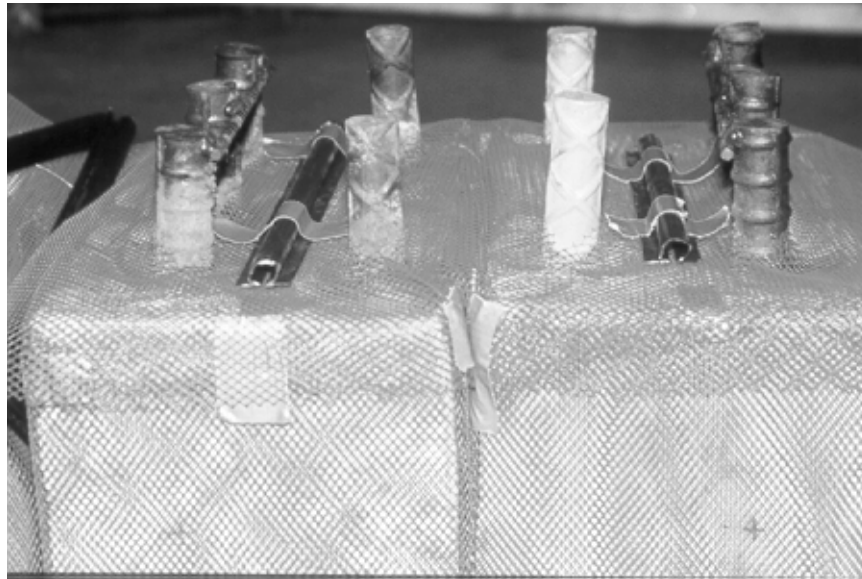
Figure 3.17. Application of Omega Channels as Injection Ports.

After the placement of the distribution media, injection ports were installed at top and bottom of the macro-cells. Omega channels were used as injection ports for macro-cells (Figure 3.17). The macro-cells were placed in plastic bags and the ends of the bags were sealed using tackey tape (Figure 3.18).

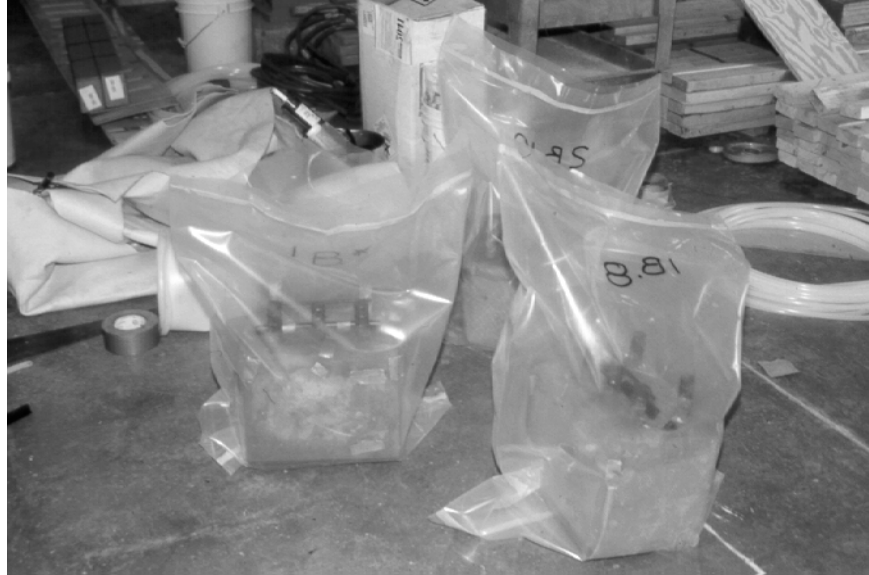
Figure 3.18. Application of Plastic Bags.

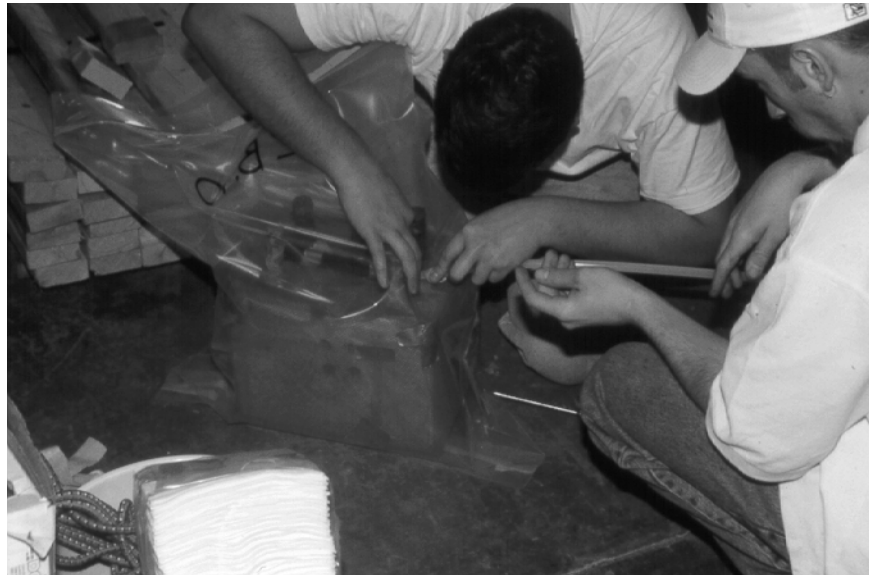
Figure 3.19. Application of Feeder Inlets.

After the airtight seal was applied, the feeder inlets were installed (Figure 3.19). As in the case of the beams, leak checks were performed and leaks were sealed with tackey tape. After 24 hours of evacuation at 27 inches of mercury, the system was ready for infusion (Figure 3.20). The resin mixed for the beams was used for infusion of the macro-cells as well. The system was designed as in the beams to draw resin from the bottom inlet ports, up through the structure, and out through the top vacuum ports (Figure 3.21).

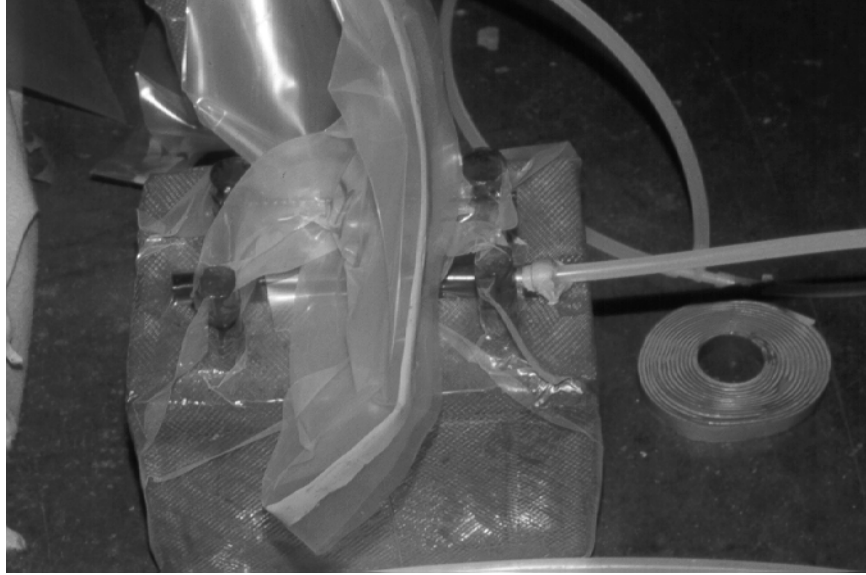
Figure 3.20. Evacuation Process.

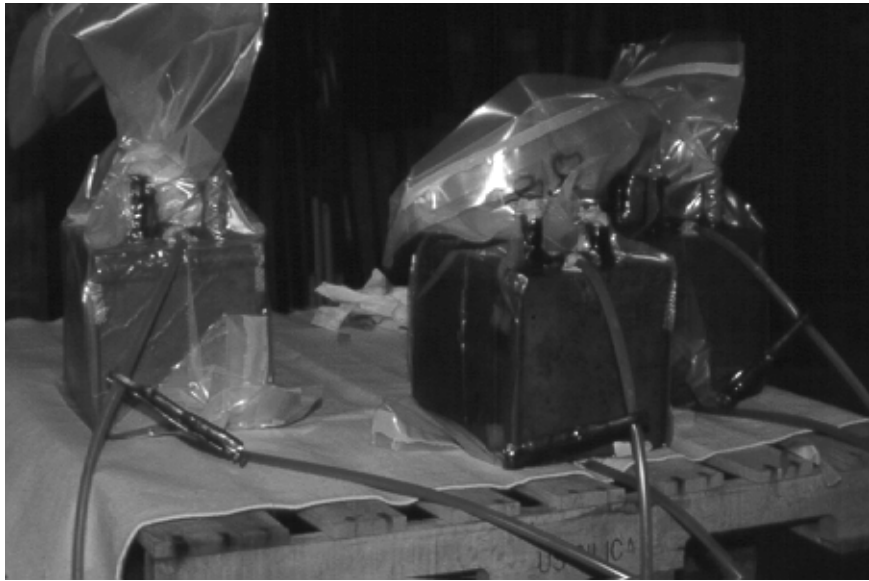
Figure 3.22. End of Process.

Once the adhesive hardened, the infusion process was complete (Figure 3.22). As in the beams, vacuum remained on the system for 24 hours until the adhesive reached its specified mechanical properties. After a 24 hour curing period, all hoses were removed and the macro-cells were taken out of the plastic bags (Figure 3.23).

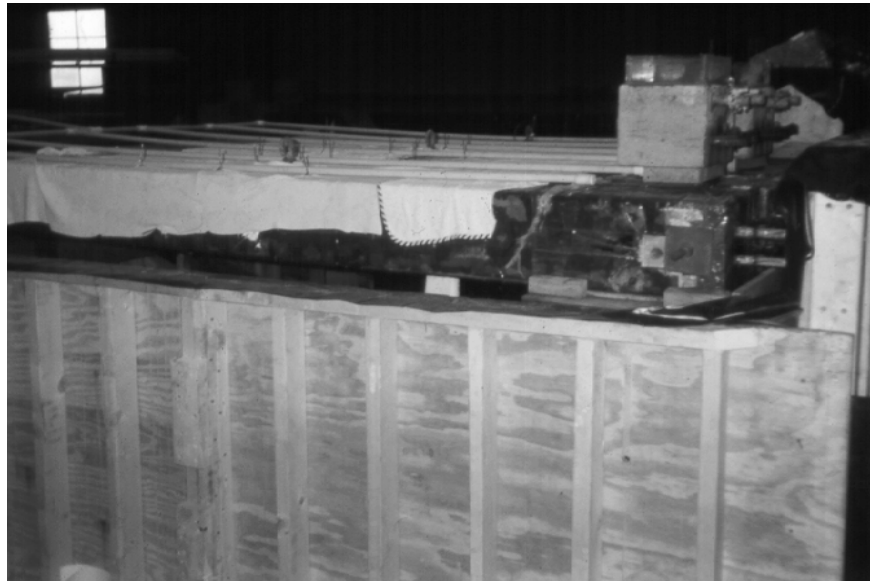
Figure 4.1. Cloth on Beams.

The beams were exposed to a 3.5% saline solution. The same solution was used in the previous study. Exposure time and beam surface area exposed were different than in the previous study. Each exposure cycle consisted of a one week wet period followed by three week dry period. Rather than exposing a defined area, the entire beam surface was exposed in order to assess the effectiveness of encapsulation. During the wet cycle, the corrosive solution was circulated over the beams continuously and then the beams were allowed to air dry for three weeks. Cloth was placed on the beams during the wet cycle in order to provide more uniform exposure over the entire beam since the corner plates of encapsulated beams formed a channel for water to flow and prevented the sides of the beams from exposure (Figure 4.1). A total of thirteen cycles were applied to the beams.

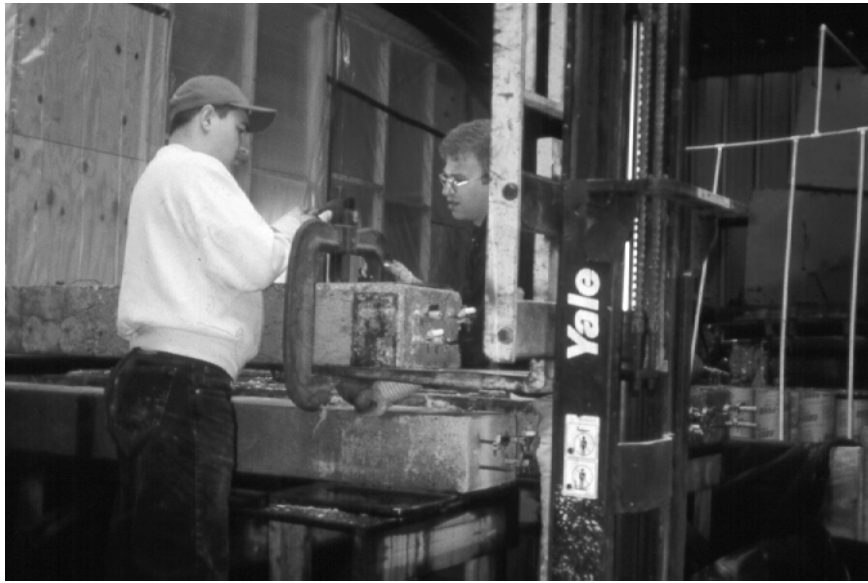
Figure 4.3. Placing the Beams on Wood Stands in the Retaining Pool.

The beams were placed on wood stands inside the pool to keep them above the collected water. Figure 4.3 shows the placement of the beams on the stands. Figure 4.4 shows the retaining pool, the recirculation pump, and the PVC distribution pipes.

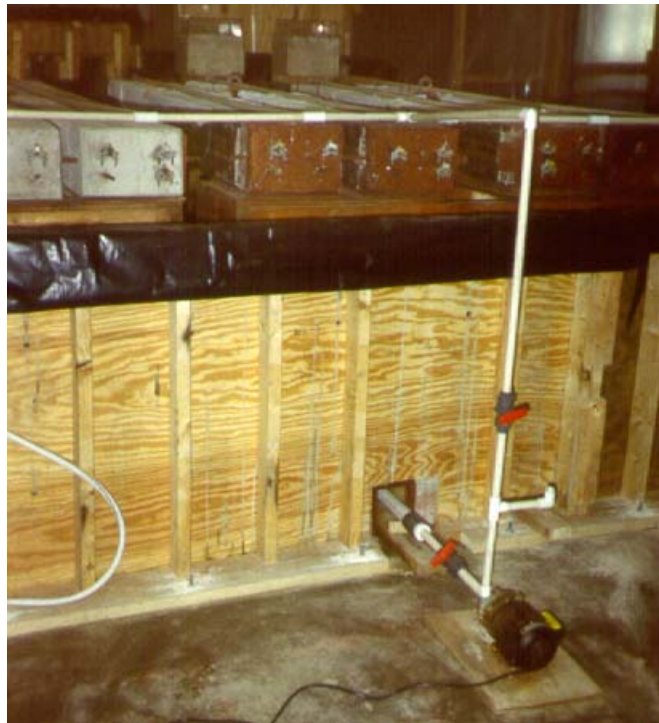
Figure 4.4. Retaining Pool, Recirculation Pump, and PVC Distribution Pipes.

polyurethane sheet on the bottom which extended partially along the sides and served as the catch basin for the solution, and the remainder of the plywood was covered with plastic sheets in order to protect the plywood. The polyurethane sheet was placed on an existing elevated slab. A drain in the base of the pool was connected to a pump which recirculated the water to the top of the beams through a distribution system of PVC pipes. Holes were drilled into the bottom of the PVC pipes to distribute the saline solution over the length of the beams.

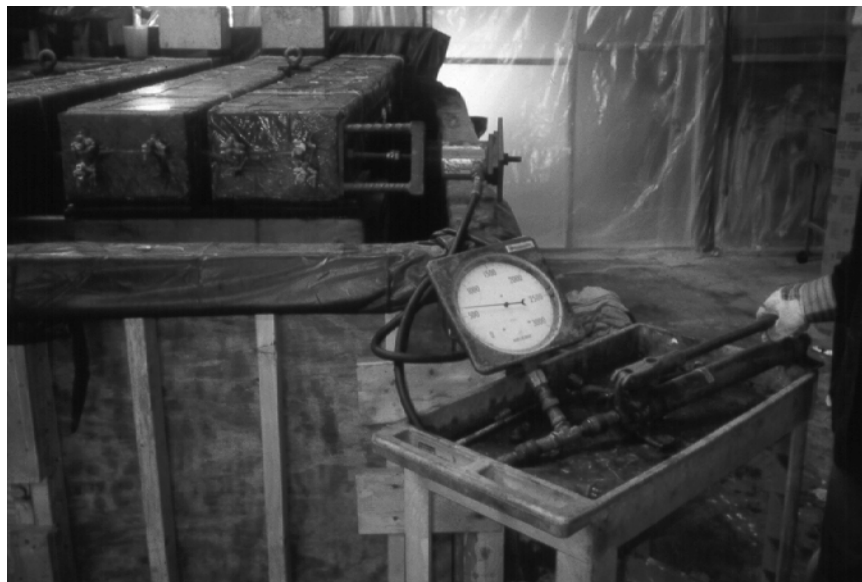
Figure 4.6. The Loading Process.

Once the exposure study started, four of the six beams (two encapsulated, two control beams) were loaded back to back, while two were not loaded. The loading setup is shown in Figure 4.6. Each week the load on the loaded beams was removed. Then the beams were loaded and unloaded 5 times. The last loading remained on the beams to keep the cracks open as was done in the previous study. The beams were subjected to the same level of load as in the previous study.

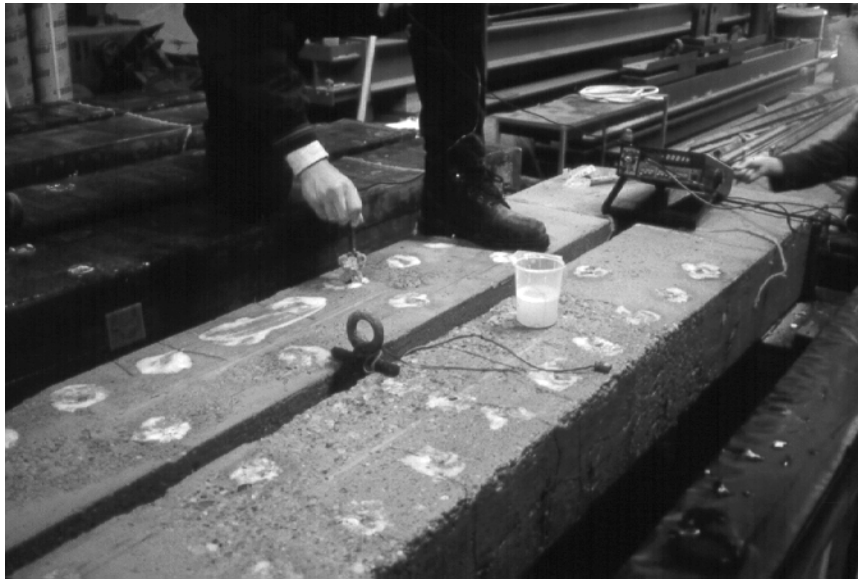
Figure 4.7. Taking Macro-Cell Readings for Unencapsulated Beams.

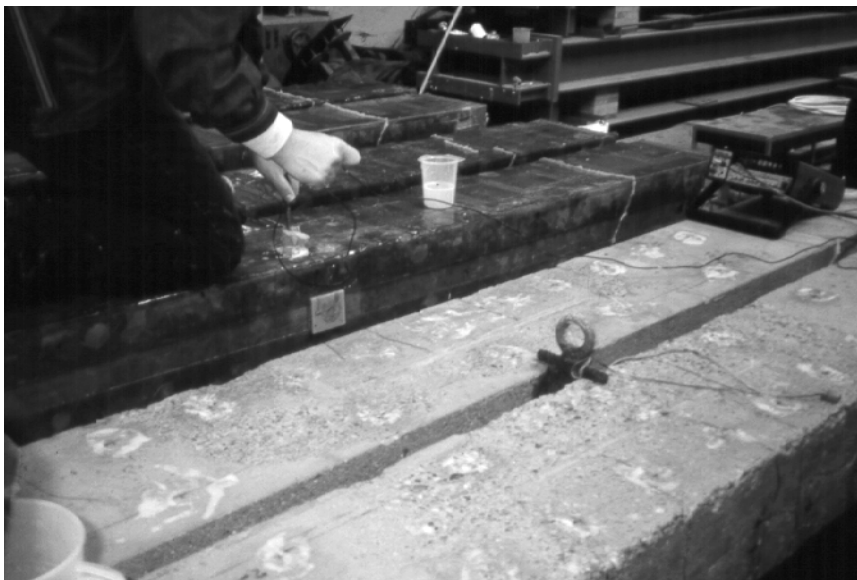
Figure 4.8. Taking Macro-Cell Readings for Encapsulated Beams.

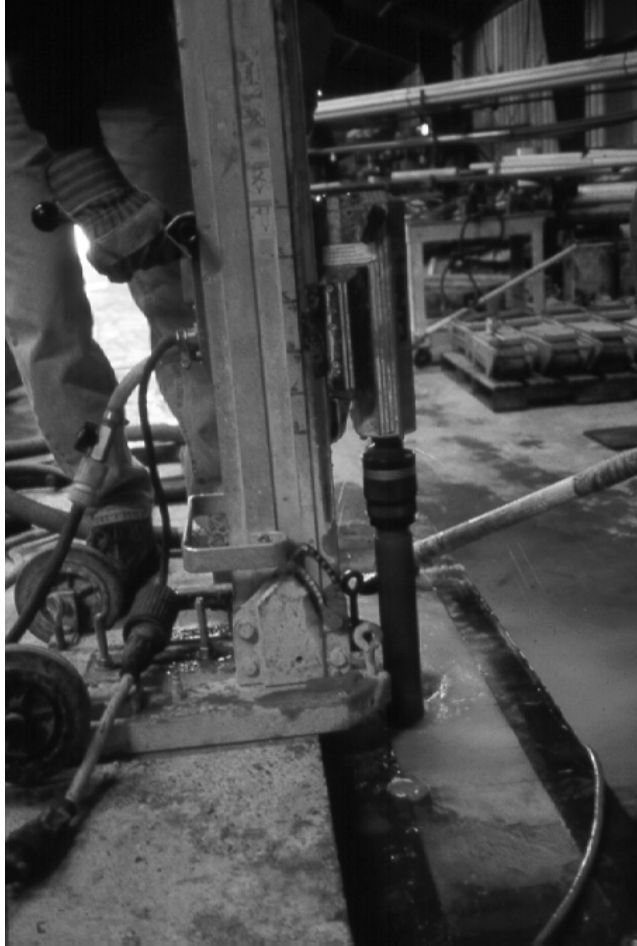
Figure 4.10. Taking Core Samples.

At the end of the exposure period, core samples were taken from the encapsulated beams to assess the depth of resin impregnation (Figure 4.10). The beams were autopsied to assess the condition of the bars and the concrete around the bars. Finally, the bars were removed from concrete. The results from the monitoring processes and the autopsies are discussed in Chapter 5.

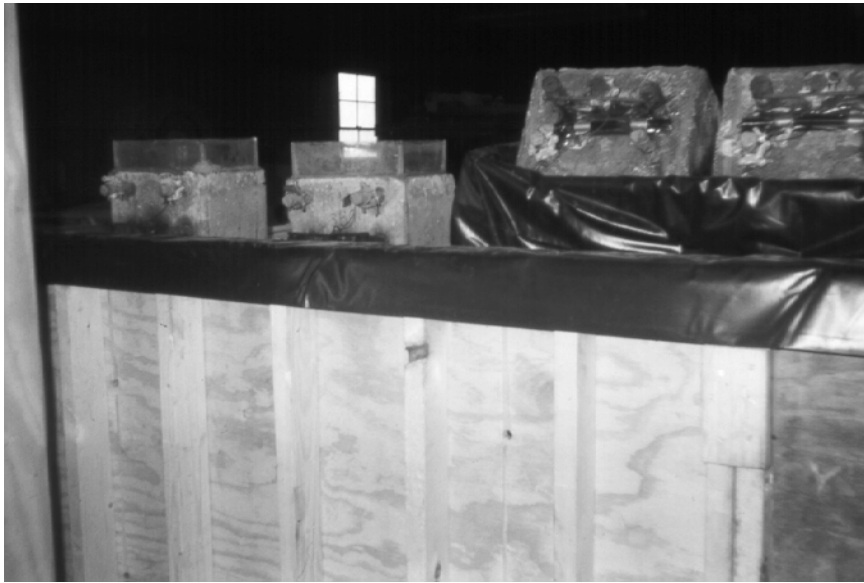
Figure 4.12. Test Orientation for Macro-Cells.

In the case of macro-cells, the exposure cycles consisted of a 2 week wet period followed by a 2 week dry period. This was the same exposure cycle used for the previous study. The test setup for the encapsulated macro-cells was designed help understand the effectiveness of the encapsulation and epoxy injection procedure. During the wet period, the encapsulated macro-cells were placed upside down inside a small retaining pool that had a 30° angle with the horizontal and the pool was filled with the saline solution. When the wet period ended, the specimens were taken out of the water. In this way the corners which are harder to seal using epoxy would also be exposed and the effectiveness of the resin used in encapsulation could be studied. The control specimens were ponded just as they had been for the last 5 years. Thirteen exposure cycles were completed during this study. Figure 4.11 shows the retaining pool and the test setup for the encapsulated macro-cells and Figure 4.12 shows the test orientation both encapsulated and control macro-cells.

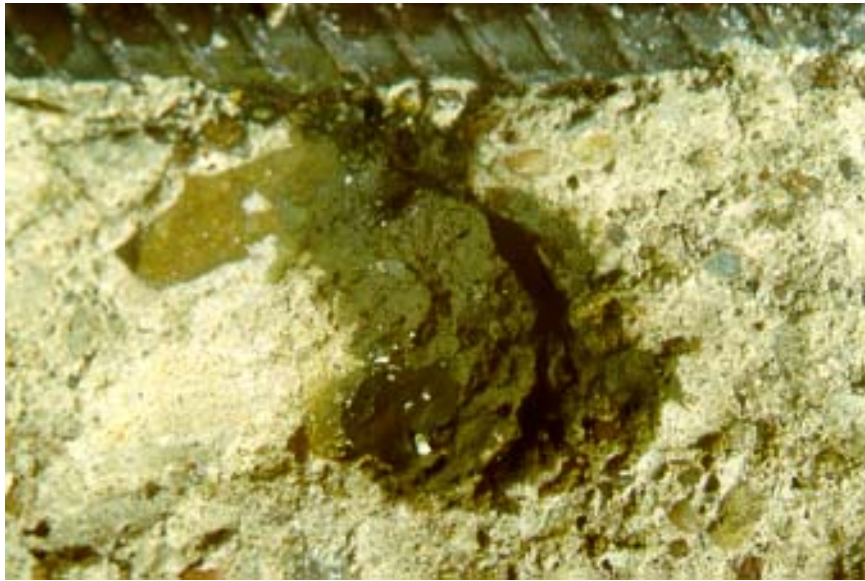
Figure 5.8. Green Corrosion Fluid on Beam 34.

beam. Figures 5.7 and 5.8 show this corrosion fluid on beams 30 and 34 respectively.

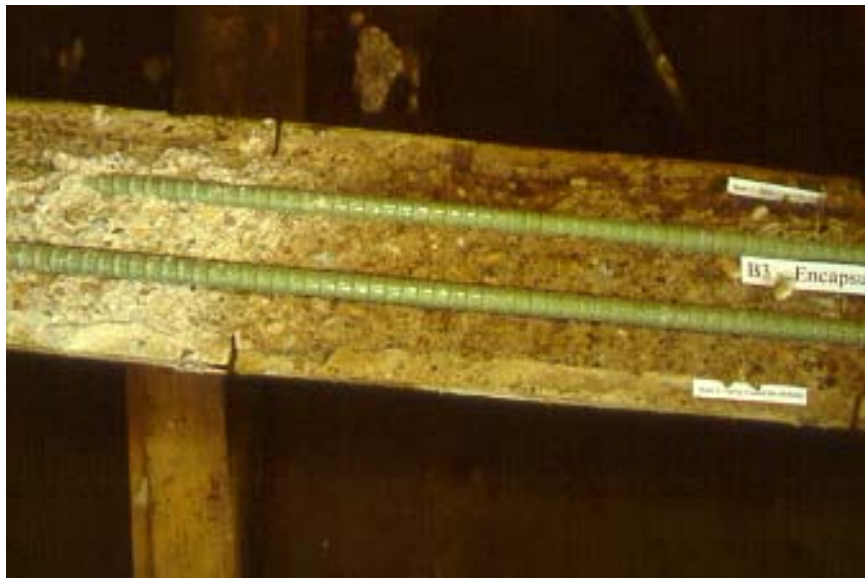
Figure 5.9. Difference in Appearance of Concrete in Beam 3.

A difference in color of the concrete at previously exposed areas and the rest of the beam was consistently found in encapsulated specimens (Darker area to the right in Figure 5.9). The “wet” appearance indicated that moisture remained inside the beams and, as a consequence, half-cell potential readings remained stable. Corrosion activity was continuing inside the beams as before encapsulation.

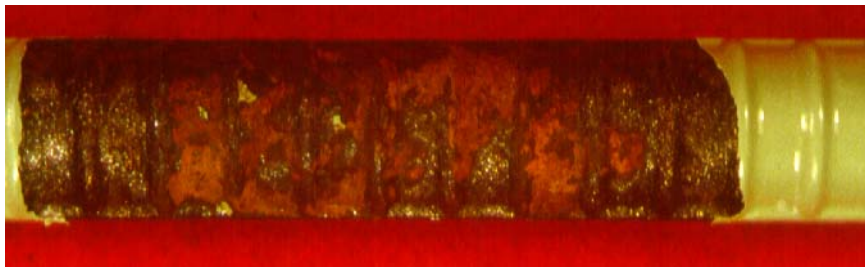
Figure 5.10. Epoxy Coated Bars (Beam 34).

Figure 5.11. Rust Stains on Epoxy Coated Bar (Beam 6).

Figure 5.12. Rust Stains Underneath Coating on Epoxy Coated Bar (Beam 6).

Figure 5.13. Rust Stains Underneath Coating on Epoxy Coated Bar (Beam 12).

Figure 5.14. No Damage Underneath Coating on Epoxy Coating Bar (Beam 12).

Another observation was that the epoxy coated bars usually performed well while the uncoated bars were severely corroded. Beam 34, which had spliced bars, was the only beam with damage to epoxy coated bars. The end of the bars where epoxy was patched were corroded. Other than that, visible damage to the epoxy coated bars was insignificant. There were some stains near the stirrup in all the beams. The stains were probably caused by corrosion of tie wire. In some cases the corrosion extended underneath the epoxy coating and was found only after the epoxy coating was peeled away. The bar surface was mottled with rust. The locations where corrosion was observed under the coating generally corresponded with the locations of splices, intentionally damaged areas on epoxy coating, intentionally damaged and patched areas on epoxy coating, and crack locations. Figure 5.10 shows how well the epoxy coated bars performed. Figures 5.11 and 5.12 show the rust stains on and underneath the epoxy coating. Figure 5.13 shows the damage underneath the epoxy coating for Beam 12, while the same bar is seen without any damage in spite of the intentional damage shown in Figure 5.14. These differences were primarily related to crack locations.

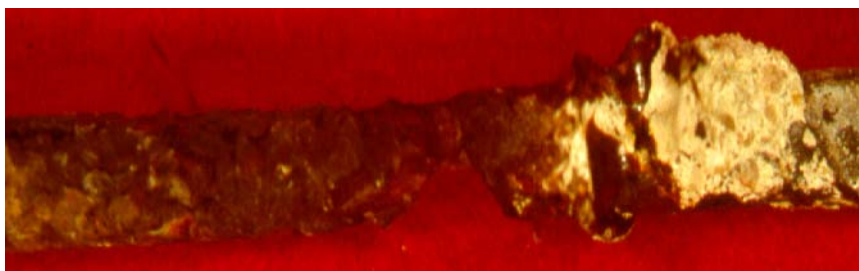
Figure 5.15. Significant Loss of Bar Area (Beam 19).

In the uncoated bars of all beams, significant loss of steel areas as well as pitting in several locations was observed. Significant loss of steel area is shown in Figure 5.15 for Beam 19 bottom black bar near stirrup, in Figure 5.16 for Beam 6 bottom black bar in the previously exposed region, and in Figure 5.17 for Beam 12 top black bar in the previously exposed area. The loss of bar area shown was typical of the black bars of all the beams. Significant loss of bar area is defined as loss of more than 15-20% of the bar area. For the control specimens, corrosion damage extended outside the previously exposed region in the form of pitting (Figures 5.18, 5.19). In pitting corrosion the profile of the bar remains the same. There are pits that do not significantly (less than 10%) change the bar area. For the encapsulated specimens the damage was usually within the previously exposed region. All of the encapsulated specimens, however, showed pitting corrosion at the end of the beams (Figures 5.20, 5.21). It is likely that the ends of the encapsulated beams were not sealed properly around the protruding bars and corrosion was initiated in regions where no corrosion had occurred earlier. Corrosion activity on the black bars in the encapsulated specimens appeared to be greater than the damage in the control (unencapsulated) specimens.

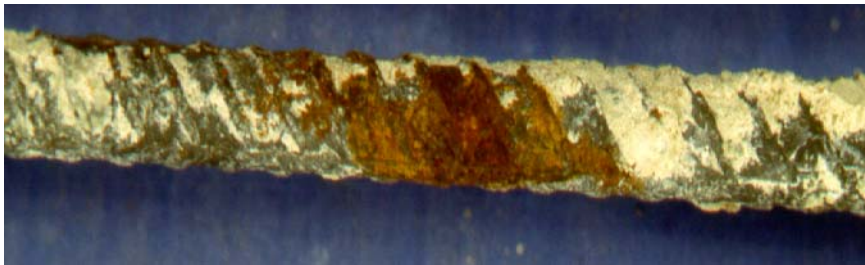
Figure 5.18. Corrosion Outside the Previous Exposed Region (Beam 12).

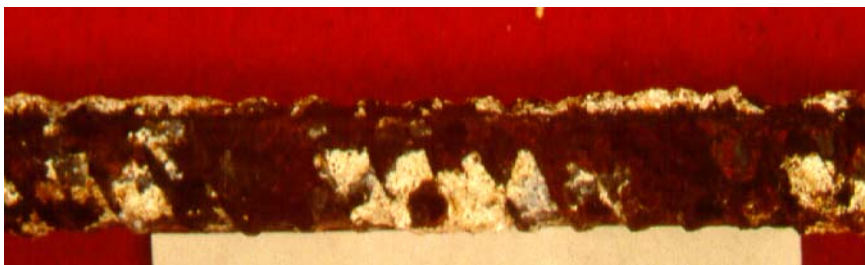
Figure 5.19. Corrosion Outside the Previous Exposed Region (Beam 30).

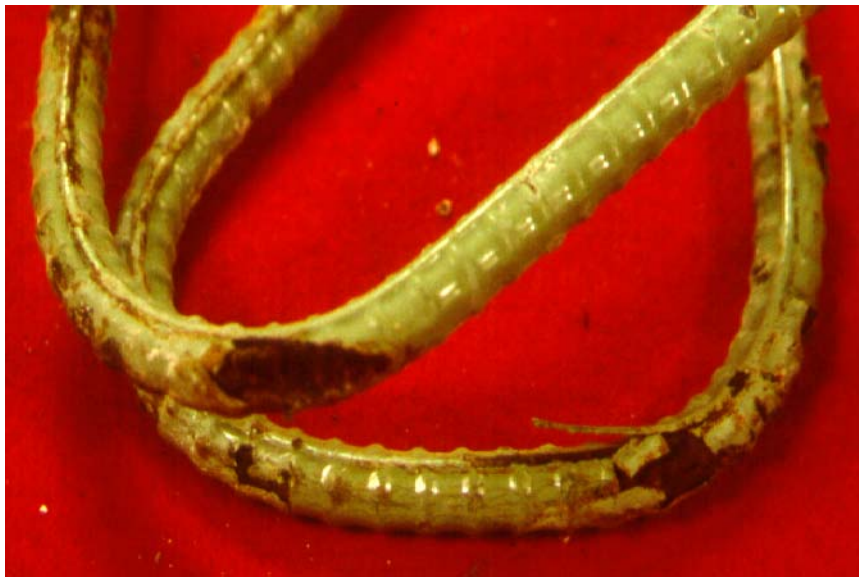
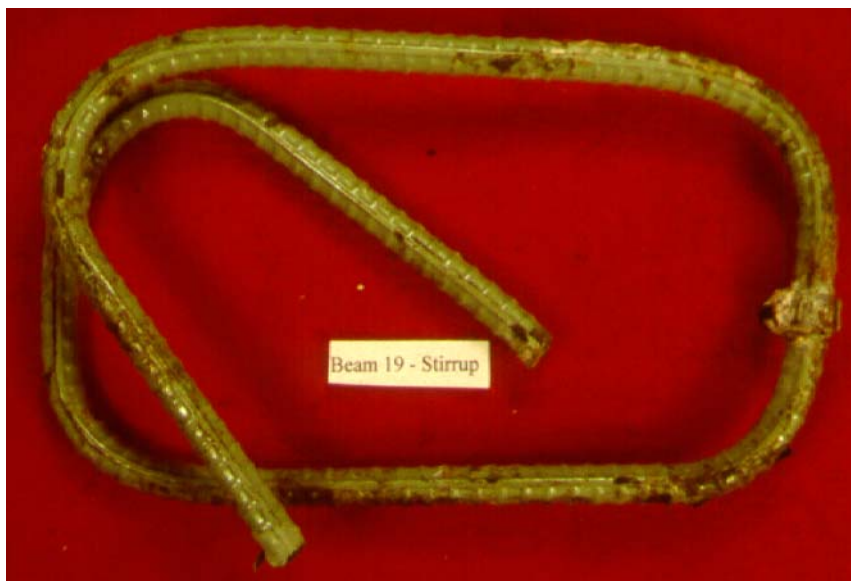
Figure 5.22. Corrosion Damage on Stirrup (Beam 30).

Figure 5.23. Corrosion Damage on Stirrup (Beam19).

In the three beams where the stirrups were monitored (B19, B30, and B34), significant corrosion damage was observed in the stirrups. There were stains on the epoxy coating and when the coating was peeled, the bars had a nearly total rusted surface. In the previous study it was found that the bars bent after coating did not perform well [Vaca, 1998]. Figures 5.22 and 5.23 show the stirrups after removal from the beams.

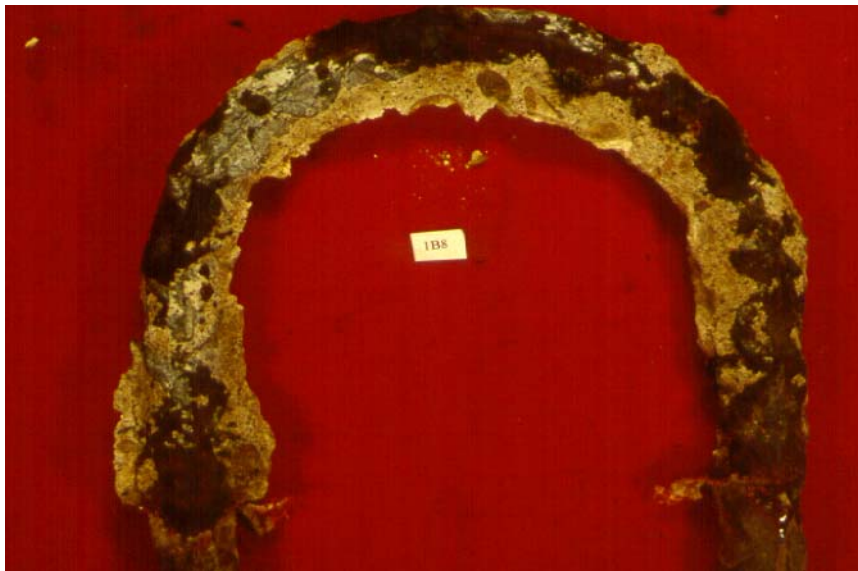
Figure 5.34. Damage on Bent Black Bar (1B8).

Figure 5.35. Damage on Concrete for Bent Black Bar (1B8).

A lot of pitting damage was found both in black and in epoxy coated bent bars. Figures 5.34 and 5.35 show the pitting corrosion on the black bent bar and the severely stained concrete after this bar was removed. Similarly, Figures 5.36 and 5.37 show the pitting corrosion on epoxy coated bent bar and concrete stains after the bar was removed.

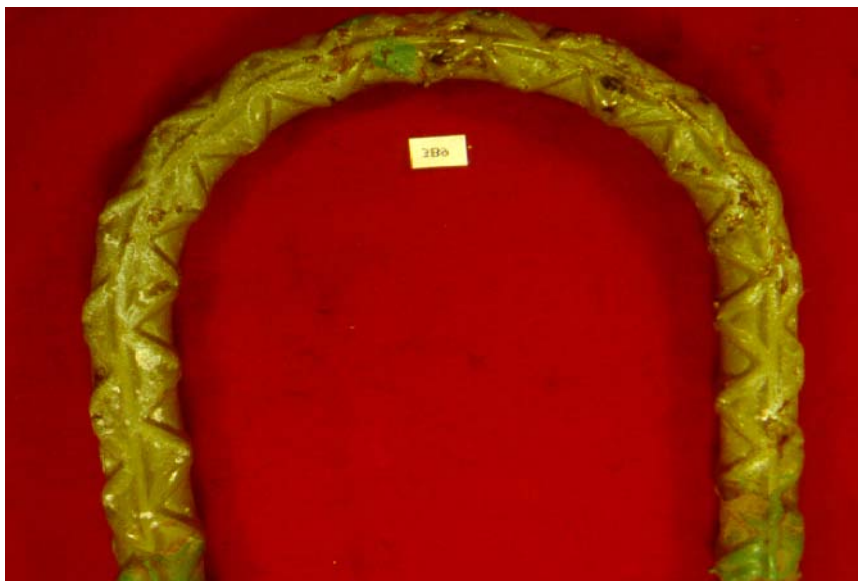
Figure 5.36. Pitting Damage on Epoxy Coated Bent Bar (3B9).

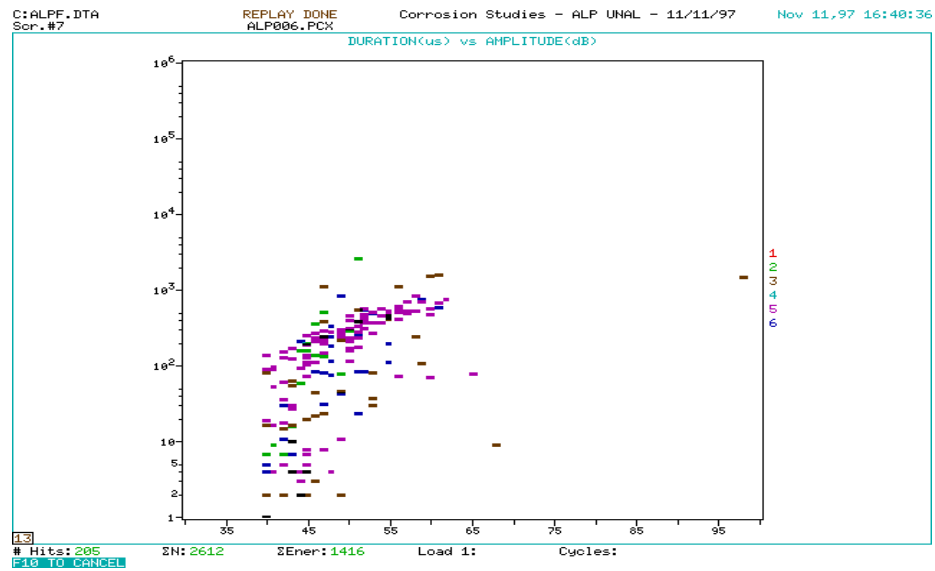
Figure B.1. Typical Wave Form.

Figure B.2. Typical Wave Form.

Figure B.3. Correlation Plot.

Figures B.1 and B.2 show the typical wave form for a hit obtained during the test. Figure B.3 shows the correlation plot after filtering the data obtained from the acoustic emission testing. The data obtained at the end of the acoustic emission testing program indicated that corrosion was occurring. The hits were short duration, medium amplitude (40-60 dB) and occurred in bursts of emission which are expected as indicated from previous corrosion tests in which acoustic emission was used.

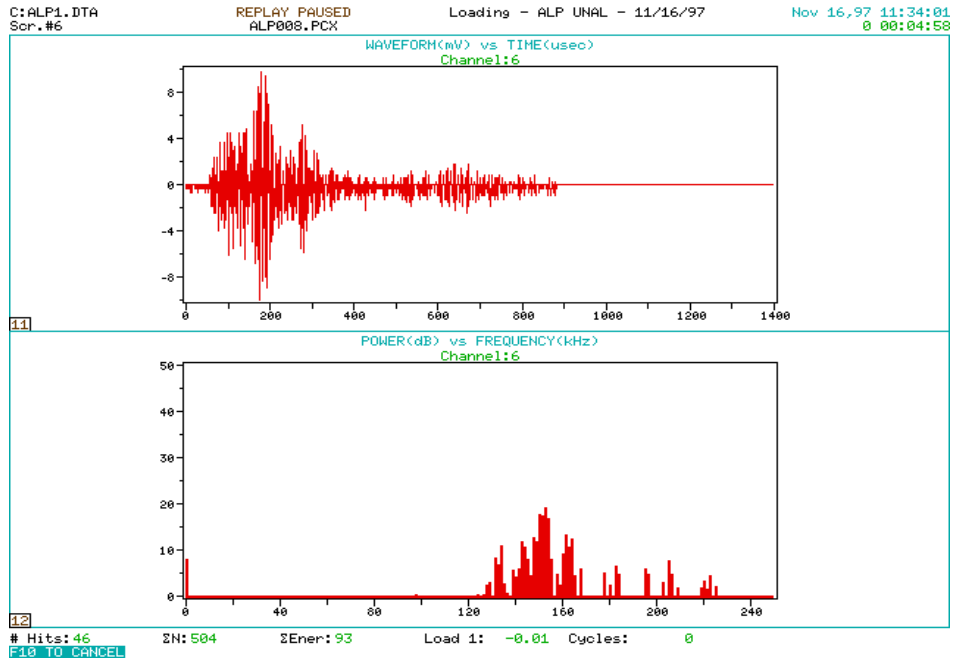
Figure B.4. Typical Wave Form During Loading.

Figure B.5. Typical Wave Form During Loading.

Figure B.6. Correlation Plot During Loading and Unloading.

Figures B.4 and B.5 show typical hits during loading of the beams. Figure B.6 is the correlation plot obtained during loading and loading of the beams. The hits were short duration and medium amplitude and the wave forms indicated occurrence of corrosion. The data shows the accelerated corrosion occurring during loading and unloading. After the loading and unloading process, the beams were quiet (no emission) for some time. The data was not produced by cracking or any damage to concrete due to loading since such damage generates emission of high amplitude (70-80 dB) and short duration.
