Experimental Investigation of Crushing Capacity of I-Girder Webs
Containing Post-Tensioning Ducts

Thesis

The University of Texas at Austin

December 2012

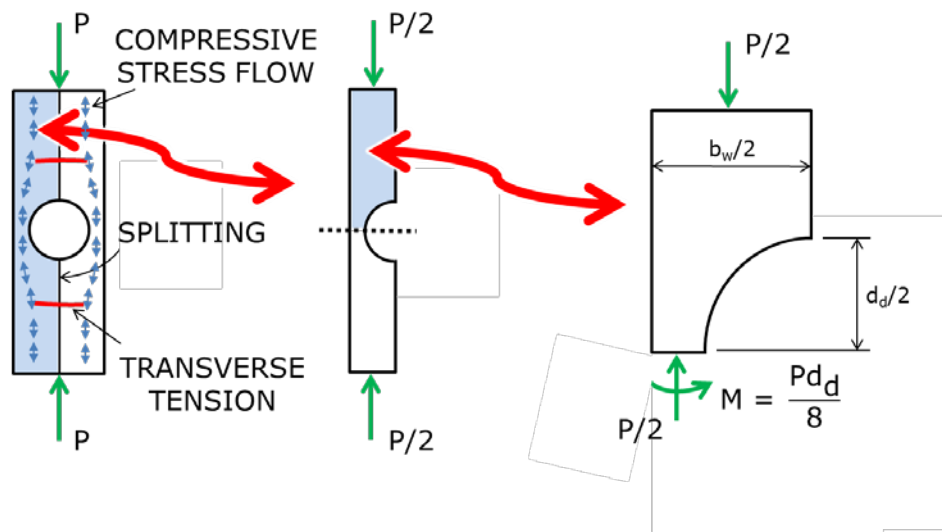
Figure 2-4: Main Failure Mechanism of Panels/Prisms (Adapted from Campbell and Batchelor (1981))

Chitnuyanondh explained that providing spiral reinforcement boosts capacity. A prism with a duct first splits into two equal, slender halves due to the tension produced from compression stress flow deviation. Then, these pieces of the entire specimen fail by a combination of axial load and flexure that develops due to a net eccentric compressive load applied to each segment. This is depicted in Figure 2-4. Under this combination of axial load and flexure, the two prism halves fail with a total load less than would be predicted based on the pure axial compressive strength of the net prism section at the level of the duct. Ultimately, the spiral reinforcement works by holding the splitting halves together.

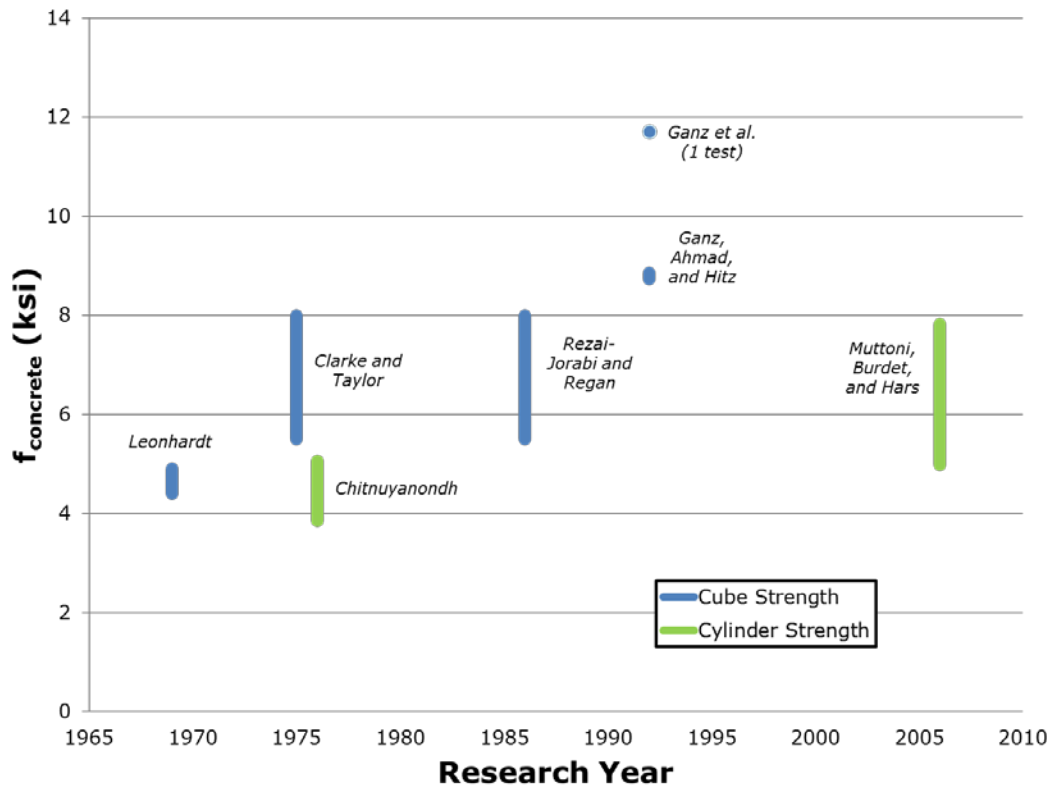
Figure 2-8: Historical Perspective of Panel/Prism Concrete Strength

- Testing was not carried out in any studies on the effects of concrete or grout strengths or the ratio of the two. Also, the effects of ducts in webs were rarely considered when using very high concrete strengths. In Figure 2-8, the ranges of concrete strengths (whether measured with cubes or cylinders) utilized in past research studies are shown. With the exception of one test specimen, no prior testing has been conducted with high-strength concretes of 10 ksi.

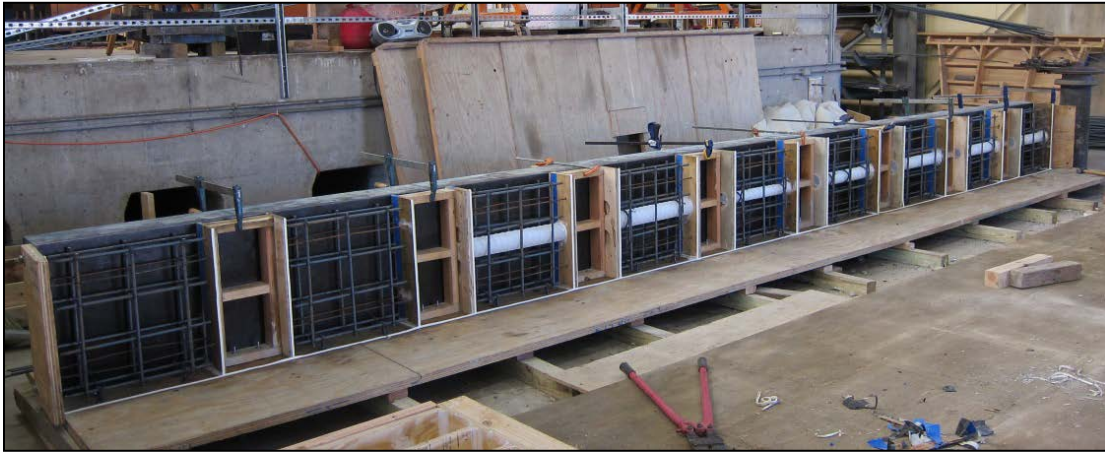
Figure 3-1: Formwork for Panel Casting

Each of the panels was fabricated in the lab using a formwork setup shown in Figure 3-1. Two 24-in. deep steel side forms were bolted to a plywood base soffit. The side forms were separated by a distance of 5-, 7-, or 9-in. to produce the desired panel thicknesses. A number of interior, wooden form spacers were constructed and bolted down between the side forms to create 24-in. long segments for casting individual panels (Figure 3-2). The spacers contained removable, interchangeable end caps, as seen in Figure 3-3, with holes of varying sizes and configurations bored out so that sections of post-tensioning duct could be inserted and held in place between spacers during concrete

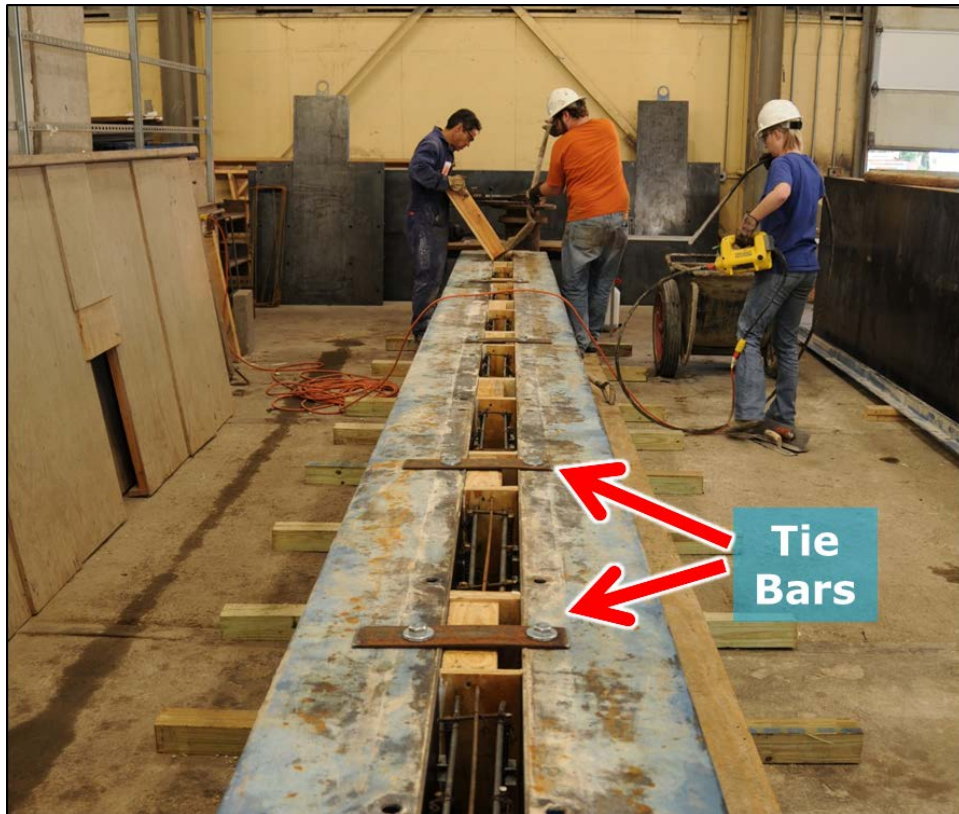
Figure 3-4: Side Form Tie Bars

placement. Lastly, as shown in Figure 3-4, 0.25-in. thick steel spreader tie bars were bolted to the side forms in order to keep the side forms adequately tied together to maintain uniform specimen thicknesses.

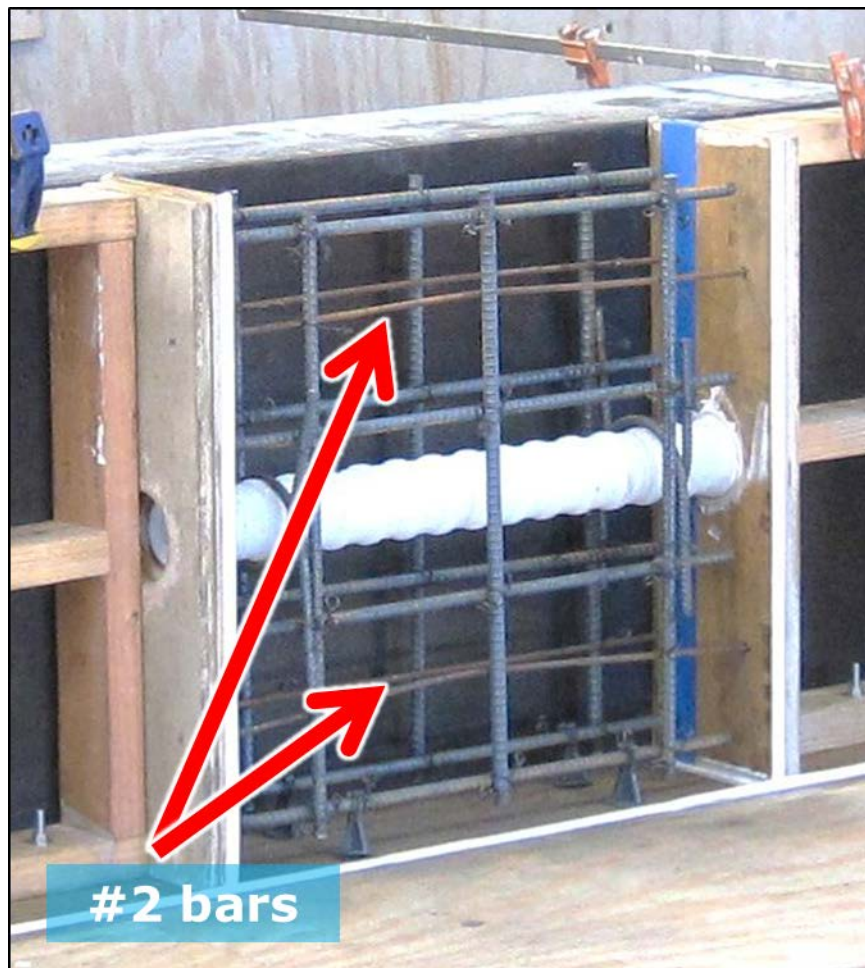
Figure 3-7: #2 Bars for Mesh Reinforcement Support

The four horizontal bars (parallel with the duct) were added for construction purposes to help hold the vertical bars in place. In the first two sets of panels, the two layers of reinforcement were tied together with small, straight pieces of #2 reinforcing bars through the panel thickness and subsequently tied to the duct. For all other panels, the layers of reinforcement were tied down to #2 bars placed in-between the interior form spacers (Figure 3-7). The clear cover was 0.5-in. for all panels and reinforcement patterns.

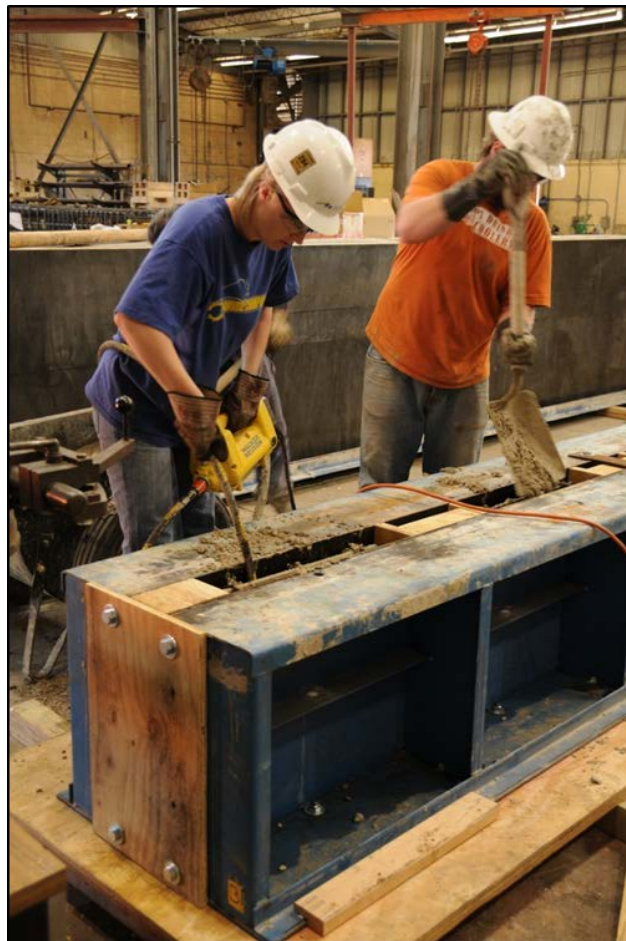
Figure 3-8: Panel Casting and Internal Vibration Procedure

Each set of panels was vertically cast and care was taken to ensure good consolidation of concrete, especially beneath the ducts. No external vibration was used, but internal vibration was employed to minimize the possibility of voids around the ducts (Figure 3-8). The casting direction was the same as the eventual loading direction.

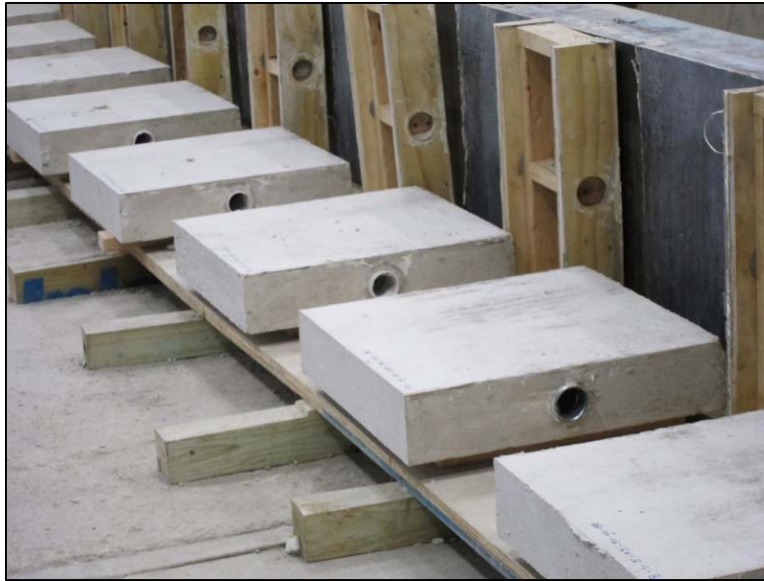
Figure 3-10: Completed Panel Set Cured and Removed from Forms

A complete set of test specimens is shown in Figure 3-10. The panels were normally removed from the formwork about two days after casting and were stored on the laboratory floor for approximately a week before grouting the ducts.

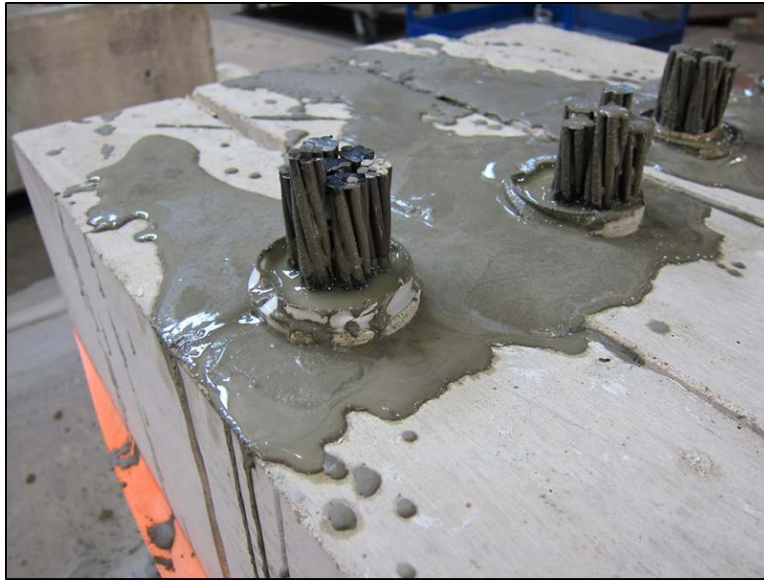
Figure 3-11: Duct Grouting Procedure

A vertical grouting operation was employed. Each panel was tilted upright with one of the exposed duct ends capped with plywood. A small amount of gypsum hydrostone was poured into the ducts to harden and seal the duct end so that no grout would leak out. Sets of bundled lengths of prestressing strand were placed in each duct, and then grout was hand-mixed and poured into each duct (Figure 3-11). Low-bleed, well-mixed batches of grout were used to achieve a good consistency without voids along the duct.

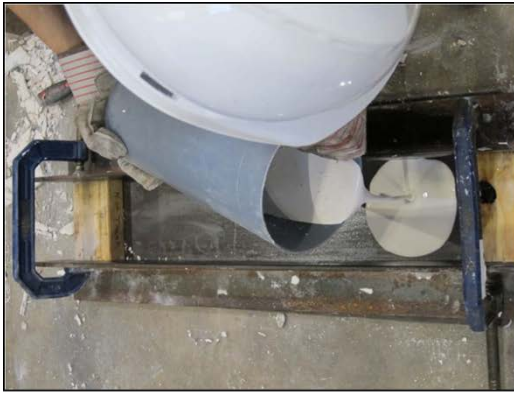
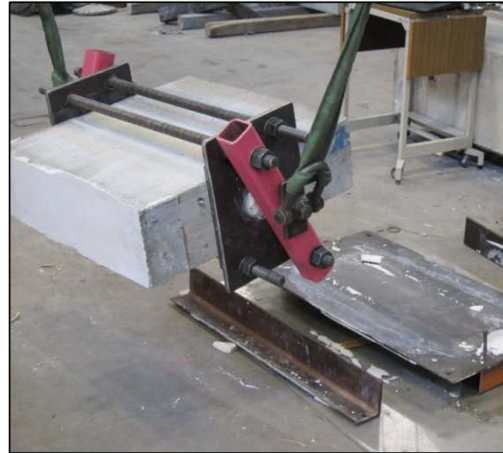
a) Placement of hydrostone

b) Removal of panel from hydrostone platform

Figure 3-13: End-Capping Panels with Gypsum Hydrostone

The lifting harness was clamped to the sides of a panel around openings for ducts so that the panel could be safely lifted and placed into a bed of liquid hydrostone on a level steel plate (Figure 3-13a). After the hydrostone hardened, the panel could be lifted up and rotated 180° using the rotating harness to allow hydrostone to be applied to the other surface. This entire process was fast and ensured that the hydrostone would not crack during panel transport. In Figure 3-13b, a panel with hydrostone applied to one surface is being moved from the hydrostone platform.

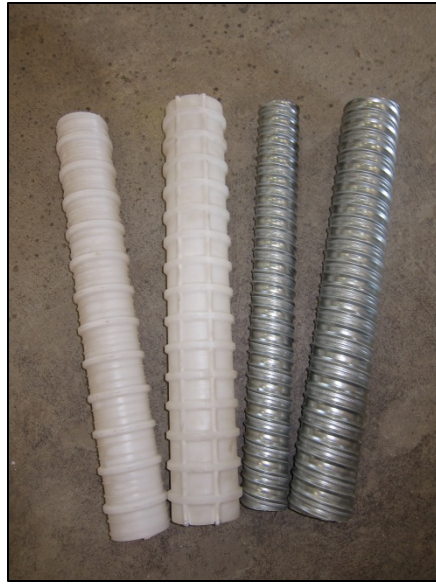
Figure 3-14: HDPE and Steel Ducts

Cylindrical, corrugated metal and high density polyethylene (HDPE) ducts were used in this study (Figure 3-14). The metal ducts are thin-walled, galvanized steel with angled corrugations. The HDPE ducts are thick-walled, low-friction plastic with thick, concentric ribs perpendicular to the longitudinal axis formed during the extrusion processes used in manufacturing the ducts. Additional protrusions exist parallel to the duct axis for those plastic ducts with a nominal diameter of 3.375-in. and greater. The steel and plastic ducts used had nominal interior diameters of 2.375-, 3-, 3.375-, and 4-in. All discussions of and calculations performed with results from this study utilize the nominal interior duct diameter rather than the exterior or outer diameter (which accounts for duct thickness).

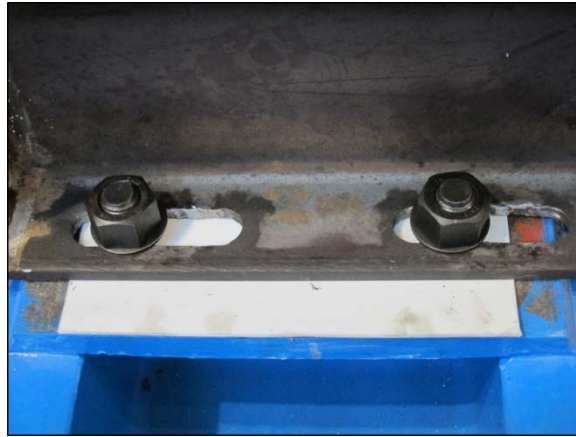
Figure 3-17: Connection Between Frame Beam and Brace Beam

end of the test frame. This allowed the frame beams to move under load while still maintaining proper alignment and without transfer of load through the brace beams. Additionally, sheets of Teflon were placed between the brace beams and frame beams at the connections to eliminate the generation of friction during loading.

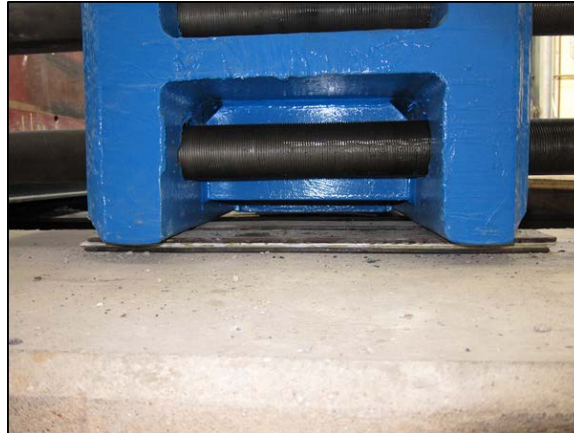
Figure 3-18: Teflon Track

In an effort to maintain a test setup in which there would be no loss of load between the points of load application and load measurement (at the rods), Teflon-mounted steel plates were placed between the frame beams and underlying concrete support beams (Figure 3-18). By providing a Teflon-on-Teflon boundary between these large elements, the frame beams could freely slide on top of the concrete under the application of load, thus eliminating any loss of load to friction and ensuring that the final

load measurements based on the tension in the rods would accurately reflect the true failure load of each specimen.

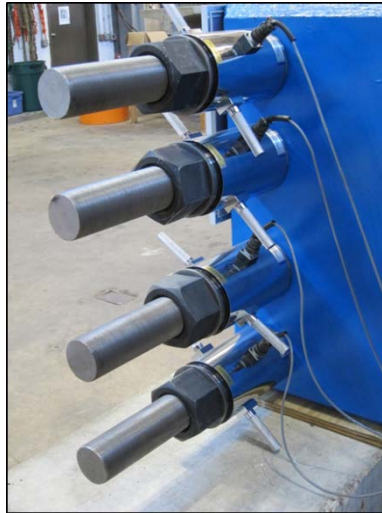
Figure 3-22: Load Cells

load cell was situated on a rod at the ram-end frame beam as shown in Figure 3-22. The data from all load cells were added to determine the compression applied to the test panel.

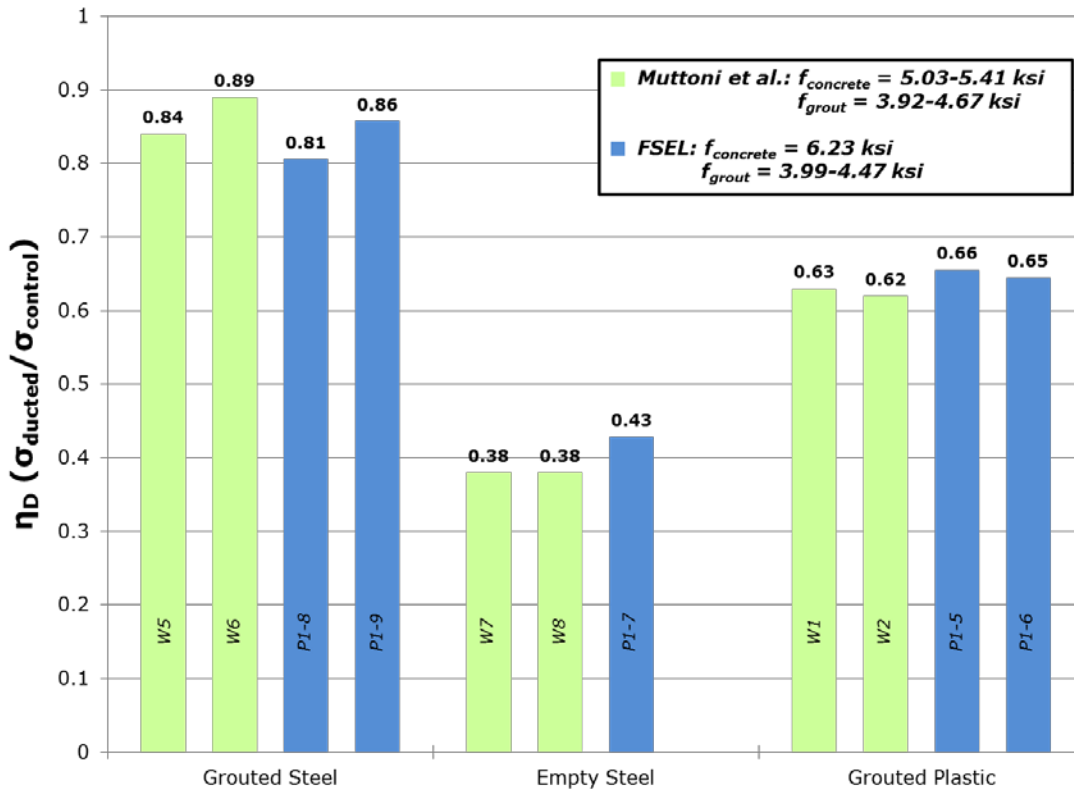
Figure 4-2: Comparison of 5-in. Panel Results and Tests by Muttoni et al.

Six tests from the first panel set (one control and five ducted panels) were compared to those from the work of Muttoni et al. In Figure 4-2, η_D values calculated for similar tests from the two sources are compared. No comparison could be made for a panel with an empty, plastic duct. Overall, the only difference between the two sets of panels was the material properties. Measured concrete and grout strengths are also shown in Figure 4-2.

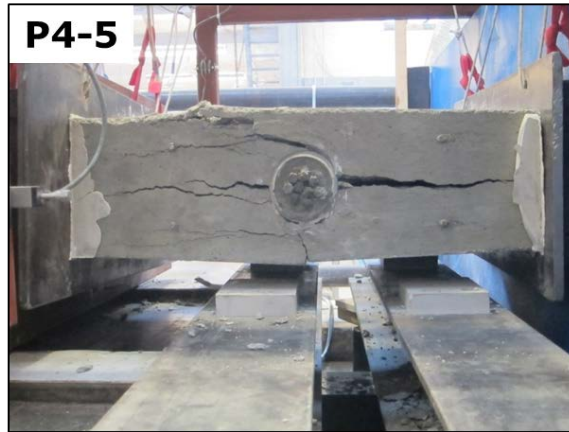
Figure 4-4: Tensile Splitting of Panels

Regardless of duct type, each specimen ultimately failed by the initiation of splitting of the specimen near mid-thickness and near the duct rather than by crushing (Figure 4-4). This splitting was relatively abrupt, typically with little to no warning of impending failure. An example of this load-deflection behavior is seen in Figure 4-5. Initially, deflections increased rapidly under minimal load during specimen seating until the specimen's loading surfaces and the bearing pads became fully engaged. Under continued loading, deflections increased – quickly at first and more gradually at higher loads. Ultimately, the slope of the load-deflection curve did not change much, if at all, when a panel failed. The splitting of panels was accompanied by the expulsion of concrete at the sides of the panels and buckling of the reinforcement in the direction of loading.

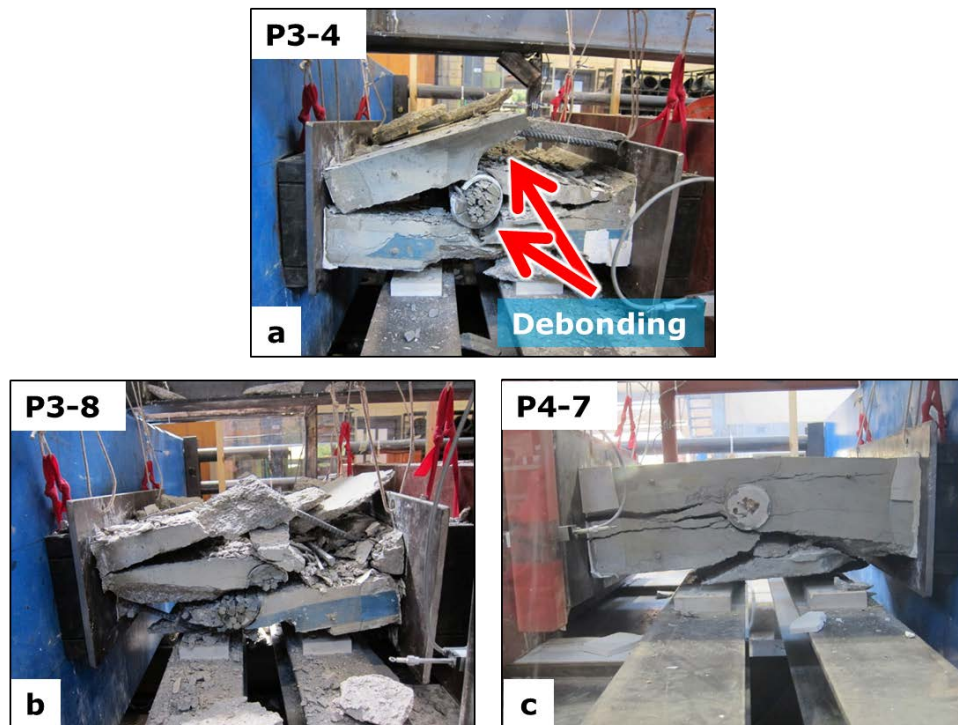
Figure 4-6: Common Failures of Plastic- or Steel-Ducted Panels

The primary link to understanding the difference in capacities depending on duct type used lies in the observed sequence of cracking up to failure. In many cases, panels with plastic ducts split in half exhibiting complete separation or debonding between the duct and surrounding concrete (Figure 4-6a). The duct did not always remain completely intact though, and the grout was often seen to be partially cracked; however, this was mostly the result of the energy release when the panel failed rather than a characteristic of failure itself. On the other hand, the panels with steel ducts almost never experienced debonding between the concrete and duct. In some cases, the failure could be categorized as a complete mid-thickness splitting failure, with the duct itself being severed and cracking propagating through the grout (Figure 4-6b). In other instances, splitting still dominated at failure, although cracks propagated from mid-thickness at panel ends toward the outer duct edges while leaving the duct and grout undamaged (Figure 4-6c).

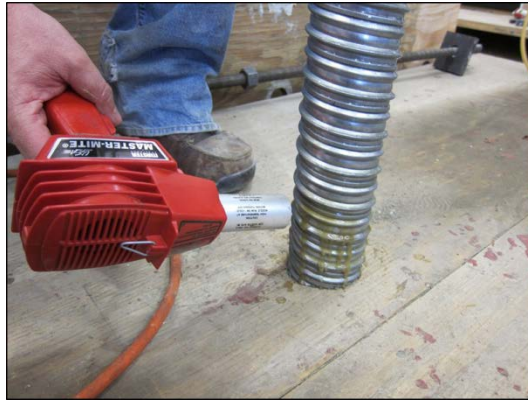
Figure 4-7: Application of Wax Bond Breaker to Steel Ducts

The entire exterior surface of the 3-in. steel ducts used in two panel tests were coated with a thin layer of melted wax in order to break the bond between the ducts and concrete. The wax was melted and evenly applied using a heat gun. This was done to ensure that the nominal thickness of the ducts would not be impacted and that there would be a uniform layer of wax on the duct (Figure 4-7).

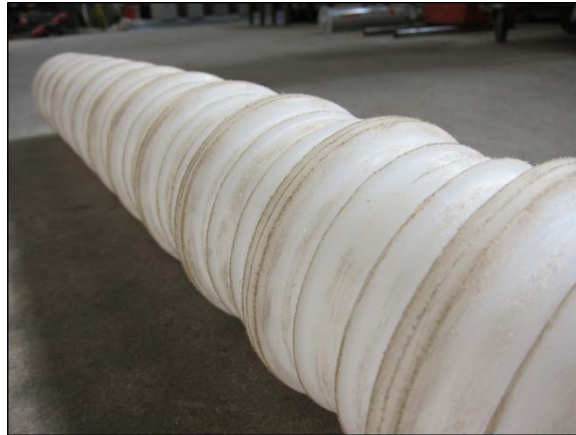
Figure 4-9: Sanded, Plastic Duct

An additional panel was tested that contained a plastic duct shown in Figure 4-9, whose surface was scored using 80 grit sandpaper to provide a roughened surface to possibly improve mechanical bond. The procedure used did not improve performance; this panel (P7-9) failed at an η_D of 0.37. Other ways of improving bond of plastic ducts may be possible; however, determining a viable solution would likely involve significant alterations to construction and/or duct manufacturing practices. Thus, the role of bond will have to be taken into consideration in design procedures.

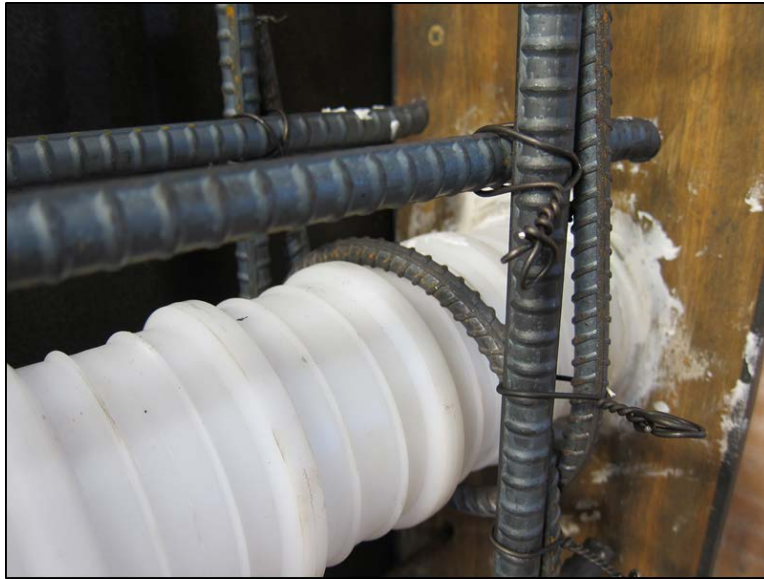
Figure 4-24: ‘Normal’ Hairpin Configuration

For tests considering variation in reinforcement amounts, only one reinforcement configuration was used. This standard ('normal') layout consisted of two pieces of hairpin-bent reinforcement (with a bend diameter of 4-in.) hooked around the duct in either direction of loading located at discrete points along the duct's length (Figure 4-24). The bent portion of each individual piece was meant to resist tension through the panel thickness on a single side of the duct. In no case described here were multiple pieces of reinforcement bundled on the same side of the duct to potentially increase the amount of reinforcement at a single location. The potential benefits of bundling multiple bars on the same side of a duct will be addressed later.

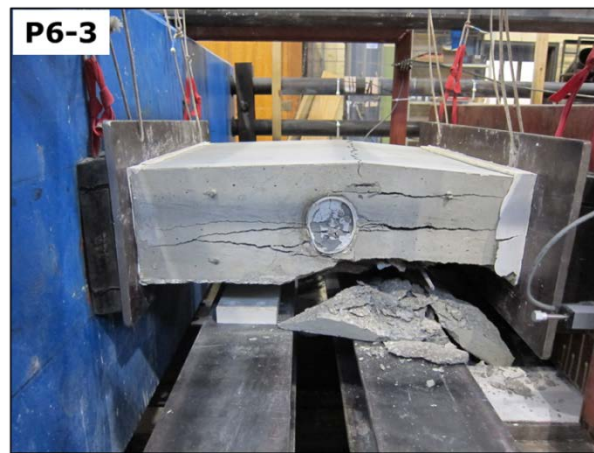
Figure 4-30: Failure of Reinforced Panel with Cracking at Level of Duct

The failure behaviors of the panels discussed were similar but illustrate some slight differences. As for all reinforced panels, mid-thickness cracking occurred, but load increased without the two halves of a panel suddenly separating. For the panels with bars located ‘far’ from the duct, failure involved some crushing of the concrete around the ducts and of the ducts themselves along with cracking at the sides of the panel near the duct (Figure 4-30). This behavior was similar for panels with bars at the ‘midway’ position. The presence of cracking near the duct verified general panel behavior as outlined by Chitnuyanondh (1976). At splitting, a panel acts as two separate, eccentrically-loaded halves failing in combined axial load and flexure. Half of a panel

bending outward would produce tension at the outer fibers with the greatest tensile stress located exactly in the middle near the duct. The presence of through-thickness reinforcement enabled this cracking to be observed by holding the panel together whereas in panels without this reinforcement, the explosiveness of an unrestrained splitting failure precluded visual confirmation of such a secondary failure mechanism. Meanwhile, panels with bars ‘close’ or against the duct exhibited increased crushing behavior compared to those with bars placed farther from the duct (Figure 4-31).

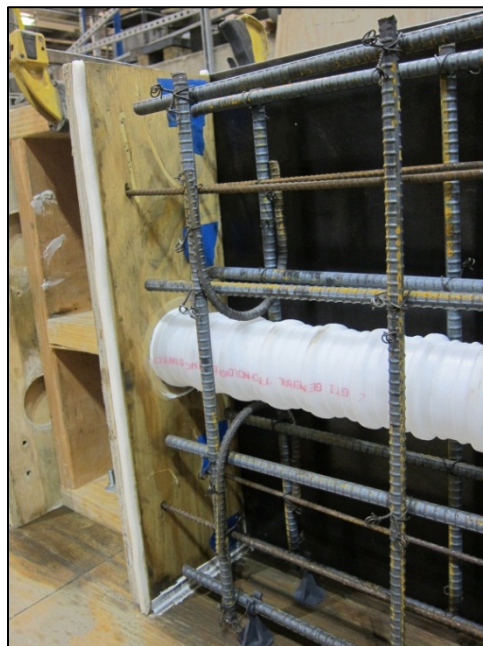
Figure 4-35: Inverted Hairpin Configuration

The inverted hairpin configuration was designed as a simple orientation modification to the ‘normal’ hairpin scheme mainly to determine if the direction of installing the hairpins mattered. On occasion, panels tested with ‘normal’ hairpins showed signs of distress upon failure, suggesting that the orientation of the panels might be hindering the panel from reaching a higher capacity. In Figure 4-34 this post-failure shape of a ‘normal’ hairpin is illustrated, showing that the hairpin legs are no longer straight and parallel to each other as they were originally constructed but are rather angled away from the bend. Due to the nature of hooking the hairpin around the duct, the hairpin legs were directly in the vicinity of the largest component of the tension field developed in the panel. Consequently, the tension may have led to the legs pushing outward and inducing a prying effect on the outer fibers of the panel leading to a premature loss of capacity. Thus, in an effort to determine if this was the case, the inverted hairpins were not hooked around the duct. Rather, the bend was butted against the duct on either side with legs still in the direction of loading but extending away from the duct (Figure 4-35). This was intended to move the legs further from the region of highest tension.

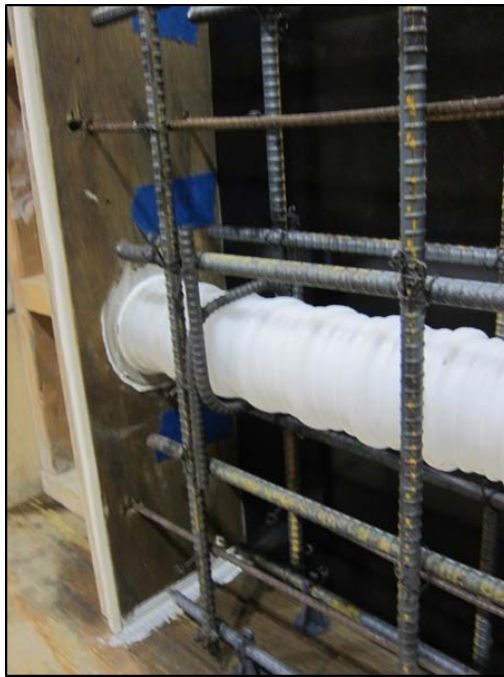
Figure 4-36: ‘Flattened’ Hairpin Configuration

The ‘flattened’ hairpin setup (Figure 4-36) was created as a minor alteration of the physical shape, but not orientation, of the ‘normal’ hairpin scheme. Rather than have each individual piece of reinforcement continuously bent into one arc, the flattened hairpins were bent at two locations to provide a flat portion that was placed against the duct instead of a curved portion. Each bend was kept at the minimum code-required radius, and a 4-in. spacing between the legs of each piece of reinforcement was maintained.

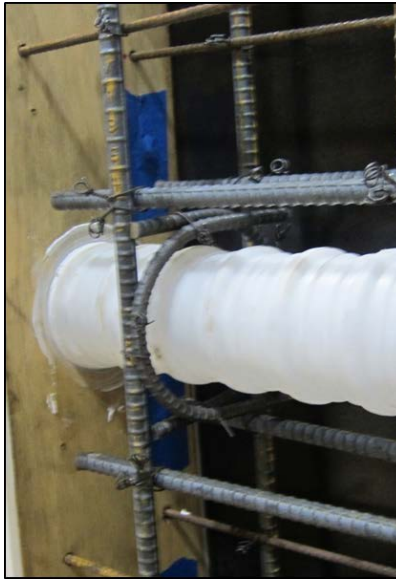
Figure 4-39: 'Staple' Configuration

This setup incorporated hairpin-bent pieces of reinforcement with the same 4-in. diameter bend as previously used, the difference being that these pieces were inserted through the thickness of the panel from the sides rather than above and below the duct in the direction of loading (Figure 4-39). While fitting the 'staples' into a congested region of a reinforcement cage was slightly simpler than the 'normal' hairpins, securing the 'staples' was more cumbersome. The bent portion of the reinforcement had to be tied very securely to the vertical bars. The legs of opposite bars were tied together, but they were not tied to any main horizontal or vertical bars.
