1. Report No. FHWA/TX-03/1857-2	2. Government Accession No.	3. Recipient's Catalog No.	
4. Title and Subtitle Nondestructive Testing of Prestressed Bridge Girders with Distributed Damage		5. Report Date August 2002

Nondestructive Testing of Prestressed Bridge Girders with Distributed Damage

Research Report 1857-2

STRUCTURAL ASSESSMENT OF IN-SERVICE BRIDGES WITH PREMATURE CONCRETE DETERIORATION

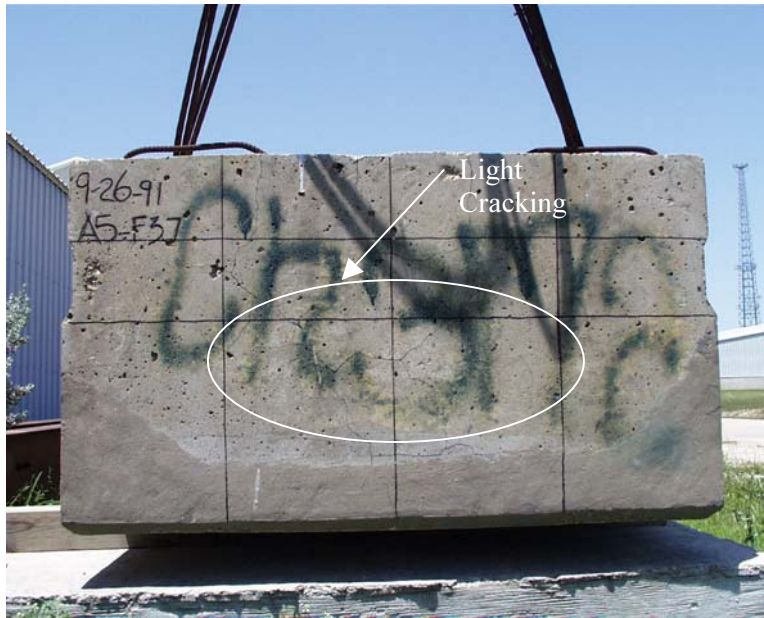
Figure 3.1 – End View of A-Side of BG1

The least deteriorated specimen was BG1; it serves as the control against which the other girders may be compared. Even this specimen was showing some signs of deterioration. Most of the damage was concentrated in the 26 inch long end block, with crack widths ranging from 0.002 inches to 0.06 inches. In addition, a horizontal crack at the joint between the first and second pours (5.5 inches from the bottom of the girder) ran the entire length. The final crack worth noting was a horizontal crack 17 inches from the bottom that ran intermittently along the length. Girder BG1 is shown in Figure 3.1 to Figure 3.4.

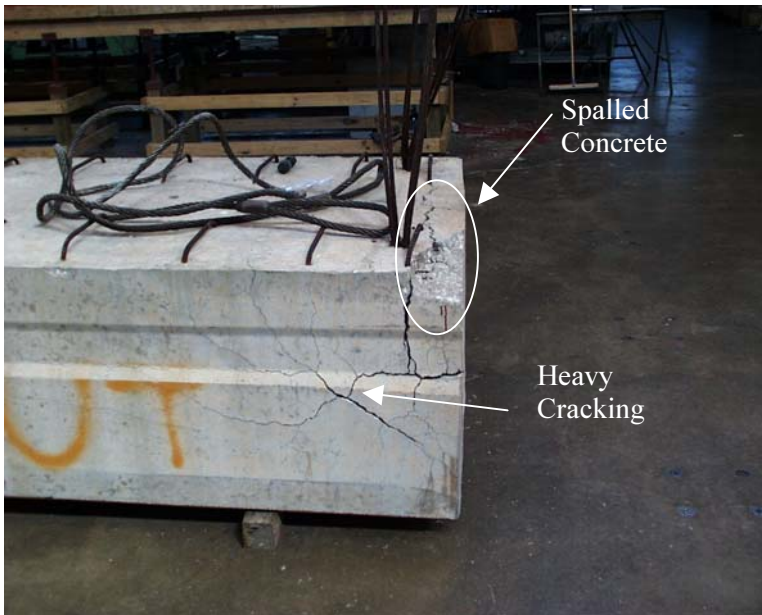
Figure 3.8 – Side View on B-End of BG3

The third girder, BG3, was chosen because its damage, while not as severe as that of BG2, was more distributed along the length, and was also quite severe at the ends and near the interior blockouts. A crack along the pour joint had a maximum width of 0.01 inches. Figures 3.7 though 3.9 document the condition of BG3.

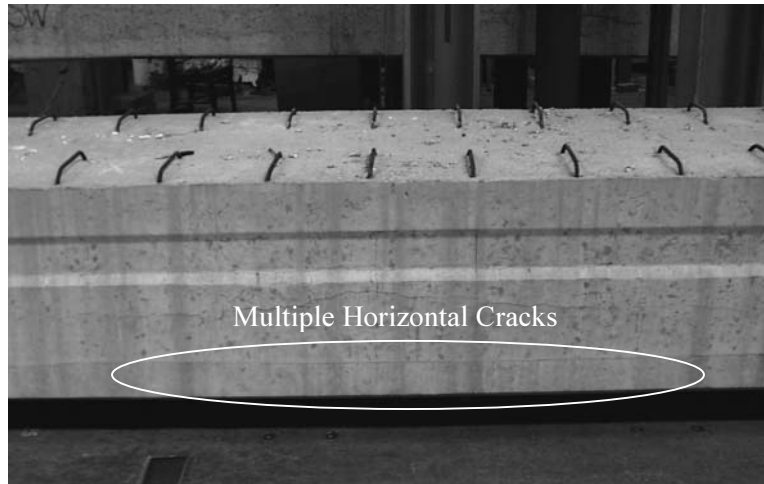
Figure 3.9 – Damage at Interior Blockout on BG3

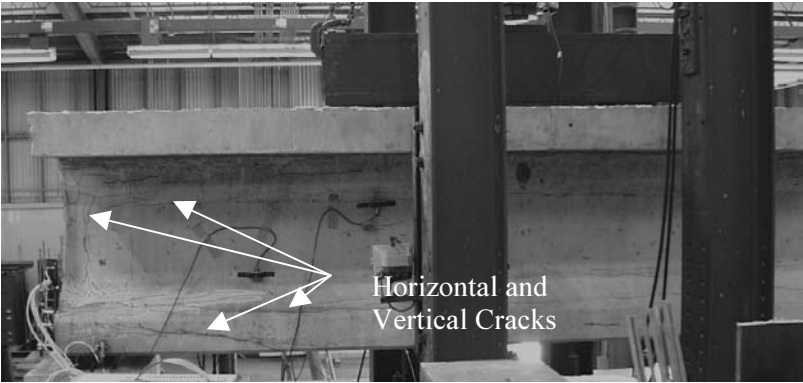
Figure 3.13 – West End of Girder 1

Figures 3.13 though 3.15 show the typical condition of the Type C girders.

Specimen	Crack Ratio, %
Girder 1 – East End (G1ES)	1.64
Girder 1 – West End (G1WS)	1.57
Girder 2 – East End (G2ES)	0.71
Girder 2 – West end (G2WS)	1.76

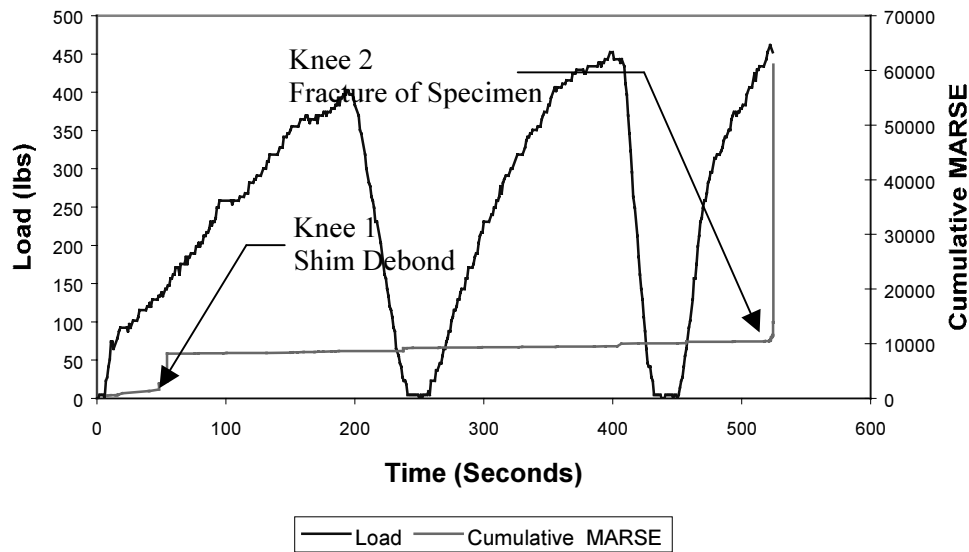
Figure 4.8 – AE Response of a Typical Notched Specimen

The cumulative MARSE plot of a representative notched specimen just prior to fracture is shown in Figure 4.8. This chart shows two distinct slope changes, or "knees," that indicate a significant change in the specimen. The first knee coincides with the first opening of the notch, corroborated by the clip gauge and a metallic sound heard at that time. The combination of these events indicates that the slope increase is most likely due to debonding of the steel shim used for the notch initiation. After the crack opened, no further damage occurred as shown by the flat slope of cumulative MARSE. Knee 2 occurs immediately before the final fracture. From the acoustic emission while loading, it was possible to predict imminent failure from the increased rate of emission.

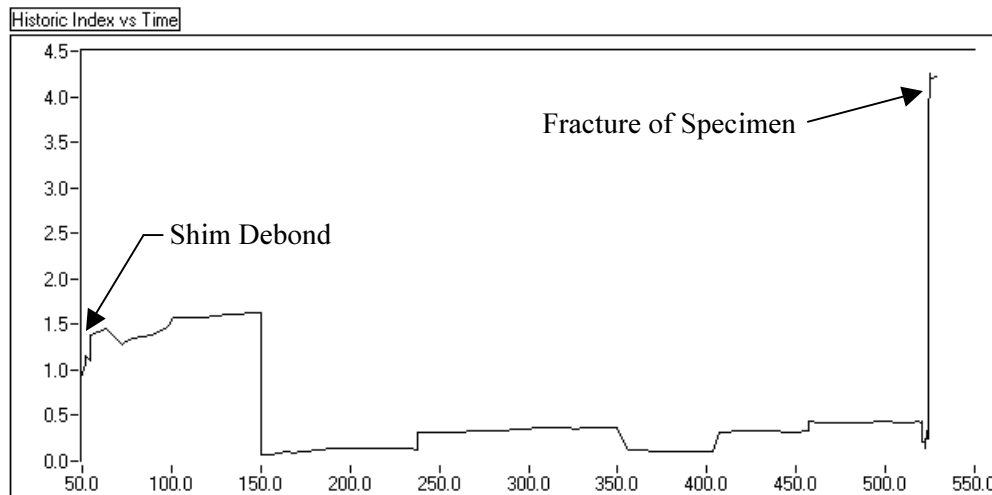
Figure 4.9 – Historic Index for a Typical Prenotched Specimen

In this study, the Historic Index was calculated using a program written in C++ and then plotted in a program written in LabView. Figure 4.9 shows the Historic Index for the small-scale specimen whose cumulative MARSE plot is shown in Figure 4.8. The knees in the MARSE curve can readily be identified because they correspond to sharp increases in the Historic Index plot. The first peak in Figure 4.9 lasts for a long time, since Historic Index is independent of time and is only updated when a new hit occurs. After the shim had fully debonded, very few new hits occurred, resulting in a long plateau.

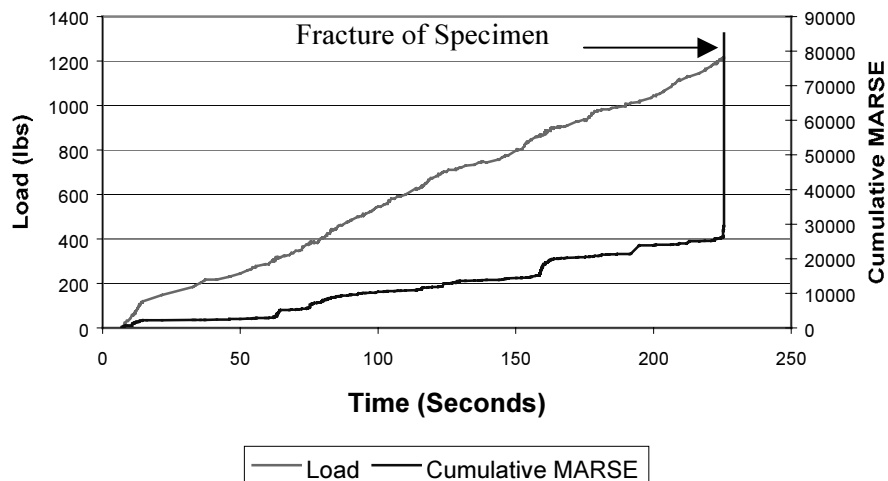
Figure 4.10 – Typical AE Response of Notch Free Specimen

While the notched specimens displayed little acoustic emission except at the knees in the cumulative MARSE curve, the notch-free specimens (Figure 4.10) showed relatively constant low-level emission until just prior to failure, when the rate of emission increased significantly. A probable explanation for the difference in trends between the notched and the notch-free specimens can be explained by crack initiation. Cracks form in concrete when distributed microcracks coalesce into a single crack. The notched specimens have a significant stress concentration, focusing the microcracking to a small area. If the microcracking occurs only in a small area, less microcracking will occur before a crack forms. Because acoustic emission detects the stress waves emitted from the microcracking, a notched specimen will have less emission. Another explanation is that the notched specimen fails at a much lower load than the notch-free specimens. The higher loads produce a higher stress, which causes more microcracking and more emission.

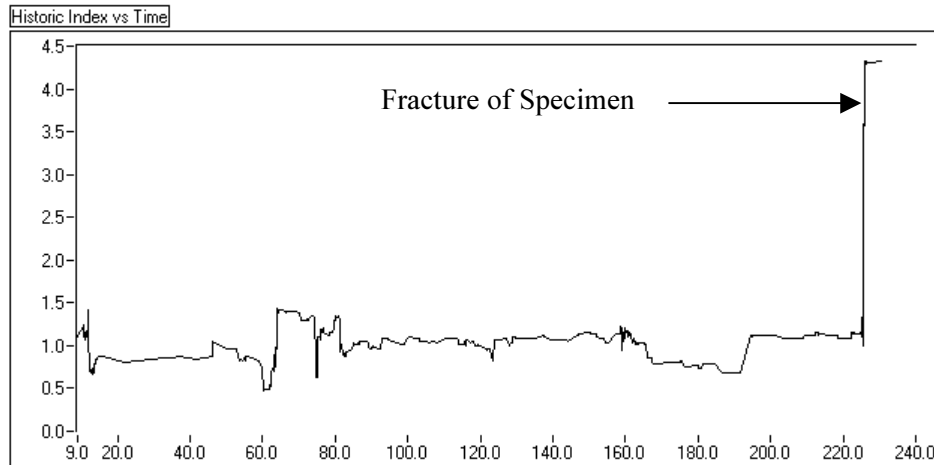
Figure 4.11 – Historic Index for a Typical Notch free Specimen

As with the notched specimens, the Historic Index of the notch-free specimens is a good indicator of significant events. Figure 4.11 shows the Historic Index for the specimen whose cumulative MARSE plot is shown in Figure 4.10. The only large, sharp jump in this graph corresponds to fracture of the specimen. The Historic Index for the notch-free specimen has more scatter than that of the notched specimen.

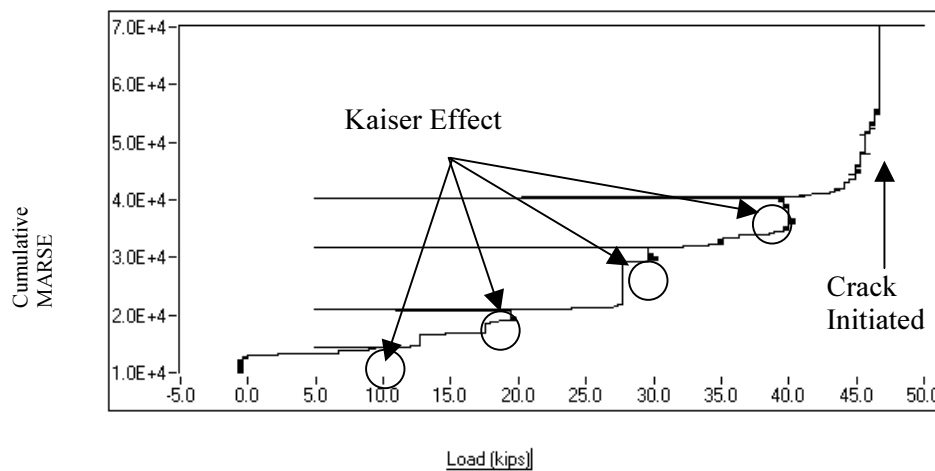
Figure 4.17 – Load vs. Cumulative MARSE before Cracking for BG1

Figure 4.17 is the graph of cumulative MARSE vs. load until cracking for BG1, the least damaged of the specimens tested. The Kaiser Effect holds true at all load increments up to cracking. This is shown by the fact that a graph of cumulative MARSE vs. load graph is horizontal until the previous maximum load is reached. Very little emission occurs during load holds, before cracking, or during unloading.

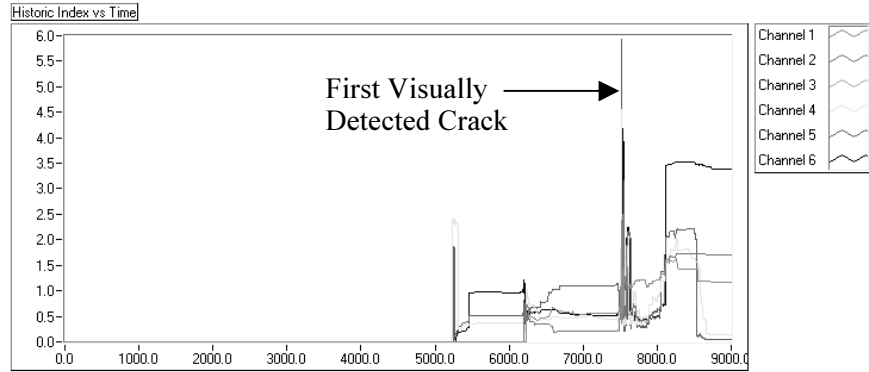
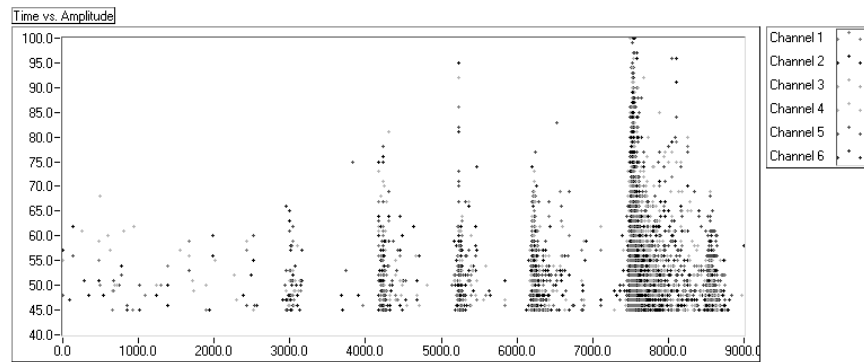
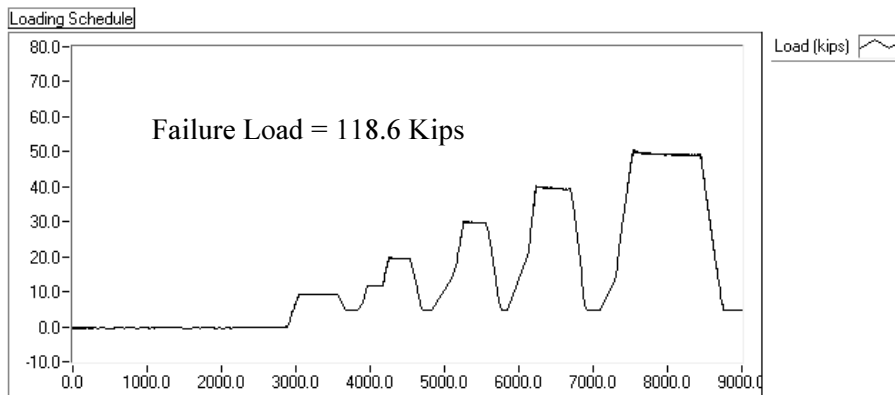
Figure 4.18 – Time Based Graphs for BG1

The plot of Historic Index vs. time (Figure 4.18) shows one peak at cracking, and a few smaller peaks before cracking. All of these peaks are small (less than 5), and the results show significant scatter.

The amplitude vs. time plot (Figure 4.18) shows very few high amplitude hits until cracking. In fact, there is only one hit above 90 dB before cracking.

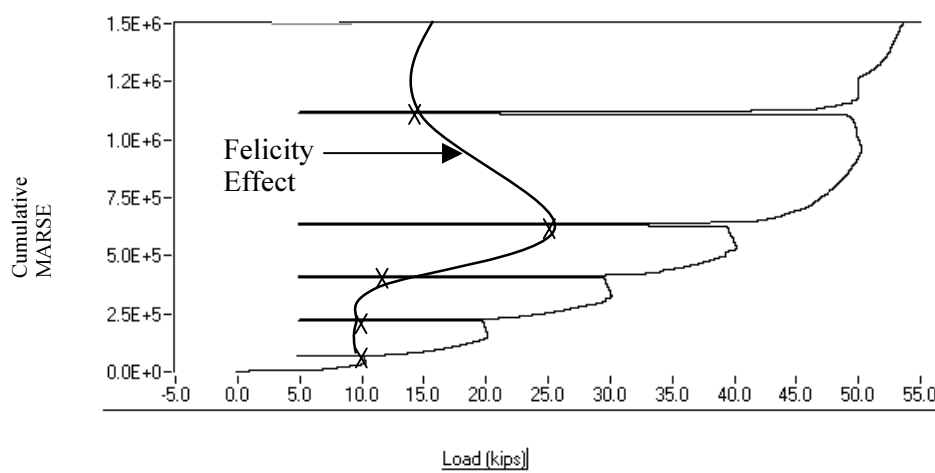
Figure 4.19 – Cumulative MARSE vs, Load for BG2

Figure 4.19 is the graph of cumulative MARSE vs. load for BG2, the most damaged of the specimens tested. The Kaiser Effect does not hold for this specimen. Instead, the Felicity Effect is detected very early as seen by the separation in the unloading and reloading lines marked by "X" in Figure 4.19. The point where the Felicity Effect begins, as defined in Section 4.4.2.1, is drawn in Figure 4.19 and presented in Table 4.8. Significant emission occurs during load holds, as shown by the fact that cumulative

MARSE increases at a relatively constant load (a vertical increase in Figure 4.19). Total emission is quite large as can be seen by the scale of the vertical axis.

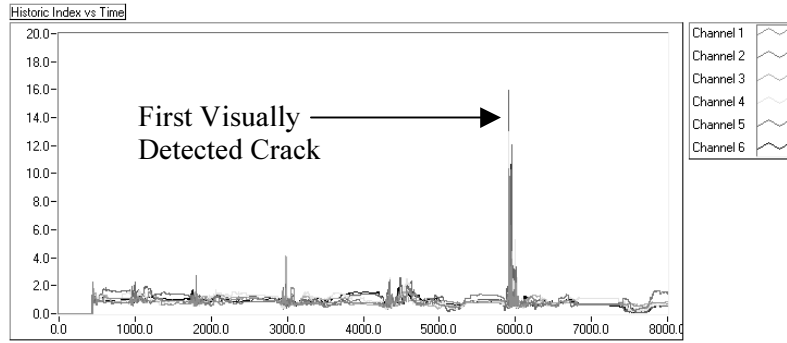
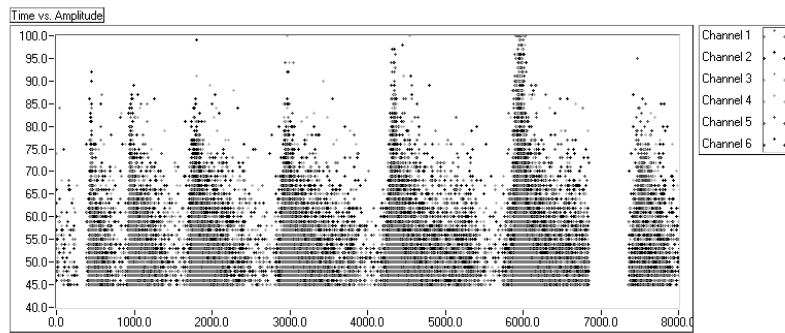
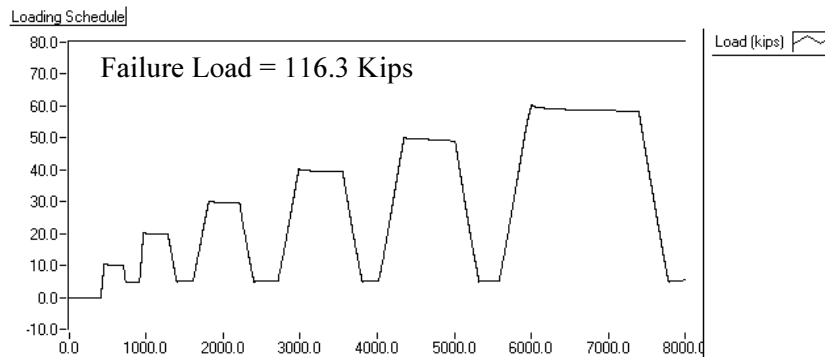
Figure 4.20 – Time Based Graphs for BG2

Graphs of amplitude vs. time and Historic Index vs. time for BG2 are shown in Figure 4.20. The only major peak in the Historic Index corresponds to the cracking load. At lower loads, there is little scatter and the Historic Index stays close to 1.0. Also, high amplitude hits occurred in every loading cycle.

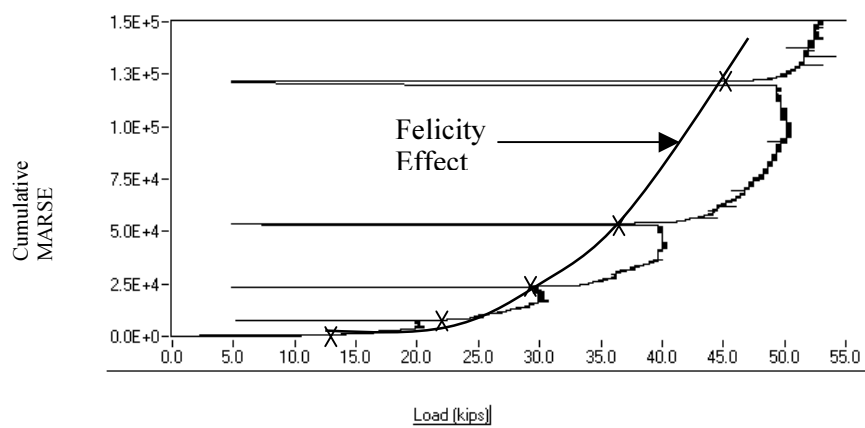
Figure 4.21 – Cumulative MARSE vs. Load for BG4

The graph of cumulative MARSE vs. load for BG4 is shown in Figure 4.21. Felicity Ratios were calculated and are shown in Table 4.9. Felicity Ratios stayed high (greater than 0.9) until cracking, and then dropped off dramatically. This same trend was seen in BG1. The amount of emission in Figure 4.21 is small, and very similar to that of BG1. In addition, most emission occurs during loading and very little during load holds.

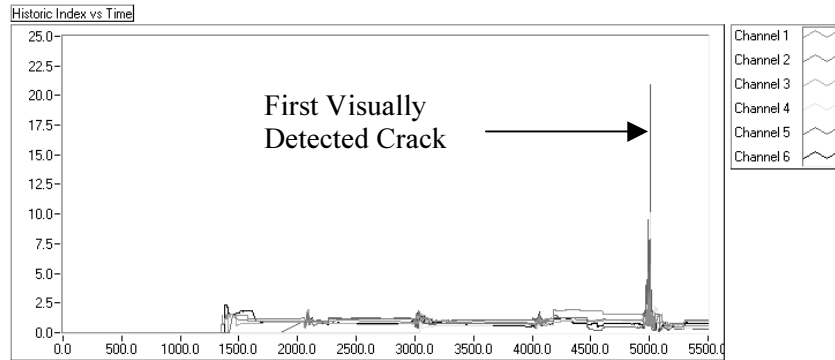
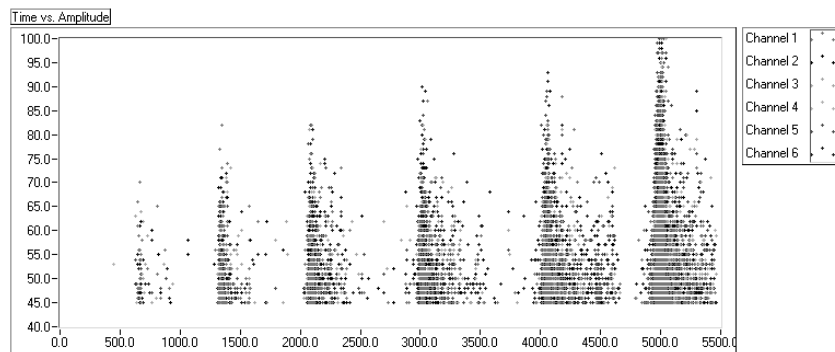
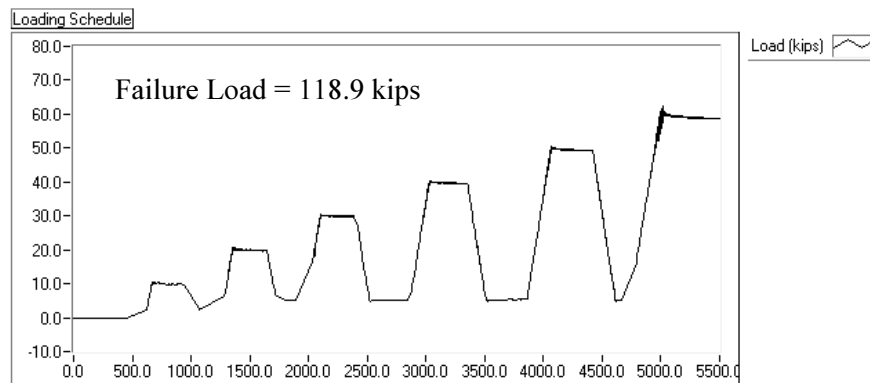
Figure 4.22 – Time Based Graphs for BG4

Graphs of amplitude vs. time and Historic Index vs. time for BG4 are shown in Figure 4.22. The only major peak in the Historic Index corresponds to the cracking load. Amplitudes steadily increase until the cracking load, where hits over 95 dB are recorded.

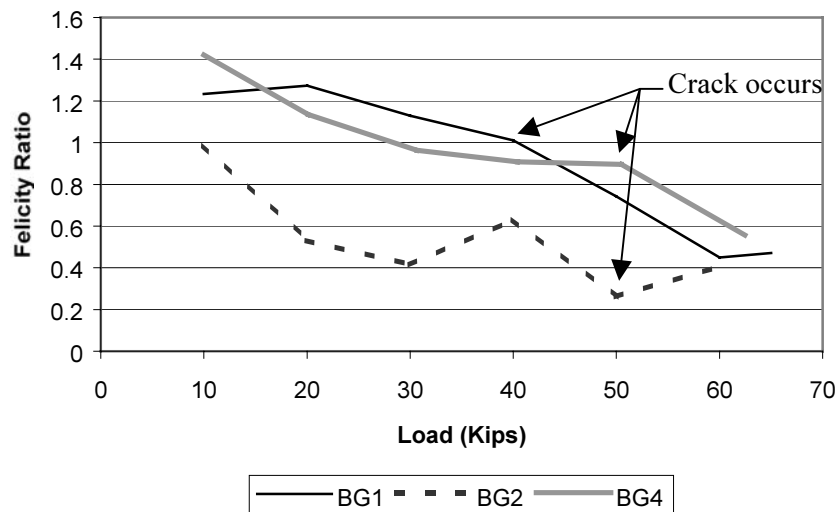
Figure 4.23 – Felicity Effect for Flexure Specimens

3. Finally, the Felicity Effect is detected before cracking in the badly damaged specimen, while in the better specimens it was not seen until after crack initiation. Felicity ratios for BG1, BG2 and BG4 are presented in Figure 4.23. The Felicity Ratio for BG1 does not decrease below 1.0 until cracking has occurred. For the more heavily damaged specimen BG2, however, the Felicity Ratio is considerably below 1.0 after the first interval.

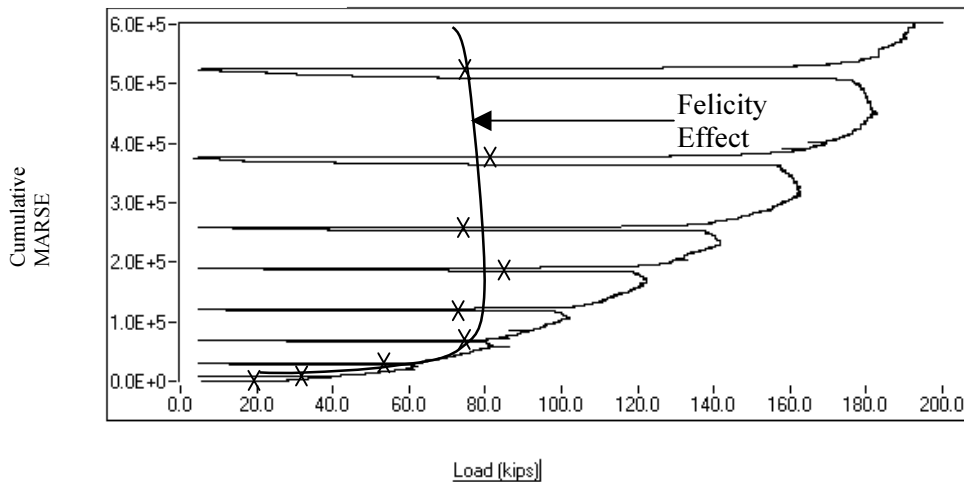
Figure 4.28 – Load Vs Cumulative MARSE for BG1S

Figure 4.28 shows the graph of cumulative MARSE vs. load for BG1S, up to the cracking load of 160 kips. The Felicity Ratio was as in the flexure tests (a cumulative MARSE increase of 300 above the value at 8 kips when reloading). Results are shown in Table 4.10. The Felicity Ratio is around 0.9 for BG1S until about 80 kips; during the next increment it then starts to decrease, and emission during load holds begins to increase.

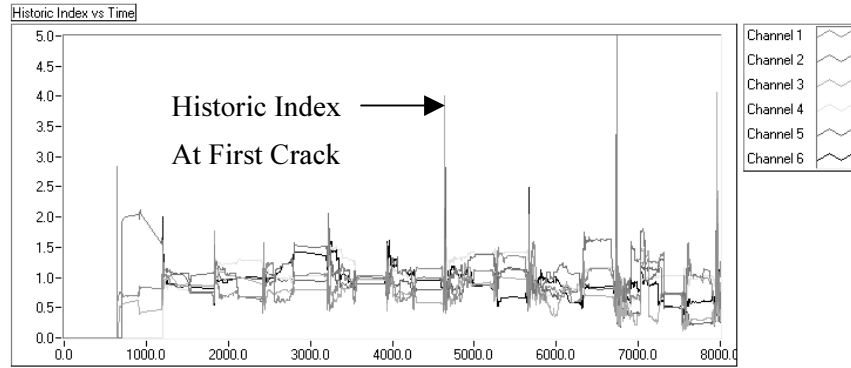
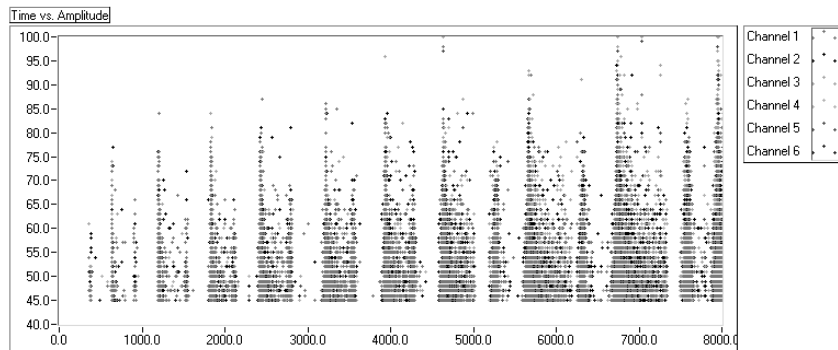
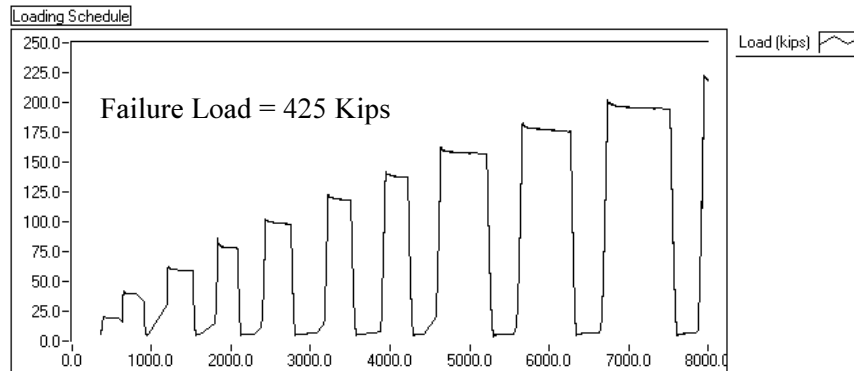
Figure 4.29 – Time Based Graphs for BG1S

The time-based graphs for BG1S are shown in Figure 4.29. Amplitudes at low loads are larger than in the flexure tests, but still relatively low. In fact, no hits above 90 dB occur until 140 kips is reached. Historic Index shows a major peak at the cracking load.

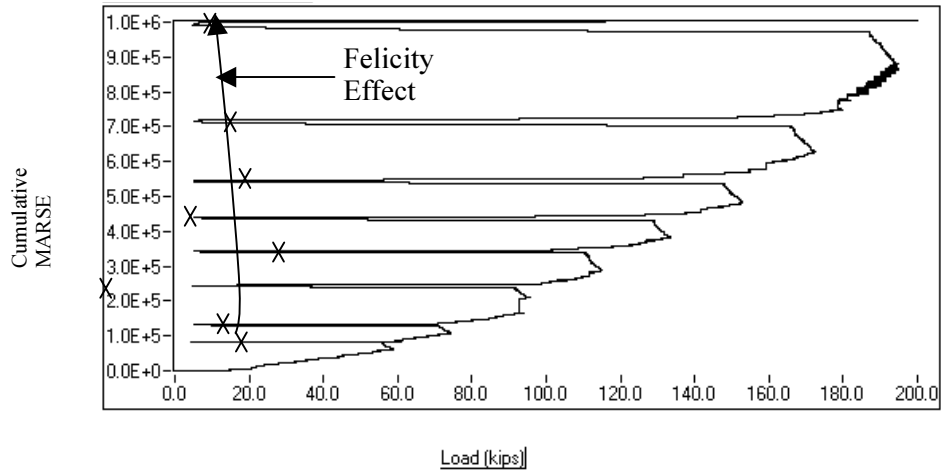
Figure 4.30 – Cumulative MARSE vs. Load for BG2S

The badly damaged beam, BG2S, was also tested in shear. The load was accidentally increased to 55 kips for the first interval. While this made it impossible to examine the Felicity Effect at low loads, general behavior can be examined. Figure 4.30 shows the graph of cumulative MARSE vs. load for BG2S before cracking was detected. Results from the shear test resemble those from the flexural test. The badly damaged beam shows emission during load holds, and the Felicity Effect is prevalent, especially at higher loads (Table 4.11). In every cycle except the first, the Felicity Ratio is below 0.7.

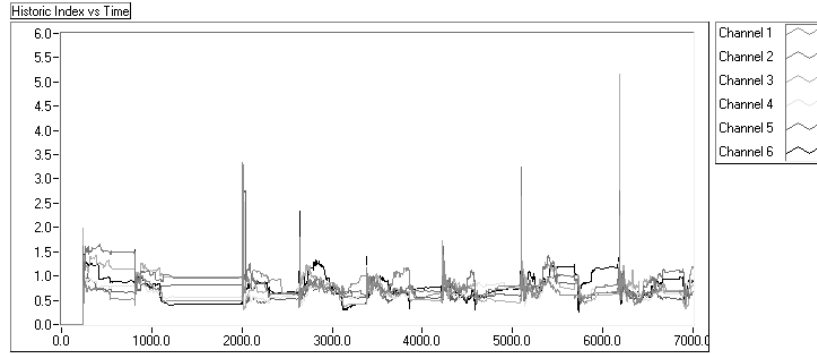
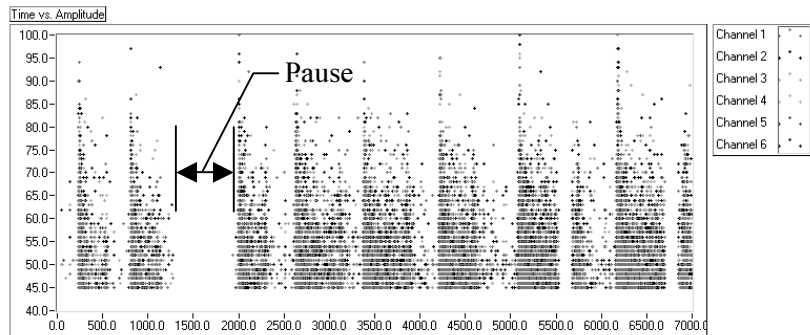
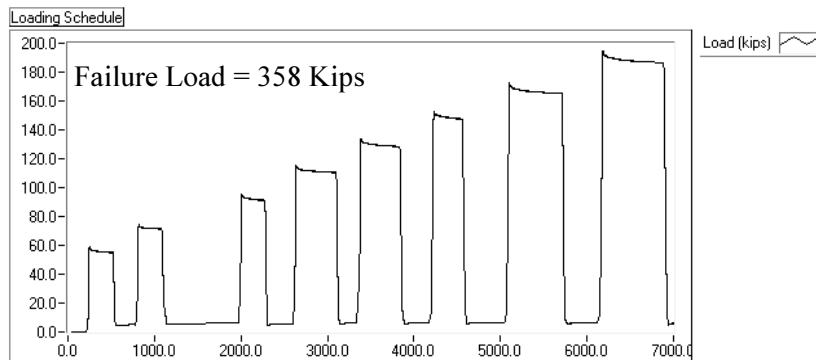
Figure 4.31 – Time Based Graphs for BG2S

Figure 4.31 shows hit amplitudes consistently above 90 dB for the entire test, and a few are from 95 to 100 dB.

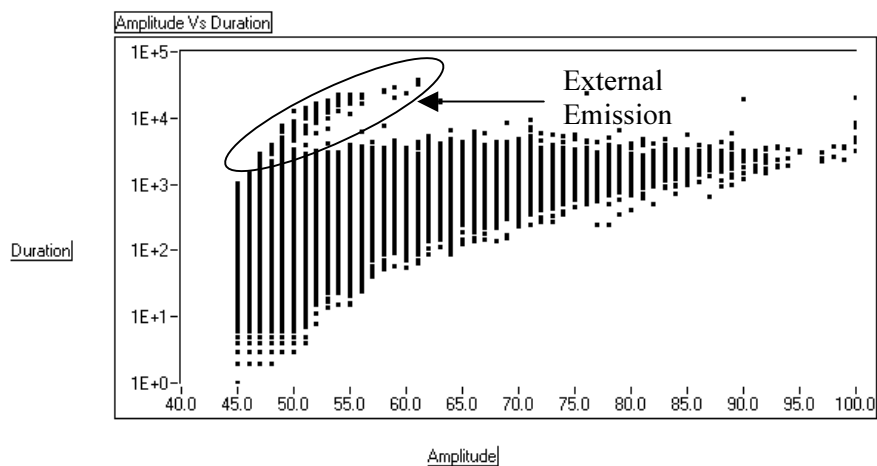
Figure 4.34 – Amplitude vs Log Duration for BG4S

During the test, a metallic clicking sound was heard periodically from the test setup. Although it did not originate from the test specimen, its cause was not found. By watching the acoustic emission as the noise was heard, the associated emission was determined to be low amplitude, long duration, and high MARSE, all characteristic of mechanical rubbing. This is also shown in the plot of amplitude vs. log duration in Figure 4.34. As this clicking was heard, hits were detected in the area marked on that figure. No emission in this area had been noted in any other tests, indicating that it was probably due to external sources. This external emission was eliminated with a Swansong II filter.

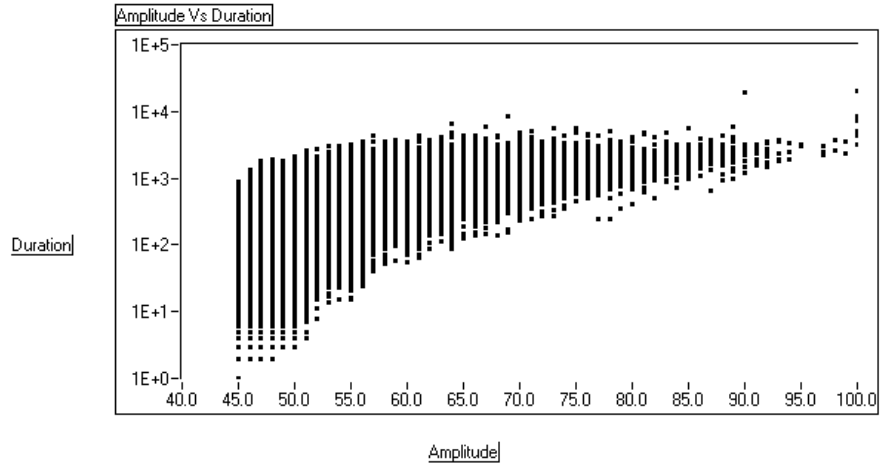
Figure 4.35 – Amplitude vs Log Duration for BG4S after Swansong II Filter

The filtered plot of amplitude vs. log duration is shown in Figure 4.35. Hits in the uncharacteristic area are removed, indicating that the filter was effective. Remaining discussion of BG4S refers to filtered data.

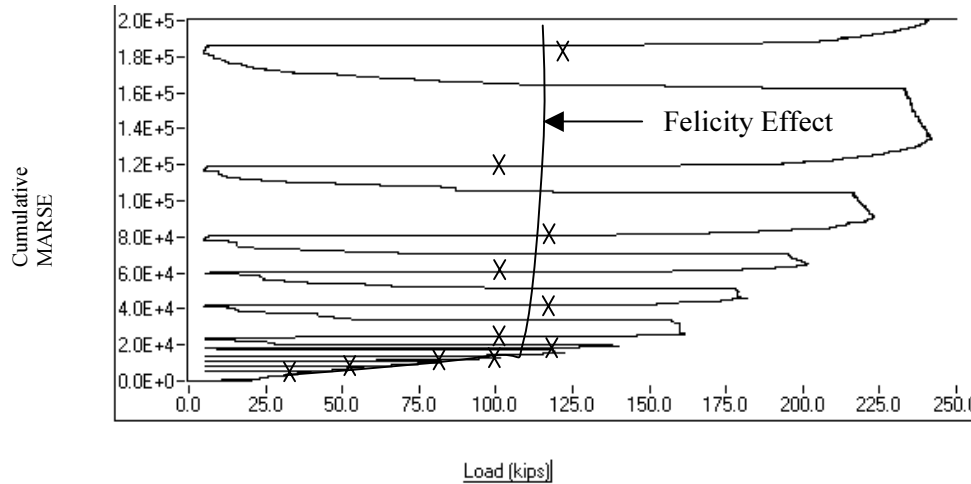
Figure 4.36 – Cumulative MARSE vs. Load for BG4S

The acoustic emission response of BG4S was much different from that of the previous shear specimens. The graph of cumulative MARSE vs. load before cracking is shown in Figure 4.36. The major difference between this test and the previous shear tests is the emission during unloading. This trend is shown clearly for loads above 125 kips in Figure 4.36. If lower loads are examined more carefully, however, emission during unloads can be seen even in the first few cycles. This graph also shows that the overall amount of MARSE is low relative to the other shear specimens. The Felicity Ratios for this specimen are shown in Table 4.13. They stay around 1.0 until about half the cracking load, and then start to decrease.

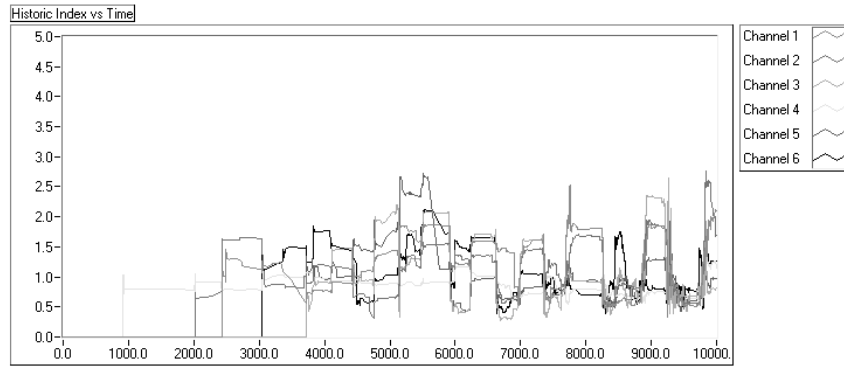
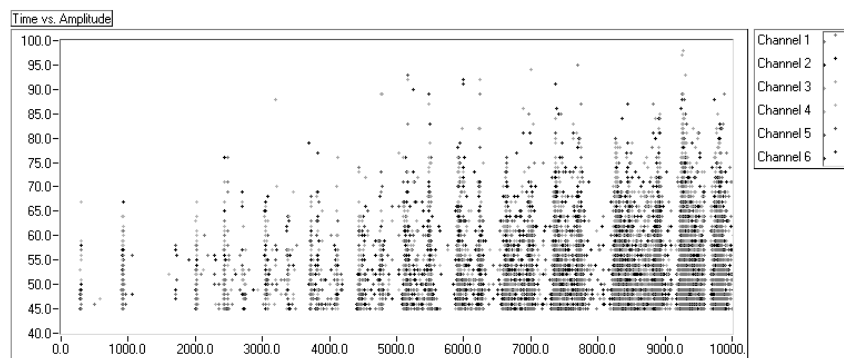
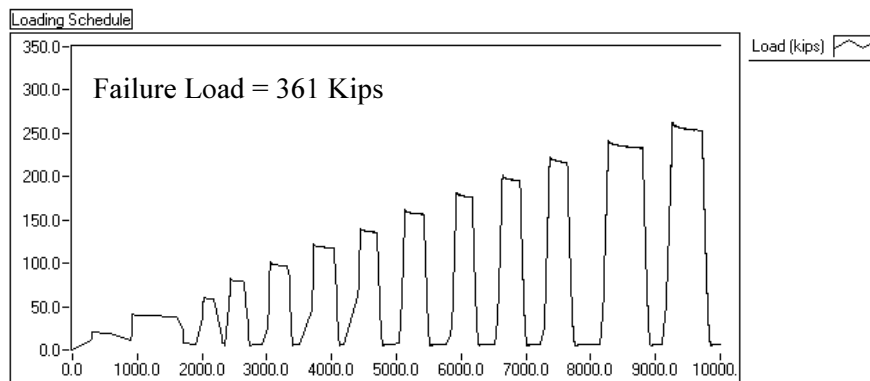
Figure 4.37 – Time Based Graphs for BG4S

As shown in Figure 4.37, no large peaks occur in the Historic Index before cracking, and no high amplitude hits occur until the 125 kip loading increment. Significantly, this is also where the Felicity Ratio begins to decrease.

If the vertical delamination in the web is the cause for the difference in acoustic emission response of this test specimen, future tests should either use impact-echo to inspect for delaminations before monitoring with acoustic emission, or monitor acoustic emission closely during unloading cycles.

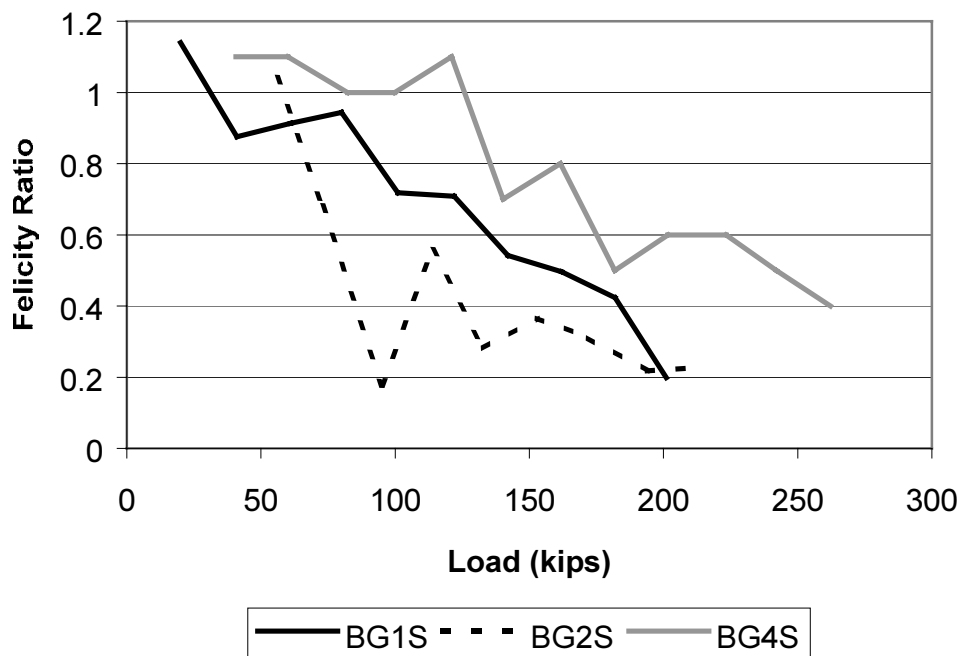
Figure 4.38 – Felicity Ratios for the Shear-Dominated Test on Box Girders

The other two shear tests, BG1S and BG2S, can be compared directly since they failed by the same mechanism. As shown in Chapter 3, BG2S was more deteriorated than BG1S. From these tests, cumulative MARSE is a good indicator of the amount of deterioration. Even though BG1S underwent more cycles than BG2S, its cumulative MARSE is lower. It is important to compare similar load levels, since the graph scales are different. The cumulative MARSE plots also show that emission during load holds starts at a lower load in BG2S. Finally, a graph comparing the Felicity Ratios for the two shear specimens is presented in Figure 4.38. Although the first point for BG2S is above 1.0, the ratio drops off significantly for the other cycles and is below BG1S for every other load increment.

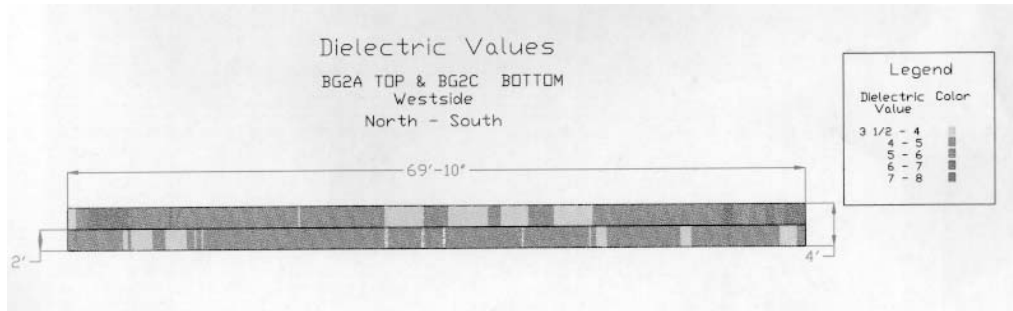
Figure 5.4 – Dielectric Values on West Side of BG2

It can be seen from Figures 5.4 and 5.5 that while dielectric values do vary along the length of BG2, this variation seems random and does not correlate with observed damage.

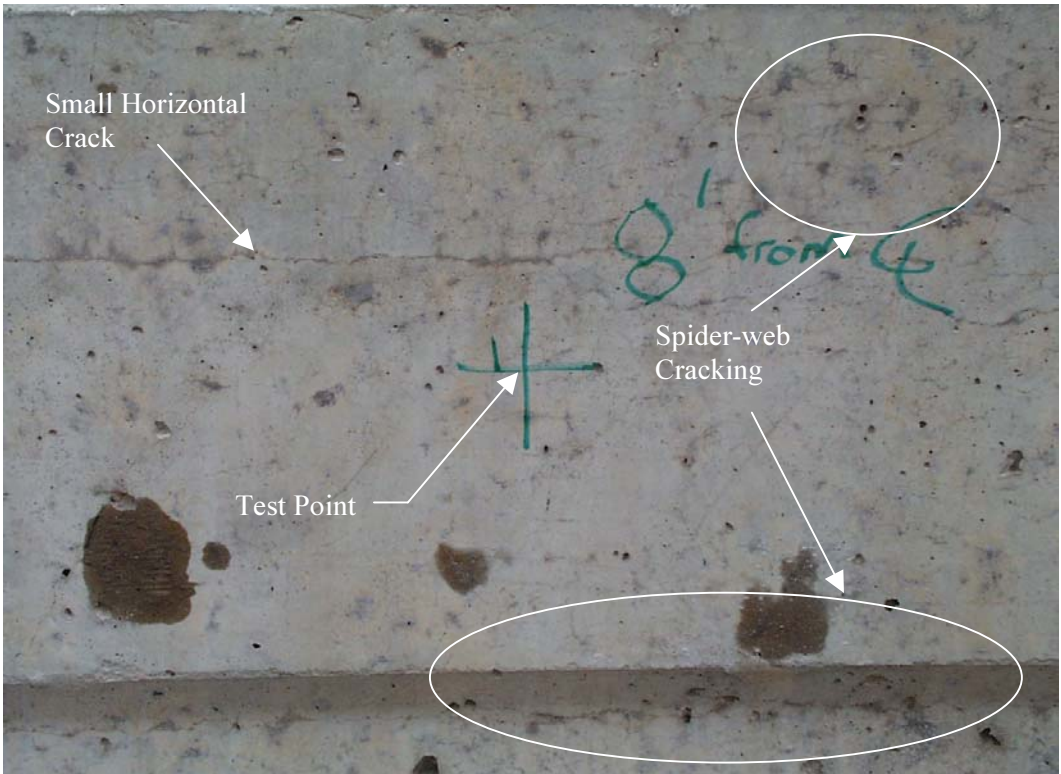
Figure 6.5 – Photo of the Test Point 8 feet from Centerline on BG1

As discussed in Chapter 3, BG1 was a control girder with the least amount of cracking of any of the girders tested. Impact-echo tests were performed in areas of that girder that appeared visually to be in good condition. Although this girder had little damage compared to the others, it was not damage-free. Data were taken 5 feet from the south end, 7 feet from the south end, and 8 feet from the centerline. These areas were chosen since the visible damage there was small, clear P-wave peaks could be found on the waveform, and the test indicated that the thickness was close to the expected 127 mm, indicating solid concrete. Figures 6.5 and Figure 6.6 show the damage. The tested areas have light spider-web cracking, but no major cracks.

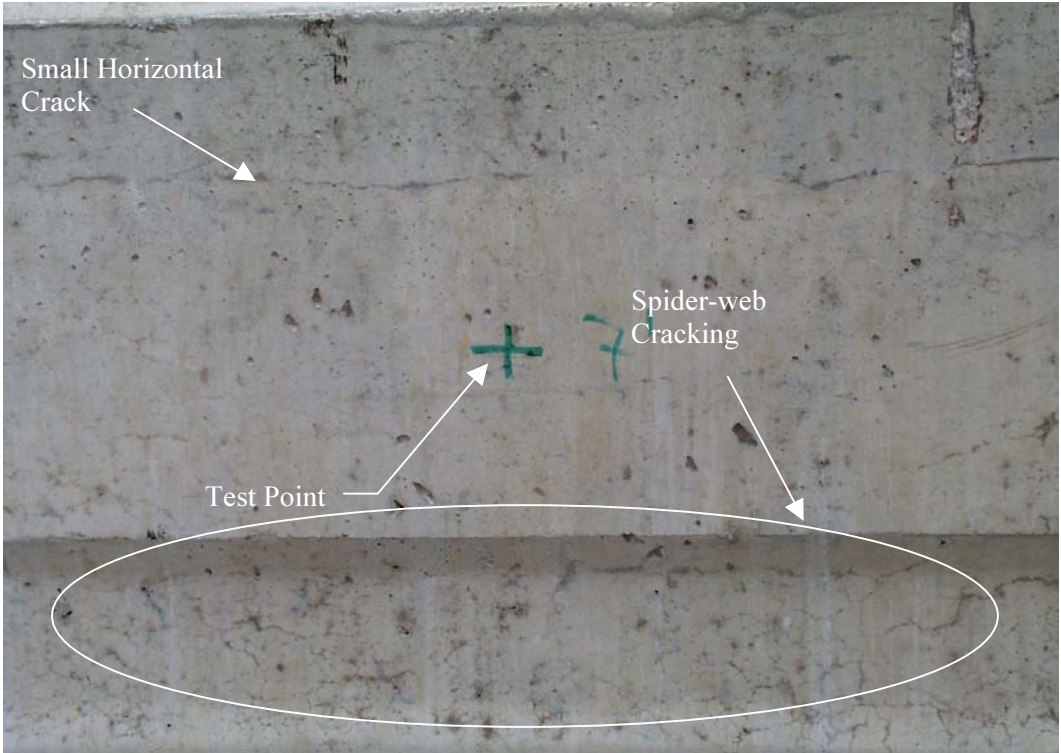
Figure 6.6 – Photo of the Test Point 7 feet from the South End of BG1

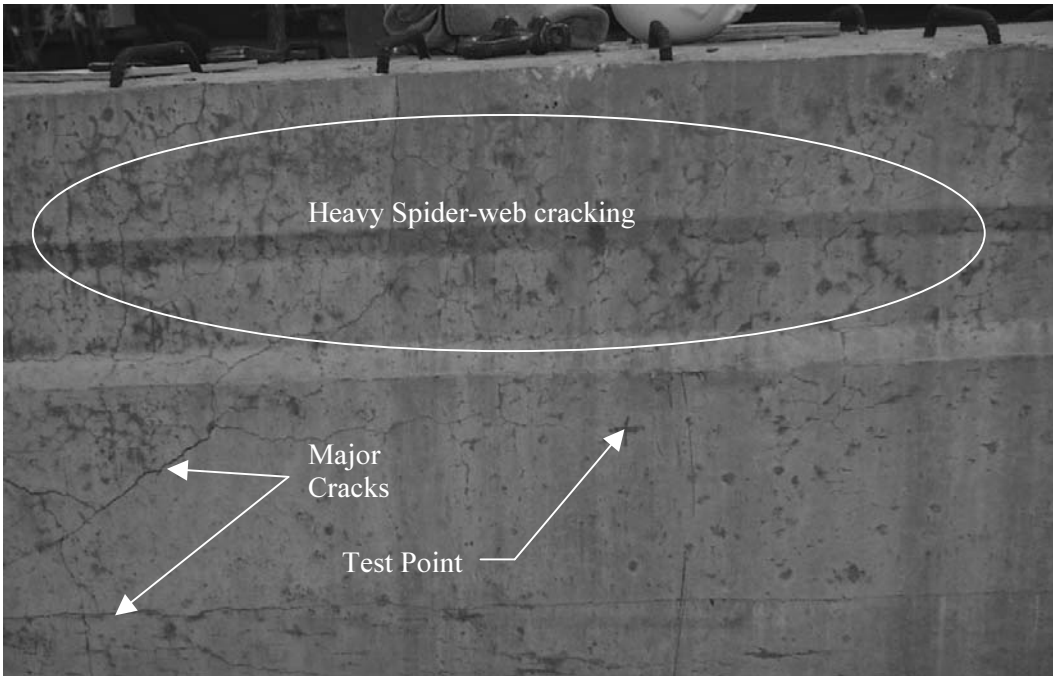
For comparison, tests were also conducted on BG3, the specimen with damage along its length. This specimen was chosen for its extensive spider-web cracking and lack of many large cracks. Tests were performed on this girder 3 feet from the north end and 22 feet from the south end. The point 3 feet from the north end is shown in Figure 6.7. There is extensive cracking on the left hand side as well as above the test point. The other testing point on BG3 is shown in Figure 6.8. Although there were no cracks in the immediate area, there were some in the web on the left side.

Figure 6.7 – Photo of the Test Point 3 feet from the North End of BG3

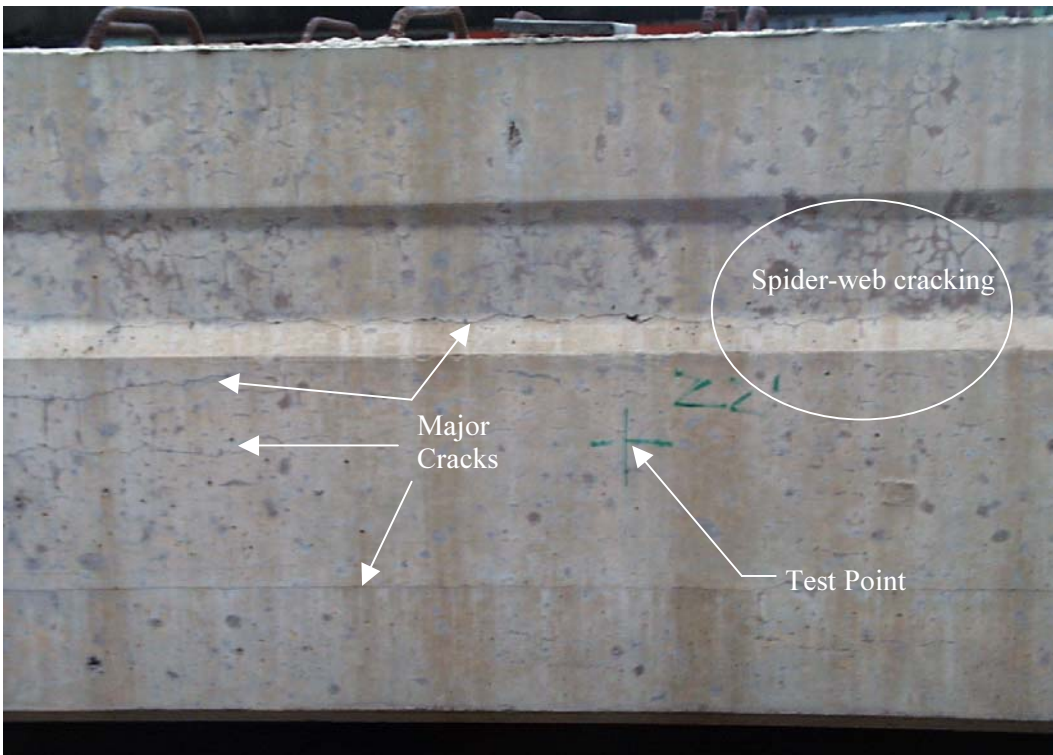
Figure 6.8 – Photo of the Test Point 22 feet from the South End of BG3
