1. Report No. FHWA/TX-0-1401-1	2. Government Accession No.	3. Recipient's Catalog No.	
4. Title and Subtitle Bending Fatigue Response of Grouted Stay Cables		5. Report Date July 2008

Bending Fatigue Response of Grouted Stay Cables

CTR Research Report:	1401-1
Report Date:	July 2008
Research Project:	0-1401
Research Project Title:	Determination of Fatigue Damage in Stay Cables
Sponsoring Agency:	Texas Department of Transportation
Performing Agency:	Center for Transportation Research at the University of Texas at Austin

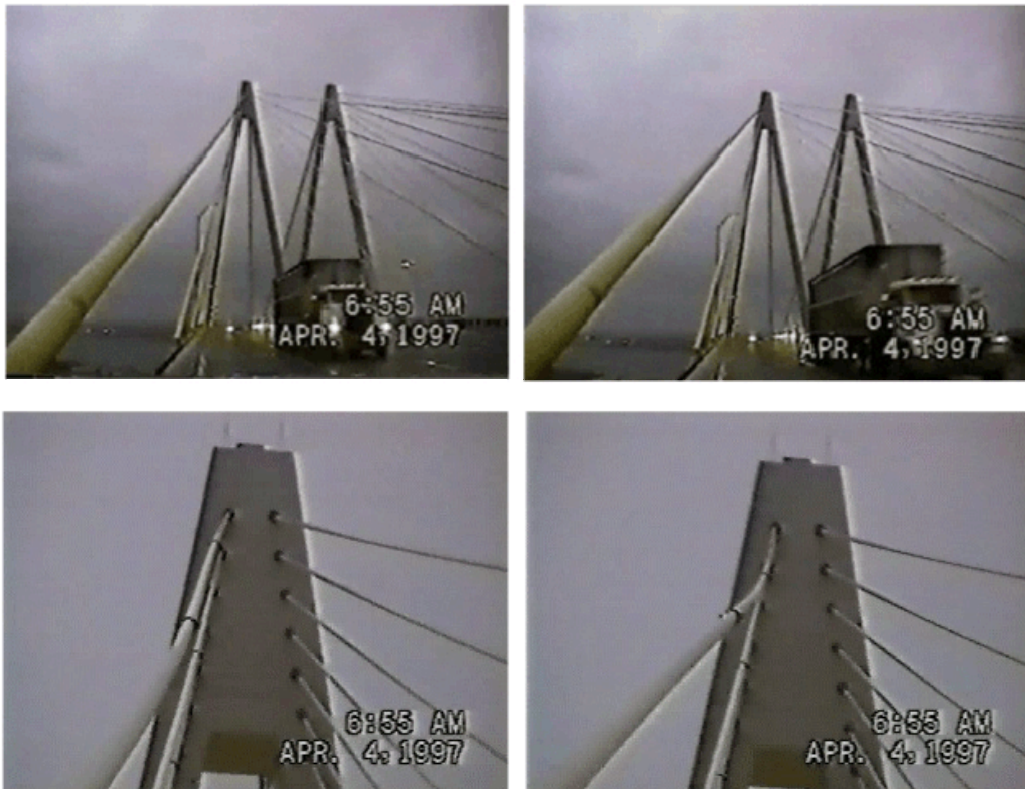
Large-amplitude stay cable vibrations were observed on the Fred Hartman Bridge numerous times since its opening in 1995. One of the first estimates (Poston 1998) of the amplitude of these vibrations is from visual observations during a four-day period between 1 April and 4 April 1997 (Table 1.2). Video taken on 4 April 1997 (Figure 1.4) show the large-amplitude deformations of cable 24 during this event. At 650 ft, cable 24 is the longest cable on the bridge.

Figure 1.4 Stay Cable Vibrations – Fred Hartman Bridge

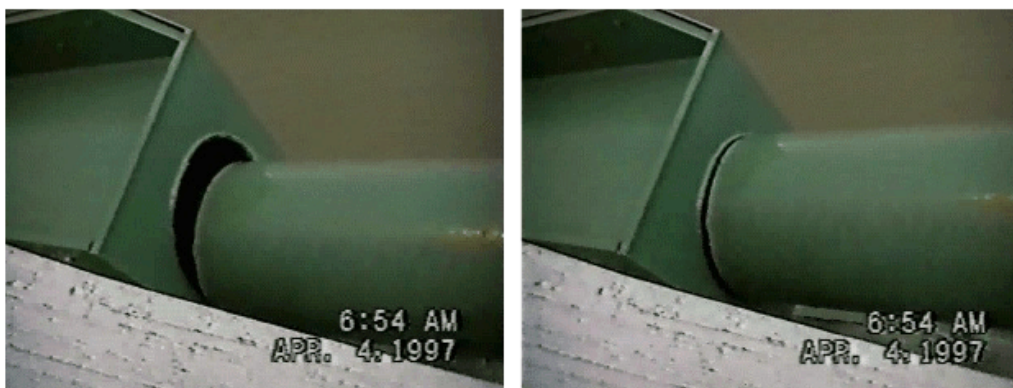
These large-amplitude vibrations caused visual damage to the Fred Hartman Bridge. Broken guide pipes (Figure 1.5) were found on more than 100 of the 192 cables. The broken guide pipes are a visual indication of the forces and displacements generated by these events and the damage that might occur. Of great concern is the possible hidden fatigue damage of the stay cables and the anchorage. The stays would have to be dismantled to detect damage reliably. Nondestructive inspection techniques are not applicable due to the limited access at the anchorages and the grout surrounding the strand.

Figure 1.5 Broken Guide Pipe – Fred Hartman Bridge

WDP (Witthoft et al. 2001) developed the designs to repair the existing damage and to minimize future cable vibrations. The broken guide pipes were strengthened with stiffeners. A temporary solution to control the cable vibrations was the installation of restrainers (Figure 1.6). The restrainers connect the stay cables and allow vibration energy to be transferred between adjacent stays. These restrainers proved to be a very effective means of reducing the cable displacements and were left in place on the bridge.

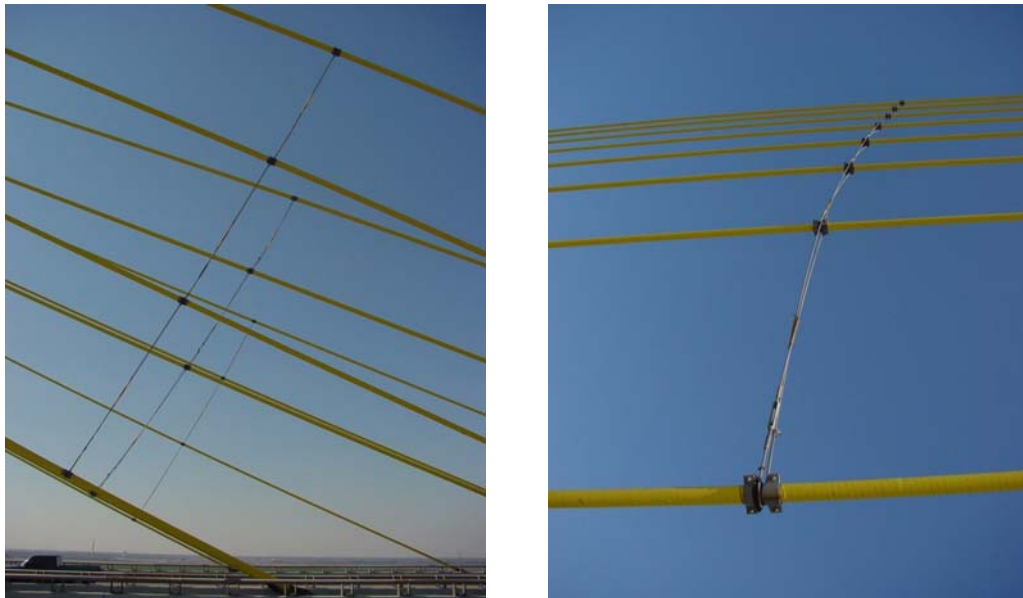
Figure 1.6 Cable Restrainers

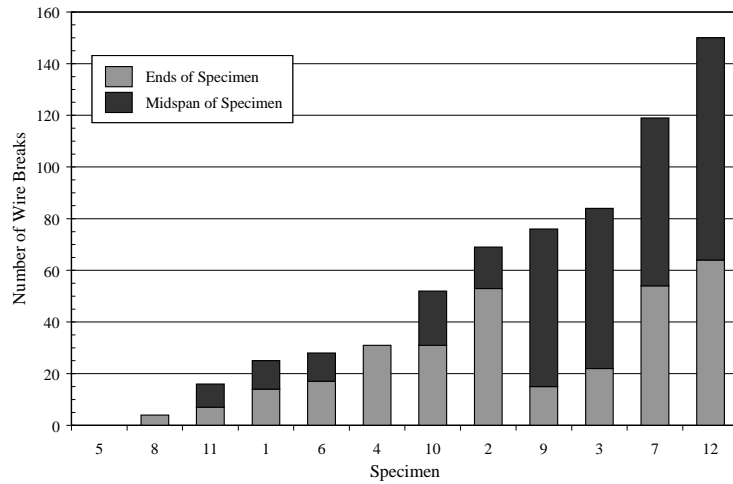
Figure 3.2 Number of Wire Breaks Observed in Cable-Stay Specimens

Among the experimental parameters considered in this set of experiments, the fatigue life of the cable-stay specimens appeared to be most sensitive to two. The ungrouted specimens (Specimens 5 and 8) experienced far fewer wire breaks than the grouted specimens (Figure 3.2). In addition, the fatigue life was considerably longer for the three specimens that were subjected to lower-amplitude displacement cycles during the fatigue tests (Specimens 4, 10, and 11).

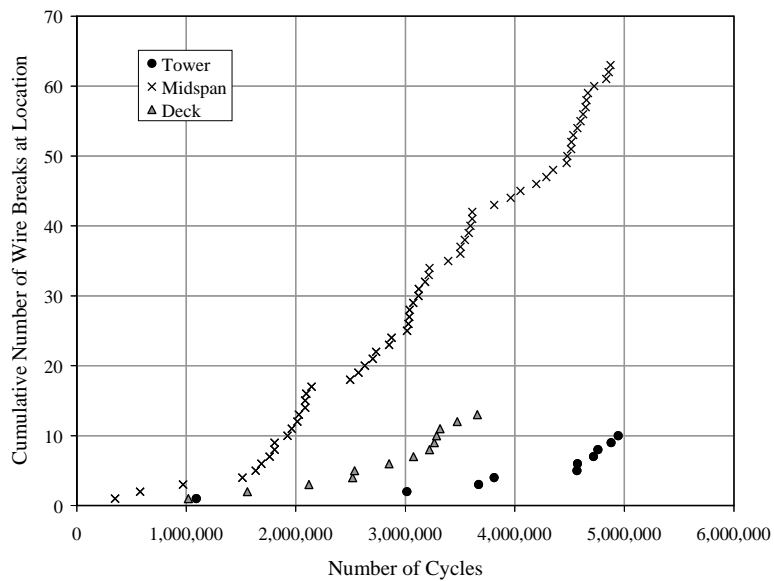
The results of the fatigue tests are summarized in Table 3.1. It should be noted that damage within the test specimens accumulated gradually with the number of loading cycles at the beginning of the fatigue tests (Figure 3.3). The presence of one or two wire breaks had essentially no impact on the structural integrity of the stay-cable specimens. However, the rate of damage did increase during the fatigue tests, and this increase occurred at a different number of loading cycles for different specimens and for different locations within the same specimen.

Figure 3.3 Wire Breaks Detected from Acoustic Data – Specimen 3

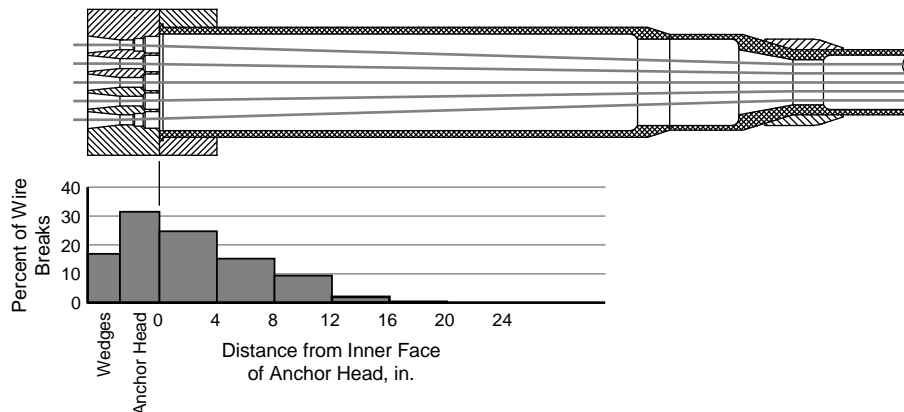
Three hundred eight wire breaks were identified at the ends of the cable-stay specimens. Nearly 50% of the wire breaks (Figure 3.4) occurred within the anchor head, with more than 15% within the wedges. Approximately 25% of the wire breaks were located within the threaded nut used in phase 1 or the smooth end sleeve used in phase 2. The remaining wire breaks were distributed along the transition region. All wire breaks occurred within 20 in. of the inside face of the anchor head.

Figure 3.4 Distribution of Observed Wire Breaks at Ends of Stay-Cable Specimens

As shown in Figure 3.4, approximately 50% of the wire breaks observed at the ends of the stay-cable specimens occurred within the anchor head. In most cases, the failures in this region were caused by fretting of adjacent wires within the strand. The teeth of the wedges initiated only 6% of the total number of wire breaks. All wire breaks occurred within 16 in. of the inside face of the anchor head. Near the loading clamp, more than 50% of the wire breaks were within ± 5 in. of the centerline of the actuator and all wire breaks were within ± 20 in. of the centerline (Figure 3.5). Less than 10% of the wire breaks occurred beyond the PE cushion used as a transition between the PE pipe and the steel clamp.

Because the geometry of the cable-stay specimens more closely models that of the prototype stays, the discussion will focus on those specimens. All the observed wire breaks in the cable-stay specimens occurred within 16 in. of the inner face of the anchor head (Figure 3.4). The acoustic sensors provided an excellent estimate of the total number of wire breaks at the ends of the specimens; however, the estimated locations of those breaks tended to be further from the anchor head than observed (Figure 3.28). This is not surprising, due to the large volume of steel at the ends of the specimens, the location of the acoustic event is more difficult to pinpoint. Therefore, when wire breaks are reported on the Fred Hartman or Veterans Memorial Bridges within 3 ft of the anchor head, the possibility that the wire break is within the anchor head should be considered.

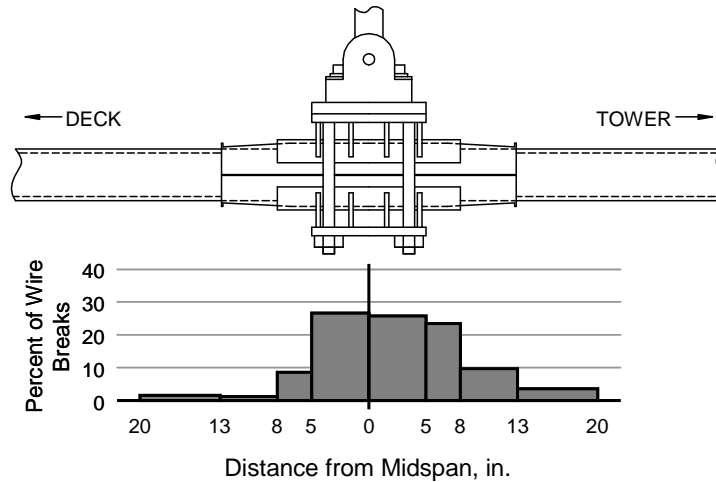
Figure 3.5 Distribution of Wire Breaks at Midspan of Stay-Cable Specimens

Three hundred forty-two wire breaks were observed at midspan of the test specimens (Figure 3.5). Nearly 85% of the wire breaks occurred within the metal clamp used to attach the hydraulic actuator to the test specimens, with more than 50% of the wire breaks directly beneath the head of the actuator. Only 5% of the wire breaks occurred beyond the PE cushion and all wire breaks were within 20 in. of midspan.

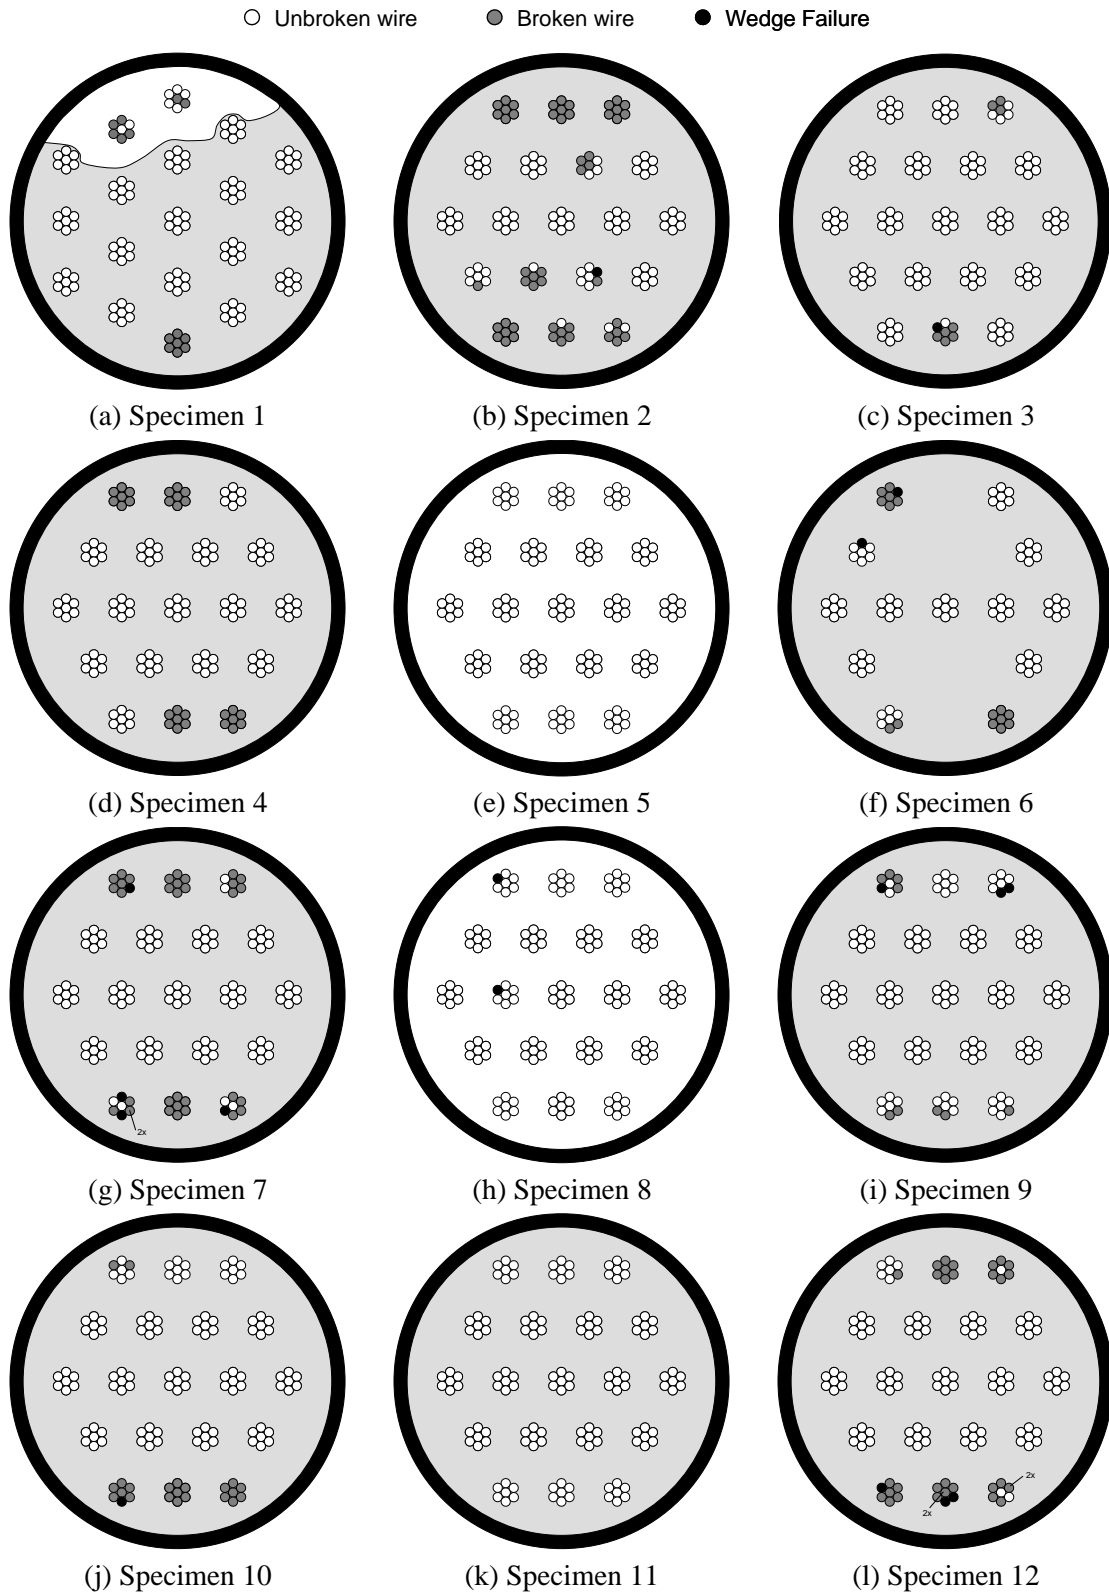
Figure 3.6 Summary of Wire Breaks at Tower End of Stay-Cable Specimens

The distributions of wire breaks within the cross sections at each end and at midspan are summarized in Figure 3.6 through Figure 3.8. For the grouted test specimens, the wire breaks at the ends tended to occur in the layers of strand at the top or bottom of the cross section. Only in Specimens 1, 2, 6, and 12 did the wire breaks occur in an inner layer of strand. The large number of wire breaks in the top and bottom layers of Specimens 2 and 12 likely caused the damage to spread to the inner layers. However, in Specimen 1, the presence of the grout void seems to have influenced the damage pattern. Specimen 8, which was ungrouted, was the only specimen to experience wire breaks in the middle layer of strands.

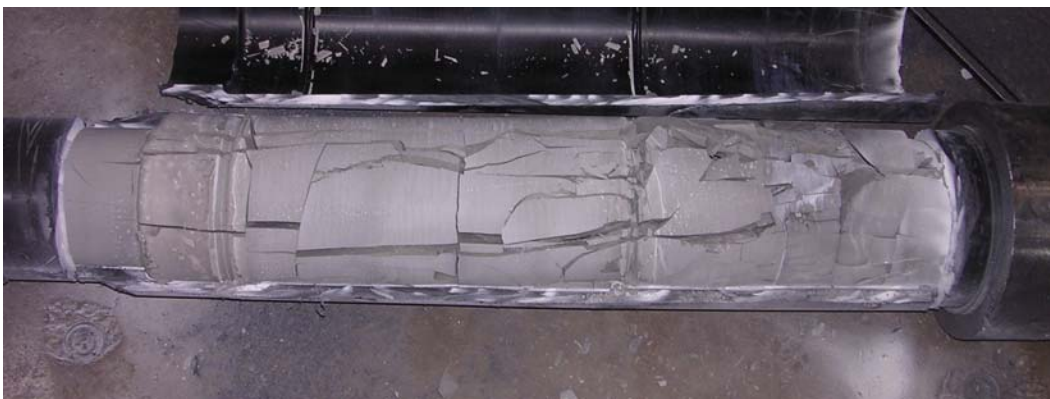
Figure 3.10 Condition of Grout at Deck End Immediately after Removing PE Pipe – Specimen 10

In the vicinity of wire breaks, the grout was often severely cracked (Figure 3.10 and Figure 3.11). Longitudinal cracks in the grout were characteristic of wire breaks, whereas fine circumferential cracks were observed in regions that were undamaged (Figure 3.12). These circumferential cracks were representative of cracks observed along the free length of the cables on the Fred Hartman Bridge (Figure 3.13). The width of the circumferential cracks in the test specimens tended to increase with time as the grout was exposed to the environment. These cracks were believed to be caused by shrinkage of the grout.

In the laboratory, it was easy to identify the presence of wire breaks at the completion of the fatigue test by opening the PE pipe. Longitudinal cracks in the grout accompanied wire breaks in all cases (Figure 3.10 and Figure 3.11). However, TxDOT is cautioned that opening the PE pipe may cause damage – due to the formation of shrinkage cracks – and compromise the corrosion protection system for the cable. Therefore, it is recommended that openings in the PE pipe not be cut unless a large number of wire breaks have been detected in a localized area and the possibility of stay replacement is being considered seriously.

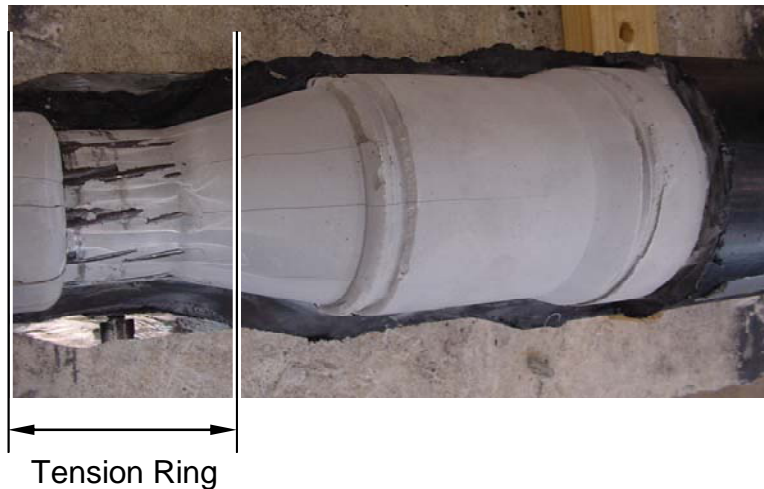
Figure 3.14 Exposed Strand at Tension Ring – Specimen 1

The strands were observed to be most severely congested in the vicinity of the tension ring (Figure 3.14). The strands around the perimeter of the cross section were not encased in grout at this location.

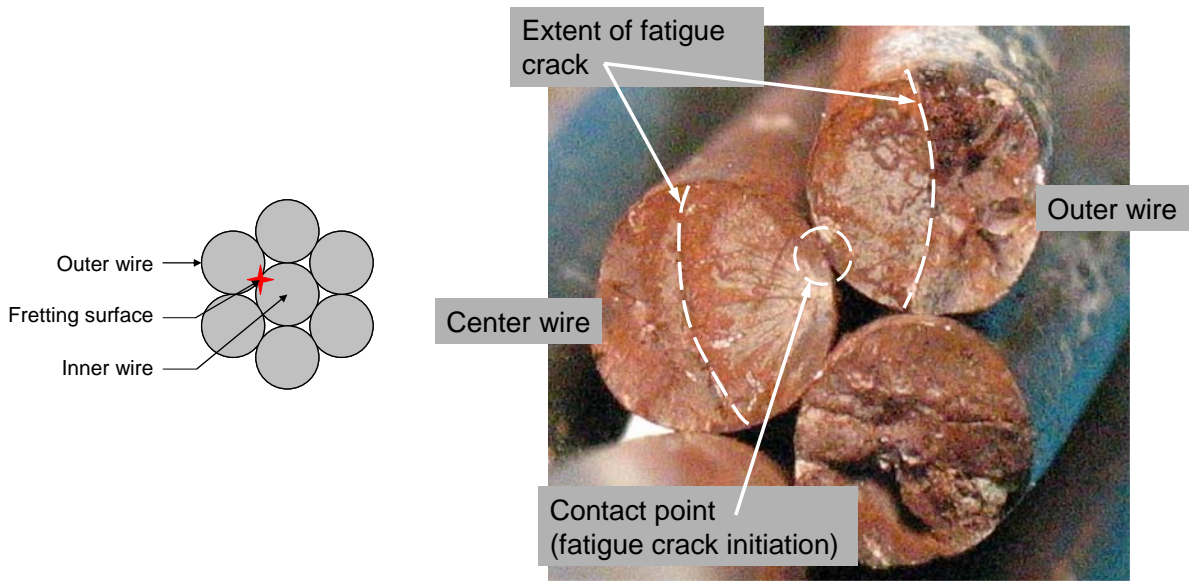
Figure 3.20 Fretting between Center Wire and an Outer Wire

Two types of fretting fatigue failures were most common. The first type occurred due to fretting between the center wire and an outer wire, as shown in Figure 3.20. This type of fretting can lead to fracture of the center wire, the outer wire, or both wires at the contact point. The second type of fatigue failure was due to fretting between two adjacent outer wires as shown in Figure 3.21. Failures caused by fretting of adjacent wires in the strand, center-outer and outer-outer, represented nearly 90% of the observed wire breaks.

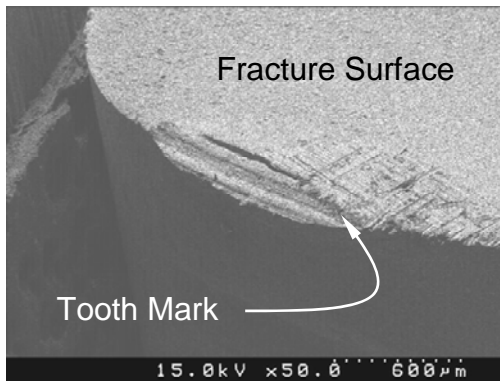
Figure 3.23 Fracture Initiation

A third, less common type of fatigue failure was observed where the fatigue crack initiated at a point that was not in contact with other wires in the strand. The point where the first tooth on the wedge engaged the strand often served as the initiation point for this type of crack (Figure 3.22 through Figure 3.24). This type of fretting failure represented approximately 6% of the total.

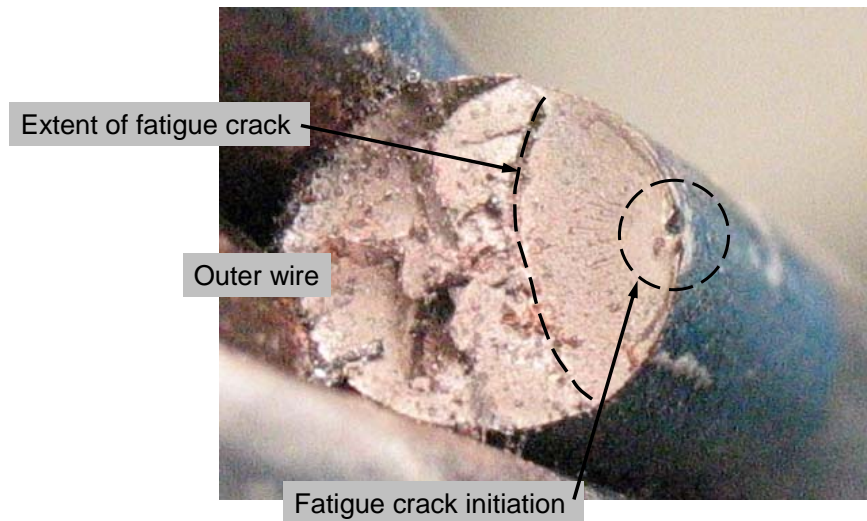
Figure 3.25 Fatigue Failure Caused by External Source

Occasionally fatigue failures were also observed to initiate at a point where an exterior wire was not in contact with the other wires in the strand. It is unknown what caused this type of failure, although possible sources are corrosion, defects on the wire, or fretting with the helical spacer wire (Figure 3.25). The remaining 5% of the wire breaks were in this category.

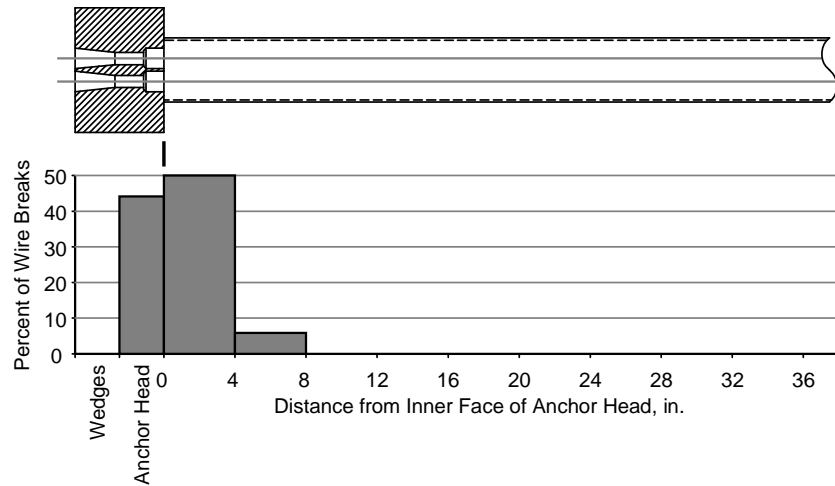
Figure 4.1 Distribution of Observed Wire Breaks at North End of Small-Diameter Specimens

Due to the location of the applied transverse loads, damage in the small-diameter specimens was concentrated near the north end (Table 4.1). At least half the wires fractured at this location in each of the test specimens, and all the wires fractured in Specimen 1. Approximately 45% of the wire breaks occurred within the north anchor head and 50% of the wire breaks occurred within 4 in. of the inside face of the anchor head (Figure 4.1). All wire breaks occurred within 8 in. of the inside face of the anchor head.

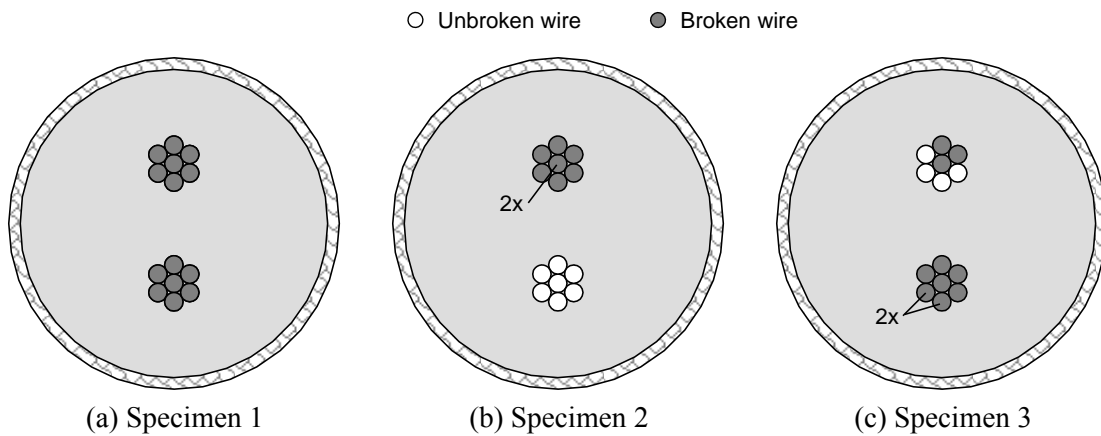
Figure 4.2 Summary of Wire Breaks at North End of Small-Diameter Specimens

The distributions of wire breaks within the cross section are shown in Figure 4.2. Multiple wire breaks were observed in individual wires in Specimens 2 and 3. The level of damage was extremely high in all three specimens at the conclusion of the fatigue tests.

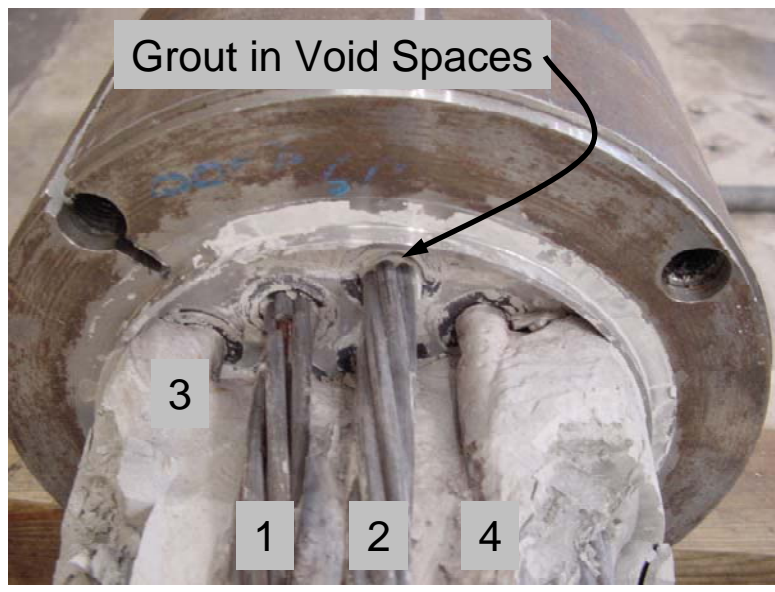
Figure D.4 Exposed Strand within Grout Void at Tower End of Specimen 1

When the PE transition pipe was removed, a large grout void was observed near the anchor head at the tower end of the specimen (Figure D.3). The void was approximately 20 in. long and had a maximum depth of 1.5 in. Strands 1 and 2 were fully exposed within the grout void along a length of approximately 12 in. (Figure D.4). A very thin layer of grout covered strands 3 and 4.

It is unclear whether strands 1 and 2 were in contact with grout at some point during the grouting operation. The openings in the anchor head for strands 1 and 2 were fully grouted (Figure D.4), which is an indication that the entire stay cable was initially grouted and that the grout void is a result of a bleed-water concentration at the top of the specimen. Excessive bleed water was also observed on the top surface of the grout cubes. This suggests that the sections of the strand exposed within the void were at one time exposed to bleed water. However, no significant signs of corrosion were found on the exposed strands in the grout void or on the anchor head. The surface corrosion seen in Figure D.4 is light surface corrosion that was found on the shim plate.

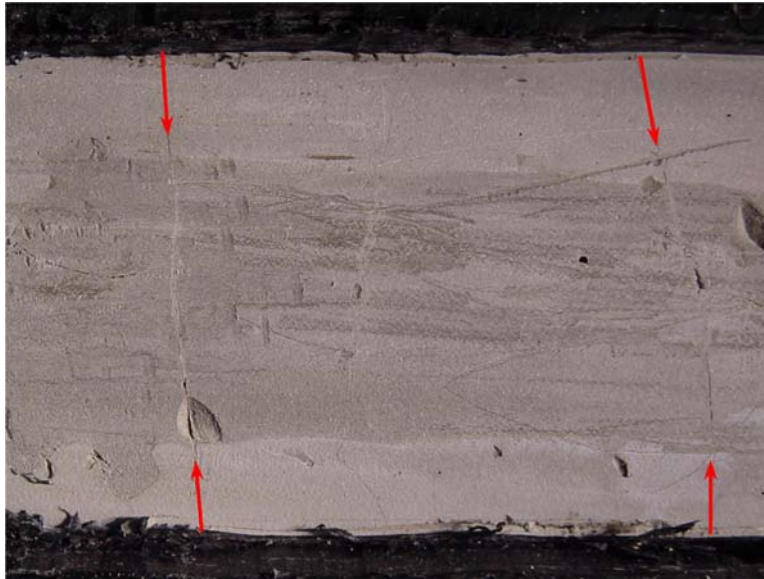
Several windows were cut into the PE pipe during the fatigue test of Specimen 1. Shortly after the windows were opened, fine, parallel, transverse cracks formed in the grout (Figure D.6). These hairline cracks were caused by shrinkage of the grout in the exposed area. Similar shrinkage cracks (Dowd 2001) were found in all the windows that were cut into the actual stay cables of the Fred Hartman Bridge (Figure D.7) and in a previous investigation of stay cables (Hamilton 1995).

Figure D.6 Hairline Transverse Grout Cracks – Specimen 1

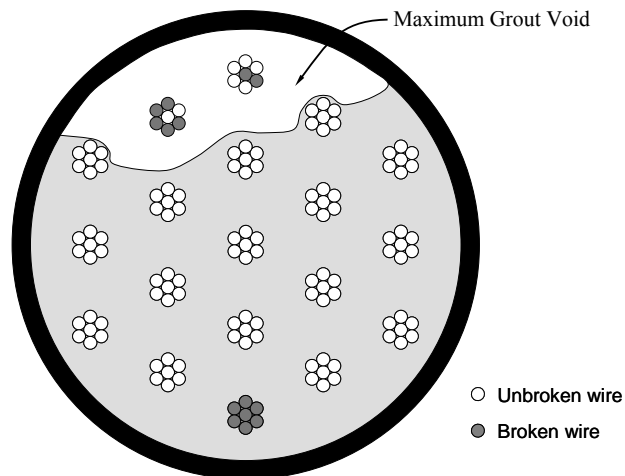
Figure D.10 Distribution of Wire Breaks near Tower End – Specimen 1

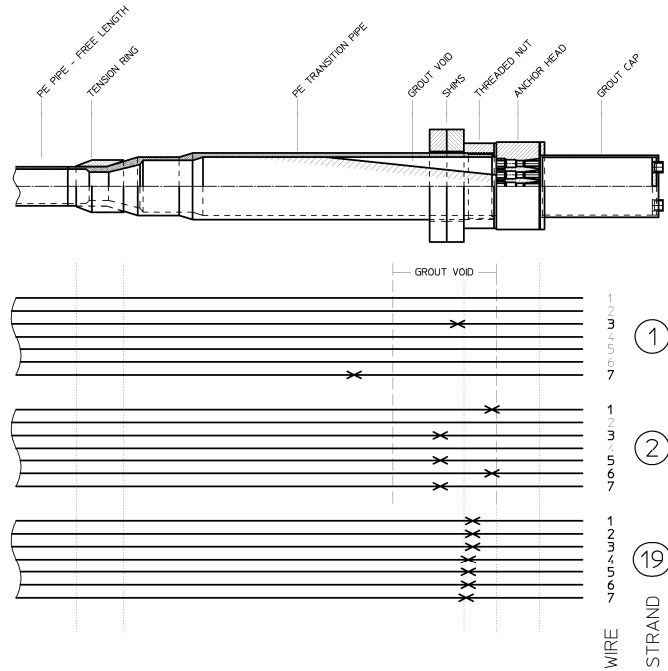
Figure D.11 Location of Wire Breaks near Tower End – Specimen 1

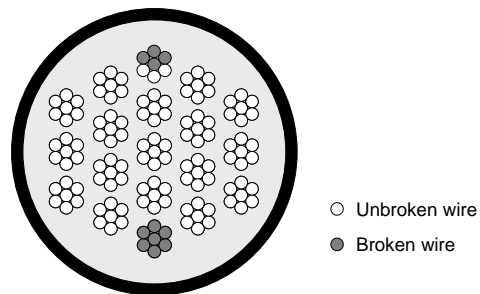
Under the loading point, the eleven wire breaks occurred in the strands at the top and bottom of the cross section (Figure D.12). Interestingly, both strands also experienced fractures in the tower anchorage region. All breaks were located in a 23-in. window, with a bias towards the deck anchorage side (Figure D.13).

Figure D.12 Distribution of Wire Breaks near Midspan – Specimen 1

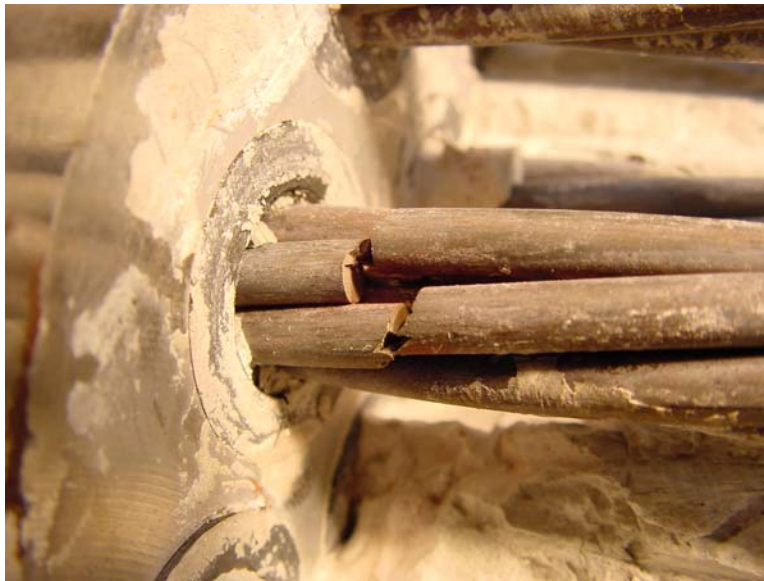
The wire fractures that occurred within the grout void at the tower end did not exhibit any signs of corrosion. Figure D.14 shows the wire fractures that occurred in strand 2 at the tower end.

Figure D.14 Wire Breaks in Strand 2 near Tower End of Specimen 1

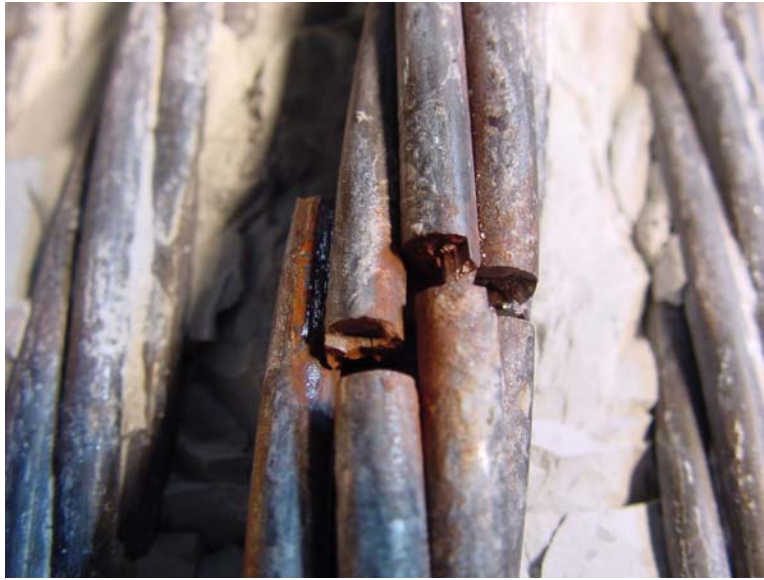
The area around the wire breaks on strand 19 at the tower end exhibited orange surface corrosion (Figure D.15) characteristic of corroded fretting product. The contact points, which served as initiation points for fretting fatigue, are clearly visible in Figure D.16. Orange surface corrosion was also observed along the contact points of strand 1 near midspan (Figure D.17).

Figure D.15 Wire Breaks in Strand 19 near Tower End of Specimen 1

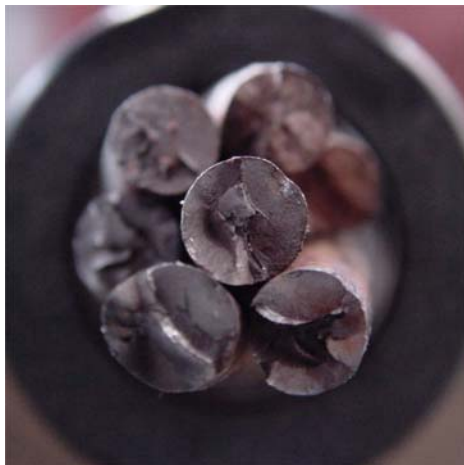
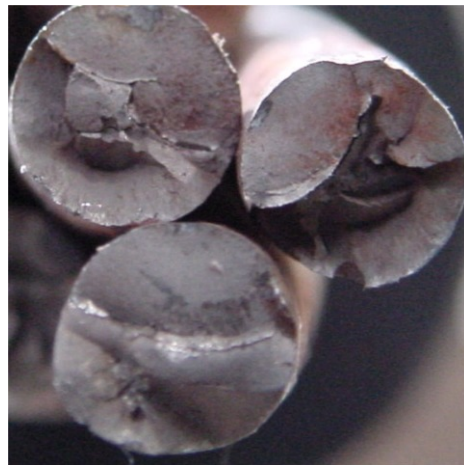
Figure D.16 Fracture Surfaces for Strand 19 at the Tower End of Specimen 1

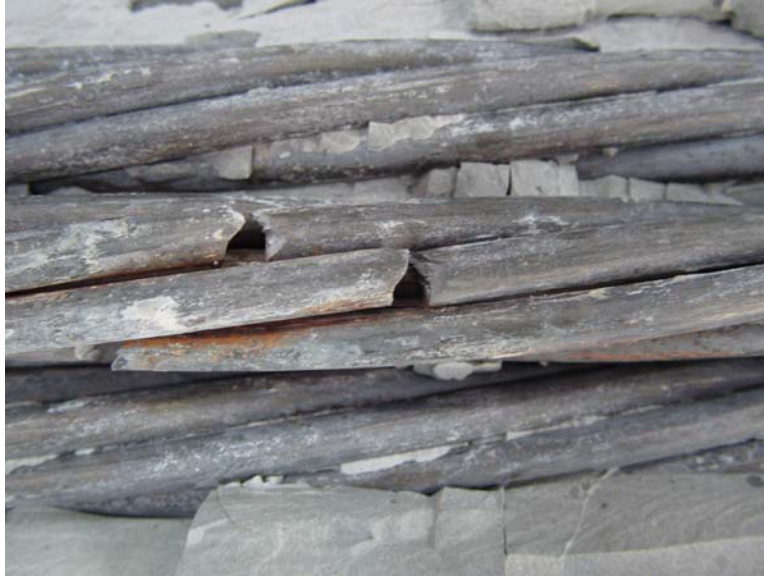
Figure D.17 Wire Breaks in Strand 1 near Midspan of Specimen 1

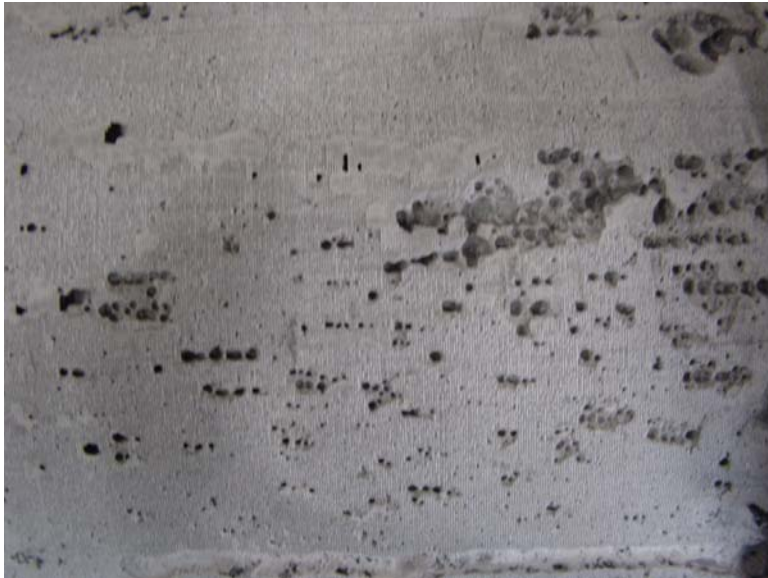
An anti-bleed admixture was mixed with the grout for Specimen 2. Closely spaced air voids (Figure D.20) were observed at the deck end when the PE pipe was removed, but a grout void was not present at the tower end. The research team noted that it was much easier to chip the grout immediately after removing the PE pipe than after the grout had been exposed to the environment for several days. However, no measurements were taken to verify this observation.

Figure D.20 Air Voids in Grout near the Deck End – Specimen 2

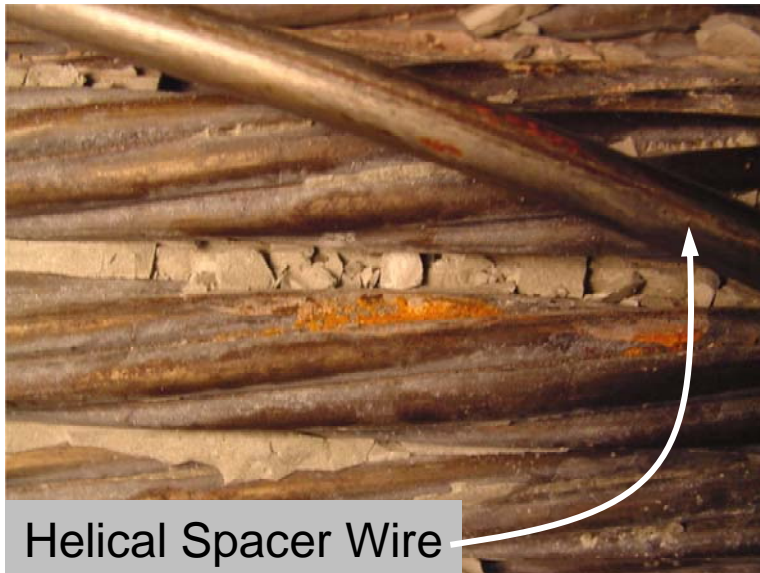
There were some localized signs of orange corrosion on some intact strands, as well as some fine corrosion spots on the helical spacer wire. Figure D.21 shows a typical example of this type of corrosion from midspan of the test specimen.

Figure D.21 Localized Corrosion on Strand and Helical Spacer Wire – Specimen 2

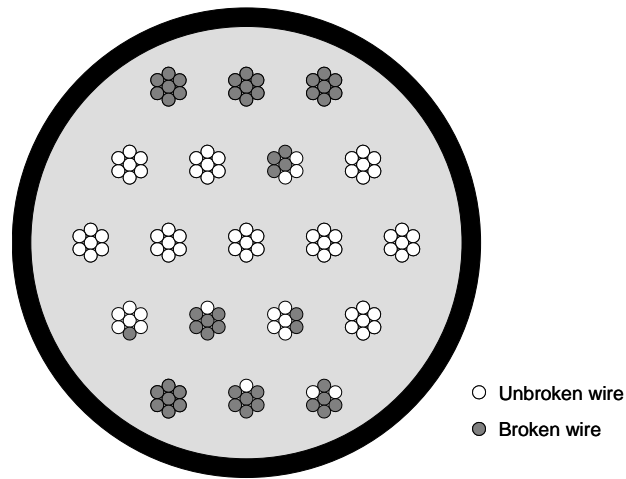
The fifty-two wire breaks near the tower end were distributed among ten different strands (Figure D.22), which were located near the top and bottom of the cross section. Figure D.23 shows the longitudinal location of the wire breaks. Most of the fractures occurred within the anchor head. All breaks occurred within 3.25 in. of the inside face of the anchor head. Representative examples of the breaks within the anchor head are shown in Figure D.24 for strand 1. The fracture surfaces, with the fatigue cracks and the points of initiation, can be clearly identified in this photograph.

Figure D.22 Distribution of Wire Breaks near Tower End – Specimen 2

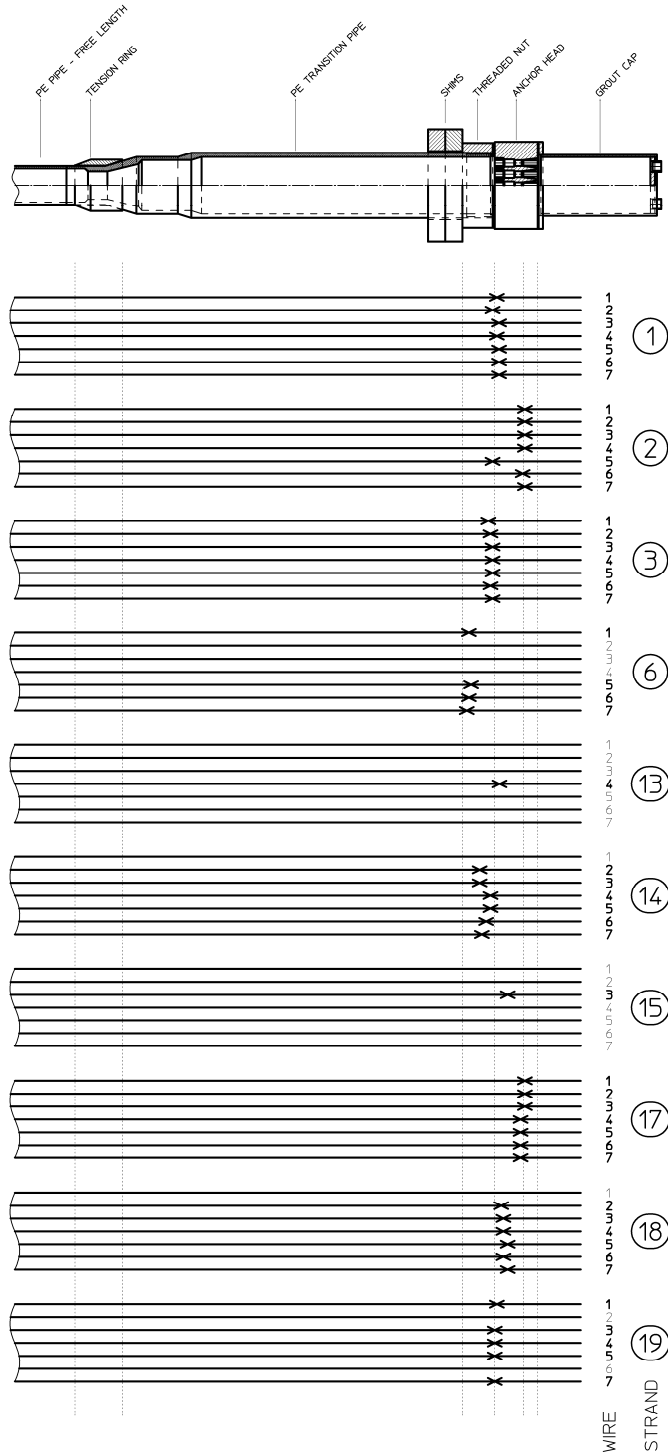
Figure D.23 Location of Wire Breaks near Tower End – Specimen 2

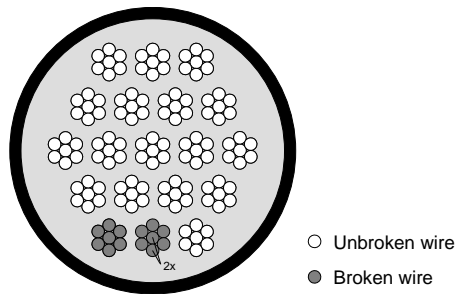
Near midspan, the sixteen wire breaks occurred in strands 17 and 18, which were both in the bottom layer of strands (Figure D.27). All breaks were located in a 10-in. window, with a bias towards the deck side. Interestingly, wires 4 and 7 of strand 18 experienced two fractures within the same strand (Figure D.28).

Figure D.27 Distribution of Wire Breaks near Midspan – Specimen 2

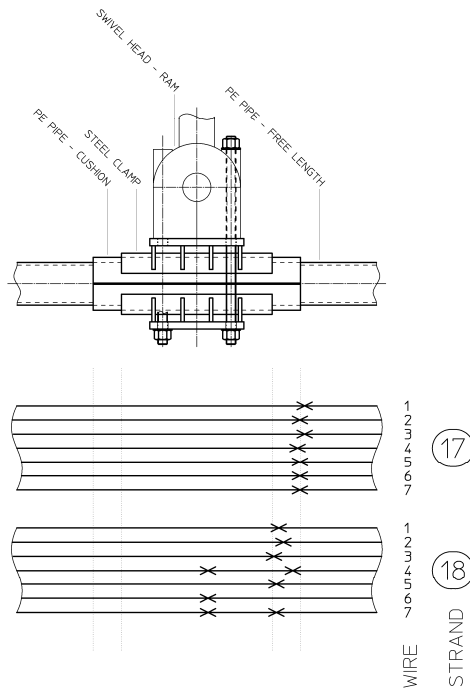
Figure D.28 Location of Wire Breaks near Midspan – Specimen 2

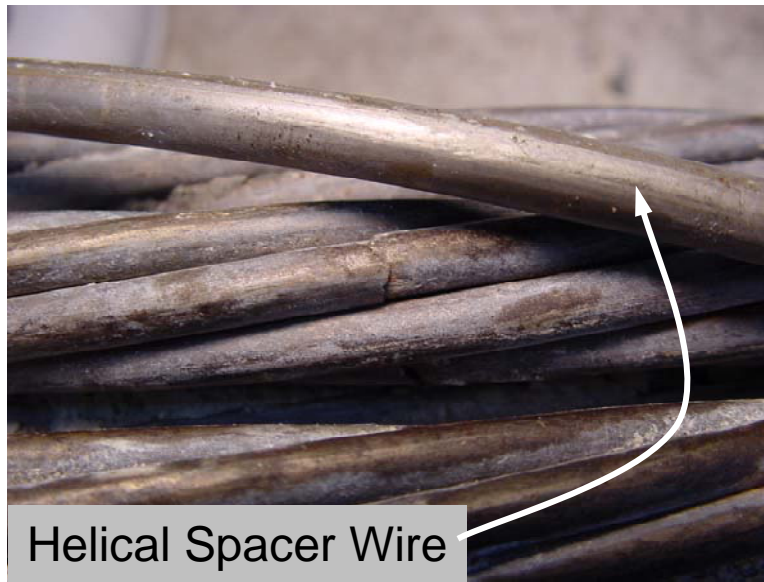
One of the fractures in strand 18 occurred near a possible contact point with the helical spacer wire as shown in Figure D.29. The fracture surface for that wire indicates; however, that the fracture was initiated at the contact point with the center wire, which was also fractured (Figure D.30). The fatigue crack is also significantly larger than on all other failure locations, which indicates that the tension in the strand was negligible at the time of fracture. Consequently, this fracture was the second fracture that occurred on this particular wire.

Figure D.29 Wire Break Close to Helical Spacer near Midspan – Specimen 2

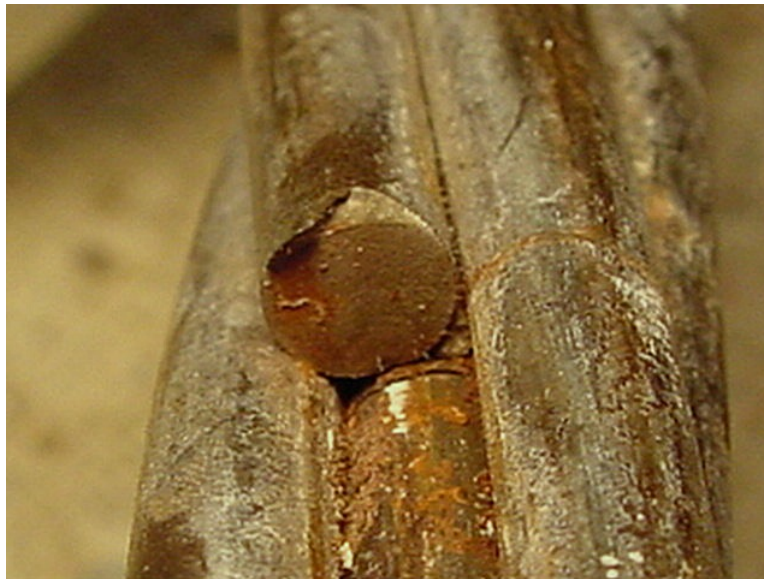
Figure D.30 Detail of Fractured Wires shown in Figure D.29

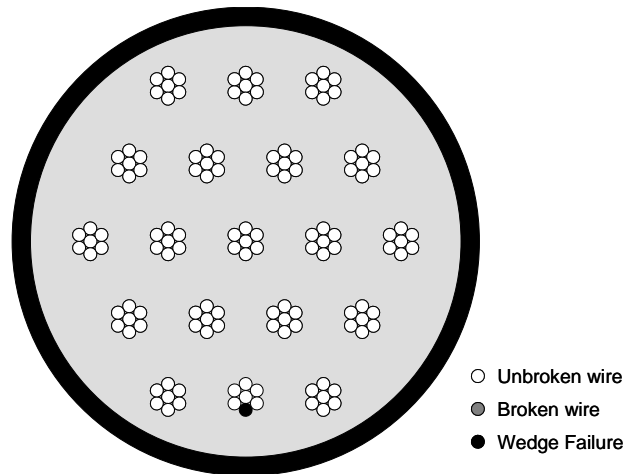
The break at the deck anchorage was found in strand 17 (Figure D.31). The break was initiated at the first tooth of the wedge (Figure D.32). Figure D.33 shows a fairly rounded tooth mark on the wire.

Figure D.31 Distribution of Wire Breaks near Deck End – Specimen 2

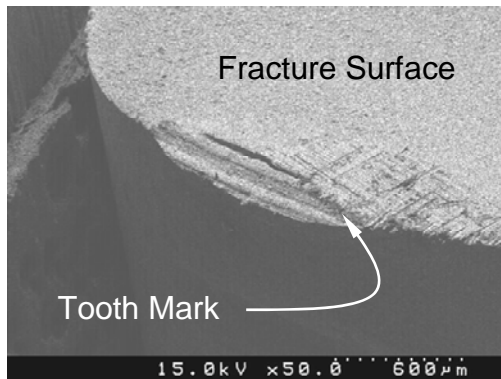
Figure D.32 Fracture Initiation

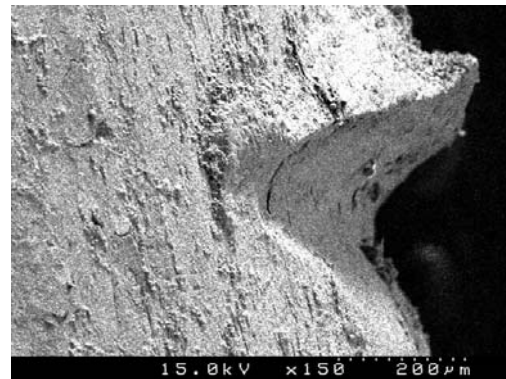
Figure D.33 Typical Tooth Mark

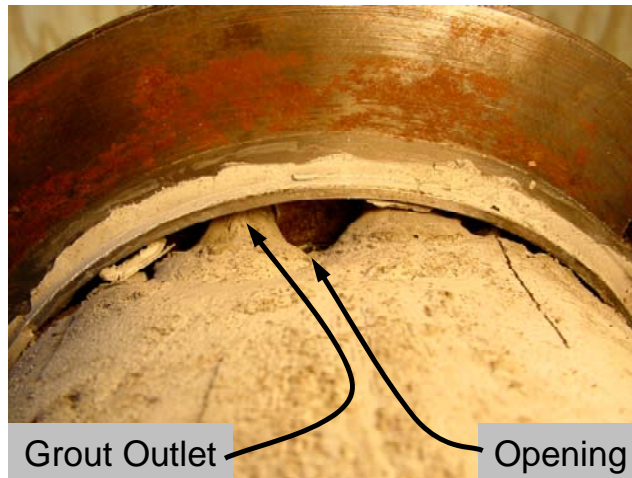
Small grout voids, which partially exposed an opening in the anchor head, were observed at the tower end of Specimen 3 (Figure D.36). Closely spaced air voids were observed at both ends of the specimen (Figure D.37).

Figure D.36 Air Voids at Tower End of Specimen 3

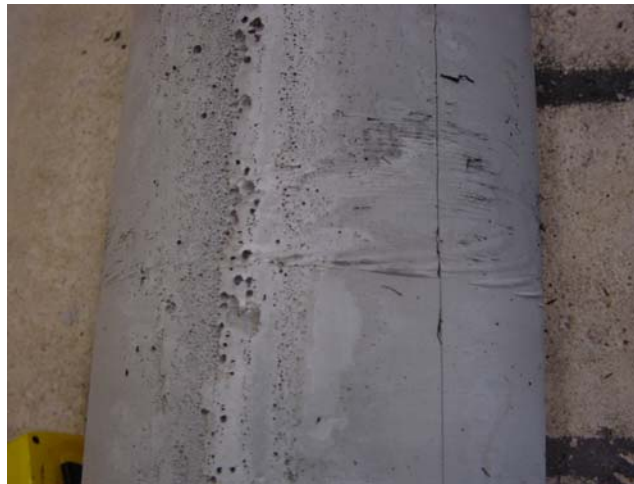
Figure D.37 Distributed Air Voids at Tower End of Specimen 3

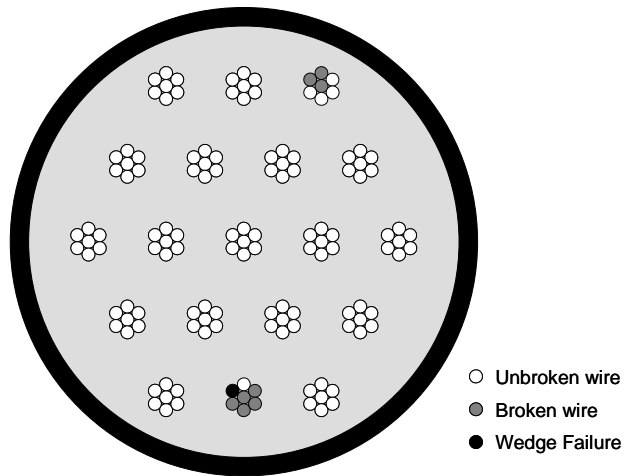
All the fractures near the tower end occurred within the anchor head and were concentrated in two strands (Figure D.38). No breaks occurred at the contact points of the intentionally crossed strands. Figure D.39 shows the longitudinal location of the wire breaks. One of the wire breaks in strand 18 initiated at the first tooth mark from the wedge. All other wire breaks initiated at the contact points between adjacent strands.

Figure D.38 Distribution of Wire Breaks near Tower End – Specimen 3

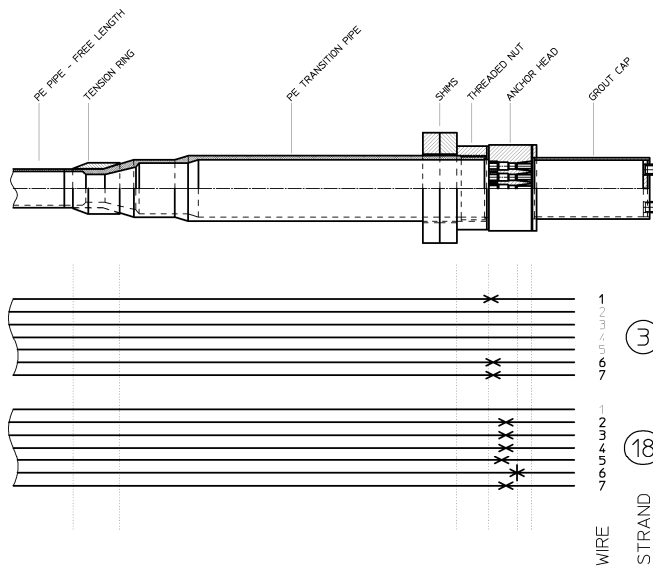
Figure D.39 Location of Wire Breaks near Tower End – Specimen 3

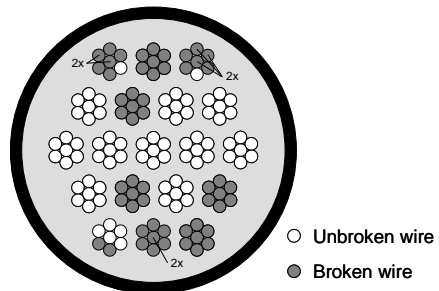
Near midspan, the sixty-two wire breaks occurred in nine different strands (Figure D.40). Six wires fractured at two locations. The distances between the multiple wire breaks varied from 5 in. in strand 1 to 16 in. in strand 18. All breaks were located in a 20-in. window under the loading point, with a slight tendency towards the tower end (Figure D.41).

Figure D.40 Distribution of Wire Breaks near Midspan – Specimen 3
