1. Report No. FHWA/TX-0-1401-1	2. Government Accession No.	3. Recipient's Catalog No.	
4. Title and Subtitle Bending Fatigue Response of Grouted Stay Cables		5. Report Date July 2008

Bending Fatigue Response of Grouted Stay Cables

CTR Research Report:	1401-1
Report Date:	July 2008
Research Project:	0-1401
Research Project Title:	Determination of Fatigue Damage in Stay Cables
Sponsoring Agency:	Texas Department of Transportation
Performing Agency:	Center for Transportation Research at the University of Texas at Austin

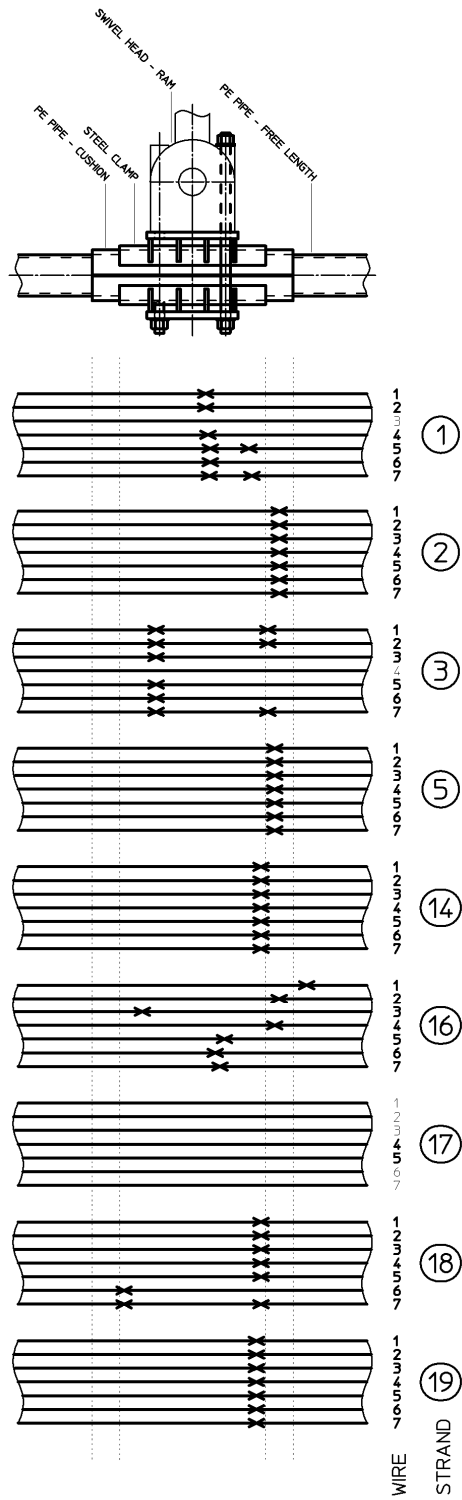
Near midspan, the sixty-two wire breaks occurred in nine different strands (Figure D.40). Six wires fractured at two locations. The distances between the multiple wire breaks varied from 5 in. in strand 1 to 16 in. in strand 18. All breaks were located in a 20-in. window under the loading point, with a slight tendency towards the tower end (Figure D.41).

Figure D.41 Location of Wire Breaks near Midspan – Specimen 3

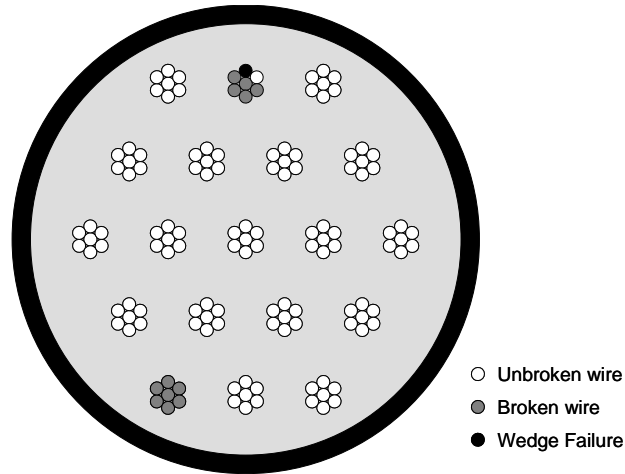
Near the deck end of the specimen, the fractures occurred in strands 2 and 17 (Figure D.42). Figure D.43 shows the longitudinal location of the wire breaks. The breaks in strand 17 occurred within 2 in. of the inside face of the anchor head. Five of the six breaks in strand 2 occurred within the anchor head, and one of the breaks occurred at the first tooth mark from the wedge. No wire breaks occurred at the contact points of the intentionally crossed strands.

Figure D.42 Distribution of Wire Breaks near Deck End – Specimen 3

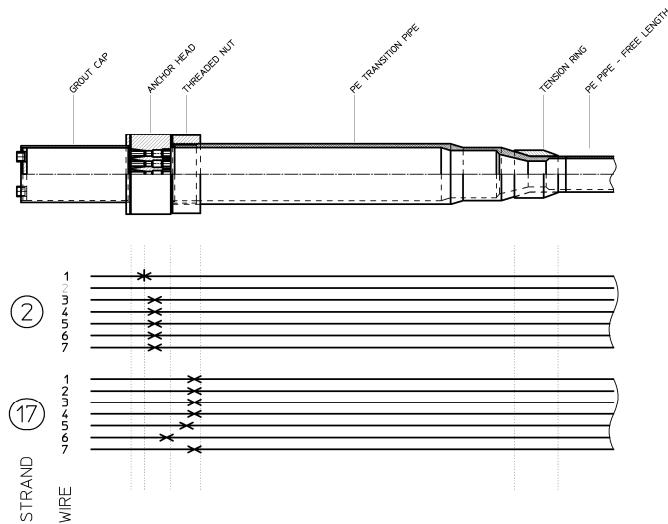
Figure D.43 Location of Wire Breaks near Deck End – Specimen 3

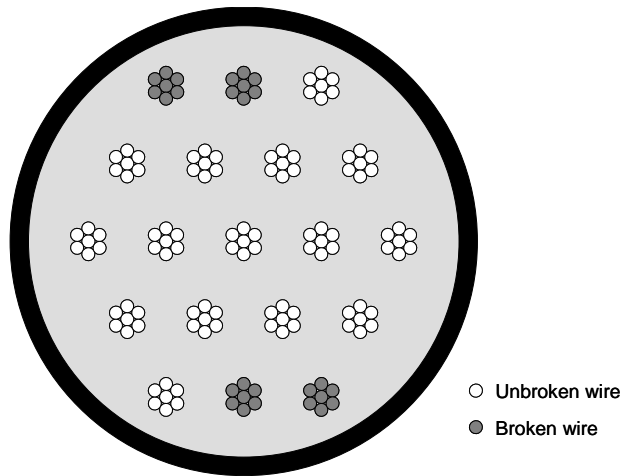
Thirty-one wire breaks were identified during the autopsy of Specimen 4. Twenty-eight wire breaks occurred near the tower anchorage and three occurred near the deck anchorage. Near the tower end, all seven wires fractured in each of four strands (Figure D.45). All breaks occurred within ± 0.5 in. of the inside face of the anchor head (Figure D.46). The three fractures near the deck end occurred in strand 18 (Figure D.47). All breaks occurred within ± 0.5 in. of the inside face of the anchor head (Figure D.48).

Figure D.45 Distribution of Wire Breaks near Tower End – Specimen 4

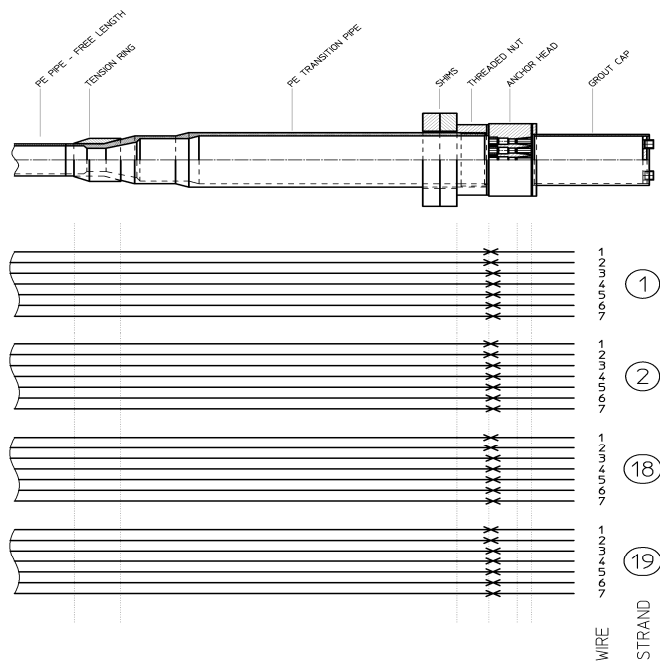
Figure D.46 Location of Wire Breaks near Tower End – Specimen 4

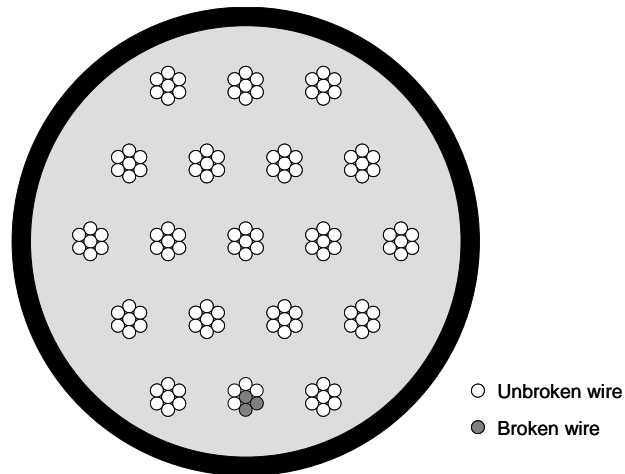
Figure D.47 Distribution of Wire Breaks near Deck End – Specimen 4

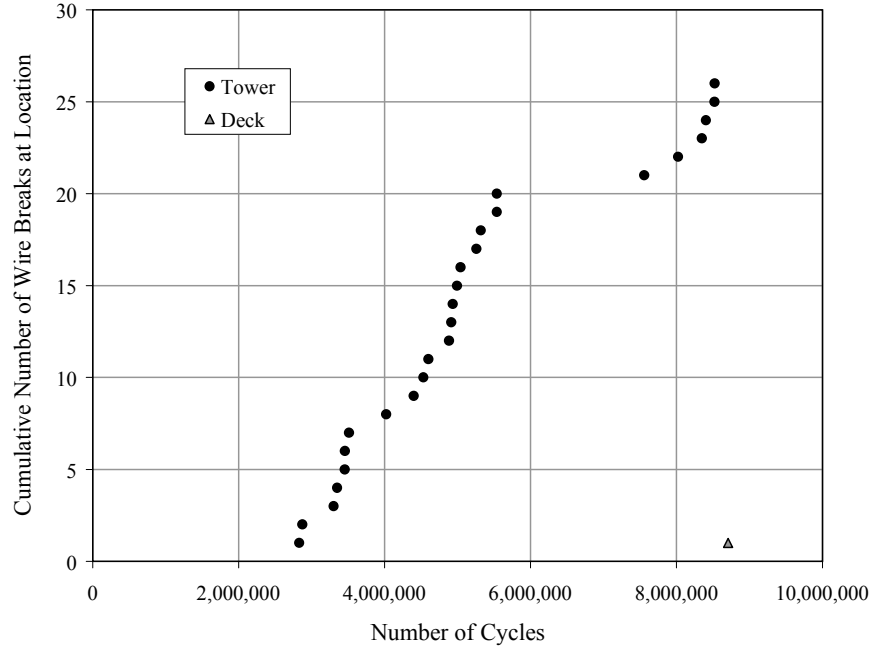
Figure D.49 Wire Breaks Detected from Acoustic Data – Specimen 4

The acoustic sensors detected twenty-seven wire breaks during the fatigue test for Specimen 4 (Table D.8). The number of wire breaks detected was two less than the number observed at each end of the specimen. The first wire break was detected after 2,830,000 fatigue cycles (Figure D.49).

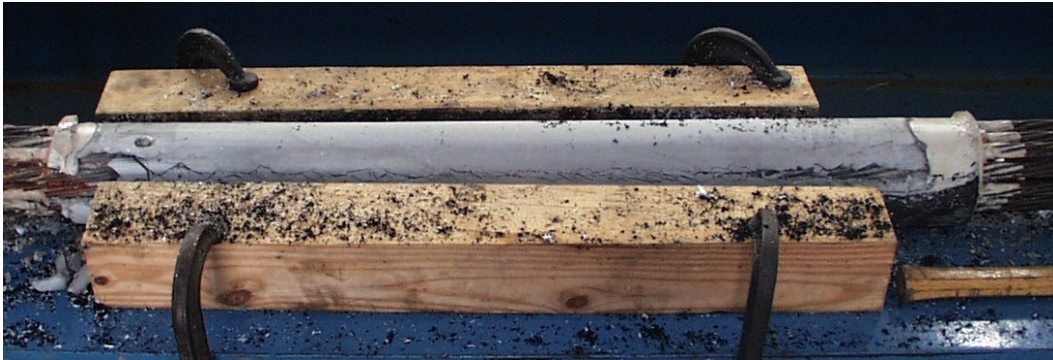
Figure D.50 Condition of Grout in Center Section of Specimen 5

The only portion of Specimen 5 that was grouted was a 3-ft section at the center. The grout had no appreciable voids, apart from a small defect at the location of the vent hole used for grouting, and appeared to be homogeneous. The grout appeared to be essentially uncracked immediately upon opening

the PE pipe (Figure D.50). The longitudinal cracks visible in Figure D.50 were caused by the router used to open the PE pipe. Longitudinal cracks characteristic of wire breaks were not observed. However, within minutes of opening the polyethylene pipe, circumferential shrinkage cracks began to appear and the grout began to fall away in pieces.

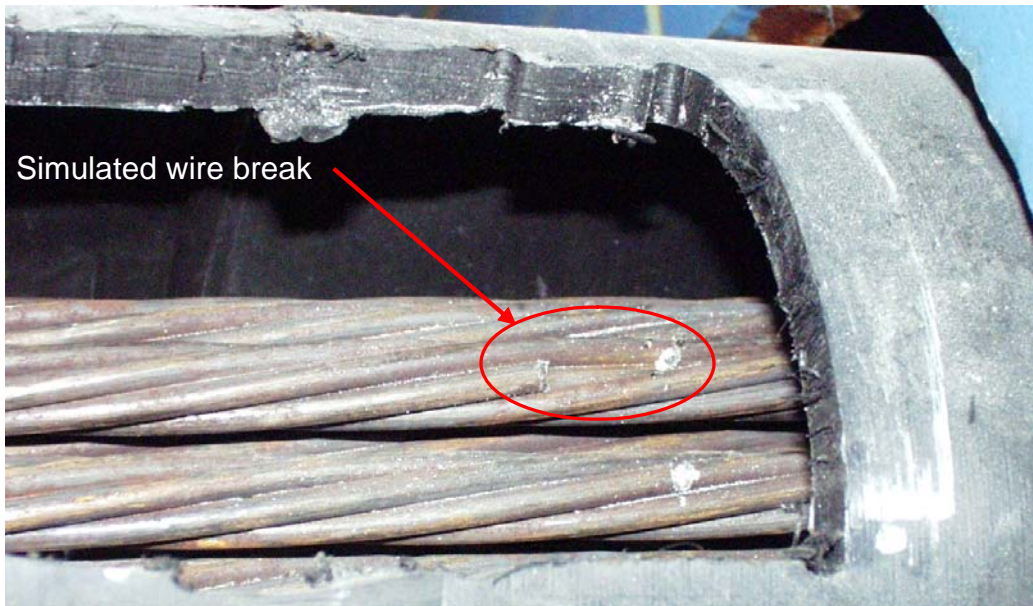
Figure D.52 Simulated Wire Break in Specimen 5

Specimen 5 did not experience any wire breaks during the fatigue tests. To ensure accurate calibration of the Soundprint® monitoring system, the research team intentionally generated two wire breaks (Figure D.52). A Dremel tool was used to cut the wires, and then the cable was displaced until the damaged wire broke. The acoustic monitoring system accurately captured the simulated wire breaks.

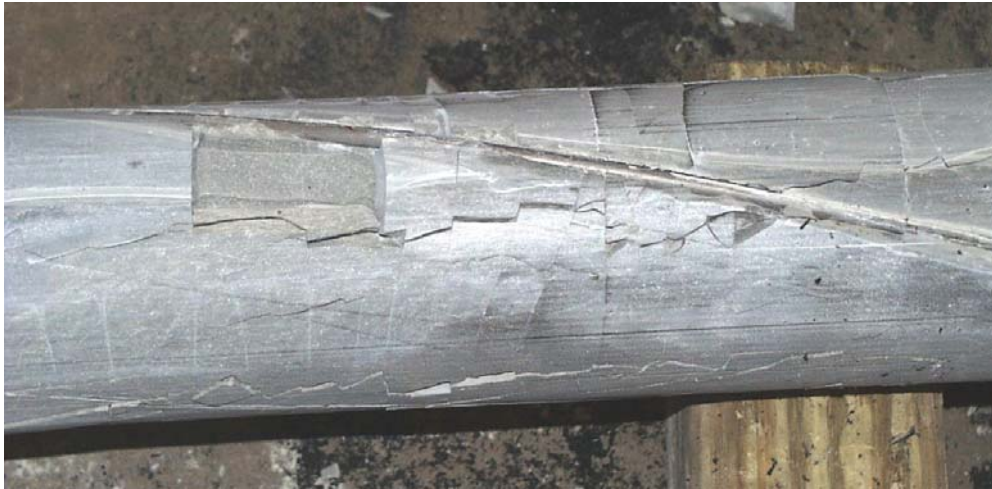
The grout near midspan exhibited severe longitudinal cracks characteristic of wire breaks (Figure D.59). Thin, parallel circumferential cracks were also observed. As with the other portions of the stay, the cracking in the center portion of the specimen became more severe after exposure to the air.

Figure D.59 Grout near Midspan of Specimen 6

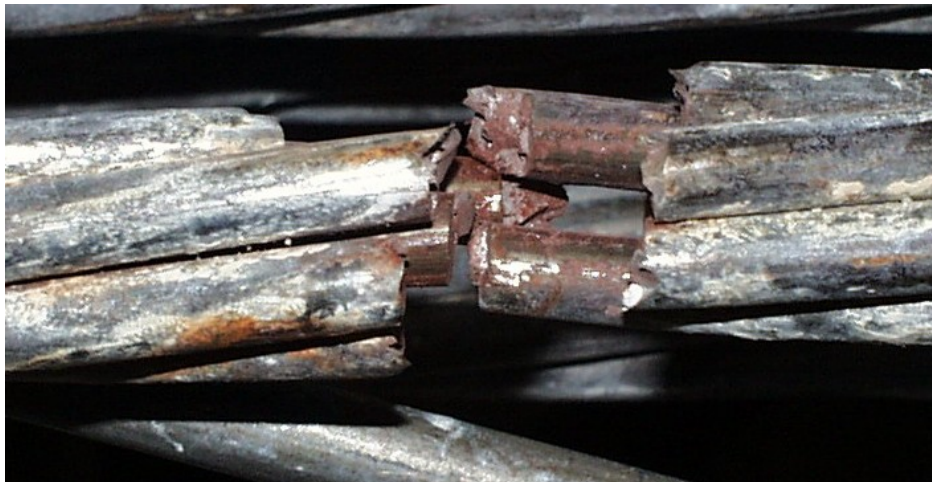
Upon opening the PE pipe, corroded fretting product was observed near the wire breaks. As wires fret against each other, microscopic particles of steel begin to rub off the wire surfaces. These particles have a very high surface area to volume ratio, thus corrode very easily to form an abrasive product that aggravates fretting (Frank 2004). In most cases, this corroded fretting product was not evident on the exterior of the strand and could only be seen by taking apart the strand and inspecting the contact surfaces between wires. An example of corroded fretting product can be seen in Figure D.60.

Figure D.60 Corroded Fretting Product on Strand 19 – Specimen 6

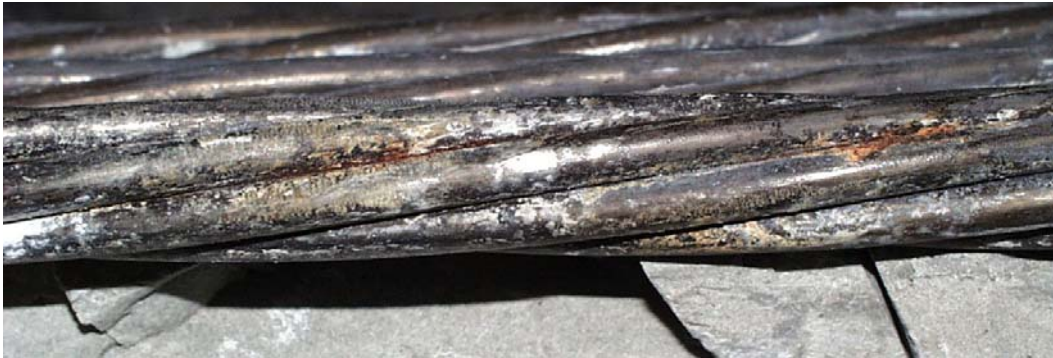
In the case of Specimen 6, the evidence of fretting near the wire breaks at the tower anchor head was more severe than the evidence of fretting found elsewhere. In some places, corrosion was evident on the exterior of the strand and was accompanied by a white substance that coated the strand, shown in Figure D.61. In this region, corrosion was also seen on the grout surface at the interface between the grout and the strand (Figure D.62).

Figure D.61 Corrosion on Strand 19 near Tower Anchor Head – Specimen 6

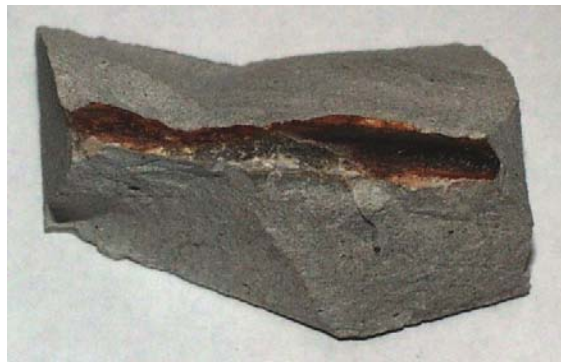
Figure D.62 Corrosion Product on Grout from Tower End of Specimen 6

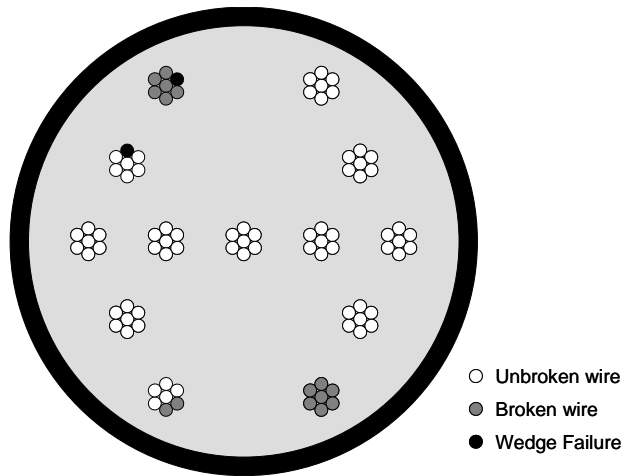
Figure D.63 Distribution of Wire Breaks near Tower End – Specimen 6

Twenty-eight wire breaks were identified during the autopsy of Specimen 6. Seventeen wire breaks occurred near the tower anchorage and eleven occurred near the loading point. The seventeen wire breaks near the tower end were distributed among four strands (Figure D.63). Figure D.64 shows the longitudinal location of wire breaks near the tower anchorage. Nearly all breaks at the tower end of the specimen occurred within 2 in. of the inside face of the anchor head in the region confined by the smooth end sleeve. Examples of wire breaks occurring in this region are shown in Figure D.65 and Figure D.66.

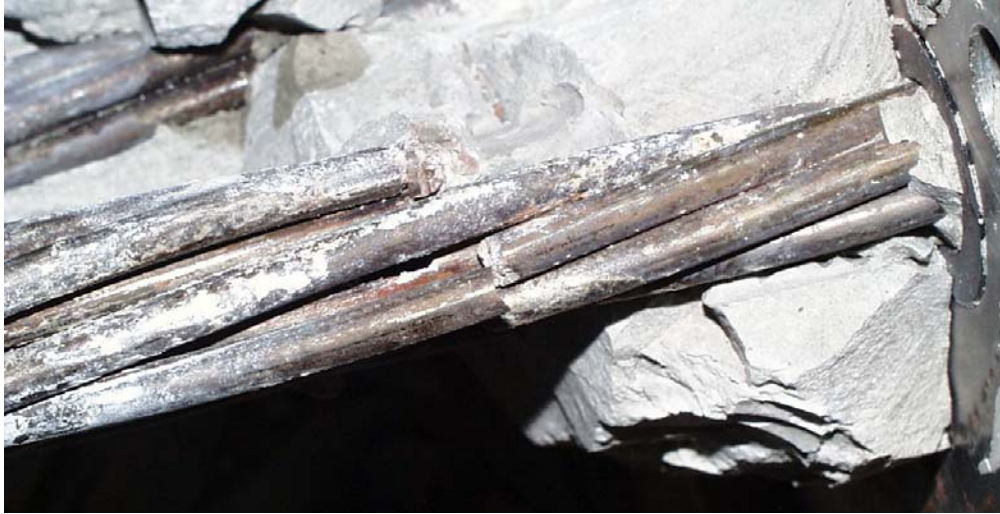
Figure D.65 Wire Breaks in Strand 1 near Tower End – Specimen 6

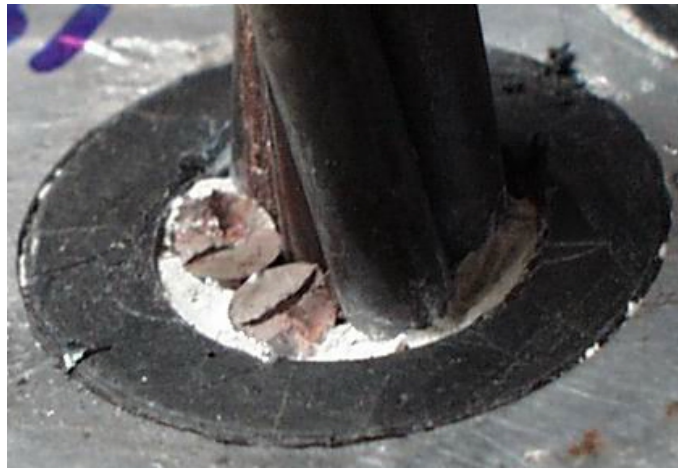
Figure D.66 Wire Breaks in Strand 17 at the Inside Face of the Tower Anchor Hear – Specimen 6

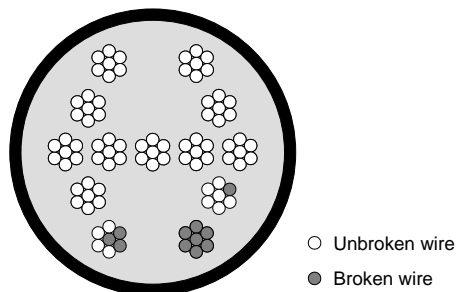
Figure D.67 Distribution of Wire Breaks near Midspan – Specimen 6

At midspan, the eleven wire breaks occurred in three strands (Figure D.67). The longitudinal distribution of the breaks is shown in Figure D.68. All breaks occurred beyond the tapered polyethylene cushioning pipe.

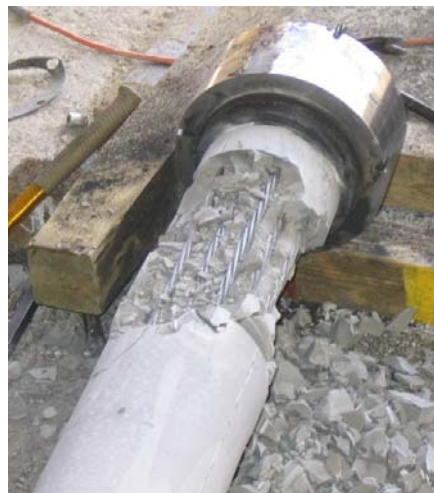
The grout at the deck end appeared homogeneous with no significant air voids. Some circumferential cracks were observed (Figure D.73). Despite the presence of wire breaks in the region, the grout appeared to be in good condition immediately after exposing the grout to the atmosphere (Figure D.73). However, the grout cracked significantly with time (Figure D.74).

Figure D.74 Condition of Grout near Deck Anchor Head Several Minutes after Removing Polyethylene Pipe – Specimen 7

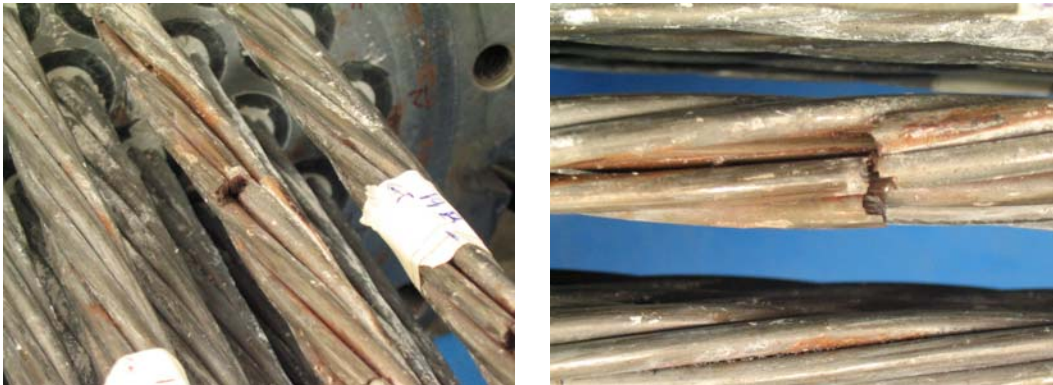
Most of the corrosion and corroded fretting product observed after removing the PE pipe was in the vicinity of the wire breaks. Figure D.76 shows a typical example of the corroded fretting product found in these areas.

Figure D.76 Corrosion Observed near Tower Anchorage on Strand 18 – Specimen 7

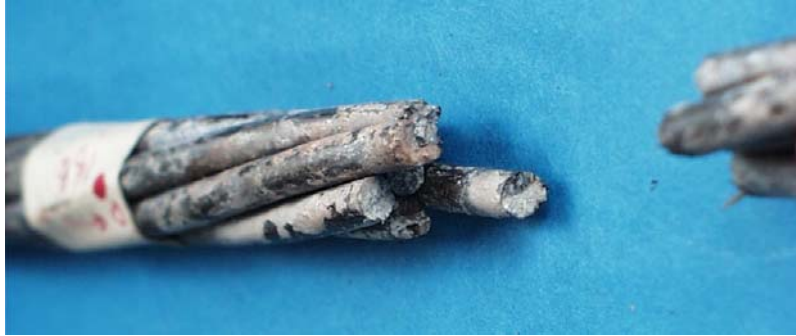
Figure D.77 White Substance on Surface of Strand 17 at Midspan – Specimen 7

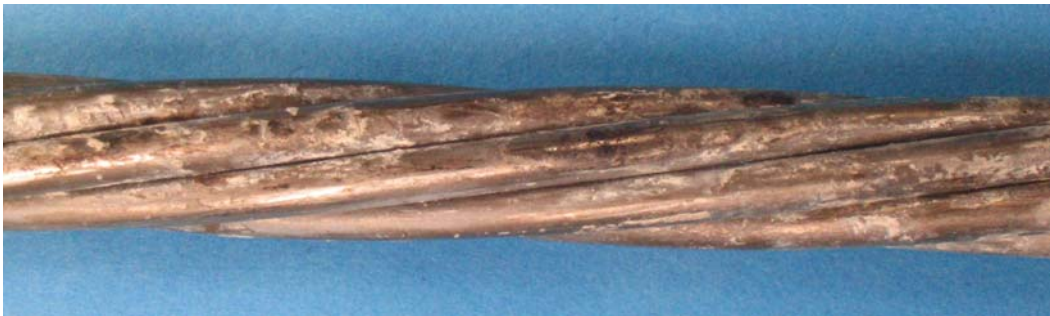
In the center of the stay, a white substance was found near most wire breaks (Figure D.78). In addition to the white substance, red-orange corroded fretting product was typically observed between the wires in the strands in which wire breaks occurred. The corroded fretting product was often not visible on the surface of the strand.

Figure D.78 Corrosion on Surface of Strand 17 at Midspan – Specimen 7

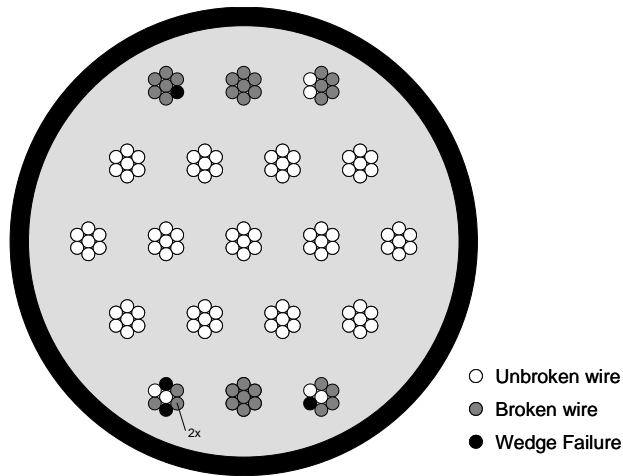
Figure D.79 Distribution of Wire Breaks near Tower End – Specimen 7

The thirty-seven wire breaks near the tower end were distributed among six strands (Figure D.79). Figure D.80 shows the longitudinal location of wire breaks near the tower anchorage. A majority of the breaks occurred within 9 in. of the inside face of the anchor head. Wire breaks in Specimen 7 occurred as far as 16 in. from the face of the anchor head.

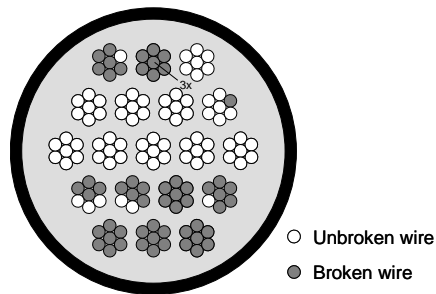
Figure D.82 Distribution of Wire Breaks near Midspan – Specimen 7

Figure D.82 shows the distribution of the wire breaks among ten strands at midspan. The longitudinal distribution of the breaks at midspan is shown in Figure D.83 and Figure D.84. The breaks tend to be centered near the edge of the load plate where the clamp is bolted to the cable. The center wire in strand 2 fractured in three places.

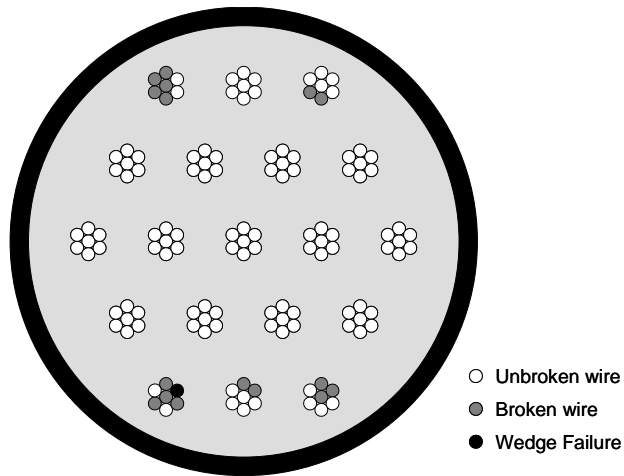
Figure D.85 Distribution of Wire Breaks near Deck End – Specimen 7

The seventeen wire breaks near the deck end were distributed among five strands (Figure D.85). Figure D.86 shows the longitudinal location of wire breaks near the deck anchorage. Most of the wire breaks occurred within 4 in. of the inside face of the anchor head or inside the anchor head. One wire in strand 18 broke approximately 14 in. from the inside face of the anchor head.

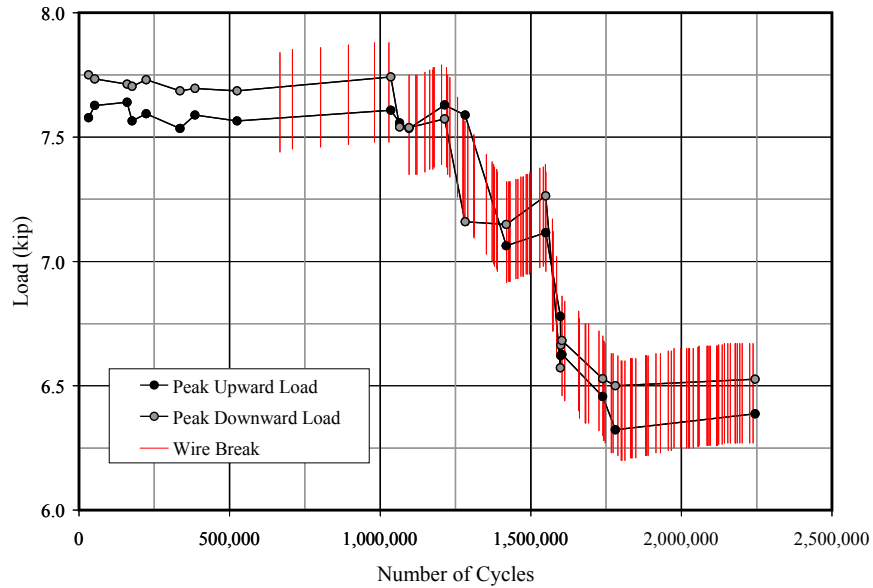
Figure D.88 Variation of Applied Loads during Fatigue Test – Specimen 7

The variation in the maximum and minimum applied forces needed to achieve the target displacement levels of ± 1.6 in. are shown in Figure D.88. The vertical lines also indicate the approximate number of cycles corresponding to each wire break detected by the acoustic sensors. The final average dynamic stiffness was less than 85% of the initial average dynamic stiffness (Table D.14). Nearly fifty wires fractured before the average dynamic stiffness decreased by more than 10%.

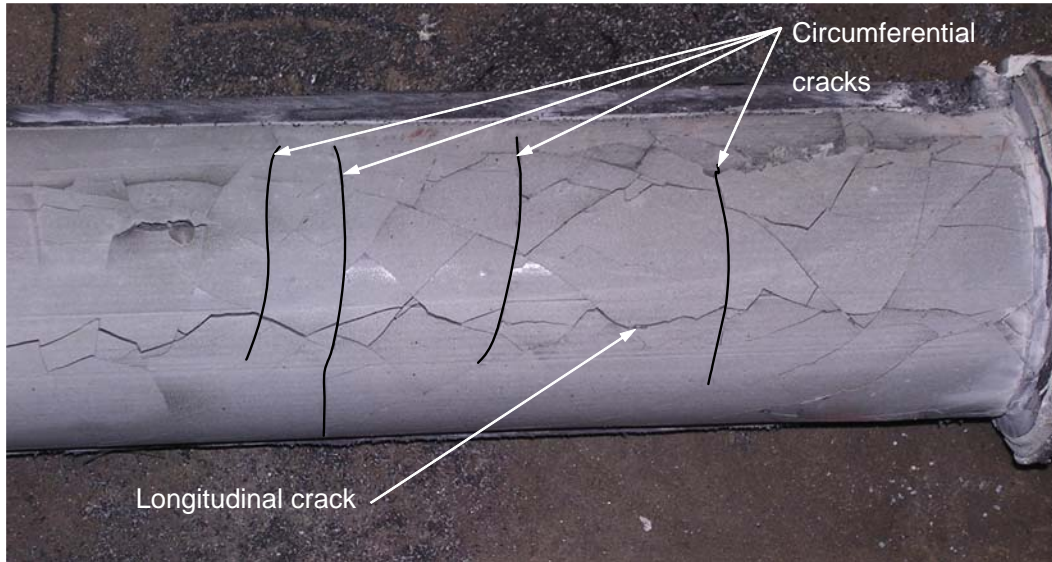
The only portion of Specimen 8 that was grouted was a 3-ft section at the center. The grout had no appreciable voids apart from a small defect at the location of the vent hole used for grouting, and appeared to be homogeneous. Immediately after removing the PE pipe, longitudinal cracks were observed along the entire length of the grouted section. Circumferential cracks were also present and were concentrated near the PVC end caps (Figure D.90). The cracks in the grout were more severe near the ends of the grouted section.

Figure D.90 Condition of Grout in Center Section of Specimen 8

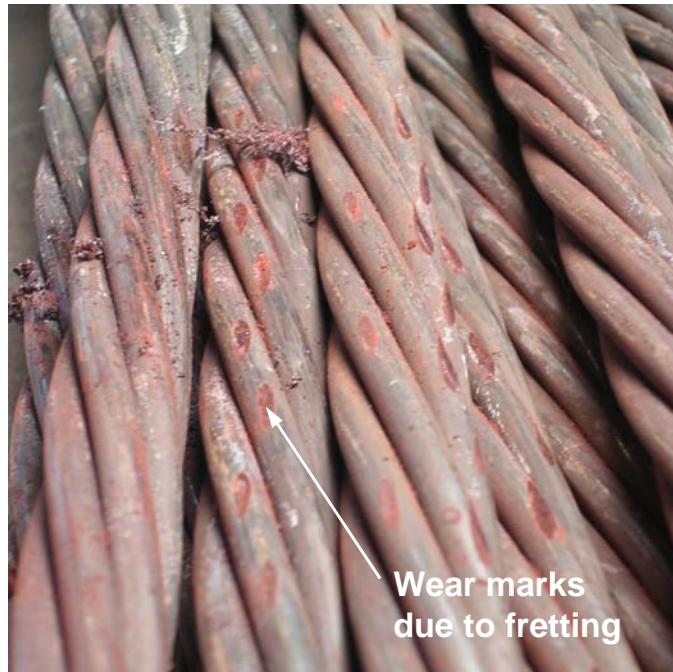
Corroded fretting product was observed on the surface of the strands at both tension rings after fewer than 1,000,000 fatigue cycles. Fretting was more severe at the deck end (Figure D.91) due to a misalignment of the strands (Section B.4.5). The strands were aligned at the tower end; however, fretting was observed at this location also. Wear of the wires at the contact points due to the fretting was observed during the autopsy of the specimen (Figure D.92).

Figure D.92 Reduction of Cross-Sectional Area of Strands Due to Fretting – Specimen 8

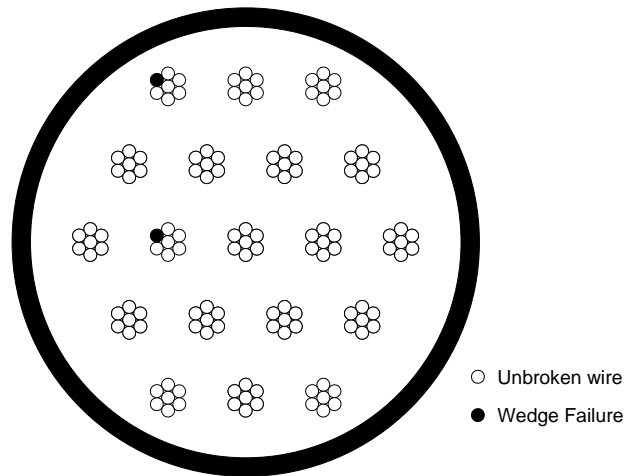
Figure D.94 Distribution of Wire Breaks near Tower End – Specimen 8

Four wire breaks were identified during the autopsy of Specimen 8. Two wire breaks occurred near the tower anchorage and two occurred near the deck anchorage. The two wire breaks near the tower end occurred in two strands (Figure D.94). Both wire breaks occurred at the contact point between the strand and the wedge (Figure D.95 and Figure D.96). Scraping was evident on the strand which is caused by the teeth as the strand is pulled through the wedge during stressing (Figure D.97).

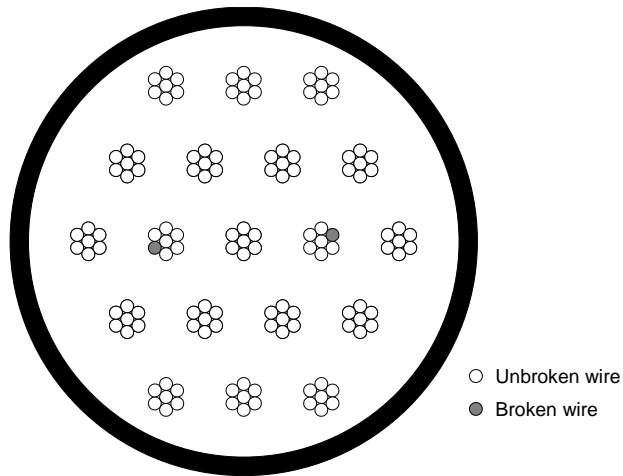
Figure D.98 Distribution of Wire Breaks near Deck End – Specimen 8

At the deck end, the two wire breaks were distributed in two strands (Figure D.98). Both breaks occurred in the center layer of strands. Figure D.99 shows the longitudinal location of each wire break near the deck anchorage and photographs are shown in Figure D.100 and Figure D.101. The fracture in strand 9 initiated within the wedge, but was caused by fretting against an adjacent wire.

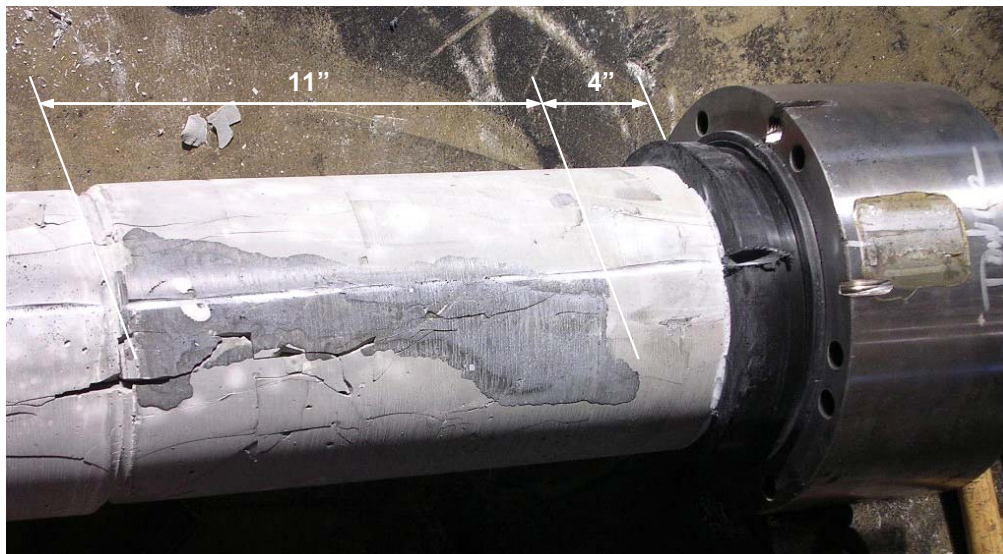
Figure D.105 Intentional Grout Lens at Tower End – Specimen 9

An intentional grout void was created at the tower end during the initial grouting of Specimen 9. This void was filled with SikaGrout 300 PT one week later to investigate the effects of filling a grout void, which had been identified by TxDOT personnel on the Fred Hartman Bridge. The SikaGrout, identified by its darker color, formed a lens on the surface of the original grout approximately 11 in. long starting 4 in. from the anchor head (Figure D.105) and ending at the ring formed by the weld in the polyethylene transition pipe. This lens ranged from 1/16 in. thick near the anchor head to 1/32 in. thick at the far end of the lens.

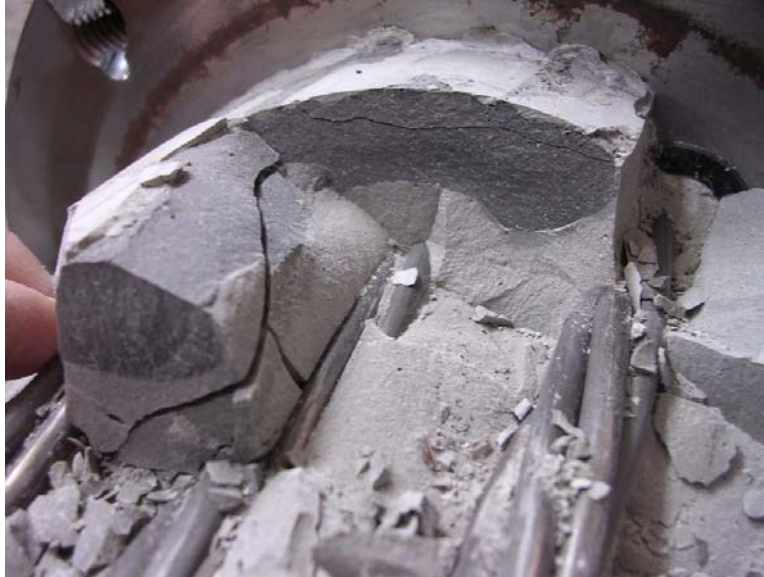
Figure D.106 Interface between Grout Used to Construct Specimen 9 and Grout Used to Repair Intentional Void at Tower End

Apart from the grout lens, no evidence of the grout used to repair the void was found on the exterior of the cable at the face of the anchor head. However, the repair grout was found around the grout inlet holes in the anchor heads under the surface of the original grout (Figure D.106). No strands intersected the grout void, thus no strand had contact with the repair grout.

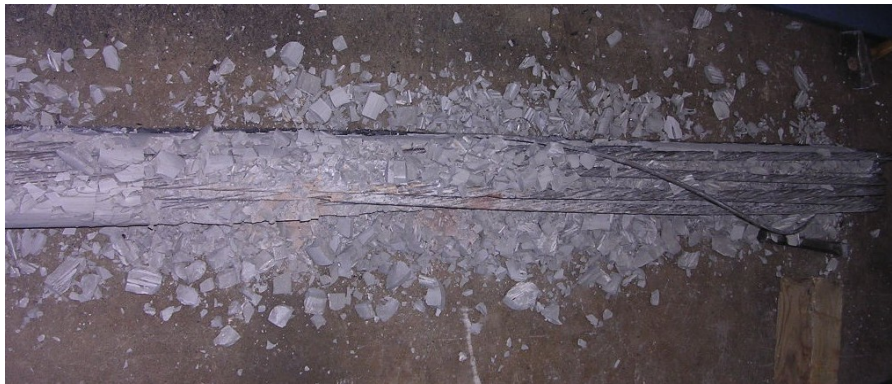
Figure D.107 Condition of Grout under Load Point – Specimen 9

The grout at the deck end of the stay was homogeneous and relatively uncracked, consistent with finding no wire breaks outside the anchor head. The grout in the center section, under the load point, was heavily damaged (Figure D.107).

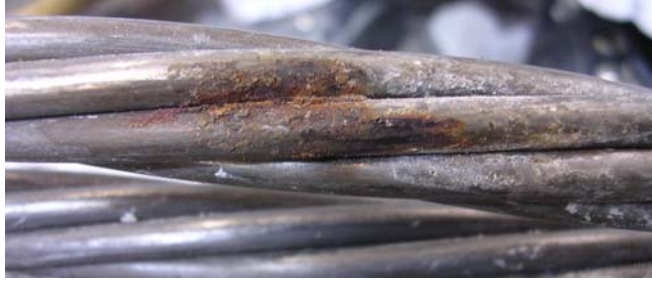
Figure D.108 Corrosion on Surface of Strand near Tower End – Specimen 9

Near the anchorages, corrosion was generally mild and found only near wire breaks. Several spots of heavy corrosion that were unaccompanied by wire breaks were found near the tower anchorage as seen in Figure D.108. These areas were all located under the intentional grout void.

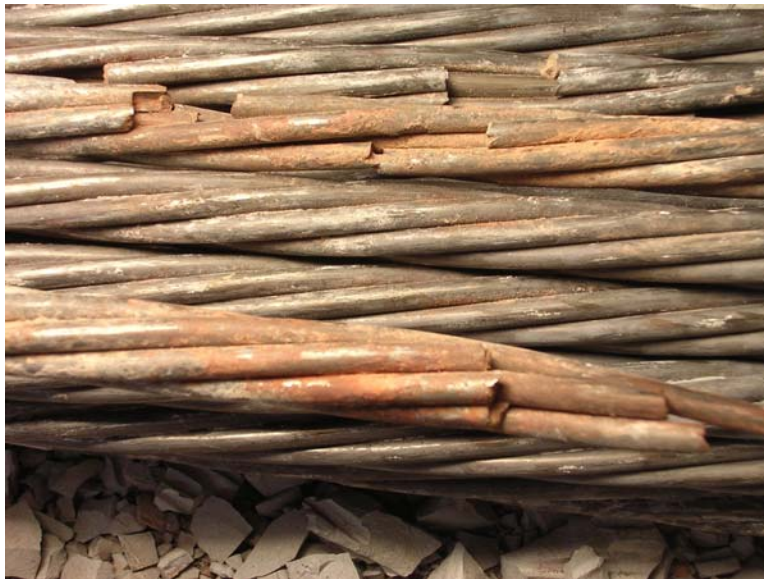
Figure D.109 Corrosion on Surface of Strand near Midspan – Specimen 9

Extensive corrosion was observed in the region near the center of the stay. Heavy, red-orange corroded fretting product near wire breaks (Figure D.109) was accompanied by black and red pitting corrosion in several places. Several breaks appeared to initiate at these points of pitting corrosion. White powder and grout coated many of the strands and obscured some fracture surfaces in this region. The amount of fretting residue tended to be more severe when all (or nearly all) the wires of a strand had fractured, which may indicate that such corrosion forms after wire breaks occur.

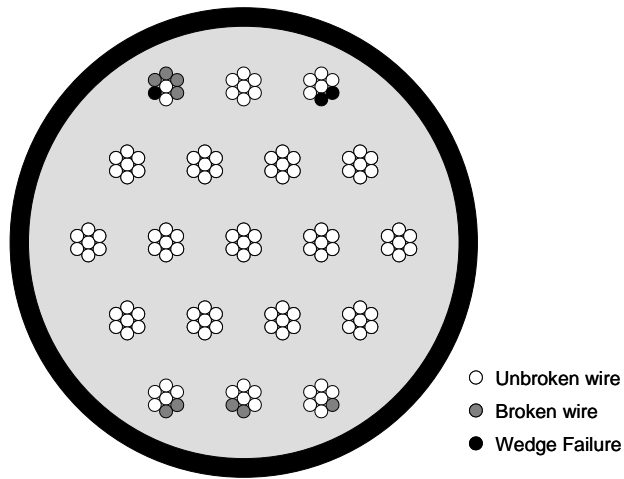
Figure D.110 Distribution of Wire Breaks near Tower End – Specimen 9

The twelve wire breaks near the tower end were distributed among five strands, which were distributed along the extreme fibers of the cross section (Figure D.110). Figure D.111 shows the location of each wire break near the tower anchorage. Three wires broke inside the anchor head at the contact point between the wedge and the strand. Two wire breaks in strand 1 occurred 15 in. from the anchor head at the location of a weld in the polyethylene transition pipe.

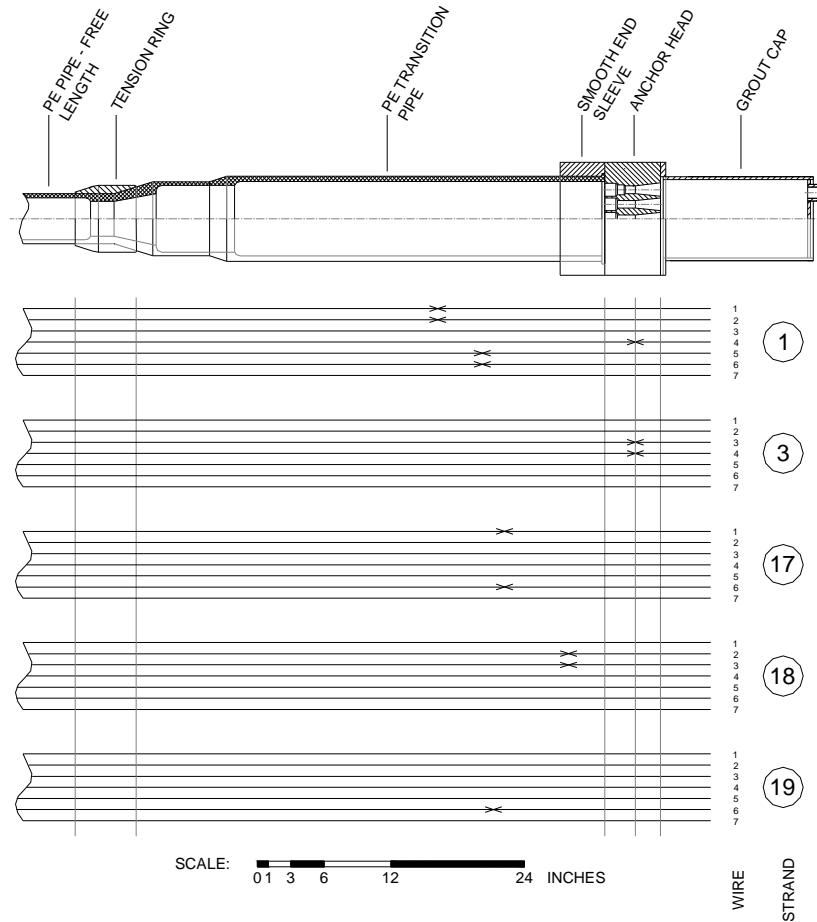
Figure D.111 Location of Wire Breaks near Tower End – Specimen 9

The distribution of wire breaks in Specimen 9 should be compared with those in Specimen 1, which was constructed with an unintentional grout void (Figure D.3). The grout void in Specimen 1 was not repaired and it was approximately four times larger than the void created in Specimen 9. Nearly half of the wire breaks at the tower end of Specimen 1 (Figure D.10 and Figure D.11) occurred in strands that were exposed in the grout void. Although no strands were in exposed in the grout void in Specimen 9, the four wire breaks in the top layer of strands that were not caused by the wedges, were considerably further from the inside face of the anchor head than was common in the other grouted test specimens.

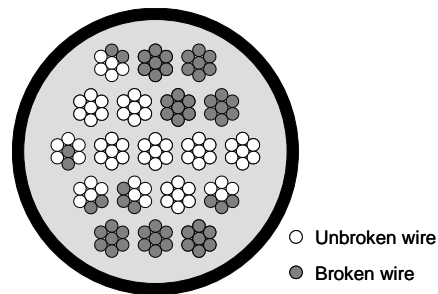
Figure D.112 Distribution of Wire Breaks near Midspan – Specimen 9

Figure D.112 shows the distribution of wire breaks at midspan. The sixty-one breaks occurred in twelve strands. Specimen 9 was the only stay to experience wire breaks within the middle layer of strands under the load point. Figure D.113 and Figure D.114 show the location of each wire break relative to the load point.

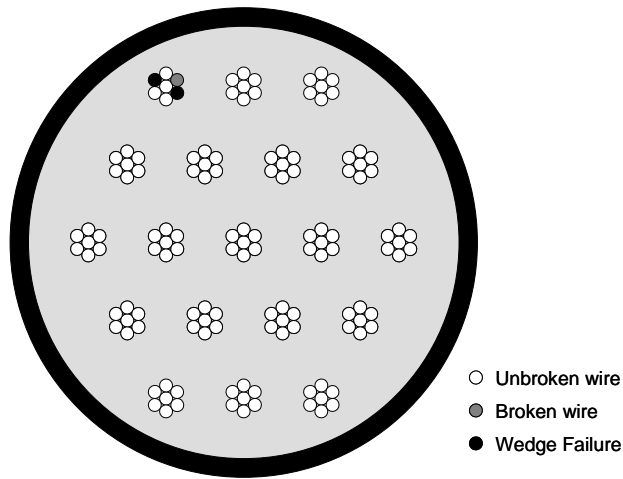
Figure D.115 Distribution of Wire Breaks near Deck End – Specimen 9

The three wire breaks at the deck end were concentrated in a single strand (Figure D.115). As shown in Figure D.116, all three breaks occurred within the anchor head. Two breaks were initiated by the first wedge tooth and one break occurred at the front of the polyethylene bushing at the face of the anchor head.

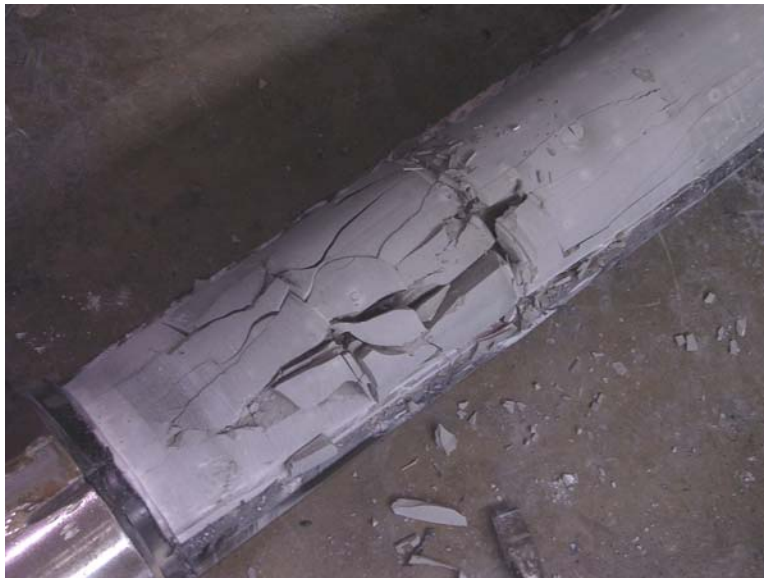
Figure D.120 Condition of Grout at Tower End Immediately after Removing PE Pipe – Specimen 10

Figure D.120 shows the condition of the grout at the tower end immediately after removing the PE transition pipe. Severe longitudinal cracks were observed, which indicate wire breaks in the region. Apart from the cracking, no other visual imperfections in the grout were observed. Figure D.121 shows the condition of the grout under the load point. The grout in this region was also severely cracked. Figure D.122 shows the condition of the grout at the deck end. Large longitudinal cracks were observed, despite the fact that no wire breaks were found outside of the anchor head. This level of cracking was not expected, and may be due to the large-amplitude cycles at the beginning of the fatigue test.

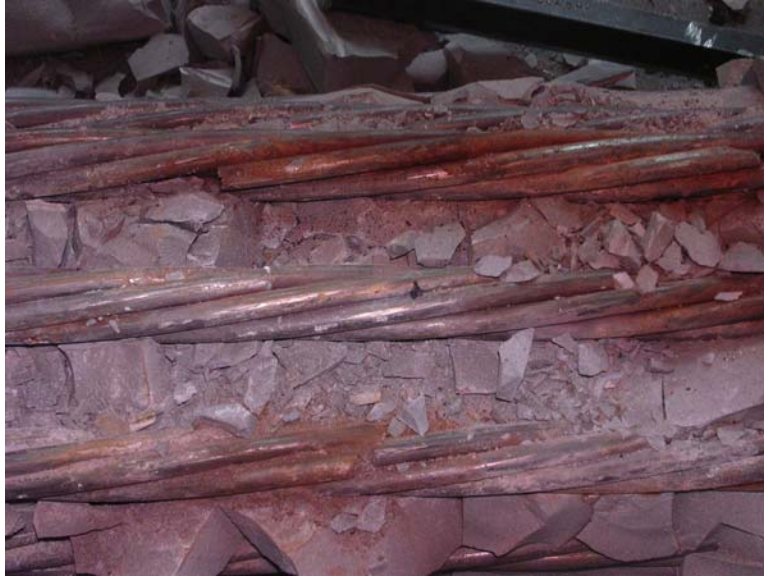
Figure D.123 Corroded Fretting Product near Tower End – Specimen 10

Corroded fretting residue was found near the wire breaks at the tower end (Figure D.123) and under the load point (Figure D.124). The amount of fretting residue observed was less than that observed in Specimens 7 and 9. Traces of corroded residue were found in the grout at the tower end.

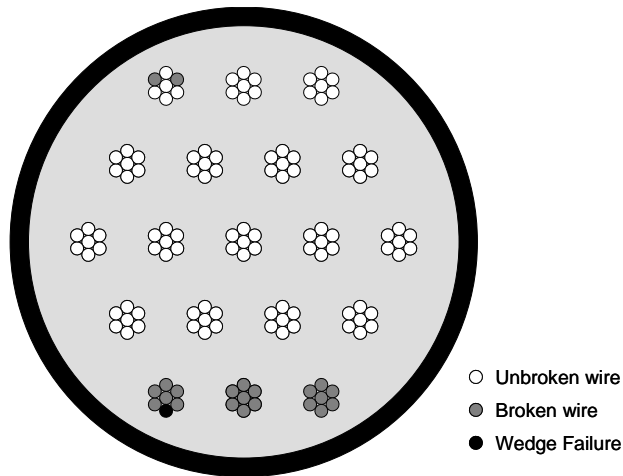
Figure D.125 Distribution of Wire Breaks near Tower End – Specimen 10

The twenty-three wire breaks near the tower end were distributed among four strands (Figure D.125). Most of the breaks at the tower end occurred on the bottom layer of strands. In addition to the twenty-three wire breaks, a fatigue crack was found $3\frac{3}{4}$ in. from the inside face of the anchor head on wire 4 of strand 18. The wire was not fractured at this point because the wire had fractured $4\frac{3}{4}$ in. away and there was not enough tension in the wire to cause the second crack to fracture before the fatigue test was stopped. Figure D.126 shows the longitudinal location of each wire break relative to the tower anchorage.

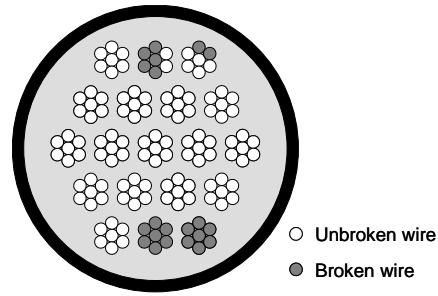
Figure D.127 Distribution of Wire Breaks near Midspan – Specimen 10

Figure D.127 shows the distribution of wire breaks near midspan. The twenty-one breaks occurred in four strands. Figure D.128 shows the location of each wire break relative to the load point. The breaks all occurred within the clamp region, and tended to occur between the edge of the load plate and the end of the steel clamp.

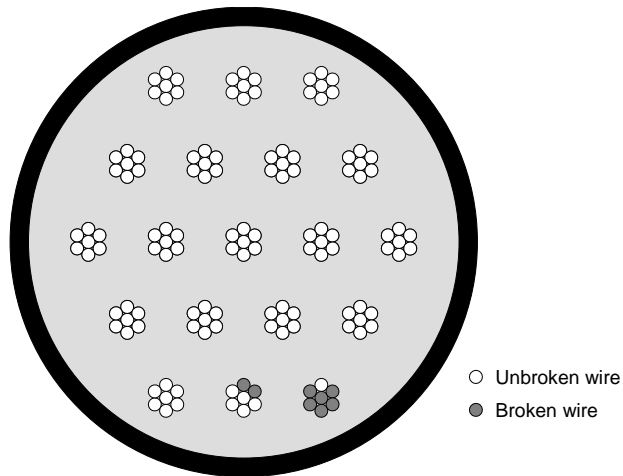
Figure D.129 Distribution of Wire Breaks near Deck End – Specimen 10

The eight wire breaks at the deck end were distributed in two strands (Figure D.129). All wire breaks occurred within the anchor head, but no wires fractured at the wedges (Figure D.130).

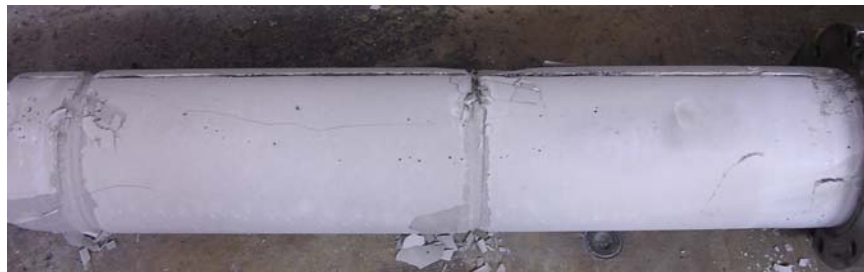
Distributed, small air voids were observed on the surface of the grout at the tower end of the specimen (Figure D.134). Minor longitudinal cracks were also observed. The surface of the grout exhibited similar small voids at the deck end of the specimen (Figure D.73); however, a significant longitudinal crack was present near the bottom of the cross section. At midspan, the grout appeared to be free of grout voids, but had extensive cracks in the longitudinal and circumferential directions (Figure D.75).

Figure D.134 Condition of Grout at Tower End – Specimen 11

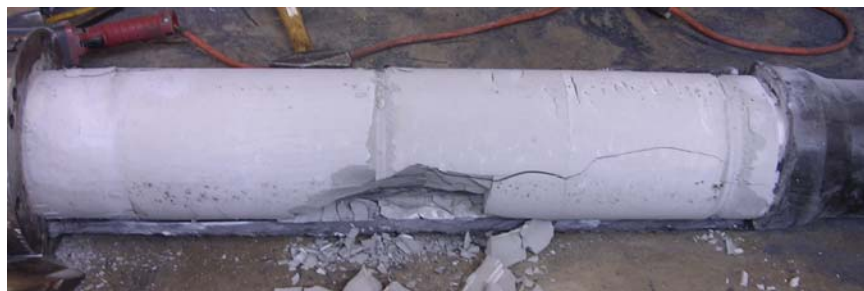
Figure D.135 Condition of Grout near Deck End – Specimen 11

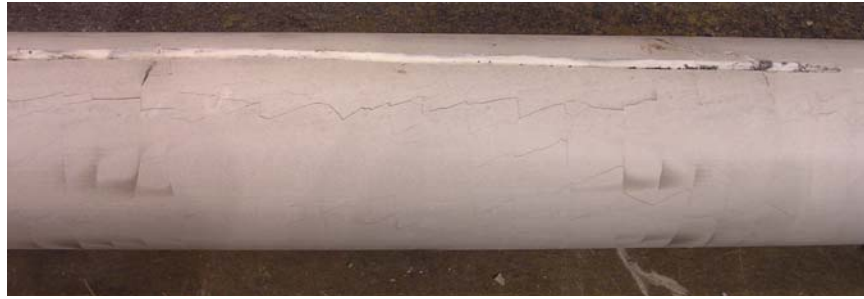
Figure D.136 Condition of Grout under Load Point – Specimen 11

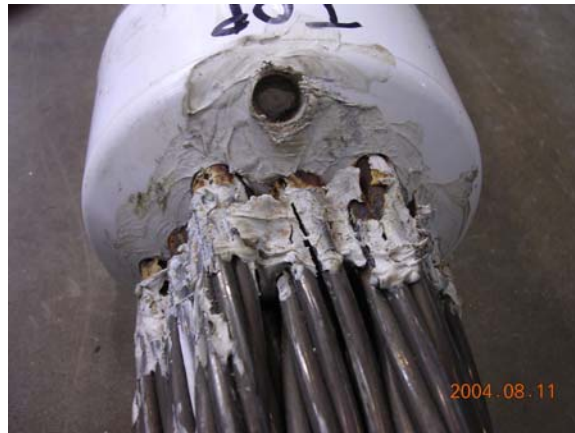
Like the grouted specimens, corrosion of the reinforcement was observed at the interface of the grout and the caulk (Figure D.137). Modest amounts of corroded fretting product were also observed near midspan (Figure D.138), but were not present near the deck end.

Figure D.137 Corrosion at Interface between Grout and Caulk near Midspan – Specimen 11
