1. Report No. FHWA/TX-0-1401-1	2. Government Accession No.	3. Recipient's Catalog No.	
4. Title and Subtitle Bending Fatigue Response of Grouted Stay Cables		5. Report Date July 2008

Bending Fatigue Response of Grouted Stay Cables

CTR Research Report:	1401-1
Report Date:	July 2008
Research Project:	0-1401
Research Project Title:	Determination of Fatigue Damage in Stay Cables
Sponsoring Agency:	Texas Department of Transportation
Performing Agency:	Center for Transportation Research at the University of Texas at Austin

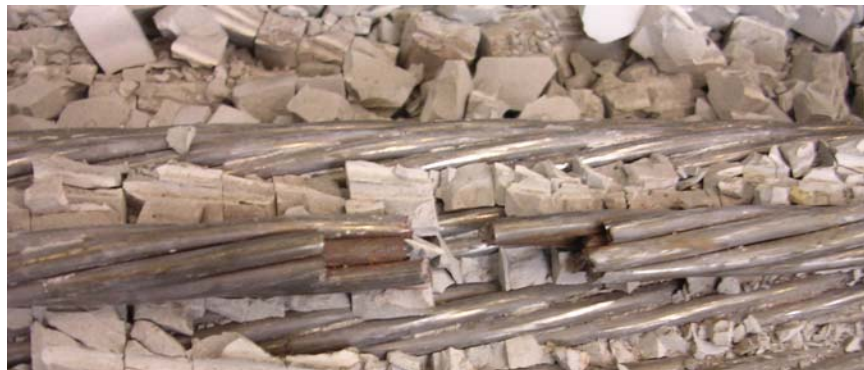
Like the grouted specimens, corrosion of the reinforcement was observed at the interface of the grout and the caulk (Figure D.137). Modest amounts of corroded fretting product were also observed near midspan (Figure D.138), but were not present near the deck end.

Figure D.138 Corroded Fretting Product on Surface of Strand 18 at Midspan – Specimen 11

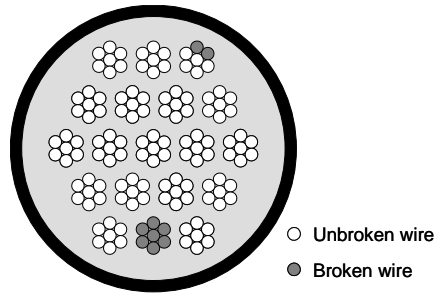
Sixteen wire breaks were identified during the autopsy of Specimen 11. Nine occurred near the loading point, and seven occurred near the deck anchorage. The nine wire breaks at midspan occurred in two strands (Figure D.139). Failure of all wires in strand 18 at midspan led to the termination of the fatigue test (Figure D.140).

Figure D.139 Distribution of Wire Breaks near Midspan – Specimen 11

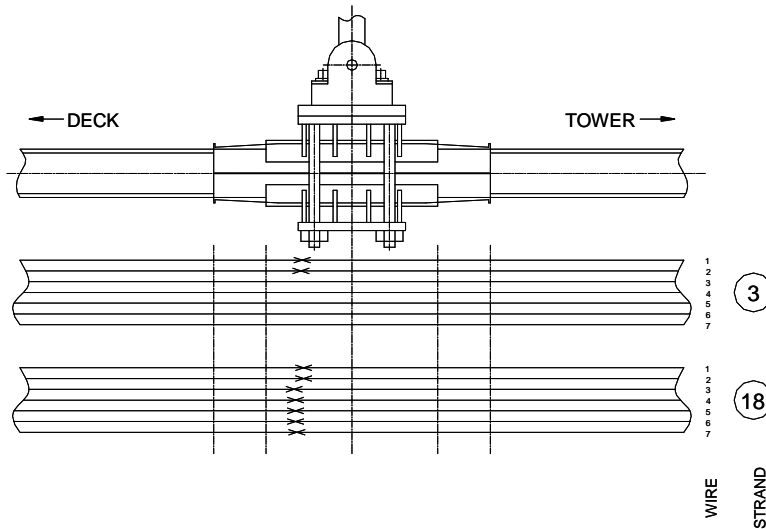
Figure D.140 Location of Wire Breaks near Midspan – Specimen 11

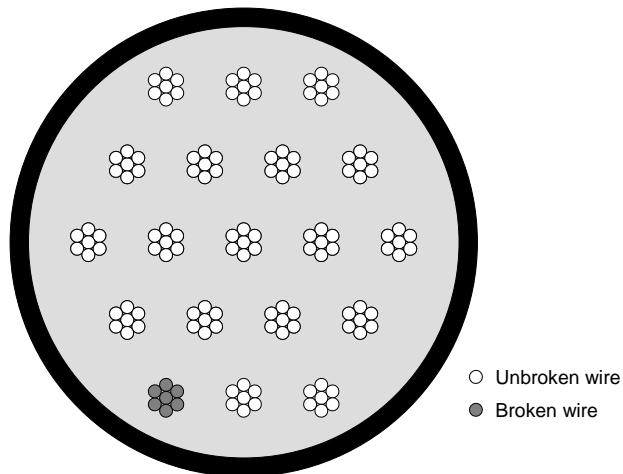
The seven wire breaks near the deck end were concentrated in strand 17 (Figure D.141). All wires fractured near the inside end of the smooth end sleeve (Figure D.142).

Figure D.141 Distribution of Wire Breaks near Deck End – Specimen 11

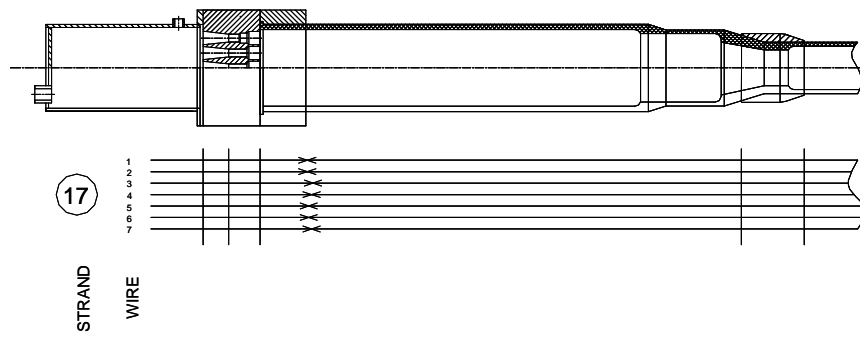
Figure D.142 Location of Wire Breaks near Deck End – Specimen 11

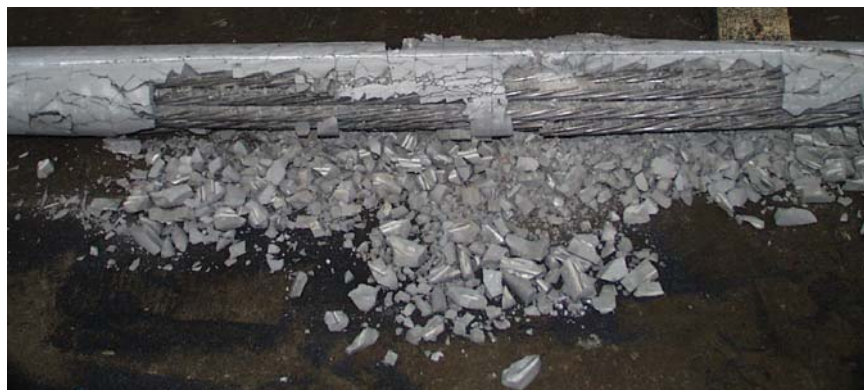
Due to the large number of wire breaks, the grout was severely cracked at the conclusion of the fatigue test. Photographs of the condition of the grout at midspan and the deck end are shown in Figure D.146 and Figure D.147, respectively.

Figure D.146 Condition of Grout near Midspan – Specimen 12

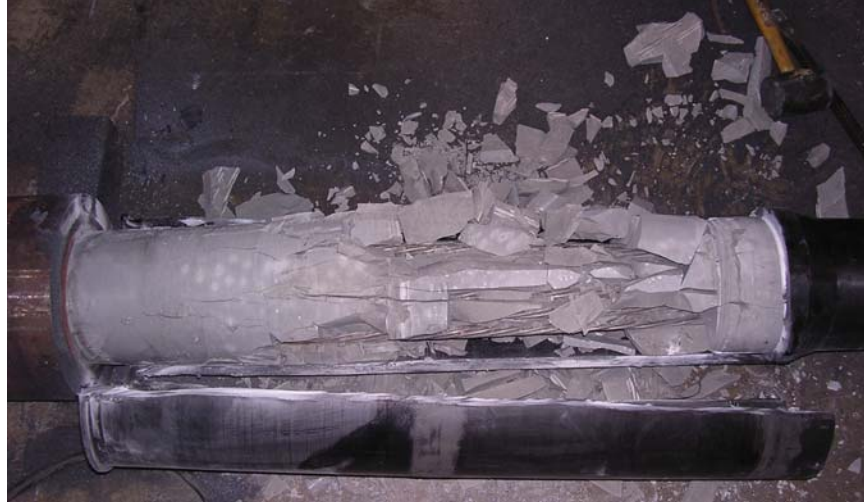
Figure D.147 Condition of Grout near Deck End – Specimen 12

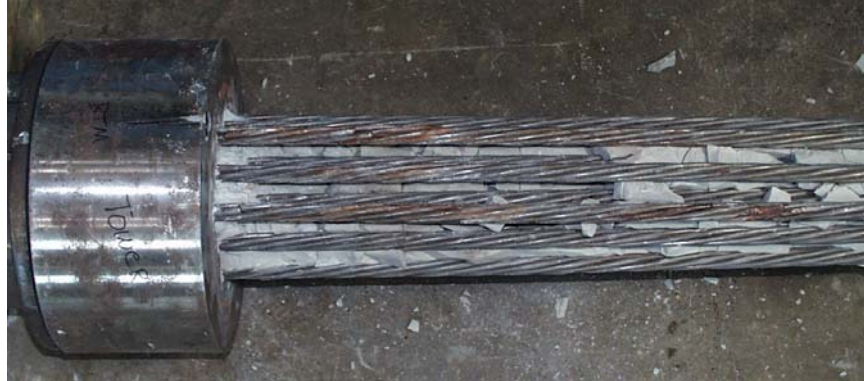
Large amounts of corroded fretting product were observed in the vicinity of the wire breaks near midspan (Figure D.148). The white corrosion product observed in Specimens 6 and 7 was also present on the surface of the strand. Extensive corrosion was also observed on the surface of the strand near both anchor heads (Figure D.149 and Figure D.150). Near the ends of the specimen, the corrosion was not limited to the immediate vicinity of the wire breaks. Evidence of black corrosion was observed in a few locations (Figure D.151), and all the wedges removed from the anchor heads exhibited corrosion on the surface (Figure D.152).

Figure D.149 Corrosion on Surface of Strand near Tower End – Specimen 12

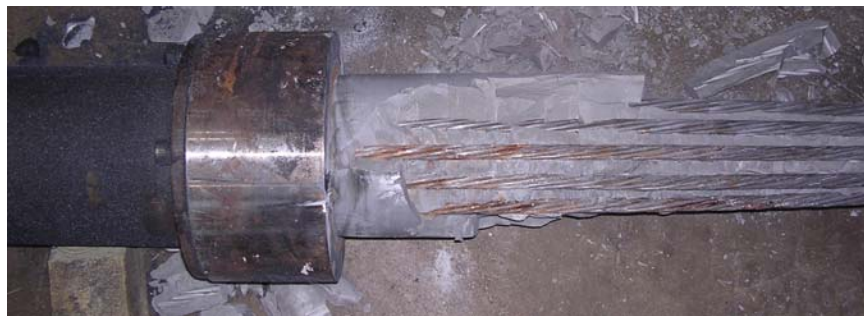
Figure D.150 Corrosion on Surface of Strand near Deck End – Specimen 12

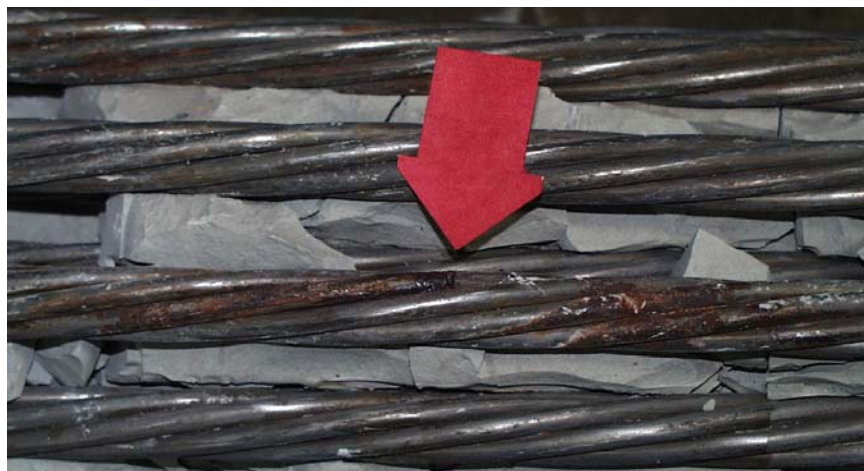
Figure D.151 Black Corrosion on Surface of Strand near Tower End – Specimen 12

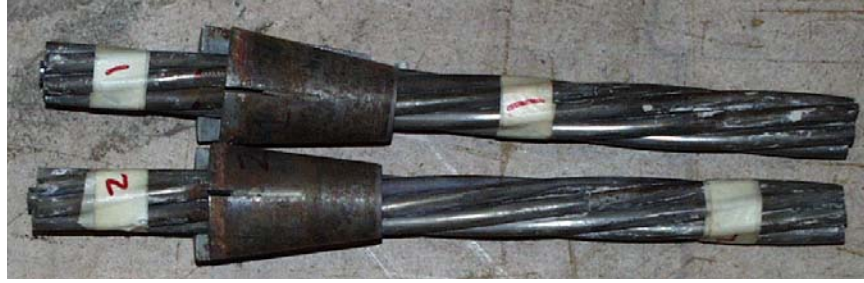
Figure D.152 Corrosion of Wedges at Tower End – Specimen 12

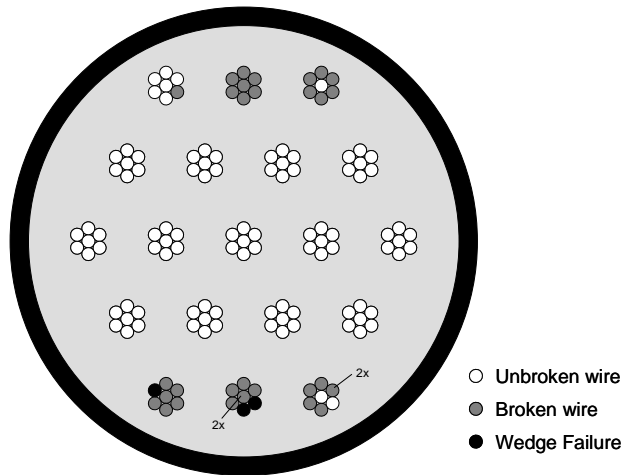
The thirty-five wire breaks at the tower end were distributed among six strands, and all breaks occurred in the top and bottom layers of strand (Figure D.153). Two wires in the bottom layer of strand experienced two wire breaks. Most of the wire breaks were within 12 in. of the inside face of the anchor head (Figure D.154); however, wire 2 in strand 19 fractured more than 15 in. from the face of the anchor head.

Figure D.153 Distribution of Wire Breaks near Tower End – Specimen 12

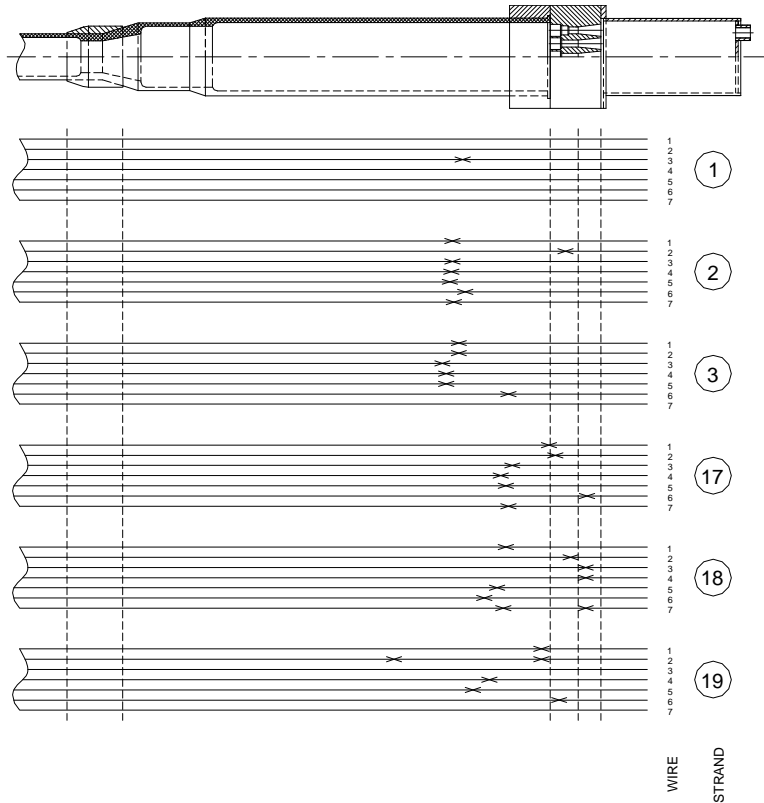
Figure D.154 Location of Wire Breaks near Tower End – Specimen 12

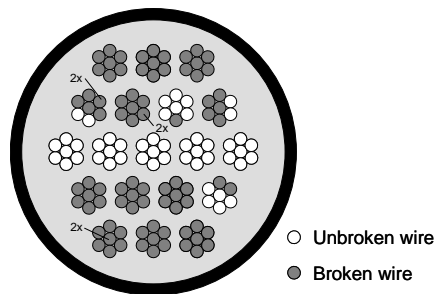
At midspan, the eighty-six wire breaks were distributed among fourteen strands (Figure D.155). Three wires experienced two wire breaks. Only the five strands in the middle row survived the fatigue test without a wire break. All wire breaks occurred within ± 8 in. of the centerline of the hydraulic actuator (Figure D.156 and Figure D.157).

Figure D.155 Distribution of Wire Breaks near Midspan – Specimen 12

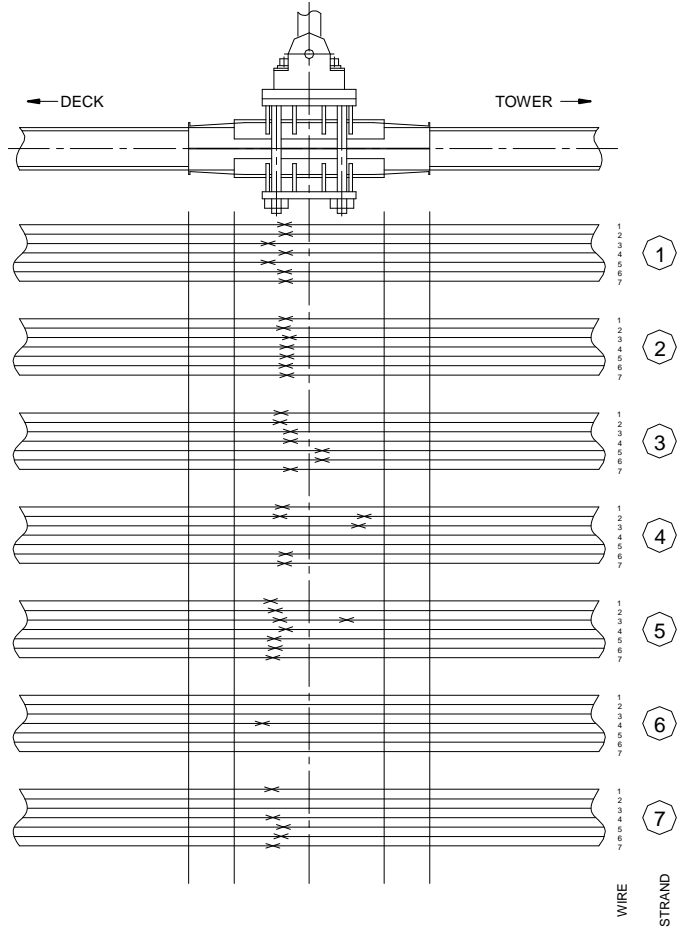
Figure D.156 Location of Wire Breaks near Midspan – Specimen 12 (Part 1)

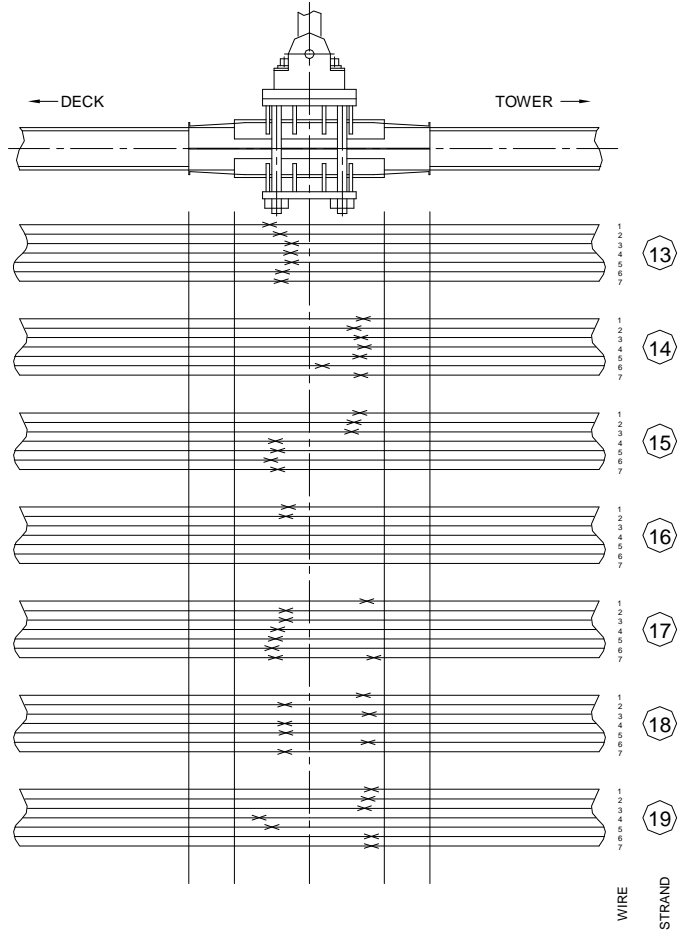
Figure D.157 Location of Wire Breaks near Midspan – Specimen 12 (Part 1)

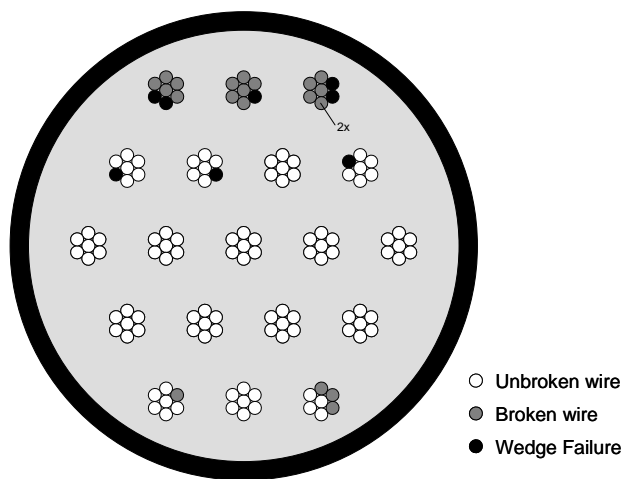
The twenty-nine wire breaks near the deck end were distributed among eight strands (Figure D.158). The damage was concentrated near the top of the cross section. All wires fractured in the three strands along the top row and one wire experienced two wire breaks. All wires in strands 1 and 2 fractured within the anchor head (Figure D.159).

Figure D.158 Distribution of Wire Breaks near Deck End – Specimen 12

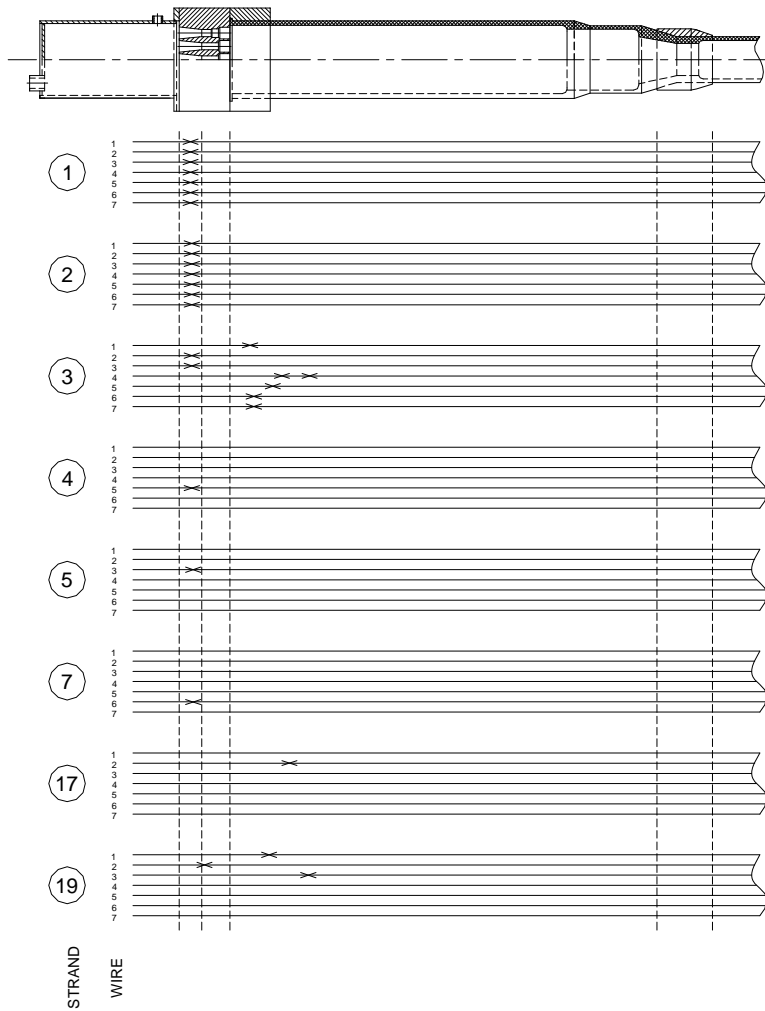
Figure D.159 Location of Wire Breaks near Deck End – Specimen 12

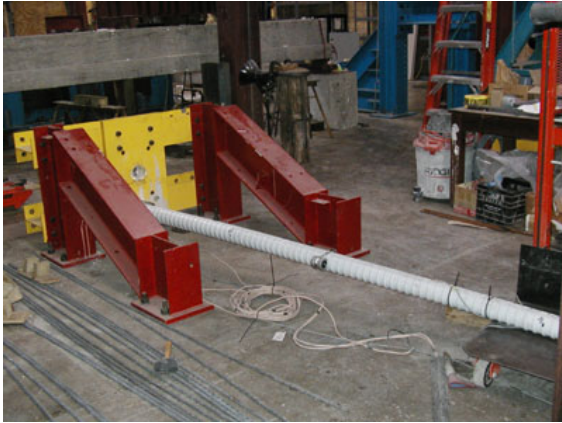
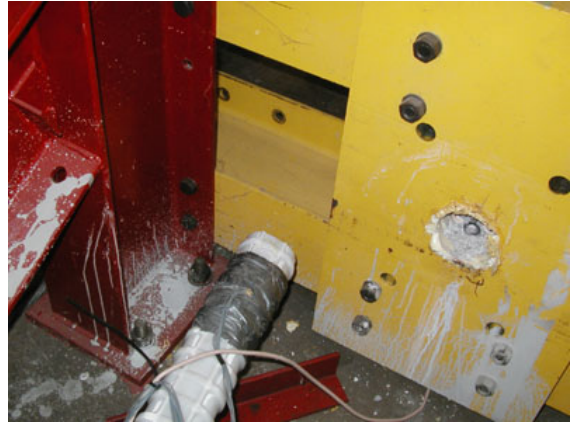
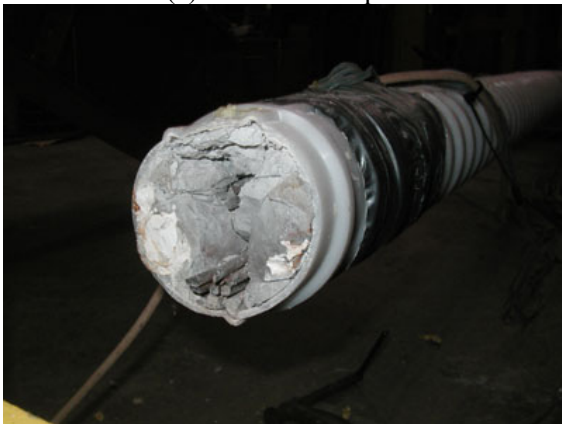
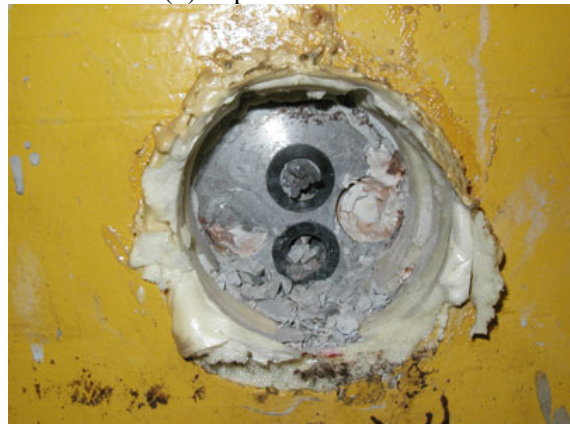
Figure E.6 Collapse of Specimen 1

The fatigue test was terminated after all fourteen wires fractured at the north end of the specimen and the specimen collapsed (Figure E.6). All wires in the top strand failed within 2-in. of the inside face of the anchor head and all wires in the bottom strand failed inside the anchor head (Figure E.7). Sixteen wire breaks were identified during the autopsy. In addition to the fourteen wire breaks near the north anchor head, two adjacent wires fractured near midspan (Figure E.7).

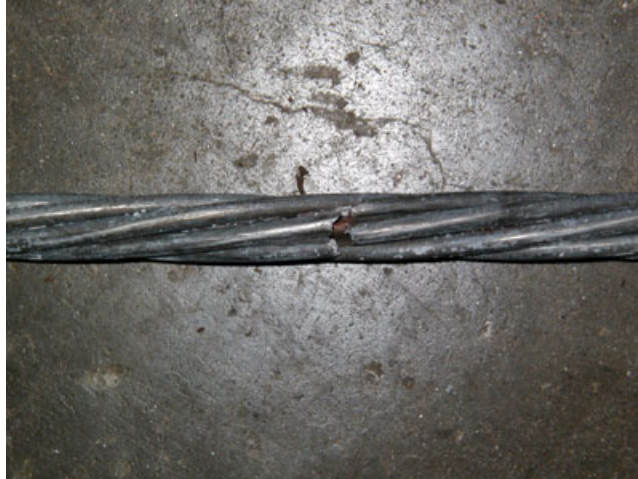
Figure E.8 Wire Breaks near Midspan – Specimen 1

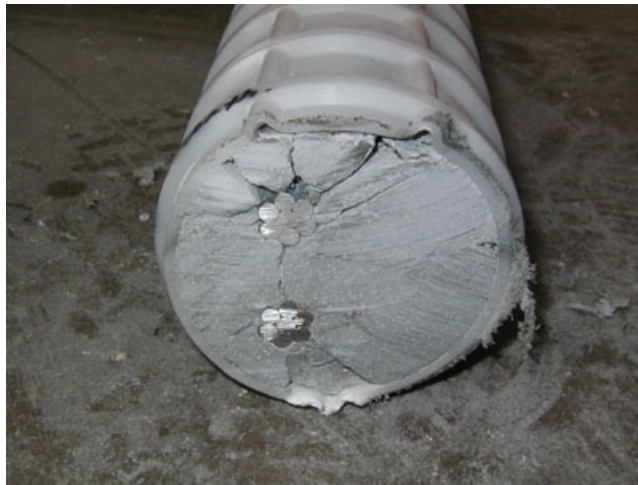
Grout at the north end of the specimen was severely cracked. Grout also cracked vertically at many sections. The crack developed from the top and bottom of the sections and continued through both of strands (Figure E.9).

Figure E.9 Typical Vertical Crack in Grout – Specimen 1

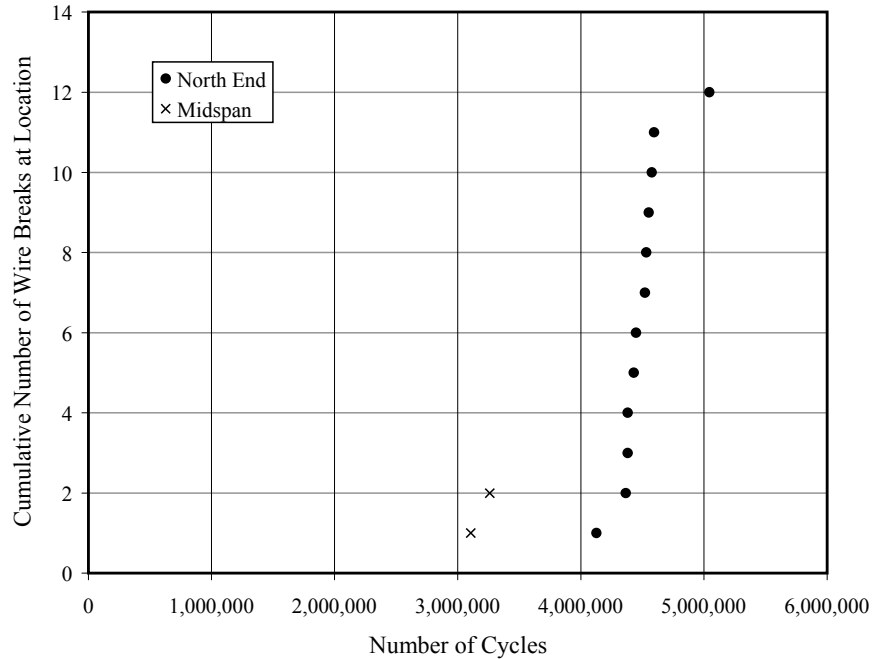
Figure E.10 Wire Breaks Detected from Acoustic Data – Specimen 1

The acoustic data indicated that the two wire breaks at midspan were 2 ft apart. As shown in Figure E.8, the wire breaks were adjacent. The acoustic data indicated that the wire breaks at the north end ranged from 2.5 to 14.5 in. from the inside face of the anchor head, with an average distance of 8.5 in. As shown in Figure E.7, all wire breaks were within 2 in. of the inside face of the anchor head.

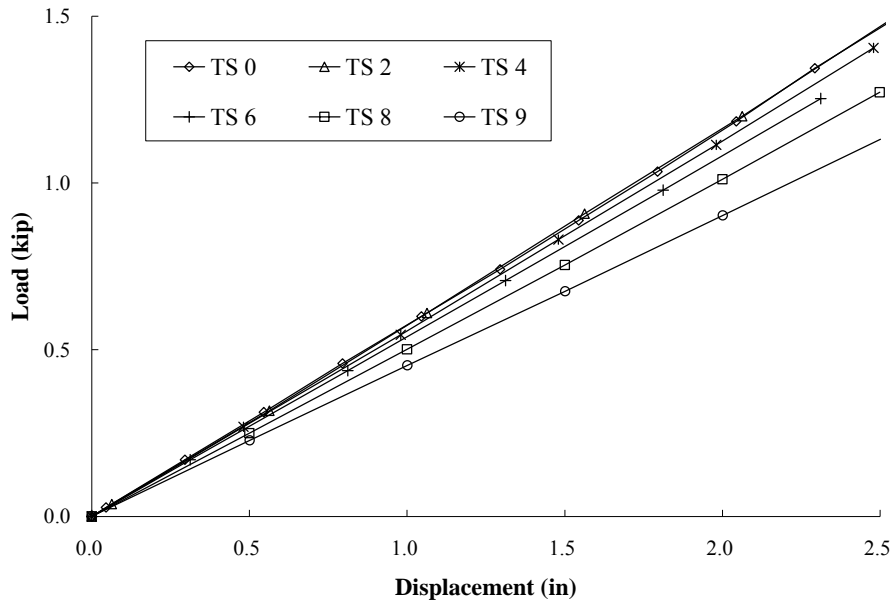
The transverse stiffness measurements for Specimen 2 are shown in Figure E.11 and summarized in Table E.6. The load-displacement relationships exhibited linear trends. The measured transverse stiffness decreased from 0.59 to 0.45 kip/in. from TS 0 to TS 9. The reduction between TS 0 and TS 5 was small, but increased after TS 6. In particular, the measured stiffness decreased from 0.51 to 0.45 kip/in. between TS 8 and TS 9.

Figure E.11 Measured Transverse Stiffness of Specimen 2

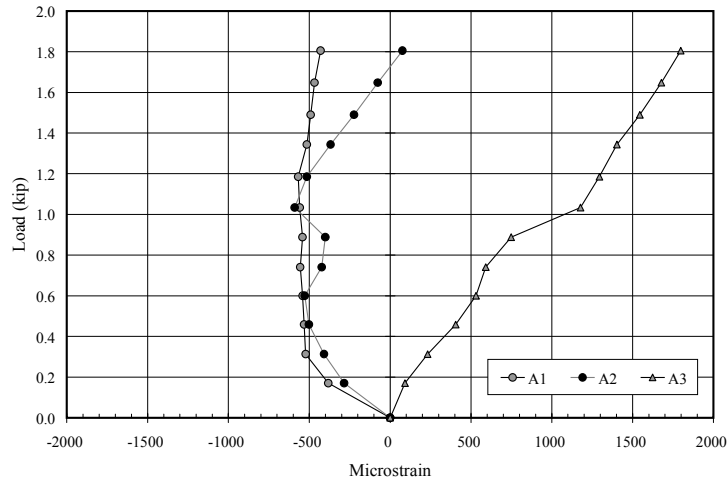
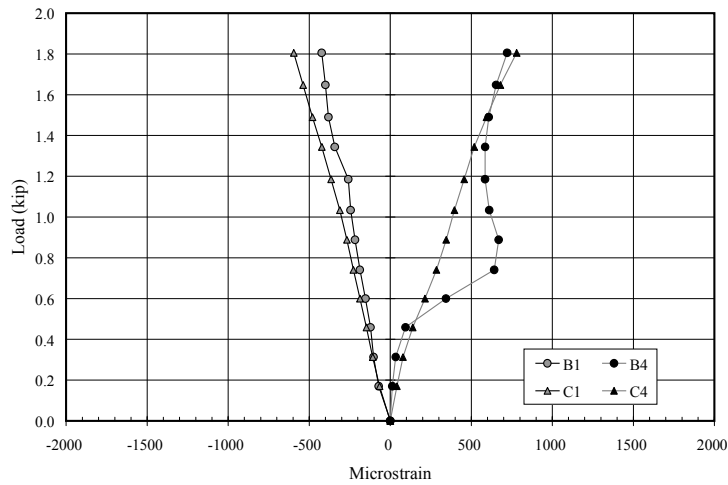
Strain gages closest to the north anchor head (Line A) malfunctioned after the initial test. A maximum strain variation of $1800 \mu\epsilon$ was recorded in gage A3 during this test, which corresponds to a stress of 56 ksi in the wire. The maximum strain variations in Lines B and C decreased as the number of fatigue cycles increased.

Figure E.12 Measured Strains – Test S 0 – Specimen 2

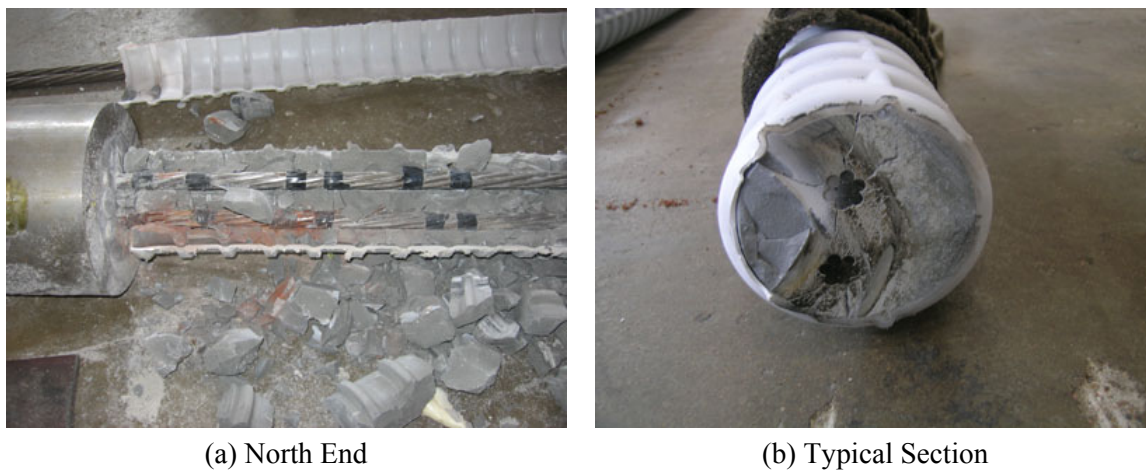
Grout near the north end was severely cracked. Vertical cracks were also identified along the entire length as shown in Figure E.16.

Figure E.16 Condition of Grout – Specimen 2

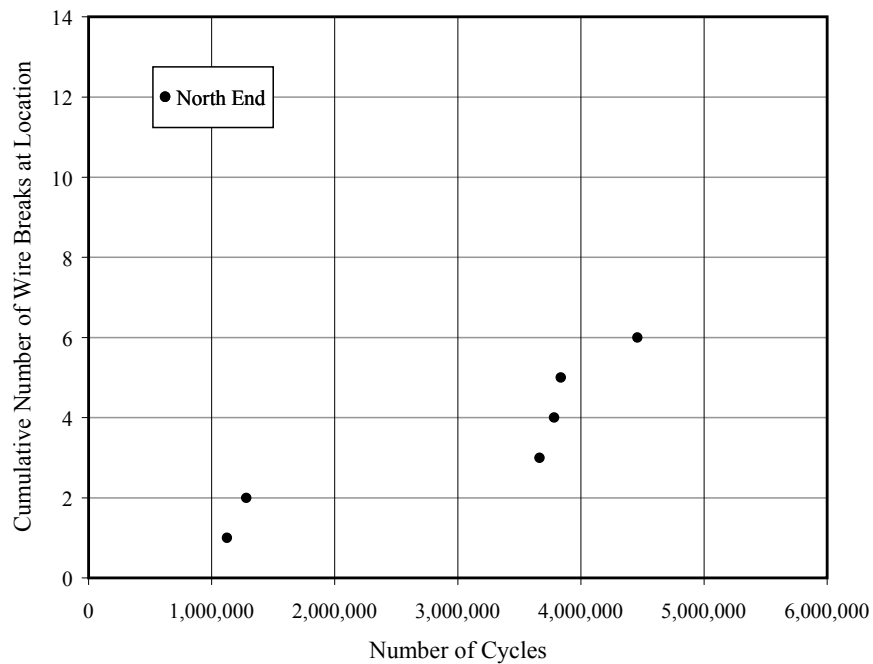
Figure E.17 Wire Breaks Detected from Acoustic Data – Specimen 2

The acoustic data indicated that the wire breaks at the north end ranged from 10 to 26 in. from the inside face of the anchor head, with an average distance of 18.5 in. As shown in Figure E.15, all wire breaks were within 8 in. of the inside face of the anchor head.

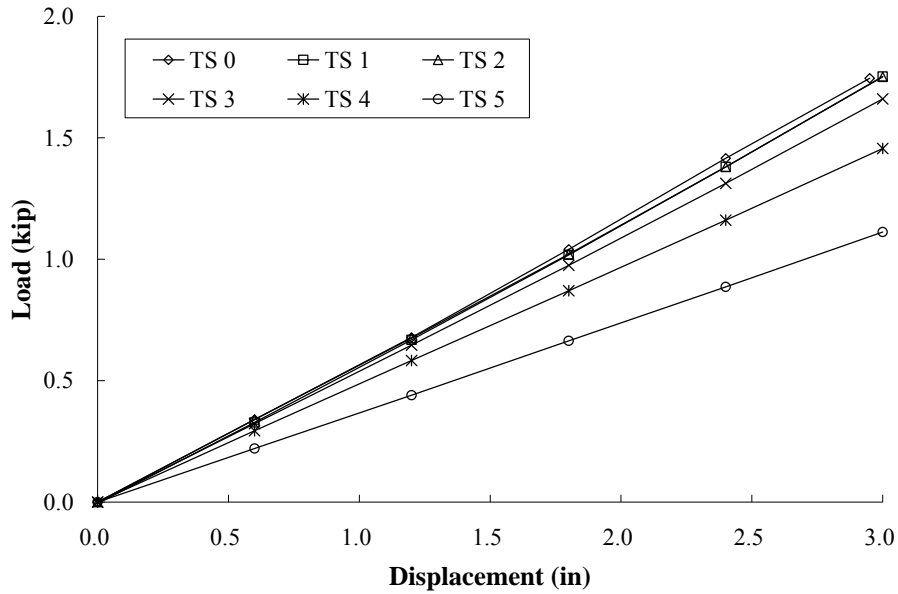
Figure E.18 Measured Transverse Stiffness for Specimen 3

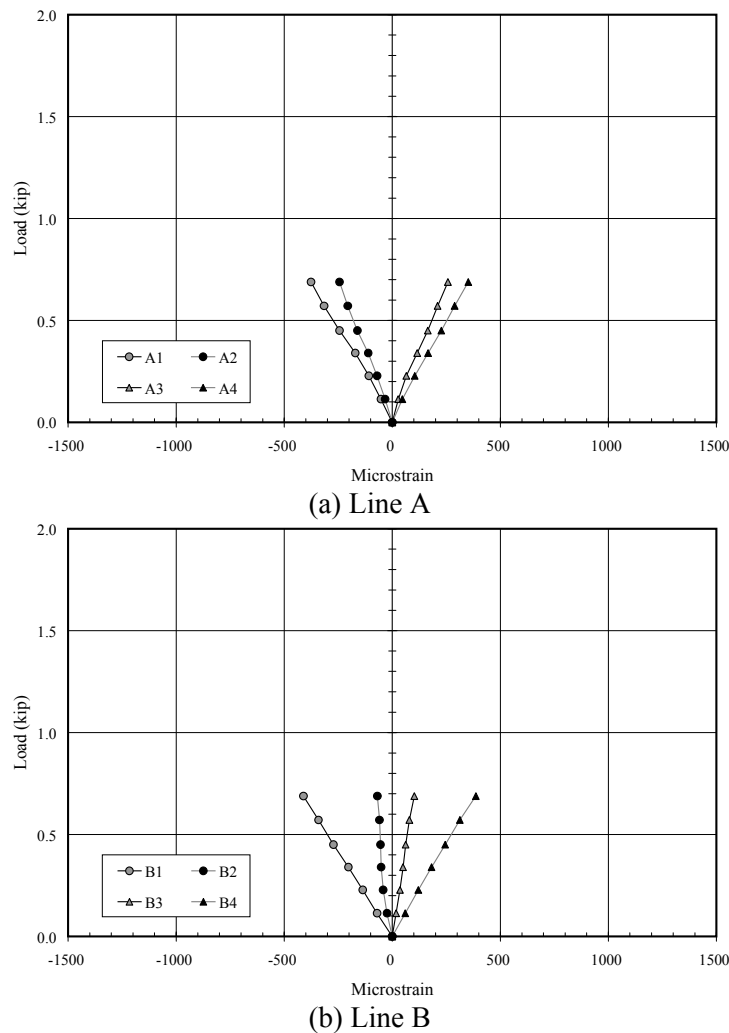
The measured strains from the two lines of gages nearest the north anchor head (Lines A and B) are plotted in Figure E.19 for Test S 0-2, in Figure E.20 for Test S 0-4, and in Figure E.21 for Test S 0-6. The strain increased linearly with increasing load in Test S 0-2; however, the maximum strains recorded along Line B exceeded the maximum strains recorded along Line A.

Figure E.19 Measured Strains – Test S 0-2 – Specimen 3

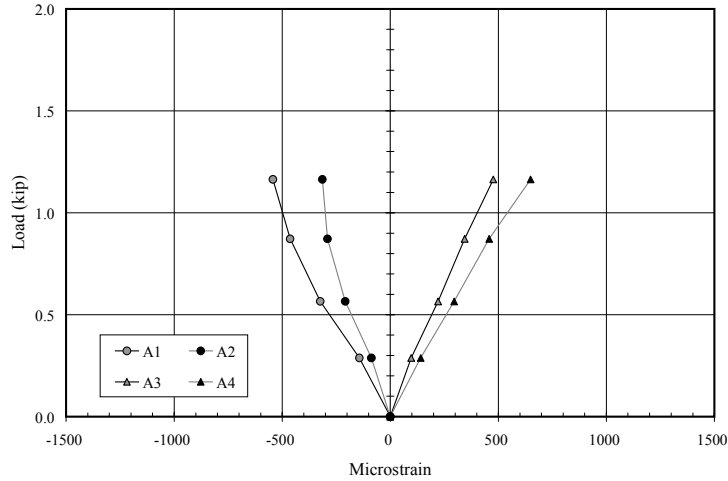
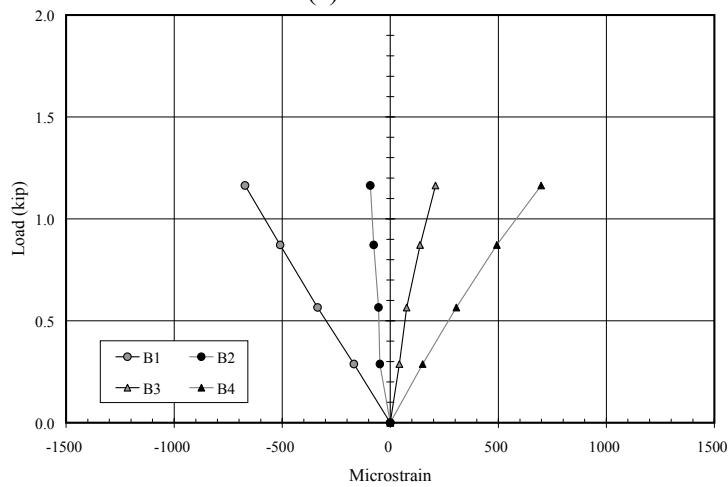
Nonlinear response was observed along Line A during Test S 0-4 (Figure E.20). The strains along Line B increased linearly with increasing load. Again, the maximum strains recorded along Line B exceeded the maximum strains recorded along Line A.

Figure E.20 Measured Strains – Test S 0-4 – Specimen 3

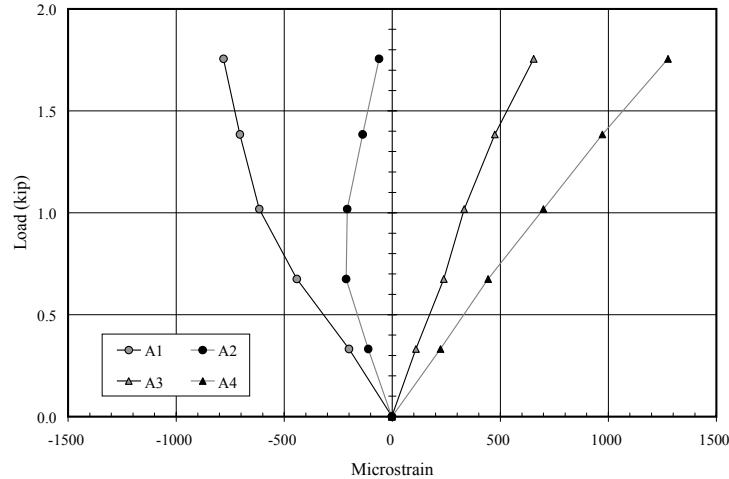
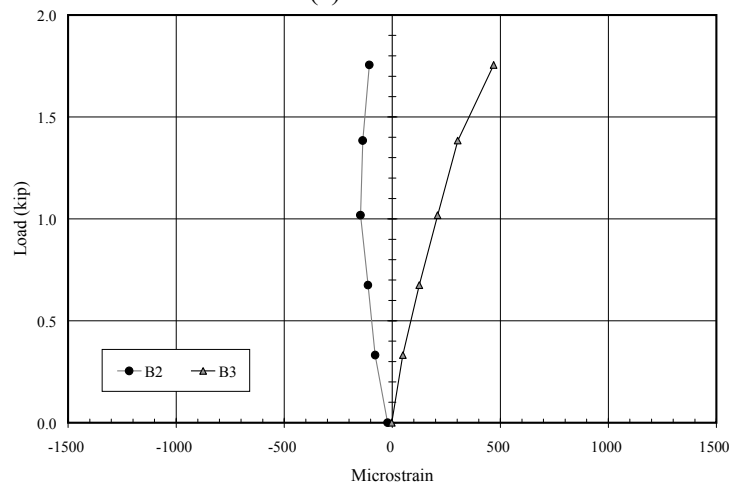
By Test S 0-6 (Figure E.21), two of the strain gages along Line B had malfunctioned, and all working gages along Lines A and B exhibited nonlinear response. A maximum strain variation of $1280 \mu\epsilon$ was recorded in gage A4 during Test S 0-6, which corresponds to a stress of 40 ksi in the wire.

The strain data suggest that cracking of the grout, which would be expected to increase during the initial set of measurements, influences the strains in the strand. By Test S 1, five of the eight strain gages along Lines A and B had malfunctioned.

Figure E.21 Measured Strains – Test S 0-6 – Specimen 3

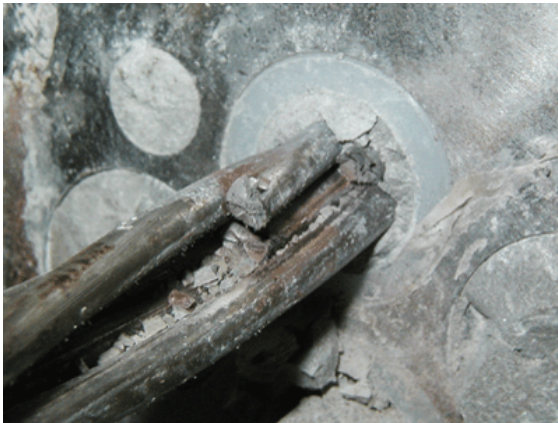
In the bottom strand, six wires fractured inside the anchor head. Three of the outer wires in the bottom strand fractured outside the anchor head. Two of these outer wires sustained two wire breaks – one inside the anchor head and one outside. In the top strand, all three wire breaks occurred within 1 in. of the inside face of the anchor head.

(a) Wire Breaks in Top Strand

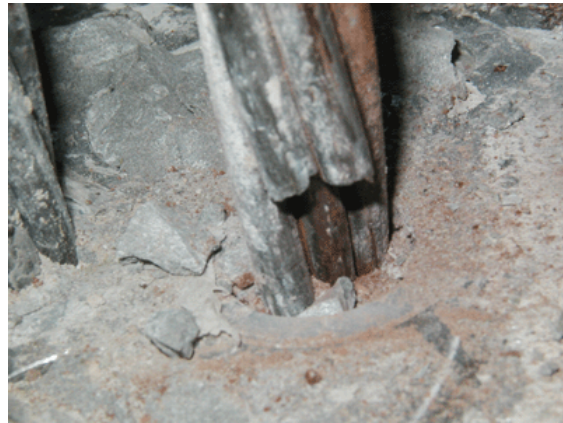
(b) Wire Breaks in Bottom Strand outside Anchor Head

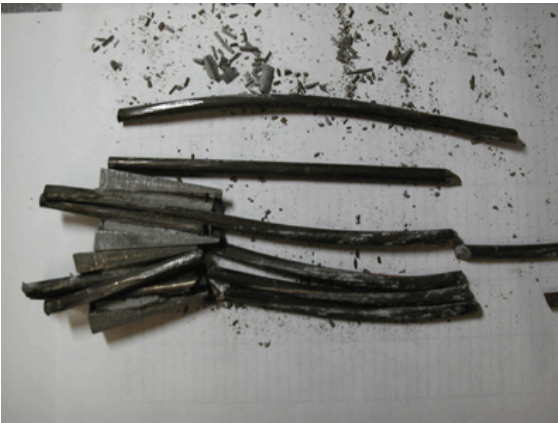
(c) Wire Breaks in Bottom Strand inside Anchor Head

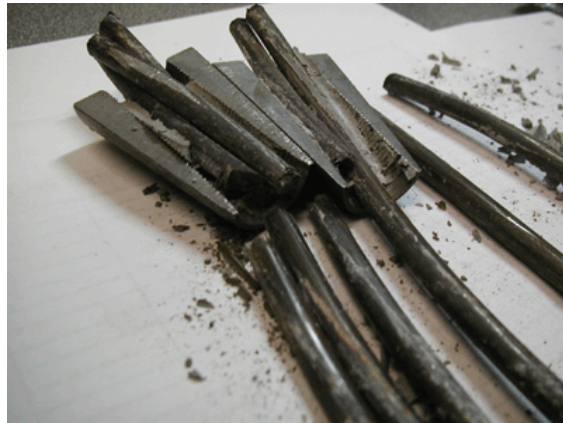
(d) Four Wire Fractures in Bottom Strand at Wedges

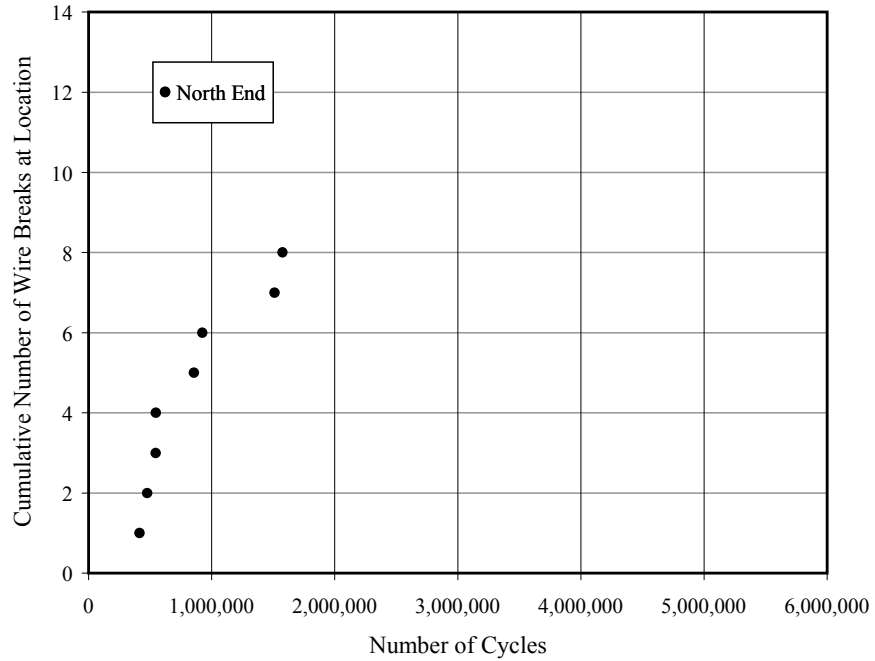
Figure E.24 Wire Breaks Detected from Acoustic Data – Specimen 3

The acoustic data indicated that the wire breaks at the north end ranged from 15 to 37 in. from the inside face of the anchor head, with an average distance of 17.5 in. As shown in Figure E.22, all wire breaks were within 1 in. of the inside face of the anchor head, and half of the breaks occurred within the anchor head.
