**STUDIES ON DAMAGE AND CORROSION PERFORMANCE OF
FABRICATED EPOXY-COATED REINFORCEMENT**

Research Report 1265-1

Structural Integrity of Epoxy-coated Bars
Research Project 3-5-91/3-1265

January 1993

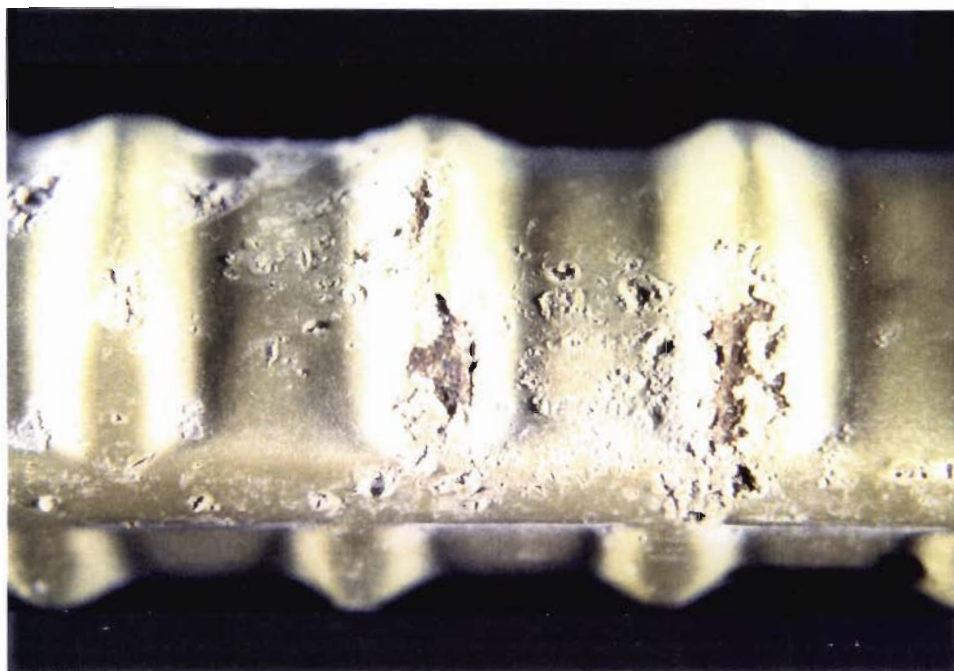
(a) A bar with parallel deformations.

4.4.4 Slab Specimen With #8 Bars. Damaged spots on #8 bars were larger and more frequent than those on #4 bars. The largest spot was a little less than 1/2 in. x 1/4 in. (0.12 in.²) which occurred on one side bar with cross deformations. The side bars, in general, had the worst damage, especially near the ends. Figure 4.14 shows examples of the damage found on these side bars.

Figure 4.14 Damage due to vibration on #8 bars – slab specimen.
