**CORROSION PERFORMANCE OF EPOXY-COATED
REINFORCEMENT-BEAM TESTS**

Research Report No. 1265-4

STRUCTURAL INTEGRITY OF EPOXY-COATED BARS

Texas Department of Transportation

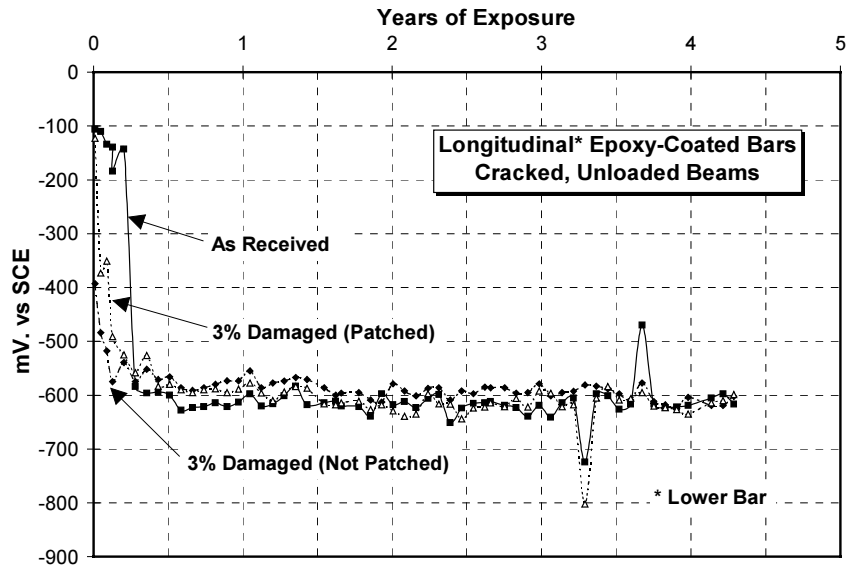
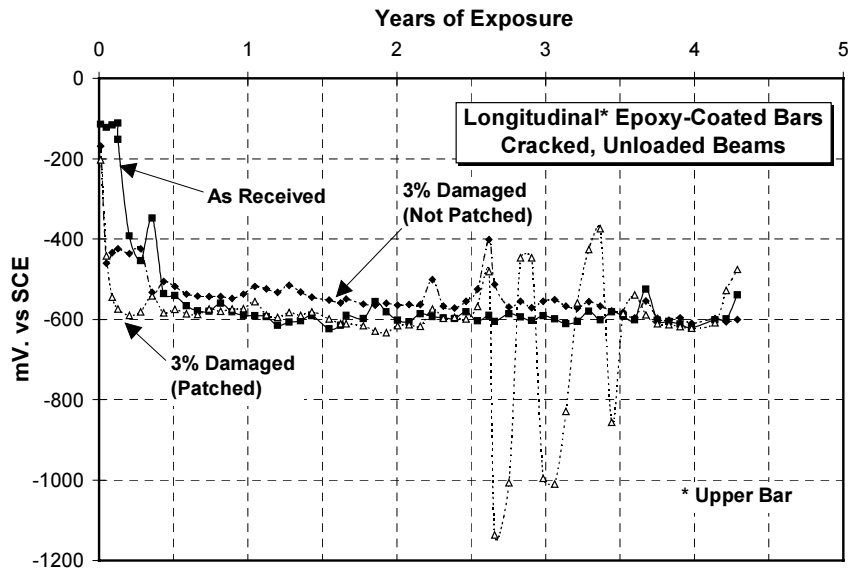
Figure 2.8 Comparison of average corrosion potentials (wetted region) of longitudinal bars in cracked, unloaded beams with different levels of damage.

- There was little difference in behavior of cracked beams with different damaged conditions. The corrosion potentials were different during the first three to six months of exposure, but thereafter, the potentials for different coating conditions evened out and became similar (Figure 2.8).

- There was no clear difference in the corrosion potentials between unpatched and patched damaged bars (cracked beams). In one case (cracked unloaded beams), potentials for the upper bar with patched 3% damage (beam B14) decreased faster to the -600 mV SCE region and stayed slightly more negative than potentials for the upper bar with 3% damage without repair (beam B10). See Figure 2.8(b).

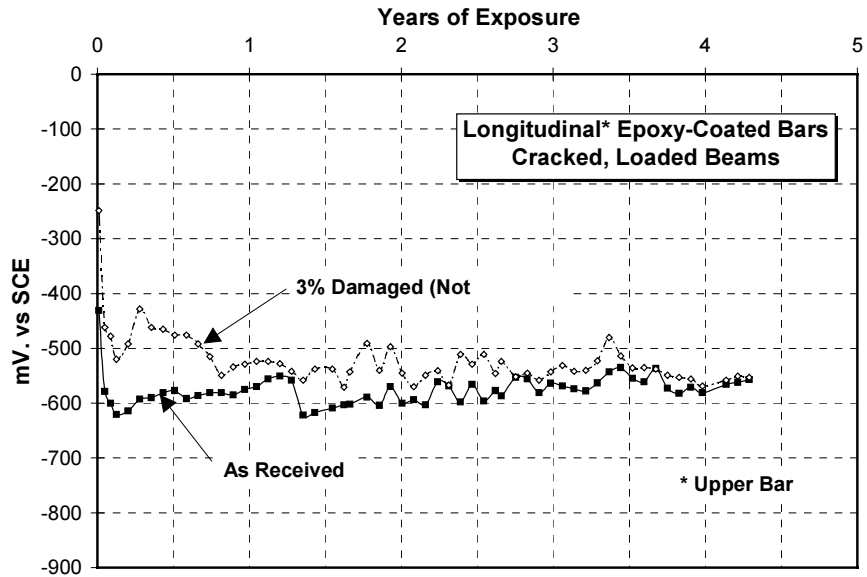
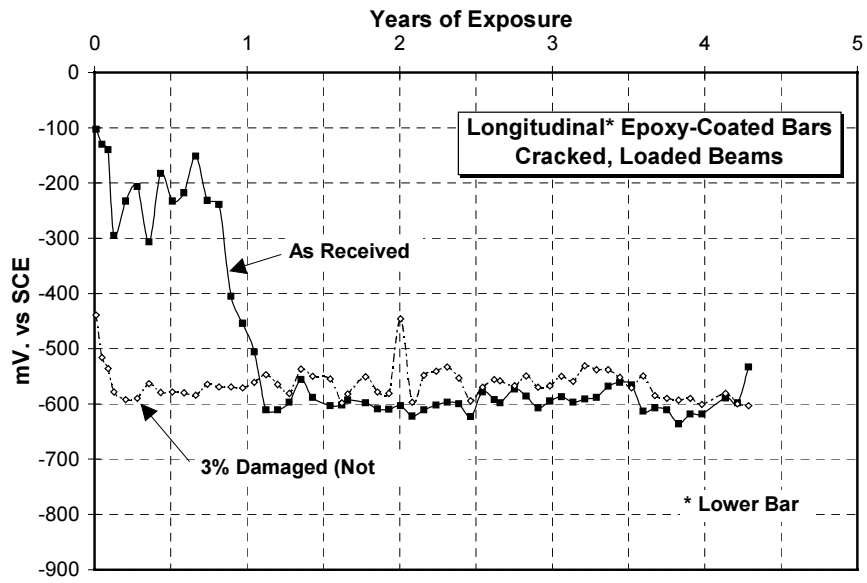
Figure 2.9 Comparison of average corrosion potentials (wetted region) of longitudinal bars in cracked, loaded beams with different levels of damage.

- Overall, coated bars with different damage conditions experienced very similar corrosion potentials over the long term. Differences in coating condition were evident for uncracked beams from 1 to 3 years of exposure; thereafter, corrosion potentials became similar. Bars in an as-received condition generally had lower negative potentials than bars with 3% damage, both patched and unpatched [Figures 2.9(b), 2.10].

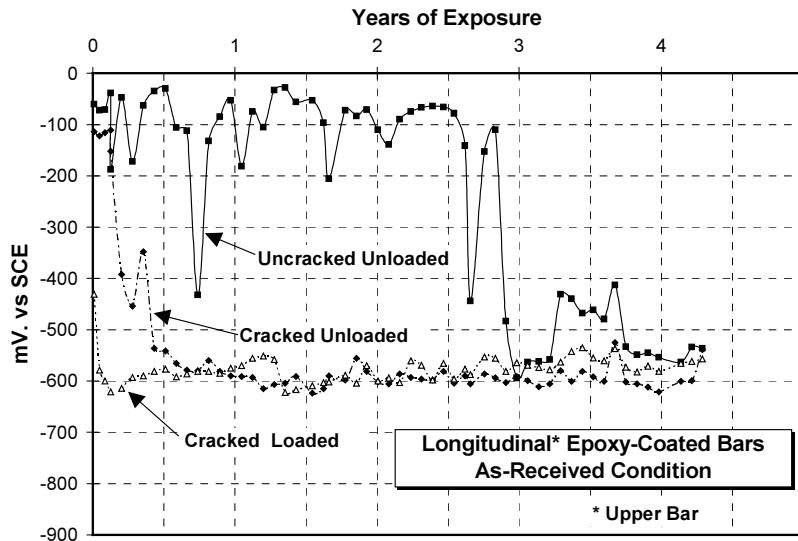
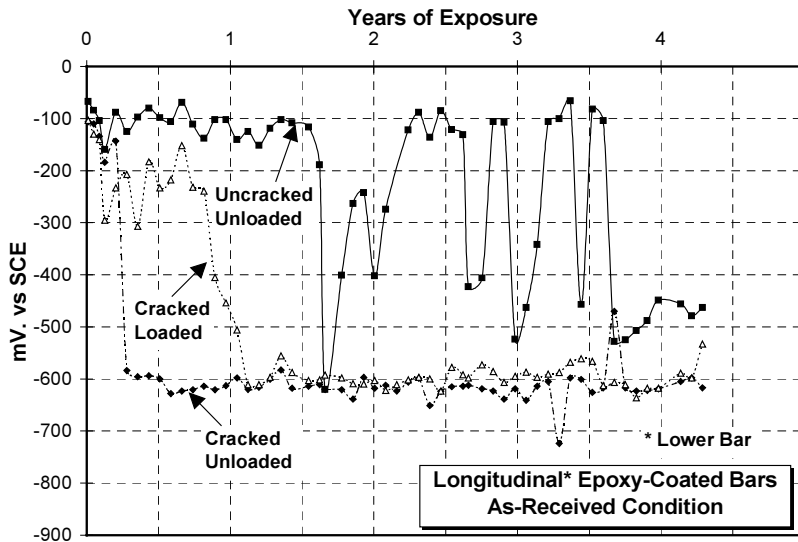
Figure 2.11 Comparison of average corrosion potentials (wetted region) of longitudinal bars with as-received condition with different loading conditions.

- *Bars in As-received Condition.* Uncracked beam had lower negative potentials than cracked beams for about 3 to 3.5 years. Thereafter, corrosion potentials of the uncracked beam suddenly dropped to the same level as bars in cracked beams (Figure 2.11a).

- Loaded and unloaded beams showed only minor differences regardless of coating condition (Figures 2.11, 2.12). In general, bar potentials for cracked, unloaded beams decreased to -500 to -600 mV SCE within 6 or less months, and potentials for cracked loaded beams dropped to the same level within 3 months.

-500 mV SCE range and the -100 mV SCE region [Figure 2.11(b)]. This may be the result of poor electrical connections to the bar or some other instrumentation problem.

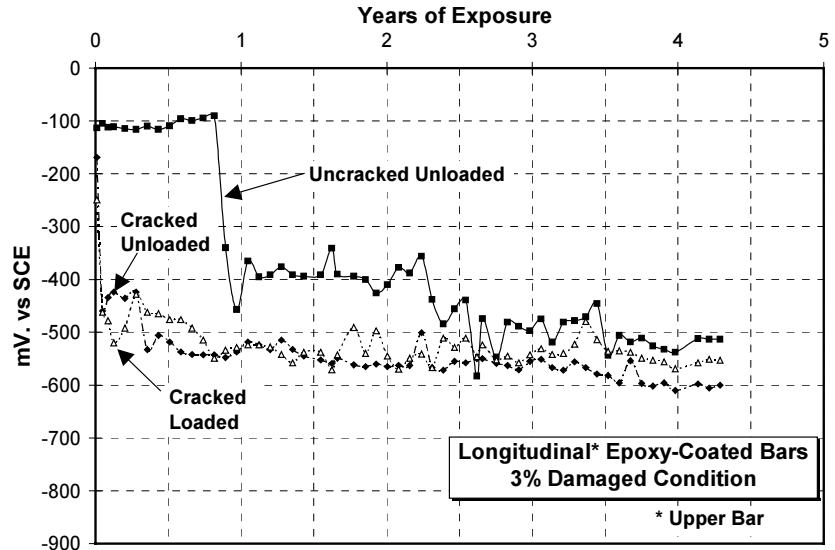
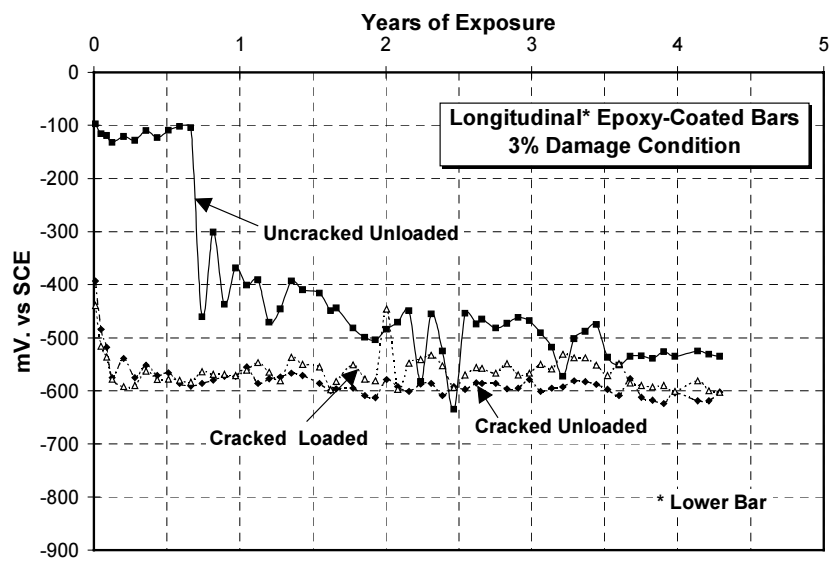
Figure 2.12 Comparison of average corrosion potentials (wetted region) of longitudinal bars with 3% damage to coating and different loading conditions.

- *Bars with 3% Unrepaired Damage.* Uncracked beam had lower negative potentials than cracked beams for about 8 months to 1 year. Potentials for the uncracked beam experienced a large drop at about 1 year of exposure, and then gradually decreased to levels similar to cracked beams at about 3 years. Thereafter, potentials between cracked and uncracked beams remained similar (Figure 2.12b).

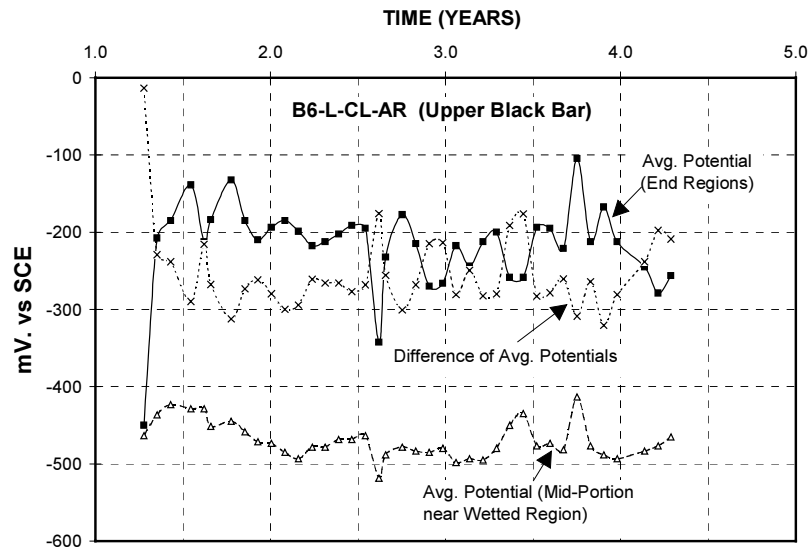
Figure 2.13 Corrosion potentials at different regions along upper, uncoated bar in beam B6.

- For most beams, average black bar potentials in the inner zone (closer to wet zone) were more negative (typically in the -500 mV SCE region) than those at the outer regions (farther away from wet zone), which were typically in the -200 mV to -300 mV SCE range, as seen in Figure 2.13.

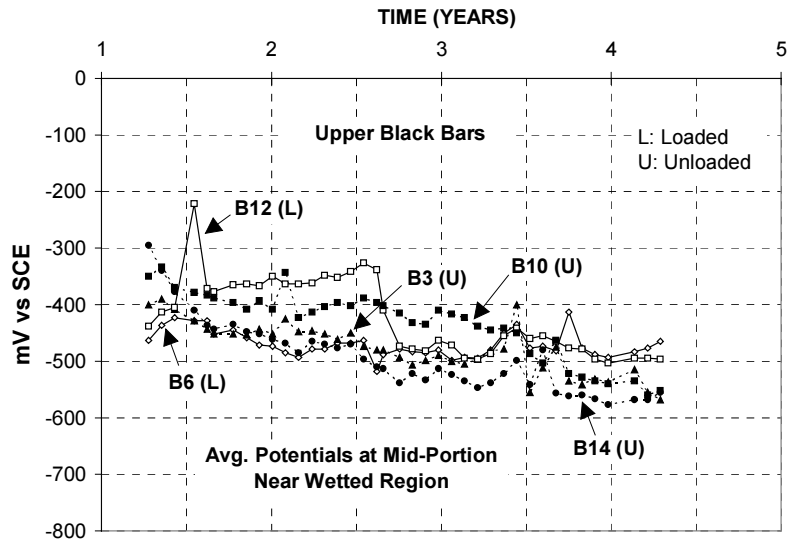
Figure 2.14 Corrosion potentials for upper, uncoated bars in cracked beams with different loading conditions.

- Corrosion potentials in most cracked beams, loaded or unloaded, tended to become more negative with time and approached the potentials of the nearest longitudinal coated bar after 4.3 years of exposure (Figure 2.14). Potentials in cracked, loaded beam B12 were highly negative from the beginning.
- The upper black bar potentials in beam B1 (uncracked, unloaded) dropped from -200 mV to -500 mV SCE after about 6 months of exposure and the readings remained more negative than upper coated bar potentials (coating in as-received condition) up to 3 years (-520 mV vs. -70 mV SCE, approximately). However, at that time, upper coated bar potentials decreased rapidly and were similar to the upper black bar potentials for the remainder of the exposure period (Figure 2.15).

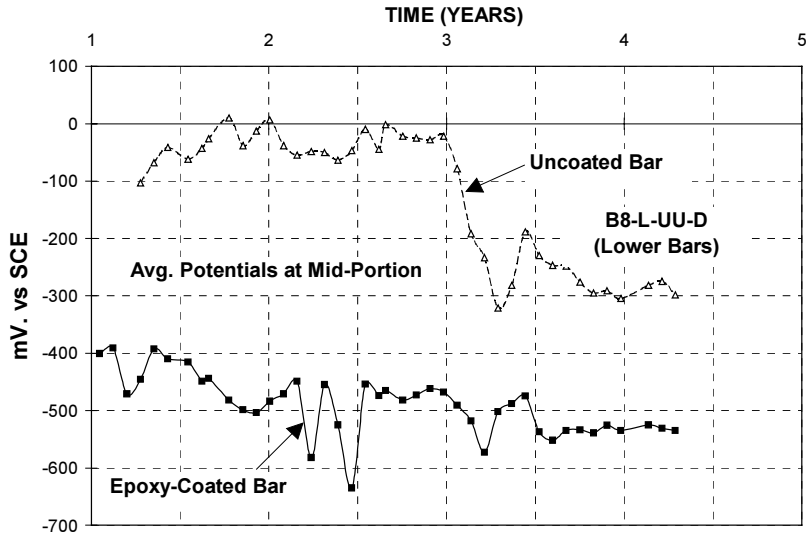
Figure 2.16 Corrosion potentials for lower, coated and uncoated bars, in uncracked beam B8.

- For beam B8 (uncracked, unloaded with 3% damage to coating), black bar potentials were less negative than coated bar potentials throughout the exposure period (Figure 2.16).

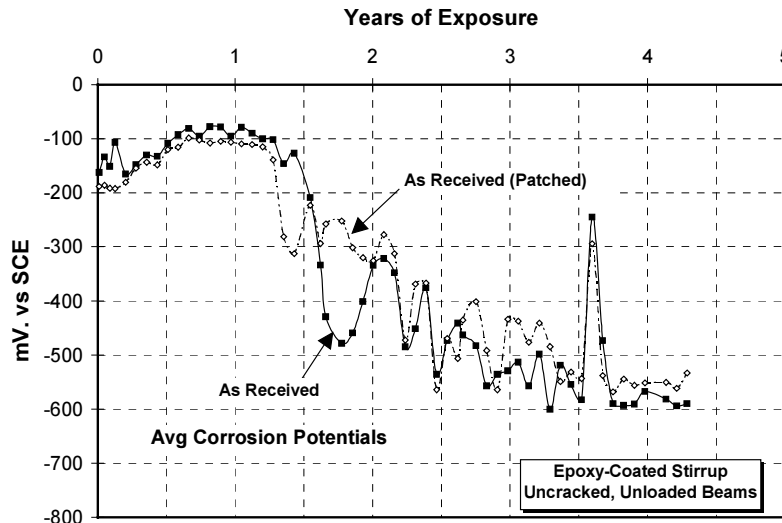
Figure 2.17 Comparison of potentials of stirrups in uncracked beams with different coating conditions.

- In uncracked beams, stirrups with coating in the as-received condition, patched or unpatched, exhibited very similar behavior. Corrosion potentials were in the -200 mV SCE region up to 1.5 years of exposure and, subsequently, the potentials continuously declined up to the -550 to -600 mV SCE zone (Figure 2.17).

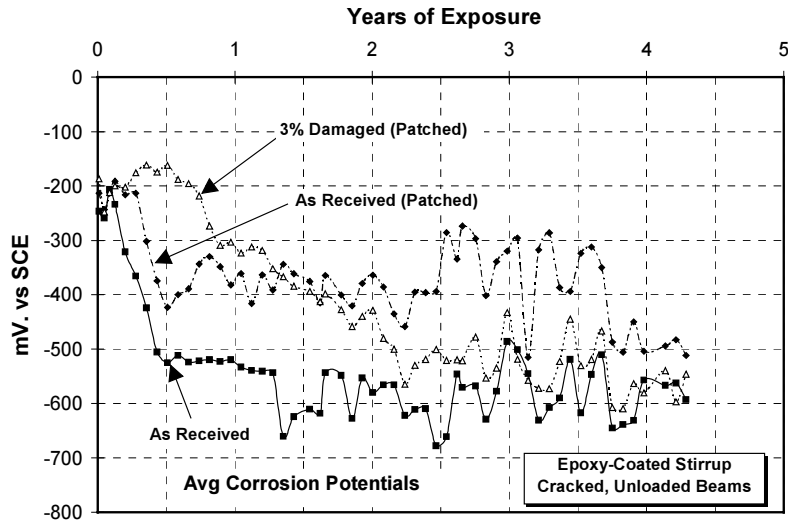
Figure 2.18 Comparison of potentials of stirrups in cracked, unloaded beams with different coating conditions.

- In cracked unloaded beams, a stirrup in the as-received condition without patching exhibited more rapid decline in potential readings than an as-received, patched stirrup and a stirrup with 3% patched damage. However, after about 2 years of exposure, the potentials for the 3% damaged patched stirrup were nearly the same as the potential readings for by the as-received stirrup without repair (Figure 2.18). The as-received and patched stirrup experienced relatively large fluctuations in potential after 2.5 years but seemed to have approached the potentials of the as-received stirrup at the end of exposure (Figure 2.18).

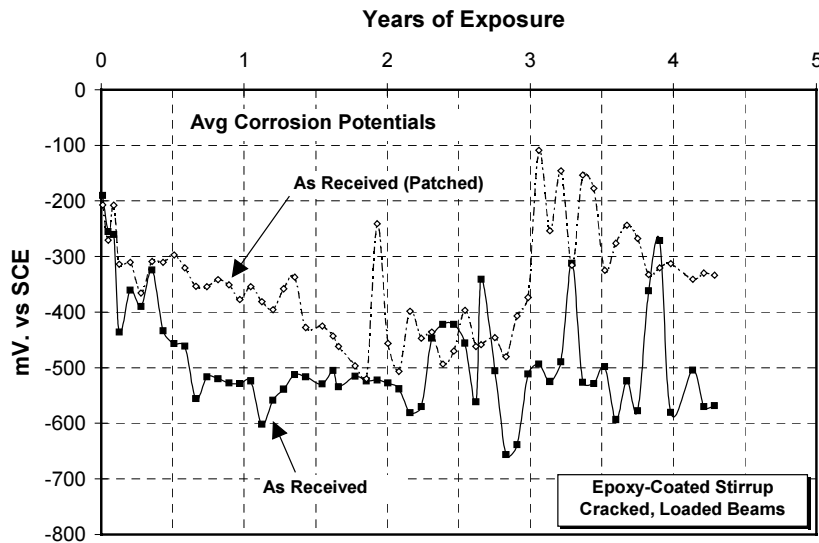
Figure 2.19 Comparison of potentials of stirrups in cracked, loaded beams with different coating conditions.

- In cracked loaded beams, as-received and patched stirrup exhibited less negative potentials than those of an as-received stirrup did without repair throughout the exposure period. As can be seen in Figure 2.19, both stirrups experienced large fluctuations in readings in the last 2.3 years of exposure.

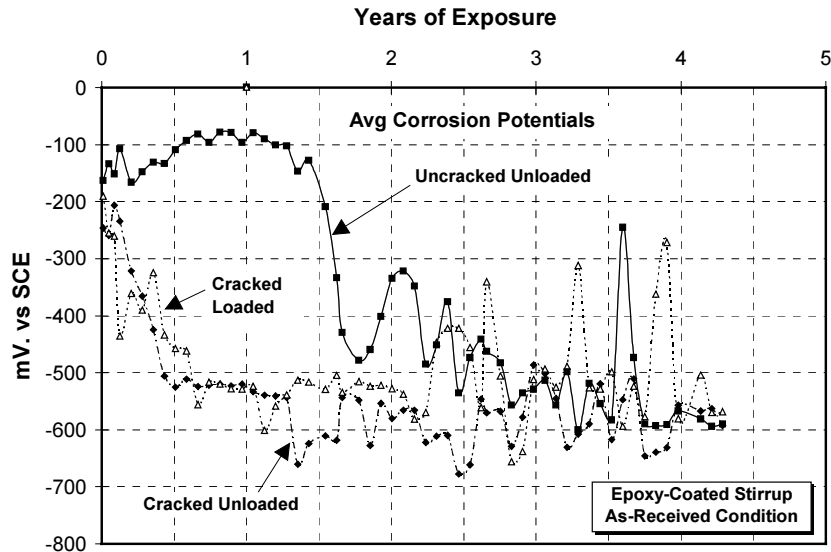
Figure 2.20 Comparison of potentials of stirrups in as-received condition and different loading conditions.

- Uncracked beams stayed in the low negative potential region for about 1 to 1.5 years of exposure. Thereafter, corrosion potentials declined continuously to values around -600 mV SCE. The behavior between cracked and uncracked beams was similar after about 2.5 years of exposure (Figure 2.20). In one case (beams with as-received and patched coated bars), potentials for uncracked beams became more negative than those of cracked beams after 2.5 years of exposure (Figure 2.21).
- There was no distinctive performance between cracked loaded and cracked unloaded beams regardless of coating condition (Figure 2.20).

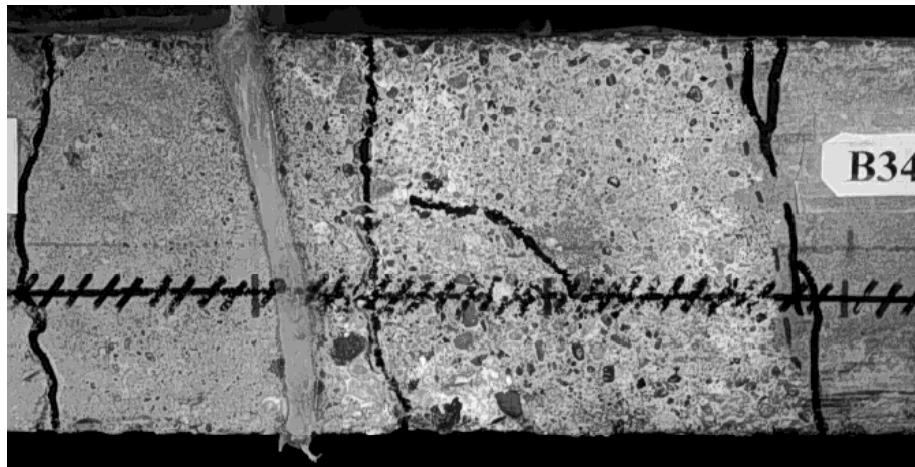
Concrete surfaces deteriorated and scaled within the wet zone and neighboring regions outside the wet zone of all beams (Figure 2.30). Salt crystals accumulated and were visible on scaled surfaces. Salt crystals could not be removed with a putty knife. Extent of concrete scaling outside the wet zone was more extensive and severe at the bottom surfaces in the exposure position. Degree of scaling ranged from light to severe. Concrete surfaces away from wet areas remained in good to excellent condition in all beams.

Figure 2.30 Concrete scaling and deterioration outside wetted region (front surface as in exposure).

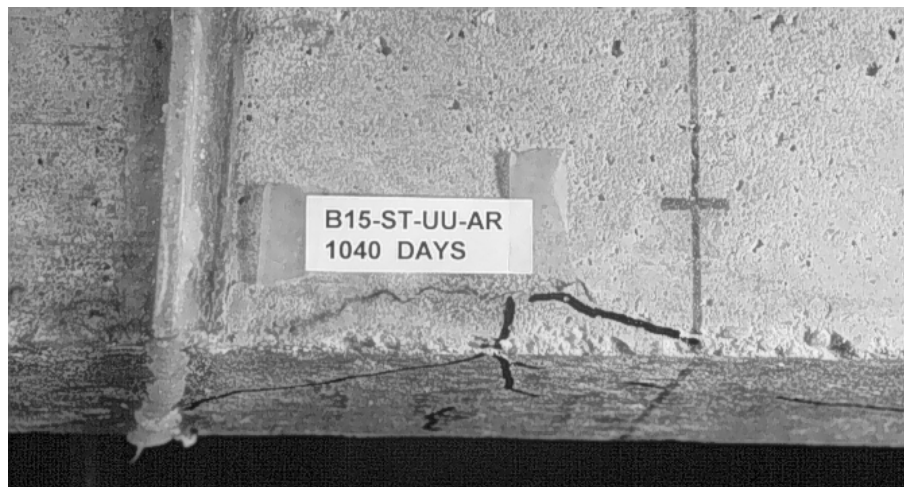
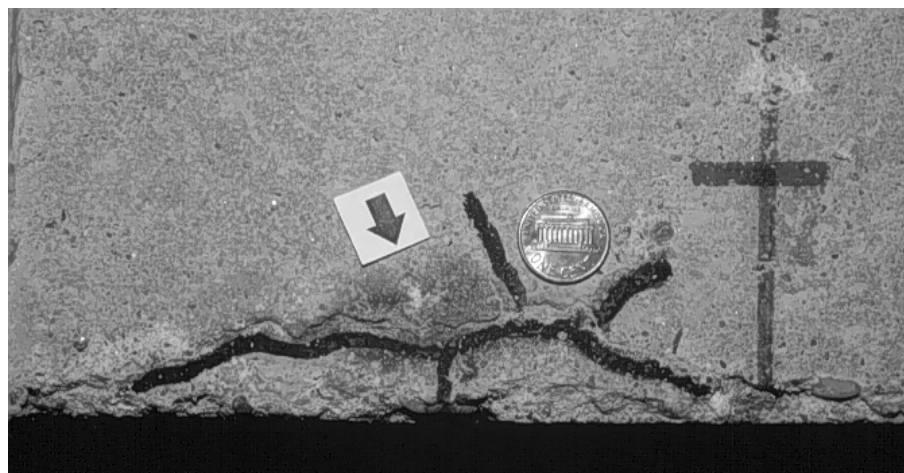
An apparent corrosion-induced crack was detected on the top surface of the beam, within the wet zone, to the left of midspan (Figure 2.34). The crack was detected at 1.5 years of exposure and ran parallel to the beam longitudinal axis and close (2cm) to the beam edge. The crack had a width of 0.15mm. Brownish staining was observed around the crack. At 1.9 years, a build-up of rust was observed along the crack. A crack perpendicular to the first one extended towards and around the edge of the beam (crack width was 0.15mm). At 2.1 years, additional rust was evident and the initial crack widened to 0.4mm. At 2.2 years, the crack extended and rust staining increased. More rust products and staining accumulated on the top surface after 2.5 years (Figure 2.34). Overall, the size of the rust spot increased from about 7cm² at 1.5 years to 11cm² at 2.8 years. Rust staining around cracking on the top surface stabilized at the end of 3 years and was less prominent at the end of 4.3 years.

Figure 2.34 Crack with rust exudation on top surface of beam B15.

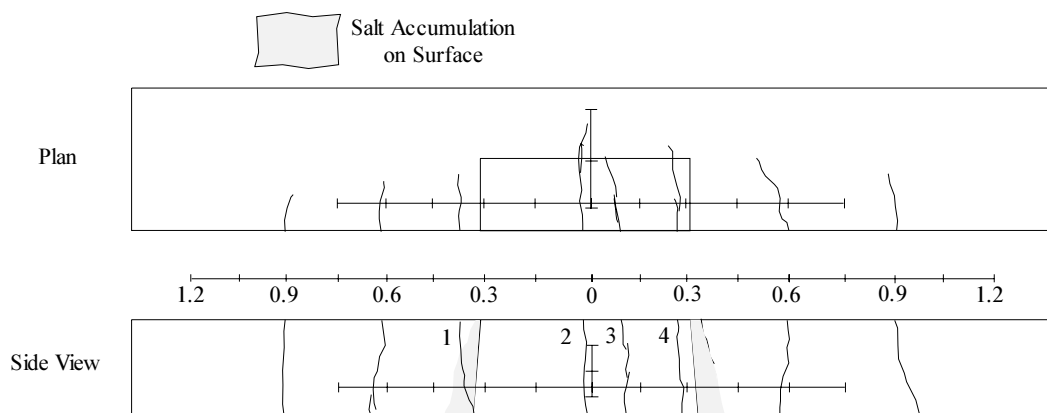
Figure 2.41 Surface condition of beam B29 (Group III) after one year of exposure showing monitored cracks.

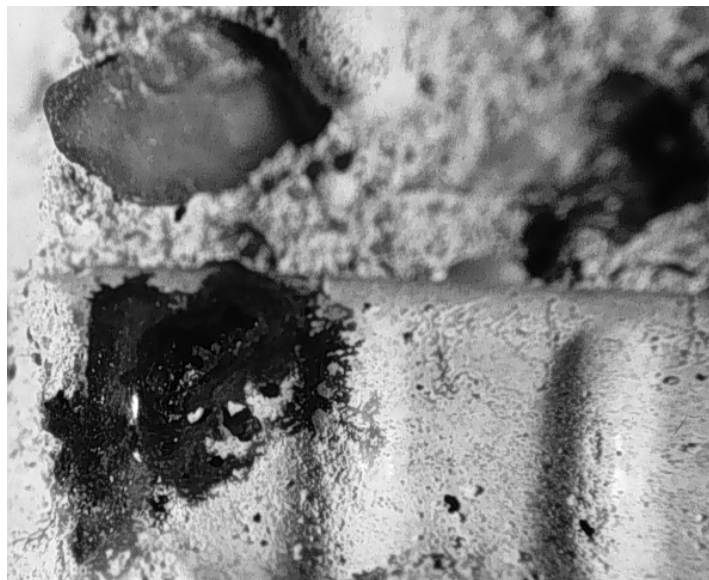
Figure 2.44 Corrosion spots coincident with voids in concrete (specimen removed after one year).

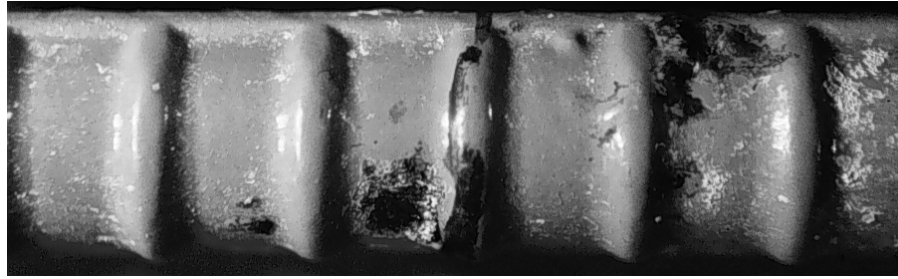
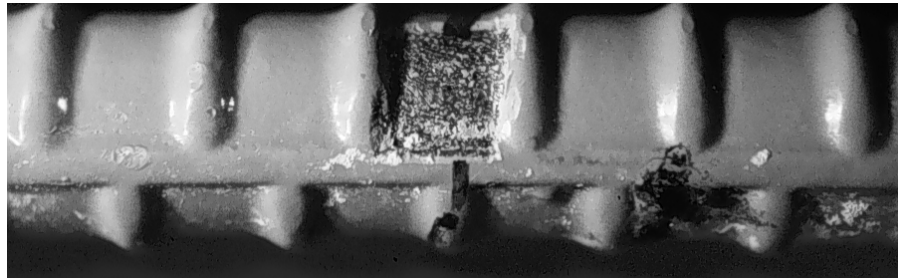
The corrosion products in all cases were black and brown. The products were mostly brown in the vicinity of cracks. In some instances, upon exposing the bars around stirrups in beams with splice bars, a greenish-black corrosion product was found in a soluble form. The dark greenish product rapidly converted to brown on contact with air. Similar to macrocell observations, steel corroded spots on the longitudinal bars almost always coincided with voids in the surrounding concrete as shown in Figure 2.44. Of particular interest was the observation that corrosion occurred at holidays and exposed steel areas mainly on the side of the bar facing concrete cover on the short side of beam, *i.e.* the lower side of the bar in casting position. Even at crack locations, where corrosion was apparent on exposed steel areas facing the cover, no corrosion occurred on exposed areas on the other side. Figure 2.45 shows the two sides of a damaged bar at the crack location with rust only on one side.

(a) Corrosion on lower side of bar (facing cover)

(b) No corrosion on upper side of bar

Figure 2.45 *Difference of corrosion performance between upper and lower sides of bar at the same crack location after one year.*

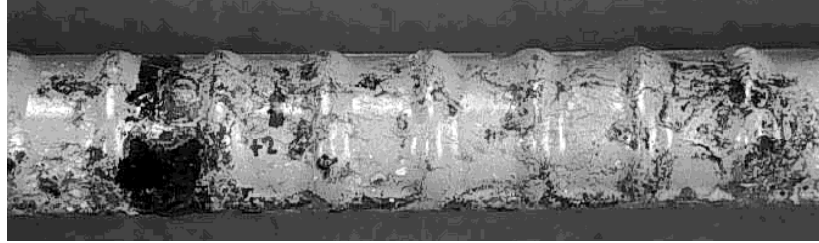
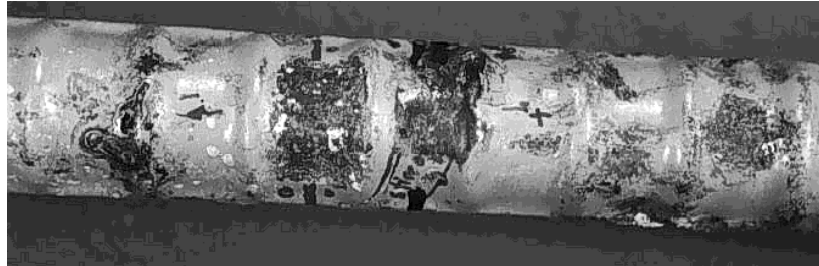
The manifestation of corrosion consisted of rust staining, coating blistering, and corrosion attack of exposed areas (Figure 2.46). The color of rust stains ranged from dark to light brown, and their appearance varied from dense to tenuous. Blisters size varied, with smaller ones being more prevalent. Corrosion did not always occur at the damaged, exposed areas. Minor corrosion was observed on patched areas. There was almost always a void in the concrete surrounding a blister. However, corrosion did not always occur at coating areas adjacent to concrete voids. Contrary to the observations from coated bars in macrocells, the appearance of brownish, liquid, acidic solution was not as pronounced in bars from beam specimens after 4.3 years of exposure. The time between autopsy and end of exposure was longer for beams and could explain the difference observed.

(a) Rust stains at lower bar of beam B10, portion within the wetted zone
 Damaged spot at crack location

(b) Bar of beam B10, portion at midspan (wetted zone)

Figure 2.46 Corrosion of longitudinal coated bars after 4.3 years of exposure.

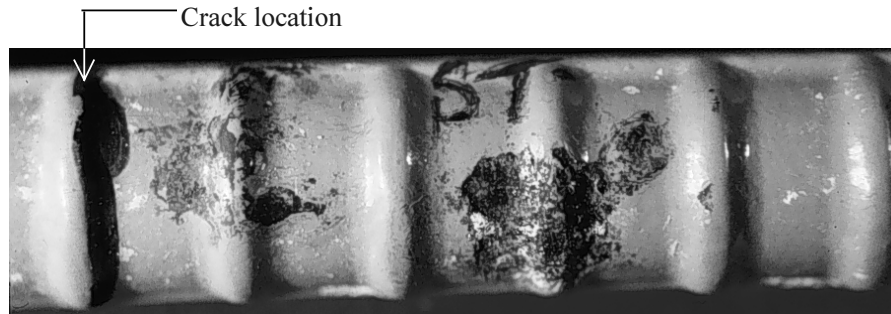
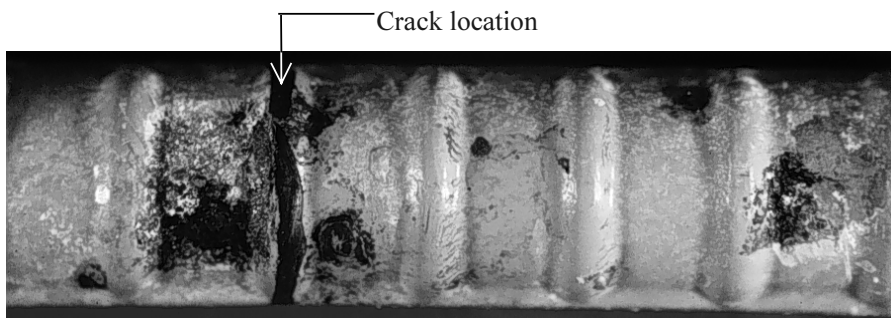
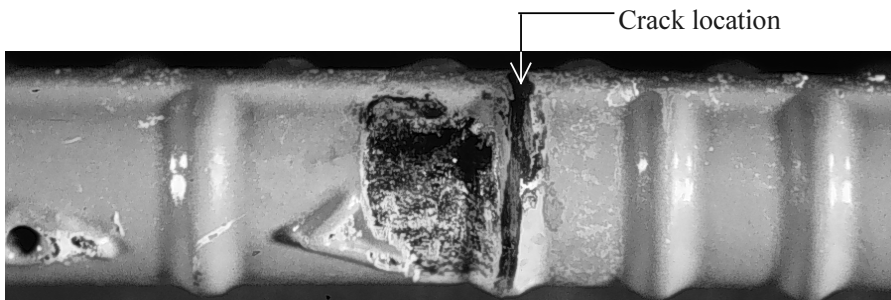
Bars in uncracked beams showed rust spotting on some exposed steel areas facing the concrete cover. It was evident that blisters were also forming on the coating on the same side of the bar. Again, more corrosion spots and blisters (facing the concrete cover) were visible on bars in cracked loaded and unloaded beams within about 40 to 60mm (1.5 to 2.5in.) from crack location. Figure 2.48 shows examples of damaged bars removed from cracked beams (the approximate crack location is marked by a thick line

(a) Damaged upper bar from cracked unloaded beam B9

(b) Damaged upper bar from cracked loaded beam B11

(c) Damaged lower bar from cracked loaded beam B11

Figure 2.48 Corrosion on lower side of bars removed from beams after one year of exposure.

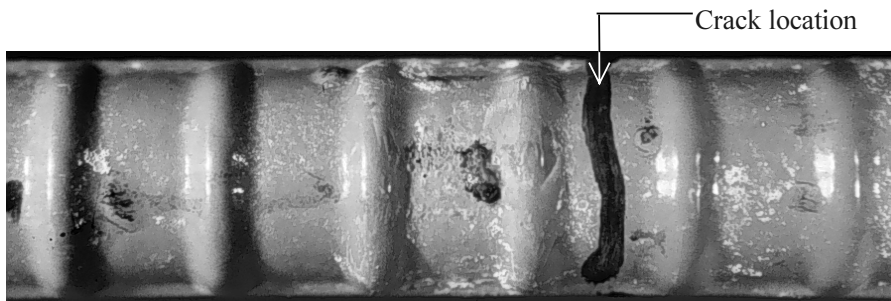
around the bar and an arrow in the figures). Bars with patched damage showed minor rust spotting on the patched areas with evidence of coating cracking and blistering as shown in Figure 2.49.

Figure 2.49 Corrosion on lower side of patched bar removed after one year of exposure.

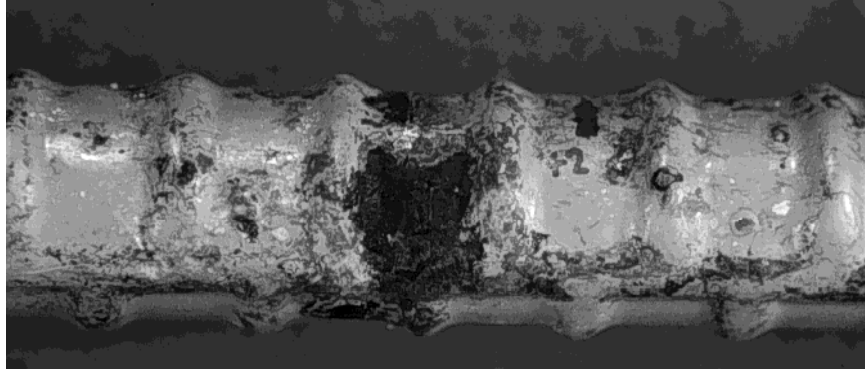
All bars with 3% damage underwent some degree of corrosion and rust staining on the coating surface, regardless of loading condition and presence of cracks. Damaged areas had uniformly dark brown rust, in some cases with buildup of rust products (Figure 2.50). No deep pits were noticed. Interestingly, not all damaged areas corroded, and there were several exposed areas with a clean metallic surface, even in proximity with cracks! (Figure 2.51). There was no specific pattern regarding location of corroded areas. Frequently, concrete adjacent to uncorroded exposed sites had only a few small voids.

Figure 2.50 Build up of rust products at damaged spot on bar from beam B10 after 4.3 years.

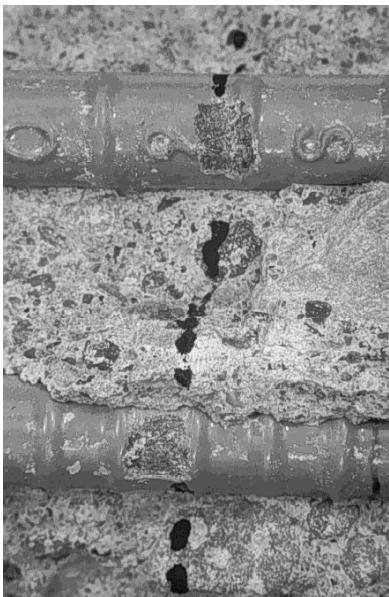
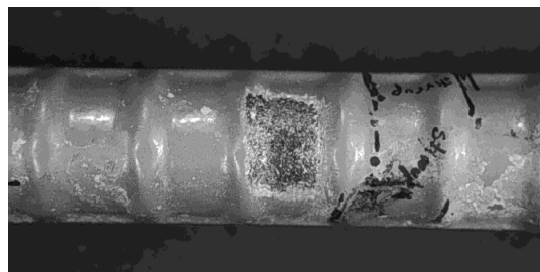
(a) Outside the wet zone of beam B10, about 43cm to the left of midspan

(b) Damaged spot located near stirrup and crack inside wetted region (Beam B10)

Figure 2.51 Uncorroded damaged areas near crack locations after 4.3 years.

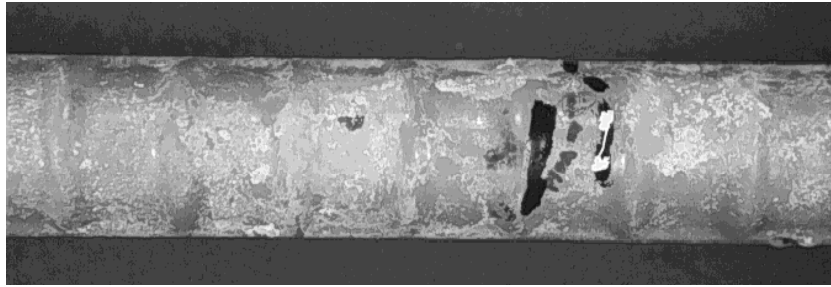
Bars with 3% patched damage (beam B14, cracked, unloaded) showed less extensive corrosion than bars with unrepaired damage. Several patched areas showed brown rust staining, from tiny freckles to larger stains. Several other patched spots had no rust spotting (Figure 2.52).

Figure 2.52 Aspect of uncorroded patched area on upper bar in beam B14, near crack location within the wetted zone after 4.3 years.

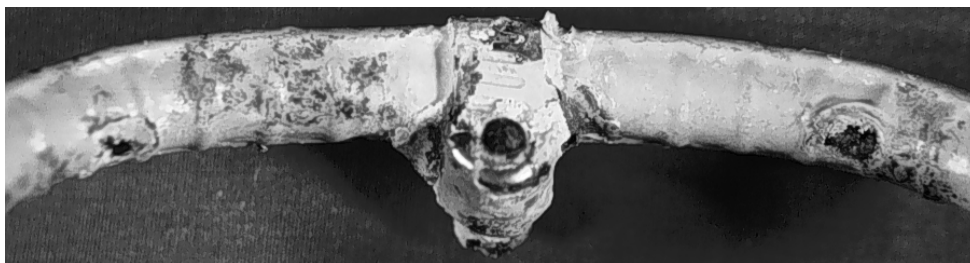
Stirrups in uncracked beams showed corrosion spots, blisters and coating cracking at the hook end closest to the lower concrete surface. In addition to blistering, stirrups in beams with unopened cracks exhibited corrosion spots at areas of contact with uncoated bars as shown in Figure 2.53. Similar but worse corrosion appeared along the continuous ribs, hook end, and bends of stirrups in beams with opened cracks as shown in Figure 2.54.

Figure 2.53 Corrosion at areas of contact between stirrup and uncoated bars at one year.

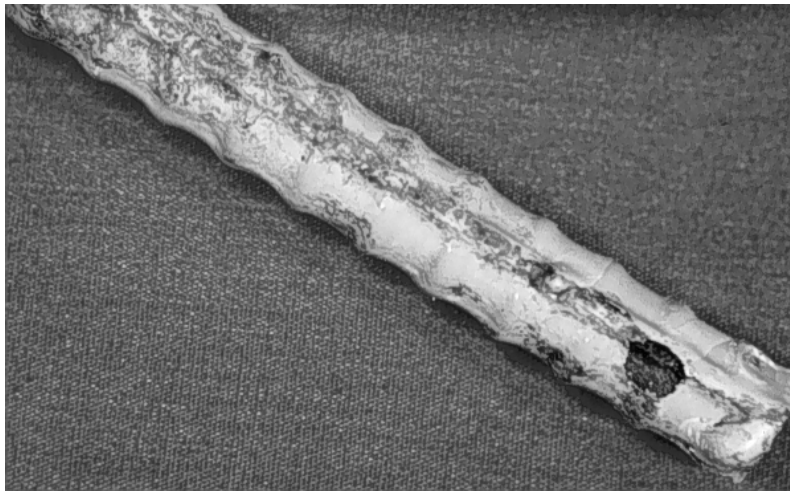
Figure 2.54 Corrosion on hook end of stirrup removed from cracked loaded beam after one year of exposure.

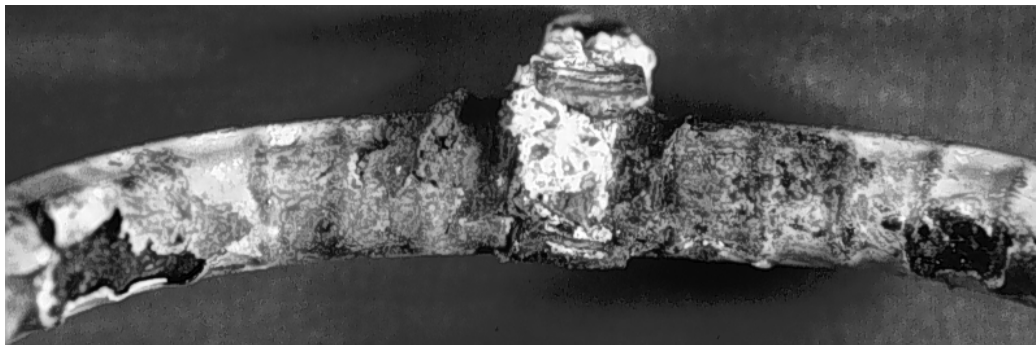
Stirrups with patched bends in uncracked beams were free of visible corrosion. Other patched stirrups in cracked beams had a similar condition to that described above for stirrups without patching. Figure 2.55 shows corrosion spots on the inside surface of patched bends in contact with uncoated bars.

Figure 2.55 Corrosion at areas of contact between patched stirrup and uncoated bars at one year.

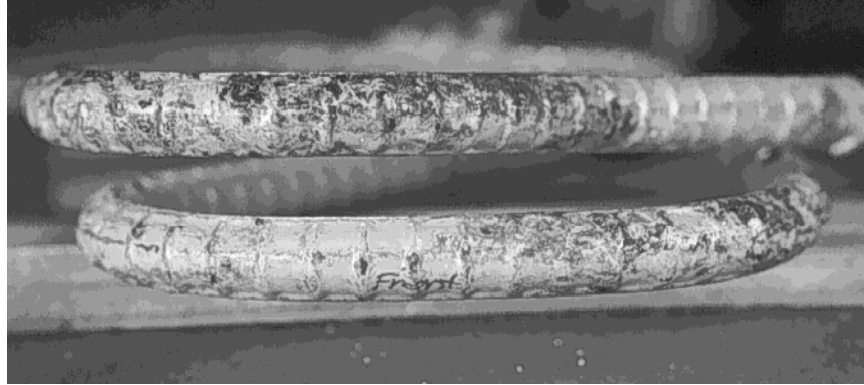
The stirrup from an uncracked, unloaded beam (B15) underwent extensive staining on two legs and on two bends. One leg was practically stain free. At the time of autopsy, there were four greenish or dark-greenish rust spots on one leg; after one or two days, their appearance changed to reddish-brown or orange-brown. The stirrup from a cracked, unloaded beam (B17) had rust staining that was denser on the portion of the stirrup within the wetted zone (Figure 2.56).

Figure 2.56 Rust staining of stirrup from beam B17 (portion within the wet zone) after 4.3 years.

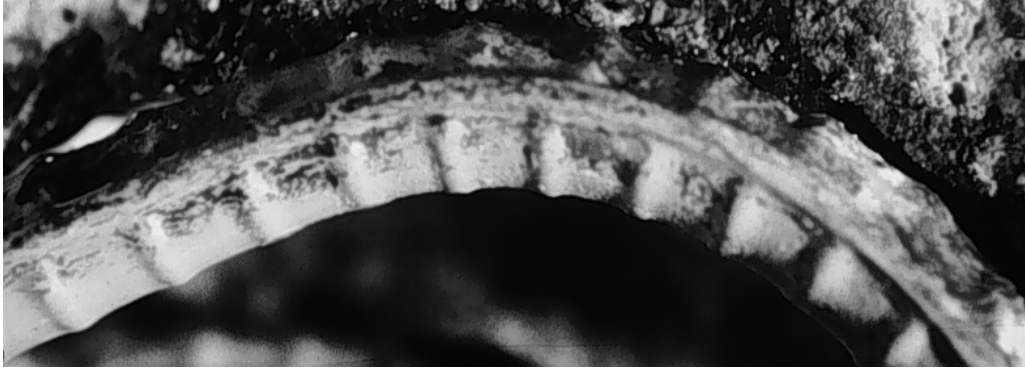
These stirrups had similar, but more visible, signs of corrosion as the stirrups in an as-received condition. Stirrups used in splice regions at midspan, in particular, showed the worst rust spotting (breakdown of coating) along hook ends, continuous ribs, and bends, and longitudinal cracks in the coating. The patched damaged areas were severely corroded as shown in Figure 2.58.

Figure 2.58 Corrosion on patched damaged areas of stirrup after one year of exposure.

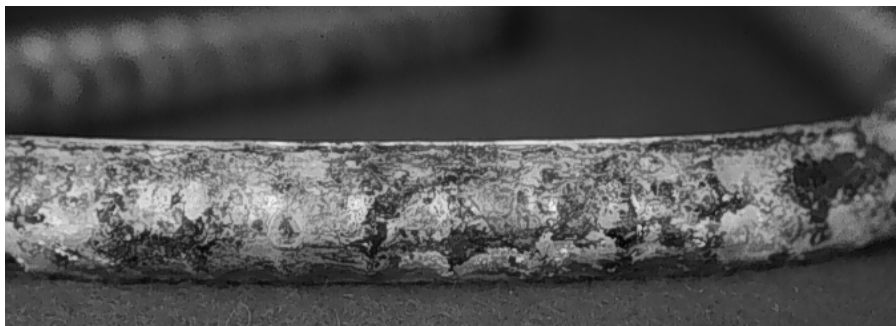
The stirrup from cracked, unloaded beam B27 experienced extensive rust staining at three legs and one bend. Several blisters and coating breaks were observed on one leg. The stirrup in cracked, unloaded beam B32 (with splice bars) developed widespread rust staining at two legs and two bends (Figure 2.59). The coating was in good condition at two legs. Patched areas at one bend and on one cut end did not develop corrosion and showed a clean steel surface. Remaining patched areas experienced tearing of the patch with visible dark corrosion of the exposed steel areas.

Figure 2.59 Rust staining on a stirrup leg near the front beam surface (beam B32) after 4.3 years.

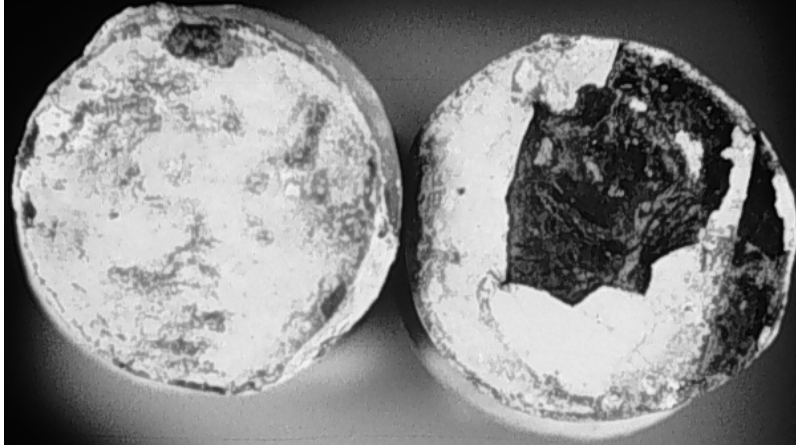
As shown in Figure 2.60, rust covered about 10 to 60% of the patched cut ends of bars. Additionally, coating cracking and blistering were visible up to about 140mm (5.5in.) from the bar end.

Figure 2.60 Corrosion on patched cut ends of splice bars after one year of exposure.

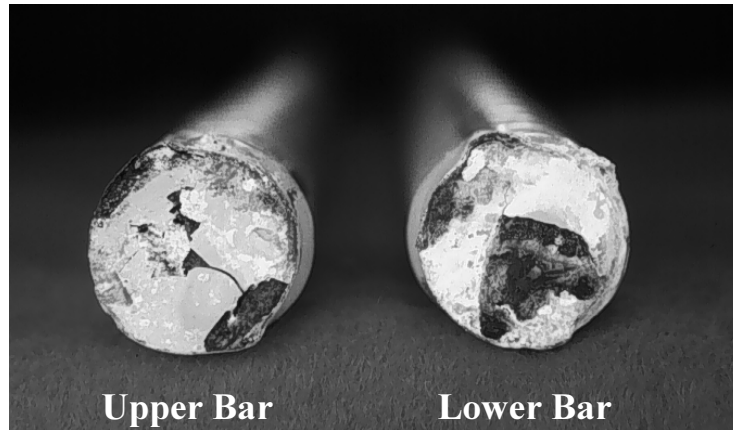
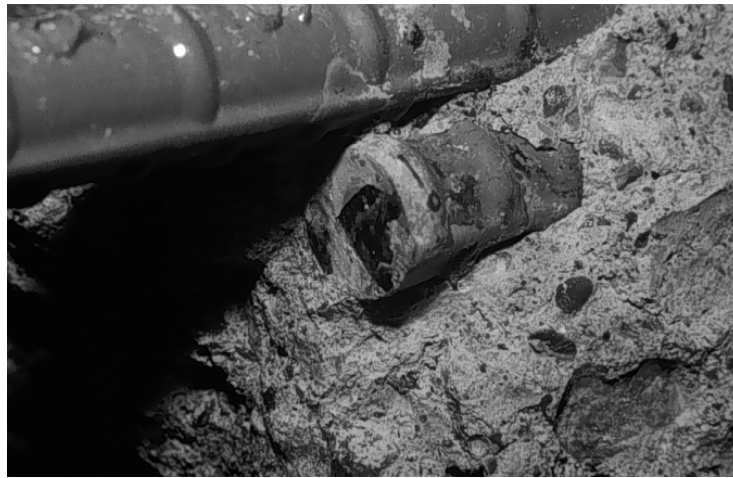
The patch at the cut end of the bar cracked and left some portions of steel uncovered. The steel surface of unprotected areas was black or dark rust (Figure 2.61). Several dispersed rust stains, ranging from dark to light, formed on the epoxy surface, mainly towards the top and front side of the bar (closer to the exterior beam surfaces). Rust staining extended about 23cm from the bar cut end.

At the lower bar, the patch at the bar cut end broke and left a large exposed steel area. The exposed steel surface color was black rust (Figure 2.61). Concrete paste residues stuck to remaining patched areas. Several dark, brown rust stains developed on the coating surface on the bottom side of the cast position of the bar, that is, towards the exterior front surface of the beam. No staining was observed on the opposite side of the bar. Rust staining extended up to 17cm from the bar cut end.

(a) Patch at bar ends of splice bars broke during autopsy, showing a dark corroded surface underneath

(b) Lower splice bar, appearance of bar end at time of autopsy

Figure 2.61 Patched ends of splice bars from beam B32 after 4.3 years of exposure.

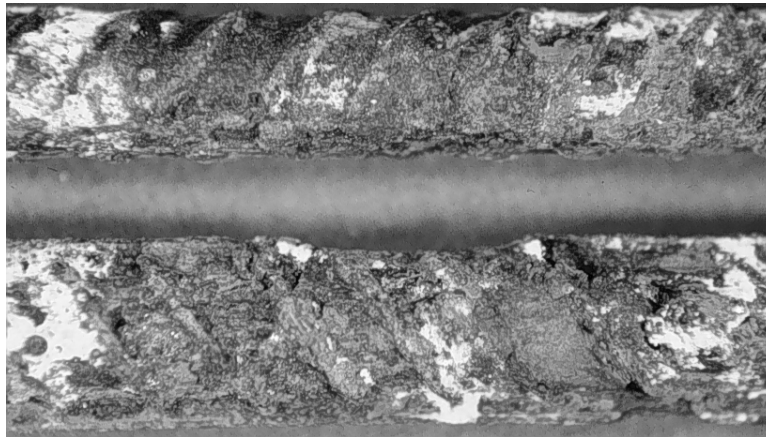
During removal of stirrups, short lengths of the uncoated bars in the compression zone were uncovered. In many cases, the uncoated bars were severely corroded with extensive surface degradation and loss of metal around contact points with the stirrup. Corrosion spread along the bar about 75mm (3in.) and was associated with chloride solution transport through the wide transverse cracks near beam midspan as shown in Figure 2.62.

Figure 2.62 Corrosion of uncoated compression bars at crack location after one year.

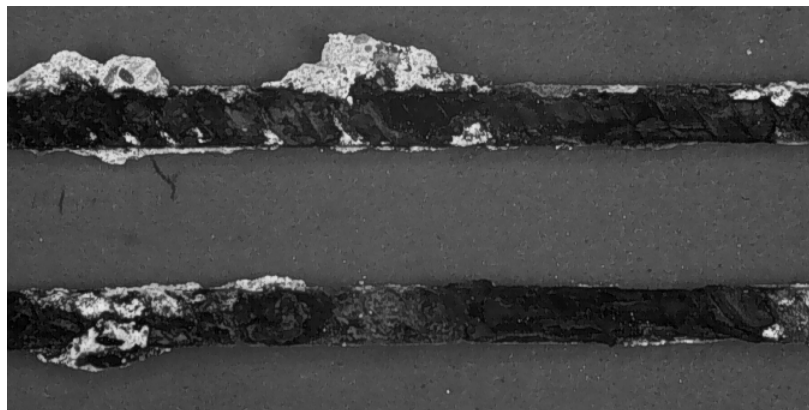
Black bars were moderately to extensively corroded and several moderate to severe pits were observed. Corrosion typically consisted of uniform black or dark rust with widespread shallow pitting (Figure 2.63). Several moderate to severe pits were observed in more corroded bars, as shown in Figure 2.64. Dark-green rust was frequently observed at severe pits at the time of autopsy (Figure 2.65). Severe pitting with

Figure 2.63 Dark corrosion with widespread pitting on uncoated bars from beam B14 after 4.3 years.

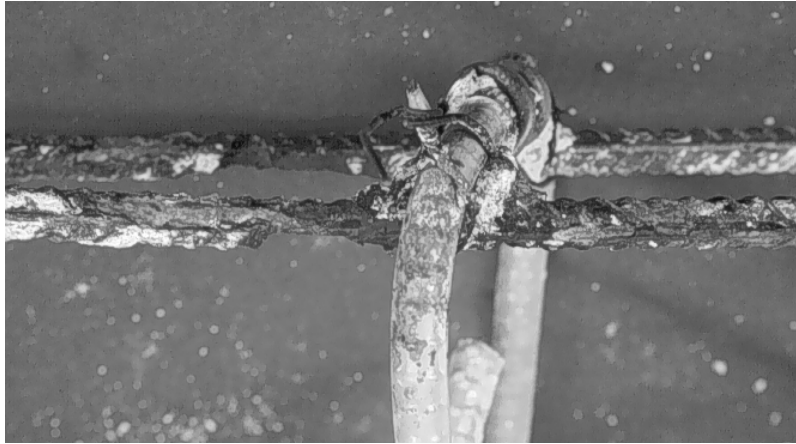
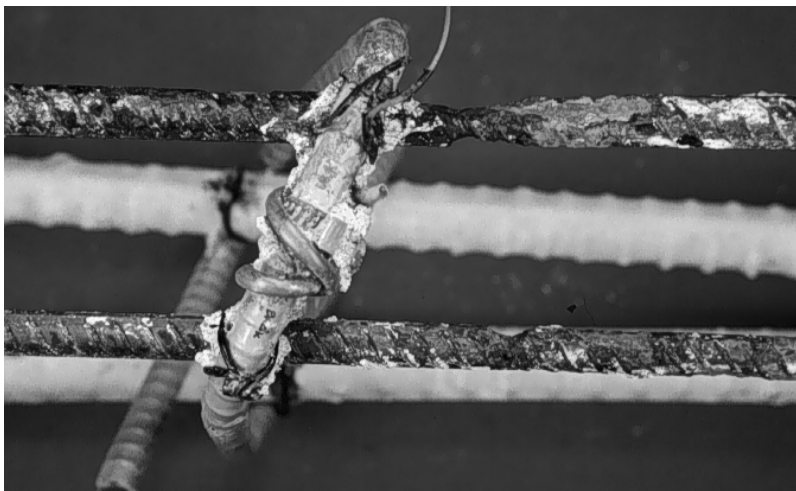
(a) Severe pitting on lower black bar near coated stirrup (beam B23).

(b) Severe pitting on black bars near coated stirrup (beam B23)

Figure 2.64 Severe pitting and loss of cross section on uncoated bars near crack locations after 4.3 years.

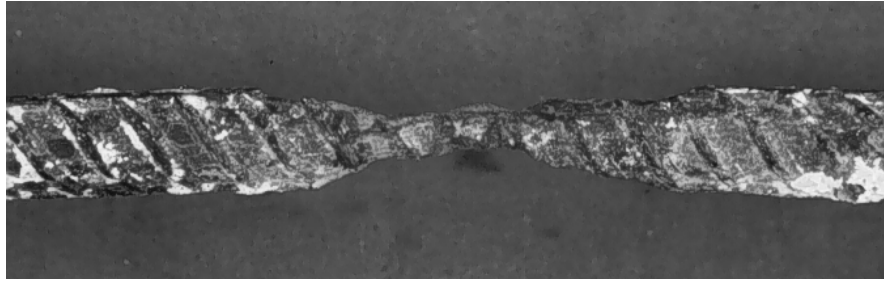
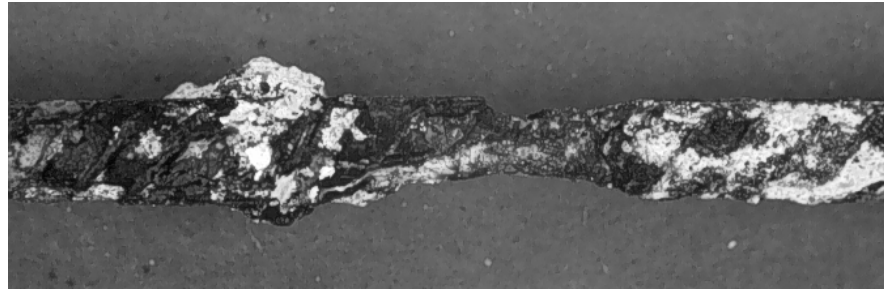
loss of cross-sectional area was evident at crack locations. Maximum loss of cross-sectional area was 78% at the lower bar of beam B27 (group II), as shown in Figure 2.66. One bar in beam B25 (group II) was so weakened at the severely pitted cross section, that the bar accidentally fractured while being examined (Figure 2.67). After being exposed to oxygen, dark-green areas changed to reddish-brown or dark color. Numerous, scattered reddish-brown rust spots appeared above the black corroded surface of the bars after being exposed to air for several hours and days. Similar to uncoated bars in macrocells, drops of brown, acidic solution, formed on the bar surfaces a day after removal from the concrete. Corrosion was generally confined to the wet zone in bars from group I but extended beyond the smaller wet zone in bars from groups II and III. Unquestionably, black bars suffered more severe corrosion than longitudinal and transverse coated bars. Fragments of concrete of different size remained stuck to several portions of bar surfaces, evidence of good adherence between concrete and uncoated steel. A more detailed description of examined black bars is included in Appendix A.

(a) Lower black bar of beam B27

(b) Lower black bar of beam B23

Figure 2.66 *Very severe pitting and loss of cross section on uncoated bars at crack locations (beam group II) after 4.3 years.*
