**CORROSION PERFORMANCE OF EPOXY-COATED
REINFORCEMENT-BEAM TESTS**

Research Report No. 1265-4

STRUCTURAL INTEGRITY OF EPOXY-COATED BARS

Texas Department of Transportation

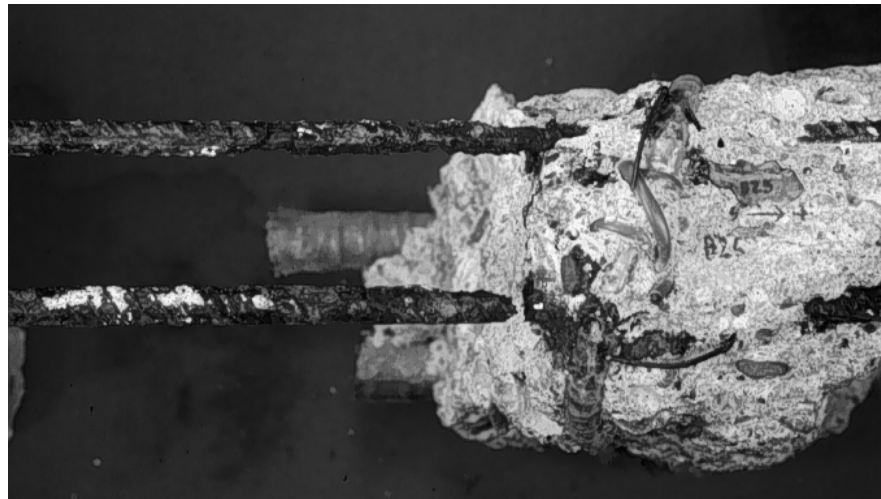
Figure 2.67 *Upper black bar in beam B25 fractured during autopsy at severely pitted location after 4.3 years.*

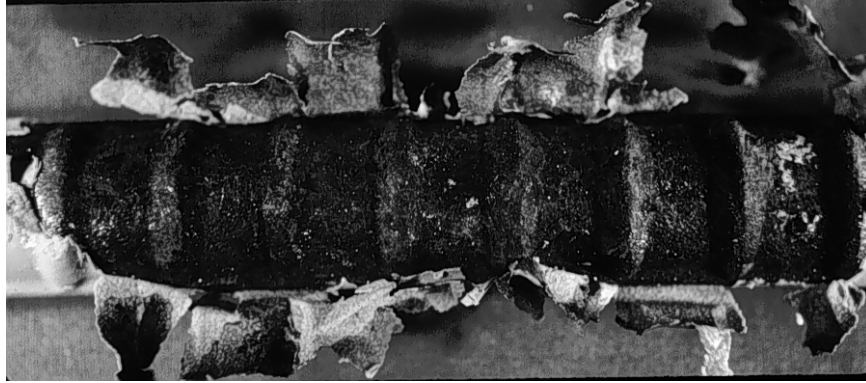
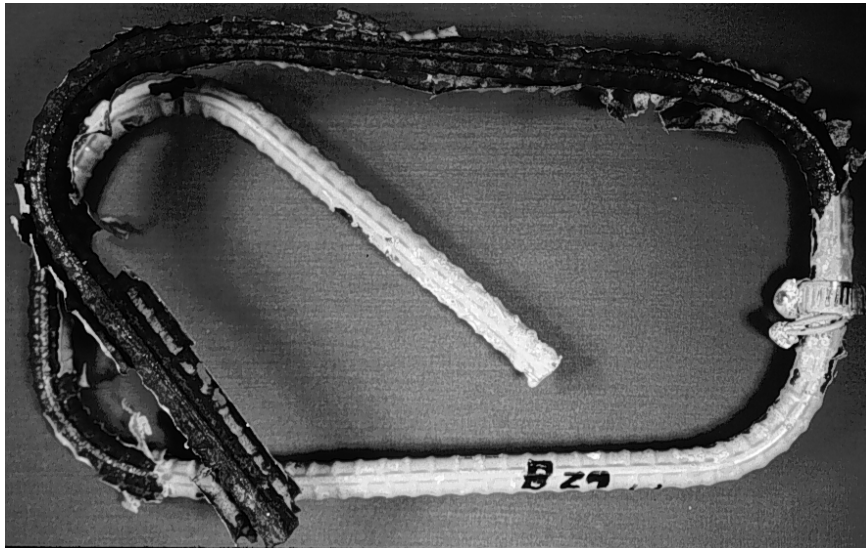
For stirrups, coating debonding was much more prevalent on stirrups in cracked beams than in uncracked beams. The areas of stirrup most vulnerable to coating debonding were the bent portions and the patched ends. In addition, the coating was debonded to some extent along the rust areas. Debonding was particularly extensive (over 60% of stirrup surface) in those specimens where stirrups were used with longitudinal or splice bars. For cut bar ends, debonding took place along the cracked coating extending from the cut end. Figure 2.68 illustrates the extent of debonding of the epoxy coating on a longitudinal bar and a stirrup.

(a) Upper longitudinal bar (B29)

(b) Stirrup (B29)

Figure 2.68 Coating debonding after one year of beam exposure.

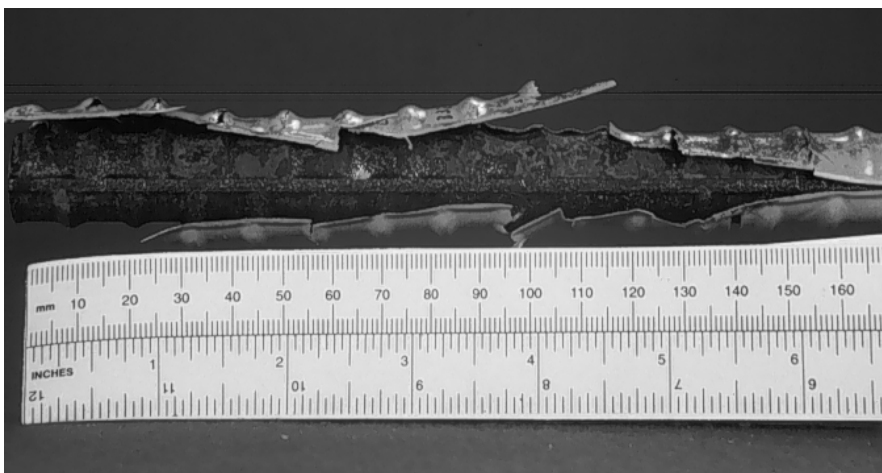
Coating debonded more extensively after 4.3 years of exposure. The coating was usually easy to peel on the portion of the bars within the exposure (wet) zone of the beams and gave an indication of nearly complete loss of coating adhesion (Figure 2.69). Coating debonding progressed from the wet areas at midspan towards the outer, dryer zones and was more extensive in cracked beams than in uncracked beams. Coating adhesion was preserved outside the wet zones of the beams, usually about 0.50 m beyond midspan in beams with larger exposed areas (Group I). At splices (cracked, unloaded beam B32), coating debonded from the cut ends up to a distance of about 20 to 24cm. In the uncracked beams, bars with 3% damage to coating showed much more adhesion loss than bars in an as-received condition. It was observed that adhesion was always lost around damaged, exposed areas, and the regions with good adhesion were located away from the damaged spots. The as-received bars in uncracked beam B1 had good adhesion within the wet zone, with only limited, isolated areas losing adhesion. The coating could be removed only in small chips (Figure 2.70).

Figure 2.69 Coating debonding of splice bar within the wetted region (beam B32) after 4.3 years.

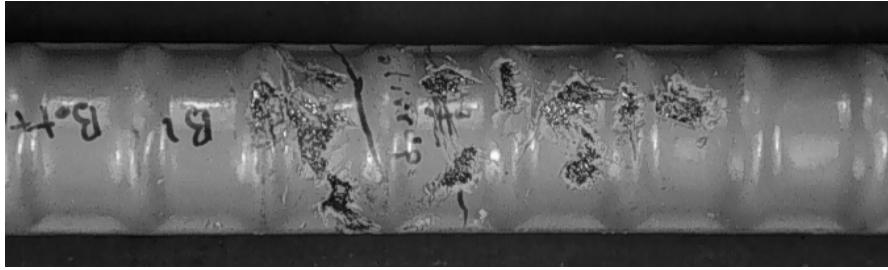
Figure 2.70 Coating adhered well throughout most portions of bars from beam B1 after 4.3 years of exposure.

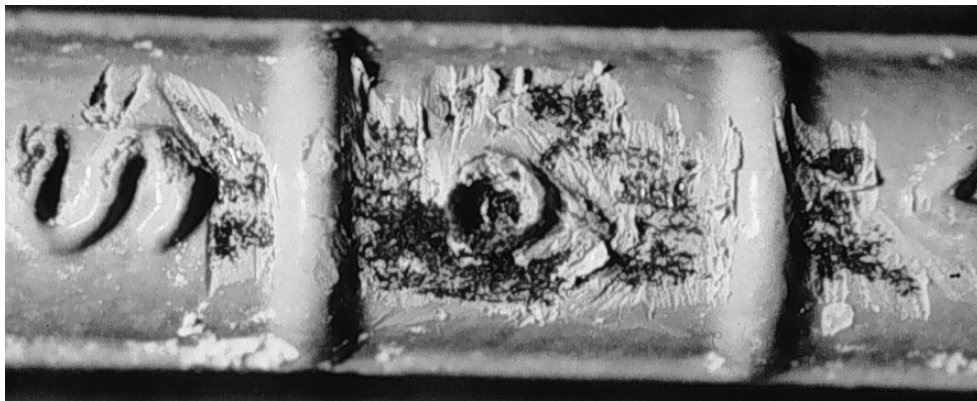
Generally, bars and stirrups in uncracked beams suffered the least substrate corrosion. The metal either remained bright with no visible corrosion activity, or was slightly discolored with minor surface disruption at sporadic locations as shown in Figure 2.72.

(Coating scraped away)

Figure 2.72 Minor surface corrosion of undamaged bar removed from uncracked beam after one year of exposure.

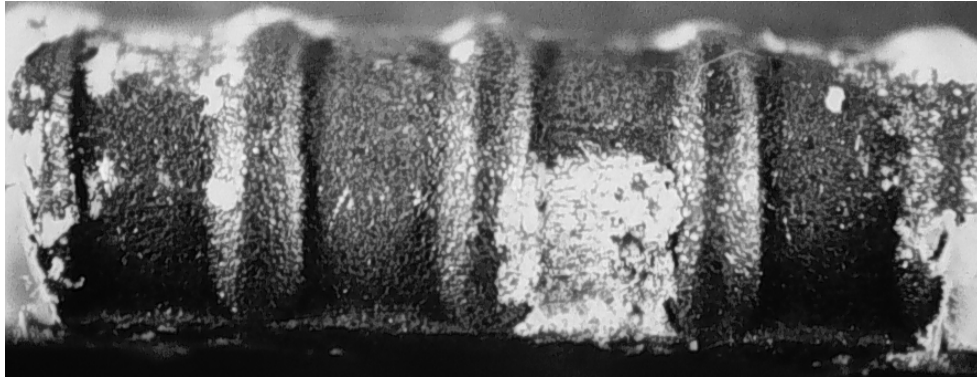
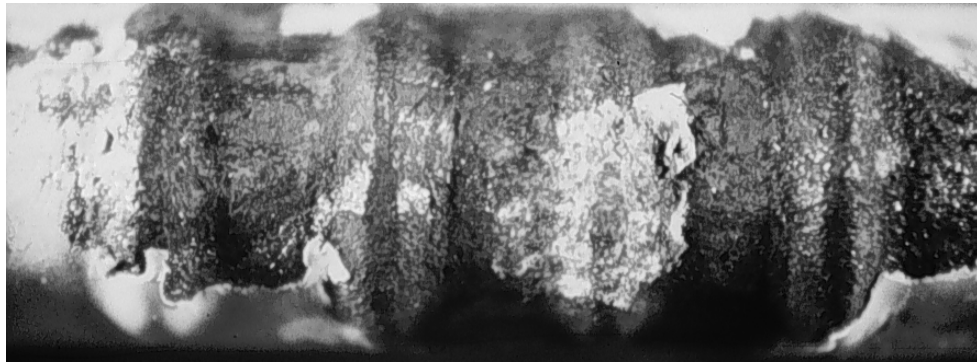
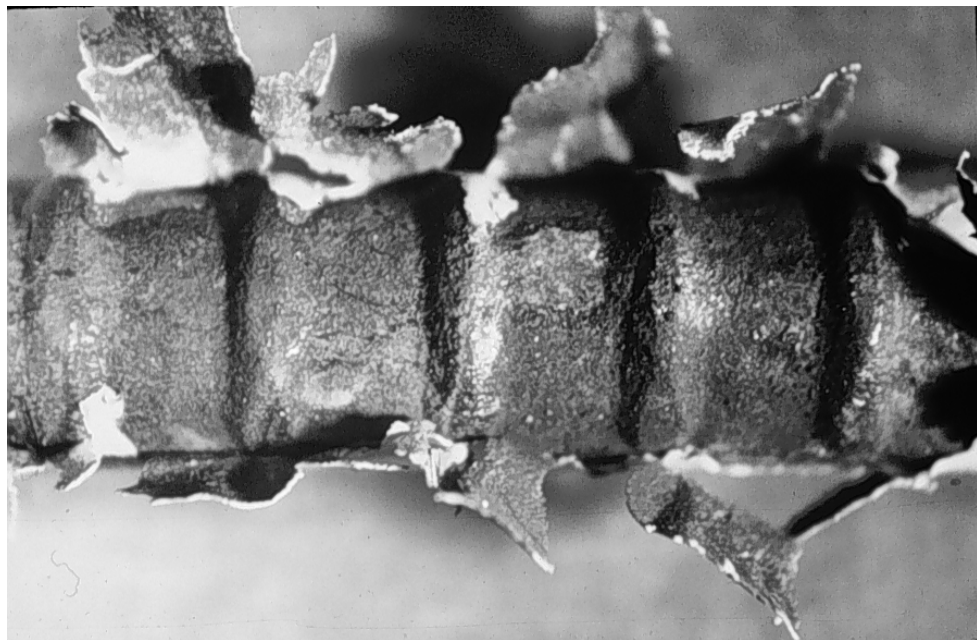
Metal corrosion on the longitudinal bars in cracked beams was mainly concentrated on the bar side facing concrete cover. Thin black -sometimes brown- corrosion products covered the metal surface around the affected sites. Underfilm corrosion spread to about 75mm from crack location, and up to about 45mm from the edge of the damaged areas. There was not any appreciable difference in the extent or severity of substrate corrosion between as-received bars in cracked loaded and unloaded beams. However, bars with intentionally introduced damage showed more substrate corrosion in cracked loaded beams than in cracked unloaded beams as illustrated in Figure 2.73.

(a) Corrosion on bar from uncracked beam B7

(b) Corrosion on bar from cracked unloaded beam B9

(c) Corrosion on bar from cracked loaded beam B11

Figure 2.73 Substrate corrosion on bars with introduced damage and variable beam loading condition after one year.

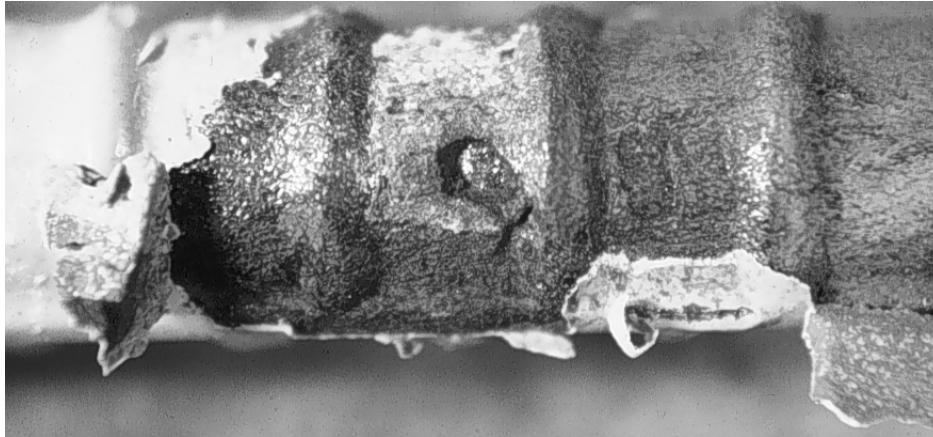
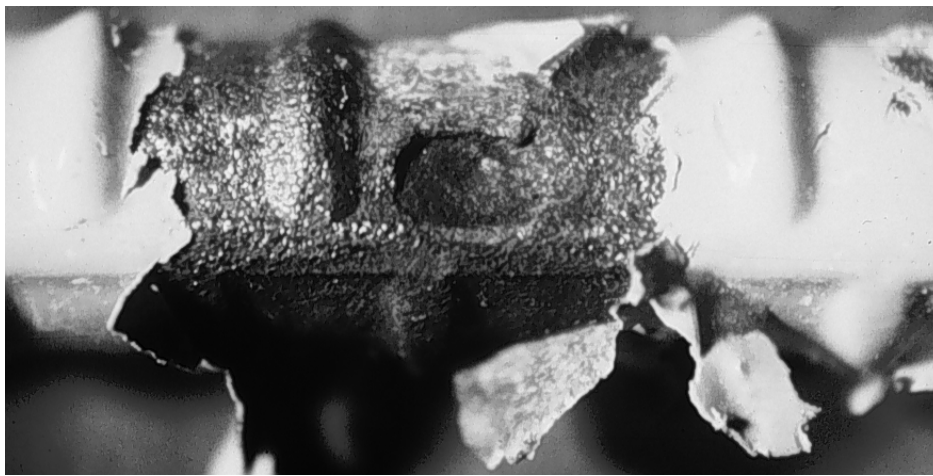
Indeed, the most severe metal corrosion was found on the damaged bars retrieved from the cracked loaded beam. Significant pitting occurred at the edges of the exposed steel areas intercepting wide cracks.

These pits were elliptical measuring about 6 x 9mm (1/4 x 3/8in.) in perpendicular directions and up to 1.25mm (0.05in.) in depth as shown in Figure 2.74. Several smaller pits existed beneath the coating in adjacent areas. The pits were covered with dark brown corrosion products.

(a) Pitting on upper longitudinal bar

(b) Pitting on lower longitudinal bar

Figure 2.74 Pitting on exposed steel areas of bars removed from cracked loaded beam B11 after one year of exposure.

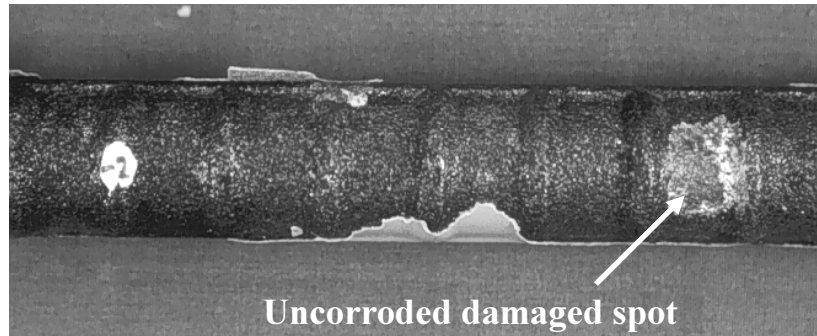
As in the macrocell study (Report 1265-3²³), two types of surface appearance were found beneath areas with debonded coating: 1) Surfaces with a mottled, glittery golden-brown or bronze appearance, with no corrosion products, as shown in Figure 2.78; and 2) Dark or black corroded surfaces with accumulation of rust products (Figure 2.79). Mottled surfaces were thought to be areas where cathodic disbondment took place, as was discussed in Research Report 1265-3.²³ There was not a specific pattern for location and distribution of mottled surfaces: At some bars mottled surfaces predominated in the middle 30-cm portion of the beams, while at other bars, most mottled surfaces were closer to outer portions of wet areas. Mottled surfaces were found more frequently on longitudinal bars than at stirrups.

Figure 2.78 *Mottled surface at lower bar of beam B8 within the wetted region.*

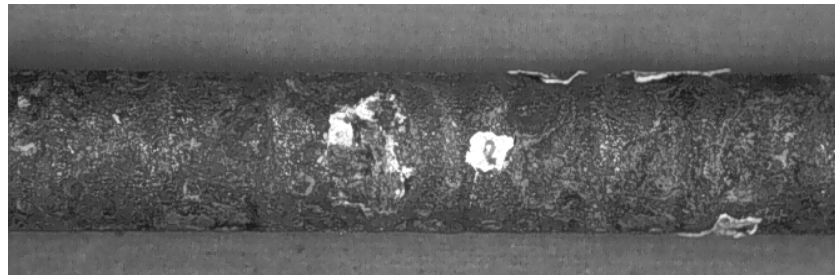
Figure 2.79 *Dark corroded surface on longitudinal upper bar of beam B8 within the wetted region (zone at midspan).*

A uniformly black or dark rusted surface developed at corroded portions of the bar. Depending on the severity of corrosion, shallow pitting and metal depletion, rust volume increase, and blistering developed to varying degrees (Figure 2.79). No severe, localized, deep pits were found in longitudinal bars. Moderate pits were observed in some stirrups. The largest pits were less than 0.5mm deep in longitudinal bars and 1.0mm in stirrups. Figure 2.80 shows the worst pit observed in a stirrup. No drastic reduction of cross-sectional area was found in any longitudinal coated bar. Moderate reductions in cross-sectional area were observed in worst corroded stirrups. Variable amounts of dark rust powder came off during removal of the coating. Blisters were of different sizes and smaller blisters were more abundant than larger blisters. Blistered areas had a very hard, solid consistency.

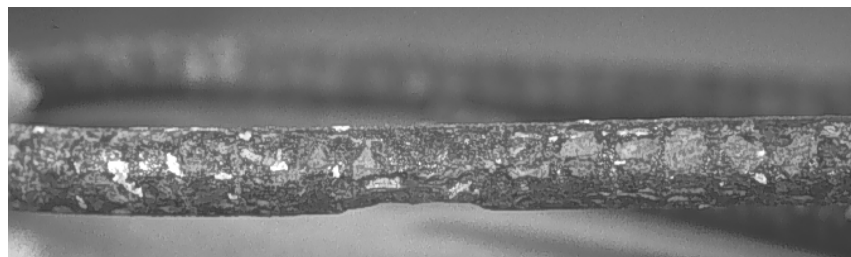
Figure 2.80 *Pitting on stirrup leg near the bottom beam surface (beam B17).*

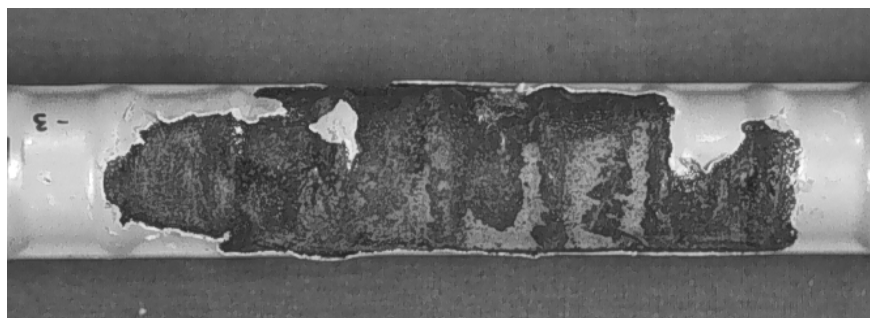
Areas with mostly reddish-brown rust deposits or pockets of varying size, shape, appearance, and amount were usually present above the dark corroded surface (Figure 2.81). The size of such rust spots ranged from very large to small flecks. Appearance of rust spots was dependent on rust concentration, varying from a light film of rust to thicker layers of rust deposits. In a few instances, spots with whitish, pasty

Figure 2.81 *Reddish-brown rust products on lower bar of beam B8 (Zone just outside of wetted region).*

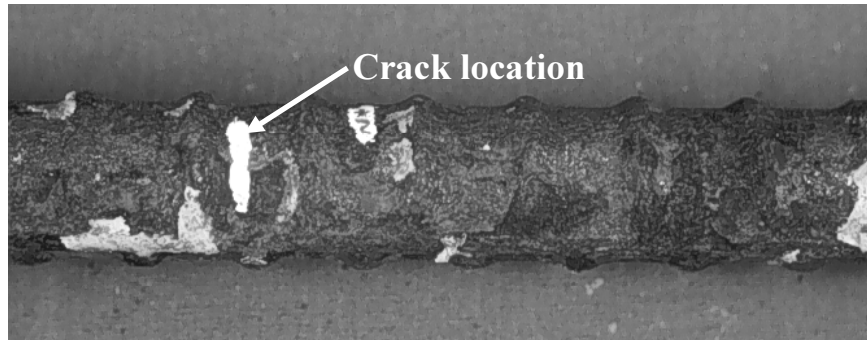
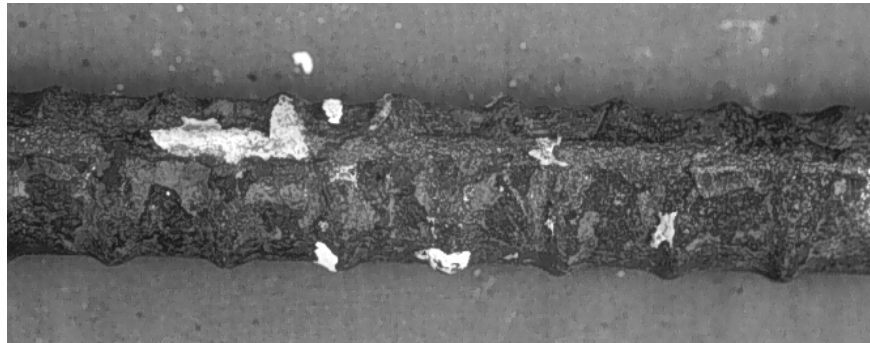
(a) Zone around crack location near the edge of wetted region

(b) Another view of zone around crack location near the edge of wetted region

Figure 2.82 Corroded portion on lower bar of beam B10.

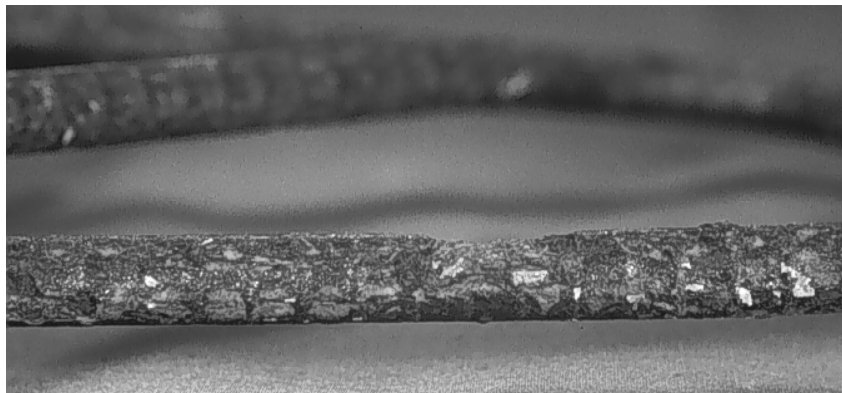
The as-received stirrup from cracked unloaded beam B17 experienced more widespread and severe corrosion than the as-received stirrup from uncracked, unloaded beam B15. The stirrup from beam B17 had several pits (0.3mm to 0.7mm deep) at the most critically corroded portions. Figure 2.83 shows one such pitted area. The rusted metal was cracked and came off in flat pieces. As-received and patched stirrups had less severe corrosion than as-received stirrups. Patched stirrups exhibited uniformly dark corrosion with shallow pitting. In one case (cracked, unloaded beam B23), metal beneath a patch on the hook end was clean and bright (Figure 2.57). Stirrups with 3% repaired damage exhibited widespread dark corrosion and relatively deep pitting, up to 1mm deep, as shown in Figures 2.84 and 2.85.

Figure 2.83 Pitting on stirrup leg near the bottom beam surface (beam B17).

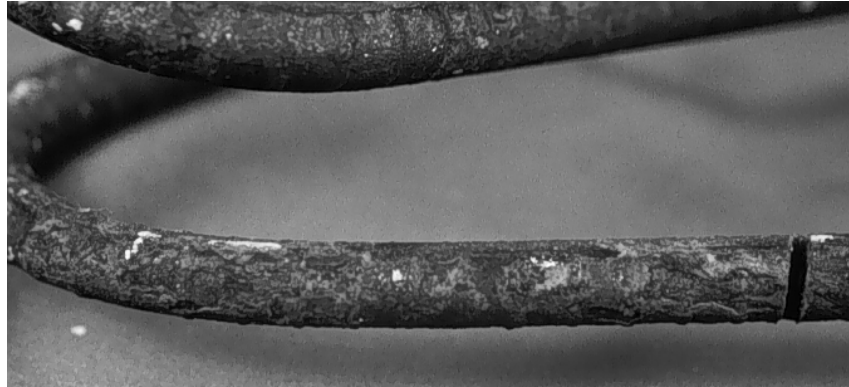
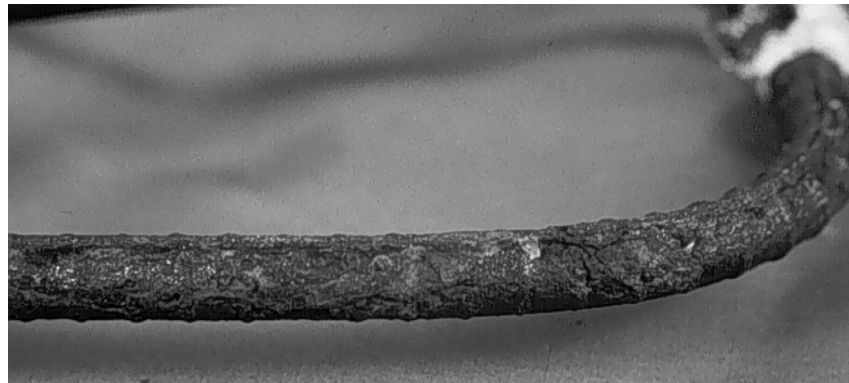
(a) Portion within the wetted region

(b) Portion outside the wetted region

Figure 2.84 Pitting along stirrup leg near the bottom beam surface (beam B27).

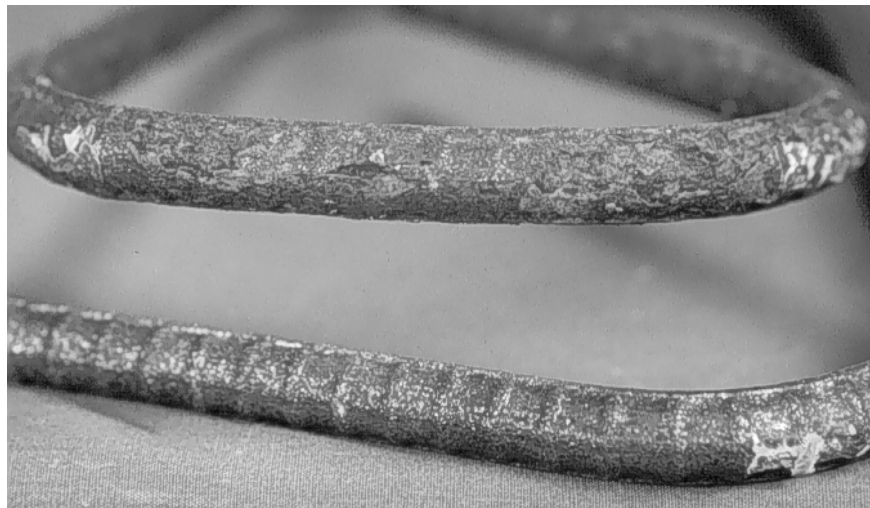
Figure 2.85 Corrosion on stirrup leg (top in photo) and mottled surface on stirrup hook (bottom in photo). Portion near the front beam surface (beam B32).

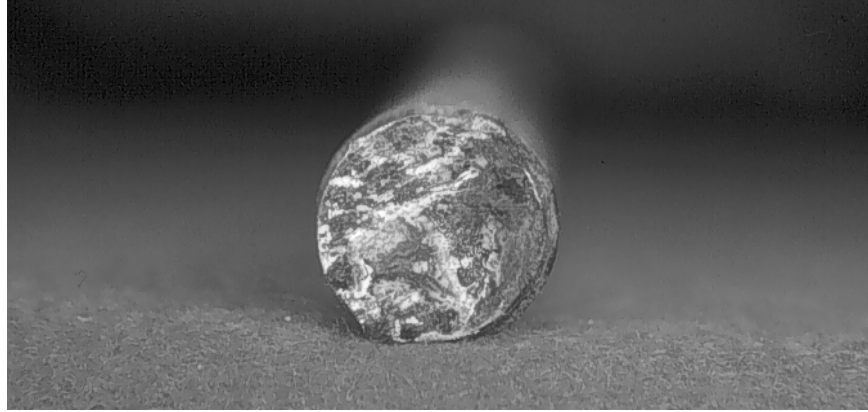
Cut ends of spliced bars showed a uniformly dark or black corroded metal surface with shallow pitting (Figure 2.86). A dark corroded surface with shallow pitting extended from the patched ends of the bars on one side of the bars. The steel exhibited a mostly mottled surface on the side opposite to the corroded surface (Figure 2.87). Undercutting extended 20cm to 24cm from patched bar ends.

Figure 2.86 Dark corrosion on steel surface beneath the patch at lower splice bar end of beam B32.

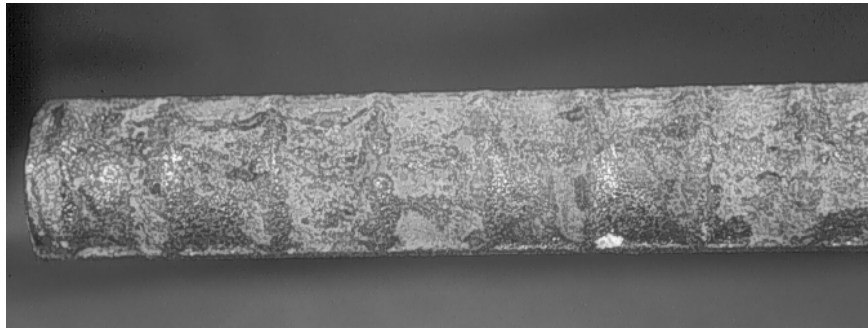
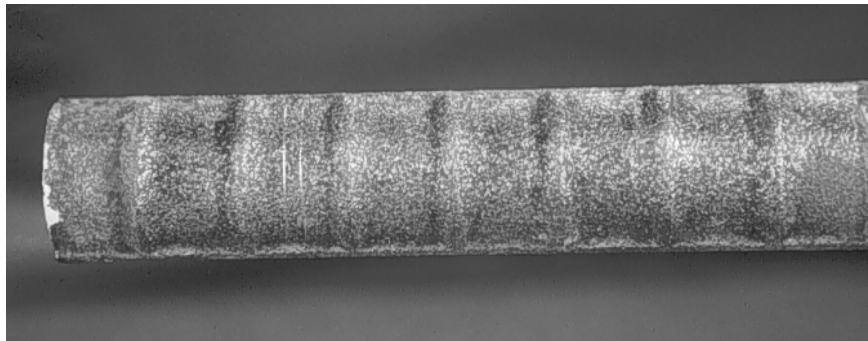
(a) Accumulation of reddish-brown rust products on side near the concrete surface

(b) Mottled surface on opposite side facing the beam core

Figure 2.87 Appearance of steel surface of lower splice bar after 4.3 years of exposure (beam B32).

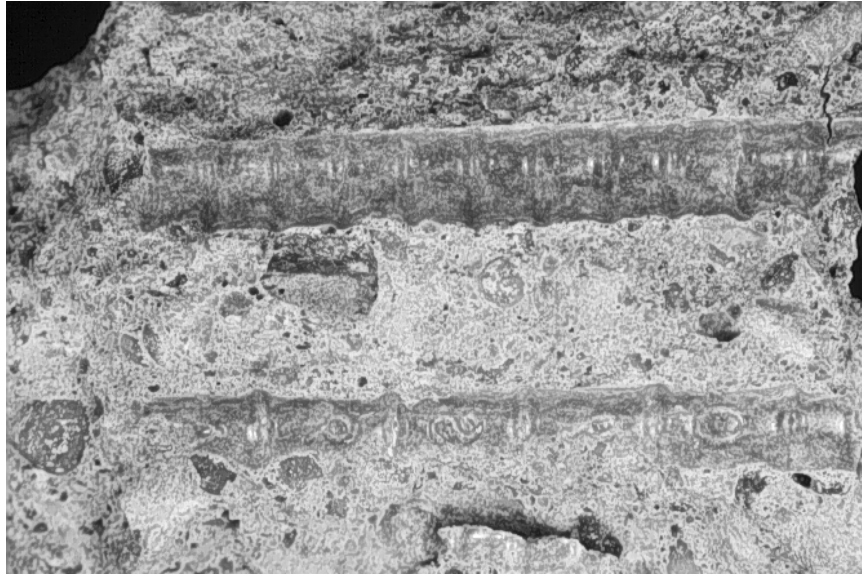
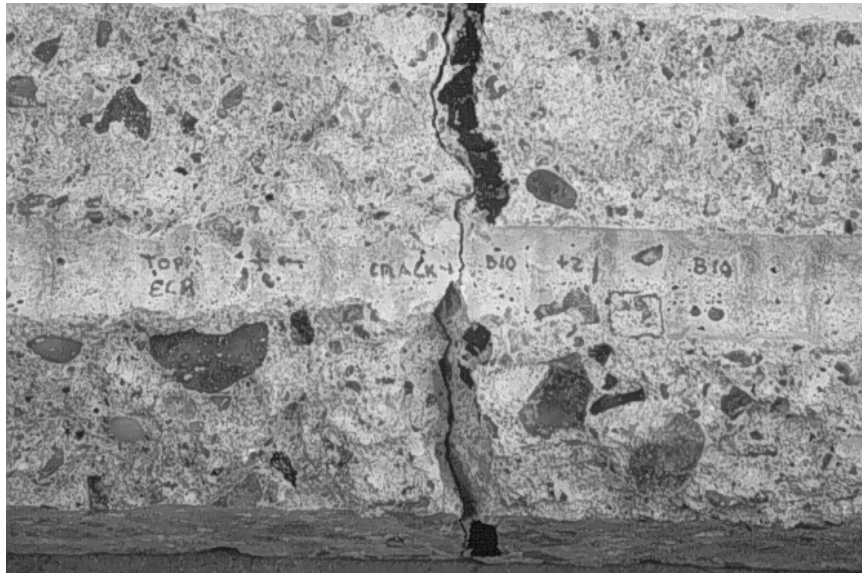
Bar traces of coated steel confirmed the previously mentioned findings from the macrocell study.²³ Concrete on top of the coated steel (in casting position) appeared glossy, smooth with a grayish-like appearance, the rib imprints were clearly defined, and was generally free of voids [Figure 2.88(a)]. Concrete on the underside of the coated steel appeared whitish, dusty, and porous with laitence and had many voids of different sizes [Figure 2.88(b)]. In general, more rust products were visible in and around the voids at the bottom trace than at the top. Chemical adhesion to concrete was lost, as evidenced by the ease in removing the bar from the concrete and lack of concrete adhering to the bar. Only a film of white dust from the concrete paste adhered to the bottom of the bars.

(a) Above epoxy-coated bars as in casting position

(b) Under epoxy-coated bar as in casting position

Figure 2.88 Bar trace in concrete above and below epoxy-coated bars (as in casting position).

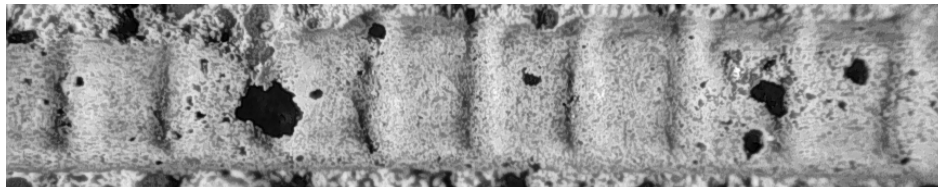
The stirrup trace did not have a similar distinct pattern. There were some voids distributed along the stirrup legs and concrete was not as glossy as it appeared on top of the longitudinal bars. Figure 2.89 shows an example of a stirrup trace in concrete. An interesting observation was that the patching material used at the coating plant to repair stirrup ends remained on the stirrup imprint in concrete as shown in Figure 2.90.

Figure 2.89 Stirrup trace in concrete.

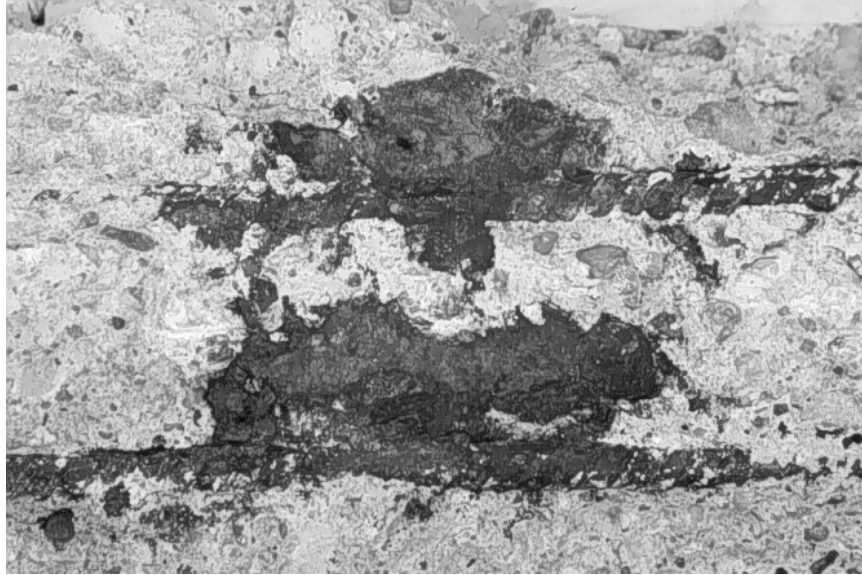
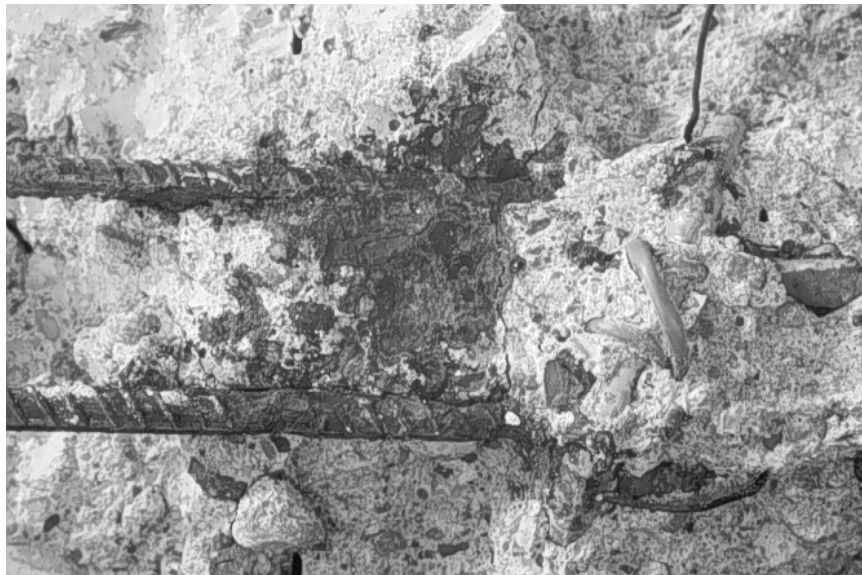
Concrete surrounding heavily corroded uncoated bars was extensively rust stained after 4.3 years of exposure (Figure 2.91). Rust stains were very large, mostly black or dark and reddish-brown colored. Other observed stains were dark-green, bright orange, brownish, and yellowish-brown. Typically, dark-greenish stains would turn orange-brown, reddish-brown, or dark a few hours after exposure to the atmosphere. In general, rust stains penetrated the concrete far beyond the bar location at most areas where the bar was pitted. Stains penetrated cracks and expanded towards the exterior surface. Rust staining was mostly reddish-brown and orange-brown at areas closer to the exterior surface while it tended to be dark or black at the rebar level. Reddish-brown and dark rust was also observed inside large concrete voids above and below the bar.

(a) Black bars in beam B14

(b) Black bars in beam B25

Figure 2.91 Extensive dark or dark-greenish rust staining was observed on concrete around uncoated bars at severely pitted locations.

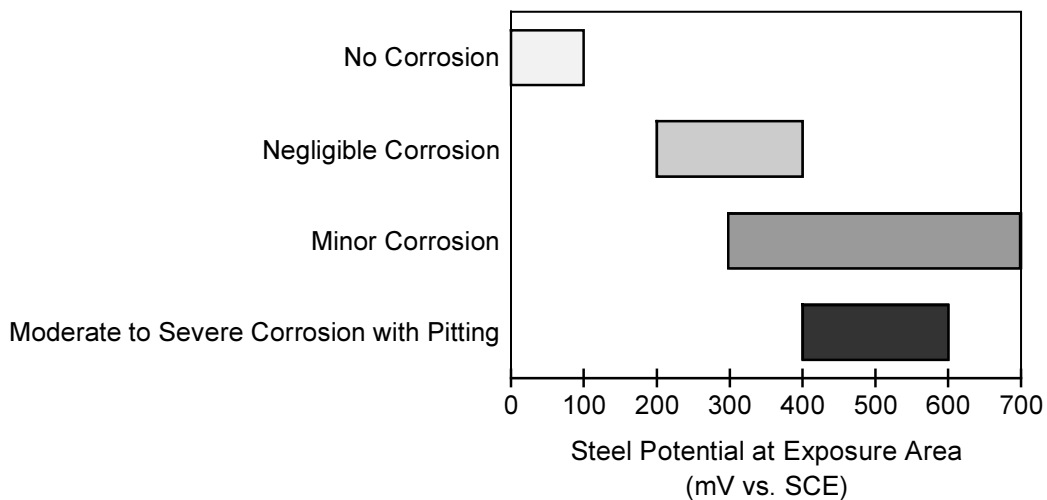
Based on the discussion above and observations of actual bar condition, corrosion potential values correlated well with the state of corrosion of coated steel after one year of exposure. Figure 3.1 summarizes the relation between the ranges of measured potentials and corrosion state. Although the extent of corrosion spreading on the bar surface did not correlate with steel potential, the corroded area tended to increase as corrosion severity increased. This relationship became less clear after 4.3 years of exposure. Figure 3.2 illustrates the relation between corrosion activity and steel potential for epoxy-coated and black bars from beams autopsied after one and 4.3 years. Although there was a tendency for readings to become more negative as corrosion activity of epoxy-coated bars increased, there was a wide overlap of corrosion performance in the potential range of -300 to -550 mV SCE. Corrosion potentials less negative than -300 mV SCE indicated negligible or no corrosion. Likewise, corrosion potentials more negative than -550 mV SCE indicated moderate to severe corrosion with some cases showing only minor corrosion.

Figure 3.1 Relation between corrosion activity and steel potential after one year of exposure.

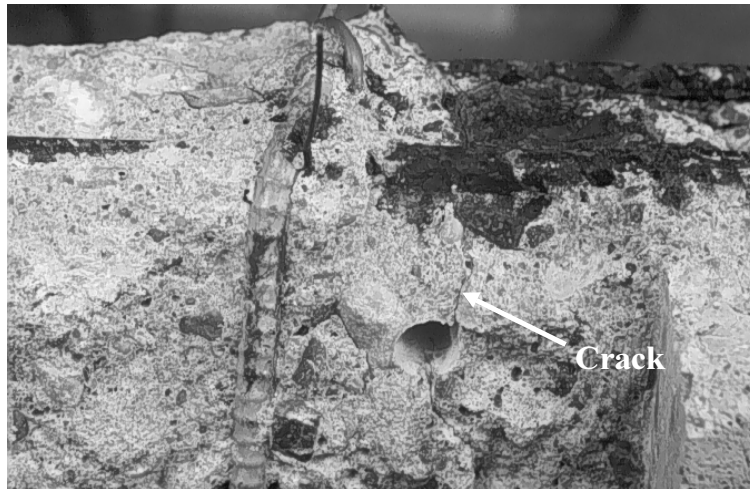
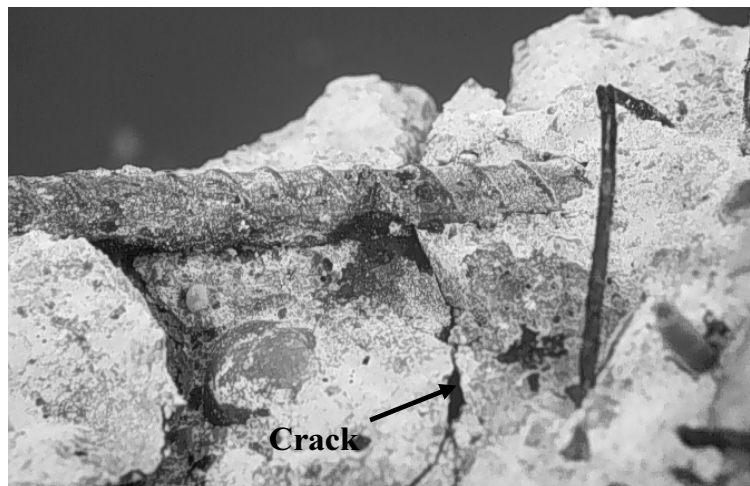
Pitting corrosion is characterized by high chloride concentration and low pH, and both occur at a crack tip. Chlorides accumulate at crack sites as a result of frequent wetting by a salt solution, and free access provided by the crack. Free oxygen and other atmospheric pollutants (such as carbon dioxide) also accessed the bars through the cracks during dry periods. Periodic cyclic loading during wet and dry periods pumped water, chlorides, and oxygen towards the crack tip. Concrete alkalinity at a crack location is lowered by carbonation due to exposure to carbon dioxide CO₂. Hence, passivity of bare steel areas, such as damaged spots and pinholes in the immediate vicinity of the cracks, is locally lost and corrosion progresses at an increasing rate. Such effects were much worse for uncoated bars because of a much larger steel surface available for cathodic reactions.

(a) Pitting corrosion of uncoated bars at crack location (beam B25)

(b) Pitting corrosion of black bar at crack location (beam B23)

Figure 3.4 Uncoated bars exhibited severe corrosion at crack locations.

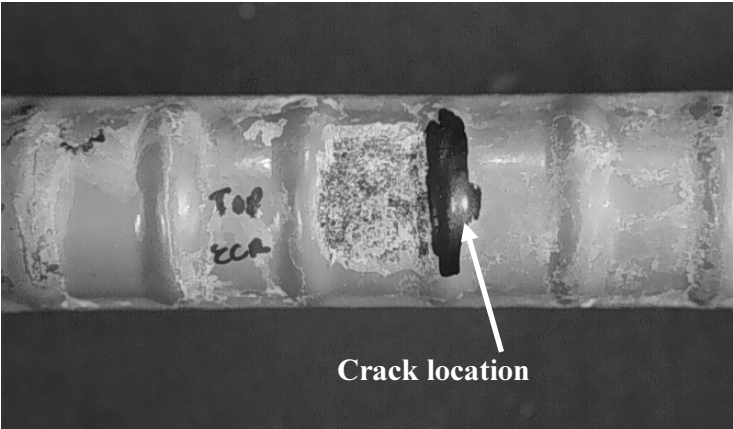
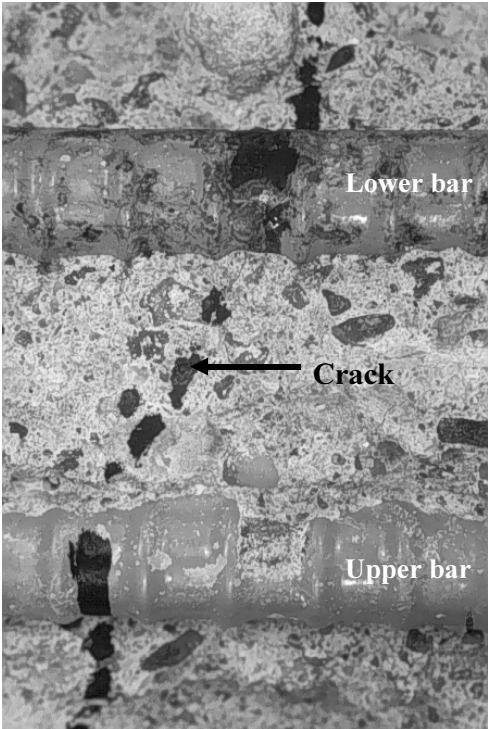
Several longitudinal coated bars did not experience corrosion on some damaged sites (patched or unpatched), even when located near crack locations within the wetted zone (Figure 3.6). The steel surface beneath the coating around such locations was mottled. It seemed that some damage sites near crack locations remained passive while other damaged sites tended to become anodically polarized. Cathodic polarization may have protected damaged sites near cracks from active corrosion. Strangely enough, surrounding concrete at such spots was often porous and with many voids (Figure 3.7).

(a) Uncorroded damaged spot near a crack within the wetted region (Upper bar)

(b) Uncorroded damaged spot near a crack on upper bar. Damaged spot at crack location experienced extensive corrosion on lower bar

Figure 3.6 *Uncorroded damaged spots on longitudinal bars of beam B10.*

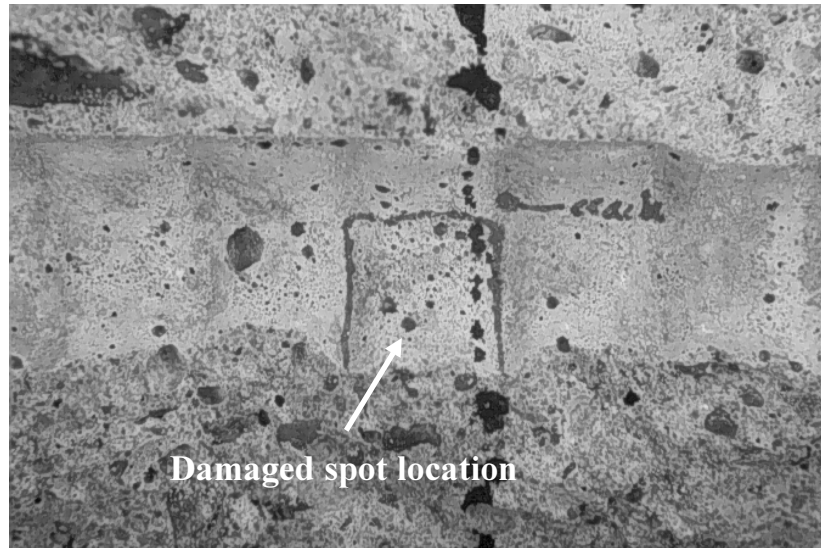
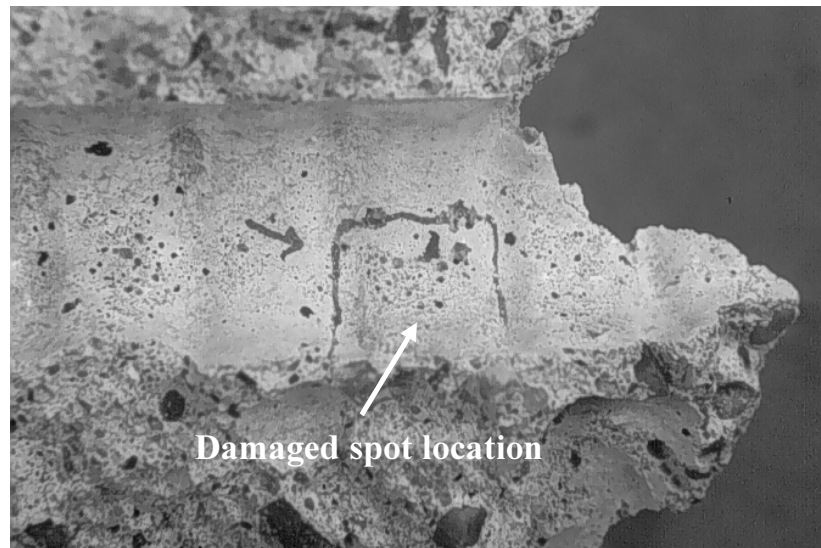
(a) Concrete surrounding uncorroded damaged spot outside the wetted region

(b) Concrete surrounding uncorroded damaged spot within the wetted region

Figure 3.7 Concrete surrounding uncorroded damaged spots (Upper bar of beam B10).

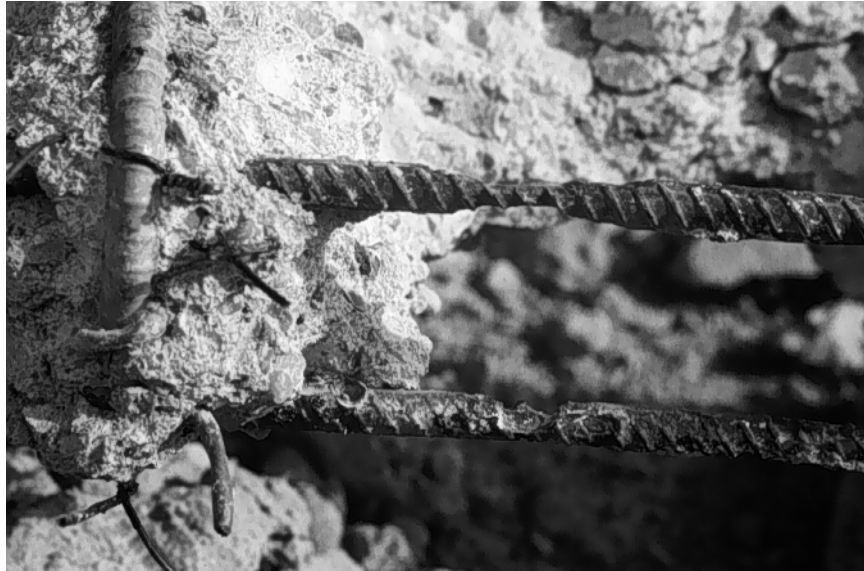
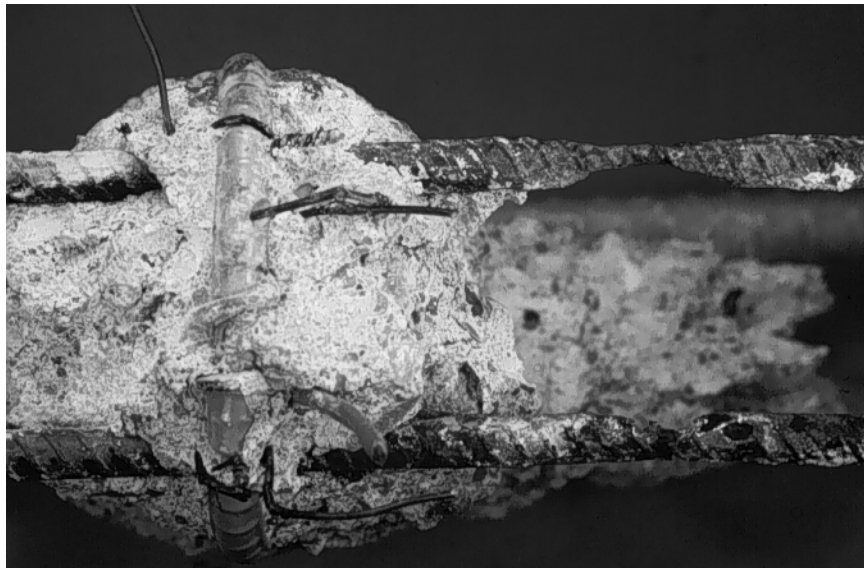
Interestingly, uncoated bars in beams from group I (longitudinal bars) underwent less severe pitting than uncoated bars in beams from groups II and III (stirrups and splice bars) after 4.3 years. Pits in uncoated bars from groups II and III were very deep and produced significant loss of cross-sectional area (Figures 3.8 and 3.9). Several factors may have contributed to this phenomenon. First, a larger area on the beam surface (twice as large) was exposed to chloride solution in beams from group I. Second, several cracks (from two to four) were enclosed within the wetted, exposed surface of beams in group I, while one crack only (sometimes two) was enclosed within the exposed areas of beams in groups II and III. In addition, cracks in group II beams were wider (0.15 to 0.35mm) than those in group I beams (0.08 to 0.20mm). Therefore, uncoated bars from beams in group I were exposed to chlorides and moisture over a larger portion compared to uncoated bars from groups II and III. A smaller surface area of bar tended to

(a) View immediately after autopsy

(b) Another view after autopsy

Figure 3.8 Severe pitting corrosion of uncoated bars at crack location (beam B27).

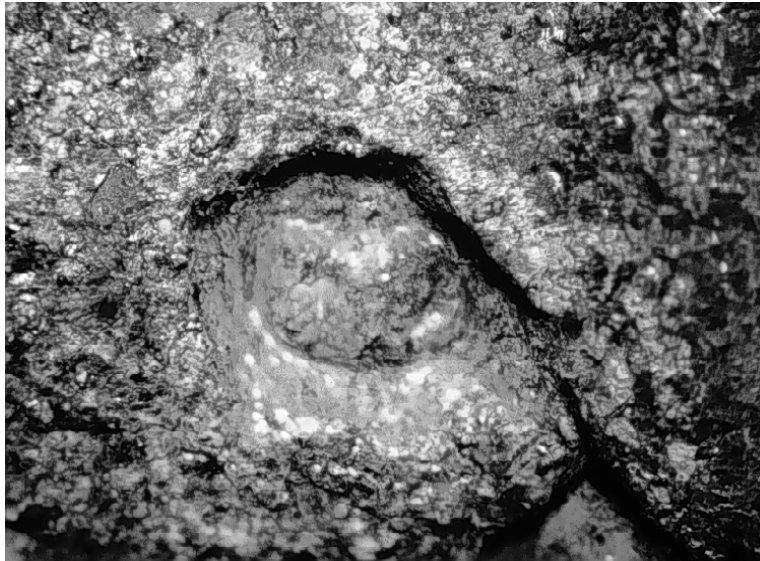
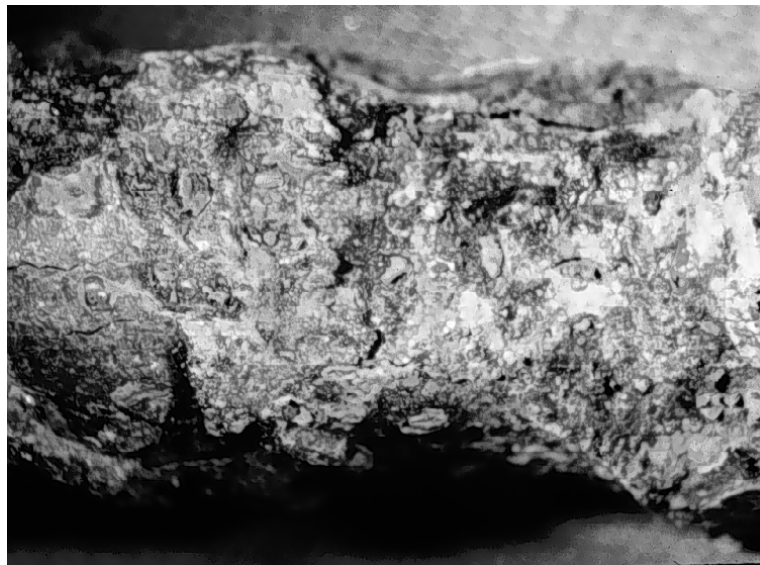
Significant pitting was only observed on damaged longitudinal bars in beams with opened cracks. However, corrosion severity on these coated bars was still less than that observed on uncoated bars recovered from cracked beams. Figure 3.11 shows a close up of one pit that formed on an exposed area of a coated bar at a crack location, and an example of surface degradation of an uncoated bar at another crack location. Hence, coated bars, even with heavy damage, had improved performance relative to uncoated bars.

(a) Pitting on damaged longitudinal bar (B11-upper)

(b) Pitting on uncoated bar (B26)

Figure 3.11 Pitting corrosion on coated and uncoated bars in beams with opened cracks (at one year).

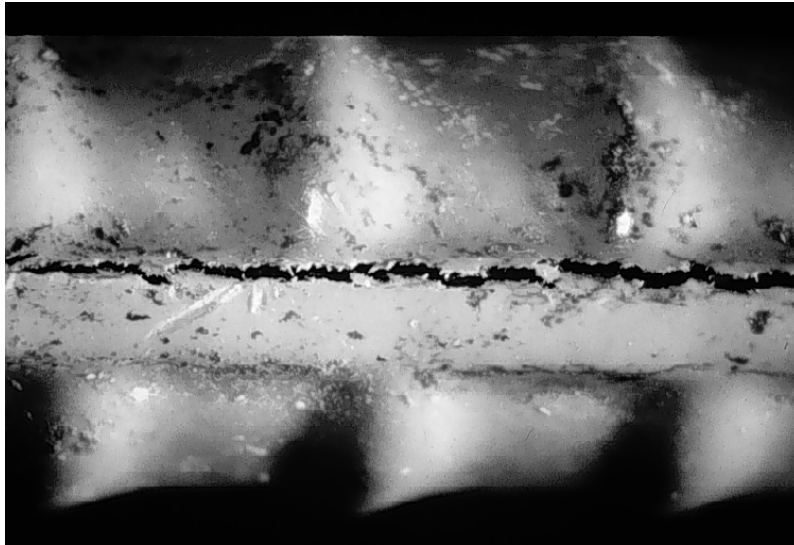
Generally, the coating of stirrups tended to break down along the longitudinal rib as observed on a number of corroded stirrups. A typical crack in the coating extending along a stirrup leg is shown in Figure 3.12. The coating on the bar rib is particularly weak.

Figure 3.12 Cracking of coating along stirrup leg.

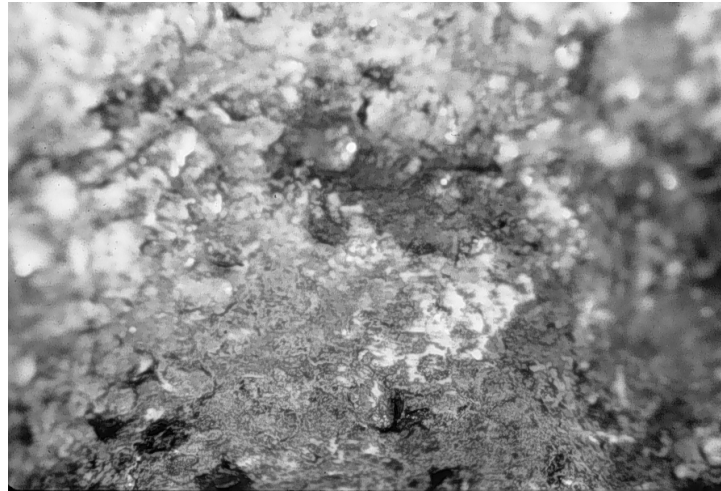
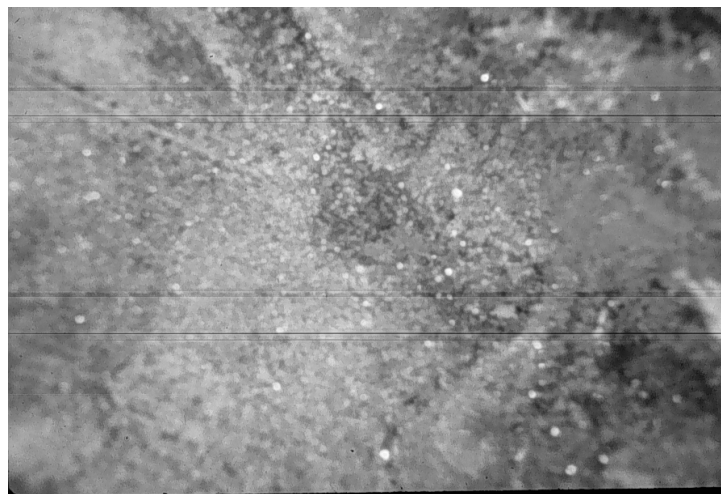
Among the major factors affecting the effectiveness of patching are the thickness of patching material and surface anchor pattern. The thickness of a chipped piece of patch material from a bar cut end was measured and found to be only 75-100 μm (3-4 mils) thick which is approximately one-third of the required fusion-bonded coating thickness. Cut ends of bars are usually not prepared for patching; the steel

surface is not roughened to provide an anchor profile. As a result, coating adhesion at cut areas remains weaker than that at the bar surface. Figure 3.14 demonstrates the difference in appearance of the backsides of two chipped pieces of coating: one from electrostatically sprayed coating; and the other from brushed patching compound.

(a) Fusion-bonded epoxy coating

(b) Patching coating

Figure 3.14 Roughness on contact surface of coating after one year.

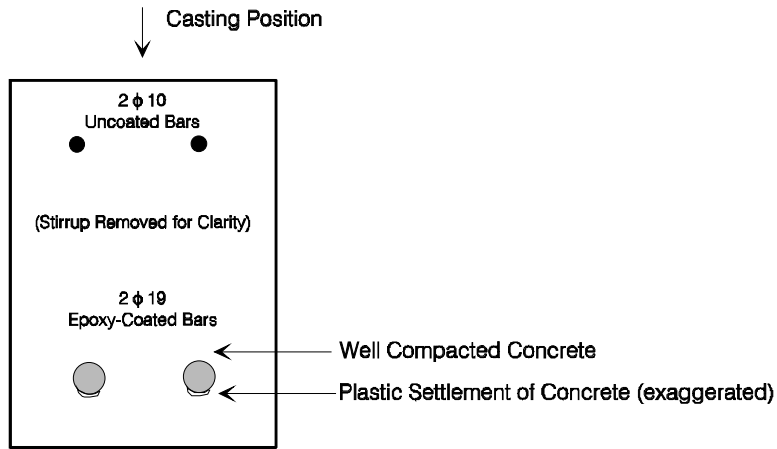
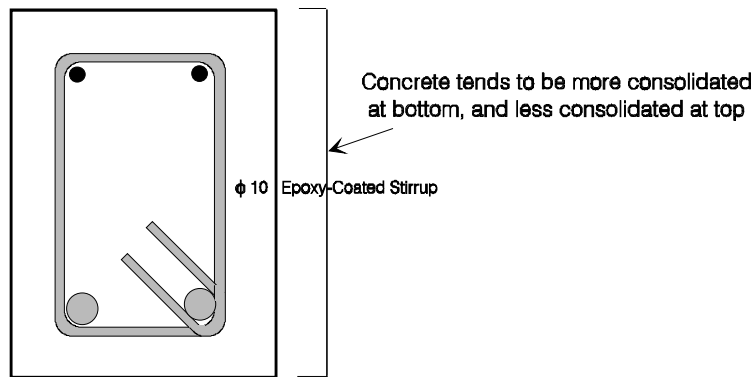
Small gaps and air pockets may form under the coated bar during concrete consolidation. By contrast, a smooth and continuous interface layer may form on top of the bar. Such variation in the concrete density was more noticeable for longitudinal bars than for stirrups. Figure 3.16 shows two cross sections of a beam specimen in the casting position to demonstrate the variation in concrete quality at different regions.

(a) Cross-Section of Beam Showing Longitudinal Bars

(b) Cross-Section of Beam Showing All Details

Figure 3.16 Variation of concrete quality in beam cross section.
