**CORROSION PERFORMANCE OF EPOXY-COATED
REINFORCEMENT-BEAM TESTS**

Research Report No. 1265-4

STRUCTURAL INTEGRITY OF EPOXY-COATED BARS

Texas Department of Transportation

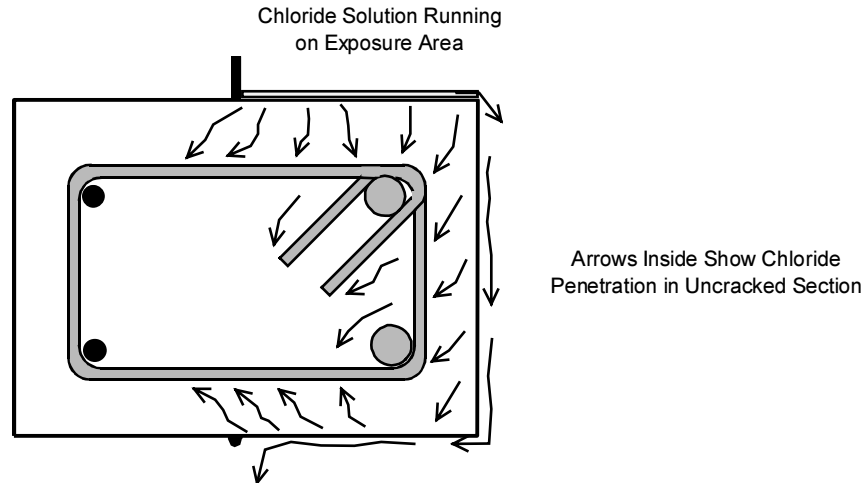
Variation in the concrete density surrounding the reinforcing bar creates concentration cells which, in turn, produce differences in potential and lead to macrocell action. Non-uniform chloride concentrations around the bar were probably the most significant contributor to corrosion initiation and acceleration in the beam test. Differences in chloride concentration at the top and bottom of the bar result from variations in chloride penetration as illustrated in Figure 3.17. In addition, the amount of chloride ions that can accumulate in the zone immediately above the bar may be limited by concrete density. However, the less dense zone beneath the bar can retain more chlorides. Moreover, the surface below the coated bars (in the cast position) was closer to the exterior, irrigated surfaces. Consequently, slightly more corrosion and blistering were observed on the lower half of the longitudinal bars than on the top half. Concrete surfaces below the bars had more extensive rust staining than concrete surfaces above the bars. Nevertheless, corrosion was observed on the upper half of the bars and was more extensive after 4.3 years than after one year.

Figure 3.17 Chloride penetration in uncracked beam cross section.

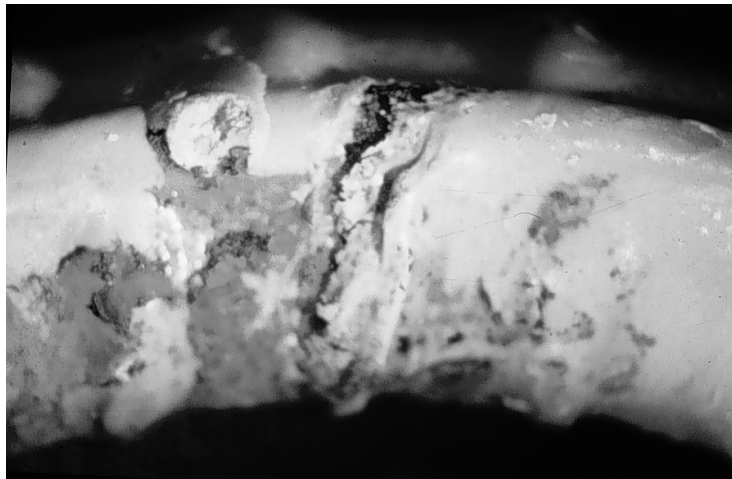
Electrical continuity between the stirrup and uncoated bars was possibly present through damage at contact points and may have affected corrosion performance. Damage on the inside of the bend of stirrup was introduced either during fabrication (in the form of mashed spots) or by cutting through the coating during cage assembly. An example of the later is shown in Figure 3.25. Sometimes, the protected tie wire was stripped under the action of twisting causing the metal to be uncovered. Another possible source of continuity could be semiconducting corrosion products that accumulated around the contact points, bridging the gap between uncoated bars and exposed areas in stirrups, as shown in Figure 3.26.

Figure 3.25 Damage of coating of stirrup at contact with uncoated bar.

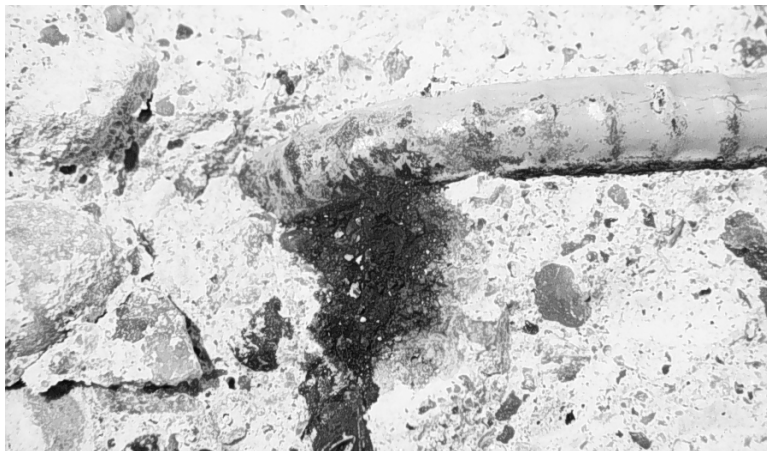
Figure 3.26 Corrosion at location of contact of coated stirrup and uncoated bar.

During the first year of exposure, a strong macrocell action was developed between the stirrup in a highly contaminated region and uncoated bars stretching along uncontaminated concrete. In many cases, cracks facilitated the ingress of chlorides and oxygen to the contact points and promoted corrosion initiation. The uncoated bars, for the most part, were initially cathodic with respect to the stirrup and corrosion activity occurred near the contact points because of the distance effect (anodes tend to locate closest to cathodes). Figure 3.27 demonstrates the macrocell formation for stirrups in cracked beams. Due to availability of a large cathode in the form of the intersecting longitudinal bar, corrosion on stirrups was extensive and anodically controlled.

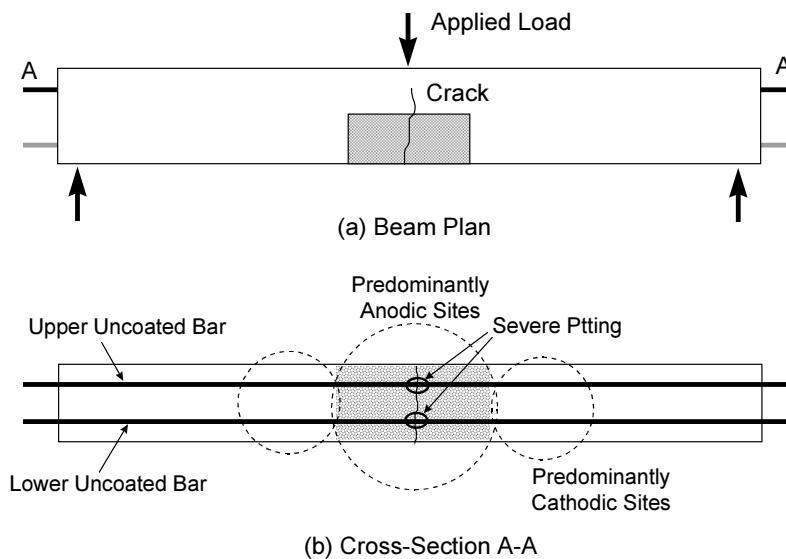
Uncoated bars in the compression zone of the beams exhibited severe macrocell corrosion. The lack of a protective coating allowed the steel surface to be continuously exposed through wetted and dry regions, and through regions with variable moisture content and chloride contamination (Figure 3.28). Bars became anodic within wetted regions, at crack locations or other locations where chlorides accumulated in high concentrations. Anodic regions were characterized by moderate or severe pits with dark-greenish corrosion products. Cathodic portions generally developed at wet-dry transition regions, where chloride content was slightly lower than that at wetted regions near midspan, but some moisture (and a highly alkaline environment) was available. Sometimes, cathodic regions were within the wetted zone, to the left or right of midspan, while the rest of the bar within the wetted region was anodic. The differential alkaline and salt concentrations generated a potential difference between contaminated parts and adjacent areas. As a result, galvanic corrosion currents flowed between the small anodes and large cathodes. Unrestricted availability of oxygen maintained corrosion under anodic control.

Figure 3.28 Macrocell corrosion of uncoated bars.

Uncoated bars in beams groups II and III underwent very severe pitting, with significant reduction of cross-sectional area and metallurgical degradation of sound steel. The macrocell effect was more intense than in beam group I, possibly because of a smaller wetted region typically enclosing one wide crack. Group I beams had a larger wetted region enclosing more narrow cracks. Consequently, a smaller

anode/cathode ratio developed in bars from groups II and III, resulting in severe pitting at the crack location. Although corrosion spread from the active area at the crack, intensive macrocell action was sufficient to cause severe localized metal consumption in a very small portion.

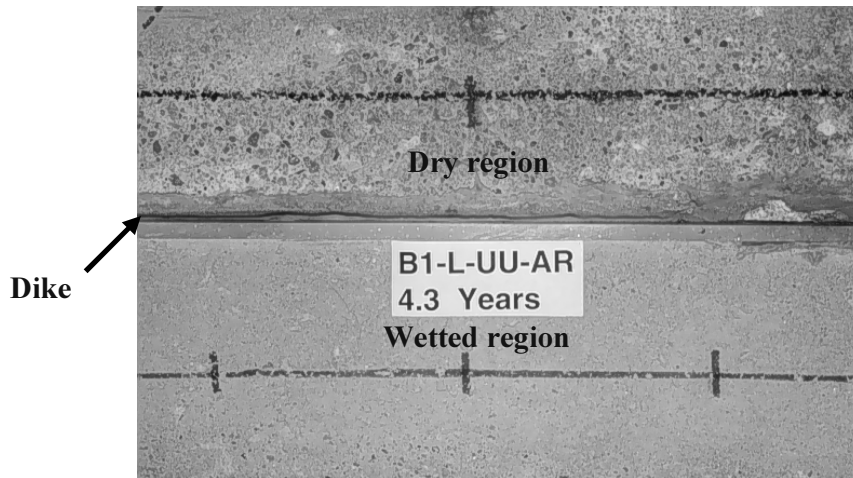
(a) Beam B1, top surface (plan view)

A mechanism of concrete deterioration, similar to that of macrocell specimens with uncoated bars, took place in all beams. As was mentioned in Chapter 2, the concrete surface deteriorated and scaled within the wet zone and in regions outside the wet zone (Figure 3.29). Concrete scaling outside the wet zone was more extensive and severe at the bottom surfaces, and the degree of scaling ranged from light to severe. Scaling was usually worse outside the wetted regions. Scaling extended up to 76cm to each side of midspan in beams group I and up to 51cm to each side of midspan in beam groups II and III.

Concrete scaling and non-structural cracks were caused by forces from expansive hydrated salt crystals that were driven through concrete pores after periodic cycles of wetting and drying. When water evaporated during dry cycles, salts in the form of crystals were left in the capillary pores. Upon subsequent wetting, the crystals re-hydrated and grew, exerting an expanding force on the surrounding cement paste. The crystallization of salt in a zone having a free evaporation surface or one that the solution reaches by capillary forces, such as the regions adjacent to the wetted zone in the beams, results in destructive internal pressures that may crack and deteriorate the concrete.^{1, 45, 46} Such surfaces are vulnerable because free evaporation results in an increase of salt concentration. At scaled areas, the hardened cement paste and embedded fine aggregate particles were removed, leaving behind protruding coarse aggregate particles (Figure 3.29). Large deposits of salt crystals were visible at scaled surfaces.

Figure 3.29 Concrete scaling inside and outside wetted regions. Scaling was more severe outside (but near) wetted regions.

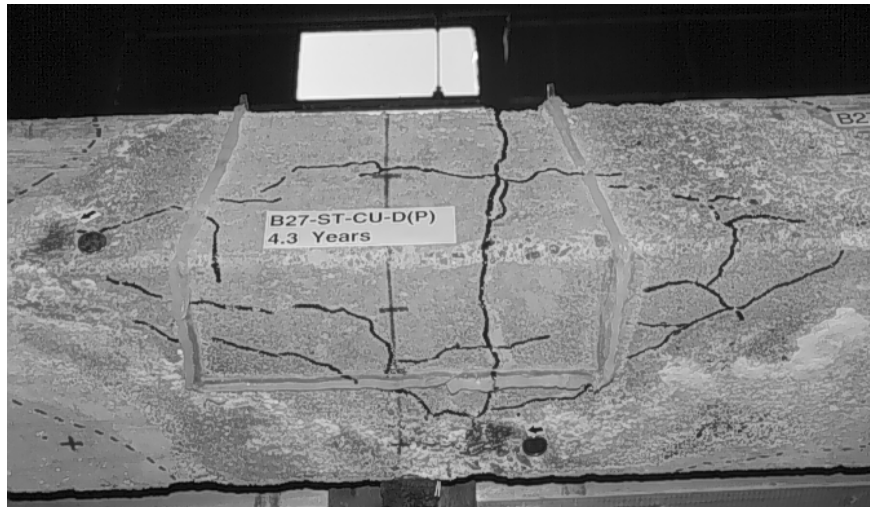
In addition to concrete scaling, loaded and unloaded beams experienced cracking with random orientation, mainly longitudinal, at and around the wet zone (Figure 3.30). Such cracks appeared between 2.5 and 3.6 years, and had a maximum width of 0.20mm, with most between 0.08 and 0.10mm. No signs of rust were found inside or around such cracks.

Figure 3.30 Random cracking at and around wetted region of beam B27.

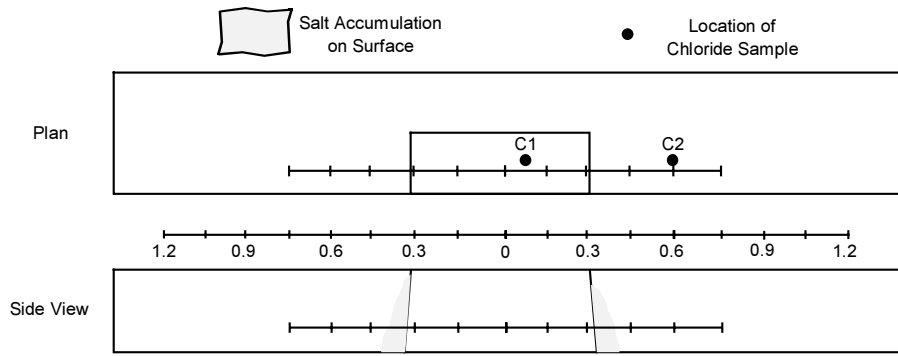
Figure A.23 Surface condition of beam B2-L-UU-AR after one year of exposure.

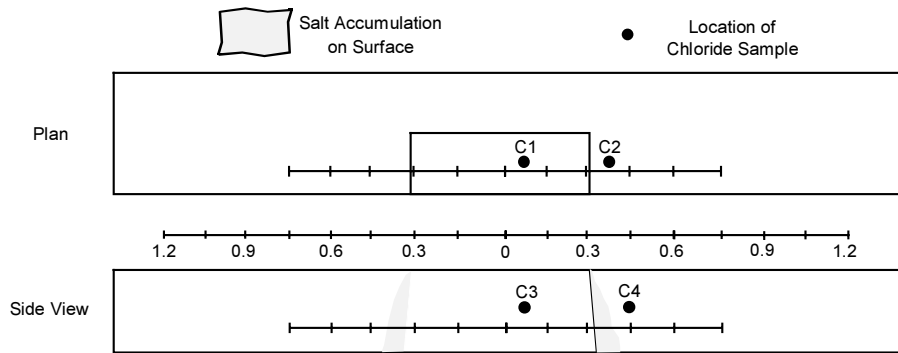
Figure A.24 Surface condition of beam B7-L-UU-D after one year of exposure.

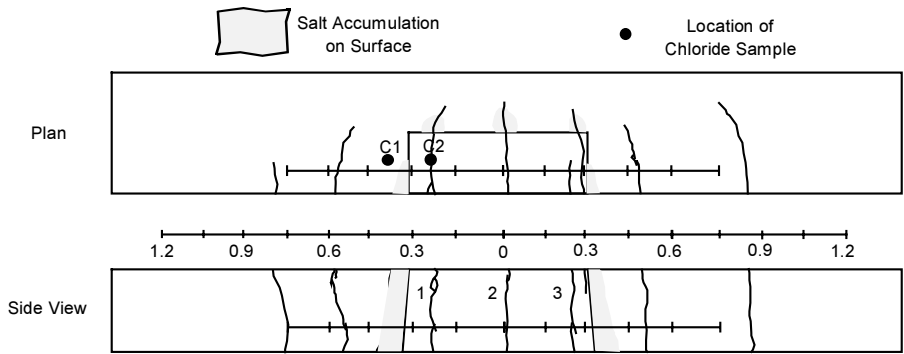
Figure A.25 Surface condition of beam B4-L-CU-AR after one year of exposure.

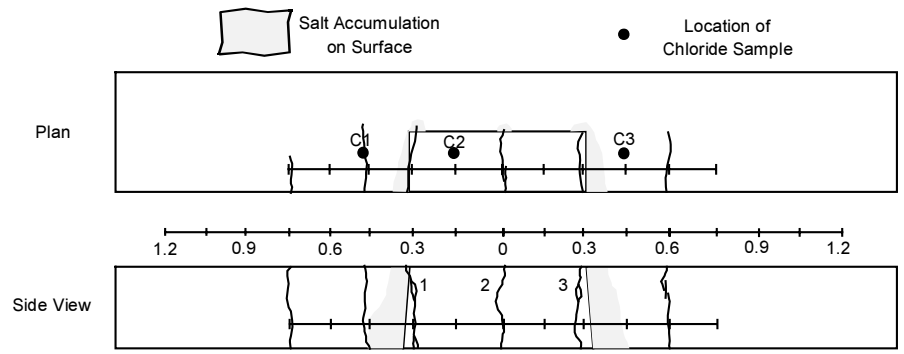
Figure A.26 Surface condition of beam B5-L-CL-AR after one year of exposure.

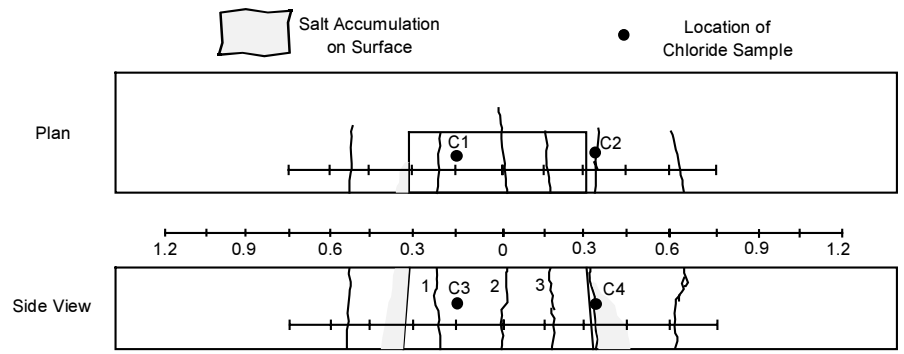
Figure A.27 Surface condition of beam B11-L-CL-D after one year of exposure.

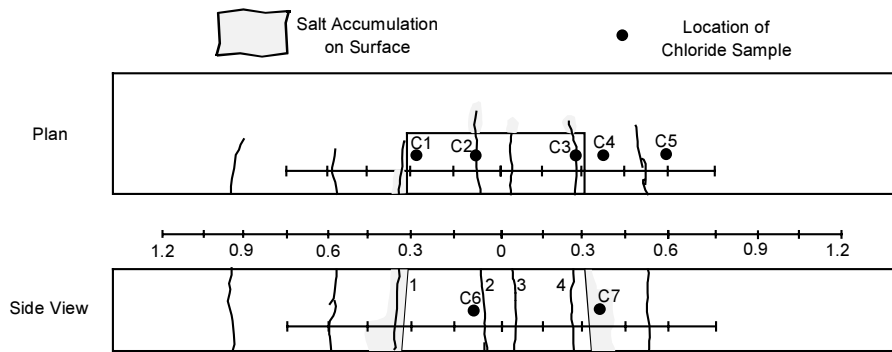
Figure A.28 Surface condition of beam B9-L-CU-D after one year of exposure.

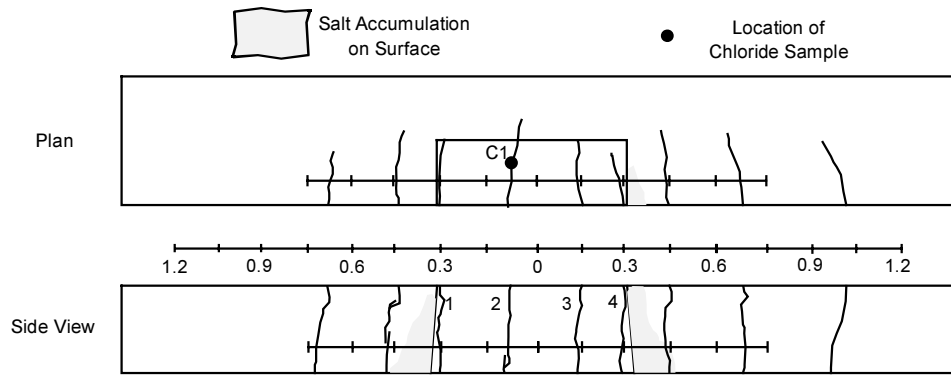
Figure A.29 Surface condition of beam B13-L-CU-D(P) after one year of exposure.

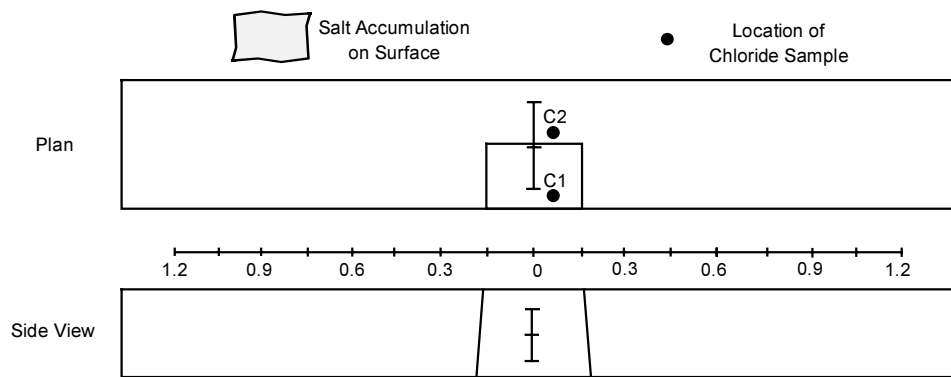
Figure A.30 Surface condition of beam B16-ST-UU-AR after one year of exposure.

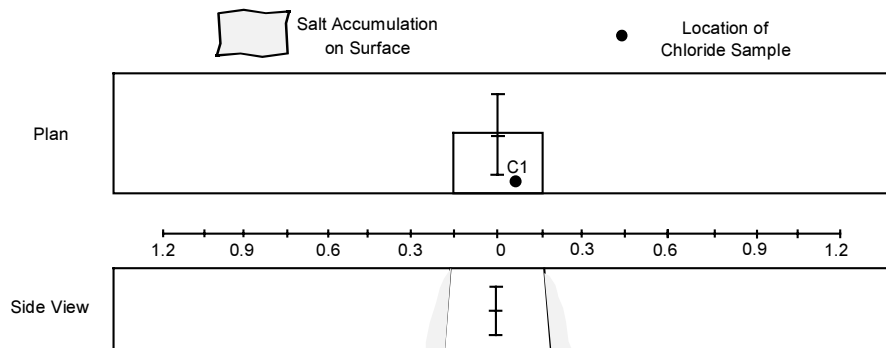
Figure A.31 Surface condition of beam B21-ST-UU-AR(P) after one year of exposure.

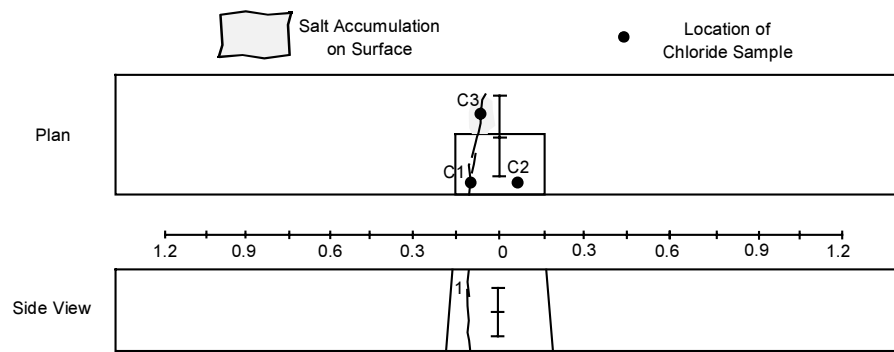
Figure A.32 Surface condition of beam B18-ST-CU-AR after one year of exposure.

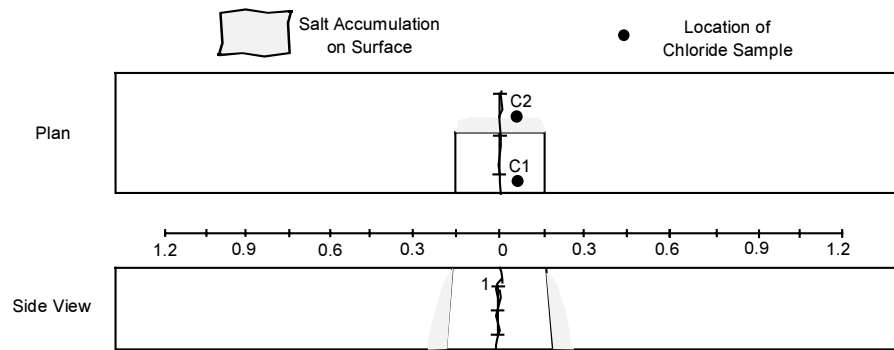
Figure A.33 Surface condition of beam B20-ST-CL-AR after one year of exposure.

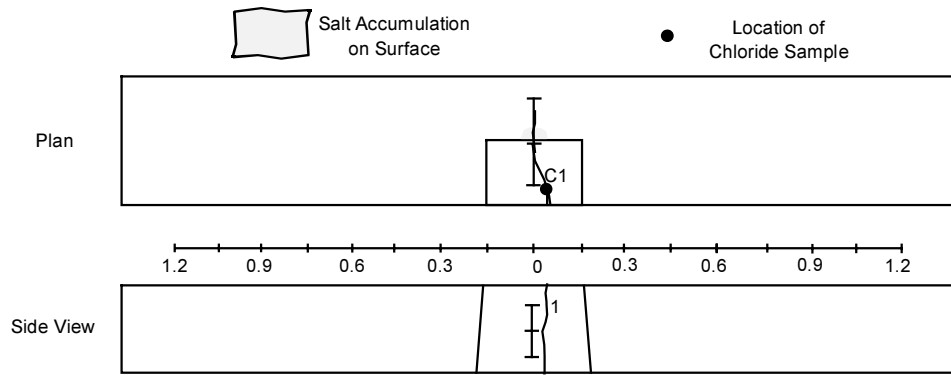
Figure A.34 Surface condition of beam B26-ST-CL-AR(P) after one year of exposure.

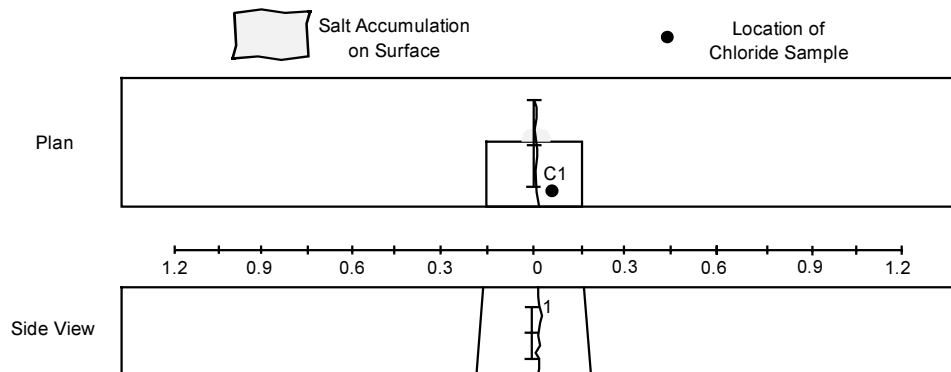
Figure A.35 Surface condition of beam B24-ST-CU-AR(P) after one year of exposure.

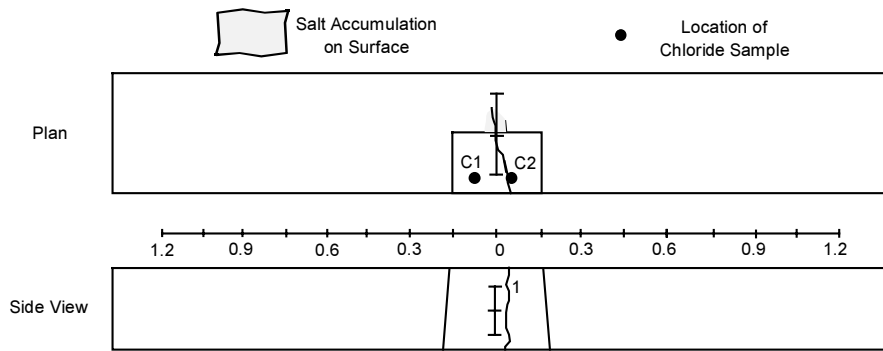
Figure A.36 Surface condition of beam B28-ST-CU-D(P) after one year of exposure.

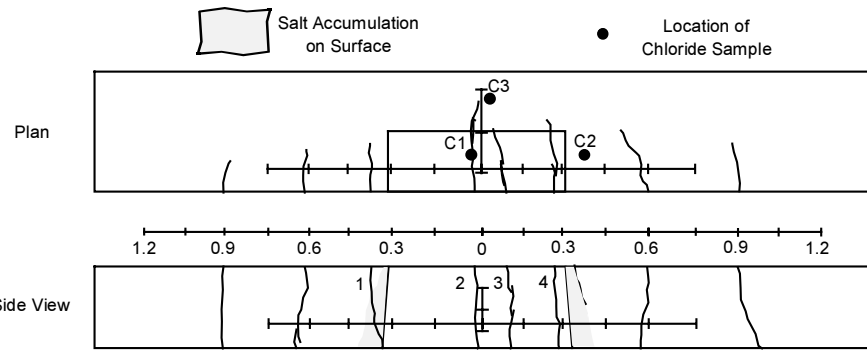
Figure A.37 Surface condition of beam B29-L/ST-CU-D(P) after one year of exposure.

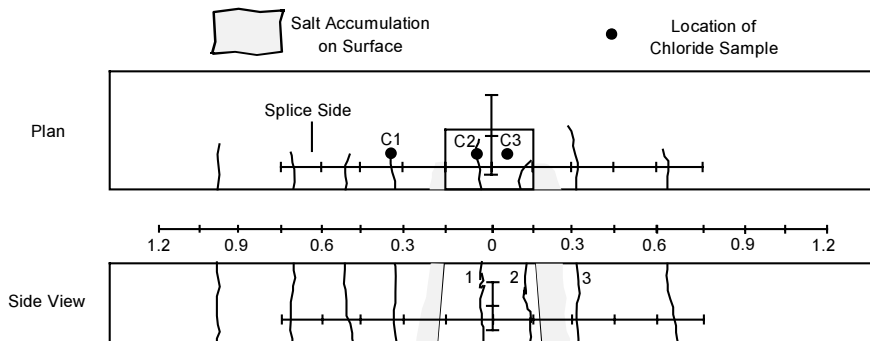
Figure A.38 Surface condition of beam B31-SP-CU-D(P) after one year of exposure.

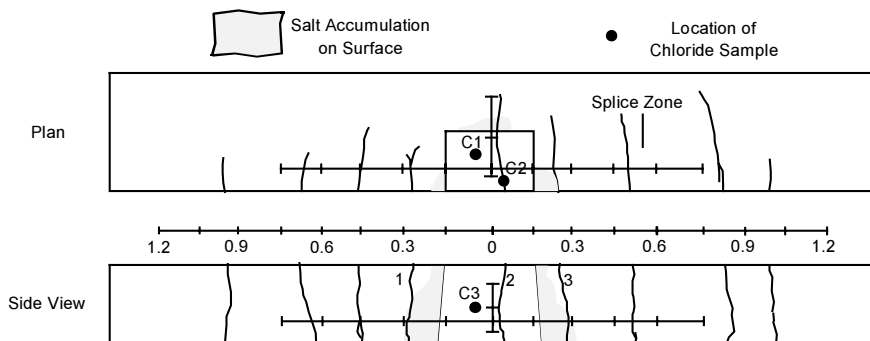
Figure A.39 Surface condition of beam B33-SP-CU-D(P) after one year of exposure.

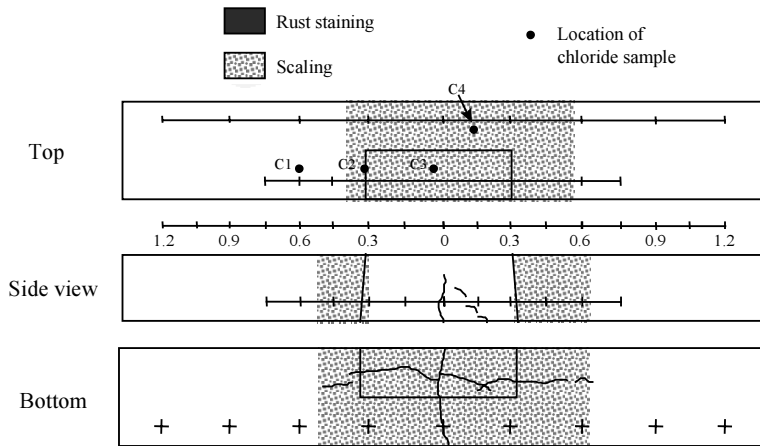
Figure A.40 Surface condition of beam B1-L-UU-AR after 4.3 years of exposure.

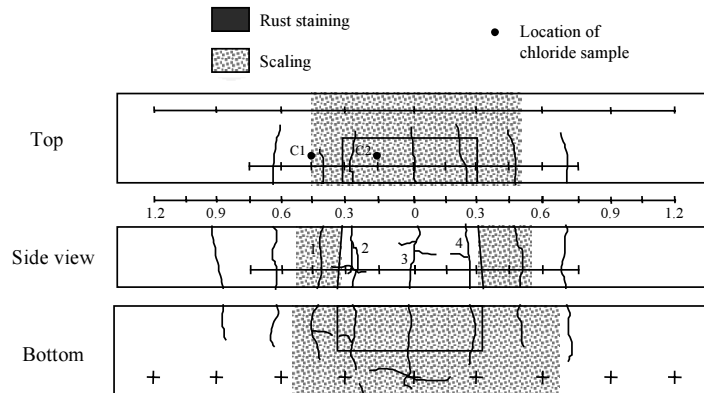
Figure A.41 Surface condition of beam B3-L-CU-AR after 4.3 years of exposure.

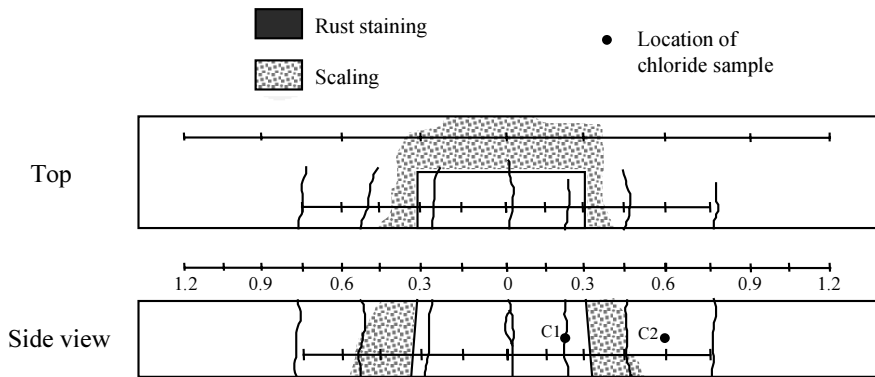
Figure A.42 Surface condition of beam B6-L-CL-AR after 4.3 years of exposure.

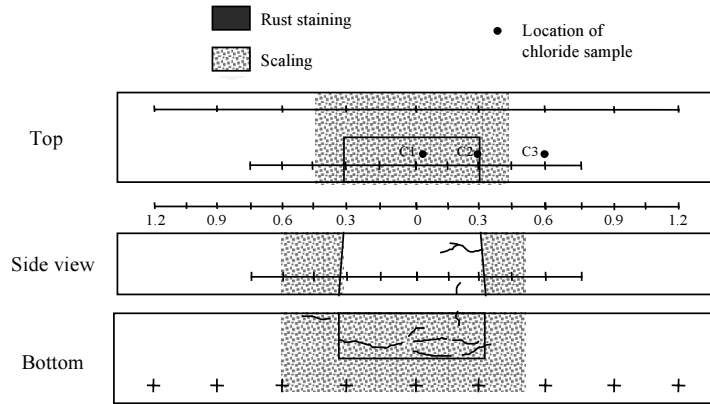
Figure A.43 Surface condition of beam B8-L-UU-D after 4.3 years of exposure.

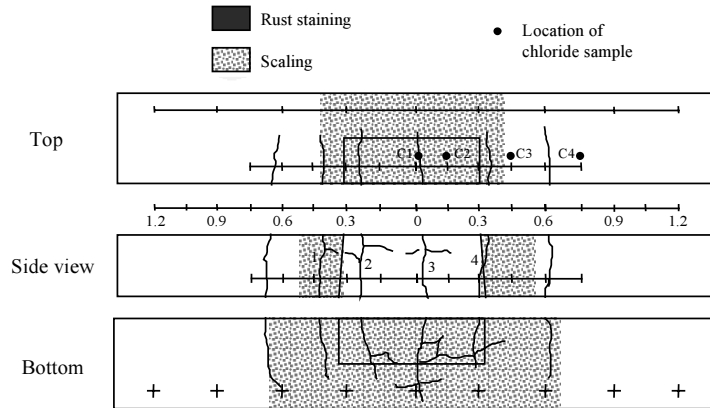
Figure A.44 Surface condition of beam B10-L-CU-D after 4.3 years of exposure.

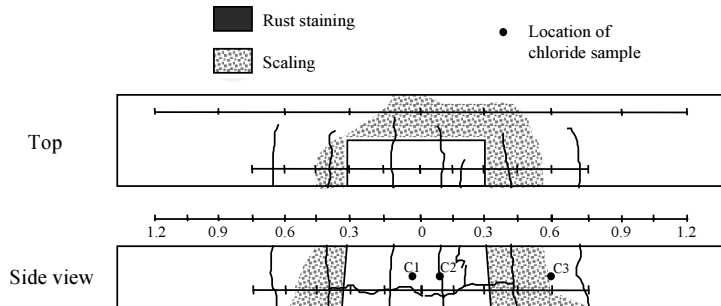
Figure A.45 Surface condition of beam B12-L-CL-D after 4.3 years of exposure.

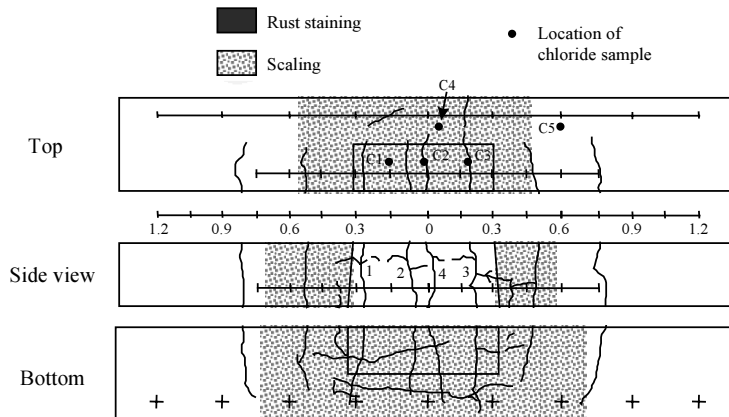
Figure A.46 Surface condition of beam B14-L-CU-D(P) after 4.3 years of exposure.

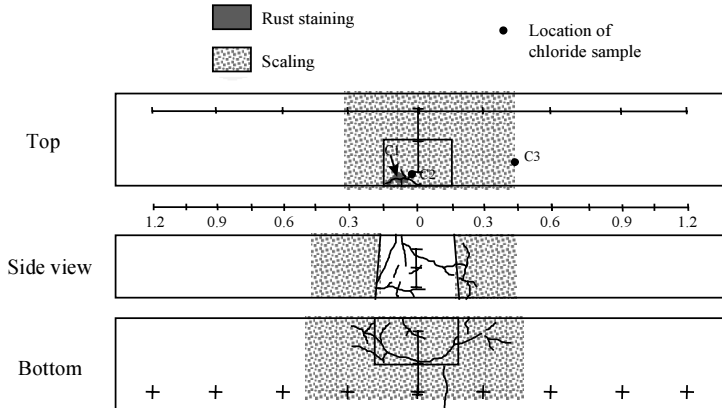
Figure A.47 Surface condition of beam B15-ST-UU-AR after 4.3 years of exposure.

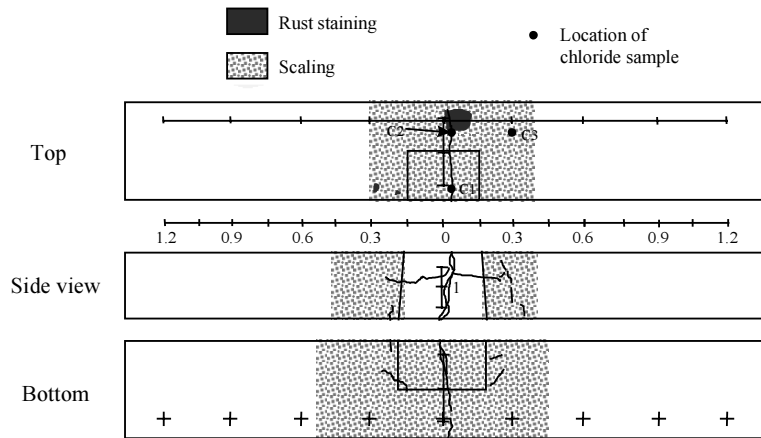
Figure A.48 Surface condition of beam B17-ST-CU-AR after 4.3 years of exposure.
