REPAIR OF EPOXY-COATED REINFORCEMENT

Research Report No. 1265-5

STRUCTURAL INTEGRITY OF EPOXY-COATED BARS

Texas Department of Transportation

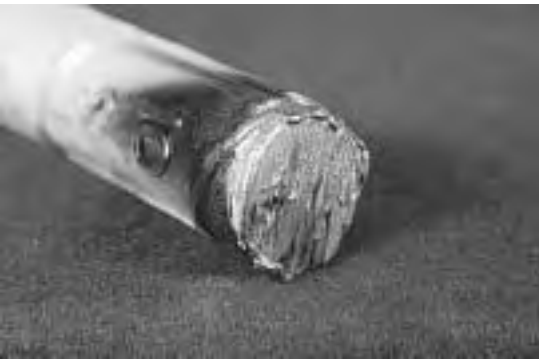
(c) Torch-cut bar end (IV).

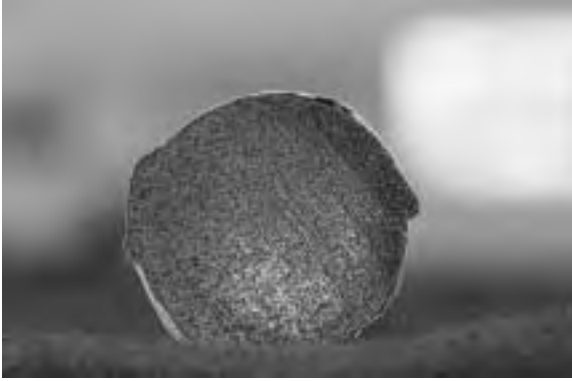
(a) Uncleaned bar end surface after 2 weeks of exterior exposure.

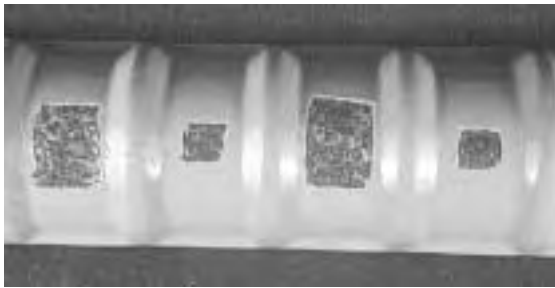
(c) Appearance of damaged areas after two weeks of outside exposure.

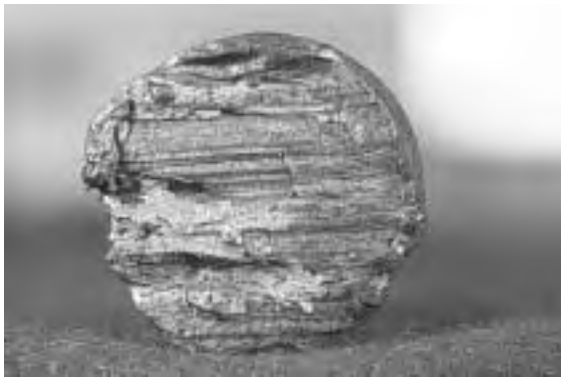
(e) Appearance of torch-cut end after two weeks of exterior exposure.

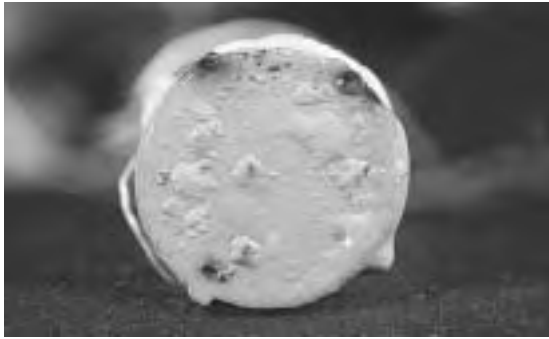
1. Salt solution permeated through patch layers until patch eventually lost adhesion and slightly bulged at certain areas of small to medium size [Figure 3.5(a)]. Solution seemed to be trapped underneath patch at such areas. This phenomenon is called patch softening in this discussion

because the patch felt soft at these areas. Small to medium size blisters developed on patched surface. At patched areas on bar sides, rust spotting or staining of small size formed anywhere on the patch surface (around blisters, at patch boundaries, on pinholes, etc.). On patched ends, rust spotting or staining of small or medium size formed preferentially around perimeter of bar end, at burrs, at slag ridges, and around blisters [Figure 3.5(a)].

(a) Corrosion stage 1.

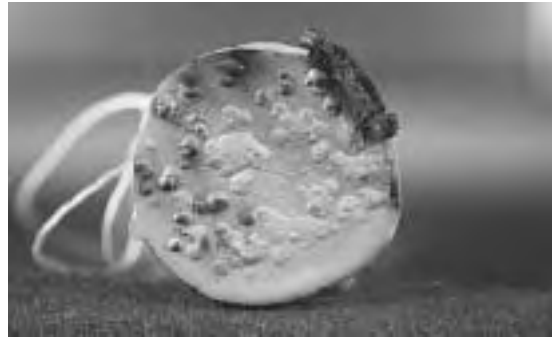
2. Corrosion progressed with subsequent wet-dry cycles. Debonded, softened patch areas increased in size. More blisters formed and existent blisters enlarged and bulged further. Already present rust spots and stains gradually increased in size and additional rust spotting sometimes appeared, especially around perimeter of ends [Figure 3.5(b)].

(b) Corrosion stage 2.

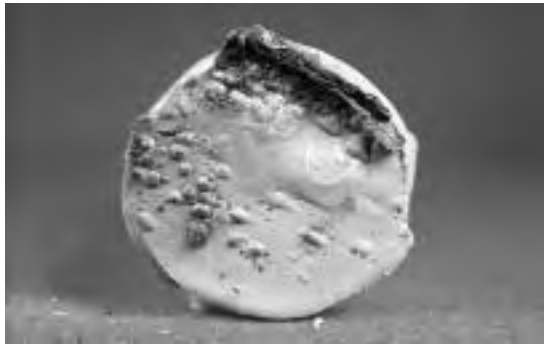
3. Patch broke and rust exuded at blister edges (all patched areas) and perimeter edges (bar ends) [Figure 3.5(c)]. More salt solution and oxygen was accessible to steel surface through small zones of patch breakage. Areas of debonded patch material were of medium or large size. Medium to large rust stains were present. There was widespread rust staining around perimeter of bar ends and at sharp, projecting burrs and slag ridges [Figure 3.5(c)]. Rust staining and blistering spread beyond patched end section into adjacent bar side surface.

(c) Corrosion stage 3.

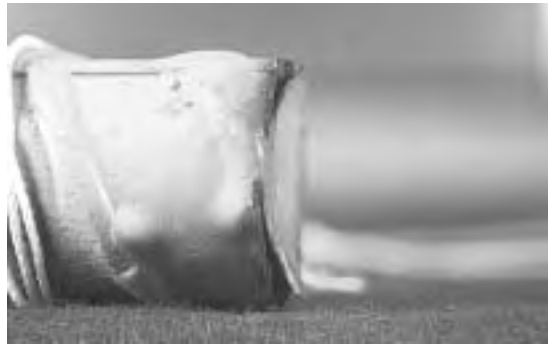
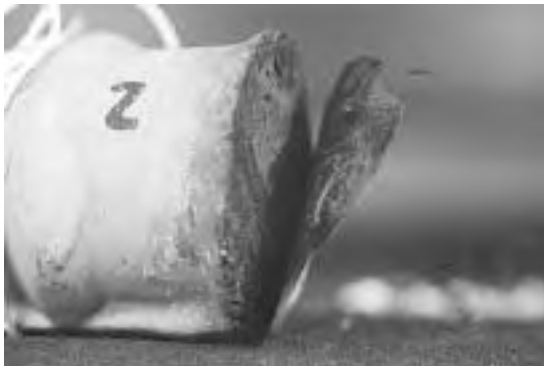
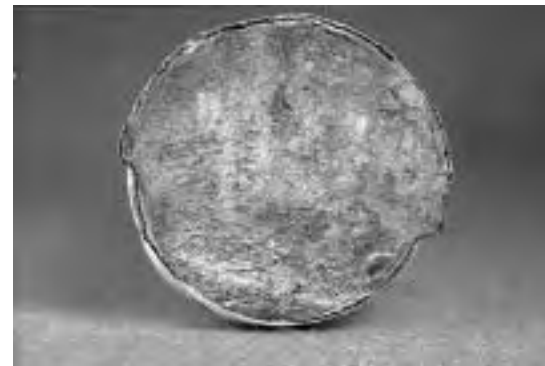
4. Widespread rust staining spread over the whole patch surface on bar ends (less extensive on other patched areas). Patch continued to break and separate from steel surface at perimeter of bar ends [Figure 3.5(d)]. In a few samples, patch material completely separated and lifted from the steel surface [Figure 3.5(e)]. Uniform corrosion (black or dark with spots of brown rust) developed on steel surface underneath the patch. Extent of uniform corrosion varied from a large portion of repaired area to the full patched area and spreading a few millimeters (centimeters on bar ends) into adjacent surface underneath epoxy coating [Figure 3.5(f)]. Fine reddish-brown (or other tones of brown) rust accumulated at areas where more salt solution was concentrated (softened or debonded patch and blisters). At blistered patch locations, corrosion products accumulated and formed hard mounds or protrusions. In some cases, shallow pits developed.

(d) Corrosion stage 4.

Figure 3.5 Corrosion progression of patched bar ends.

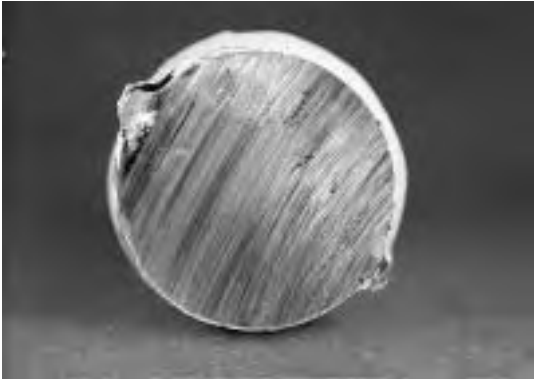
(a) Rating 1.

Figure 3.10 Corrosion rating of patched specimens.

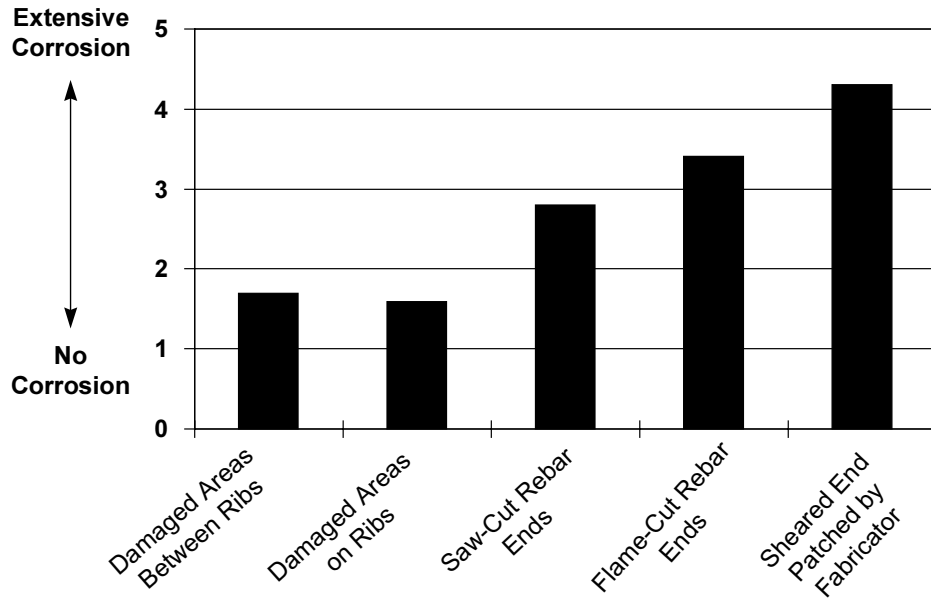
Most patched areas on the bar surface exhibited relatively good corrosion performance with an average corrosion rating of 1.7 (Type I) and 1.6 (Type II) (Figure 3.11). When corrosion occurred, it was rather superficial, with no appreciable amount of metal loss or pitting. Many specimens did not experience corrosion at all and the steel surface maintained its original condition (either cleaned or unclean). However, more specimens with patched ends experienced extensive corrosion, with an average corrosion rating for saw-cut ends of 2.8 and 3.4 for flame-cut ends. Shear-cut ends patched at the coating plant performed very poorly, with an average corrosion rating of 4.3 (Figure 3.11). Poor performance of patched rebar ends was due to the vulnerability of sharp edges as discussed earlier.

Figure 3.11 Corrosion rating of different damaged areas.

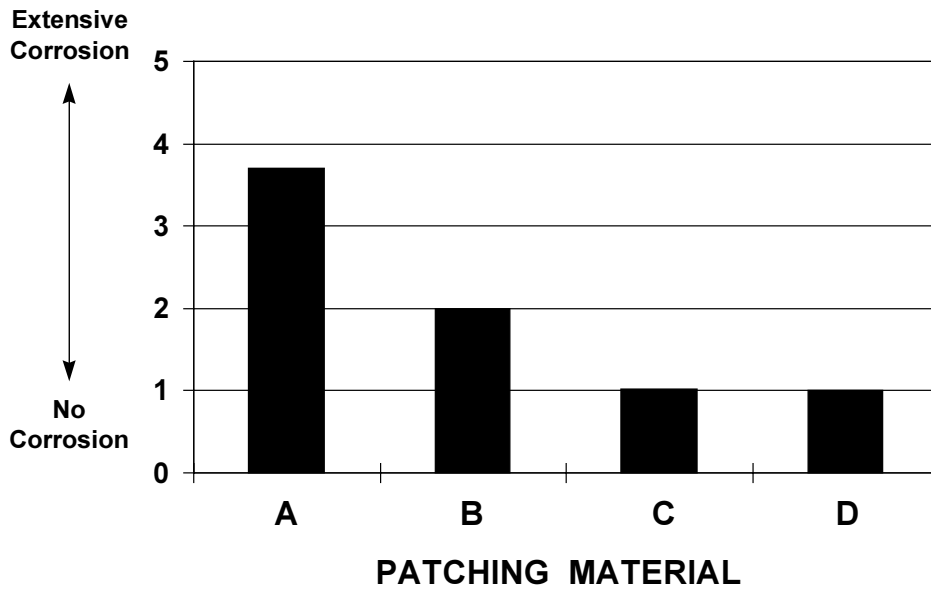
Consistently, specimens patched with materials *C* and *D* showed excellent corrosion performance (Figure 3.12). Specimens repaired with material *B* exhibited more corrosion than those specimens patched with materials *C* and *D*. Specimens patched with material *A* performed poorly. Figure 3.13 illustrates the performance of areas type I (patched damage between ribs), type II (patched damage on ribs), type III (saw-cut and patched rebar ends), and type IV (flame-cut and patched rebar ends) repaired with different patching materials. For all cases, patching material *C* performed best and material *A* worst. The average thickness obtained with each patching material is plotted at the top of both figures. Clearly, as patch thickness increased, corrosion performance improved.

Figure 3.12 Corrosion performance of different patching materials.

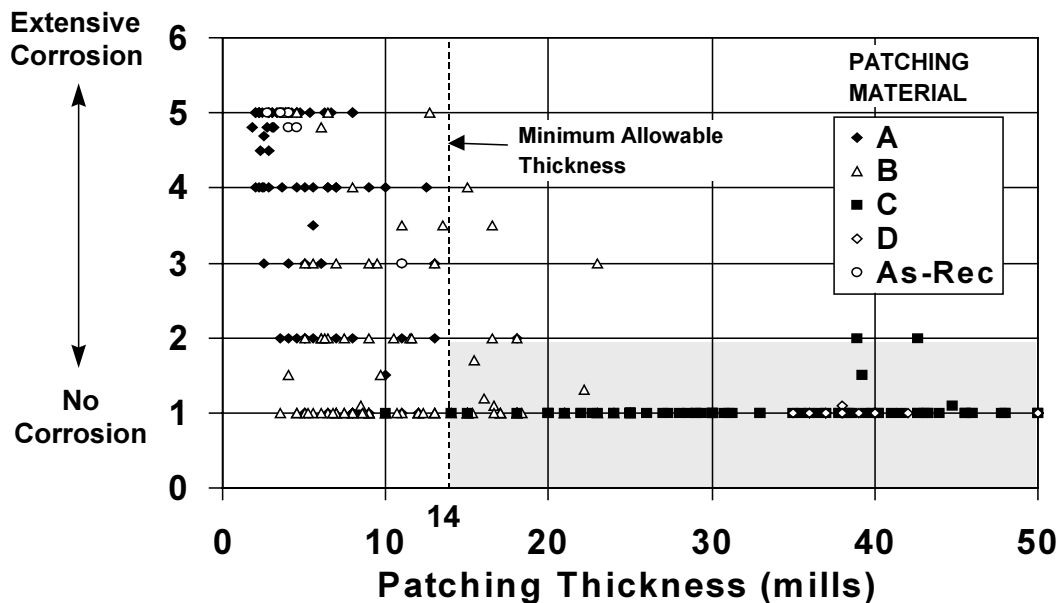
In Figure 3.14, thickness and corrosion performance are plotted for all patched areas. Although the data is scattered, trends can be observed. More specimens patched with material A lie in the high corrosion region and smaller patch thickness of the graph than specimens patched with other materials. For specimens patched with material B, more data points are in the low corrosion region and have greater

thickness than specimens patched with material A. Finally, specimens patched with materials C and D are prevalent in the region of greatest patch thickness and little to negligible corrosion. Again, performance improved with increasing patch thickness. Diffusion of chlorides through the patch was significantly delayed as patch thickness increased. Thicker patches provided good protection at vulnerable areas such as sharp edges of rebar ends, as shown in Figure 3.15.

A statistical evaluation of the data in Figure 3.14 may help determine minimum patch thickness. If ratings of 1 and 2 are considered acceptable (little to no corrosion) and ratings above 2 are unacceptable (moderate to extensive corrosion), analysis of the latter group of points shows that a thickness of 14 mils roughly corresponds to the 95 percentile of points with ratings greater than 2. In other words, 95% of data points with ratings above 2 (unacceptable performance) had thicknesses lower than 14 mils. Similarly, only 5% of data points with ratings above 2 had thicknesses greater than 14 mils (Figure 3.14). If it is assumed that the data constitutes a representative sample and 14 mils is established as the minimum effective patch thickness, material A would not be acceptable, material B would not be acceptable in most instances (only about one third of samples patched with material B had a thickness equal or greater than 14 mils), and materials C and D would be acceptable. The region containing data points with thicknesses greater than 14 mils and acceptable performance (ratings lower than 2) is shaded in the graph (Figure 3.14).

Figure 3.14 Corrosion rating vs. patch thickness of all specimens.

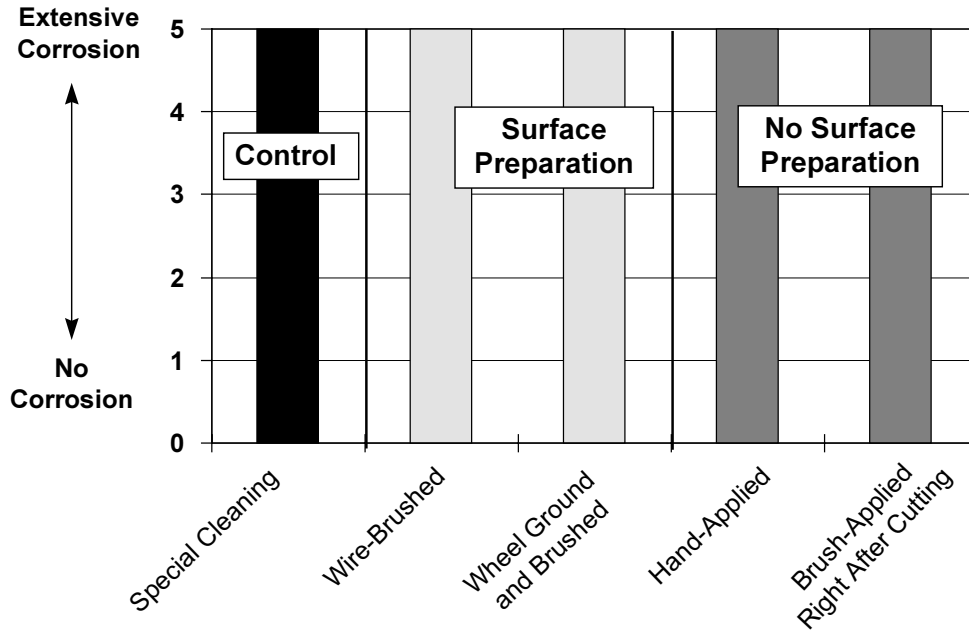
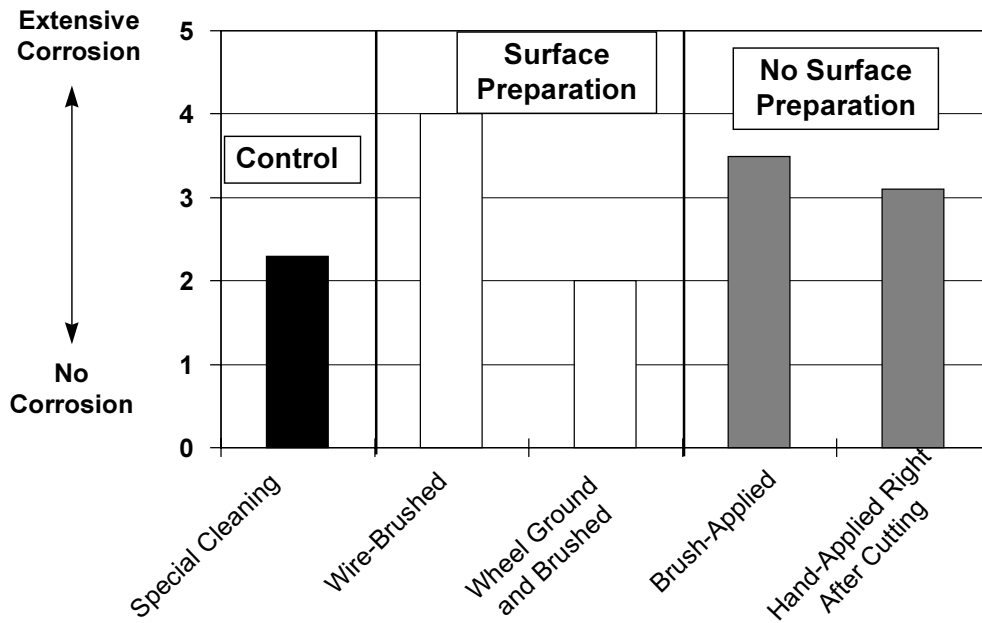
No clear trend was observed in terms of surface preparation. No improvement in performance was observed with surface cleaning before patching, as can be seen in Figures 3.16 and 3.17. Rounding and smoothing sharp edges at bar ends did not prove successful. Even some control specimens where the surface was specially cleaned showed poor performance (Figure 3.18). Manufacturers' application procedures indicate that proper surface preparation is important for satisfactory performance but this correlation is not supported by results obtained in this study. No correlation was found between size of patched areas and corrosion performance, as illustrated in Figure 3.19.

Figure 3.16 Corrosion rating for different surface preparations of flame-cut ends.
