EVALUATION OF FAILURE IN BRIDGE EXPANSION JOINT RAILS

Research Report Number 1309-1F

This report summarizes the investigation into the cause of failures of strip seal expansion joints at the US 83 and US 281 interchange at McAllen, Texas. The investigation was made at the request of the Texas Department of Transportation. The interchange of US 83 and US 281 at McAllen, Texas, opened in December of 1993, is composed of four unidirectional ramps (1, 2, 3, 4). Each of the ramps uses a mix of simple span AASHTO girders and continuous steel girders. The supporting substructure includes both concrete and steel bent cap systems with concrete piers. Concrete systems are inverted tee bents, hammerhead or tee piers and concrete beam straddle bents. Decking for all of these structures is 8-inch reinforced concrete with a design strength of 24.8 MPa (3600 psi). Concrete mixes for the deck were standard TxDOT S class mixes with a maximum aggregate size of 38 mm (1-1/2 inches). All ramps have vertical grade and most are in horizontal curves with super elevation.

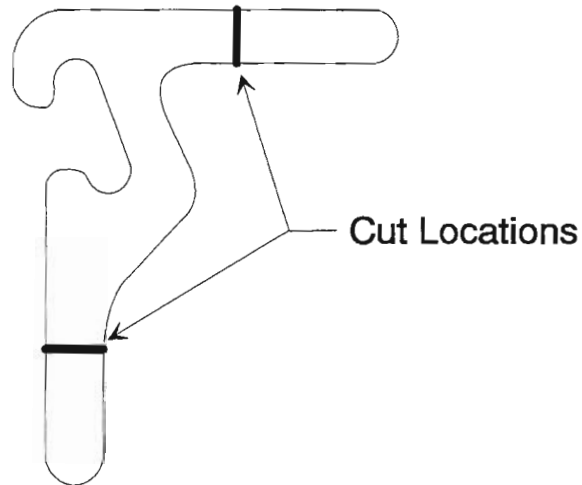
Figure 38 Locations of cuts to be made in rail

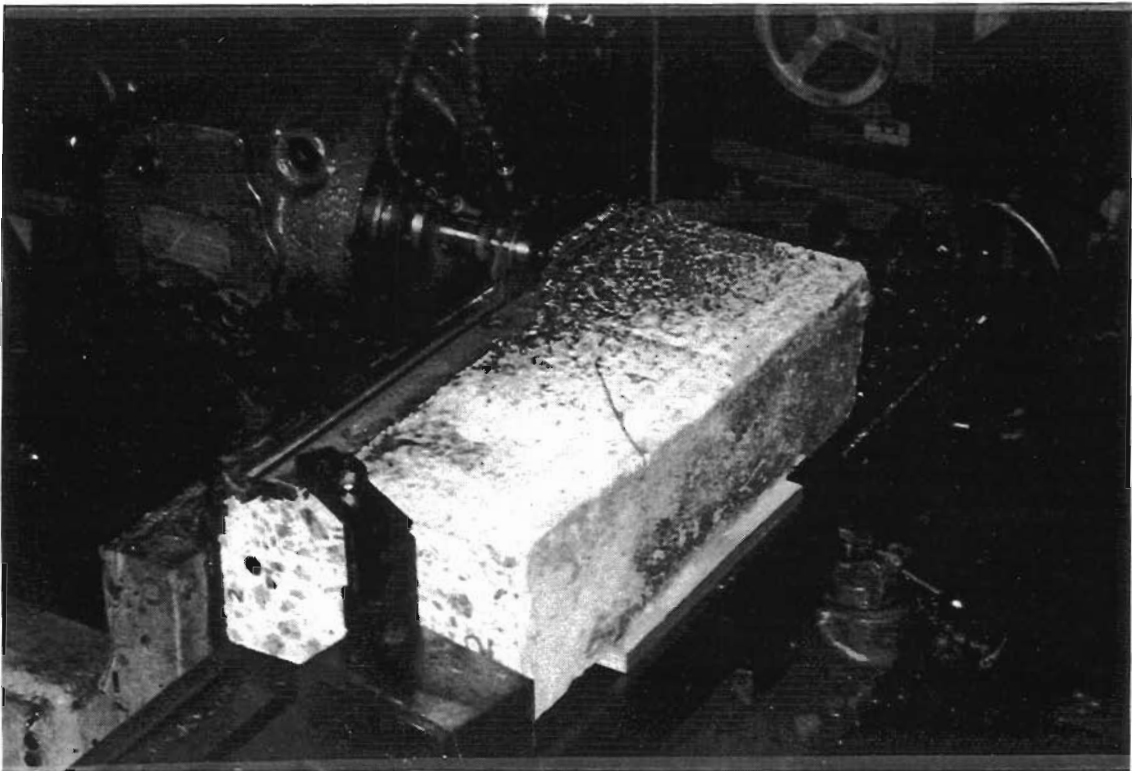
Figure 39 Roadway section in milling machine

Figure 40 Roadway section in milling machine

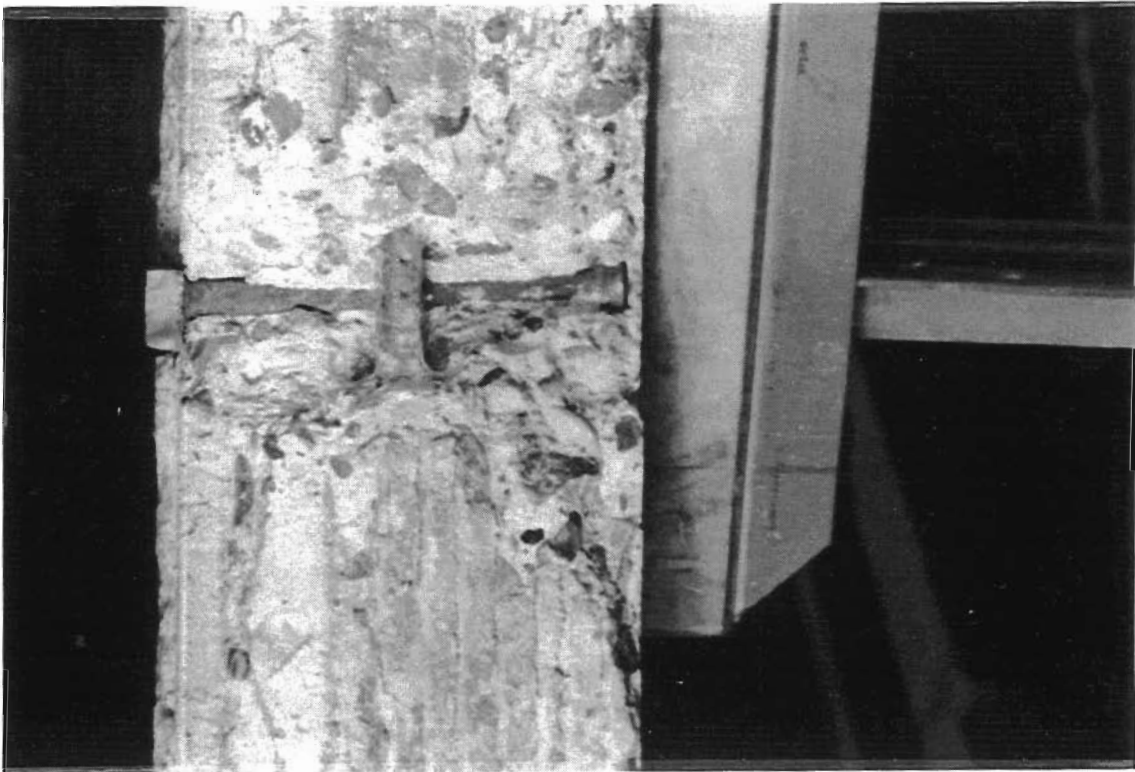
Before excavation of the stud, the excess rail on both sides of the stud was removed from the block. It was also noted that the area near the base of the stud had a void. This void is shown in Figures 47 and 48. The stud was excavated as shown in Figures 49 and 50. Excavation revealed that there was a small open area around the base of the stud. After completely exposing the stud it was removed from the block by cutting the reinforcing bar shown in Figure 50. The removed stud was then placed in a vise and the stud was bent over using a hammer. This bending over of the stud was done to test the soundness of the stud weld. The stud failed in this test and revealed an interesting fracture surface. By examining the fracture surface, Figures 51, 52 and, 53, it is apparent that the smooth semicircular region is a fatigue crack propagating through the stud. This type of crack would ultimately lead to failure of the stud. Figure 54 shows the orientation of the stud, fatigue crack, rail and roadway.

Figure 50 Excavation of study in roadway section

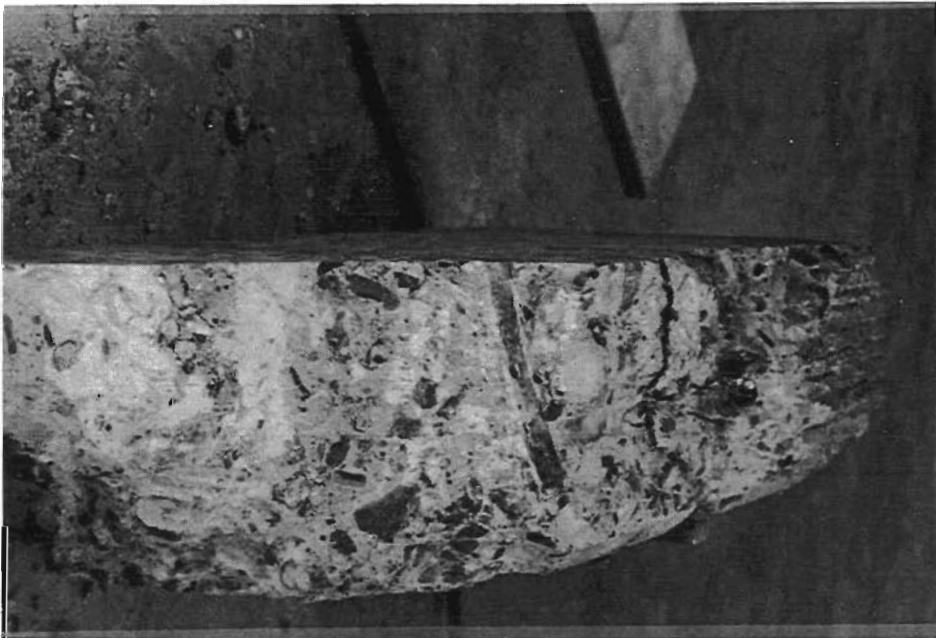
The second stud was then excavated from the section. It was assumed that this stud was already fractured at the time of the section's removal from the bridge deck. The location of the stud is indicated by the hole at the 431 mm (17") point in Figure 46. Excavation of this stud did not show any signs of improper consolidation along the stud section remaining in the block, Figure 55. This stud was a bent stud, but fracture occurred in a

Figure 55 Cross-section of roadway section after removal of stud
