**EVALUATION AND REPAIR OF IMPACT-DAMAGED PRESTRESSED
CONCRETE BRIDGE GIRDERS**

Research Report No. 1370-3F

Research Project 0-1370

MAY, 1996

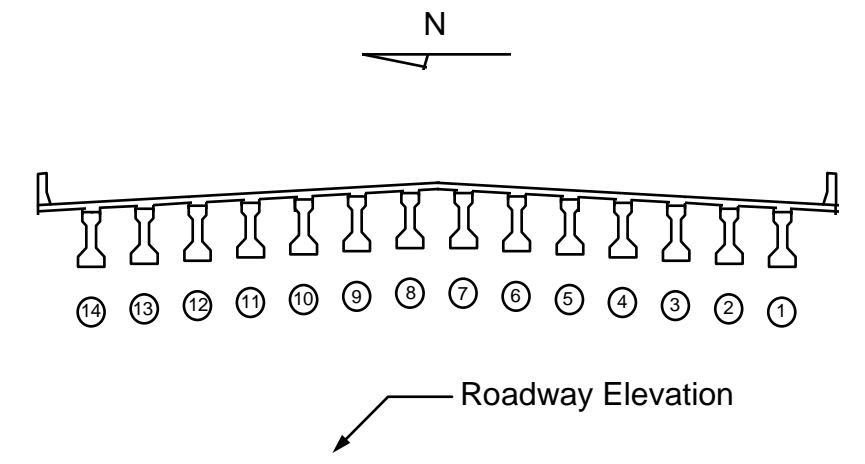
Figure 2-1 Transverse section of College Station Bridge

Visual inspection revealed that the first girder struck was the southern exterior girder (girder 1 in Figure 2-1). The damage to girder 1 was classified as moderate; the spalled region along the lower flange was approximately 2 ft. (0.61 m) long, cracking extended into the web of the member, and approximately 10 in. (0.25 m) of prestressing strand was left exposed. A small piece of metal was embedded between two wires of the seven wire strand (refer to Figure 2-2), however, inspection of the strand indicated no apparent damage to the strand. The second girder was not damaged, girders 3 and 4 sustained several nicks and scrapes, classified as minor damage. Girders in the center portion of the structure were not damaged due to the increased vertical clearance at these locations.

Girders 11 through 14 were also damaged from the impact. The damage to girder 11 consisted of a 1 ft. (0.30 m) spalled region as well as evidence of cracking extending into the web on the nonimpacted side of the girder. One tendon was exposed in this region for approximately a 6 in. (0.15 m) length as shown in Figure 2-3. The damage sustained by girder 12 consisted of a 6 ft. (1.83 m) length of lost cover on the impacted face and exposure of two tendons as shown in Figure 2-4. Girder 13 also sustained damage similar to girder 12; a 6 ft. (1.83 m) spalled region as well as evidence of cracking extending outward from the spalled region and an 18 in. (0.46 m) length of three exposed undamaged tendons as shown in Figure 2-5. Girder 14, the exterior north side girder, sustained damage resulting in exposure of three tendons over a 2 ft. (0.61 m) length as well as an extensive region of side cover concrete splitting over an 11 ft. (3.35 m) length as shown in Figure 2-6. The damage sustained by girders 11 through 14 was classified as moderate, since exposed tendons appeared to not have been damaged by the impact.

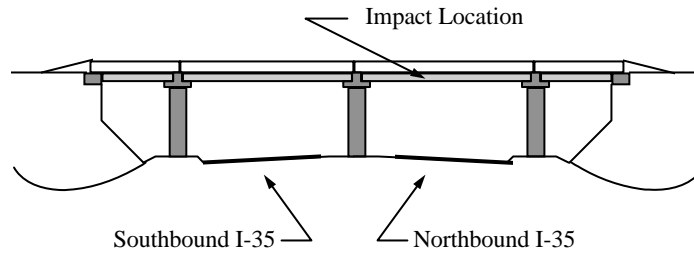
Figure 2-7 Evaluation of bridge structure at Jarrell, Texas

over Interstate Highway 35 (IH-35) near Jarrell, Texas. An elevation and transverse section of the structure is shown in Figures 2- 7 and 2-8, indicating the approximate location of impact. The boom of a truck-mounted crane loosened during transit causing the crane arm to rise upwards as the truck traveled north on IH-35. As a result, the overall height of the vehicle increased above the minimum vertical clearance of the bridge structure without the knowledge of the driver and resulted in impact.

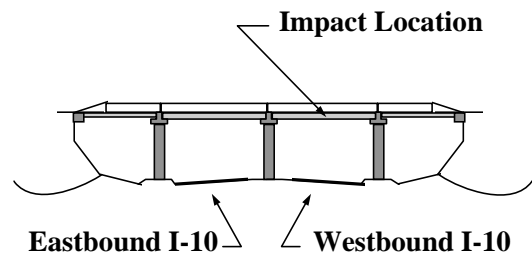
Figure 2- 16 Elevation of Waelder Bridge over I-10

In February of 1993 a bridge over Interstate Highway 10 (IH-10) near Waelder, Texas was struck by a vehicle with an over-height load traveling west. As-built drawings in Appendix B indicate that the structure was built in 1969 and consists of exterior spans 65 ft. (19.8 m) long and interior spans 95 ft. (29 m) long and at a 5 ° 30 ‘ right forward skew angle. A schematic of the bridge elevation and transverse section of the structure are shown in Figures 2-16 and 2-17, respectively.

Girders 1, 2, and 4 were damaged, with the most severe damage at girder 1. Impact occurred near the north strand draping location at the hold-down point. Four tendons were completely severed by the impact and almost all of the remaining strands in the section were exposed over approximately a 16 ft. (4.88 m) length just south of the centerspan location as shown in Figures 2-18 and 2-19. The damage to girder 1 was classified as severe.

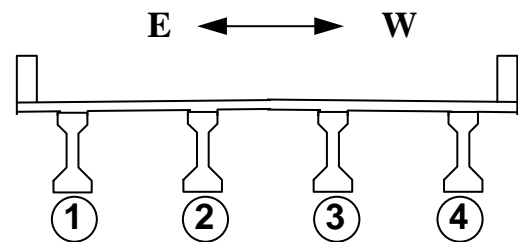
Figure 2- 17 Transverse section of Waelder Bridge over I-10

The second girder also sustained damage as evidenced by cracking of the concrete extending outward from the point of impact on the bottom flange as shown in Figure 2-20. It appeared that the south diaphragm served as a reaction point for the transverse impact load as evidenced by the path that the cracking of the section followed: outward from the point of impact, down the side of the bottom flange, and across the bottom surface of the girder to the nonimpacted face near the diaphragm location. Since there did not appear to be any damage to tendons or loss of prestress, the damage sustained by girder 2 was classified as moderate. The damage that occurred to girder 4 consisted of several scrapes and spalled areas and was classified as minor damage. The extent of the damage to girder 4 can be seen in Figure 2- 21.

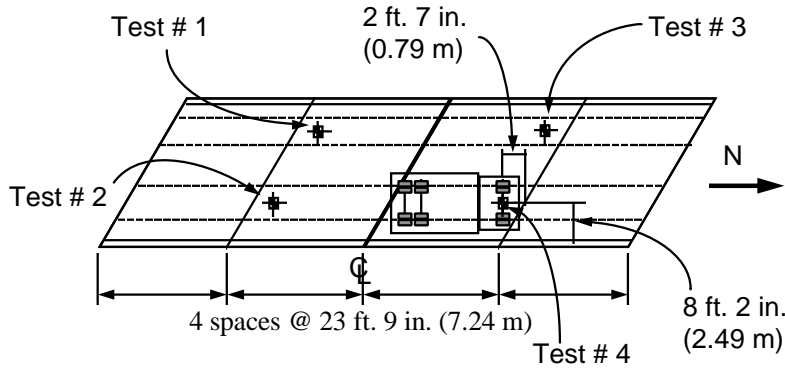
Figure 2- 30 Vehicle test locations for damaged north interior span — Waelder Bridge

Concerning only the damaged span (north interior span), several observations can be made about the results of the in-situ load testing. The most interesting observation is that very little difference in centerspan displacement was observed for the different vehicle locations (load tests 1 through 4). The magnitude of this displacement ranges from 0.21 in. (5.3 mm) to 0.22 in. (5.6 mm). Since the most severe damage occurred for girder number 1 just north of centerspan, it might be expected that the centerspan displacement would be largest for load tests 2 and 4. This is not the case, as is shown in Figures 2-33 and 2-35. There was very little difference in the load-deflection response at centerspan even though the damage was much more severe on the east side at girder 1. Comparing the displacements at the north and south quarter points, again very little difference in response was measured when the load was placed at the northwest and southwest locations (load tests 1 and 3, Figures 2-32 and 2-34, respectively). However, when the vehicle was placed at the northeast and southeast locations (load tests 2 and 4, Figures 2-33 and 2-35, respectively), there does appear to be a slight unsymmetric response with respect to the quarter point displacements, a maximum difference of 0.02 in. (0.51 mm). When the load was placed at the southeast location (load test #2, Figure 2-33) the displacement at the northeast quarter point was observed to be larger than at the southeast quarter point where the load was located. It appears that the unsymmetric nature of the observed displacements is consistent with the

unsymmetric nature and location of the damage; the girder that was most severely damaged was girder 1 and this damage occurred north of centerspan where the observed quarter point displacements were largest. It should be noted, however, that the measured displacements were on the order of 1/5000th of the span, well within acceptable limits for servicability and functionality of the structure even in the damaged state.

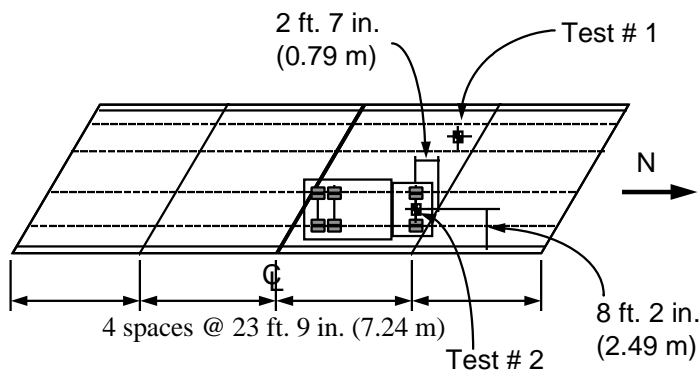
Figure 2- 31 Vehicle test locations for south interior span — Waelder Bridge

Comparison load tests performed on the undamaged south interior span revealed that a very slight difference in response was evident. The maximum centerspan displacement measured on the undamaged span was 0.16 in. (4.1 mm), compared to the displacement of the damaged span of 0.22 in. (5.6 mm), a difference of 1/16th inch. To summarize the results of the in-situ load tests performed on the Waelder Bridge, it is apparent that although severe damage occurred as a result of vehicle impact, the overall servicability of the structure remained intact, and therefore repairs could be performed to extend the service life of the structure.

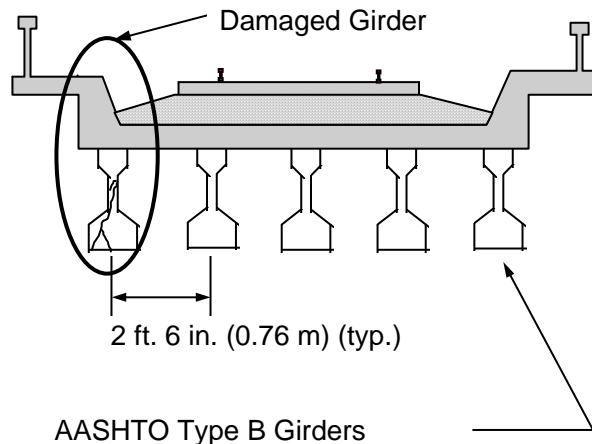
Figure 2- 38 Transverse section of Steck Bridge structures

An exterior girder of a prestressed concrete railroad bridge in Austin, Texas, was struck and severely damaged by an unknown overheight vehicle or load (Figure 2-38). The girder was eventually removed and replaced. Although the damage did not threaten the integrity of the bridge, the girder provided an excellent specimen for investigating assessment and repair techniques in the laboratory on field damage. The girder was removed from the south span of a two-span simply supported bridge which carries the Missouri Pacific Railroad over Steck Avenue in Austin, Texas.

Structural as-built drawings of the superstructure of the Steck Avenue bridge which were obtained from the Texas Department of Transportation and are included in Appendix A. In order to remove the girder, a pneumatic hammer was used to break through the slab along its length. The side railing and supporting slab were also removed, all attached reinforcement was cut to free the girder, and it was then lifted from the bridge with a crane. The cross section remaining after removal from the structure is shown in Figure 2-39. It was transported to Ferguson Structural Engineering Laboratory at the University of Texas at Austin.

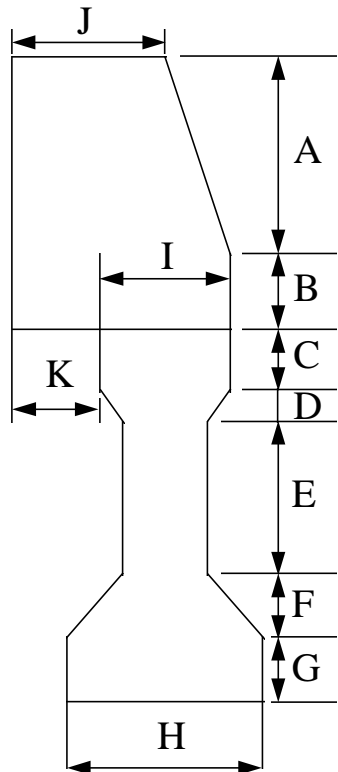
Figure 2- 39 Girder cross section after removal from Steck Bridge

Once the girder was removed and brought to the laboratory, visual observations were made and research plan was devised. Laboratory investigations were divided into three phases to address different areas related to impact damage: 1) assessment of damage, 2) concrete repair, and 3) strand repair.

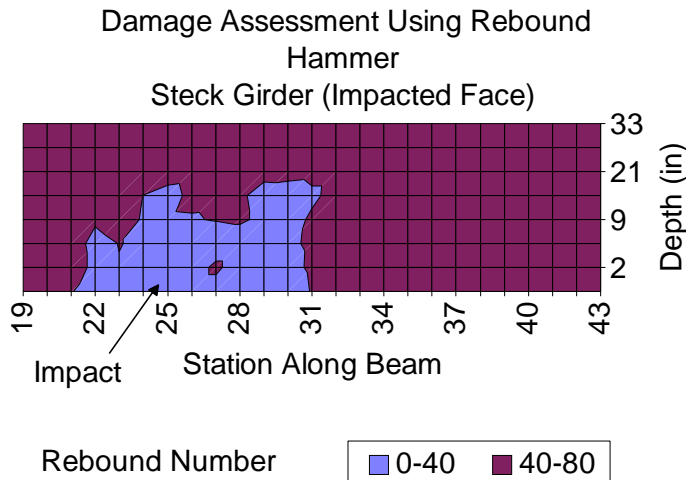
Figure 4-11 Results of damage assessment by rebound hammer - impacted face - Steek girder

The results of rebound hammer tests on both the impacted and nonimpacted faces of the girder are shown in the contour plots in Figures 4-11 and 4-12 respectively. Shown on each plot is the approximate location of impact. Plotted horizontally are the station numbers used for evaluation and the distance from the bottom of the girder is plotted vertically. The contour indicates the variation of rebound numbers on each face of the girder.

By direct comparison, it can be seen that damage on one side of the girder is not detectable when readings are taken on the opposite side. For example, at a height of 2-in. (5-cm) from the bottom of the girder, damage on the impacted face appears from station 21 to station 31, indicated by rebound numbers below 40. However, at the same location on the other side of the girder, much of the lower flange was intact in this region and the rebound numbers, all between 40 and 80 in this region, do not reflect the damage on the opposite side of the member.

On both sides of the girder the zone of delaminated and fractured material is very clearly defined by rebound measurements; however, damage that occurs deeper in the member or on the opposite side cannot be detected (refer to zone 1 in Figure 4-6 and Figures 4-11

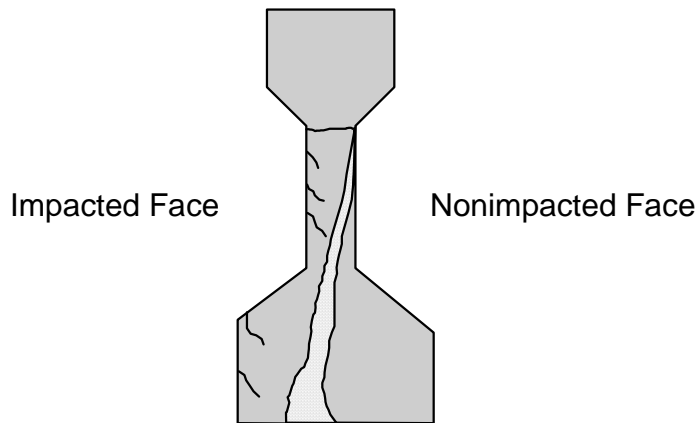
Figure 4-13 Cross section at sampling station 26 - based on rebound measurements and visual inspection

and 4-12). Comparing the rebound values with the photographs in Figures 4-2 through 4-5, it appears that with the rebound hammer it is possible to delineate between sound and unsound material. The cross section at station 26, for example, based on visual observation, is shown in Figure 4-13. However, detailed information about damage that was not visible from the surface of the member was not able to be clearly defined using the rebound hammer.

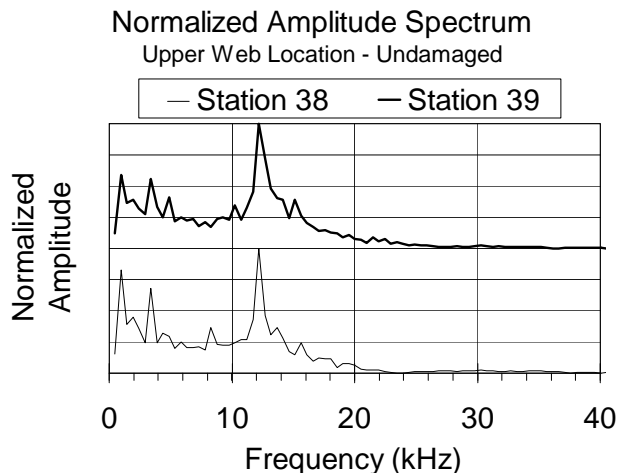
Figure 4-14 Damage assessment by impact echo - upper web undamaged locations

impacted side of the girder at stations 38 and 39 generated from impact echo sampling along the web. The peak amplitude at these locations occurs at a frequency of 12.2 kHz. Based on the measured compression wave velocity of 15,800 ft/s (4820 m/s) and measured frequency at peak amplitude, the corresponding thickness of the web at stations 38 and 39 was determined to be 7.77-in. (20-cm). The actual thickness of the web at the ends and center of the girder varied from 7.5 to 8.5-in. (19 to 22-cm).

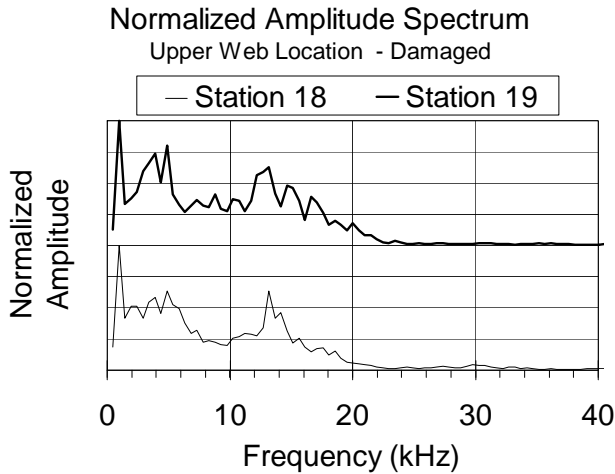
Figure 4- 15 Damage assessment by impact echo - upper web damage location

damage is clearly indicated by a shift in the peak amplitude from a frequency of 12.2 kHz (the solid thickness response in Figure 4-14) to lower dominant frequencies (Figure 4-15). It should be noted that the most dominant frequency of 0.97 kHz in each case (the largest peak at the left end of each spectrum with an amplitude of 1.0) is the resonant frequency of the displacement transducer of the instrument, and, hence, is a false reading. However, the other high amplitude peaks that are evident in each normalized amplitude spectrum are meaningful and require further explanation. At station 18 there are three other dominant peaks; one at a frequency of 4.88 kHz and a normalized amplitude of 0.63 which corresponds to a thickness of 19.4-in. (49.4-cm), a second peak at a frequency of 7.32 kHz and normalized amplitude of 0.32 corresponding to a thickness of 12.9-in. (32.9-cm), and a third peak at a frequency of 13.18 kHz and normalized amplitude of 0.63 corresponding to a thickness of 7.2-in. (18.3 mm). At station 19 there are three dominant peaks other than the one corresponding to the resonant frequency of the instrument: one at a frequency of 3.91 kHz and a normalized amplitude of 0.74 which corresponds to a thickness of 24.3-in. (67.1-cm); a second peak at a frequency of 4.88 kHz and normalized amplitude of 0.80 corresponding to a

It is obvious when comparing the spectra in Figure 4-14 and Figure 4-15 that damage is clearly indicated by a shift in the peak amplitude from a frequency of 12.2 kHz (the solid thickness response in Figure 4-14) to lower dominant frequencies (Figure 4-15). In comparison to the actual web thickness of 7.5 to 8.5-in. (19.1 to 21.6-cm), all of these peaks correspond to a thickness greater than the web with the exception of the peaks occurring at a frequency of 13.18 kHz, very close to the solid thickness frequency of the web (12.21 kHz). The lower frequency vibration responses are indicative of a delaminated concrete. The impact echo response of samples taken over a delamination behaves much like a plate restrained at its edges undergoing flexural vibration. The flexural

vibrations are characterized by lower frequencies than the solid thickness mode of vibration and, hence, are an indication in some instances that a delamination is present at the sampling location (24,25).

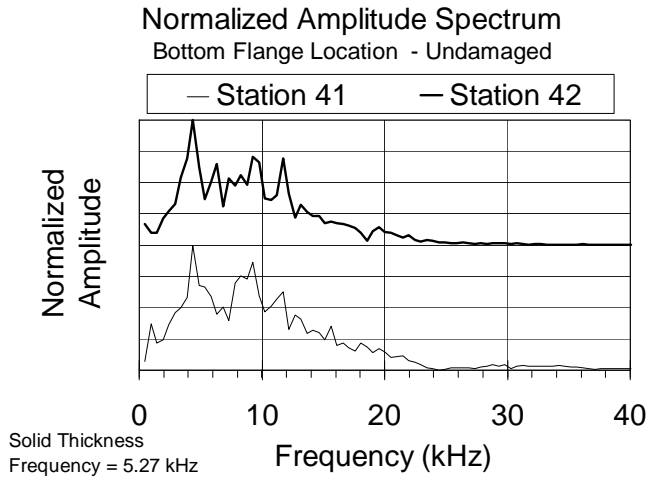
Figure 4-17 Damage assessment by impact echo - undamaged bottom flange locations

(54.9-cm). Although this is not exactly the solid thickness frequency, interpretation of these tests reveals that there is relatively no damage in the bottom flange at this location which was also confirmed by visual inspection. It is possible that the geometry of the flange itself causes the response to contain some flexural modes of vibration which could account for the discrepancy between measured and expected frequencies.

Figure 4-17 shows the results of impact echo sampling at stations 41 and 42 on the impacted face of the member for a bottom flange sampling location. The frequency which corresponds to the solid thickness of the flange was calculated to be 5.27 kHz. As shown in Figure 4-17 the most dominant peaks of each normalized amplitude spectrum appear very near this solid thickness frequency. The actual response at each of these locations results in a dominant peak at a frequency of 4.39 kHz which corresponds to a thickness of 21.6 in

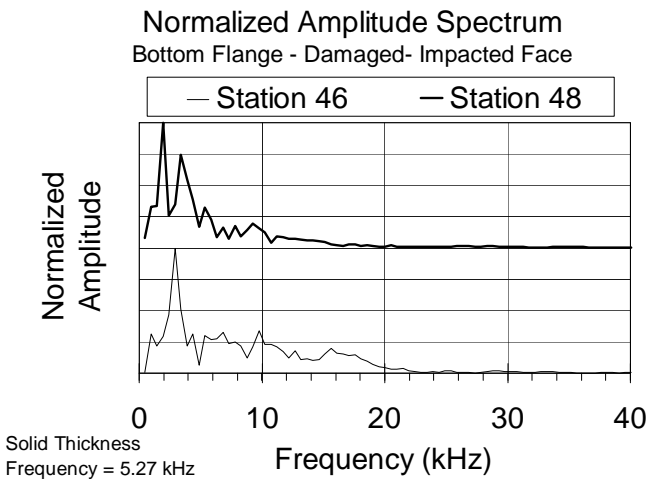
Figure 4-18 Damage assessment by impact echo - damaged bottom flange locations

In contrast to the undamaged flange locations at stations 41 and 42, Figure 4-18 shows the results of impact echo sampling of the bottom flange at stations 46 and 48 on the impacted side of the girder. It was evident by visual inspection at these locations that there was a crack running through the bottom flange of the member; however, it was not known how deep into the member the cracks extended. Between stations 46 and 48 this crack was very near the surface of the member. The response at these locations is dominated by low frequency flexural modes of vibration indicative of a delamination. In this instance, where the crack is near the surface, it is reasonable that the response is dominated by flexural frequencies indicating delaminated concrete. At station 46 the dominant frequency is 2.93 kHz and at station 48 the dominant frequency is 1.95 kHz, both of which are much less than the solid thickness frequency of 5.27 kHz, indicating near surface damage.

impacted face the response was interpreted as a delamination; the crack was very near the surface. Visual observations revealed that the crack was closer to the side face of the flange at station 48 than at 46. Referring to Figure 4-6, zone 2, the crack propagated from the nonimpacted face to the impacted face across the bottom flange and also up the face of the flange on the impacted side of the member. Again, the extent of this crack was not clearly evident, but impact echo results will show that the damage is clearly detectable from either side; however, interpretation of the results is simpler from the nonimpacted face.

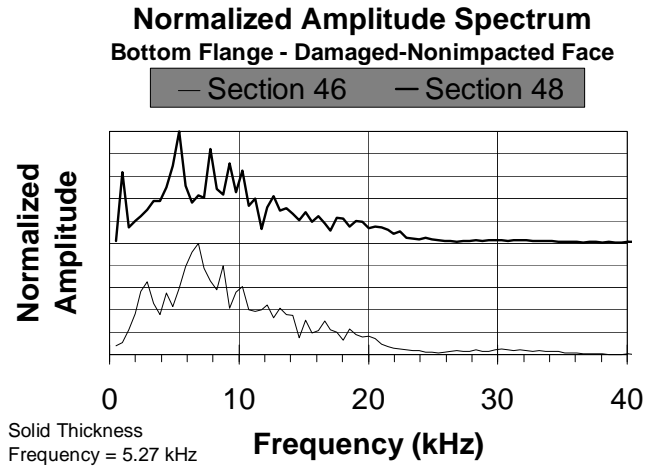
Figure 4-19 Damage assessment by impact echo - damaged bottom flange location - nonimpacted face

Figure 4-19 shows the results of impact echo testing at a bottom flange location for stations 46 and 48 on the nonimpacted side of girder. Again the frequency corresponding to the solid thickness of the flange was calculated to be 5.27 kHz. An interesting comparison to the solid thickness frequency can be made for the results at stations 46 and 48 on the nonimpacted face of the member. The dominant frequency response at station 46 was found to be 6.84 kHz with a corresponding calculated thickness of 13.89-in. (35.3-cm). The dominant frequency response at station 48 was found to be 5.37 kHz with a corresponding calculated thickness of 17.68-in. (44.9-cm). Remembering that the actual thickness of the bottom flange of the girder was measured to be 18-in. (45.7-cm), several observations can be made regarding the results of impact echo tests on both the impacted and nonimpacted face of the member.

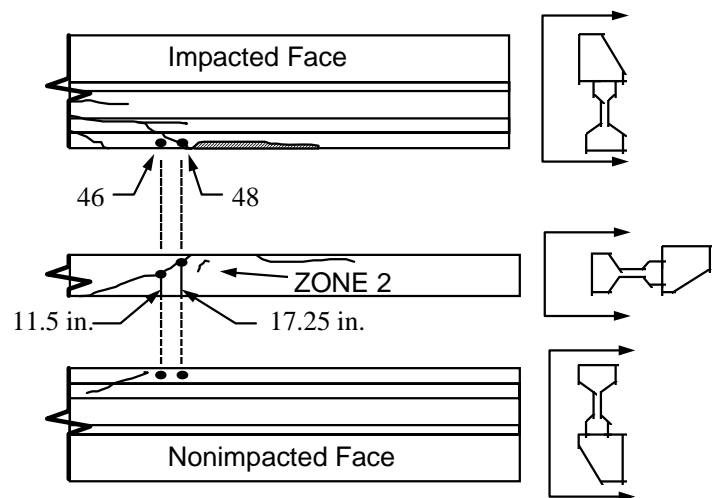
Figure 4-20 Detailed schematic of Zone 2 damage of Steek girder

First, in order to lend perspective to the location of these measurements, a more detailed schematic of Figure 4-6, zone 2 is shown in Figure 4-20. This schematic shows that measurements locating the crack in the bottom flange at stations 46 and 48 were very close to the results obtained from impact echo sampling on the nonimpacted face of the member. At station 46, the crack was measured to be approximately 11.5-in. (29.2-cm) from the nonimpacted face. Impact echo results indicated that the crack was 13.89-in. (35.3-cm) from the edge. It should be noted, however, that measurements for this sampling location were taken approximately 3-in. (7.6-cm) from the bottom of the member, while exact location of the crack was measured

on the bottom surface of the girder. It is likely that the crack did not extend perpendicularly from the bottom surface, but rather at an angle, and may account for the discrepancy between impact echo results and actual measurements. At station 48, where the crack was very near the surface on the impacted face, measurements located this crack to be 17.25-in. (43.8-cm) from the nonimpacted face, while impact echo results located the crack at 17.68-in. (44.9-cm) from the nonimpacted face. The results in this instance were easily verified due to the proximity of the crack to the surface of the member. It is much easier to interpret the vibrational response when flexural modes are not present as is the case at stations 46 and 48 on the nonimpacted face of the member. Delaminations are not as easily or confidently identified using the impact echo method; however it is possible to detect both visible and hidden damage in concrete using the impact echo technique.

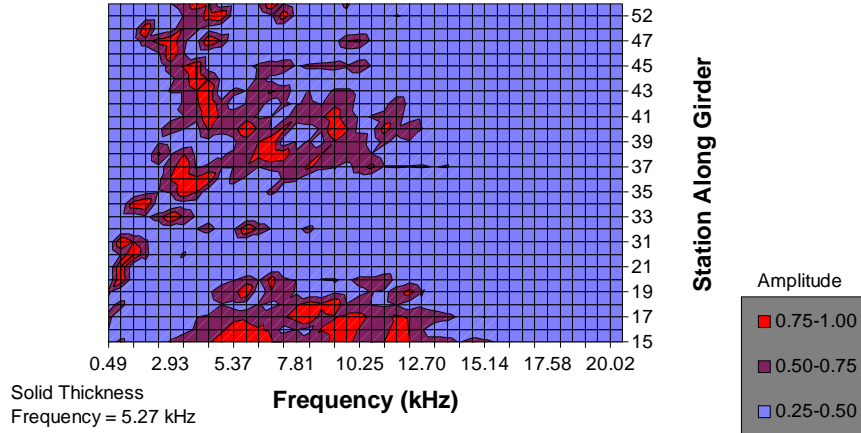
Figure 4- 22 Global damage assessment using impact echo - bottom flange location - nonimpacted side of girder

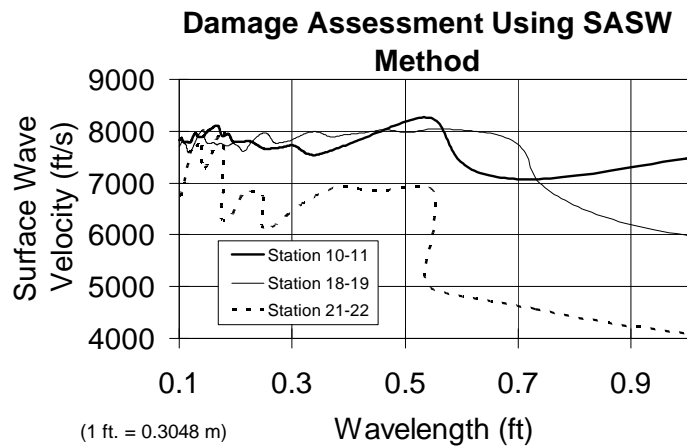
Figure 4-23 shows the dispersion curves generated from SASW testing between stations 10-11, 18-19, and 21-22. These three cross sections represent zones of varying degrees of visible damage on the impacted side of the girder. The dispersion curve over the station 10-11 interval corresponds to undamaged concrete. It shows relatively constant velocity as a function of wavelength varying from about 7,100 ft/s (2,150 m/s) to about 8,200 ft/s (2,500 m/s). Comparison of this dispersion curve with the cross section in Figure 4-24(a) shows that even though some damage exists on the non-impacted side of the girder, it is not directly beneath the array axis, and therefore does not affect the observed surface wave velocities.

Dispersion curves over the 18-19 and 21-22 station intervals show reductions in surface wave velocity (Figure 4-23). These reductions in velocity occur at longer wavelengths (deeper in the member) for the 18-19 interval, but affect shorter wavelengths (shallower) for the

Figure 4- 23 Damage assessment using SASW Method - bottom haunch location - impacted side of Steck girder

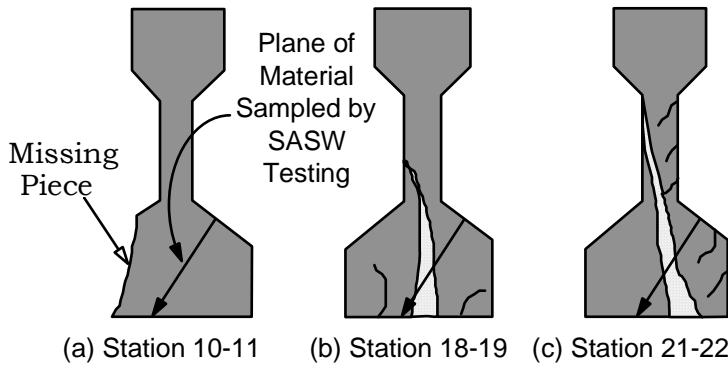
Figure 4- 24 Interpretation of SASW test results for damage assessment of Steck girder

21-22 interval. Figure 4-24(b) and ©, based on visual observation, indicate deep damage between interval 18-19 and shallow damage between interval 21-22 respectively. Comparing visual observations with SASW results over these station intervals shows how the dispersion curves can be used qualitatively to evaluate the extent and relative depth of damage.

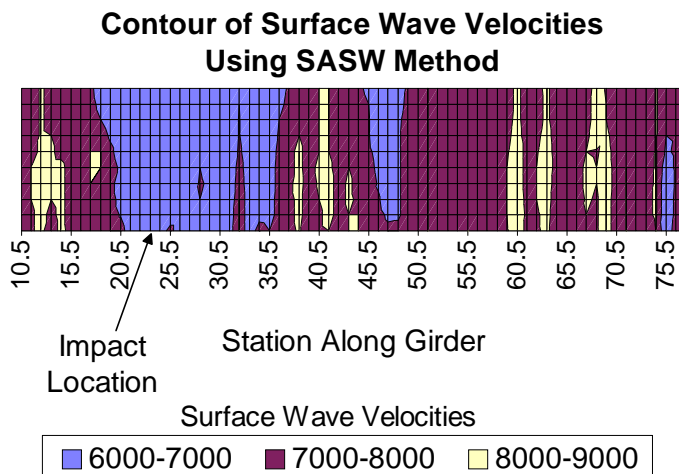
information which allow localized assessment of damage. However, if the individual dispersion curves are combined to form a contour of surface wave velocities, global assessment of the damage is made possible in much the same way as was shown using impact echo test results. Figure 4-25 shows a contour of surface wave velocities along the bottom haunch of the impacted side of the damaged girder.

Figure 4- 25 Global damage assessment using SASW Method

The trends observed in the contour plot (Figure 4-25) reveal how the SASW method, like the impact echo method, is capable of delineating between sound and unsound material. The apparent decrease in surface wave velocities between stations 17 and 21 correspond to a transition from sound concrete to the beginning of severely fractured material. The low surface wave velocities present between stations 22 and 36 represent the severely damaged zone in the region nearest the impact, and another transition zone from damaged to more sound material exists from station 37 to 46. Between stations 46 and 48 another zone of low surface wave velocity exists, which correlates

very closely with impact echo measurements taken in the same region (Figures 4-18 and 4-21).

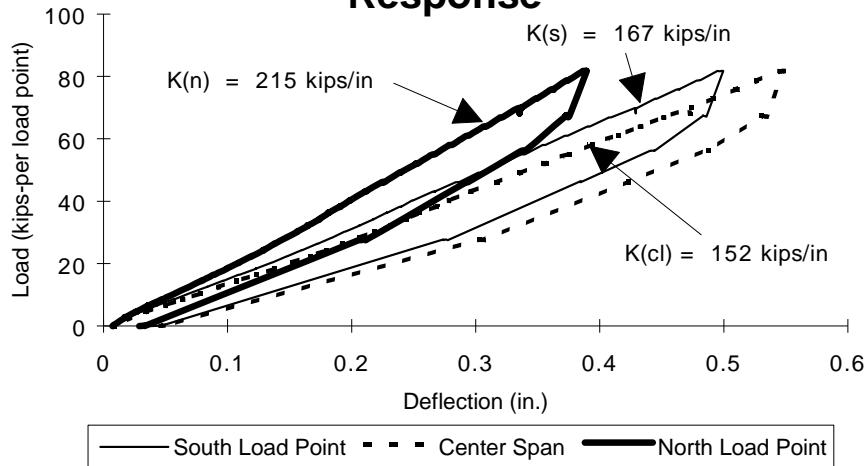
Experimental Load-Deflection Response. The measured load-deflection response at the load application points and center span locations are shown in Figure 4-29. It should first be noted that the locations at the south load point and center span were both damaged, whereas the location at the north load point remained relatively undamaged. Several observations can be made regarding the experimentally measured load-deflection response at each of the instrumented cross sections.

The slope of the load-deflection curve, or member stiffness, for the south load point, based on least squares regression of experimental data was found to be 167 kips/in. (29,250 kN/m). The stiffness at the north load point was experimentally determined to be 215 kips/in. (37,650 kN/m), while at center span, the stiffness was measured to be 152 kips/in. (26,620 kN/m). It is evident when comparing the response at the north and south load application points that the difference in measured stiffness reflects the

Figure 4- 29 Experimentally Measured Load-Deflection Response of Damaged Steck Girder (1 kip = 4.45 kN)

unsymmetrical nature of the damage to the girder; the south location was severely damaged resulting in a lower stiffness than the essentially undamaged north cross section. The stiffness at the center span location was less than that found at both north and south cross sections as expected. The center of the girder should experience more deflection than at either load point, and this was reflected in the experimental response. It should be noted, however, that the stiffness of a damaged girder does not appear to be an extremely important factor when assessing the extent of damage. In this instance comparison of stiffness is made to distinguish the unsymmetrical nature of the response. When in-situ nondestructive load testing was performed on the Waelder bridge, stiffness did not play a major role in the overall performance of the damaged structure. The measured displacements were on the order of $1/5000^{\text{th}}$ of the span length, while for the Steck girder, after removal from the bridge, the displacements were on the order of $1/1000^{\text{th}}$ of the span length, still within acceptable limits. While the girder from the Steck Avenue bridge was still in place, displacements of the damaged girder were measured as a train passed over the bridge, but deflection of the girder was barely perceptible. It is evident that when a damaged girder is removed from a bridge, the damage effects are more pronounced in terms of load-deflection response than when the load is able to be shared by other parts of the structure by load transfer through the slab and diaphragms. It is reiterated that reduction in stiffness alone should not be a deciding factor as to repair-in-place or replace damaged girders, but rather the decision should be based in part on remaining and repaired load capacity as well as durability of the repair.

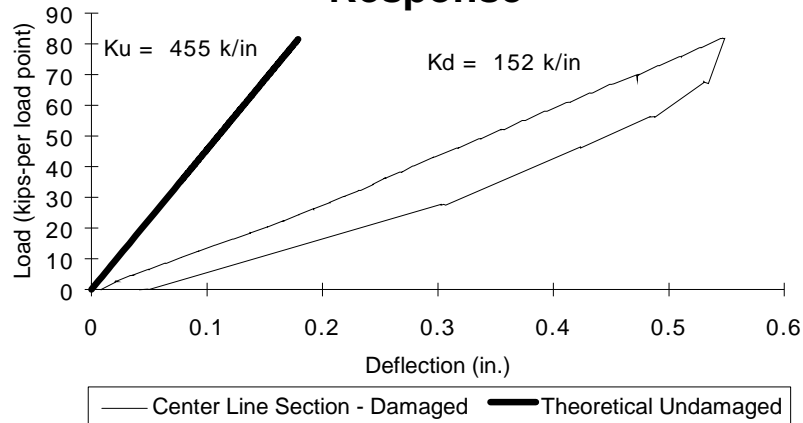
Using an elastic analysis procedure, the theoretical load-deflection response at center span was determined and compared to the experimentally measured response at the same location in order to evaluate the reduction in stiffness due to impact damage. Figure 4-30 compares the theoretical and experimental behavior at the center span location. The theoretical stiffness of the center span section was determined by analysis to be 455 kips/in (79,680 kN/m), and, as previously shown, the experimentally observed stiffness at center span was only 152 kips/in (26,620 kN/m). It is obvious that the extent of impact damage incurred was quite severe and that the experimentally derived stiffness is only 33 % of the

Figure 4- 30 Comparison of Theoretical Load Deflection Response of Damaged Steel Girder at the Centerspan Location (1 kip = 4.45 kN)

theoretical value. Again, stiffness should not be considered as the deciding factor for repair or replacement of a damaged girder.

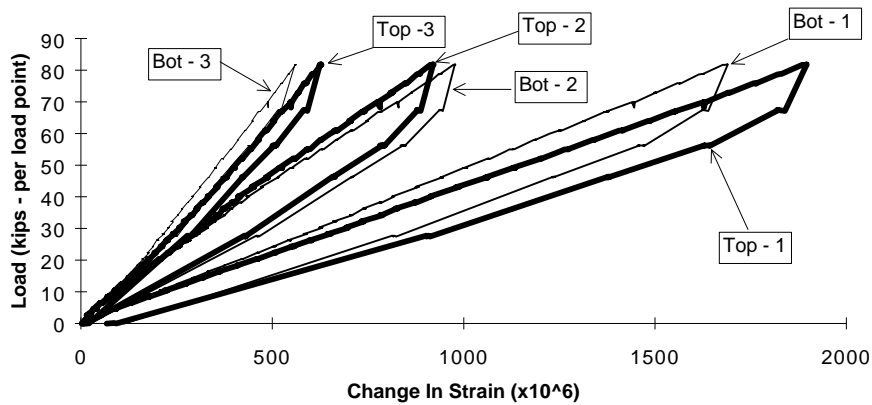
Several observations can be made regarding the measured tendon deformations. First and foremost, the relative magnitudes of the tendon deformations at each cross section correlate closely with the extent of damage based on both visual observations as well as the measured girder displacements. Cross section one appeared visibly to have sustained the most severe damage, and this is reflected in the measured tendon deformations at this location; the maximum changes in elongation of the tendons were between 1600 and 1800 microstrain. Cross section two sustained less damage than cross section one, and cross section three sustained little damage with the exception of cracking of the concrete near the bottom on the impacted side of the girder. Again, the magnitude of the tendon deformations at cross sections two and three correlate well with the observed visible damage of the girder.

It would normally be expected that if a tendon is below the centroid of the cross section, the strain due to applied loading should be higher than a tendon with smaller eccentricity from the centroid (for a simply supported girder). However, this was not the case for the measured tendon strains at each cross section. Although the results appear perplexing, the reason for this behavior became evident upon further inspection of the girder especially at cross section three. At this location, as previously mentioned, it appeared that the concrete surrounding the tendon was cracked, and upon application of load on the girder this zone of cracking increased, signifying an increased length along which the bottom tendon became

Figure 4- 31 Experimentally Measured Deformations of Instrumented Tendons - Steck Girder - Damaged (1 kip = 4.45 kN)

debonded. Debonding would cause the measured strains in the bottom tendon to be less than for the top as was the case. The same could be said for the tendon behavior at cross section one; however, the damage was so extensive that visual observations were not sufficient to determine exactly where this debonded zone occurred. The observed tendon strains at cross section two, center span on the nonimpacted face of the girder, exhibited the expected response where the lower tendon became more highly stressed as the load on the girder increased. The following chapter describes in detail the materials, methods of application, and evaluation of concrete repair of the damaged girder.

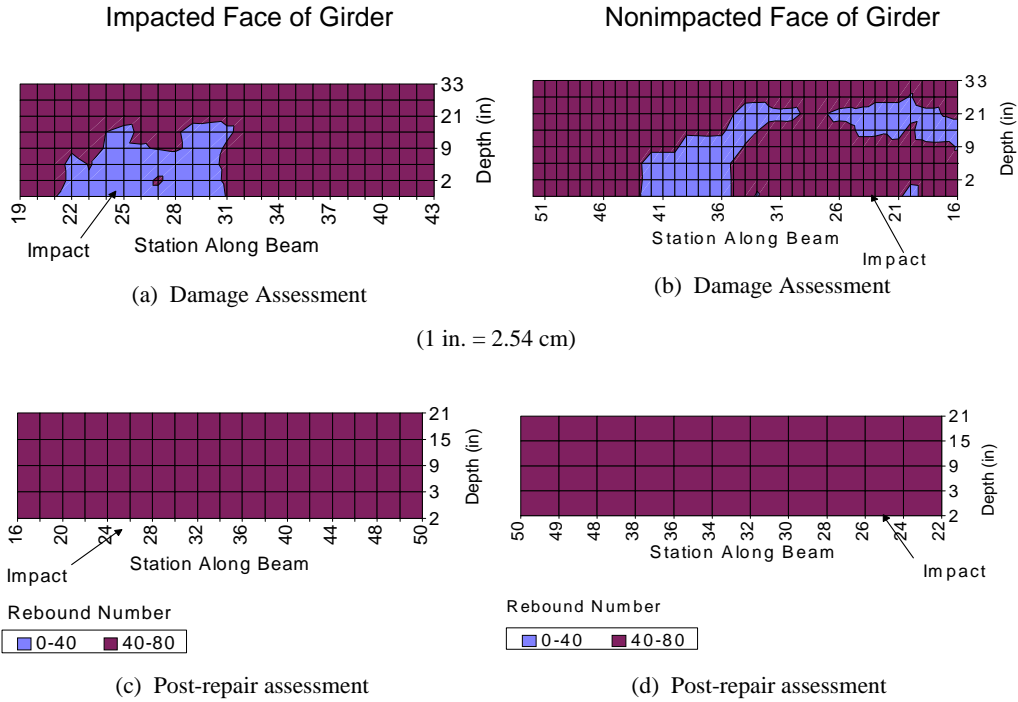
Figure 5- 24 Comparison of rebound measurement before and after concrete repair

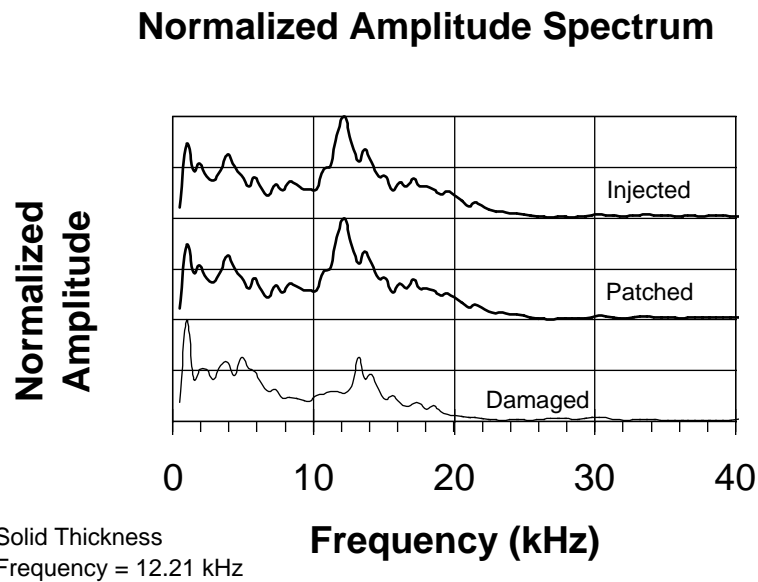
Impact echo measurements were taken during and after the repair. The normalized amplitude spectrum for each location was generated and used for qualitative comparison. As an example, Figure 5.25 shows a comparison of pre- and post-repair impact echo responses for a web location at station 18. The normalized amplitude spectrum for the upper web location on the impacted side is shown. In the damaged state delaminated concrete is detected at this location (refer to Figure 4.15 and discussion of damage assessment). After patching the damage, there was an evident shift in the response to a peak amplitude at a frequency of 12.21 kHz, the web solid thickness frequency. The response following injection at this location did not change significantly between the patched and injected phase; both reveal a peak amplitude at the solid thickness frequency.

Figure 5- 25 Quality assessment of concrete repairs using impact echo — upper web location — Station 18 — impacted face

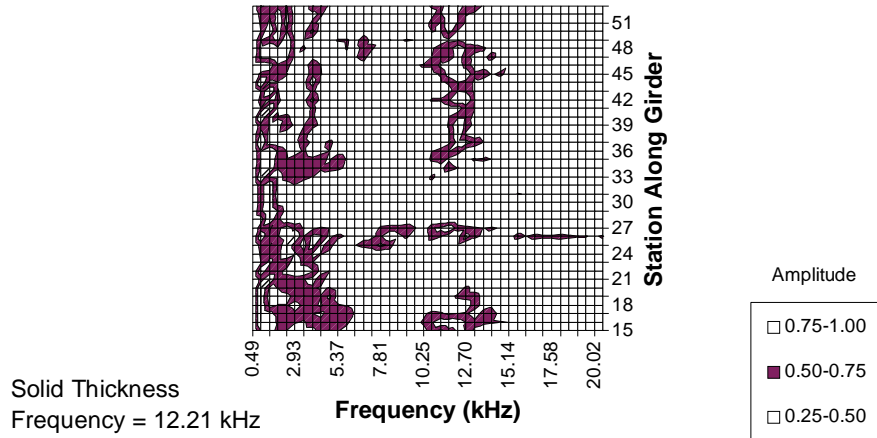
The amplitude spectra at each web location were then used to generate a contour of spectra along the web for the impacted side. Figures 5.26 and 5.27 show the spectral contours for the impacted side of the girder in the damaged state and after concrete patching and epoxy injection, respectively. It should be noted that these contours do not differentiate between the maximum peak amplitude at each location, but instead are meant to be interpreted in a qualitative fashion by showing relative changes in the impact-echo response as the member underwent repair.

Figure 5-26 Global damage assessment using impact echo - upper web location

Figure 5.26 indicates that stations 15 through 42 are dominated by peak amplitudes composed of low frequency response or delaminated areas. The dark zones indicating frequency responses at amplitudes from 0.75 to 1.0 are observed at low frequencies which were interpreted as delaminated zones. The interpretation of the impact echo response was substantiated by visual inspection as discussed in Section 4.3.5. When the epoxy was injected after the concrete was patched using various materials, a shift towards a solid vibrational mode of response was indicated for the most dominant peaks in the 0.75 to 1.0 range (Figure 5.27). There is a distinct decrease of what appears to be low frequency vibration indicating that partial restoration of member integrity has occurred over its length at the upper web sampling location.

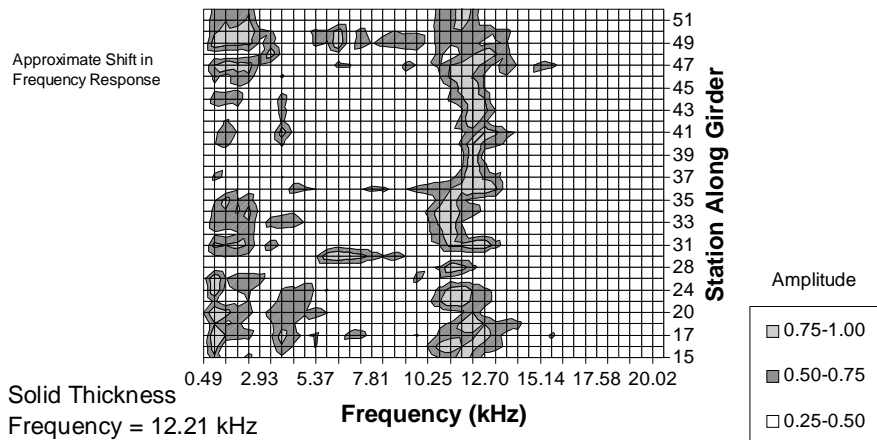
Figure 5-27 Global assessment of epoxy injection phase - upper web area - impacted face

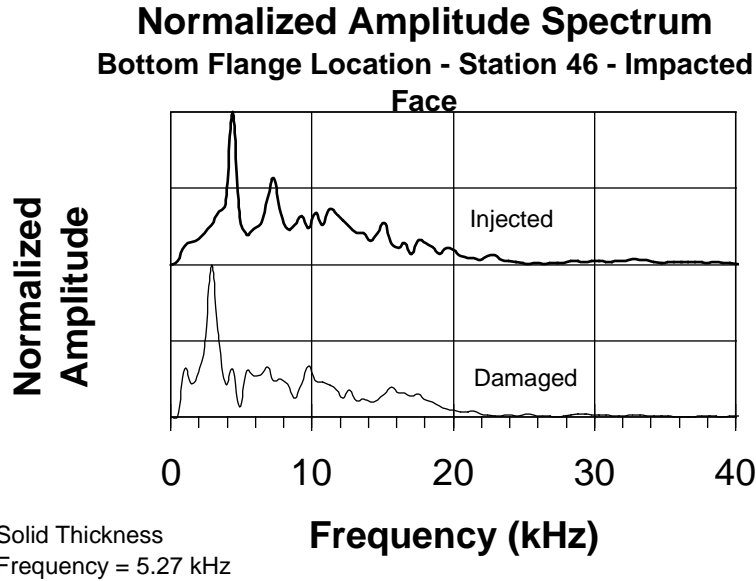
Figure 5- 28 Localized assessment of concrete repair using impact echo - bottom flange - impacted face

In terms of localized assessment of the repair, station 46 only required epoxy injection, not any patching of the concrete. Figure 5.28 shows the results from pre- and post-repair impact echo results for the bottom flange location at station 46. It is evident that the epoxy injection improved the integrity of the member at this location as revealed by a shift in the peak amplitude towards the solid thickness frequency of 5.27 kHz. In the damaged state the maximum amplitude occurred at a frequency of 2.93 kHz and, once the girder was injected, the peak amplitude occurred at a frequency of 4.39 kHz. Again, as stated in the discussion of impact echo results for the bottom flange sampling locations (Section 4.3.5), there appears to be a discrepancy between the measured frequency and the calculated solid thickness frequency (5.27 kHz vs. 4.39 kHz). However, it is possible that the geometry of the flange itself causes the response to contain some amount of flexural vibration which could account for the discrepancy between measured and expected frequencies (refer to Figure 4.17 and the corresponding discussion of damage assessment results for stations 41 and 42 respectively).

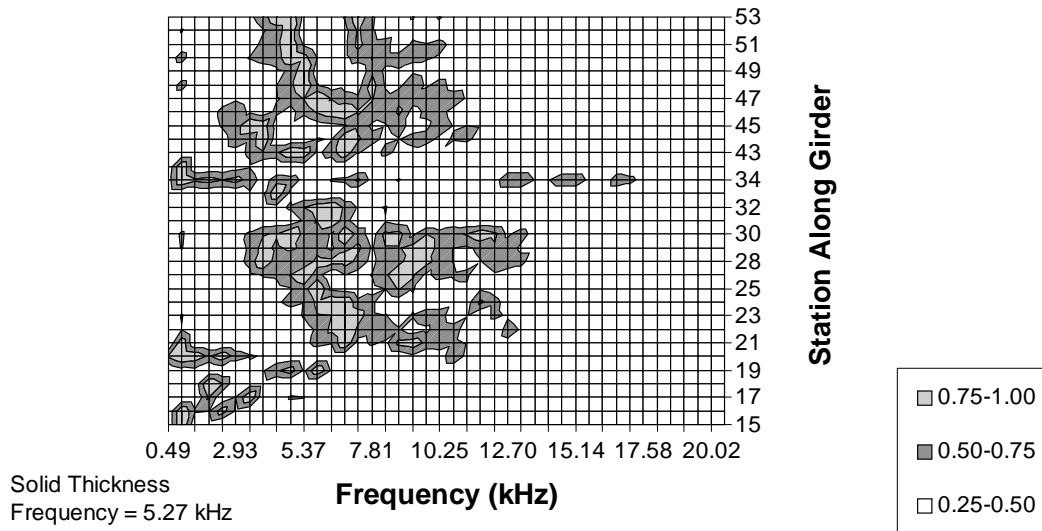
Again, the individual spectra for each location along the bottom flange were combined to form a spectral contour along the length of the member for the damaged state and after the girder was both patched and injected. These are shown in Figures 5.29 and 5.30. As discussed in Section 4.3.5, the results of global damage assessment using the impact echo method revealed that no clear pattern existed in the spectral contour, and that damage was indicated throughout the length of the girder. The range of maximum normalized amplitude, or most dominant peak of the frequency response, was very large with a minimum frequency of 0.98 kHz to a maximum of 9.28 kHz indicating damage throughout the length of the member (Figure 5.29). However, as the repair progressed, impact echo data indicated a shift towards a solid vibrational mode of 5.27 kHz (compare high amplitude regions in Figures 5.29 and 5.30). Following concrete repair by patching and epoxy injection, the range of frequency content was drastically reduced as compared to the damaged state. The minimum dominant frequency measured 3.42 kHz and the maximum measured was 4.39 kHz, both of which are much closer to the solid mode vibrational frequency of 5.27 kHz (Figure 5.30). The shift in the peak amplitudes found from the

Figure 5- 29 Global damage assessment using impact echo - bottom flange area - impacted face

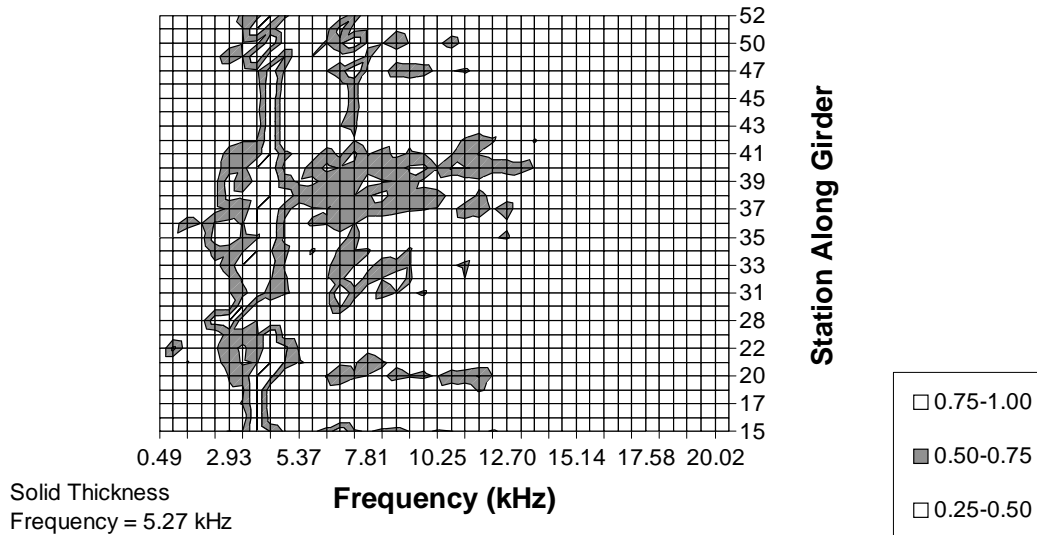
Figure 5- 30 Global assessment of epoxy injection phase - bottom flange area - impacted face

injection assessment spectral contour indicated that along the length of the repaired girder integrity had for the most part been restored. The peak amplitudes for the bottom flange sampling locations along the length of the girder became much more uniform indicating a clear pattern of a solid vibrational mode of response.

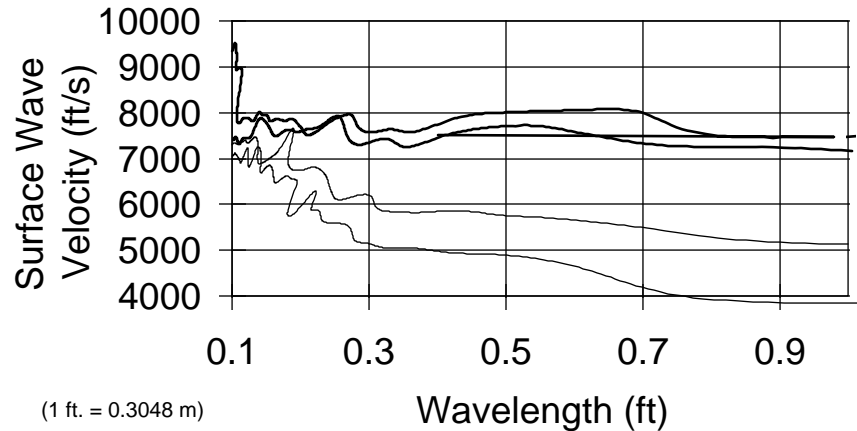
Figure 5- 31 Assessment of concrete repair using SASW method - bottom haunch location (47-48)

SASW measurements were taken after application of preload and patching of damage, after epoxy injection, and removal of preload. Dispersion curves were generated for each interval over the length of the beam for comparison. As an illustration, the dispersion curves for the different repair phases at interval 47 to 48 are shown in Figure 5.31. Prior to repair, surface wave velocities were less than 7,000 ft/s (2,130 m/s) due to damage beneath the surface of the beam. After the application of preload and patching of the concrete with various materials, surface wave velocities decreased and the integrity of the beam at this location appeared to deteriorate. This was most likely due to the development of additional cracking upon application of preload. Note that no new concrete was placed at this location. After epoxy injection, surface wave velocities were greater than 7,000 ft/s (2,130 m/s) at all wavelengths indicating that integrity had been restored.

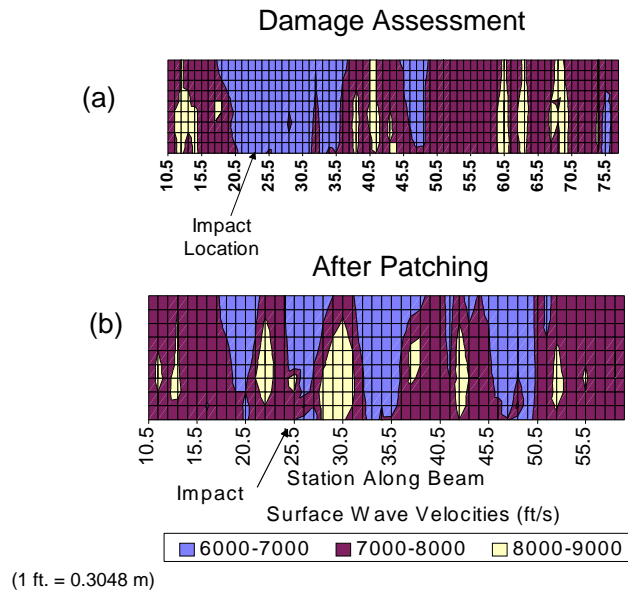
The dispersion curves developed between each station interval were combined to generate a contour of surface wave velocity versus wavelength along the length of the girder for each phase as well as in the damaged state. Comparison of the contours in Figure 5.32 and Figure 5.33 give an indication of the ability of the SASW technique to monitor effectiveness of the patching and epoxy injection. In the damaged, state several zones of low surface wave velocity are evident (Figure 5.32-a) from stations intervals 17 to 18 (plotted at 17.5) through interval 37 to 38 (plotted at 37.5) and then again from intervals between stations 45 and 50. Once the patching phase was complete (Figure 5.32-b), there appeared to be a definite increase in surface wave velocities from station intervals between 17 and 33 (plotted at 17.5 through 32.5) indicating the effectiveness of the repair in this region. However, between station intervals 33 to 38 (plotted at 33.5 through 37.5) the zone of low surface wave velocity appears to have increased in size, and station intervals between 45 and 50 surface wave velocities appear to have

Figure 5- 32 Global assessment of damaged and patched girder using SASW - lower haunch area - impacted face

decreased. This is most likely due to the formation of additional cracking upon application of the preload. After epoxy injection was complete, very low surface wave velocity zones ranging from 4,000 to 5,000 ft/s (1,219 to 1,524 m/s) exhibited a velocity increase to 6,000 to 7,000 ft/s (1,830 to 2,130 m/s) range (Figure 5.33-a) and upon removal of the preload the few zones below 7,000 ft/s (2,130 m/s) surface wave velocity practically disappeared (Figure 5.33-b). This is more than likely due to the closing of any remaining cracks upon the removal of preload.

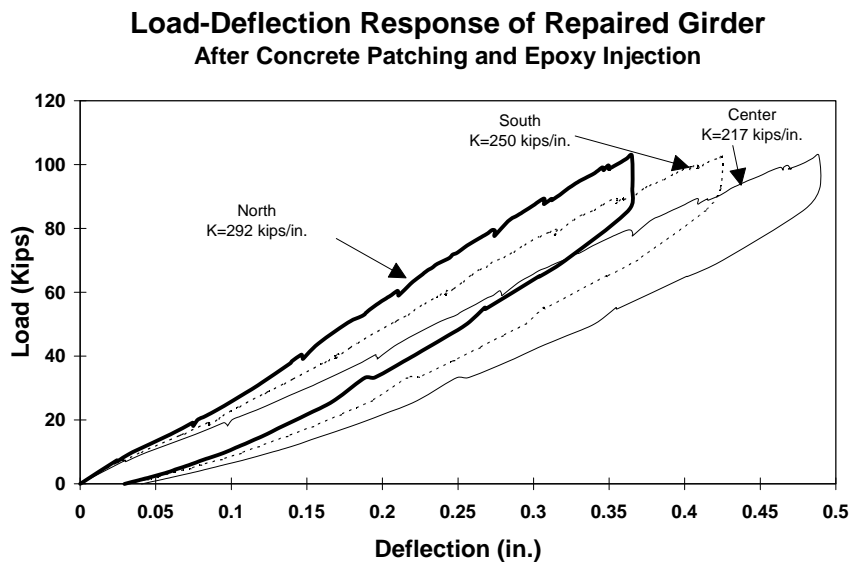
Figure 5- 33 Load deflection response of Steck girder after concrete repair and epoxy injection

Experimental Load-Deflection Response and Section Stiffness. Figure 5.33 shows the experimental results obtained for the load-deflection response at each of the three instrumented cross sections. Linear regression of experimental measurements revealed that the slope of the load-deflection response, or member stiffness, at the south load point was 250 kips/in. (43,800 kN/m), an increase of 18 % from the damaged state. The center span stiffness was measured to be 217 kips/in. (37,950 kN/m), an increase of 14 % from the damaged state, and at the north load point the measured stiffness was 292 kips/in. (51,000 kN/m), an increase of 17 %.
