**EVALUATION AND REPAIR OF IMPACT-DAMAGED PRESTRESSED
CONCRETE BRIDGE GIRDERS**

Research Report No. 1370-3F

Research Project 0-1370

MAY, 1996

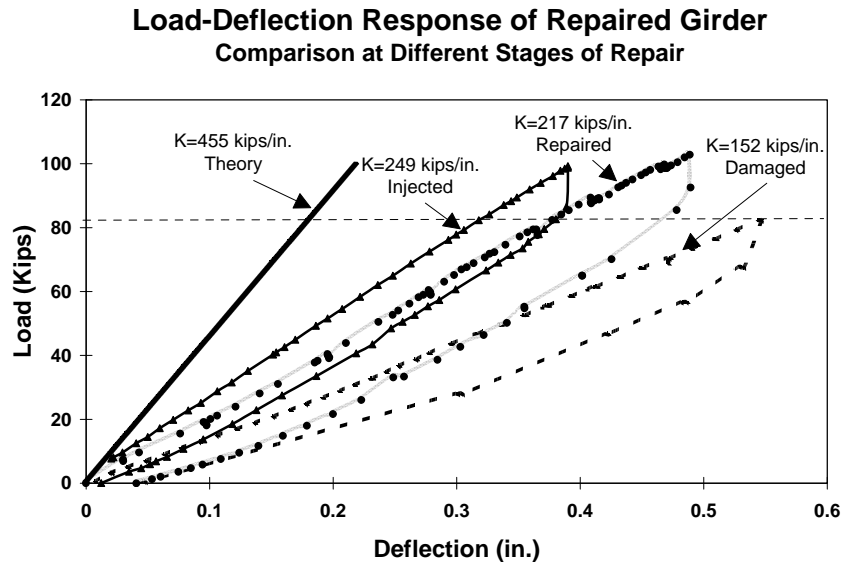
After the initial post-repair load test was performed, the cracks in the top siderail portion of the girder were injected with epoxy. Once the epoxy cured, the girder was load tested for comparison with the damaged and repaired states. The displacement at the south load point reduced from 0.33 in. (8.4 mm) to 0.28 in. (7.1 mm) at a load of 82 kips (365 kN), a 15 % decrease in displacement. The experimental stiffness at this location increased from 250 kips/in. (43,800 kN/m) to 289 kips/in. (50,600 kN/m). The

Figure 5- 34 Experimental load deflection response of Steck girder after concrete repair and epoxy injection

midspan displacement decreased from 0.38 in. (9.7 mm) at a load of 82 kips (365 kN) to 0.32 in. (8.1 mm), approximately a 15 % decrease, while the stiffness increased from 217 kips/in. (37,950 kN/m) to 249 kips/in. (43,600 kN/m). The displacement at the north load point decreased from 0.28 in. (7.1 mm) to 0.25 in. (6.4 mm) at a load of 82 kips (365 kN), a decrease of approximately 10 %, and the stiffness increased from 292 kips/in. (51,000 kN/m) to 323 kips/in. (56,600 kN/m).

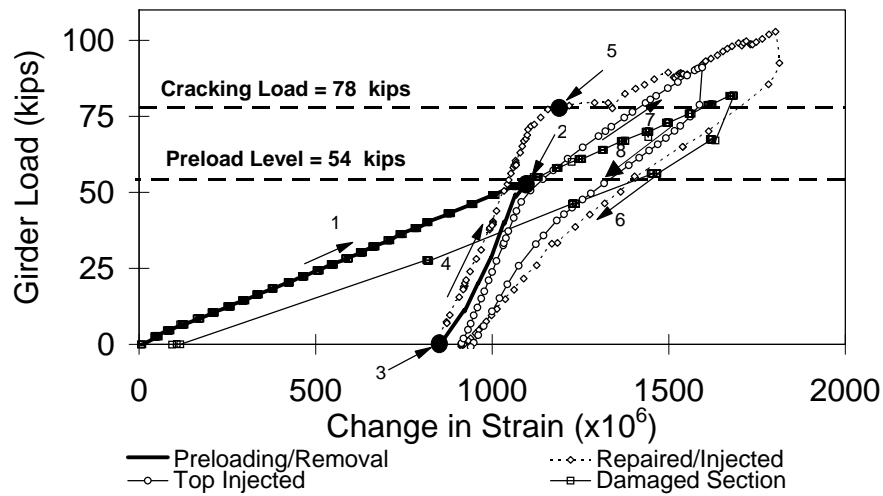
Measured Response of Instrumented Tendons. The measured strains in the bottom instrumented tendon at the south cross section are shown in Figure 5.35. Tendon strains are shown for the damaged state, the effects of preloading prior to repair, the repaired state, and after the final injection of the siderail cracks. The first observations that can be made concerning the experimental measurements of tendon deformations at this location, is that the slope of the load-deformation response in the damaged state is much less than after the initial repair was complete. It is possible to follow the history of the tendon response from stage 1(damaged state) up to a preload level of 54 kips (240 kN) per load point to stage 2 when the repair was performed. Once the concrete patching and epoxy injection were accomplished while maintaining the preload at stage 2, the preload was removed. The tendon strains then followed the unloading curve to stage 3 after removal of preload. Stage 3 identifies a very important effect of preloading the girder prior to repair. By applying preload it is shown here that the effective prestress in the tendon increases and, at the same time, the patch material in the bottom flange is compressed. Upon subsequent load application, the response of the tendon follows the loading curve beyond the level of applied preload (stage 4) until stage 5 is reached. Cracks form within the patch at stage 5 at an applied load of 78 kips (347 kN) per load point when both the precompression supplied by preloading as well as the tensile resistance of the patch material are eventually overcome. Following the loading history through stage 5, the response changes from uncracked behavior (prior to stage 5) through a transition to cracked response, and eventually unloading through stage 6. Once the siderail cracks were repaired and the girder again loaded, the load history of the tendon follows through stage 7 where the transition from an uncracked to a cracked response is again experienced. However, it should be noted that this transition

Figure 5- 35 Experimental load-deformation response of tendon at south cross section following concrete repair

occurs very near the level of preload at approximately 54 kips (240 kN) rather than at the higher level of load when not only precompression needed to be overcome, but the tensile strength of the patch as well, which, after initial loading, had already experienced flexural cracking .

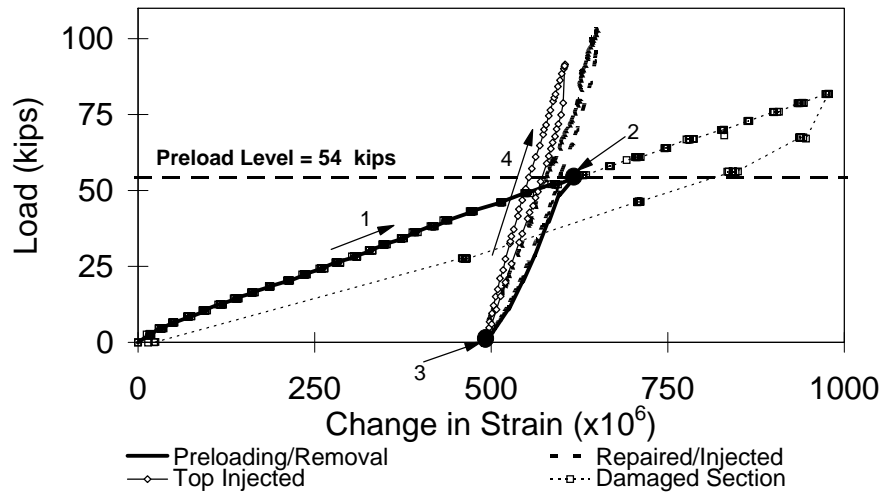
The measured response of the bottom instrumented tendon at the midspan cross section is shown in Figure 5.36. Here again a comparison is made between behavior in the damaged state, effects of preloading prior to repair, repaired state, and after final injection of the sidewall cracks. The behavior is very similar to the results shown for the south cross section. It is evident that the effects of preload lead to an obvious change in slope of the curve before and after the repair was performed. As the preload was applied deformations followed the same path as measured in the damaged state (refer to stage 1 in Figure 5.36). The repair was performed while the preload was sustained at 54 kips (240 kN) per load point (refer to stage 2 in Figure 5.36). After concrete patching and epoxy injection, the preload was removed and the unloading path defined between stage 2 and stage 3. Again the effects of preload are evident: increased stiffness, higher effective prestress, and precompression of the patched zone. The difference between the response at the midspan and the south cross sections was that the centerspan section was not stressed as highly as the severely damaged south cross section and therefore did not crack upon subsequent loading.

Figure 5- 36 Load-deformation response of tendon at center span cross section following concrete repair

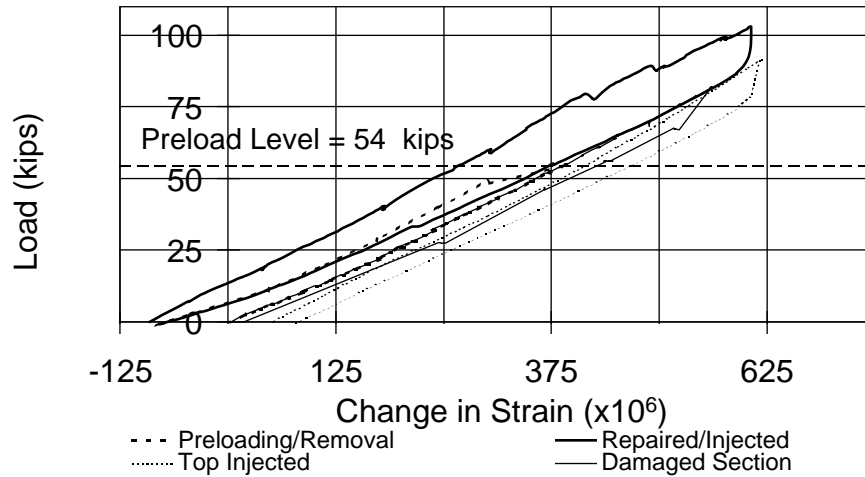
In comparison to the south and center span locations, the tendon behavior at the north cross section changed very little (Figure 5.37). It was shown in Chapter 4 that the north cross section sustained very little concrete damage. As a result, the effects of preload and concrete repair are not as significant as was shown for the other two cross sections. However, there does appear to be a slight change in the behavior

Figure 5- 37 Experimental load-deformation response of tendon at north cross section following concrete repair

when comparing the damaged to the repaired state; the slope of the girder load versus change in tendon strain curve increases, signifying that the repair had a beneficial effect.

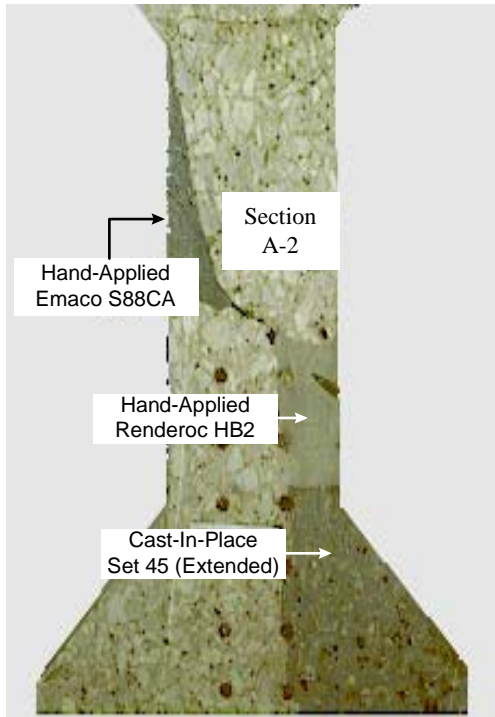
The most evident observation from these photographs is that the low pressure epoxy injection system combined with the internal injection procedure was effective at sealing and filling the remaining internal cracks and voids following the concrete patching. Figure 5.40 and Figure 5.41 clearly reveal the depth of epoxy penetration when using the low pressure injection system and internal injection ports. The void space within the web of the member was completely filled with epoxy at this location (Figure 5.40). It is also evident from the close-up photographs that, for the most part, the hand-applied materials bonded to the concrete substrate around the perimeter of the patches. In some locations where the bond appeared questionable, the injected epoxy was able to penetrate and fill any spaces that existed around the patch perimeter.

Figure 5- 39 Photograph of interior of repaired girder showing cast-in-place, hand-applied, and injected repair materials

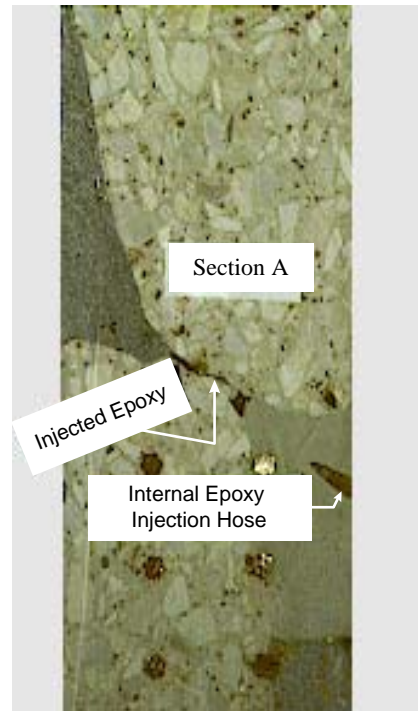
Figure 5- 40 Close-up detail of web section of repaired girder showing benefits of epoxy injection through internal injection ports.

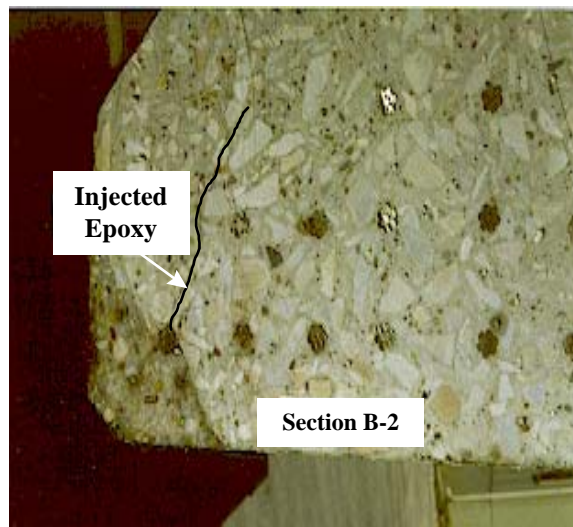
Figure 5- 41 Photograph showing epoxy penetration at a bottom flange repair location

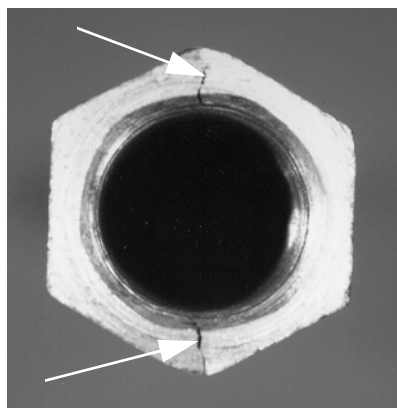
Without using any lubrication the turnbuckle was very difficult to torque. The initial test was stopped when the applied torque reached 550 lb.-ft. (746 N-m) and resulted in an induced tension of only 17.5 kips (78 kN). The results varied significantly from the recommended torque value. The test was halted when the turnbuckle began to show signs of failure; cracks formed through the entire thickness of the turnbuckle and the torque wrench began to slip and strip the outside of the turnbuckle. Figures 6.10 and 6.11 show the interior and exterior of the turnbuckle respectively after removal from the stress bed.

Figure 6-10 Grab-It™ cable splice — cracks through interior threads - dry threads - torque proof test

When the external threads were cleaned with a wire wheel and then lubricated, the required torque was closer to the expected value; tensioning of the splice was more reliable and much safer to install when the threads were lubricated. At an applied torque of 250 lb.-ft. (339 N-m) the induced tension was measured to be 25 kips (111 kN). Figure 6.12 shows the exterior of the turnbuckle after the test with lubricated threads. It is evident from the results that if the Grab-It™ splice assembly is to be used safely and reliably, the threads must

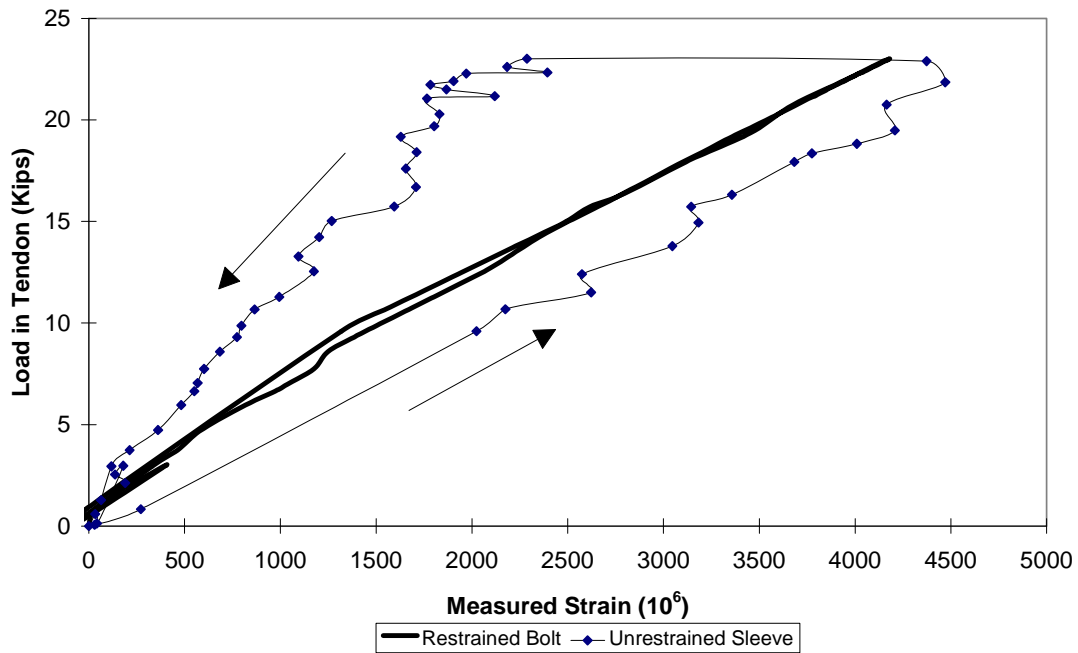
It is obvious when evaluating the results from the additional stress monitoring tests of the Alberta splice that the effects of twisting of the strand are observed in the measured deformation response of the tendon.(Figure 6.19 and Figure 6.21). When torque is applied to one side of the splice while the other side is restrained against twisting, rotational energy is stored in the strand on the unrestrained side. As the direction of the applied torque is reversed (the splice unloaded), this energy is immediately released as evidenced by the flat portion of the unrestrained curves in Figure 6.19 and Figure 6.21. It is also evident that when the splice is stressed hydraulically, this twisting behavior is not observed as shown in Figure 6.20. These tests reveal more detailed behavior than was possible for splices that were installed in the girder as the load in the tendon could be directly monitored with a load cell.

Figure 6- 19 Test of Alberta splice in stress bed — bolt restrained and torque applied to unrestrained sleeve

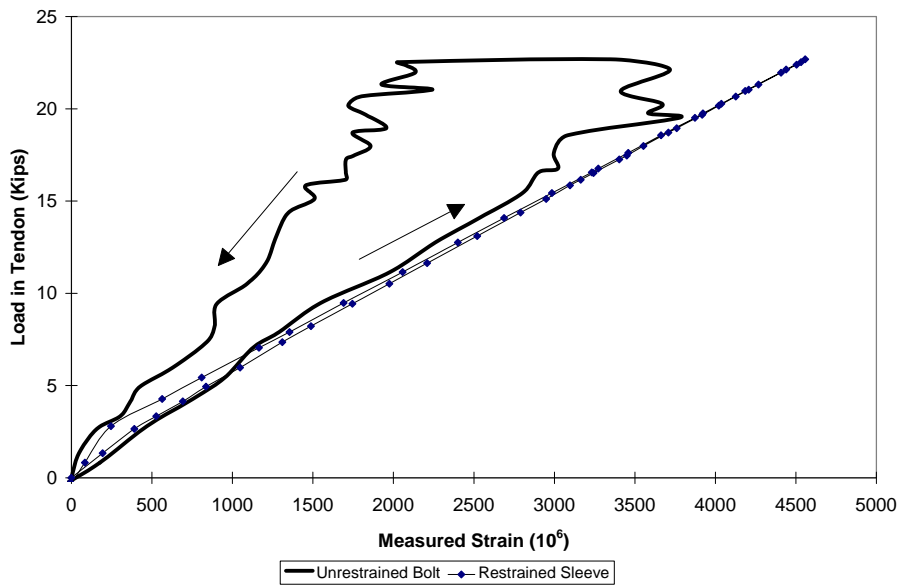
Figure 6-21 Test of Alberta splice in stress bed — sleeve restrained and torque applied to unrestrained bolt

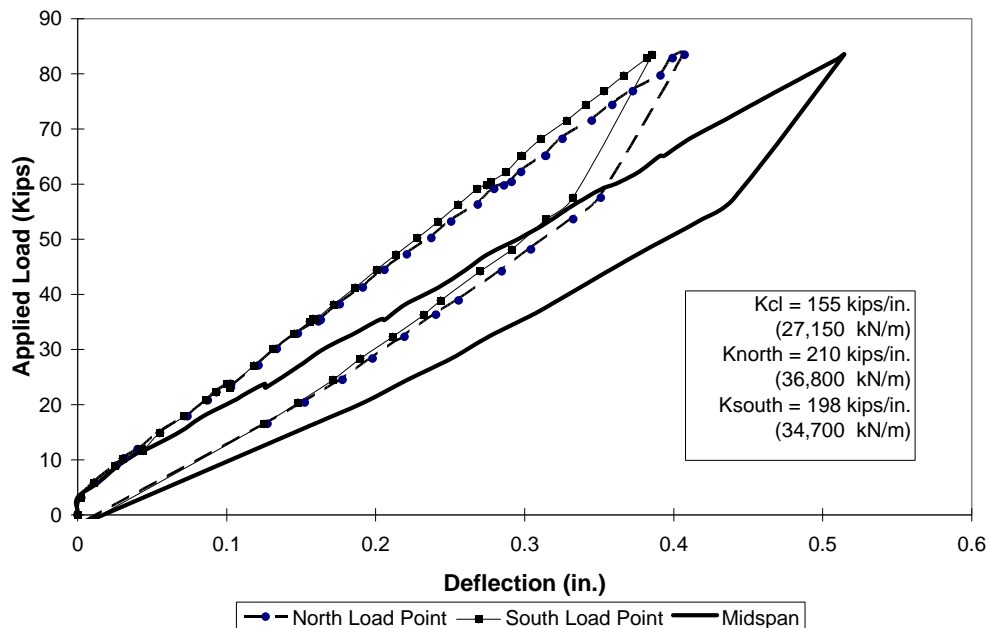
Figure 6- 22 Load-deflection response of Steck girder with four strands repaired using the Alberta splice

Figure 6.22 shows the load-deflection response of each instrumented cross section when all four tendons were spliced. At a maximum applied load of approximately 83 kips (369 kN) the measured displacements at the north, midspan, and south cross sections were 0.39 in. (9.9 mm), 0.51 in. (13 mm), and 0.41 in. (10 mm) respectively. The member stiffness at these locations, based on least squares regression analysis of experimental measurements are shown in Figure 6.22.

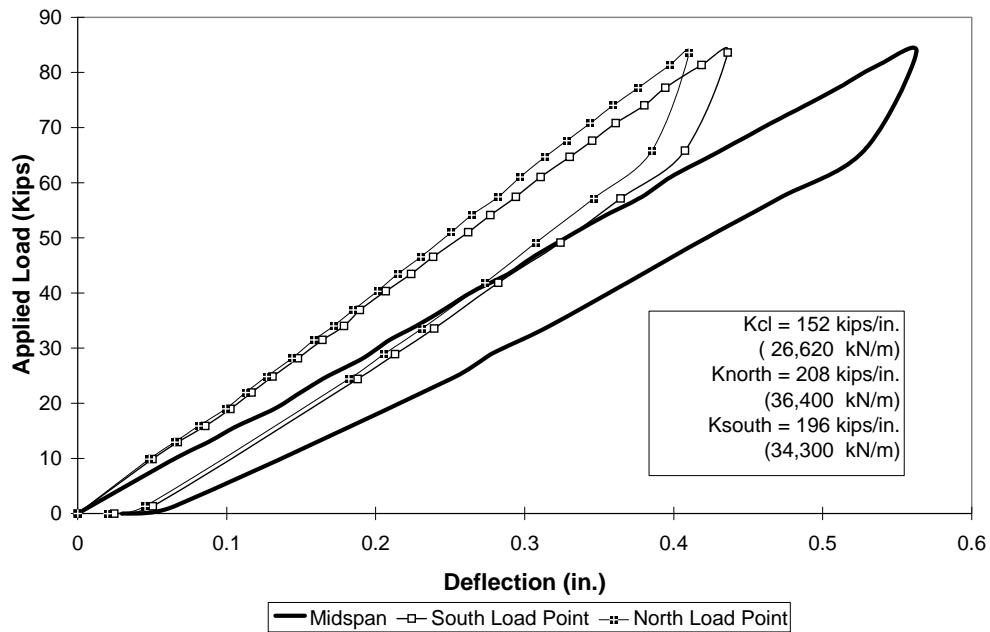
Figure 6- 23 Load-deflection response of Steek girder with two strands repaired using the Alberta splice and two strands damaged

When the two outside strand splices were removed and load applied to the girder, there was very little change in load-deflection response of the girder. Figure 6.23 shows the results of load testing carried out on the girder when the two interior strands were repaired and the two exterior strands were not. It is obvious in comparing the differences in load-deflection response that two or four tendons are repaired, that there is very little change.

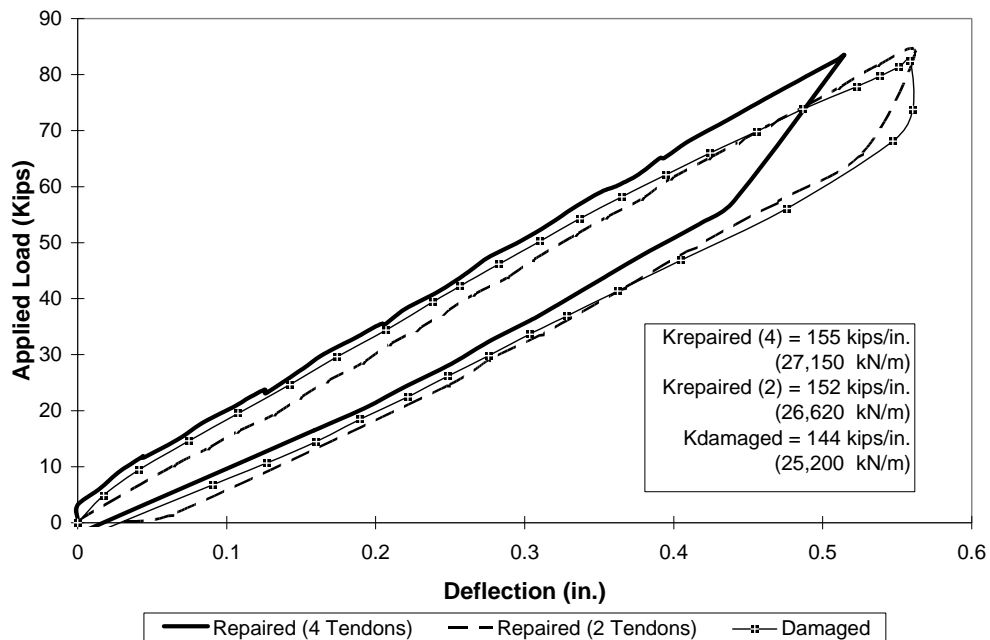
Figure 6- 24 Comparison of midspan load-deflection response of damaged and repaired girder using Alberta splice assembly

Figure 6.24 shows the midspan response for the damaged and repaired girder. When four strands were damaged and only two were repaired, there was little evidence of any benefit in performing the repair of only a portion of the damaged tendons. However, if comparison is made to the undamaged condition when all of the tendons remained intact, there was a definite change in member stiffness. When all tendons were undamaged, the midspan stiffness was measured to be 183 Kips/in. (32,050 kN/m). After four tendons were cut the stiffness was 144 kips/in. (25,200 kN/m), and when only two of the four damaged strands were repaired with the Alberta splice the midspan stiffness was 152 Kips/in. (26,600 kN/m). When all four tendons were spliced, the stiffness changed very little when compared to the case where only two tendons were repaired. Comparison of the midspan stiffness during different stages of the repair show that there is very little difference between repairing two or four strands out of a total of 28.

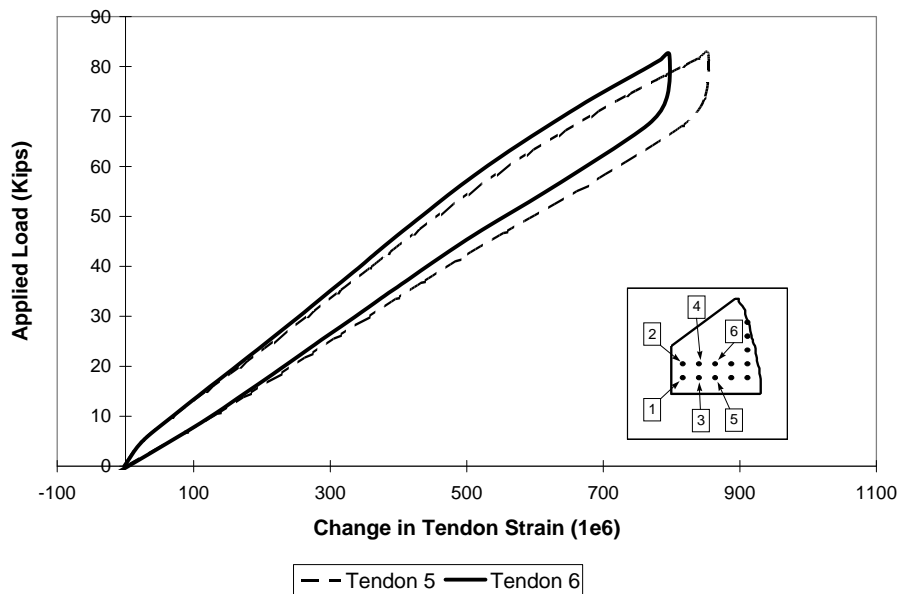
Figure 6- 25 Load-deformation response of tendons 5 and 6 (intact tendons), strands 1 through 4 not repaired

Strain Response of Repaired Tendons. There were six strands instrumented with strain gages and the results have been organized by location within the girder: results for lower tendons (tendons #1, #3, and #5) and results for upper tendons (tendons #2, #4, and #6). When tendon numbers 1 through 4 were not spliced, strains were measured for the undamaged tendons (5 and 6) for comparison with the strains measured when the damaged tendons were spliced. The measured strains of the intact tendons for the damaged state (none of the severed tendons were spliced) are shown in Figure 6.25. As might be expected the tendon with less eccentricity (number 6) experienced less strain than the tendon below (number 5). It is also evident that there was a very slight transition from an uncracked to a cracked response as the applied load approached 60 Kips (267 kN).

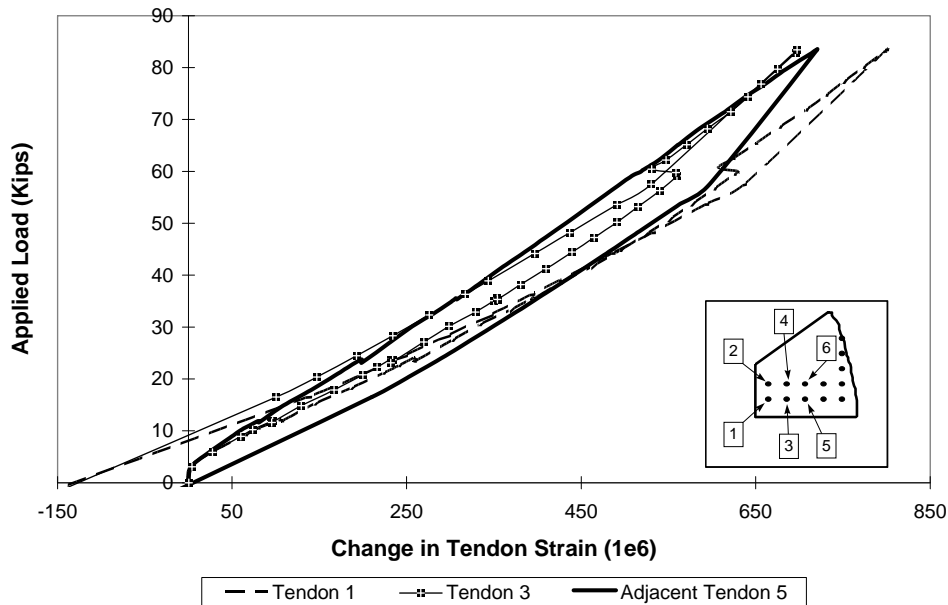
Figure 6- 26 Load-deformation response of bottom tendons — four severed strands repaired with Alberta splice

When the four severed tendons were repaired with the Alberta splice, the load-deflection response did not change much; however, the measured strains in the undamaged tendons were reduced. When repairing damaged strands with the Alberta splice, there did not appear to be any transition from an uncracked to a cracked section; there was a higher prestress in the section due to the tensioning the damaged strands, and therefore more load was required to produce or open flexural cracks (Figure 6.26 and 6.27). Measured

strains for both the upper and lower tendons reveal that anchorage losses occurred for the tendons which have splices installed, while the intact tendons exhibit none. In each plot (Figure 6.26 and Figure 6.27) both a gradual and sudden slippage within the anchorages of either the splice or the coupler are evident; the slope of each splice curve is less than the corresponding response of the intact tendon, and a very sudden decrease of strain was evident for three of the four spliced tendons. As the load was removed from the girder there was a residual negative strain for every tendon that had a splice installed, a further indication of anchorage seating.

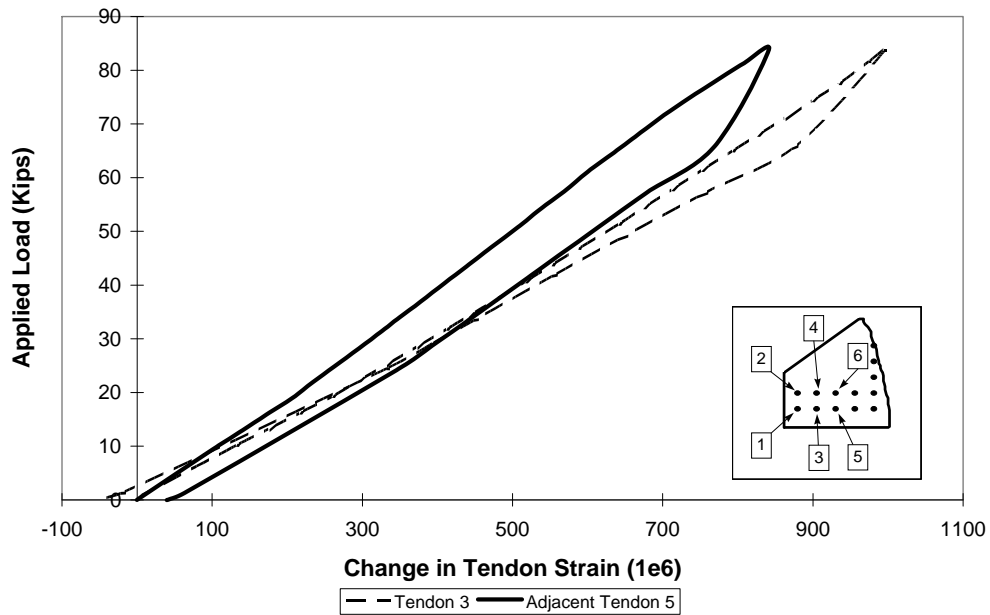
Figure 6-28 Load-deformation response of bottom tendons — two strands repaired using the Alberta splice

the spliced and undamaged tendons increased accordingly; there was less prestress and not as much reinforcement to share the tension due to applied loads. Figure 6.28 and 6.29 show the response of the spliced and undamaged lower and upper tendons respectively. Not as much anchorage seating was experienced during the second load cycle as was during the first; the residual strains are less than shown for the previous load cycle when most of the anchorage seating occurred. The repaired strands experienced higher strains than the undamaged tendons.

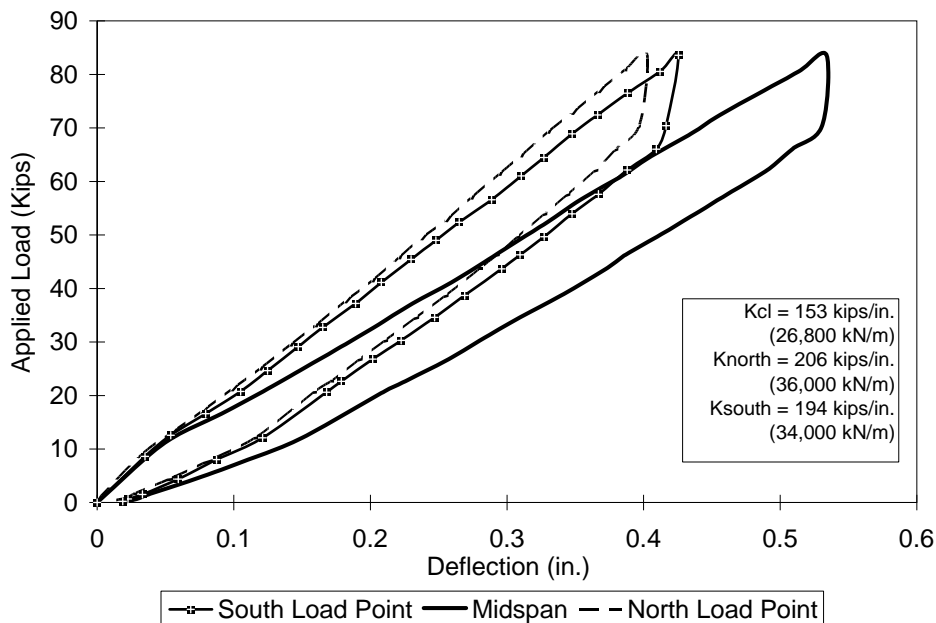
Figure 6- 35 Load-deflection response of Steck girder with four strands repaired using the multi-bolt swaged splice

Figure 6.35 shows the load-deflection response of each instrumented cross section when all four tendons were spliced. At a maximum applied load of approximately 83 kips (369 kN) the measured displacements at the north, midspan, and south cross sections were 0.40-in. (10-mm), 0.53-in. (13-mm), and 0.43-in. (11-mm), respectively. The member stiffnesses at these locations based on least squares regression analysis of experimental measurements were 206 kips/in. (36,000 kN/m), 153 kips/in. (26,800 kN/m), and 194 kips/in. (34,000 kN/m), respectively.

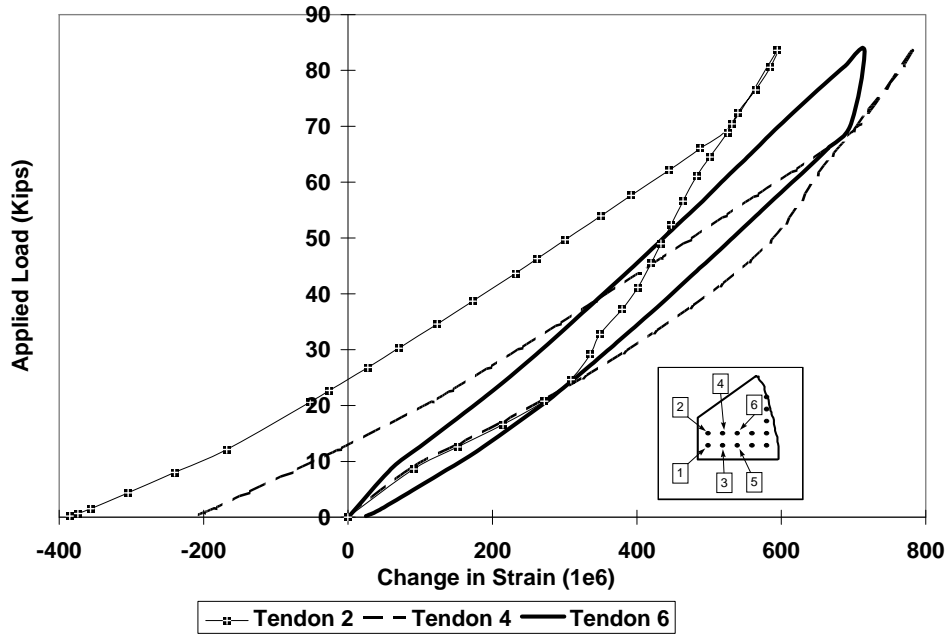
Figure 6-39 Load deformation response of top tendons — four severed strands repaired with multi-bolt swaged splice

A reduction in the level of strain experienced by the undamaged tendons was observed when all four damaged strands were spliced with the multi-bolt splice mechanism. With the increase in internal prestress from strand splice installation, the transition to a cracked response was no longer observed (Figures 6.38 and 6.39). Even though there should be no anchorage losses within the swaged assembly, installation required usage of two strand couplers which have wedge anchorages. Anchorage losses did occur as observed by the residual strains of all four spliced strands, and it appeared that the losses occurred within the couplers rather than within the swages (Figures 6.38 and 6.39).

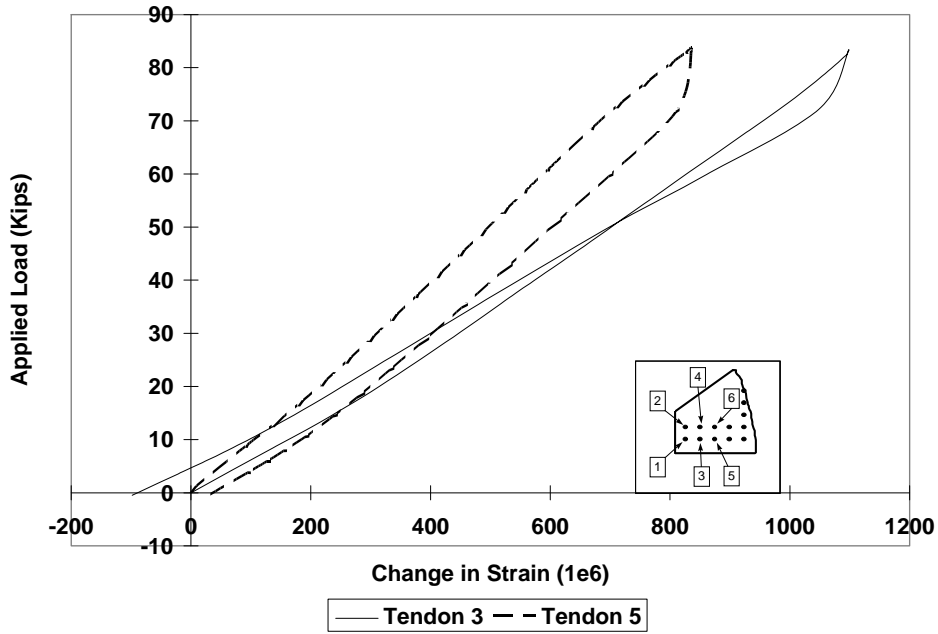
Figure 6-40 Load deformation response of bottom tendons — two strands repaired using the multi-bolt swaged splice

second cycle of static load testing. Figures 6.40 and 6.41 show the results for the second stage of the repair where only two of the tendons were spliced with the multi-bolt swaged splice. The strains of the spliced and undamaged tendons increased as expected when compared to the first stage of the repair when all four damaged tendons were spliced. Figures 6.40 and 6.41 show the response of the spliced and undamaged lower and upper tendons respectively. As was observed for the Alberta splice tests most of the anchorage seating for the multi-bolt splice occurred during the first stage of static loading as well.

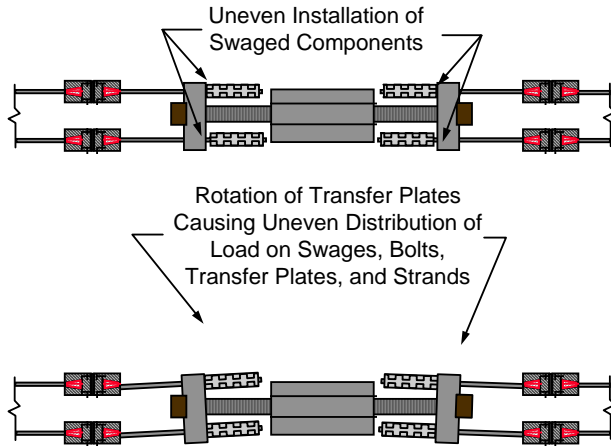
Figure 6-44 Schematic of difficulties encountered installing dual tendon splice — unequal distribution of load between splice components

swages were equidistant. This caused rotation of the transfer plates and uneven load distribution throughout the splice components. It was also difficult to restrain the ends of the splice assembly. Rather than having a bolt or nut which could be rotated to facilitate gripping with a wrench, the transfer plates had to be gripped to provide restraint against rotation while applying torque to the turnbuckle. The transfer plates had a fixed vertical position which made gripping with a wrench difficult and slippage frequent.

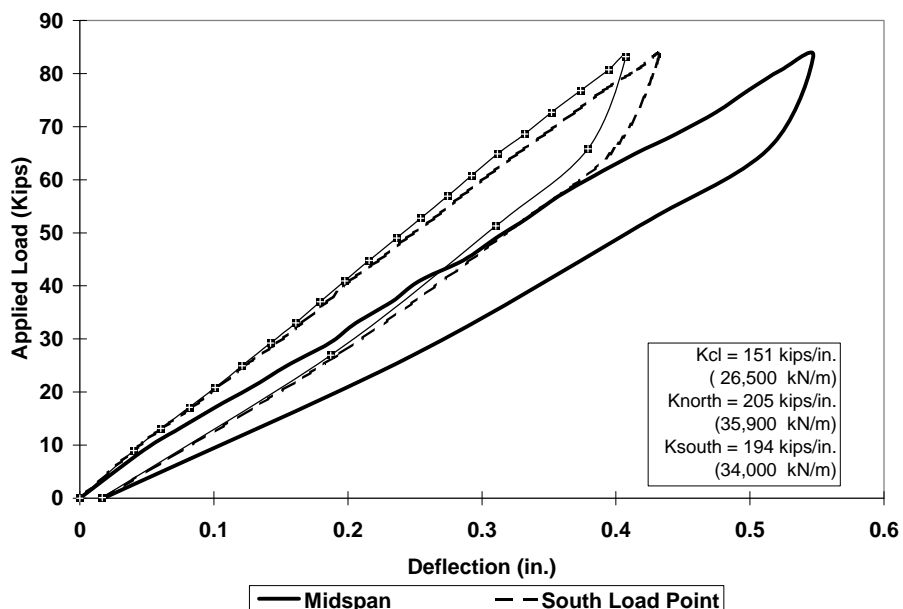
Figure 6- 47 Load-deflection response of Steck girder with two strands repaired using the dual strand swaged splice

Figure 6.47 shows the load-deflection response of each instrumented cross section when tendons 3 and 4 were spliced. At a maximum applied load of approximately 83 kips (369 kN) the measured displacements at the north, midspan, and south cross sections were 0.41-in. (10-mm), 0.55-in. (14-mm), and 0.43-in. (11-mm), respectively.

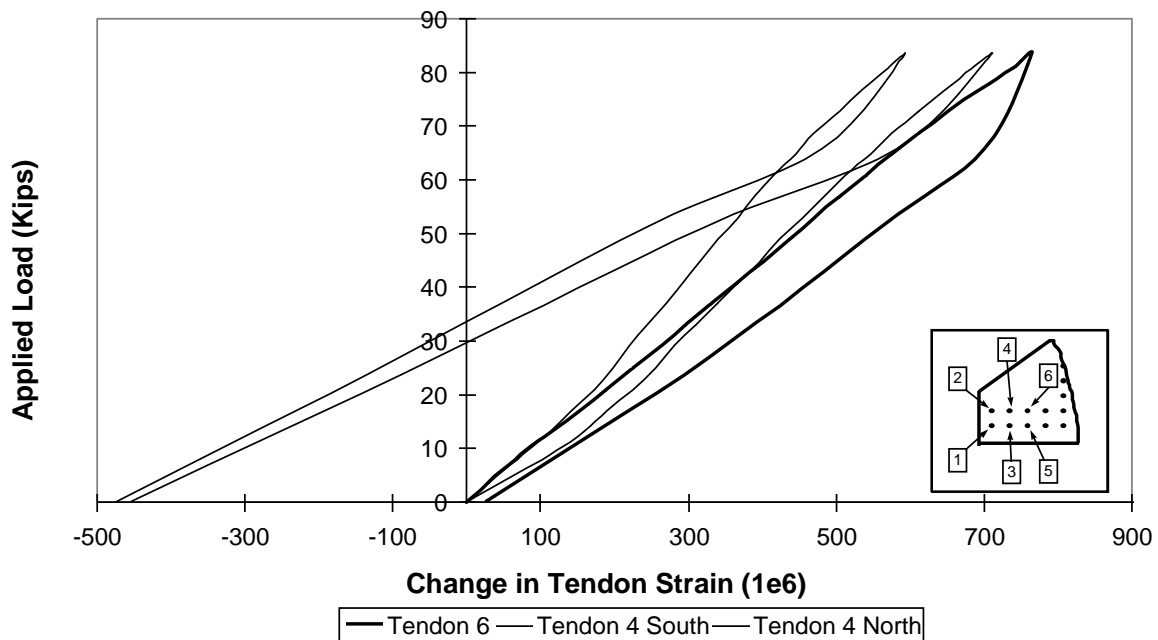
Figure 6- 48 Load-deformation response of top tendons — two strands repaired with dual strand swaged splice

Figure 6.48 and 6.49 show the measured strains for each side of the splice assembly for both the bottom and top strands respectively, as well as the adjacent strands 5 and 6. A reduction in the level of strain experienced by the undamaged tendons (5 and 6) was observed when two of the four damaged strands were spliced with the dual tendon splice. As shown with previous splices, there was an increase in internal prestress from strand splice installation and there was no longer a transition to a cracked response. Anchorage losses occurred within the strand couplers similar to that in the multi-bolt swaged splices.

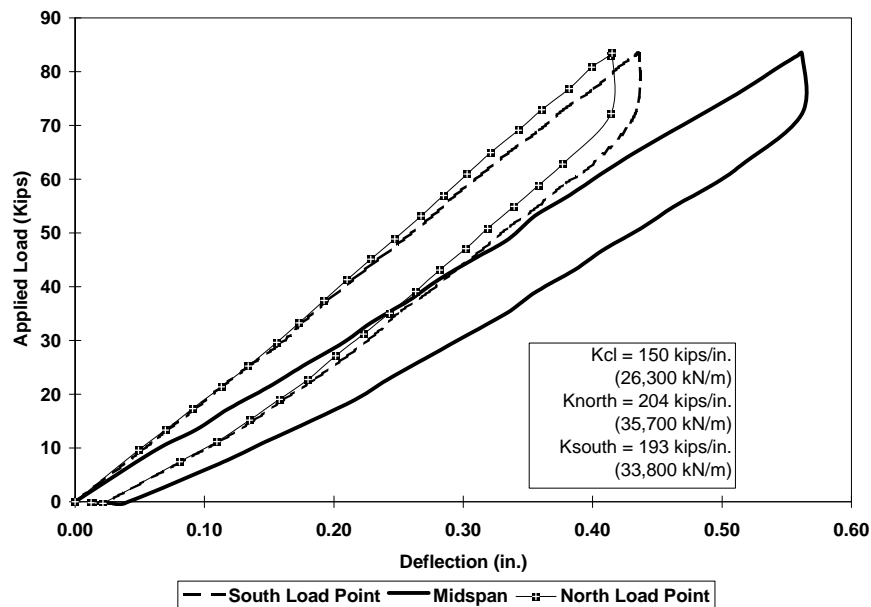
Figure 6-56 Load-deflection response of Steck girder with two strands spliced using the Grab-It™ cable splice assembly

After the two outside splices were removed from tendons 1 and 2 the girder stiffness was reevaluated. Figure 6.56 shows the results of the reevaluation. There was very little change in the stiffness of the girder. Figure 6.57 compares the response at midspan for the damaged and repaired girder.

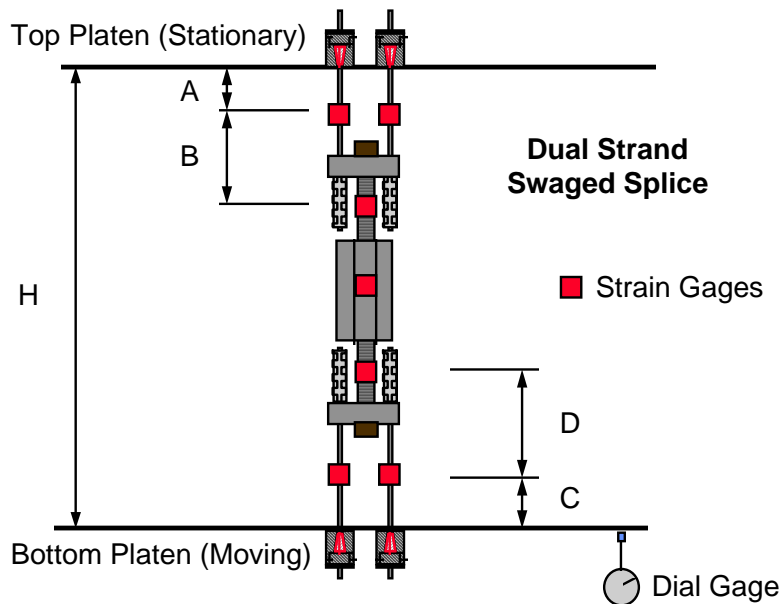
Figure 6- 62 Tensile test setup for dual strand swaged splice assemblies

Discussion of Ultimate Strength Test Results. The two tests performed on the dual strand swaged splice resulted in different modes of failure. One strand of the first specimen failed within the swage as expected. The failure occurred at 91 % of the ultimate strength of the strand; the manufacturer rates the swaged tendon for 90 % of the ultimate

strength of the strand due to the swaging process. The second specimen, however, failed through the threads of the bolt. Some problems were encountered while fabricating the some of the turnbuckles for the dual strand splices. In some instances the threads within the turnbuckle were not cut to full depth through the entire length of the turnbuckle. With less than the full depth of threads there is less area to resist the load as it is transferred from the bolt to the turnbuckle and failure through the threads would be likely in this instance. It appeared that the second specimen failed through the threads due to fabrication errors. Although it was not immediately apparent upon inspection of the second specimen tested, two other assemblies were not tested due to improper thread depth. It is very likely that improper depth of the threads within the turnbuckle lead to premature failure of the second specimen which reached only 81 % of the ultimate strength of the strand. The expected mode of failure for this splice was substantiated by further tests of the swaged portion of the splice in bearing (Table 6.8) where each of the three tests resulted in failure of the strand within the swage.

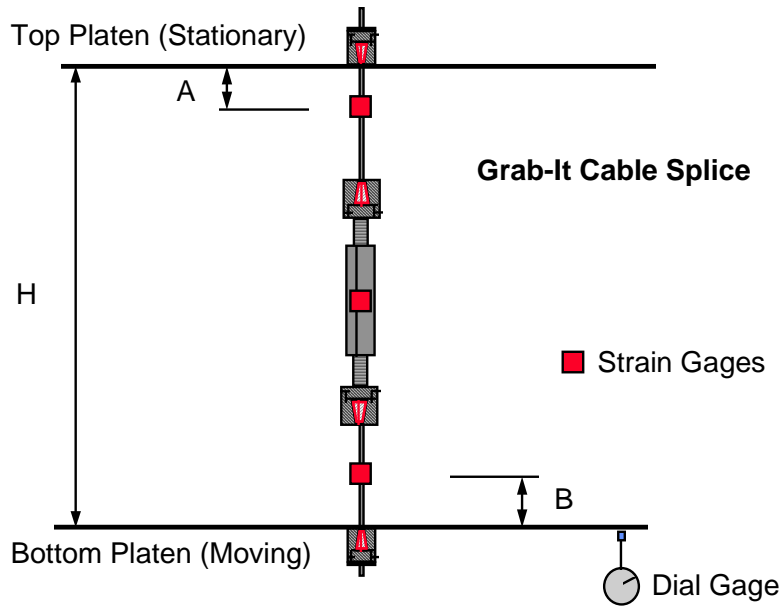
Figure 6- 63 Tensile test setup for Grab-It™ cable splice assemblies

For the first of two specimens tested using the Grab-It™ Cable Splice failure occurred within the strand inside of the wedge anchorage holding the strand at the top of the testing machine. The maximum strength achieved was 91 % of the strand ultimate strength. As previously discussed, this low strength was due to strand notching effects within the wedge anchorage. Onset of strand yielding did occur; however, premature failure resulted within the anchorage. On the other hand, the second test resulted in failure of the strand at the wedge grips within the splice resulting in a strength at failure of 81 % of the strand ultimate strength. It appears that this was the result of the quality of the strand grips supplied with the Grab-It™ Cable Splice.

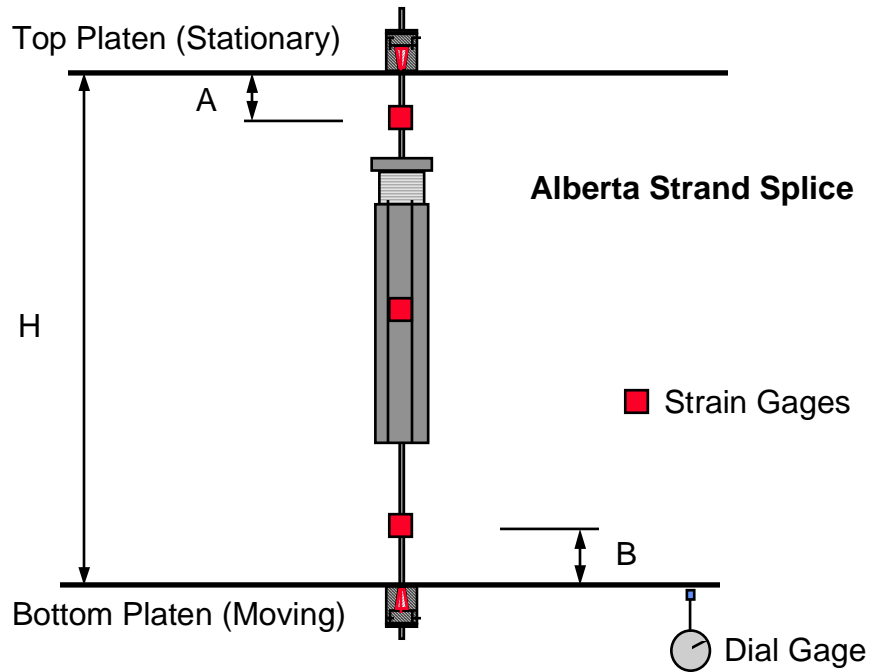
Figure 6- 64 Tensile test setup for Alberta splice assemblies

The ultimate strength of the three specimens using the Alberta splice performed very well. Although the ultimate strength of the strand was not reached, premature failure in each case was caused by notching effects within the anchorages. This was substantiated by tests performed on strands held in the test machine with two different types of anchorages, American and Supreme multi-use strand grips. The grips used for the Alberta tests were all American multi-use strand grips which caused premature failure in every case of strand only tests. Onset of yielding occurred in all three cases, and the ultimate strength of the splice assemblies was between 93% and 96% of the ultimate strength of the strand.

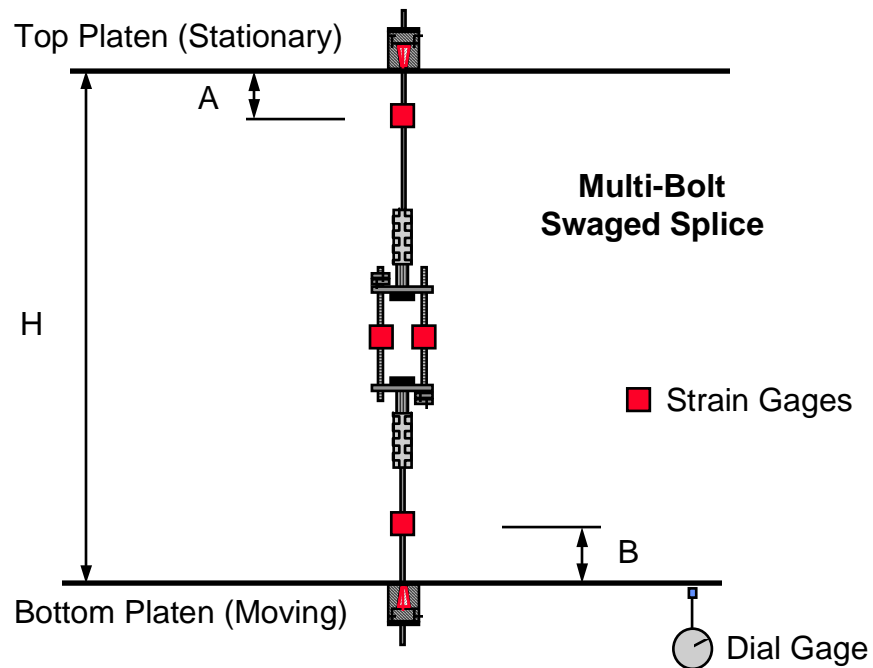
Figure 6- 65 Tensile test setup for multi-bolt swaged splice assemblies

Four ultimate strength tests were performed using the multi-bolt swaged splice. In each case the strand did not break, but failure occurred through the threaded portion of the swage. None of the four splices reached the rated value of 90 % of the ultimate strength of the strand. Two of the specimens reached 86 % and two reached 87 % of the strand ultimate strength. It appears that when the swage is placed in tension the failure occurs within the swage, and when the swage is placed in compression, as used in the dual strand splice, failure occurs within the strand inside of the swage.

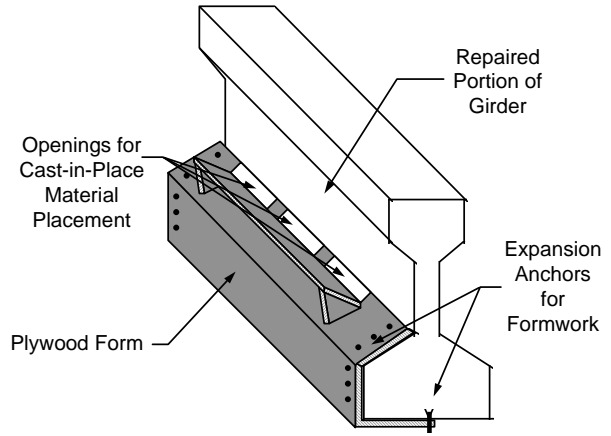
Figure 6- 66 Schematic of formwork for cast-in-place repair of Steck girder — final phase

A schematic of the forms used for the repair is shown in Figure 6.66. The patch material was placed into the forms through openings in the top as shown schematically. A photograph of the bottom portion of the forms in place along with installed splices is shown in Figure 6.67. Once the forms were in place, preload was applied to the girder using the hydraulic rams as before. After preloading, the patch material was placed, allowed to cure, and the forms were removed the next day; however the preload was maintained for three days after the patching was performed.

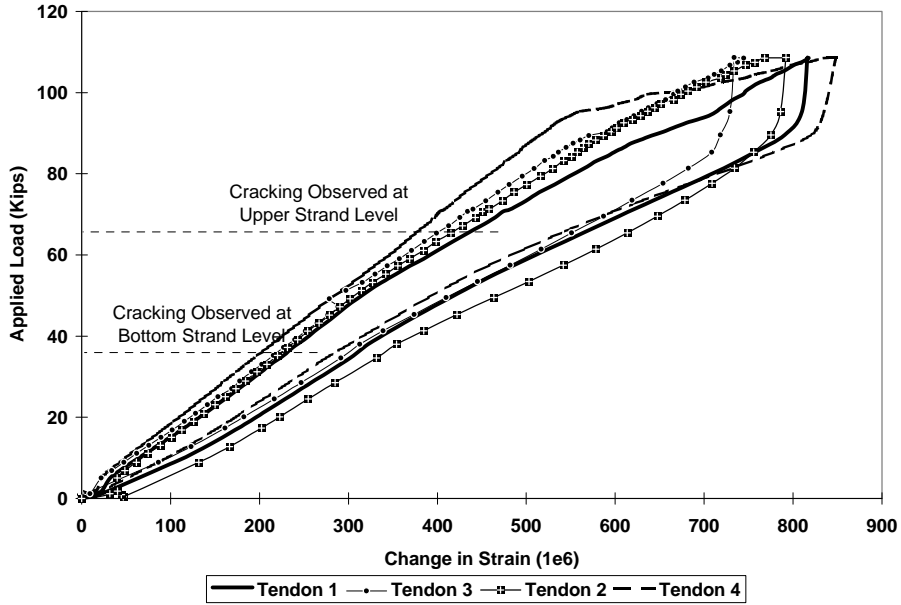
Figure 6- 74 Strain response of instrumented tendons during sixth load cycle — final phase of repair

Figure 6.74 shows the strain response of the repaired tendons during the sixth cycle of loading, the first cycle of equivalent live load plus impact. The main difference between the sixth cycle response and the first cycle response is that flexural cracking of the repaired zone was observed visually and was evident in the measured strain responses. The response of tendon 1, the bottom outside tendon, revealed that flexural cracking within the bottom flange occurred at a load just below the level of preload. The response of tendon 4, the upper inside repaired tendon, revealed that the flexural cracking extended higher and deeper into the flange as the applied load increased to a level approximately 15 kips (67 kN) below the equivalent live load plus impact.

It appears from the results of the first load cycle that the increased prestress due to both strand repair and preloading of the girder prevented cracking of the repaired zone at loads at or below the equivalent live load. When several cycles of equivalent live load were applied and then increased to a level equivalent to live load plus impact the repaired zone experienced some flexural cracking. However, upon removal of the load all flexural cracks closed due to prestressing.

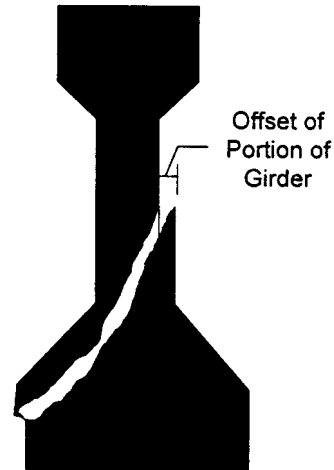
Figure 7-10 Schematic of concrete damage showing offset portion of damaged girder

- **Offset Section** — occurs in extreme cases of side impact resulting in a portion of the concrete remaining intact, yet offset horizontally from the rest of the girder (Figures 7.10 and 7.11). An offset of more than 5% of the girder bottom flange width should be studied in detail and the traffic rerouted until the girder strength can be verified
