**PMFSEL 90-2
DECEMBER 1990**

TESTS OF HIGHLAND WAREHOUSE ROOF JOISTS

**PHIL M. FERGUSON STRUCTURAL ENGINEERING LABORATORY
Department of Civil Engineering / Bureau of Engineering Research
The University of Texas at Austin**

December 1990

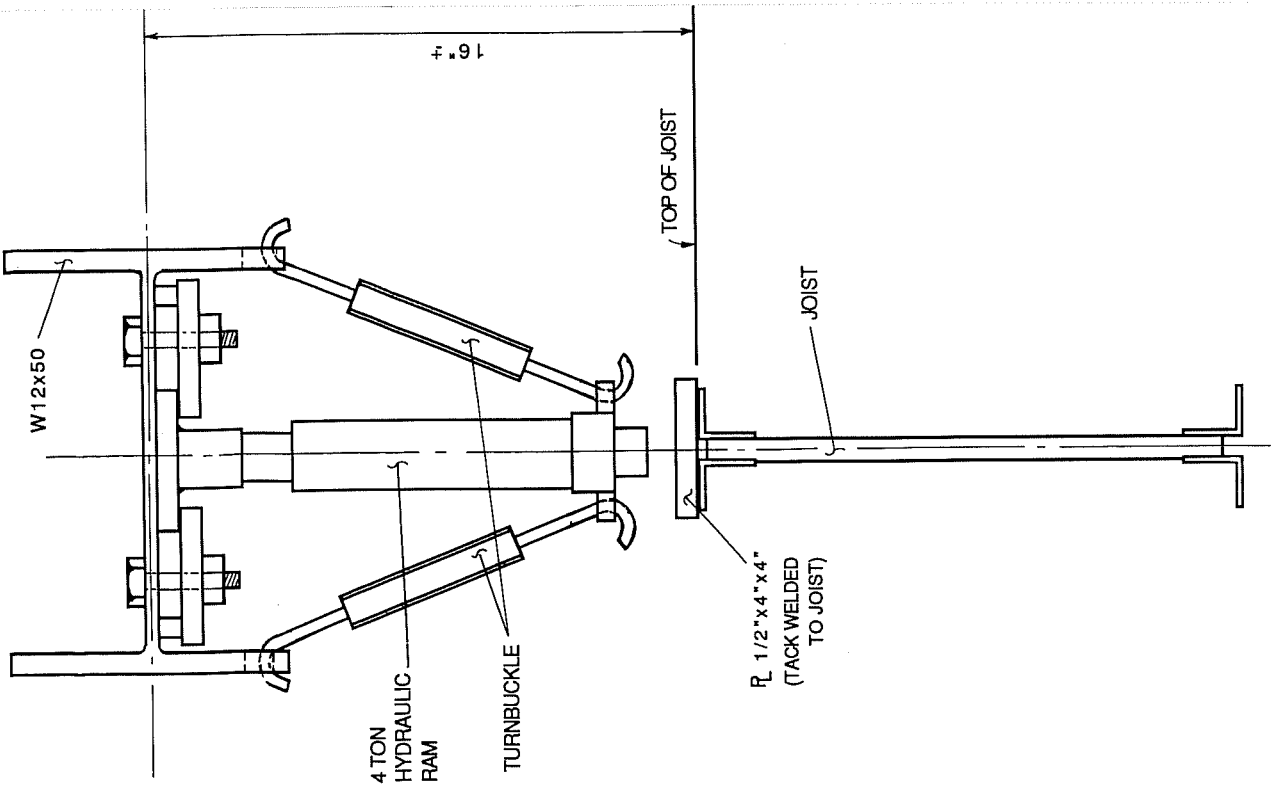
Fig. 2.11 Typical Detail at Hydraulic Loading Ram

Figure 2.11 illustrates the details at a hydraulic ram. The rams, rated at 4 tons maximum capacity, were connected to the $W12 \times 50$ beam. Beneath each ram, a $1/2''$ steel plate was tack welded to the top of the joist in order to distribute the load to the joist. Figure 2.12 shows a photograph of the loading rams.

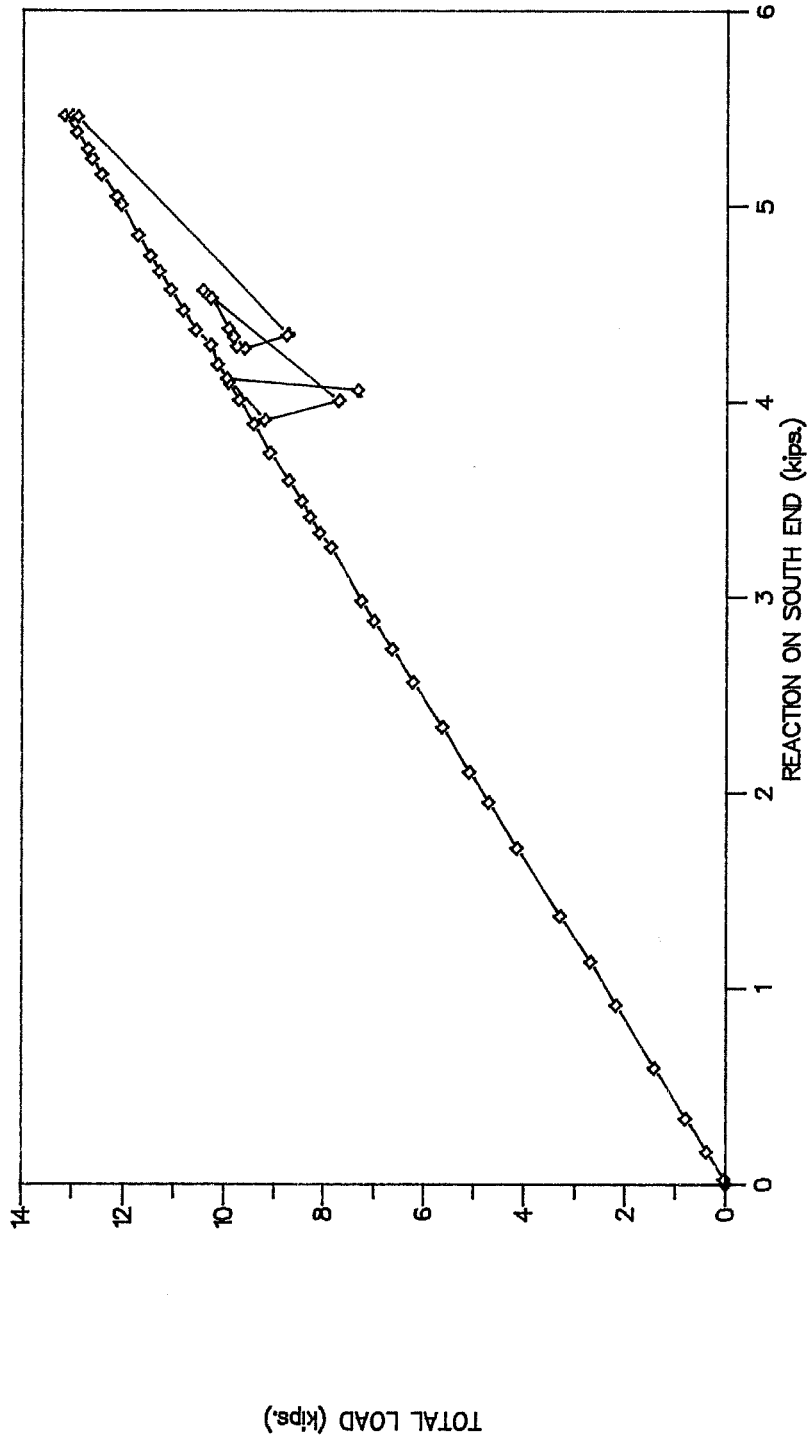
Fig. 3.6 Joist No. 3 - Load vs. Reaction at South End of Joist

The plot of load versus displacement for Joist No. 3 is shown in Fig. 3.5., and a plot of load versus the vertical reaction measured at the south end of the joist is in Fig. 3.6. The peak load held by this joist was 13,200 lbs., at which point the midspan deflection was measured at 2.37 inches. At the peak load, the first compression diagonal at the north end of the joist buckled. This diagonal buckled primarily in the plane of the joist.

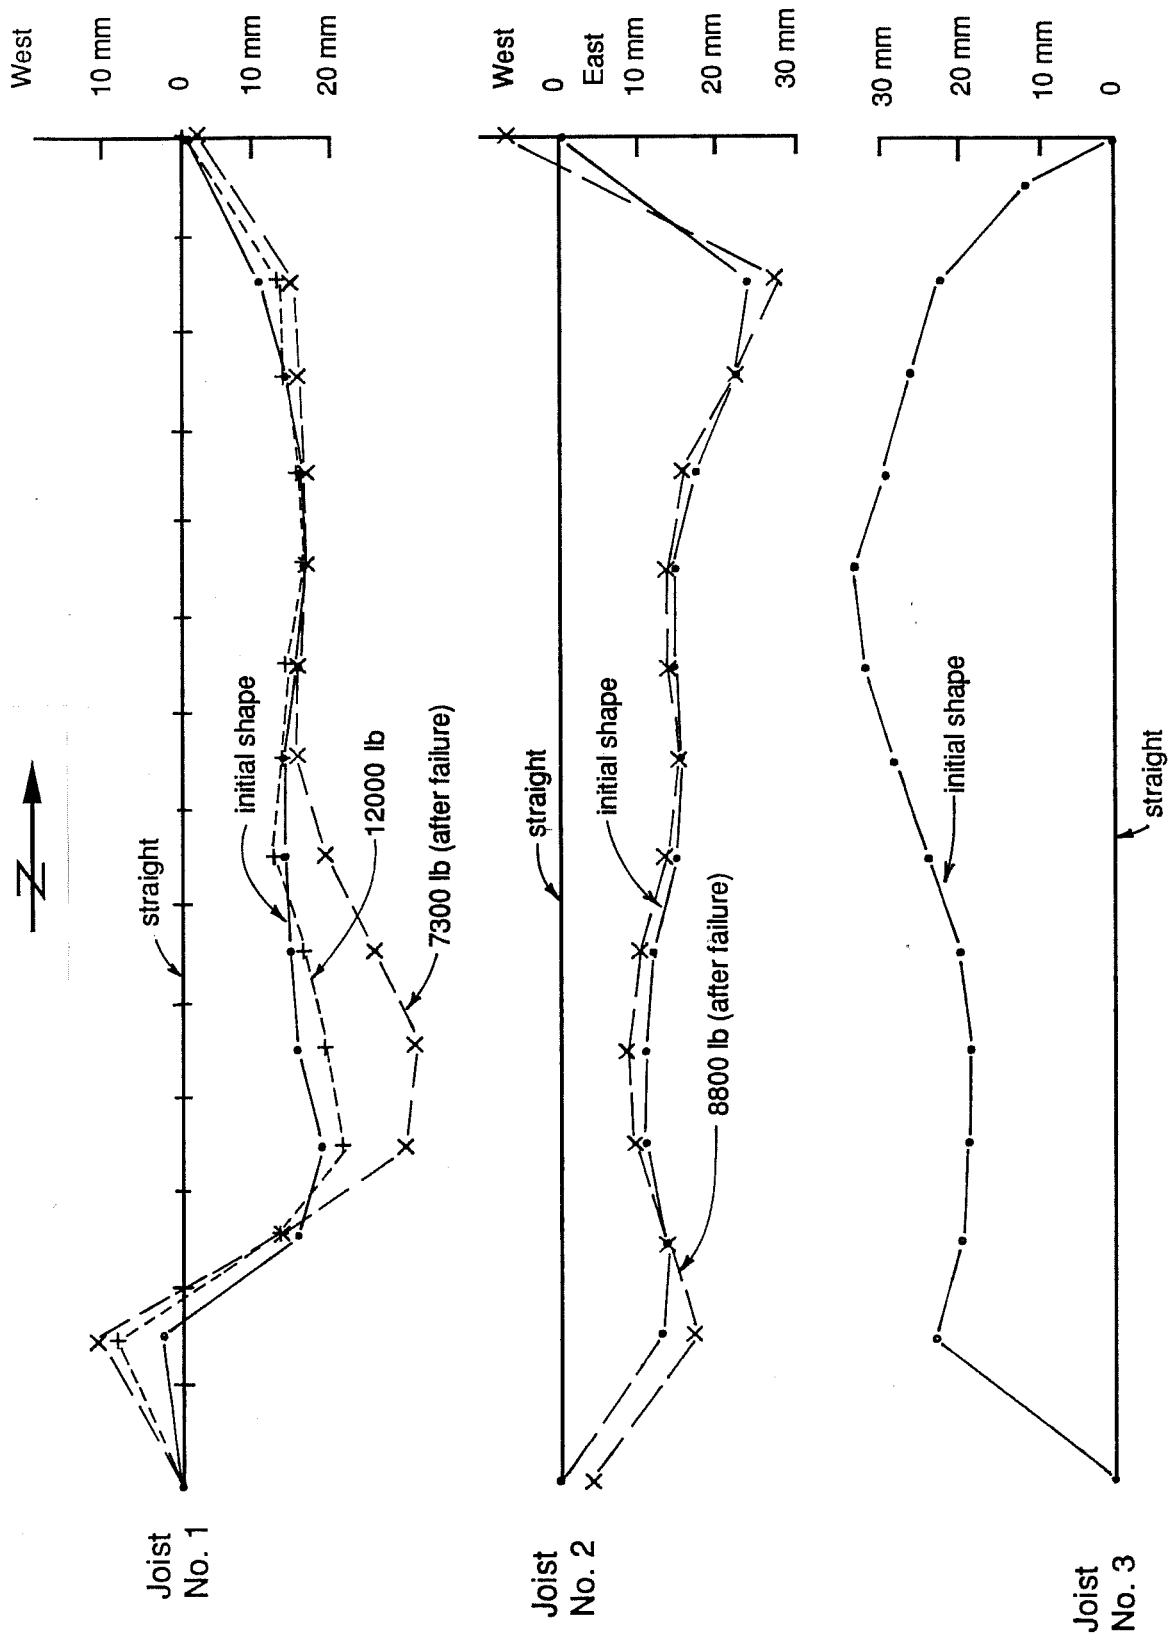
Fig. 4.1a Lateral Displacements of the Top Chord

The lateral displacement readings for each joist are presented in Tables 4.1 to 4.3. At each location along the joist, the absolute reading is provided, as well as the change in reading from the initial unloaded state. Some selected results are shown graphically in Fig. 4.1a. The initial shape from a straight line through the two end supports is shown for each joist. Each joist had an initial lateral displacement of the top chord of at least 1/2 inch over most of the length. The data suggest that each joist had a kink near the first panel point at each end. This initial deformation pattern is also visible in the photographs in Fig. 2.17.

Because the top chord was laterally braced, these initial deformations had little effect on the joist behavior. This is demonstrated by the lateral displacements measured prior to buckling of the end diagonal and also after buckling. For Joist No. 1, the lateral displacements of the top chord at 12,000 lb. (maximum = 13,200 lb.) show only slight deviations from the initial shape. There is a significant change in lateral displacement only after the failure load was reached. In Joist No. 2, the lateral displacement did not even change significantly after buckling. The same observation can be applied to Joist No. 3; the data are not shown in Fig. 4.1a for clarity.

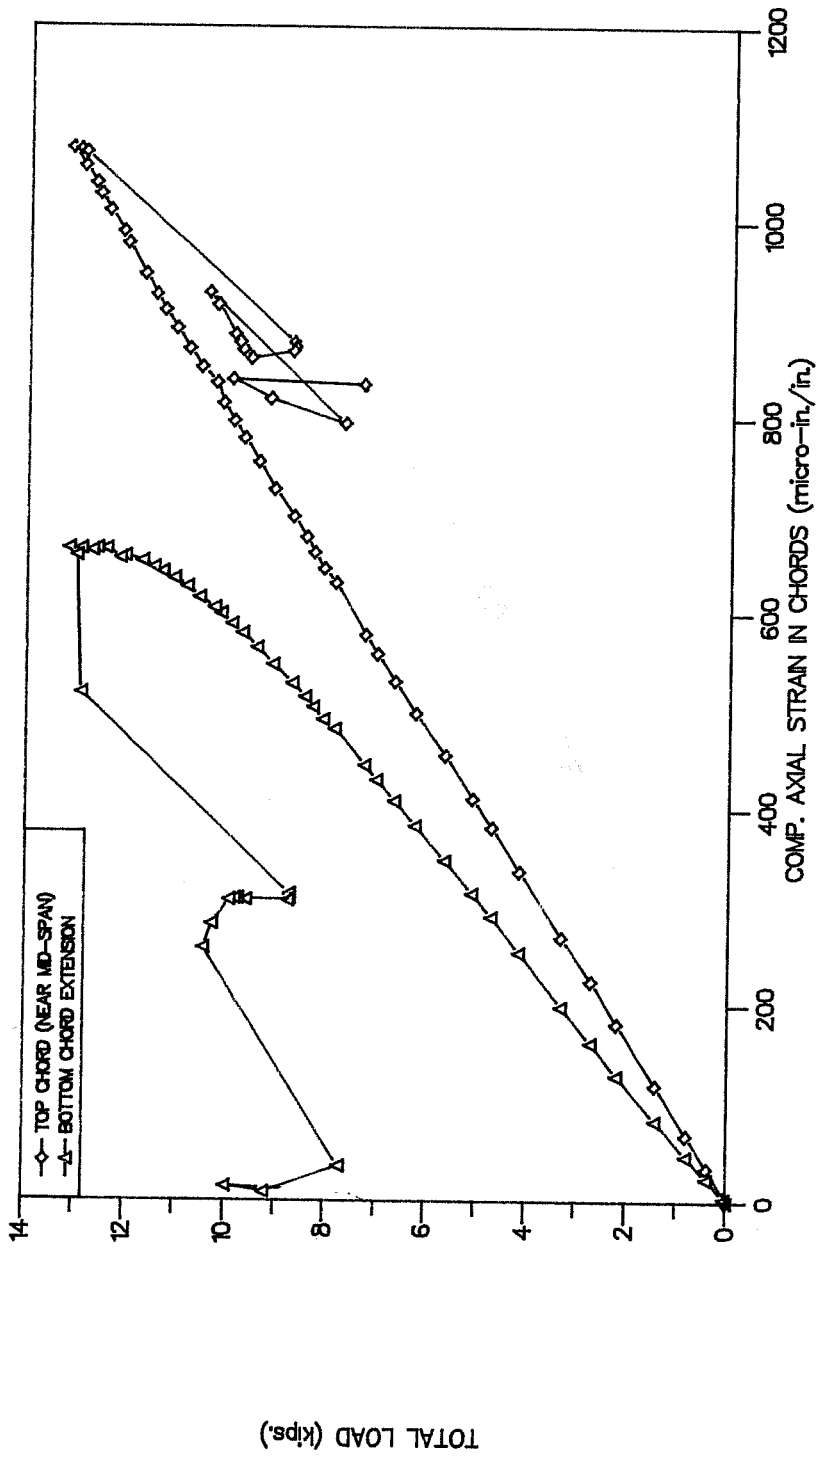
Fig. 4.9 Joist No. 3 - Estimated Axial Strain in Chord Members

Figs. 4.9 and 4.10 show some interesting results for the bottom chord extension in Joist No. 3. These plots indicate that the force in the bottom chord extension did not increase in proportion to the load on the joist. These data indicate buckling of the bottom chord extension, consistent with visual observations made during the test (see Chapter 3). The bottom chord extension appears to have buckled elastically, since no residual deformation was visible in the member at the end of the test. The nonlinear relationship between joist load and the force in the bottom chord extension in Figs. 4.9 and 4.10 is therefore the result of elastic buckling of the member and not due to yielding of the member. The elastic buckling of the bottom chord extension explains the somewhat nonlinear load – deflection plots for Joist No. 3 (Fig. 3.5).
