# **REHABILITATION OF EXISTING REINFORCED CONCRETE BUILDINGS IN MEXICO CITY**

## **Case Studies**

**PMFSEL 96-3**

**Ferguson Structural Engineering Laboratory  
The University of Texas at Austin**

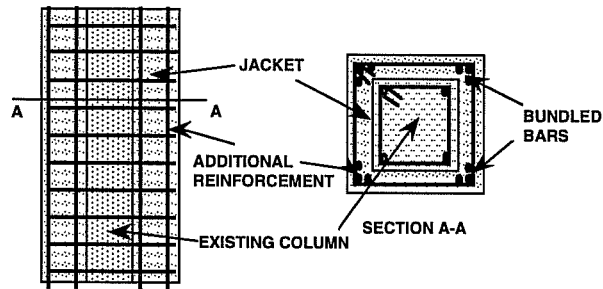
Figure 4-2 Column jacketing

A) JACKETING WITH LONGITUDINAL REINFORCEMENT

Column sections were increased by adding materials to only one or to several faces of an existing column depending on accessibility. However, for better performance, complete jacketing or encasement is recommended. Longitudinal reinforcing steel was placed at the corners to keep the additional transverse reinforcement in position. If more than four bars were used, care was taken to place the bars at positions that would not intersect the existing beams to minimize constructability problems. To increase flexural strength, as well as axial and shear capacity, longitudinal bars were often continuous through the floor slabs. Concrete was then cast through holes bored in the slab. Figure 4-2A shows the longitudinal bar distribution that can be used to minimize holes drilled in the existing beams.

Welded wire mesh was used primarily to increase the shear and axial strengths and the ductility of columns. The mesh was not passed through the floor (Figure 4-2B). Shotcrete was used to increase the speed of construction.

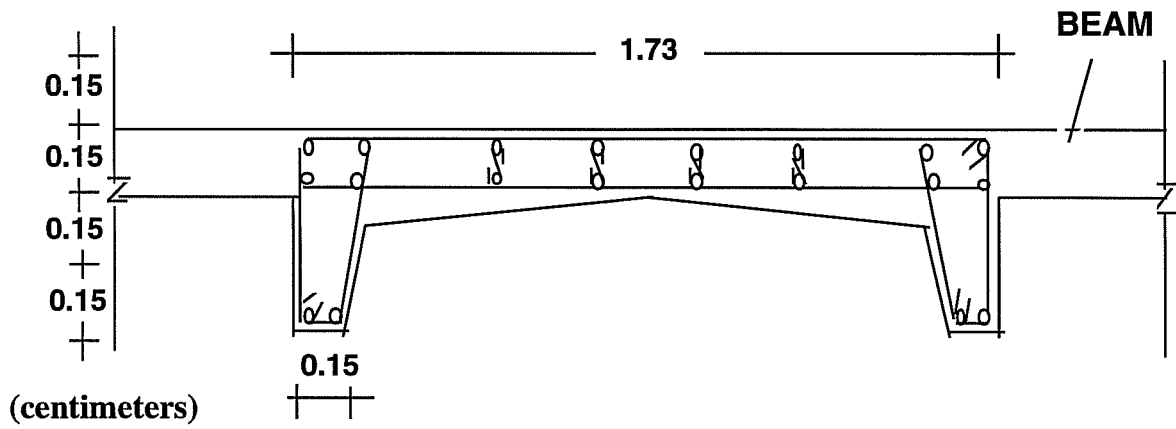
Figure 5- C2 Existing column

Two reinforced concrete perimeter frames provided lateral capacity in the long direction. These frames have deep beams that extended above and below the slab in each floor with the remaining space left for windows. The beams had a 60 cm. projection below the slab and 80 cm. above. The deep beams are supported on 1.73 m long channel shaped columns. The column flanges are 15 x 45 cm. in cross sectional dimensions and the column web is 1.43 m long with varying thickness from 15 cm at center to 25 cm at the flange connection (Fig. 5-C2)..

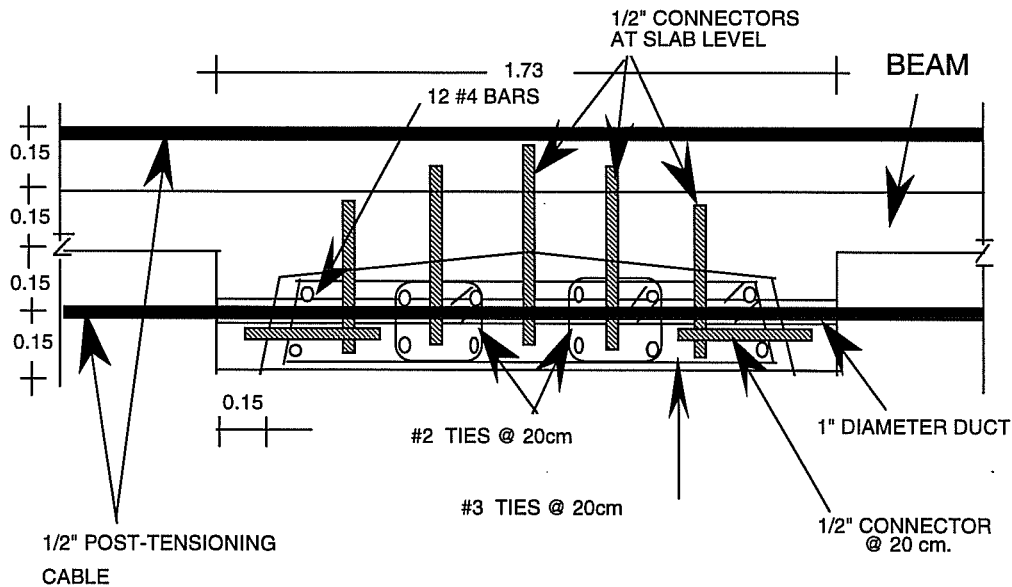
Figure 5- C4 Column and beam strengthening

After the 1985 Mexico City Earthquake, the reinforced concrete beams in the longitudinal frames showed moderate to severe cracking. It was considered that the damage was not significant enough to require any temporary shoring measures.

All of the cracked structural elements were injected with epoxy. Heavily cracked beams were repaired by removing the damaged concrete, adding ties, and recasting a new concrete section. Adequate bond between the new and old concrete surfaces was achieved by cleaning debris from the old concrete surfaces, saturating the surfaces, and using additives to control volume contraction in the new concrete.

The deep beams in the longitudinal frames were externally post-tensioned to increase their shear capacity in the first five floors. This was done by using two 1/2" post-tensioning cables parallel to the beams and anchored at the shear walls on lines 1 and 7. The cable position can be seen in Figures 5-C4 and 5-C5. The cables were placed symmetrically, on the inside and outside the building, and below and above the floor slabs to avoid creating any bending stresses on the perimeter frames due to the post-tensioning. The exterior cables were installed inside a 1" diameter duct that passes through the frame columns. The interior cables lie below the top chord of the truss girders that span in the perpendicular direction.

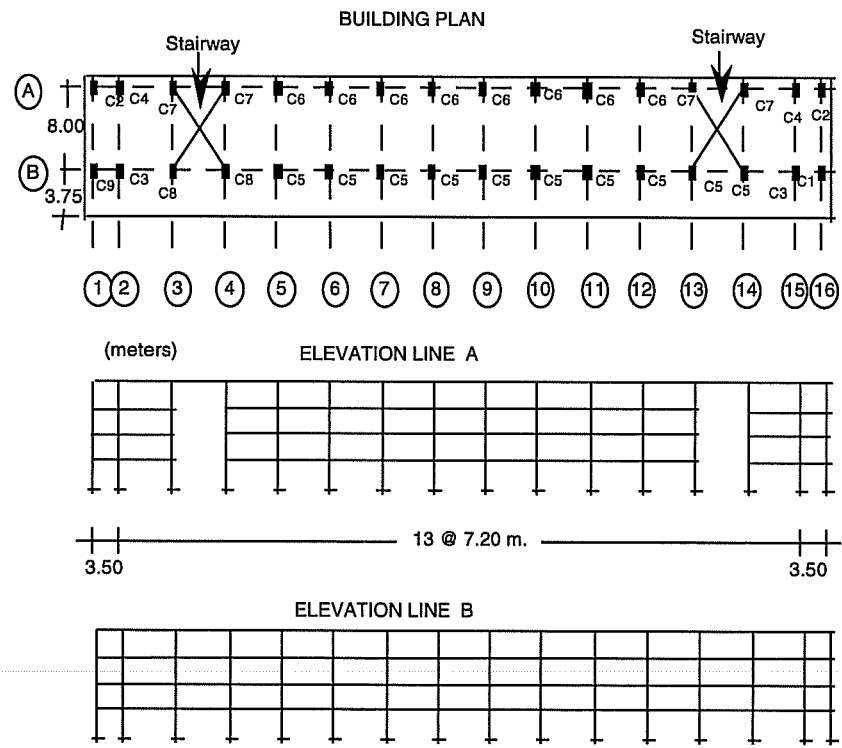
Figure 5- D1 Building plan and elevation

The arrangement of perimeter walls produced short columns in line A. The 1985 earthquake produced cracks (>1mm) in columns around stairway areas, particularly captive columns in line A. School buildings with similar structural systems constructed on transition soil zone adjoining the lake bed in Mexico City had lighter damage at the same locations in the structure.

Because the waffle slab was interrupted in the bays that correspond to the stairway areas (between lines 3 and 4; and between lines 13 and 14. See Figure 5-D1), steel beams were provided for continuity between the bays bordering the stairway area (Fig. 5-D9). Steel beams were added to reduce the structural discontinuity in the stairway areas where column damage was concentrated.

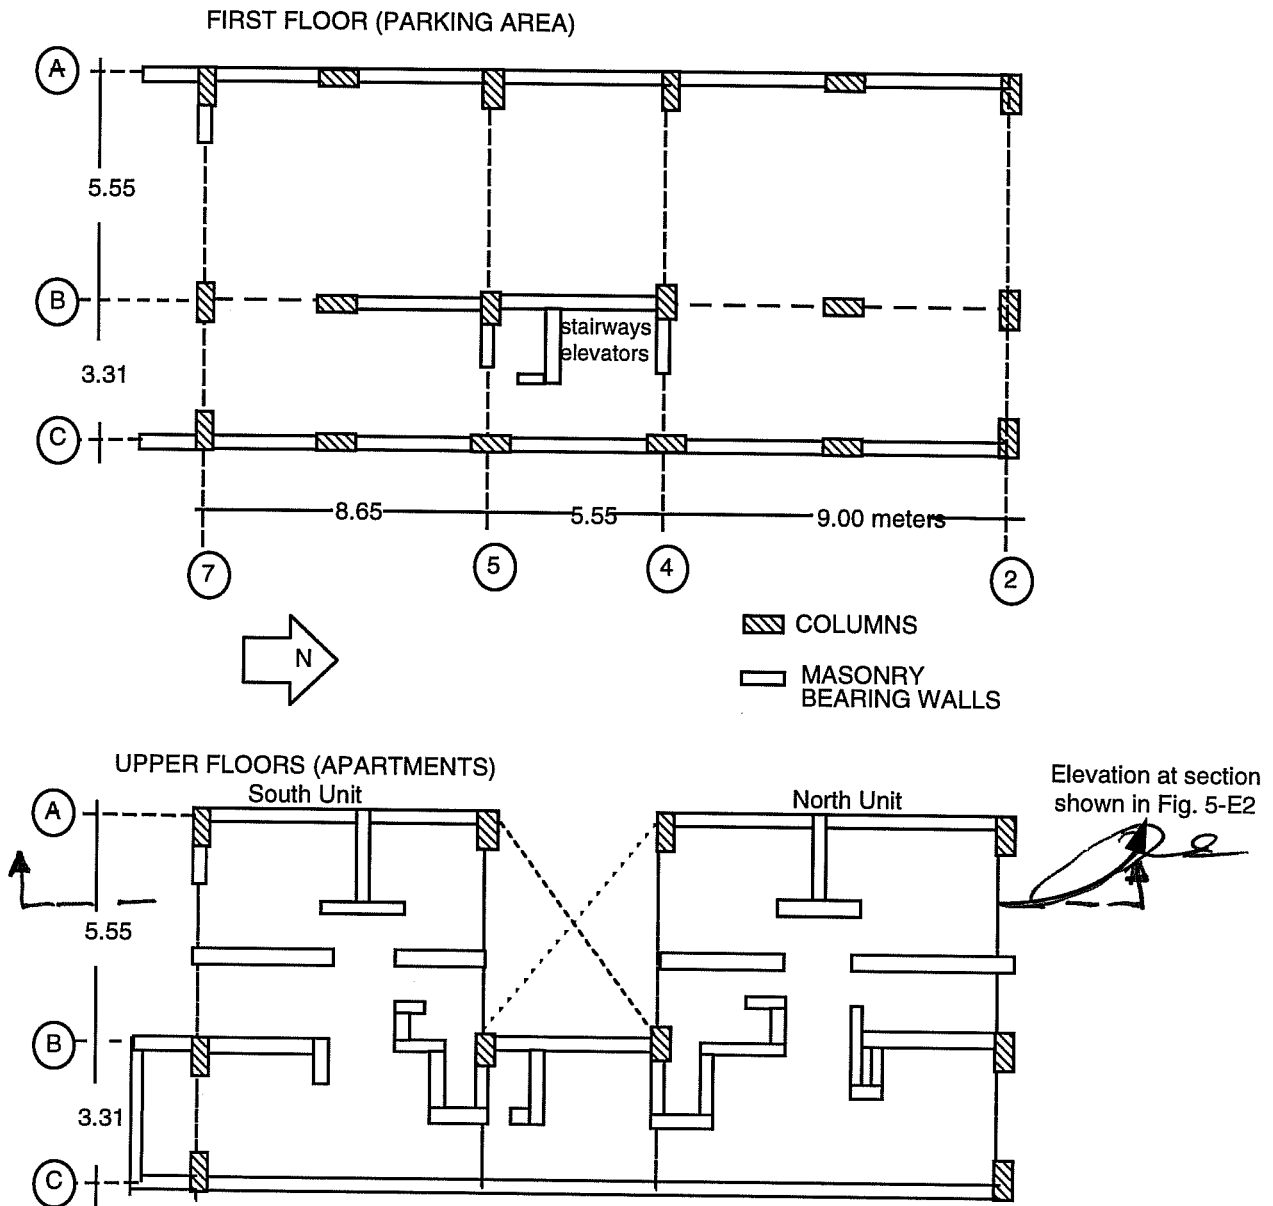
*Figure 5- E1 Building plan*

Figure 5-E4 shows the exterior wall on line A, which developed local failure due to the movement of the framing perpendicular wall. The rest of the walls in the N-S direction did not present any damage. This direction has considerably larger strength than the short direction, due to the massive continuous boundary walls on lines A and C (Figure 5-E1).

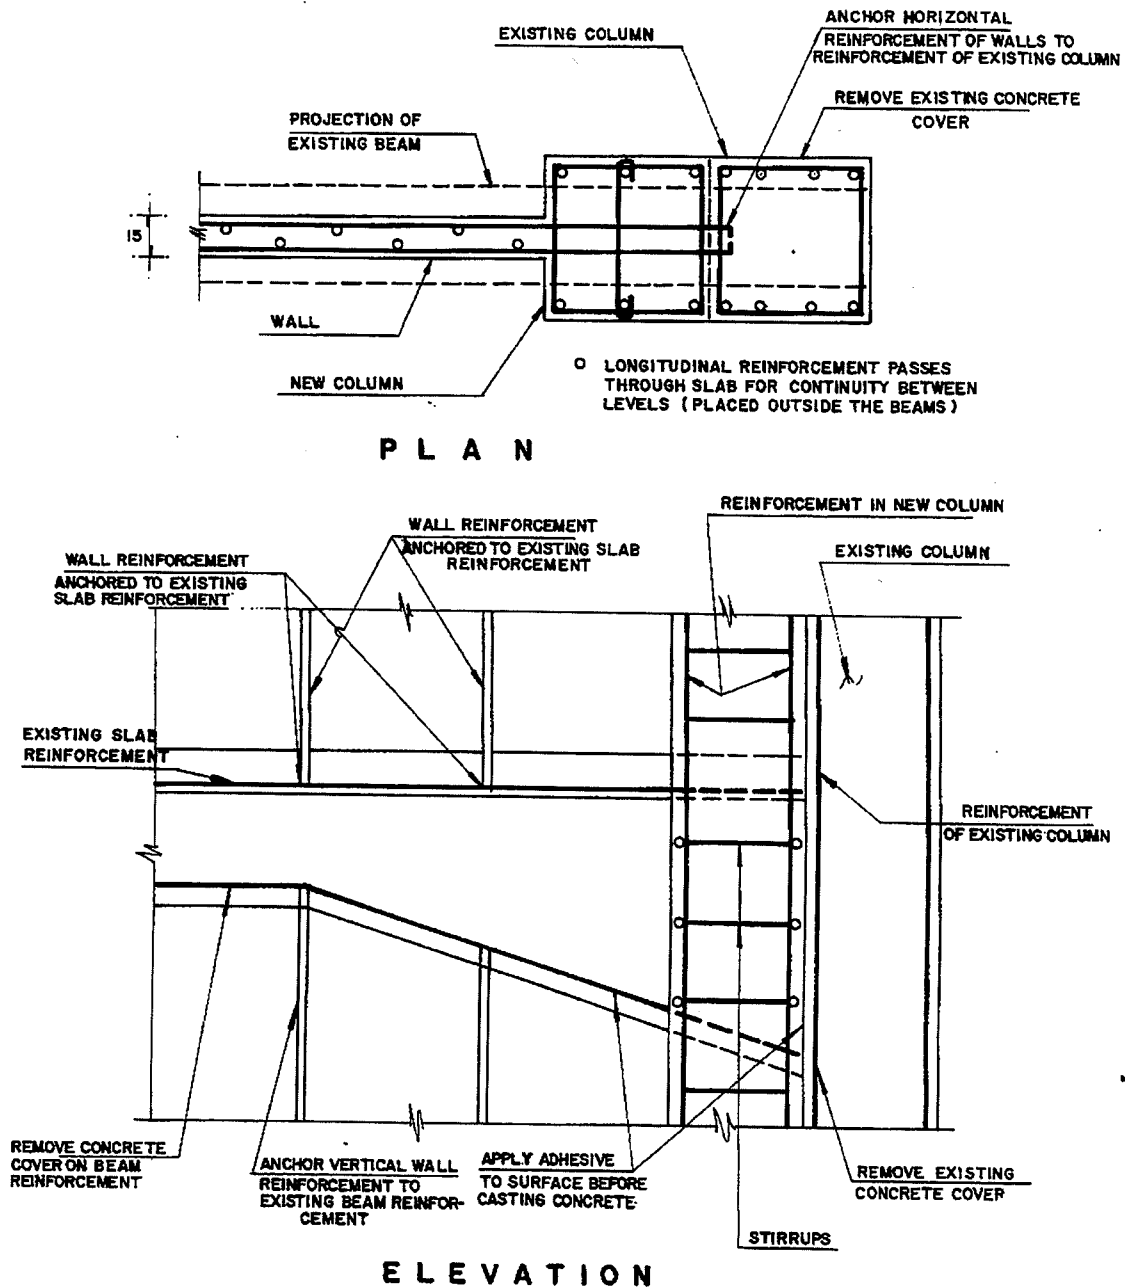
Figure 5- F3 Connection detail of concrete walls added after 1979 earthquake

In the 1979 earthquake the structure had some damage, mainly light cracking of structural elements. It was strengthened with the addition of three reinforced concrete walls, 15 cm thick, anchored to the existing reinforcement and their boundary columns enlarged. Also, two masonry walls were strengthened with wire mesh and a mortar layer on both faces, as noted in Figure 5-F1.

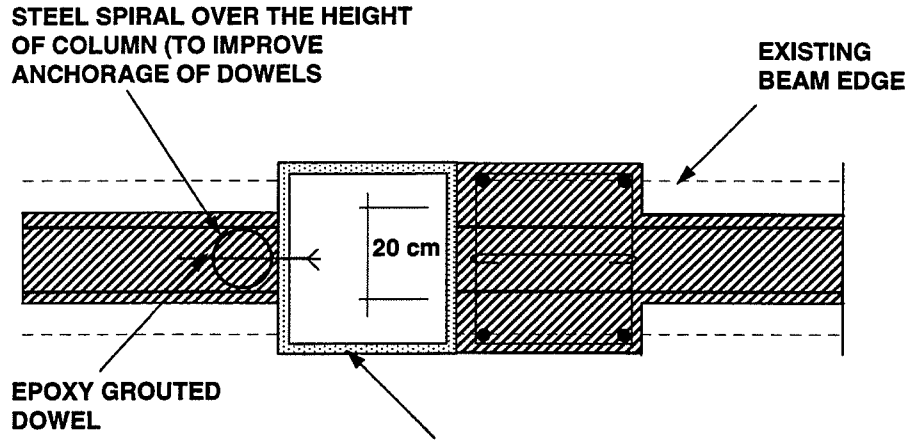
Figure 5- F14 Connection detail of new concrete wall in column C-5

In the three lower stories, the boundary columns of the walls strengthened after the 1979 earthquake had severe damage (Fig. 5-F5). The column C-5 was the most damaged and included fractured bars as shown in Figure 5-F6. Approximately 30% of the rest of the columns on these levels had crack widths of one millimeter or more. On the upper levels the number of damaged columns and the width of the cracks decreased.

The strengthening approach consisted of adding reinforced concrete walls, 20 cm thick, and upgrading boundary columns with concrete jackets. Seriously damaged masonry and concrete walls were demolished and replaced by new walls. In concrete walls with moderate damage, cracks were injected with epoxy resins and their thickness was increased to 20 cm. The layout of strengthened and new concrete walls is shown in Figure 5-F12. Connections between walls and existing elements consisted of epoxy grouted dowels. Details of this procedure can be seen in Figures 5-F13 to 5-F14.

Before jacketing boundary columns with buckled bars, the damaged concrete and reinforcement were replaced. The same amount of reinforcement was provided, welded to the existing bars, and ties were added. In columns with less damage, the cracks were injected with epoxy resin.

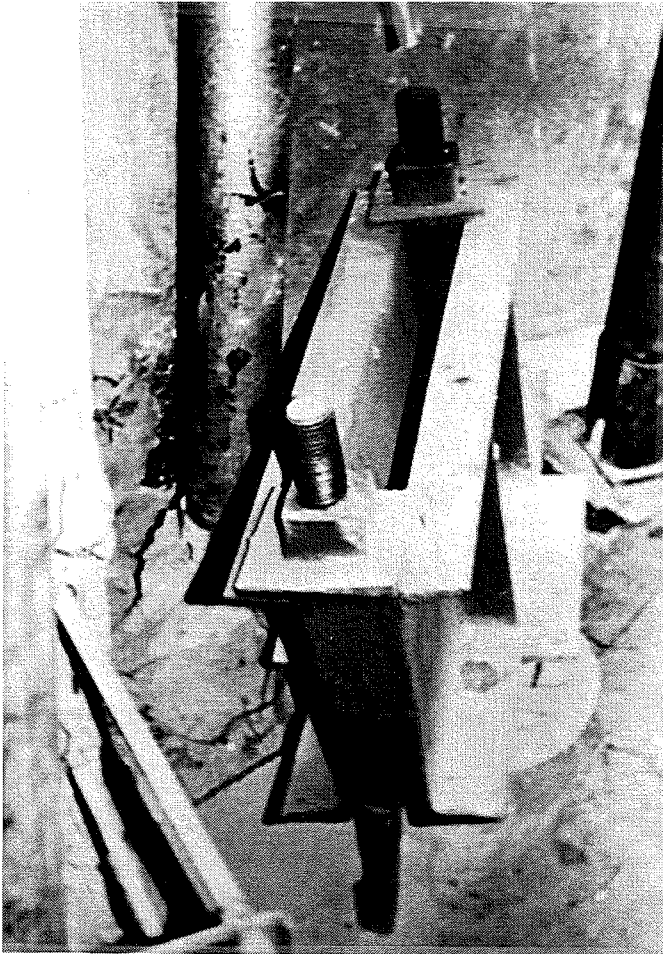
Figure 5-13 Buckling of anchor rods in control pile caps

In most control pile caps the threaded anchor rods of the control device buckled, as shown in Figures 5-13 and 5-14.

The foundation system, with 24 existing piles ( $\varnothing = 50 \text{ cm}$ ), was upgraded with 70 new control piles (30x30 cm, 27.0 m long) beneath the concrete walls. The damaged pile control devices were replaced, as shown in Figure 5-19. The foundation slab was also upgraded by adding a new slab on top of the existing slab along the perimeter of the building where the new piles were placed.

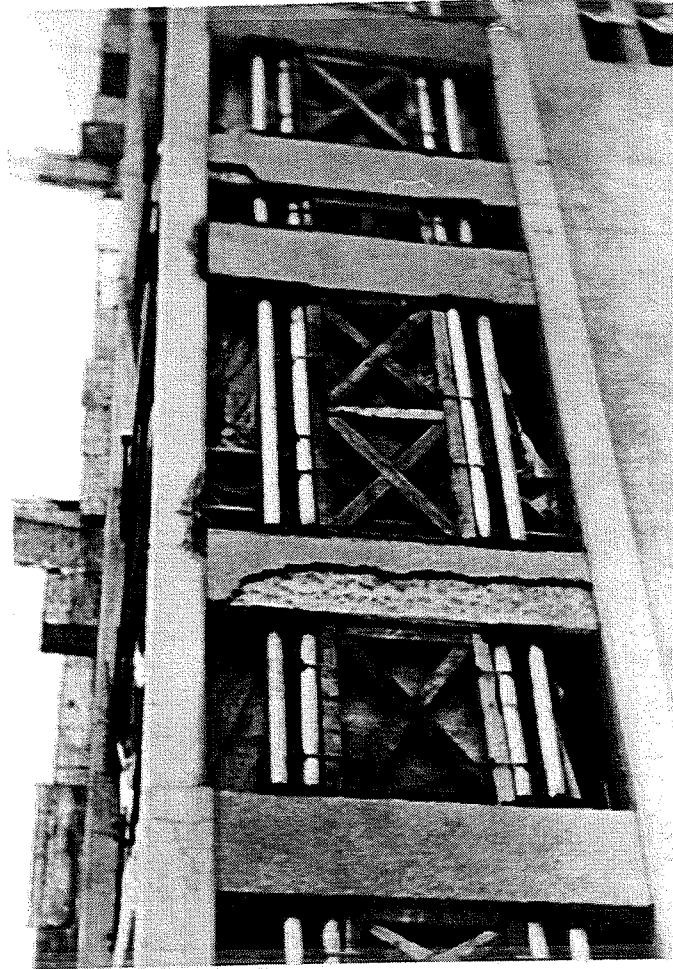
*Figure 5- 15 Shoring system*

operation, even during the retrofitting construction. The shoring consisted of braced wood elements with steel pipes carrying vertical loads, as shown in Figure 5-15.

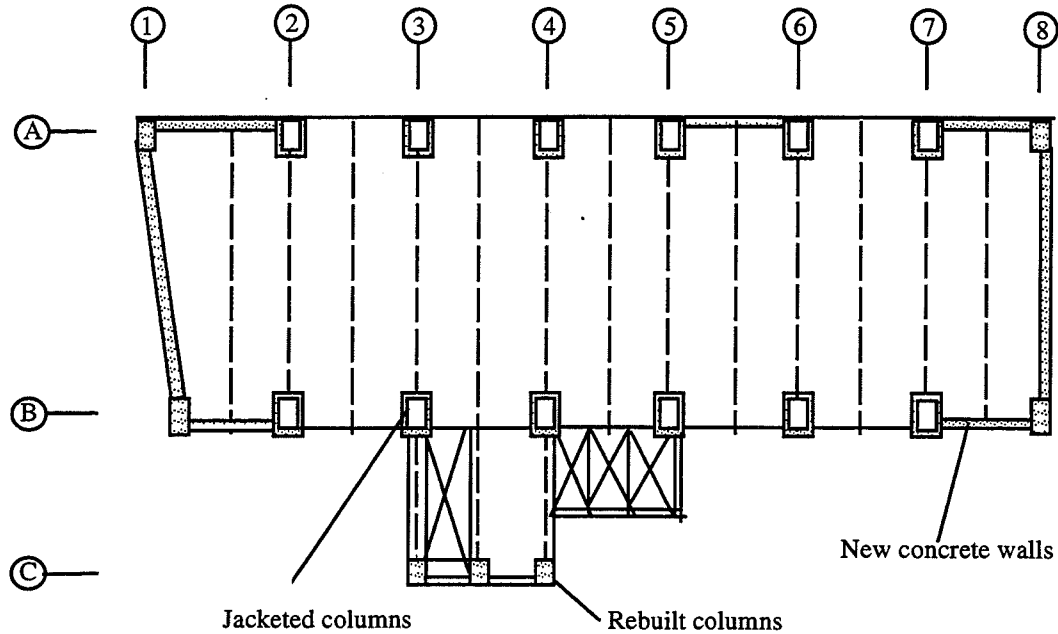
Figure 5-16 Strengthening plan

In the short direction, "C" shaped walls (25 cm thick) were placed at both ends of the building. Also, concrete walls (20 cm thick) were added to the service core and along line A. The walls were continuous from the foundation to the roof. The columns at the corners and the three columns on line C were demolished and recast along with the new walls. The arrangement of reinforced concrete walls is shown in Figure 5-16.

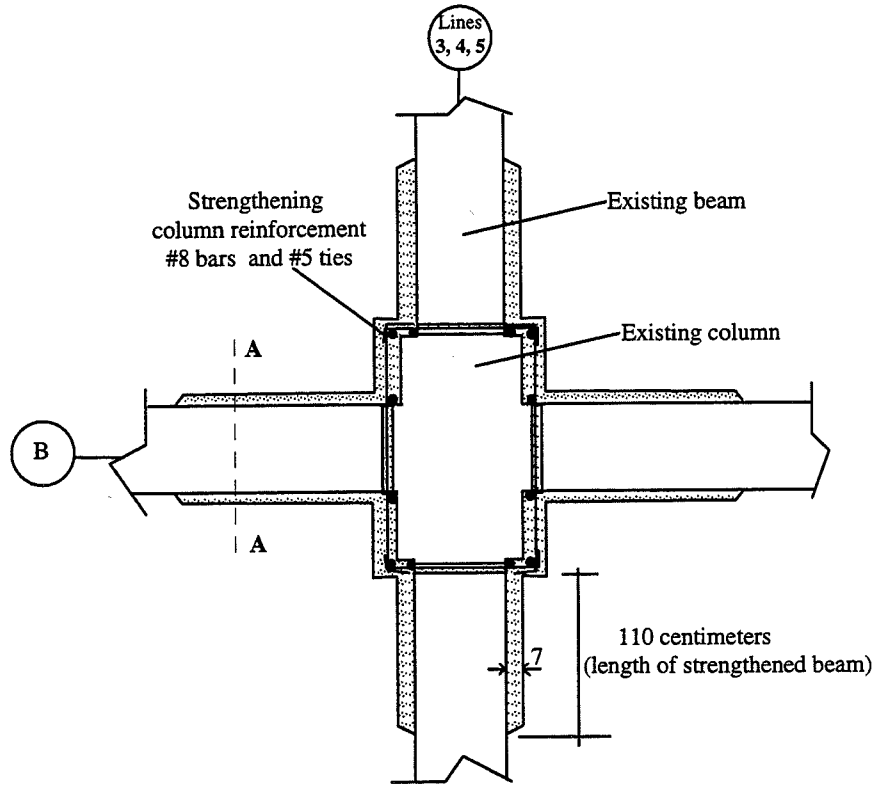
Figure 5-17 Jacketing of columns

The columns in the boundary and outside the walls were jacketed with reinforced concrete. In Figure 5-17 a typical plan view of the column jacket is presented. The beams were jacketed only at the joint region over a length of about 1.10 meters from the existing columns. Figure 5-18 shows the alternatives used for beam jacketing. Alternative 2 was used in the beams below operating telephone equipment units, and alternative 1 for all others.

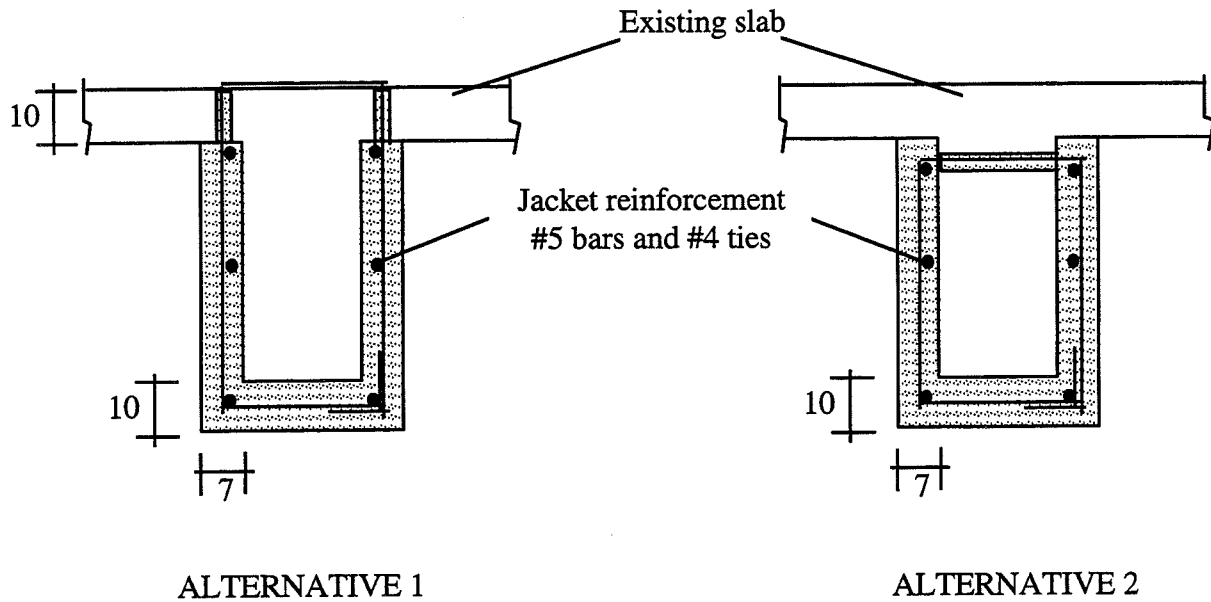
Figure 5-18 Detail of beam strengthening (Section A-A in Figure 17)

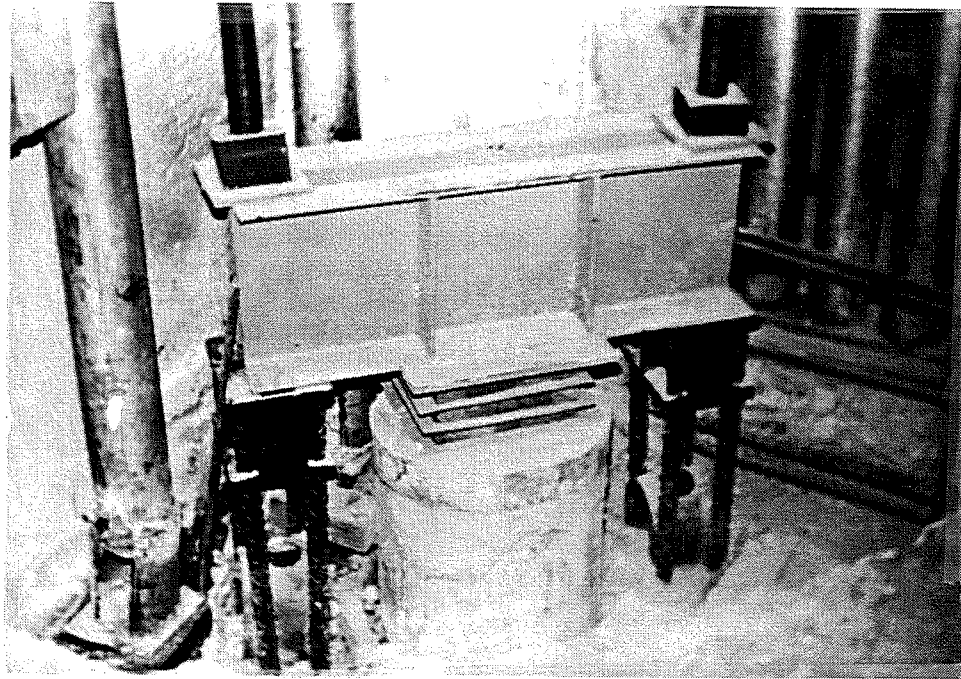
*Figure 5- I9 New control devices on pile caps*

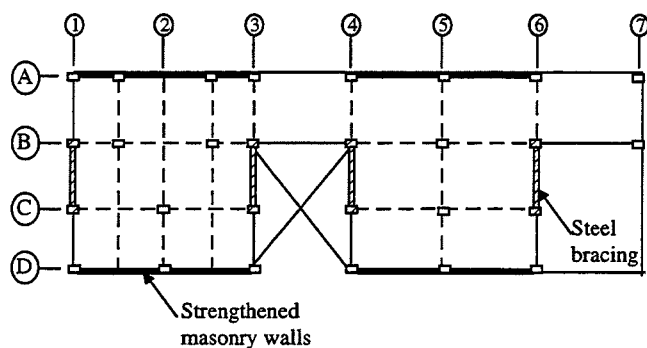
ELEVATION ON LINE 6

Figure 5- J3 Strengthening scheme

The steel bracing was placed on the middle of the frames on lines 1, 3, 4 and 6 from the ground floor to the roof (Fig. 5-J3). The steel braces were formed of two welded angles. The boundary columns were jacketed with steel angles at the corners by straps. Details of the bracing and jacketing are shown in Figures 5-J4 and 5-J5. The bracing elements were added symmetrically to avoid torsional effects in the case of an earthquake during construction.

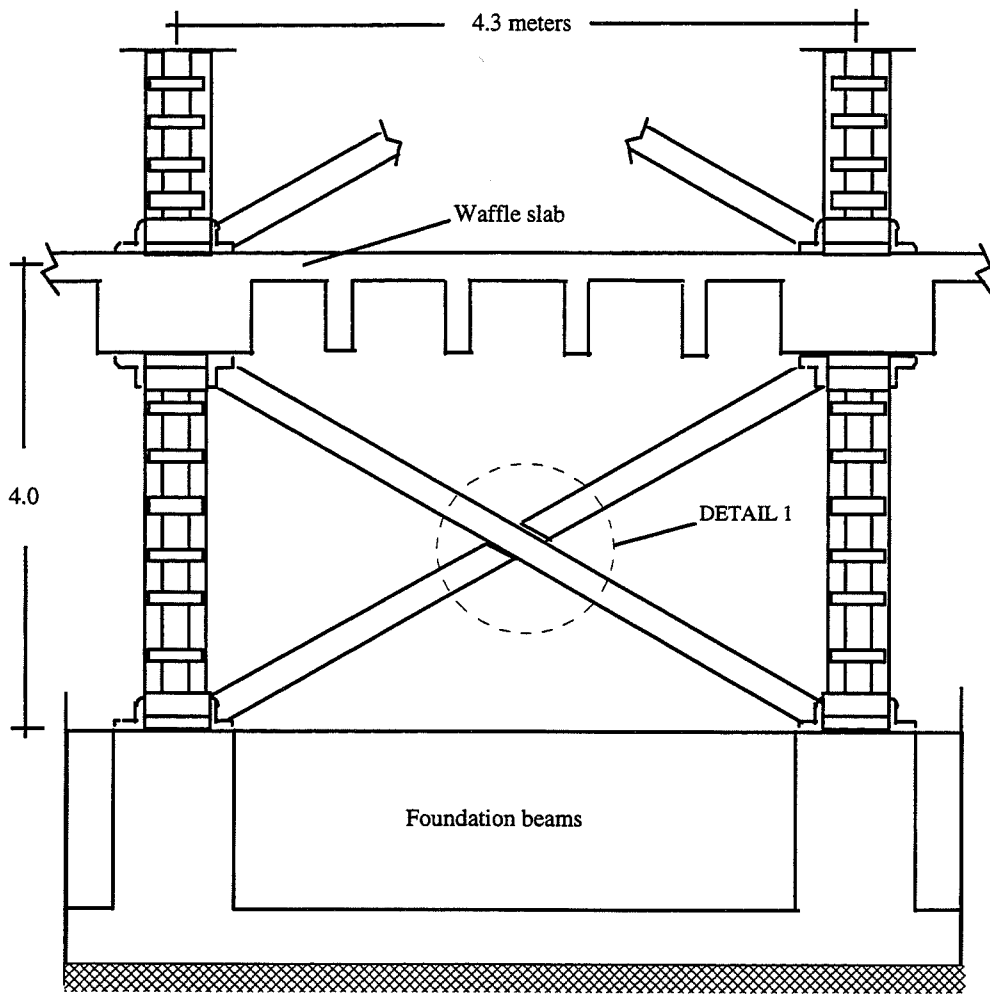
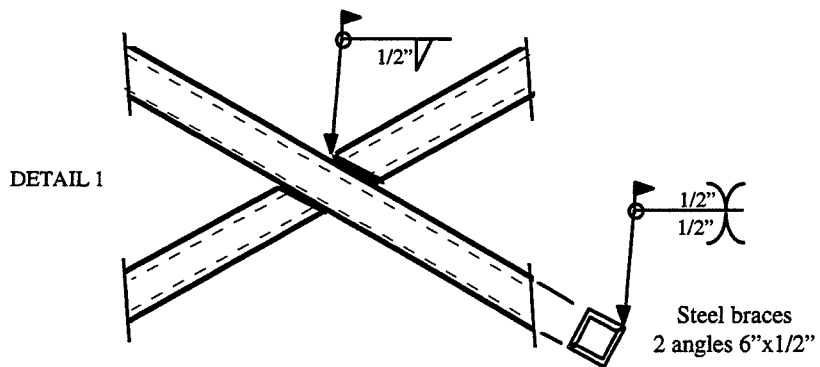
Figure 5- J4 Steel bracing

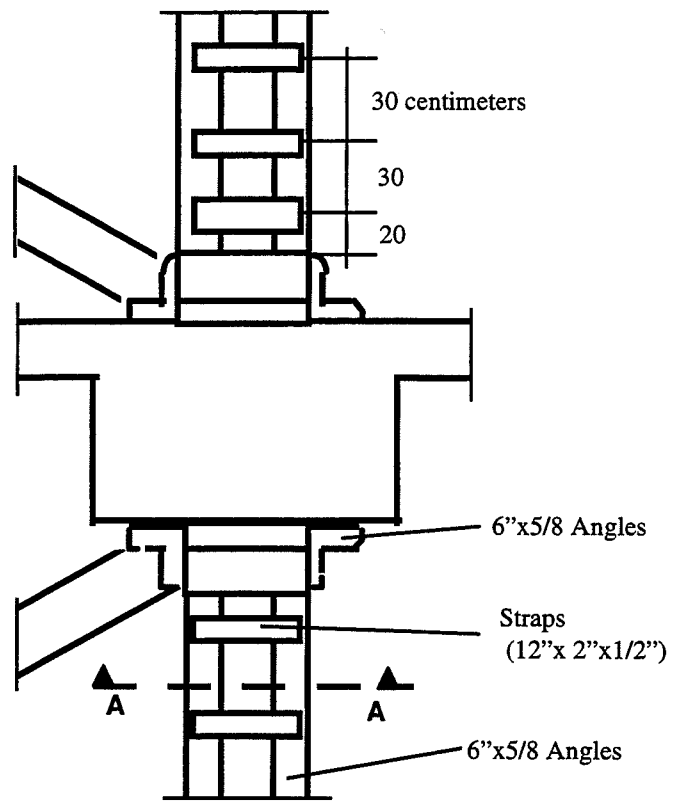
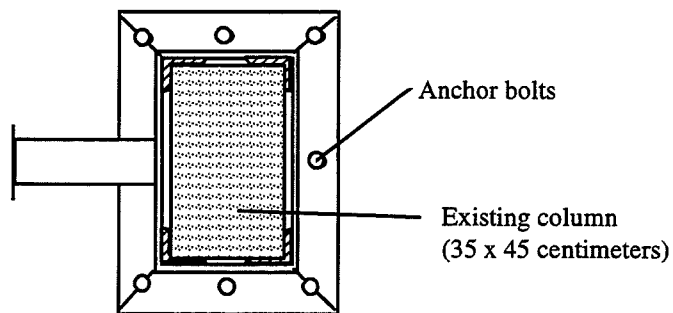
SECTION A-A

Figure 5- J5 Column jacketing details

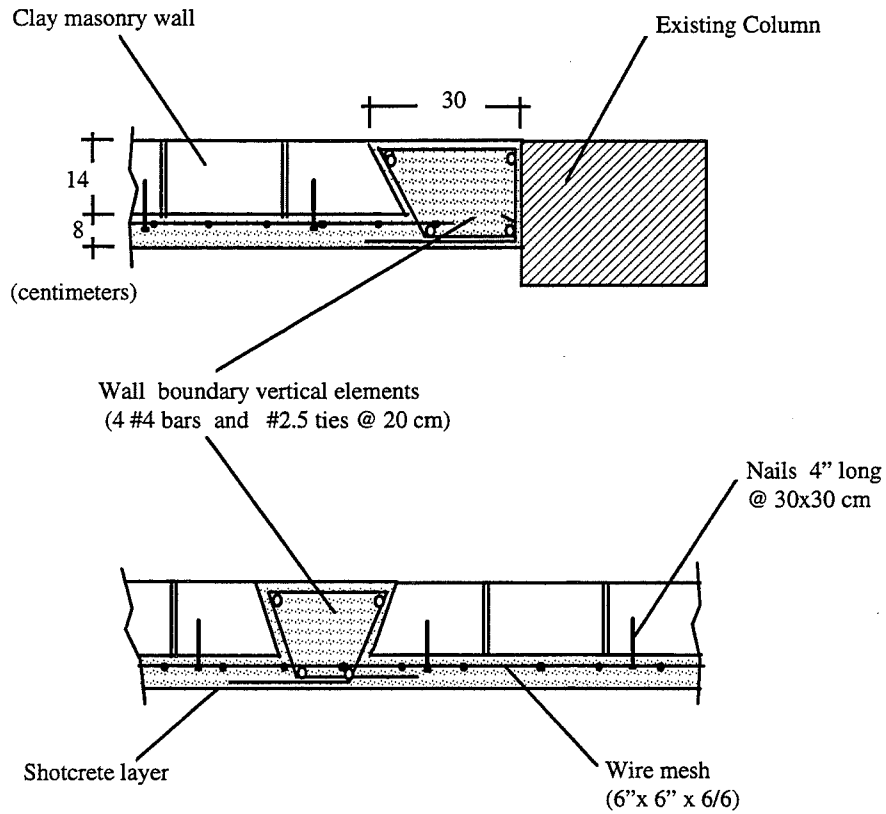
Figure 5- J6 Strengthening of boundary masonry infill walls

The masonry infill walls on lines A and D were strengthened by first filling all the cracks with a cement and sand (1:3) grout and an additive to control volume changes. The interior faces of the walls between axes 1 and 3, and 4 and 6 were covered with a welded wire mesh, fastened with 4" nails, and a layer of shotcrete. To anchor the mesh to the existing walls, new concrete boundary elements were built integrally with the new concrete cover (Fig. 5-J6).

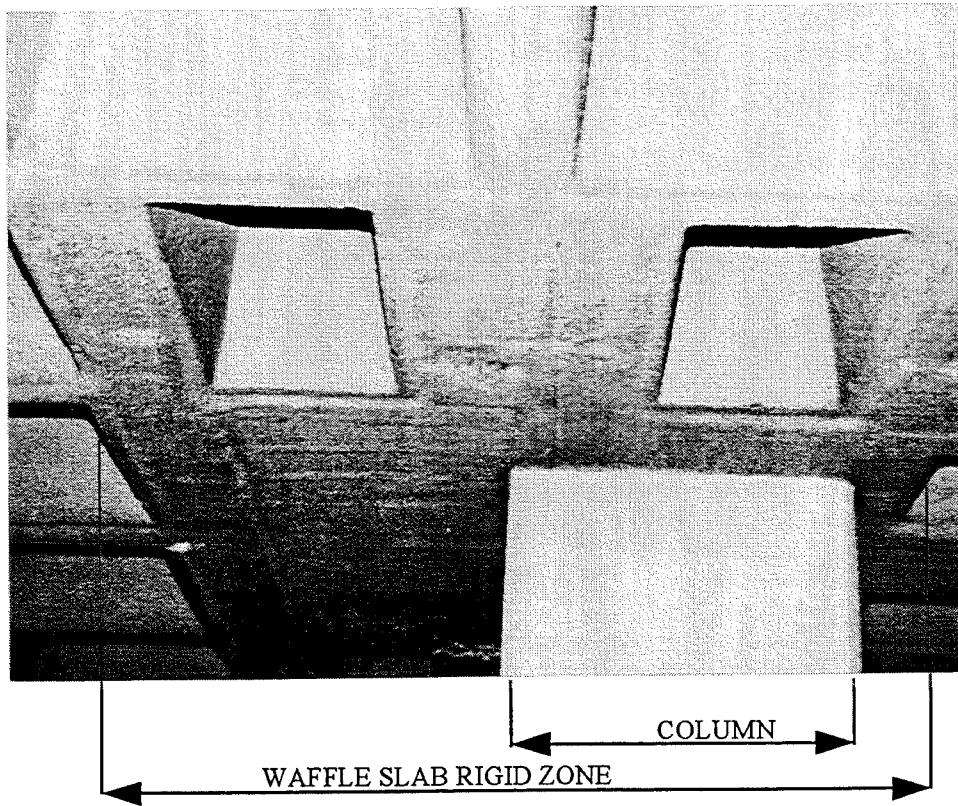
The structural review indicated that there were eccentric slab-column connections that differed from the design drawings (Figure 5-K3). Some tilting of the building was detected but there was not enough evidence to conclude that the problem was due to the earthquake. The report of the concrete core tests

Figure 5- K3 Eccentric slab-column connection

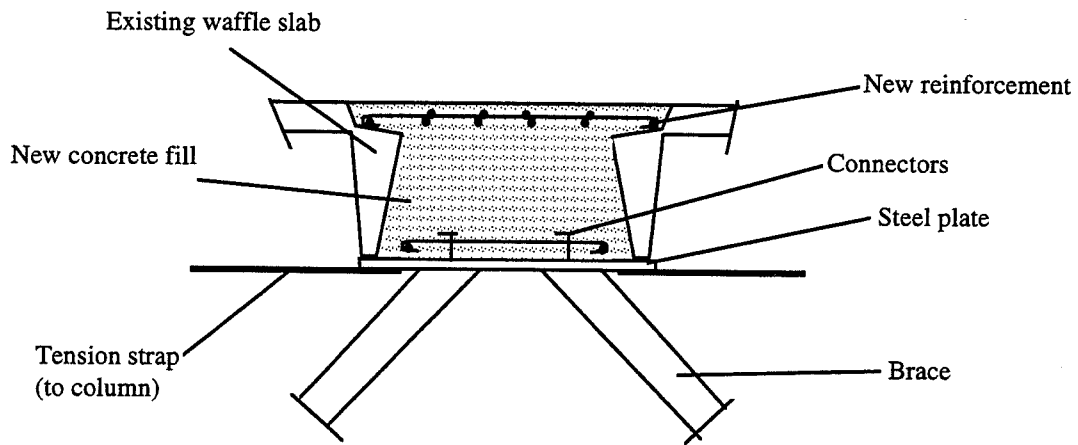
Figure 5- K10 Connection detail midway between columns

Steel jacketing was used to reinforce the columns bounding the braced bays. At the midspan between columns where the braces are connected to the floor, the voids in the waffle slab were filled with reinforced concrete to create a solid zone with a steel plate below. The top of the jacketed columns was connected to the midspan steel plate by tension steel straps. A detail of the midspan connection is shown in Figure 5-K10.

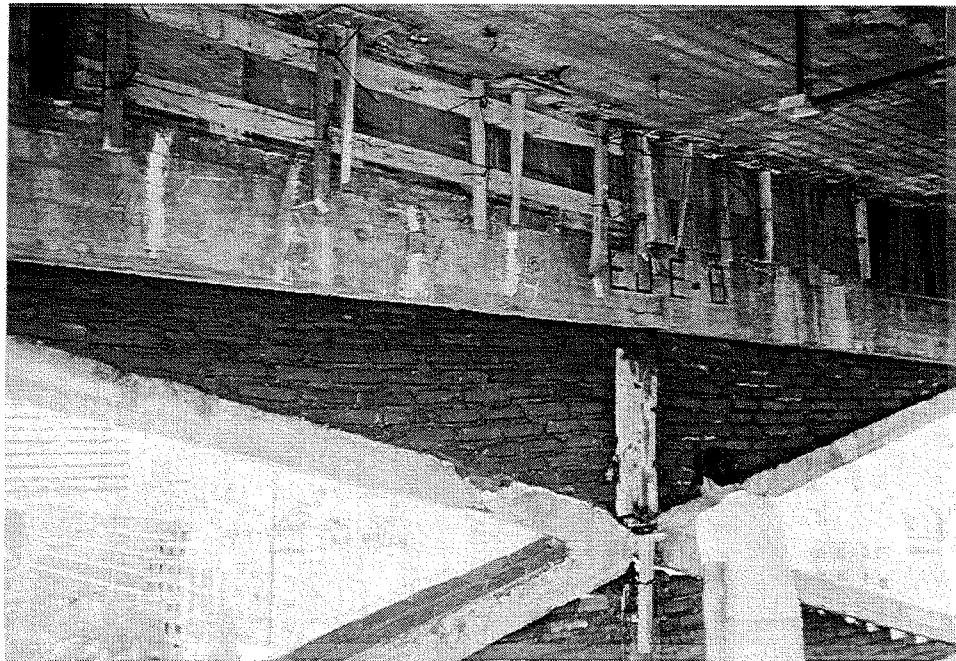
In the 1957 earthquake, the building suffered severe structural damage to the columns. It was repaired and strengthened by increasing the size of some columns but without significant additional reinforcement. The exterior frame in column line 8 was stiffened with reinforced concrete braces and masonry infill walls as shown in Figure 5-L3.

Figure 5- L3 Existing concrete braces in column line 8

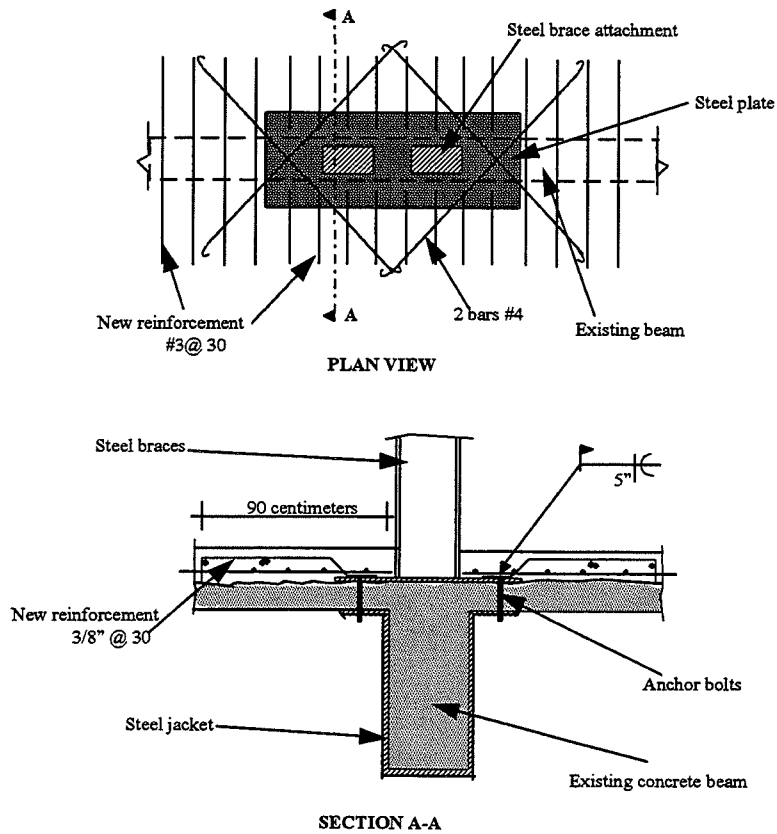
Figure 5- L11 Connection of steel braces to the existing beams

The connections between the braces and beams were made using steel base plates. The base plates were bolted to a steel box around the bottom of the beams as shown in Figures 5-L11 and 5-L12. The damaged concrete braces and masonry walls in line 8 were removed and rebuilt increasing the reinforcement in the braces (Figure 5-L13). The masonry infill walls on line 1 were restored without changes.

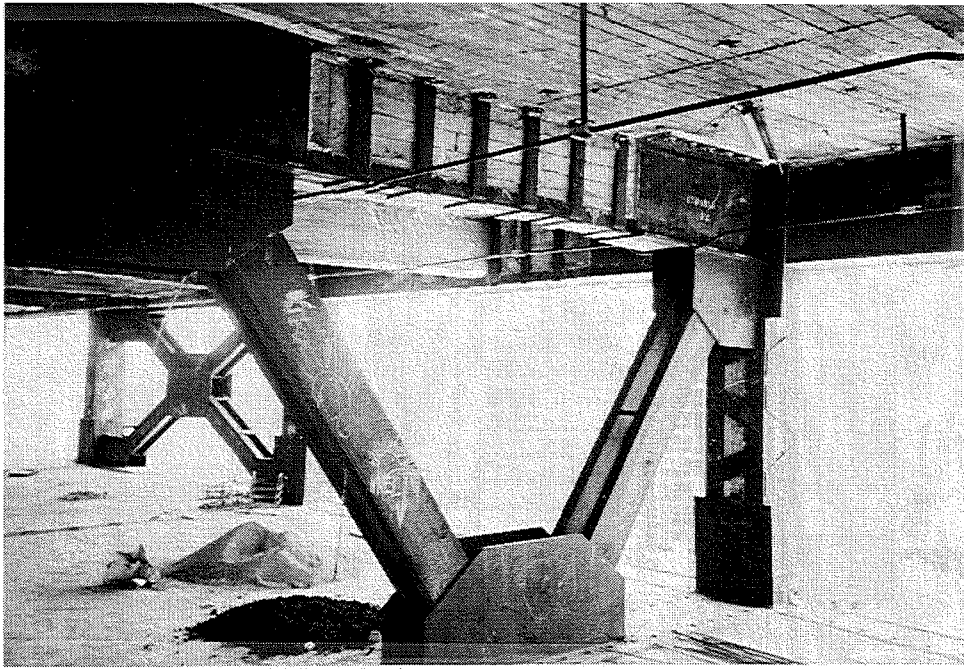
*Figure 5- L12 Steel braces on line 6*

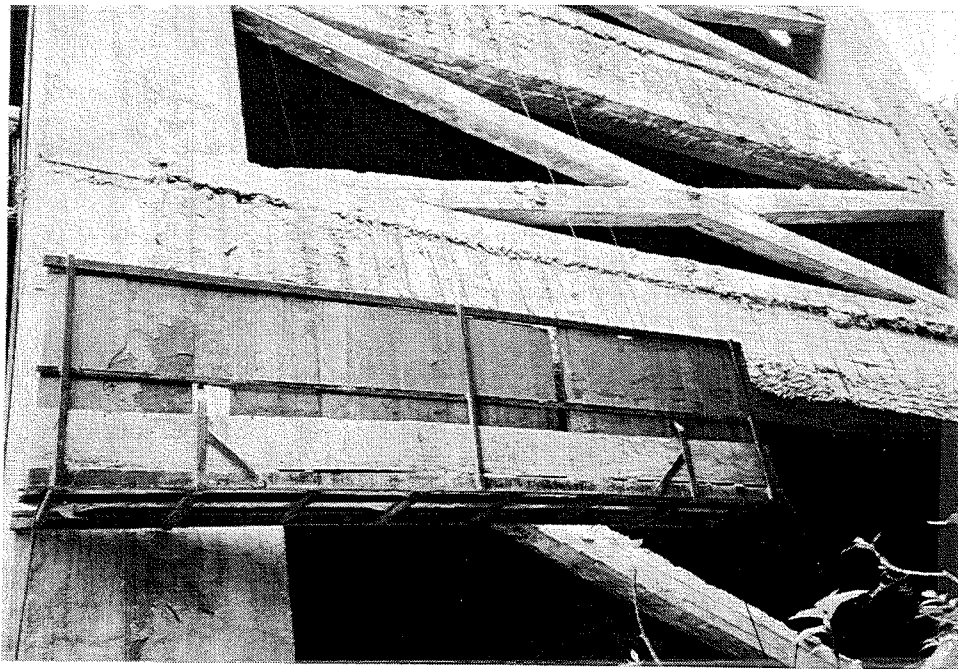
*Figure 5- L13 Reinforced concrete braces on line 8*

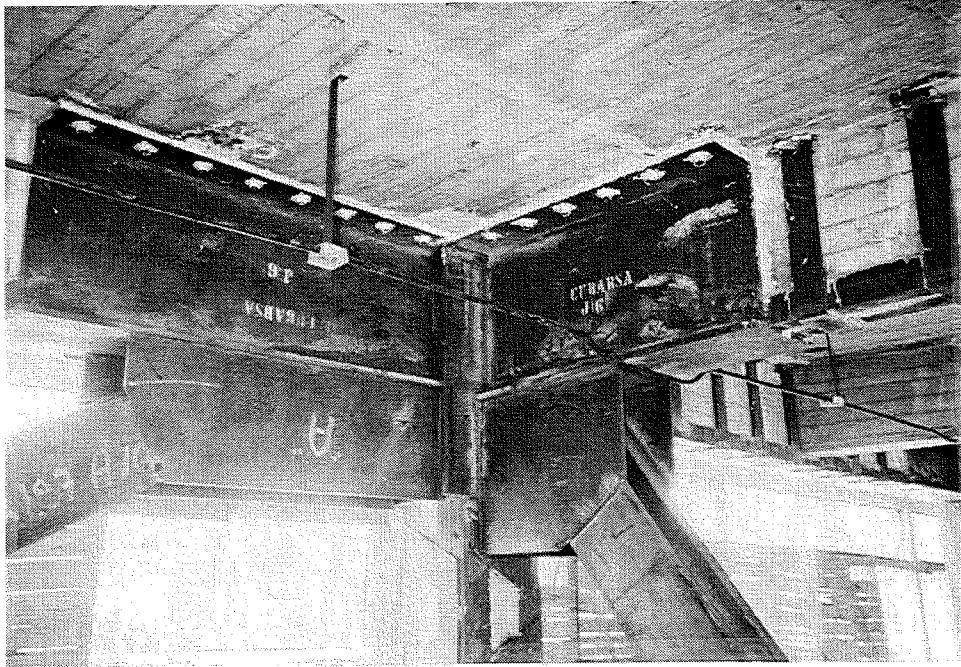
Figure 5- L14 Brace connection on lines 6 and A

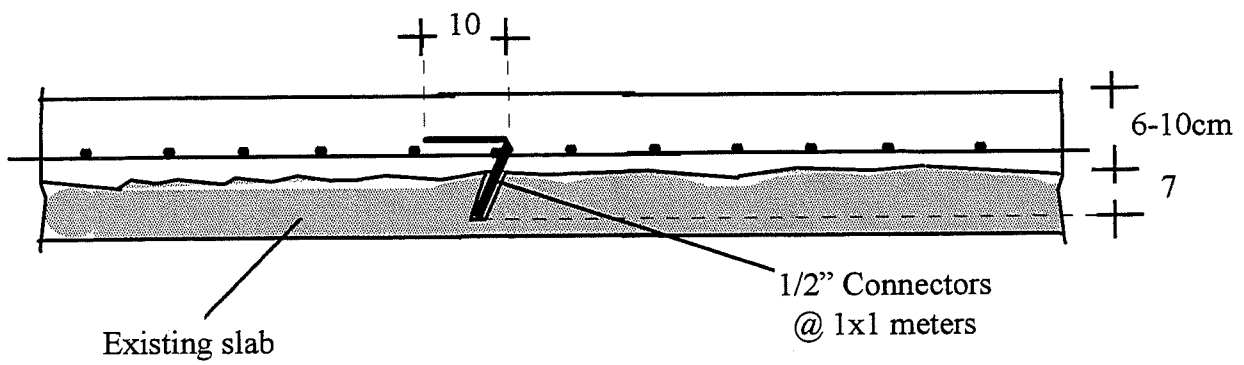
Figure 5- L15 Restoration of slabs

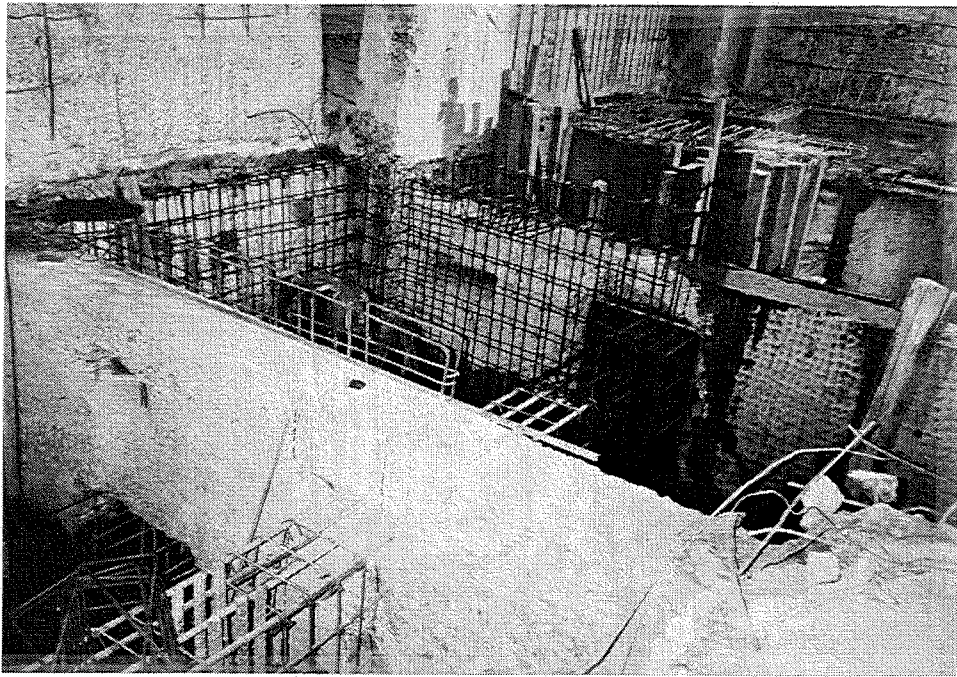
*Figure 5- L16 Construction of new foundation beams*

Because of the changes in the superstructure, 56 new piles were added to the 26 existing piles and new foundation beams were constructed (Figure 5-L16).
