**Effects of Wrapping Chloride Contaminated Concrete with Fiber
Reinforced Plastics**

Emily Wason Berver, B.S.C.E.

Thesis

The University of Texas at Austin

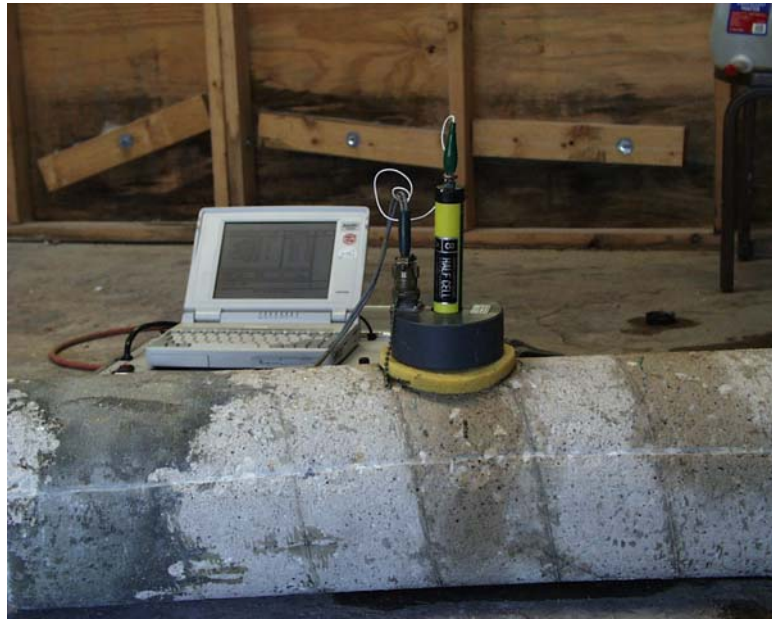
Figure 6.8 PR-Monitor test setup on specimen CC5.

Specimen	Location	
	Splash zone	4 in. above the waterline
CC3		
E_{corr} (mV)	N/A	-248
I_{corr} ($\mu\text{A}/\text{cm}^2$)	N/A	0.74
Rate (mpy)	N/A	0.34
CC5		
E_{corr} (mV)	-475	-411
I_{corr} ($\mu\text{A}/\text{cm}^2$)	4.88	4.27
Rate (mpy)	2.23	1.95
CC6		
E_{corr} (mV)	-504	-458
I_{corr} ($\mu\text{A}/\text{cm}^2$)	3.09	5.23
Rate (mpy)	1.41	2.39
CNC10		
E_{corr} (mV)	-549	-275
I_{corr} ($\mu\text{A}/\text{cm}^2$)	8.45	1.27
Rate (mpy)	3.86	0.58

The results from the linear polarization tests indicate that severe corrosion is taking place in most of the specimens. Specimen CC3 was the only specimen to fall into the moderate corrosion rate level. From visual observations of the specimens, there were no outward signs of corrosion activity on the middle portions of CC3 and CNC10. There was minimum cracking on CC3, and CNC10 did not have the cast-in-chlorides. The lower portion of CNC10 showed signs of corrosion activity as seen in Figure 6.10. Rust stains were visible at both locations on specimen CC6, and in the splash zone of CC5.

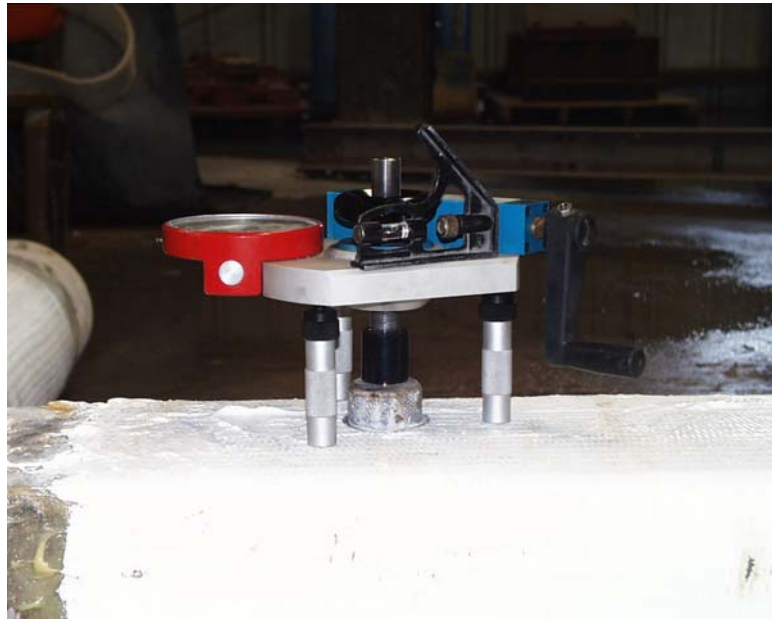
Figure 6.11 Test setup for DYNA Z16 Pull-Off Tester.

Test #	Location	Depth of Failure (in)	Failure Strength (N/mm ²)	Failure Strength (psi)
1	Top, downstream end	¼	0.7	101.5
2	Top, upstream end	0	1.22	176.9
3	Side, downstream end	1/8	1.3	188.5
4	Side, upstream end	1/8	1.63	236.4

All of the tests failed in the substrate except for test #2, which failed at the bond between the wrap and the concrete surface, as shown in Figure 6.12. This indicates that the bond strength was stronger than the concrete tensile strength for

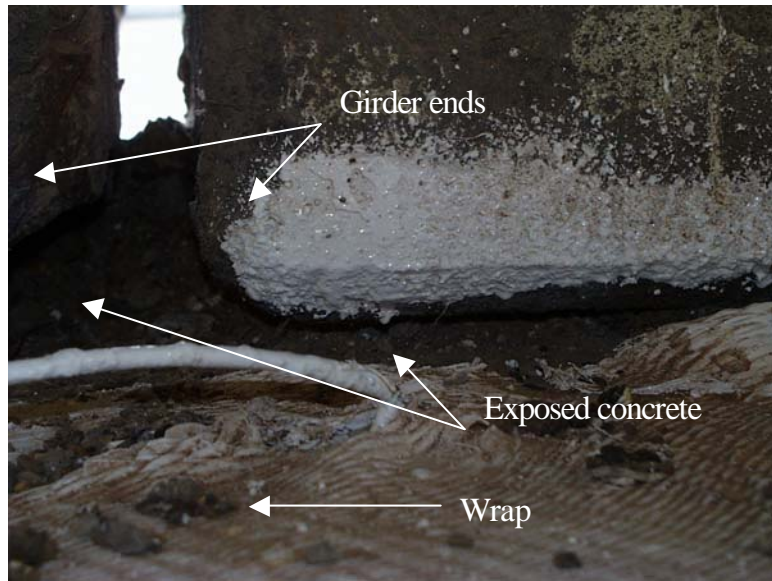
The bents that had the embedded probes were examined each time the linear polarization testing was performed. Moderate debris accumulation was found on top of all of the bents. The FRP composite on the bridge bents had been cut around the bearing pads. In some places, the wrap was finished with epoxy to seal it around the bearing pad; in other places it was not. The finishes around the bearing pads near probes 7.1, 8.3, and 8.4 seemed to have the best seals. There was a 1 in. gap between the wrap and the bearing pad near the location of probes 12.1 and 12.2. This allowed for exposed concrete on the top of the bent as shown in Figure 7.4. Figure 7.5 shows the finish around the bearing pad near probe 7.2. Figure 7.6 shows the finish around the bearing pad near probe 8.3, and is an example of how the wrap around the bearing pad may be sealed off. However, little is known about the viability of the seal if there are movements of the girder and bearing pad.

Figure 7.4 Finish of FRP wrap around girders of Structure #12.

There is some correlation between the finish of the wrap and the corrosion rate measurements. The readings from probe 7.1, and the readings from Structure #8, were generally lower than the readings from probes 7.2, 12.1, and 12.2. Cracks were found on the ends of the girders near probes 8.3 and 8.4. Cracks with rust stains were found on the ends of the girders near probes 7.2, 12.1, and 12.2. The cracks may be an indication of exposure to runoff containing deicing salts.

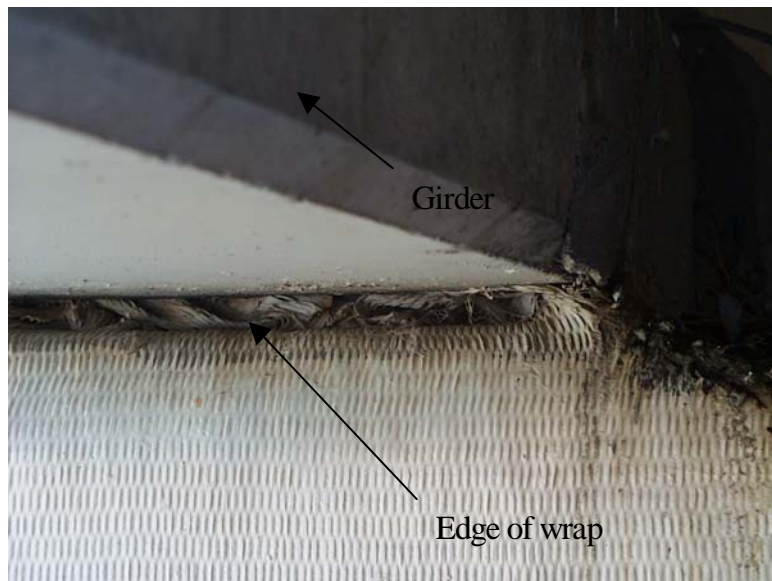
Figure 7.5 Finish of FRP wrap around girders of Structure #7.

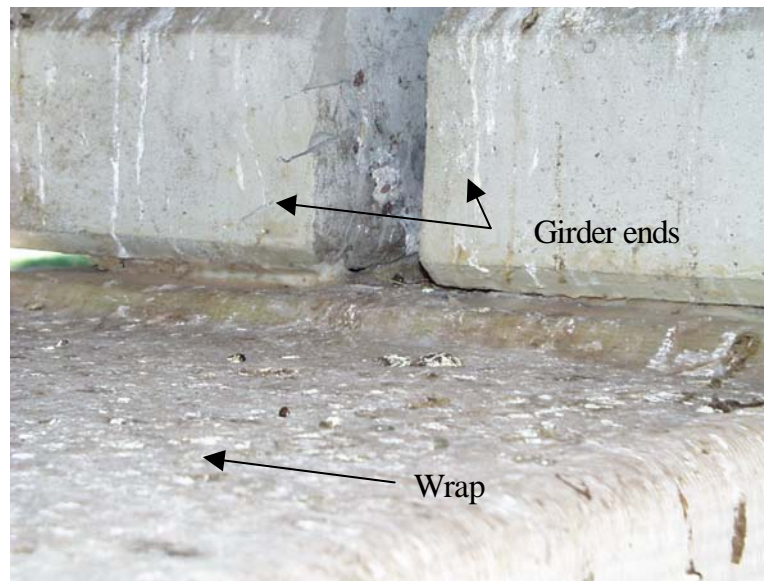
Figure 7.6 Finish of FRP wrap around girders of Structure #8.

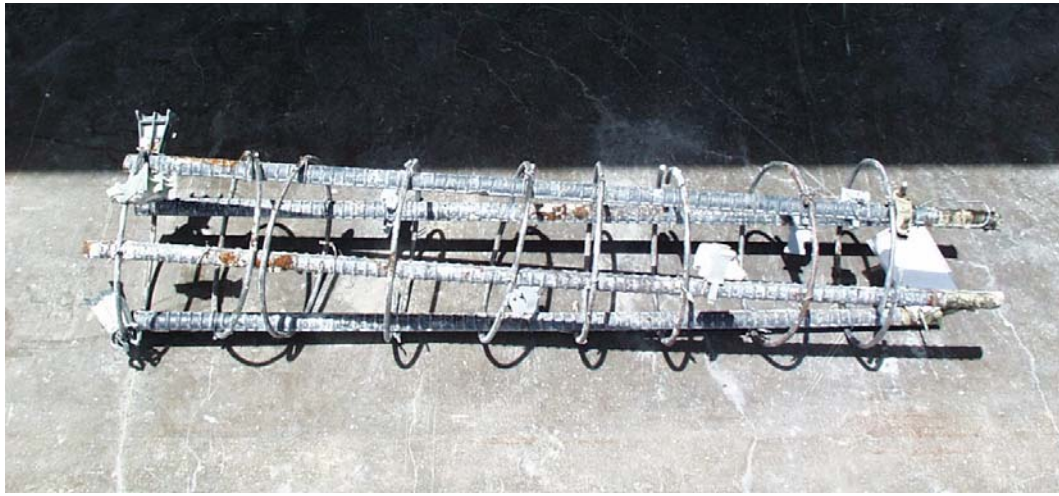
Figure D1 Specimen CC7

Specimen	Corrosion activity
CC7	The top 2' were wrapped. Epoxy that had dripped down from the wrap covered half of the exposed surface on the bottom 1'. Heavy corrosion was found on bars and stirrups near cracks. Minor corrosion was found throughout the upper 2'.
CC18	The entire surface was exposed. A small honeycombed area was located at the bottom of the specimen. Areas of heavy corrosion were found throughout on the bars and stirrups near cracks and also near the honeycombed area. A small amount of section loss was found at the lower ends of two bars near the honeycombing.
CNC8	The entire surface was exposed. A honeycombed area was at the bottom of the specimen. Heavy corrosion with substantial section loss was found on the bottom stirrup near the honeycombing. Moderate corrosion was found on the lower half of the bar by the honeycombing and on the lower 5 stirrups.
CNC13	The top 2' were wrapped. A corrosion inhibitor was applied. Light to moderate corrosion was found on the lower 6" of the bars and on the bottom 2 stirrups. Corrosion activity corresponded with crack locations.
