**EVALUATION OF LONGITUDINAL CRACKING  
IN END REGIONS OF PRETENSIONED BOX BEAMS**

**Craig Morgan Chamberlain, B.S.C.E.**

**THESIS**

The University of Texas at Austin

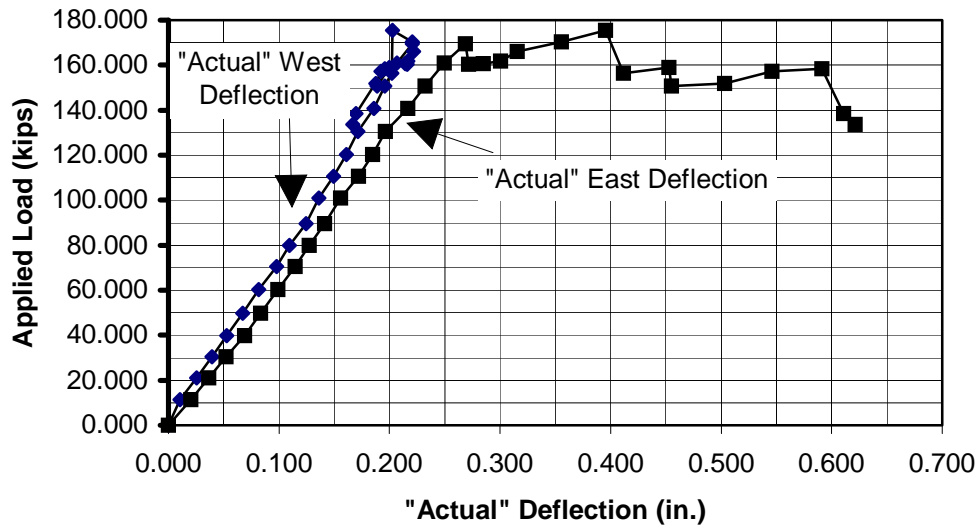
Figure 3.1: Load vs. “Actual” West and East Load-Point Deflections for Test 1

Load versus deflection plots were generated for the data, and help to explain an observation during the test that was alluded to earlier in Section 3.2.1. It was observed that the web on the West side of the beam carried much of the load until web spalling initiated in the web. Some of this load was then picked up by the East side web. Figure 3.1 shows the “actual” West and East load-point deflections. The plot demonstrates that the East deflections were slightly larger than the West deflections up to 169 kips. The higher stiffness of the West side response is consistent with the shorter shear-span. Larger bearing pad deformations were also observed on the West side, and are indicative of the larger percentage of load resisted initially by the West web. After the 169-kip load level was reached, the “actual” East deflection curve rapidly increases while the West load-point curve appears to no longer deflect under successive load increments. The West load point was actually experiencing nearly equal deflection measurements at the linear potentiometers at the load point and at the bearing pads near the loading frame. Damage experienced by the East web for load

increments beyond the 169-kip level was indicative of the increasing percentage of load being resisted by the East web.

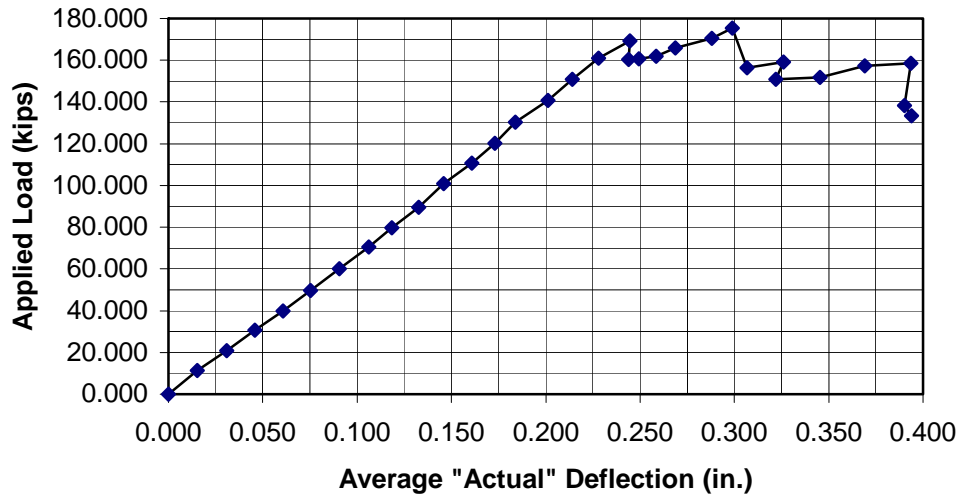
Figure 3.2: Load vs. Averaged Load-Point Deflections for Test 1

An attempt was made to demonstrate the overall load vs. deflection response for this girder by averaging the two “actual” West and East deflection records as shown in Figure 3.2. Because of the skewed beam end and unequal East and West shear spans, care must be taken in the interpretation of this data. The purpose of this plot was to demonstrate a general load-versus-deflection response for the beam. The maximum deflection, as plotted here, was 0.39 inches at the final load step of 133.5 kips.

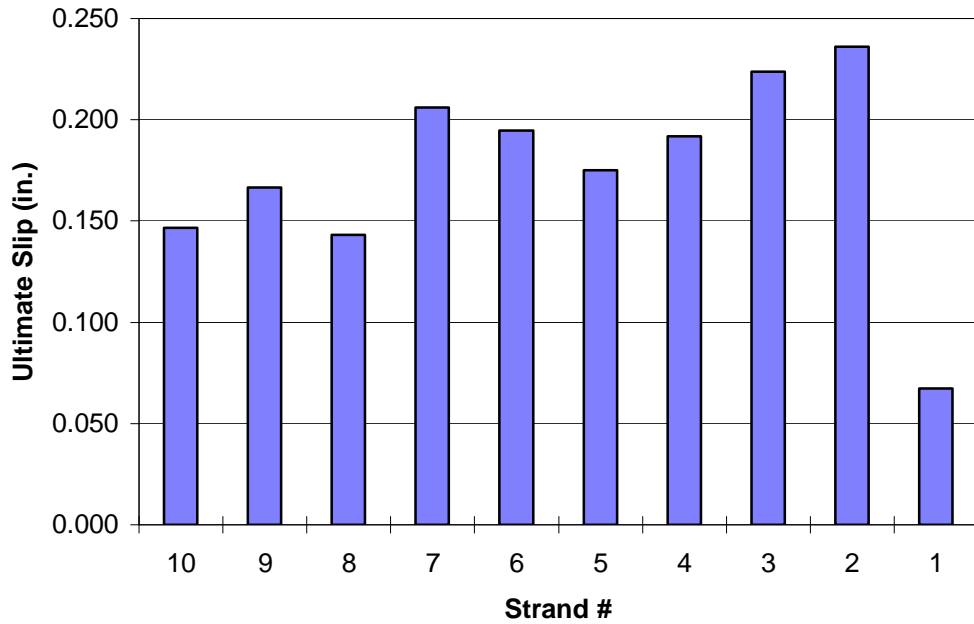
Figure 3.3: Maximum Measured Slip of Monitored Strands During Test 1

Monitoring the relative displacement of the ends of prestressing strands during the test provided important data. Little to no slip was detected in any of the monitored strands (see Figure 2.11) until the 169 kip load level was reached when all monitored strands except Strand #1 registered slips of several hundredths of an inch. For the remainder of the test, strands slipped during nearly every load increment. Figure 3.3 displays the maximum measured slip for each monitored strand. Strand #2 had the largest slip of nearly ¼ inch.

Slip of the strands during the test never exceeded three hundredths of an inch in any one load increment. Accumulation of slip over the remaining load increments past the 169 kip load level is the maximum slip illustrated in Figure 3.3. A general increase in strand slip was observed from Strand #10 to Strand #2. It is likely Strand #1 did not follow this pattern because it was fully bonded.

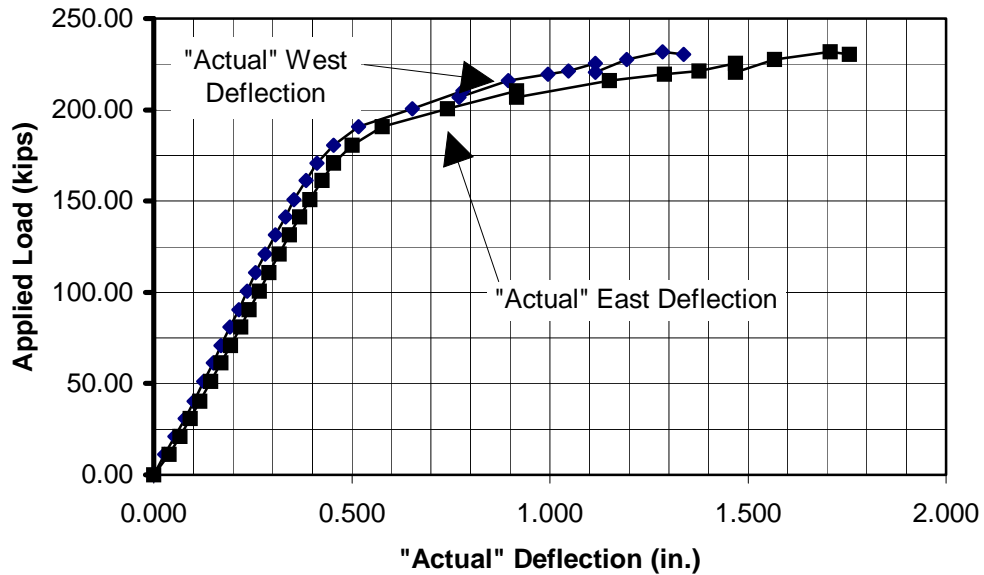
Figure 3.9: Load vs. “Actual” West and East Load-Point Deflections for Test 2

As for Test 1, load vs. deflection plots were produced. The "actual" East and West deflections were more similar for this test than for Test 1. The East side began to deflect significantly more than the West near the 200 kip load level, and reached a maximum differential of more than 0.4 inches at the final load step. Figure 3.9 illustrates the load-deflection plots for the East and West sides of the girder.

The maximum deflection from the average of the East and West responses was 1.56 inches at the final load of 230.5 kips.

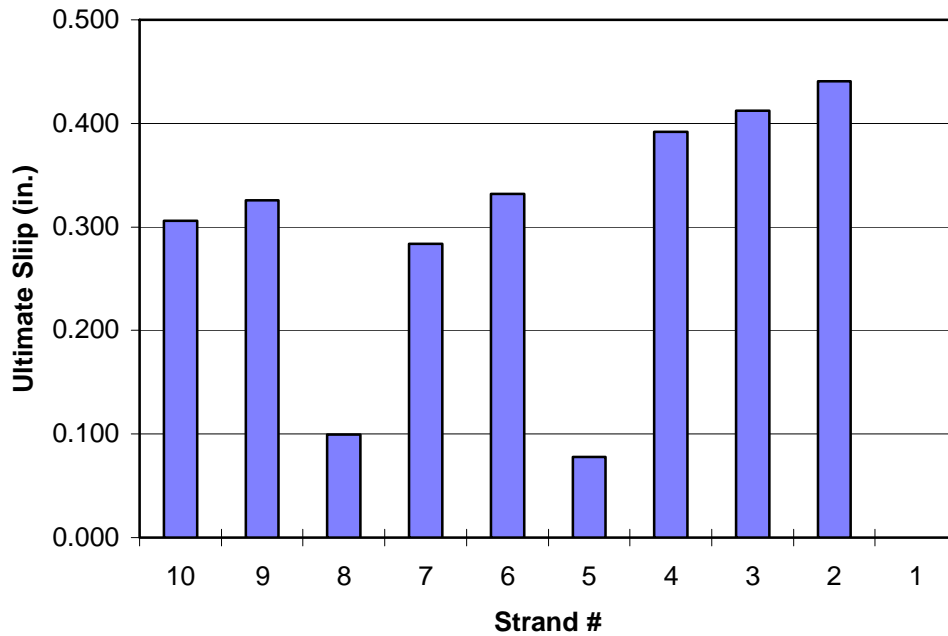
Figure 3.11: Maximum Slip of Monitored Strands in Test 2

Prestressing strands were monitored at the same locations as in Test 1, and as indicated in Figure 2.11. Little noticeable slip occurred until the 200 kip load level. At the next load step (210 kips) all instrumented strands except Strand #1 demonstrated an increase in slip of approximately 0.01 inches. This slip

increased as the test progressed and reached 0.015 inches for Strand #4 at the final load step of 230.5 kips. As described earlier, testing was discontinued here when the specimen failed. Large slips were recorded for most of the strands when failure occurred. The linear potentiometer on Strand #1 fell off at failure because of the severe slip experienced by the strand. Figure 3.10 shows a photograph of the twisting of the strands and gages during slip at failure of Strands #1-7. The maximum slip recorded by the linear potentiometer was 0.44 inches for Strand #2, but the slip on Strand #1 (where the gage fell off the strand) likely exceeded this value. Figure 3.11 displays the maximum slip for each monitored strand.

The slip of any one strand did not exceed 0.03 inches during any load increment before the last attempted load step. The accumulation of slip during the entire test for each instrumented strand is the maximum slip recorded in Figure 3.11. Note that no slip is shown for Strand #1, however the strand actually slipped enough to remove the gage from the strand.

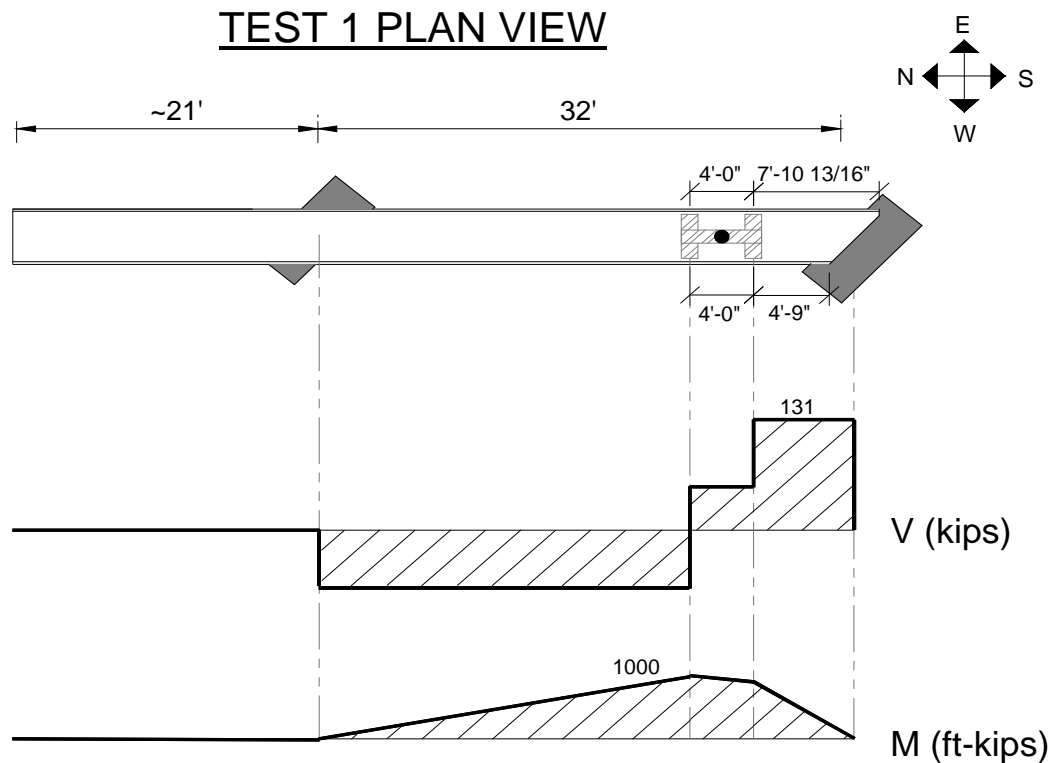
Figure 4.5: Moment and Shear Diagrams at Ultimate Load - Test 1

This box beam resisted a maximum applied load of 175 kips. Based on the approximations discussed in Section 4.2, the maximum shear and moment experienced by the beam were approximately 131 kips and 1000 ft-kips, respectively. The moment and shear diagrams at ultimate applied load are shown in Figure 4.5.

The maximum moment achieved was well within the elastic range, as indicated by the moment-curvature analysis (see Figure 4.4). Coincidentally, virtually no flexural cracks were observed during testing of this beam. Because a flexural failure did not occur, comparisons with computed nominal flexural capacities revealed little about the methods used to compute those capacities.

The maximum shear achieved did not reach the level predicted by the AASHTO Specification, but did exceed the required capacities for both assumptions of either adequate or inadequate box beam interaction. Cracking in the bottom flange and related strand slip very likely influenced the shear capacity.

Test results reported in Chapter Three indicated the beam failed when crushing occurred in the West web of the girder. Failure was accompanied by substantial strand slip at the end of the girder. This suggests that failure may have occurred when shear capacity was reduced as the result of loss of prestress force because of slip. Slip of the strands was likely influenced by existing cracks in the bottom flange as well as cracks that propagated during testing.

Much of the applied load during this test was directed from the nearest point of load application to the near support on the West side of the beam. Because failure appeared to precipitate in the West web, it is possible that the shear strength model may overestimate strength because the strengths of the two webs were not reached simultaneously.

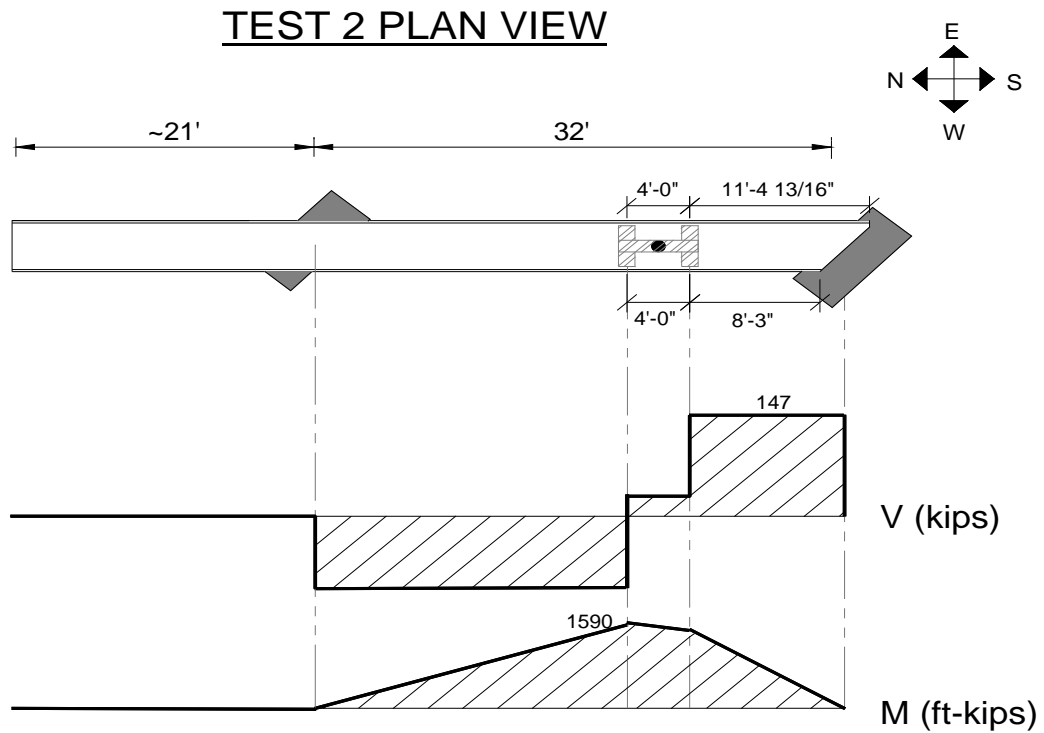
Figure 4.6: Moment and Shear Diagrams at Ultimate Load - Test 2

An ultimate applied load of nearly 232 kips was applied during this test. Maximum moment and shear values of 1590 ft-kips and 147 kips, respectively, were computed for the loading at ultimate. Figure 4.6 shows the shear and moment diagrams for the ultimate applied loading.

The maximum moment attained during this test was substantially higher than during the previous test. Flexural cracking propagated quite heavily in the region surrounding the load point. The first flexural crack, based on  $f_r = 7.5\sqrt{f'_c} = 1222$  ft-kips corresponded to an applied load of approximately 180 kips during the test, which, coincidentally was the load at which the first flexural crack was observed. This suggests that the approximate analysis used to accommodate the skewed beam end and the assumptions regarding material properties were reasonably accurate. The maximum moment reached during this test was again lower than the AASHTO projected capacity; but flexural behavior was not responsible for failure of the beam.

Web-shear cracks, flexure-shear cracks, and flexural cracks all propagated into existing cracks along the bottom of the beam. Original cracks in the bottom flange were also observed to propagate and widen.

As for the previous test, the skewed end likely resulted in shear strength being mobilized in the West web (with the shorter shear span) before it could be reached in the East web. The sum of the two shears resisted by the webs when failure precipitated in the West web should likely be less than the predicted capacity that assumed strength of the two webs being mobilized simultaneously.
