**Durability Evaluation of Post-Tensioned Concrete Beam Specimens
After Long-Term Aggressive Exposure Testing**

Thesis

Master of Science in Engineering

The University of Texas at Austin

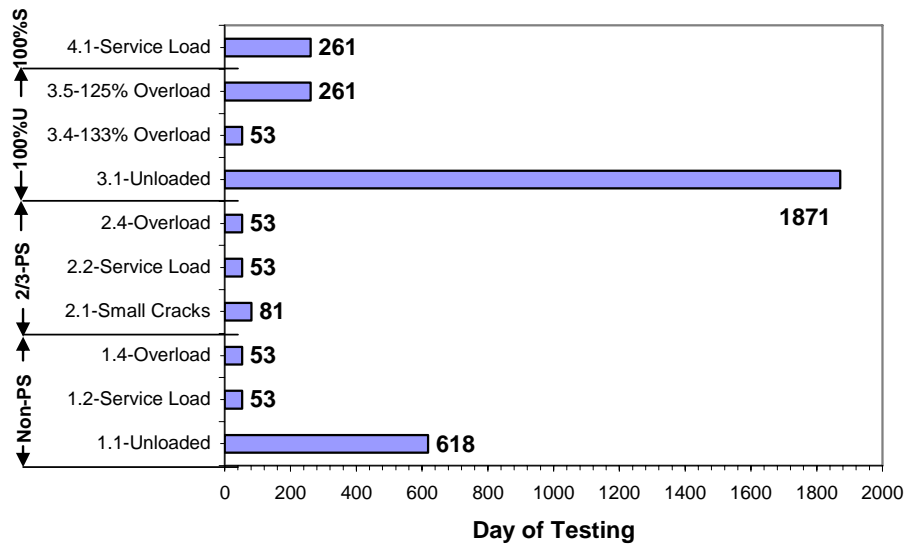
Figure 4.2: Estimated Time of Initiation of Corrosion: Phase I Beams

- All of the loaded specimens indicated corrosion within the first year of exposure testing, while the two unloaded specimens, 1.1 (Non-Prestressed) and 3.1 (100% Prestressed), showed a time to initiation of corrosion of 1.7 years and 5.1 years respectively. The delay in corrosion was likely due to the absence of cracking in these specimens.

- Among specimens with identical loading, the time to corrosion only increased when the specimen was fully prestressed, since the partially prestressed (2/3-PS) specimens and the non-prestressed specimens at service load began corroding at the same time as one another. The fully prestressed specimen (4.1) at service load had a much longer time for initiation of corrosion, most likely from better crack control since the specimen was fully prestressed.

- Among the partially prestressed and non-prestressed specimens, the overloaded and service load specimens began corroding at the same time. The partially prestressed specimen with small cracks (2.1) and the unloaded non-prestressed specimen (1.1) had a longer duration to initiation of corrosion. Thus, once cracks of sufficient size form, the time to initiation of corrosion is

not effected by any additional loading beyond the point at which the necessary crack width for corrosion is reached.

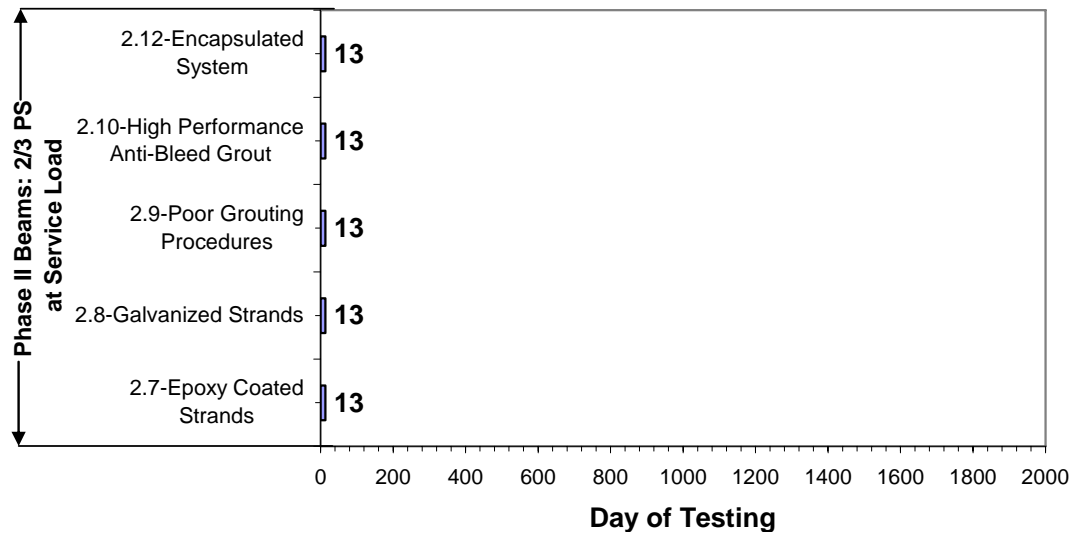
Figure 4.4: Estimated Time of Initiation of Corrosion: Phase II Beams

All Phase II Beams began corroding after only 13 days of testing. Even though all Phase II specimens had different post-tensioning details (either strand type, duct type, or grout type), the presence of cracking likely initiated the corrosion of the reinforcing bars at the same time in all five specimens. Thus, the corrosion in the reinforcing bars likely caused the crossing of the threshold.

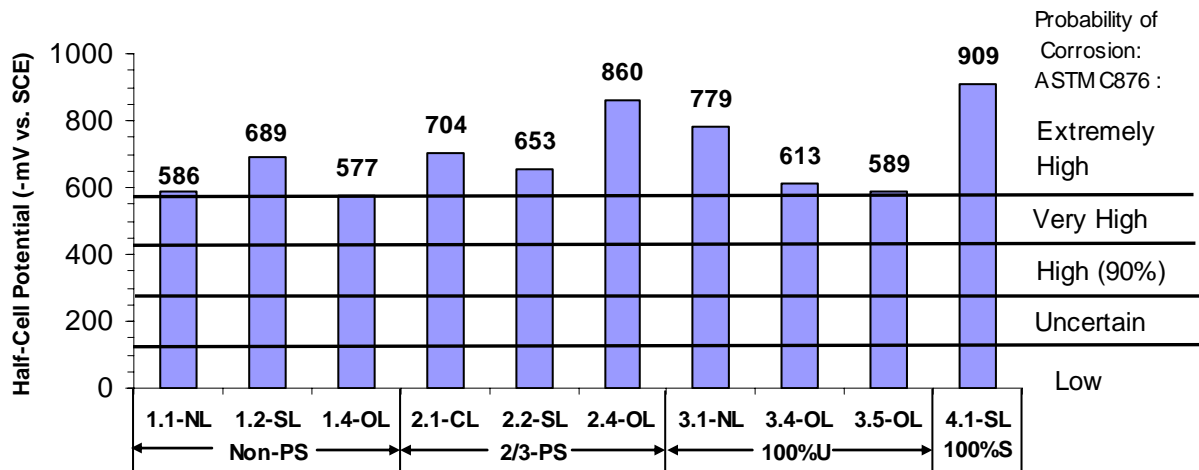
Figure 4.5: Maximum Final Half-Cell Potential Readings for Phase I Beams

- In the case of the non-prestressed and 2/3 prestressed specimens, there is no trend between increased loading and the half-cell readings. For the Non-PS specimens, the half-cell values did not increase (in terms of absolute value) with increased loading, and all three specimens were just at or above the extremely high probability of corrosion threshold. The same trend was observed in the 2/3-PS specimens, and all of those values were far above the threshold for extremely high probability of corrosion.
- For the 100% U specimens (fully prestressed), all specimens were above the threshold for extremely high probability of corrosion. The half-cell values did not increase with loading. Instead, they actually decreased.

Therefore, there is no overall trend between level of loading and the probability of corrosion after 8 years of testing.

- In the case of the overloaded specimens (1.4, 2.4, 3.4, 3.5), a similar trend to that of the unloaded and service load specimens is observed

Therefore, according to the half-cell data, there is no correlation between the level of prestress and the probability of corrosion after 8 years of testing.

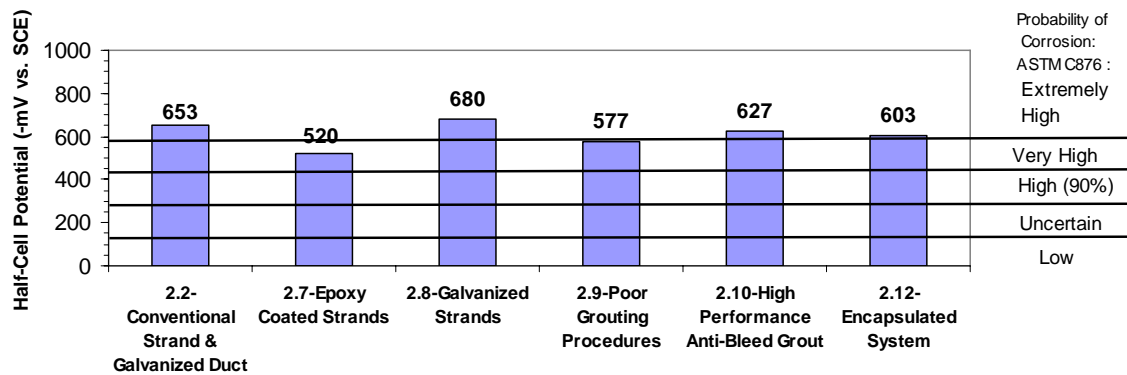
Figure 4.6: Maximum Final Half-Cell Potential Readings for Phase II Beams, Including Phase I Beam 2.2

Only the specimen with epoxy coated strands (2.7) had a probability of corrosion in the very high range. The remainder of the Phase II specimens were in the extremely high range. Beam 2.9 was essentially at the extremely high threshold (580 mV). It is interesting to note that according to the half-cell data, the use of the plastic duct did not decrease the probability of corrosion in relation to the other specimens. However, it needs to be stressed that the half cell readings include the conventional bars and metal ducts, since all the steel elements in the beam form a circuit. Therefore, the relative performance of only the post-tensioning hardware (namely the strand) cannot be readily estimated from the half-cell potential data.

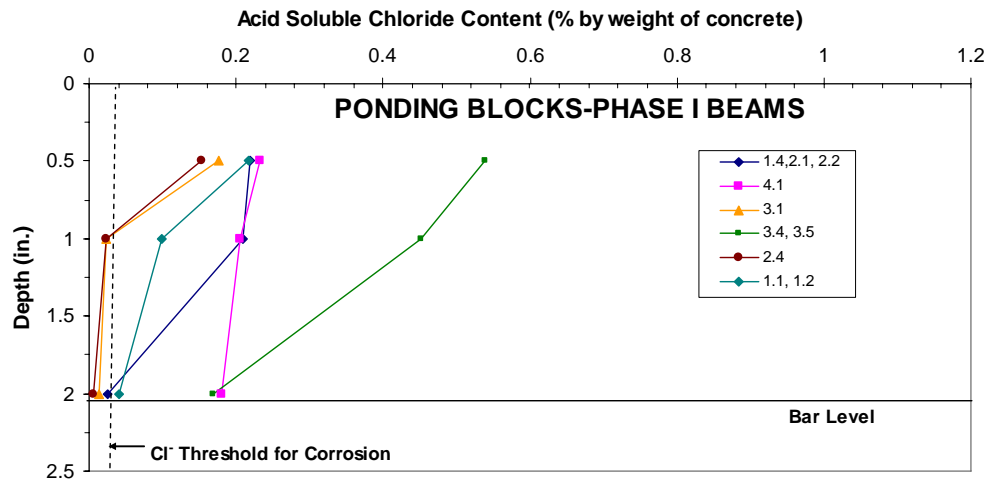
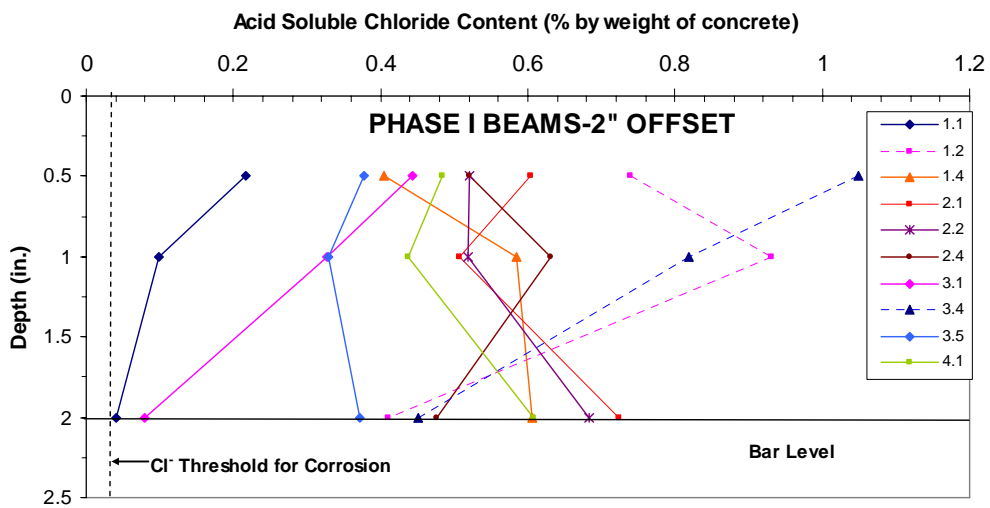
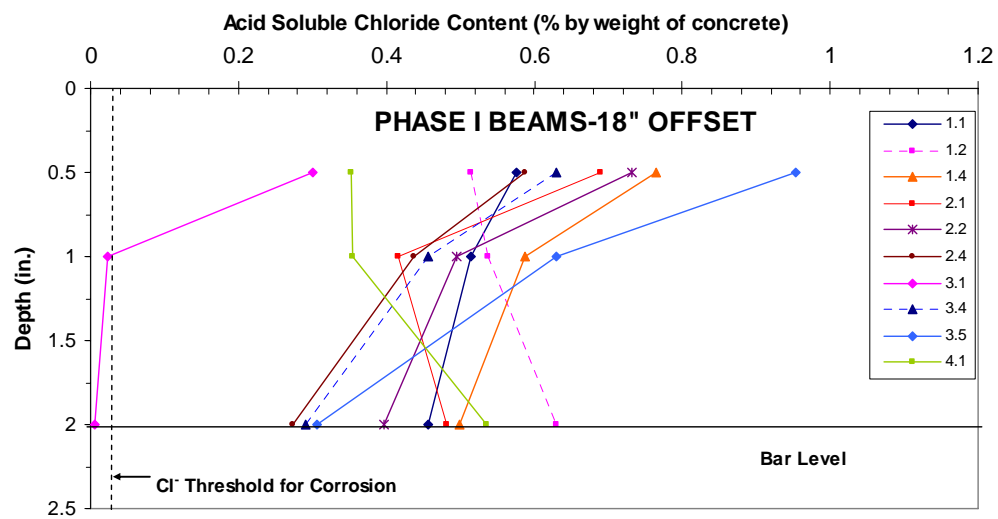
Figure 4.7: Beam and Block Chloride Penetration for Phase I Beams

For all Phase I ponding blocks the chloride content decreased appreciably with depth. In the ponding blocks with the concrete used in beams 3.4, 3.5, and 4.1 the chloride contents are far above the corrosion threshold at the level of the bars. This is significant because it suggests that even without cracking corrosion could occur in these specimens. In other words, the corrosion threshold could be reached just from the permeability of the concrete. Unlike the ponding block specimens, the chloride content did not always decrease with depth in the case of the beam specimens. The chloride

content at 2-in. depth was larger than that near the surface surely due to the large amount of cracking that was seen in the specimens (See Chapter 5). Also, the threshold for corrosion was reached at bar level for both offsets for all specimens, except the 18” offset for beam 3.1. The reason for this, as later stated in Chapter 5, is that beam 3.1 did not have any cracking in the vicinity of the 18” offset. In addition, outside the ponded region all samples for beam 3.1 were below the threshold for corrosion. In the case of beam 1.1, the samples outside the ponded region still showed values above the threshold for corrosion. A possible explanation for this is that the salt solution was leaking out of the salt bath onto the rest of the beam. This is supported by the fact that large amounts of staining were observed outside the ponded region in the case of beam 1.1.

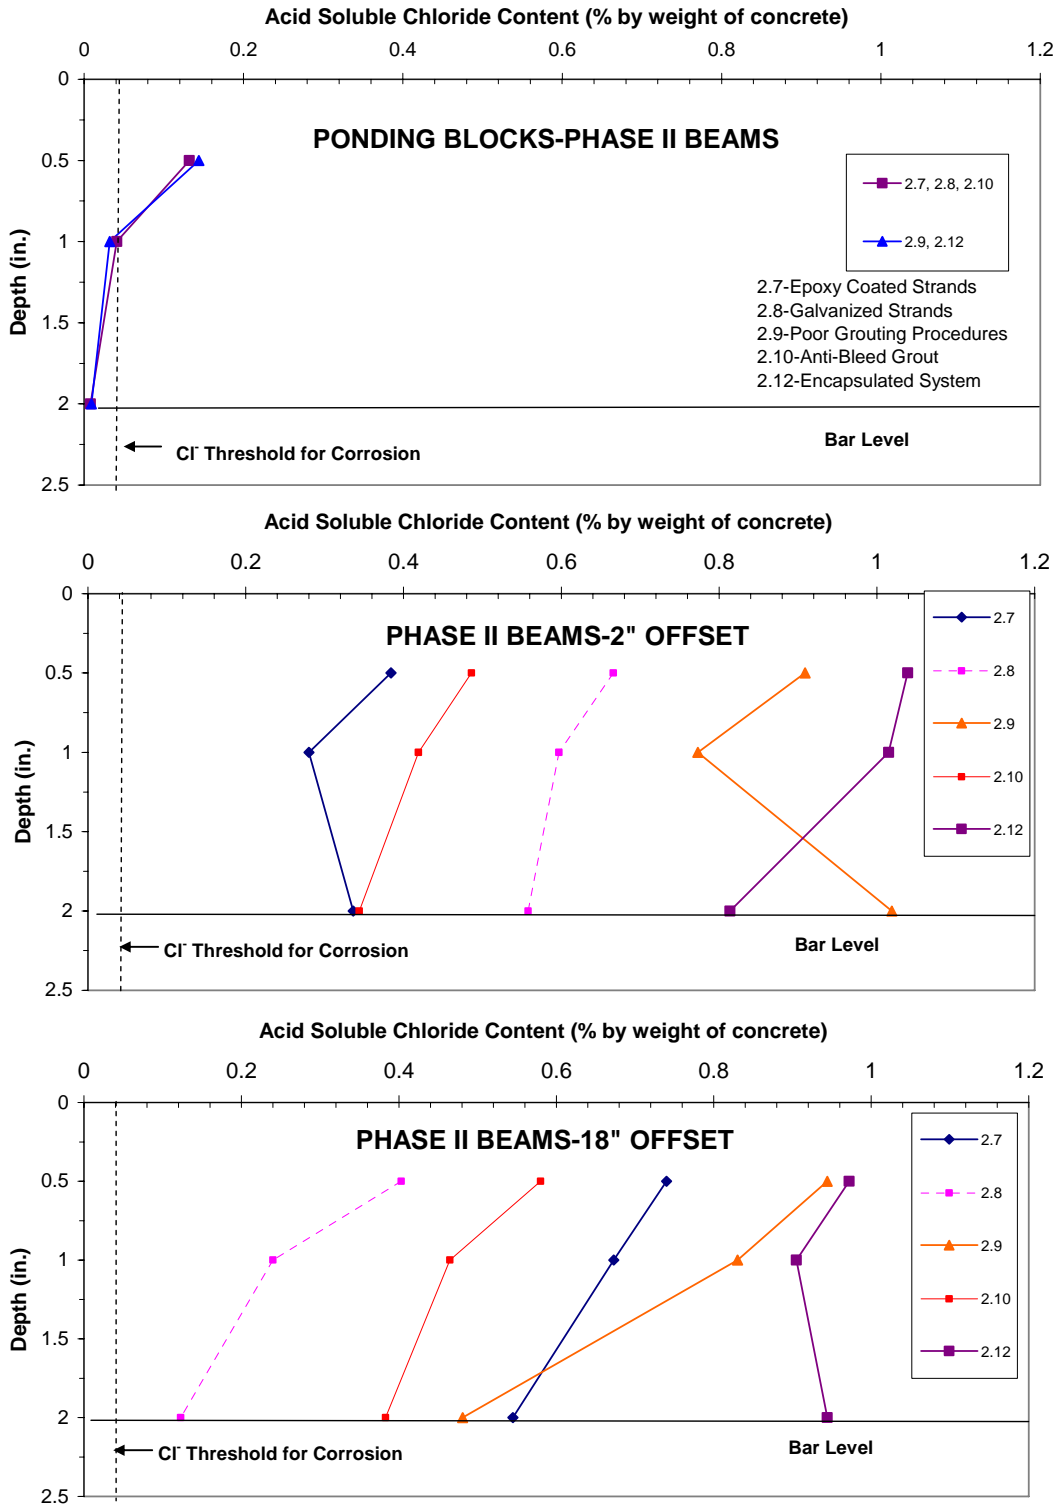
Figure 4.9: Beam and Block Chloride Penetration for Phase II Beams

In the case of the Phase II ponding blocks similar behavior was seen among all five specimens. At the depth of the reinforcing bars the ponding block chloride contents were far below the threshold for corrosion. In addition, the chloride content decreased appreciably with depth. In the case of the Phase II beam offsets, the values were substantially larger than the ponding blocks and did not always decrease with depth. At the depths of the bars all samples were far above the threshold for corrosion. As later shown in Chapter 5, the large amount of cracking in the Phase II specimens likely caused the chloride content to be higher at the bar level than at the surface. In addition, the profiles were not the same at both offsets. However, at both offsets all beams are well above the threshold for corrosion at the level of the bars.

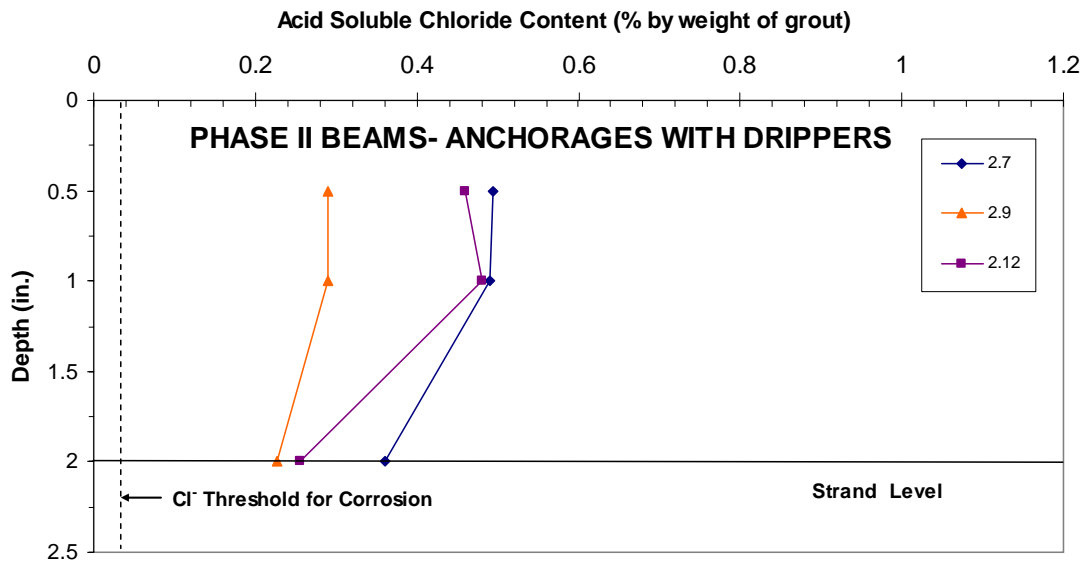
Figure 4.10: Chloride Penetration for Anchorages of Phase II Beams Subjected to End Anchorage Exposure

According to these data the anchorage exposure cycles were rigorous enough to produce corrosion in the anchorages. For all three specimens the chloride content at the level of the strand tails is far above the threshold for corrosion. The presence of any corrosion in the anchorages will be determined in the forensic analysis in Chapter 5.

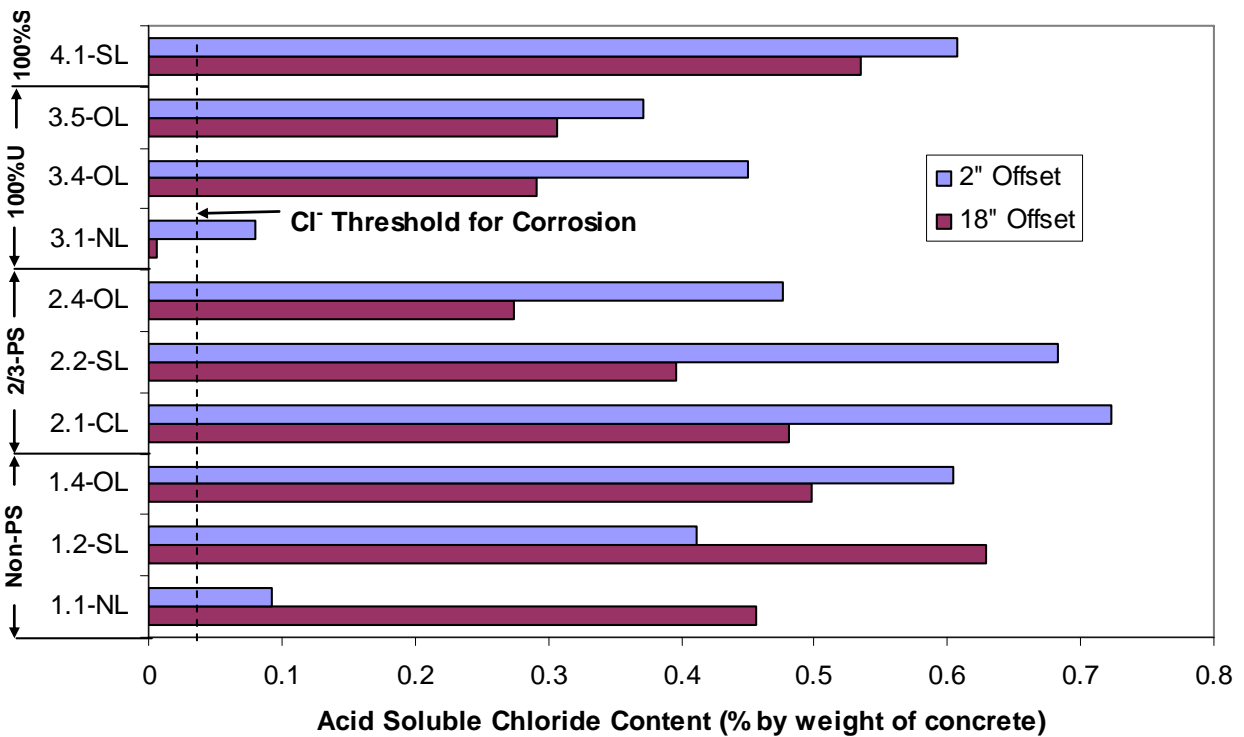
Figure 4.11: Chloride Penetration at Reinforcing Bar Depth-Phase I Beams

Except for the 18" offset in the unloaded fully prestressed specimen 3.1, all chloride levels exceeded the threshold for corrosion - even the reinforced concrete unloaded specimen. While the contents at the 2" offsets were not always the same, in all loaded specimens the contents were far above the threshold, so the difference in values is irrelevant. The only trend observed when comparing specimens with the same level of

prestress is with the fully prestressed beams: Beam 3.1 clearly demonstrated the effect of an uncracked section when compared to beams 3.4 and 3.5.

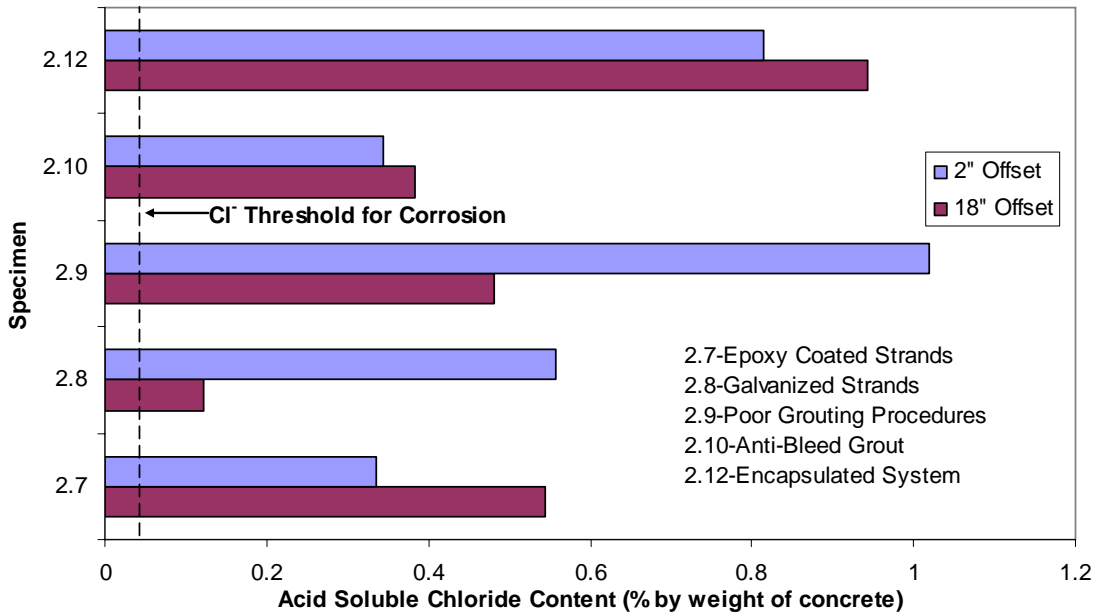
Figure 4.12: Chloride Penetration at Bar Depth-Phase II Beams

All values are well above the threshold for corrosion. The fact that the threshold is exceeded is most likely due to corrosion of the steel reinforcing bars and galvanized ducts. Thus the difference in values among specimens does not reveal any information about the effects of different grouts, strand, or duct type. The values only indicate the potential for corrosion at the levels of the bars and ducts.

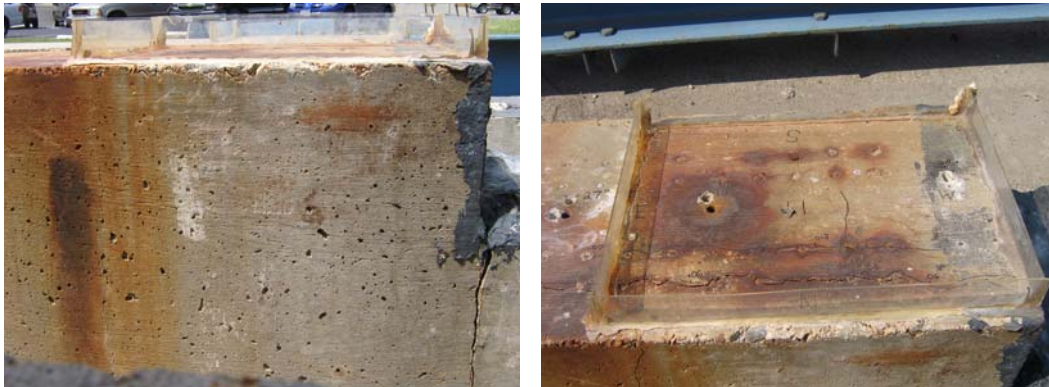
Figure 5.15: Beam 1.1-Side View (Left) and Top View (Right)

As shown in Figure 5.15 and Figure 5.18, there was severe staining and longitudinal cracking inside the ponded region as well as outside the north corner of the ponded region. The staining was centralized around the location of the bolster strips. Staining was also found around the locations of the chloride sampling points from the previous autopsies. The holes appeared to have never been sealed after the first partial autopsy. On the north side of the ponded region a crack averaging 0.06 in. in width was found along the line of the bolster strips. A transverse crack of 0.002 in. in width was found in the center of the ponded region. On the north side of the beam was an apparent flexural crack with large amounts of staining around it. It is likely that small cracks formed when the beam was handled during the 4-year partial autopsy. The crack width data are given in Figure 5.16. The “Average of Peak Crack Widths” is the average of the peak crack width at each cracked location in the autopsy area. This includes both the longitudinal and flexural cracks. The maximum crack width is the overall maximum crack width found at any point in the autopsy area.

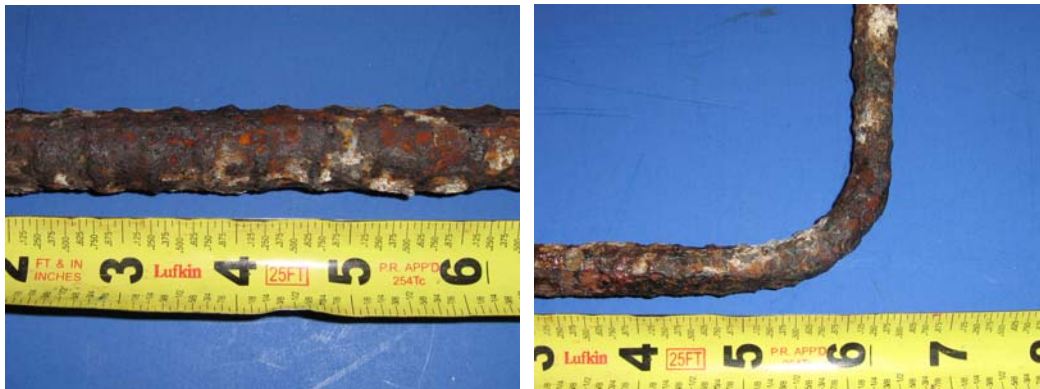
Figure 5.17: Beam 1.1 Autopsy Elements-Longitudinal Bar (Left) and Stirrup (Right)

There was pitting and some cross-sectional area loss on all longitudinal bars and most of the stirrups. The stirrup which was outside the ponded region exhibited pitting on its top portion but only moderate corrosion on its legs. The stirrups and bars are shown in Figure 5.17. The ratings for the stirrups and bars along with the beam crack maps are shown in Figure 5.18. In these plots the sum of the ratings for all longitudinal bars in each 2-in. interval is plotted. The total of the ratings for each stirrup along the length of the autopsy area is also shown. The corrosion ratings for the stirrups and bars are summarized in Table 5.4. In order to compare this beam with the other beams, additional stirrup and bar data were extrapolated in order to have a full 72 in. worth of data. This was done by “mirroring” the data from the section currently autopsied.

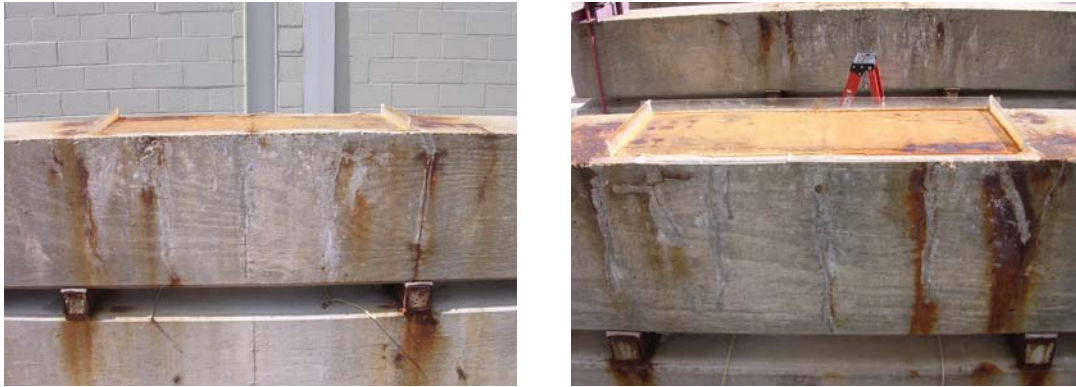
Figure 5.19: Beam 1.2-Side View (Left) and Top View (Right)

As shown in Figure 5.19 and Figure 5.23, there was severe staining and cracking both inside and outside the ponded region. There were large 1/8-in. cracks running from the west end of the salt bath through the entire remaining length of the autopsy area. Bolster strip corrosion was found in multiple locations in the ponded region. Some of the flexural cracks coincided with stirrup locations, while flexural cracks were found in other locations as well. Severe staining was found in the area of these flexural cracks. Also, there was longitudinal cracking on the side face of the beam. The combination of longitudinal cracking on the top and side of the beam would suggest severe bar corrosion, since the expansive effect of the corrosion products is essentially pushing the top corners of the beam off. The crack width data are given in Figure 5.21 . After cutting of the beam, it was observed that the longitudinal 1/8-in. cracks actually formed a crack plane right through the level of the severely corroded bars. Thus corrosion of the bars is

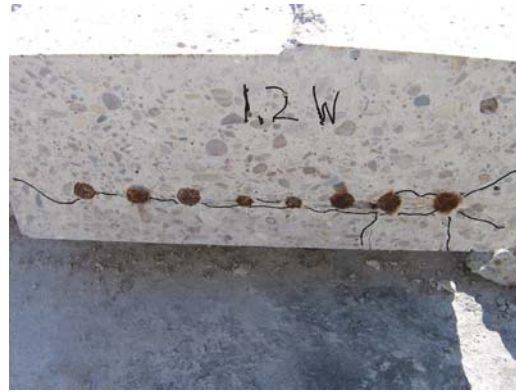
Figure 5.20: West End of Autopsy Block-Beam 1.2

responsible for the longitudinal cracking. As the bars corroded, the expansive effects of the corrosion products cracked the concrete. This is shown in Figure 5.20. Note that the block is upside down compared with its position during exposure testing.

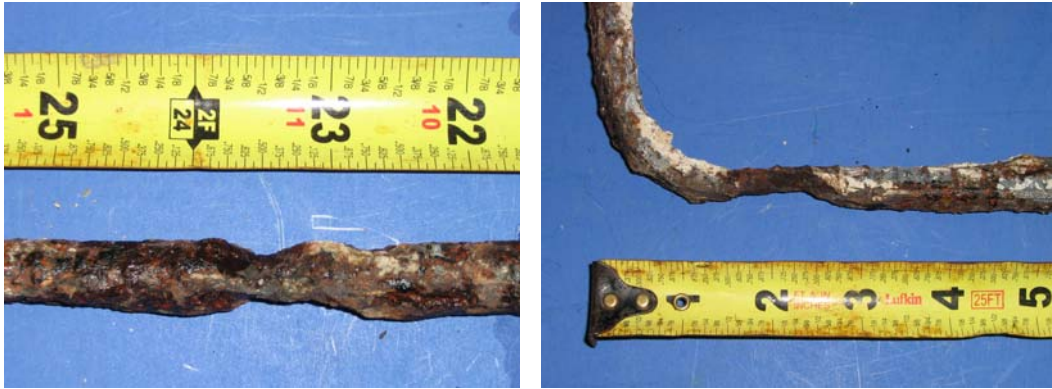
Figure 5.22: Beam 1.2 Autopsy Elements-Longitudinal Bar (Left) and Stirrup (Right)

During autopsy, pitting and cross-sectional area loss was found throughout all the longitudinal bars and the stirrups. The most severe section loss in the bars was found in the area of the flexural cracks. The most corroded stirrup was that located 54 in. from the west end of the autopsy area. The corroded bars and stirrups are shown in Figure 5.22. Bar and stirrup corrosion ratings are given in Figure 5.23, and the corrosion ratings are summarized in Table 5.5.

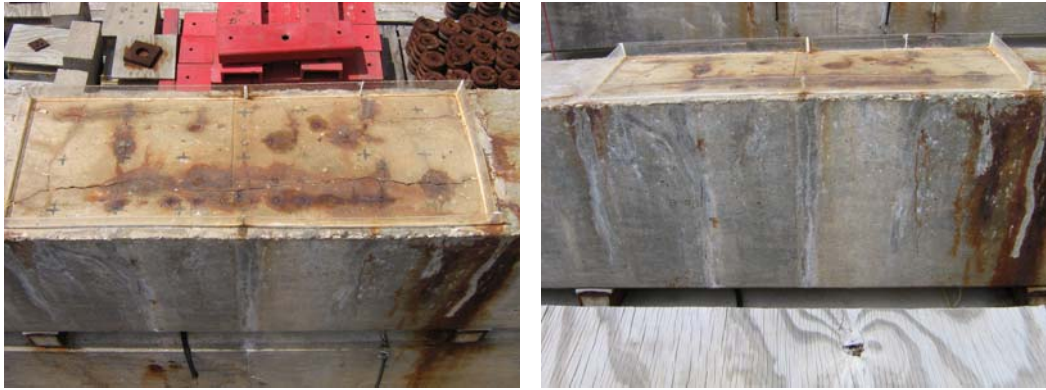
Figure 5.24: Beam 1.4-Top View (Left) and Side View (Right)

As shown in Figure 5.24 and Figure 5.27, there was severe staining and cracking throughout the ponded region. The staining was concentrated around longitudinal cracks. These longitudinal cracks typically measured 0.1 in. in width. In general these cracks corresponded to the locations of the steel bolster strips. The maximum width of these longitudinal cracks was 1/8-in.. There was also staining on the side of the beam, especially just outside the west end of the ponded region (This is shown on the far right sides of the pictures in Figure 5.24). Similar to beam 1.2, upon removal of the block from the center of the beam it was found that the longitudinal cracks formed a crack plane right through the bars. The crack width data are given Figure 5.25.

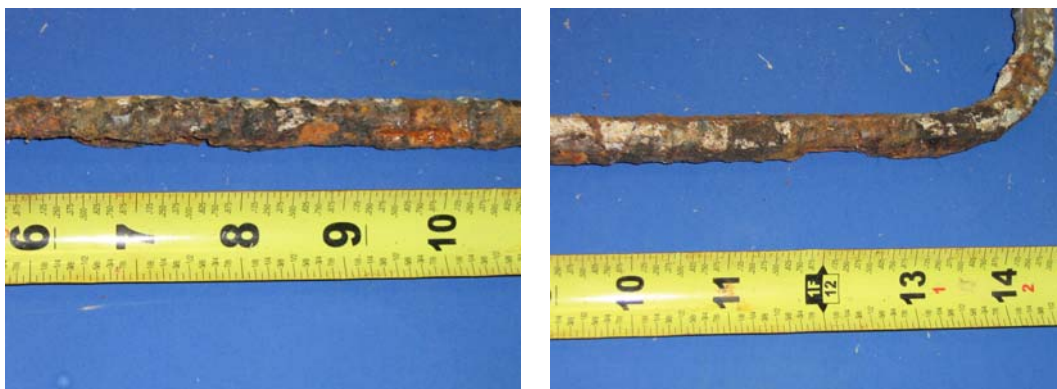
Figure 5.26: Beam 1.4 Autopsy Elements-Longitudinal Bar (Left) and Stirrup (Right)

Considerable cross-sectional area loss and pitting was found on all bars and most of the stirrups, with the most severe area loss in the bars corresponding to the locations of flexural cracks. The pitting was less severe outside the ponded region, but present nonetheless. The most severely corroded stirrup corresponded to the flexural crack at 29 in. from the west end of the autopsy area. The worst damage seen on the stirrup was essentially a reduction in diameter from ½-in. to approximately 3/8-in.. As previously stated, considerable staining was seen at the flexural crack at this location. The bars and stirrups are shown in Figure 5.26. Crack patterns and corrosion rating graphs are given in Figure 5.27.

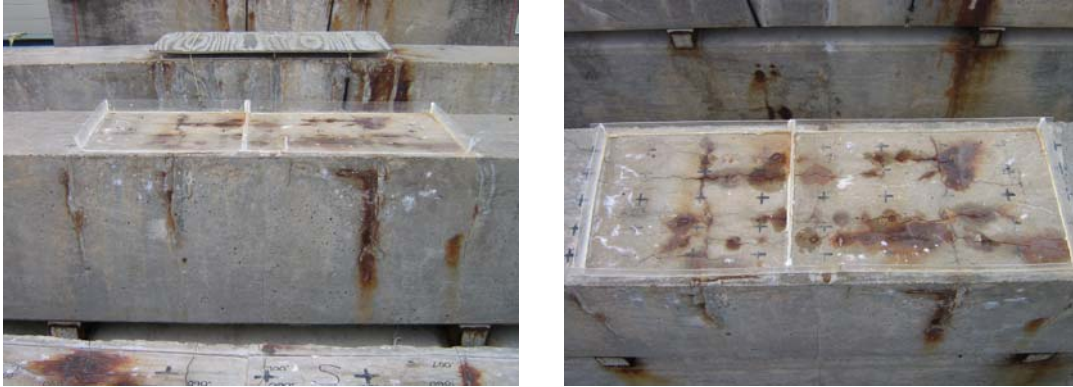
Figure 5.28: Beam 2.1-Side View (Left) and Top View (Right)

As shown in Figure 5.28 and in the crack maps in Figure 5.32, heavy staining and cracking was observed in the ponded region. Minor staining was seen outside the west end of the ponded region, with small cracks running in both directions. Inside the ponded region, longitudinal cracks following the bolster strips measured about 0.01 in. in width. Severe staining was seen in the area of these cracks. The flexural cracks also showed severe staining on the top of the beam. The largest crack width was from a longitudinal crack about 18-in. to the east of the beam centerline. This crack measured 1/8-in. in width. On the side faces of the beam, the flexural cracks had severe staining emanating from them, which was likely from the corrosion of stirrups because all flexural crack locations corresponded with stirrup locations. Longitudinal cracks with staining were also

found on the side of the beam as well. The large amounts of longitudinal cracks suggest severe corrosion within the beam. Indeed, when the autopsy block was removed from the center of the beam cracking through the bars was seen similar to that in the Non-PS beams. The crack width data for the beam are given in Figure 5.29.

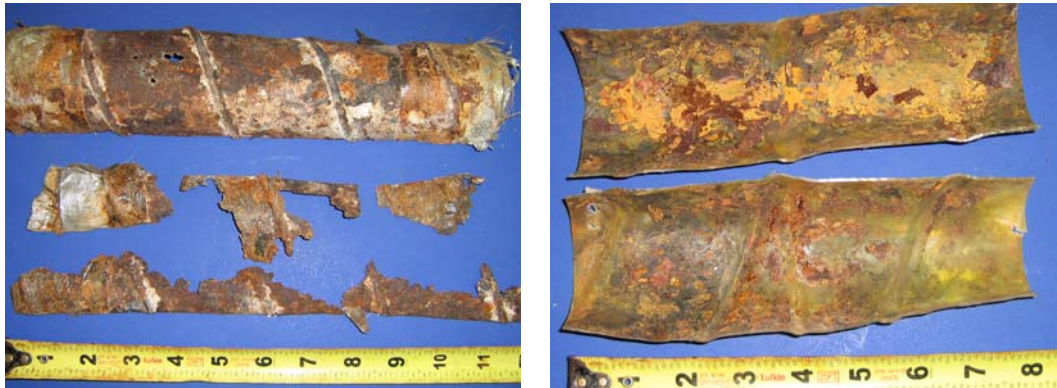
Figure 5.30: Beam 2.1 Duct Splices-South Duct Industry Standard Splice (Left) and North Duct Heat Shrink Splice (Right)

The south duct was fitted with an industry standard splice, while the north duct had a heat shrink splice. The industry standard splice suffered tremendous area loss to its top portion and pitting corrosion was found on the remains of the inside surface of the splice. The duct beneath had large holes and pitting. The heat-shrink splice on the south duct showed severe staining and corrosion deposits on the inside. The section of duct beneath the splice was found to be heavily pitted and holed. In this case the holes were

smaller than those in the splice zone of the south duct. The splices are shown in Figure 5.30.

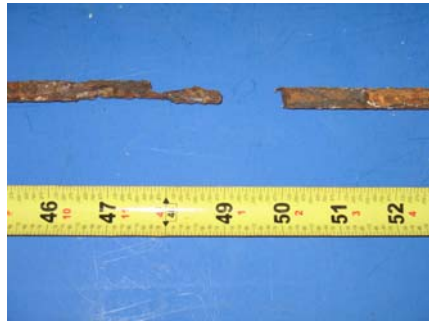
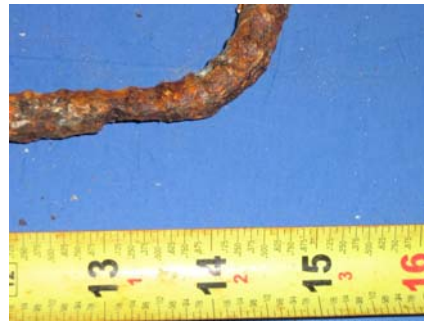
Figure 5.31: Beam 2.1 Autopsy Elements

Upon autopsy, it was found that all stirrups and bars suffered severe pitting and cross-sectional area loss (See Figure 5.31). In the area of the flexural cracks, the smaller bars completely corroded away, some losing almost 2-in. in length. The stirrups also had severe pitting and area loss, with the worst stirrup 12-in. to the west of the beam centerline. The ratings along the length of the beam for the bars and stirrups, as well as the other elements of the beam, are given in Figure 5.32. The corrosion ratings are summarized in Table 5.7.

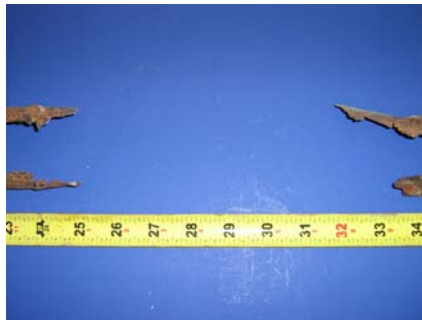
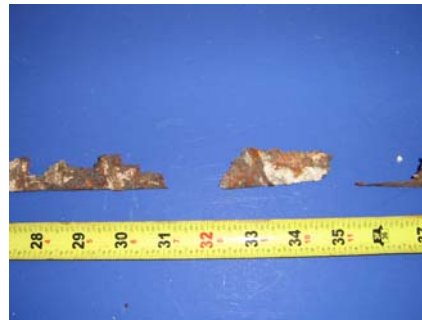
Both ducts were heavily pitted with large holes that caused large surface area loss. The south duct suffered severe surface area loss throughout, with the entire top portion of the duct gone from 14 in. to 18 in. to the west of the beam centerline. The north duct showed similar large surface area loss, however, little corrosion was seen in the portion outside the ponded region. The surface area loss was not as large as that beneath the south duct splice. The ducts are shown in Figure 5.31. The corrosion ratings for the ducts are plotted in Figure 5.32. The ratings are summarized in Table 5.7.

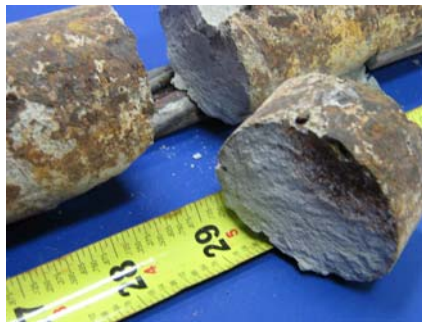
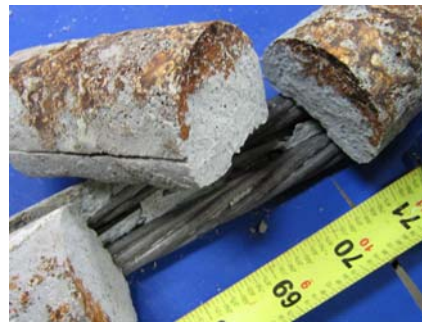
The south duct grout showed no large voids. However, there was some evidence of porosity in the form of bubbles at the top of the grout. The grout was found to be cracked in numerous locations, and staining was found on the crack faces. The maximum chloride content in the south duct grout was 0.237% by weight, far above the corrosion threshold of 0.033%. This maximum value occurred at the far east end of the duct. The north duct grout was similar. However, small surface voids were found on the north duct, and in some cases corrosion products were found inside the voids. The maximum chloride content in the north duct grout was 0.649%, which was found 6 in. to the west of the beam centerline. This is over 20 times larger than the threshold for corrosion. The grout from both ducts is shown in Figure 5.31. The grout chloride contents are plotted in Figure 5.32.

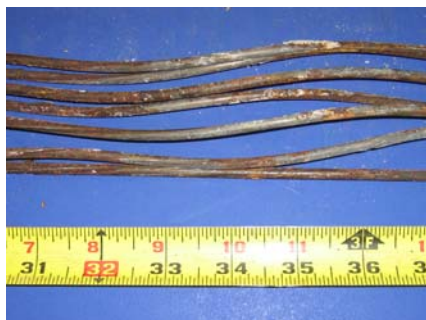
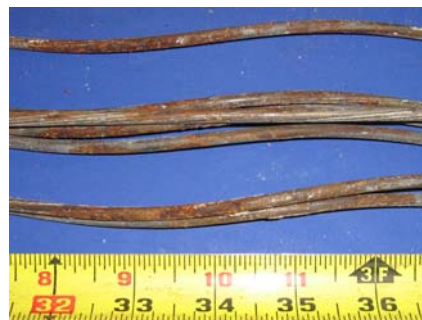
The strands in both ducts were pitted. The two south duct strands showed mild pitting throughout, and moderate to severe pitting on a few wires within the ponded region. Mild pitting was also found on portions of the strands outside the ponded region. The north duct strands had much less pitting than the south duct strand, with only mild pitting found at the 3 flexural crack locations near the beam centerline. The strands are shown in Figure 5.31. Corrosion ratings for the strand are plotted in Figure 5.32 and are summarized in Table 5.7.

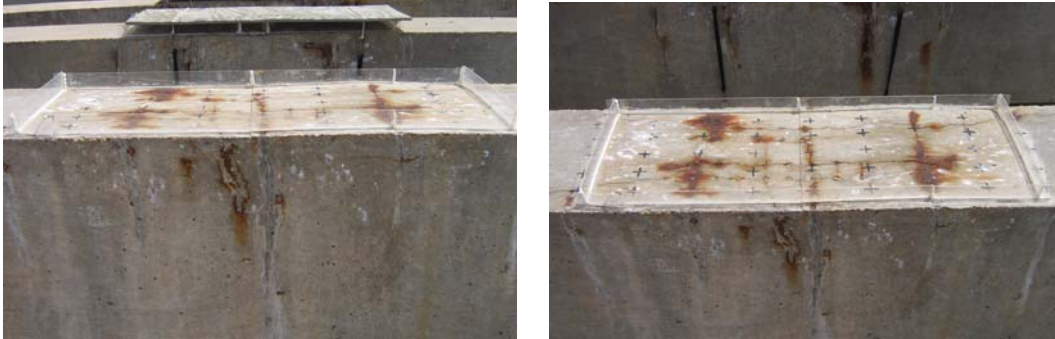
Figure 5.33: Beam 2.2-Side View (Left) and Top View (Right)

As shown in Figure 5.33 and Figure 5.37, severe staining and cracking was observed inside the ponded region. The staining was concentrated around the flexural cracks at 30, 42, and 53 in. from the west end of the autopsy area. Staining was also observed at bolster strip locations. Longitudinal cracks were observed running along the length of the beam. These cracks typically measured about 0.06 in. in width inside the ponded region. The longitudinal cracks extended outside the west end of the ponded region. The maximum crack width found was located 1 in. inside the west end of the ponded region, where one of the longitudinal cracks measured 1/8-in. in width. Staining was also observed emerging from the flexural cracks on the side of the beam. The large longitudinal cracks and staining suggests severe corrosion within the beam. The crack width data for the beam are given in Figure 5.34.

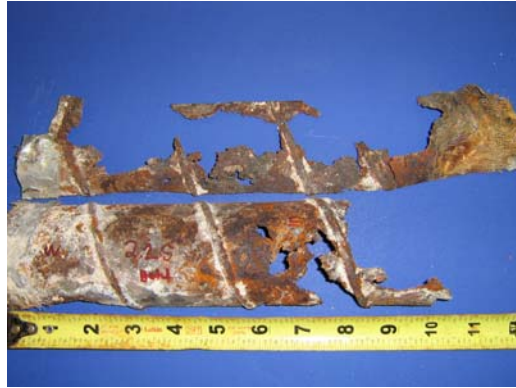
Figure 5.35: Beam 2.2 South Duct Splice

The south duct had an industry standard splice, while the north duct had no splice. The industry standard splice suffered very severe area loss, both to its top and bottom portions. Pitting corrosion was found on the inside of the splice. The length of galvanized

duct beneath the splice suffered severe pitting and the loss of nearly half of the top portion of the duct. The splice is shown in Figure 5.35.

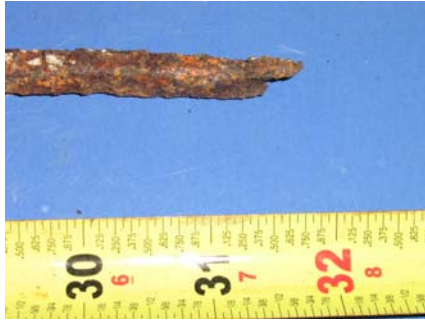
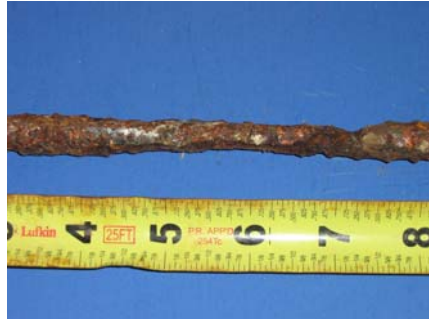
Figure 5.36: Beam 2.2 Autopsy Elements

Upon autopsy, it was found that the longitudinal bars and stirrups suffered severe pitting and area loss throughout the autopsy area (See Figure 5.36). Pitting was found even outside the ponded region. Approximately 8-in. of one of the #3 bars was completely corroded away in the vicinity of the flexural crack at 30 in. from the west end of the autopsy area. In the vicinity of the flexural cracks from 42 to 54 in., approximately 6-in. of one of the #3 bars was completely corroded away. The worst stirrup was that 12 in. to the west of the beam centerline. This corresponds to 30 in. in the crack maps and corrosion rating graphs in Figure 5.37. In one location this stirrups diameter was reduced by half. This corresponded to one of the areas of severe staining seen on the exterior surface of the beam. The longitudinal bars and stirrups are shown in Figure 5.36. The ratings for the stirrups and bars are shown in Figure 5.37, and are summarized in Table 5.8.

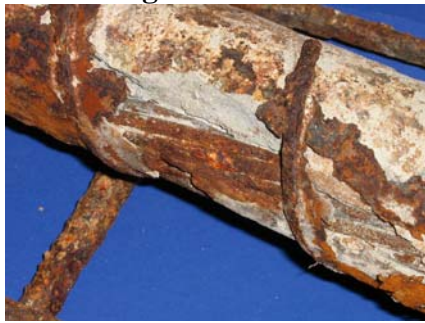
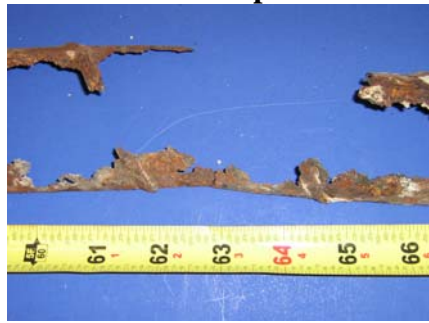
Both ducts were heavily holed and as a result both ducts had tremendous surface area loss. The north duct suffered surface area loss and pitting, even outside the ponded region, with the loss of more than half of the top of the duct in several locations in the vicinity of the centerline of the beam. Pitting was also found on the inside of the duct in the vicinity of the holes. The south duct was more severely corroded than the north duct. The last two feet of the top portion of the south duct were basically missing. Only fragments of the duct ribbing were recovered in this area. At 26 in. from the west end of autopsy area, the duct loss was so severe that the strand could be plainly seen and was severely pitted. The ducts are shown in Figure 5.36. The duct corrosion ratings are plotted in Figure 5.37 and are summarized in Table 5.8.

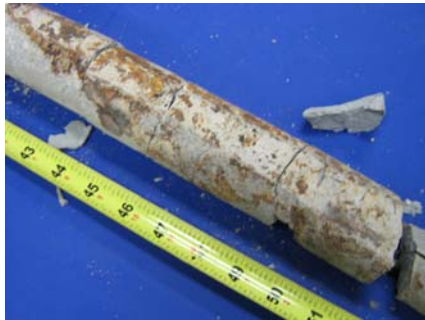
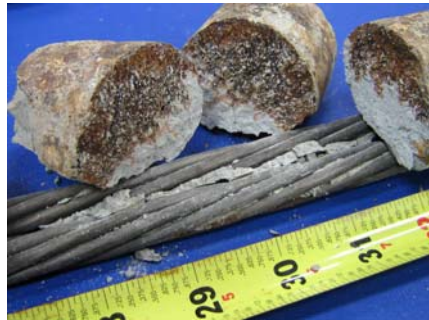
Corrosion products were found deposited on the grout throughout both ducts. The north duct grout was cracked at multiple locations, with severe staining on the crack faces. The most severe staining was at a crack 30 in. from the west end of the autopsy area. Small voids were found indicating either bleed water accumulation or air pockets. The maximum chloride content in the north grout was 0.290%, which was at a location 12 in. to the east of the beam centerline. This corresponds to a flexural crack location. The south duct grout was also cracked. A large bleed water void was found in the south duct in the vicinity of the beam centerline. The void was about 1.2 in. wide. This void continued through the entire length of the autopsy area. Staining was also found on the

crack faces of the grout, corresponding to locations of severe loss in duct surface area. The maximum chloride content in the south duct was 0.329%, slightly higher than the north duct. The grout from both ducts is shown in Figure 5.36. The grout chloride contents from both ducts are plotted in Figure 5.37.

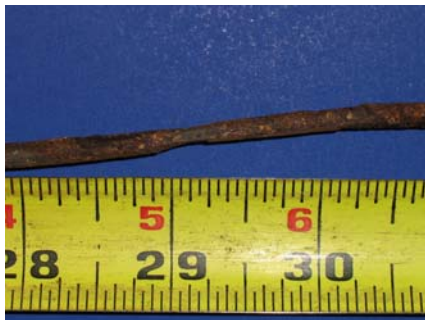
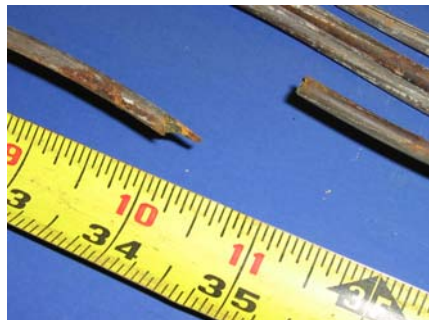
The strands from both ducts varied in the severity of corrosion. The north duct strands showed moderate corrosion throughout, with mild pitting in the vicinity of the beam centerline. Severe pitting was found on some wires at 30 to 32 in. from the west end of the autopsy area. One of the wires actually broke during unwinding of the strand. This is shown in Figure 5.36. The south duct strand was much more heavily corroded than the north duct strand. Mild pitting was found throughout, with instances of moderate to severe pitting found in multiple locations. At 28 in. from the west end of the autopsy area it was found that three wires on one of the strands had been reduced in diameter by about 33%. One of these wires is shown in Figure 5.36. It interesting to note from Figure 5.37 that the peaks in the south duct strand damage occurred within the vicinity of the centerline crack and the flexural crack at 12 in. to the west end of the centerline. The corrosion ratings for the strand are plotted in Figure 5.37 and are summarized in Table 5.8.

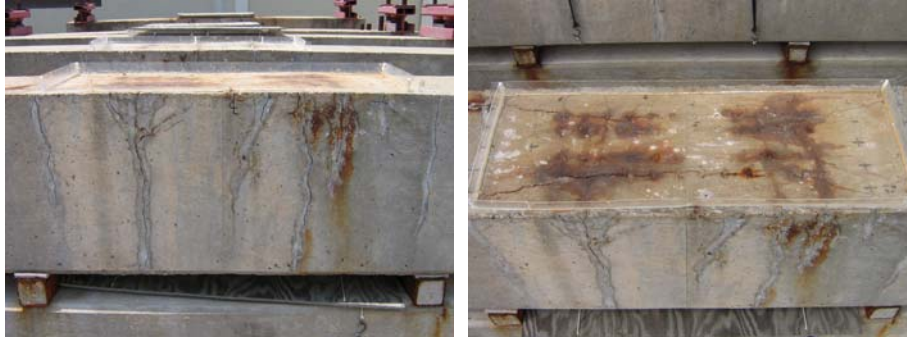
Figure 5.38: Beam 2.4-Side View (Left) and Top View (Right)

As expected, more flexural cracks were observed on this beam than in 2.1 and 2.2 because of the temporary overloading which was done at the beginning of exposure testing. As is apparent in Figure 5.38 and in Figure 5.42, severe staining and longitudinal cracking was observed inside the ponded region. The staining was concentrated around the longitudinal cracks which ran the length of the ponded region. The largest crack width observed for these longitudinal cracks was 1/8-in.. This was at the extreme east end of the ponded region. These cracks continued even outside the ponded region. The cracks seemed to run parallel to the steel bolster strips. Crack width data are given in Figure 5.39. Staining was also seen emerging from the flexural cracks on the side of the beam as well. Overall, the exterior appearance of the beam suggests severe corrosion. When the block was removed from the center of the beam, the longitudinal cracks were found to

form the typical crack plane which went through the corroded bars. The crack widths are given in Figure 5.39, while the crack patterns are plotted in Figure 5.42.

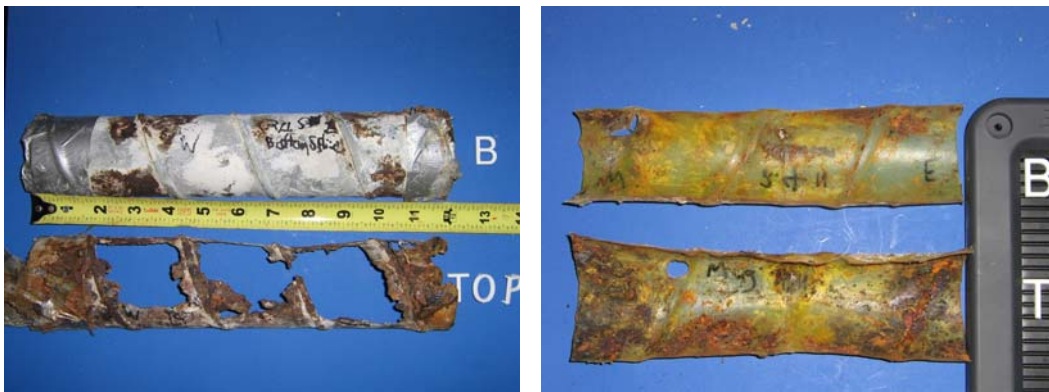
Figure 5.40: Beam 2.4 Duct Splices-South Duct Industry Standard Splice (Left) and North Duct Heat Shrink Splice (Right)

Both ducts in the beam were spliced at the beam centerline. The south duct had an industry standard splice while the north duct had a heat shrink splice. Most of the top

half of the south duct splice corroded away, while the remainder was pitted. The inside surface had severe pitting adjacent to the holes. The bottom portion of the splice did not have any holes, but was pitted on the exterior in a few locations. The duct portion directly beneath the splice showed large holes and pitting. The north duct heat shrink splice showed discoloration on its inside surface. The portion of duct beneath it had large holes and pitting. Therefore, in this instance both splices performed very poorly in keeping moisture out of the splice zone. The heavy duct corrosion in the splice zone suggests large moisture ingress. The splices are shown in Figure 5.40.
