**Durability Evaluation of Post-Tensioned Concrete Beam Specimens
After Long-Term Aggressive Exposure Testing**

Thesis

Master of Science in Engineering

The University of Texas at Austin

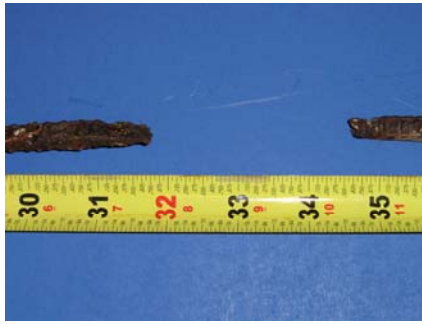
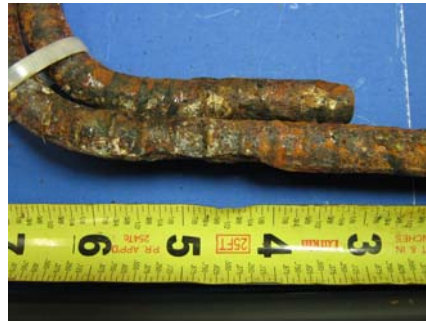
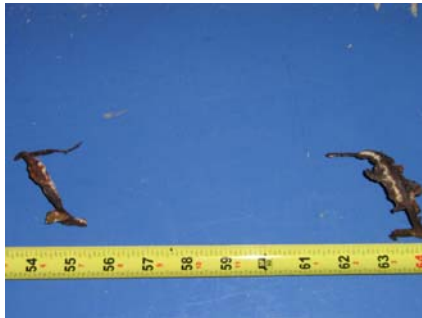
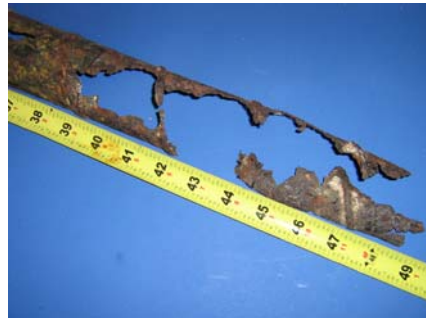
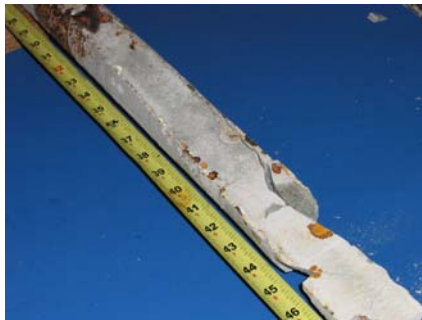
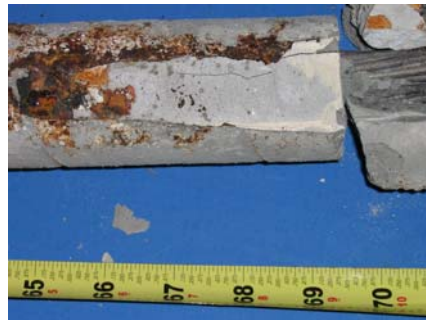
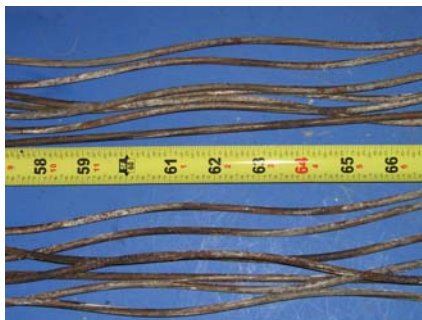
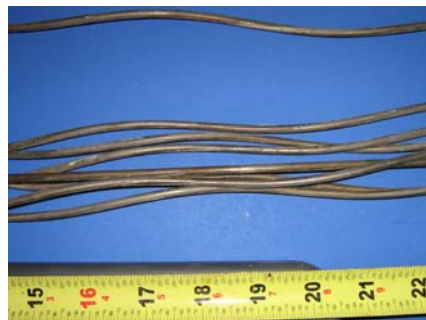
Figure 5.41: Beam 2.4 Autopsy Elements

The south duct grout had corrosion deposits throughout from the duct corrosion. Bubbles indicating porosity were evident. The grout was cracked and staining was found in some areas. At about 22 in. from the west end of the autopsy area, a large bleed water

The strands in both ducts varied had varied amounts of corrosion. The north duct strands showed light to moderate corrosion in the area outside the ponded region. Inside the ponded region, moderate corrosion was observed on more wires. At 8 to 12 in. east from the centerline (Corresponding to 54 in. on the corrosion rating graphs), mild pitting was observed on both the outer wires and on the center wires on one of the two strands. No pitting was seen on the second strand. This area of pitting corresponds to the location of a flexural crack and where very severe surface area loss was observed in the duct itself. The south duct strand was more severely corroded, with pitting first observed in the center wire at 18 in. to the west of the beam centerline. At 26 in. from the west end of the autopsy area moderate pitting was seen on the center wire. Pitting was seen on the outer wires starting at the beam centerline, and mild strand pitting continued through to the end of the autopsy area. The strands are shown in Figure 5.41, with the corrosion ratings shown in Figure 5.42, and summarized in Table 5.9.

It is very significant to note that the lack of grout at the end of the south duct resulted in more severe damage to the duct and to the strand (In comparison to the north duct) at the end of the duct.

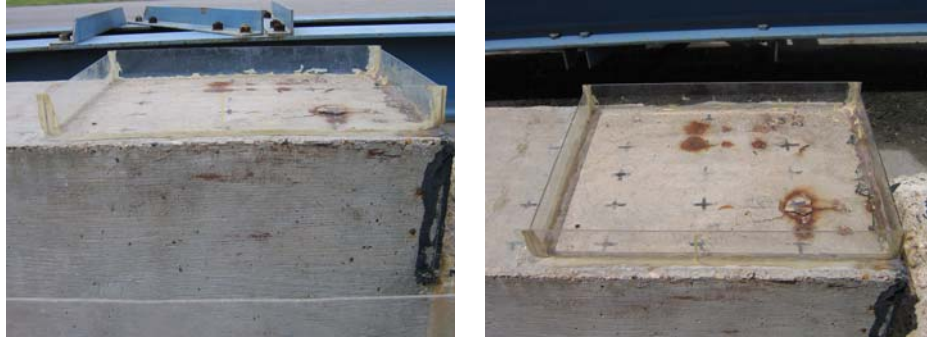
Figure 5.43: Beam 3.1-Side View (Left) and Top View (Right)

As shown in Figure 5.43 and Figure 5.46, the only damage observed on the outside of the beam was spalling and minor staining in the vicinity of the bolster strips. This was at the west end of the autopsy area near the cutting surface from the previous autopsies. No actual cracking was seen on the specimen. Therefore, no crack width data are given.

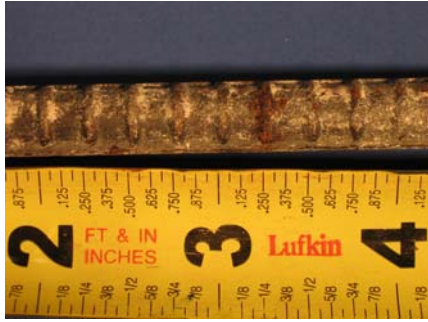
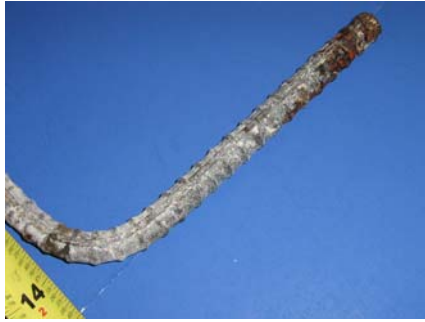
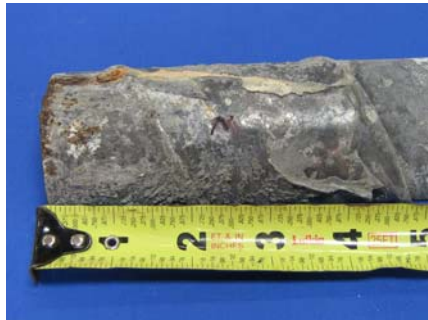
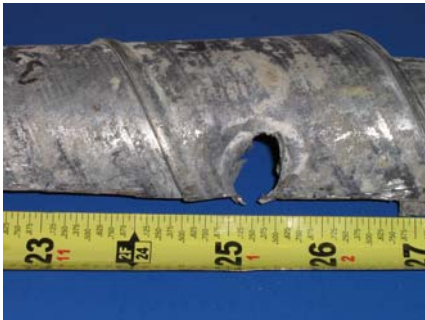
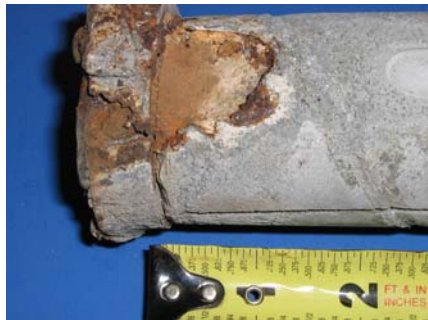
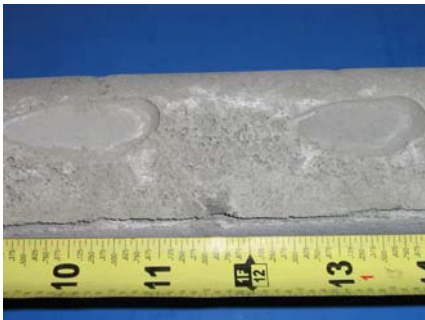
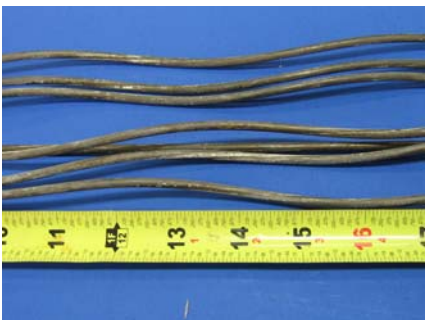
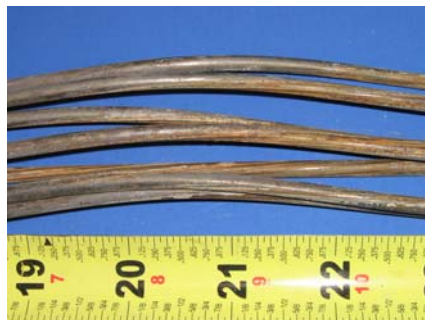
Figure 5.45: Beam 3.1 Autopsy Elements

In general, the longitudinal bars only showed slight discoloration. However, at the face of the cutting area from the previous autopsies moderate corrosion was found on both bars. The stirrups were slightly discolored with only a few instances of light to moderate corrosion. However, the stirrup which was near the cutting area from the previous autopsies had mild area loss and pitting in its top portion. The stirrups and bars are shown in Figure 5.45, with the corrosion ratings plotted in Figure 5.46 and summarized in Table 5.10. In order to have a fully 72 in. worth of data for comparison to the other beams, additional data was extrapolated by “mirroring” the data about the beam centerline.

Both ducts were only slightly corroded. The top outside surface of the south duct did have pitting near the previous cutting area, beneath the industry standard splice. Only a few instances of light corrosion were found on the inside and outside of the remainder of the duct. The north duct performed similarly, with pitting found in the same general location as the south duct. In this case the staining was about 1 in. to the east of the end of the heat shrink splice. The ducts are shown in Figure 5.45, with the ratings plotted in Figure 5.46 and summarized in Table 5.10.

The south duct grout showed evidence of a shallow bleed water void on the west end, right at the previous autopsy cutting area. The void was only about 2-in. long and was stained on the inside. Smaller bleed water voids were also seen at the top of the grout, spaced about every 8-in.. These voids terminated about 2 feet from the west end of the autopsy area. The grout also showed bubbles which indicate porosity. The north duct had several small, shallow bleed water voids. The largest was 2 in. long and about ¼ in. deep. This void was located about 10 in. from the west end of the autopsy area. The grout is shown in Figure 5.45. The maximum chloride content for the south duct grout was 0.243%, while for the north duct 0.257%. These two values were found at the far west of the autopsy area, near the cut face from the previous autopsies. The chloride content data is plotted in Figure 5.46.

The strands from both ducts showed light to moderate corrosion throughout. At the cutting area on the west end of the autopsy area, the exteriors of the strand had a large buildup of corrosion products. The light to moderate corrosion for the remainder of the autopsy was concentrated in the interstitial zones. The strand is shown in Figure 5.45, and the corrosion ratings are plotted in Figure 5.46 and summarized in Table 5.10.

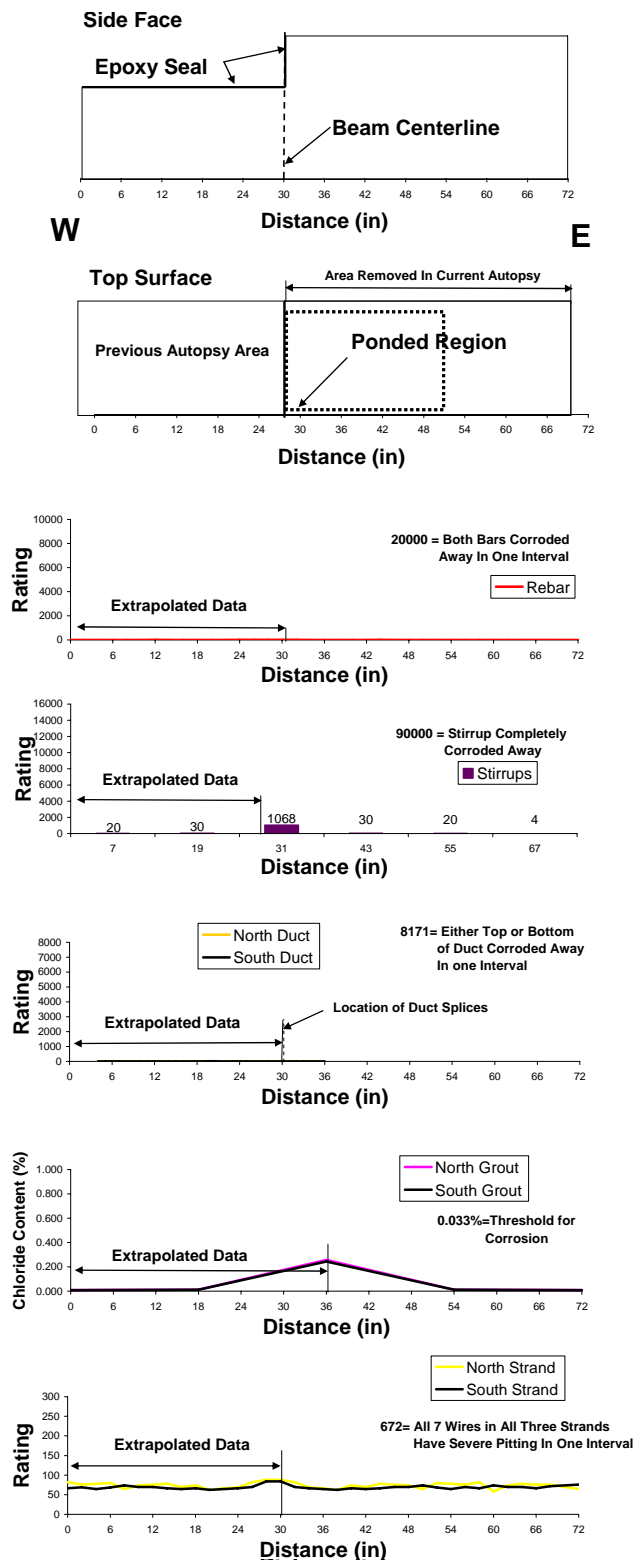
Figure 5.46: Beam 3.1-Crack Maps and Corrosion Rating Graphs

The corrosion damage to all of the autopsy elements was concentrated on the west end of the of autopsy area. This corresponds to 42 in. on the corrosion rating graphs in Figure 5.46. The chloride content data clearly shows large chloride ingress at the cut face of the beam. Thus it would appear that the damage to the beam was due to chloride ingress at the cut face of the beam. The moderate strand corrosion in the interstitial areas suggests that moisture which entered at the west end of the autopsy area was transmitted

down the entire length of the strand, causing moderate corrosion on the interstices of the wires. But other than near the previous autopsy area, the lack of serious corrosion on the bars, ducts, and stirrups clearly shows that corrosion is dramatically reduced if cracking is absent.

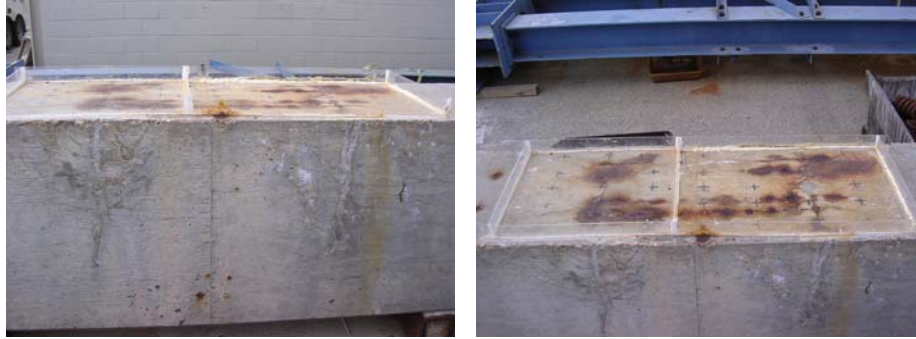
Figure 5.47: Beam 3.4-Side View (Left) and Top View (Right)

This beam was originally intended to be at constant service load, but in order to crack the beam the previous researchers were forced to overload it. As shown in Figure 5.47 and Figure 5.50, severe staining and cracking was found within the ponded region. No staining was observed outside the west end of ponded region, but staining from bolster strip corrosion was seen outside the east end. Staining was also found on the side of the beam, emanating from the flexural cracks. Longitudinal cracks ran parallel with the bolster strips, and the maximum crack width was 0.06 in., which was measured from one of the longitudinal cracks. The cracks continued outside the ponded region. Longitudinal cracks were also observed on the side of the beam, in the vicinity of the flexural cracks as well. This suggests a large amount of corrosion within the beam. The crack width data are given in Figure 5.48.

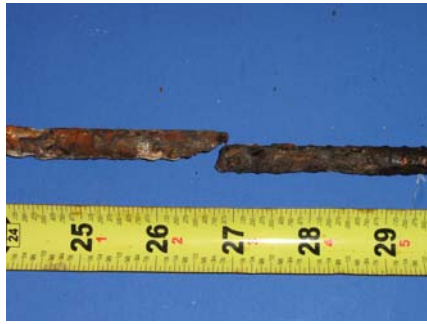
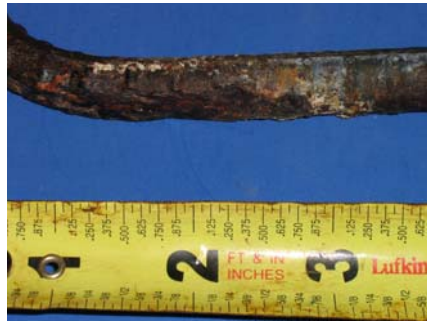
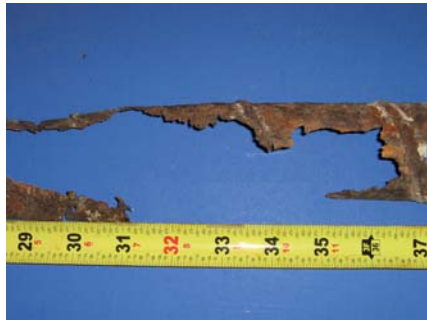
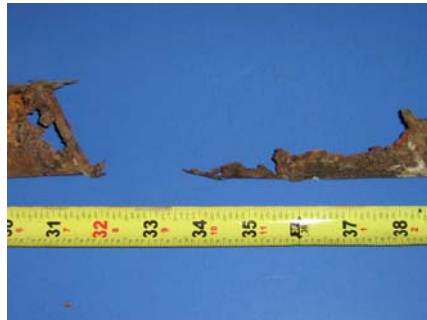
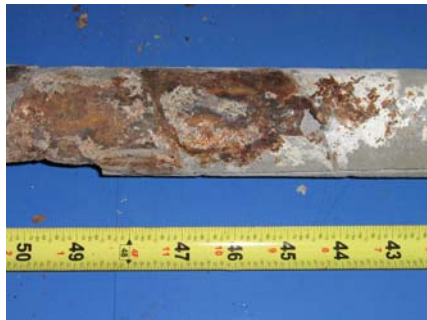
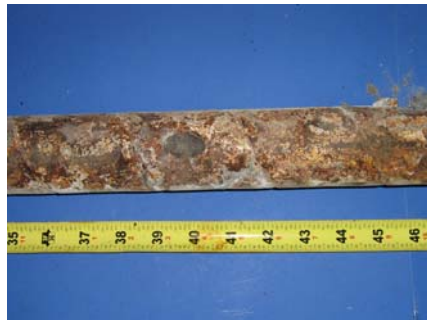
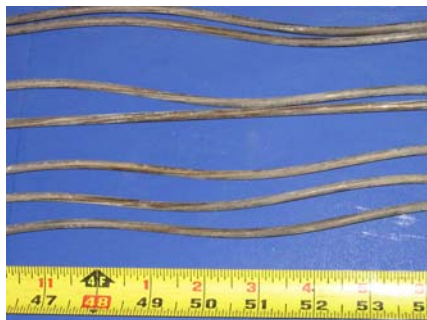
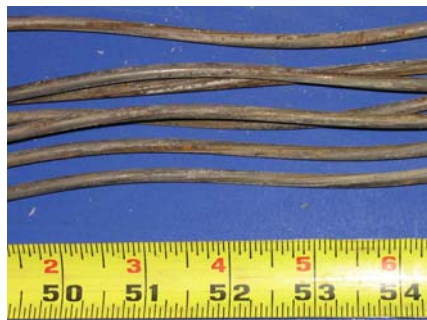
Figure 5.51: Beam 3.4 Autopsy Elements

Upon autopsy, it was found that within the ponded region, the bars were mostly pitted with area loss at flexural crack locations (See Figure 5.51). The stirrups were also heavily pitted with cross-sectional area loss. Both #3 longitudinal bars had only mild to moderate corrosion outside the ponded region. Instances of light to moderate corrosion were observed in the areas without flexural cracking that were still in the ponded region. The most severe bar corrosion was at the flexural crack 12 in. to the west of the beam centerline, where one of the bars was reduced in diameter by over 2/3. The bar broke in half at this location upon removal from the beam during autopsy. The other bar had moderate area loss at this location. The stirrups which corresponded to flexural crack locations within the ponded region were severely pitted and suffering from cross-sectional area loss. The area loss was the worst on the stirrup 12 in. to the west of the beam centerline. In one interval the stirrups diameter was reduced to 0.375 in. from an original diameter of 0.5 in.. The stirrup which was outside the west end of the ponded region but still beneath a flexural crack was only moderately corroded. The bars and stirrups are shown in Figure 5.51, with the ratings plotted in Figure 5.50 and summarized in Table 5.11.

Both ducts were severely holed and pitted, thus they had large surface area loss. The south duct was severely pitted and holed within the ponded region. Discolorations to moderate corrosion with some pitting were observed in the duct portion outside the ponded region. Some of the worst damage duct was approximately 12 in. to the west of the beam centerline-corresponding to the location of one of the flexural cracks. In this location the top portion of the duct was nearly corroded away in several intervals. The bottom portion was also heavily corroded with holes and pitting. Another area of major damage was the loss of 6 in. of the top portion of the duct at the end of the autopsy area (east end). The north duct was also holed and pitted, with some of the worst damage again 12 in. to the west of the centerline. At this location the top part of the duct was almost completely corroded away in several intervals. The bottom portion had large holes. However, the worst damage to the south duct overall was the loss of 6-in. of length of the entire top of the duct at the east end of the autopsy area. The ducts are

shown in Figure 5.51, with the corrosion ratings plotted in Figure 5.50 and summarized in Table 5.11.

The south duct grout had large deposits of corrosion products throughout. The grout was also cracked at numerous locations. Small bleed water voids were observed in many locations. Many of the voids had corrosion products inside. Most of the voids were around 1/2-in. in diameter and 1/4-in. deep. There was a large bleed water void at the extreme east end of the autopsy area. This void was wide and 3/8-in. deep maximum. The maximum chloride content in the south duct grout was 0.209%, measured at 18 in. to the west of the beam centerline. The north duct grout was similar, with corrosion products deposited on it throughout. Bleed water voids were seen, with similar sizes to the voids in the north duct. These also had corrosion products in them. The maximum chloride content measured in the north duct grout was 0.091%, found at 12 in. to the east of the beam centerline. The grout for each duct is shown in Figure 5.51. The chloride contents for the grout in each duct are plotted in Figure 5.50.

The three south duct strands were moderately corroded with instances of pitting. Mild pitting was observed on wires just outside the ponded region, with pitting also found on the center wire (this location corresponds to 12 in. on the corrosion rating graphs). The fact that there was pitting on the center wire suggests that the pitting in the ponded region is due to moisture traveling down the strands from the ponded region. Mild pitting with one instance of moderate pitting was found in the vicinity of the flexural crack 12 in. to the west of the beam centerline. Other instances of mild pitting were found near the centerline of the beam. Another concentration of pitting was in the vicinity of the “undamaged” industry standard splice. In this location the center wire of two of the three strands was also pitted. Even though the “undamaged” splice is in this vicinity, it should be noted that the south duct was almost completely corroded away just east of this area. The three north duct strands had moderate to light corrosion, with instances of mild pitting near the east end of the autopsy area. This was also in the vicinity of the “undamaged” heat shrink splice; however, there was also severe holing

and area loss in the duct in this vicinity as well. The strands are shown in Figure 5.51 and the corrosion ratings are plotted in Figure 5.50 and summarized in Table 5.11.

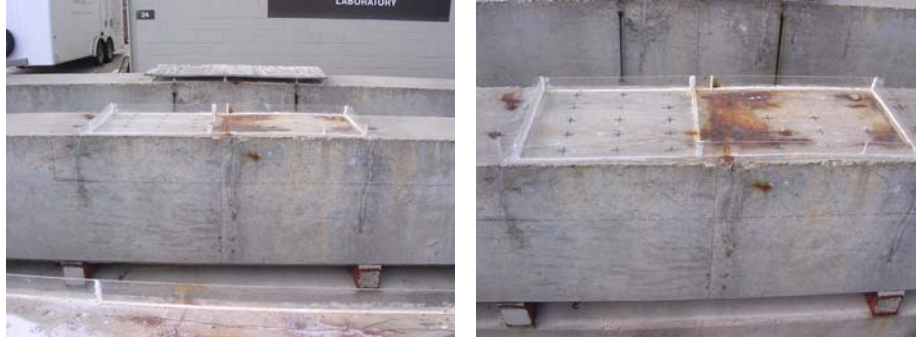
Figure 5.52: Beam 3.5-Side View (Left) and Top View (Right)

As shown in Figure 5.52 the beam was heavily stained and cracked. At the beginning of exposure testing the ponded region was partitioned in half in order to improve the watertight integrity of the salt bath. The west portion of the salt bath had larger amounts of staining than the east portion. As shown in Figure 5.52 and Figure 5.56, there were longitudinal cracks with a maximum width of 0.06 in. running parallel to the bolster strips. Staining was observed emanating from these cracks. These cracks continued outside the ponded region to the end of the autopsy area. Outside the ponded region minor staining was seen in the vicinity of the flexural crack just to the west and east of the ponded region. Minor longitudinal cracking was also observed on the sides of the beam, in the vicinity of the flexural cracks. The large amounts of staining and

cracking suggest large amounts of corrosion within the specimen. The crack width data are given in Figure 5.53.

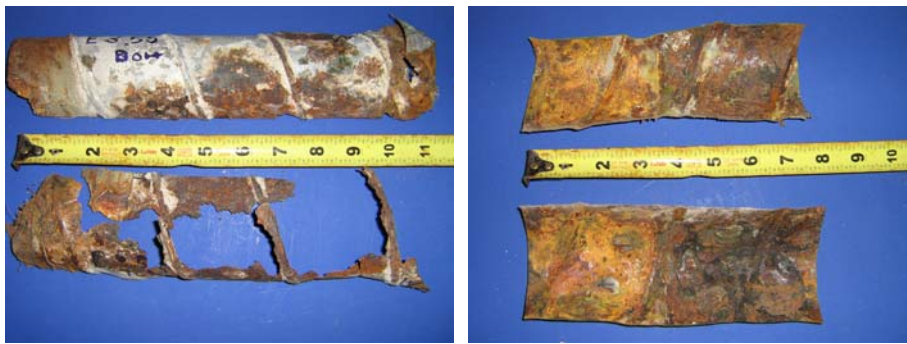
Figure 5.54: Beam 3.5 Duct Splices-South Duct Industry Standard Splice (Left) and North Duct Heat Shrink Splice (Right)

Both ducts were spliced at the beam centerline. The south duct had an industry standard splice while the north duct had a heat shrink splice. The top portion of the south duct splice was nearly corroded away, with only large fragments remaining. The bottom portion was heavily pitted with some small holes. Pitting was found on the inside surfaces of both the top and bottom of the splices as well. Pitting and holes were found on the duct surface directly beneath the splice. On the inside surface of the duct directly next to these holes pitting was also found. The north duct heat shrink splice had corrosion deposits on the inside surface. Pitting was observed on the duct surface directly beneath the splice. Pitting was also observed inside the duct directly next to the duct joint. The splices for both tendons are shown in Figure 5.54.

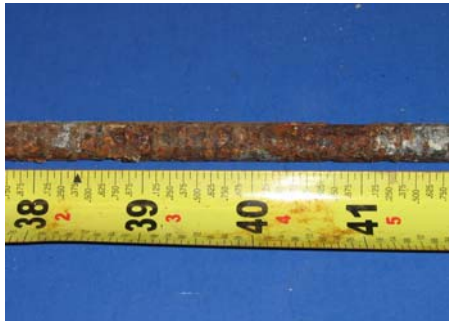
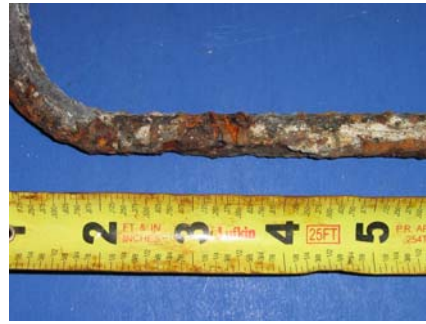
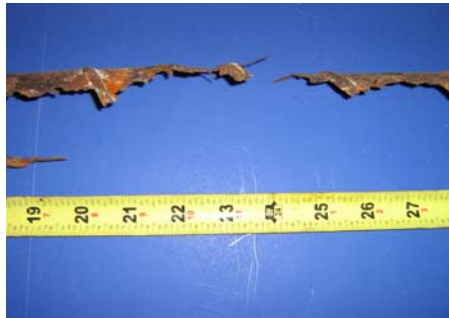
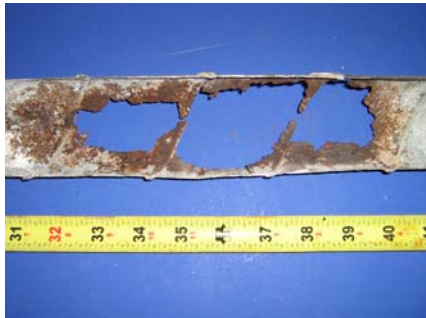
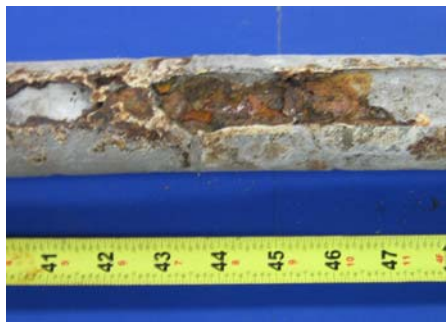
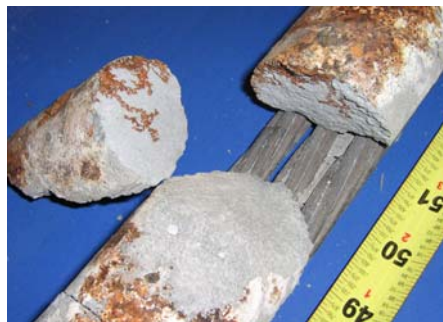
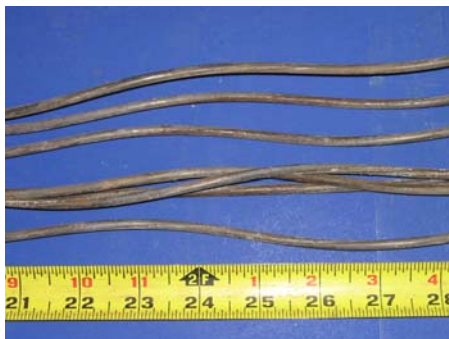
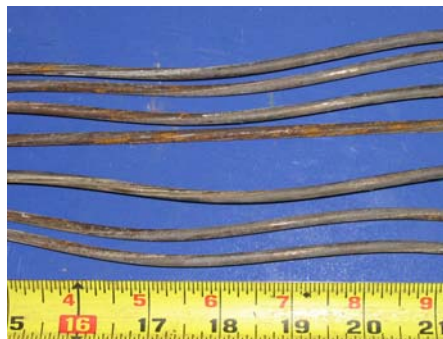
Figure 5.55: Beam 3.5 Autopsy Elements

It was discovered during autopsy that both the stirrups and longitudinal bars were heavily corroded inside the ponded region (See Figure 5.55). Instances of pitting and cross-sectional area loss were found on the bars near the flexural cracks in the ponded region. Area loss was observed in the northern most bar for several intervals east from the beam centerline. This was directly beneath one of the longitudinal cracks. The worst bar damage was about 2 in. to the west of the beam centerline, where one of the #3 bars was reduced to ¼-in. in diameter. The other bar was also significantly reduced in area at this location. This location corresponded to the flexural crack in the vicinity of the centerline. Outside the ponded region the bars were only discolored or lightly corroded. The three most heavily corroded stirrups were at the locations of flexural cracks. These bars had significant cross-sectional area loss. The stirrups which were still within the ponded region but not beneath flexural cracks were moderately corroded with only a few instances of some pitting. The stirrups outside the ponded region were only discolored or moderately corroded. The most heavily damaged stirrup was directly beneath the west end of the ponded region. The stirrup had heavy cross-sectional area loss in several intervals, with the bar diameter reduced by around a 1/3. The bars and stirrups are shown in Figure 5.55, and the ratings are plotted in Figure 5.56 and summarized in Table 5.12.

Both ducts were heavily pitted and holed. The large amount of holes produced large section loss in the ducts. The south duct was lightly corroded outside the ponded region. Inside the ponded region the duct was heavily pitted and heavily holed. From 14 to around 24 in. from the west end of the autopsy area (28 to 24 in. to the west of the beam centerline), the top portion of the duct was almost completely corroded away. The inside of the duct was heavily pitted. The bottom portion of the duct was also heavily pitted, on the outside surface and, to a lesser extent, the inside surface. At about 6 in. to the west of the beam centerline the top portion of the duct was also heavily holed. Small holes were found on the bottom of the duct in this area. Pitting was also observed on the inside of the duct. Large holes were also observed on the top portion of the duct at the

east end of the autopsy area as well, with pitting on the inside of the duct also. The north duct was also pitted and holed. The largest amount of damage was just to the west of the beam centerline. At this location the duct had extremely large holes on the top surface. Pitting was observed on the inside of the duct as well. Small holes were also observed on the top of the duct at 18 in. from the west end of the autopsy area. The ducts are shown in Figure 5.55, with the ratings plotted in Figure 5.56 and summarized in Table 5.12.

The three strands in the south duct showed light to moderate corrosion overall, with some instances of mild pitting. The mild pitting was found on the center wire of one of the strands at 24 in. to the west of the beam centerline (18 in. on the corrosion rating

graphs). In addition, at approximately 4 in. to the west of the beam centerline mild pitting was also found on a single wire from one of the strands. The three strands in the north duct showed light to moderate corrosion as well, but no pitting. Strands from both ducts are shown in Figure 5.55. The corrosion ratings for the strand along the length of the autopsy area are shown in Figure 5.56, and are summarized in Table 5.12.

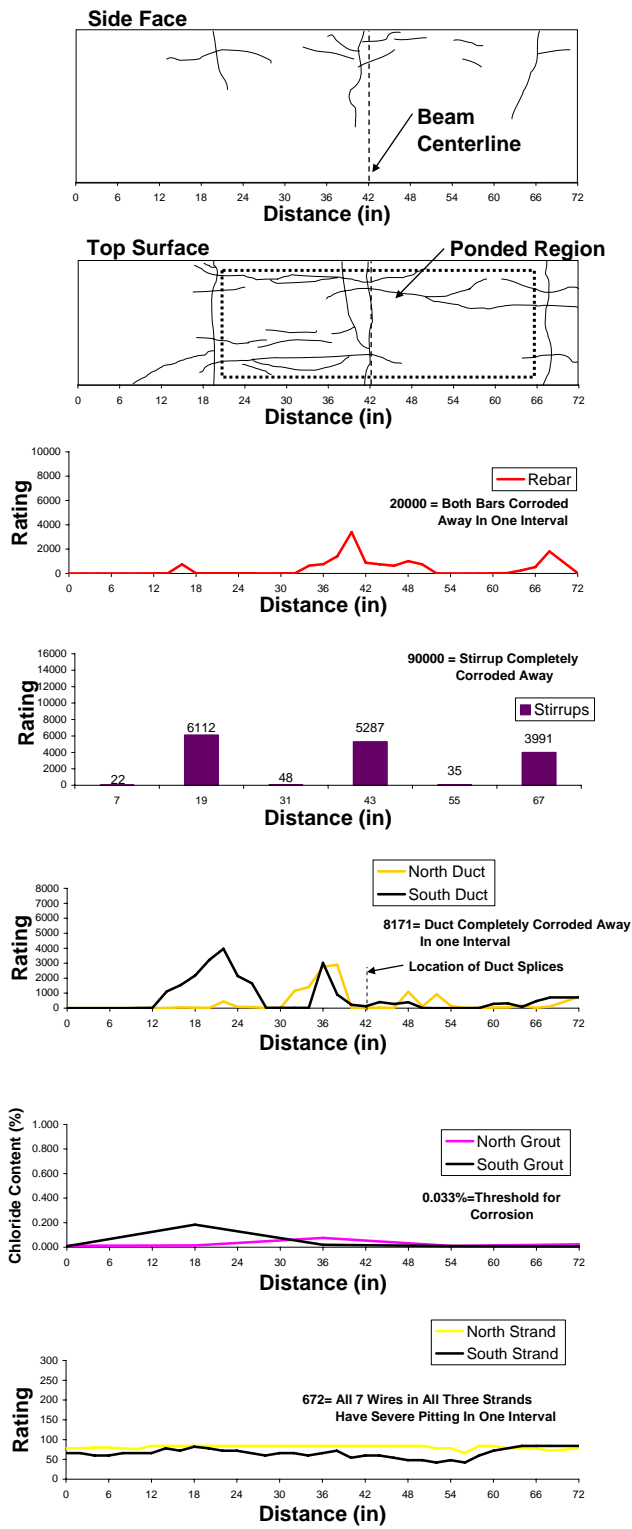
Figure 5.56: Beam 3.5-Crack Patterns and Corrosion Rating Graphs

The south duct grout had small voids at the west end of the autopsy area. These voids were approximately $\frac{3}{4}$ -in. in diameter and a $\frac{1}{4}$ -in. deep. The most significant void was 12 in. from the end of the autopsy area. At approximately 23 in. to the west of the beam centerline, transverse cracks were observed with staining on their faces. When this grout was separated from the strand, corrosion could be seen on the strand directly beneath these cracks. A large bleed water void was found in the vicinity of the beam centerline. It was more than 16-in. long and about $\frac{3}{8}$ -in. deep. Corrosion products from the duct were found inside portions of the void. Several small circular voids were found on the east end of the grout, with duct corrosion products inside. The maximum chloride content measured in the south duct grout was 18 in. from the west end of the autopsy area. The chloride content was 0.184%, far above the threshold for corrosion of 0.033%. The north duct also had small voids on the west end of the autopsy area, with a larger circular void at 18 in.. This void was about 1-in. in diameter and $\frac{3}{8}$ -in. deep. Several more small voids were seen in the vicinity of the centerline, with corrosion products inside. The grout was transversely cracked at multiple locations, with staining on the crack faces in the vicinity of the beam centerline. The maximum chloride content measured in the south grout was 0.076%. This was measured 6 in. to the west of the beam centerline. This is well about the threshold for corrosion of 0.033%. The grout from both ducts is shown in Figure 5.55. The grout chloride content along the length of the autopsy area is plotted in Figure 5.56.

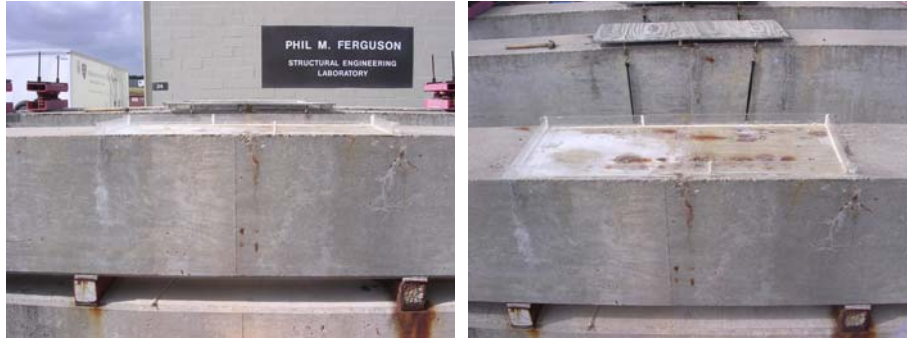
Figure 5.57: Beam 4.1-Side View (Left) and Top View (Right)

As shown in Figure 5.57 and Figure 5.61, the beam was substantially cracked and stained. Patches of staining were found in the ponded region. The staining was concentrated around longitudinal cracks which seemed to follow the bolster strips/longitudinal bars. These cracks were typically between 0.002 and 0.009 in. in width, while the largest longitudinal crack width was 0.016 in.. Longitudinal cracks were also found on the side of the beam, with staining emanating from one of these cracks just outside the west end of the autopsy area. This crack continued almost to the beam centerline. Flexural cracks were also found on the beam. This is significant for this beam because it was designed not to crack under long term loading at service load. Three flexural cracks were found, one at the beam centerline and two additional cracks each 24 in. to the east and west of the centerline. In general these flexural cracks were wider than

the aforementioned longitudinal cracks. Staining was found emanating from the side of the flexural crack at the beam centerline. This crack continued almost to the beam centerline. The largest crack width measured was from the flexural crack just outside the east end of the ponded region. This crack was 0.04 in. in width. This was the only beam where the largest crack width was measured at an actual flexural crack. The crack width data for this beam are given in Figure 5.58.

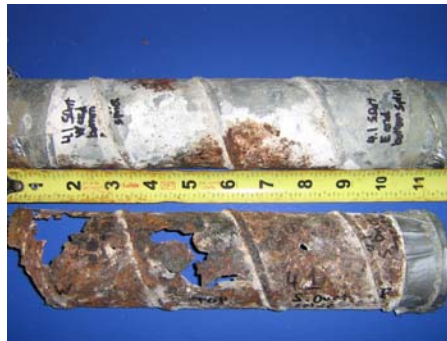
Figure 5.59: Beam 4.1 South Duct Industry Standard Splice

The south duct was fitted with an industry standard splice, while the north duct was not spliced. The top portion of the south duct splice was severely holed and pitted. The bottom portion of the splice was also pitted in some locations. Pitting was also found on the inside of both the top and bottom portions of the splice. Pitting and holes were found on the portion of the south duct directly beneath the splice, with pitting also found on the inside of the duct at this location. The south duct splice is shown in Figure 5.59.

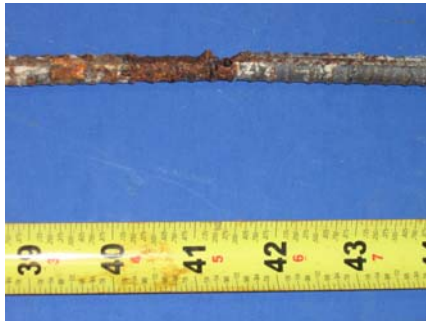
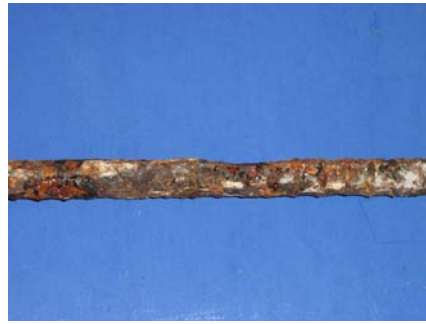
Figure 5.60: Beam 4.1 Autopsy Elements

When the beam was autopsied, both the longitudinal bars and stirrups were found to have considerable corrosion (See Figure 5.60). The longitudinal bars were found to be pitted and have cross-sectional area loss near the locations of the flexural cracks in the ponded region. Significant cross-sectional area loss was also found at the location of the flexural crack just outside the west end of the ponded region. Staining was seen at this crack previously. Pitting and slight cross-sectional area loss were found on one of the bars at the location of the flexural crack just outside the east end of the ponded region. The other bar was pitted at this location. The worst longitudinal bar damage was at the centerline flexural crack, where one of the #3 bars was reduced to about a 1/4-in. in diameter. At this location the other bar had moderate uniform corrosion. Pitting was also found in areas where there were no flexural cracks, but where longitudinal cracks were located. The stirrups are bars are shown in Figure 5.60, and the corrosion ratings are plotted in Figure 5.61 and summarized in Table 5.13.

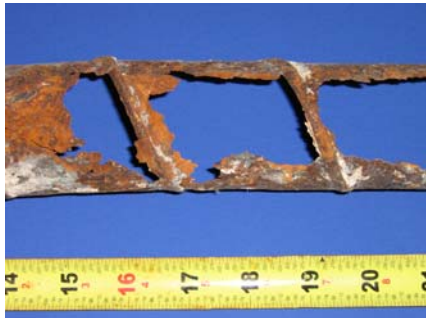
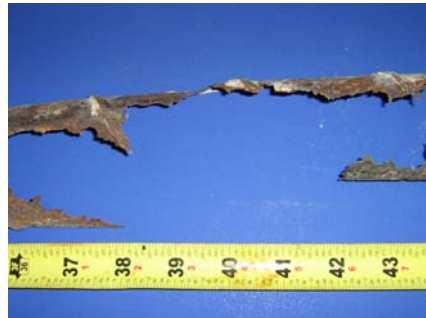
Both ducts were pitted and holed thus causing large amounts of surface area loss. In the case of the south duct the surface area loss was concentrated in the area between the western most flexural crack and the centerline flexural crack. Pitting was also found on the inside of the duct in this area. For approximately 12 in. from the centerline of the beam to about 12 in. from the east end of the autopsy area, only slight discoloration was found on the outside of the duct. For the last 12 in. of the autopsy area, however, the duct was pitted and had small holes. This area was outside the ponded region. The north duct was only pitted with some minor holes until about the beam centerline, where the top portion of the duct was almost completely corroded away across several inches. The inside surface of the duct at this location was pitted. Large holes and pitting were also found starting at about 14 in. east of the beam centerline. More large holes were seen further east, terminating about 2 in. short of the end of the autopsy area, where the duct was pitted. The ducts are shown in Figure 5.60, and the corrosion ratings are plotted in Figure 5.61 and summarized in Table 5.13.

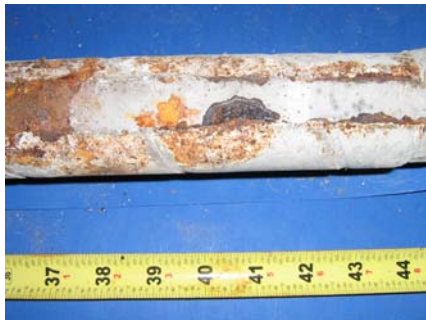
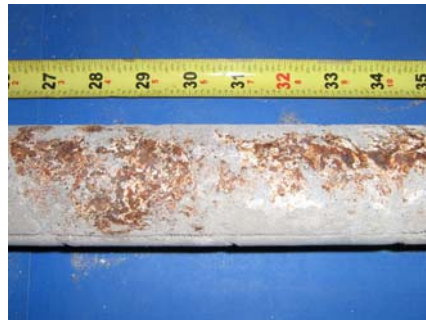
Both the south and north grouts were cracked. The south duct grout had a large bleed water void from 30 in. to about 46 in. from the west end of the autopsy area. At its deepest the void was 0.25 in. deep. Numerous corrosion deposits were found both in the void and around it. Small bubbles and small circular bleed water voids were seen east of this point. Very little to no deposition of corrosion was seen on the grout in this area. However, the last 8 in. of grout had corrosion deposit. The largest chloride content at strand level for the south duct grout was 0.04%, close to the corrosion threshold for 0.033%. This value was at 6 in. to the west of the beam centerline. The north duct grout had a large bleed water void from 12 to 28 in. (Again, in reference to the west end of the autopsy area), and corrosion products were found inside the void. At approximately 12 in. from the east end of the autopsy area, staining was found on the face of one of the transverse cracks. Many small bubbles were found on the top of the grout as well. The highest chloride content measured in the north duct grout was 0.06%, also at 6 in. to the west of the beam centerline. This is far above the threshold of 0.033%. The grout from both beams is shown in Figure 5.60. The chloride content along the length of the autopsy area for the grout from both ducts is shown in Figure 5.61.

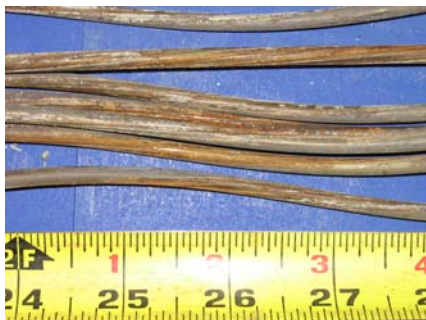
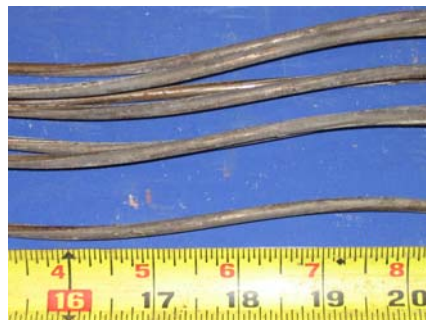
The four strands in the south duct had light to moderate corrosion. The four strands in the north duct had light to moderate corrosion as well. The strand from both ducts is shown in Figure 5.60. The strand ratings along the length of the beam are shown in Figure 5.61 and are summarized in Table 5.13.

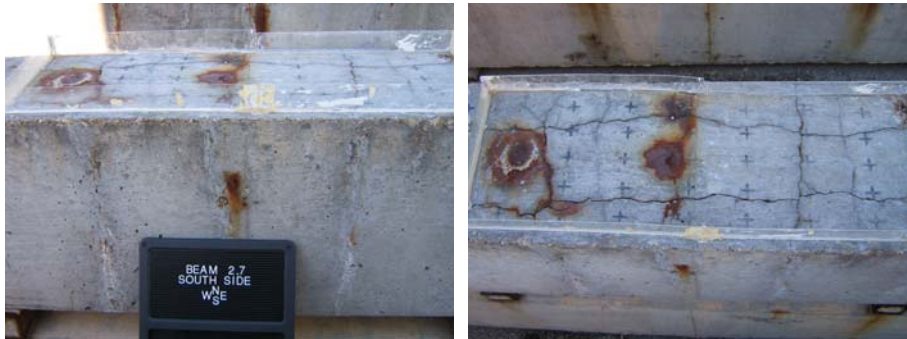
Figure 5.62: Beam 2.7-Side View (Left) and Top View (Right)

As shown in Figure 5.62 and Figure 5.70, staining and longitudinal cracking was found in the ponded region. One major area of staining was at the flexural crack at the beam centerline. The other was at the west end of the autopsy area. At this location the staining was concentrated around a flexural crack and where the hole had been drilled to create a grout vent during beam construction. The hole had been sealed with epoxy after grouting. Staining was also seen on the flexural crack just to the west of the ponded region. Staining was also seen on the side of the beam corresponding with the location of the centerline flexural crack. The maximum crack width was from a longitudinal crack and measured 0.14 in.. This value was measured near the beam centerline. Very little

staining was observed from these longitudinal cracks. Crack width data for this beam are given in Figure 5.63.

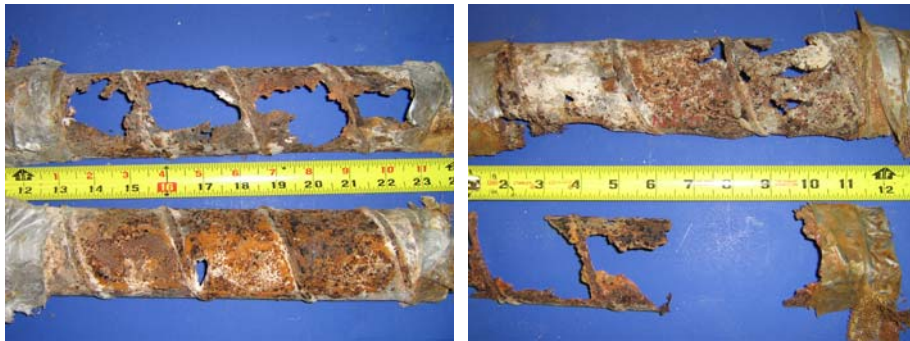
Figure 5.64: Beam 2.7 Industry Standard Duct Splices-South Duct Splice (Left) and North Duct Splice (Right)

Both the north duct and south duct had industry standard splices at the beam centerline. The south duct splice was severely corroded with very large area loss. The top portion of the splice had large holes across its length, with pitting. The bottom portion of

the splice was pitted on the outside with a small hole at the centerline. Both the top and bottom portions of the splice were pitted on the inside as well. The top section of the south duct directly beneath the splice was almost completely corroded away. Only fragments were found at the beam centerline. The north duct industry standard splice was also severely corroded. The top portion of the splice was almost completely corroded away, and only fragments were recovered. The bottom of the splice had several holes with pitting throughout. The top portion of the north duct directly beneath the splice was pitted with small holes, while the bottom was only pitted. Both splices are shown in Figure 5.64.

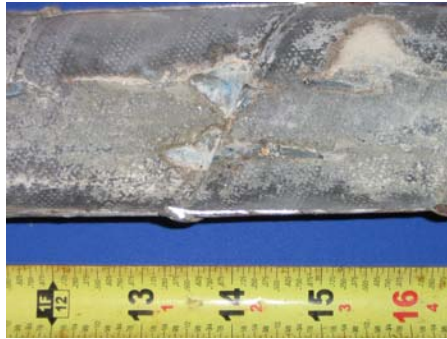
Both ducts were severely pitted and holed, resulting in large surface area loss. The top portion of the south duct was pitted even outside the ponded region. Starting at approximately 19 in. from the west end of the autopsy area, several in. of the duct was completely corroded away. At approximately 12 in. from the east end of the autopsy area several in. of duct were also corroded away. Upon inspection of the inside of the bottom of the duct, evidence of abrasion of the epoxy on the strand was found at 14 in. from the west end of the autopsy area. Corrosion deposits which were likely from the strand were found in this area. This is shown in Figure 5.65. This may have occurred at other locations as well, but the severe duct corrosion further east of this location made any other abrasion evidence on the duct impossible to find.

Figure 5.65: Beam 2.7-Evidence of Abrasion of Epoxy Coating from Strand on Bottom of South Duct

A small amount of epoxy coating on the bottom of the south ducts strands was missing at about 14 in. from the west end of the autopsy area. This confirms the evidence of epoxy abrasion observed on the bottom of the duct. Starting at about 24 in. from the west end of the autopsy area, a large amount of corrosion products as well as damage to the bottom of the strand coating was observed. This is shown in Figure 5.66. The coating on the strand was then chipped off and the strand examined. The coating seemed very brittle and easily cracked when pierced with a screwdriver. After removal of the coating, large amounts of light to moderate corrosion and mild pitting were found on the strands exterior throughout their length. Moderate pitting was found on one of the wires at 18 in. from the west end of the autopsy area. The strand after removal of the coating is shown in Figure 5.66. When the strands were unwound, pitting was also found on the center wire of one of the strands. The unwound strand from the south duct is shown in Figure 5.69 .

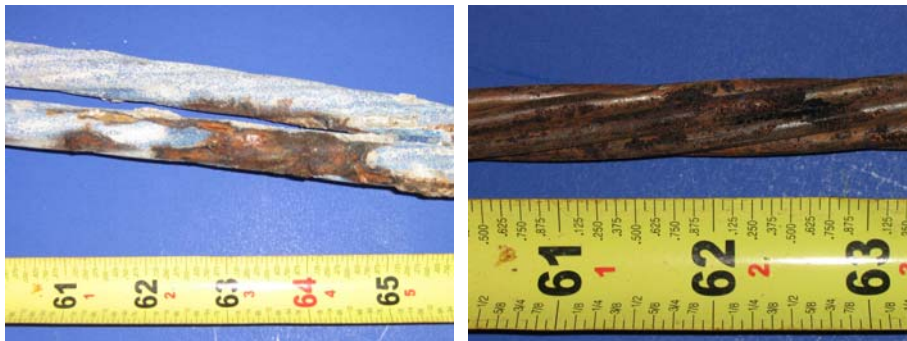
Figure 5.66: Beam 2.7-South Duct Strand With Coating (Left) and After Removal of Coating (Right)

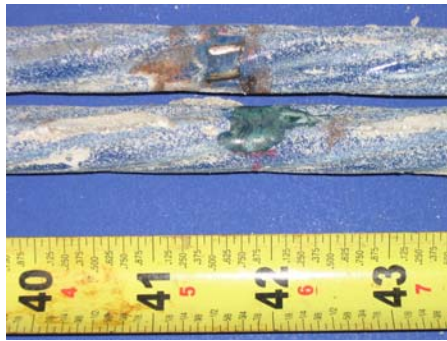
In contrast to the south duct strand, the coating of north duct strand was intentionally damaged by the previously researchers, in order to test the effectiveness of epoxy repair kits. As explained in Chapter 2, numerous small holes were made in the epoxy coating on the two strands at five locations: At the beam centerline and 4 holes at approximately 12 in. spacing to the right and left of the centerline. One of the strands had these holes repaired with a standard epoxy repair kit before installation in the beam. An example of one of the holes is shown in Figure 5.67.

Figure 5.67: Beam 2.7-Example of Strand Coating Damage to North Duct Strand- Patched Strand (Bottom) and Unpatched Strand (Top).

Upon autopsy, corrosion deposits were found on the epoxy next to the unpatched holes. Abrasion damage to the epoxy was found 7 in. from the east end of the autopsy area, where the strand actually made contact with the bottom of the duct. Pitting was found on the exposed strand surface at this location. Upon removal of the coating, light corrosion was found adjacent to the hole locations. Mild pitting was found on the west end of the strands, with instances of pitting found on the center wires. Additional instances of mild pitting were found adjacent to the abrasion damage at the east end of the autopsy area. The strand which was patched also had mild pitting on the west and east ends, as well as light to moderate corrosion. Not as many instances of pitting were observed as in the unpatched strand. Abrasion damage was also found at the same location as the other strand. Light corrosion was found in the vicinity of one of the patched holes, but otherwise the exterior of the strand had little corrosion in the vicinity of the other patched holes. The corrosion ratings for the strand are plotted in Figure 5.70 and are summarized in Table 5.14. The unwound strands are shown in Figure 5.69. In Figure 5.68, the ratings for the patched and unpatched strand from the north duct are plotted separately.

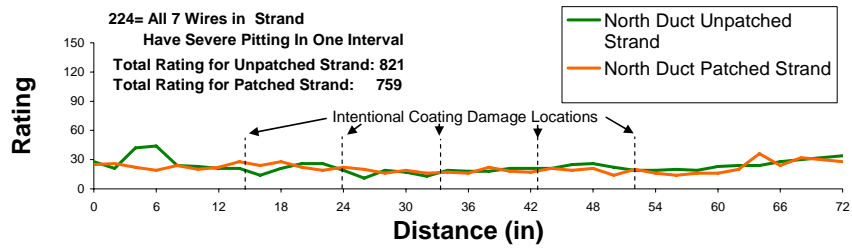
Figure 5.68: Beam 2.7- North Duct Strand Damage Ratings

As shown in Figure 5.68 the total rating for the unpatched strand was slightly larger than the patched strands. However, there is no significance difference between the ratings for the two strands in the vicinity of the holes. The visual inspection of the strand showed no significant corrosion in the vicinity of four of the five patches on the exterior of the strand. So the performance of the patches is fair.

Overall, it would appear that the primary source of moisture ingress for the epoxy coated strand is from abrasion damage caused by contact between the strand and the bottom of the duct during prestressing.

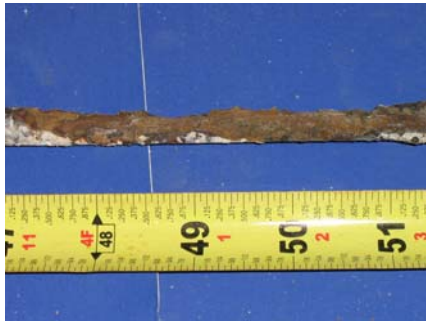
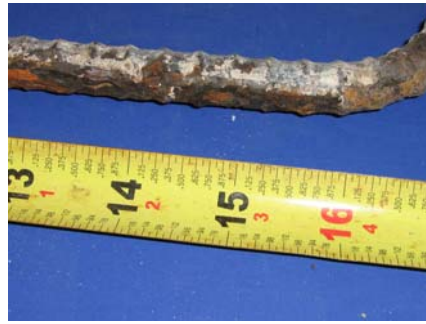
Figure 5.69: Beam 2.7 Autopsy Elements (From Center Portion of Beam)

Upon autopsy, pitting and large cross-sectional area loss was found on the longitudinal bars and stirrups throughout the ponded region (See Figure 5.69). The worst damage to an individual bar was at 12 in. to the east of the beam centerline. At this location one of the #3 bars was reduced in diameter to 0.19 in.. The stirrups beneath the ponded region were also heavily pitted with large section loss. The worst stirrup damage was also 12 in. to the east of the beam centerline, where the stirrup bar diameter was reduced from 0.5 in. to 0.4 in. in one interval. The stirrup outside the ponded region was pitted with no section loss. The stirrups and bars are shown in Figure 5.69. The stirrup and bar ratings in the autopsy area are plotted in Figure 5.70, and are summarized in Table 5.14.

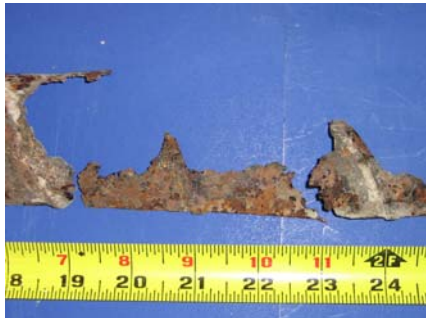
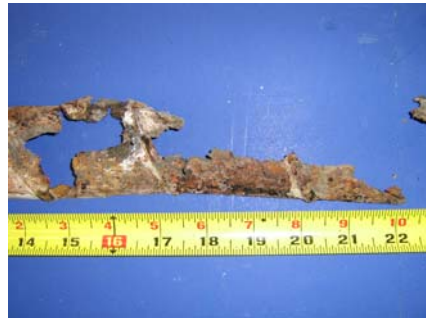
The north duct was not as severely damaged as the south duct. At about 18 in. west of the beam centerline several in. of the duct suffered large section loss. Large holes were also found for about 12 in. starting at about 12 in. to the east of the beam centerline. The worst damage was at 26 in. from the west end of the autopsy area, where nearly $\frac{3}{4}$ of the entire duct was corroded away. The ducts are shown in Figure 5.69. The duct damage along the length of the beam is shown in Figure 5.70, and is summarized in Table 5.14.

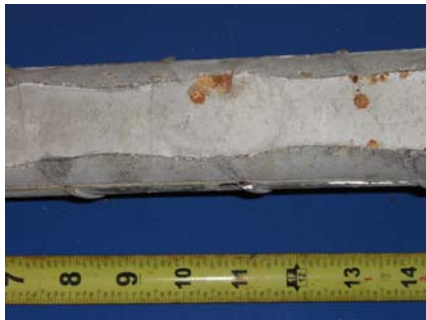
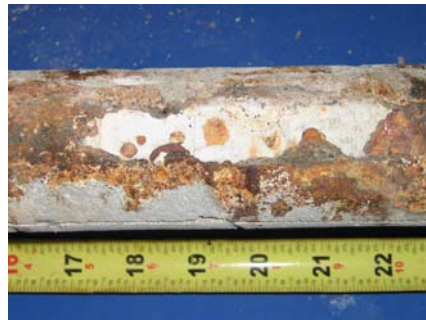
The south duct grout had a three foot long bleed water void from the far west end of the autopsy area to about 6 in. short of the centerline. In this area large corrosion deposits from the duct were found in the bleed water void. The grout was cracked at multiple locations, and at the grout crack 12 in. from the east end of the autopsy area, a large amount of staining was found on the crack face. The maximum chloride content found in the south duct was at 6 in. west of the beam centerline, where the chloride content was 0.775%. This is very far above the corrosion threshold of 0.033%. The north duct grout had a shallow bleed water void from about 17 to 21 in. west of the end of the autopsy area. From 46 to 48 in., a shallow white colored void was also observed. Transverse cracks were found at multiple locations, and staining was found at the cracks 25 and 27 in. west of the autopsy area. The grout also had many small bubbles indicating a large amount of porosity. The maximum chloride content was 0.415%, measured at 54 in. from the west end of the autopsy area. This is far above the threshold for corrosion. The grout is shown in Figure 5.69, and the chloride content data is plotted in Figure 5.70.
