**Durability Evaluation of Post-Tensioned Concrete Beam Specimens
After Long-Term Aggressive Exposure Testing**

Thesis

Master of Science in Engineering

The University of Texas at Austin

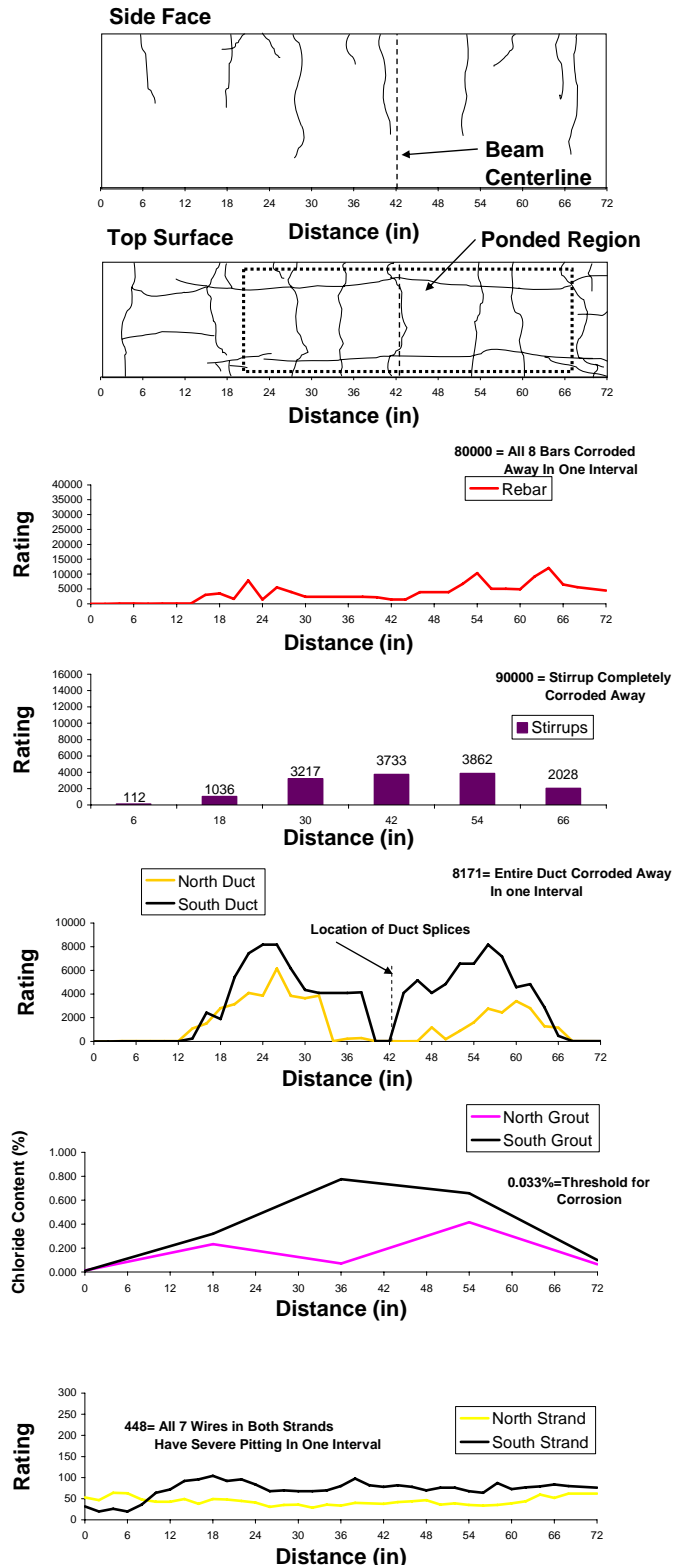
Figure 5.70: Beam 2.7-Crack Maps and Corrosion Rating Graphs

As shown in Figure 5.62 and Figure 5.70, staining and longitudinal cracking was found in the ponded region. One major area of staining was at the flexural crack at the beam centerline. The other was at the west end of the autopsy area. At this location the staining was concentrated around a flexural crack and where the hole had been drilled to create a grout vent during beam construction. The hole had been sealed with epoxy after grouting. Staining was also seen on the flexural crack just to the west of the ponded region. Staining was also seen on the side of the beam corresponding with the location of the centerline flexural crack. The maximum crack width was from a longitudinal crack and measured 0.14 in.. This value was measured near the beam centerline. Very little

Upon autopsy, pitting and large cross-sectional area loss was found on the longitudinal bars and stirrups throughout the ponded region (See Figure 5.69). The worst damage to an individual bar was at 12 in. to the east of the beam centerline. At this location one of the #3 bars was reduced in diameter to 0.19 in.. The stirrups beneath the ponded region were also heavily pitted with large section loss. The worst stirrup damage was also 12 in. to the east of the beam centerline, where the stirrup bar diameter was reduced from 0.5 in. to 0.4 in. in one interval. The stirrup outside the ponded region was pitted with no section loss. The stirrups and bars are shown in Figure 5.69. The stirrup and bar ratings in the autopsy area are plotted in Figure 5.70, and are summarized in Table 5.14.

The north duct was not as severely damaged as the south duct. At about 18 in. west of the beam centerline several in. of the duct suffered large section loss. Large holes were also found for about 12 in. starting at about 12 in. to the east of the beam centerline. The worst damage was at 26 in. from the west end of the autopsy area, where nearly $\frac{3}{4}$ of the entire duct was corroded away. The ducts are shown in Figure 5.69. The duct damage along the length of the beam is shown in Figure 5.70, and is summarized in Table 5.14.

The south duct grout had a three foot long bleed water void from the far west end of the autopsy area to about 6 in. short of the centerline. In this area large corrosion deposits from the duct were found in the bleed water void. The grout was cracked at multiple locations, and at the grout crack 12 in. from the east end of the autopsy area, a large amount of staining was found on the crack face. The maximum chloride content found in the south duct was at 6 in. west of the beam centerline, where the chloride content was 0.775%. This is very far above the corrosion threshold of 0.033%. The north duct grout had a shallow bleed water void from about 17 to 21 in. west of the end of the autopsy area. From 46 to 48 in., a shallow white colored void was also observed. Transverse cracks were found at multiple locations, and staining was found at the cracks 25 and 27 in. west of the autopsy area. The grout also had many small bubbles indicating a large amount of porosity. The maximum chloride content was 0.415%, measured at 54 in. from the west end of the autopsy area. This is far above the threshold for corrosion. The grout is shown in Figure 5.69, and the chloride content data is plotted in Figure 5.70.

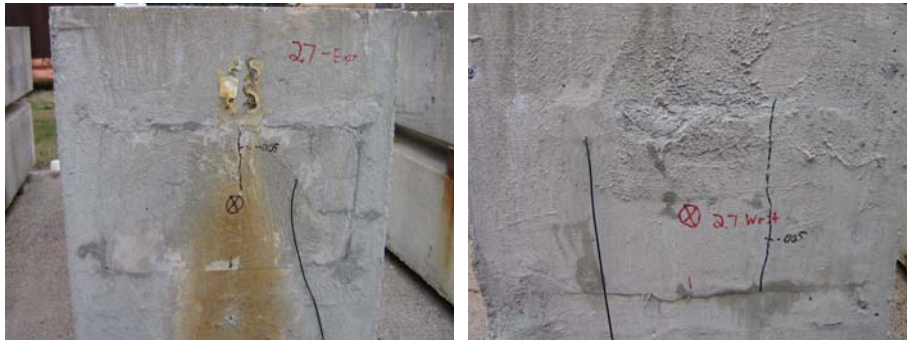
Figure 5.71: Beam 2.7 Anchorage Zones-East End (Left) with Dripper, and West End (Right) Without Dripper

As shown in Figure 5.71, the east end anchorage zone, which had been subjected to exposure testing with a saltwater dripper, had a small patch of staining. This staining was caused by the flow of the saltwater from the dripper. There was a 0.005 in. crack found on the grout which formed the pocket. This was likely a shrinkage crack. The west end anchorage, which had not been subjected to a dripper, also had a 0.005 in. shrinkage crack. As previously stated in Chapter 4, chloride samples revealed no chlorides at the west end, while high chloride content was found at strand tail depth on the east (dripper) end. Approximately two feet of each tendon was removed from each end of the beam ends during autopsy.

As shown in Figure 5.71, there were 0.005 in. wide shrinkage cracks on both ends of the beam, where the anchorage pockets had been backfilled. On the east (dripped) end anchorage, there was a large patch of staining right beneath where the saltwater exited from the dripper. Also, on the dripper end a large network of cracks was found directly above the 4x8 concrete cylinder which was used to weigh down the plastic drip pan. The cracks were on the bottom of the beam and then went up the sides approximately 3 in.. These cracks are shown in Figure 5.89.

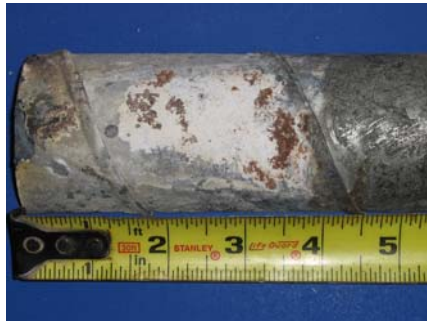
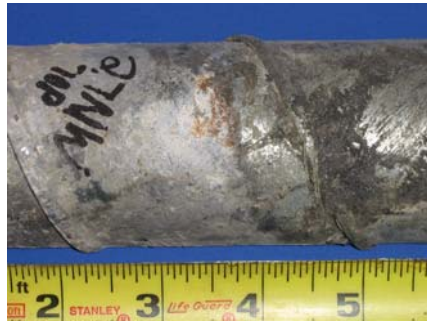
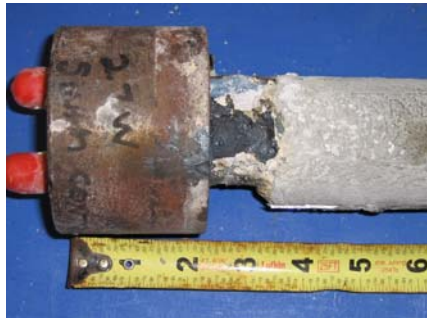
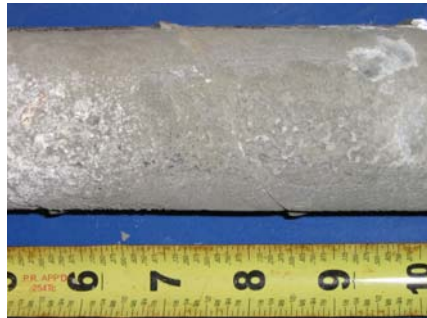
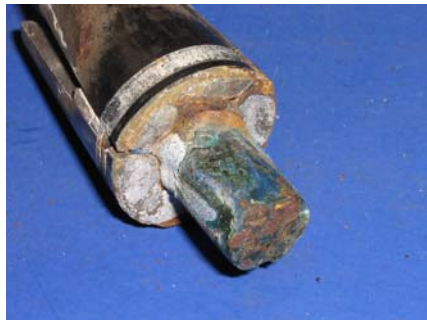
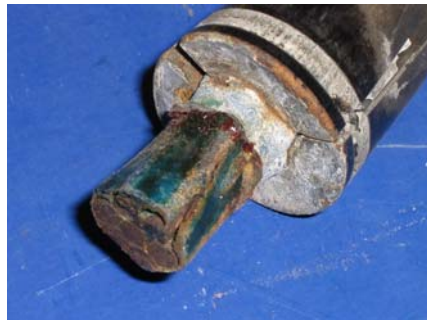
Figure 5.73: Beam 2.7-West End Anchorage Zone (Control) Autopsy Elements

As shown in Figure 5.72, the front of the bearing plate and the anchorhead in both tendons were slightly corroded, while the back of the bearing plates showed no corrosion. The fronts of the wedges also showed some slight corrosion as well. The portion of the north duct in the anchorage zone had light corrosion directly underneath the duct tape seal between the duct and the back of the anchorhead. Light corrosion was also found on the inside of the duct surface in this area. Otherwise the rest of the duct showed no evidence of corrosion. The south duct was similar, with light corrosion also found in the vicinity of the duct tape seal on the outside of the duct. No evidence of corrosion was found inside the south duct itself. The ducts are shown in Figure 5.73. Note that the white substance on the south duct is zinc oxide, which is from the corrosion of the galvanized

The north duct grout showed bubbles indicating porosity, but otherwise nothing else significant was observed in the appearance of the grout. Chloride samples of the grout taken at strand depth revealed negligible chloride content from the back of the anchorhead (Where the first sample was taken), all the way to end of the portion of the duct removed from the anchorage zone. The south duct grout showed evidence of bleed water accumulation for a length of 1 in. behind the anchorhead. Similarly to the north duct grout, negligible chloride content was found at strand depth along the length of the duct at the anchorage. The grout from both ducts is shown in Figure 5.73.

Mostly light to moderate corrosion was found in all the strands from both ducts. However, in the vicinity of where the wedges “bit” into the epoxy coated strand, full penetration of the coating was found in all the strands. In the north duct pitting was found on a single strand on both the center wire as well as some of the outer wires in this vicinity. A single strand in the south duct showed similar mild pitting. The likely source of the corrosion is that moisture from the center of the beam found its way through the interstices into the anchorages. The autopsy elements removed from the anchorage are shown in Figure 5.73. The strand ratings for the anchorage are given in Figure 5.76 and are summarized in Table 5.15.

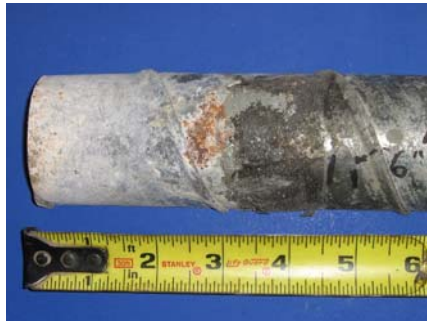
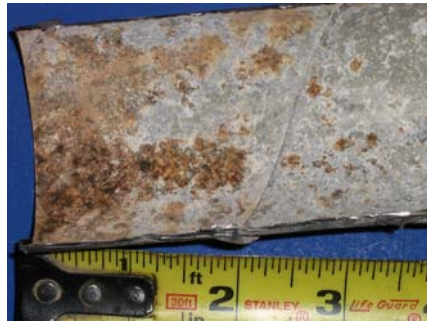
As shown in Figure 5.74, both bearing plates and the anchorheads were slightly corroded. The fronts of three of the four wedges were only slightly corroded. But one of the wedges in the south duct had pitting on its front surface. The north duct had pitting on its top inside and outside surfaces in the area right behind the bearing plate, with some light corrosion observed on the inside and outside surfaces of the bottom of the duct in this area. All other portions of the duct showed no evidence of corrosion. The south duct had light corrosion on both the top and bottom portions on the inside and outside surfaces. All other parts of the duct showed no evidence of corrosion. The ducts are shown in Figure 5.75. The duct ratings in the anchorage zones are plotted in Figure 5.76 are summarized in Table 5.15.

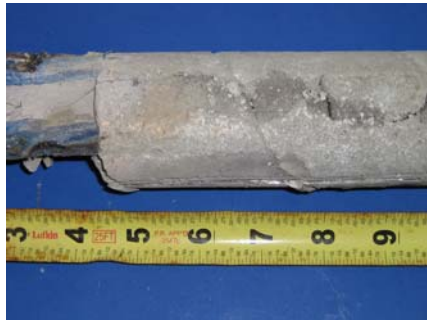
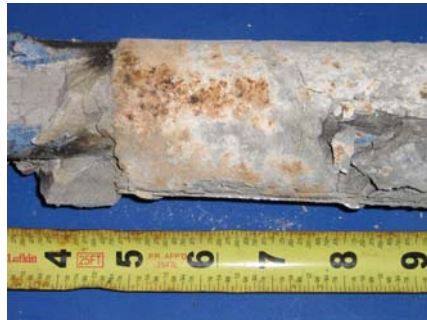
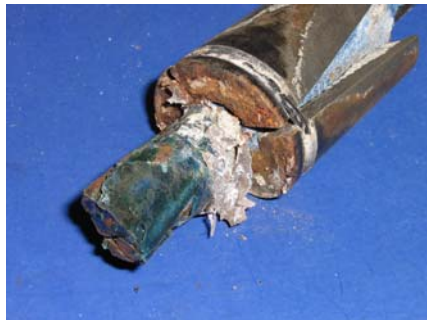
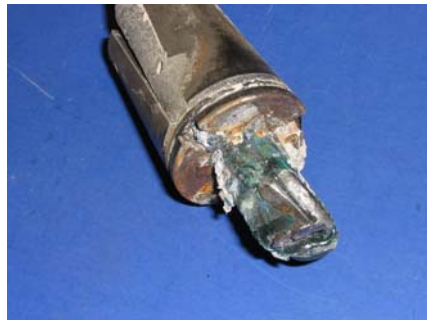
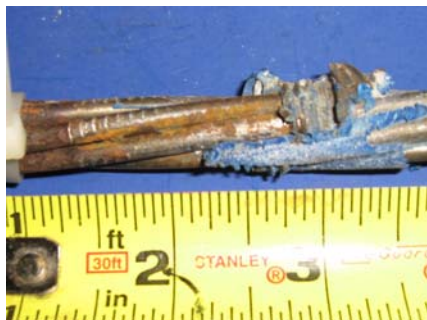
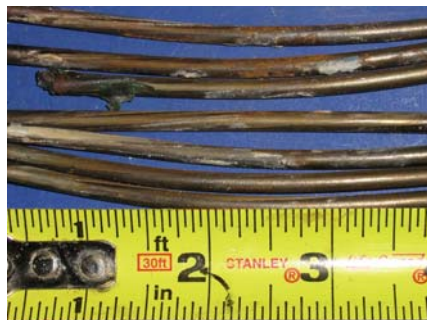
Figure 5.75: Beam 2.7-East End Anchorage Zone (Dripped End) Autopsy Elements

The north duct grout was slightly stained from the pitting corrosion on the inside of the duct. There was evidence of bleed water accumulation directly behind the anchorhead. Further towards the interior of the beam there were very small voids

indicating a small amount of bleed water accumulation. The chloride content samples taken at strand level showed negligible chlorides in the grout. The south duct grout showed shallow voids which may have been the result of segregation and/or bleed water accumulation during pumping of the grout. The possibility of segregation is mentioned because the voids did not appear similar to bleed water voids observed previously. A definite bleed water void was seen directly behind the anchorhead. Like the north duct, no chlorides were found at strand depth in the south duct. The grout from both ducts is shown in Figure 5.75.

The north duct strand was lightly to moderately corroded throughout the anchorage, including the portion outside the anchorhead. The south duct strand was similar, except there was mild pitting at the tips of one of the strands outside the anchorhead. At this location five of the six outer wires had moderate pitting, as well as the center wire. Beyond this point only light to moderate corrosion was found on the center wire. In the case of both the north and south strands moderate corrosion was observed directly beneath the locations where the wedges “bit” into the strand and punctured the epoxy coating. The strands are shown in Figure 5.75. The ratings for the strand in the anchorage are shown in Figure 5.76 and are summarized in Table 5.15.

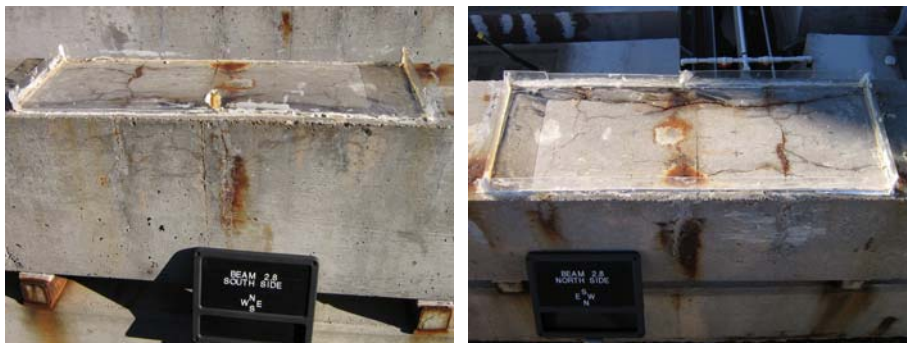
Figure 5.77: Beam 2.8-Side View (Left) and Top View (Right)-Note: These Views are from Opposite Sides of the Beam

As shown in Figure 5.77 and Figure 5.82, there was longitudinal cracking and staining centered around the flexural cracks in the ponded region, on both the sides and top surface of the beam. The worst staining was at the centerline flexural crack. As observed in all the other loaded beams, the flexural cracks corresponded with stirrup locations. The maximum crack width was from one of these longitudinal cracks in the ponded region, near the centerline. The crack measured nearly 1/8-in. in width. There was heavy staining at the beam centerline around one of the longitudinal cracks. Patches

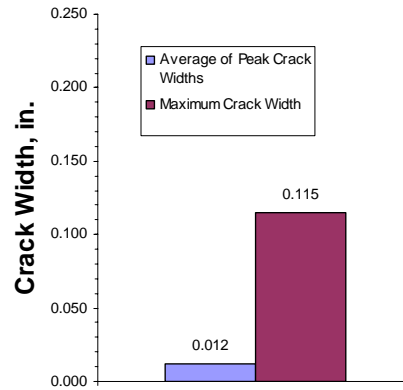
Figure 5.78: Beam 2.8 Crack Widths

of staining were also seen outside the ponded region as well. Crack width data for the beam are given in Figure 5.78.

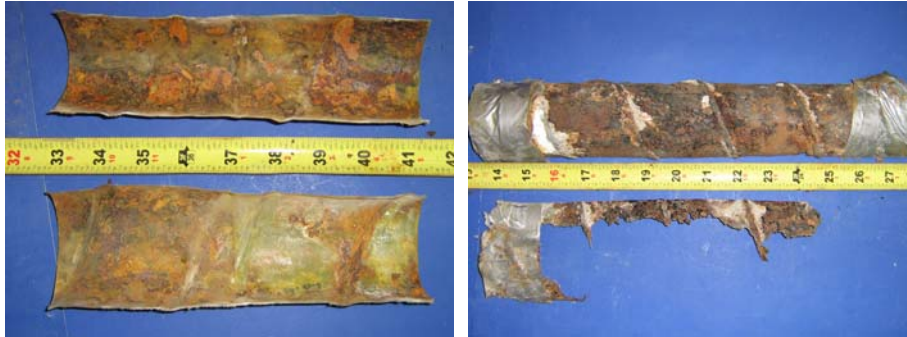
Figure 5.79: Beam 2.8 Duct Splices-South Duct Heat Shrink Splice (Left) and North Duct Industry Standard Splice (Right)

The splice configuration in this beam was an industry standard splice on the north duct at the beam centerline, with a heat shrink splice on the south duct also located at the beam centerline. The south duct heat shrink splice had a large amount of corrosion deposits on both the inside and outside surfaces, with the duct portion beneath the splice heavily pitted. The top portion of the industry standard splice was essentially corroded

away, with a pitted fragment recovered. The bottom portion of the splice was pitted on both the inside and outside surfaces. The top of the duct portion beneath this splice was very heavily holed resulting in large section loss. Also, the bottom portion of the duct in this area was heavily pitted. Both splices are shown in Figure 5.79.

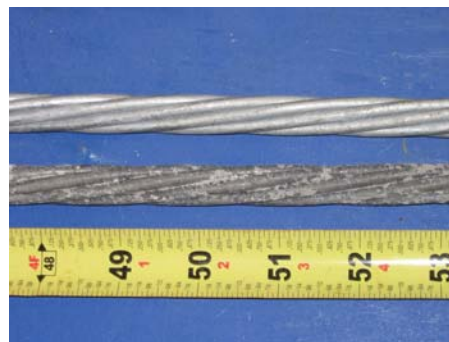
Figure 5.80: Autopsied Galvanized Strand (Bottom) vs. New Galvanized Strand (Top)

The two south duct galvanized strands had a wide range of corrosion. Both strands were discolored with instances of light to moderate corrosion. There were some instances of mild pitting on only a few wires. Whitish powder, likely zinc oxide, was found in the interstices between several of the wires. The amount of discoloration in the galvanized strand is shown in Figure 5.80. Here, new galvanized strand which was in environmentally controlled storage at FSEL is shown with the galvanized strand removed from the beam. The north duct strand was similar, but with many more instances of mild pitting in multiple locations. The strand from both ducts is shown in Figure 5.81, while the corrosion ratings along the length of the autopsy area are shown in Figure 5.82 and are summarized in Table 5.16.

It is significant that pitting and other heavy corrosion was found on the galvanized strand. The overall discoloration of the strand as well as the presence of zinc oxide suggests that the zinc coating had almost corroded away on all the strands, and that the actual steel in the strand was under attack. This is similar to what occurred to the galvanized ducts, where the galvanization only delayed the onset of corrosion in the actual steel.

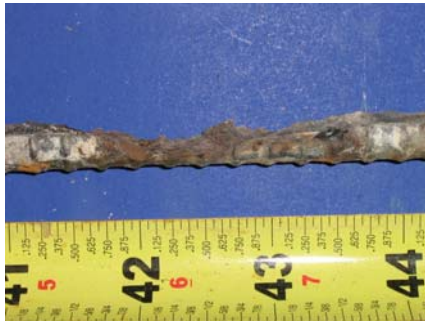
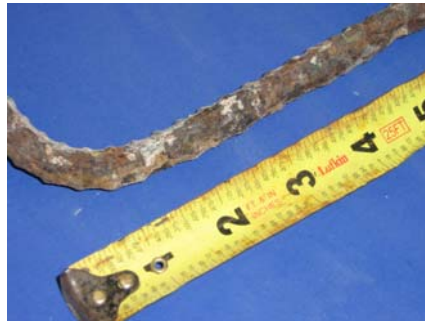
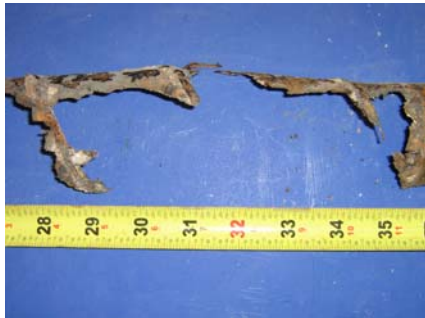
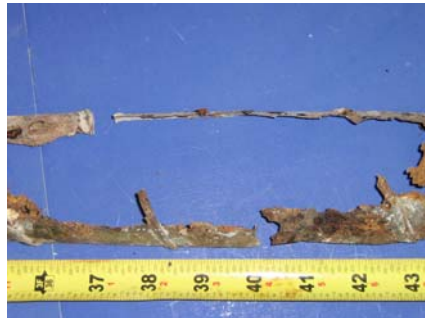
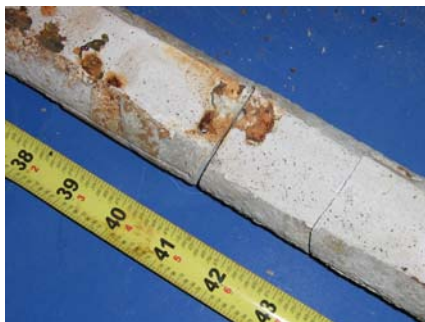
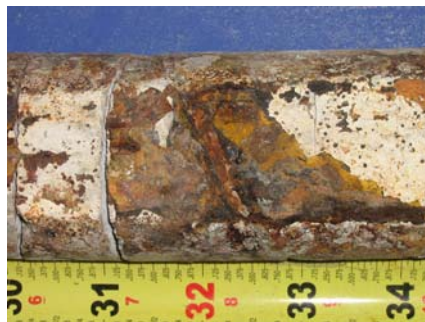
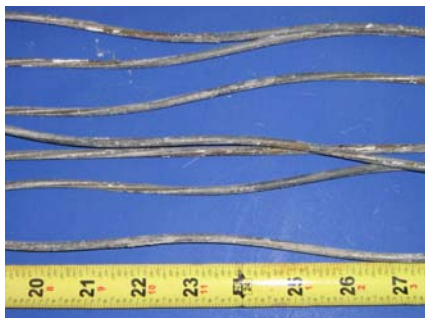
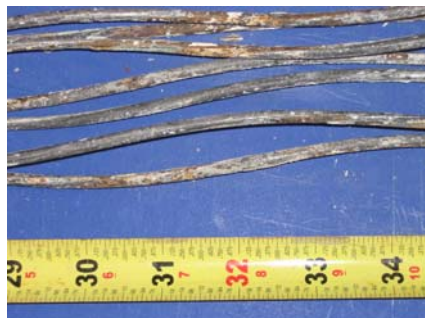
Figure 5.81: Beam 2.8 Autopsy Elements

Once the beam was autopsied, pitting and cross-sectional area loss were found on the longitudinal bars and stirrups in the ponded region (See Figure 5.81). The worst reinforcing bar damage was 10 in. to the west of the beam centerline, where one of the #3 bars was completely corroded away in one interval. This corresponded to a flexural crack location. The most corroded stirrup was that at the beam centerline. Here the stirrup was heavily pitted and at one location the stirrup bar diameter was reduced from ½-in. to 3/8-in.. This makes sense since the heaviest amount of staining seen on the exterior of the beam was at the centerline flexural crack. Outside the ponded region the stirrups and bars had mainly moderate corrosion with some pitting. The stirrups and bars are shown in Figure 5.81, with the corrosion ratings shown in Figure 5.82 and summarized in Table 5.16.

Both ducts were heavily pitted and holed and thus had large surface area loss. The top portion of the south duct was nearly corroded away at both 12 in. west of the beam centerline and 6 in. to the east of the beam centerline (The beam centerline is at 42 in. in the corrosion rating graphs shown in Figure 5.82). The inside surfaces of the duct were also pitted. The north duct was also heavy holed and pitted, with large amounts of section loss. The worst damage to the north duct was 12 in. to the west of the centerline, where nearly the entire top portion of the duct was corroded away, and the bottom of the duct was holed and pitted as well. Like the south duct, instances of pitting were found on the inside surfaces of the north duct as well. The ducts are shown in Figure 5.81. The duct corrosion ratings along the length of the beam are shown in Figure 5.82 and are summarized in Table 5.16.

The south duct grout had multiple large bleed water voids. The largest was at 26 in. to the west of the beam centerline. The bleed water void at this location was nearly $\frac{3}{4}$ -in. wide. The grout was also transversely cracked, with staining found on several crack faces. The maximum chloride content measured in the north duct grout was 0.662%, far above the threshold for corrosion of 0.033%. This was measured 12 in. to the east of the beam centerline. The north duct grout had two large bleed water voids. The largest was

8-in. long and 1.25 in. wide and was just west of the beam centerline. Here duct corrosion products were found in the void. The north duct grout was transversely cracked in multiple locations with staining found on some crack surfaces. The largest chloride content found in the north duct grout was 0.205%, at 6 in. west of the beam centerline. This value is, again, far above the threshold for corrosion. The grout from both ducts is shown in Figure 5.81, and the chloride contents are plotted in Figure 5.82.

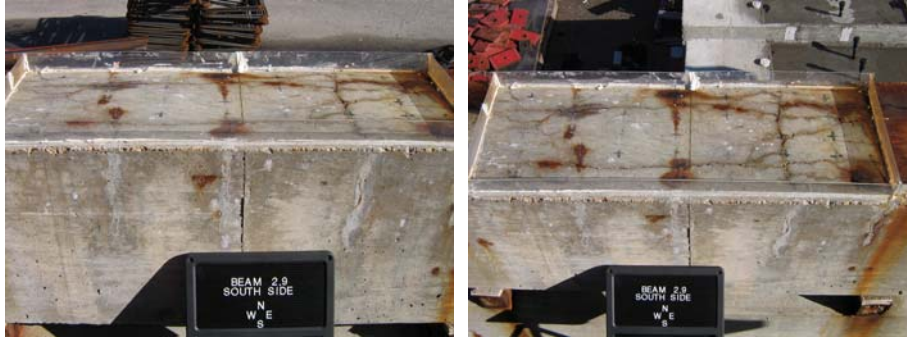
Figure 5.83: Beam 2.9-Side View (Left) and Top View (Right)

As shown in Figure 5.83 and Figure 5.87, there was staining and longitudinal cracking in the ponded region. An additional large patch of staining was observed just outside the east end of the ponded region. The patches of staining inside the ponded region were centered around the flexural cracks. One of the longitudinal cracks in the ponded region continued into the heavily stained area outside the east end of the ponded region. This crack and several other longitudinal cracks continued outside both ends of the ponded region. The largest crack width was recorded near the centerline of the beam, where one of the longitudinal cracks was 0.09 in. in width. Staining was also seen on the side of the beam, emanating from the flexural cracks inside the ponded region. The crack width data are given in Figure 5.84.

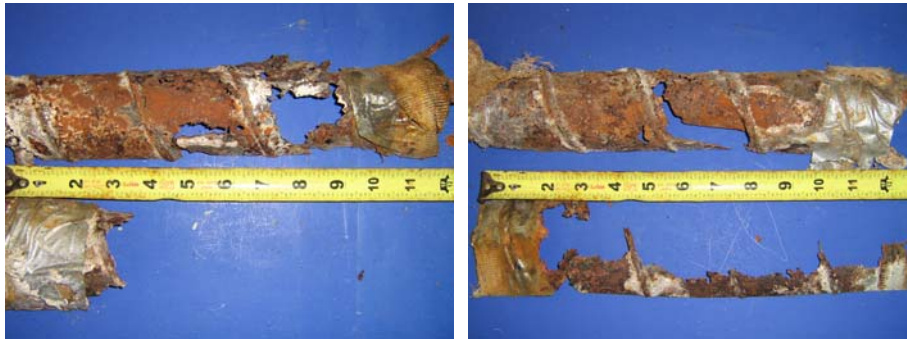
Figure 5.85: Beam 2.9 Industry Standard Splices-South Duct Splice (Left) and North Duct Splice (Right)

Both ducts were spliced with industry standard splices at the beam centerline. Both splices suffered tremendous section loss to their top portions. Only a 3-in. long fragment remained of the top portion of the south duct splice. The bottom portion had very large holes in it. The other areas of the bottom portion were heavily pitted. The duct

portion beneath the splice was heavily pitted and holed. In the case of the north duct splice a 12-in. long fragment of the top portion was recovered, while the bottom portion had a very large hole near its centerline and was severely pitted. The length of the duct beneath the splice was heavily pitted with small holes. The splices are shown in Figure 5.85.

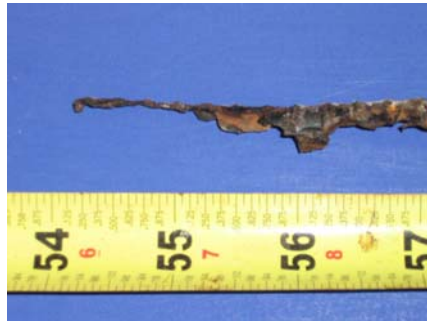
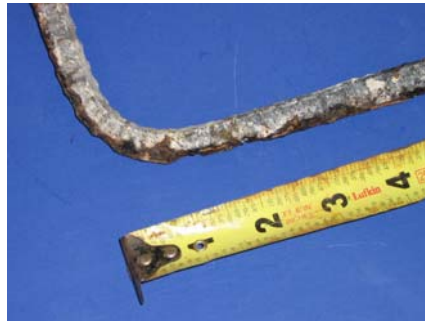
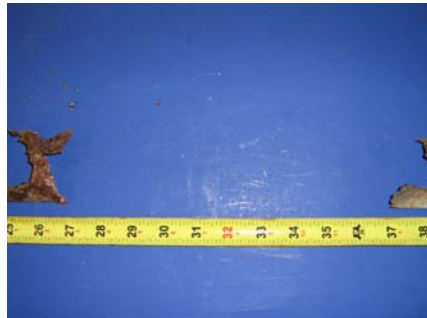
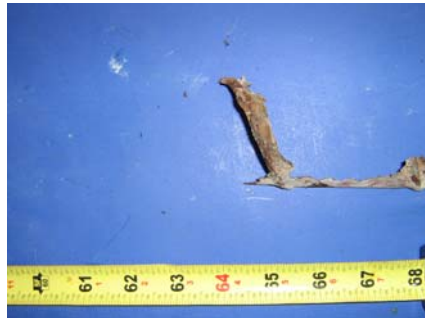
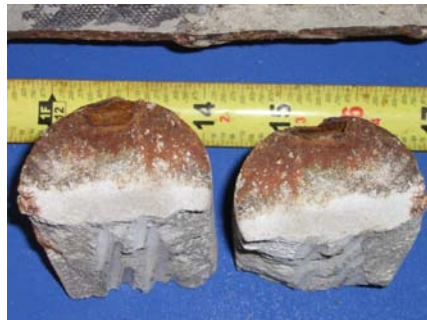
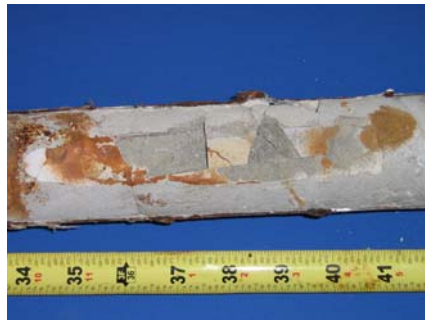
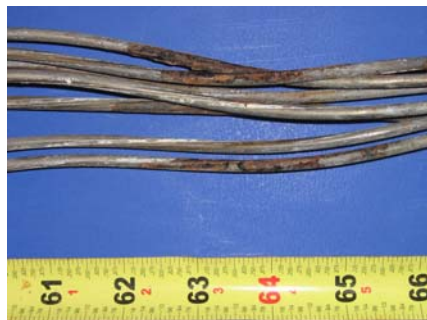
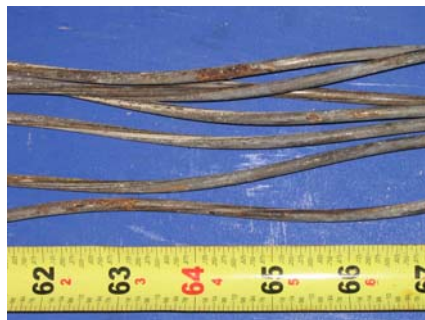
Figure 5.86: Beam 2.9 Autopsy Elements (From Center of Beam)

Upon autopsy of the center portion of the beam, large amounts of pitting and cross-sectional area loss were found on all longitudinal bars and stirrups (See Figure 5.86). In some instances the #3 longitudinal reinforcing bars were completely corroded away for several in. of length. This occurred over a broad area centered about 18 in. west of the beam centerline, where in one 2-in. interval two of the #3 bars were completely corroded away. Loss of bar lengths also occurred intermittently in an area about 18 in. long which was just to the east of the beam centerline. Again, in this area two of the four #3 bars were completely corroded away for several 2-in. intervals. The worst stirrup damage was just outside the east end of the ponded region, corresponding to the location of the heavy staining mentioned previously. The stirrup at this location suffered significant section loss in several 2-in. intervals, and was also heavily pitted. The stirrups and bars are shown in Figure 5.86, while the corrosion ratings for the stirrups and bars within the autopsy area are plotted in Figure 5.87 and are summarized in Table 5.17.

Both ducts were heavily holed and pitted, resulting in large surface area loss. The highest amount of damage in the south duct was approximately 12 in. to the west of the beam centerline, where nearly 4-in. of the entire duct was corroded away. The north duct was also heavily holed and pitted, with the entire corroded away for several in. at a location about 18 in. to the east of the beam centerline. The duct corrosion ratings along the length of the beam are shown in Figure 5.87, are summarized in Table 5.17. The ducts are shown in Figure 5.86.

As described in Chapter 2, this beam was used to evaluate the effect of poor grouting procedures. The poor procedures included delays of up to 10 minutes during pumping of the grout, letting air into the pump, and capping the grout vents at the first sign of grout at the vents. Upon autopsy of the tendons, the south duct grout was found to have larger surface bubbles than compared to the beams with the “proper” grouting procedures. Bleed water voids of various sizes were present, and some evidence of segregation of the grout mix was found when examining the faces of the transverse cracks in the grout. This may have been caused by the 10-minute delays in pumping. Many of these transverse crack faces were also heavily stained. An example of the

segregation and staining is shown in Figure 5.86. Note the small bleed water voids at the tops of the grout sections. The maximum chloride content measured in the north duct was 0.267%, this was at the extreme east end of the autopsy area. The north duct was similar, with a large bleed water void near the beam centerline which was 1-in. wide and almost a ½-in. deep. The maximum chloride content measured in the north duct was 0.245%, and was located at 12 in. to the east of the beam centerline. Thus the maximum chloride content for both ducts was far above the threshold for corrosion. The grout from both ducts is shown in Figure 5.86. The chloride content in the grout along the length of the autopsy area is plotted in Figure 5.87.

The two south duct strands had instances of light to moderate corrosion throughout, with some instances of mild and moderate pitting found on one strand in a zone about 20 in. long at the east end of the autopsy area. Here mild pitting was found on some wires, with one case of moderate pitting on one wire at 16 in. to the east of the beam centerline. The other strand had only two instances of mild pitting. One was at the beam centerline and the other was about 18 in. to the west of the beam centerline, in the same general vicinity as where the moderate pitting was found on the other strand in the duct. Both strands in the north duct had mild pitting in the same general areas as the south duct strands, but no instances of moderate pitting were found in either of the strands. The strand is shown in Figure 5.86, and the corrosion ratings for the strand in the autopsy area are given in Figure 5.87 and are summarized in Table 5.17.

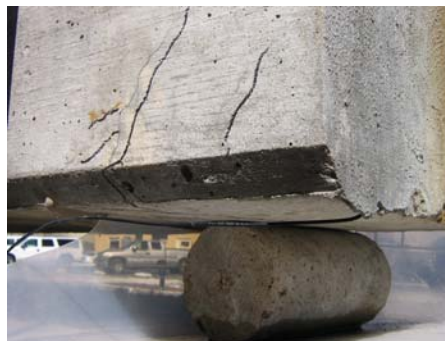
Figure 5.89: Beam 2.9: Bottom Corner of East End Anchorage Zone

The widest crack width in this crack network was 0.01 in., which was on the side of the beam. A small patch of staining was found right next to this crack. When an attempt was made to remove the 4x8 cylinder, it was discovered that the cylinder was actually pinned beneath the test beam and the reaction beam. This is likely the source of

the cracking on the bottom of the beam. As the beam “crept” downward under sustained load during the nearly 8 years of testing, the cylinder was loaded more and more, and it finally caused local cracking in the beam itself.

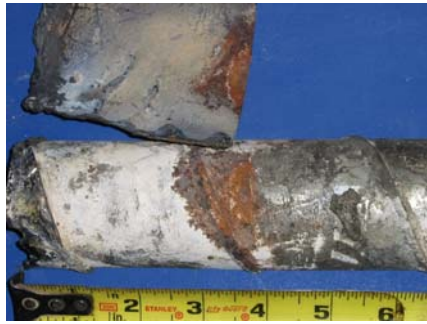
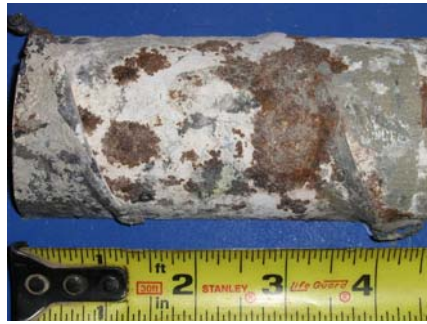
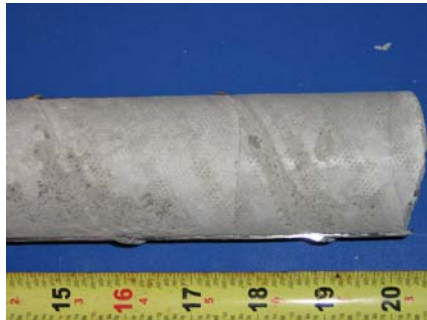
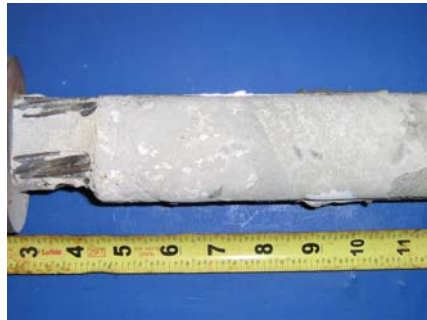
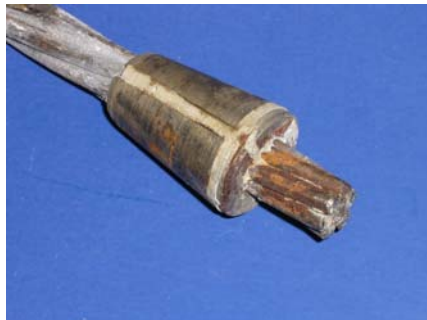
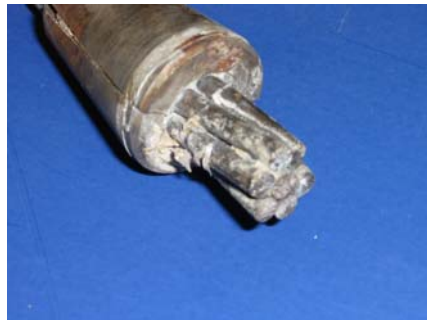
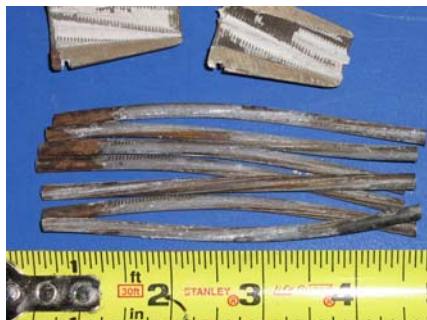
Figure 5.91: Beam 2.9-West End Anchorage Zone (Control) Autopsy Elements

As shown in Figure 5.90, the front of the bearing plate and anchorhead in both tendons were only slightly corroded. The fronts of the wedges also showed slight corrosion as well. The portion of the north duct in the anchorage zone had moderate corrosion on its outside surface inside the duct taped connection between the back of the bearing plate and the duct. Otherwise, no other evidence of corrosion was found on the north duct. The south duct had moderate corrosion in the same location as the north duct, and, some small instances of light corrosion were found on the inside of the duct as well, near where the duct met the bearing plate. The corrosion ratings for the ducts in the anchorage are given in Figure 5.94 and are summarized in Table 5.18. The ducts removed

from this anchorage are shown in Figure 5.91. Note that in the latter figure the duct is shown next to the top half of the back of the bearing plate, which it was in contact with during test. Notice that there are corrosion deposits on that component from the corrosion of the duct.

The north duct grout showed evidence of bleed water accumulation just behind the anchorhead, and deep, but small in diameter, bubbles in the top of the grout. Negligible chlorides were found at the level of the strand in the grout. The south duct had a transverse crack at about 18 in. from the back of the anchorhead. However, the south duct grout did not have the deep bubbles that the north duct grout had. No evidence of bleed water accumulation was found behind the anchorhead in this duct. Similar to the north duct grout the south duct grout had negligible chlorides at the level of the strands. The grout from both ducts is shown in Figure 5.91. Light to moderate corrosion was found on the strands in the north and south ducts in the anchorage zone. Most of the moderate corrosion was concentrated in the interstices, but in the south duct strands moderate corrosion was observed on the outside of the strand at the ends of both tendons outside the anchorhead. The likely source of this corrosion is that corrosion from the center of the beam spread through the interstices down to the anchorages. No corrosion was found where the wedges “bit” into the wires. The strands from both ducts in the west end anchorage are shown in Figure 5.91. The strand ratings in the anchorage are given in Figure 5.94 and are summarized in Table 5.18.

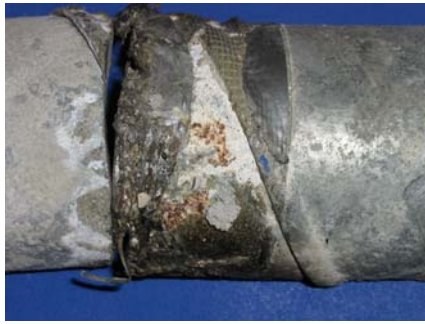
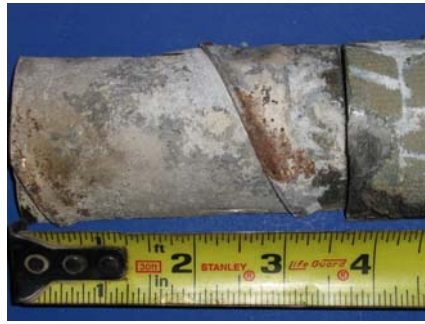
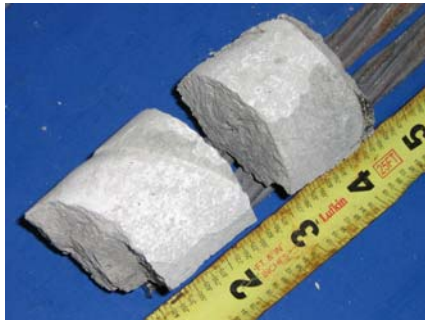
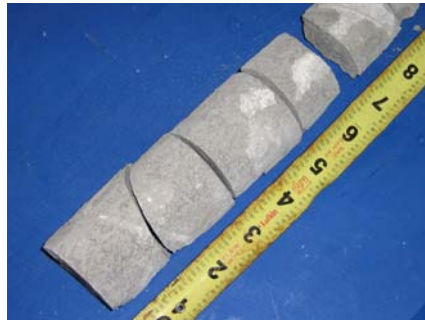
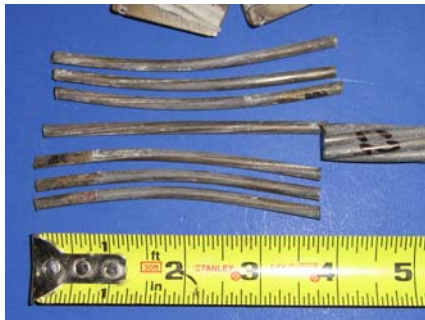
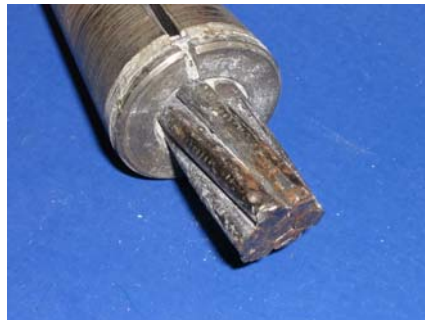
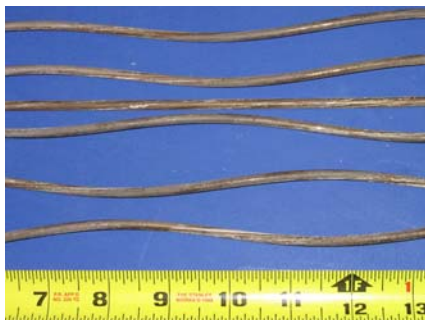
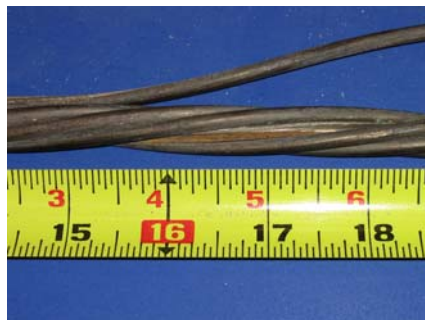
Figure 5.93: Beam 2.9-East End Anchorage Zone (Dripped End) Autopsy Elements

As is evident in Figure 5.92, in the case of both tendons more corrosion was found on the face of the bearing plate and anchorhead at the dripped end of the beam than at the control end. However, there was no evidence of corrosion in the area behind the bearing plate. The outside of the top portion of the south duct had severe corrosion in the vicinity of the duct tape connection, and instances of light corrosion on both the outside and inside of the bottom portion of the duct right at the end of the duct at the anchorhead. Light corrosion was also found underneath the duct tape at the duct/bearing plate

interface. It is known from the aforementioned industry standard splices that duct tape does not act as an effective barrier for moisture ingress. But the absence of corrosion on the exposed portion of the duct behind this area suggests that failure of the duct tape was not the likely culprit for the corrosion on the duct behind the anchorhead. The outside of the north duct had light corrosion at the end of the duct behind the anchorhead, on the top surface. At the same end of the duct light corrosion was found on the outside of the bottom surface of the north duct. The ducts from the anchorage are shown in Figure 5.93. The corrosion ratings for the ducts in the anchorages are given in Figure 5.94 and are summarized in Table 5.18.

The south duct grout was cracked in a similar fashion to the grout at the center of the beam. No evidence of staining was found on the crack faces. The north duct grout was also cracked, but again, no evidence of staining was observed on the crack faces. In both ducts the grout chloride content at strand depth was negligible. The grout from both ducts in the anchorage are shown in Figure 5.93.

Moderate corrosion was found on all the strand wires in both ducts. Behind the anchorhead the moderate corrosion was generally found in the interstices. However, in front of the anchorhead, instances of moderate corrosion were found on the outside of the strands in both ducts. No evidence of corrosion was found inside the “bite” marks caused by the wedges in either duct. The strand from both ducts is shown in Figure 5.93. The strand ratings for the anchorages are given in Figure 5.94 and are summarized in Table 5.18.

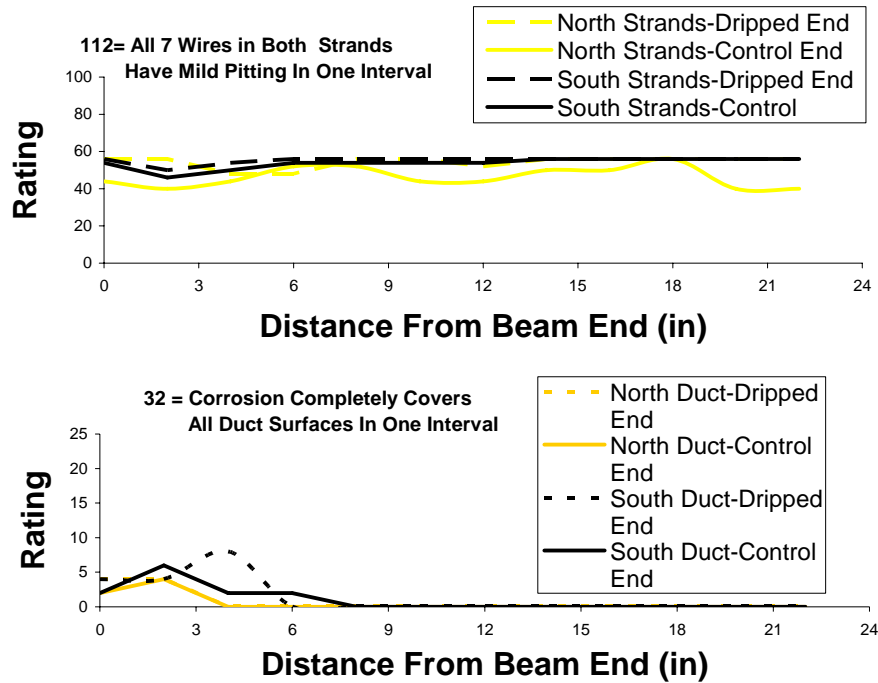
Figure 5.94: Beam 2.9-Corrosion Rating Graphs for Anchorages

In Figure 5.94, the corrosion ratings for the ducts and strands in both the end anchorage zones are plotted. This data is also summarized in Table 5.18. The data from both ends are plotted together so that a direct comparison can be made between the control end and the dripped end. The x axis value “Distance From Beam End” is the distance from the respective ends of the beam for each anchorage element. For this analysis it is assumed that the corrosion at the center of the beam had an equal effect on both end anchorages.

In Figure 5.94 there is no increase in strand corrosion at very ends of the beam (Which is “0” on the x axis) in either the dripped end of the beam or the control end of the beam. However, from the same plot and from Table 5.18, an increase in the total

strand corrosion for both ducts between the dripped and the control end is apparent. In the case of the ducts the significant corrosion was found at the bearing plate/duct interface. As demonstrated in Beam 2.7 (Epoxy Coated Strand), the corrosion of the duct at its interface with the bearing plate is likely a form of galvanic corrosion. In Figure 5.94 and Table 5.18 it is clear that the corrosion in the ducts is greater in the end with the dripper. It is possible that chlorides entered through the strand holes in the anchorhead. While this did not penetrate the grout deep enough to produce significant chloride content at the level of the strand in tee grout, it still may have found it's way to the interface between the galvanized steel of the duct and the regular steel of the anchorhead. The presence of these chlorides would then accelerate the galvanic corrosion process between the galvanized duct and the steel bearing plate.

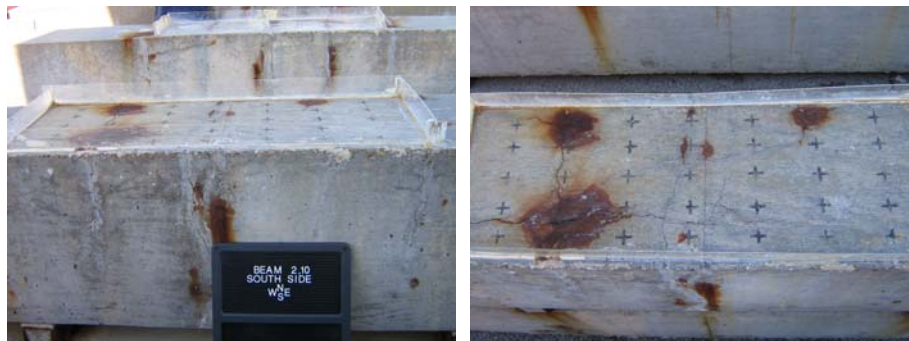
Figure 5.95: Beam 2.10-Side View (Left) and Top View (Right)

As shown in Figure 5.95, and the crack maps in Figure 5.99, there was heavy staining and longitudinal cracking in the ponded region. The heaviest patches of staining were at the intersection of one of the flexural cracks and two of the longitudinal cracks, 12 in. west of the beam centerline. There was also staining on the side of the beam near the flexural crack at the beam centerline. The largest crack width was 0.094 in., and was measured at one of the longitudinal cracks near the beam centerline. There were a few small patches of staining outside the ponded region, but no wide longitudinal cracking. The crack width data are given in Figure 5.96.

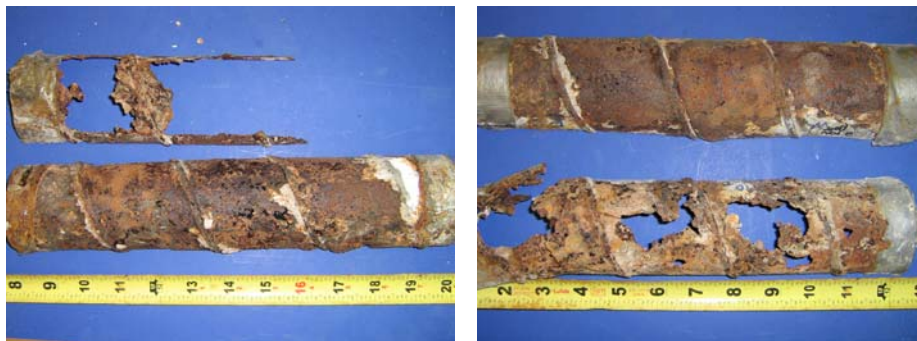
Figure 5.97: Beam 2.10 Industry Standard Duct Splices-South Duct Splice (Left) and North Duct Splice (Right)

Both ducts were spliced at the beam centerline. Both splices were industry standard splices, and were heavily corroded. The top portion of the south duct splice was almost completely corroded away. The top portion of the duct beneath it was nearly corroded away. The bottom of the splice was heavily pitted. The north duct splice had large holes and pitting in the top portion, with the bottom portion heavily pitted on the inside and outside. The top portion of the duct beneath it was pitted and small holes were present as well. Both splices are shown in Figure 5.97

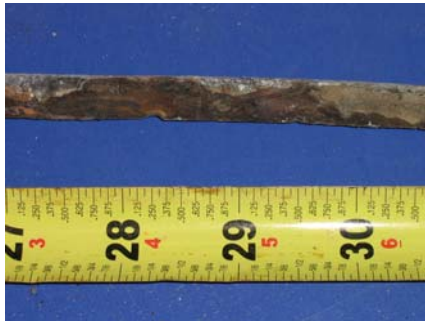
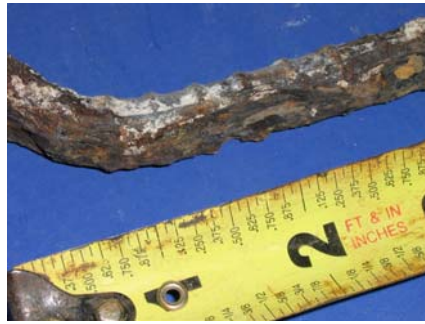
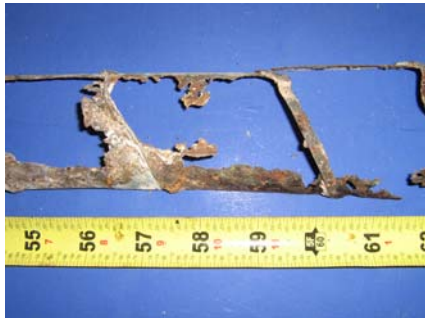
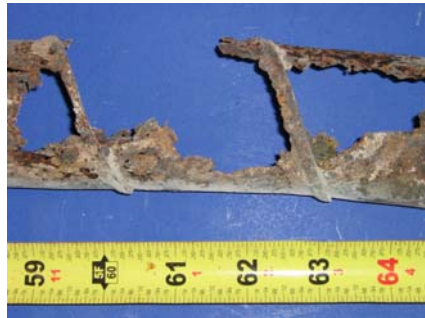
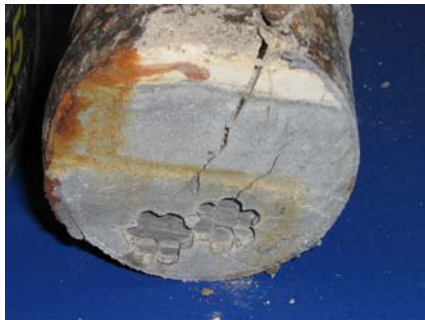
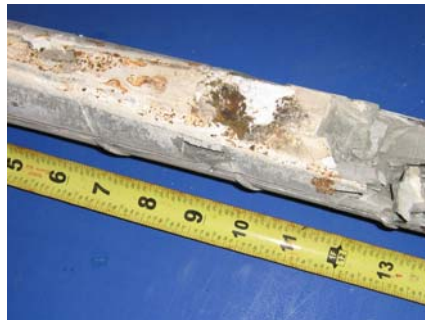
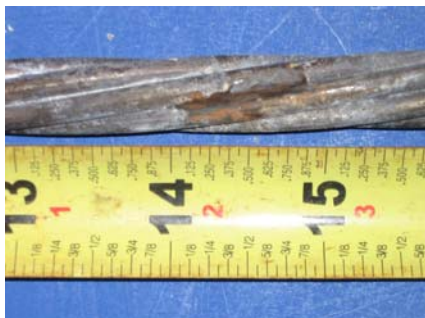
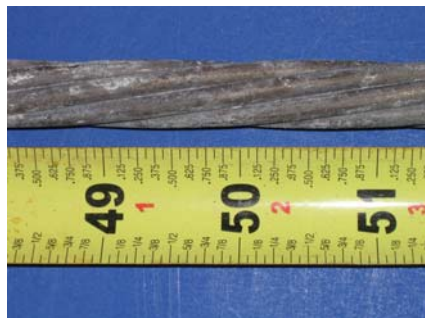
Figure 5.98: Beam 2.10 Autopsy Elements

Upon autopsy of the beam, pitting and cross-sectional section loss was found on the stirrups and longitudinal bars (See Figure 5.98). The worst longitudinal bar corrosion was at 16 in. to the west of the beam centerline, where one of the #3 bars was reduced in diameter to 0.25 in.. In the same location the four #4 bars also had considerable area loss. This area roughly corresponds to large patches of staining seen in Figure 5.95. The most highly corroded stirrup was also in this vicinity. In one area this stirrup had a reduction in diameter from 0.5 in. to 0.4 in.. The stirrup and longitudinal bar corrosion ratings are given in Figure 5.99 and are summarized in Table 5.19.

Both ducts were heavily pitted with large surface area loss. In the case of the south duct the top portion was almost completely corroded away at about 18 in. to the east of the beam centerline. In the case of the north duct the majority of the top of the half of the duct was corroded away at a location 14 in. to the west of the beam centerline, and at the same location the bottom half of the duct had significant holes as well. The ducts are shown in Figure 5.98, while the corrosion rating graphs for the ducts are given in Figure 5.99 and are summarized in Table 5.19.

Both the south duct grout and north duct grout were an anti-bleed grout mix designed by Schokker². The grout mix was described in Chapter 2. Upon autopsy of both tendons, a large degree of segregation was found in the grout in both ducts. This resulted in shallow voids which ran almost the entire length of the autopsied ducts. Therefore, it appears that the anti-bleed admixture did not fully engage. When viewing the cross section of the grout, directly beneath the shallow void was a distinct layer of more

whitish grout, then grout which was more normal in appearance. The grout at the level of the strands appeared to be better quality than that seen with the grout in the other autopsied beams. The segregation and thus the anti-bleed admixture not engaging may have been caused by the mixing method used, which was mixing the grout for a short period in a bucket with a hand mixer, instead of using a dedicated grout mixer/pump assembly.* In the south duct the maximum chloride content at strand level was 0.162%, which was at 36 in. from the west end of the autopsy area. This is far above the threshold of 0.033%. The maximum chloride content in the north duct was 0.06%, which was at 18 in. from the west end of the autopsy area. The grout is shown in Figure 5.98, and the chloride contents in the grout in the autopsy area are plotted in Figure 5.98.

The south duct strand had light to moderate corrosion, with a few instances of pitting at 14 and 26 in. from the west end of the autopsy area. The north duct strand also had to light to moderate corrosion, but with no pitting. The strands from both ducts are shown in Figure 5.98, with the corrosion ratings plotted in Figure 5.99 and summarized in Table 5.19.

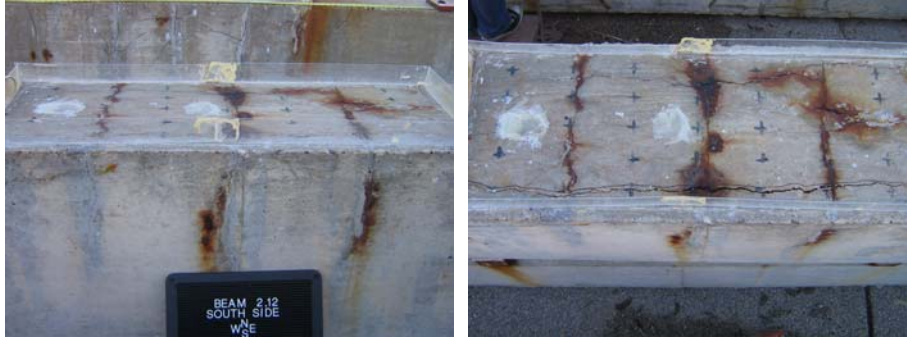
Figure 5.100: Beam 2.12-Side View (Left) and Top View (Right)

As shown in Figure 5.100, and in the crack patterns in Figure 5.105, severe staining and wide longitudinal cracks were seen on the top surface of the beam within the ponded region, with staining also emerging from the flexural cracks on the side of beam. The largest amount of staining on the top of the beam was centered around the intersection of the centerline flexural cracks and the pair of wide longitudinal cracks which ran the length of the ponded region. Staining was also seen emerging from the tops of the flexural cracks both to the west and east of the beam centerline. The largest overall crack width was at 14 in. east of the centerline, where one of the longitudinal cracks was 0.13 in. in width, which is slightly over 1/8-in.. The crack widths are given in Figure 5.101.

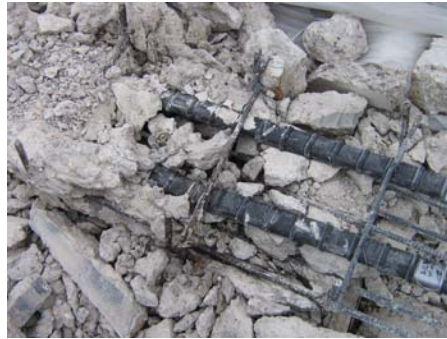
Figure 5.102: Beam 2.12 During Autopsy

The ribbed plastic ducts were continuous in both ducts, so no splices were present to be evaluated. During the breaking up of the block from the beam centerline, it was found that bracing bars had been placed across the bottoms of the stirrups during construction to hold the ducts up. The ducts had then been tied to these bars. This is shown in Figure 5.102. Note that the block is upside down, so the surface on the bottom of the block, facing the ground, was where the saltwater was ponded upon during exposure testing.
