**Durability Evaluation of Post-Tensioned Concrete Beam Specimens
After Long-Term Aggressive Exposure Testing**

Thesis

Master of Science in Engineering

The University of Texas at Austin

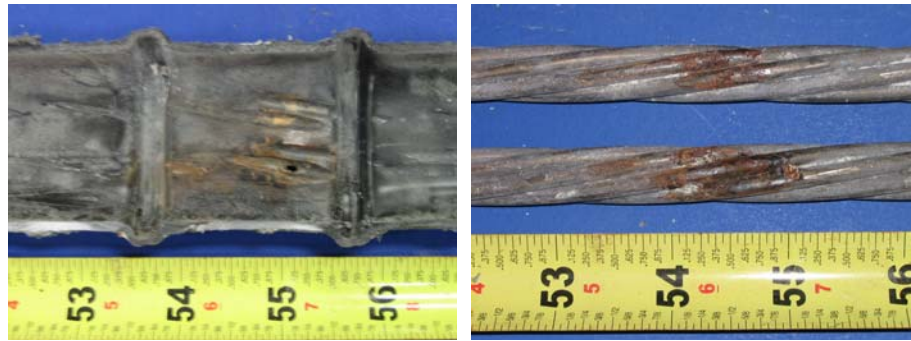
Figure 5.103: Beam 2.12-Abrasion Damage to Interior of North Duct (Left) and Strand From Same Location (Right)

At multiple locations, including all the stirrup locations, heavy corrosion deposits were seen on the top of the plastic ducts along the length of the autopsy block. Once the ducts were opened, evidence of abrasion was found between the strand and the bottom of the ducts. The abrasion was in the form of deep gouges in the bottom of the duct (See Figure 5.103). The damage was similar to fretting. At a point 12 in. to the west of the beam centerline (54 in. on the corrosion rating graphs), a small hole was found on the bottom of the north duct inside once of these gouges, with corrosion products inside. This was directly over one of the bracing bars which contributed to the damage. Corrosion products were found on the outside of the duct in this area. Severe pitting was found on the strand wire surface which had caused this gouge. Mild pitting was found on two other wires in this vicinity. The other strand in the north duct had mild to moderate pitting on three wires at the same location. Mild pitting was also found on the center wire of this strand, suggesting that the chlorides which had entered the duct had made their way into the interstices of the strand. While at first the remainder of the strand appeared unaffected on the outside, once the strand was unwound moderate corrosion was found on all wires in both strands for rest of the autopsy area. This damage to the north duct is shown in Figure 5.103.

Very small cracking was found in one of the strand gouges on the bottom of the south duct in the exact same location along the length of the beam as the damage to the north duct. This resulted in basically the same situation as that in the north duct. Corrosion products were found in the gouge where the crack was located and mild to moderate pitting was found on three of the outer strand wires, with moderate pitting found on the center wire as well. The other strand had mild pitting on two of its wires in the same area. The strand from both ducts is shown in Figure 5.104, with the corrosion ratings for the strand shown in Figure 5.105 and summarized in Table 5.20. Corrosion ratings for the ducts are not plotted since the ducts are plastic; however, the location of the damage to the ducts is marked on the plot of strand damage. An explanation for this damage is as follows: When the strand was prestressed, it actually pushed down onto the duct, causing damage similar to fretting. Consequently, at a point 12 in. to the west of the beam centerline the plastic ducts had been “squeezed” between the strand and the bracing bar, and as a result the ducts failed mechanically. This damage must have occurred right when the beams were prestressed, even before exposure testing began. As shown in Figure 5.105 once the beam was loaded a flexural crack formed at the point where the ducts were damaged, since a stirrup was located there. Chlorides in the salt bath found their way through the flexural crack and corroded the bracing bar which held the ducts up. The corrosion then spread through the holes in the duct into the strand.

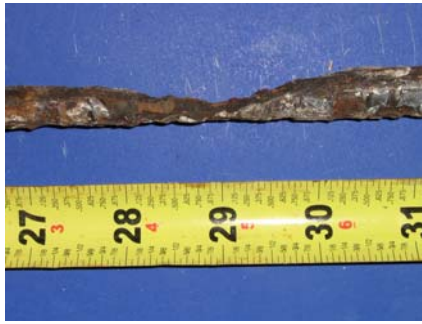
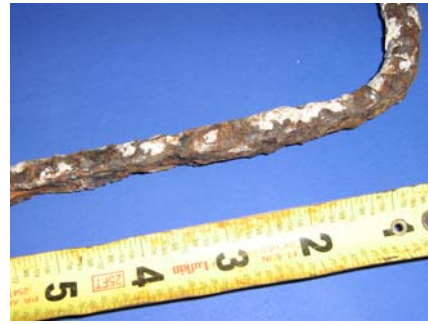
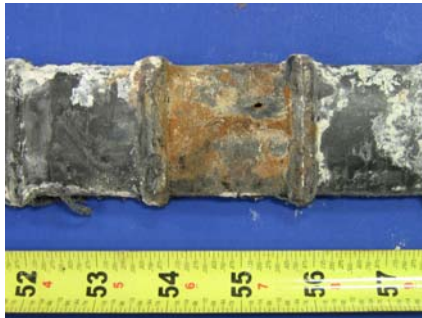
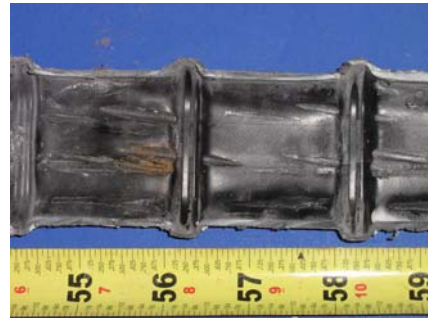
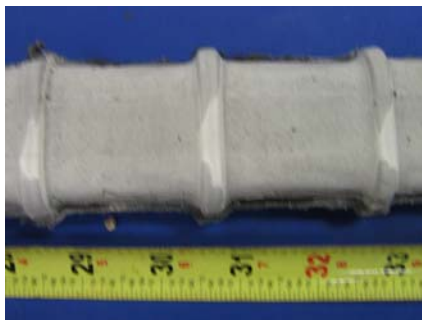
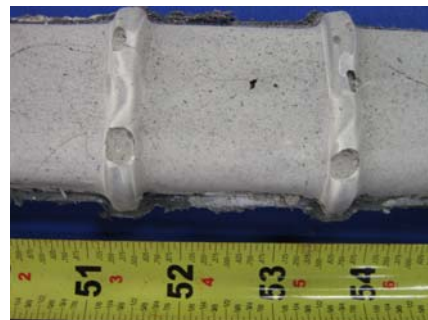
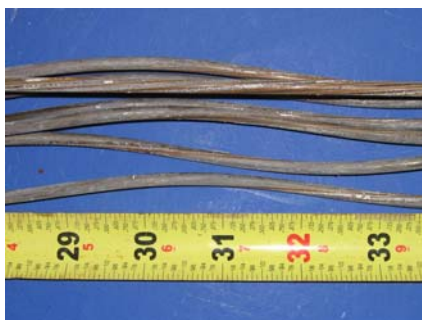
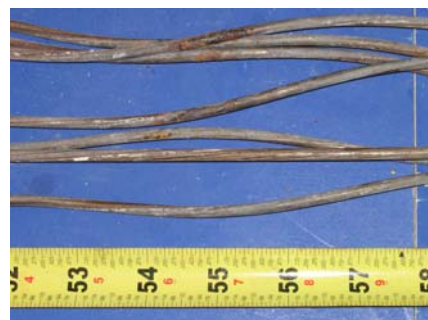
Figure 5.104: Beam 2.12 Autopsy Elements (Center Portion of Beam)

All longitudinal bars and stirrups were pitted with large amounts of cross-section loss (See Figure 5.104). The worse longitudinal bar damage was in an area about 18 in. to the west of the beam centerline, where nearly 6 in. of two of the #3 bars were completely corroded away. The worst stirrup damage was at 12 in. to the east of the beam centerline, where the top portion of the stirrup had its diameter reduced from ½-in. to around 0.375 in.. The stirrup which was at the far west end of the autopsy area, outside the ponded region, had pitting but no cross-sectional area loss. The longitudinal bars and stirrups are shown in Figure 5.104. The corrosion ratings for the bars and stirrups are plotted in Figure 5.105 and are summarized in Table 5.20.

Both ducts were well grouted. The bleed water accumulated on the peaks of the ribs along the length of the duct, preventing large bleed water voids from forming as seen

in the galvanized ducts. The evidence for bleed water accumulation at the peaks of the ducts was large bubbles on the tops of many of the ribs. Negligible chlorides were found in the grout right at the level of the strand. This is surprising considering the aforementioned damage to the duct. What likely happened was the chlorides entered the strands directly and did not absorb into the grout. This is also likely because obviously there was no grout between the damaged areas of the ducts and the strand, so unlike typical strand damage seen in the other autopsies the chlorides did not have to pass through the grout to get to the strand. The chloride contents along the length of the ducts in the autopsy area are shown in Figure 5.105. The grout from both ducts is shown in Figure 5.104.

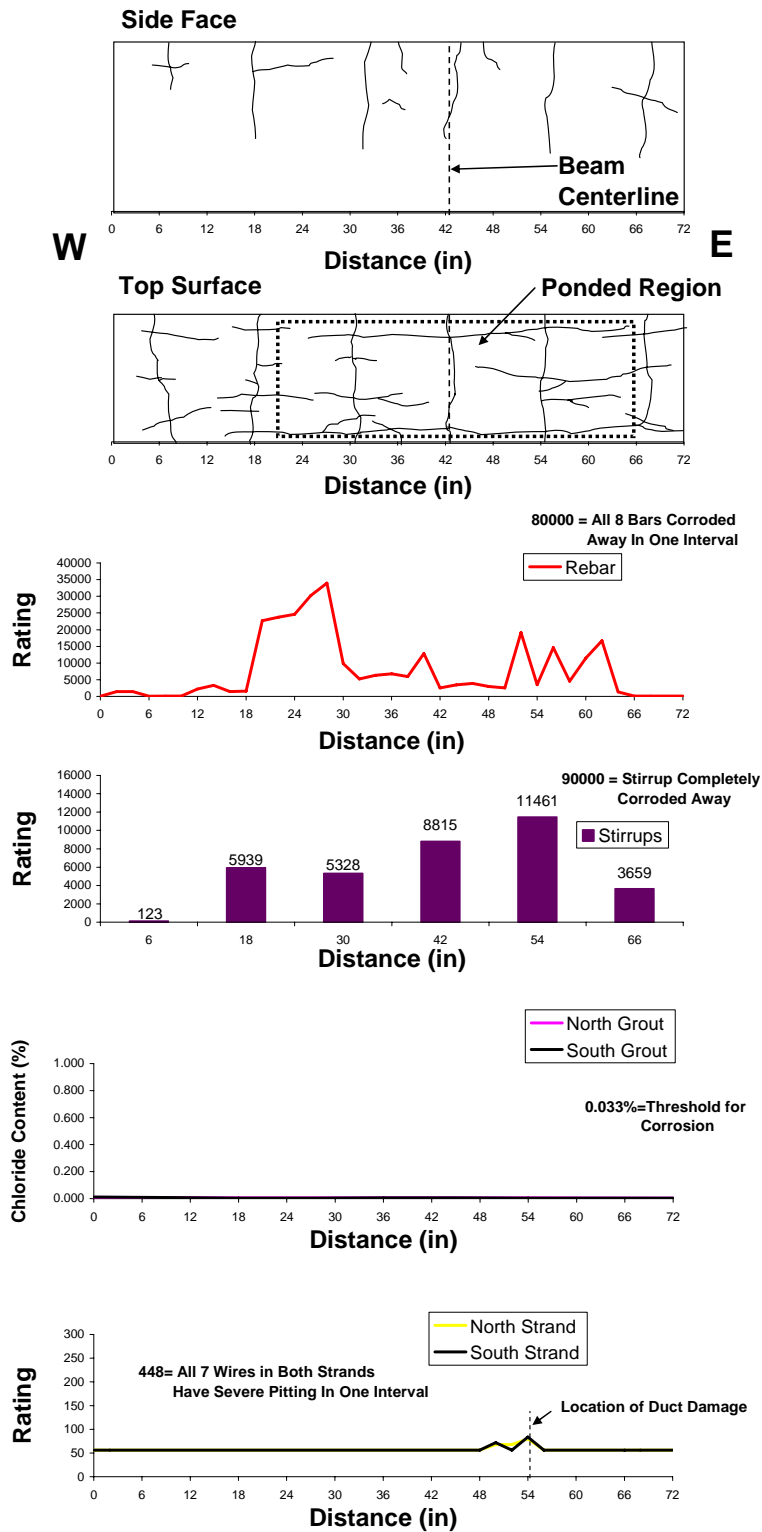
Figure 5.105: Beam 2.12-Crack Patterns and Corrosion Rating Graphs (Center Portion of Beam)

As shown in Figure 5.100, and in the crack patterns in Figure 5.105, severe staining and wide longitudinal cracks were seen on the top surface of the beam within the ponded region, with staining also emerging from the flexural cracks on the side of beam. The largest amount of staining on the top of the beam was centered around the intersection of the centerline flexural cracks and the pair of wide longitudinal cracks which ran the length of the ponded region. Staining was also seen emerging from the tops of the flexural cracks both to the west and east of the beam centerline. The largest overall crack width was at 14 in. east of the centerline, where one of the longitudinal cracks was 0.13 in. in width, which is slightly over 1/8-in.. The crack widths are given in Figure 5.101.

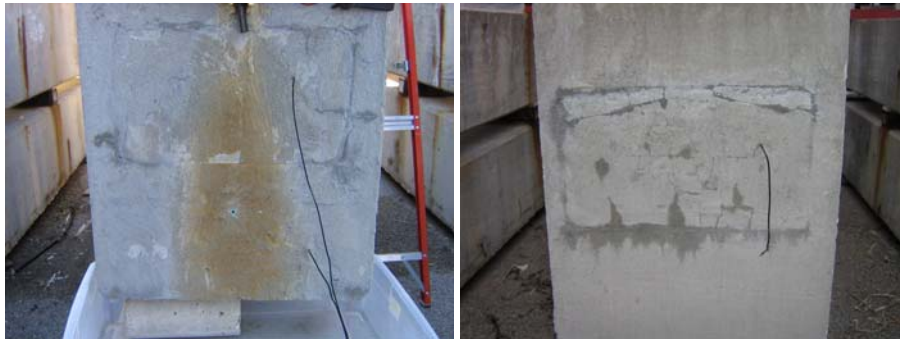
Figure 5.106: Beam 2.12 Anchorage Zones: East End Anchorage With Dripper (Left) and West End Anchorage Without Dripper (Right)

As shown in Figure 5.106, there was staining on the dripped end of the beam where the saltwater had exited from the dripping system. There was no staining on the west end anchorage. No shrinkage cracks were seen on the grout pockets in either anchorage zone. On the underside of the east end anchorage a network of cracks were observed above the 4x8 concrete cylinder used to stabilize the saltwater drip pan. The cracks spread up the sides of the end of the beam around 3 in.. The cracking is shown in Figure 5.107. This photograph was taken once the anchorage block was removed from the beam and flipped upside down. This cracking was likely caused by the same mechanism as the anchorage cracking in beam 2.9.

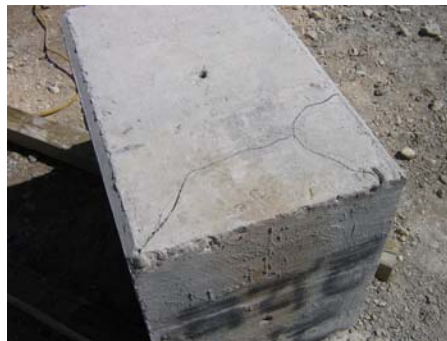
Figure 5.107: Beam 2.12-Cracking in East End Anchorage Zone

The maximum crack width in this crack network was 0.005 in.. This was measured on the side of the beam. However, there was no staining from any of the cracks.

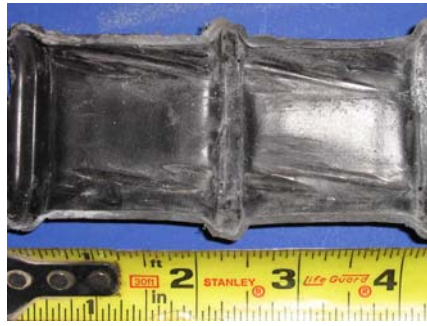
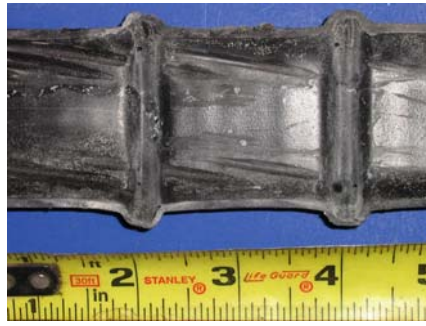
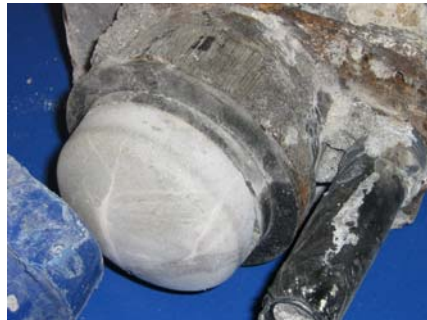
The portion of the south duct and north ducts within the anchorage were in good condition. Some evidence of strand abrasion was found on both ducts, but no punctures

or cracks were found in the ducts. The duct portions from the anchorage are shown in Figure 5.109. Corrosion damage ratings for the ducts are not plotted since they are plastic.

Both ducts were well grouted, and no evidence of bleed water accumulation was found. The grout completely filled the end caps in both ducts, and as previously mentioned, filled the area under the collar. Chloride content testing of the grout in both ducts showed negligible chlorides. Grout from the caps and the collars also showed negligible chlorides. The grout from both ducts are shown in Figure 5.109.

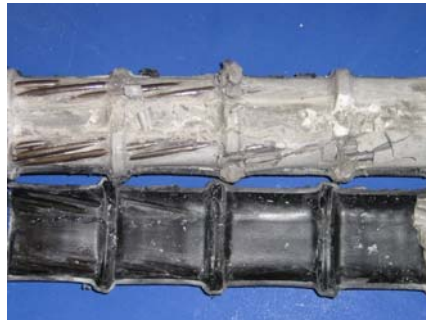
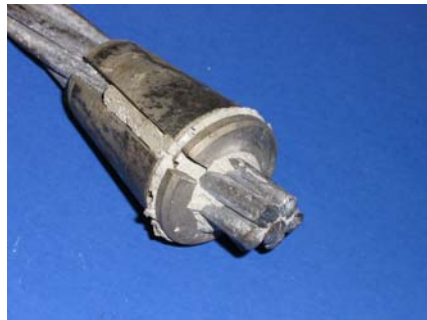
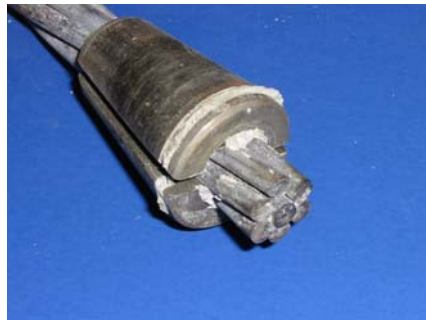
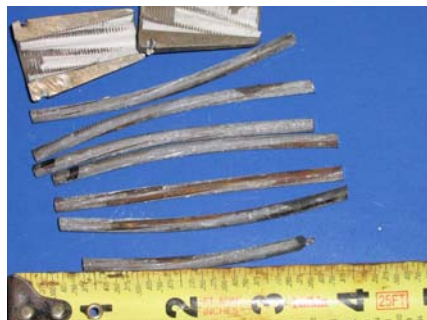
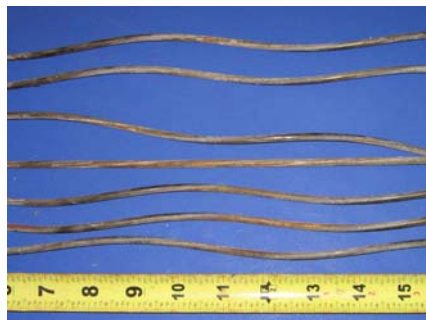
Figure 5.109: Beam 2.12 West End Anchorage (Control End) Autopsy Elements

The exterior of the strands from both ducts were in excellent condition, but when the strands were unraveled light to moderate corrosion was found in the interstices throughout the anchorage. What likely occurred was corrosion from the center of the beam spread down the length of the strand through the interstices. The wedges from both ducts had only some instances of slight discoloration inside the anchorhead. The strand from the anchorage is shown in Figure 5.109. The strand corrosion ratings in the anchorage are plotted in Figure 5.113 and are summarized in Table 5.21.

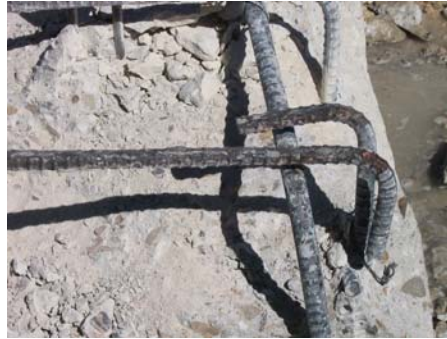
Figure 5.110: Beam 2.12-Corroded Stirrup in East End Anchorage Zone (Dripped End)

During autopsy of the end block containing the east end anchorages, moderate corrosion was found on the stirrups above the cracks in the anchorage as mentioned previously. The stirrup is shown in Figure 5.110.

The stirrup was likely corroded by saltwater splash from the drip pan when the dripper system was run, since the crack was directly beneath the stirrup and above the drip pan for the saltwater.

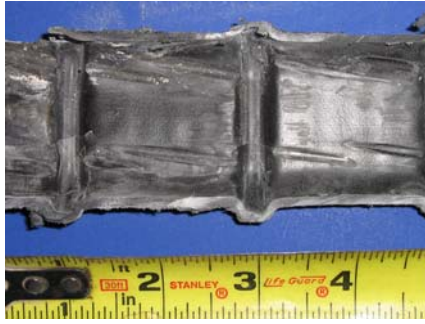
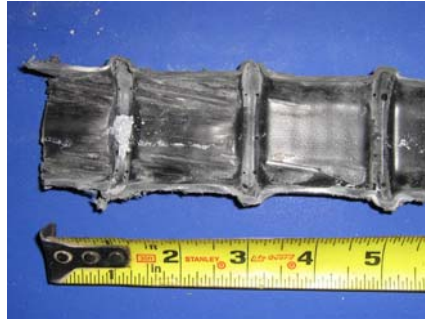
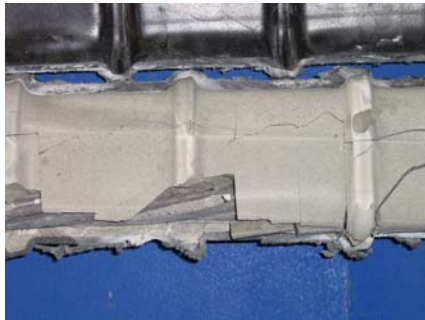
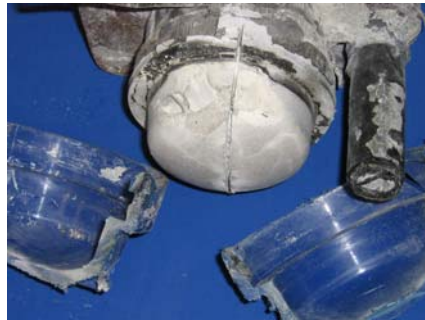
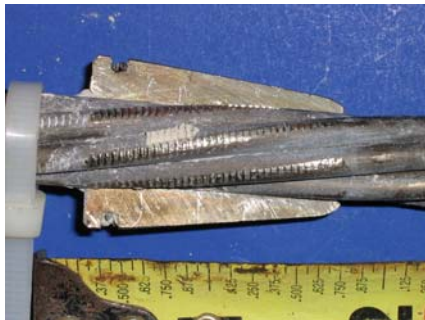
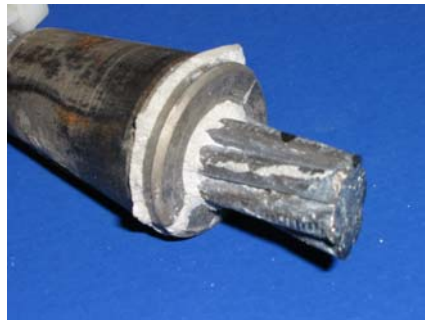
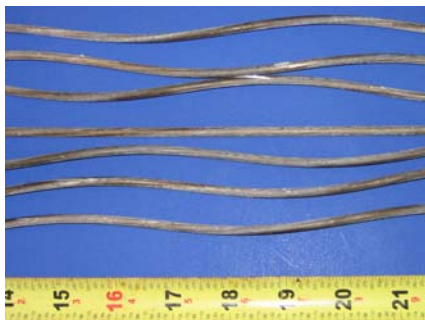
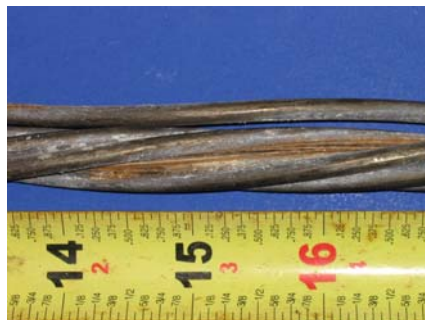
Figure 5.112: Beam 2.12 East End Anchorage Zone (Dripped End) Autopsy Elements

Both the north and south duct portions in the anchorage zone were in good condition. Evidence of abrasion in the plastic duct was found where the strands were in contact with the ducts, but no cracks or holes were found in the ducts. The ducts from the anchorage are shown in Figure 5.112.

beneath the collar was completely filled with grout in the north duct. Chloride content testing of the grout from the cap and collar as well as the duct showed negligible chlorides in both the north and south tendons. The grout from both tendons is shown in Figure 5.112.

The strands in both ducts had light to moderate corrosion, with the corrosion essentially only in the interstices, similar to the strand from the control end of the beam. The wedges in both ducts only had some very light corrosion. The strands from the anchorage are shown in Figure 5.112. The corrosion ratings for the strand in the anchorages are plotted in Figure 5.113 and are summarized in Table 5.21.

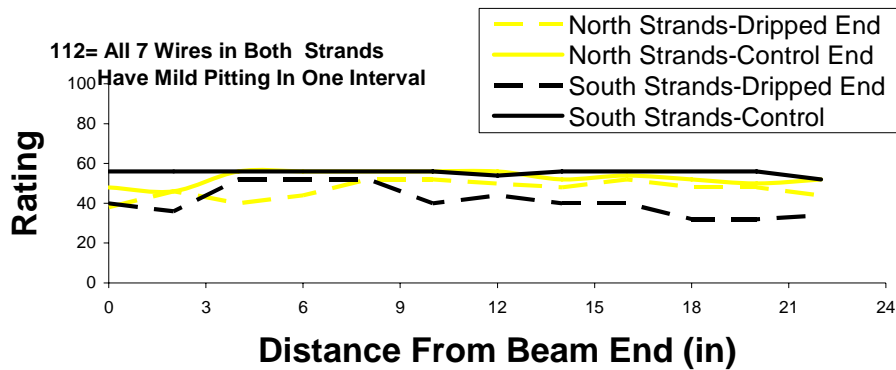
Figure 5.113: Beam 2.12-Strand Corrosion Ratings for Anchorages

In Figure 5.113 the strand corrosion ratings are plotted. Data from both beam ends are plotted together so that a comparison can be made between the dripped end and control end of the beam. It is assumed that the influence of the corrosion of the strands at the center portion of the duct had the same influence on either beam end. The x value “Distance From Beam End” indicates the distance from the respective beam end. The corrosion ratings for the anchorages are summarized in Table 5.21.

From Table 5.21 and Figure 5.113 it is clear that the strand corrosion did not increase between the control end and the dripped end. In addition, the lack of chlorides in both the caps and collars suggest that the encapsulated system prevented chlorides from entering the duct at all. In addition, the tips of the strands outside the anchorhead in both ends of the beam were in much better condition than the strand tips in the non-encapsulated anchorages (Beam 2.7 and Beam 2.9).

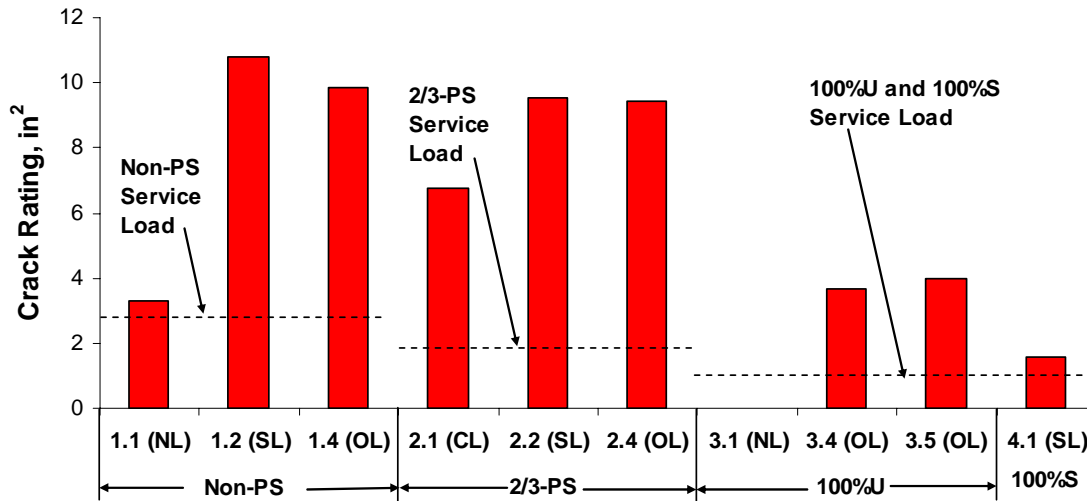
Figure 6.1: Phase I Beams- Crack Ratings

In all loaded beams except 4.1 (100% S) the crack ratings are much higher than the baseline, due to the extensive longitudinal cracking from the duct and bar corrosion. Beam 1.1, which was never loaded, actually exceeded the crack rating for service load just from the effect of the bar corrosion. When comparing specimens with similar loading, it is clear that the long-term cracking was only reduced for the beams that were fully prestressed (100% U and 100% S), since the loaded Non-PS beams and the loaded 2/3-PS beams had essentially the same level of cracking.

When comparing specimens with the same levels of prestress, it is evident from the 2/3-PS beams and the Non-PS beams that once the specimen reaches service load cracking levels there is no real difference in the long-term cracking behavior. However, the 2/3-PS specimen which was initially loaded to only a small crack width did have a considerably lower long-term cracking rating. Even though all the 2/3-PS specimens had wide longitudinal cracks, the somewhat lower rating in this beam was caused by the fact that the flexural cracks were smaller in width than the other 2/3-PS beams.

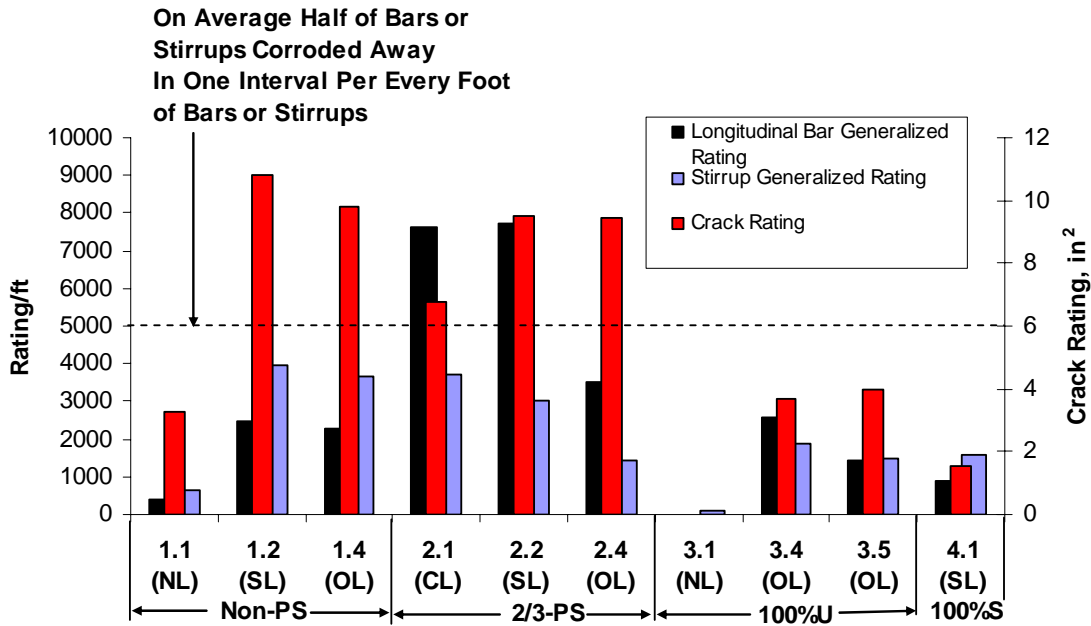
Figure 6.2: Phase I Beams- Stirrup and Longitudinal Bar Generalized Ratings vs. Crack Ratings

Figure 6.2 shows that when comparing specimens with same level of applied load, the stirrup and longitudinal bar damage was substantially less for fully prestressed specimens. The high ratings in the 2/3-PS beams are caused by the fact that the #3 bars were completely corroded away in many locations. The damage was not as severe in the Non-PS beams because the bars were larger (#4's and #5 bars).

Increasing the initial level of loading did not have any appreciable effect on the bar or stirrup damage in the Non-PS or 2/3-PS beams. Of course, the unloaded Non-PS beam (1.1) had little damage due to the lack of an applied load.

Only in the Non-PS beams do the crack ratings follow the trend of the bar corrosion. In the prestressed beams the duct corrosion as well as bar corrosion are contributing to the longitudinal cracking. This explains why the crack ratings do not follow the trend of bar damage in the prestressed beams.

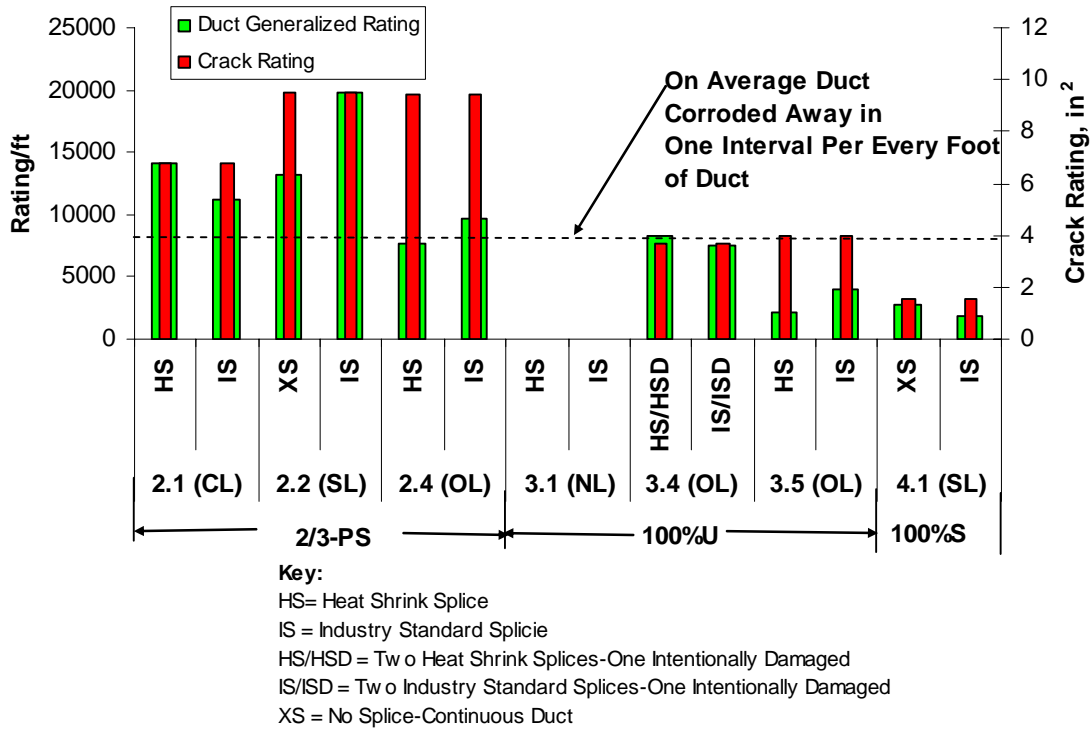
Figure 6.3: Phase I Beams-Generalized Duct Ratings (Organized by Splice Type)

When comparing specimens/ducts with similar loadings and with the same splice types, it is clear that the amount of damage in the ducts clearly decreased once the beam was fully prestressed.

Increasing the level of loading, which can be only be analyzed with the 2/3-PS beams, had no significant effect on the amount of damage in the duct.

There is no trend between the crack ratings and duct corrosion when comparing beams with similar levels of prestress. This is likely from the fact that bar corrosion, not just duct corrosion, is attributing to the cracking.

It is also clear the presence of the splice was not a significant factor in the amount of duct corrosion, since large portions of duct were corroded away even in areas where there were no splices.

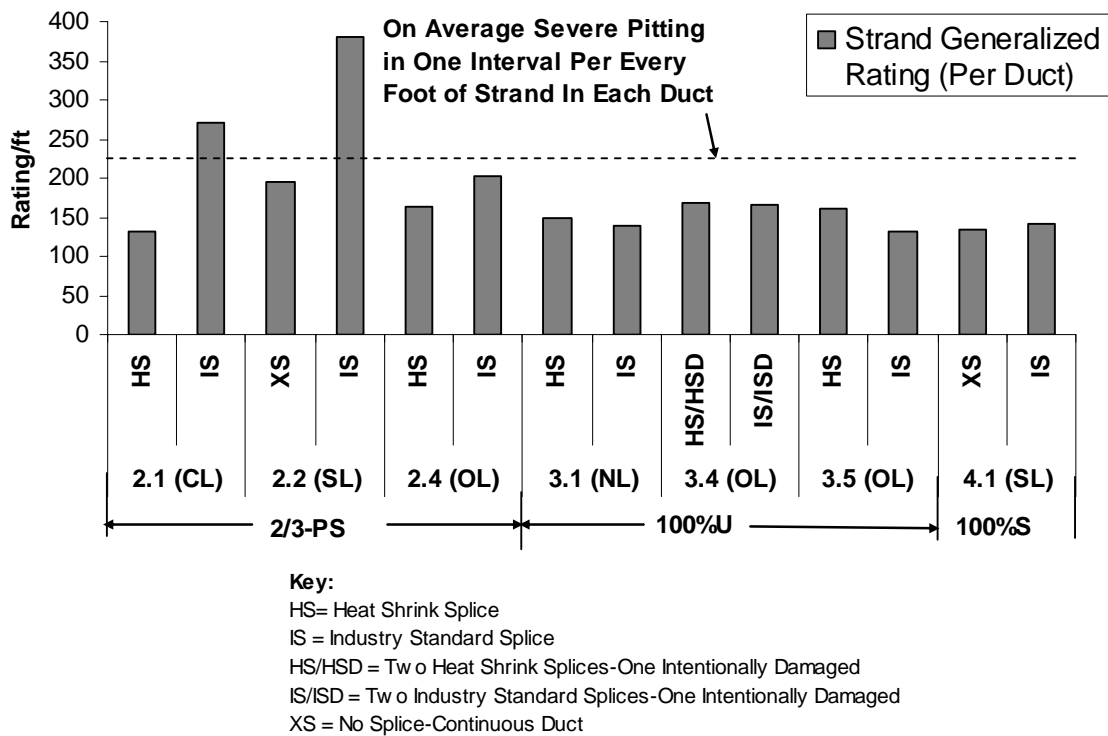
Figure 6.4: Phase I Beams-Strand Generalized Ratings

In Figure 6.4, when ducts with similar loadings and splices are compared, there is in general a decrease in strand corrosion with increased levels of prestress. This is especially true when comparing beams 2.2 and 4.1. However, when comparing the specimens at overload, beams 2.4 and 3.5, there is no difference between the ducts with the heat shrink splices. In general, the differences in strand corrosion are not as dramatic as the differences in bar and stirrup and in duct corrosion. Given the large amount of interstitial corrosion in the strands (mentioned in Chapter 5), it is likely that once a single part of the strand is corroded then the chlorides can be transmitted through the interstices and thus corrode the entire length of strand. .

When comparing the identical ducts in the 2/3-PS beams, there is no clear trend between strand damage and the level of applied load.

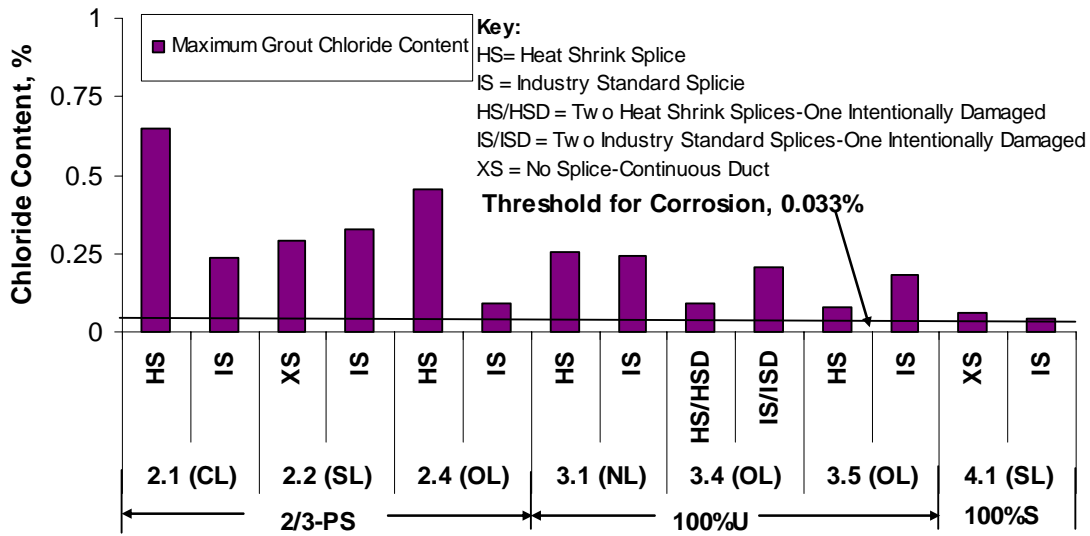
Figure 6.5: Phase I Beams-Maximum Grout Chloride Content in Each Duct

As shown in Figure 6.5, and as mentioned repeatedly in Chapter 5, the maximum chloride contents in all the tendons were higher than the threshold for corrosion of 0.033%. Therefore, any differences between specimens with similar loadings or prestress are inconsequential.

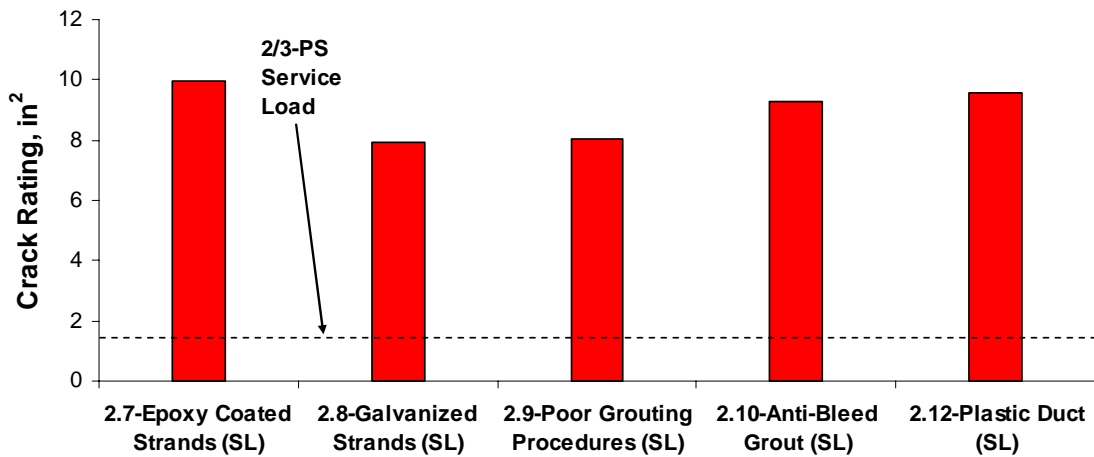
Figure 6.6: Phase II Beams-Crack Ratings

As shown in Figure 6.6, all the Phase II beams exhibited similar very poor long-term cracking behavior. Their cracking behavior is comparable to the 2/3-PS service load beam from Phase I (Beam 2.2).

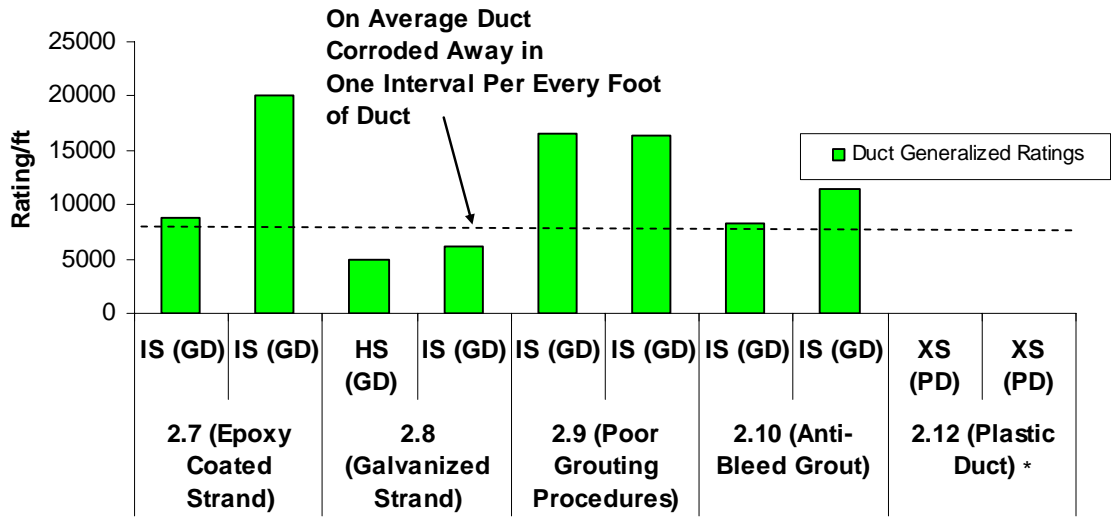
Figure 6.8: Phase II Beams-Duct Generalized Ratings

As shown in Figure 6.8 and as was found previously with the Phase I beams, the galvanized ducts performed extremely poorly. As mentioned in Chapter 5, the plastic ducts in beam 2.12 were punctured due to mechanical failure. As shown in Figure 6.9 this resulted in greater strand damage than with the comparable specimen with galvanized duct, beam 2.9 (The proper comparison is with beam 2.9 since it has the same grout type in addition to conventional strand). As shown in Figure 6.10 the chloride content in the plastic duct specimen was still lower than the threshold for corrosion. As explained in Chapter 5, this is likely from the fact that the chlorides entered the strand almost directly through the punctures and as a result only a small amount of chloride may have been deposited into the grout. This puncture problem had been noted previously in the industry. One solution proposed to alleviate this problem is to use metal cradles between any bracing bars and the plastic duct.²¹ However, a metal cradle could corrode in an aggressive environment, so placing sturdy rubber or plastic pads between the duct and any bracing bars may be a better solution. In addition, in previous research done under TxDOT Project 0-4562 in 2004/2005, Luthi, Diephuis, and Icaza⁶ performed pullout and friction tests on industry standard HDPE (High Density Polyethylene) plastic ducts with very small radii of curvature (as little as 10 ft). These plastic ducts were larger in thickness and diameter than those used in this study and would thus be more typically of those widely used in bridge applications. After testing, the ducts were removed and examined. In their study somewhat similar “grooves” were observed in the plastic ducts.

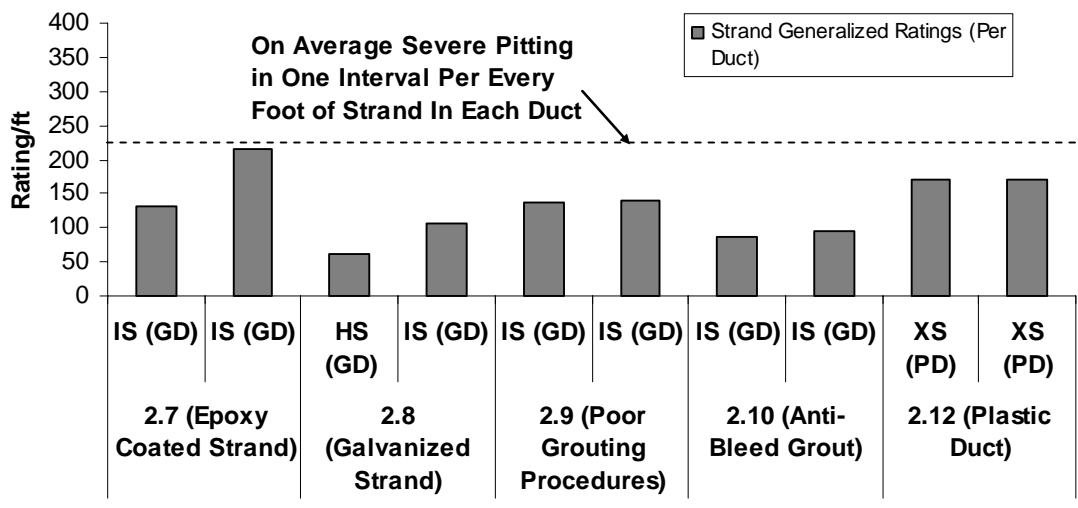
Figure 6.9: Phase II Beams-Strand Generalized Ratings

As shown in Chapter 5 and clearly shown in Figure 6.9, the non-flow filled epoxy coated strand used in this study performed poorly in comparison to conventional strand (this comparison is made between beams 2.7 and 2.9 since both have the same type of grout). Abrasion damage to the brittle epoxy coating as a result of prestressing operations allowed chloride ingress onto the strand surface. Because the coating did not also fill the interstices of the strand, the moisture was able to spread throughout the length of the strand. The damage might have been minimized if the epoxy had filled the interstices, so called “flowfilled” epoxy strand. It would also be preferable if the epoxy had better mechanical properties to resist abrasion and wedge tooth penetration.

As presented in Chapter 5 and as shown in Figure 6.9, galvanized strand performed only slightly better than conventional strand. Thus it still performed poorly. The presence of the galvanized coating only delayed the onset of corrosion.

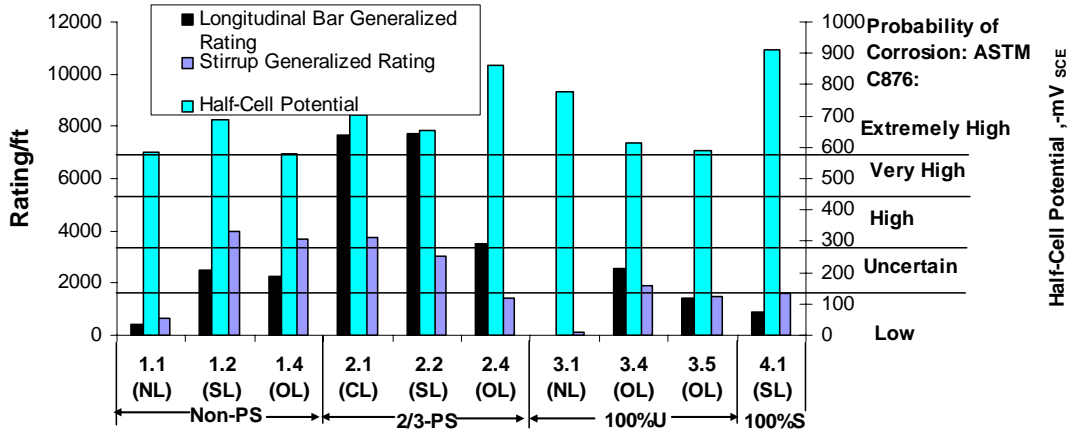
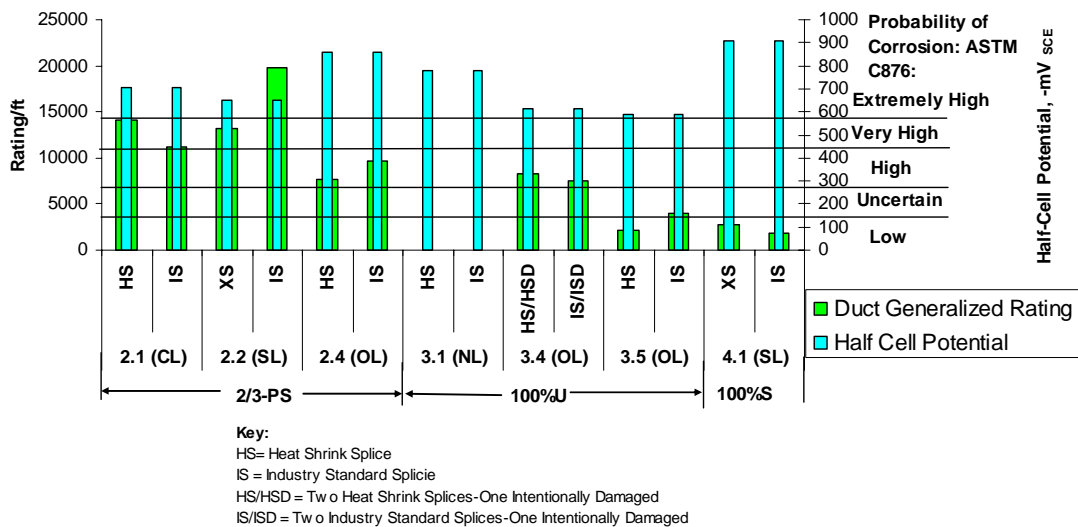
In Figure 6.11 and Figure 6.12 the half-cell data essentially indicate a greater than 90% probability of corrosion (extremely high probability) for all beams. Indeed, all bars, stirrups, and ducts were at the very least significantly corroded in all specimens. Thus, the half-cell potentials were correct in this matter. However, it is also clear that half-cell readings do not give a good estimate of the relative corrosion damage in the specimens. This is exemplified in Figure 6.11 by beams 3.1 and 4.1, where the relative bar and stirrup damage was low but these two beams had some of the highest half-cell potential readings. This is also true Figure 6.12 for the duct ratings for these beams as well. Only in the Non-PS beams do the half-cell data show the same trend as the stirrup and longitudinal bar data. This is significant because the bars and stirrups are the only elements corroding in the Non-PS beams since the Non-PS beams have no tendons. Since the galvanized ducts are in metal to metal contact with reinforcing bar cage in the prestressed specimens, a circuit is formed between the tendons and the bars and stirrups. Thus there is a large amount of interaction which may be causing the behavior shown in the half-cell potential data. The reinforcing bar, stirrup and duct ratings for the Phase II beams are plotted with the half-cell potential data in Figure 6.13.

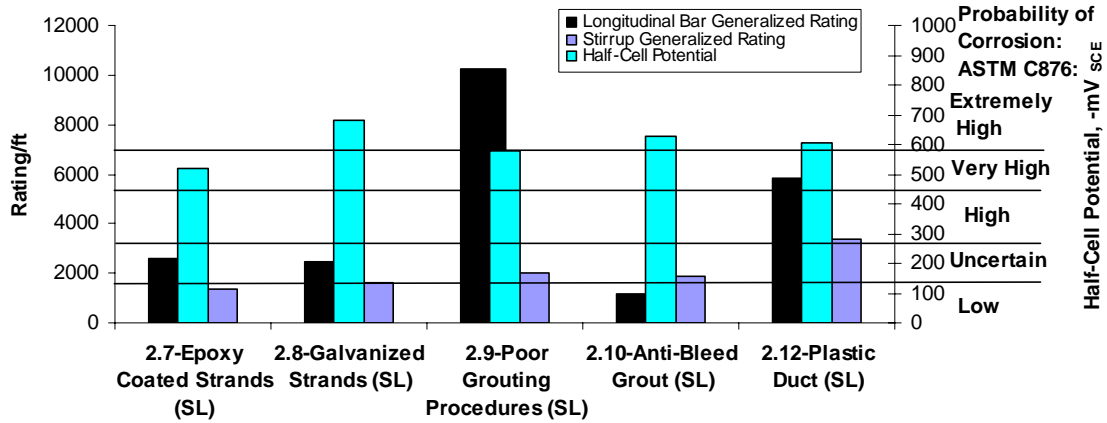
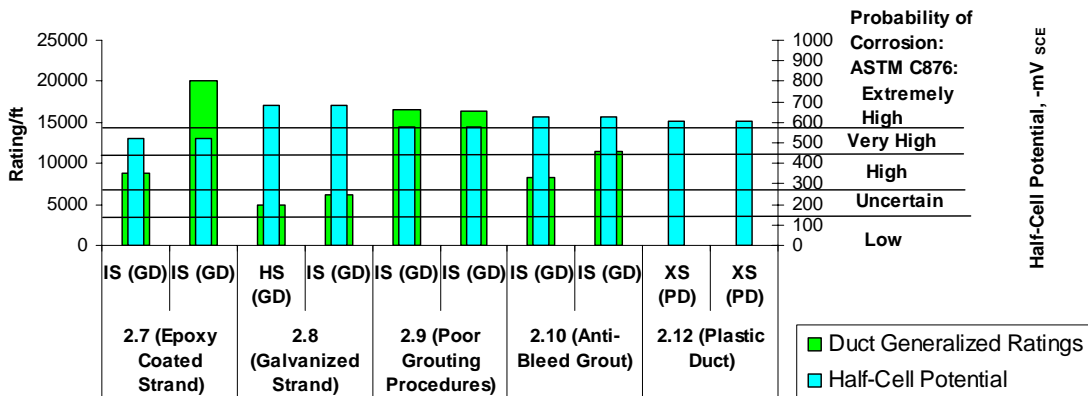
In Figure 6.13 all the half-cell potential data from all phase II beams suggested at least a very high probability of corrosion for all beams (All beams except for 2.7 were in the extremely high range). Indeed, the stirrups and the bars in all the beams were heavily corroded. So using the half-cell data to conclude that corrosion was present was accurate. However, there is no clear trend between the amount of the bar and stirrup corrosion damage and the half-cell potential readings. Careful examination of Figure 6.14 reveals that in general the half-cell potential data actually decreased (in absolute value) with increased duct corrosion, but only slightly. All the galvanized ducts in the Phase II beams were heavily corroded at the end of testing. Of course, beam 2.12 (plastic ducts)

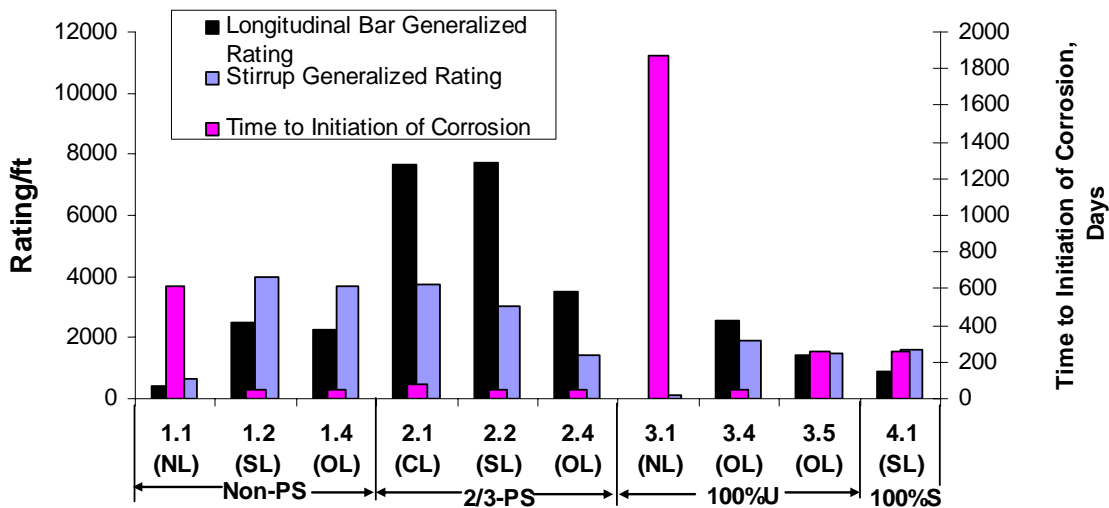
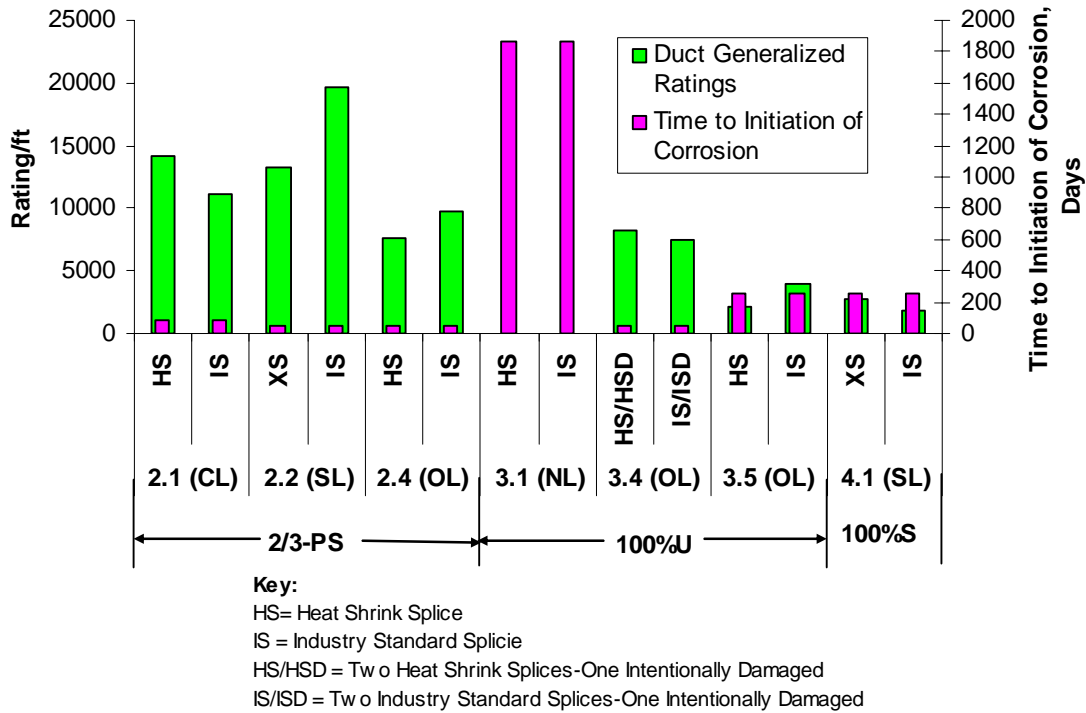
As stated in Chapter 4 and as shown in Figure 6.15 and Figure 6.16, the two unloaded beams (1.1 and 3.1) showed much longer times to initiation of corrosion than the other specimens. In the case of the 2/3-PS beams, maintaining the load at small crack levels delayed the onset of corrosion. Also, the time to initiation of corrosion was significantly delayed when the beams were fully prestressed (the service load and overload Non-PS beams and 2/3-PS beams began corroding at the same time). It is clear from Figure 6.15 and Figure 6.16 that the delay in the time to initiation of corrosion had no real effect overall on the final amount of corrosion in the beams. Of course, beams 1.1 and 3.1 had little corrosion due to the lack of cracking due to an applied load, which also delayed the onset of corrosion. This is not surprising considering the fact that all the loaded beams began to corrode within 1 year, which is insignificant considering that the length of exposure testing was a little over 8 years. In Figure 6.17 the Phase II beam stirrup and longitudinal bar ratings are plotted along with the time to initiation of corrosion.

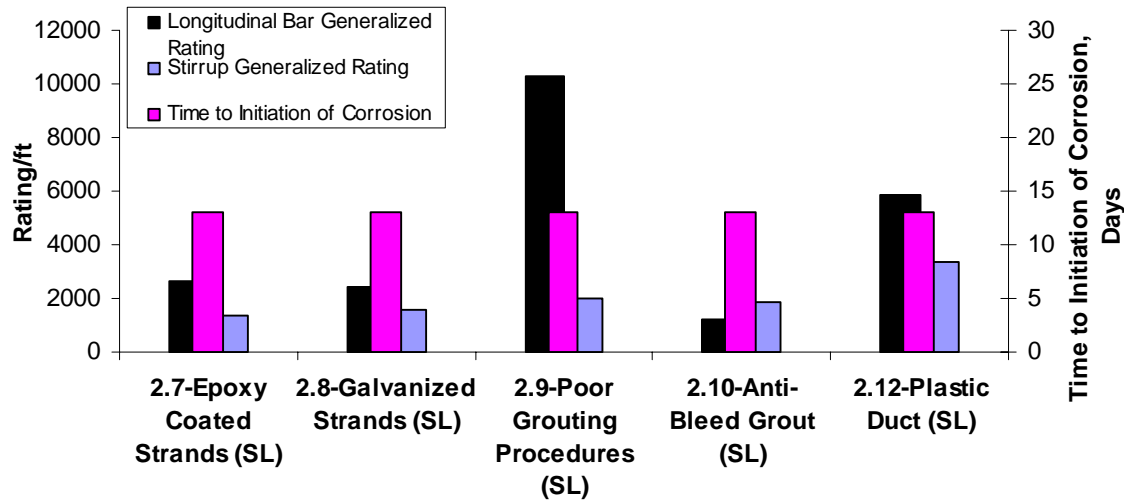
Figure 6.17: Phase II Beams-Stirrup and Bar Generalized Ratings vs. Time to Initiation of Corrosion

As mentioned in Chapter 4 and shown in Figure 6.17, all the Phase II beams indicated corrosion when the first set of readings were taken at 13 days. The bar and stirrup ratings varied among the specimens (as well as the duct ratings, shown in Figure 6.8), but all were very severe. This also suggests that the time to initiation of corrosion in cracked loaded beams has no effect on the final amount of corrosion, since the time to initiation of corrosion among the Phase II beams was the same but the bar, stirrup and duct ratings, while all severe, still varied. Indeed, the time to initiation of corrosion, 13 days, is extremely insignificant when considering the testing time of nearly 8 years.

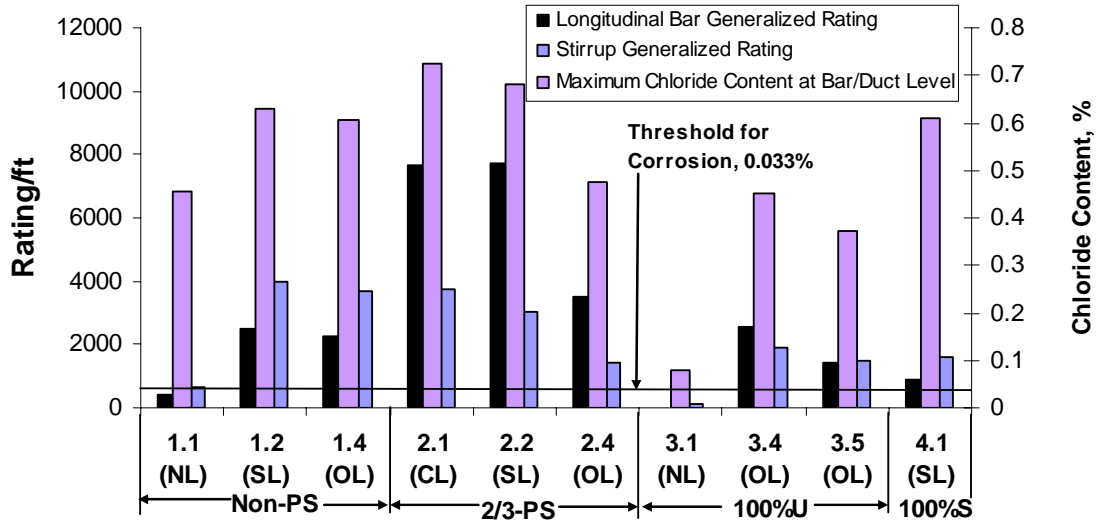
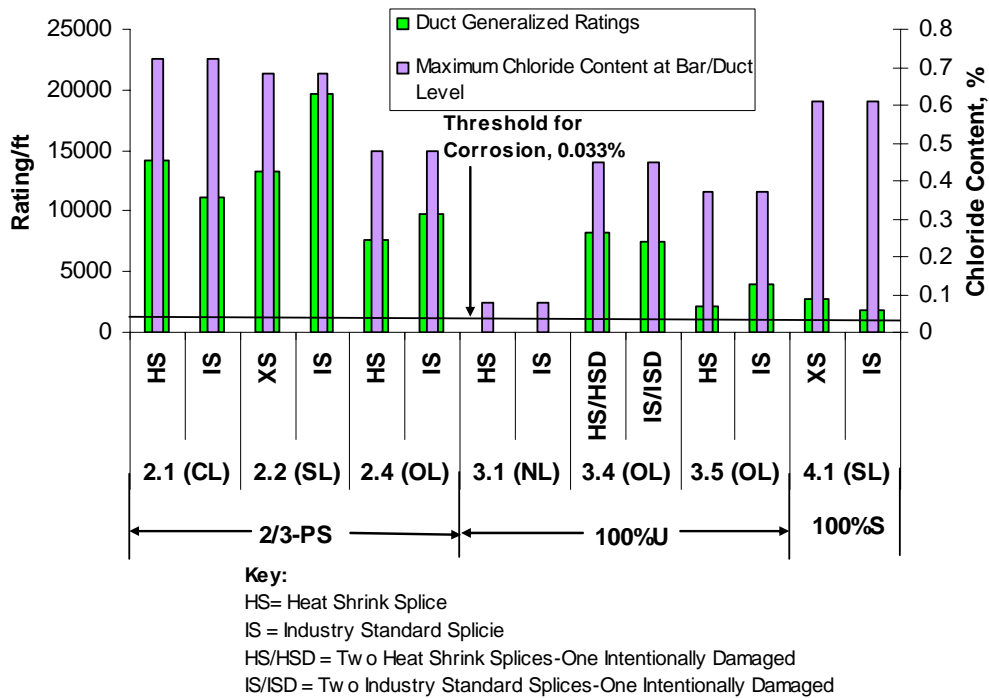
As shown in Figure 6.18 and Figure 6.19 , and as mentioned in Chapter 4, the threshold for corrosion was reached at bar/duct level in the ponded region in all beams. During autopsy the bars and stirrups in all beams were found to be severely corroded.
