**Durability Evaluation of Post-Tensioned Concrete Beam Specimens
After Long-Term Aggressive Exposure Testing**

Thesis

Master of Science in Engineering

The University of Texas at Austin

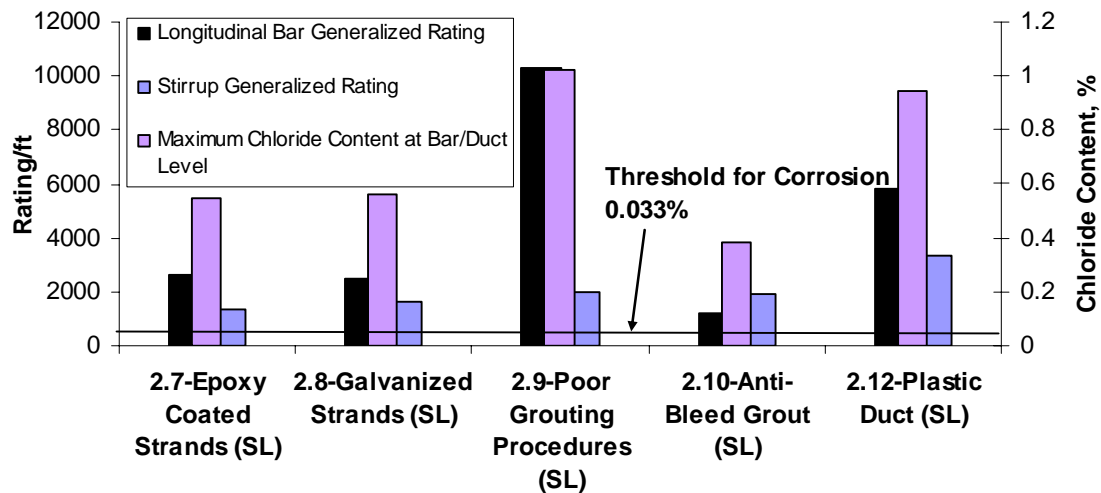
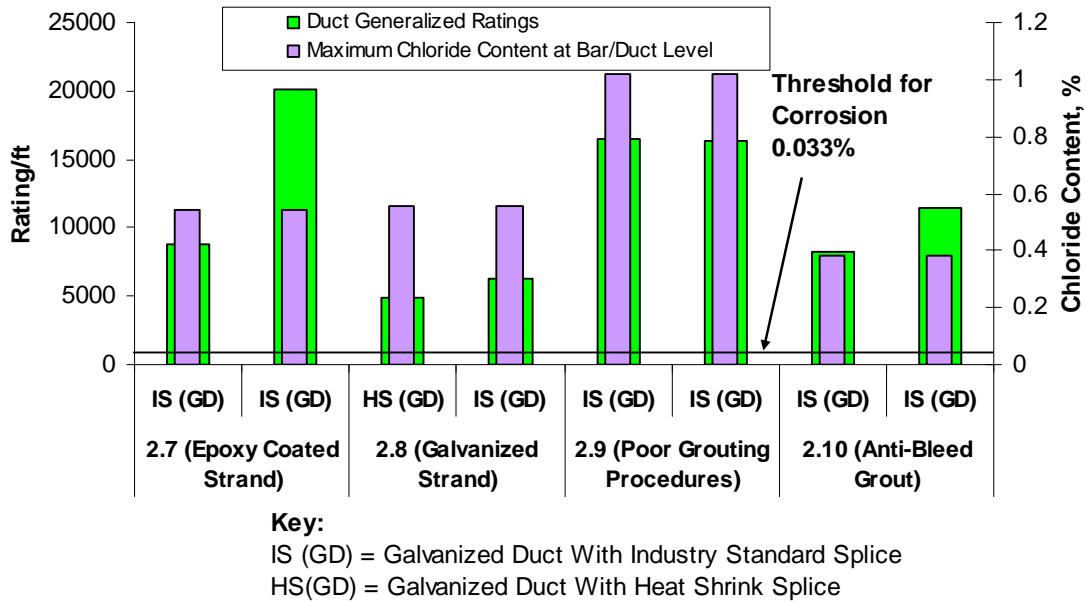
Again, the threshold for corrosion was reached in all beams and severe bar, stirrup and duct corrosion were found. It is interesting to note in Figure 6.20 that the relative bar ratings coincide with relative chloride content. However, the stirrups do not. In Chapter 5 it was noted that in the Phase II beams flexural cracks would formed at stirrup locations. So the stirrups are corroded by chlorides entering at the flexural cracks for the most part. The fact that the relative values of the chloride contents and the longitudinal bar ratings coincide further suggests that concrete permeability, not just flexural cracks, was playing a major role in the corrosion damage of each beam after the long period of exposure.
