**Testing of Emergency Wood Shoring Towers for use in Urban Search  
and Rescue Operations**

**Thesis**

**The University of Texas at Austin**

**May 2012**

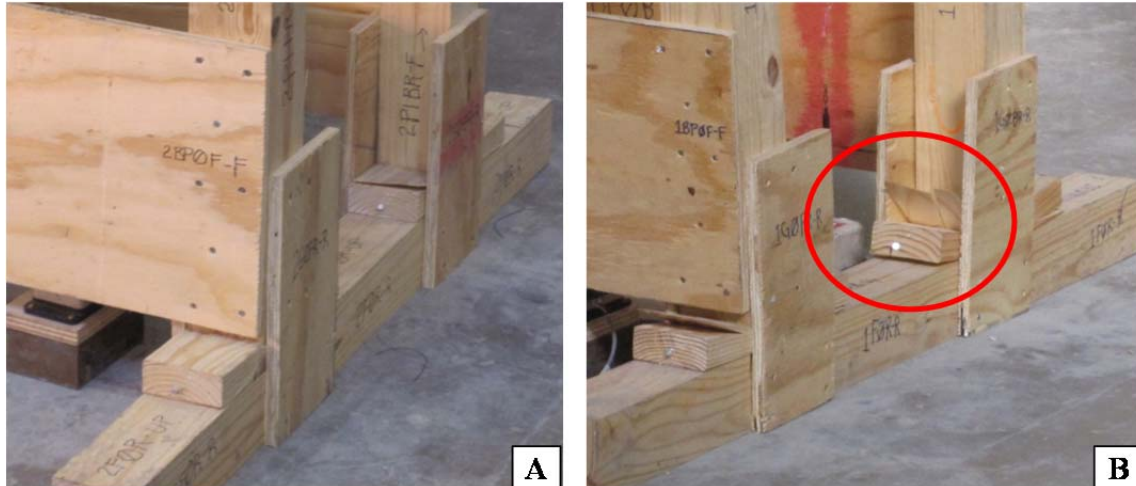
The wedges, located at the base of each of the four posts can be used as an emergency fuse. These wedges will often “cup” or bow upwards as the load in the post increases. The presence of and amount of cupping can alert US&R individuals that the shore is experiencing loading that may be approaching the capacity of the shore. Figure

**Figure 4.13** Photographs of Cupping Wedges A) Initial Cupping Under Smaller Loads  
B) Extreme Cupping Under High Loads

It can be seen in Figure 4.13-B that a set of wedges under one post can cup significantly more than under another post in the same shore. In some cases, cupping may not be significant in any set of wedges under extreme loading. These observations will be discussed in greater detail in Chapters 5 and 6.

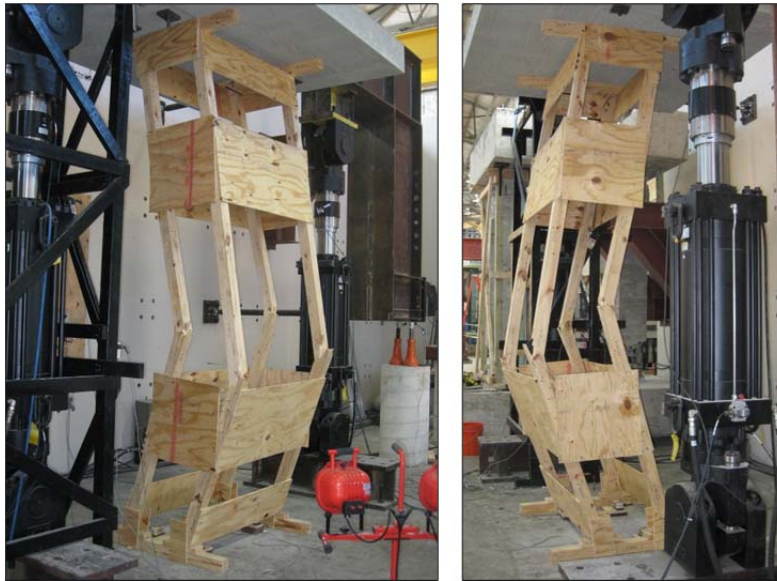
Prior to failure, all four posts began to bow outward towards the front. The first failure occurred at a knot in the back right post at approximately the midpoint between the intermediate braces at a total vertical load of 65kips. The front right post also cracked around a spike knot just above the lower intermediate brace at 65kips and progressively split as loading continued. At approximately 32kips, the two left posts simultaneously failed at knots. This load progression is presented using the load-displacement curve in Figure 5.3. Photographs of the failures are also provided.

**Figure 5.5** Final Failed Condition at the End of Test 1

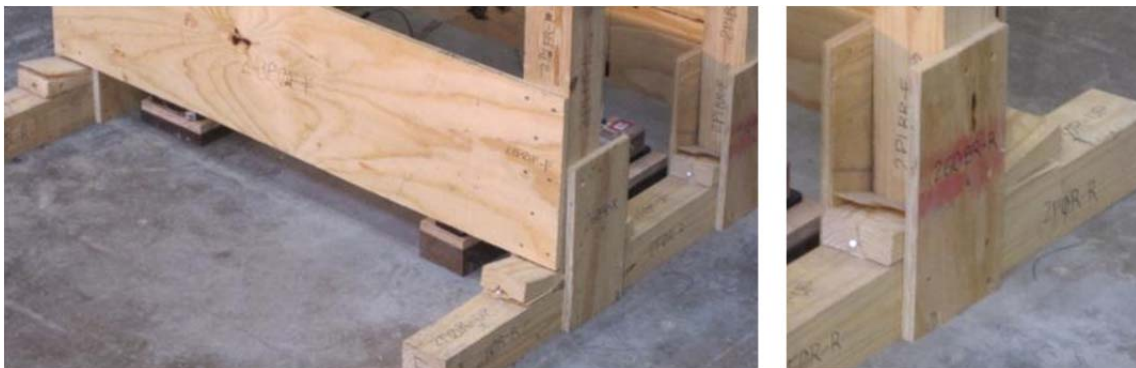
During testing, audible creaking and cracking of wood could be heard starting at 20kips and continuing to failure. These noises intensified in magnitude and frequency as the applied load approached the peak value. Cupping of the wedges initiated at around 65kips and widened as the test progressed. Cupping of each set of wedges was very uniform and consistent between all four sets. Figure 5.8 shows the performance of the wedges.

**Figure 5.8** Test Specimen 2 Wedge Cupping

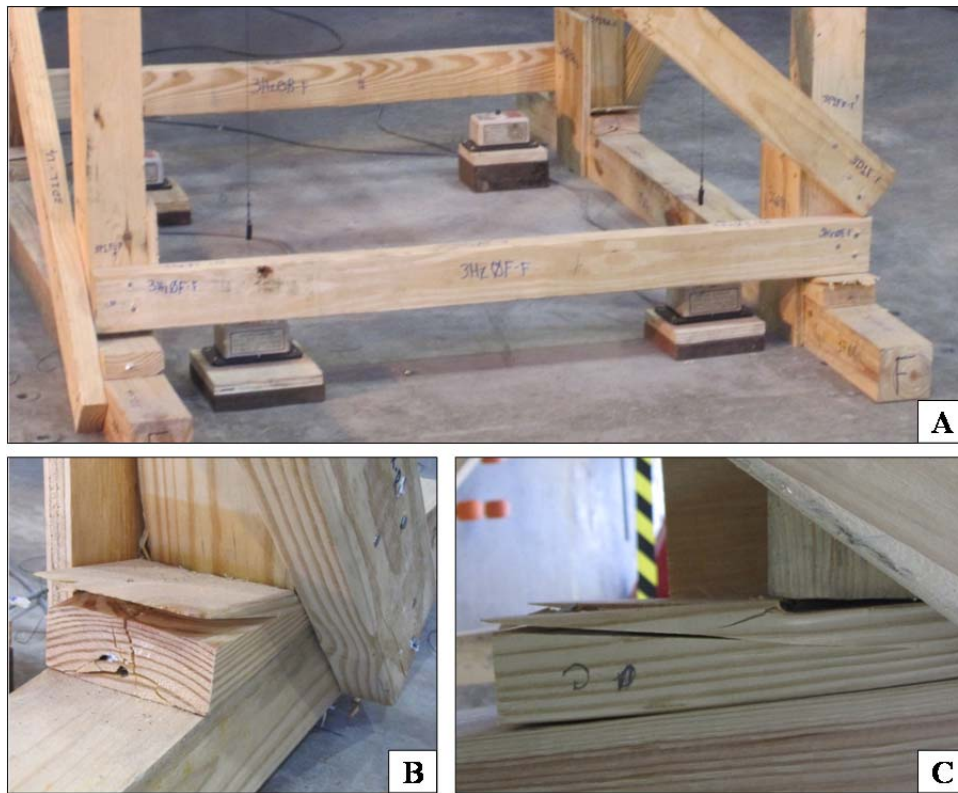
During testing, creaking of the wood could be heard as early in the loading process as 17kips, and increased in frequency and magnitude at loads above 50kips. At 50kips, cupping of the back right wedge was noticeable, and cupping of the back left wedge was slightly noticeable, but did not progress a significant amount during loading. Cupping of the front two pairs of wedges was noticeable around 75kips. The performance of the wedges is shown in Figure 5.14.

**Figure 5.14** Specimen 3 Wedge Photos A) Cupping at Approx. 60 kips B) Back Right Wedge at End of Test C) Front Left Wedge Cupping and Post Bearing

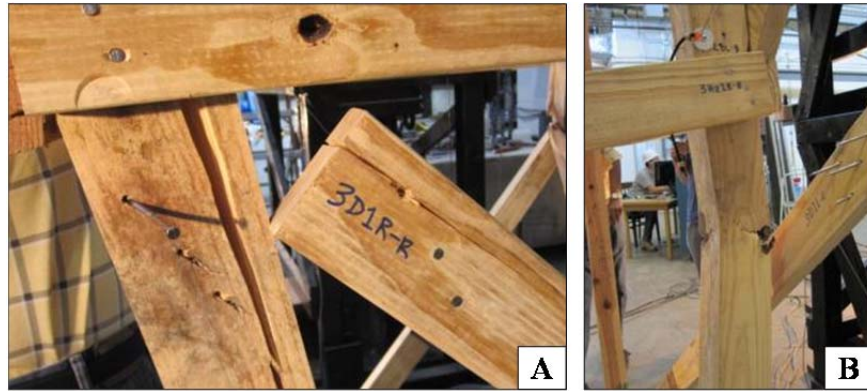
**Figure 5.19** Connection Failure Photographs A) Nail Pullout from Split Brace B) Nail Pullout from Post

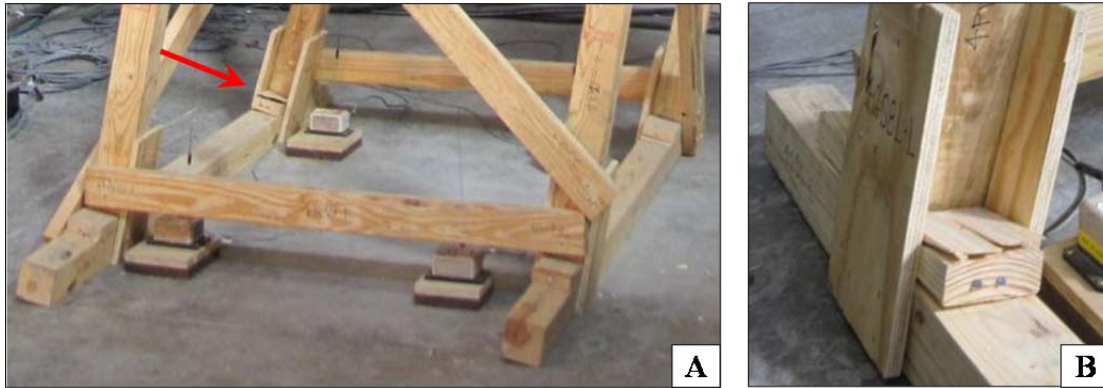
wedges was very minor throughout the duration of the test. Only the back left set of wedges appreciably cupped, as shown in Figure 5.20.

**Figure 5.20** Specimen 4 Wedges A) Wedges at Failure B) Back-left Wedge Cupping

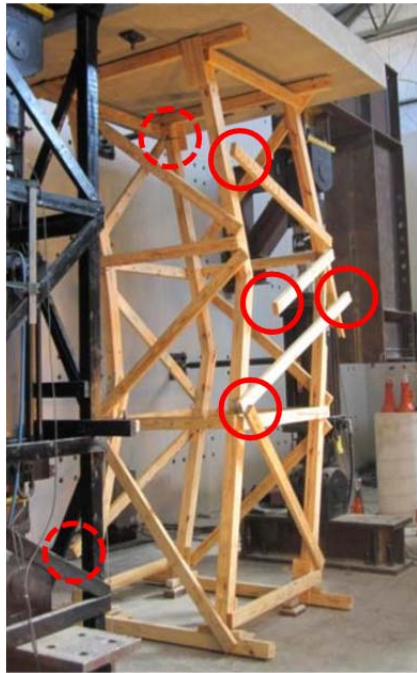
With the buckling action to the right, the majority of the braces on the front and back sides failed at their connections. All connection failures were characterized by nail withdrawal from the post, and did not include nail pull through by means of a split in the 2x4 brace, as was seen in Specimen 3. Complete brace connection failures included all of the diagonal braces on the front face, the second level horizontal brace on the front (4Hz2F), level 1 diagonal on the back (4D1B) and level 3 diagonal on the back (4D3B). Partial nail withdrawal locations were also observed on many of the other braces including those on the left and right sides. Figure 5.24 shows the six complete connection failure locations, and Figure 5.25 presents examples of these failures.

**Figure 5.24** Locations of Connection Failures on Specimen 4

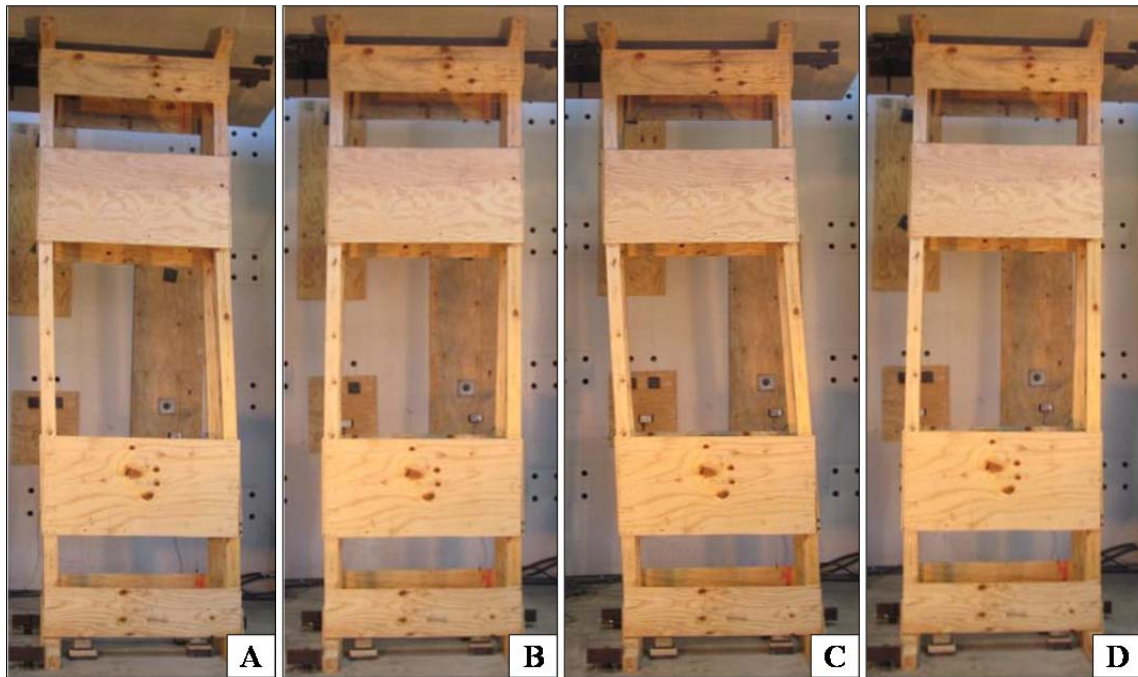
A series of four photographs showing the four lateral displacement amplitudes is provided in Figure 5.27. Double curvature in the posts can be seen as the top of the shore moved laterally while maintaining a level loading head. Steel lateral braces installed at the headers and soles prevented the shore from sliding during testing.

**Figure 5.27** Specimen 5 Displacement Phases A) 2in Left B) 2in Right C) 4in Left  
D) 4in Right

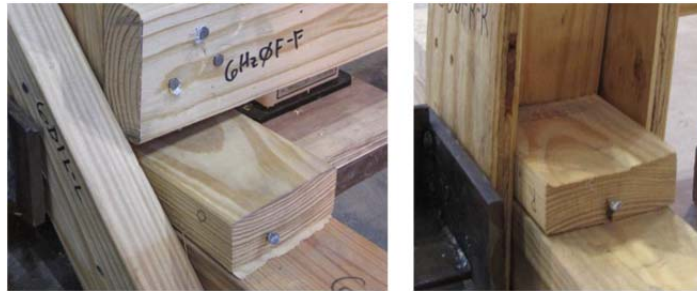
Wedge cupping was relatively absent throughout the entire loading sequence. Splitting of the wedges was also not observed, as was common in other tests. Figure 5.35 shows the condition of the wedges at the conclusion of the test.

**Figure 5.35** Condition of Wedges after Loading

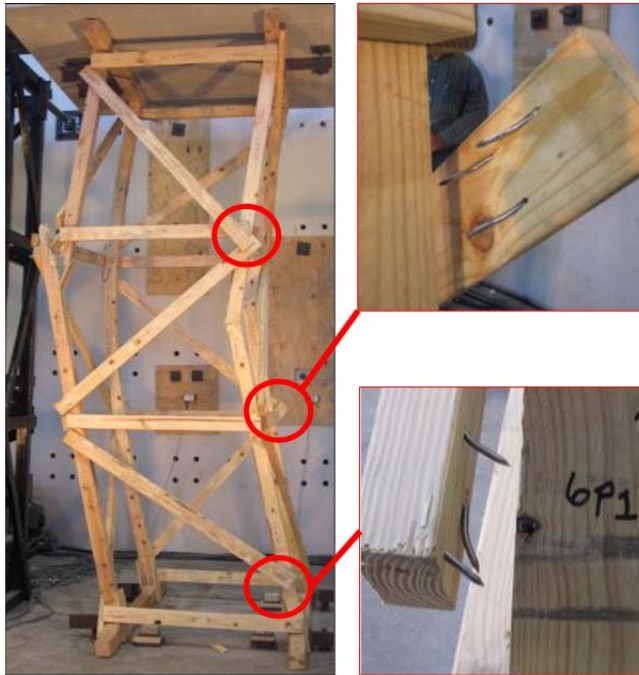
Three 2x4 braces failed via nail withdrawal from the post. These braces locations are shown in Figure 5.40. Numerous other braces experienced partial withdrawal failures, in particular, around the regions of post failure.

**Figure 5.40** Brace Failure Locations

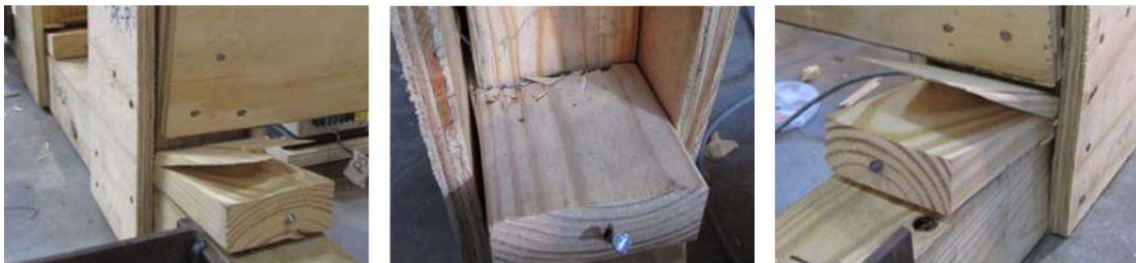
Wedge cupping was noticeable under all four posts, initiating at approximately 80kips. Splitting of the wedges was also observed, in particular, at the location of the toe-nail. Significant bearing of the post into the wedges was observed in the post-test autopsy, as seen in Figure 5.41.

**Figure 5.41** Wedge Cupping and Bearing Under Posts During Loading

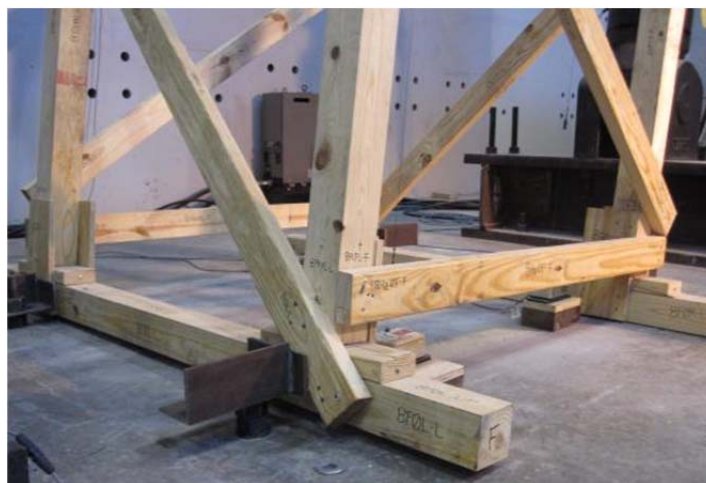
Throughout both the lateral displacement phase and vertical loading phase, no cupping of any of the four pairs of wedges was witnessed. Shown in Figure 5.46 is the status of the wedges at 15in. displacement under vertical load.

**Figure 5.46** Photograph of Wedges at 15in. Displacement

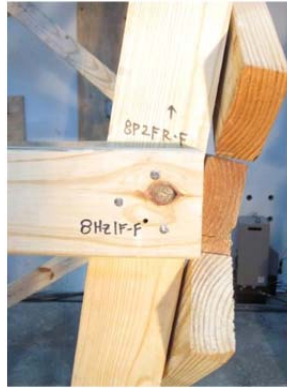
The horizontal braces did not disconnect from the posts, however considerable rotation at the joint can be seen. Figure 5.52 shows a close up of the first level horizontal brace connection at the front right post. The angle between these members is no longer 90 degrees, but the brace connection did not pullout.

**Figure 5.52** Photograph of 1<sup>st</sup> Level Front Right Joint

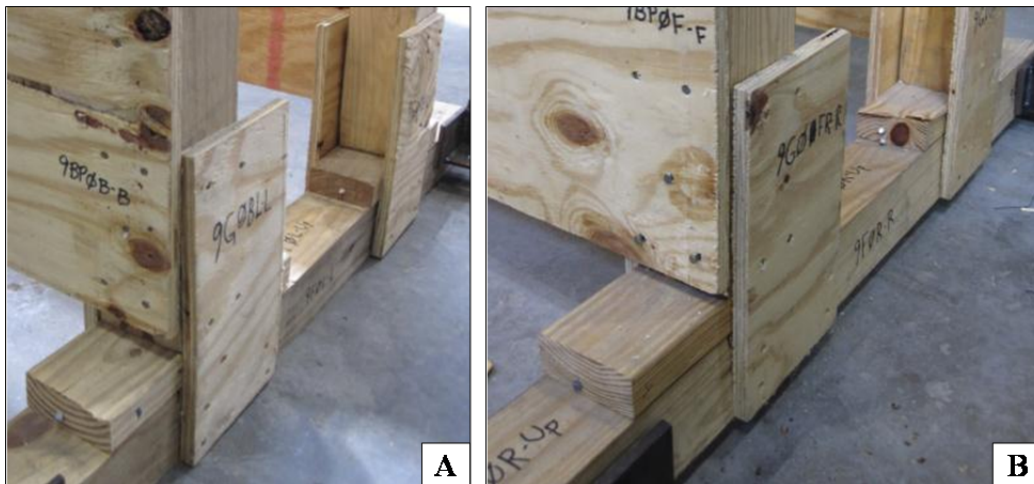
Cupping was not observed during either phase of loading. The back right wedge had a slight gap between the two wedges in the set, but was not significant enough to be considered a fuse.

**Figure 5.53** Photographs of Wedges A) Left Side B) Right Side

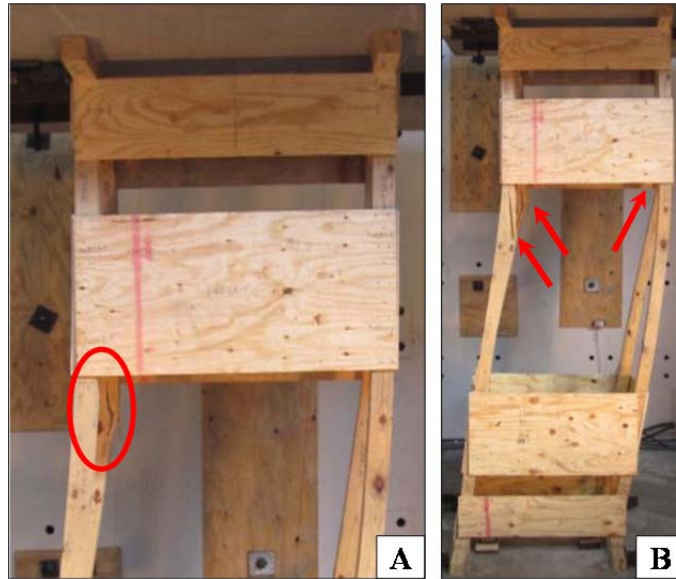
At approximately 14.9in of lateral displacement, the back left post split around a knot near the second level of bracing. The vertical load of 32kips was maintained after the split, and the full 15in. of displacement was attained. Therefore the displacement was held constant and vertical load was increased until complete failure of the shore was achieved. Shown in Figure 5.54 and Figure 5.55 are the vertical load-displacement curve and lateral load-displacement curve for specimen 9. The vertical load-displacement curve depicts both phases of the test, constant load during lateral movement and increasing load during constant 15in. displacement.

Once the 15in. lateral limit was reached the shore was vertically loaded while the 15in. lateral displacement was held constant. Just prior to reaching 45kips, the back right post began to split and fail within the second level brace region. As the loading was maintained, the splits in both the back right and back left posts increased in magnitude until the front left post failed, concluding the test. Figure 5.57 shows the initial failure at 14.9in. lateral deflection, and the final condition of the shore.

**Figure 5.57** Post Failure Locations A) Initial Failure During Lateral Displacement B) Final Shore Condition

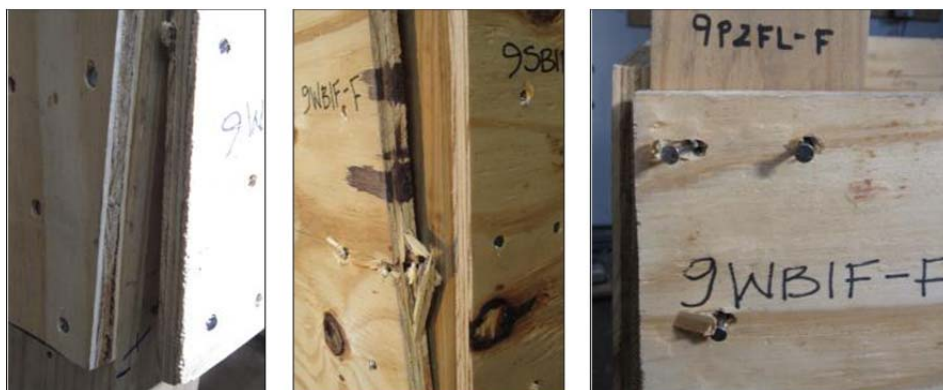
The plywood braces and their respective connections performed well. Only minor nail withdrawal was observed on the front and back braces (see Figure 5.59).

**Figure 5.59** Photographs of Brace Connection Failures

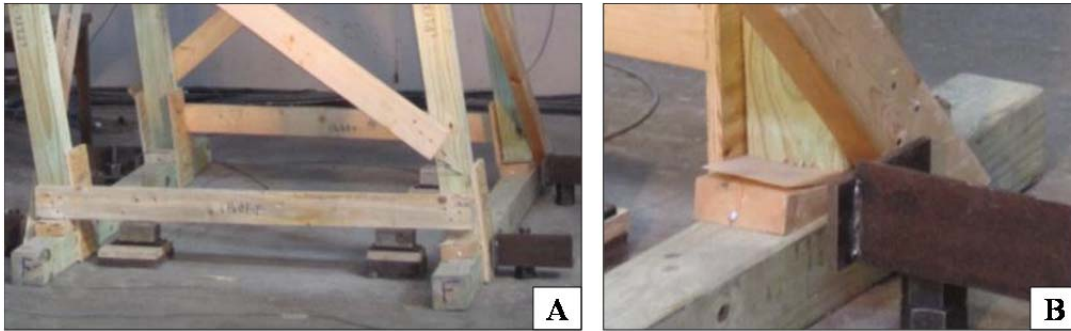
The back right wedges were the only wedges that cupped during testing. These wedges began cupping during the initial 32kip loading sequence, and slightly increased up until failure. Photographs of the wedges are provided below.

**Figure 5.60** Wedge Performance A) Shore Base at Failure B) Back Right Wedge

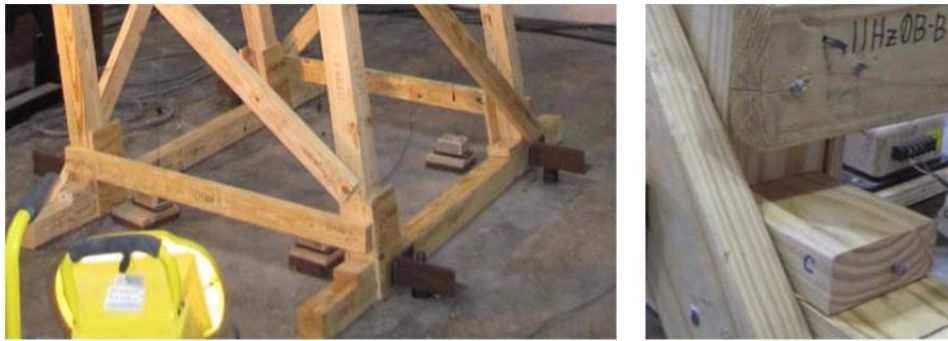
Wedge cupping was not observed during the loading sequence. The wedges did not appear to be impacted by the cyclic motion nor the vertical loads applied. Photographs of the wedges at failure are shown below.

**Figure 5.67** Status of the Wedges at Failure

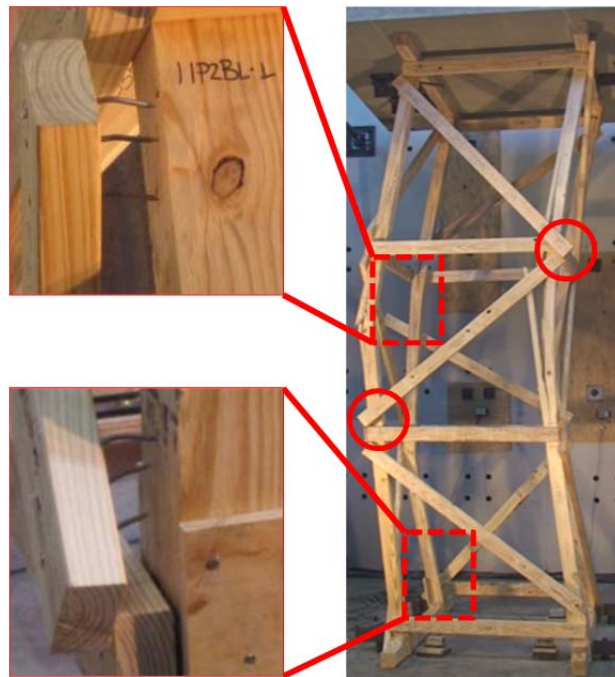
Diagonal brace failures occurred during the testing sequence both prior to and after the initial failure of the back right post. The top connection of the second level diagonal brace on the back of the shore pulled out prior to first failure as well as the bottom connection of the first level diagonal on the back face. Partial withdrawal of the bottom connection of the second level diagonal brace on the front was also observed prior to first failure. After first failure, the bottom connection of the third level diagonal on the front of the shore failed. Photographs of these brace failures are presented below.

**Figure 5.73** Brace Connection Failures

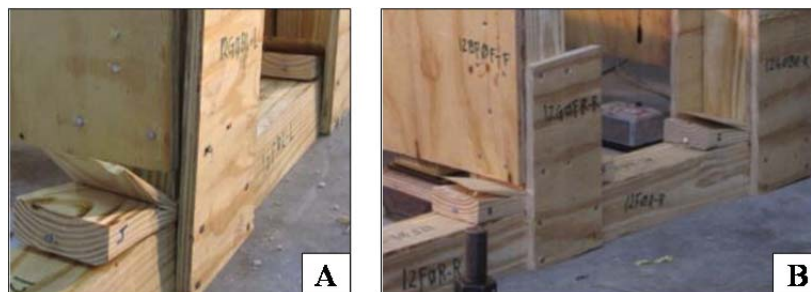
**Figure 5.74** Wedge Performance A) Left Side B) Right Side

Wedge cupping was observed during loading. All four sets of wedges began noticeably cupping at approximately 60kips, and increased as loading continued. Each set of wedges cupped to a different magnitude, but all were clearly recognizable. Photographs of the wedges are provided below.

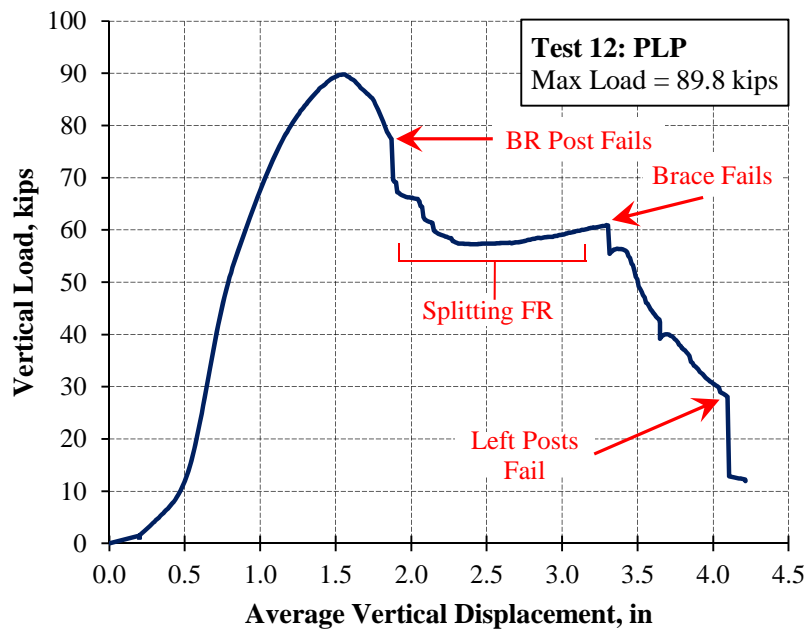
**Figure 5.75** Load-Displacement Curve for Specimen 12

After reaching a peak load of 89.8kips, audible sounds of cracking and distress were very frequent and very loud. The right side began to buckle towards the front, and initial failure occurred in the back right post at a load of 78kips. Splitting of the front right post in the region of the second intermediate brace began at approximately 65kips. The right side was noticeably bent forward, and considerable twisting of the plywood braces on the front, back and right side was observed. Also at this point, considerable bearing of the post and top plywood brace into the left header was witnessed. As seen in Figure 5.75, the capacity slightly increased before losing capacity at 60kips, which correlated to the connection failure of the second intermediate plywood brace on the right side from back right post. Large deformations occurred as the tower tilted to the left, lifting the right footer completely off the ground. Final failure occurred at approximately 28kips as the two left posts buckled to the left. The load-displacement curve for specimen 12 is presented in Figure 5.75. Also shown below are photographs of the progressive failures.

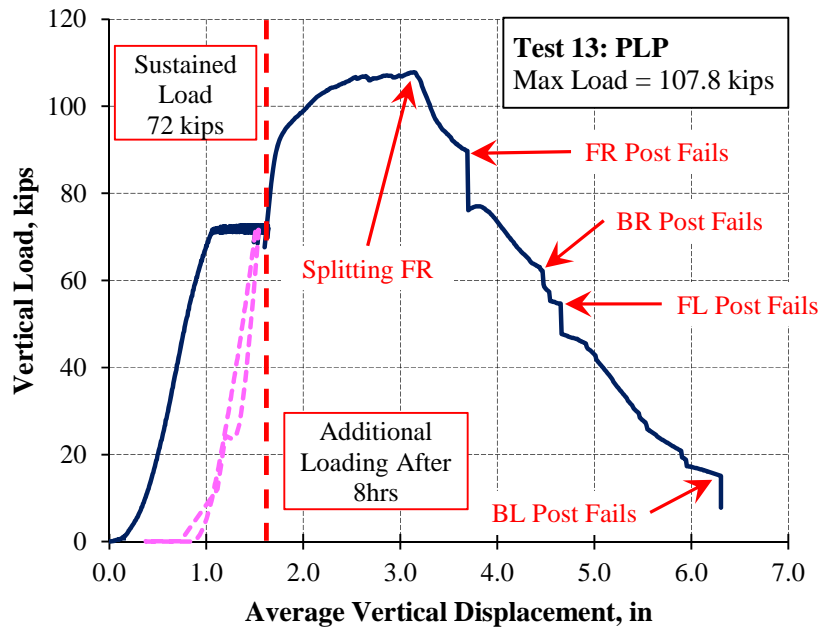
**Figure 5.81** Load-Displacement Curve for Specimen 13

Loading of the specimen began at 9:00am and concluded at 5:00pm. At 2:00pm, an error occurred in the loading program controlling the actuators. The system was unloaded, re-equilibrated and the 72kip load reapplied. This unloading and reloading

period can be seen by the dotted magenta line on the load-displacement curve presented in Figure 5.81. Specimen 13 successfully completed the full 8hours under the sustained load of 72kips without any signs of failure. The total amount of vertical deformation under the sustained lateral load was 0.55in. Mild creaking sounds were heard throughout the test, but did not become serious.

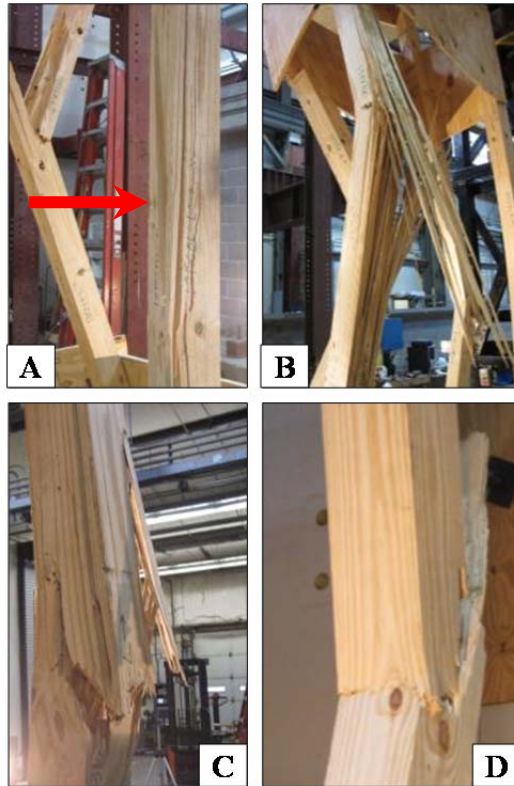
**Figure 5.83** Post Failures A) Back Left B) Back Right C) Front Left  
D) Front Right

As the peak load of 107.8kips was reached, bearing of all four posts into their respective headers was noticeable. This was followed by the progressive longitudinal splitting of the front right post. The front right post was the first to rupture at

approximately 90kips, followed by the longitudinal splitting of the back right post at 63kips and fracturing of the front left post at 55kips. After these three failures, the shore continued to fold inward on itself towards the back left post, lifting the front right post off of the footer and down from the header. The back left post split longitudinally with the tension face towards the back at approximately 16kips. The progressive failure of the shore is displayed in Figure 5.82 as well as detailed photographs of the failures in Figure 5.83.

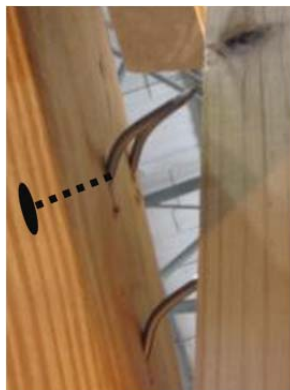
**Figure 6.6** Example of Yield Mode IV from Specimen 8

From the design calculations using the NDS 2005, the controlling shear yield mode of the nails in the 2x4 connection was Mode IV, a double curvature failure shown in Figure 6.5.

This type of nail failure was commonly observed in the post-test autopsies, but was not the only connection failure mode documented. Failure modes II, III<sub>m</sub> and III<sub>s</sub> were also observed as well as pullout and splitting of the brace. The exact initial failure modes of the braces were difficult to observe because most of the failed braces also eventually pulled the nails out of the posts, bending the nails. However, signs of double curvature that correspond to Mode IV were observed and an example is shown in Figure 6.6. All brace failures are documented in *Chapter 5* along with photographs of the nail failures.

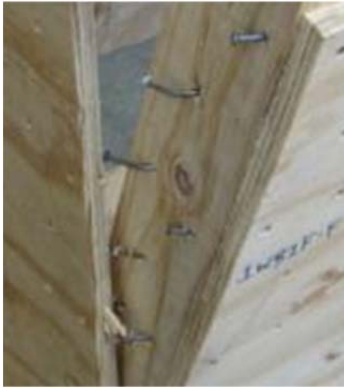
**Figure 6.8** Example of Yield Mode III<sub>s</sub> from Specimen 1

From the design calculations using the NDS 2005, the controlling shear yield mode of the nails in the plywood brace connection was Mode III<sub>s</sub> (side member yielding) shown in Figure 6.7.

Yield Mode III<sub>s</sub> shows a rigid rotation within the side member (plywood brace) while the shaft within the post remains relatively straight. As mentioned in the LP section above, the majority of the brace failures displaced enough to separate the nail from either the post or the brace itself. Also like the LP brace failures, the predicted yield mode (Mode III<sub>s</sub>) was commonly observed in the post-test autopsies, but was not the sole failure mode. Modes III<sub>m</sub> and IV were also observed as well as withdrawal failures and plywood tear out failures. An example of a Mode III<sub>s</sub> failure is shown in Figure 6.8. All brace failures are documented in *Chapter 5* along with photographs of the connection failures.
