**Assessment of Long-Term Corrosion Resistance of Recently Developed  
Post-Tensioning Components**

**Thesis**

The University of Texas at Austin

**August, 2012**

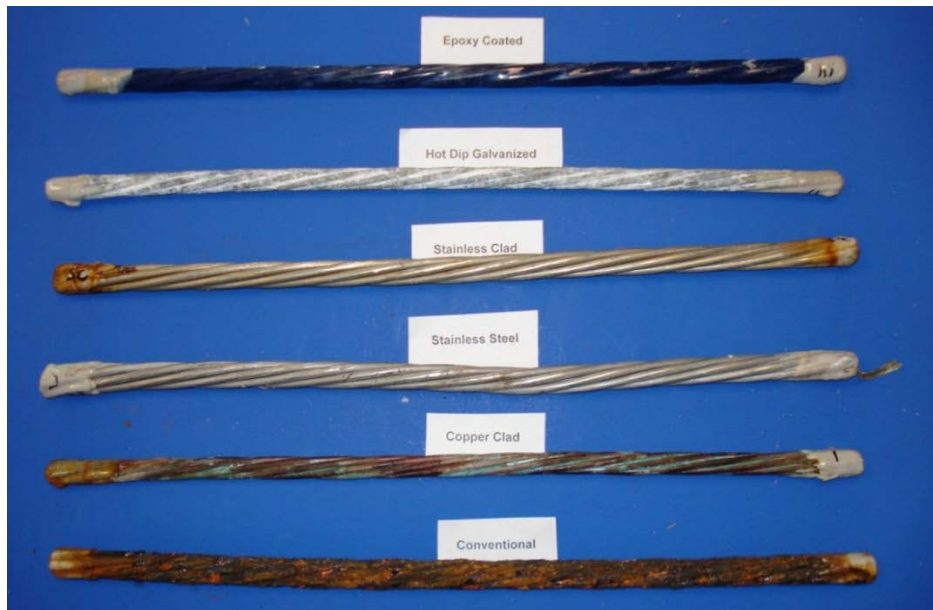
**Figure 3.6: Appearance of Strands after Six Months of Exposure**<sup>13</sup>

The results at the end of testing were not surprising. As expected the epoxy coated flow filled strand (EC) performed the best and the conventional strand (CN) performed the worst. The EC had an average weight loss of 0.60 grams and an average corrosion rating of 1.5, whereas the CN had an average weight loss of 10.13 grams and an average corrosion rating of 7.0. See Table 3.5 for final results of the testing and Figure 3.6 for the appearance of the strand after six months of exposure.

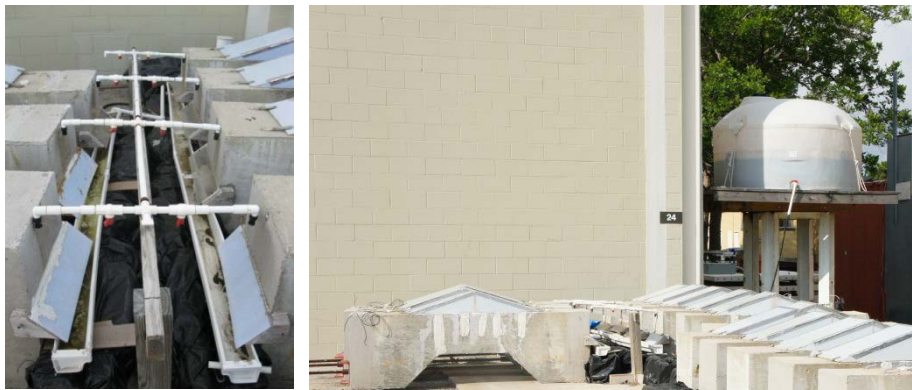
*Figure 4.2: Spray System<sup>2</sup> (Left) and Bulk Storage Tank (Right)*

In 2010, the spray system was in ill repair. The pump was inoperable due to the corrosive effects of the salt solution and the original reservoir and piping network had been damaged by ultraviolet radiation. To continue the exposure of the dead end anchorage region of the remaining drifter specimens the spray system needed to be upgraded. The spray system was upgraded with a new pump and any broken piping was repaired. The bulk storage tank was added at the same time with the help of the FSEL technicians<sup>2</sup>, Figure 4.2.

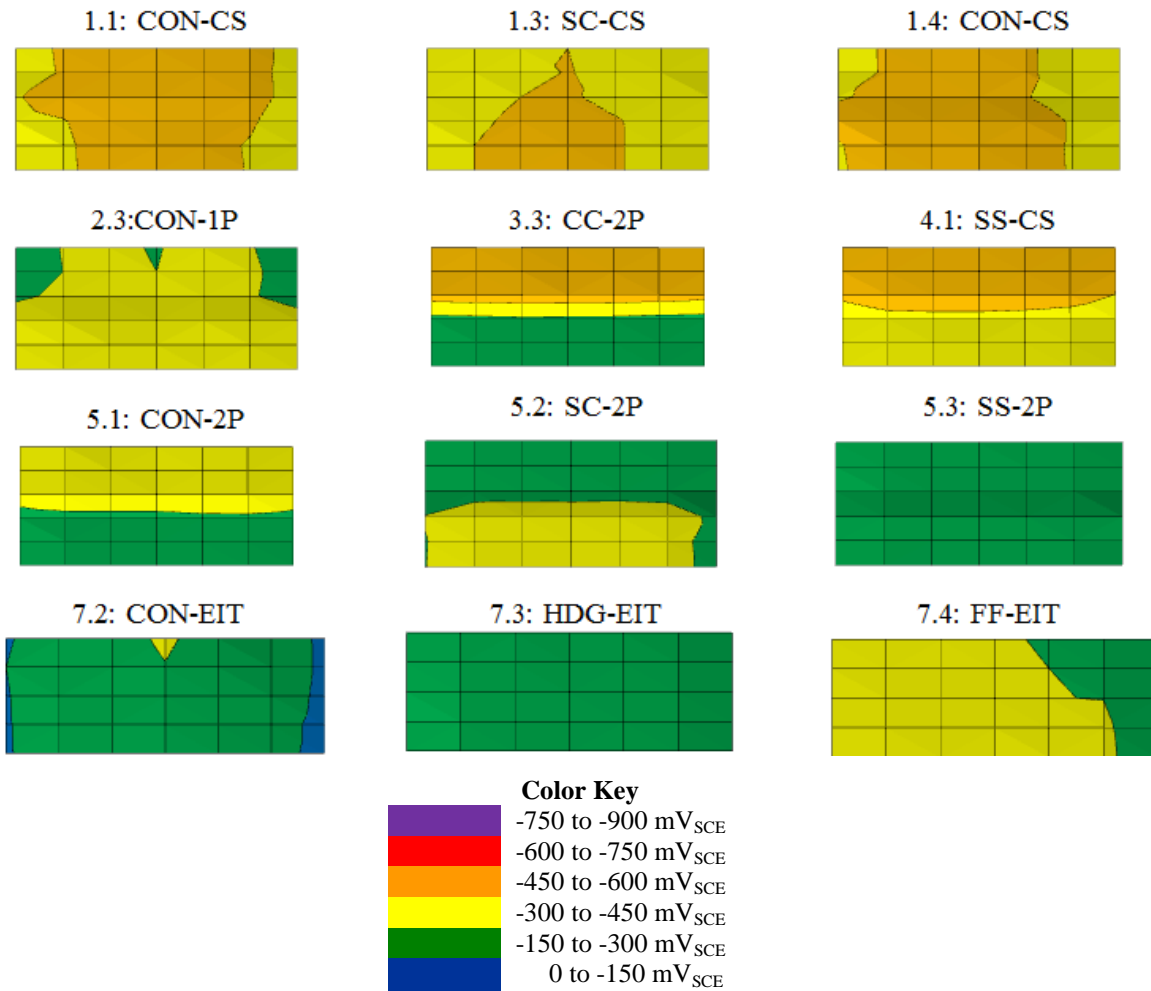
**Figure 5.1: Final Half-Cell Potential Contour Plots**

Contour plots of the final readings taken on February 29, 2012, day 2192, the final day of exposure testing, can be seen in Figure 5.1. The contour maps are an overhead view of the ponding area with the live end on the left, the dead end on the right, and the north tendon at the top. The contour plots for Specimens 3.3, 4.1, and 5.1 show a marked disparity in half-cell potential readings between the north and south tendon. The north tendon had more negative half-cell potential readings than the south tendon. This disparity in half-cell potentials might be an indication of the coupler of the spliced north duct allowing more infiltration of chlorides into the tendon than the continuous south duct. The south duct had a grout vent that was installed by drilling a hole into the apex of the duct and inserting a grout vent in the hole (Figure 2.9), whereas the coupler of the spliced north duct had a grout vent installed by the manufacturer. This chloride infiltration might increase the half-cell potential readings. In Specimens 7.2 and 1.1 a marked difference between the ends and the center portion of the ponding area can be seen. This might be because at the ends of the ponding area the tendons are further away from the surface due to increased cover over the tendons outside the ponding area. This indicates that accuracy of the half-cell potential readings decrease as the distance between the reading surface and the steel increases<sup>16</sup>.

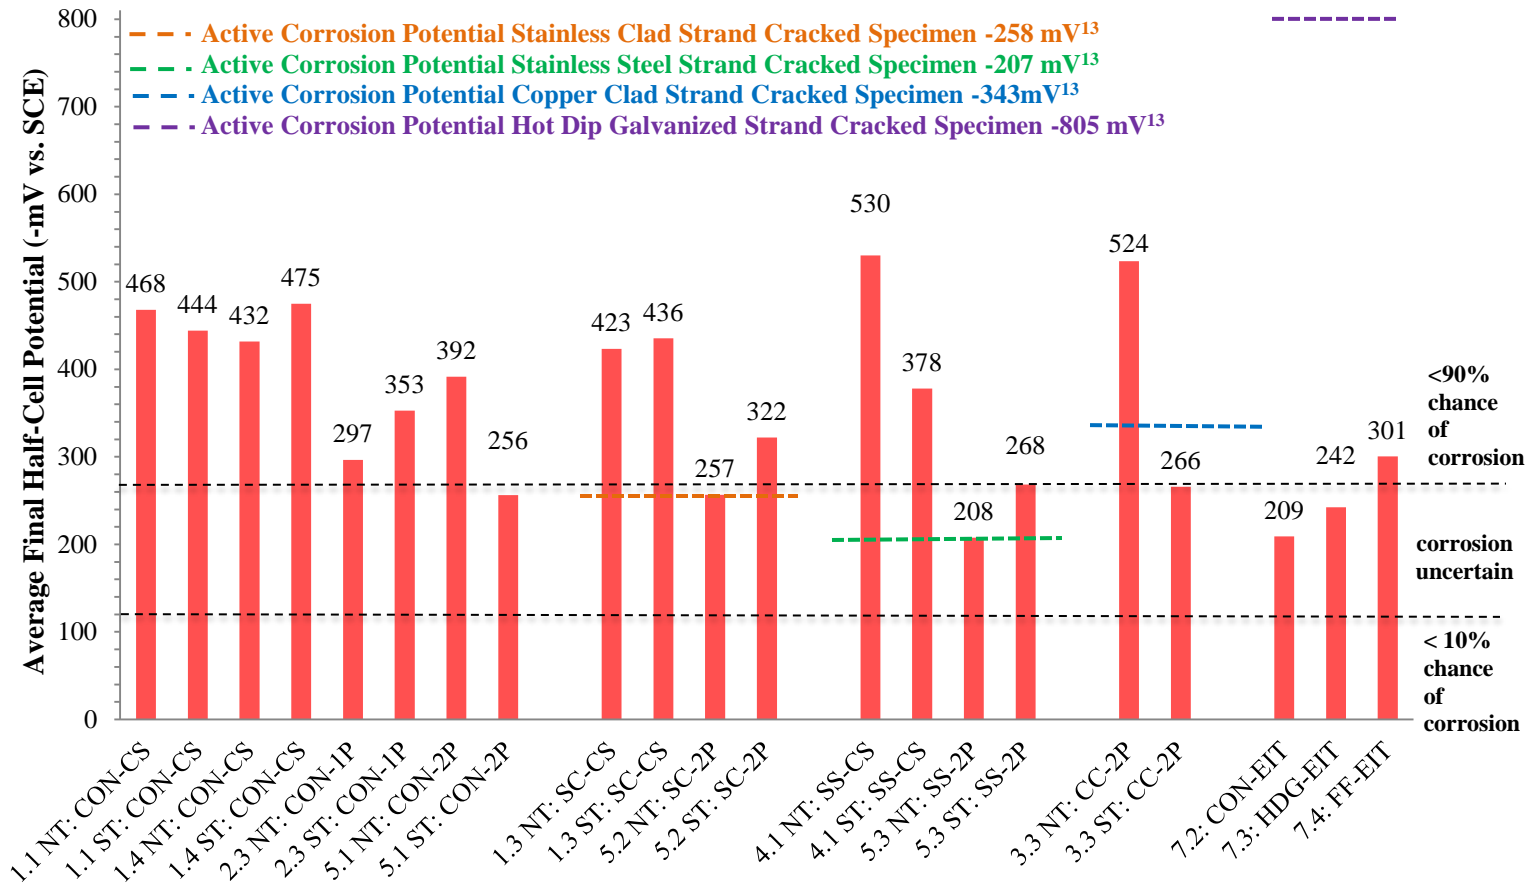
Figure 5.2: Average Final Half-Cell Potential Readings

All the tendons with the non-conventional strands cannot be effectively evaluated using the half-cell potential limits and probability of corrosion in Reference 18 because they are not entirely made of steel or are not made of steel at all. However, the average final half-cell potentials can be compared with the active corrosion potential from the LPR testing of cracked specimens from Reference 13 (Table 3.3 and Figure 5.2). The active corrosion potential from the LPR testing of cracked specimens were -343 mV vs. SCE for copper clad strand, -805 mV vs. SCE for hot dip galvanized strand, -258 mV vs. SCE for stainless clad strand, and -207 mV vs. SCE for stainless steel strand<sup>13</sup>. If the values from the LPR testing of cracked specimens are used, than Figure 5.2 is much more informative when evaluating the average final half-cell potential for the non-conventional strands.

The final average half-cell potential of the galvanized strands in Specimen 7.3 is significantly less negative than the corrosion potential from the LPR testing of cracked specimens. There might be two possible reasons for this. One the EIT system is working as hoped, fully isolating the tendon, and the zinc in the galvanized coating has not started to corrode. This is unlikely and it should become clearer why it is unlikely after reviewing the AC impedance data and chloride concentrations of the tendons. The other reason is the zinc in the galvanized coating has corroded away and the underlying steel is corroding. This might be the case and will become clearer after reviewing the data from the maximum monthly half-cell potentials for the exposure testing period.

Some of the elevated average half-cell potentials might have been affected by corrosion of the galvanized duct, corrosion of the epoxy coated conventional reinforcement and/or chloride infiltration of the duct. All of these would elevate half-cell potentials and skew the data.

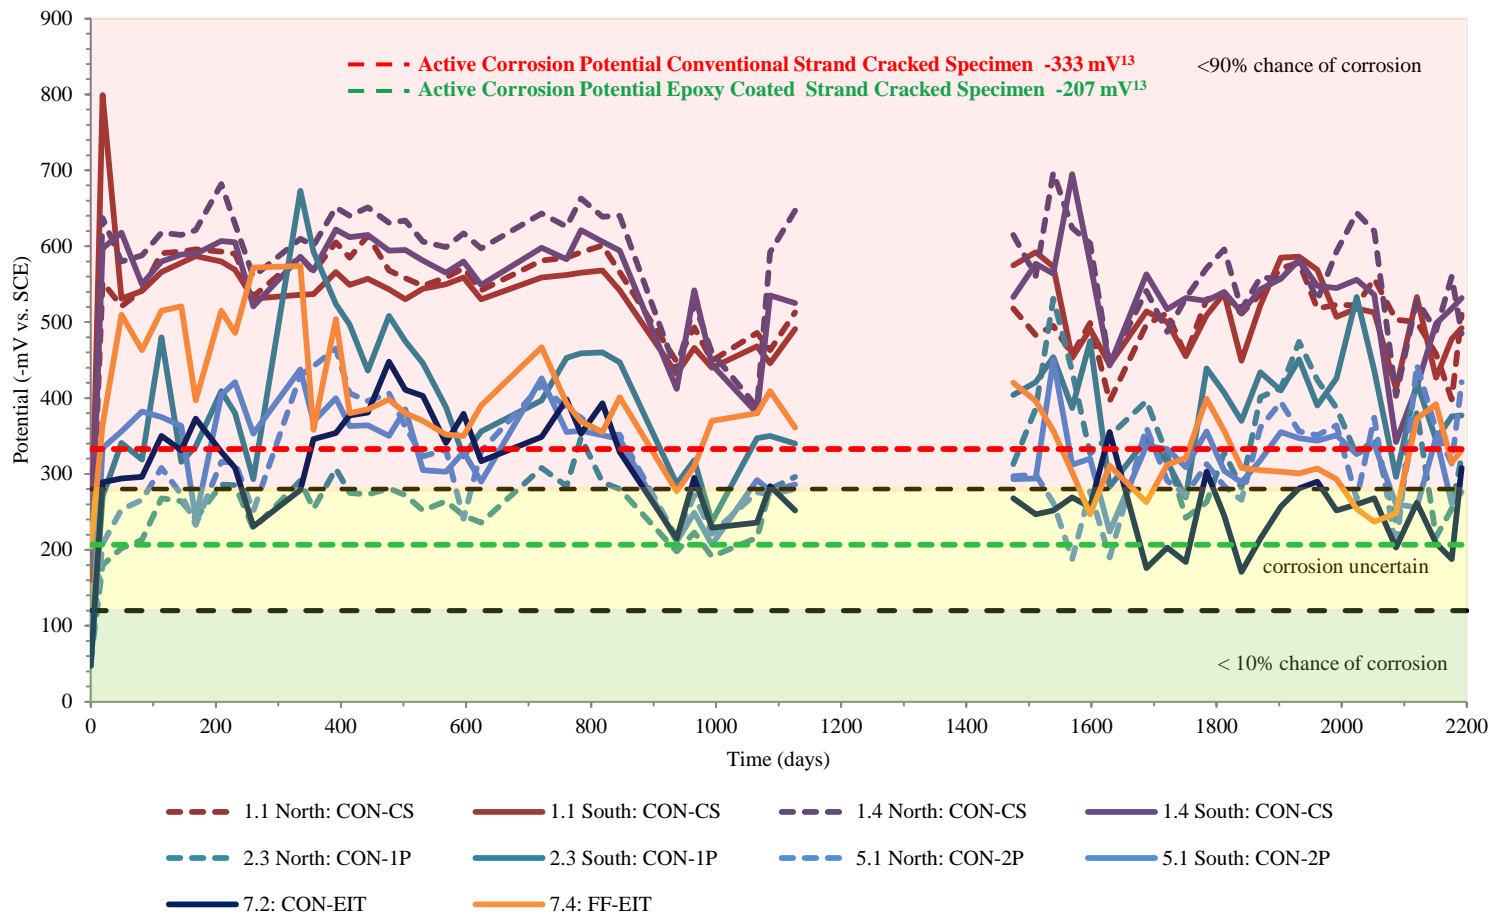
**Figure 5.3: Monthly Maximum Half-Cell Potential Readings for Conventional Strand and Flow Filled Epoxy Coated Strand for the Exposure Testing Period**

Figure 5.3 shows the monthly maximum half-cell potential reading of conventional and flow filled epoxy coated strands for the exposure testing period. It was decided that the maximum half-cell potential readings for each tendon would be graphed instead of just the maximum half-cell potential readings for the whole specimen because it was noticed that some of the tendons in the same specimen had major disparities in half-cell potential readings periodically during the exposure testing period. All the conventional strand and flow filled epoxy coated strand tendons at some point during the exposure testing period had maximum half-cell potential readings in the greater than 90% probability of corrosion range. Surprisingly, even for the fully encapsulated Specimens, 7.2 and 7.4, the maximum half-cell potential readings at some point were in the greater than 90% chance of corrosion range. These fully encapsulated specimens should not have half-cell potentials this negative unless there was a defect in the duct which allowed moisture, oxygen, and/or chlorides to enter the tendon or corrosion in the epoxy coated conventional reinforcement thus elevating the half-cell potentials and possibly inducing corrosion. Since there was essentially no corrosion found in the strands from the main autopsy region during inspection of the tendon, a defect in the duct is assumed to have allowed moisture, oxygen and/or chlorides into the tendon. The south tendon of Specimen 1.1 had the most negative maximum half-cell potential reading, which was -799 mV vs. SCE and Specimen 7.2 had the least negative maximum half-cell potential reading of -171 mV vs. SCE. If the type of duct is used to evaluate the maximum half-cell potentials, then Specimens 1.1 and 1.4, which had galvanized duct, consistently had the most negative maximum half-cell potentials for the majority of the exposure period. This might be from the corrosion of the zinc in the galvanized coating of the duct contributing the half-cell potentials.

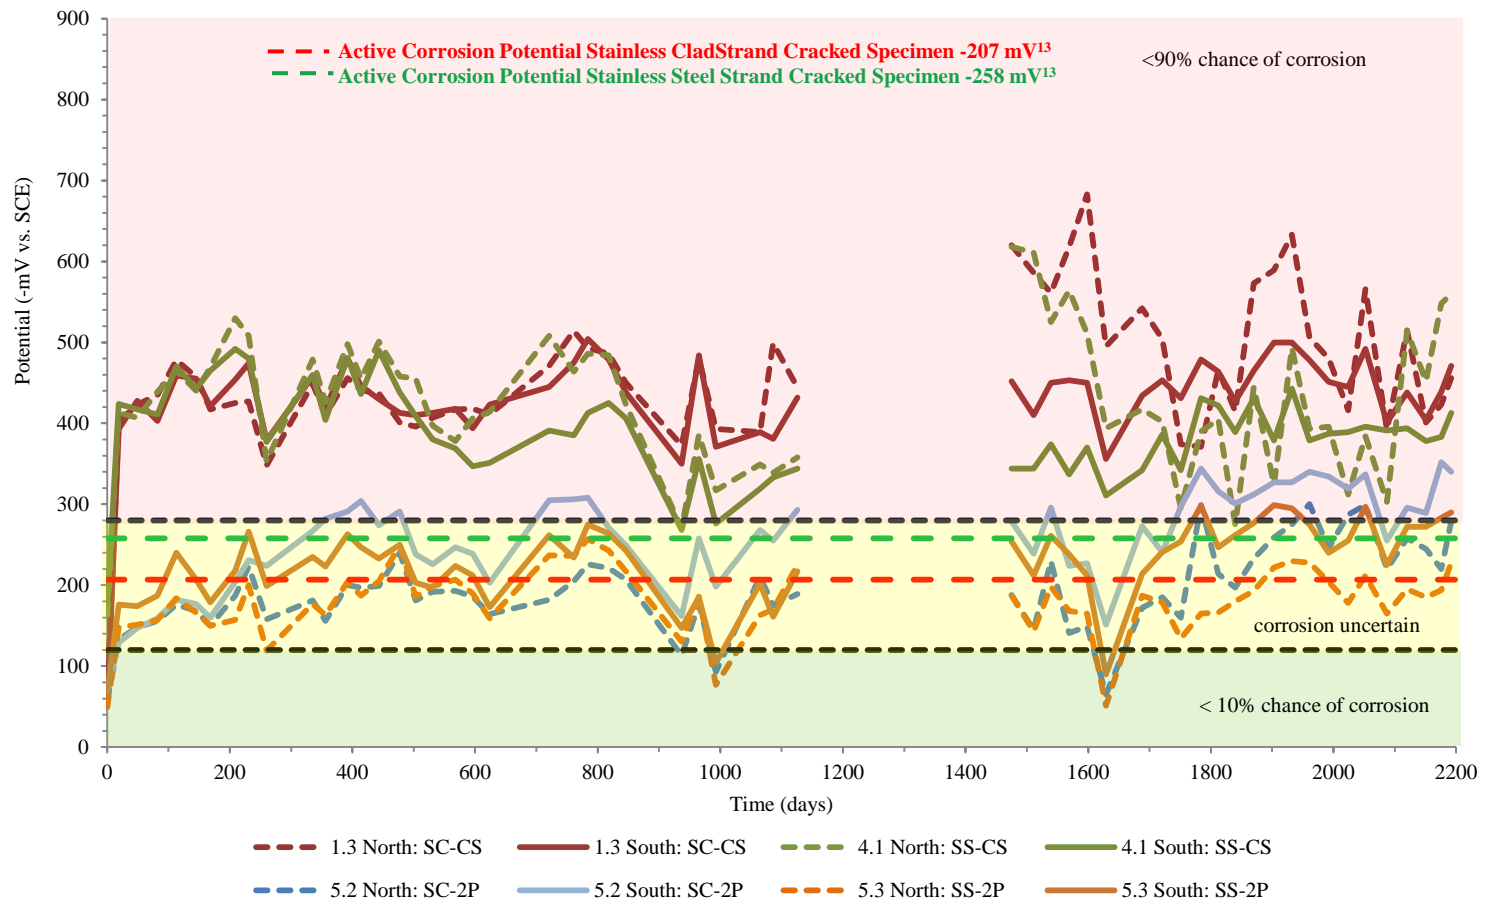
**Figure 5.4: Monthly Maximum Half-Cell Potential Readings for Stainless Clad and Stainless Steel Strands for the Exposure Testing Period**

Figure 5.4 shows the maximum monthly half-cell potential readings for stainless clad and stainless steel strand tendons for the exposure testing period. As mentioned previously, the limits of Reference 18 are not effective at evaluating the non-conventional strands but if the corrosion potentials determined in the LPR testing of cracked grouted specimens performed for Reference 13 are used as a limit, a comparison can be made. The active corrosion potentials from the LPR testing of cracked specimens for stainless clad and stainless steel strands were -258 mV vs. SCE and -207 mV vs. SCE, respectively<sup>13</sup>. For all of the exposure testing period, the tendons in galvanized duct were more negative than their active corrosion potentials. As mentioned before, this might be from the corrosion of the zinc in the galvanized coating of the duct and/or chlorides have entered the tendon, thus elevating the half-cell potential. The tendons in the plastic duct had maximum half-cell potentials around their active corrosion potentials. There is not much disparity over the majority of exposure testing period in the maximum half-cell potentials between the north and south tendon of a specimen, as there was in some of the specimens containing conventional strand.

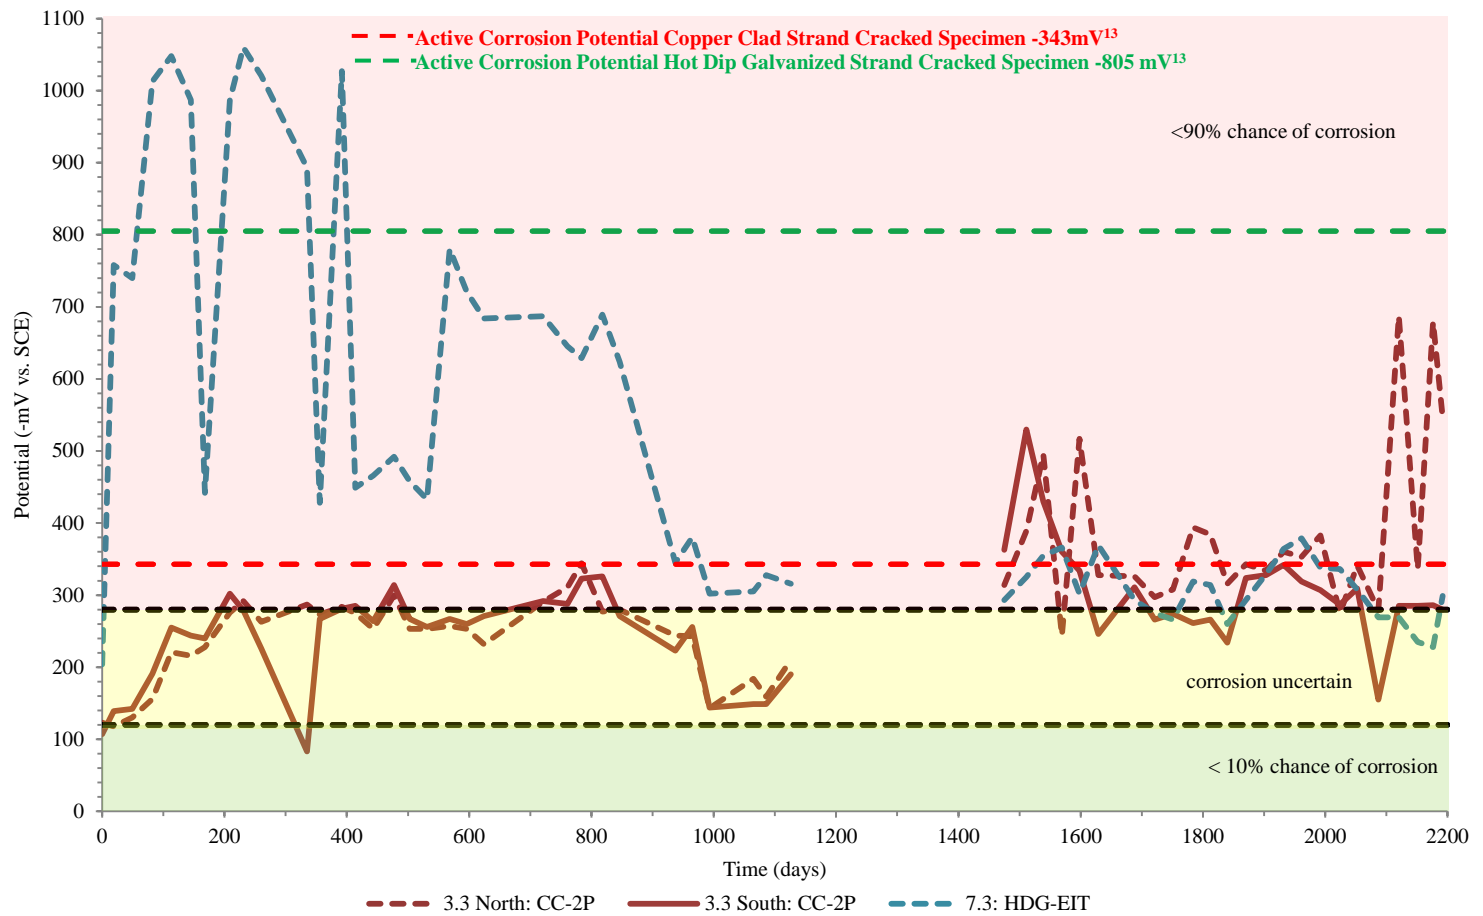
**Figure 5.5: Monthly Maximum Half-Cell Potential Readings for Copper Clad and Hot Dip Galvanized for the Exposure Testing Period**

Figure 5.5 shows the maximum monthly half-cell potential readings for copper clad and hot dip galvanized strand tendons for the exposure testing period. As mentioned previously, the limits in Reference 18 are not effective at evaluating the non-conventional strands but if the corrosion potentials determined in the LPR testing of cracked grouted specimens performed for Reference 13 are used as a limit, a comparison can be made. The active corrosion potentials from the LPR testing of cracked specimens for copper clad and hot dip galvanized strands were -343 mV vs. SCE and -805 mV vs. SCE, respectively<sup>13</sup>. The tendon in Specimen 7.3 initially had maximum half-cell potentials that were more negative than the corrosion potential for hot dip galvanized strand but the potential dropped significantly after about 1000 days of exposure testing. This drop in half-cell potential might be from the depletion of the zinc in the galvanized coating due to corrosion and the initiation of corrosion of the underlying steel. The specimen that had tendons with copper clad strand, Specimen 3.3, had maximum half-cell potentials that were less negative than the corrosion potential from the LPR testing of cracked specimens until about day 1500 of the exposure testing for the south tendon and about day 1550 of the exposure testing for the north tendon. This spike in maximum half-cell potential might be from chlorides reaching the strands in the tendon and raising the half-cell potential of the copper clad strands. There was some disparity of maximum half-cell potentials between the tendons of Specimen 3.3 towards the end of the exposure testing period. This disparity might be from the grout vent of coupler of the spliced north duct allowing more chlorides into the tendon than the grout vent in the south duct thus elevating the half-cell potential to a greater extent. The grout vent of the coupler was installed by the manufacturer of the coupler and the grout vent in the continuous south duct was installed by the research team that designed and constructed the Project 0-4562 specimens.

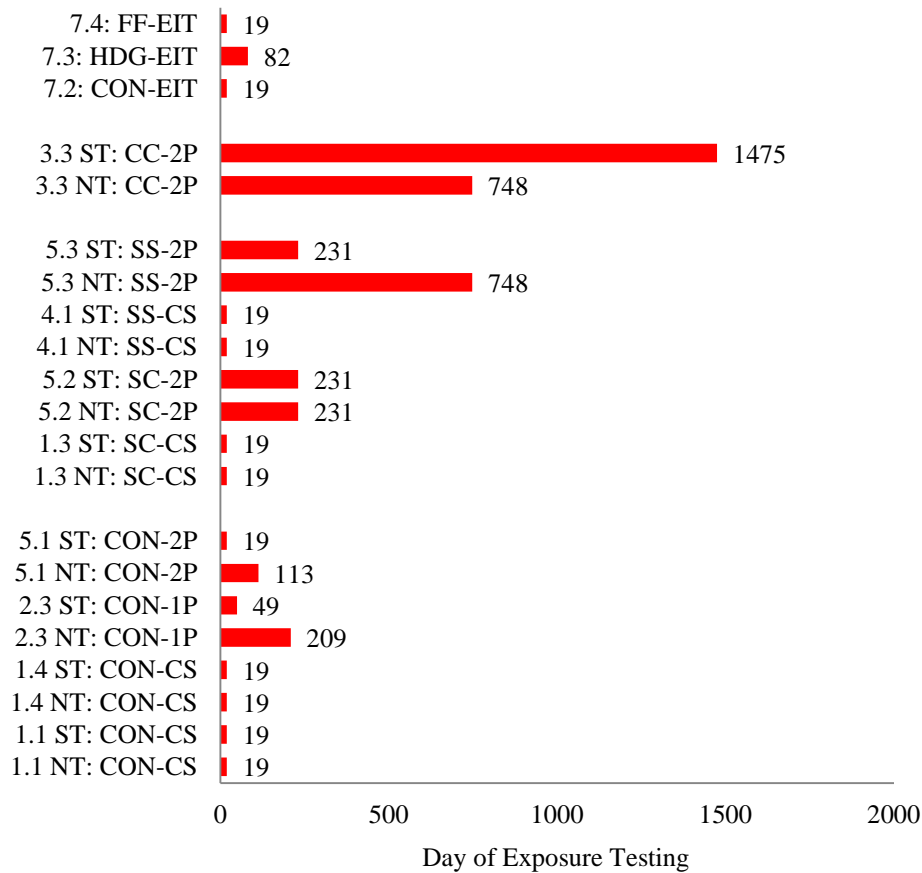
**Figure 5.6: Approximate Days to the Initiation of Corrosion**

To estimate the days to initiation of corrosion, the half-cell potential for greater than 90% chance of corrosion from Reference 18 was used for the conventional and flow filled epoxy coated strands and the corrosion potentials from Reference 13 were used for the non-conventional strands. See Figure 5.6 for the approximate days to the initiation of corrosion. All of the tendons within galvanized duct that had conventional strands had corrosion initiated at 19 days. The estimated days to corrosion varied from 19 to 209 for the tendons within plastic duct that contained conventional strand. All of the tendons in galvanized duct that contained stainless clad and stainless steel had estimated days to corrosion of 19. Most of the tendons within plastic duct containing stainless clad and stainless steel had an estimated 231 days to corrosion. The outlier was Specimen 5.3's south tendon which had estimated days to corrosion of 748. The tendons with copper clad strand performed the best, Specimen 3.3's south and north tendon. The south tendon did not initiate corrosion until 1475 days and the north tendon did not initiate corrosion until day 748. The tendons within the encapsulated specimens did not perform as well as expected. Specimens 7.2 and 7.4 had corrosion initiated at about 19 days and Specimen 7.3 had corrosion initiated at about 82 days.

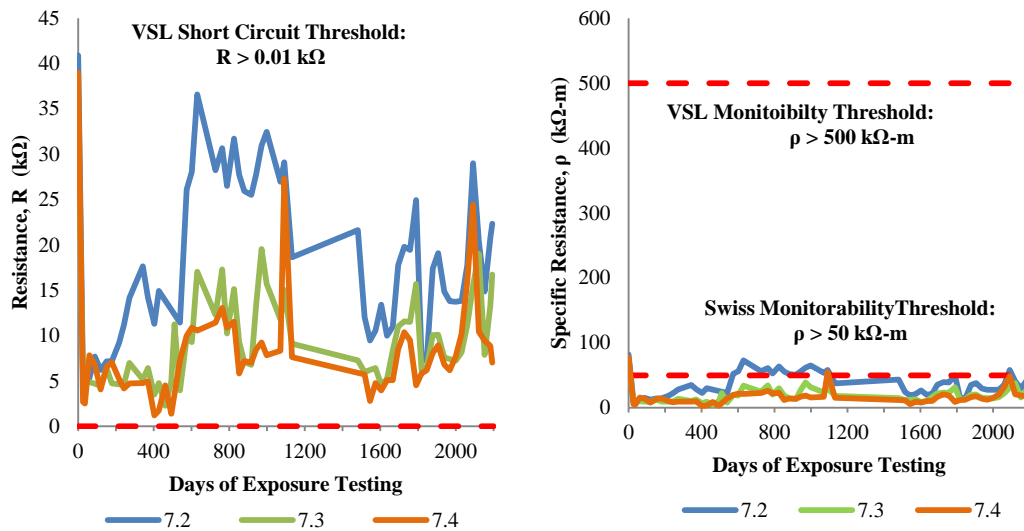
**Figure 5.7: Resistance (Left) and Specific Resistance (Right) for Specimens 7.2, 7.3, and 7.4**

Resistance and specific resistance measurements are shown in Figure 5.7. The limiting value for resistance is that it must be greater than  $0.01\text{K}\Omega$ . This resistance limit signifies a short circuit has occurred between the strand and the conventional reinforcement and is not electrically isolated due to a defect in the duct or short-circuit at

the anchorage<sup>19</sup>. The resistances for the specimens were significantly higher than 0.01k $\Omega$  over the entire exposure testing period so it can be assumed that the system did not short circuit. As expected, the resistance steadily increased over the exposure testing period because resistance should increase with age<sup>19</sup>. During the exposure testing period, there were times in which the resistance dropped to relatively low resistances, which signified that moisture had entered the duct<sup>19</sup>. The threshold specified by Reference 19 for specific resistance is 500 k $\Omega$ -m<sup>19</sup> but the threshold specified by the Reference 22 is 50 k $\Omega$ -m<sup>22</sup>. Specific resistance is the resistance times the length of the tendon. This indicates that the system is monitorable over the long term<sup>19</sup>. The standard in Reference 22 is newer than the standard in Reference 19. This standard from Reference 22 was implemented because it was found that the limit set by Reference 19 was nearly unattainable in the field<sup>22</sup>. For the entire exposure testing period, the specific resistance calculations fell well below the Reference 19 limit and for the majority of the exposure period the specific resistance was below the Reference 22 limit. Therefore, the long-term monitorability is questionable for the specimens.

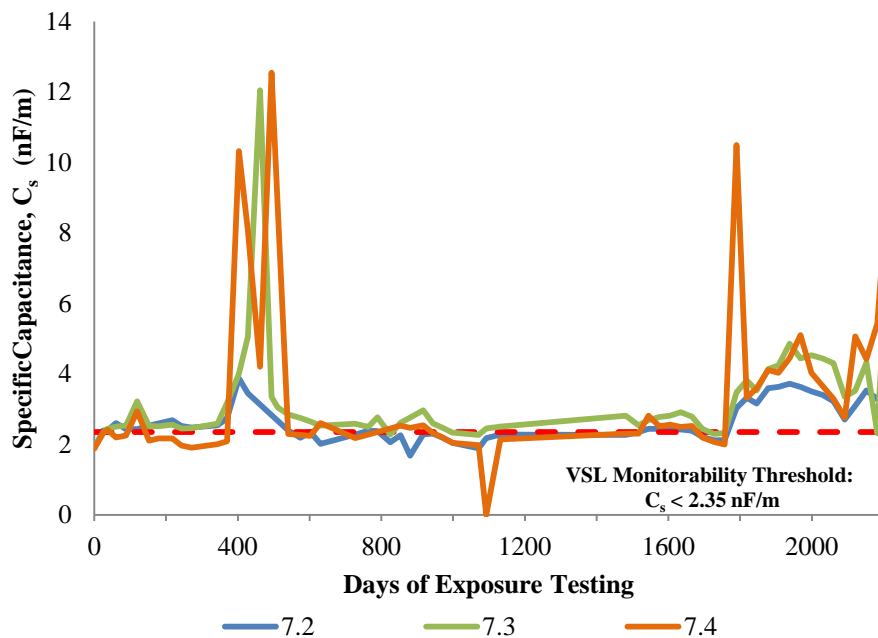
**Figure 5.8: Specific Capacitance for Specimens 7.2, 7.3, and 7.4**

Figure 5.8 shows the calculated specific capacitance for the exposure testing period of specimens 7.2, 7.3, and 7.4. Specific capacitance was calculated by dividing the

measured capacitance by the length of the tendon, which was two meters. The monitorability threshold specified by Reference 19 is that the specific capacitance shall be 2.35 nF/m or below<sup>19</sup>. Specimen 7.2 and 7.3 had specific capacitances above the threshold for monitorability for the majority of the exposure testing period. This suggests that the monitorability of Specimens 7.2 and 7.3 are suspect. Specimen 7.4 had specific capacitances that were at or below the limit for monitorability for majority of the exposure testing period, which indicates that the system was somewhat monitorable. All specimens had elevated periods of specific capacitance at about the end of the first year for three months of exposure testing and for over a year at the end of exposure testing.

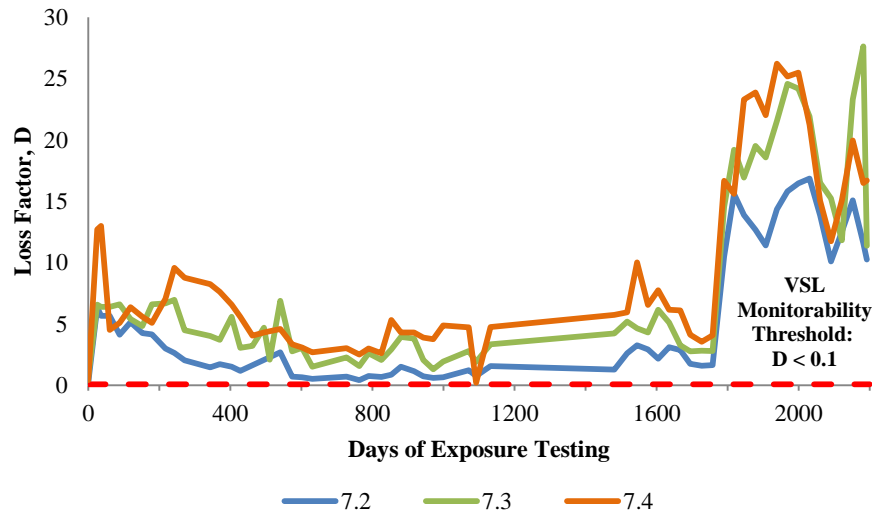
**Figure 5.9: Loss Factors for Specimens 7.2, 7.3, and 7.4**

Figure 5.9 shows the loss factors measured for Specimens 7.2, 7.3, and 7.4 for the exposure testing period. Reference 19 sets the maximum limit for monitorability for the loss factor at  $0.01^{19}$ . All specimens were above this limit for the entire exposure testing period, which indicates that the specimens were not monitorable.

The AC impedance data suggests monitorability of Specimens 7.2, 7.3, and 7.4 is questionable. The resistance data indicates that none of the 7-series specimens experienced a short circuit during the exposure testing period but the drops in resistance imply that at some point moisture had entered the duct through a defect and therefore moisture, oxygen and/or chlorides might have entered the tendon. There were signs of moisture when the tendons were cut from all the anchorages of the 7-series when grout samples were obtained for chloride concentration testing. Even with the humid climate in Austin, the readings should not have much variability from month to month. Changing the frequency to 100 Hz, as suggested in Reference 21, did not change the variability in the data. This further suggests that the measuring device used does not comply with accepted standards for measuring AC impedance<sup>21</sup>.

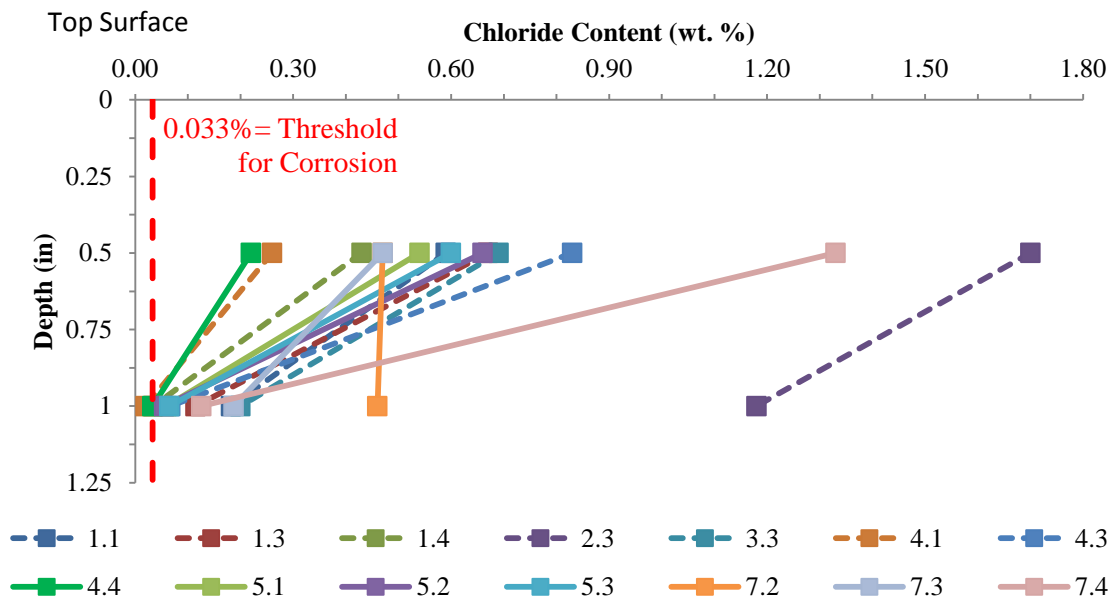
**Figure 5.10: Chloride Content of Top Surface Concrete Samples**

Figure 5.10 shows the chloride contents of the concrete powder extracted from the top surface of the ponding area. As mentioned in Chapter 4, all samples, except for the 7-series specimens, were extracted from top surface of the ponding area at two inches, in the live end direction, from the transverse centerline (Figure 4.9). The 7-series had concrete samples obtained from the top surface of the ponding area at the transverse centerline. All specimens had concrete samples taken at the extraction sites from a depth of 0.5 and 1 inch. As expected, all samples from the 0.5 inch depth had chloride contents well above the 0.033% corrosion limit. There was some scatter in chloride content among the samples taken at 0.5 inch depth. The chloride content ranged from 0.220% to 1.700%. The two specimens with the highest chloride content at the 0.5 inch depth were Specimen 2.3 (1.700%) and Specimen 7.4 (1.330%). These high chloride contents might be from micro cracking in the concrete allowing more chlorides to reach that depth. At

the 1 inch depth, all samples, except the sample from Specimen 4.1, had chloride contents above the 0.033% corrosion limit. The chloride content at the 1 inch depth were well grouped with a range of 0.020% (Specimen 4.1) to 0.187% (Specimen 3.3) with outliers at 0.46% (Specimen 7.2) and 1.180% (Specimen 2.3). Specimen 7.4 had chloride contents nearly equal for both depths, 0.47% (0.5 inch) and 0.46% (1 inch). This might be from a micro crack that ran the depth of the hole thus allowing nearly the same amount of chlorides to reach the 1.0 inch depth as did the 0.5 inch depth. It should be noted that a portion of the sample from the depth of 0.5 inch in top surface of Specimen 1.3 was sent to Tourney Consulting Group, Kalamazoo, Michigan had a chloride concentration of 0.542% by weight of concrete for testing in accordance with Reference 22. Material from the same sample tested at FSEL had a chloride concentration of 0.67% by weight of concrete using the James Instrument CL-200 Chloride Test System for chloride detection. It can be assumed that the results from the CL-200 Chloride Test System are fairly accurate because these chloride concentrations are in general agreement.

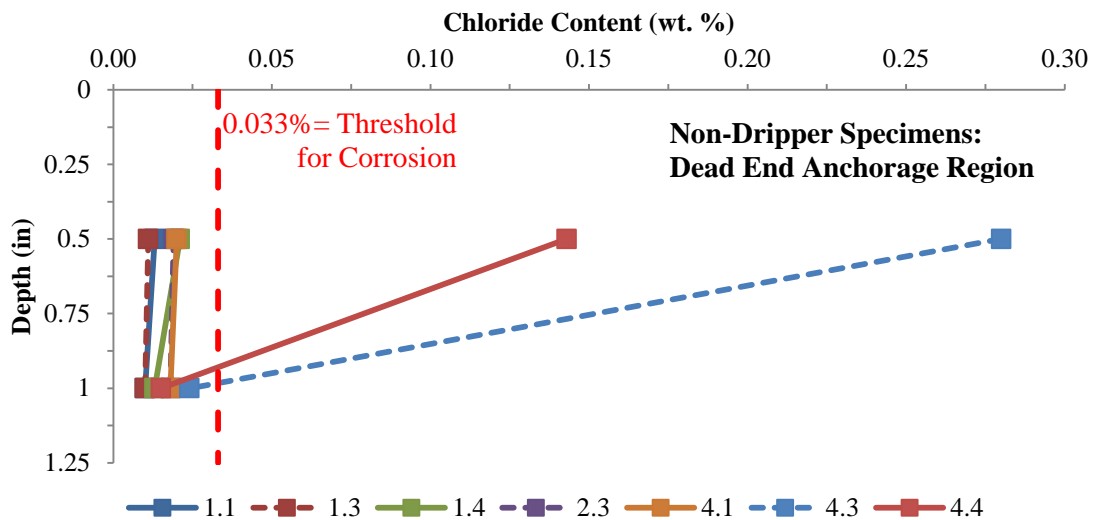
**Figure 5.11: Chloride Content Non-Dripper Specimens' Dead End Anchorage Region**

Figure 5.11 shows the chloride contents of the concrete powder extracted from the dead end anchorage region of the non-dripper specimens. Concrete powder samples from the dead end anchorage region were taken at 5 inches from the top surface of the specimen at a depth of 0.5 and 1 inch (Figure 4.10). As expected, most of the concrete samples from both depths had chloride contents below the corrosion limit. The two samples that were above the corrosion limit were both from a depth of 0.5 inch and were from Specimens 4.3 (0.28%) and 4.4 (0.143%). These outliers might be because these specimens did not have pour-backs because they were only reinforced with conventional epoxy coated and uncoated steel reinforcement and the concrete surface were scaled. Therefore when the ponding area was emptied at the end of the wet exposure period, salt may have adhered to the end of the specimen and traveled into the pore space of the concrete.

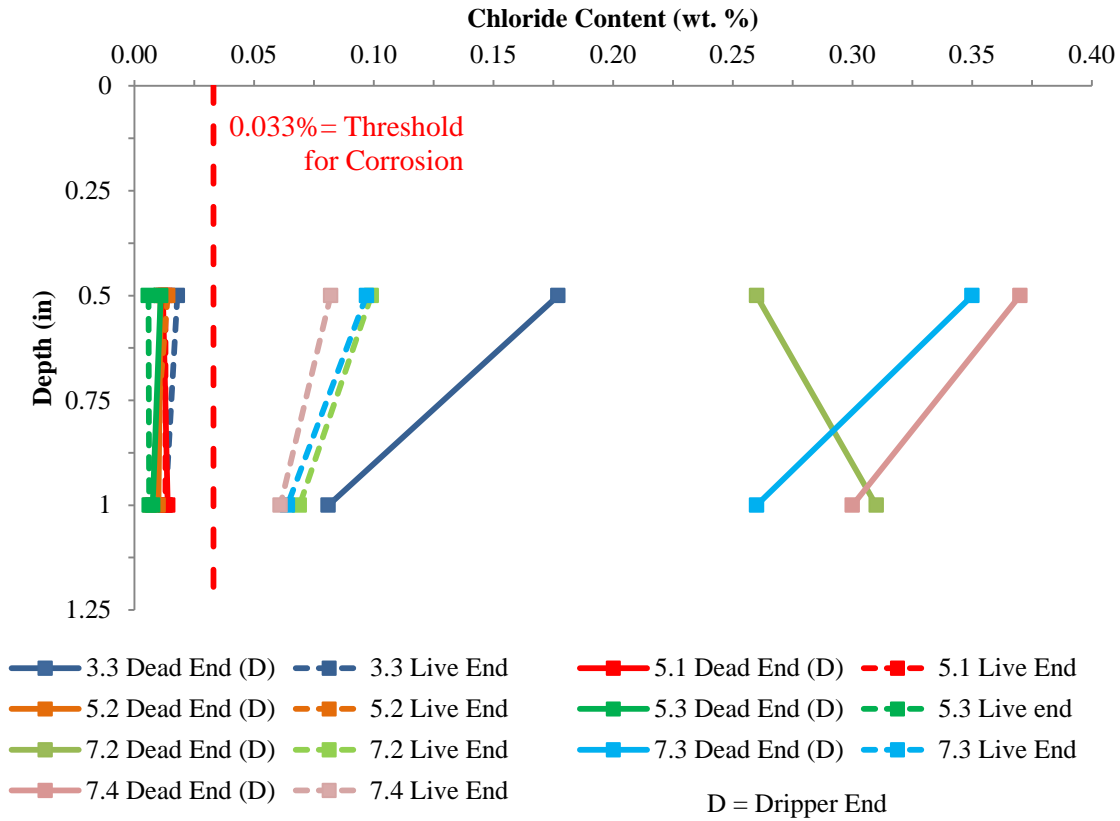
**Figure 5.12: Chloride Content for the Live and Dead Ends of the Drifter Specimens**

Figure 5.12 shows the chloride contents of the concrete powder extracted from the dead and live end anchorage regions of the dripper specimens. Except for the 7-series specimens, all specimens had the concrete powder samples taken from the dead end anchorage zone, five inches from the top surface of the specimen (Figure 4.10). The dripper specimens had concrete powder samples taken from the live end anchorage zone,

six inches from the top surface of the specimen. The 7-series specimens had concrete powder samples taken from both the live and dead end anchorage zone, six inches from the top surface of the specimen. At all extraction sites, samples were taken at depths 0.5 and 1 inch. Surprisingly, samples from the dead anchorage regions of Specimens 5.1, 5.2, and 5.3, which were the ends that received salt solution spray, did not have chloride contents above the corrosion limit. This might be due to the concrete of the pour backs being well consolidated causing the concrete to have lower permeability than the other dead end pour backs. Another interesting observation is the chloride contents of the live end anchorage regions of Specimens 7.2, 7.3, and 7.4 had chloride contents above the corrosion limit. This might be from the cracking over the vent spout in the anchorage region that had been observed during the visual inspection before autopsy, elevating the chloride content. As expected, samples from the dead end anchorage region of Specimens 3.3, 7.2, 7.3, and 7.4 had chloride levels that exceeded the corrosion limit but the chloride levels in the 7-series specimens were higher. This higher chloride content of the 7-series specimens might be for the same reason as the dead end anchorage region of the same specimens. Another anomaly is the chloride content of the concrete sample taken from the dead end anchorage region of Specimen 7.2 increased with depth. Again this might be due to the cracking over the dead end anchorage region.

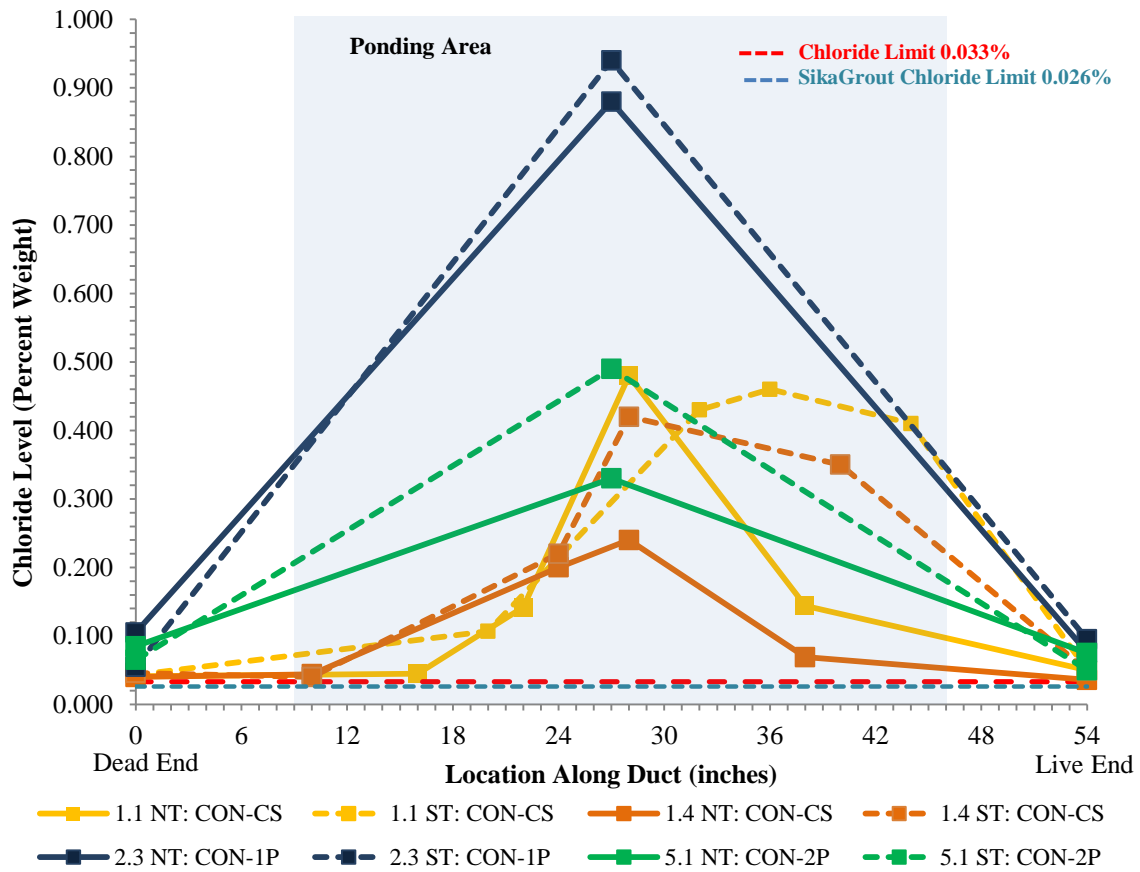
**Figure 5.13: Chloride Concentrations for Tendons Containing Conventional Strands, Expect Specimen 7.2**

Figure 5.13 shows the chloride concentrations of the tendons that contained conventional strands, except for the tendon in Specimen 7.2. All tendons had chloride concentrations along the whole length of tendon above the corrosion limit of 0.033% by weight of grout. This is consistent with the average half-cell potential readings at the end of exposure testing being more negative or close to the greater than 90% probability of corrosion half-cell potential readings that these tendons had. As expected, the chloride concentrations were greater at midspan than in the anchorages. This might be because the chlorides would take longer to get to the anchorages because the chloride ions would have to travel through the interstitial space between the grout and the duct and/or interstitial space between the grout and the strand. The chloride concentrations at the anchorages were all somewhat equivalent. Surprisingly, the tendons from Specimen 2.3 had the highest chloride contents for this grouping. North tendon had 0.880% by weight of grout and the south tendon had 0.940% by weight of grout. The tendons in specimen

2.3 were 2-way plastic ducts. This might indicate that the ducts are not water tight and freely allowed chlorides to enter the tendon earlier than the other ducts. Another interesting observation is the tendons from Specimen 5.1 had chloride concentrations comparable to the chloride concentrations from the tendons in galvanized duct. The ducts that encased the tendon in Specimen 5.1 were 2-way plastic duct, as well. Again, the water tightness of the couplers and grout vents of the plastic ducts are in question. The north tendon of Specimen 1.4 had the lowest chloride concentration at midspan. The disparity in the average final half-cell potentials between the north and south tendons of Specimen 5.1 do not correspond to the difference in chloride concentrations at midspan of the same tendons. The south tendon had chloride concentrations greater than the north tendon and midspan, whereas the average final half cell-potentials (Figure 5.2) suggest that the north tendon should have had the higher chloride concentrations. Therefore, the disparity in the average final half-cell potentials might be from corrosion of the epoxy coated steel reinforcement located closer to the north duct elevating the half-cell potentials. The live end side of the south tendons in Specimens 1.1 and 1.4 had chloride concentrations that were far greater than the chloride concentrations of the dead end side of the tendons. Specimens 1.1 and 1.4 had tendons with galvanized duct. This difference in chloride concentrations between the live and dead ends of the south tendons of Specimens 1.1 and 1.4 might be from the cracks on the live end over the south tendons of the ponding area in the concrete allowing more chlorides to reach the live end of the tendons than the dead ends. On the other hand, the chloride concentrations of the north tendons of Specimens 1.1 and 1.4 dropped significantly away from the midspan of the tendon. The elevated chloride concentrations of the tendons would make the average final half-cell potentials more negative but the average final half-cell potentials for the tendons with galvanized duct, Specimens 1.1 and 1.4, were more negative than the potentials from the tendons with plastic duct. This would suggest that the corrosion of the zinc in the galvanized duct as well as the chlorides were contributing to the average final half-cell potential of the tendons in Specimens 1.1 and 1.4. The level of chlorides in the tendons is consistent with the corrosion observed during autopsies.

The chloride concentrations were discussed in depth in Chapter 5. All the chloride concentrations were well above the 0.033% by weight of grout limit for corrosion. See Figure 5.13 for the results of the chloride concentration testing. As expected, the highest chloride concentration for the north tendon was at midspan and was 0.480% by weight of grout. The highest chloride concentration for the south tendon was not at midspan as

The chloride concentrations were discussed in depth in Chapter 5. All the chloride concentrations were above the 0.033% by weight of grout limit for corrosion. See Figure 5.13 for the results of the chloride concentration testing. As expected, the highest chloride concentration for the north and south tendons were at midspan and were 0.420% and 0.240%, respectively, by weight of grout. As expected, the anchorage regions had the lowest chloride concentrations. This might be because the chlorides would take longer to migrate to the anchorages because the chloride ions would have to travel through the interstitial space between the grout and duct and/or interstitial space between the grout and strand.

The chloride concentrations were discussed in depth in Chapter 5. All the chloride concentrations were well above the 0.033% by weight of grout limit for corrosion. See Figure 5.13 for the results of the chloride concentration testing. As expected, the highest chloride concentration for the north and south tendons were at midspan and were 0.880% and 0.940%, respectively, by weight of grout. As expected, the anchorage regions had the lowest chloride concentrations. This might be because the chlorides would take longer to migrate to the anchorages because the chloride ions would have to travel through the interstitial space between the grout and duct and/or interstitial space between the grout and strand.
