**Assessment of Long-Term Corrosion Resistance of Recently Developed  
Post-Tensioning Components**

**Thesis**

The University of Texas at Austin

**August, 2012**

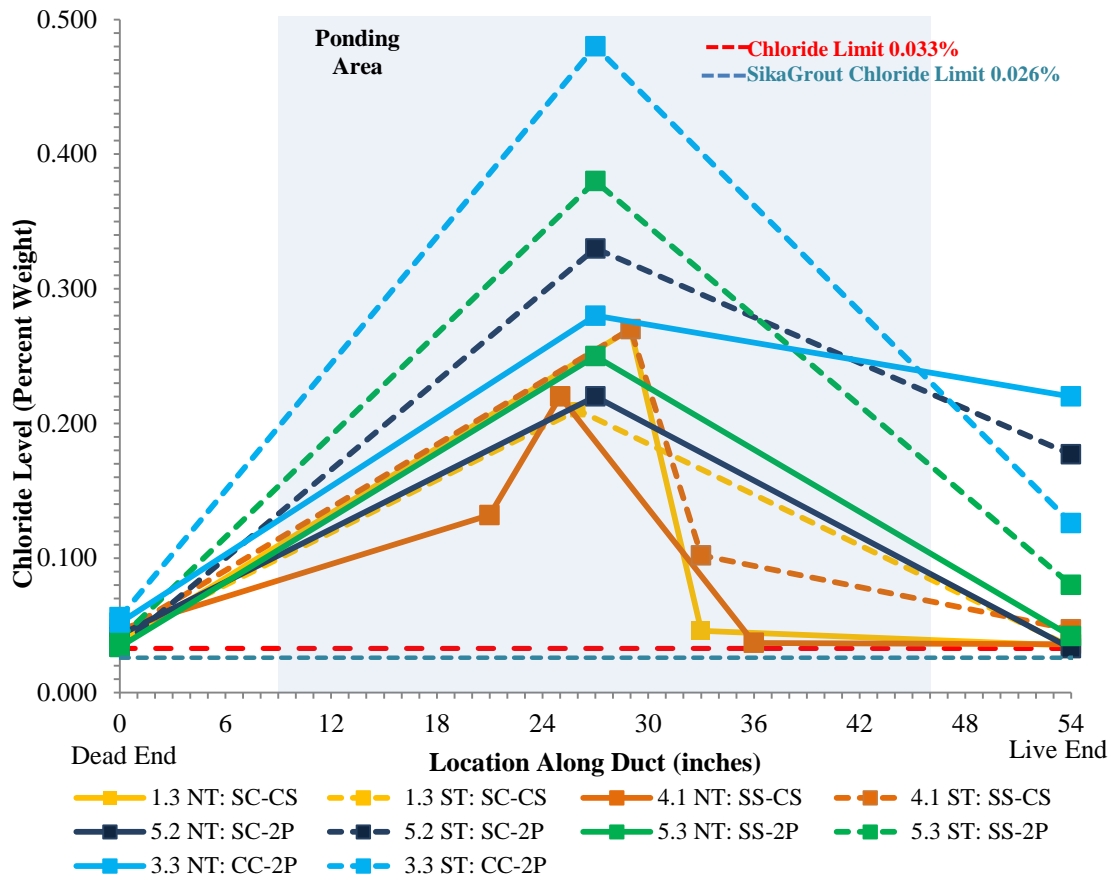
**Figure 5.14: Chloride Concentrations for Tendons Containing Stainless Clad, Stainless Steel, or Copper Clad Strands**

Figure 5.14 shows the chloride concentrations for the tendons containing stainless clad, stainless steel, or copper clad strands. Along the length of all tendons, the chloride concentrations exceeded the 0.033% by weight corrosion limit. Except for the south tendon of Specimen 3.3, this would explain why the average final half-cell potentials were at or more negative than the strand types active corrosion potentials. As expected, the chloride concentrations at midspan were higher than the chloride concentrations at the anchorages. Like mentioned previously, this might be because the chlorides would take longer to get to the anchorages because the chloride ions would have to travel through the interstitial space between the grout and the duct and/or interstitial space between the grout

and the strand. The chloride concentrations on the dead end were well grouped whereas the chloride concentrations at the live end ranged from 0.033% (north tendon Specimen 5.2) to 0.220% (north tendon Specimen 3.3) by weight of grout. All the tendons from Specimens 1.3 and 4.1 and the north tendons of Specimens 5.2 and 5.3 were well grouped at the live end region. The south tendon of Specimen 3.3 had the highest chloride concentration at midspan in this grouping, 0.480% by weight of grout. The lowest chloride concentration at midspan is from the south tendon of Specimen 3.3, 0.220% by weight of concrete. Surprisingly, the difference in levels of chlorides between the north and the south tendons of Specimen 3.3 does not correspond to the difference in average final half-cell potentials experienced by the tendons of Specimen 3.3. The greater chloride concentrations in the south tendon of Specimen 3.3 suggest that the lab installed grout vent did not work as well as the manufactured installed grout vent on the coupler at keeping out chlorides. This would also suggest that corrosion in the epoxy coated steel reinforcement might be contributing more to the average final half-cell potentials of the north tendon than the south tendon. The difference in chloride concentrations between the north and south tendons of Specimens 5.2 and 5.3 corresponds well with the disparity between the average final half-cell potentials of the tendons. This suggests that the coupler on the north duct did not work as well at keeping out chlorides as the lab installed grout vent on the south duct. The tendons of Specimens 5.2 and 5.3 were encased in plastic duct. Again, the majority of the tendons with plastic duct had chloride concentrations at midspan greater than the tendons with galvanized ducts. Again, this calls into question the ability of the plastic duct couplers to keep out moisture, oxygen, and/or chlorides. To reiterate, when the comparison of the chloride concentration and the average final half-cell potentials are made it can be shown that presence of chlorides and the corrosion of the zinc in the galvanized duct would elevate the average final half-cell potentials.

The chloride concentrations were discussed in depth in Chapter 5. All the chloride concentrations were above the 0.033% by weight of grout limit for corrosion. See Figure 5.14 for the results of the chloride concentration testing. As expected, highest chloride concentrations for the north and south tendons were at midspan and were 0.270% and 0.210% by weight of grout, respectively. As expected, the anchorage regions had the lowest chloride concentrations. This might be because the chlorides would take longer to migrate to the anchorages because the chloride ions would have to travel through the interstitial space between the grout and the duct and/or interstitial space between the grout and the strand.

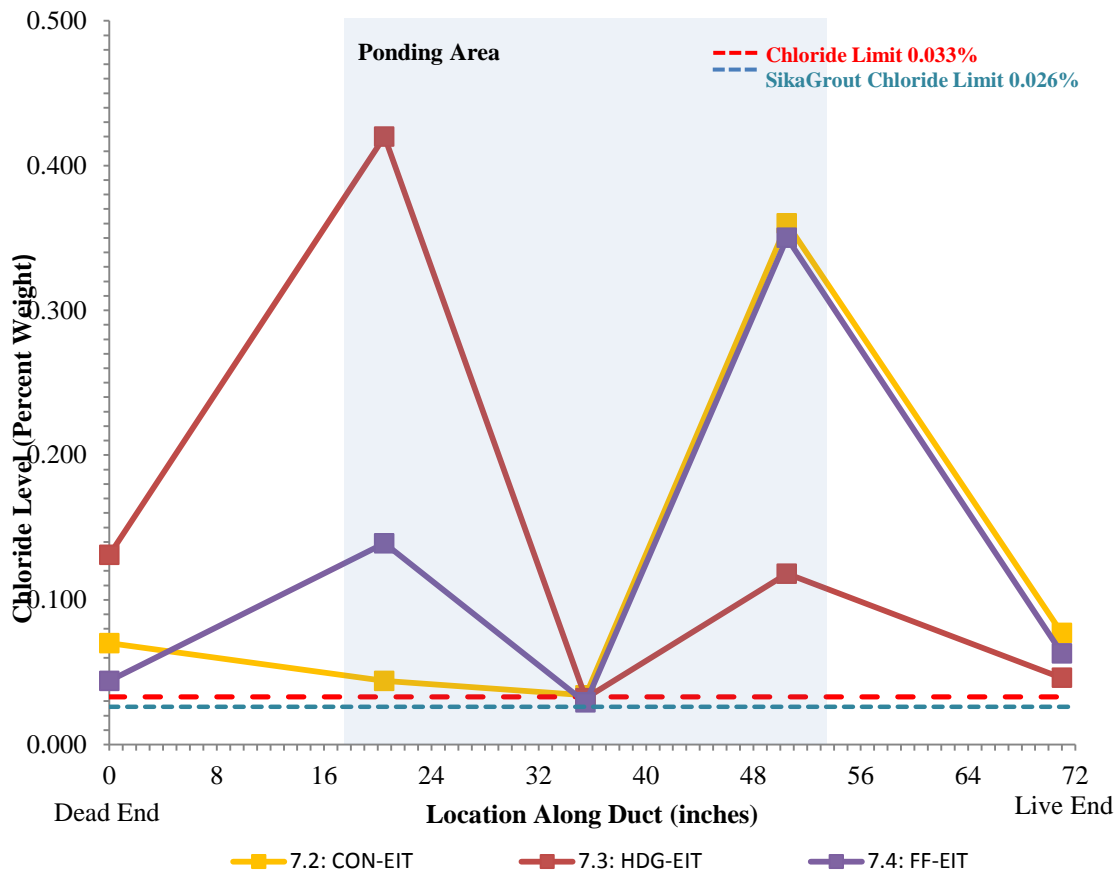
**Figure 5.15: Chloride Concentrations of Tendons in the 7-Series Specimens**

Figure 5.15 shows the chloride concentrations of the tendons in the 7-series specimens. The chloride levels at midspan were at or just below the 0.033% by weight of grout limit for corrosion and were smaller than the rest of the sample locations but were higher than Sika limit of 0.026% by weight of grout<sup>25</sup>. The chloride concentration being below the rest of the sample location was expected because the integrity of the duct at midspan was not breached due to a splice and/or grout vent and it was at the apex of the duct. The chloride concentrations being above the Sika limit is troublesome and suggests that grout may have been contaminated before it was placed in the tendon. For most of the tendons, the chloride concentrations at the locations of the splices were higher than the rest of the locations. This suggests that the splices are not water tight and corresponds to the AC impedance data. The AC impedance data indicated that there

might be a defect in the duct which allowed moisture, oxygen, and/or chlorides into the duct. There was moisture observed in the anchorage region when the tendons were cut from the anchorage to obtain grout samples for the chloride concentration testing. The chloride concentration at the dead end anchorage zone of the tendon of Specimen 7.2 was higher than the dead end splice region. This can be explained. During the autopsy of Specimen 7.2, the duct at the splice region had a crack and one of the strands was found to have severe pitting in the same location. This suggests that the concentration of chlorides in this region would be extremely elevated. No definitive reason can be given for the lower chloride concentrations of the grout in the region where the crack in the duct of Specimen 7.2 was observed. It should be noted that chlorides do not cause corrosion but contribute to corrosion process by breaking down the passive layer and raising the pH in the region of the corrosion. Except for Specimen 7.4, the chloride concentrations do not correspond to the average final half-cell potentials for the tendon with conventional strands, Specimen 7.2, or with the active corrosion potential for tendon with hot dip galvanized, Specimen 7.3. Specimen 7.4 had an average half-cell potential that was more negative than the greater than 90% probability of corrosion half-cell potential and had chloride concentrations above the corrosion limit of 0.033% chlorides by weight of grout. The tendon in Specimen 7.4 had flow filled epoxy coated strands and during autopsy the strand was found to have minimal corrosion in the main autopsy region. This suggests that the elevated average final half-cell potentials were possibly from the corrosion of the uncoated steel reinforcement that was used to conduct AC impedance readings and/or the corrosion of epoxy coated steel reinforcement.

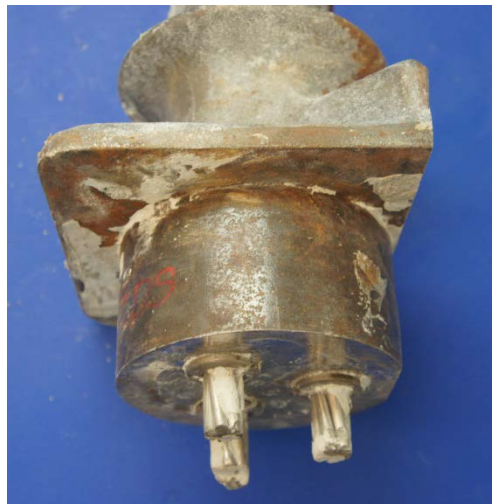
*Figure 6.7: Damage from Saw of the South Dead End Anchorage of Specimen 5.2*

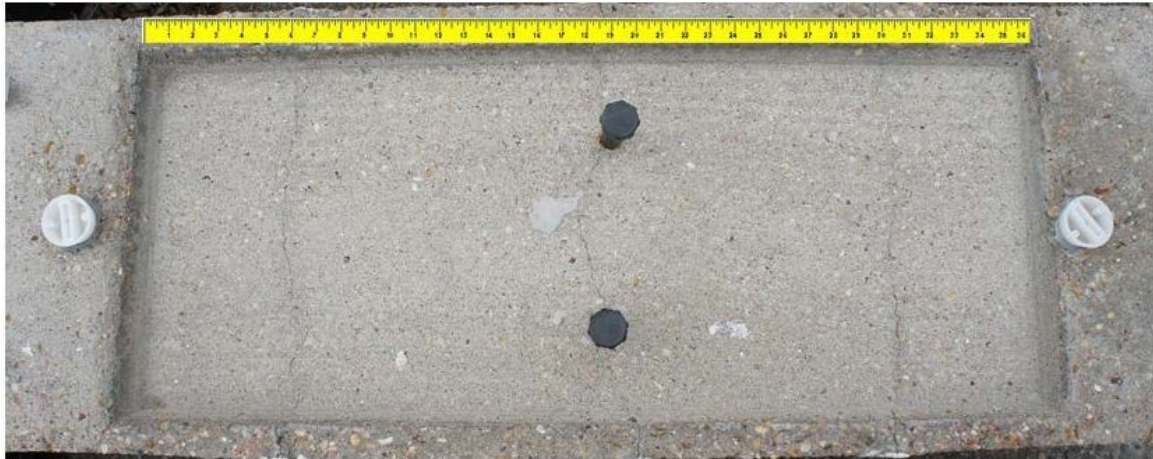
*Figure 6.11: Specimen 1.1 Main Autopsy Region and Grout Vents*

The surface of Specimen 1.1 had medium scaling over the majority of the exterior. Aggregate was visible in many locations, especially along the edges of the ponding area and sides of the specimen. The surface of the ponding area had medium scaling as well (Figure 6.11). There was a puddle of hardened grout about 2 inches in diameter approximately in the center of the ponding area. This puddle of hardened grout is from overflow during grouting operations. The base of the south grout vent had rust staining (Figure 6.11). This is an indication of corrosion inside the specimen. The backfill mortar in the live end anchorage pockets was separating from the concrete. This indicates that the mortar did not adhere well to the base concrete.

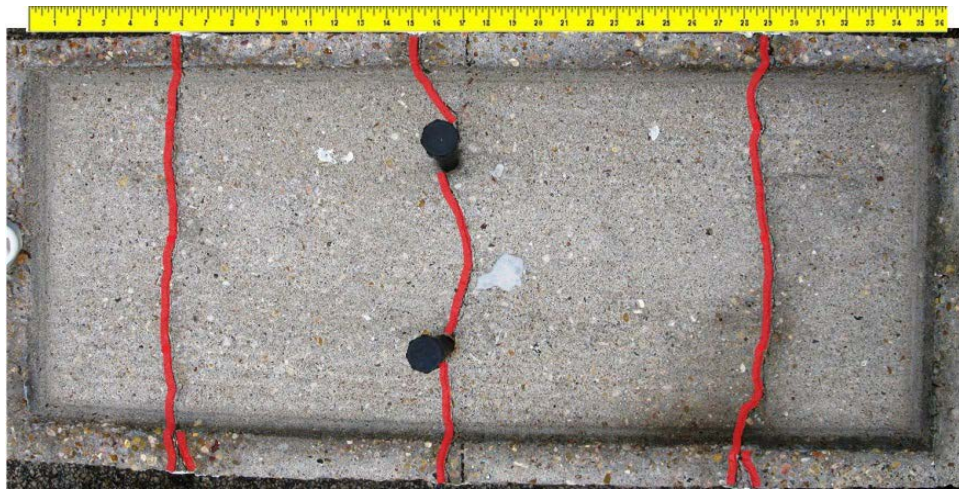
**Figure 6.12: Specimen 1.1 Crack Map of Ponding Area**

There were cracks present at the re-entrant corners of the corbel on both sides of the live end. These cracks were not present after live load application<sup>1</sup>. Therefore, the cracks had not been sealed with mortar or epoxy. The ponding area of Specimen 1.1 had 3 large transverse cracks that ran from the north to the south side of the specimen (Figure 6.12). The average crack width was approximately 0.01 inches. The crack rating for Specimen 1.1 was 0.42. See Figure 6.13 for the crack data from Specimen 1.1.

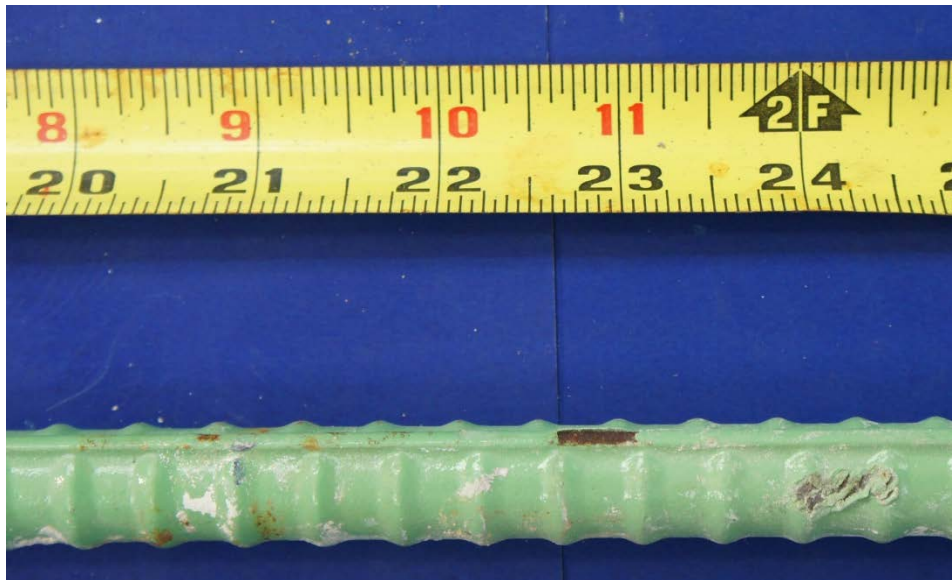
The north and south longitudinal bars had slight damage from when the bars were extracted from the specimen (Figure 6.14). Rust stains were also evident at locations where the transverse bars were tied to the longitudinal bars (Figure 6.14). This staining is from corrosion of the tie wire used to attach the transverse reinforcement to the longitudinal bars and NOT from the longitudinal bar itself. The south longitudinal bar had a spot of moderate corrosion on the longitudinal rib of the bar at approximately 23 inches from the dead end of the bar (Figure 6.14). Figure 6.20 shows the longitudinal bar's corrosion ratings and Table 6.6 shows the summary of the corrosion ratings for the longitudinal bars.

**Figure 6.14: Extraction Damage, Rust Staining, and Moderate Corrosion of South Longitudinal Bar of Specimen 1.1**

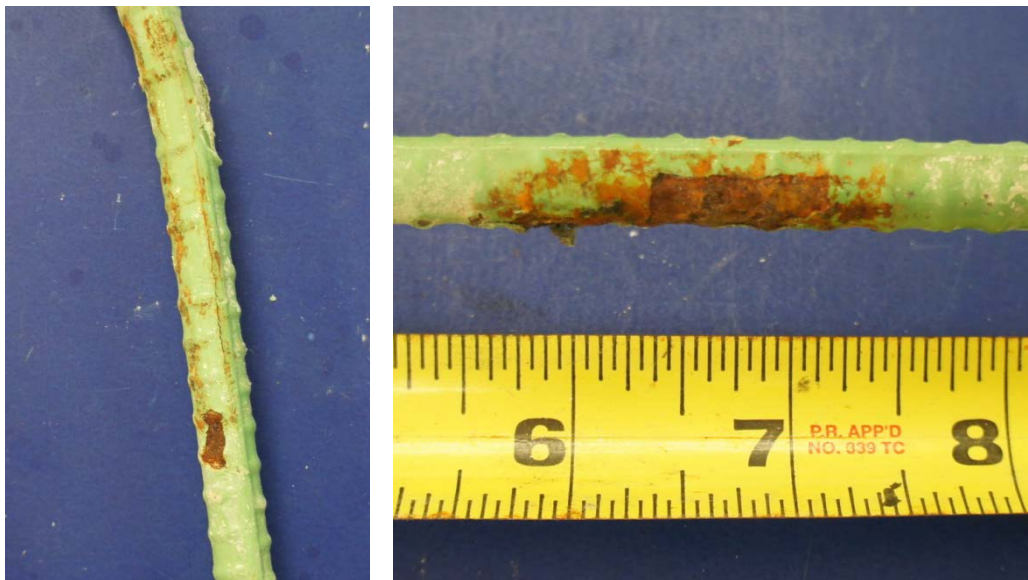
Transverse bars #1, #2, #3, #6, and #7 had damage from when they were extracted from the specimen. All the transverse bars had rust staining from corrosion of the tie wire used to attach the transverse bars to the longitudinal bars and to attach the ducts to the transverse bars. The staining is also from the corrosion of the galvanized duct. There was moderate corrosion on one of the vertical legs of bar #2 (Figure 6.15) and on the horizontal portion of bar #6. There was pitting on the horizontal portion of bar #4

(Figure 6.15). Bars #2, #4, and #6 had the highest rating, 19, 20, and 20, respectively. If any of the transverse bars were to have corrosion it would be these bars because of their close proximity to the induced deep cracks. The end bars, #1 and #7, had the lowest corrosion rating, 8 and 5, respectively. This was expected because these bars are outside the ponding area and should have had little to no exposure to chloride, moisture, and oxygen due to no evidence of cracks and increased concrete cover. Figure 6.20 shows the transverse bar's corrosion ratings and Table 6.6 shows the summary of the corrosion rating for the transverse bars.

**Figure 6.15: Moderate Corrosion on Vertical Leg of bar #2 (Left) and Pitting on Horizontal Portion of bar #4 (Right) of Specimen 1.1**

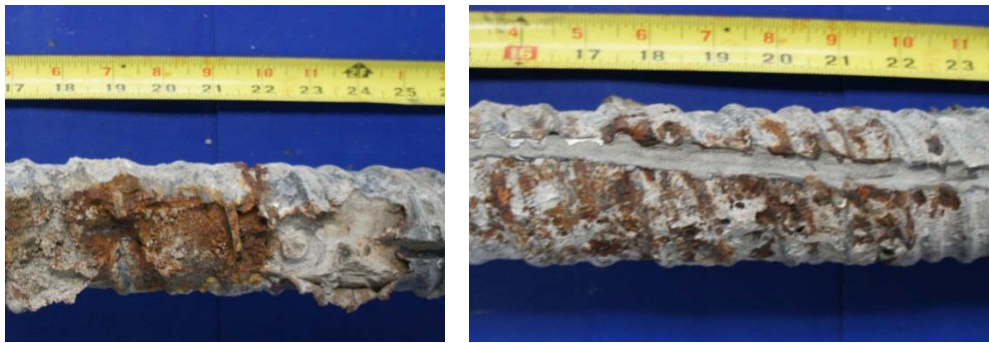
Both the north and south ducts had localized severe corrosion damage. This damage resulted in holes in the ducts. The top of the north duct had large holes at midspan and at intervals of approximately 6 inches until about the quarter points of the duct (Figure 6.16). The bottom of the north duct had moderate corrosion centered at midspan and at approximately 32 inches from the dead end of the duct (Figure 6.16). Except for the holes, the top inner surface of the north duct was in reasonably good shape with only a few locations of light corrosion next to where holes had occurred and at the

***Figure 6.16: Hole on the Top at Midspan (Left) and Moderate Corrosion on the Bottom at Midspan of the North Duct of Specimen 1.1(Right)***

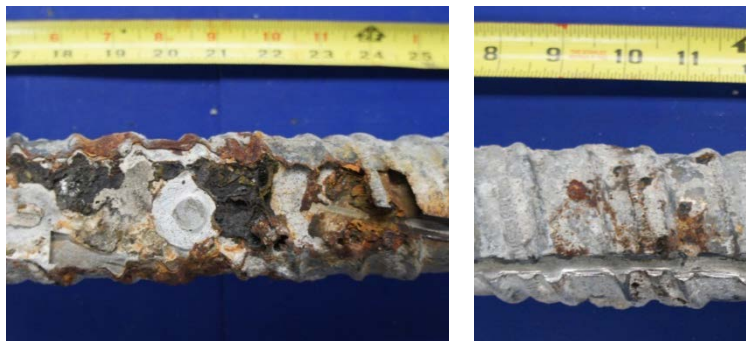
live and dead ends. The bottom inner surface of the north duct had no signs of corrosion. The top of the south duct had large holes at midspan and at the quarter points of the south duct (Figure 6.17). The bottom of the south duct had small holes at about the quarter points and moderate corrosion damage at midspan (Figure 6.17). The top inner surface of the south duct had no signs of corrosion at locations where no holes had occurred. The bottom inner surface of the south duct had light corrosion at midspan. The holes experienced by both the north and south ducts indicate that voids in the grout had formed along the top of the duct. The light corrosion observed on the bottom inner surface of the south duct might be from the chlorides traveling in the interstitial space between the grout and the duct after the holes had formed. Figure 6.20 shows the corrosion ratings for the ducts and Table 6.6 shows the summary of the corrosion ratings for the ducts.

***Figure 6.17: Hole on the Top at Midspan (Left) and Small Hole on the Bottom at the Dead End Quarter Point of Specimen 1.1 (Right)***

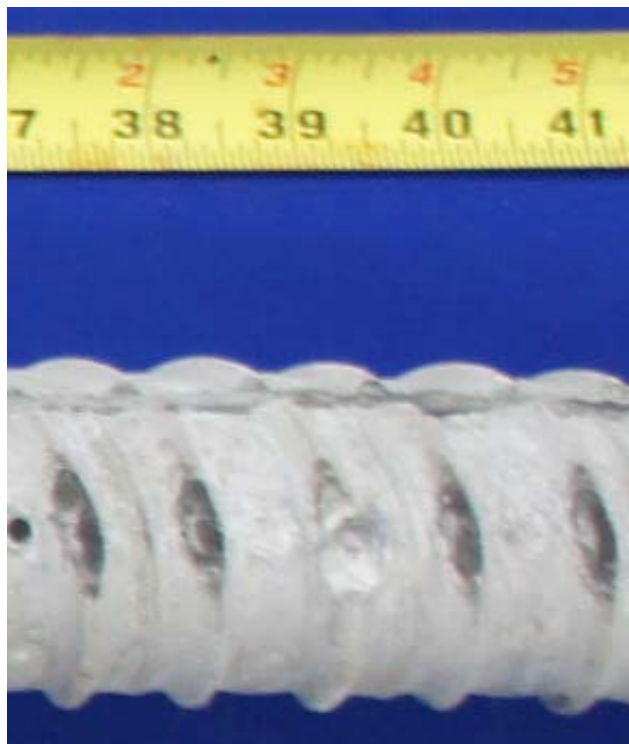
Only a few transverse cracks and no longitudinal cracks were observed during examination of grout from the north and south grouts of Specimen 1.1. Staining from corrosion of the duct was observed at locations where corrosion had caused holes in both the north and south duct. Small voids in the grout were observed in the flutes at the top of both the north and south duct along the entire length of the each duct (Figure 6.18). These voids measured approximately 0.75 inch long and were as wide as the flute width.

***Figure 6.18: Observed Flute Voids in the Grout of the North Tendon of Specimen 1.1***

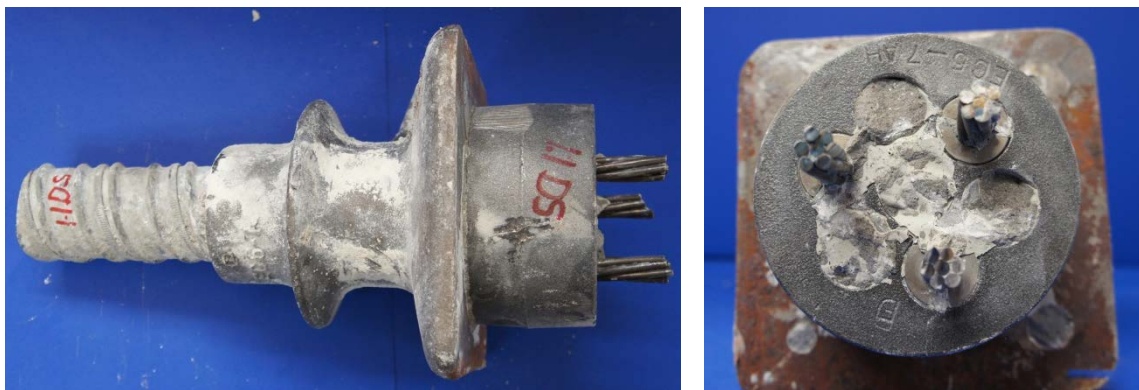
Most of the epoxy applied to the anchorage components before the anchorage cavity was backfilled had debonded from the anchorage components. The exposed faces of the north and south anchorage plate had light surface corrosion over approximately 80% of their surface but the embedded portion had no visible signs of corrosion (Figure 6.21). The sides of the north anchor head were primarily corrosion free with only light surface corrosion near the interface of the anchorage plate and anchor head but the sides of the south anchor head had no visible corrosion. The exposed face of the north and south anchor heads were corrosion free (Figure 6.21). However, the unexposed face of the north and south anchor heads had minimal spots of light corrosion. The ducts were not sealed to the anchorage plates with duct tape<sup>1</sup>.

**Figure 6.21: Dead End South Side Anchorage Assembly (Left) and Exposed Face of Anchor Head and Anchorage Plate (Right) from Specimen 1.1**

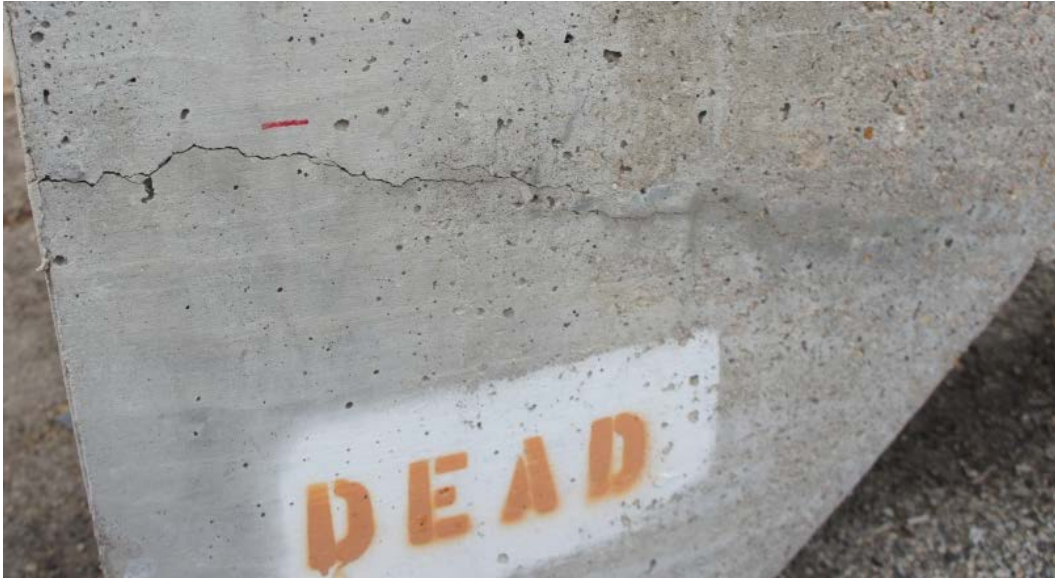
There was a crack present at the re-entrant corner of the corbel on the north side of the dead end (Figure 6.26). This crack was not present after live load application<sup>1</sup>.

*Figure 6.26: Crack at the Re-Entrant Corbel Corner on the North Side of the Dead End of Specimen 1.3*

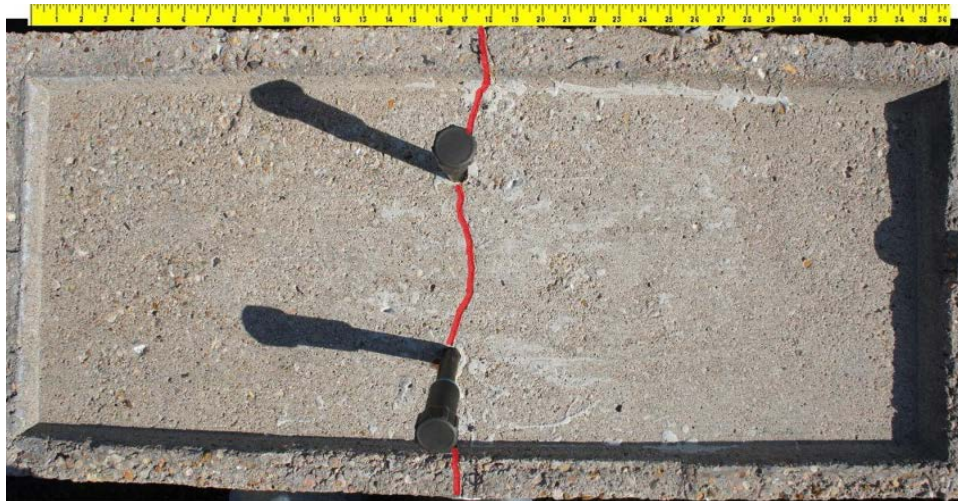
*Figure 6.27: Specimen 1.3 Crack Map of Ponding Area*

Therefore, the crack had not been sealed with mortar or epoxy. The ponding area of Specimen 1.3 had 1 large transverse crack that ran from the north to the south side of the specimen (Figure 6.27). The average crack width was 0.007 inch. The crack rating for Specimen 1.3 was 0.071. See Figure 6.28 for the crack data from Specimen 1.3.

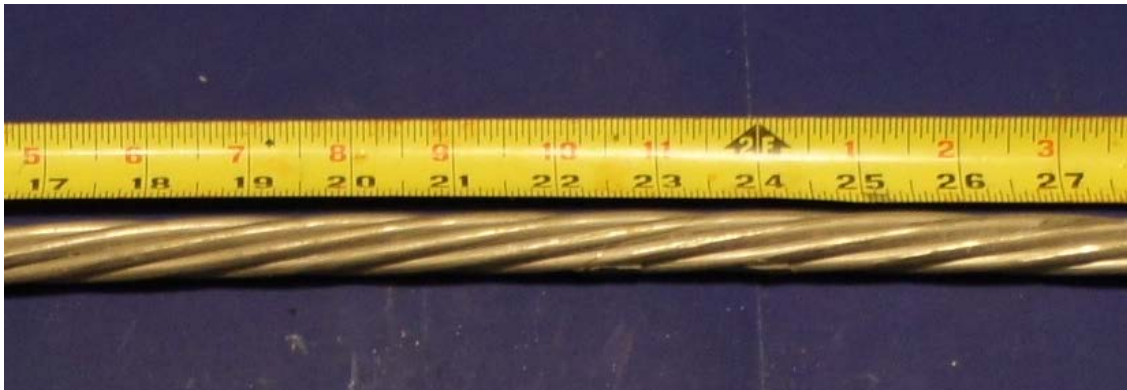
As expected, the stainless clad strands of the north and south tendons were essentially defect free. Minimal discoloration was observed on the outer wires of two

strands. One strand was from the north tendon and the other was from the south tendon. The entire length of the inner wires of 5 of the 6 strands had no visible corrosion. The one strand with corrosion had a small spot of light corrosion at midspan. The small spot of corrosion might have been from corrosion product from the duct that had migrated to the strand through micro cracking of the grout because there was no hole in the cladding of any of the strands in that duct to suggest that the corrosion product came from the underlying steel. Figure 6.31 shows a typical stainless clad strand from Specimen 1.3. Figure 6.32 shows the corrosion ratings for the strands and Table 6.8 shows the summary of the corrosion ratings for the strands.

*Figure 6.31: Typical Stainless Clad Strand from Specimen 1.3*

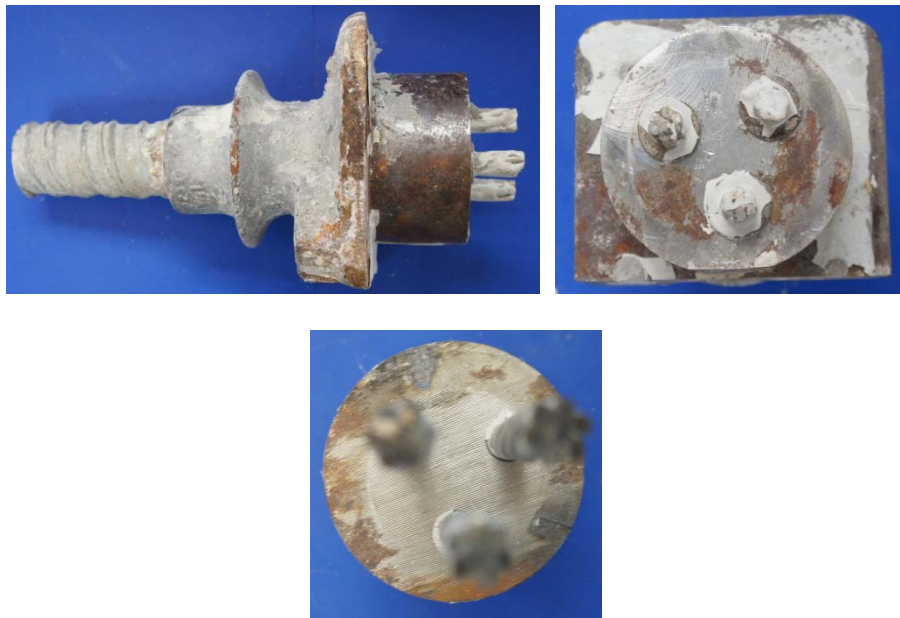
The majority of the epoxy applied to the anchorage components before the anchorage cavity was backfilled had debonded from the anchorage components of both tendons. The exposed faces of the north and south anchorage plate had light surface corrosion on their surface. The embedded portion of the south anchorage plate had light corrosion on the bottom (Figure 6.33). However, the embedded portion of the north anchorage plate had no visible signs of corrosion (Figure 6.33). The sides of the north and south anchor head had light surface corrosion (Figure 6.33). The exposed face of the north and south anchor heads had moderate surface corrosion on portions of its surface (Figure 6.33). The unexposed faces had light surface corrosion on the outer ring where the grout had not come into contact with anchor head (Figure 6.33). The ducts were not sealed to the anchorage plates with duct tape<sup>1</sup>.

***Figure 6.33: Light Surface Corrosion on Anchorage Components: Bottom of Anchorage (Top Left), Exposed Surface of Anchorage Plate and Head (Top Right), and Unexposed Surface of Anchor Head (Bottom) of Specimen 1.3***

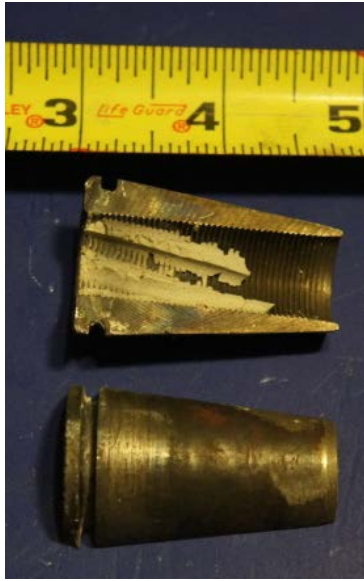
The majority of the intervals for outer wires of the strands from the dead end of the north and south tendon had no visible signs of corrosion or discoloration. The one outlier was on one strand at the interval closest to where the tendon was cut from the main autopsy region and the outer wires showed discoloration but no corrosion. Except for one interval of one strand, the inner wire was corrosion free and no discoloration was observed. The one interval had a small spot of light corrosion. This spot of light corrosion of the inner wire and discoloration of the outer wires might have come from when the tendon was cut from the main autopsy region. The wedges were intact and showed light surface corrosion on the outer surface (Figure 6.34). Figure 6.35 shows the corrosion ratings for the anchorage region strands and Table 6.9 shows the summary of the corrosion ratings for the anchorage region stands.

Figure 6.34: Light Surface Corrosion on Wedge from Specimen 1.3

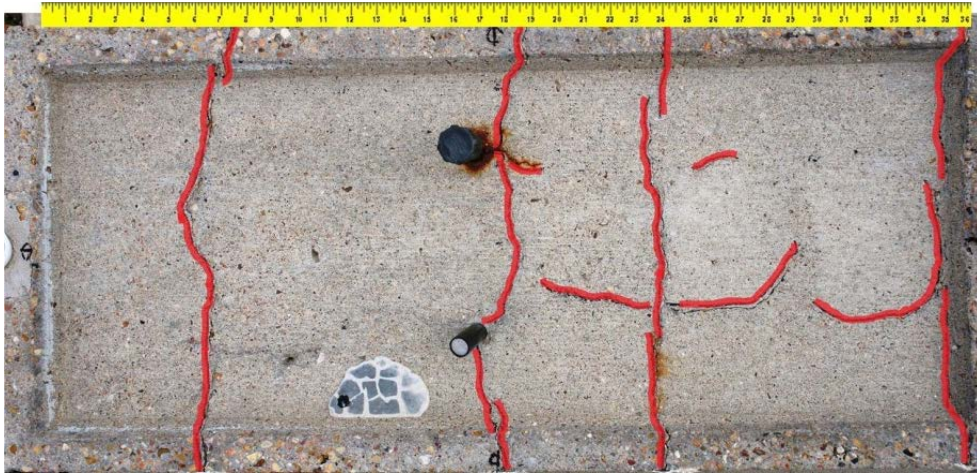
**Figure 6.38: Specimen 1.4 Crack Map of Ponding Area**

There were cracks present at the re-entrant corbel corners on both sides of the dead end and live end (Figure 6.37). These cracks were not present after live load application<sup>1</sup>. Therefore, the cracks had not been sealed with mortar or epoxy. The ponding area of Specimen 1.4 had 4 large transverse cracks that ran from the north to the south side of the specimen and 2 longitudinal cracks in the live end of the ponding region (Figure 6.38). The average crack width was 0.006 inch. The crack rating for Specimen 1.4 was 0.50. See Figure 6.39 for the crack data from Specimen 1.4.

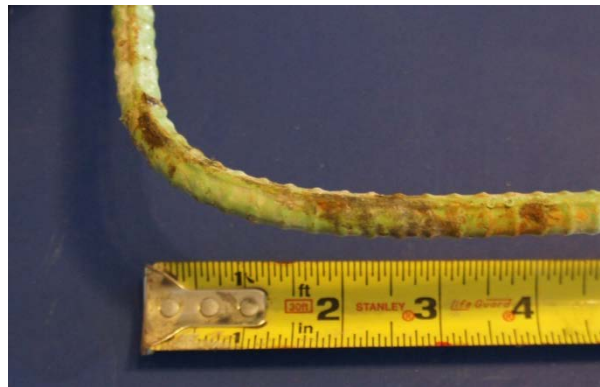
Transverse bars #1, #4, #6, and #7 had damage from when they were extracted from the specimen. All the transverse bars had rust staining at least somewhere over the length of the bar from corrosion of the tie wire used to attach the transverse bars to the longitudinal bars and to attach the duct to the transverse bars. The staining is also from the corrosion of the galvanized duct. There was moderate corrosion observed on the corner of bar #4 (Figure 6.40) and light corrosion observed on the corner of bar #5. Transverse bar #4 had the highest rating of 21. The end bars, #1 and #3, both had the lowest corrosion rating of 2. This was expected for bar #1 because this bar was outside the ponding area and should have had little to no exposure to chloride ions. Figure 6.44 shows the transverse bar's corrosion ratings and Table 6.10 shows the summary of the corrosion rating for the transverse bars.

***Figure 6.40: Moderate Corrosion on the Corner of Transverse Bar #4 from Specimen 1.4***

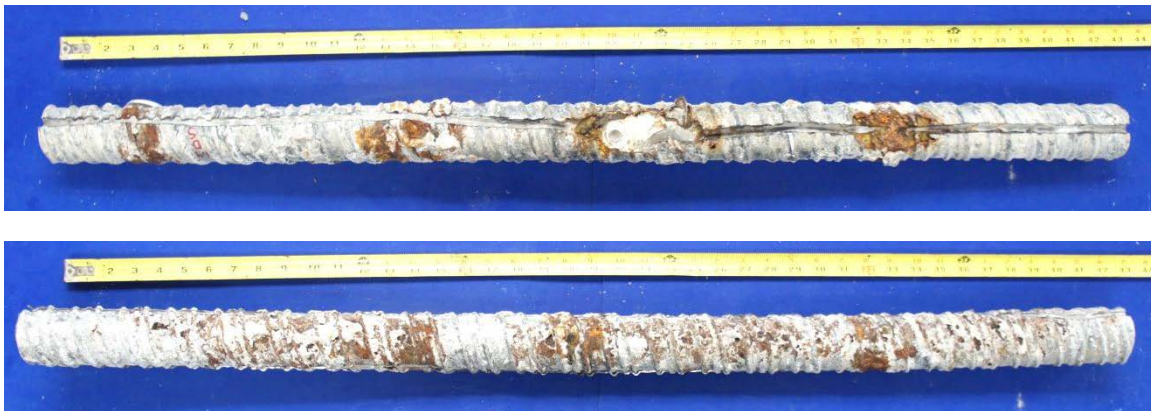
***Figure 6.41: Specimen 1.4 Top of North Duct (Top) and Bottom of South Duct (Bottom)***

Both the north and south ducts had localized severe corrosion damage. This damage resulted in holes in the ducts. The top outer surface of the north duct had large holes at midspan and around the live end quarter point of the duct and had discoloration and light to moderate corrosion (Figure 6.41). The bottom outer surface of the north duct had discoloration, light to moderate corrosion, pitting, and a small hole at midspan. The

top inner surface of the north duct had discoloration and pitting adjacent to the holes. Except at the ends, the bottom inner surface of the north duct had pitting along the entire length. The top outer surface of the south duct had large holes on the live end side of midspan and one centered at approximately 33 inches from the dead end and had small holes centered at approximately 3 inches and 15 inches from the dead end. The bottom outer surface of the south duct had a small hole centered approximately 31 inches from the dead end (Figure 6.41). The top inner surface of the south duct had one interval with pitting adjacent to the small hole centered at 5 inches from the dead end and had intervals with discoloration and moderate corrosion. The bottom inner surface had pitting almost the entire length of the duct as well as discoloration and light to moderate corrosion. The holes experienced by both the north and south ducts indicate that voids in the grout had formed along the top of the duct and a large void was evident in the south tendon that spanned approximately 60% of length of the tendon (Figure 6.42). The pitting observed on the bottom inner surface of the north and south duct might be from the chlorides traveling in the interstitial space between the grout and the duct after the holes had formed. Figure 6.44 shows the corrosion ratings for the ducts and Table 6.10 shows the summary of the corrosion ratings for the ducts.

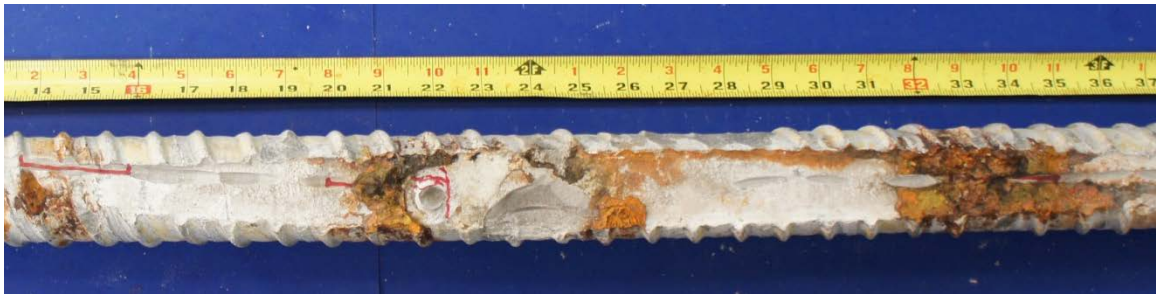
No transverse or longitudinal visible cracks were observed during examination of grout from the north and south tendons of Specimen 1.4. Staining from corrosion of the duct was observed at locations where corrosion had caused holes in the both the north and south duct. Small voids in the grout were observed in the flutes along the entire length of the top of both the north and south tendons and large voids were present at mid span of both the north and south tendons with the void in the south tendon spanning approximately 60% of the length (Figure 6.42). The small voids measured approximately 0.75 inch long and were as wide as the flute width.

**Figure 6.42: Large Void in Grout of South Tendon from Specimen 1.4**

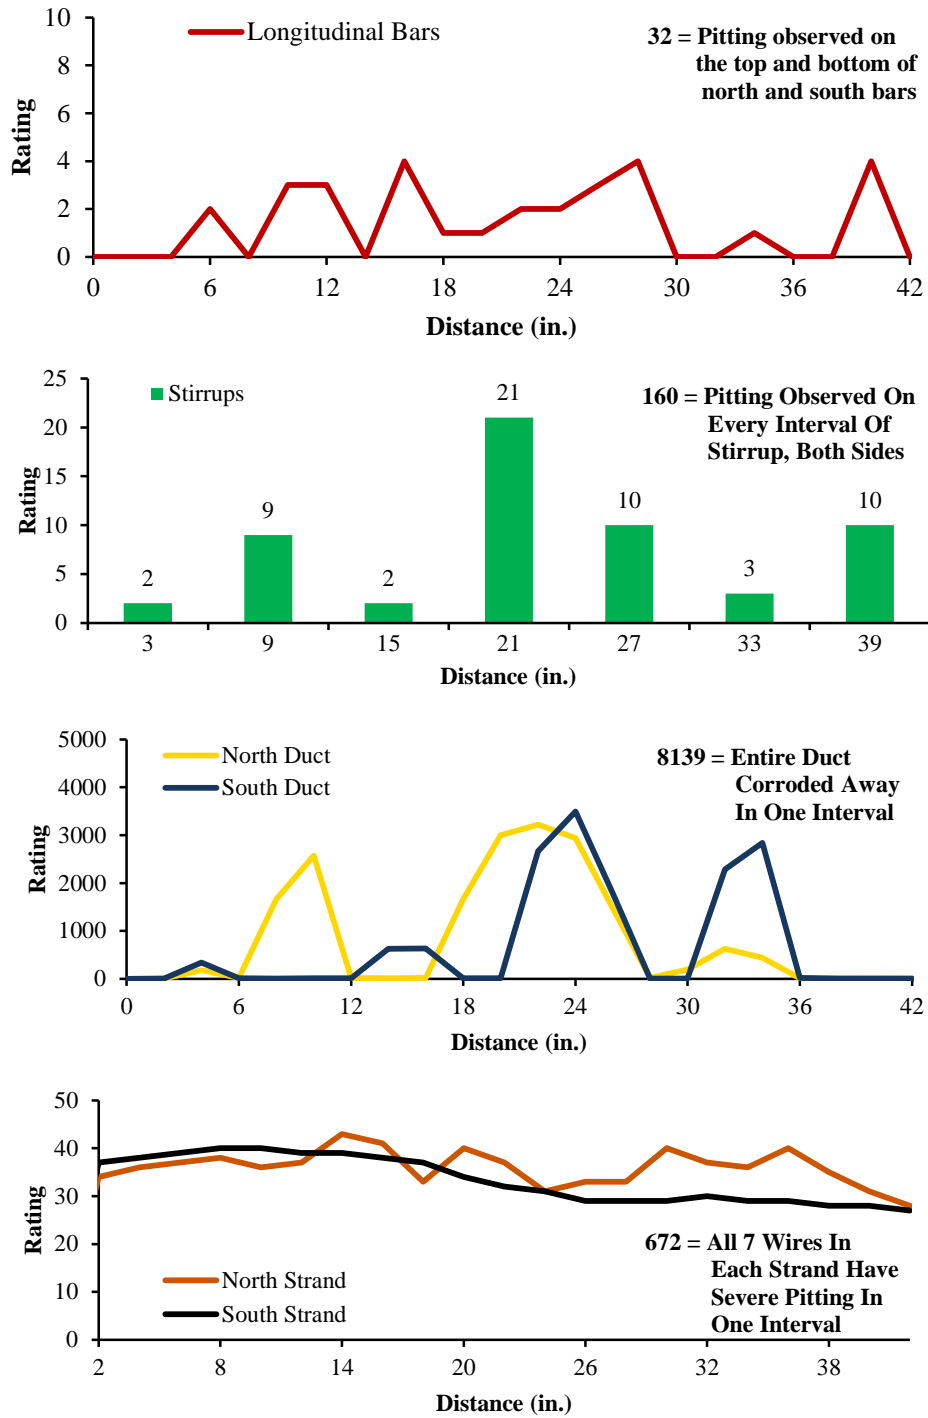
Figure 6.44 shows the corrosion ratings for the strands and Table 6.10 shows the summary of the corrosion ratings for the strands.

Figure 6.44: Corrosion Rating Plots for Main Autopsy Region of Specimen 1.4

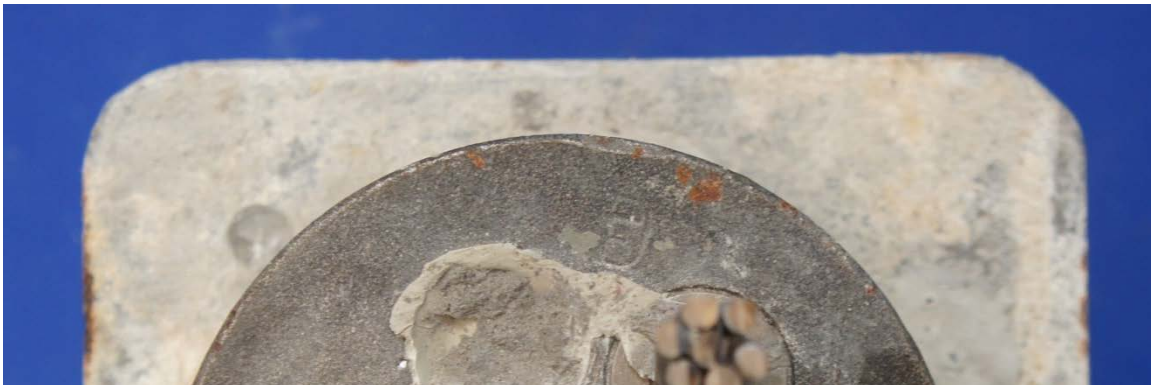
The majority of the epoxy applied to the anchorage components before the anchorage cavity was backfilled had debonded from the anchorage components. Portions of both the exposed faces of the north and south anchorage plate had light surface corrosion on their surface. The embedded portion of the north anchorage plate had no visible signs of corrosion but the embedded portion of the south anchorage plate had light corrosion on the bottom of the bearing surface. The sides of the north and south anchor heads were primarily corrosion free with only light surface corrosion near the interface of the anchorage plate and anchor head. The exposed face of the south anchor head was corrosion free but the exposed face of the north anchor head had small spots of light corrosion (Figure 6.45). The unexposed face of the north and south anchor heads had light surface corrosion. The ducts were not sealed to the anchorage plates with duct tape<sup>1</sup>.

*Figure 6.45: Light Surface Corrosion of Exposed Face of North Anchor Head from Specimen 1.4*

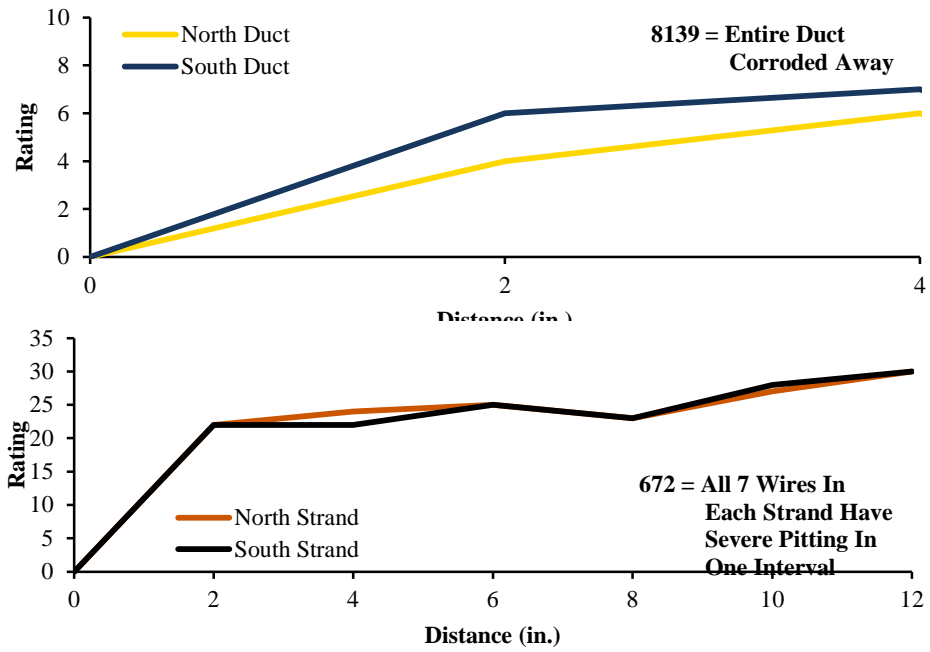
The north and south ducts from the dead end anchorage region had light corrosion in one interval of the bottom outer surface of the duct. The bottom inside surface of the north duct had light surface corrosion on one interval. The inside of the south duct had light surface corrosion on two intervals. Figure 6.46 shows the corrosion ratings for the anchorage region ducts and Table 6.11 shows the summary of the corrosion ratings for the anchorage region ducts.

The outer wires of the strands from the dead end anchorage region of the north and south tendon had discoloration and light corrosion over the length of the wires. One of the inner wires had light corrosion over the majority of its length and another inner wire had discoloration on half of its length and light corrosion on the other half. The other inner wires were primarily discolored with some light corrosion. The wedges were intact and showed no visible signs of corrosion. Figure 6.46 shows the corrosion ratings for the anchorage region strands and Table 6.11 shows the summary of the corrosion ratings for the anchorage region stands.

*Figure 6.46: Corrosion Rating Plots for Dead End Anchorage Region of Specimen 1.4*

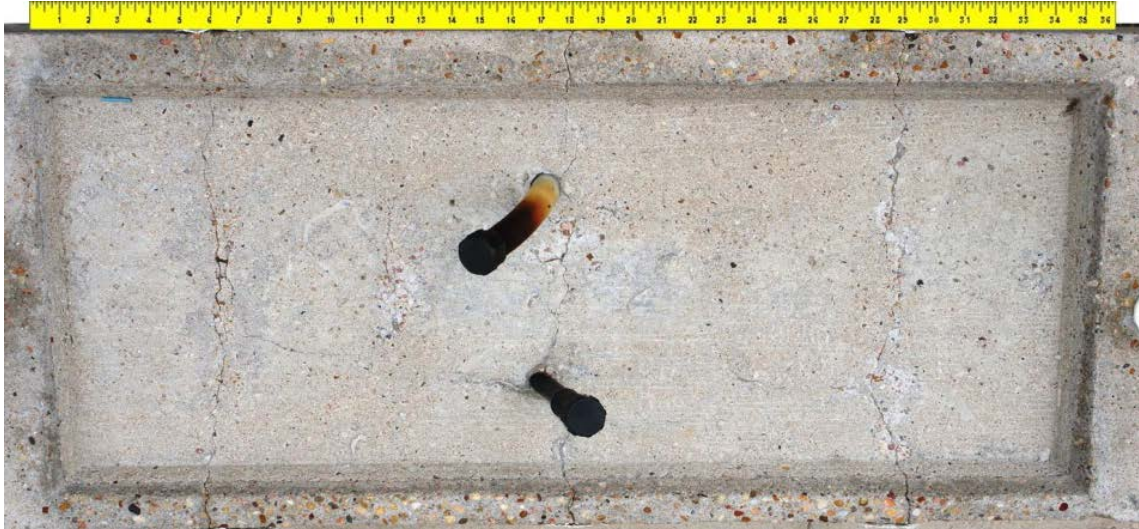
*Figure 6.47: Specimen 2.3 Main Autopsy Region and Grout Vents*

The surface of Specimen 2.3 had medium scaling over the majority of the exterior. Aggregate was visible in many locations, especially along the edges of the ponding area and sides of the specimen. The surface of the ponding area had medium scaling as well (Figure 6.47). No rust stains were observed during examination. The backfill mortar of the dead and live end anchorage pockets were separating from the concrete. This indicates that the mortar did not adhere well to the base concrete.

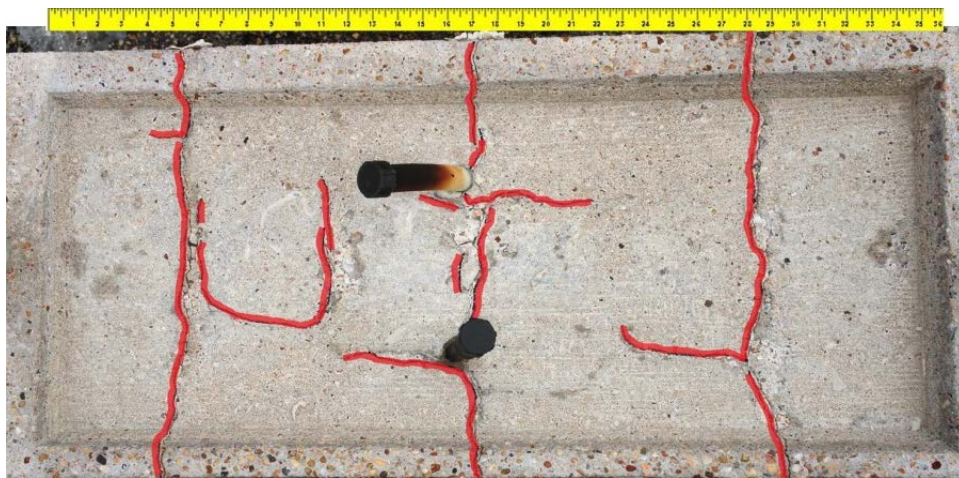
There were cracks present at the re-entrant corbel corners on both sides of the dead and live end. These cracks were not present after live load application<sup>1</sup>. Therefore, the cracks had not been sealed with mortar or epoxy. The ponding area of Specimen 2.3 had 3 large transverse cracks that ran from the north to the south side of the specimen and longitudinal cracks located on the north and south side of the ponding area (Figure 6.48). The average crack width was 0.008 inch. The crack rating for Specimen 2.3 was 0.63. See Figure 6.1 for the crack data from Specimen 2.3.

**Figure 6.48: Specimen 2.3 Crack Map of Ponding Area**

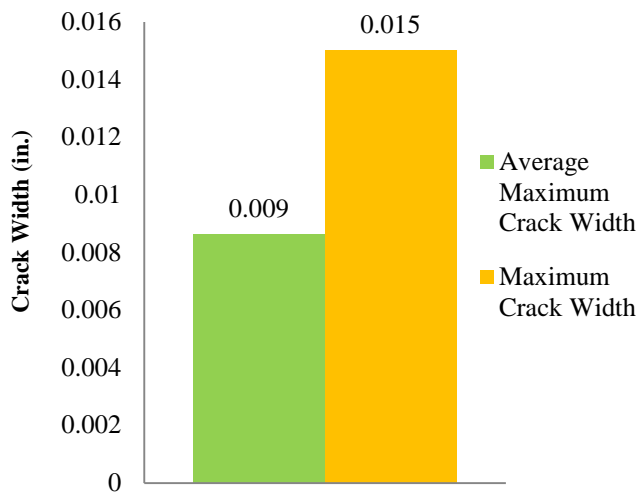
**Figure 6.49: Crack Data for Specimen 2.3**

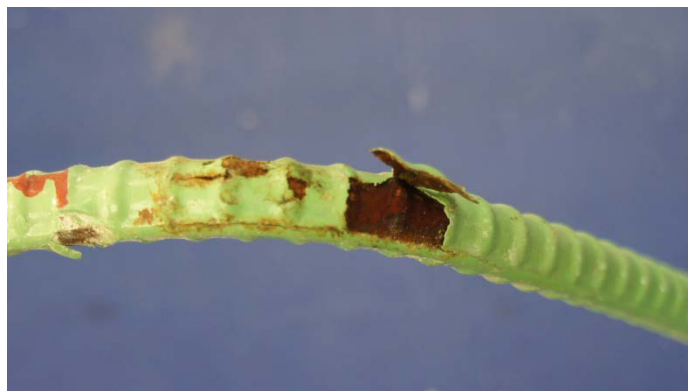
Transverse bars #1, #2, #4, and #7 had damage from when they were extracted from the specimen. All the transverse bars had rust staining at least somewhere over the length of the bar from corrosion of the tie wire used to attach the transverse bars to the longitudinal bars and to attach the duct to the transverse bars. All transverse bars had either light or moderate corrosion or both. There was moderate corrosion observed on bars #1, #3, #6, and #7 (Figure 6.50) and light corrosion observed on bars #2, #3, #4, #5, and #6. Transverse bar #6 had the highest rating of 24. Bar #4 had the lowest corrosion rating of 5. This wasn't expected because the bar was from the center of the ponding area and directly under a crack. Figure 6.54 shows the transverse bar's corrosion ratings and Table 6.12 shows the summary of the corrosion rating for the transverse bars.

***Figure 6.50: Moderate Corrosion on Transverse Bar #3 of Specimen 2.3***
