**Assessment of Long-Term Corrosion Resistance of Recently Developed  
Post-Tensioning Components**

**Thesis**

The University of Texas at Austin

**August, 2012**

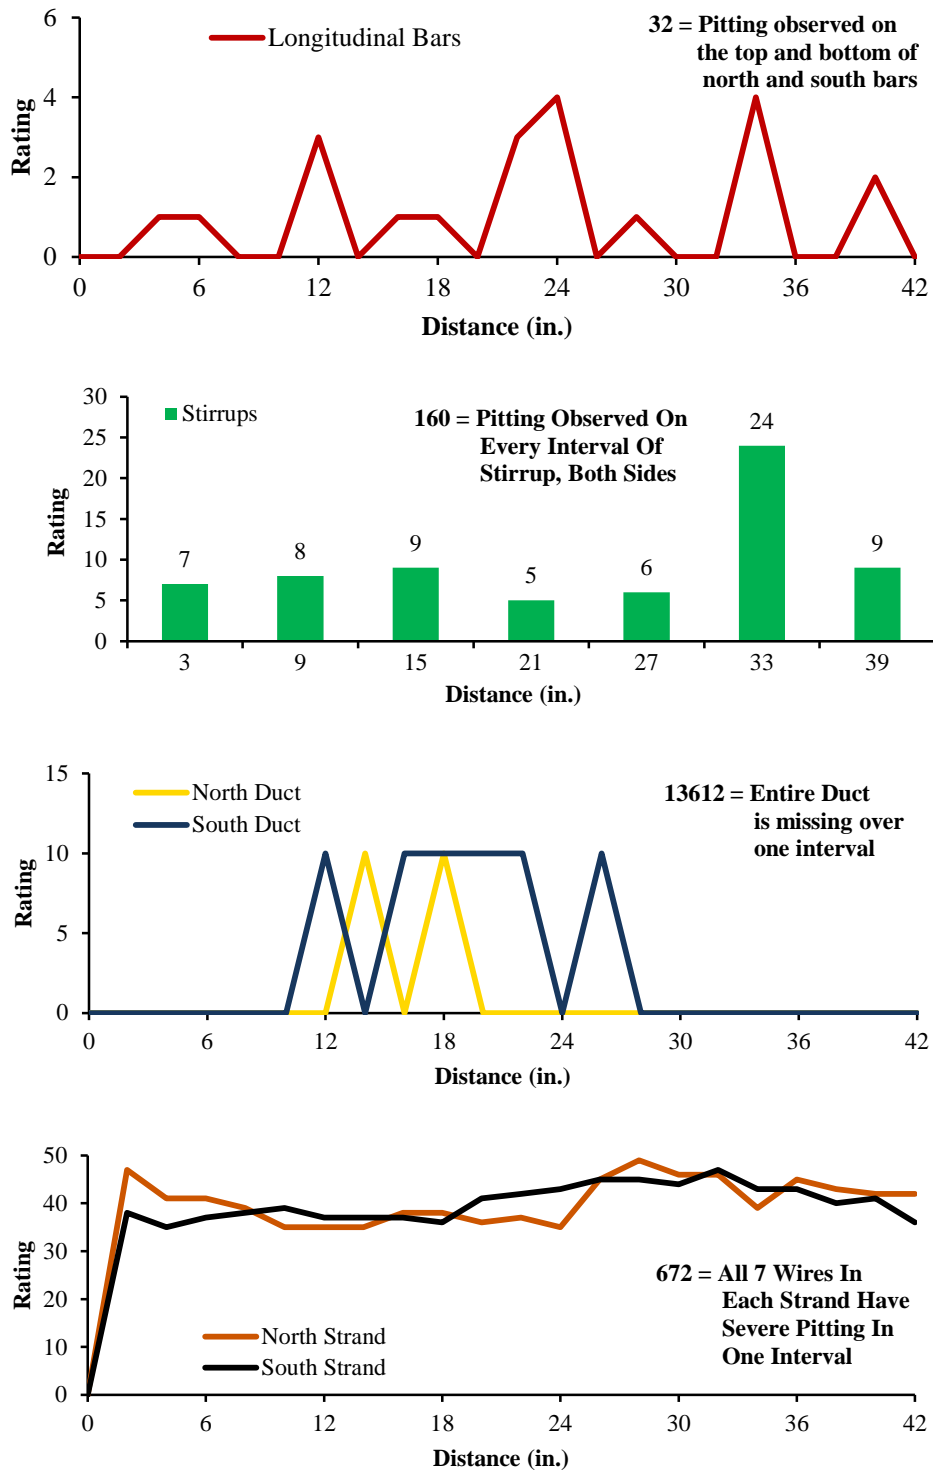
Figure 6.54 shows the damage ratings for the ducts and Table 6.12 shows the summary of the damage ratings for the ducts.

Figure 6.54 shows the corrosion ratings for the strands and Table 6.12 shows the summary of the corrosion ratings for the strands.

Figure 6.54: Corrosion Rating Plots for Main Autopsy Region of Specimen 2.3

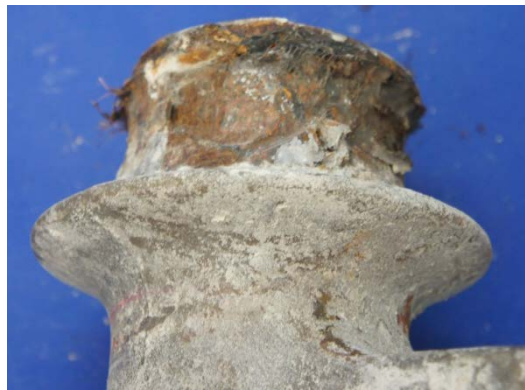
All of the epoxy applied to the both anchor heads before the anchorage cavity was backfilled had debonded from the anchorage components of both tendons. The majority of the epoxy on the anchorage plate was still bonded to the exposed surface. The exposed faces of the north and south anchorage plate had light surface corrosion on their surface. The embedded portion of both anchorage plates had moderate corrosion and pitting on the bottom and moderate corrosion where the duct was taped to the anchorage plate using duct tape (Figure 6.55). The sides and exposed face of the north and south anchor head had spots of light surface corrosion. The unexposed face of the north and south anchor heads had light surface corrosion.

**Figure 6.55: Moderate Surface at South Dead End Interface of Duct and Anchorage Plate of Specimen 2.3**

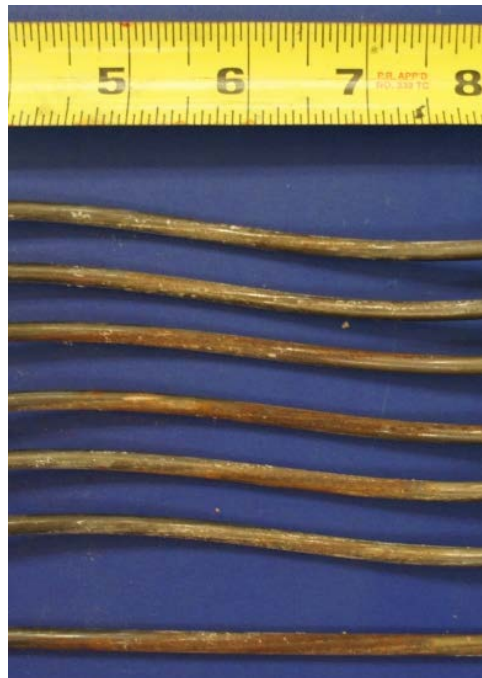
There was mild pitting observed on two of the north strands outer wires (Figure 6.56). The inner wires of the same strands had mild pitting observed as well (Figure 6.56). The other north strand had light to moderate corrosion on its outer wires and the inner wire had light corrosion along its length. The three strands from the south tendon had discoloration and light corrosion on their outer wires and moderate corrosion along the entire length of their inner wires. Figure 6.57 shows the corrosion ratings for the anchorage region strands and Table 6.13 shows the summary of the corrosion ratings for the anchorage region stands.

***Figure 6.56: Mild Pitting on Inner and Outer Wires of a Strand from the Dead End Anchorage Region of Specimen 2.3***

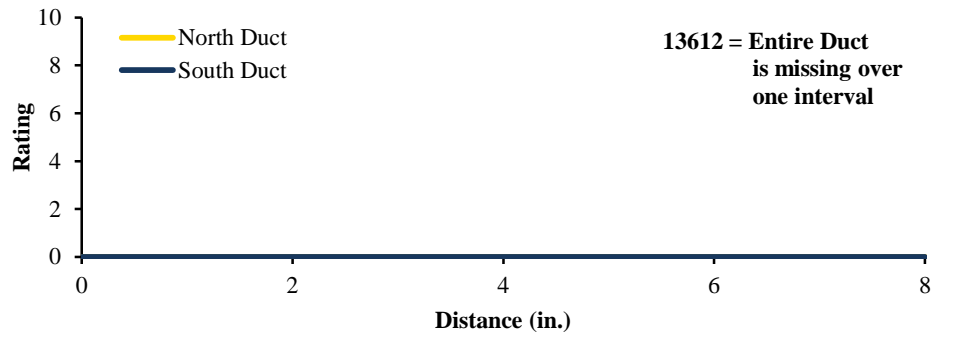
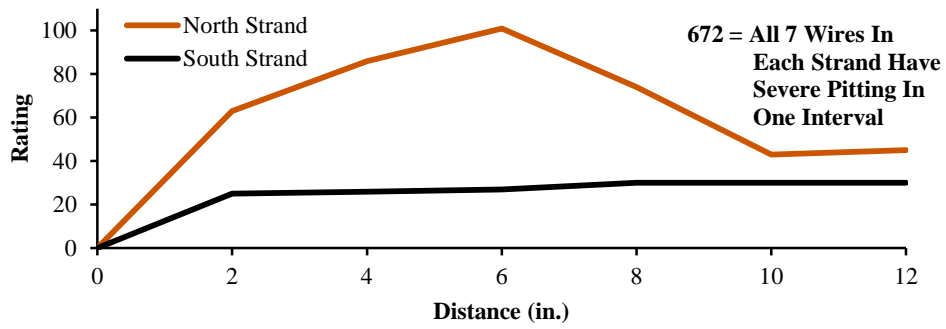
The north and south ducts no had visible signs of damage or staining. There were indications of voids in the grout of the north and south tendon along the length of the duct in the anchorage region from the flutes of the duct. Figure 6.57 shows the damage ratings

**Figure 6.57: Corrosion Rating Plots for Dead End Anchorage Region of Specimen 2.3**

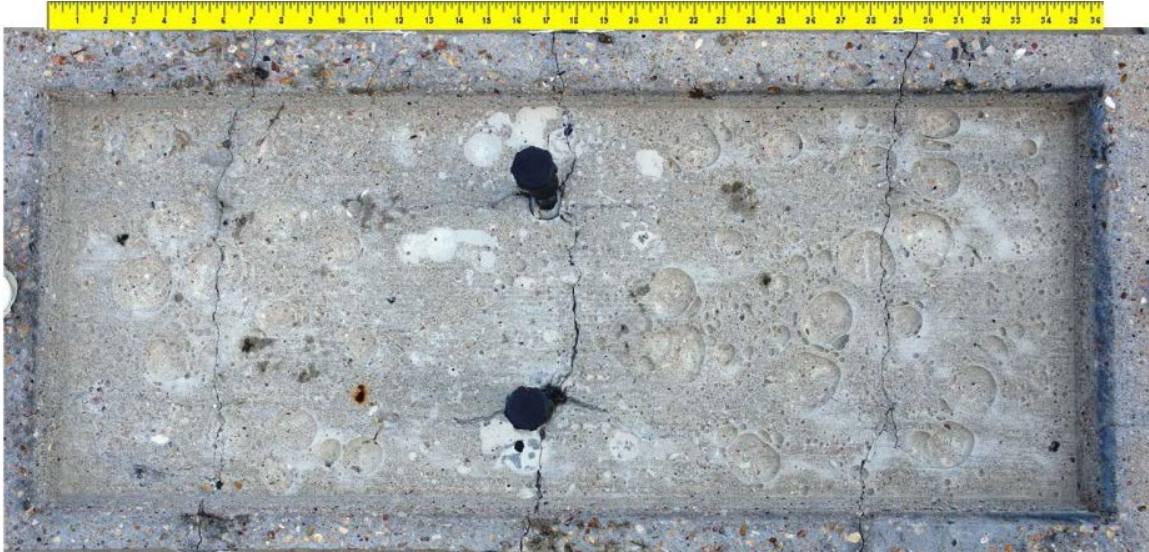
*Figure 6.58: Specimen 3.3 Main Autopsy Region and Grout Vents*

The surface of Specimen 3.3 had medium scaling over the majority of the exterior. Aggregate was visible in many locations, especially along the edges of the ponding area and sides of the specimen. The surface of the ponding area had medium scaling as well and had medium sized shallow depressions from bleed water pockets when the ponding area was formed during casting (Figure 6.58). A small rust stain from a tie wire that did

not have any concrete cover was observed in the ponding area on the dead end north side (Figure 6.58). The backfill mortar live end anchorage pocket was separating from the base concrete. This indicates that the mortar did not adhere well to the base concrete.

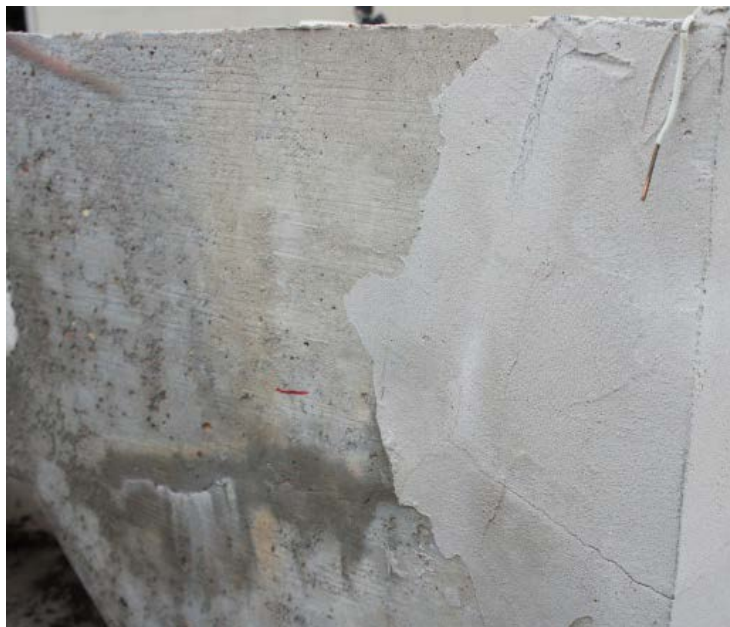
There were cracks present at the re-entrant corbel corners on both sides of the live end and efflorescence was observed coming from the crack (Figure 6.59). These cracks were not present after live load application<sup>1</sup>. Therefore, the cracks had not been sealed with mortar or epoxy. The ponding area of Specimen 3.3 had 3 large transverse cracks that ran from the north to the south side of the specimen and 1 small transverse crack on the dead end south side that ran from the edge of the specimen to approximately the center line of the south duct. The longitudinal cracks observed were located on the north and south side of the ponding area over the top of the corresponding tendons (Figure 6.60). This cracking might have been caused by the differential shrinkage or expansion because the duct and concrete have different thermal coefficients and the concrete in this region had decreased cover. The average crack width was 0.008 inch. The crack rating for Specimen 3.3 was 0.72. See Figure 6.61 for the crack data from Specimen 3.3.

***Figure 6.59: Efflorescence from Re-entrant Crack on North side of Specimen 3.3 Live End***

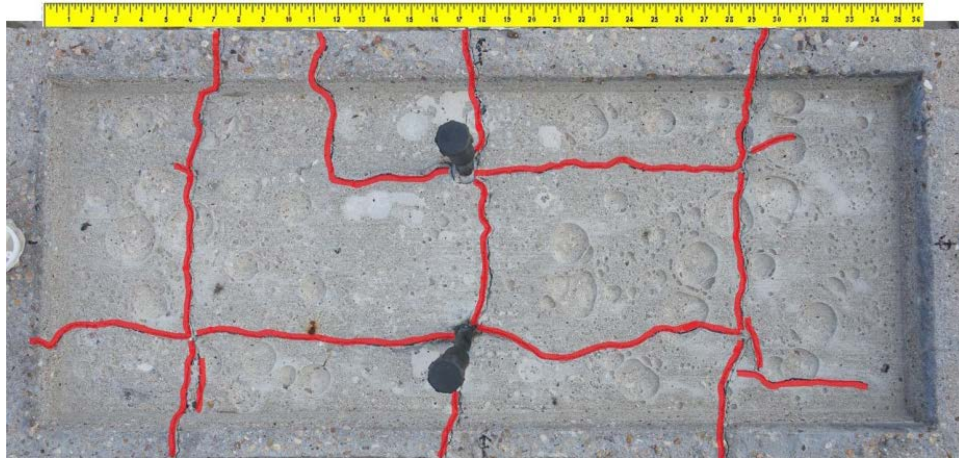
**Figure 6.60: Specimen 3.3 Crack Map of Ponding Area**

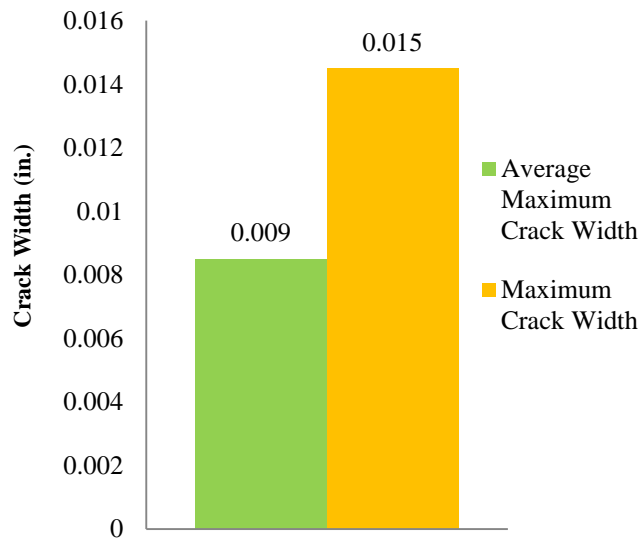
**Figure 6.61: Crack Data for Specimen 3.3**

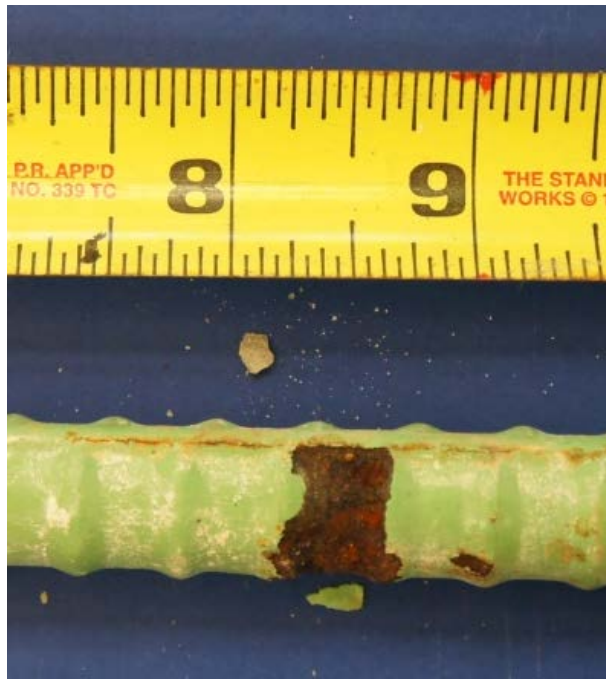
south longitudinal bars. The north bar had moderate corrosion at the dead end and the south bar had moderate corrosion at the dead end quarter point (Figure 6.62). Figure 6.67 shows the longitudinal bar's corrosion ratings and Table 6.14 shows the summary of the corrosion ratings for the longitudinal bars.

***Figure 6.62: Moderate Corrosion at the Dead End Quarter Point of Specimen 3.3 South Longitudinal Bar***

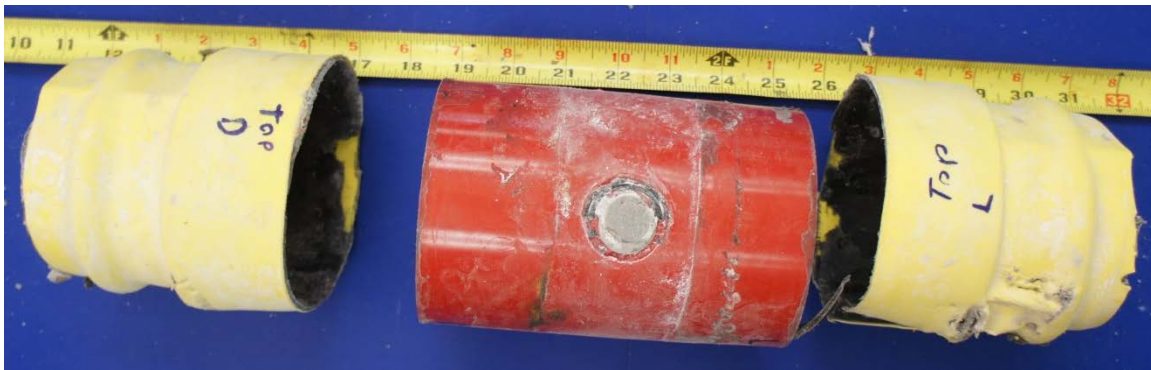
The entire outer surface of the north duct had a chalky white residue. No corrosion staining was observed on the outer or inner surface of the duct. The inner bottom surface of the north duct had slight gouges on successive intervals in the dead end side of midspan and one interval on the live side of midspan. This indicates that one or more of the strands caused damage either when the strands were being threaded through the duct or one of the strands or stands were rubbing against the duct when the strands were being stressed. In either case, the integrity of the duct was not compromised. Indications of voids were observed on the top inner surface of the duct along the entire length. No damage was observed on the coupler, grout vent, or heat shrink wrap used to seal the coupler/duct interface (Figure 6.63). However, the heat shrink wrap did not bond well to the coupler or duct (Figure 6.63). This might indicate why chloride levels were elevated.

**Figure 6.63: Coupler and Heat Shrink Wrap from North Duct of Specimen 3.3**

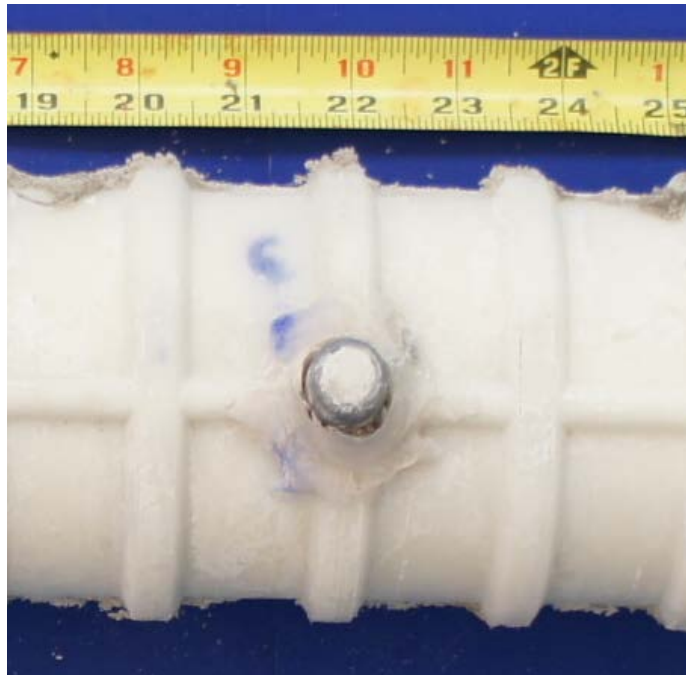
either when the strands were being threaded through the duct or possibly one of the strands or stands were rubbing against the duct when the strands were being stressed. In either case, the integrity of the duct was not compromised. The silicone that was used to seal the grout vent to the south duct was found to have debonded from the duct (Figure 6.64). It is not known if this happened during extraction or when the concrete was placed. Chloride levels indicate that the latter is the more valid explanation.

***Figure 6.64: Silicone Debonded from Grout Vent of South Duct from Specimen 3.3***

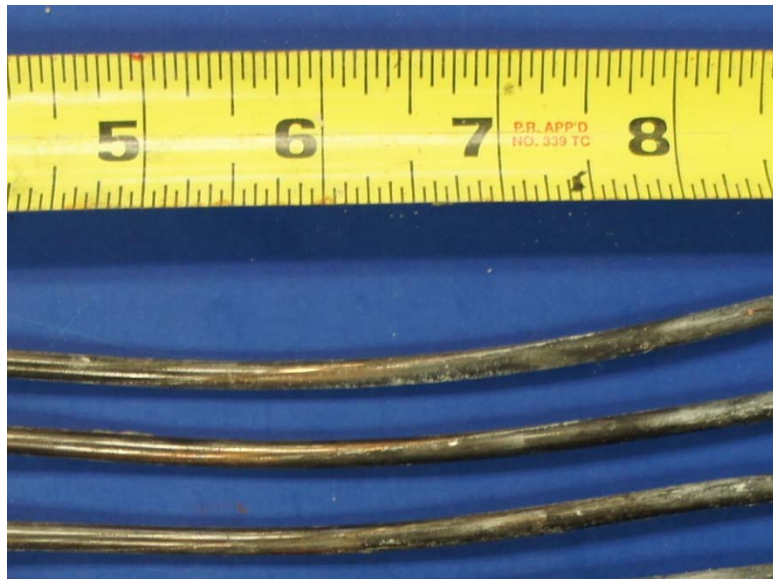
All the wires from the strands in the north and south tendons of Specimen 3.3, except for a few intervals, had a very dark brown discoloration over the majority of their length (Figure 6.66). The few intervals had small spots of reddish color corrosion product and were given the rating of 2 for light corrosion because it was easily removed from the surface with the scouring pad. The very dark brown discoloration was from the passivation of the copper cladding and was not considered corrosion. There were no visible signs of the steel core corroding. Figure 6.67 shows the damage ratings for the ducts and Table 6.14 shows the summary of the damage ratings for the ducts.

***Figure 6.66: Very Dark Brown Discoloration of Copper Cladding on Strand from Specimen 3.3***

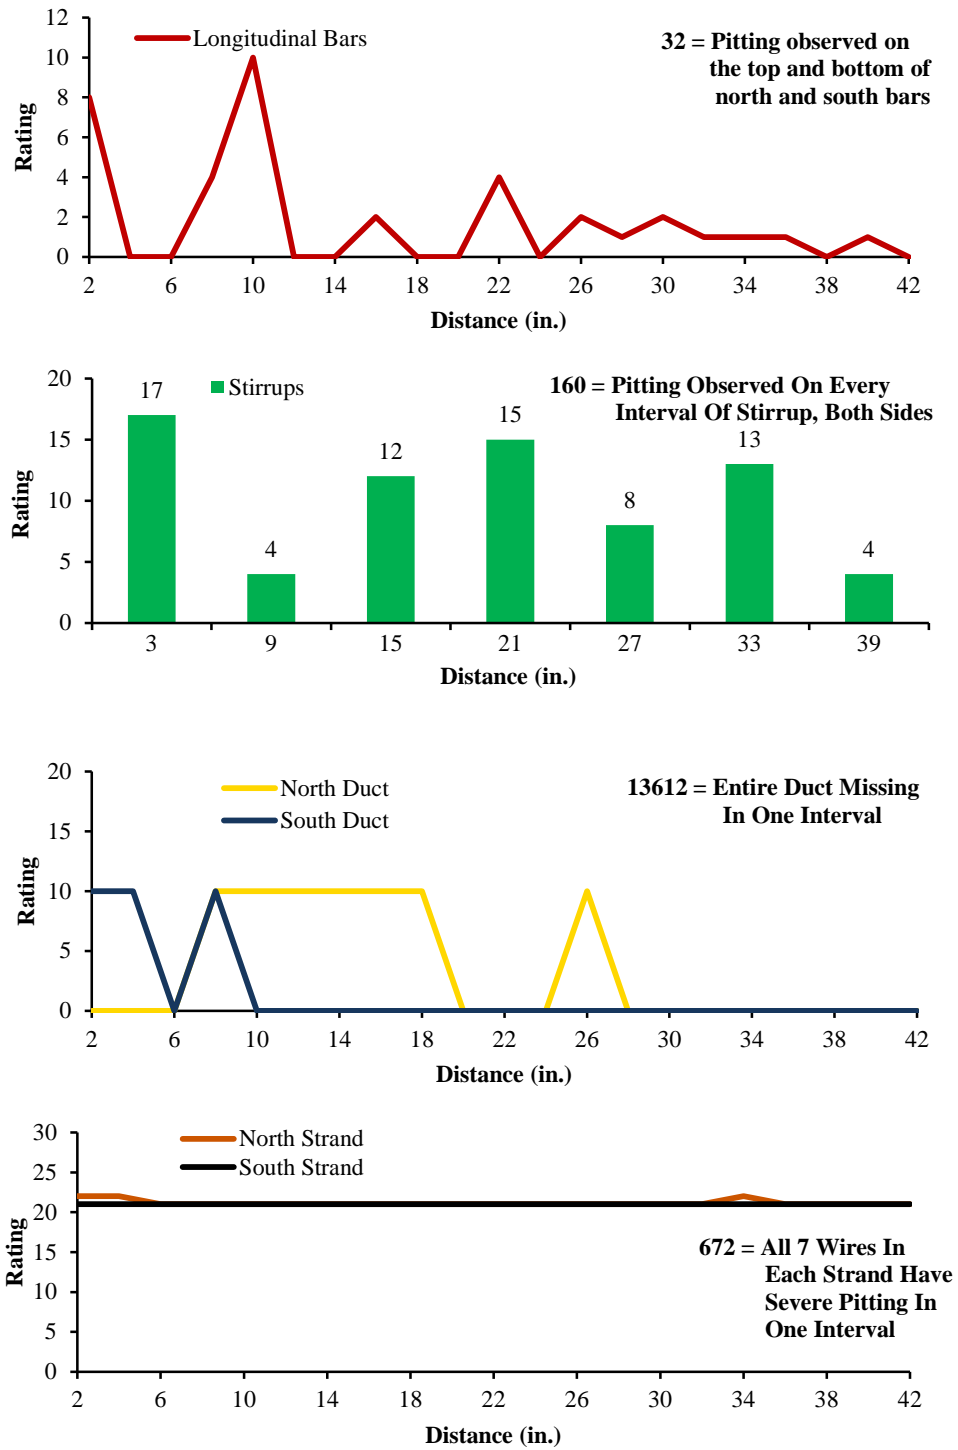
the lowest rating of 4. Figure 6.67 shows the transverse bar's corrosion ratings and Table 6.14 shows the summary of the corrosion rating for the transverse bars.

Figure 6.67 shows the damage ratings for the ducts and Table 6.14 shows the summary of the damage ratings for the ducts.

Figure 6.67: Corrosion Rating Plots for Main Autopsy Region of Specimen 3.3

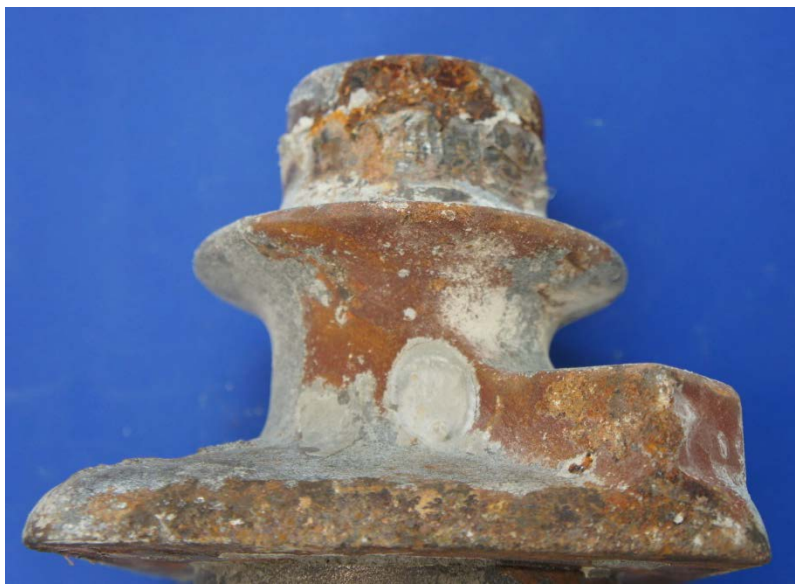
The majority of the epoxy applied to the anchorage components from the dead end before the anchorage cavity was backfilled had debonded from the anchorage components of both tendons. The exposed faces of the north and south anchorage plates from the dead end had light surface corrosion on the majority their surface. The majority of the surface of the bottom of the north and south anchorage plates and the north and south duct/anchorage plate interfaces from the dead end had light surface corrosion (Figure 6.68). The exposed faces of the north and south anchor heads from the dead end had spots of light surface corrosion. The north and south sides of the anchor heads from the dead end had light surface corrosion at the interface of the anchor head and anchorage plate. The unexposed face of the north and south dead end anchor heads had light surface corrosion.

***Figure 6.68: Light Surface Corrosion on Bottom of the North Dead End Anchorage Plate from Specimen 3.3***

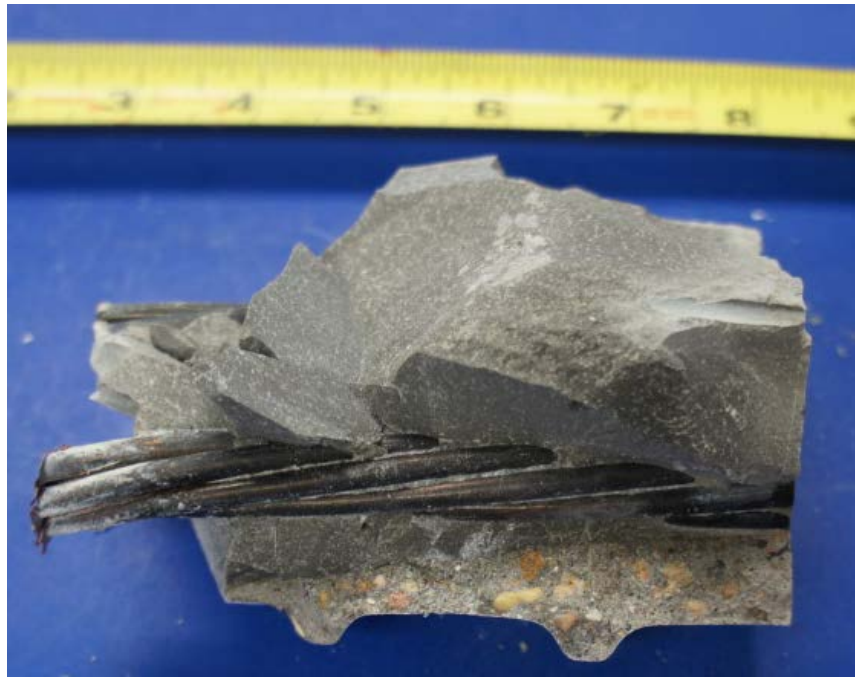
The grout from the north and south dead end tendons had no visible transverse or longitudinal cracks. The grout from both tendons from the dead end had voids and signs of “bubbling” in the area of the flutes of the ducts along the length of the top surface. Concrete was observed in the grout of the dead end of the south tendon (Figure 6.69). This might be an indication that the duct tape that was used to seal the connection of the duct and anchorage plate was not suitable to create a water tight seal.

***Figure 6.69: Concrete in Grout from the Dead End of the North Tendon of Specimen 3.3***

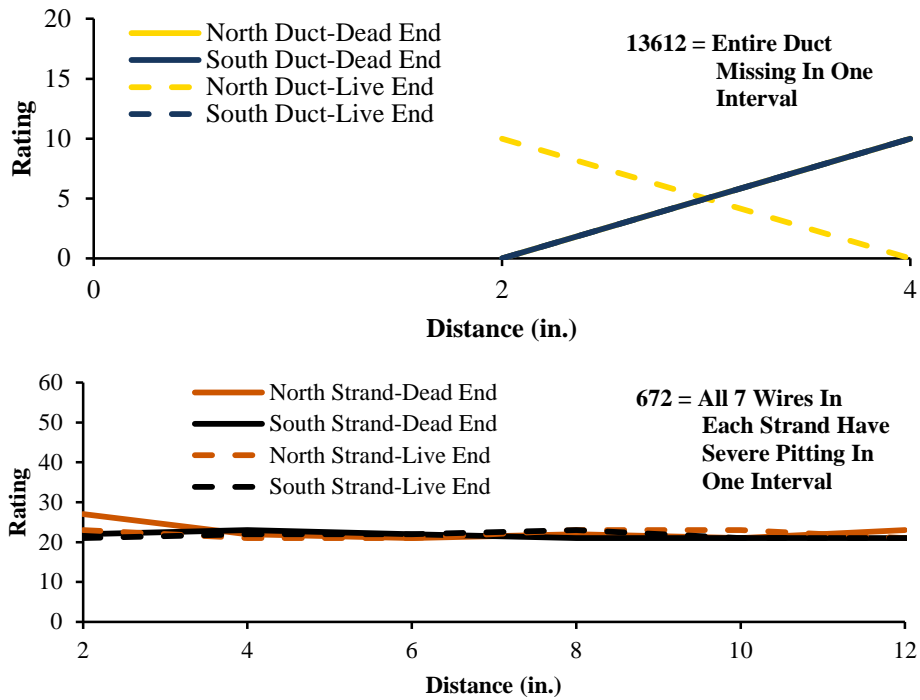
**Figure 6.70: Corrosion Rating Plots for Dead and Live End Anchorage Regions of Specimen 3.3**

discoloration over most of their lengths with a few spots of reddish colored light corrosion. The inner wires of the strand from the north and south tendons from the dead end had the same discoloration as the outer wires. Two of the inner wires (one from north tendon and one from the south tendon) had a spot of reddish colored light corrosion. Four of the outer wires from the north tendon had spots of reddish colored light corrosion in the indentions made by the wedge anchors. This was not “rust” but the same reddish colored light corrosion observed in the wires from the ponding area.

The outer wires of the strands in both the north and south live end anchorage region had very dark brown discoloration over most of their lengths with a few spots of reddish colored light corrosion, similar to the discoloration and corrosion of the dead end outer wires. The inner wires of the strand from the north and south tendons had the same discoloration as the outer wires. Four of the outer wires from the north tendon had spots of reddish colored light corrosion in the indentions made by the wedge anchors. Two other outer wires had the same reddish colored light corrosion not in the region if the wedge anchors.

Figure 6.70 shows the corrosion ratings for the dead and live anchorage region strands and Table 6.15 shows the summary of the corrosion ratings for the dead and live anchorage region strands.

The anchorage components from the live and dead ends had experienced similar damage. So, it can be assumed that the dead end anchorage spray did not make a difference when it came to the damage that was observed. However, the chloride data suggests that the spray system did increase the chloride concentrations in the backfill mortar to a level that was above the chloride limit for corrosion. In spite of this, the similar damage in the live and dead anchorage components suggests that chlorides did not migrate far enough into the backfill mortar to cause damage.

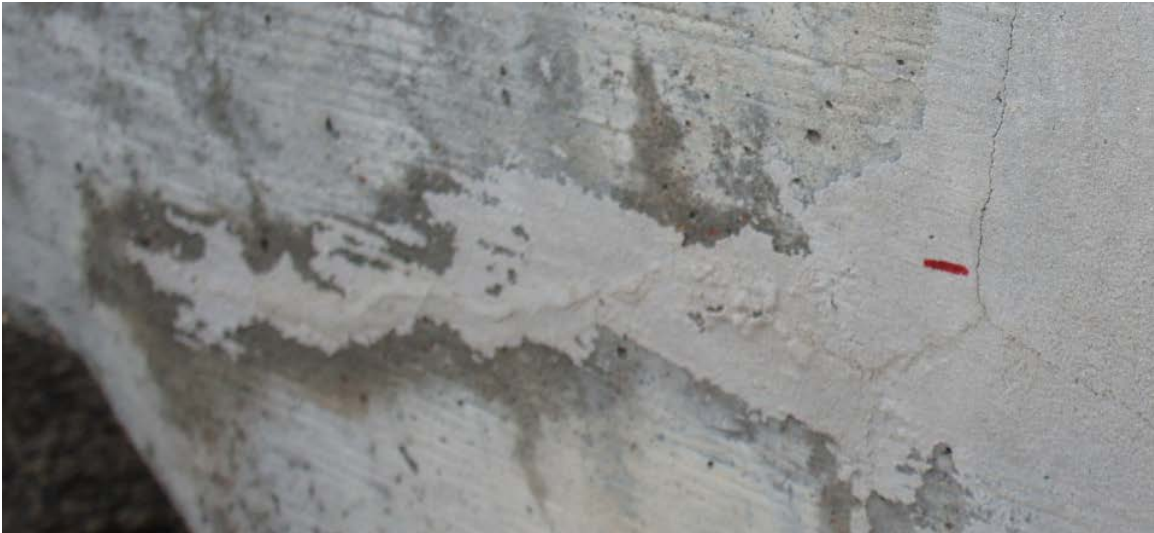
There were cracks present at the re-entrant corbel corners on both sides of the dead end and efflorescence was observed coming from the cracks. These cracks were not present after live load application<sup>1</sup>. Therefore, the cracks had not been sealed with mortar or epoxy. The repairs to the cracks from the application of live load on both sides of the live end re-entrant corbel corners were in good repair but moisture was observed around the edge of the repair (Figure 6.72). The ponding area of Specimen 4.1 had 1 large transverse crack that ran from the north to the south side of the specimen and 4 small transverse cracks on the edge of the ponding area (2 on the north side and 2 on the south side) (Figure 6.73). The average crack width was 0.006 inch. The crack rating for Specimen 4.1 was 0.06. See Figure 6.74 for the crack data from Specimen 4.1.

***Figure 6.72: Moisture Observed around the Edge of North Live End Re-entrant Corbel Corner Crack of Specimen 4.1***

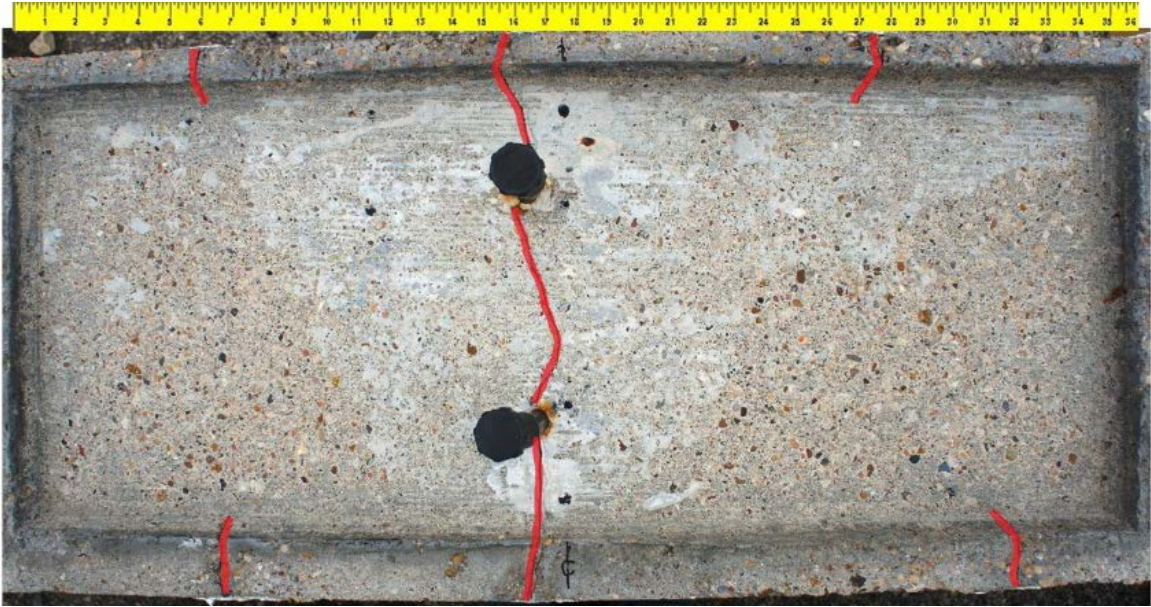
The surface of Specimen 4.1 had medium scaling over the majority of the top surface and ponding area. The rest of the exterior had no scaling but had small shallow depressions from air voids that had developed against the formwork during casting. Small rust stains were observed in the ponding area at the base of north and south grout vents. The backfill mortar from the dead and live end anchorage pockets were separating from the base concrete. This indicates that the mortar did not adhere well to the base concrete.

Figure 6.73: Specimen 4.1 Crack Map of Ponding Area

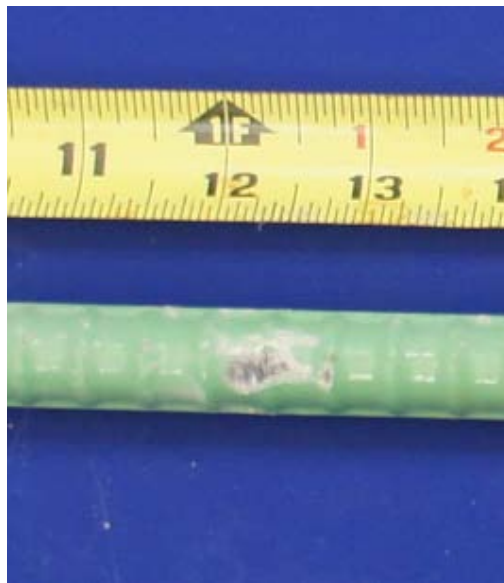
The north and south longitudinal bars had slight damage from when the bars were extracted from the specimen (Figure 6.75). Rust stains were also evident at locations where the transverse bars were tied to the longitudinal bars. This staining is from corrosion of the tie wire used to attach the transverse reinforcement to the longitudinal bars and NOT from the longitudinal bar itself. The south longitudinal bar had a spot of light corrosion at approximately 34 inches from the dead end of the bar. Figure 6.79 shows the longitudinal bar's corrosion ratings and Table 6.16 shows the summary of the corrosion ratings for the longitudinal bars.

***Figure 6.75: Extraction Damage to South Longitudinal Bar from Specimen 4.1***

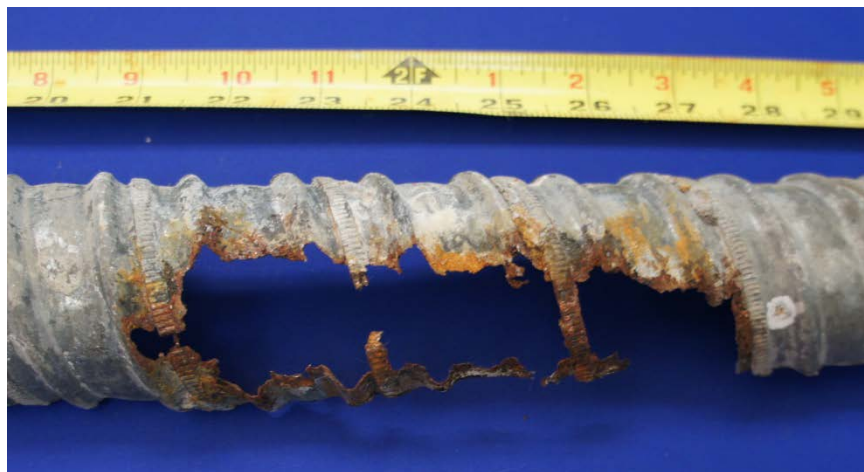
Both the north and south ducts had localized severe corrosion damage. This damage resulted in holes in the ducts. The top of the north duct had a large hole at midspan (Figure 6.76). The bottom outer surface of the north duct had light corrosion at midspan. The top inner surface of the north duct had light corrosion on the live and dead ends. The bottom outer surface of the north duct had light corrosion at midspan. The bottom inner portion of the north duct had light corrosion spanning from approximately 12 inches to approximately 30 inches. The top of the south duct had a large hole at midspan. The top outer surface of the south duct had light corrosion in intervals adjacent to the large hole at midspan. The bottom outer surface of the south duct had moderate corrosion at approximately midspan and light corrosion periodically over the length of the duct. The top inner surface of the south duct had no visible signs of corrosion on intervals that did not have holes. The bottom inner portion of the south duct had moderate corrosion at approximately 24 inches and had light corrosion on the adjacent intervals. The holes experienced by both the north and south ducts indicate that voids in the grout had formed along the top of the duct. Figure 6.79 shows the corrosion ratings for the ducts and Table 6.16 shows the summary of the corrosion ratings for the ducts.

**Figure 6.76: Hole on the Top at Midspan of the North Duct from Specimen 4.1**

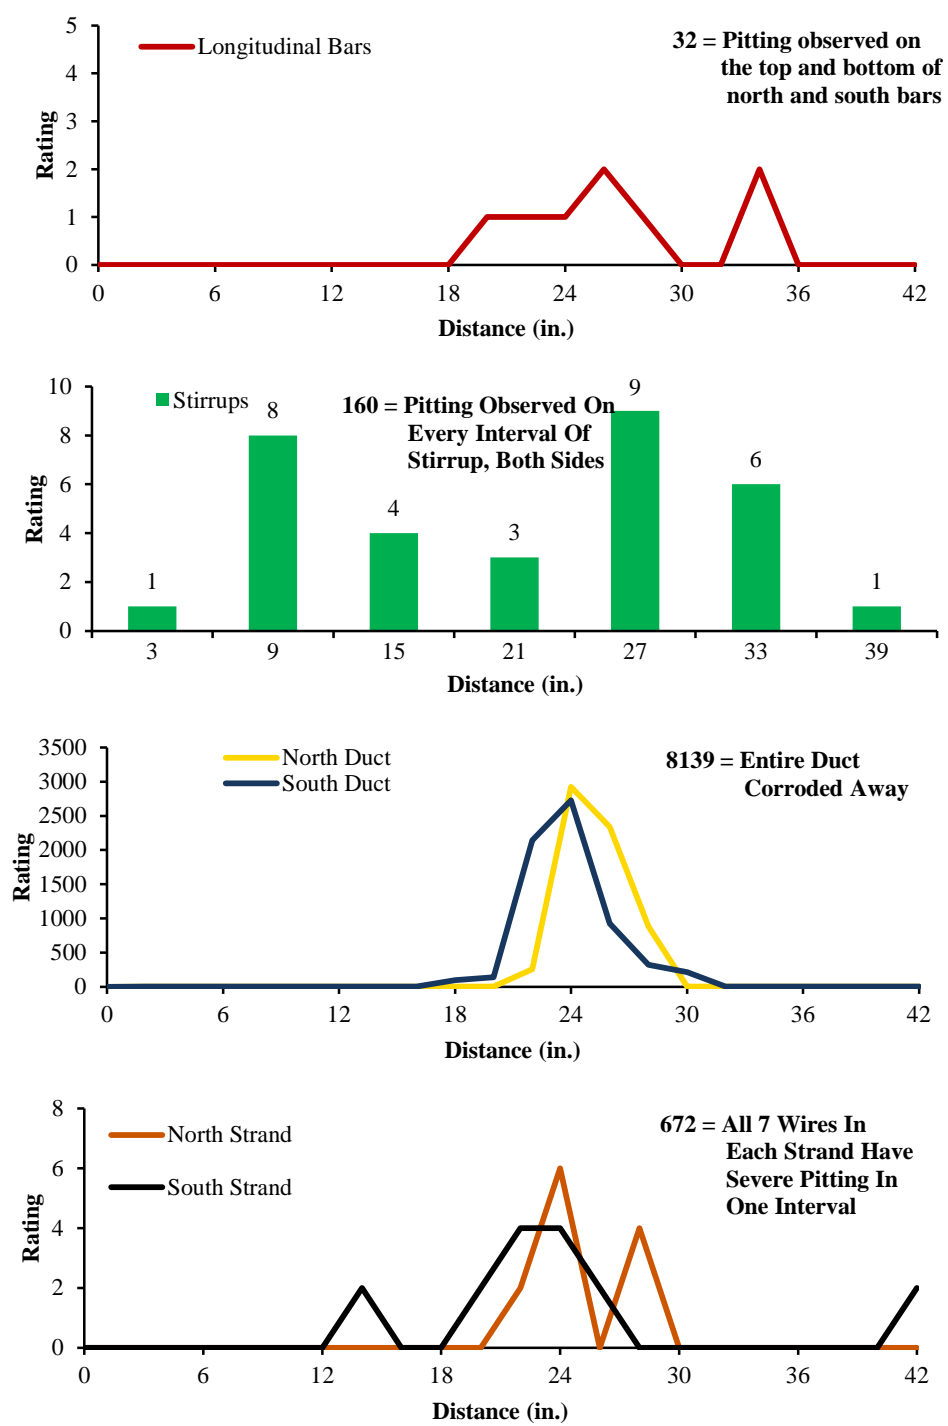
Figure 6.79: Corrosion Rating Plots for Main Autopsy Region of Specimen 4.1

to no exposure to chloride ions. Figure 6.79 shows the transverse bar's corrosion ratings and Table 6.16 shows the summary of the corrosion rating for the transverse bars.

The three strands in the north and south tendons had no visible corrosion. Minimal discoloration was observed on the outer wires. The discoloration was located primarily at the locations of the holes in the duct. The inner wires had no visible signs of discoloration or corrosion. See Figure 6.78 for a typical stainless steel strand. This outcome was expected because of the corrosion resistance properties of stainless steel. The grout did not adhere well to the strands. Because the grout did not adhere well to the strands, when the tendons were cut the strands retracted into the grout. The strands had a highly curved shape (Figure 6.78). Figure 6.79 shows the corrosion ratings for the strands and Table 6.16 shows the summary of the corrosion ratings for the strands.

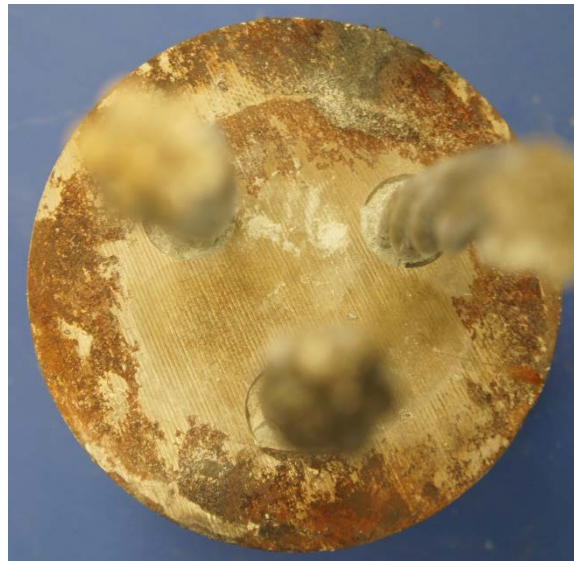
Except for a few spots at the interface of the anchorage plate and anchor head, all the epoxy applied to the anchorage components from the dead end before the anchorage cavity was backfilled had debonded from the anchorage components of both tendons. The exposed faces of the north and south anchorage plates from the dead end had light surface corrosion on the majority their surface. The majority of the bottom surface of the north and south anchorage plates and the north and south duct/anchorage plate interfaces from the dead end had light surface corrosion. The exposed face of the north and south anchor heads from the dead end had a few spots of light surface corrosion. The unexposed faces of the north and south anchor heads had light surface corrosion on the majority of their surface. The sides of the north and south anchor heads had light surface corrosion over the majority of their surface. The unexposed face had light surface corrosion on the outer ring where the grout had not come into contact with the anchor head (Figure 6.80).

***Figure 6.80: Corrosion on Unexposed Face of an Anchor Head from Specimen 4.1***

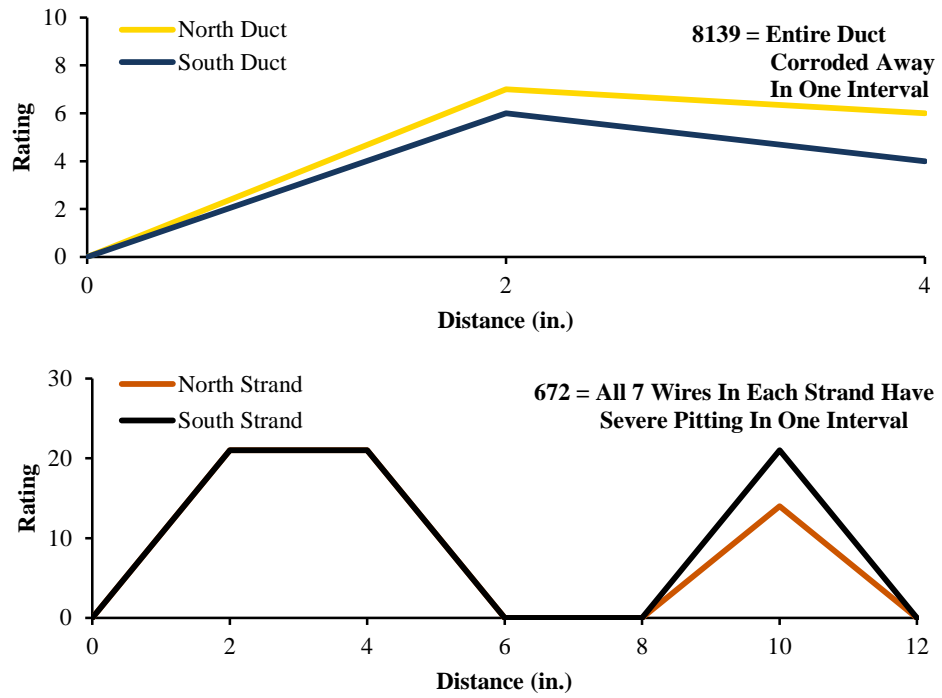
*Figure 6.82: Corrosion Rating Plots for Dead Anchorage Region of Specimen 4.1*

All outer and inner wires of the strands from the north and south tendons had discoloration in the region of the wedge anchors and in the south strands in the region close to where the tendon was cut so grout could be extracted from the anchorage region (Figure 6.81). However, the north strands had discoloration in the same region on all the inner wires but not on all the outer wires. This discoloration in the wedge anchor region is more than likely from when the anchor heads had to be heated to remove the strands. The discoloration where the tendon had to be cut to extract grout from the anchorage might be from the strand being heated during cutting of the tendon. The wedges from the north tendon were intact and had no visible signs of corrosion. However, the wedges from the south tendon were intact but had light surface corrosion on the exterior surface.

Figure 6.82 shows the corrosion ratings for the anchorage region strands and Table 6.17 shows the summary of the corrosion ratings for the anchorage region stands.

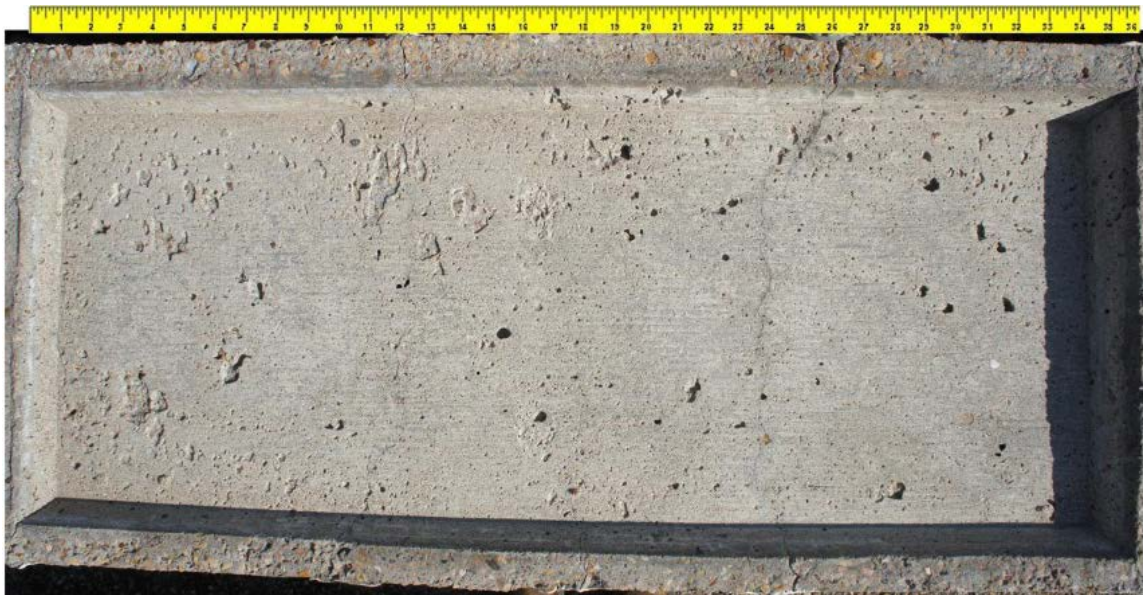
*Figure 6.83: Specimen 4.3 Main Autopsy Region and Grout Vents*

The surface of Specimen 4.3 shown in Figure 6.83 had medium scaling over the majority of the top surface and the edges of the ponding area. The ponding area had shallow to deep depressions from air voids that formed under the form that was used to create the ponding area when the specimen was cast. The rest of the exterior had no scaling but had small shallow depressions from bleed water voids that had developed against the formwork during casting.

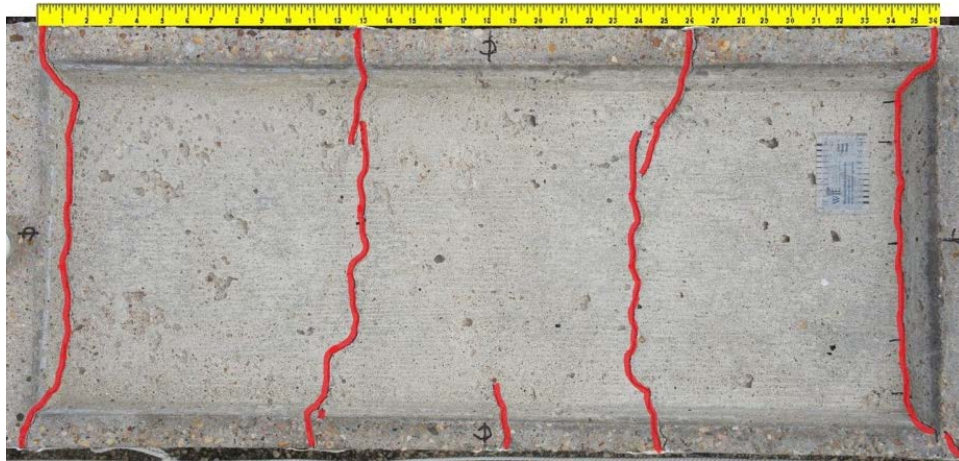
No cracks were present at the re-entrant corners on both sides of the dead and live end. Unlike the other specimens with prestressing the live load applied to this specimen was not as large. Therefore, the re-entrant corbel corners did not crack<sup>1</sup>. The ponding area of Specimen 4.3 had 4 large transverse cracks that ran from the north to the south side of the specimen and 1 small transverse crack on the edge of the ponding area at midspan and on the north side of the ponding area (Figure 6.85). The average crack width was 0.008 inch. The crack rating for Specimen 4.3 was 0.32. See Figure 6.86 for the crack data from Specimen 4.3.

*Figure 6.85: Specimen 4.3 Crack Map of Ponding Area*

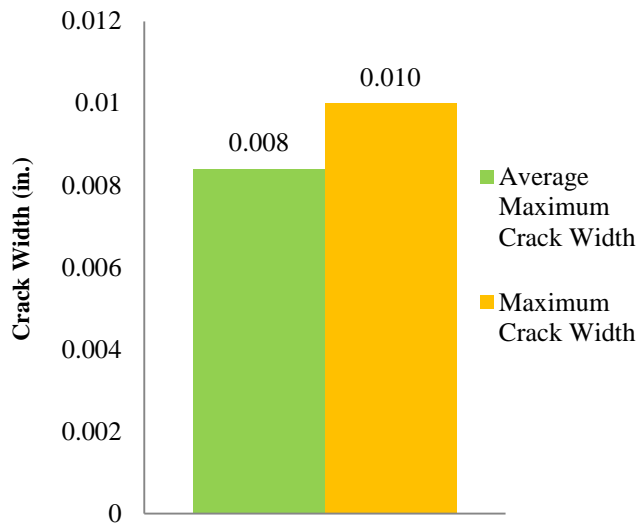
**Figure 6.86: Crack Data for Specimen 4.3**

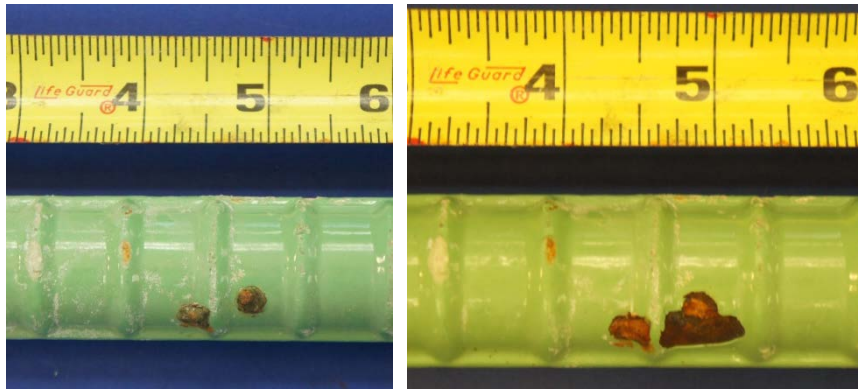
The north and south #8 longitudinal bars had slight damage from when the bars were extracted from the specimen. Light and moderate corrosion was observed on the dead end of the north #8 longitudinal bar (Figure 6.87). Rust stains were also evident at locations where the transverse bars were tied to the longitudinal bars. This staining is from corrosion of the tie wire used to attach the transverse reinforcement to the longitudinal bars and NOT from the longitudinal bar itself. Figure 6.89 shows the #4 longitudinal bar’s corrosion ratings and Table 6.18 shows the summary of the corrosion ratings for the longitudinal bars.

***Figure 6.87: “Bubbles” in Epoxy Coating (Left) and Moderate Corrosion under “Bubbles” (Right) at the Dead End of North #8 Bar of Specimen 4.3***

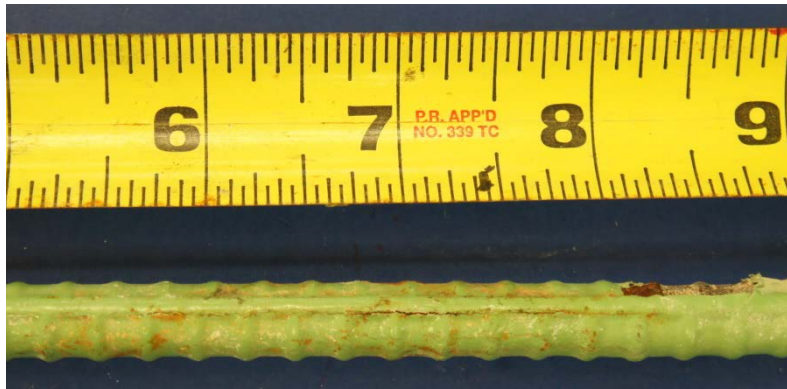
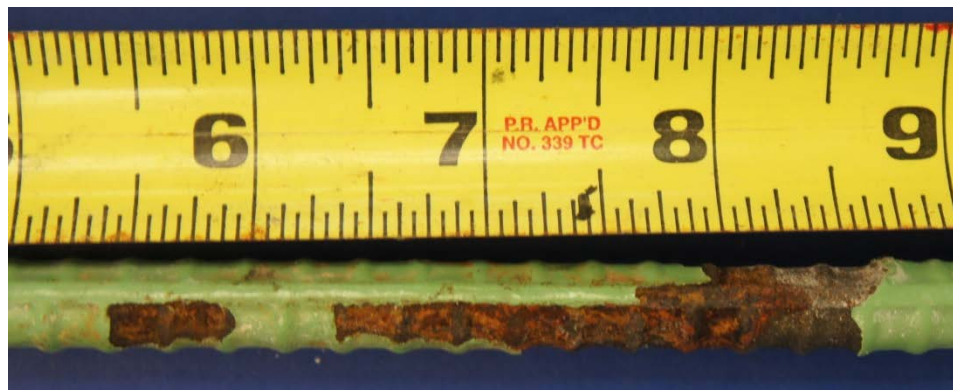
All the transverse bars, except #5, had damage from when they were extracted from the specimen. All the transverse bars had rust staining from corrosion of the tie wire used to attach the transverse bars to the longitudinal bars. Moderate corrosion was observed on bars #6 and #7 on the horizontal portion of the transverse bar (Figure 6.88). Bars #6 and #7 had the highest ratings of 20 and 29, respectively. The #1 transverse bar had the lowest corrosion rating of 6. This was expected because this bar was outside the ponding area and should have had little to no exposure to chloride ions but the #7 bar should have had one of the lowest ratings for the same reason. Figure 6.89 shows the transverse bar’s corrosion ratings and Table 6.18 shows the summary of the corrosion rating for the transverse bars.

***Figure 6.88: Crack in Epoxy Coating along the Longitudinal Rib (Top) and Moderate Corrosion at the Crack along the Longitudinal Rib (Bottom) on #6 Transverse Bar from Specimen 4.3***
