**Assessment of Long-Term Corrosion Resistance of Recently Developed  
Post-Tensioning Components**

**Thesis**

The University of Texas at Austin

**August, 2012**

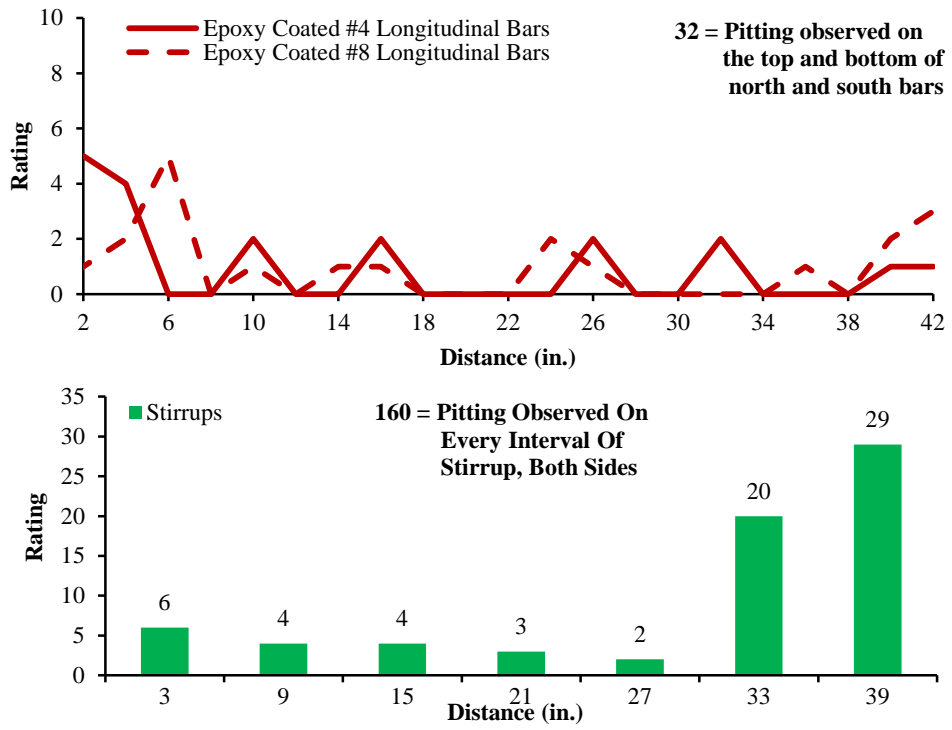
*Figure 6.89: Corrosion Rating Plots for Main Autopsy Region of Specimen 4.3*

The north and south #4 longitudinal bars had slight damage from when the bars were extracted from the specimen. Light corrosion was observed on the dead end of the north #4 longitudinal bar. Rust stains were also evident at locations where the transverse bars were tied to the longitudinal bars. This staining is from corrosion of the tie wire used to attach the transverse reinforcement to the longitudinal bars and NOT from the longitudinal bar itself. Figure 6.89 shows the #4 longitudinal bar’s corrosion ratings and Table 6.18 shows the summary of the corrosion ratings for the #4 longitudinal bars.

All the transverse bars, except #5, had damage from when they were extracted from the specimen. All the transverse bars had rust staining from corrosion of the tie wire used to attach the transverse bars to the longitudinal bars. Moderate corrosion was observed on bars #6 and #7 on the horizontal portion of the transverse bar (Figure 6.88). Bars #6 and #7 had the highest ratings of 20 and 29, respectively. The #1 transverse bar had the lowest corrosion rating of 6. This was expected because this bar was outside the ponding area and should have had little to no exposure to chloride ions but the #7 bar should have had one of the lowest ratings for the same reason. Figure 6.89 shows the transverse bar’s corrosion ratings and Table 6.18 shows the summary of the corrosion rating for the transverse bars.

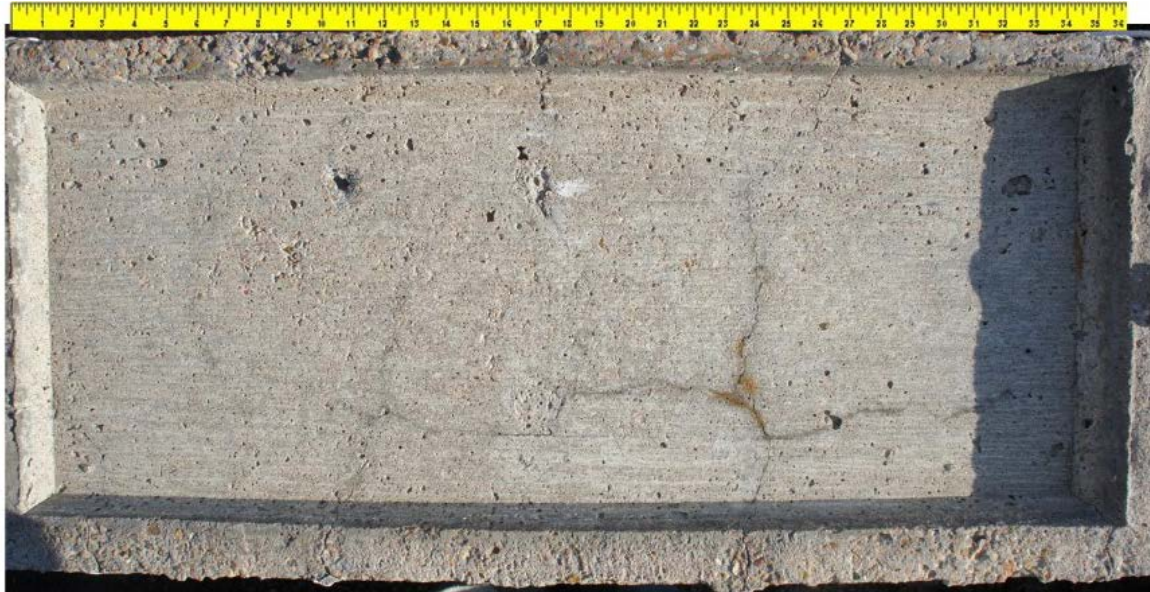
*Figure 6.90: Specimen 4.4 Main Autopsy Region and Grout Vents*

The surface of Specimen 4.4 had medium scaling over the majority of the top surface and the edge of the ponding area. The ponding area had shallow to deep depressions from bleed water voids that formed under the form that was used to create the ponding area when the specimen was cast. The rest of the exterior had no scaling but had small shallow depressions from bleed water voids that had developed against the formwork during casting. Rust staining was observed on the north side towards the live end of the ponding area in the location of the #8 uncoated longitudinal steel reinforcing bar (Figure 6.90). This rust stain indicated that the #8 uncoated steel bar was corroded.

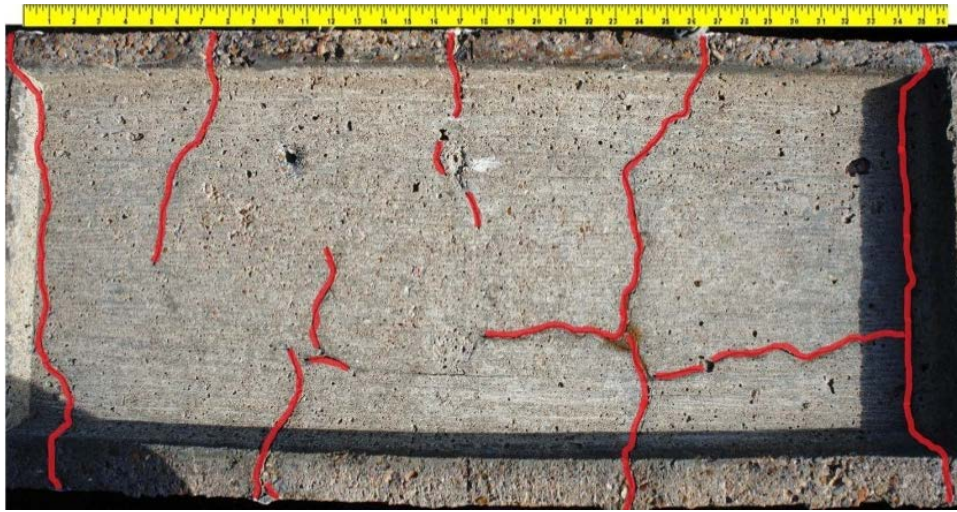
No cracks were present at the re-entrant corbel corners on both sides of the dead and live end. Unlike the other specimens with prestressing the live load applied to this specimen was not as large. Therefore, the re-entrant corbel corners did not crack<sup>1</sup>. The ponding area of Specimen 4.4 had 3 large transverse cracks that ran from the north to the south side of the specimen and 3 small transverse cracks that extended from the edge of the ponding area to about the transverse centerline of the ponding area (Figure 6.92). Two longitudinal cracks were observed on the north side towards the live end of the ponding area (Figure 6.92). This crack was also located over the north #8 uncoated longitudinal bar and might have been caused by the corrosion of the north #8 uncoated longitudinal bar creating expansive forces thus cracking the concrete. The average crack width was 0.007 inch. The crack rating for Specimen 4.4 was 0.54. See Figure 6.93 for the crack data from Specimen 4.4.

**Figure 6.92: Specimen 4.4 Crack Map of Ponding Area**

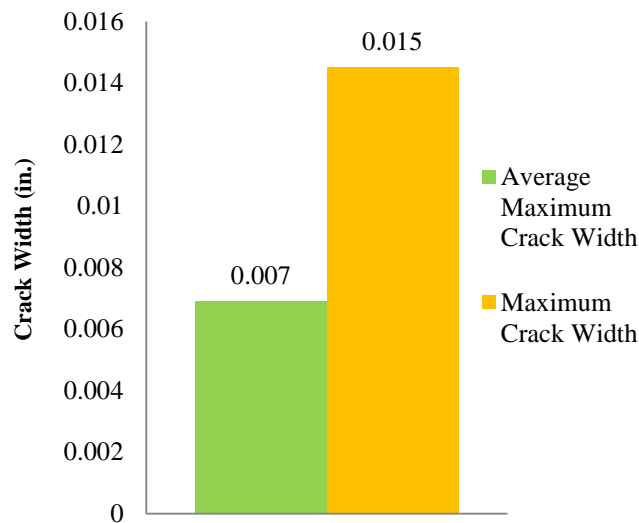
**Figure 6.93: Crack Data for Specimen 4.4**

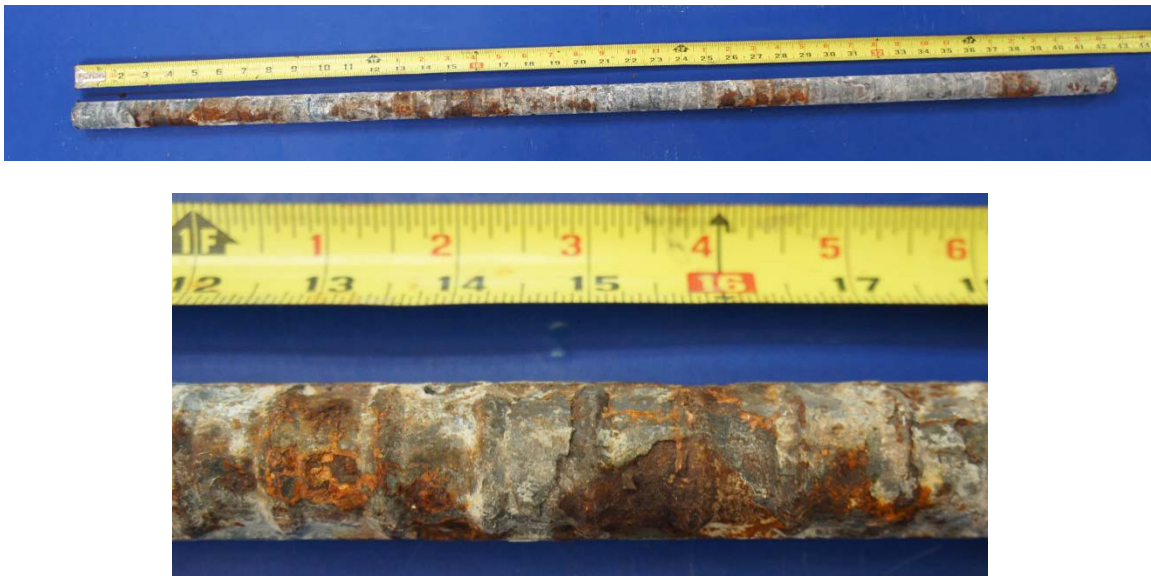
The north and south #8 uncoated longitudinal bars had slight damage from when the bars were extracted from the specimen. The north and south bars had extensive pitting, moderate corrosion, and light corrosion along their lengths (Figure 6.94). The pitting was located at locations where transverse cracks were observed. This indicates that moisture, oxygen, and chlorides reached the depth of the bars. The light and moderate corrosion was normally located on intervals adjacent to the areas of pitting. Figure 6.95 shows the #8 uncoated longitudinal bar's corrosion ratings and Table 6.19 shows the summary of the corrosion ratings for the #8 uncoated longitudinal bars.

***Figure 6.94: Moderate and Light Corrosion (Top) and Pitting (Bottom) on South #8 Uncoated Bar from Specimen 4.4***

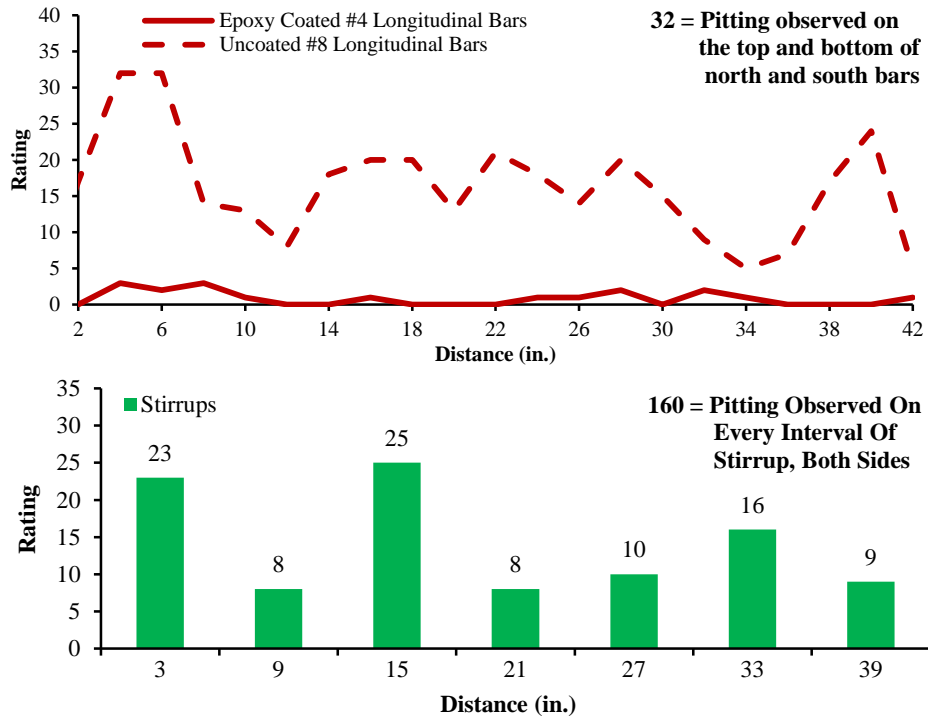
**Figure 6.95: Corrosion Rating Plots for Main Autopsy Region of Specimen 4.4**

itself. Figure 6.95 shows the #4 epoxy coated longitudinal bar's corrosion ratings and Table 6.19 shows the summary of the corrosion ratings for the #4 epoxy coated longitudinal bars.

All the transverse bars had damage from when they were extracted from the specimen. All the transverse bars had rust staining from corrosion of the tie wire used to attach the transverse bars to the longitudinal bars and from the corrosion of the #8 uncoated longitudinal bars. Moderate corrosion was observed on bars #1, #3, and #6. Light corrosion was observed on all the bars except #7. Bars #1 and #3 had the highest

corrosion ratings of 23 and 25, respectively. The #1 bar having the second highest corrosion rating was unexpected because it was from outside the ponding area and should not have been exposed to chlorides, moisture, and oxygen. The #2 and #4 transverse bars had the lowest corrosion rating of 8. Figure 6.95 shows the transverse bar's corrosion ratings and Table 6.19 shows the summary of the corrosion rating for the transverse bars.

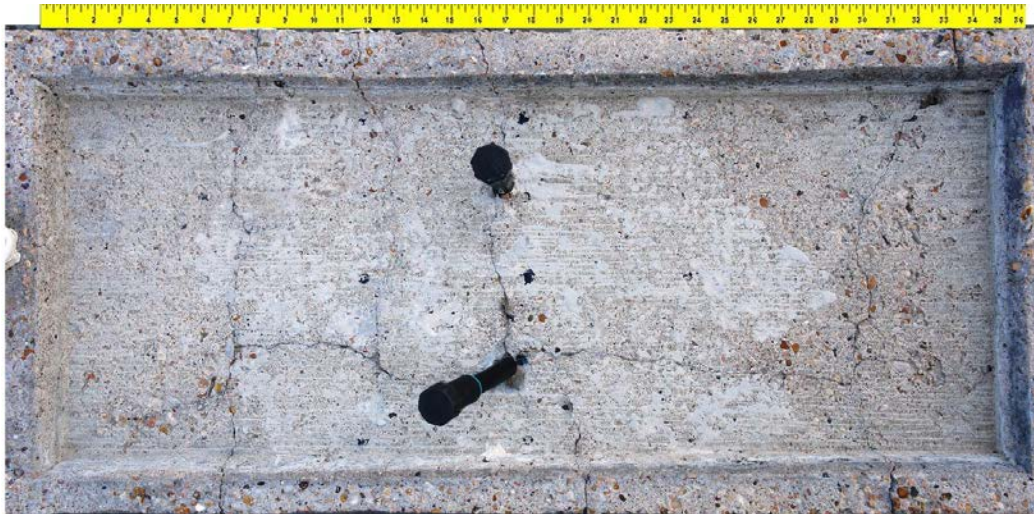
*Figure 6.96: Specimen 5.1 Main Autopsy Region and Grout Vents*

The surface of Specimen 5.1 had medium scaling on the top surface and on the edges and parts of the ponding area. Small shallow depressions were observed on the sides of the specimen where bleed water was trapped between the concrete and formwork during casting. The backfill mortar live end anchorage pocket was separating from the base concrete. This indicates that the mortar did not adhere well to the base concrete.

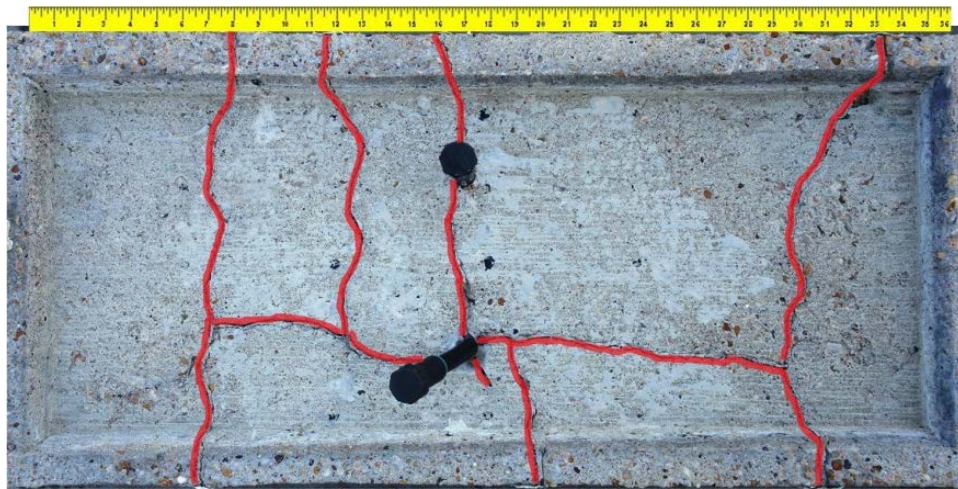
The repairs to the cracks from the application of live load on both sides of the live end re-entrant corbel corners were in good repair. No cracks on the dead end re-entrant corbel corners were observed. The ponding area of Specimen 5.1 had 2 large transverse crack that ran from the north to the south side of the specimen and 4 small transverse cracks on the edge of the ponding area (1 on the north side and 2 on the south side that extended to the area of the north tendon) (Figure 6.97). A longitudinal crack was observed in the location of the north tendon and ran the majority of the length of the ponding area. This crack might have formed because the plastic duct and concrete have different thermal coefficients. Therefore, any heating or cooling of the specimen would cause differential shrinkage or expansion between the duct and concrete. The concrete also had decreased cover in this region further exacerbating the cracking. However, this does not explain why no longitudinal cracking was observed over the south tendon. The average crack width was 0.007 inch. The crack rating for Specimen 5.1 was 0.54. See Figure 6.74 for the crack data from Specimen 5.1.

*Figure 6.97: Specimen 5.1 Crack Map of Ponding Area*

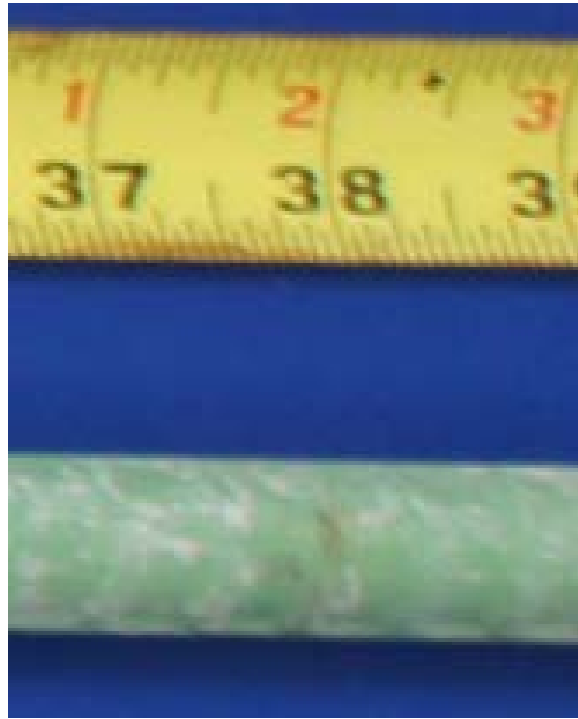
The north and south longitudinal bars had slight damage from when the bars were extracted from the specimen. Rust stains were also evident at locations where the transverse bars were tied to the longitudinal bars (Figure 6.99). This staining is from corrosion of the tie wire used to attach the transverse reinforcement to the longitudinal bars and NOT from the longitudinal bar itself. Figure 6.103 shows the longitudinal bar's corrosion ratings and Table 6.20 shows the summary of the corrosion ratings for the longitudinal bars.

***Figure 6.99: Rust Stain on North Longitudinal Bar from Specimen 5.1***

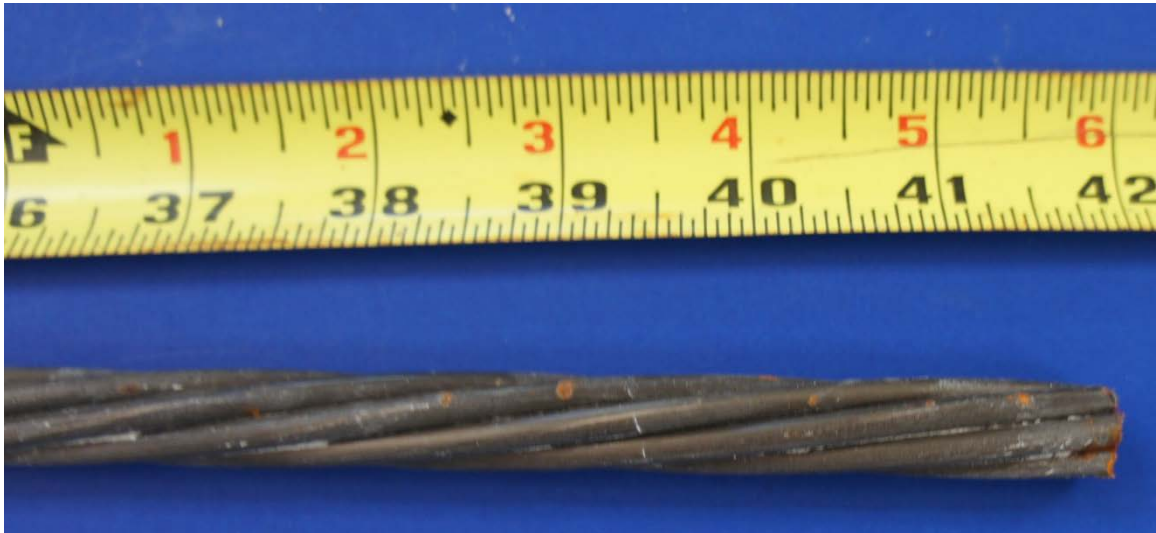
The three strands in the north tendon had only minor damage. Light corrosion was observed on the majority of the outer and inner wire intervals (Figure 6.102). This is an

indication that moisture, oxygen, and chlorides had reached the strands and corresponds to the chloride concentrations discussed in Chapter 5. The live end had the lowest ratings with an average of 32. The highest rating of 39 was at approximately 32 inches from the dead end.

***Figure 6.102: Light Corrosion on a North Strand from Specimen 5.1***

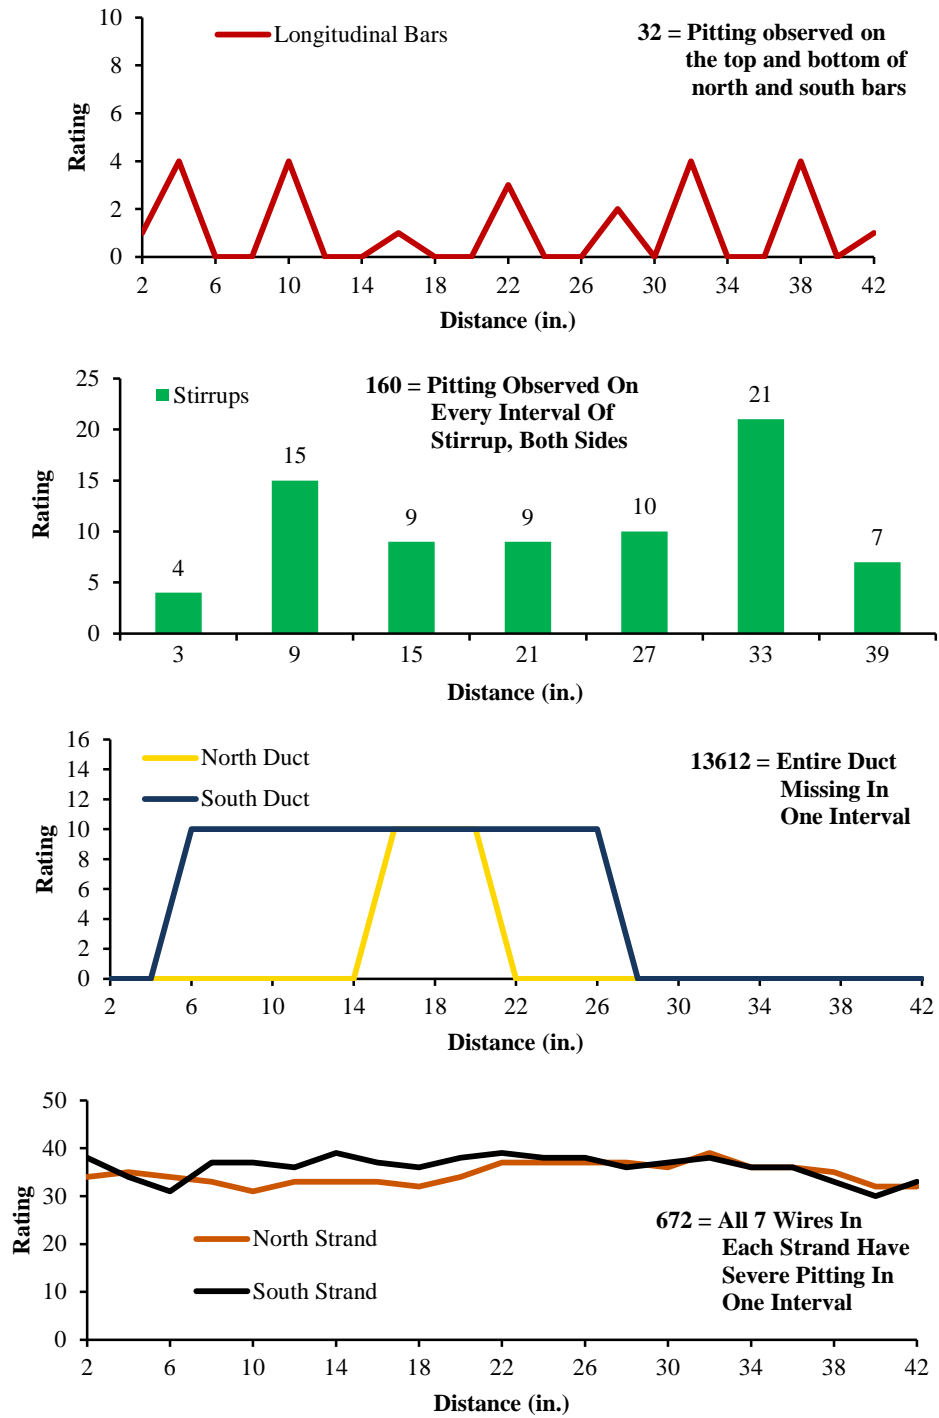
Figure 6.103: Corrosion Rating Plots for Main Autopsy Region of Specimen 5.1

The corrosion observed on the south strands was similar to the damage that was observed on the north strands. The outer and inner wires of the strands had light corrosion on the majority of their intervals. Again, this is an indication that moisture, oxygen, and chlorides had reached the strands and corresponds with the chloride concentrations discussed in Chapter 5. Two intervals had the highest corrosion rating of 39, one at 14 inches from the dead end and one at 22 inches from the dead end. The live end had the lowest corrosion ratings with an average of 32.

Figure 6.103 shows the corrosion ratings for the strands and Table 6.20 shows the summary of the corrosion ratings for the strands.

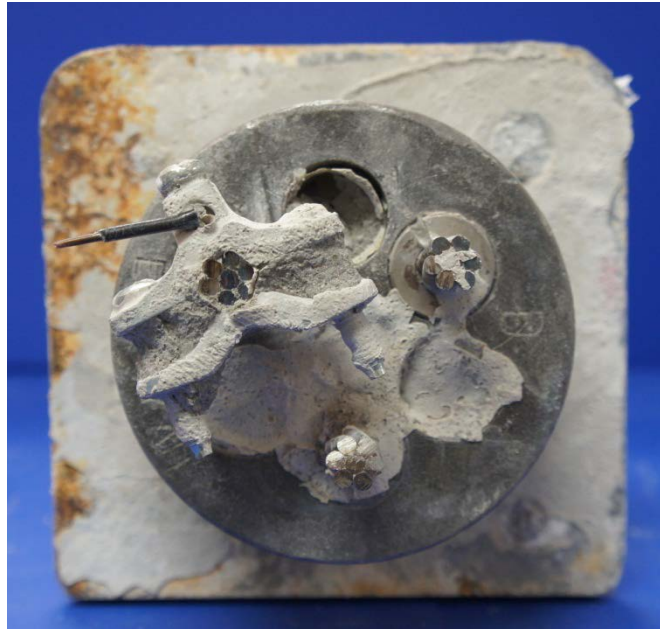
The majority of the epoxy applied to the anchorage heads from the live end before the anchorage cavity was backfilled had debonded from the anchorage components of both tendons. Most of the epoxy applied to the exposed surface of the anchorage plates from the live end before the anchorage cavity was backfilled had been still bonded to the surface. The exposed faces of the north and south anchorage plates from the live end had light surface corrosion in the locations where the epoxy had debonded (Figure 6.104). The embedded portion of the north anchorage plate from the live end had moderate corrosion where duct tape was used to seal the duct to the anchorage plate. The embedded portion of the south anchorage from the live end had no visible signs of corrosion. The exposed faces of the north and south anchor heads from the dead end had no visible signs of corrosion. The sides of the south anchor head from the live end had light surface corrosion at the interface of the anchor head and anchorage plate. The sides of the north anchor head had no visible signs of corrosion. The unexposed face of the north and south live end anchor heads had light surface corrosion.

*Figure 6.104: Light Surface Corrosion where Epoxy had Debonded from Exposed Face of North Live End Anchorage Plate from Specimen 5.1*

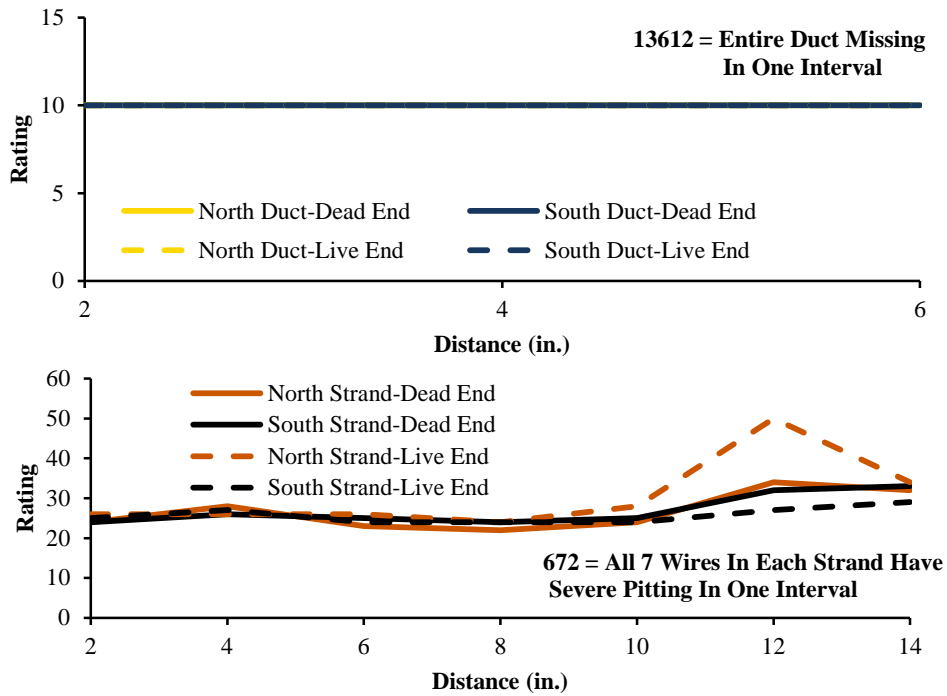
**Figure 6.105: Corrosion Rating Plots for Dead and Live End Anchorage Regions of Specimen 5.1**

The outer wires of the strands from the north and south, dead and live end anchorage regions had discoloration over most of their intervals. The intervals without discoloration had light corrosion. The inner wires of the strands from the north and south dead and live end anchorage region had light corrosion on the majority of their intervals and discoloration on the rest. The wedges from both anchorage regions and both tendons were intact and had light surface corrosion on their outer surface. Figure 6.105 shows the corrosion ratings for the dead and live anchorage region strands and Table 6.21 shows the summary of the corrosion ratings for the dead and live anchorage region strands.

The anchorage components from the live and dead ends had experienced similar damage. So, it can be assumed that the dead end anchorage spray did not make a difference when it came to the damage that was observed. The chloride concentrations further confirm this because the chloride concentrations of the dead end region were below the chloride corrosion limit.

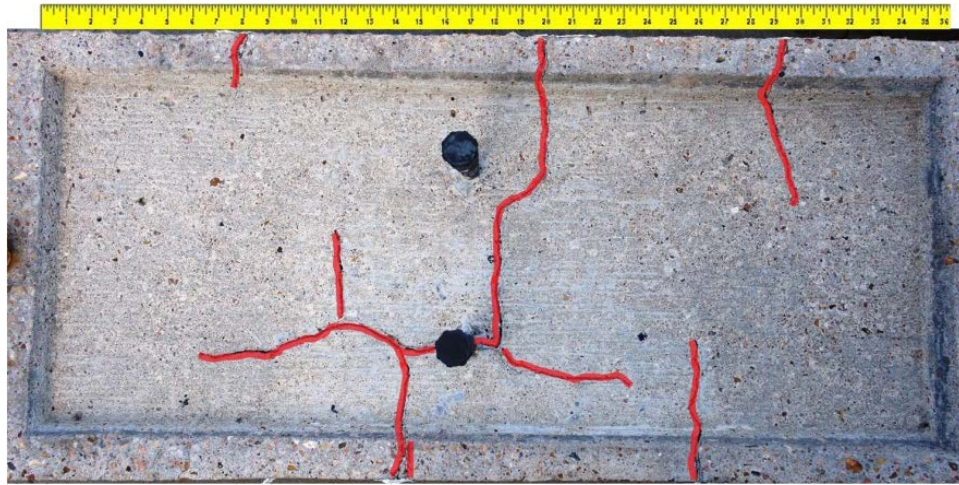
**Figure 6.107: Specimen 5.2 Crack Map of Ponding Area**

The repairs to the cracks from the application of live load on both sides of the live end re-entrant corbel corners were in good repair. No cracks on the dead end re-entrant corbel corners were observed. The ponding area of Specimen 5.2 had 1 large transverse crack that ran from the south side of the specimen to the longitudinal crack over the north tendon and 5 small transverse cracks on the edge of the ponding area (2 on the south side, 2 on the north side and one located at approximately the transverse centerline and on the dead end side of midspan) (Figure 6.107). A longitudinal crack was observed along the location of the north tendon. This crack might have formed because the plastic duct and concrete have different thermal coefficients. Therefore any heating or cooling of the specimen would cause differential shrinkage or expansion between the duct and concrete. The concrete also had decreased cover in this region further exacerbating the cracking. However, this does not explain why the no longitudinal cracking was observed over the south tendon. The average crack width was 0.005 inch. The crack rating for Specimen 5.2 was 0.19. See Figure 6.108 for the crack data from Specimen 5.2.

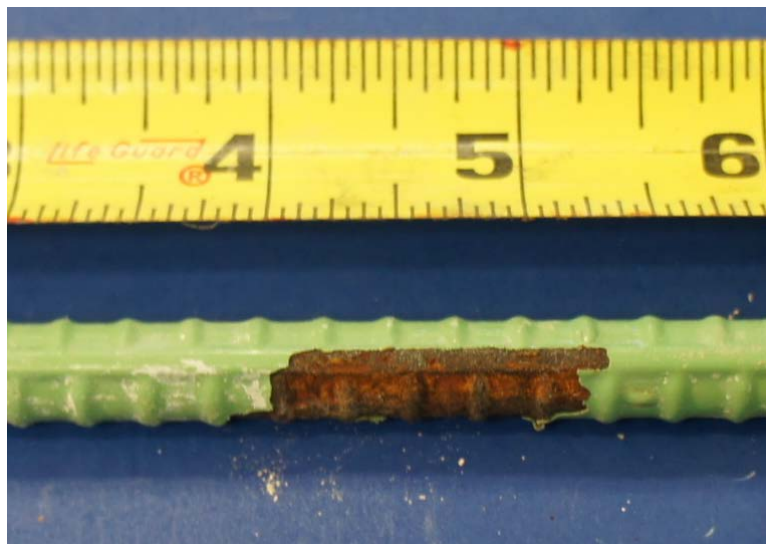
All transverse bars had damage from when they were extracted from the specimen. All the transverse bars had rust staining at least somewhere over the length of the bar from corrosion of the tie wire used to attach the transverse bars to the longitudinal bars and to attach the duct to the transverse bars. Light corrosion was observed on bars #5 and #6. Moderate corrosion observed on bars #4 and #6 (Figure 6.109). Bar #6 had the highest rating of 17. Bars #1 and #7 had the lowest ratings of 1. This was expected because both of these bars are outside the ponding area with no observed cracks and increased concrete cover. Therefore, no moisture, oxygen, and chlorides would easily reach the bars. Figure 6.113 shows the transverse bar's corrosion ratings and Table 6.22 shows the summary of the corrosion rating for the transverse bars.

***Figure 6.109: Moderate Corrosion on Transverse Bar #6 from Specimen 5.2***

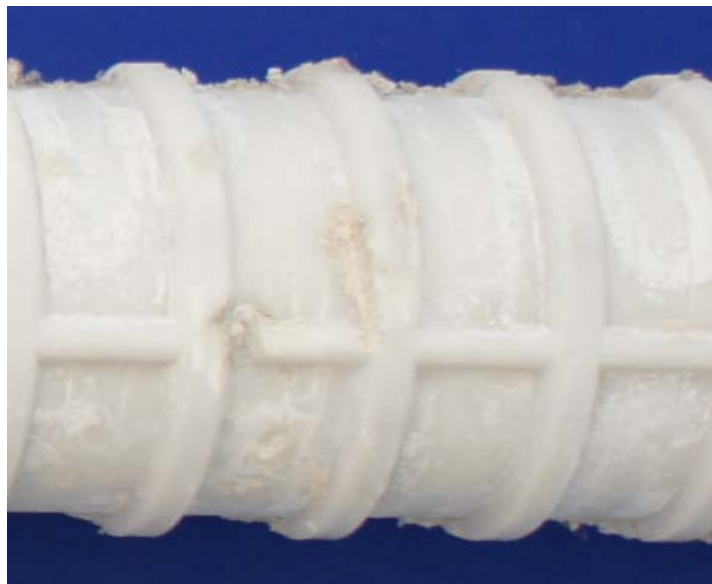
The entire outer surface of the north duct had a chalky white residue (Figure 6.110). No corrosion staining was observed on the outer or inner surface of the duct. The inner top and bottom surface of the north duct had slight gouges from midspan to the live end of the duct. This indicates that one or more of the strands caused damage either when the

strands were being threaded through the duct or one of the strands or stands were rubbing against the duct when the strands were being stressed. In either case, the integrity of the duct was not compromised. Indications of voids were observed on the top inner surface of the duct along the entire length. No damage was observed on the coupler, grout vent, or heat shrink wrap used to seal the coupler/duct interface. However, the heat shrink wrap did not bond well to the coupler or duct. This might indicate why chloride levels were elevated.

***Figure 6.110: Chalky White Residue on North Duct of Specimen 5.2***

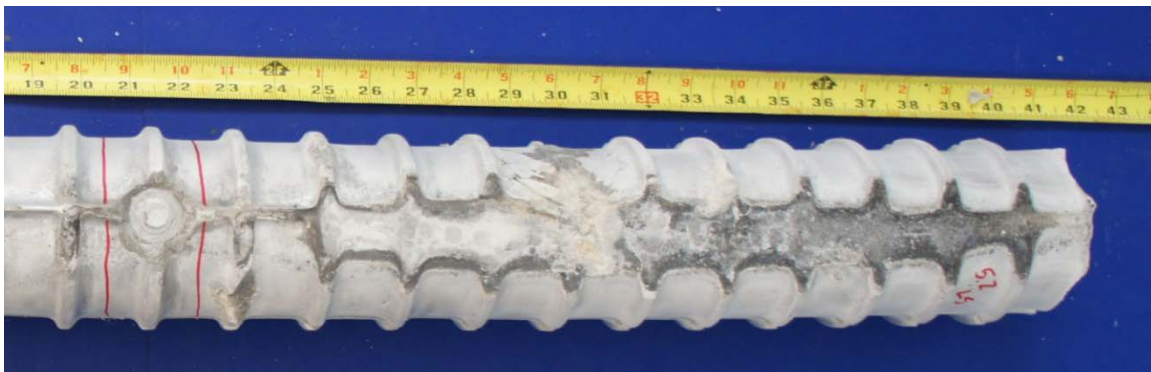
No transverse or longitudinal visible cracks were observed during examination of grout from the north and south grouts of Specimen 5.1 but when chloride samples were being taken transverse cracks became evident. No staining of the grout was observed on either the north or south grouts. Small voids in the grout were observed in the flutes along the entire length of the top of the north tendon. The south grout had small voids in the grout on the dead end side of the grout and a large void that ran almost the whole length of the grout's live end side (Figure 6.111). The small voids measured approximately 1.5 inch long and were as wide as the flute width. The coloration of the grout from the north tendon was dark grey at the ends and transitioned to light grey at midspan. A silver crystalline powder was observed on the grout bottom that ran from the dead end quarter point to the live end of the south tendon.

***Figure 6.111: Large Void in Grout on Top Live End Side of South Tendon from Specimen 5.2***

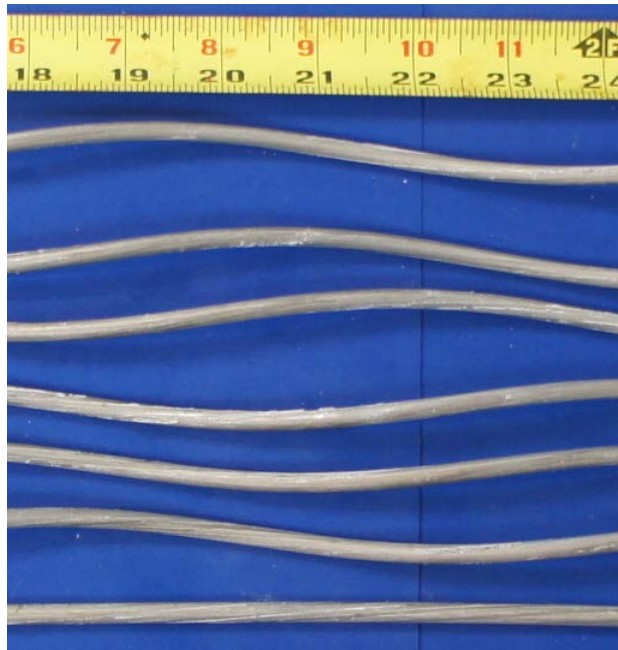
As expected, the stainless clad strands of the north and south tendons were essentially defect free. Minimal discoloration was observed on the outer wires of 5 of the 6 strands. The inner wires from the north and south tendons had minimal discoloration as well. Figure 6.112 shows inner and outer wires from a north tendon strand. Figure 6.113 shows the corrosion ratings for the strands and Table 6.22 shows the summary of the corrosion ratings for the strands.

***Figure 6.112: Inner and Outer Wires from a North Tendon Strand from Specimen 5.2***

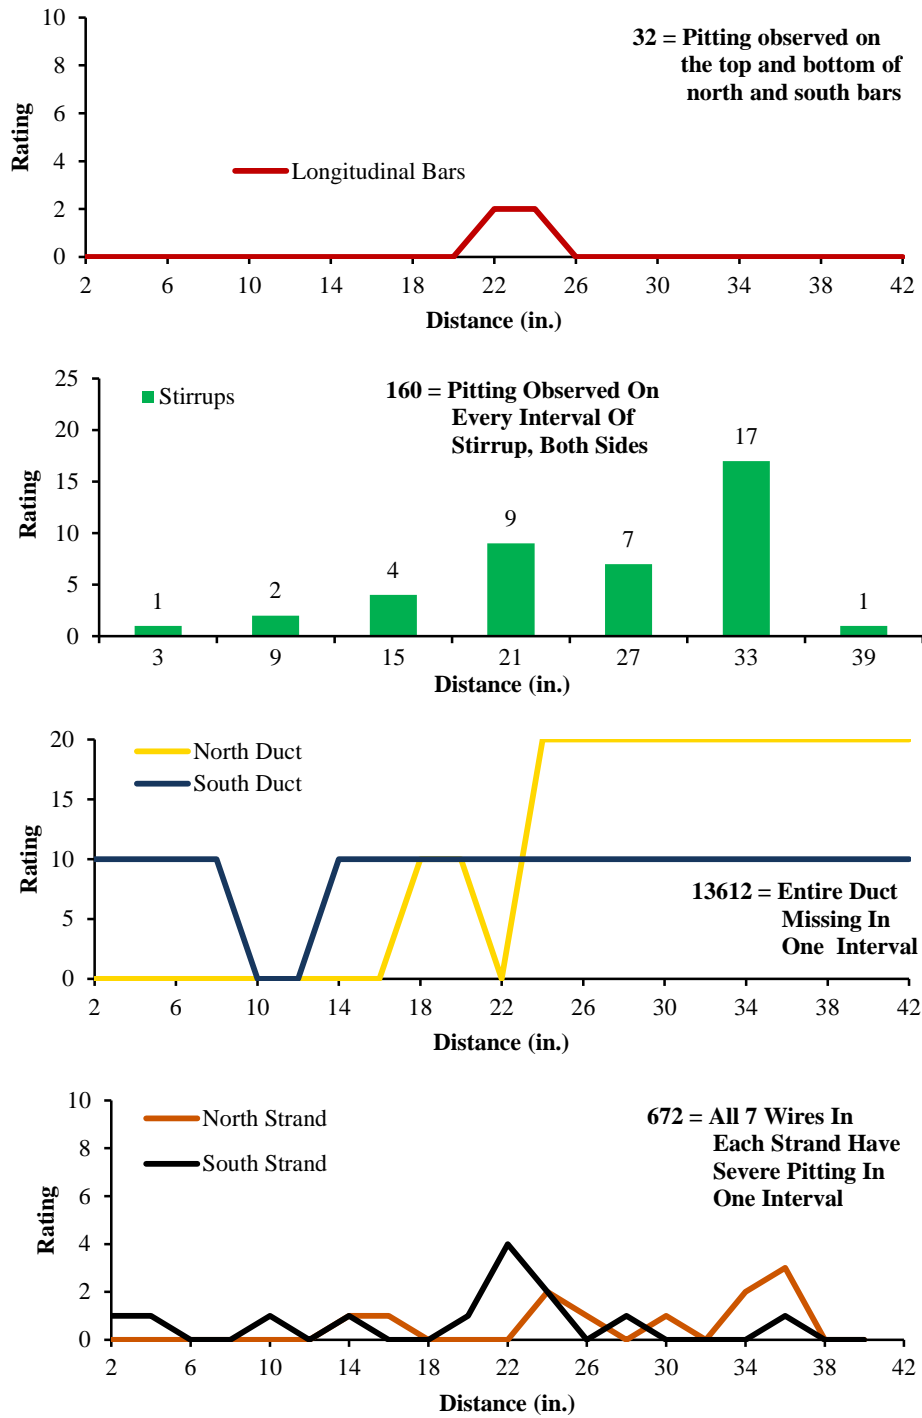
Figure 6.113: Corrosion Rating Plots for Main Autopsy Region of Specimen 5.2

The north and south longitudinal bars had slight damage from when the bars were extracted from the specimen. No rust stains were evident on either the north or south longitudinal bars. However, light corrosion was observed at approximately midspan of both the north and south longitudinal bars. Figure 6.113 shows the longitudinal bar's

Figure 6.113 shows the damage ratings for the ducts and Table 6.22 shows the summary of the damage ratings for the ducts.

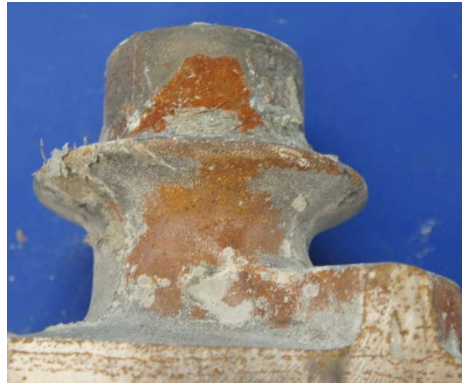
The majority of the epoxy applied to the anchorage from the dead end before the anchorage cavity was backfilled had debonded from the anchorage components of both tendons. The exposed faces of the north and south anchorage plates from the dead end had visible light corrosion in areas where the epoxy had debonded. Light corrosion was observed on the bottom of the embedded portion of the north and south anchorage plates. This corrosion was located in the area away from where the duct was sealed to the anchorage plate and also where the duct was sealed to the anchorage plate (Figure 6.114). The exposed faces of the north and south anchor heads from the dead end had spots of light surface corrosion. The sides of the north and south anchor heads from the dead end had light surface corrosion on the majority of the surface. The unexposed face of the north and south dead end anchor heads had light surface corrosion in a ring outside of where the grout came into contact with the anchor head.

***Figure 6.114: Light Corrosion on the Embedded Portion of the North Dead Anchorage Plate from Specimen 5.2***

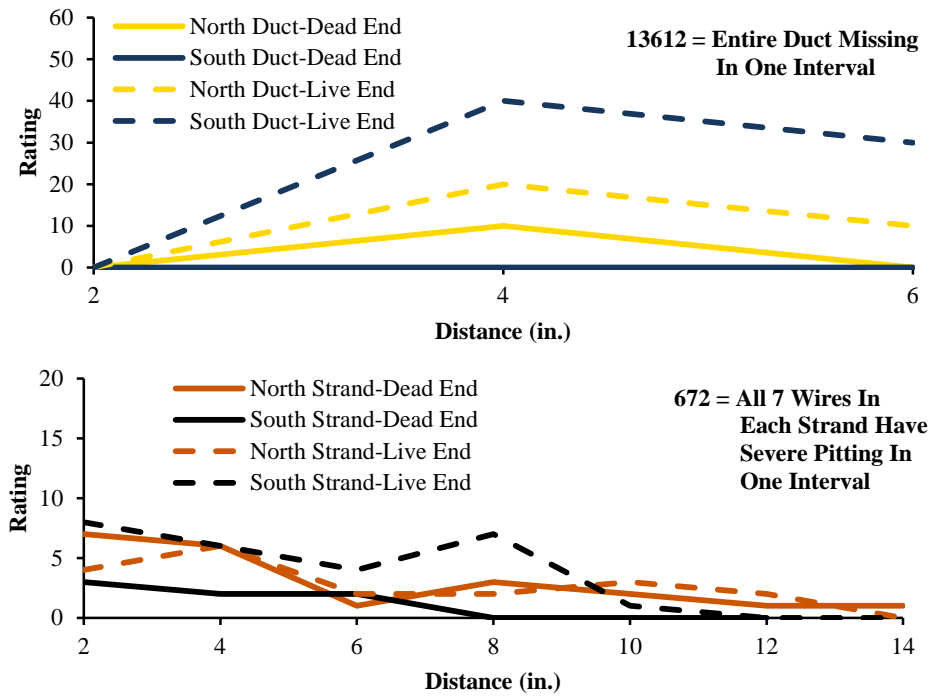
**Figure 6.115: Corrosion Rating Plots for Dead and Live End Anchorage Regions of Specimen 5.2**

As expected, the outer and inner wires of the strands from the north and south, dead and live end anchorage regions had discoloration on a few intervals. The wedges from both anchorage regions and both tendons were intact and had light surface corrosion on their outer surface. Figure 6.115 shows the corrosion ratings for the dead and live anchorage region strands and Table 6.23 shows the summary of the corrosion ratings for the dead and live anchorage region strands.

The anchorage components from the live and dead ends had experienced similar damage. So, it can be assumed that the dead end anchorage spray did not make a difference when it came to the damage that was observed. The chloride concentrations further confirm this because the chloride contents of the dead end region were below the chloride corrosion limit.

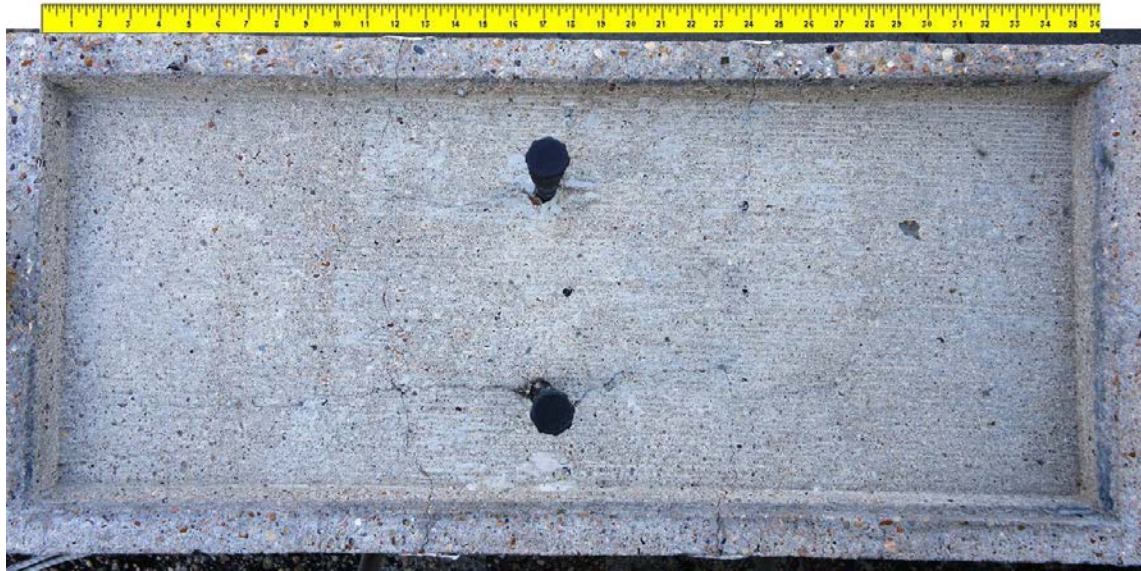
*Figure 6.116: Specimen 5.3 Main Autopsy Region and Grout Vents*

The surface of Specimen 5.3 had medium scaling on the top surface and on the edges of the ponding area. The ponding area was in good repair with only minimal scaling observed (Figure 6.116). There was one medium sized shallow depression

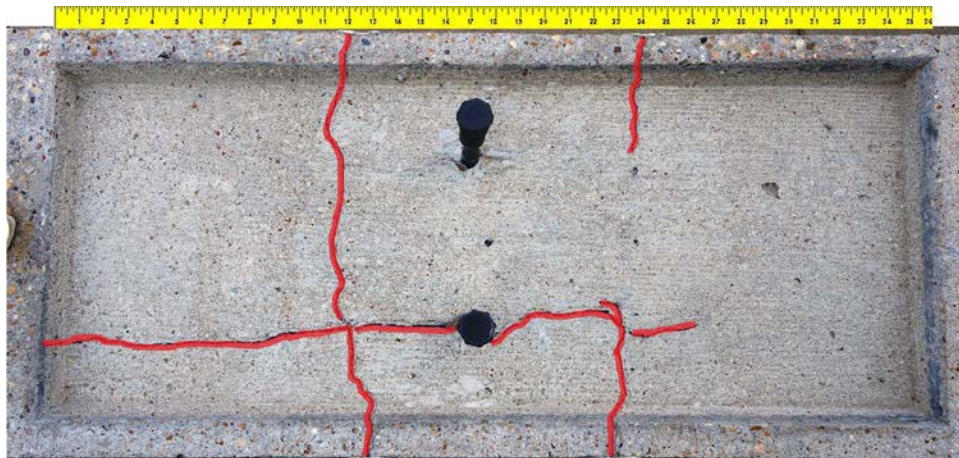
***Figure 6.117: Specimen 5.3 Crack Map of Ponding Area***

The repairs to the cracks from the application of live load on both sides of the live and dead end re-entrant corbel corners were in good repair. The ponding area of Specimen 5.3 had 1 large transverse crack that ran from the south side of the specimen to the longitudinal crack over the north tendon and 2 small transverse cracks (one on the south side that ran from the south edge of the ponding area to the location of the south tendon and one that ran from the north edge of the ponding to the location of the north tendon) (Figure 6.117). A longitudinal crack was observed above the location of the north tendon that ran from the dead end side of the ponding area to approximately the live end quarter point (Figure 6.117). This crack might have formed because the plastic duct and concrete have different thermal coefficients therefore any heating or cooling of the specimen would cause differential shrinkage or expansion between the duct and concrete. The concrete also had decreased cover in this region further exacerbating the cracking. However, this does not explain why the no longitudinal cracking was observed over the south tendon. The average crack width was 0.004 inch. The crack rating for Specimen 5.3 was 0.21. See Figure 6.118 for the crack data from Specimen 5.3.

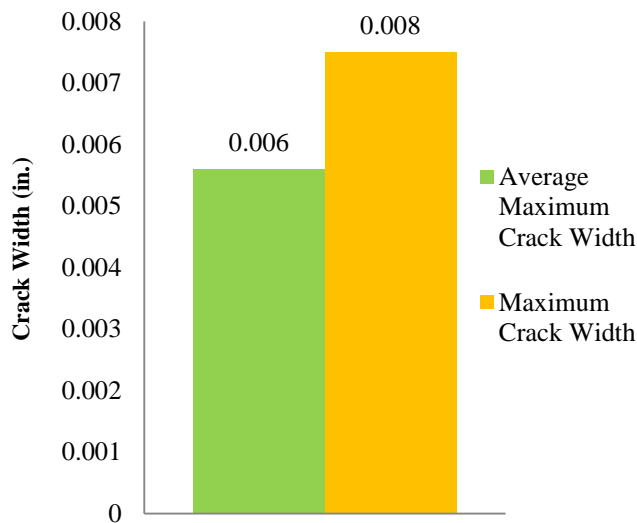
**Figure 6.118: Crack Data for Specimen 5.3**

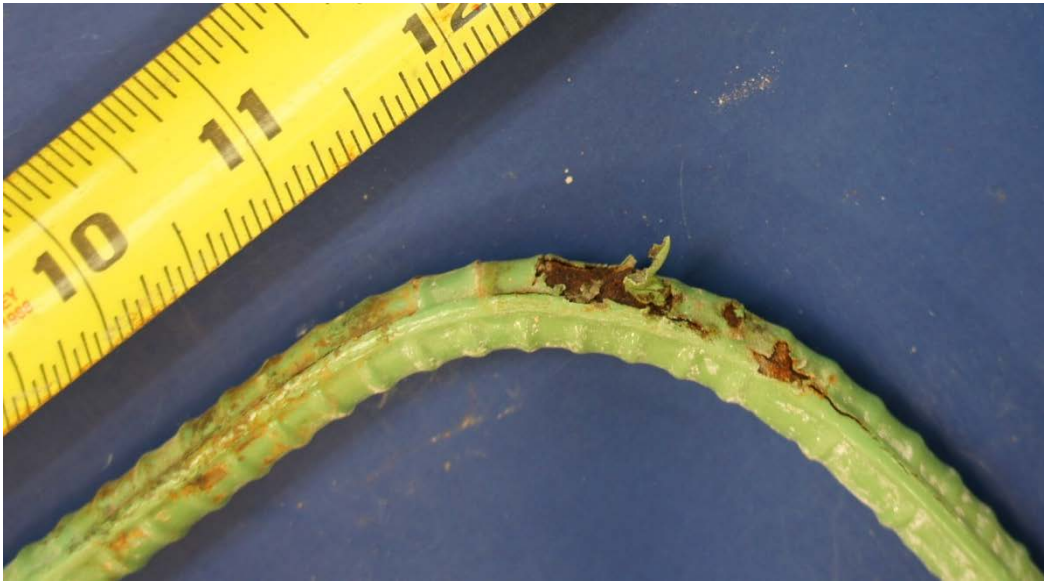
All transverse bars had damage from when they were extracted from the specimen. All the transverse bars had rust staining at least somewhere over the length of the bar from corrosion of the tie wire used to attach the transverse bars to the longitudinal bars and to attach the duct to the transverse bars. Light corrosion was observed on at least one interval on all bars and moderate corrosion observed on at least one interval of bars #3 and #4 (Figure 6.119). Bar #3 had the highest rating of 30. Bar #4 had the next highest rating of 17. Bar #7 had the lowest ratings of 4. Figure 6.124 shows the transverse bar’s corrosion ratings and Table 6.24 shows the summary of the corrosion rating for the transverse bars.

***Figure 6.119: Moderate Corrosion at South Side Corner of Transverse Bar #4 from Specimen 5.3***

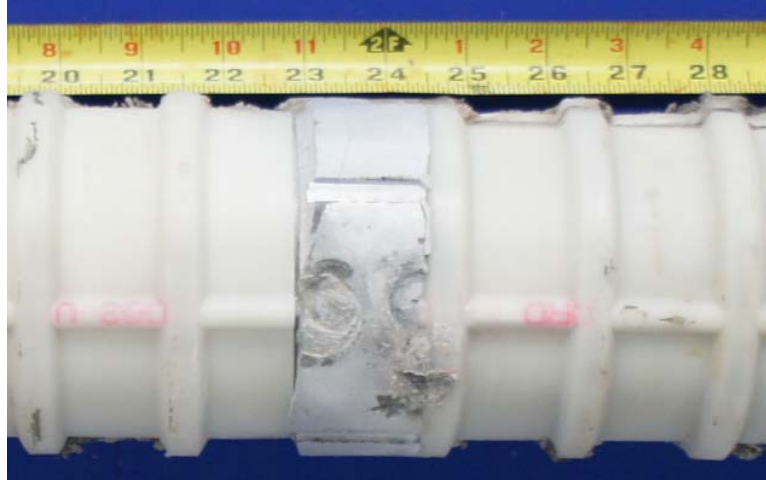
The entire outer surface of the north duct had a chalky white residue. No corrosion staining was observed on the outer or inner surface of the duct. The inner top surface of the north duct had moderate gouges on the successive intervals on the live end side of midspan. This indicates that one or more of the strands caused damage when the strands were being threaded through the duct because of the curved shape of the stainless steel strand. The bottom inner surface of the north duct had slight gouges starting at the dead end and going to over  $\frac{3}{4}$  of its length and moderate gouges the rest of the length of the bottom inner surface of the duct. This indicates that one or more of the strands caused damage either when the strands were being threaded through the duct or one of the strands or stands were rubbing against the duct when the strands were being stressed. In either case, the integrity of the duct was not compromised. Indications of voids were observed on the top inner surface of the duct along the entire length. No damage was observed on the coupler, grout vent, or heat shrink wrap used to seal the coupler/duct interface. However, the heat shrink wrap did not bond well to the coupler or duct. This

***Figure 6.120: Top Outer Surface at Midspan of North Duct from Specimen 5.3***

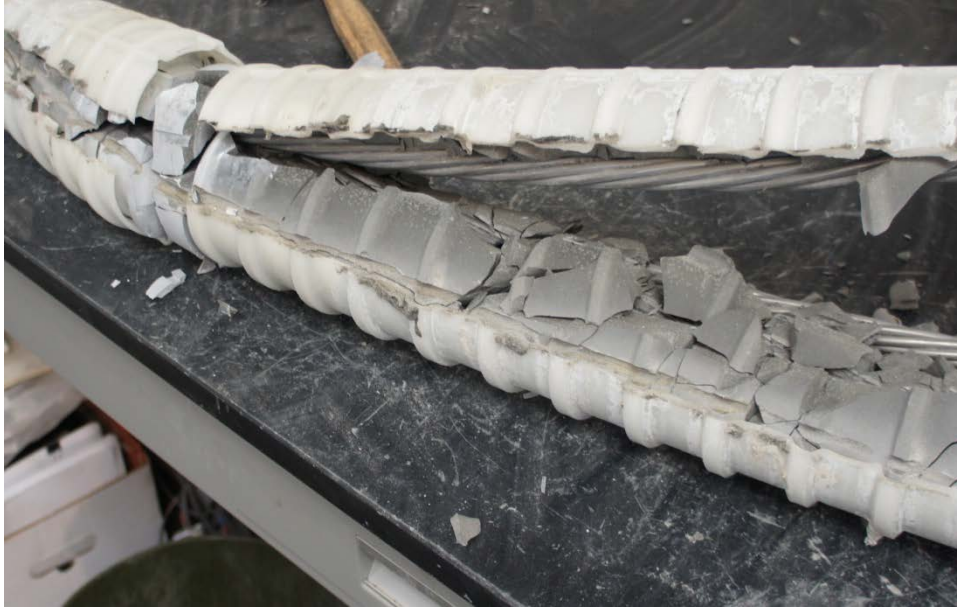
No cracking in the grout could be observed in either tendon because the grout fell apart when the ducts were removed from the tendon due to the curved nature of the

strands (Figure 6.121). Small voids in the grout were observed in the flutes along the entire length of the top of both the north and south tendons. The small voids measured approximately 1.5 inch long and were as wide as the flute width.

***Figure 6.121: Grout Falling Apart from North Tendon of Specimen 5.3***

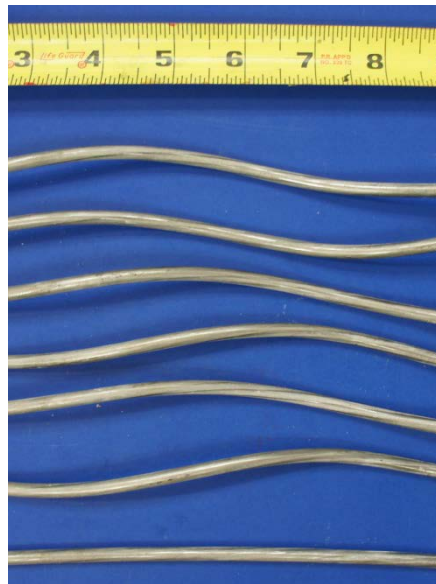
The three strands in the north and south tendons had no visible corrosion. Only two outer wires from the strands from the north and south tendons had one interval with slight discoloration and one inner wire from the one of the strands in the south tendon had slight discoloration on one interval. This outcome was expected because of the excellent corrosion resistance properties of stainless steel. Figure 6.122 shows the inner and outer wires of a stainless steel strand from Specimen 5.3. The grout did not adhere well to the strands. Because the grout did not adhere well to the strands, when the tendons were cut the strands retracted into the grout (Figure 6.123). The strands had a highly curved shape (Figure 6.78). Figure 6.124 shows the corrosion ratings for the strands and Table 6.24 shows the summary of the corrosion ratings for the strands.

***Figure 6.122: Inner and Outer Wires of a Strand from Specimen 5.3***
