**Assessment of Long-Term Corrosion Resistance of Recently Developed  
Post-Tensioning Components**

**Thesis**

The University of Texas at Austin

**August, 2012**

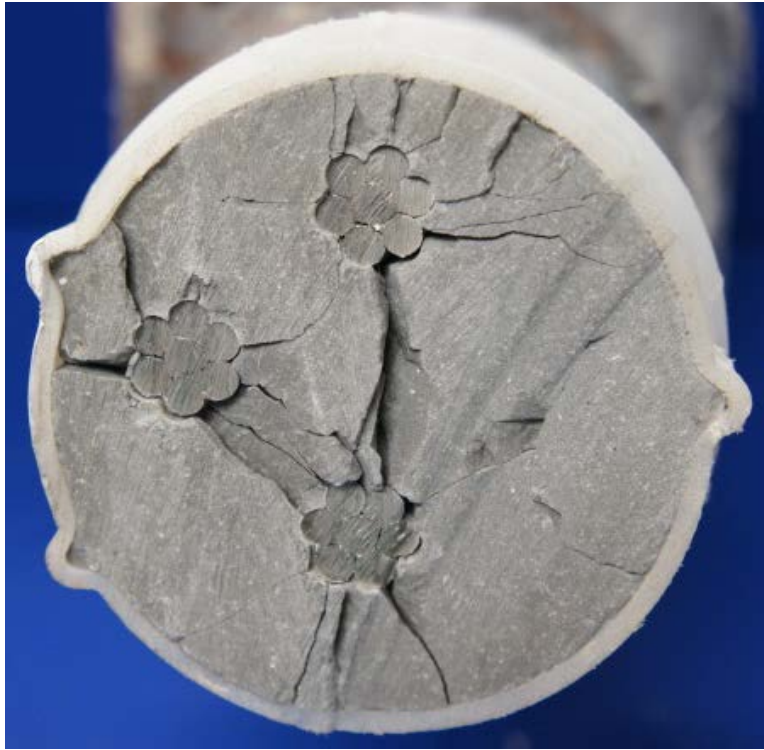
*Figure 6.123: Retracted Strands from Specimen 5.3*

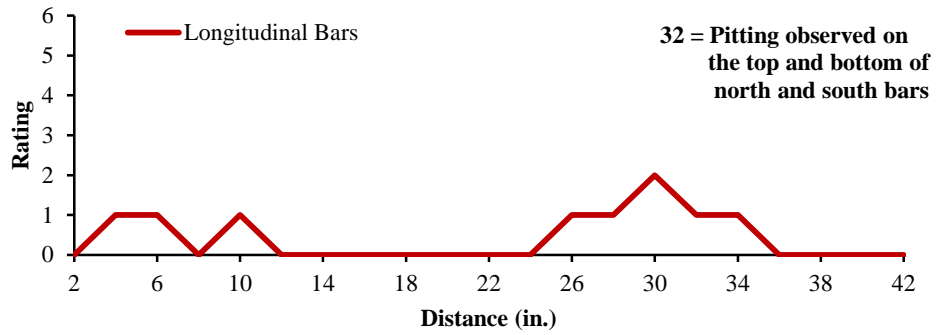
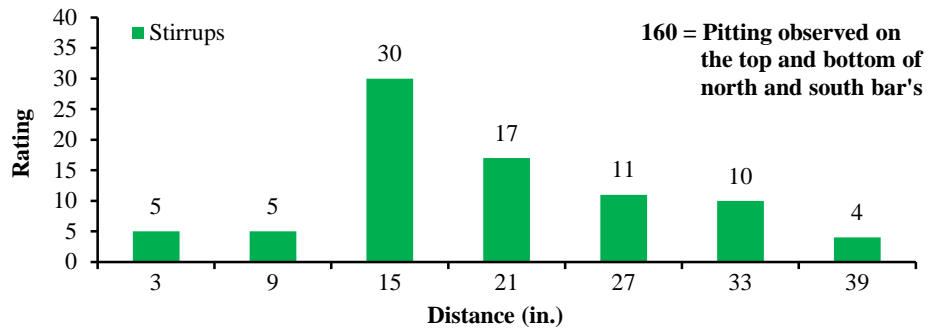
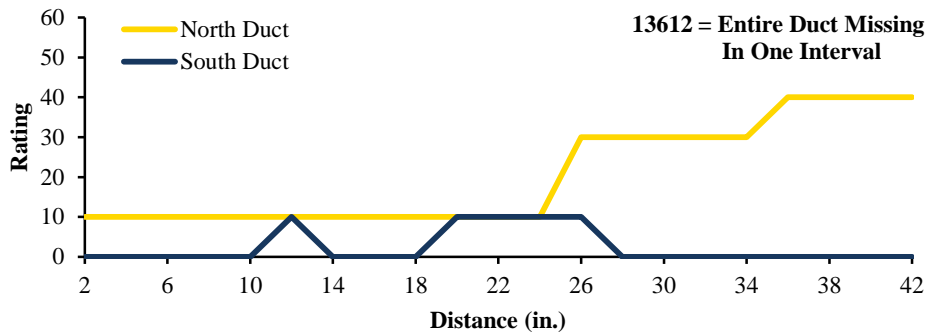
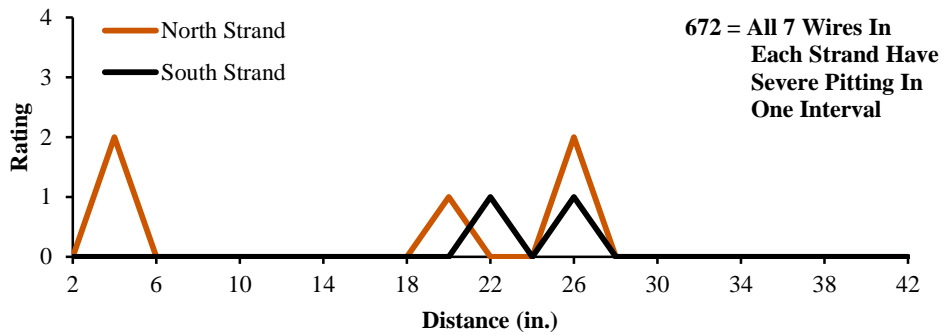
Figure 6.124 shows the damage ratings for the ducts and Table 6.24 shows the summary of the damage ratings for the ducts.

**Figure 6.124: Corrosion Rating Plots for Main Autopsy Region of Specimen 5.3**

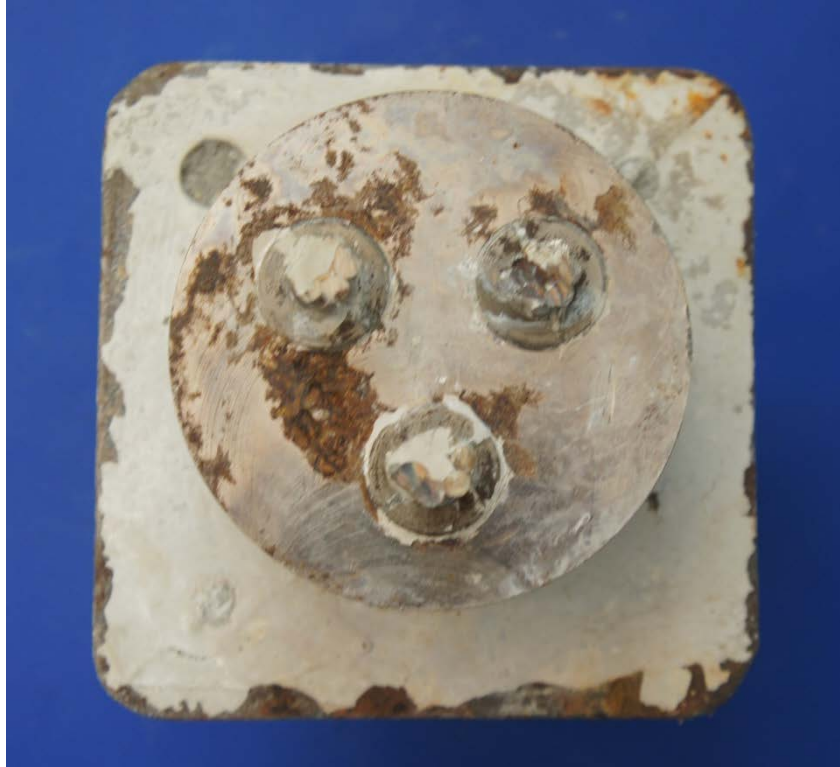
The majority of the epoxy applied to the anchorage heads from the live end before the anchorage cavity was backfilled had debonded from the anchorage components of both tendons. Most of the epoxy applied to the exposed surface of the anchorage plates from the live end before the anchorage cavity was backfilled was still bonded to the surface (Figure 6.125). The exposed faces of the north and south anchorage plates from the live end had light surface corrosion in a few spots where the epoxy had debonded. The embedded portion of the north anchorage plate from the live end had light corrosion on the bottom outside the area where the duct was sealed to the anchorage plate and where the duct was sealed to the anchorage plate with duct tape. The embedded portion of the south anchorage from the live end had light corrosion on the bottom outside the area where the duct was sealed to the anchorage plate and moderate corrosion where the duct was sealed to the anchorage plate with duct tape. The exposed faces of the north and south anchor heads from the live end had small spots of light corrosion. The sides of the north and south anchor heads from the dead end had light surface corrosion on the majority of the surface. The unexposed face of the north and south live end anchor heads

had light surface corrosion in a ring outside of where the grout came into contact with the anchor head.

*Figure 6.125: Exposed Faces of Live End South Anchorage Plate and Anchor Head from Specimen 5.3*

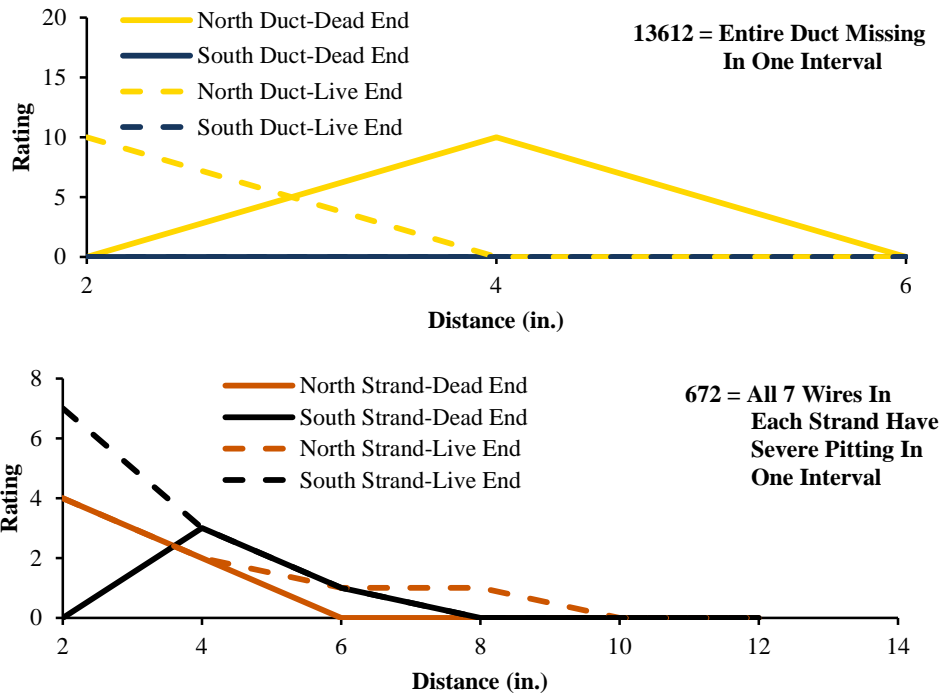
Figure 6.126 shows the damage ratings for the dead and live anchorage region ducts and Table 6.25 shows the summary of the damage ratings for the dead and live anchorage region ducts.

As expected, the outer and inner wires of the strands from the north and south, dead and live end anchorage regions had discoloration on a few intervals. Most of the discoloration was in the region of the wedges. This discoloration might be from heat of the torch when the strands were extracted. The wedges from both anchorage regions and both tendons were intact and had light surface corrosion on their outer surface. Figure 6.126 shows the corrosion ratings for the dead and live anchorage region strands and Table 6.25 shows the summary of the corrosion ratings for the dead and live anchorage region strands.

**Figure 6.126: Corrosion Rating Plots for Dead and Live End Anchorage Regions of Specimen 5.3**

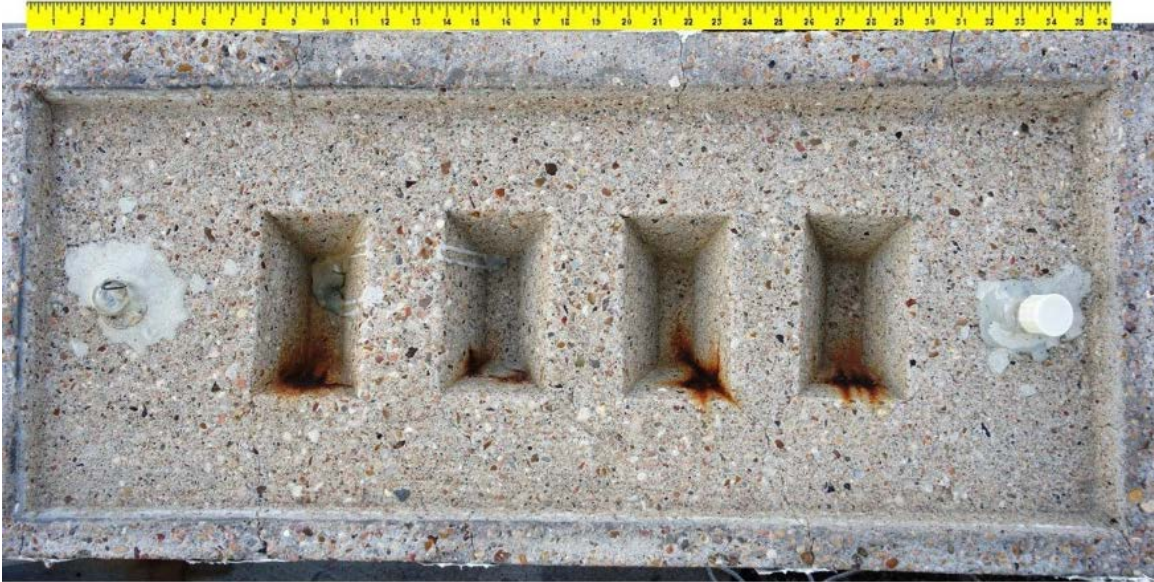
*Figure 6.127: Specimen 7.2 Main Autopsy Region and Grout Vents*

The surface of Specimen 7.2 had medium scaling on the top surface and in the ponding area (Figure 6.127). There was dried grout around the grout vents indicating that the vents had overflowed during grouting operations. Rust stains were observed on the north sides of the “wells” that were formed to reduce the concrete cover over the top of the tendon to the same concrete cover as the other specimens (Figure 6.127). Longitudinal cracks were observed at the interface of the backfill mortar and base concrete on the dead and live ends. This indicates that the backfill mortar did not adhere well with the base concrete.

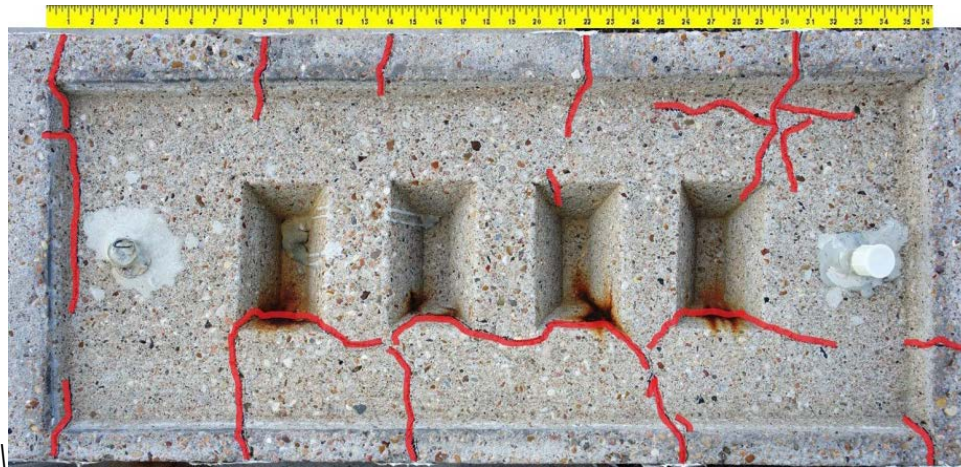
No cracks from the application of live load on both sides of the live and dead end re-entrant corbel corners were observed. Longitudinal cracking on the backfill mortar from the live and dead end anchorage pockets was observed over the top of the grout vent for the anchorage and extended from the top interface to the end interface of the backfill mortar and base concrete (Figure 6.129). This cracking is from not having sufficient concrete cover over the top of the anchorage grout vent. The ponding area of Specimen 7.2 had 1 large transverse crack that ran from the north side to the south side on the dead end side of the ponding area and 8 small transverse cracks (4 on the south side and 4 on the north side) (Figure 6.130). A longitudinal crack was observed and was located on the north side of the “wells”. It ran the length of the “wells” (Figure 6.130). This crack is almost certainly due to the expansive nature of the corrosion product from the uncoated longitudinal steel reinforcement that had been added to the specimen for taking AC

**Figure 6.130: Specimen 7.2 Crack Map of Ponding Area**

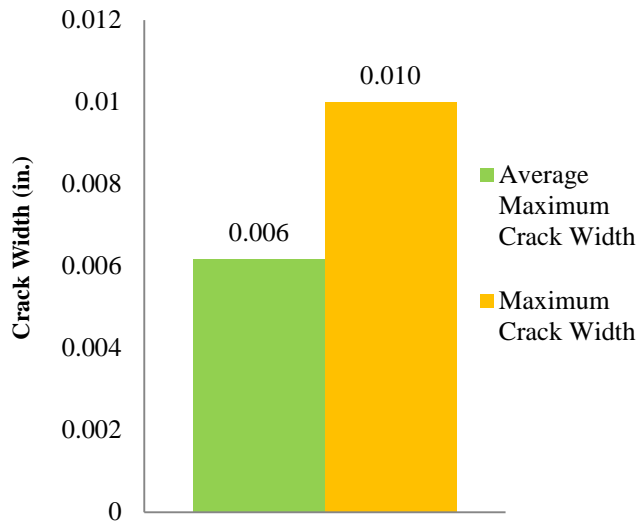
impedance readings. However, this does not explain why the no longitudinal cracking was observed on the south side of the “wells” above the similar uncoated bar. The average crack width was 0.006 inch. The crack rating for Specimen 7.2 was 0.46. See Figure 6.131 for the crack data from Specimen 7.2.

**Figure 6.131: Crack Data for Specimen 7.2**

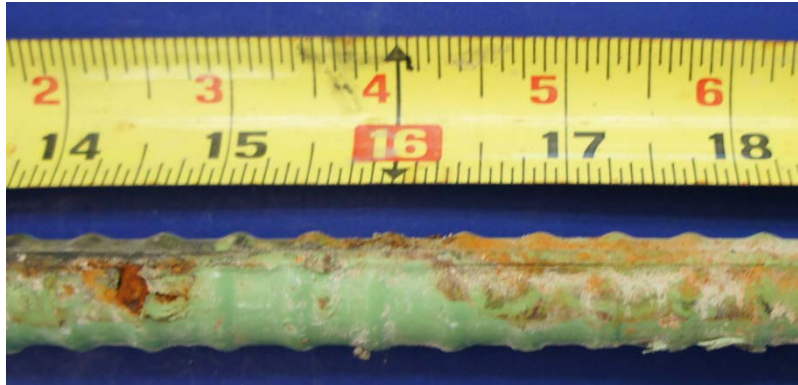
The north and south epoxy coated longitudinal bars had slight damage from when the bars were extracted from the specimen. The north coated longitudinal bar had no visible signs of corrosion. The south coated longitudinal bar had moderate corrosion and cracks in the epoxy coating located approximately at midspan on the longitudinal rid of the bar (Figure 6.132). Rust stains were also evident at locations where the transverse

***Figure 6.132: Moderate Corrosion and Crack in Epoxy Coating along Longitudinal Rib of South Epoxy Coated Longitudinal Bar of Specimen 7.2***

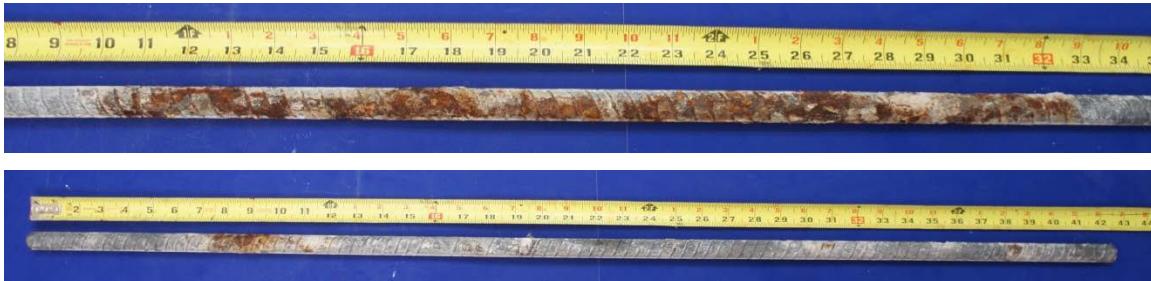
The north and south uncoated longitudinal bars had slight damage from when the bars were extracted from the specimen. The north and south bars had extensive pitting, moderate corrosion, and light corrosion along their lengths (Figure 6.133). The damage to the north bar was much more extensive than the damage to the south bar. This might indicate that the longitudinal crack observed on the north side of the “wells” was present before the bar had corroded. This indicates that moisture, oxygen, and chlorides reached the depth of the bars. The light and moderate corrosion was normally located on intervals adjacent to the areas of pitting. Figure 6.137 shows the uncoated longitudinal bar's corrosion ratings and Table 6.26 shows the summary of the corrosion ratings for the uncoated longitudinal bars.

***Figure 6.133: Corrosion Damage to North (Top) and South (Bottom) Uncoated Longitudinal Bars from Specimen 7.2***

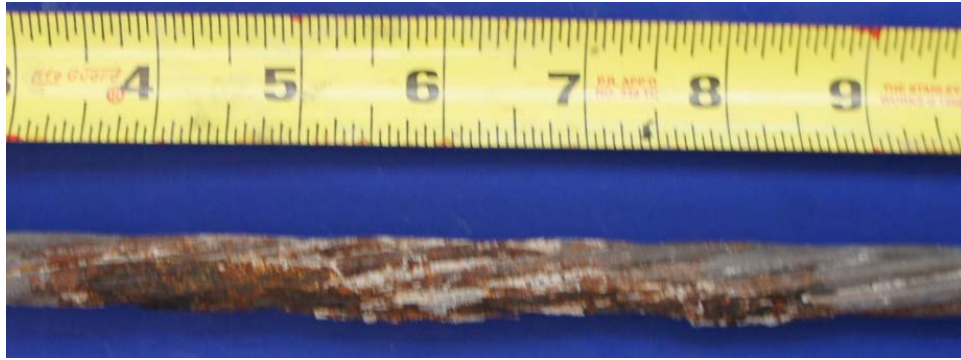
The damage to the strands was quite extensive but was expected due to the damage to the duct that was observed and the poor bond of the heat shrink to the coupler and duct. Mild pitting was observed on the outer and inner wires of one strand at the location of the dead end grout vent (Figure 6.136). Moderate corrosion was observed on the majority of the outer wire intervals and all the inner wires. Where neither pitting nor moderate corrosion was observed light corrosion was present. This is an indication that moisture, oxygen, and chlorides had reached the strands and corresponds to the chloride concentrations discussed in Chapter 5. The dead end side of the live end grout vent had the lowest rating of 47. As expected, the highest rating of 112 was at the location of the crack in the duct that was observed at the dead end grout vent. Figure 6.137 shows the corrosion ratings for the strands and Table 6.26 shows the summary of the corrosion ratings for the strands.

*Figure 6.136: Pitting at Dead End Grout Vent of Specimen 7.2*

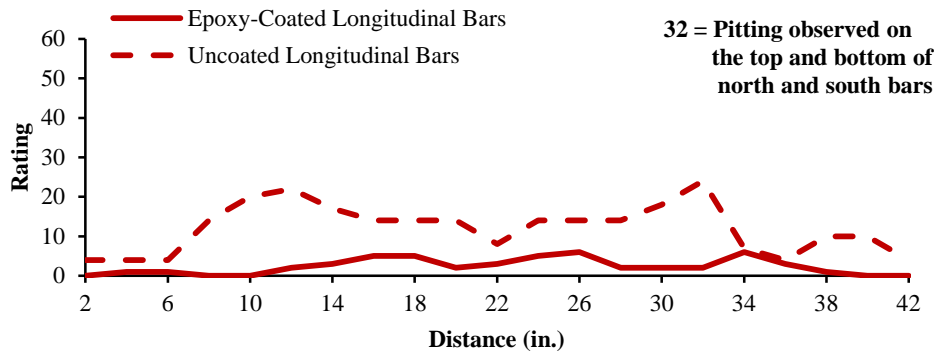
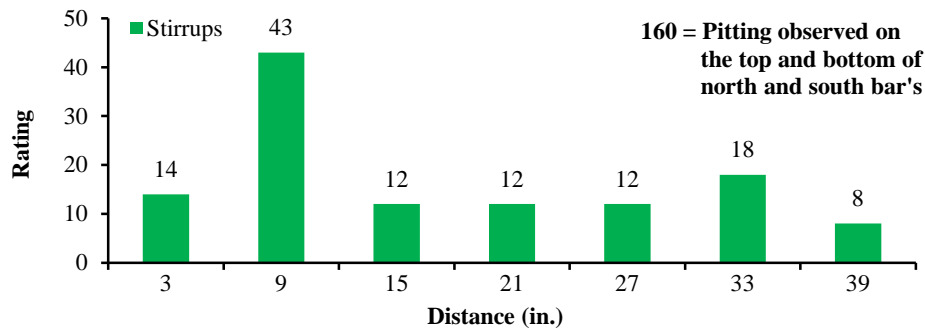
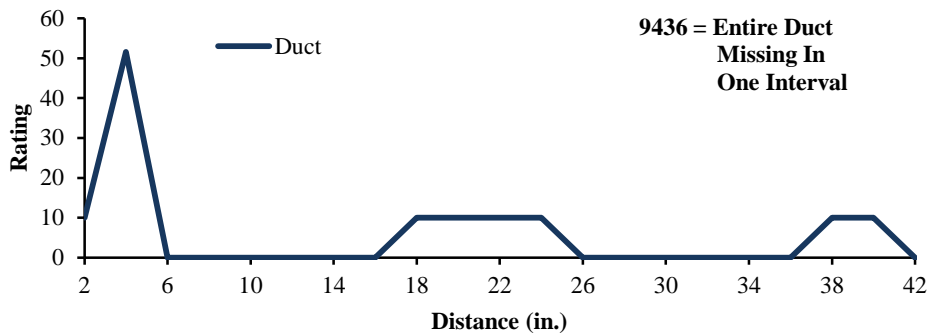
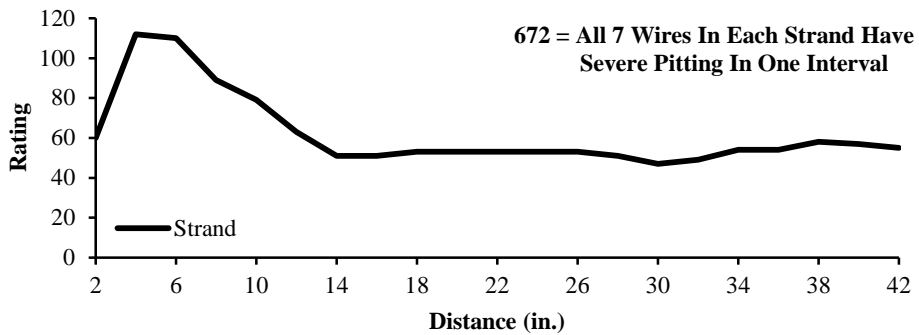
bars were tied to the longitudinal bars. This staining is from corrosion of the tie wire used to attach the transverse reinforcement to the longitudinal bars and NOT from the longitudinal bar itself. Figure 6.137 shows the epoxy coated longitudinal bar's corrosion ratings and Table 6.26 shows the summary of the corrosion ratings for the longitudinal bars.

**Figure 6.137: Corrosion Rating Plots for Main Autopsy Region of Specimen 7.2**

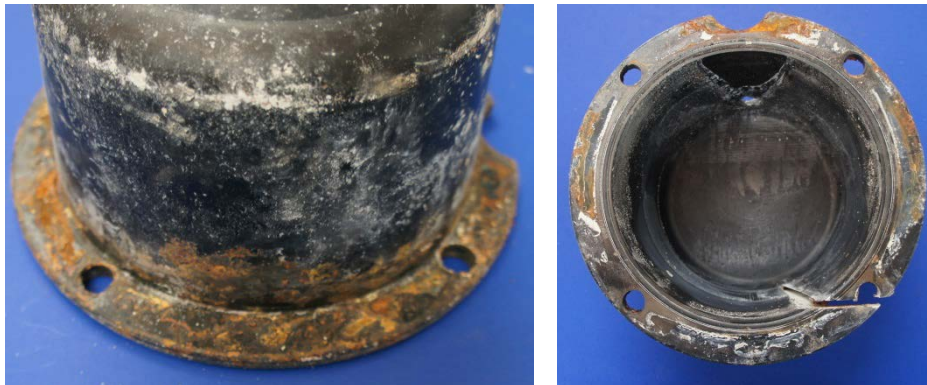
***Figure 6.139: Rust Stains on Exposed (Left) and Unexposed (Right) Faces of Lip on the Dead End Rubber Cover from Specimen 7.2***

This corrosion damage of the anchorage components might be from the salt solution entering the cracks that were observed in the live and dead end backfill mortar. The cracks would have allowed at least moisture and oxygen to infiltrate the anchorage and possible chlorides when the salt solution in the ponding area was being sprayed out. The greater damage to the dead end anchorage components might be from the salt spray from the dripper system entering the crack in the backfill mortar.

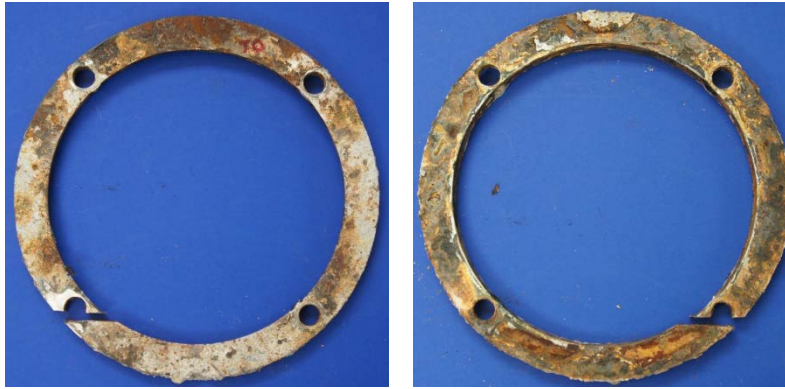
**Figure 6.140: Severe Corrosion and Pitting on Steel Ring from the Dead End of Specimen 7.2**

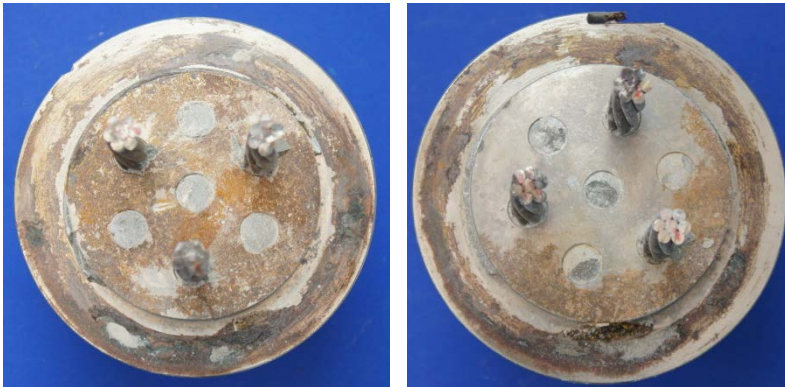
**Figure 6.141: Unexposed Faces of Dead (Left) and Live (Right) End Anchor Heads from Specimen 7.2**

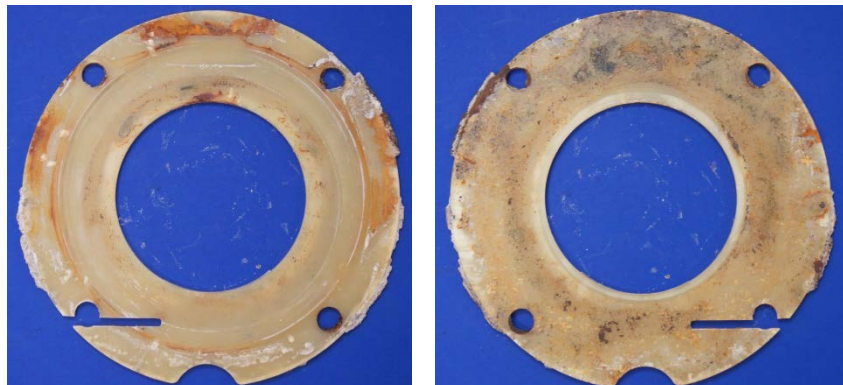
**Figure 6.142: Rubber Cover Surface (Left) and Anchor Head Surface of Live End Fiber Glass Barrier from Specimen 7.2**

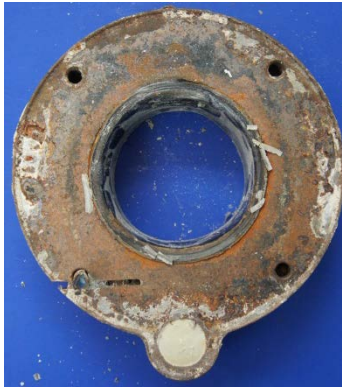
one bolt that could not be extracted had to be cut using a grinder, was from the dead end anchorage, and had been cut by the wet saw (Figure 6.143).

**Figure 6.143: Exposed Surface of Dead End Anchorage Plate from Specimen 7.2**

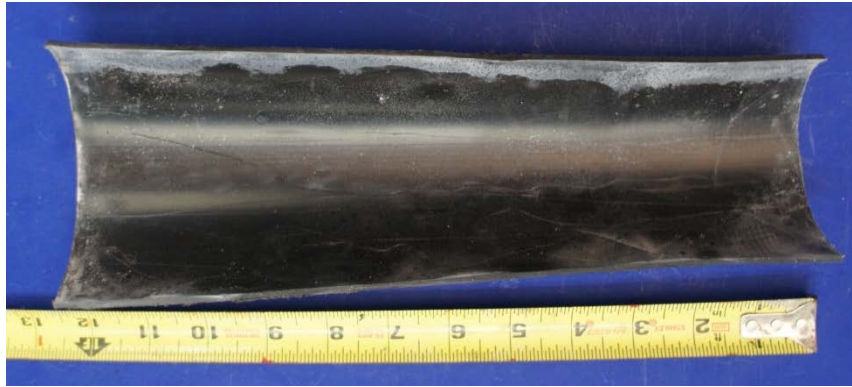
The outside surface of the dead and live end ducts had a white powder where the duct came into direct contact with the concrete. The ducts in the live and dead end anchorage region had no holes or gouges. However, light scratches were observed on the bottom surface of live and dead end ducts (Figure 6.144). There were no indications of voids in either duct section. Figure 6.147 shows the damage ratings for the dead and live anchorage region ducts and Table 6.27 shows the summary of the damage ratings for the dead and live anchorage region ducts.

***Figure 6.144: Light Scratches on the bottom of the Live End Duct Section of Specimen 7.2***

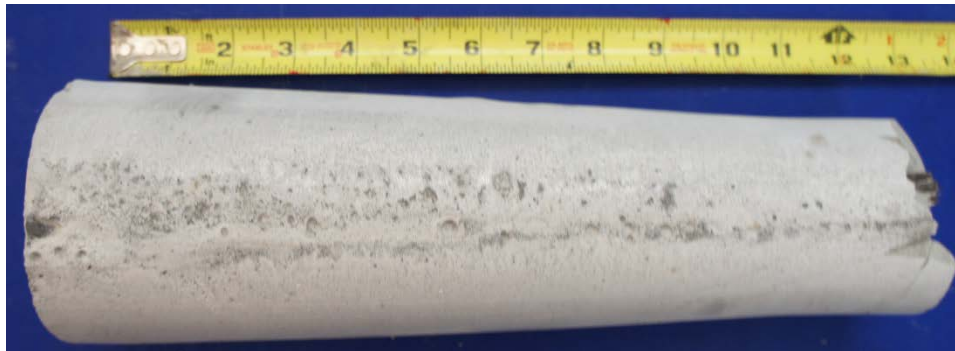
No transverse or longitudinal cracks were observed in the grout from either the dead or live end section of the tendon. The grout from both tendon sections in the anchorage regions had small voids along the top surface of the grout (Figure 6.145). There was no sign of segregation of the grout.

***Figure 6.145: Small Voids in Grout from Dead End Tendon Section of Specimen 7.2***

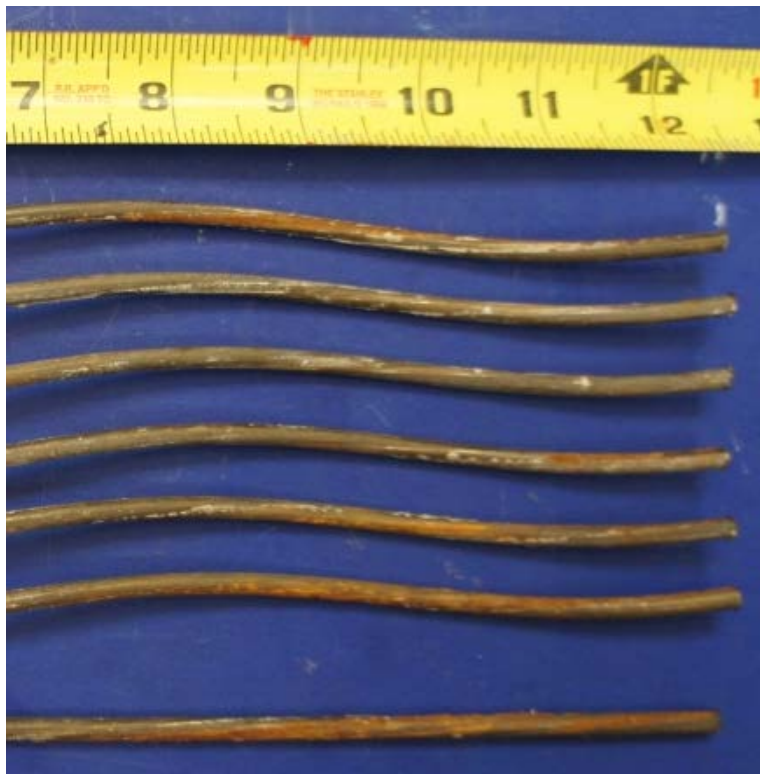
The outer wires of the dead end section of the tendon had mild pitting, moderate corrosion, light corrosion, and discoloration. The mild pitting was primarily confined to one strand (Figure 6.146). This strand was the strand that was closest to the hole that was observed in the duct section at the dead end grout vent region. This also indicates that moisture, oxygen, and/or chlorides had entered through the hole that was observed in the duct. The inner wires from the dead end section of the tendon had the same damage as the outer wires with the pitting primarily confined to the same strand as the pitting in the

***Figure 6.146: Pitting, Moderate, and Light Corrosion on Inner and Outer Wires from One Strand from the Dead End Section of the Tendon from Specimen 7.2***

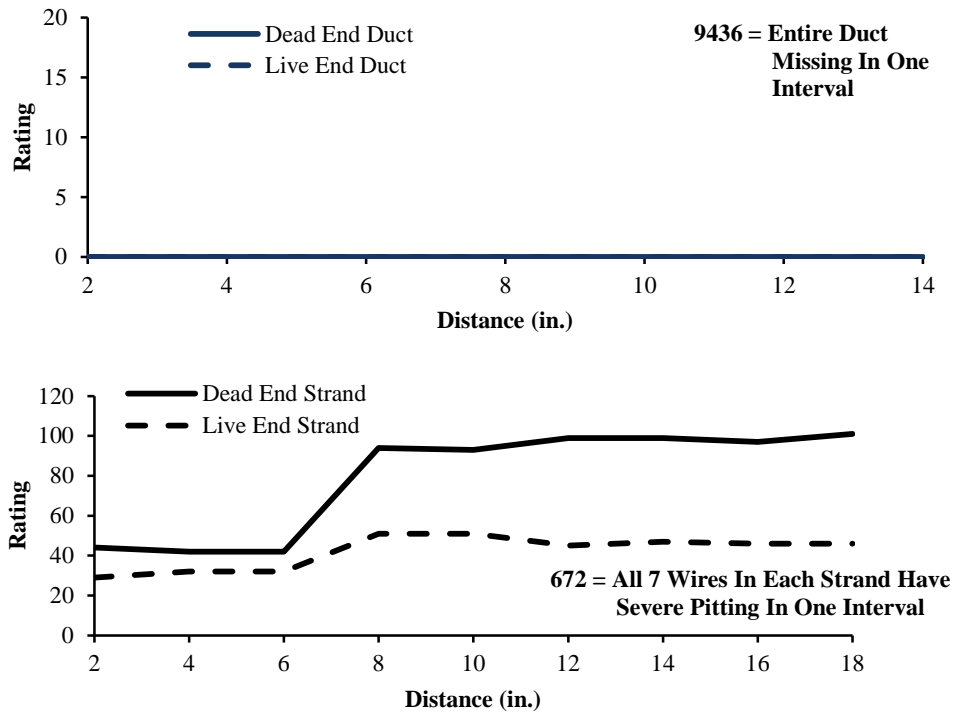
**Figure 6.147: Corrosion Rating Plots for Dead and Live End Anchorage Regions of Specimen 7.2**

The differential damage between the dead and live end post-tensioning components was from two sources. One source is the spray system where the crack in the backfill mortar exacerbated the infiltration of chlorides to the anchorage components from the spray system. The other source for the differential damage is the crack in the duct. This crack would have allowed moisture, oxygen, and/or chlorides to enter the tendon and induce corrosion.

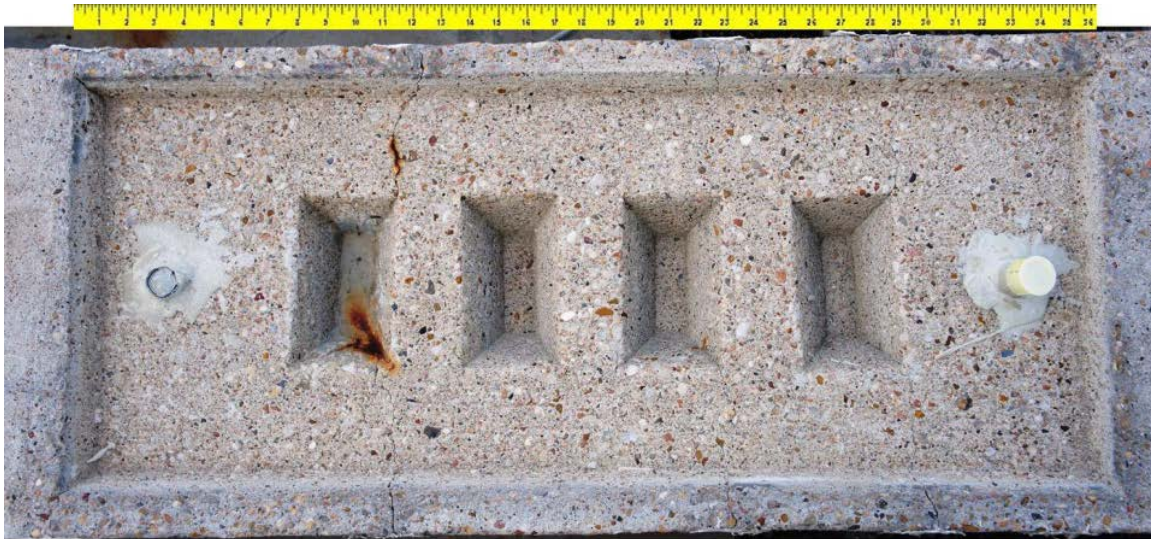
*Figure 6.148: Specimen 7.3 Main Autopsy Region and Grout Vents*

The surface of Specimen 7.3 had medium scaling on the edges of the ponding area (Figure 6.148). There was dried grout around the grout vents indicating that the vents had overflowed during grouting operations. Rust stains were observed on the north side of the dead end “well” and in the south side of the transverse crack located at the dead end well (Figure 6.148). Cracks were observed at the interface of the backfill mortar and base concrete on the dead or live ends (Figure 6.149). This indicates that the backfill mortar did not adhere well with the base concrete.

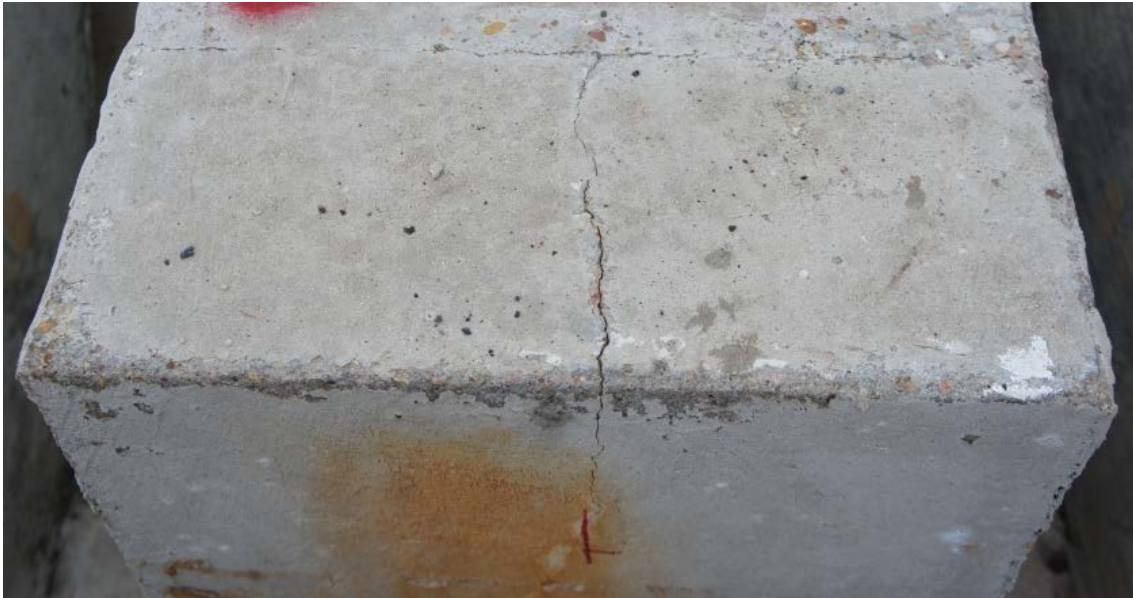
***Figure 6.149: Crack at Interface of the Backfill Mortar and Base Concrete at the Live End of Specimen 7.3***

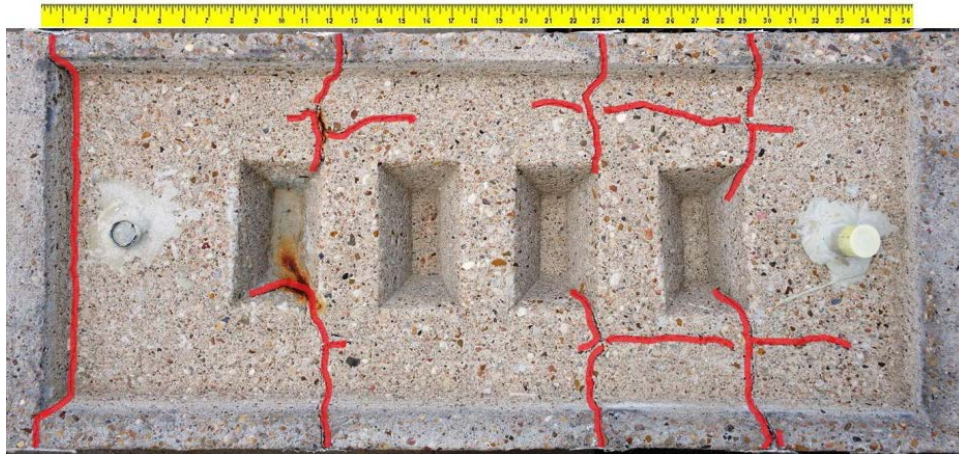
No cracks from the application of live load on both sides of the live and dead end re-entrant corbel corners were observed. Longitudinal cracking in the backfill mortar from the live and dead end anchorage pockets was observed over the top of the grout vent for the anchorage and extended from the top interface to the end interface of the backfill mortar and base concrete (Figure 6.149). This cracking is from not having sufficient cover over the top of the anchorage grout vent. The ponding area of Specimen 7.3 had 1 large transverse crack that ran from the north side to the south side on the dead end side of the ponding area and 6 small transverse cracks (3 on the south side and 3 on the north side) (Figure 6.150). Two longitudinal cracks were located on the north side and the south side of the “wells” (Figure 6.150). These cracks are due to the expansive nature of the corrosion product from the uncoated longitudinal steel reinforcement that had been used for taking AC impedance readings. The average crack width was 0.007 inch. The crack rating for Specimen 7.3 was 0.42. See Figure 6.151 for the crack data from Specimen 7.3.

**Figure 6.150: Specimen 7.3 Crack Map of Ponding Area**

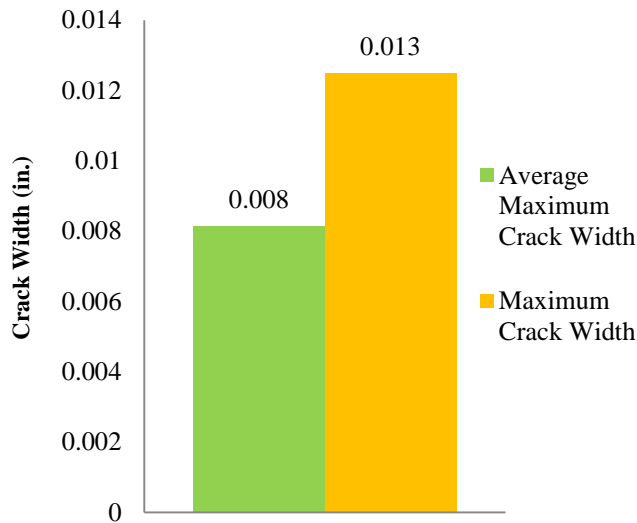
**Figure 6.151: Crack Data for Specimen 7.3**

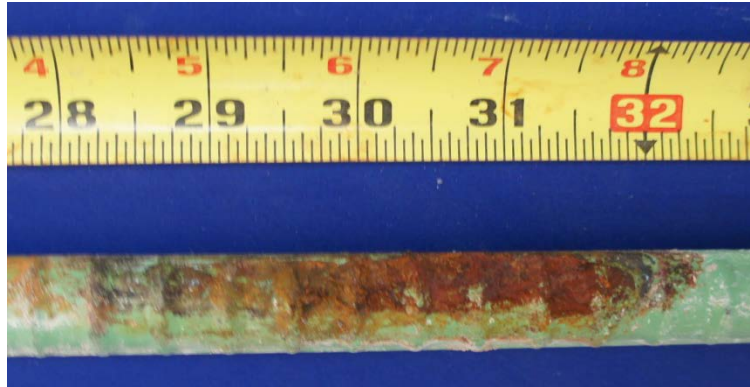
The north and south epoxy coated longitudinal bars had slight damage from when the bars were extracted from the specimen. The north coated longitudinal bar had one interval with moderate corrosion and two intervals with light corrosion. The south coated longitudinal bar had moderate corrosion on one interval, pitting on one interval, and pitting on 4 successive intervals towards the live end of the bar (Figure 6.152). Rust

***Figure 6.152: Pitting on Top of South Longitudinal Epoxy Coated Bar from Specimen 7.3***

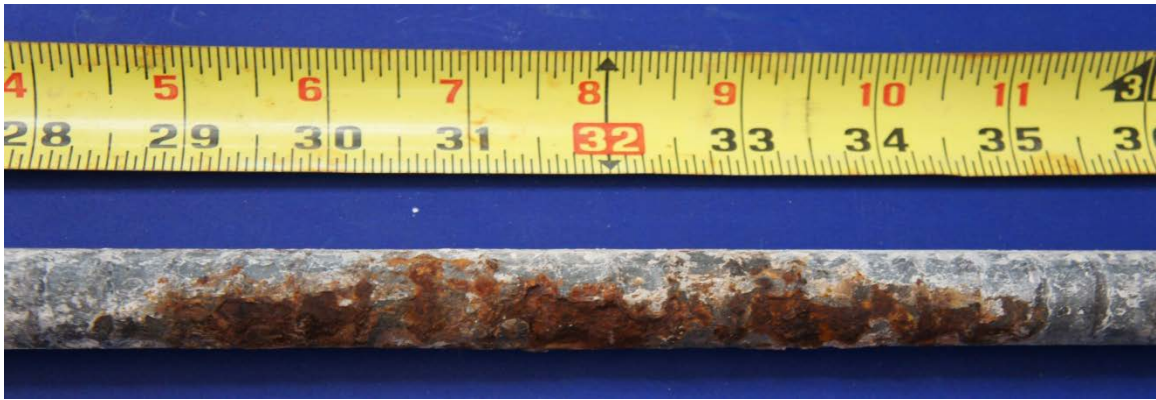
The north and south uncoated longitudinal bars had slight damage from when the bars were extracted from the specimen. The north and south bars had extensive pitting (Figure 6.153), moderate corrosion, and light corrosion along their lengths. The damage to the north and south bars was located on the same intervals. The light and moderate corrosion was normally located on intervals adjacent to the areas of pitting. The corrosion damage indicates that moisture, oxygen, and chlorides reached the depth of the bars. Figure 6.159 shows the uncoated longitudinal bar's corrosion ratings and Table 6.28 shows the summary of the corrosion ratings for the longitudinal bars.

***Figure 6.153: Pitting on North Longitudinal Uncoated Bar from Specimen 7.3***

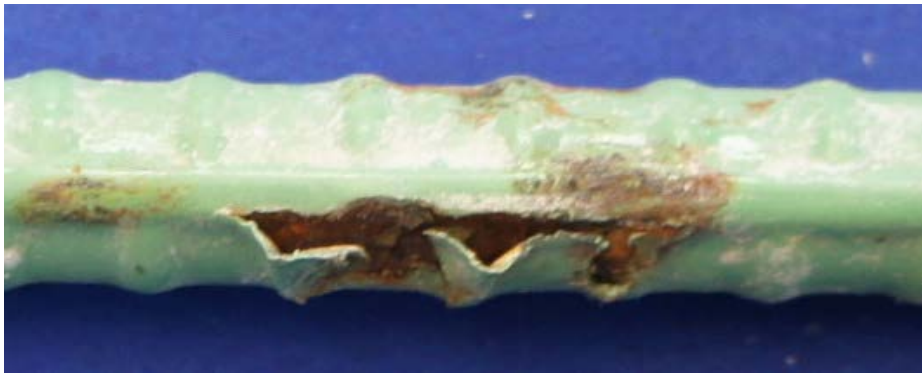
All transverse bars had damage from when they were extracted from the specimen. All the transverse bars had rust staining at least somewhere over the length of the bar from corrosion of the tie wire used to attach the transverse bars to the longitudinal bars and to attach the duct to the transverse bars. All the transverse bars had some form of corrosion damage. Light corrosion was observed on bars #1, #2, and #7. Moderate corrosion was observed on bars #3, #4, #5, and #6. Pitting was observed on bars #3, #5, and #6 (Figure 6.154). Bar #3 had the highest rating of 29 and bar #5 had the second highest rating of 28. Bar #7 had the lowest ratings of 5. Figure 6.159 shows the transverse bar's corrosion ratings and Table 6.28 shows the summary of the corrosion rating for the transverse bars.

***Figure 6.154: Pitting on Transverse Bar #3 from Specimen 7.3***

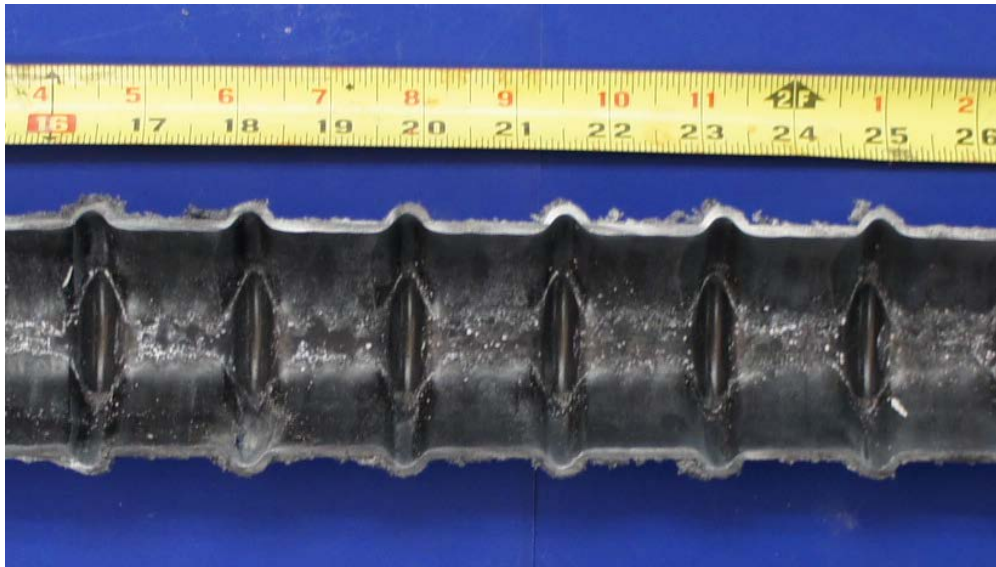
The entire outer surface of the duct had a chalky white residue. No corrosion staining was observed on the outer or inner surface of the duct. The bottom inner surface of the duct had slight gouges at the dead end, on the dead end side of midspan, and at midspan to about the live end quarter point. This indicates that one or more of the strands caused damage either when the strands were being threaded through the duct or one of the strands or stands were rubbing against the duct when the strands were being stressed. Regardless of what caused the gouges the integrity of the duct was not compromised. Indications of voids were observed on the top inner surface of the duct along the entire length (Figure 6.155). No damage was observed on the coupler, grout vent, or heat shrink wrap used to seal the coupler/duct interface. However, the heat shrink wrap did not bond well to the coupler or duct. This might indicate why chloride levels were elevated. Figure 6.159 shows the damage ratings for the ducts and Table 6.28 shows the summary of the damage ratings for the ducts.

*Figure 6.155: Indications of Voids in Grout on Top Surface of Duct from Specimen 7.3*

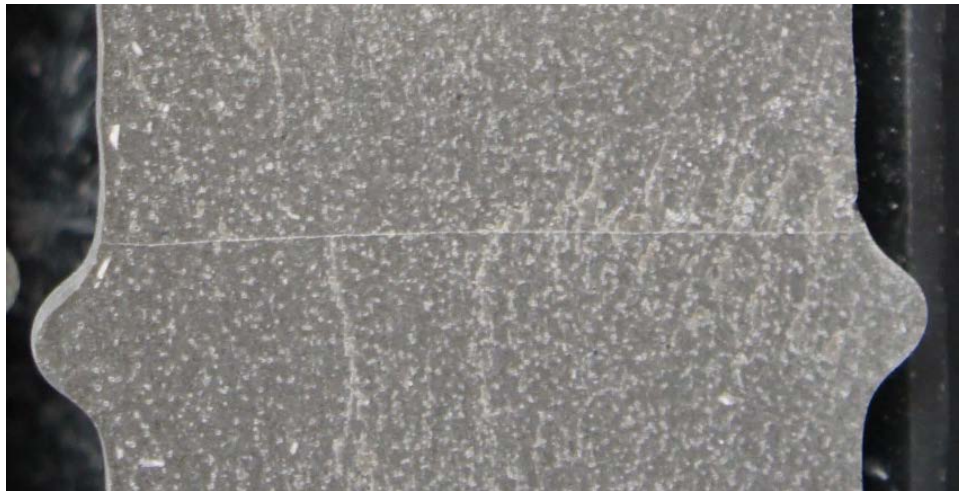
No transverse visible cracks were observed during examination of the grout. However, when the grout samples were being extracted small transverse cracks were observed (Figure 6.156). Longitudinal cracks were observed. The longitudinal cracks started at a point on the live end side of the dead end grout vent and radiated out to the live end and bisected the tendon (Figure 6.157). These longitudinal cracks might have come from the corrosion of the zinc in the galvanized coating or the tendon could have been impacted by something during the extraction process. No evidence of impact was observed on the duct so the former explanation is the more valid hypothesis. The tendon had small voids in the grout that ran the length of the tendon (Figure 6.157). The small voids measured approximately 1.5 inch long and were as wide as the flute width. The coloration on the bottom of the grout from the tendon was light grey at the ends and transitioned to dark grey at midspan. The coloration of the grout on top of the tendon was light grey along the length of the tendon (Figure 6.157). Portions of strand were visible on the bottom of the grout. The grout adhered well to the strands due to the rough nature of the galvanized coating.

***Figure 6.156: Small Transverse Crack in Grout from Specimen 7.3***

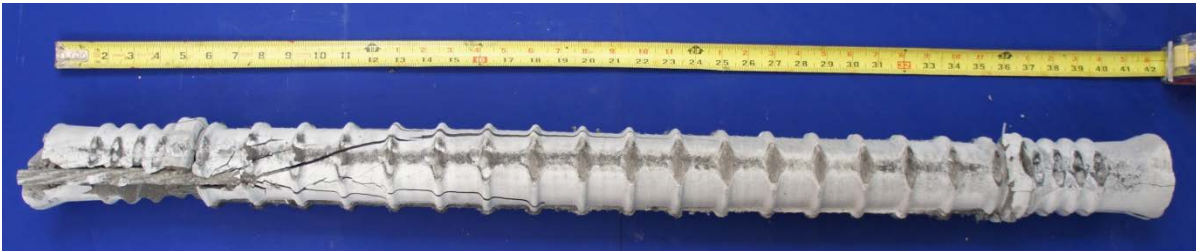
*Figure 6.157: Longitudinal Cracking and Small Voids in Grout from Specimen 7.3*

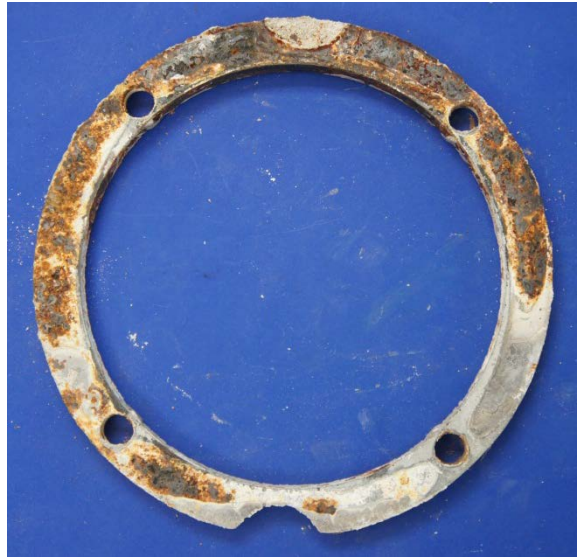
Except for the corrosion damage on their steel parts, the anchorage components from the dead and live anchorage region were in good repair. See Figure 6.128 for a layout of the anchorage components. The dead and live end grout cap was in good repair. A void in the grout was evident on the inside top surface of the north and south grout caps. Rust stains were observed on the exposed face of the lip of the grout caps where the steel retaining ring used to clamp the grout cap to the anchorage plate had corroded. The dead and live end steel retaining rings had severe corrosion and pitting over their entire surface (Figure 6.160). The unexposed sides of the dead and live end steel retaining rings had greater corrosion damage than the exposed sides. The dead and live end O-ring to seal the grout cap to the insulation plate was intact and in good repair. The anchor heads had no visible signs of corrosion of their entire surface. The dead and live end insulation plates used to electrically isolate the anchor head from the anchorage plate were in good repair. Both insulation plates had rust stains from corrosion of the steel retaining ring and anchorage plate. The exposed surface of the dead and live end anchorage plates had severe corrosion over the majority of their surface (Figure 6.161). The embedded surface of the anchorage plate was corrosion free. The bolts used to attach the grout cap and the anchorage plate were made of stainless steel therefore they were corrosion free. Except for the bolts from the dead end, they were relatively easy to extract from the anchorage plate. The bolts from the dead end had to be cut using a grinder.

*Figure 6.160: Pitting on Live End Steel Retaining Ring from Specimen 7.3*

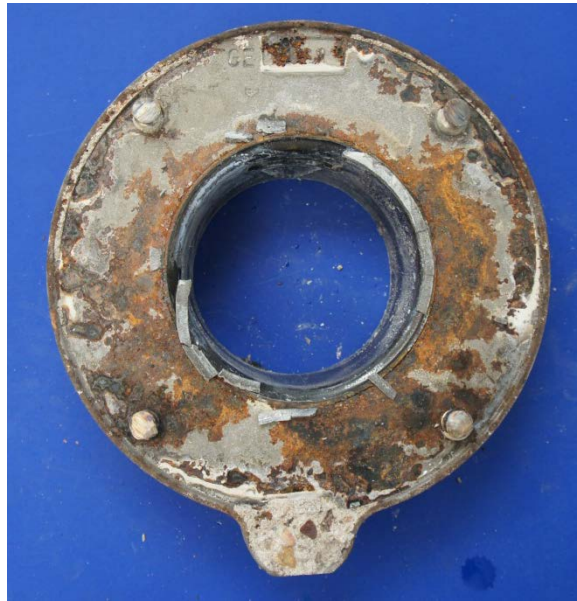
*Figure 6.161: Corrosion on Exposed Face of Dead End Anchorage Plate from Specimen 7.3*

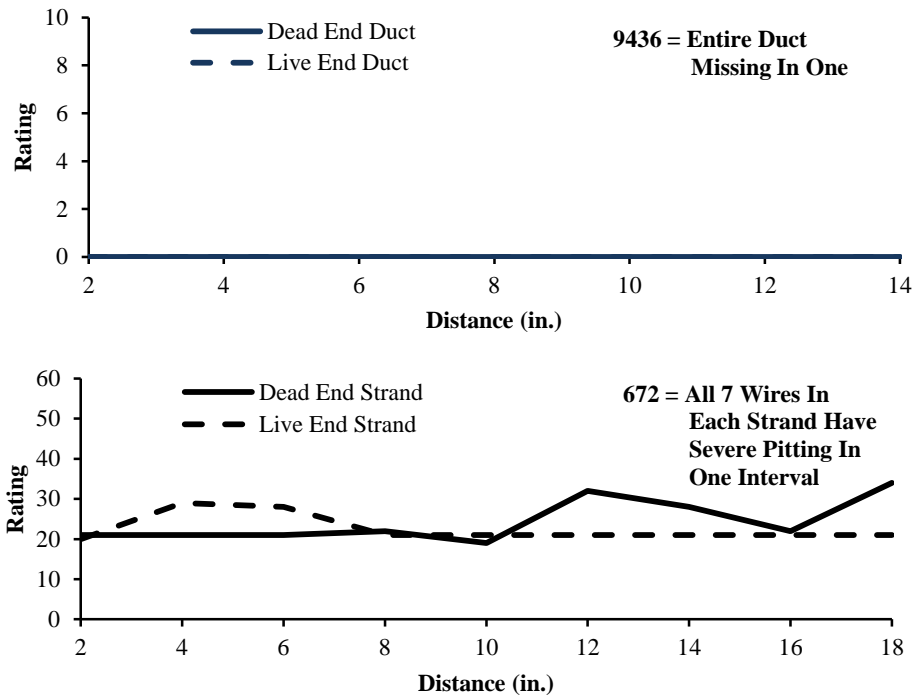
The outer and inner wires from the strands of the dead end section of the tendon had discoloration over the majority of their surface. Where discoloration was not evident moderate or light corrosion was observed. The outer and inner wires from the live were in similar condition to the outer and inner wires from the dead end. The majority of their surface had discoloration and where there was no discoloration either moderate or light corrosion was observed. The wedges were intact and had light surface corrosion. Figure 6.162 shows the corrosion ratings for the dead and live anchorage region strands and Table 6.29 shows the summary of the corrosion ratings for the dead and live anchorage region strands.

**Figure 6.162: Corrosion Rating Plots for Dead and Live End Anchorage Regions of Specimen 7.3**

The similar damage to the anchorage components suggests that the dripper system was not a major contributor to the corrosion damage observed, even though the backfill mortar was cracked on the dead end. However, the live end side was cracked as well. So when the ponding area was emptied, the salt solution could have entered the live end and induced corrosion in that region similar to the dead end.

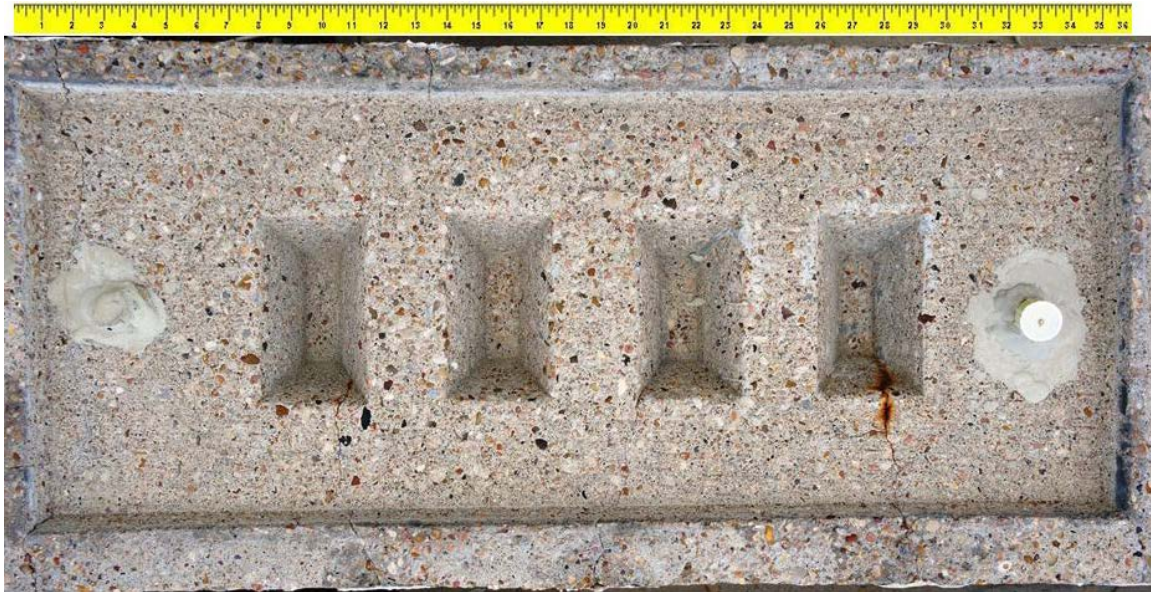
*Figure 6.163: Specimen 7.4 Main Autopsy Region and Grout Vents*

The surface of Specimen 7.4 had medium scaling on the top surface, the ponding area, and on the edges of the ponding area (Figure 6.163). There was dried grout around the grout vents indicating that the vents had overflowed during grouting operations. A rust stain was observed on the north side of the live end “well” (Figure 6.163). Cracks
