**Assessment of Long-Term Corrosion Resistance of Recently Developed  
Post-Tensioning Components**

**Thesis**

The University of Texas at Austin

**August, 2012**

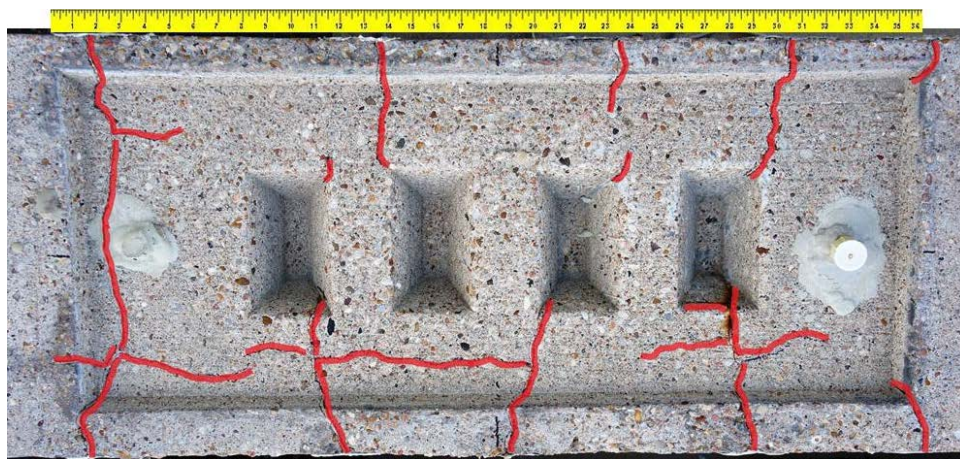
No cracks from the application of live load on both sides of the live and dead end re-entrant corbel corners were observed. Longitudinal cracking in the backfill mortar from the live and dead end anchorage pockets was observed over the top of the grout vent for the anchorage and extended from the top interface to the end interface of the backfill mortar and base concrete. This cracking is from not having sufficient cover over top of the anchorage grout vent. The ponding area of Specimen 7.4 had 1 large transverse crack that ran from the north side to the south side on the dead end side of the ponding area and 6 small transverse cracks (3 on the south side and 3 on the north side) (Figure 6.164). Multiple longitudinal cracks were located on the north side and the south side of the “wells” (Figure 6.164). These cracks are due to the expansive nature of the corrosion product from the uncoated longitudinal steel reinforcement that had been used for taking AC impedance readings. The average crack width was 0.005 inch. The crack rating for Specimen 7.4 was 0.35. See Figure 6.165 for the crack data from Specimen 7.4.

*Figure 6.164: Specimen 7.4 Crack Map of Ponding Area*

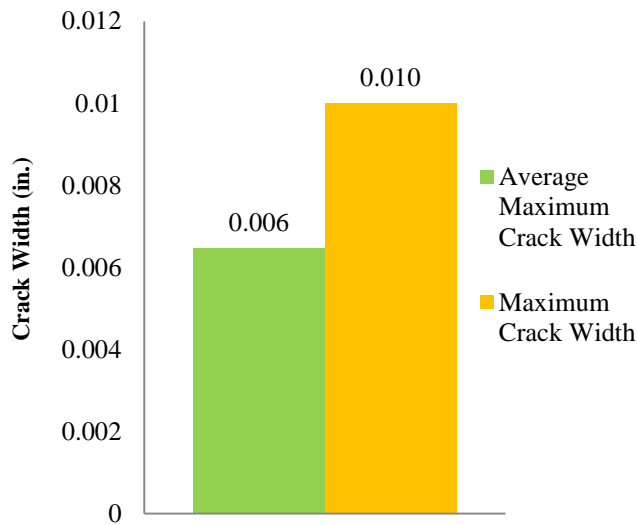
**Figure 6.165: Crack Data for Specimen 7.4**

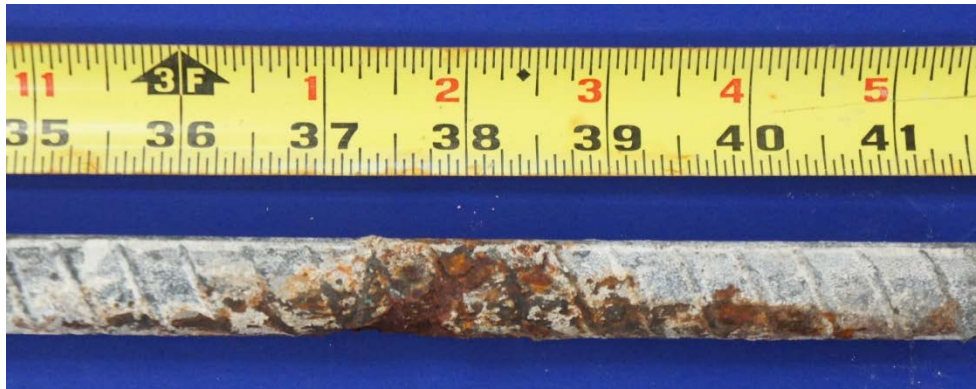
The north and south uncoated longitudinal bars had slight damage from when the bars were extracted from the specimen. The north bar had extensive pitting, moderate corrosion, and light corrosion along its length. The south bar had some pitting, light to moderate corrosion, and appreciable cross sectional area loss due to pitting on the live end of the bar (Figure 6.166). This indicates that moisture, oxygen, and chlorides reached the depth of the bars. Figure 6.172 shows the uncoated longitudinal bar's corrosion ratings and Table 6.30 shows the summary of the corrosion ratings for the longitudinal bars.

***Figure 6.166: Appreciable Cross Sectional Area Loss due to Pitting on the South Coated Longitudinal Bar from Specimen 7.4***

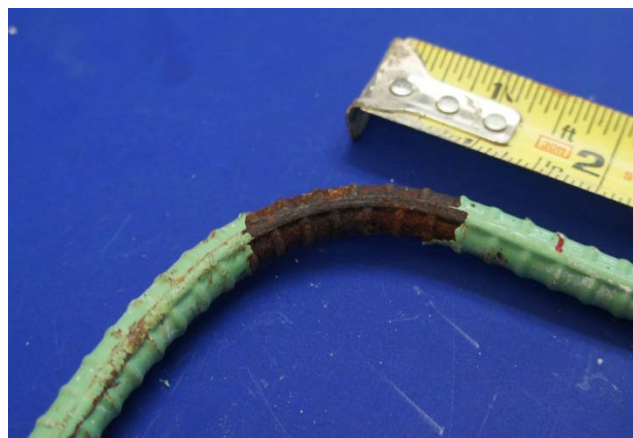
All transverse bars had damage from when they were extracted from the specimen. All the transverse bars had rust staining at least somewhere over the length of the bar from corrosion of the tie wire used to attach the transverse bars to the longitudinal bars and the duct. All the transverse bars had some form of corrosion damage, except bar #3. Light corrosion was observed on bars #2, #6, #5, and #7. Moderate corrosion was observed on bars #1, #4, #6, and #7. Pitting was observed on bar #1 (Figure 6.167). Bar #1 had the highest rating of 41. Bar #5 had the lowest ratings of 6. Figure 6.172 shows the transverse bar's corrosion ratings and Table 6.30 shows the summary of the corrosion rating for the transverse bars.

***Figure 6.167: Pitting on Transvers Bar #1 from Specimen 7.4***

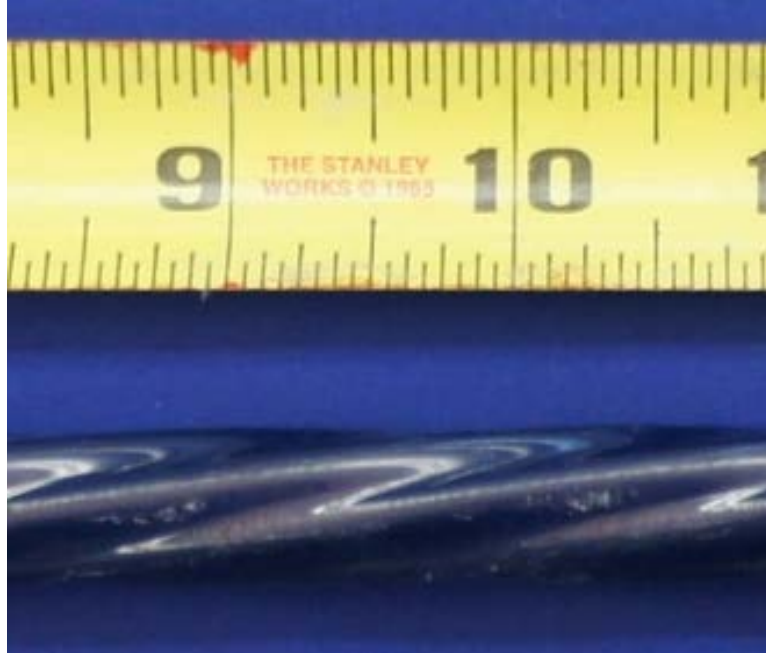
The epoxy coating on the strands had minor scratches and gouging over the majority of its surface (Figure 6.170). One tiny hole was observed on the live end of one of the strands. The holes, gouges, and scratches might be from the stressing process or from the threading of the strands through the duct. In either case, except for the hole, the integrity of the coating was not compromised. Figure 6.172 shows the damage ratings for

***Figure 6.170: Scratches and Gouges in Epoxy Coating of a Strand from Specimen 7.4***

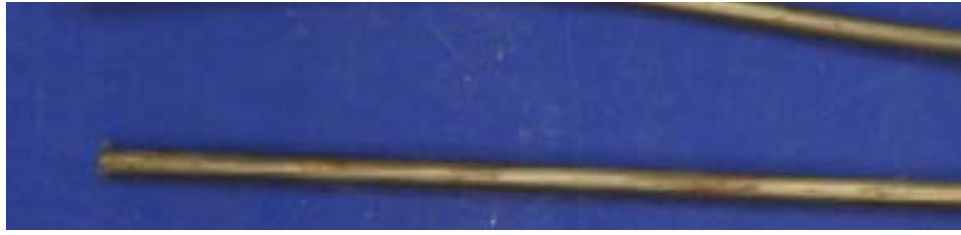
The epoxy coated strand did not perform as well as had been expected. All the outer and inner wires from the strands had some form of corrosion over their entire length (Figure 6.171). Mild pitting was observed somewhere on every outer and inner wire. One inner wire had mild pitting along its entire length. Another inner wire had mild pitting over half of its length and the rest of the length had light corrosion. The third inner wire had mild pitting on a small portion of its length and light corrosion on the rest of its length. The outer wires had mild pitting and light to moderate corrosion. This corrosion might be from two sources. One source could be that the paint stripper used to remove the epoxy coating in the autopsies could have been mildly corrosive. The other reason could be that the corrosion existed before the strands were flow filled with epoxy. The live end side of the tendon had the lowest rating of 21. The highest rating of 60 was located close to the dead end grout vent. Figure 6.172 shows the corrosion ratings for the strands and Table 6.30 shows the summary of the corrosion ratings for the strands.

*Figure 6.171: Mild Pitting and Moderate Corrosion on Inner Wire from a Specimen  
7.4 Strand*

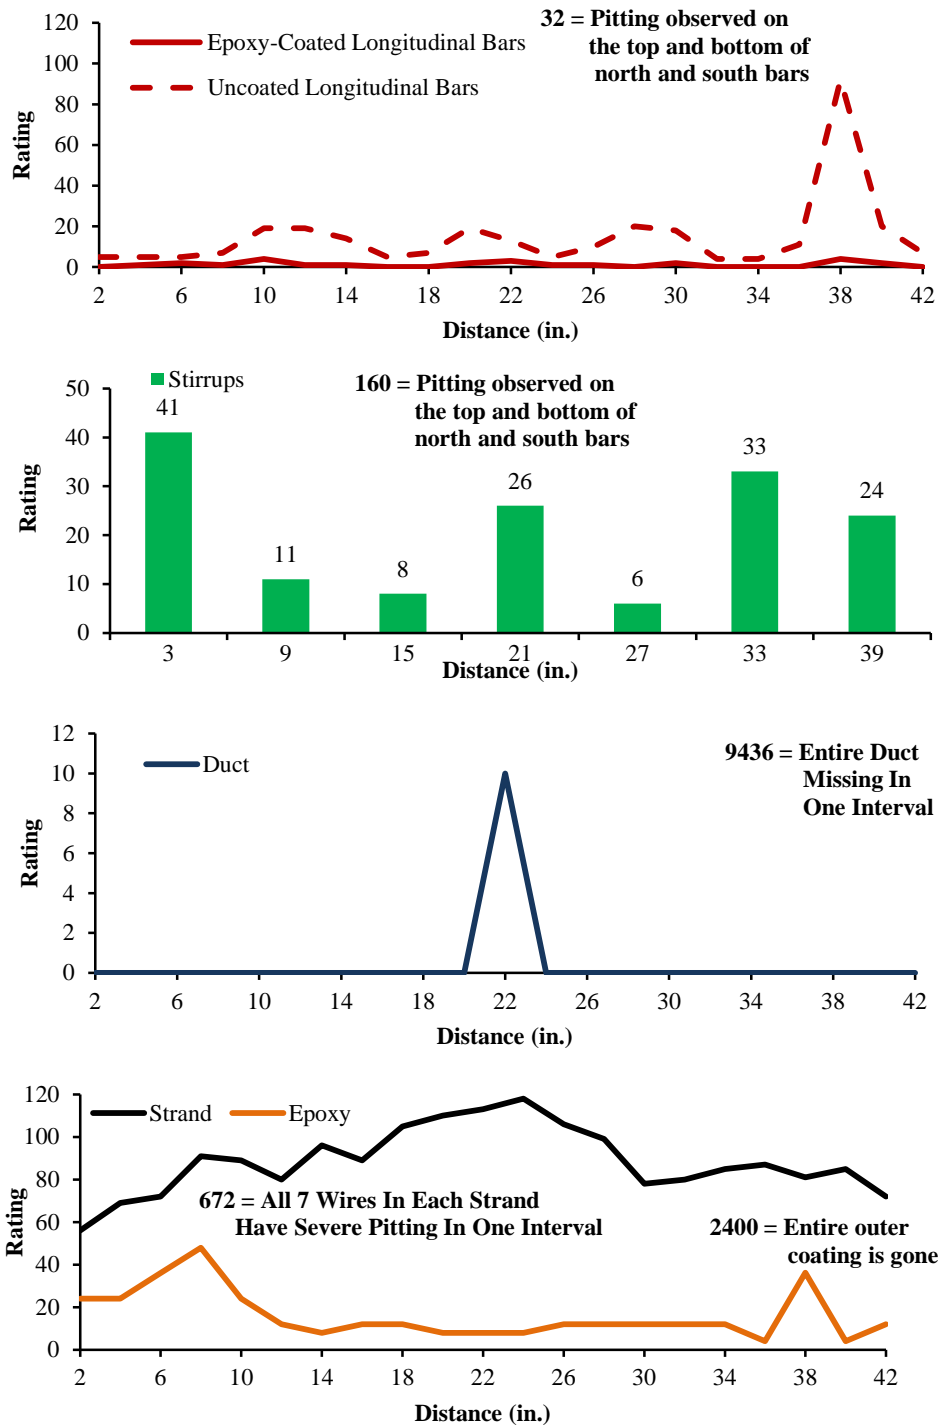
Figure 6.172: Corrosion Rating Plots for Main Autopsy Region of Specimen 7.4

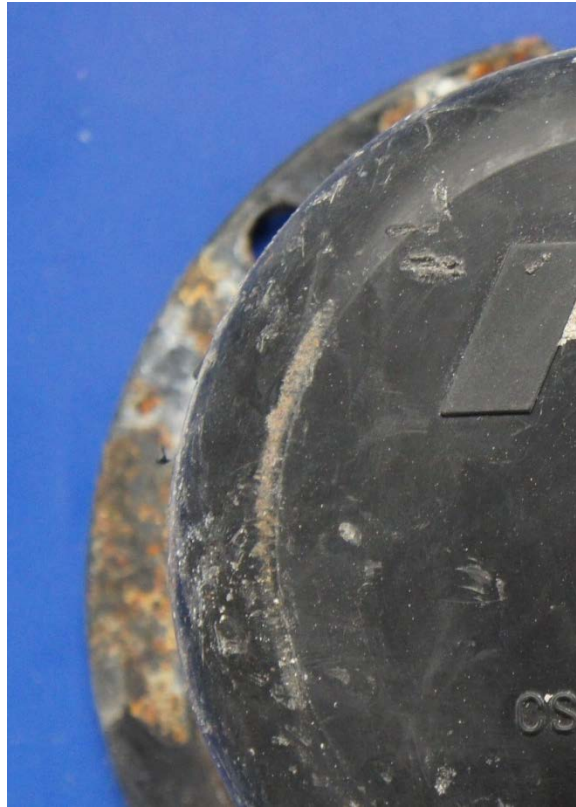
Except for the corrosion damage on their steel parts, the anchorage components from the dead and live anchorage region were in good repair. See Figure 6.138 for a layout of the anchorage components. The dead and live end grout cap was in good repair with signs of minimal damage from when the anchorage was extracted from the specimen. A void in the grout was evident on the inside top surface of the north and south grout caps. Rust stains were observed on the exposed and unexposed face of the lip of the grout caps where the steel retaining ring used to clamp the grout cap to the anchorage plate had corroded (Figure 6.173). The dead and live end steel retaining rings had severe corrosion and pitting over their entire surface. The damage done by corrosion was greater on the dead end retaining ring than on the live end retaining ring. The dead and live end O-ring used to seal the grout cap to the insulation plate was intact and in good repair. The dead and live end anchor heads had light corrosion on their exposed faces and moderate corrosion on their unexposed faces (Figure 6.174). The dead and live end insulation plates used to electrically isolate the anchor head from the anchorage plates had split where the anchor head had pressed against it (Figure 6.175). The anchor heads were not the proper anchor heads for this system and instead of primarily bearing on the anchorage plate it pressed primarily on the insulation plate damaging the insulation plate. Both insulation plates had rust stains from corrosion of the steel retaining ring and anchorage plate. The exposed surface of the dead end anchorage plate had severe corrosion over the majority of their surface. The exposed surface of the live end anchorage plate had severe corrosion over approximately 40% of its surface. The embedded surface of the anchorage plate was corrosion free. The bolts used to attach the grout cap and the anchorage plate were made of stainless steel therefore they were corrosion free. Except for the three bolts from the dead end, they were relatively easy to extract from the anchorage plate. The three bolts from the dead end had to be cut using a grinder.

***Figure 6.173: Rust Stains on Lip of Live End Group Cap from Specimen 7.4***

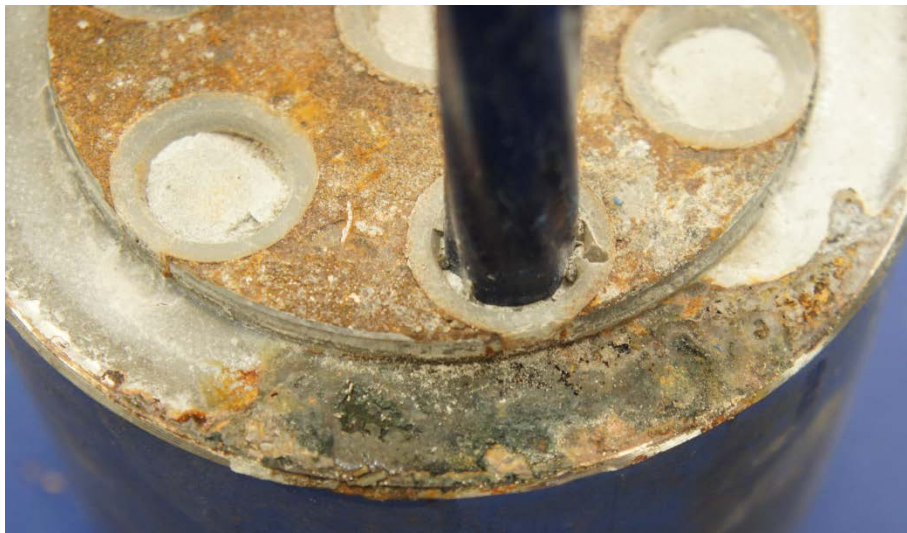
***Figure 6.174: Moderate Corrosion on Unexposed Face of the Dead End Anchor Head from Specimen 7.4***

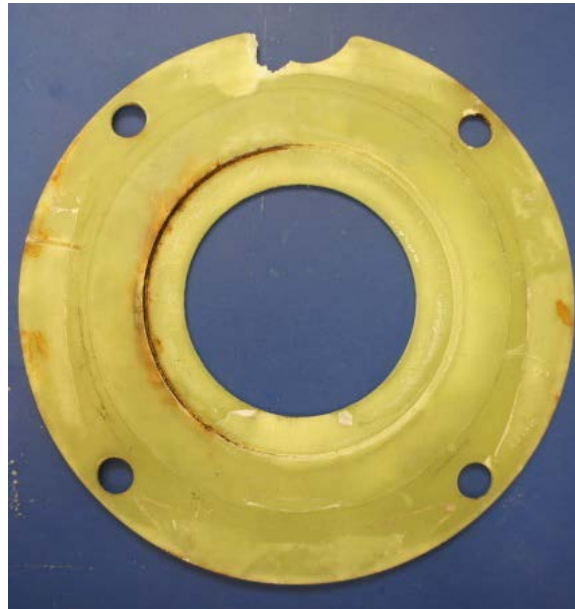
*Figure 6.175: Split in Dead End Insulation Plate from Specimen 7.4*

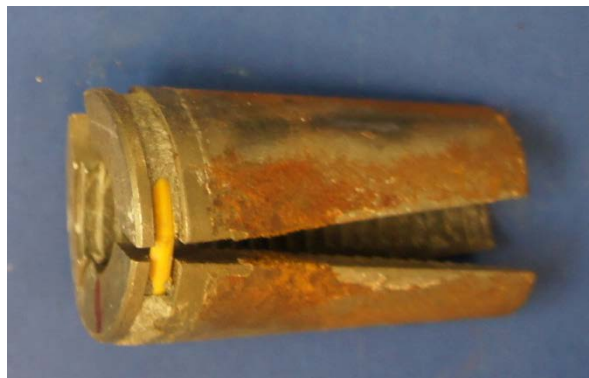
The outer and inner wires from the strands of the dead end section of the tendon had discoloration over the majority of their surface. Light corrosion was observed on the majority of the remaining intervals of the inner and outer wires that did not have discoloration. The outer wires from the live end had light corrosion over the majority of their lengths. The remaining intervals had discoloration. The inner wires had light corrosion over their entire length. The dead end wedges were intact and had light surface corrosion. The live end wedges were intact and had moderate surface corrosion (Figure 6.176). Figure 6.177 shows the corrosion ratings for the dead and live anchorage region strands and Table 6.31 shows the summary of the corrosion ratings for the dead and live anchorage region strand.

***Figure 6.176: Moderate Corrosion on a Live End Wedge from Specimen 7.4***

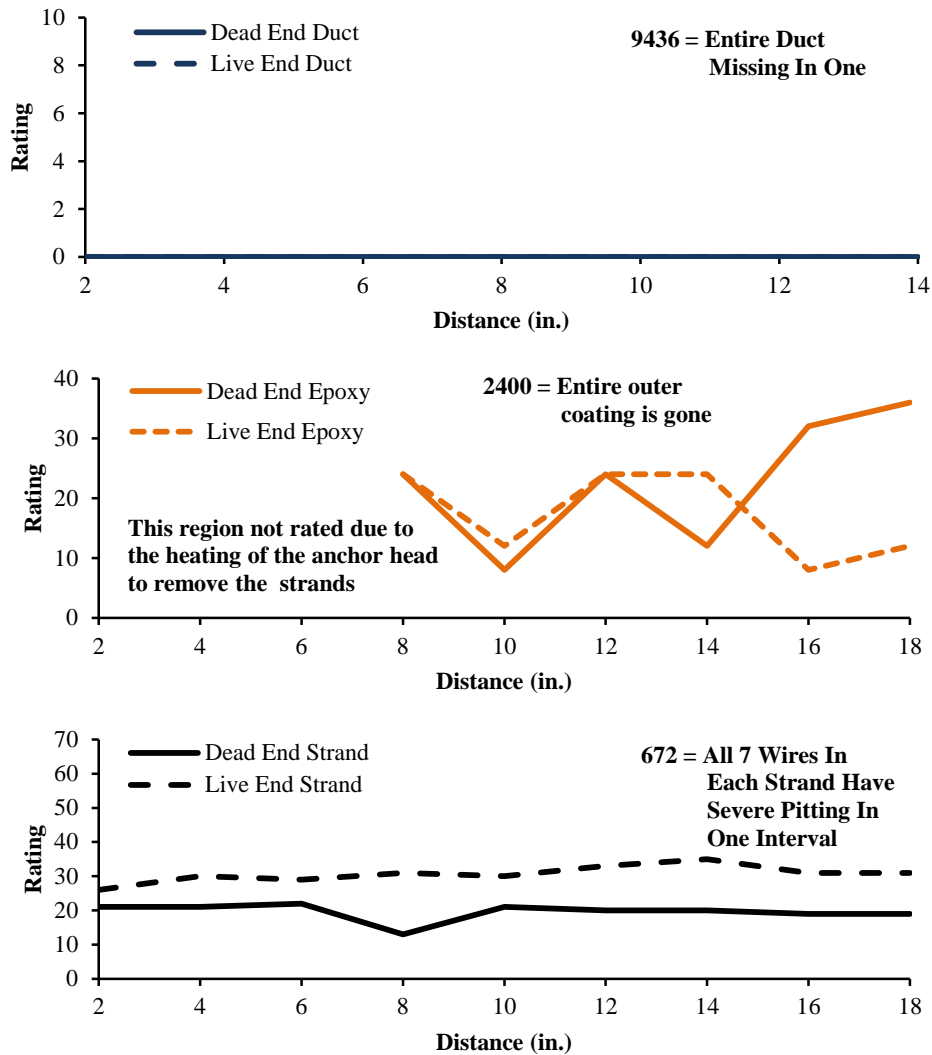
**Figure 6.177: Corrosion Rating Plots for Dead and Live End Anchorage Regions of Specimen 7.4**

The differential damage between the dead and live end post-tensioning components was from the spray system but the crack in the backfill mortar exacerbated the infiltration of chlorides to the anchorage components from the spray system. This crack would have allowed moisture, oxygen, and/or chlorides to enter the tendon and induce corrosion.

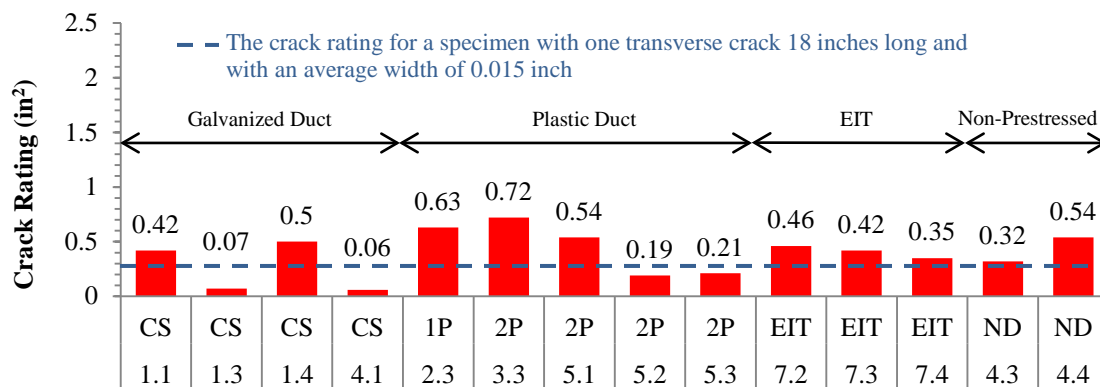
See Figure 7.1 for the crack ratings for all the specimens. Most of the specimens had a crack rating above the crack rating of 0.27, which is from a fictitious specimen with one transvers crack the width of the specimen (18 inches) and an average crack width of 0.015 inch. Specimens 1.3, 4.1, 5.2, and 5.3 were the specimens below the 0.27 crack rating. All these specimens had either 0.6 inch stainless clad or stainless steel strands. The average crack ratings for duct type were 0.26, 0.44, and 0.43 for galvanized duct, plastic duct, and non-prestress specimens, respectively. The specimens with plastic duct

had the highest average crack rating. The specimens with plastic duct all had longitudinal cracking whereas the specimens with galvanized duct did not. This would account for the higher average crack rating. The longitudinal cracking in the plastic duct specimens might be from the vastly different thermal coefficients of the plastic duct and concrete, which would have induced expansive stresses on the concrete thus inducing longitudinal cracking along the duct. Even though the galvanized duct had extensive corrosion damage, the corrosion damage did not cause further longitudinal cracking in these specimens. This might have happened because the bleed water voids in the grout allowed the corrosion product, which occupies a greater volume than the metal that produced it, to expand into the void instead of imposing transverse tensile stresses on the concrete. The non-prestressed Specimens 4.3 and 4.4 had the second highest average crack rating for two reasons. One reason, the specimens were not prestressed which resulted in the specimens having a applied Dywidag bar live load that was lower than the prestressed specimens and instead of the cracks opening wider during loading more transverse cracks formed<sup>1</sup>. The other reason is Specimen 4.4 had longitudinal cracking due to corrosion of the uncoated longitudinal reinforcement inducing transverse tensile stress on the concrete.

**Figure 7.1: Crack Ratings**

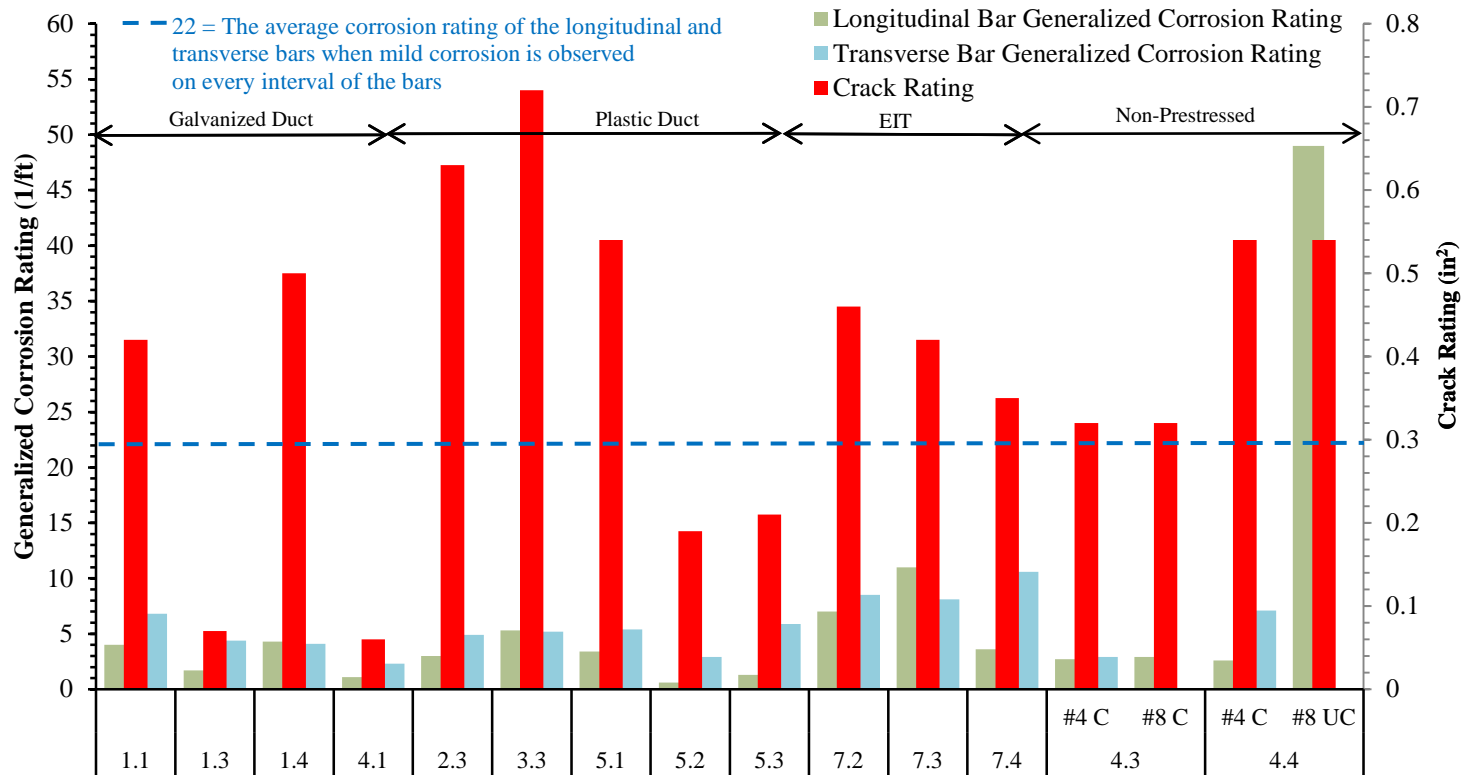
Figure 7.2 shows the longitudinal and transverse bars generalized corrosion ratings and crack ratings for each specimen. There was a slight correlation between the crack and corrosion ratings of the longitudinal and transverse bars, the higher the crack rating the higher the corrosion rating. Generally, the location of the corrosion and discoloration observed on the epoxy coated bars was located in the vicinity of the transverse cracks. For Specimen 4.4, the high crack rating corresponds to the high rating for the uncoated longitudinal steel reinforcement. As mentioned previously, the expansive stresses from the corrosion of the longitudinal steel reinforcement might have caused the longitudinal cracking observed in Specimen 4.4. The 7-series specimens had the highest corrosion ratings for longitudinal and transverse bars. This might be because the specimens were larger and therefore the reinforcement cages were larger. As size of a reinforcement cage goes up the stability of the cage goes down. Since the stability of the cage was less, the chance of the epoxy coating of the bars being damaged increased when the cage was being handled. The epoxy coating being damaged would have increased the corrosion

rating because the underlying reinforcement at the damaged coating would have had no protection from corrosion.

**Figure 7.2: Longitudinal and Transverse Bars Generalized Corrosion Ratings and Crack Ratings**

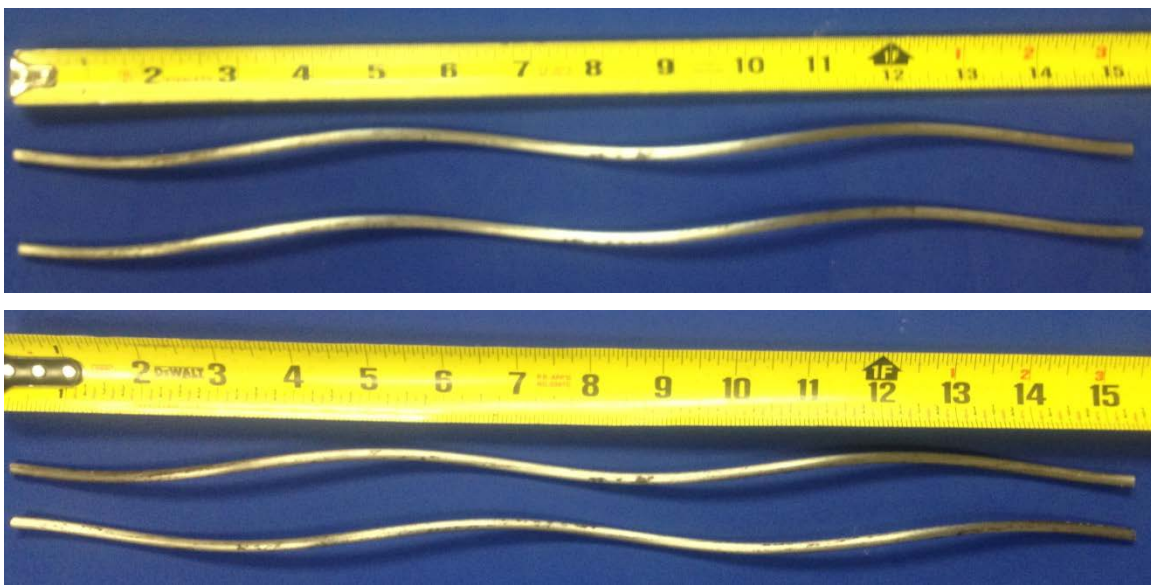
stripper, and encased in aluminum foil for seven days. After seven days, the wires were examined for any corrosion that would be similar to that observed on the flowfilled epoxy coated strand. There was no corrosion on the wires and this differed greatly from the flowfilled epoxy coated strand. Figure 7.3 shows the appearance of the wires before and after seven days of exposure to the paint stripper. This observation indicates that the paint stripper was not the cause of the corrosion observed on the flowfilled epoxy coated strand.

***Figure 7.3: Conventional Wires Before (Top) and After (Bottom) Exposure to Paint Stripper***

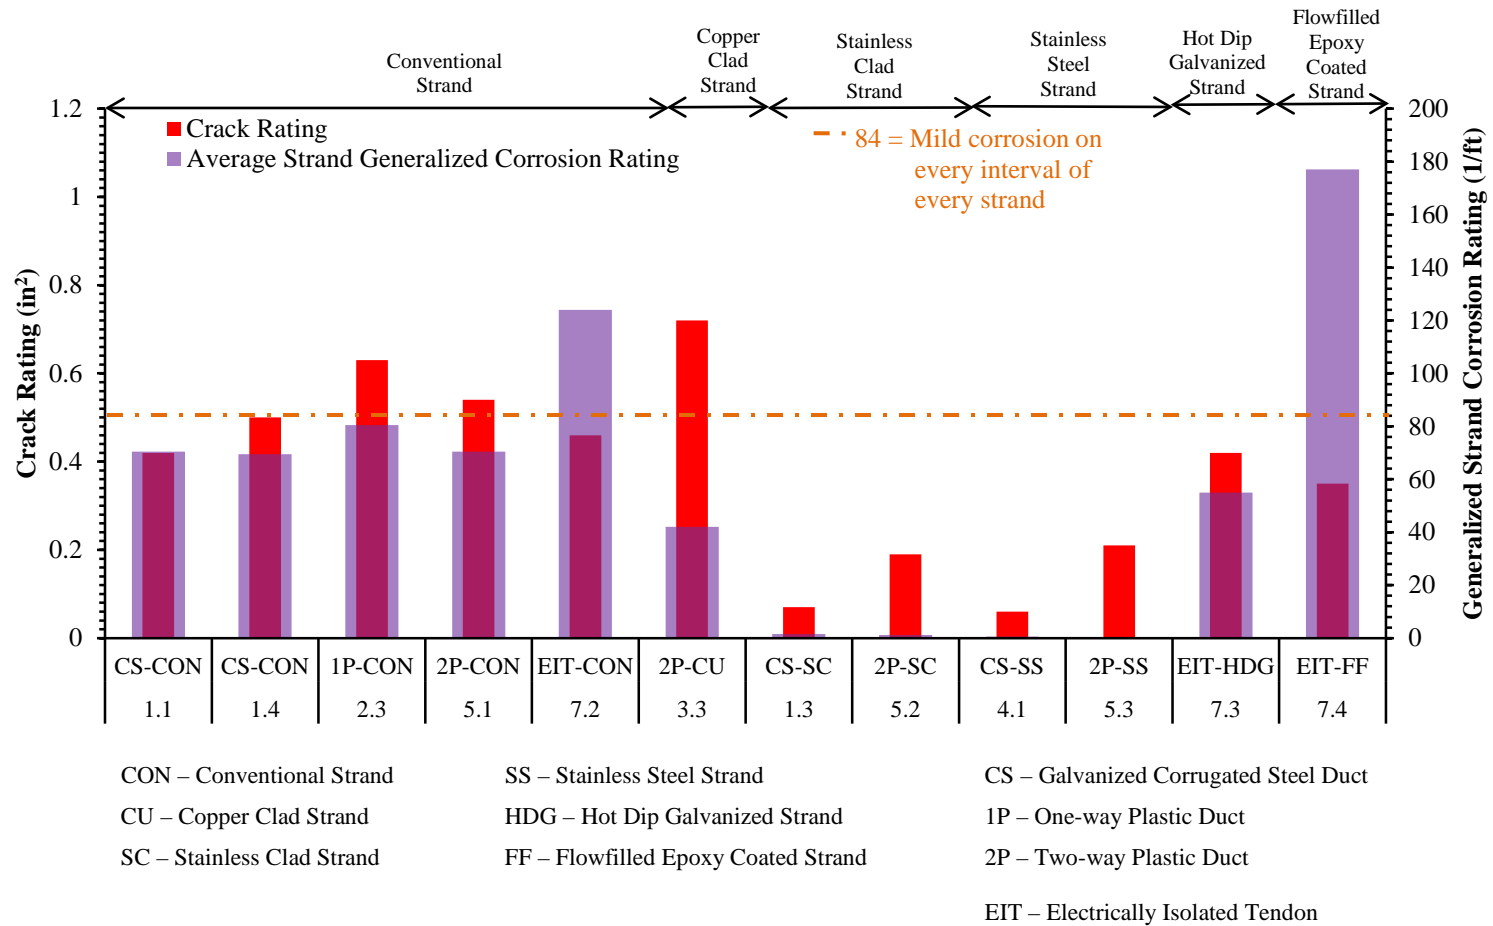
The average strand generalized corrosion ratings are plotted with crack ratings for each specimen in Figure 7.5 and are organized according to strand type. There is no correlation between corrosion rating and crack rating for each strand type. In the case of the strands, a high crack rating does not mean that the corrosion rating will be high as well.

**Figure 7.5: Average Generalized Strand Corrosion Rating and Crack Rating**

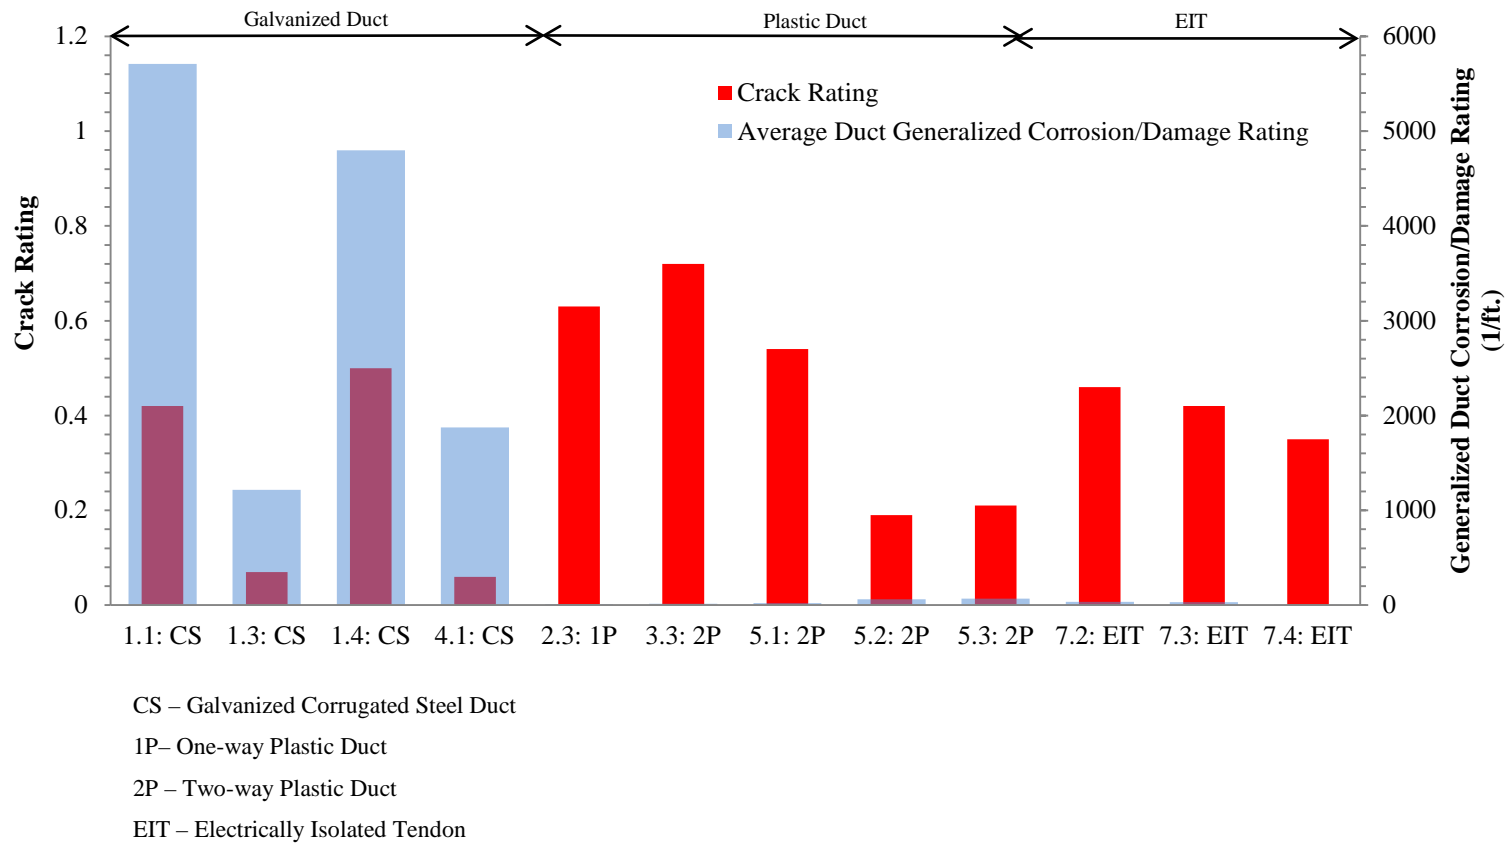
Figure 7.7 shows the average generalized duct corrosion/damage ratings plotted with the crack rating for each specimen. For the galvanized ducts there was a definite correlation between the corrosion rating and the crack rating. For the majority of the specimens with galvanized duct, the higher crack ratings correspond to the higher duct corrosion ratings. In the autopsy it was noted that Specimen 1.1 had larger voids in the grout than the grout from the tendons in Specimen 1.4. This would suggest that both the number and size of voids and the number and size of the cracks contributed to the corrosion damage observed on the ducts.

**Figure 7.7: Average Generalized Duct Corrosion/Damage Rating and Crack Rating**

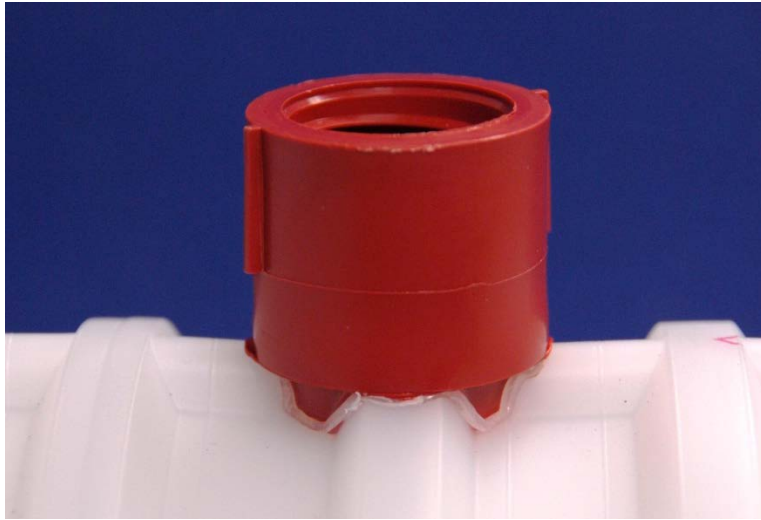
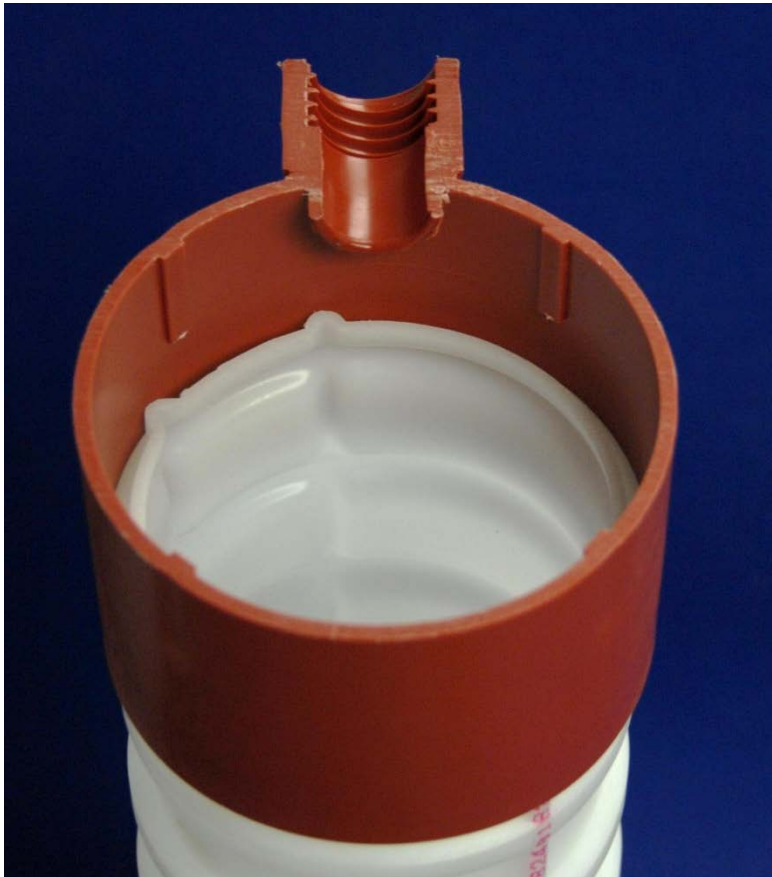
Except for Specimen 7.2, the integrity of the plastic ducts away from the splices and vents was intact at time of autopsy. The damage observed on Specimen 7.2 was more than likely from when the ducts were installed in the reinforcement cage. Even though high chloride concentrations were observed in the grouts encased in plastic duct, plastic duct can be a more effective barrier against chloride infiltration than galvanized duct if the points of infiltration can be properly sealed. The couplers, grout vents, and heat shrink wrap need to have a positive water tight seal to the duct. If a positive water tight seal can be formed, then the plastic duct can be an effective barrier against chloride infiltration even in a high chloride environment. Such water tight seals are routinely used in PVC water supply systems where solvents or pipe threads are used in the connection process. It is imperative that such a positive water tight seal be developed for the plastic ducts. The current grout vents used on plastic duct are threaded and “welded” to the duct or coupler (Figure 7.8).

*Figure 7.8: Threaded Grout Vent “Welded” to Plastic Duct (Top) and Cut Away of Slip-on Coupler with “Welded” Threaded Grout Vent*

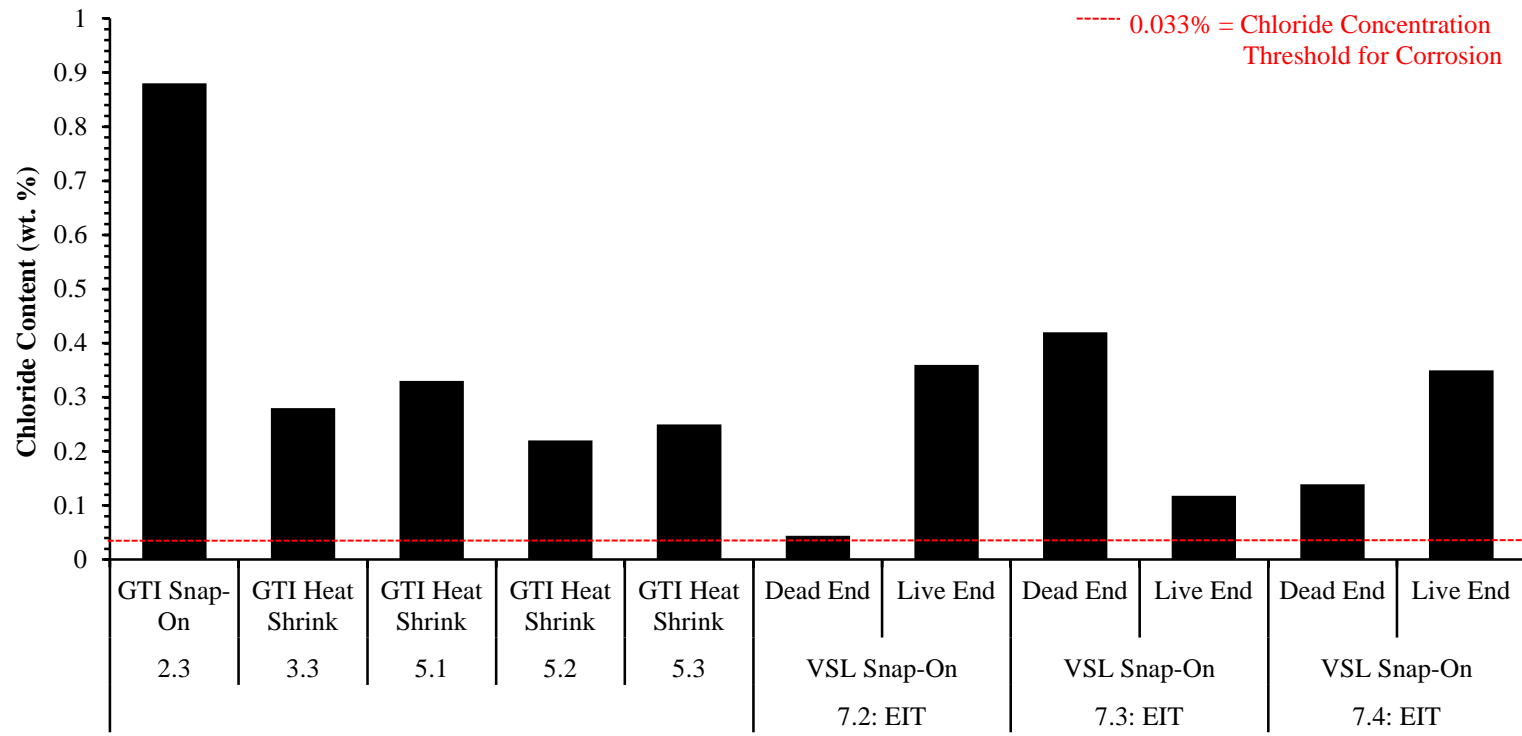
Figure 7.9 shows the grout chloride concentration in the tendon at the location of each coupler. The highest grout chloride concentration was found in the duct with a GTI snap-on coupler. This was expected since during the autopsy grout was seen in the space between the duct and the coupler past the seal of the coupler. This indicates that the seal was not water tight and was the access point for chloride infiltration. The lowest grout chloride concentration was at the dead end coupler of Specimen 7.2. This was the region in which the duct had been cracked. There is no definitive reason for the low chloride concentration in the region of the cracked duct. On average the heat shrink wrapped GTI slip-on couplers had the lowest grout chloride concentration but the concentrations were still well above the corrosion threshold. The couplers and heat shrink for the 7-series specimens did not perform as well as expected. Most of the grout chloride concentrations were well above the corrosion threshold. The high grout chloride concentrations support the corrosion observed on the strands during the autopsies.

**Figure 7.9: Grout Chloride Concentrations at Coupler Location**

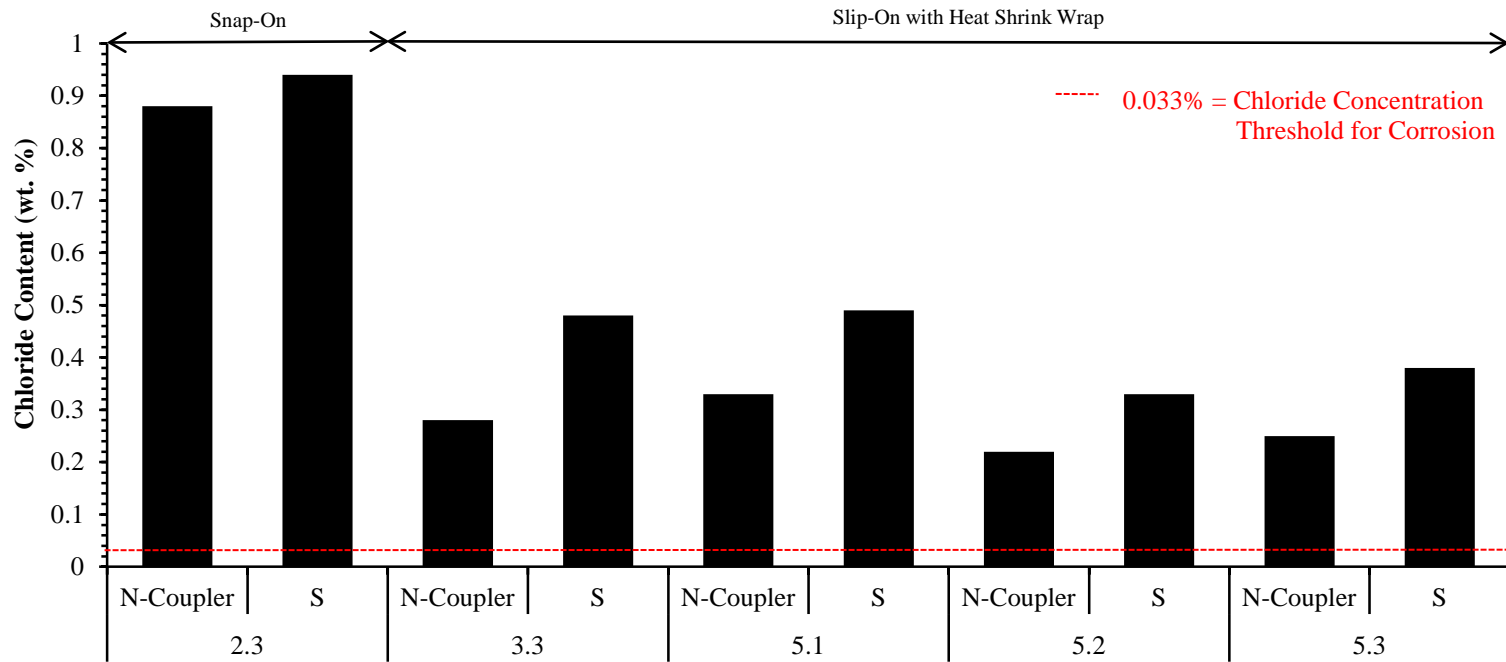
Figure 7.10 shows the grout chloride concentrations at midspan for specimens that contained two tendons encased in plastic duct. All the grout chloride concentrations were above the corrosion threshold. The south tendons, which were encased in continuous ducts that had grout vents attached by project staff during manufacture, had grout chloride concentrations that were consistently higher than the north tendon, which were encased in a coupled duct with a manufacture installed grout vent on the coupler. While both ducts allowed excessive amounts of chlorides into the tendon, the continuous duct, with the researcher installed grout vent, performed the worst. This reaffirms the corrosion observed in the strands during the autopsies.

**Figure 7.10: Grout Chloride Concentrations at Midspan for Specimens with Two Plastic Ducts**

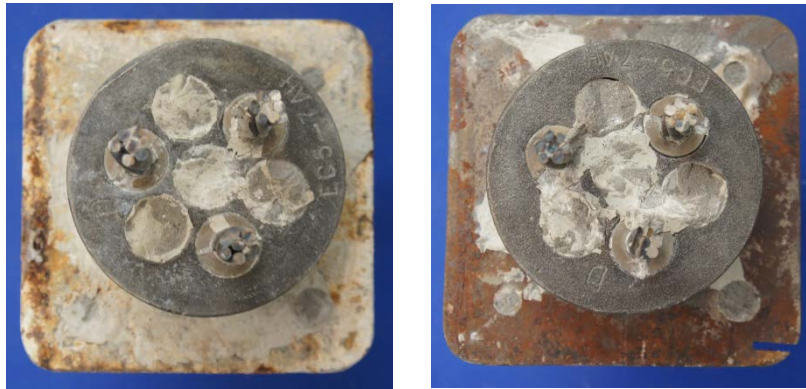
Of the specimens autopsied in this series, only Specimens 1.4 and 5.1 had galvanized anchorage plates. Duct tape was not used to seal the ducts to the anchorage plates for Specimens 1.1, 1.3, 1.4, and the 7-series specimens. All of these did not have visible signs of corrosion on the embedded portion of the anchorage plate but all did have visible corrosion of the exposed face of the anchorage plate. Duct tape was used to seal the ducts to the anchorage plates of the remainder of the specimens and all had visible signs of corrosion on the bottom of embedded portion and the exposed face of the anchorage plates. However, the corrosion of Specimen 5.1 was less severe and not as wide spread. In general, all the non-galvanized anchorage plates had visible signs of corrosion.

**Figure 7.11: Corrosion on Exposed Faces of Galvanized (Left) and Non-Galvanized (Right) Anchorage Plates**

In all, the galvanized anchorage plates from Specimen 1.4 performed better than the non-galvanized anchorage plates from Specimen 1.1. However, caution must be taken before deciding on using galvanized anchorage plates because it is not clearly understood how the galvanized coating will affect the steel components of the system. The level of corrosion on the non-galvanized anchorage plates was not severe enough to effect structural integrity after six years of aggressive exposure.

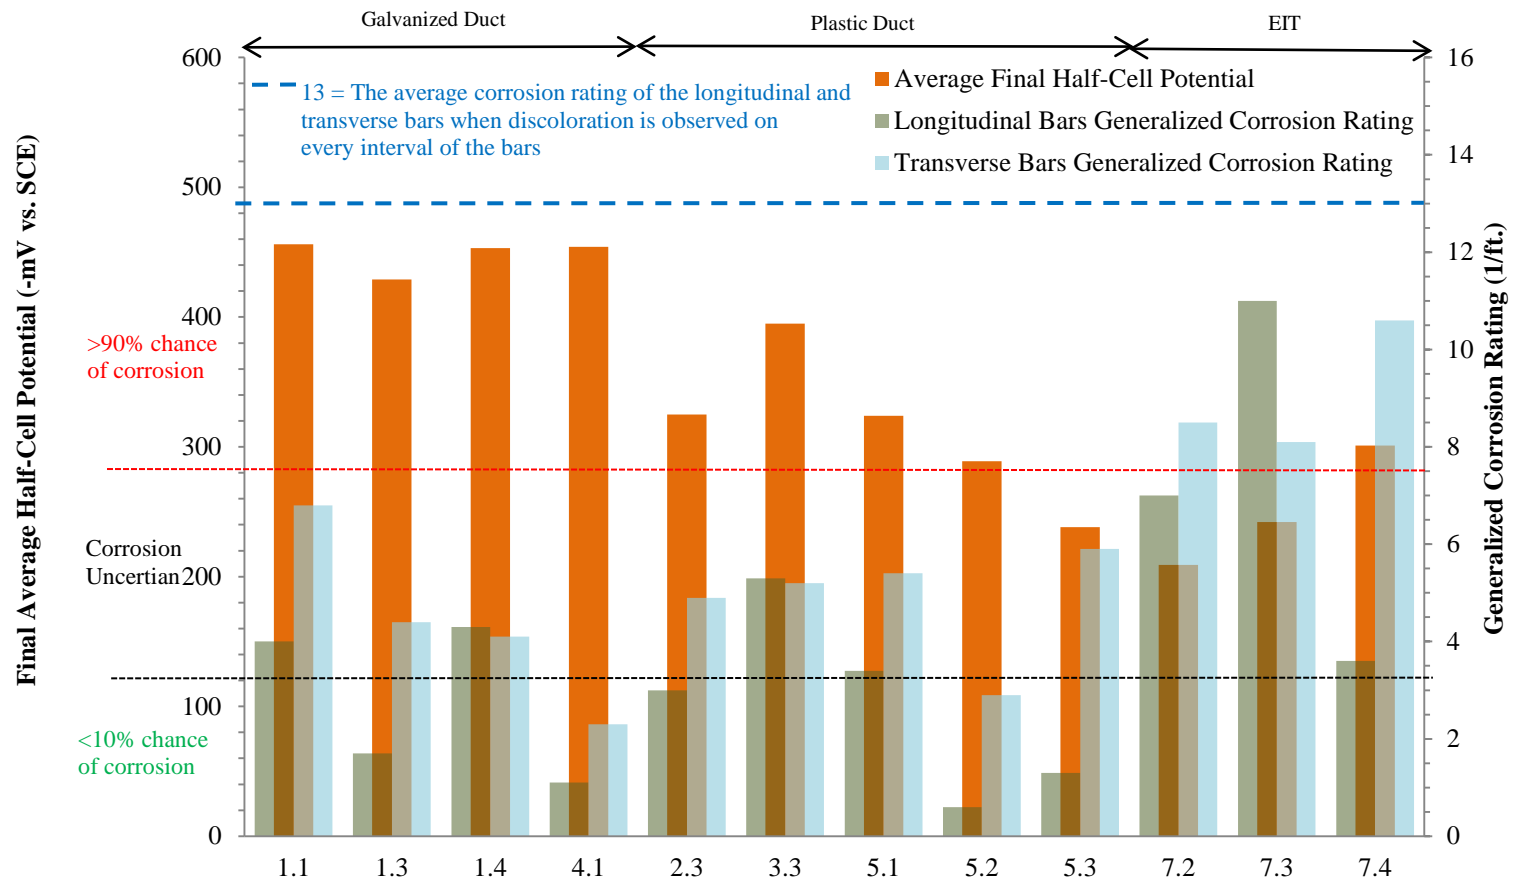
Figure 7.12 shows the corrosion ratings for longitudinal and transverse bars plotted with the final average half-cell potential for each specimen. Expect for Specimens 5.3,

Figure 7.12: Longitudinal and Transverse Bars Generalized Corrosion Ratings and Average Final Half-Cell Potential

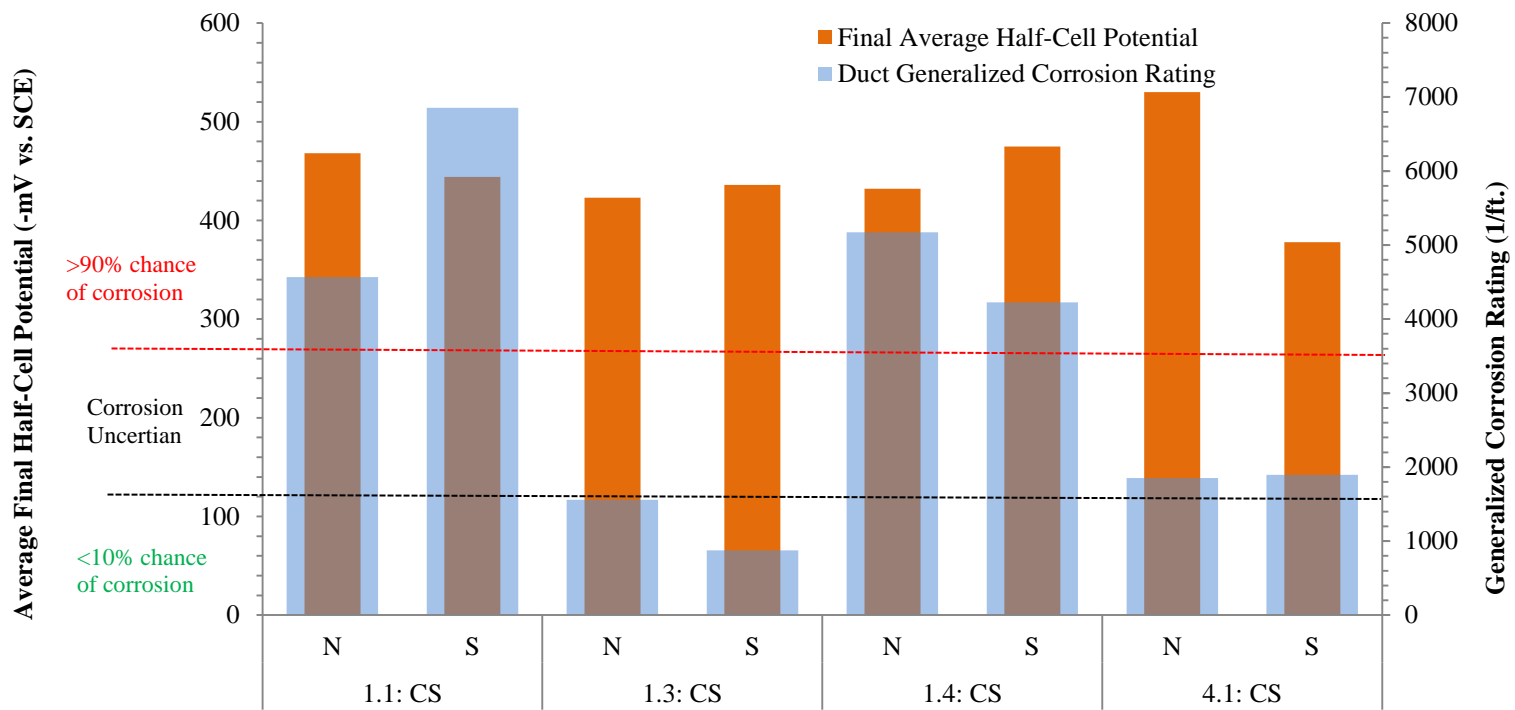
Figure 7.13 shows the generalized duct corrosion rating plotted with average final half-cell potential for each specimen with galvanized duct. Only the specimens with galvanized duct are shown because half-cell potential readings would not be an accurate indicator of plastic duct damage. For all the specimens with galvanized ducts, the average final half-cell potentials were more negative than the half-cell potential limit for 90% chance of corrosion. Figure 7.12 shows that while the specimens with plastic ducts had half-cell potential readings indicating corrosion or the uncertainty of corrosion, the half-cell potential readings from the specimens with galvanized duct were more negative than the half-cell potential readings from the plastic duct. This is a good indicator that the corrosion of the galvanized duct might have made the half-cell potential readings more negative.

**Figure 7.13: Generalized Duct Corrosion Rating and Average Final Half-Cell Potential**
