**Assessment of Long-Term Corrosion Resistance of Recently Developed  
Post-Tensioning Components**

**Thesis**

The University of Texas at Austin

**August, 2012**

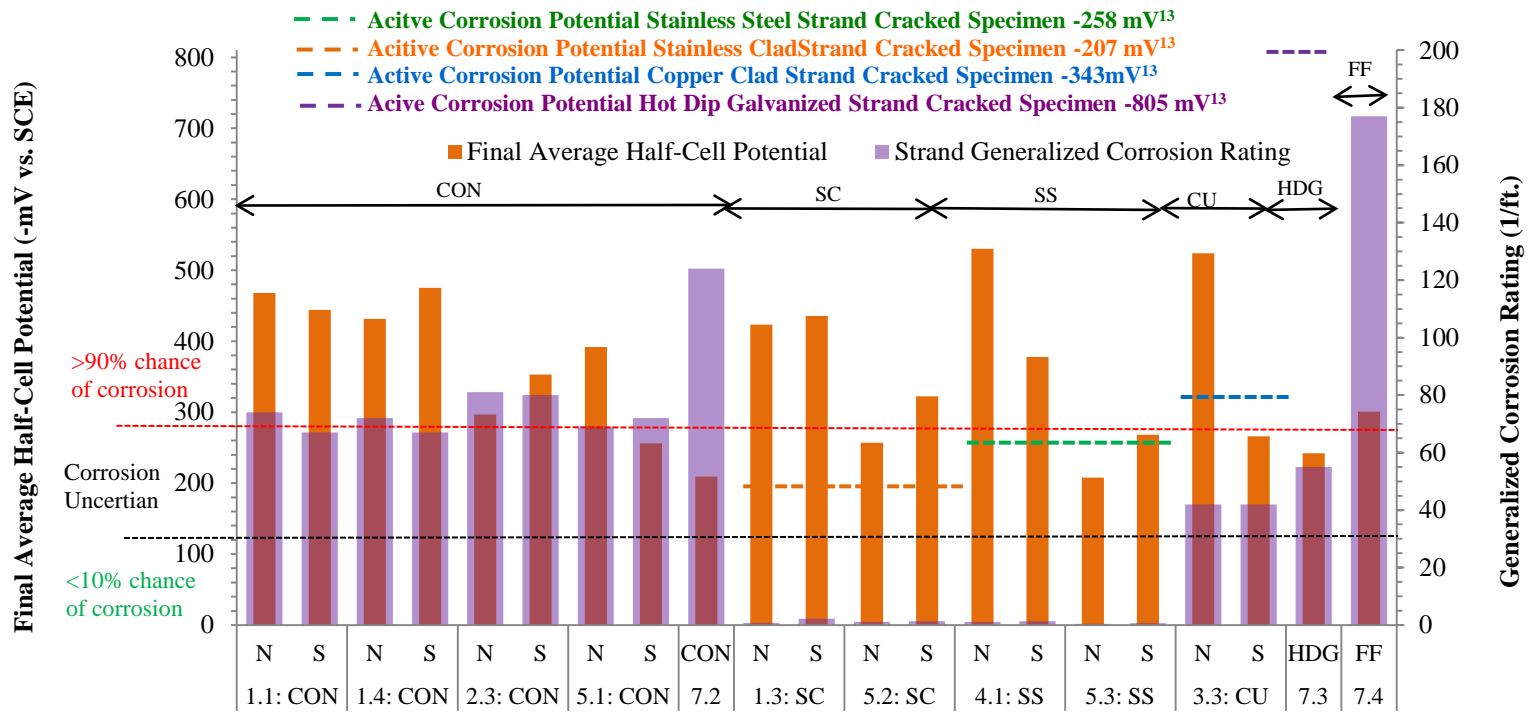
Figure 7.14 shows the corrosion ratings for the strands plotted with the average final half-cell potentials for each specimen organized by strand type. All the tendons with conventional and flowfilled epoxy coated strands had average final half-cell potentials either more negative than the half-cell potential for greater than 90% chance of corrosion or in the corrosion uncertain range. Since all these strands types had some form of corrosion observed on them the half-cell potential readings were a good indicator of corrosion. However, there was no correlation between the half-cell potential readings and the corrosion rating as mentioned previously.

Figure 7.14: Generalized Strand Corrosion Ratings and Average Final Half-Cell Potential

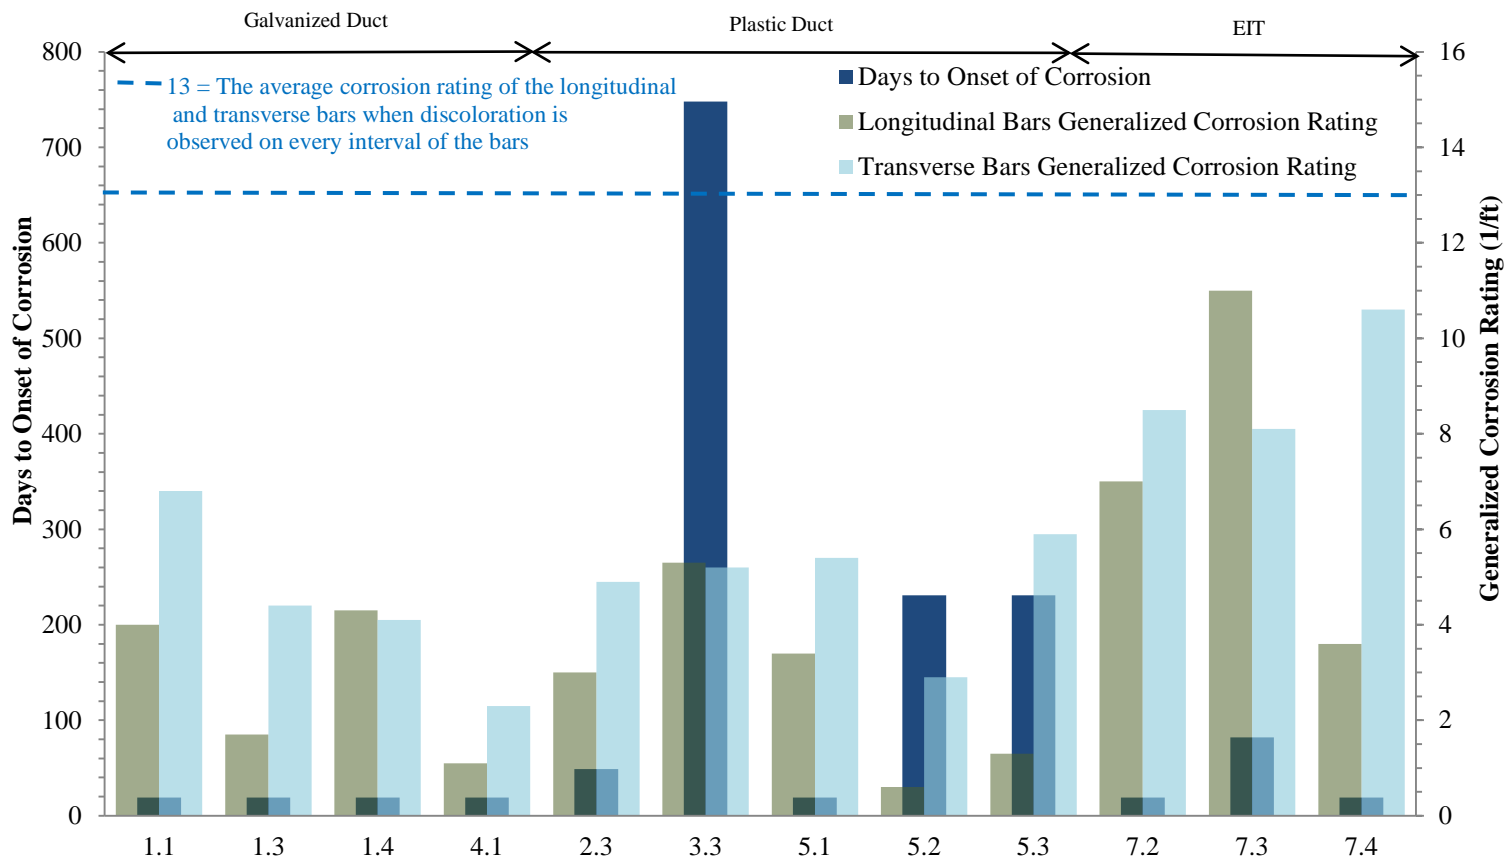
Figure 7.15 shows the generalized longitudinal and transverse bar corrosion rating plotted with days to onset of corrosion for each specimen. There is not much of a correlation between corrosion rating of the longitudinal and transverse bars and days to the onset of corrosion. However, the bars with the highest corrosion ratings seemed to have the lowest days to onset of corrosion.

**Figure 7.15: Generalized Longitudinal and Transverse Bar Corrosion Rating and Days to the Onset of Corrosion**

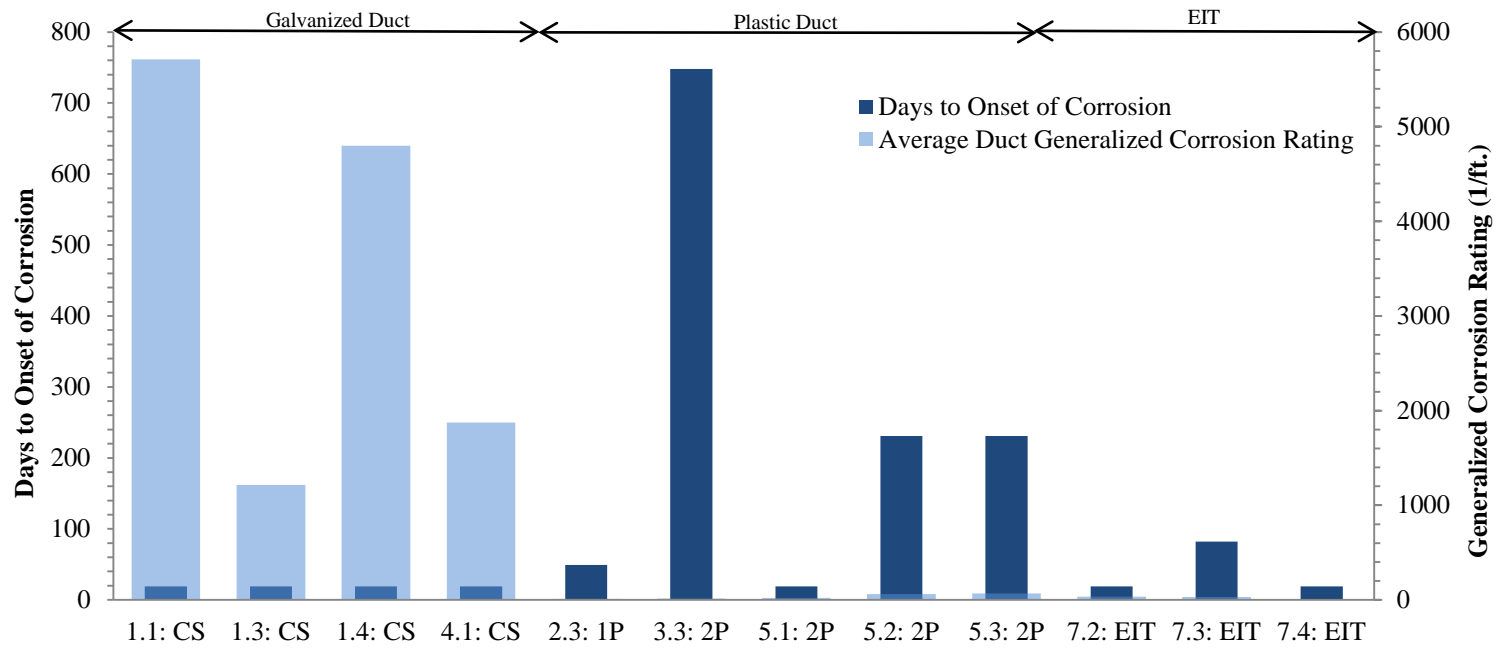
Figure 7.16 shows the average generalized duct corrosion rating plotted with days to the onset of corrosion for each specimen. The specimens with galvanized ducts had the lowest days to onset of corrosion and the highest corrosion ratings. However, there was much variability to the corrosion rating. Therefore, correlation cannot be made to the severity of corrosion and days to onset of corrosion. The specimens with plastic ducts

**Figure 7.16: Generalized Duct Corrosion/Damage Rating and Days to the Onset of Corrosion**

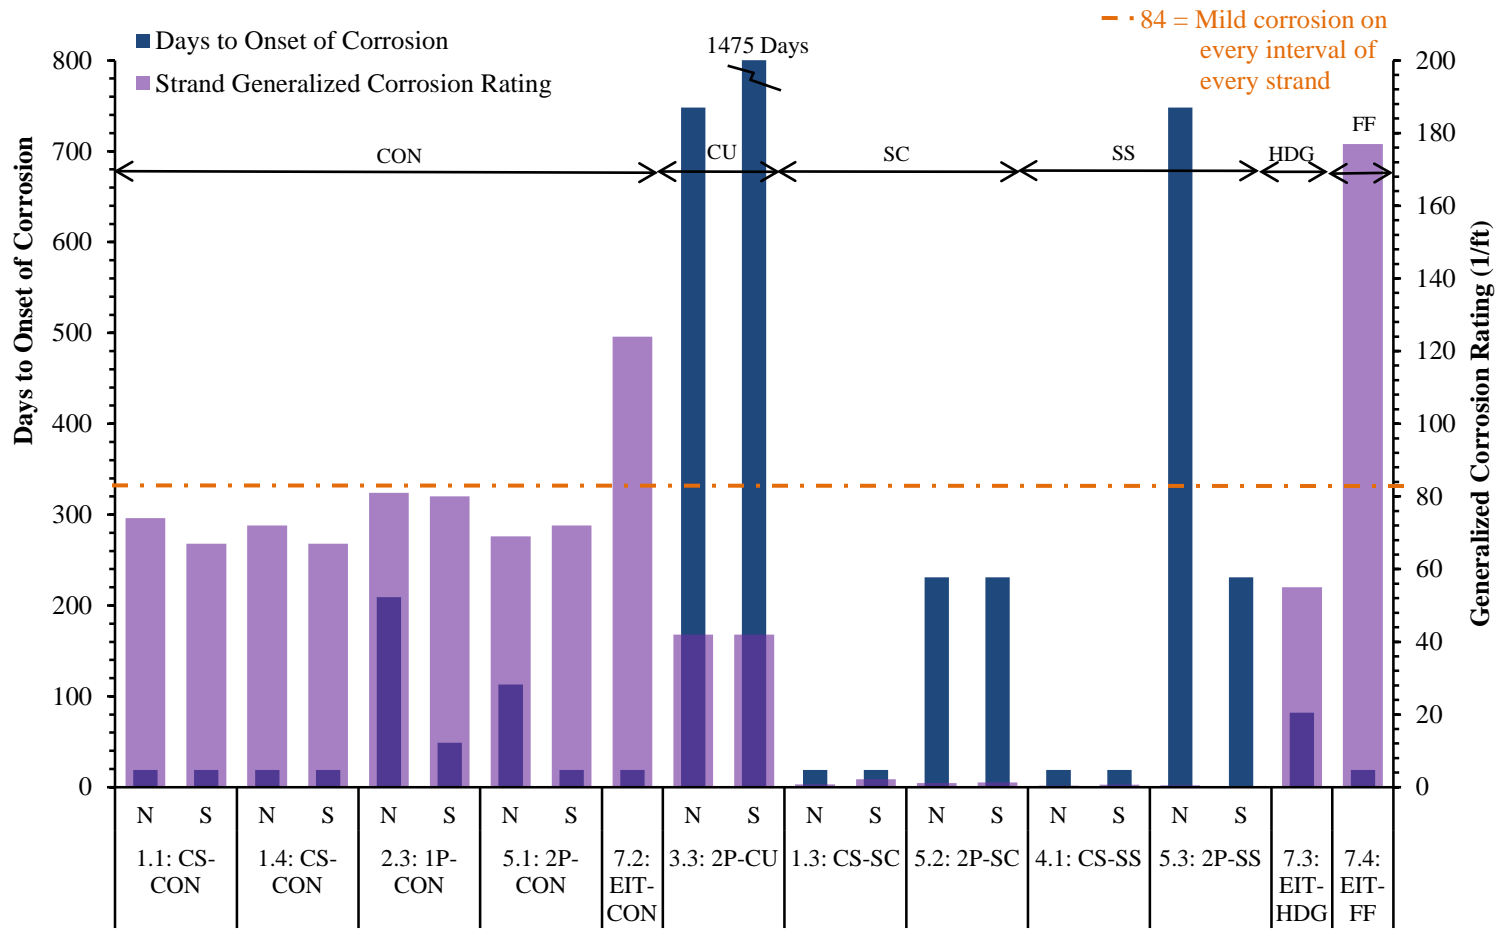
Figure 7.17 shows the generalized strand corrosion rating plotted with day to onset of corrosion for each tendon. The tendons with conventional and epoxy coated strands generally had the lowest days to onset of corrosion and the highest corrosion ratings. Not much variability was seen between the days to onset of corrosion and corrosion rating so a determination cannot be made if lower days to onset of corrosion correlated to higher corrosion ratings. The tendons with copper clad strand had equal corrosion ratings but a large gap between days to onset of corrosion. The stainless clad tendons had relatively equal corrosion ratings but the days to onset of corrosion were different between the tendons encased in galvanized duct and the tendons encased in plastic duct. The days to onset of corrosion was higher in the tendons encased in plastic duct for the tendons with stainless clad strand. The tendons with stainless steel strands were similar to the tendons with stainless clad. The corrosion ratings were essentially the same between tendons but the days to onset of corrosion differed between duct types. The tendons encased in plastic ducts had higher days to corrosion than the tendons encased in galvanized ducts. There were no other tendons with hot dip galvanized strands so a comparison cannot be made between strands types. However, the galvanized strand can be compared to conventional strands with regards to days to onset of corrosion. The tendon with hot dip galvanized strand had a longer time to days to onset of corrosion than the tendons with conventional strand.

**Figure 7.17: Generalized Strand Corrosion Rating and Days to the Onset of Corrosion**

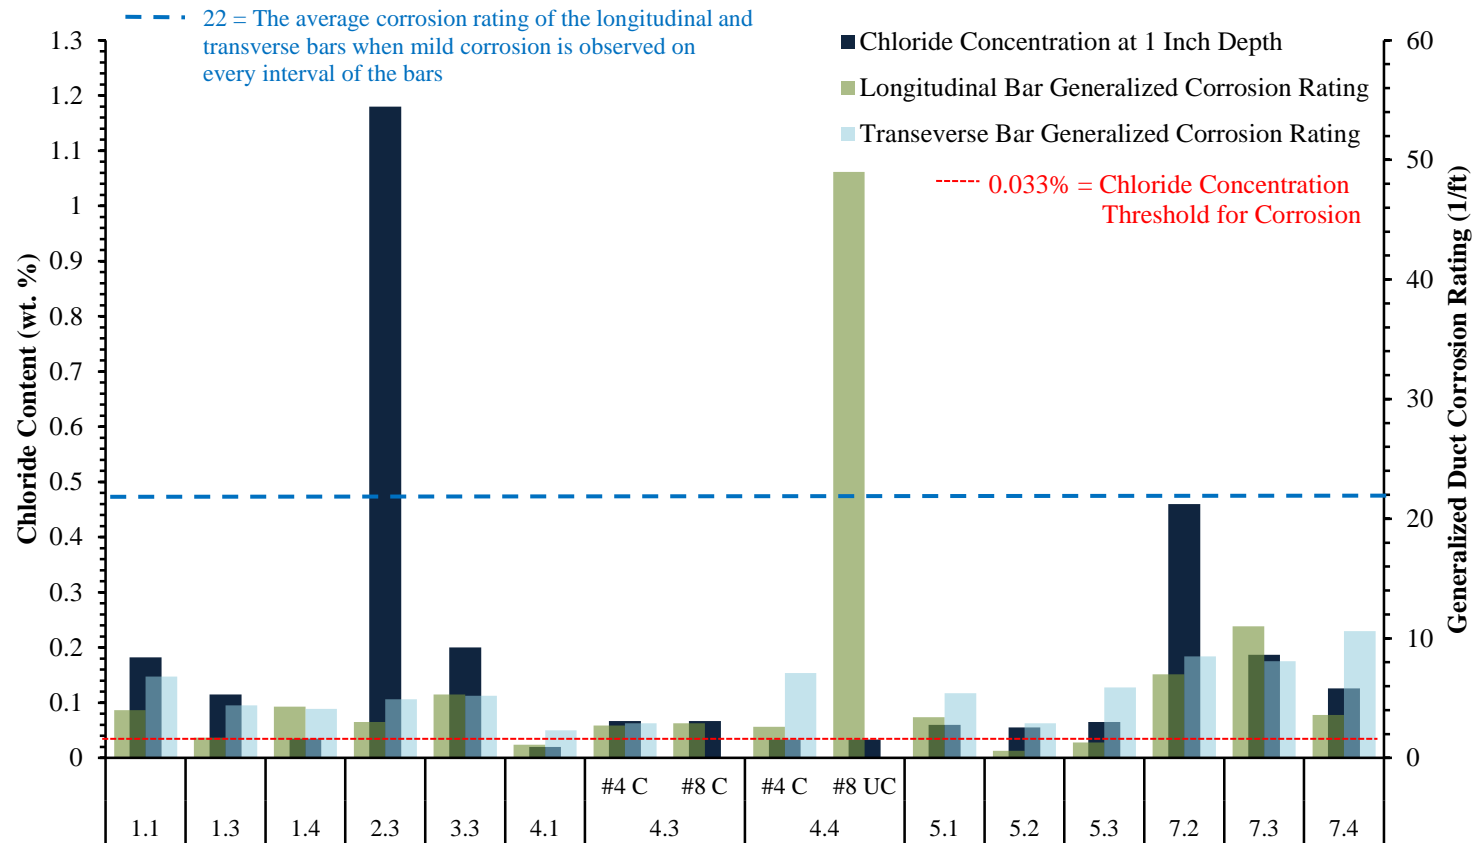
Except for Specimens 1.4, 4.1, and 4.4, all specimens had chloride concentrations at a one inch depth considerably higher than the corrosion threshold from Reference 5. Specimens 1.4, 4.1, and 4.4 had chloride concentrations very near the corrosion threshold. Specimen 4.1 had the lowest chloride concentration, the lowest transverse bar corrosion rating, and the second lowest longitudinal bar corrosion rating. Specimen 4.1 also had the lowest crack rating (Figure 7.2). As expected, the uncoated longitudinal bars from Specimen 4.4 had the highest corrosion rating. However, Specimen 4.4 had a chloride concentration at the corrosion threshold. The 7- series specimens had some of the highest chloride concentrations and generally had the highest corrosion ratings. In general, the higher the chloride concentration the higher the corrosion rating. However, since the specimens were cracked, the bars would have experienced greater concentrations of chlorides with cracks than what was present in the concrete. The chloride concentrations to which the bars might have been exposed at the locations of the cracks are probably better represented by the chloride concentration from Specimen 2.3. Specimen 2.3 had the highest chloride concentration and its corrosion ratings were around the average.

**Figure 7.19: Generalized Longitudinal and Transverse Bars Corrosion Rating and Chloride Concentration at One Inch Depth**

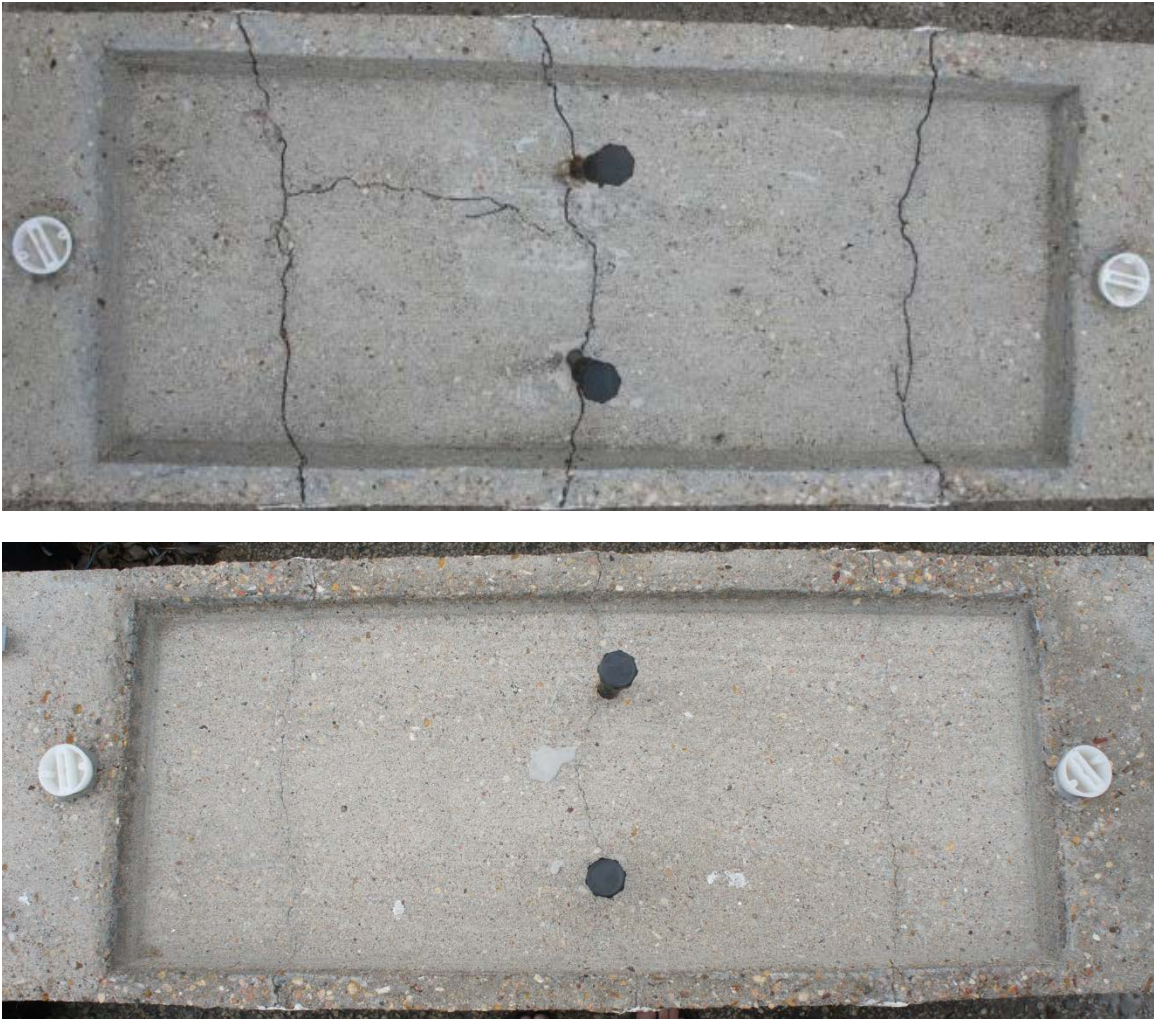
The condition of the 6 year and 4 year autopsied specimens was similar. All the specimens had limited rust staining around the grout vents of specimens containing galvanized ducts. Some of the specimens from both autopsy periods had additional cracks form in the re-entrant corbel corner after the application of live load. Some of the specimens from both autopsy periods had efflorescence around the cracks of the re-entrant corbel corner. All the specimens from both autopsy periods had medium scaling on the top surface and the bottom surface of the ponding area. Some of the specimens from both autopsy periods had small shallow bleed water voids in the ponding area. See Figure 7.20 for the typical condition of the ponding area for a 4 year and 6 year autopsied specimen.

*Figure 7.20: Typical Condition of Ponding Area for a 4 Year<sup>2</sup> (Top) and 6 Year (Bottom) Specimen*

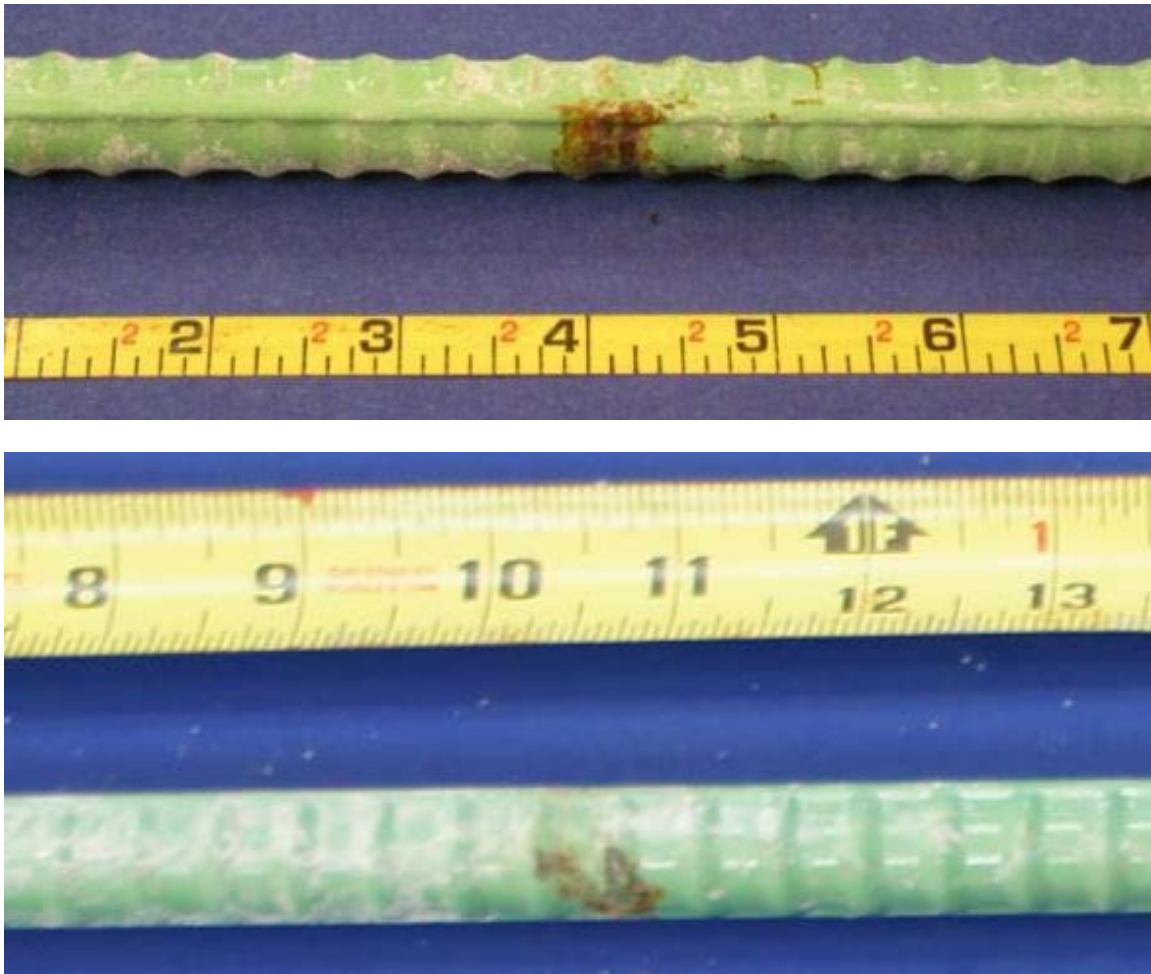
The longitudinal and transverse bars from both autopsy periods had epoxy coated steel reinforcement. The condition of the bars was similar for both autopsy periods. Discoloration was found on all bars. Minimal moderate and light corrosion was found on some of the bars. Pitting was observed on very few bars. Generally, the corrosion was limited to areas in which the epoxy coating had been breached. Normally, the epoxy coating had been breached at curves in the bar and points where separate bars had touched. For the most part, the condition of the epoxy coating remained intact and

prevented widespread corrosion. The good condition of the longitudinal and transverse bars from the 4 year and 6 year autopsy periods is an indication that there is great value in using epoxy coated steel reinforcement in aggressive environments. The overall condition of the bars from the 6 year autopsy period was better than the overall condition of the 4 year autopsy period. This was unexpected. The overall condition of the 6 year autopsy period bars were expected to be worse than the overall condition of the 4 year autopsy period due to the longer exposure to chlorides. This discrepancy might be because the 6 year autopsy period had more specimens with plastic duct and had two specimens that had no post-tensioning components. Therefore, transverse reinforcement would have had less staining on them decreasing the corrosion rating, thus decreasing the average corrosion rating for the transverse bars. Figure 7.21 shows a typical bar from the 4 year and 6 year autopsy period.

*Figure 7.21: Typical Longitudinal Bar from 4 Year<sup>2</sup> (Top) and 6 Year (Bottom) Autopsy Period*

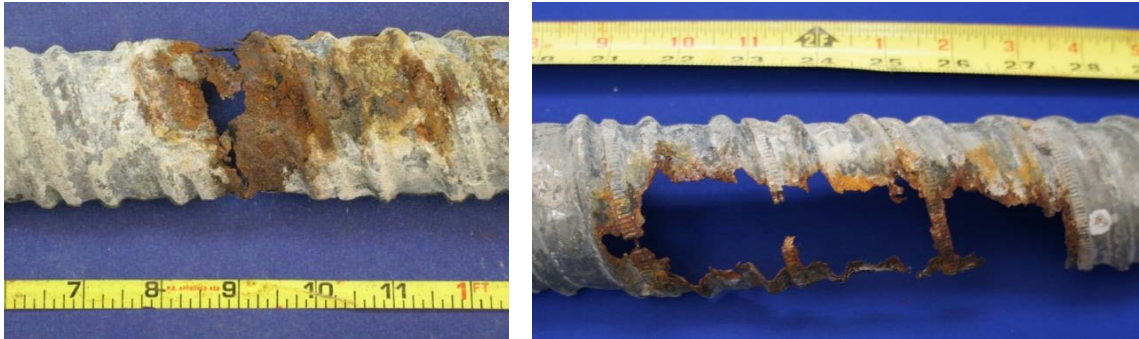
The condition of the galvanized ducts for the 6 year and 4 year autopsy periods were similar. All the galvanized ducts from both autopsy periods had holes on top of the ducts caused by corrosion. These holes were normally located at voids in the grout and at the locations of transverse cracks in the concrete. The majority of the ducts from both autopsy periods had pitting observed on their bottom inner surface. Moderate and light corrosion was observed on the outer and inner surfaces of all ducts from both autopsy periods. However, the 6 year autopsy specimens had somewhat more corrosion damage

than the 4 year autopsy specimens with larger holes where voids in the grout were located. The increase in damage over the 2 year period was approximately 15%. This was expected because the galvanized duct from the 6 year autopsy period were exposed to chlorides longer than the galvanized duct from the 4 year autopsy period. See Figure 7.22 a typical galvanized duct from the 4 year and 6 year autopsy period.

***Figure 7.22: Typical Galvanized Duct from 4 year<sup>2</sup> (Right) and 6 Year (Left) Autopsy Periods***

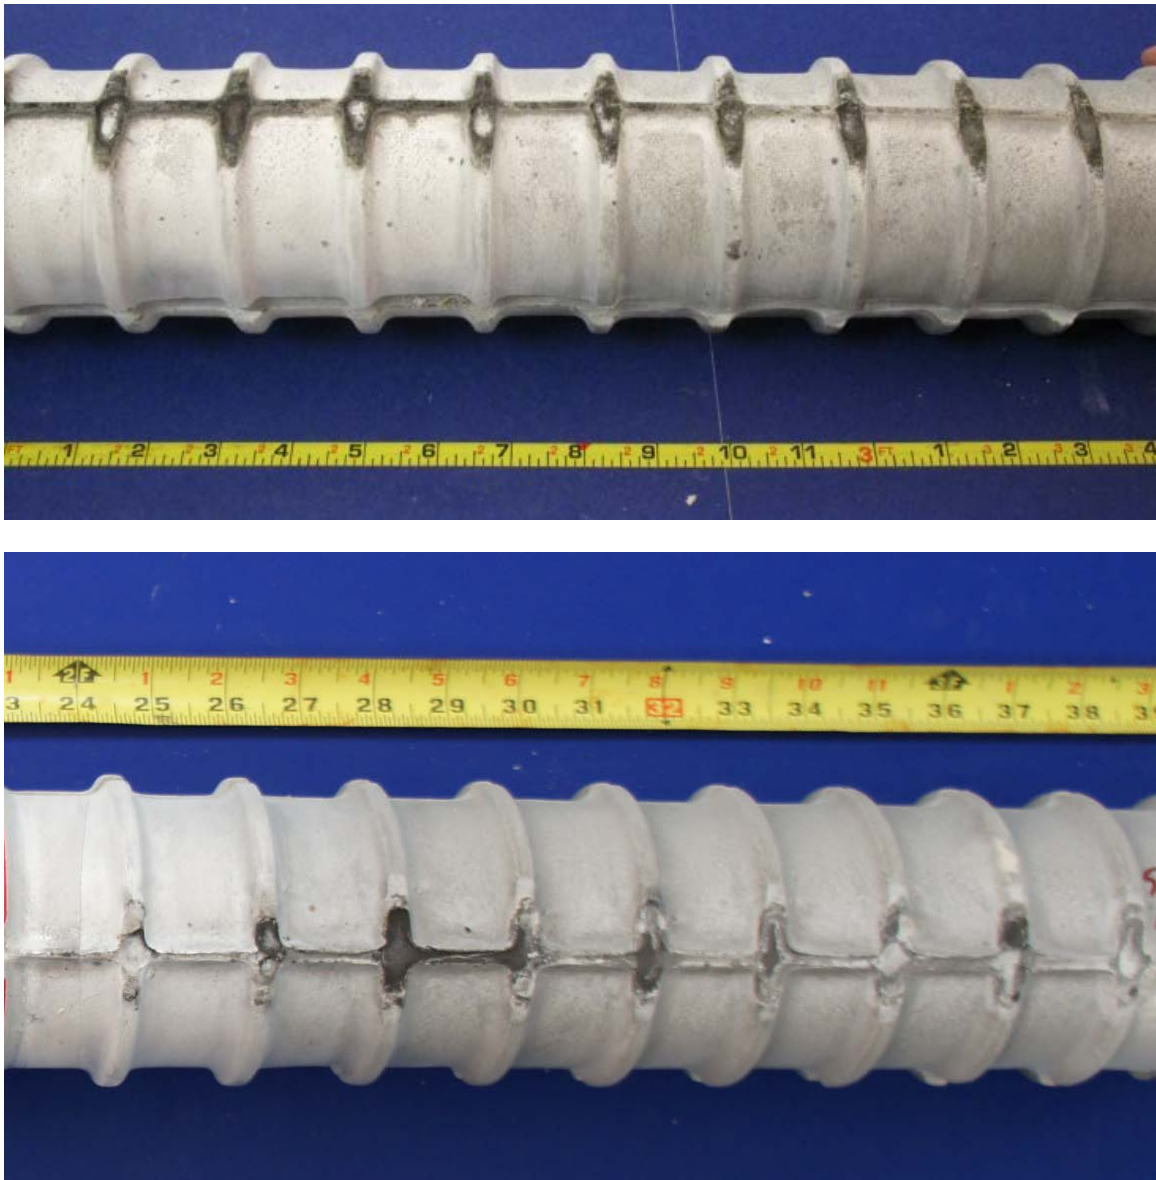
The grout condition from both autopsy periods varied from specimen to specimen. Both autopsy periods had grouts that had little variation in color, were smooth to the touch, and resilient against breaking. Also both autopsy periods had grouts that were rough to the touch, had large variations in color, and easily broke apart. The quality of grout improved in the specimens that had been grouted later. Grouts from both autopsy

periods had small voids on the top portion of the grout and some had large voids on the top portion of the grout. Strands were visible on the bottom of the grout from both study periods. The grout from galvanized ducts for both autopsy periods had rust stains from the corrosion of the duct. Most of the chloride concentrations were well above the corrosion threshold of 0.033% by weight for both study periods. However, if the chloride concentrations from like ducts are compared from both autopsy periods, the average 6 year autopsy chloride concentrations were approximately 19% greater than the average chloride concentrations from the 4 year autopsy period. This is expected because of the increased exposure time would have allowed more chlorides to accumulate in the grout. Figure 7.23 shows the typical grout from plastic ducts for both autopsy periods.

*Figure 7.23: Typical Grout from Plastic Duct for 4 Year<sup>2</sup> (Top) and 6 Year (Bottom) Autopsy Periods*

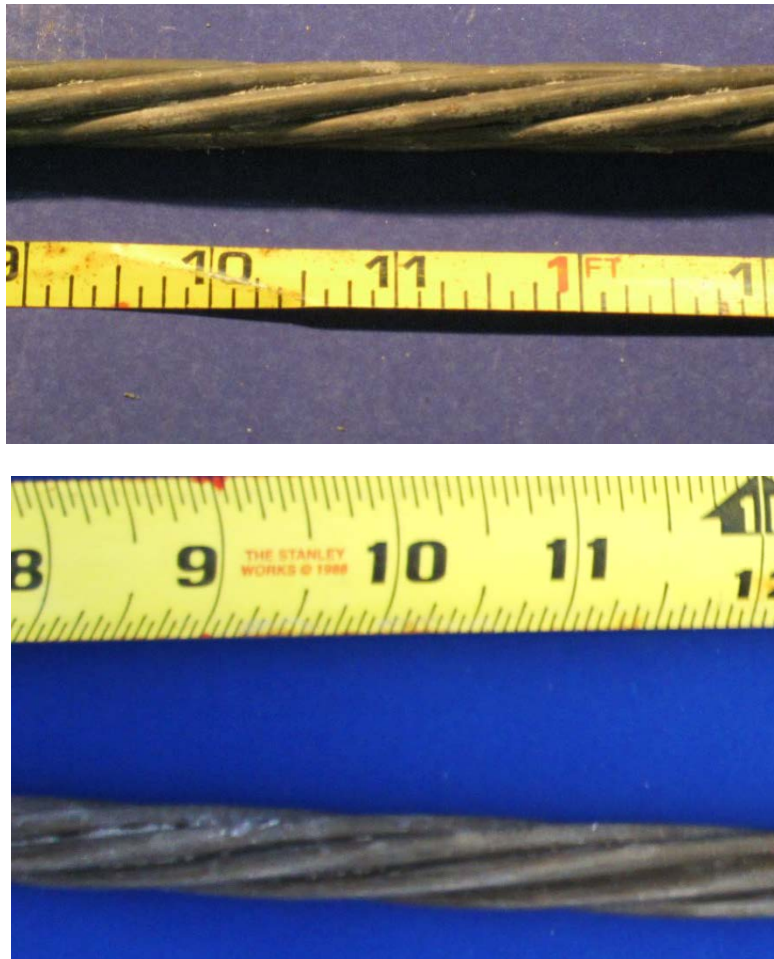
The conventional strands from both autopsy periods showed discoloration and spots of light corrosion on their outer strands and to some degree the corrosion on the inner wires was more severe. However, the corrosion on the inner and outer wires of the

6 year autopsy period was somewhat more widespread and pitting was observed on some of the wires. There was approximately a 220% increase in corrosion damage to the conventional strands over the two year period between autopsies. The condition of the hot dip galvanized strands from both autopsy periods was somewhat similar, with the strands from the 6 year having greater and more widespread damage. There was approximately 240% increase in corrosion damage to hot dip galvanized over the two year period between autopsies. The copper clad strands from both autopsy periods had a very dark brown patina on them and the patina did not change during the 2 year period between autopsies. There was no difference in the condition of the stainless steel strands from the 4 and 6 year autopsy periods. No specimens from the 4 year autopsy period contained either stainless clad or flowfilled epoxy coated strands. Figure 7.24 shows a typical conventional strand from the 4 year and 6 year autopsy periods.

*Figure 7.24: Typical Conventional Strand from 4 Year<sup>2</sup> (Top) and 6 Year (Bottom) Autopsy Periods*

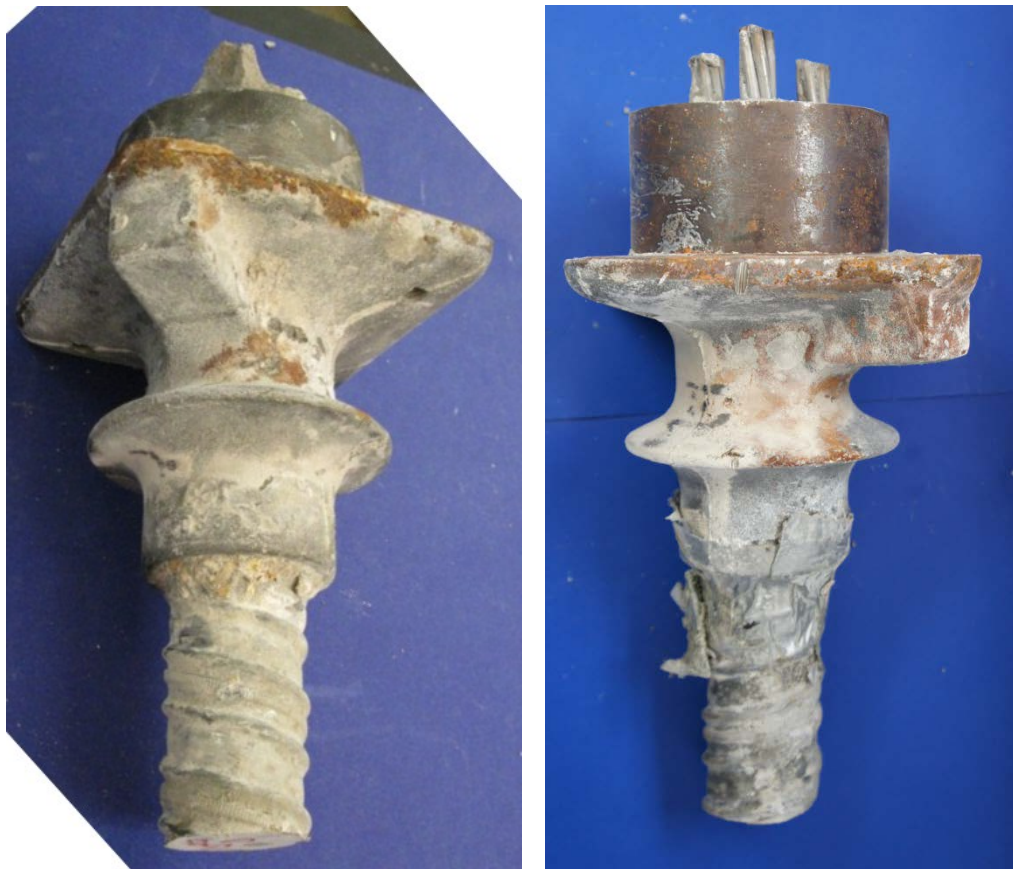
The condition of the anchorage components from both autopsy periods was similar in condition. The anchorage plates from both autopsy periods had corrosion on the underside of the embedded portion. The ducts from both autopsy periods had somewhat similar damage with the galvanized ducts having a little more widespread and little more severe corrosion. The strands from the 4 year autopsy period were to some extent similar to the strands from the 6 year period. The strands from the 6 year period had a little more widespread and a little more severe corrosion damage. The conventional strands had a 50% increase in the corrosion damage over the 2 year period. The copper clad and the

stainless steel strands had no increase in corrosion damage over the two year period. The hot dip galvanized strands had a 37% increase in damage over the two year period. No specimens from the 4 year autopsy period contained either stainless clad or flowfilled epoxy coated strands. The wedges from both autopsy periods were somewhat intact with observed light corrosion. Figure 7.25 shows the typical anchorage from both autopsy periods.

*Figure 7.25: Typical Anchorage from 4 Year<sup>2</sup> (Left) and 6 Year (Right) Autopsy Periods*

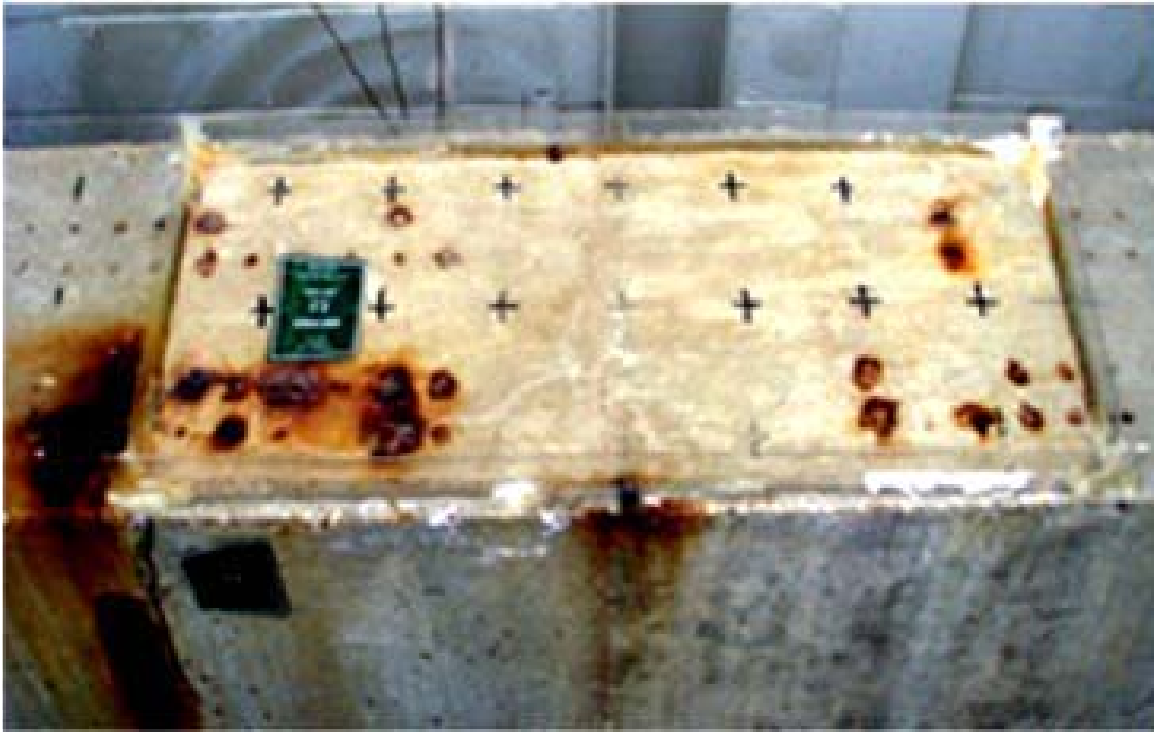
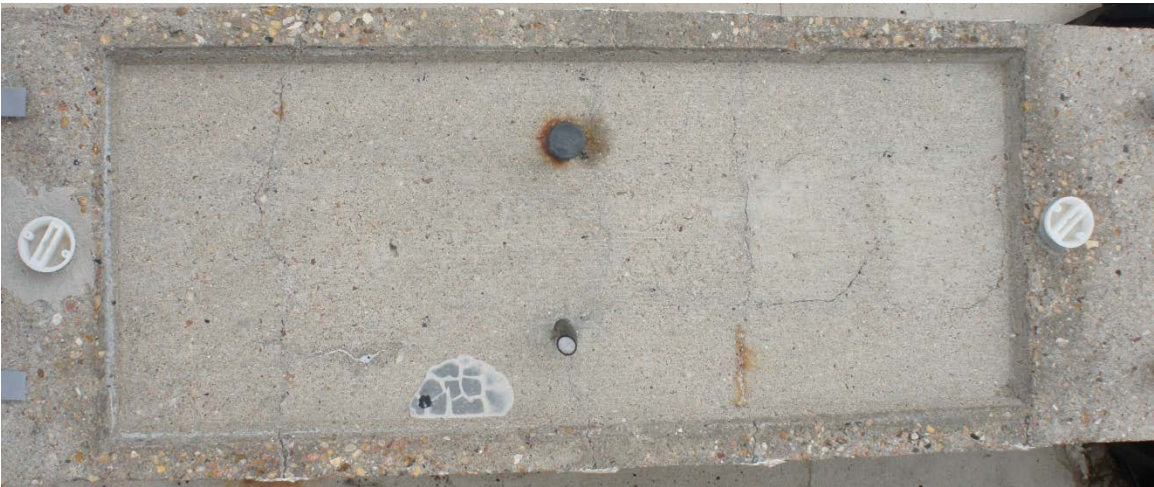
The appearances of Project 0-1405 specimens were dismal. Moderate to severe rust staining was found on the tops of most of the specimens. Surface cracking observed on some of the specimens was from flexural loading but much of the wide cracks were due to tensile stresses caused by internal corrosion of the uncoated reinforcement and galvanized duct. These cracks allowed the chlorides from the ponding area to easily infiltrate the concrete. The chlorides then could easily spread to other portions of the specimens where no flexural cracks were observed.

The exterior condition of the Project 0-4562 specimens was much improved over the condition of the Project 0-1405 specimens. Limited rust staining was observed and normally was contained around the grout vents of the specimens with galvanized duct. Of the specimens with galvanized duct the majority of the specimens had no visible longitudinal cracking. Figure 7.27 shows the typical external appearance of specimens from both projects. The switch to epoxy coated reinforcement was very significant in preserving external appearance.

*Figure 7.27: Typical Specimen from Project 0-1405<sup>5</sup> (Top) and Project 0-4562 (Bottom)*

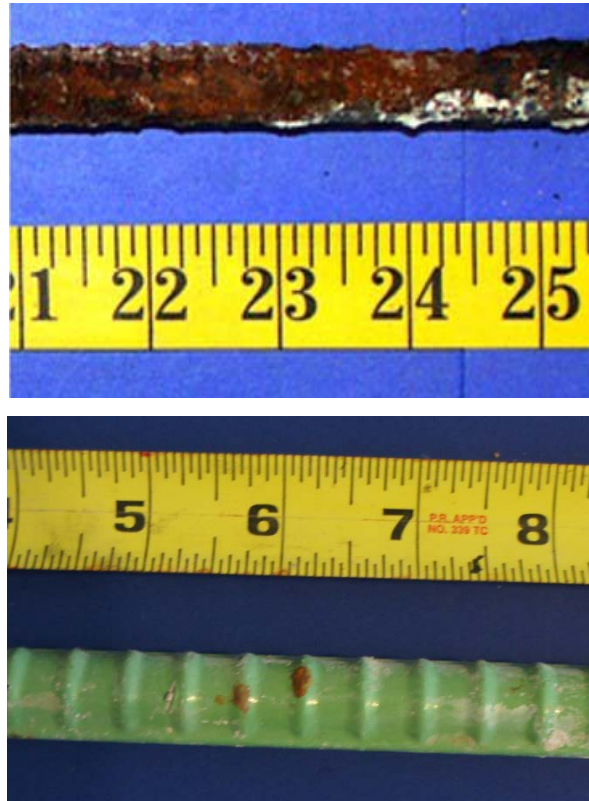
The specimens from Project 0-1405 contained uncoated steel longitudinal and transverse bars. These bars were seriously damaged due to corrosion over the majority of the autopsy region. The steel bars had substantial cross-sectional area loss due to this corrosion, particularly in the partially prestressed specimens. The wider crack widths in the latter were found to have influenced the corrosion of the bars.

Project 0-4562 used epoxy coated longitudinal and transverse bars. Minimal discoloration, light to moderate corrosion, and on some occasion mild pitting were observed along the length of the bars. All in all, the epoxy coating remained intact and hindered further corrosion of the bars. There was a reduction of almost 100% in the average corrosion rating of transverse reinforcement of Project 0-1405 compared to Project 0-4562. There was also a reduction of 95% in the average corrosion rating of longitudinal reinforcement of Project 0-1405 compared to Project 0-4562. This indicates that the use of epoxy coated bars in an aggressive environment is very effective. Figure 7.28 shows typical longitudinal bars from both projects.

*Figure 7.28: Typical Bar Longitudinal Bar from Project 0-1405<sup>5</sup> (Top) and Project 0-4562 (Bottom)*

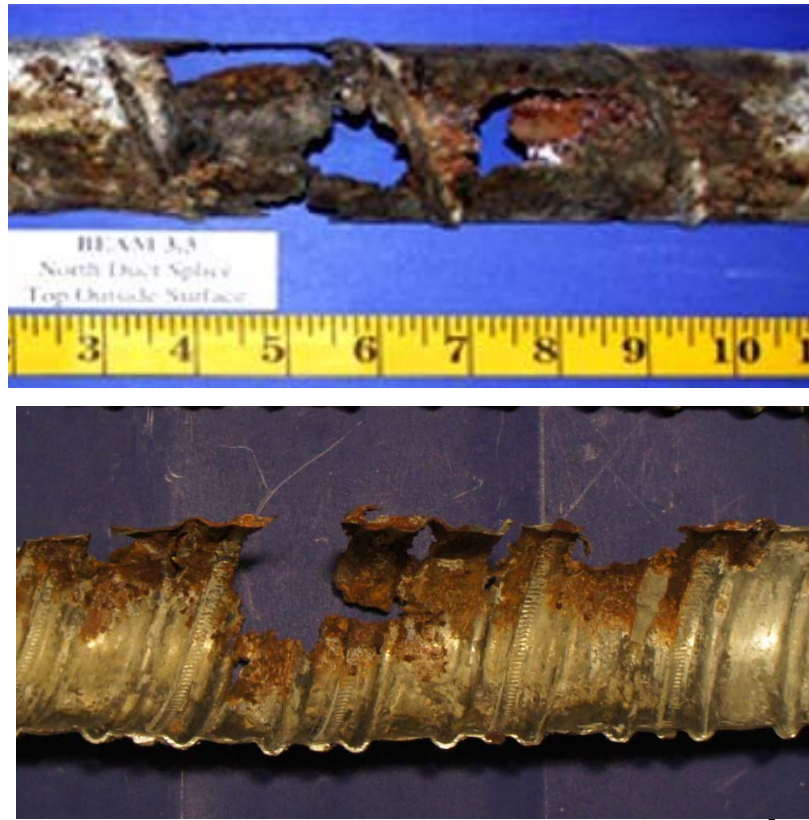
Pitting and area loss was observed in the galvanized steel ducts from Project 0-1405. The worst corrosion occurred at locations where large bleed water voids had formed in the grout. The splices using heat shrink and “industry standard” (duct tape) did not perform well. This created a path for chlorides to infiltrate the duct at the splices. Reference 5 did not include any specimens with plastic duct.

The corrosion observed on the galvanized duct from both projects was comparable. Like Project 0-1405, the galvanized ducts from Project 0-4562 had severe corrosion at the locations of bleed water voids in the grout and at the locations of transverse cracks. However, there was a 400% increase in galvanized duct corrosion damage in the Project 0-4562 specimens. The average corrosion ratings for galvanized duct were 677 and 3400

for Project 0-1405 and Project 0-4562, respectively. Project 0-1405 used level of prestress and live load as variables for the project. This would have caused the flexural cracks to vary widely from specimen to specimen and would have caused less damage to some of the ducts. Therefore the average corrosion rating would be less. Figure 7.29 shows a typical galvanized duct from both projects. The similar damage to the galvanized ducts from both projects indicates that the testing conditions were fairly consistent, except that the improved grouting in Project 0-4562 resulted in fewer large bleed water voids and less loss of duct area.

*Figure 7.29: Typical Galvanized Steel Duct from Project 0-1405<sup>5</sup> (Top) and Project 0-4562 (Bottom)*

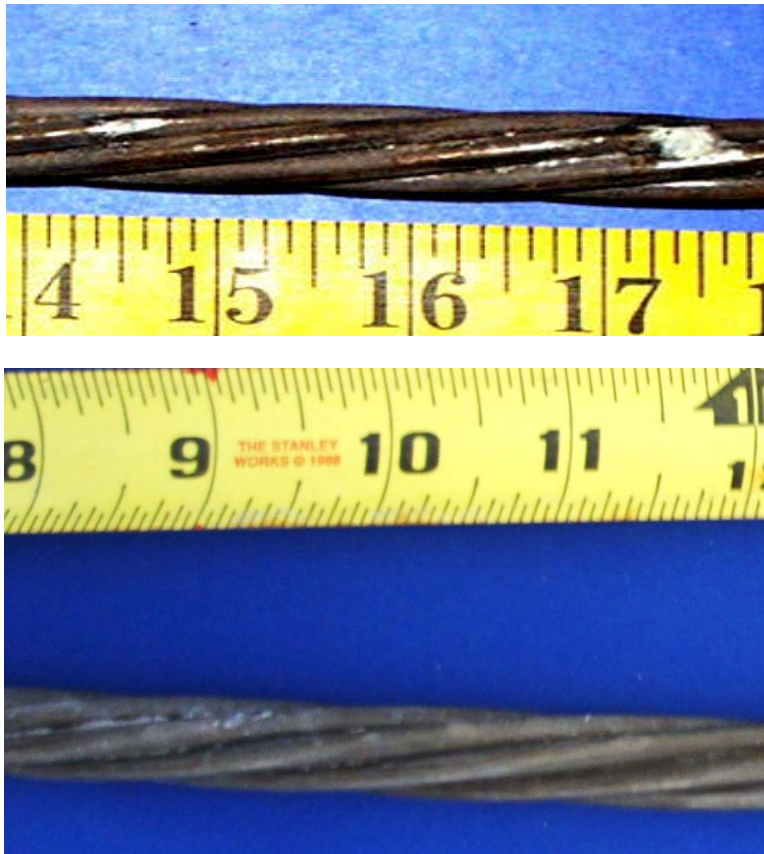
The corrosion damage observed on the conventional strands of Project 0-1405 was substantial. Pitting and cross sectional area loss was commonplace. Some strands even fractured during the autopsy process. The non-flowfilled epoxy coated strand was found to not be in much better shape. Damage to the coating allowed corrosive contaminants to enter and migrate down the strand. The galvanized strand was substantially corroded and pitted. However, the galvanized strand did not begin to corrode till much later than the other strand types.

Since copper clad, stainless, and stainless clad strands were not evaluated in Project 0-1405, they will not be discussed in this section. The conventional strands from Project 0-4562 had far less damage. The strands showed discoloration and spots of light corrosion on their outer wires and to some degree the corrosion on the inner wires was more severe. The galvanized strand from Project 0-4562 had far less damage, with discoloration and light to moderate corrosion on the inner and outer wires of the strand. The flowfilled epoxy coated strand did not perform as well as expected. The inner and outer wires had corrosion ranging from mild pitting to light corrosion over the majority of their lengths. The average corrosion ratings for all the strands from Project 0-1405 and the like strands from Project 0-4562 were 124 and 83, respectively. This is approximately a 50% reduction in corrosion damage. The improved grout condition and plastic duct helped mitigate the damage that the strands experienced. Figure 7.30 shows a typical strand from Project 0-1405 and Project 0-4562.

*Figure 7.30: Typical Conventional Strand from Project 0-1405<sup>5</sup> (Top) and Project 0-4562 (Bottom)*
