**Effect of Galvanization on the Fatigue Strength of High Mast  
Illumination Poles**

**Thesis**

The University of Texas at Austin  
May 2010

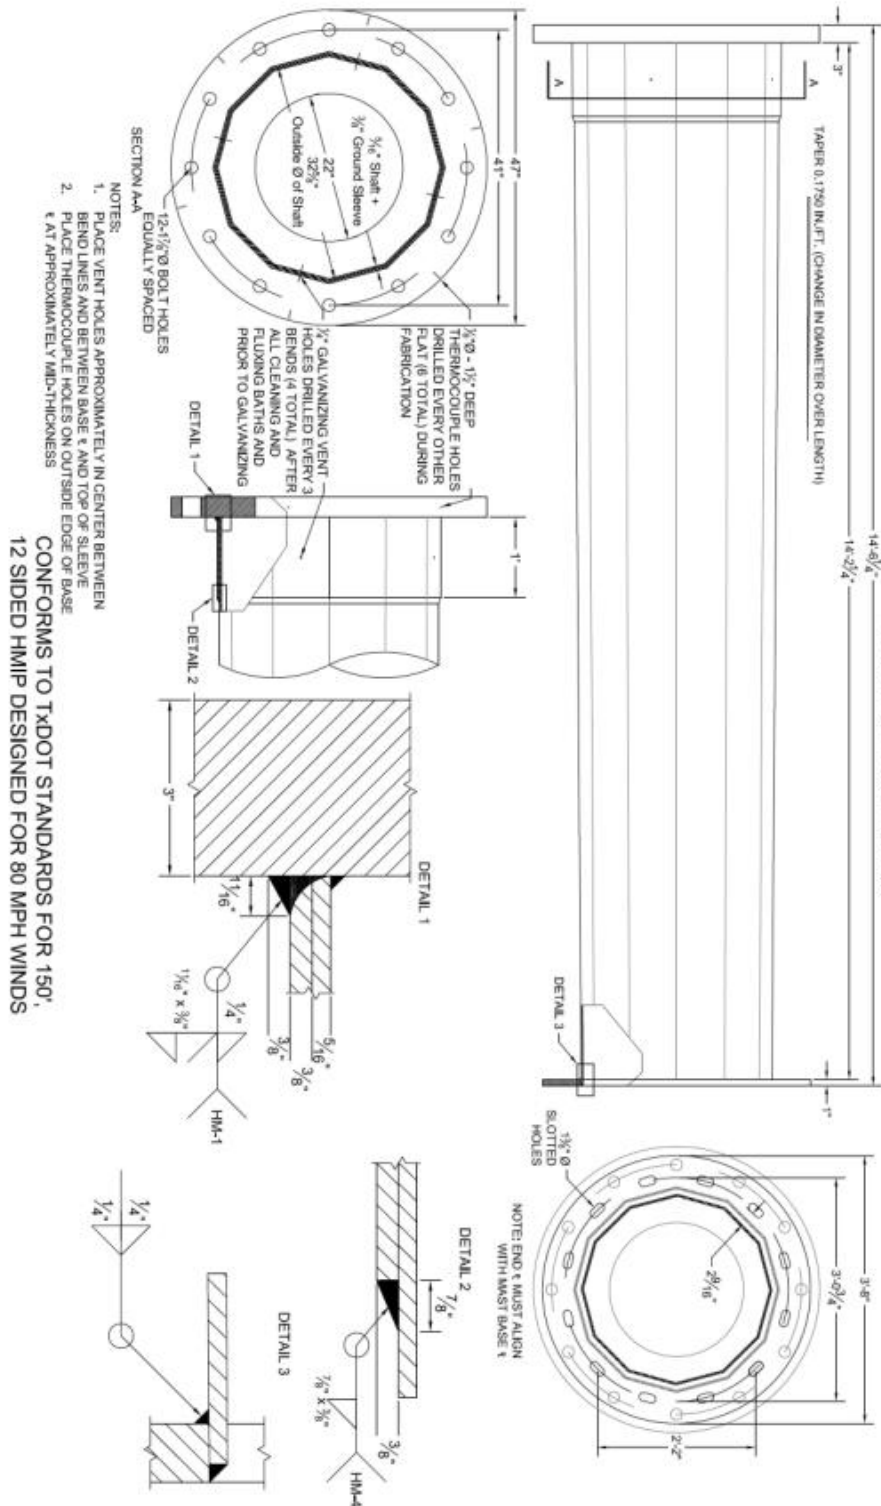
Figure 2.9 External Collar Specimen Design

The other major change in this specimen design was the addition of the external collar. The external collar was a  $\frac{3}{8}$ " thick by one foot tall plate wrapped around the base of the pole. As can be seen in the design provided in Figure 2.9, the detail for welding this plate on with the pole shaft is different than the previous weld details. For this design, the full penetration weld was made through both the external collar and the shaft wall. Also, an unequal leg fillet weld was provided around the top of the external collar to connect the collar to the shaft.

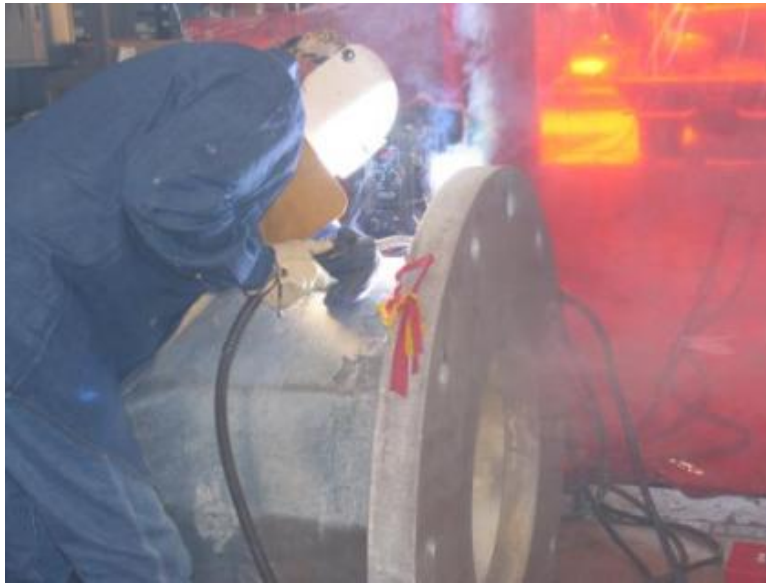
Figure 2.12 FCAW Being Performed at the Ferguson Lab

It was also helpful that this weld procedure only necessitated grinding down to one half of the wall thickness, comparatively less grinding than the field procedure. Having a larger root face enabled the welder to use more heat without fear of burning through to the other side, and to repair the weld in one pass. Figure 2.12 below is a picture of the FCAW shop repair procedure being performed on the specimen at the Ferguson Lab.

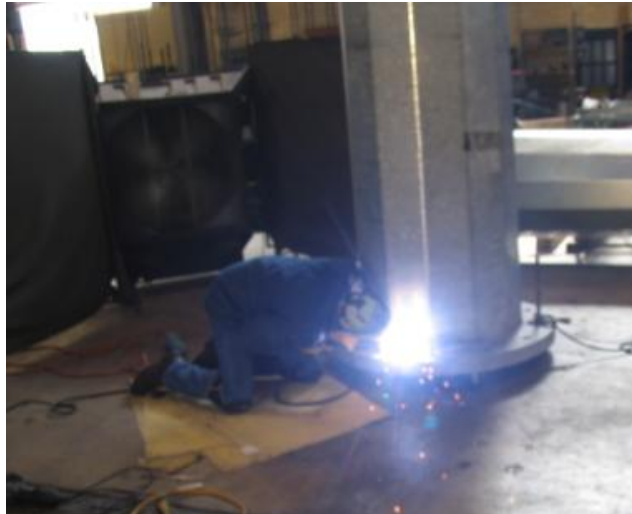
Figure 2.14 SMAW Repair Procedure Performed at Ferguson Lab

The tight controls on the depth of the grinding also added additional time into the weld repair process. Not only was it necessary for the welder to be careful to maintain the correct root face, one sixteenth of an inch, but if too much was ground off, the welder ran the risk of blowing through the root material during welding. In fact, the welder did burn through and had to fill the location of the hole, further contributing to a longer repair time, as well as risking disruption to the continuity of the surface on the inside of the pole. The welder performing the SMAW repair is shown in Figure 2.14.

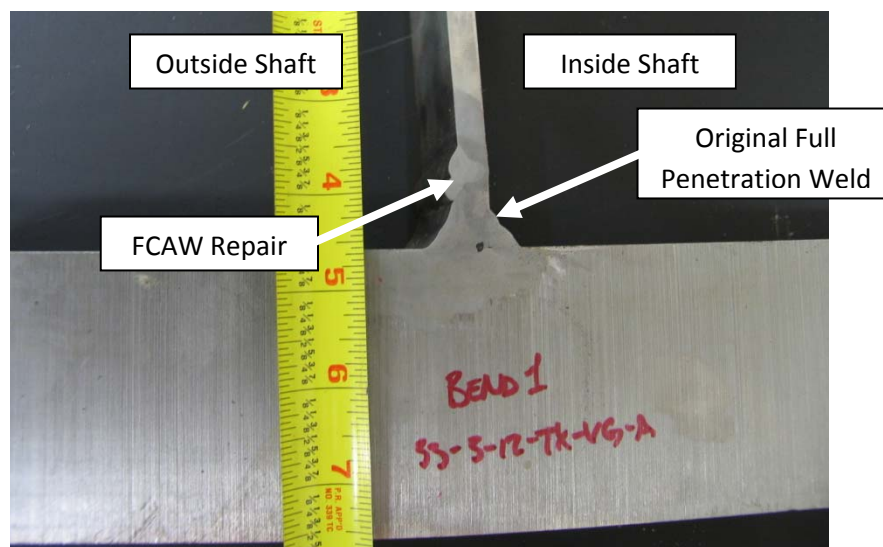
Figure 2.15 Cross Section of SMAW Repaired Weld

To maintain the one sixteenth inch root face, the welder recommended using smaller electrodes, minimizing heat input into pole wall. This helped to maintain the root without burning through, but resulted in the larger number of passes to fill the ground opening. In doing so, the exterior of the weld had a noticeably rougher surface with many discontinuities. The roughness of this weld profile can clearly be seen in Figure 2.15, which is a section trough a test weld on another sample.

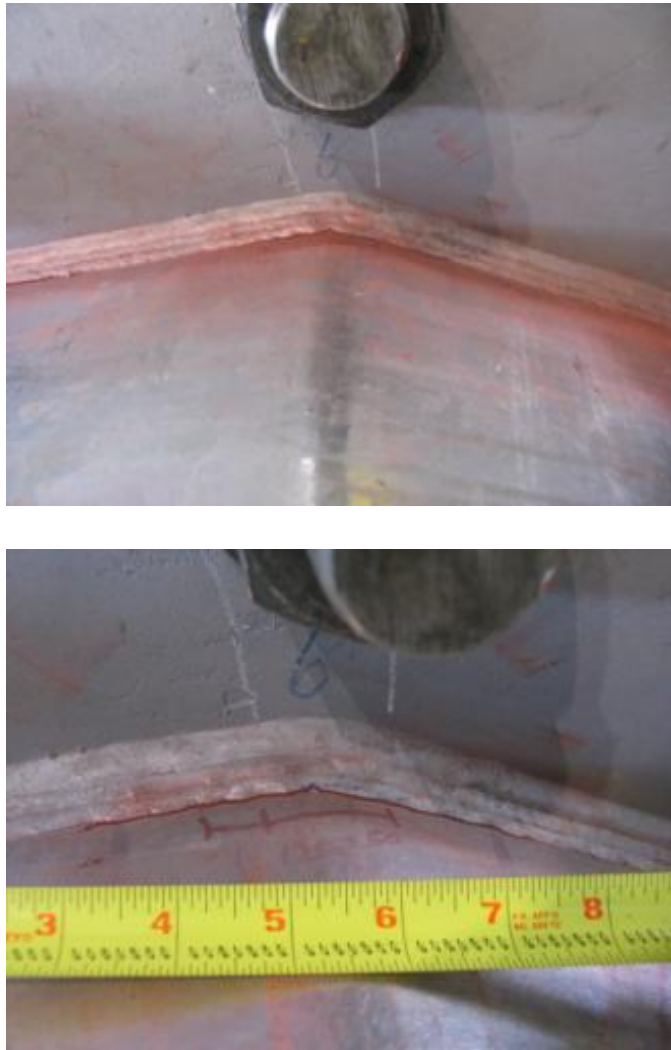
Figure 3.3 Above: Magnetic Particle Test of Bend in Compression. Below: Same Bend Tested in Tension

Apart from over-estimating cracks, when observing high masts under significant compressive forces, toe cracks tend to close resulting in poorly accentuated indications, which can introduce a margin of error into the reading. Figure 3.3 below is a comparison of the same bend tested for cracks using magnetic particle testing under compression and tension. Further, the experience on

this study with magnetic particle testing has shown that it is ineffective at indicating initial cracks from galvanizing or subsurface defects. Therefore, despite the usefulness in using magnetic particle testing to find cracks on smooth surfaces, the problems encountered using magnetic particle testing based on the base plate-pole wall weld profile do not justify relying on magnetic particle testing to determine crack locations.

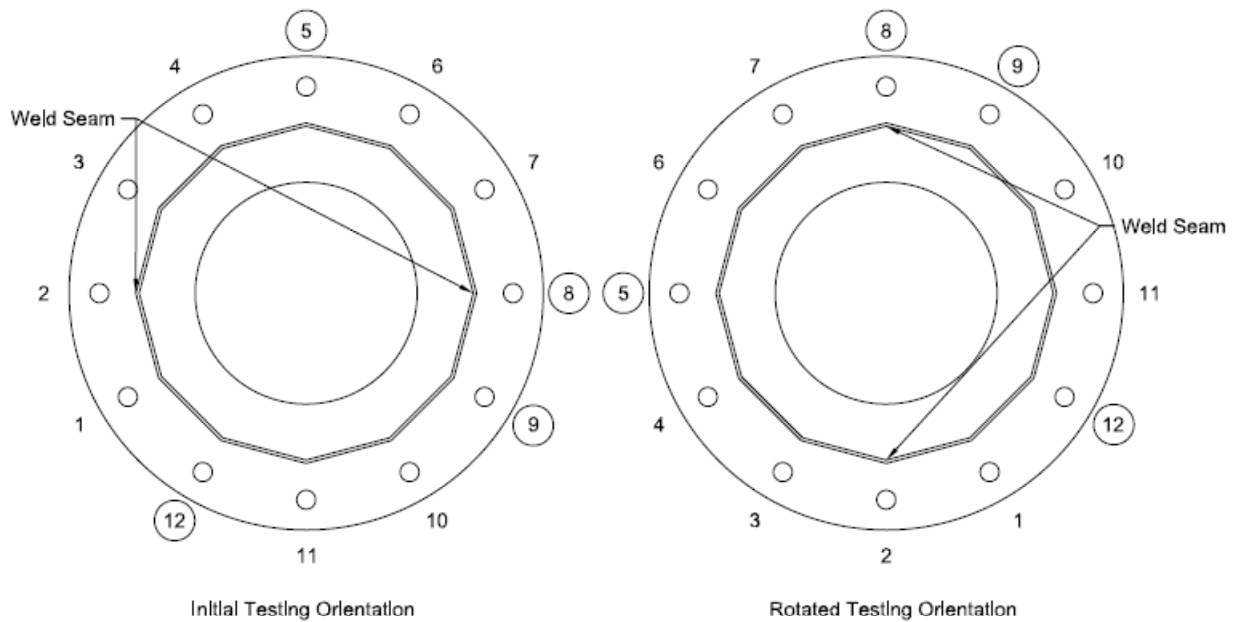
Figure 4.2 Initial and Rotated Orientation of 33-3-12-TX-SG-A with Circled Bends Further Investigated

The initial orientation of the galvanized sample was selected to keep the weld seams of the sample at the neutral axis. The neutral axis is located 90° from the up position discussed in Chapter 3. According to simple beam theory, the neutral axis experiences no bending stress. Figure 4.2 shows the initial orientation and rotated orientation, along with the location of bends discussed in this section. Bend 5 of the galvanized sample was selected to be placed upwards in the test setup, subjecting that bend to the maximum fatigue stress. The ultrasonic inspection of bend 5 before testing had found a crack indication roughly 1.625" long.

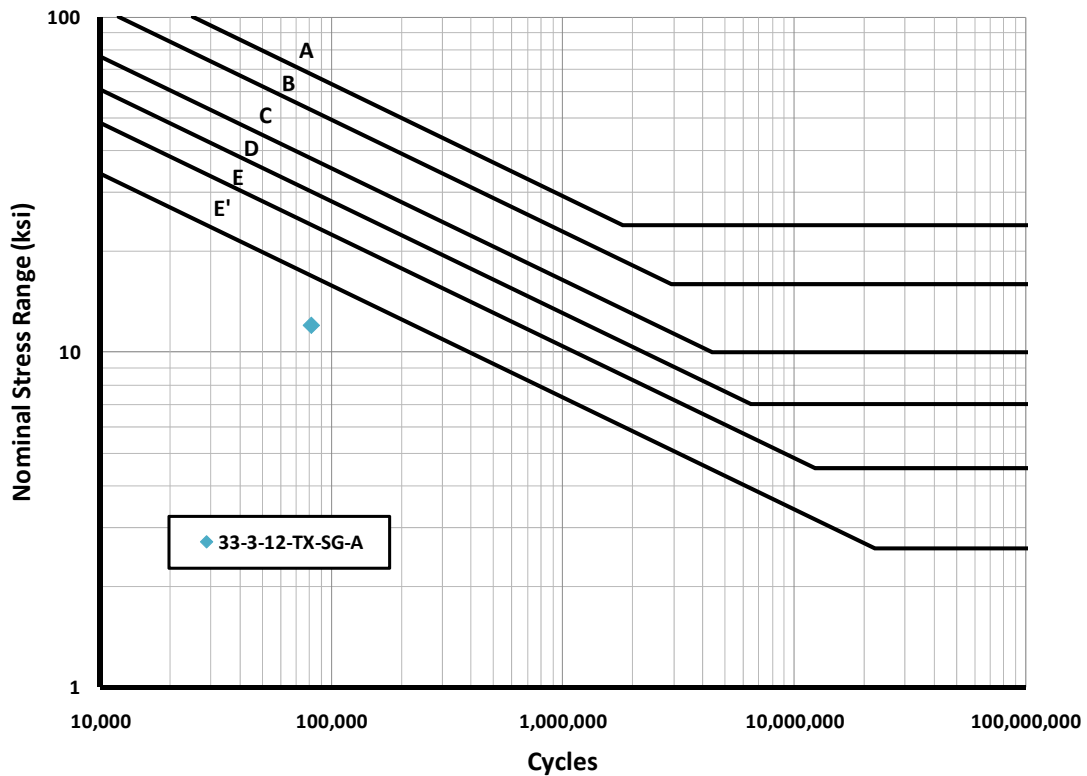
Figure 4.4 Fatigue Life of Galvanized Specimen Compared to AASHTO Fatigue Categories

Considering the number of cycles run and the stress range in the specimen, the galvanized specimen failed below AASHTO's lowest fatigue category of E', as shown in Figure 4.4.

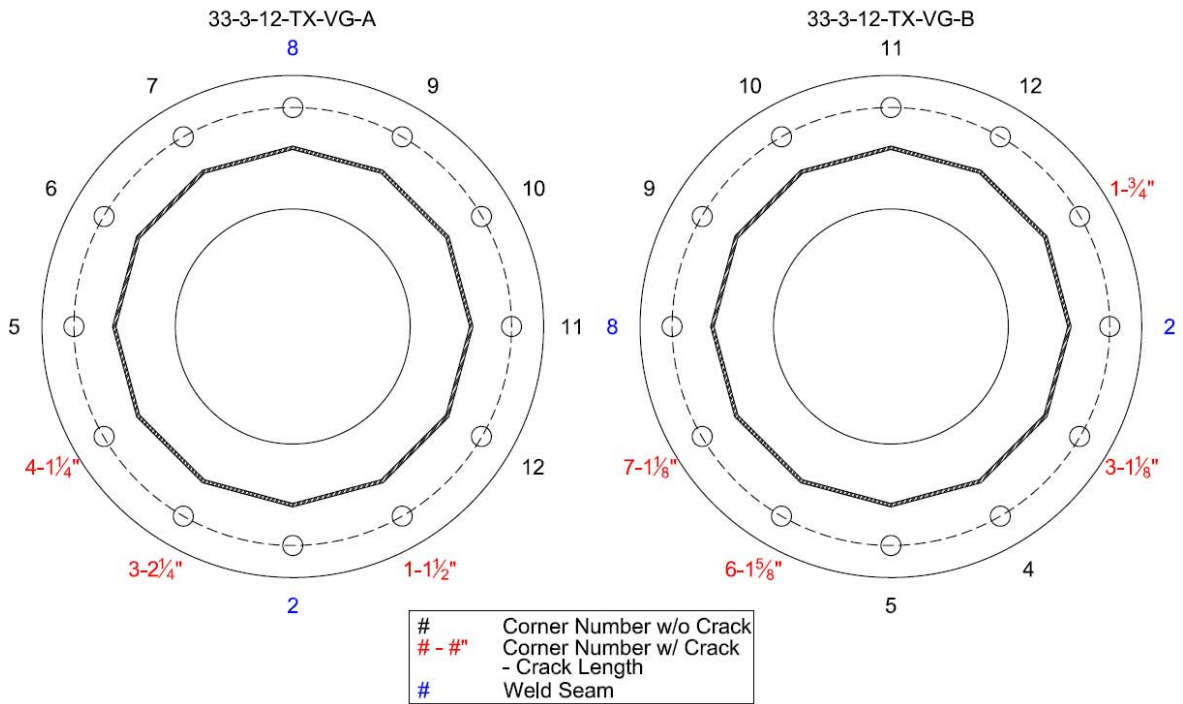
Figure 4.11 Ultrasonic Results and Initial Orientation of 33-3-12-TX-VG-A and 33-3-12-TX-VG-B

As before, the specimens were first submitted to ultrasonic testing prior to fatigue testing. Figure 4.11 below shows the results of the ultrasonic test along with the initial testing orientation, with bends shown at the top placed in the top of the test setup. The specimens were later rotated 180° (i.e. bend #2 placed in the upward position on specimen A) and retested (denoted in results as “flipped”). Bend numbers in black contained no crack indications, while bend numbers marked in red contain an initial crack indication with the length of the indication next to the corner number. Bends marked in blue denote weld seams and were, once again, not tested with the ultrasound.

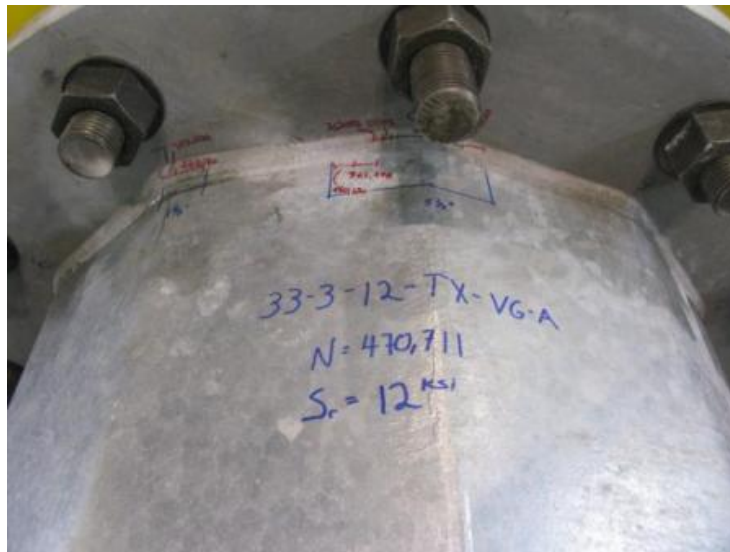
Figure 4.12 is a picture of specimen A immediately after failure. The specimen had a  $1\frac{7}{8}$ " crack at bend 7 and a  $5\frac{1}{2}$ " crack at bend 8. There were no initial cracks found at these bends prior to testing.

Figure 4.12 Specimen 33-3-12-TX-VG-A after Fatigue Testing

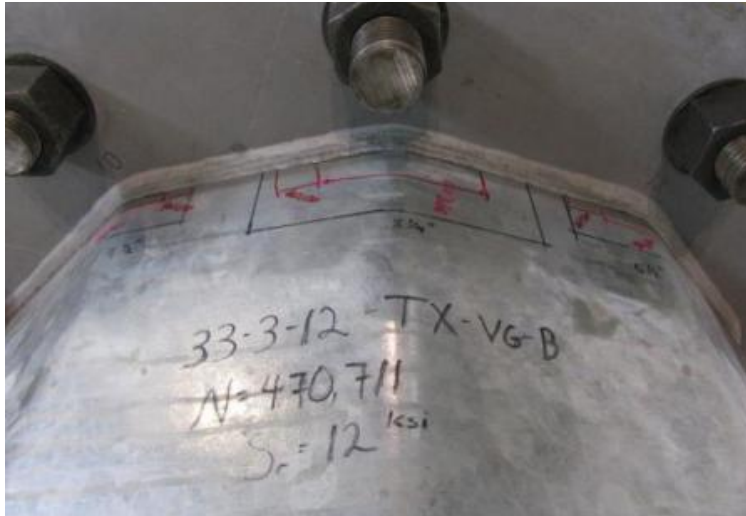
Figure 4.14 is a photograph of specimen B immediately after failure. The specimen had a 4½" crack at bend 10, an 8¼" crack at bend 11, and a 5½" crack at bend 12. All cracks were located at the toe of the weld connecting the shaft to the base plate. Again, there were no initial cracks found at these bends prior to testing.

Figure 4.14 Specimen 33-3-12-TX-VG-B after Fatigue Testing

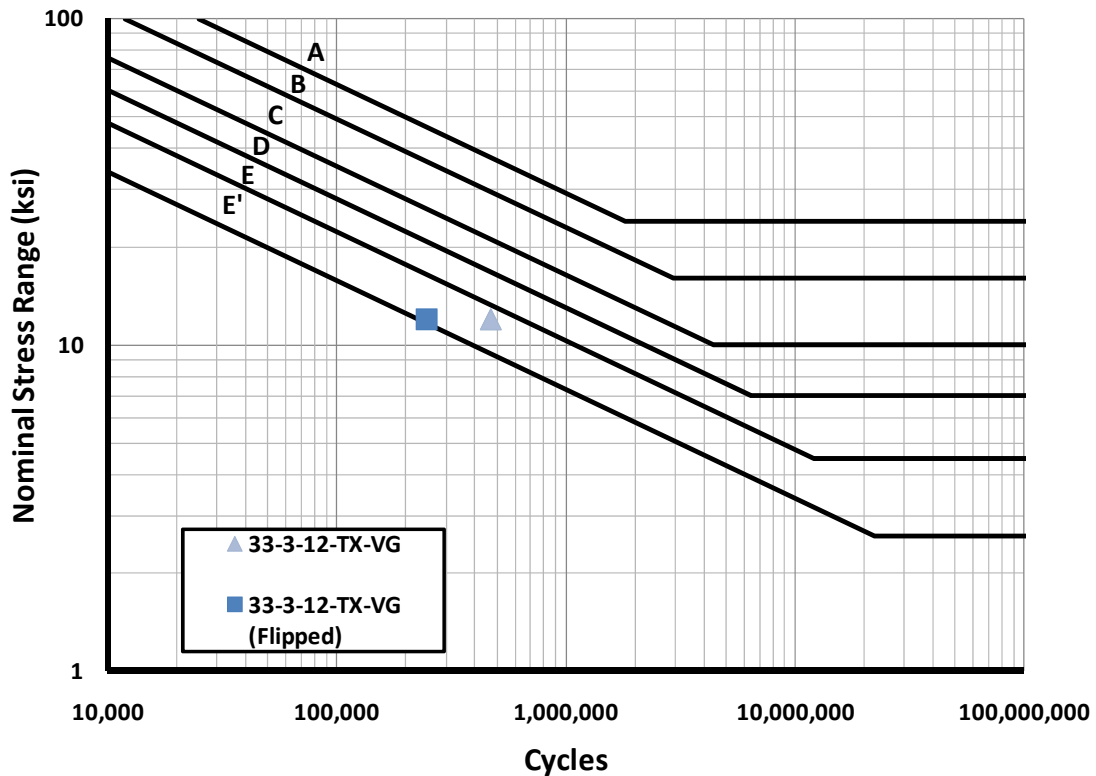
The chart in Figure 4.15 indicates how the specimens performed relative to AASHTO's fatigue ratings. Because both specimens failed at the same number of cycles, there is only one data point representing the two failures in each orientation. Both orientations of the specimens performed at an E' level, although the flipped specimens (representing the specimens tested at the 180° rotation from the initial test) only just made the E' category.

Figure 4.15 S-N Plot for Samples in Initial Orientation and Flipped Orientation

From this, it can be deduced that the initial cracks had an apparent effect on the fatigue strength of the specimens. With the initial cracks undergoing fatigue loading the specimens could handle approximately 50% fewer cycles before failure than without the initial cracks being fatigued. It is difficult to tell, however, what effect cycling the side with the initial cracks into compression has on these results.

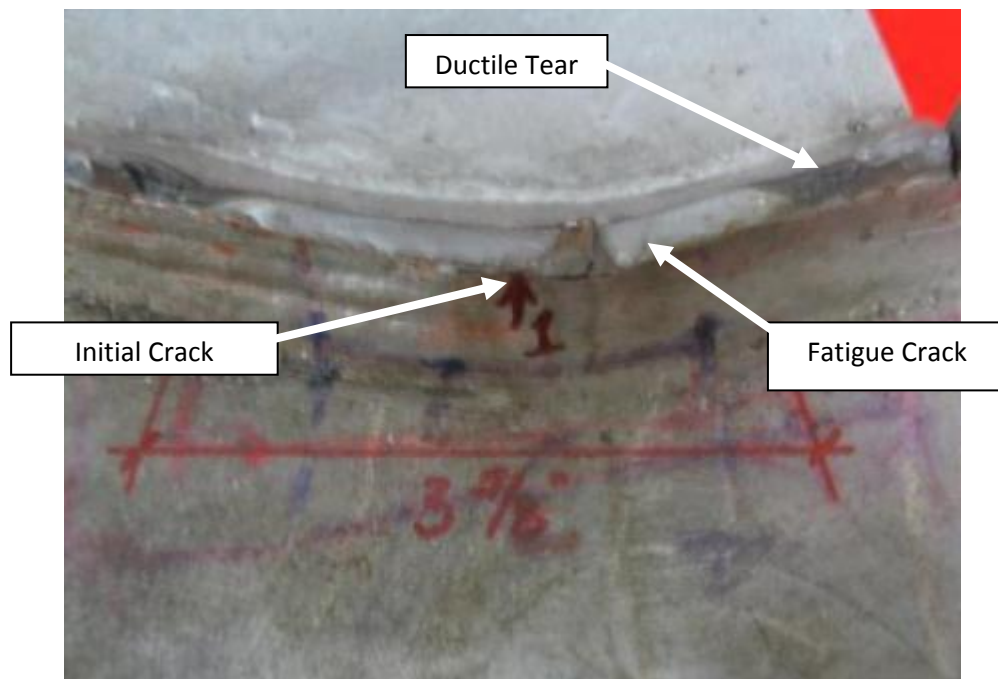
Figure 4.16 and Figure 4.17 are pictures of bend 3. In these pictures the red marker line drawn on the sample denotes the length of the fatigue crack and the blue marker line denotes the initial crack indication found before testing. Although it is difficult to see in these pictures, there appears a darker portion of the crack along the outside edge of the fatigue crack. This is the initial crack and it corresponds well the length of the crack indications.

Figure 4.16 Bend 3 of Specimen 33-3-12-TX-VG-A

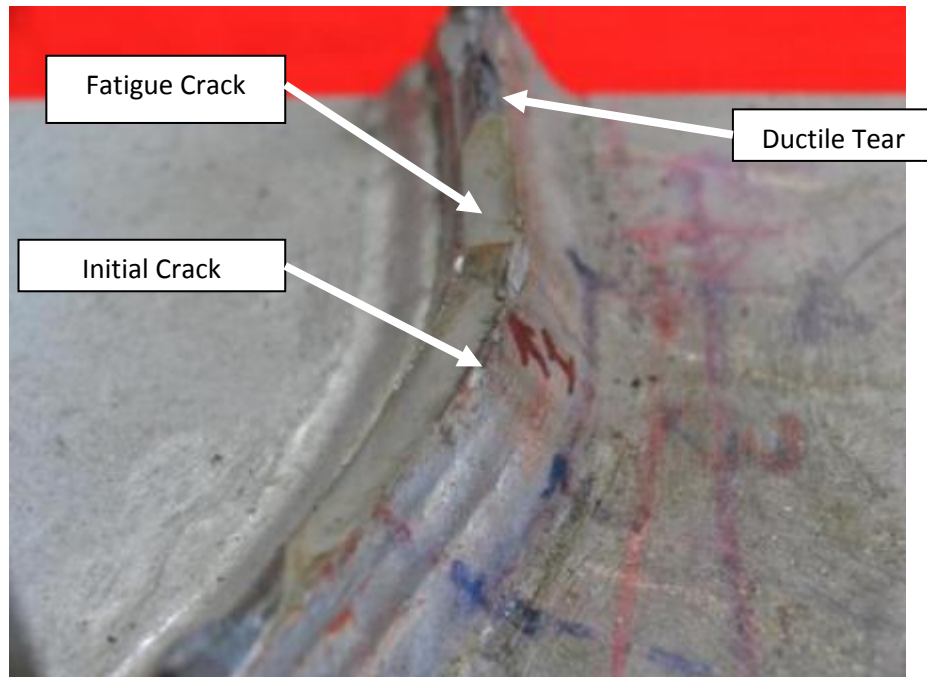
Figure 4.17 Bend 3 of Specimen 33-3-12-TX-VG-A

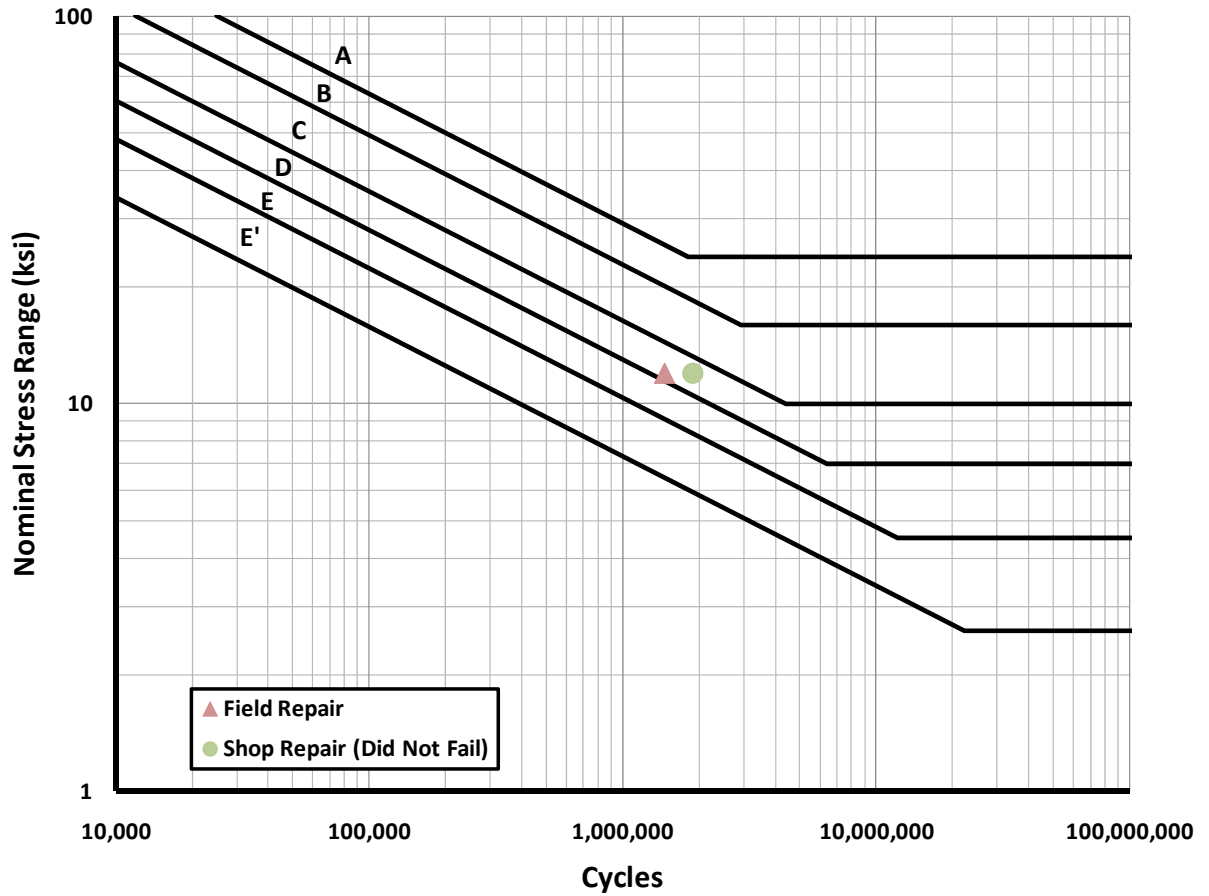
This failure occurred after 1,467,734 cycles, which places the Field Repair specimen in the D category, and shows a substantial improvement from the fatigue strength of the specimen prior to weld repair. This type of failure also progressed much slower than previous failures. The crack became visible after approximately 600,000 cycles, but no substantial loss in stiffness occurred until just before failure. The slow rate of propagation is possibly due to the fatigue cracks progressing through the thicker weld profile instead of the thinner shaft. This slow loss of stiffness highlights another advantage to the use of the weld repairs: visible cracks can be found long before the system is likely to fail.

The Field Repair specimen was rotated and testing was restarted. Testing was stopped after 1,893,306 total cycles had been applied to the Shop Repair specimen. No cracks were found in the shop repair specimen when ultrasonically inspected at the end of the test. The test was stopped because the number of cycles to which the specimen had been subjected indicates a

substantial improvement in the fatigue strength compared to the galvanized specimen without the weld repair. It was also believed that the stress range that the test was running at was too low to fail the specimen, which would lead to the specimen being termed a “run out” and would indicate that the specimen is at least a category D, if not better. Figure 4.21 displays these results on an S-N plot.

Figure 4.21 S-N Plot of Weld Repair Specimens

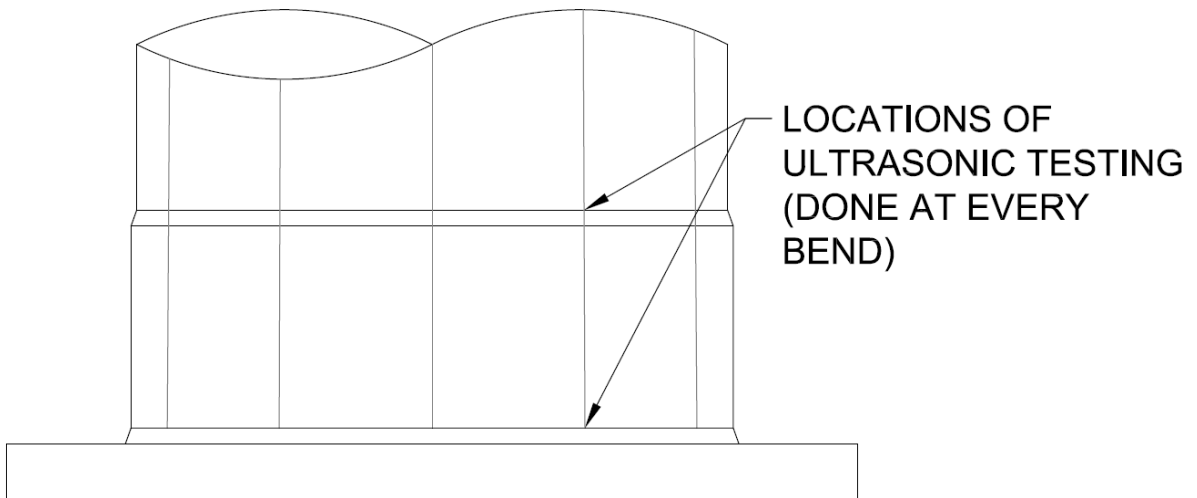
Ultrasonic testing was first performed on the specimens by a trained TxDOT inspector. Both the connection of the collar to the base plate and the connection of the collar to the pole were inspected. No crack indications were found at the connection of the external collar to the pole. Figure 4.22 shows the locations that were inspected and Figure 4.23 displays the results of this inspection. The inspector did note that typical crack depths were around  $\frac{1}{16}$ " , shallower than on the specimens without external collars.

Figure 4.22 Locations Inspected Using Ultrasonic Testing on External Collar Samples

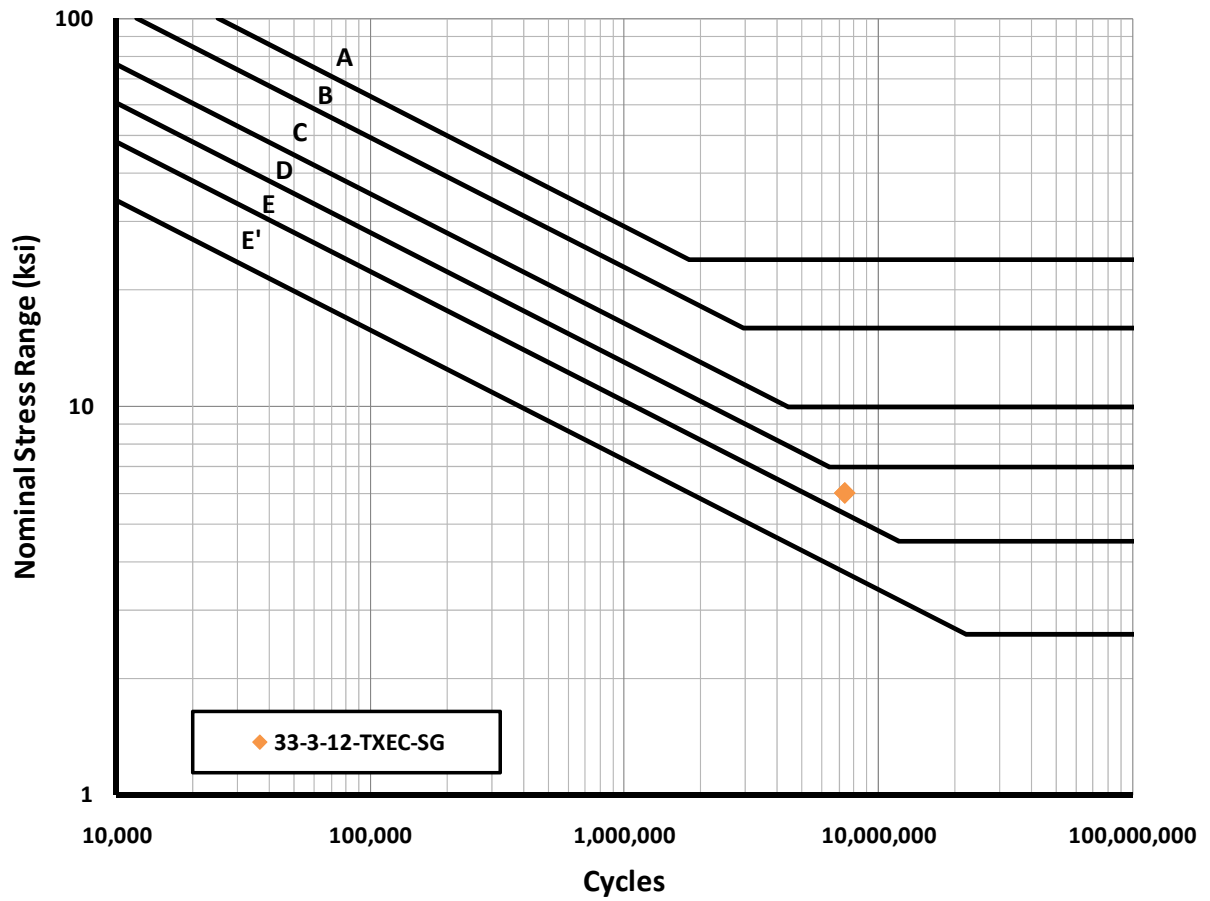
The samples ran for 7,374,384 cycles. There was no noticeable drop in stiffness or visible cracks. The test was stopped and determined to be a “run out”, meaning that the stress range was too low to cause fatigue damage on the specimens and giving the specimens at least a Category E rating. Ultrasonic testing afterwards confirmed this as only the original initial crack indications were found. Figure 4.24 shows where these specimens fall on an S-N plot. Note that, as before, both specimens are denoted by a single data point.

Figure 4.24 S-N Plot of External Collar Samples

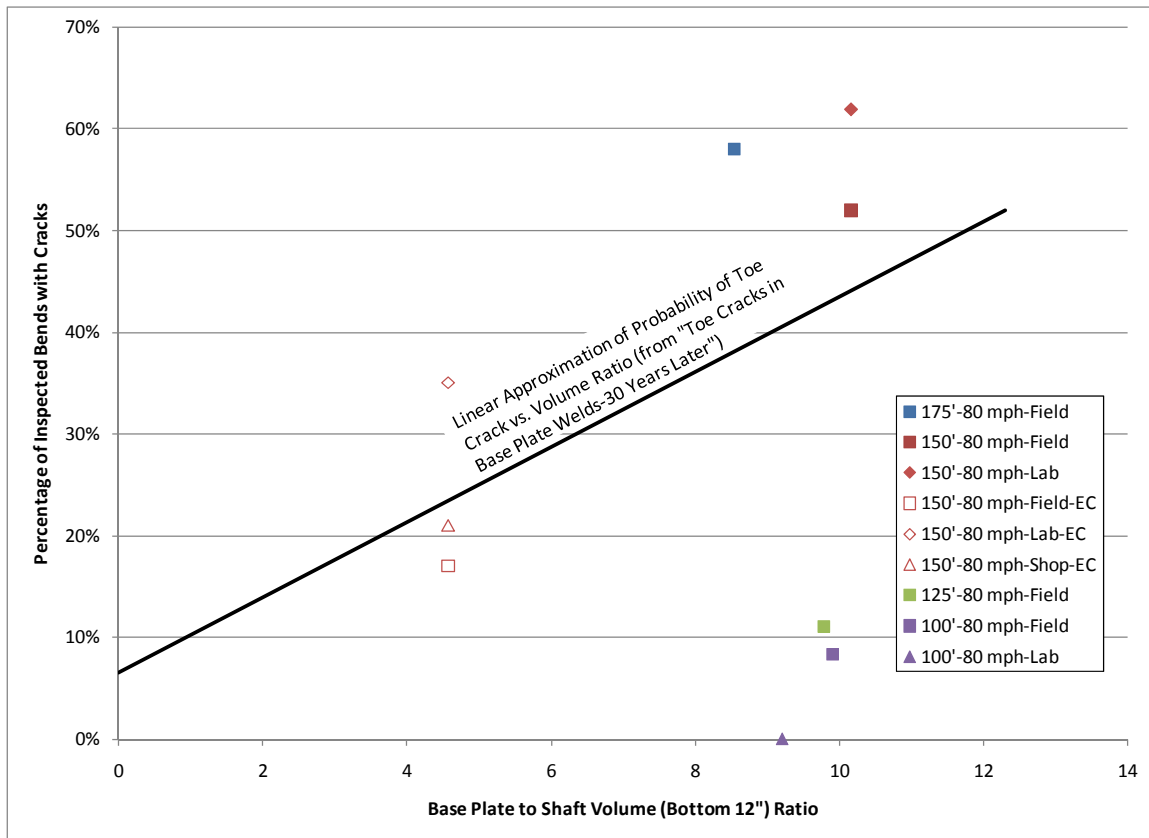
A comparison of volume ratio to crack probability is shown in Table 4.3. "EC" on the graph stands for poles with an external collar. Included in this is a linear approximation of the probability of toe cracks vs. volume ratio from Aichinger and Higgins (2006) discussed in Chapter 1. From this graph, a slight trend can be seen following what the Valmont paper had predicted. This is evident in the larger 150' and 175' design poles, but the trend is not followed by the two smaller designs.

Table 4.3 Percentage of Cracks Found Compared to Ratio of the Volume of the Base Plate to the Volume of the Shaft

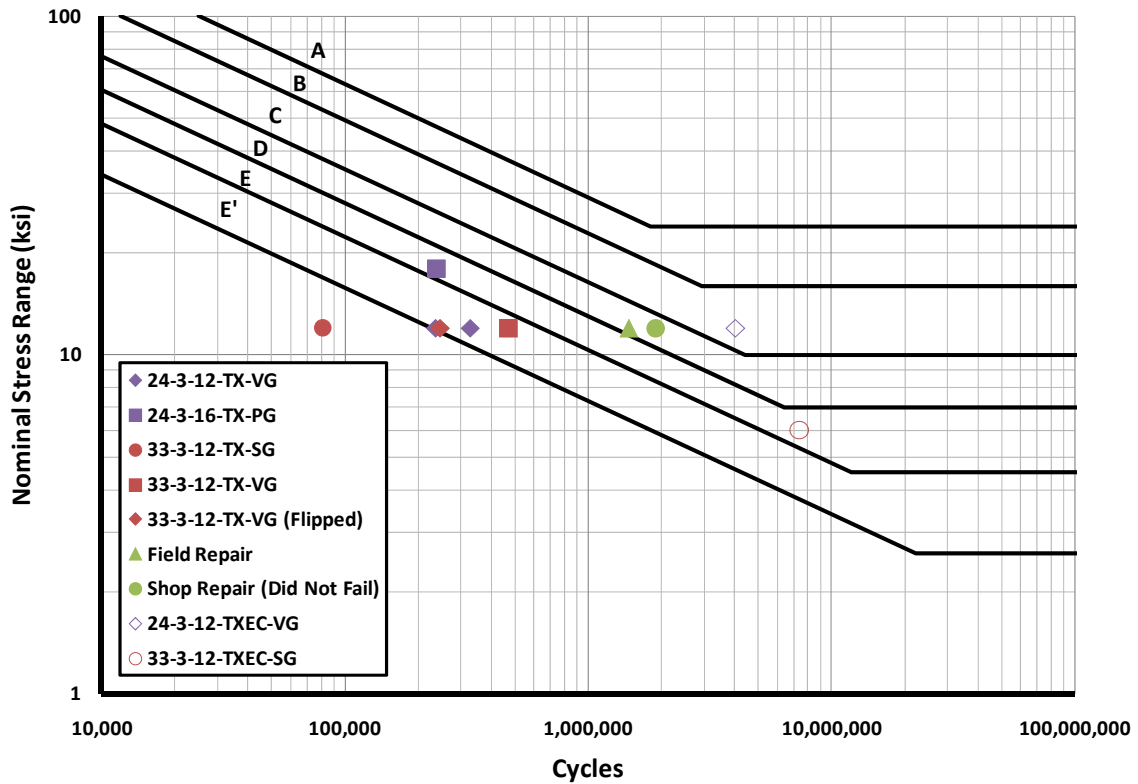
Figure 4.30 shows the results of all of the specimens' fatigue tests plotted on one S-N plot. AASHTO fatigue design curves are included for reference. The AASHTO Specification places these details as Category E fatigue details. It is evident from curve that only the repaired specimens and the external collar specimens were able to attain this fatigue life, indicating that the AASHTO Specifications are possibly unconservative.

Figure 4.30 S-N Plot of All Specimens

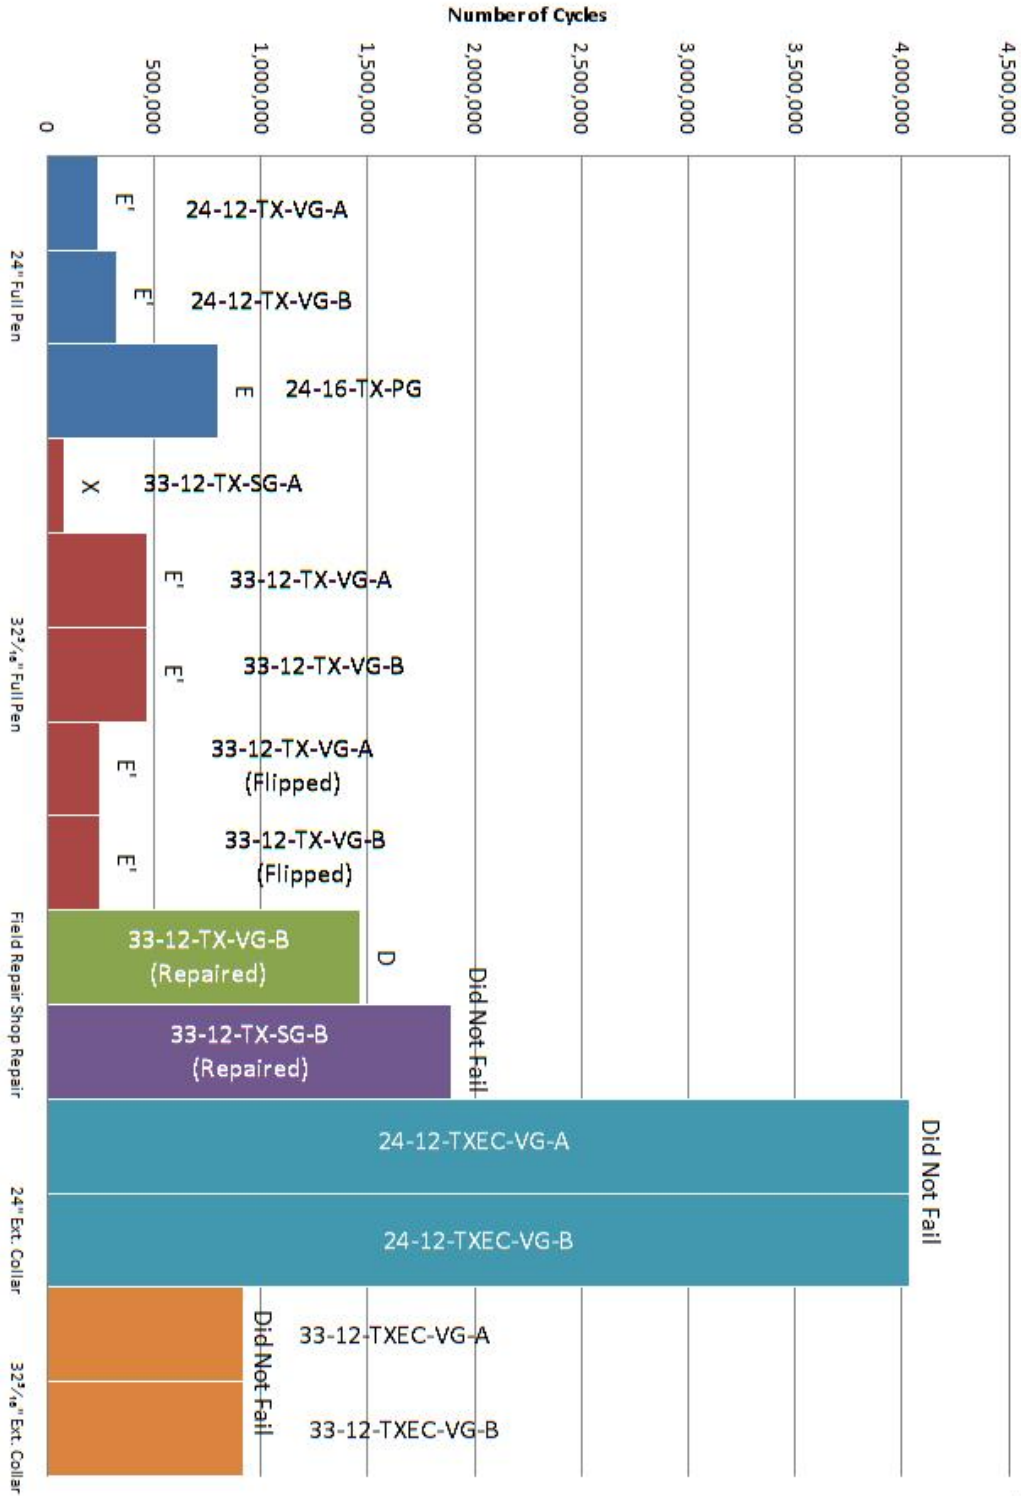
The bar chart in Figure 4.31 is another way of showing these results. The number of cycles has been normalized for a 12 ksi stress range to aid in comparison between specimens. From this chart the beneficial effects of adding an external collar or performing weld repairs can clearly be seen.

Figure 4.31 Fatigue Results by Specimen Normalized for 12 ksi Stress Range
