**Full-Scale Bending Fatigue Tests on Stay Cables**

**Thesis**

The University of Texas at Austin

**December 2001**

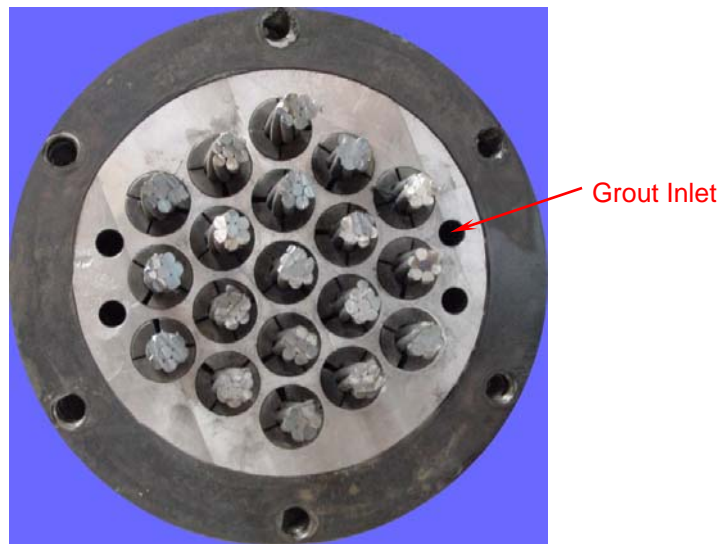
*Figure 3-30: Anchor Head Orientation –Specimen #1*

The anchor head was orientated with the four grout inlets and outlets placed on the side of the anchor head as shown in Figure 3-30. This orientation of the anchor head might have caused a grout void at the tower end of the stay. However, there are no mechanical aids on the bridge anchorage that ensure correct placing of the anchor head nor is there a special note on the drawings. Furthermore, it was found that some of the larger stays on the Fred Hartman Bridge have grout outlets within the strand pattern. This means that there are always strands above the grout outlet, very similar to the configuration in test #1.

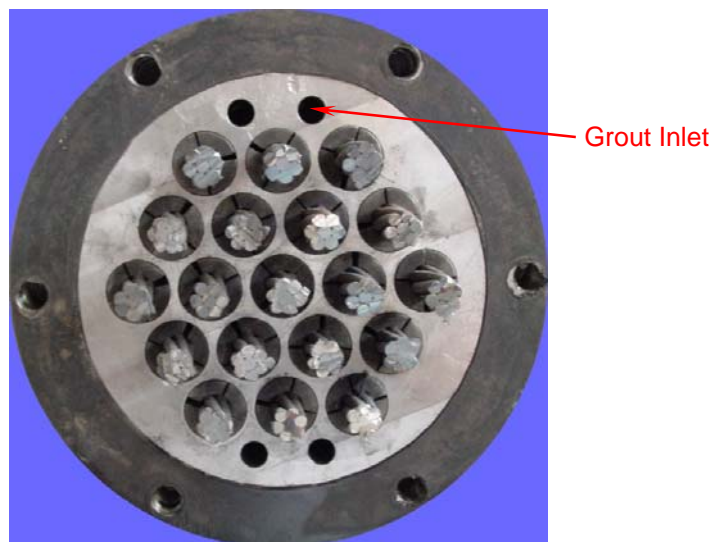
*Figure 3-32: Anchor Head Orientation – Specimen #2*

The anchor head was orientated with the grout inlet and outlet at the top and bottom of the anchor head as shown in Figure 3-32. This orientation resulted in a fully grouted specimen without any major voids. However, it is unclear whether the orientation of the grout ports is the only reason for the grout void which occurred in specimen #1.

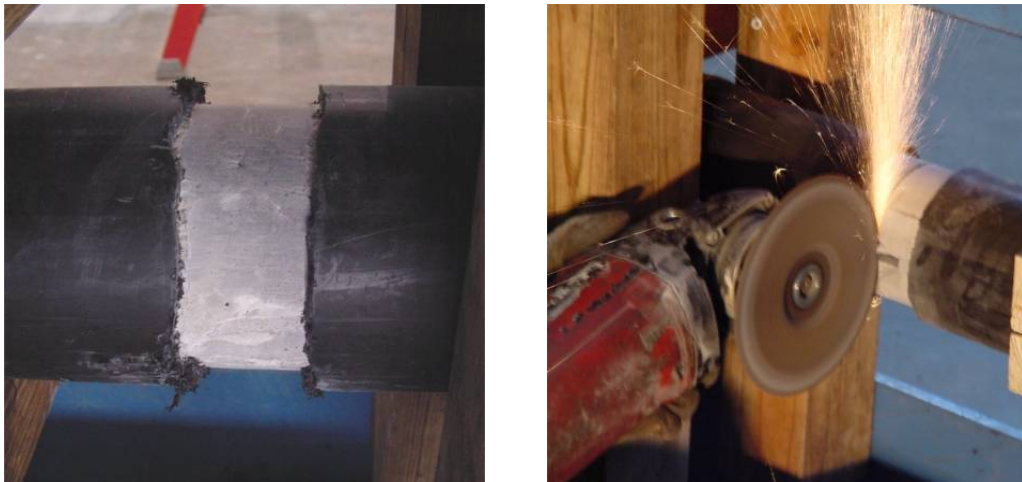
*Figure 4-1: Cutting of the Specimen*

After the fatigue test was performed, the ram was disconnected and a post mortem investigation (autopsy) was performed. The specimen was cut into five 7-ft (2.1-m) segments in two steps: first a 1-in. (25-mm) ring was cut out of the PE pipe using a router, and then the grout and strand were cut using a disc grinder as shown in Figure 4-1.

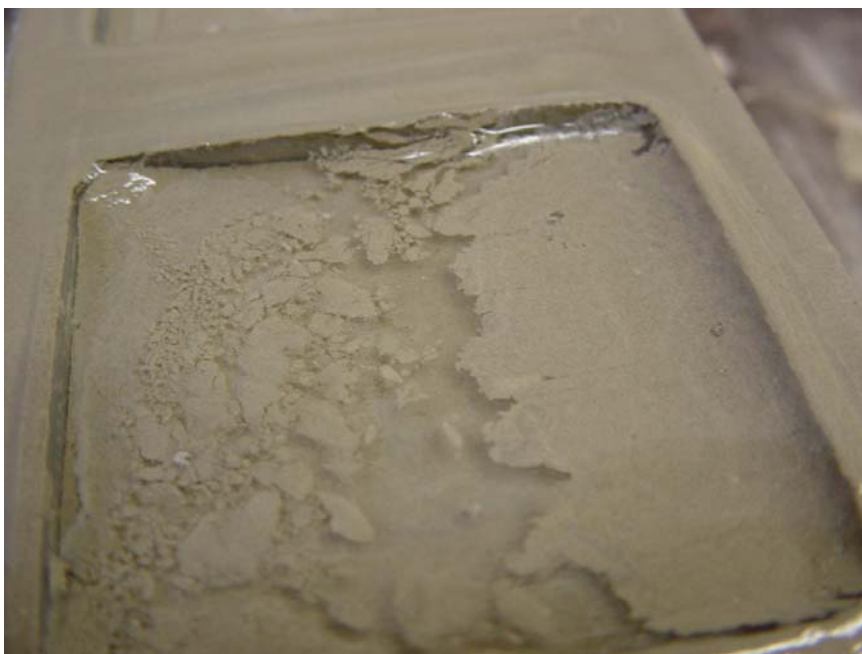
Large amounts of bleed water were observed on all 6 test-cubes that were taken at the end of the grouting operation. Figure 4-4 shows the bleed water that had accumulated at the surface of the 2 x 2 x 2 in. (50 x 50 x 50 mm) test cube about one hour after the grouting operation. The bleed water had evaporated 12 hours after the cubes had been cast and a solid coupon remained. The discharge of bleed water resulted in test coupon with dimensions of 2 x 2 x 1.75 in. (50 x 50 x 45 mm). The surface of the test coupons had no visual imperfections.

*Figure 4-4: Bleed Water on the Surface of a Test Cube*

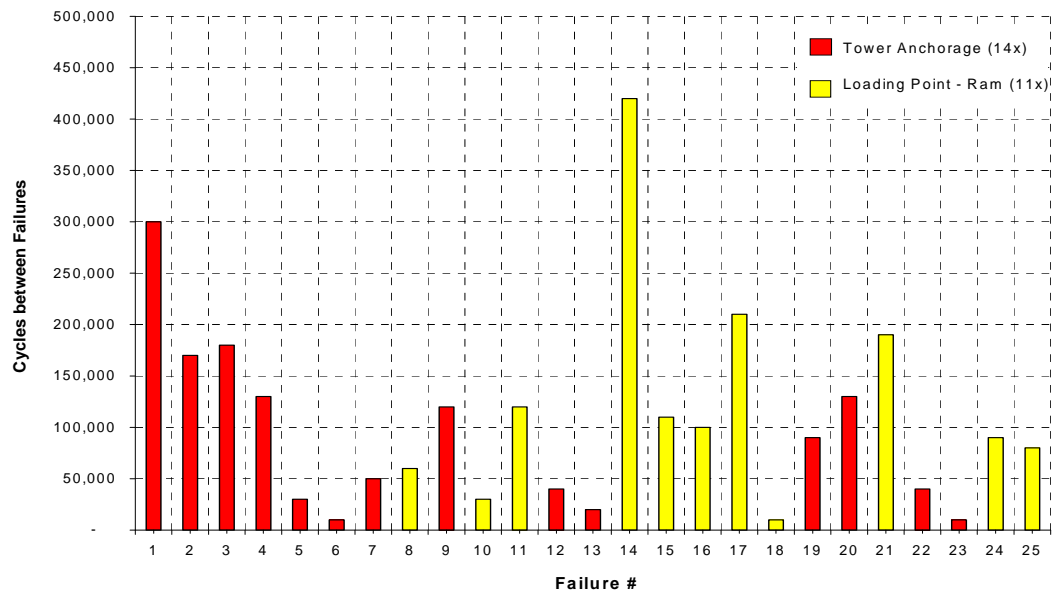
The number of cycles between the individual failures based on Soundprint (see Section 4.6) is shown in Figure 4-14. The first break occurred at 300,000 cycles, where after wire breaks occurred in intervals between 10,000 and a maximum of 240,000 cycles. The fatigue test was stopped after 2,808,398 cycles.

**Figure 4-14: Cycles between Failures (based on Soundprint) – Specimen #1**

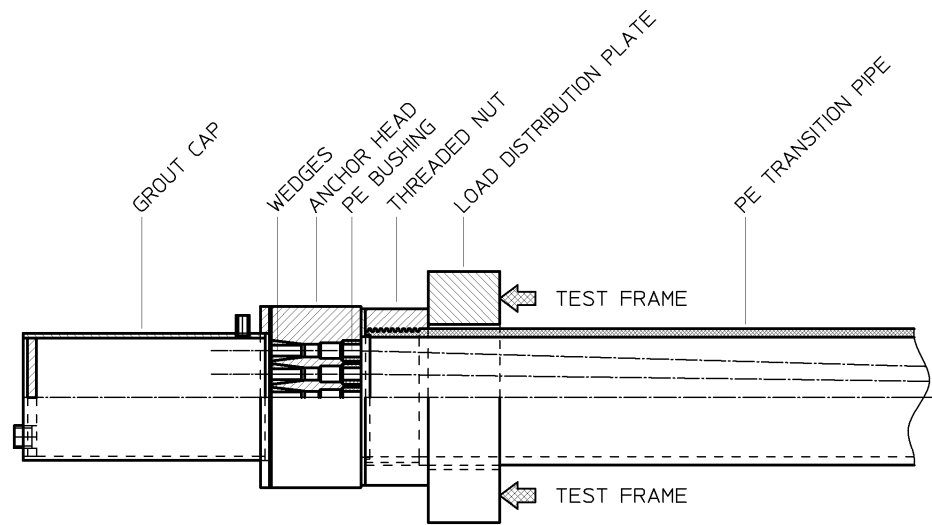
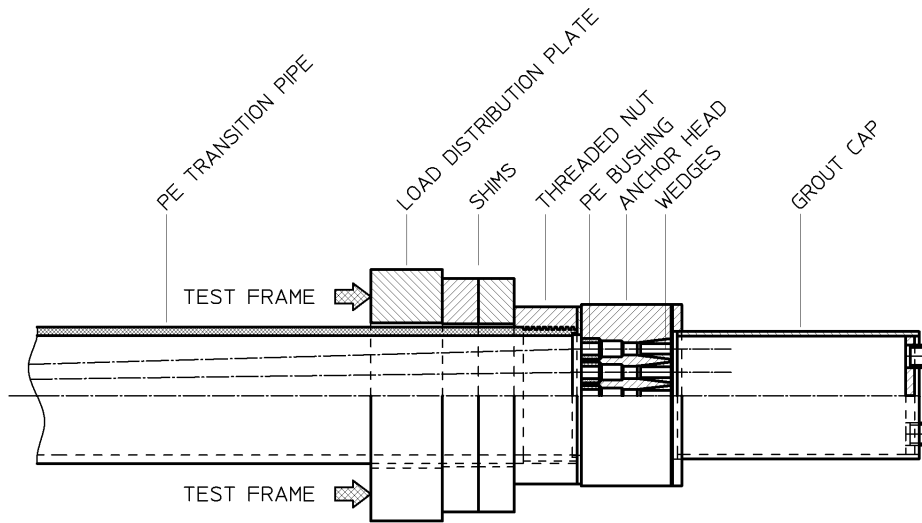
**Figure 4-16: Anchorage Detail**

Figure 4-17 shows the longitudinal location of the wire breaks. Two of the total of 6 breaks that occurred within the grout void occurred just past the anchor head. The strands that were fully exposed within the grout void were surrounded by grout and therefore confined within the opening in the anchor head. All 7 breaks on strand #19 occurred just inside of the threaded nut. Within the threaded nut the PE Pipe is threaded into the nut that stiffens the stay cable. A close up of this region is shown in Figure 4-16.

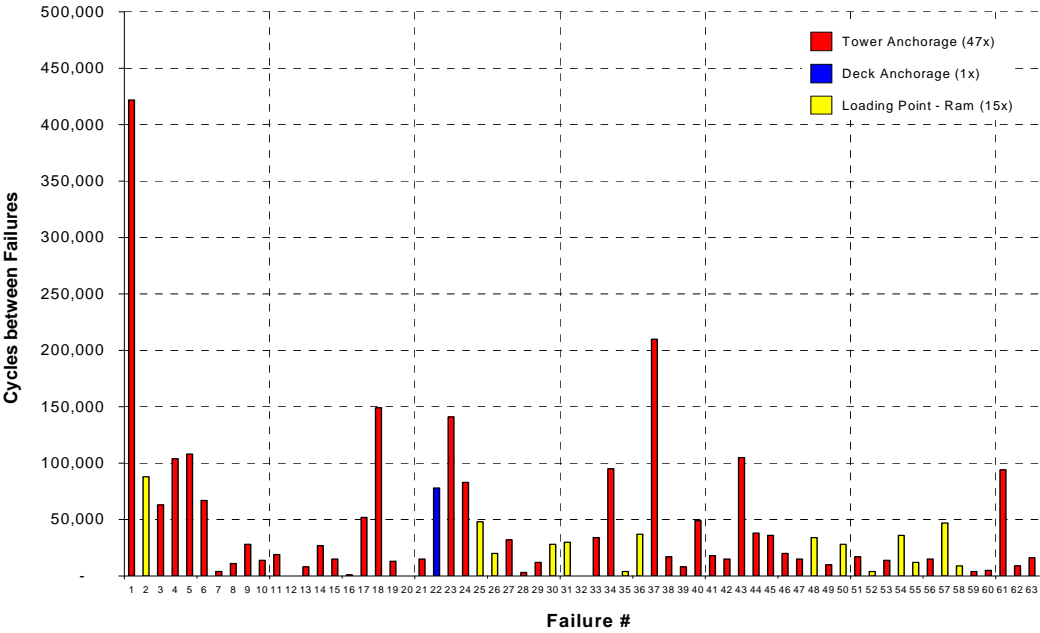
The number of cycles between the individual failures, detected by Soundprint, is shown in Figure 4-25. The first wire break occurred at 420,000 cycles, where after wire breaks occurred in intervals between 1 and a maximum of 210,000 cycles. The fatigue test was stopped after 2,865,103 cycles.

**Figure 4-25: Cycles between Failures (based on Soundprint) – Specimen #2**

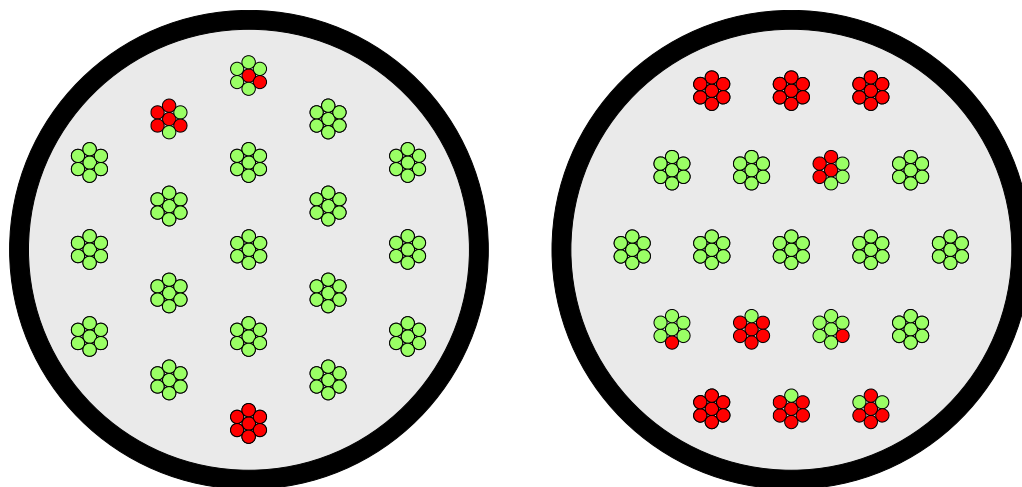
As expected in a bending fatigue test, all the breaks occurred at the outer fibers of the cable cross-section where the bending stress ranges are highest. The orientation of the strands was different for the two specimens as described in Chapter 3. However, assuming a fully composite cross section, both specimens have the same moment of inertia and therefore stiffness. The maximum outer fibers of specimen #1 are on strands #1 and #19 and are 2.9 in. (74 mm) away

from the neutral axis of the stay. The outer fibers of specimen #2 are on strands #1, #2, #3, #17, #18, and #19 and have a maximum distance of 2.5 in. (64 mm) from the neutral axis.

**Figure 4-35: Strand Orientation and Wire Breaks for Specimen #1 and #2**

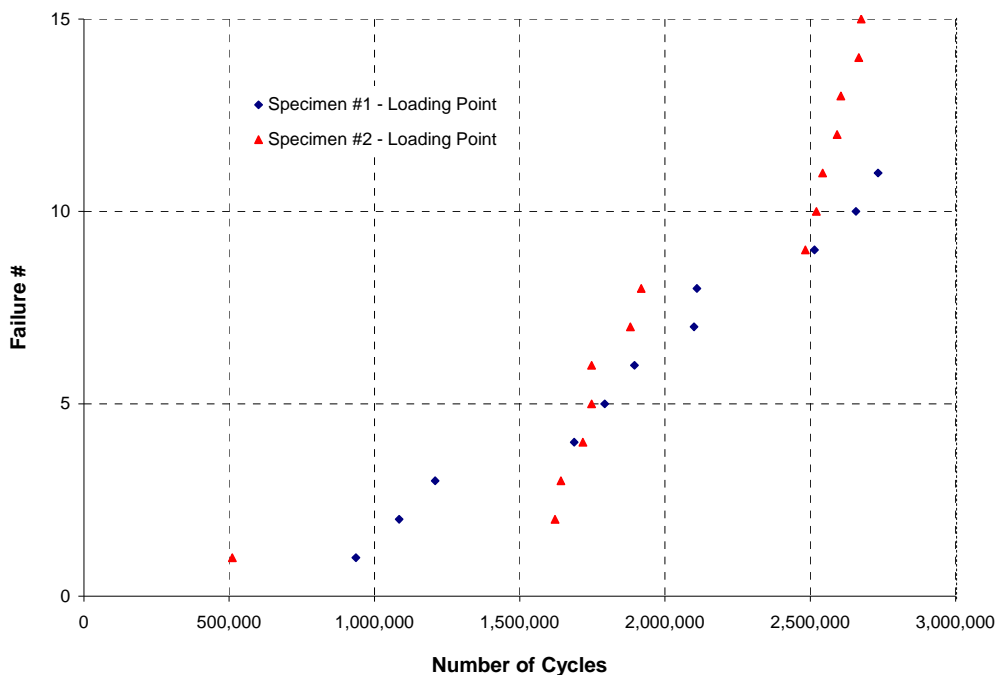
Figure 4-36 and Figure 4-37 show the cumulative number of wire breaks under the loading point and at the tower anchorage versus the number of cycles. Note that there is a reasonably constant rate of occurrence of wire breaks once the first break was initiated. The data from the two specimens under the loading point compare very well for a fatigue test. The data at the tower anchorage are similar below 800,000 cycles. After roughly 800,000 cycles, the number of failures on specimen #2 starts increasing drastically, which might be because of the larger number of strands exposed to a relatively higher stress range.

**Figure 4-36: Cumulative Number of Failures vs. Cycles – Loading Point**

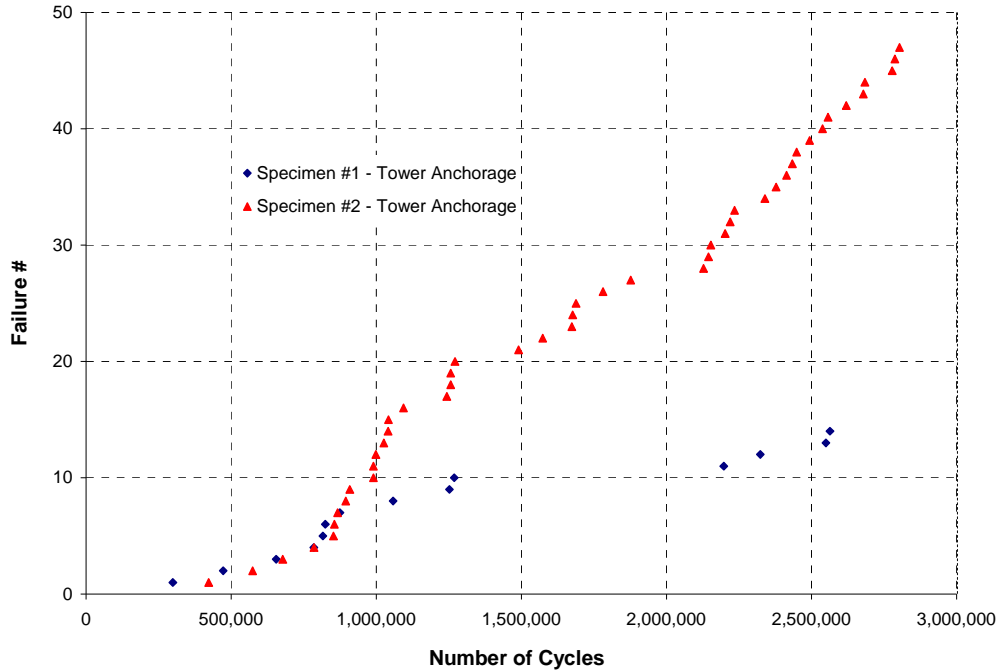
**Figure 4-37: Cumulative Number of Failures vs. Cycles – Tower Anchorage**

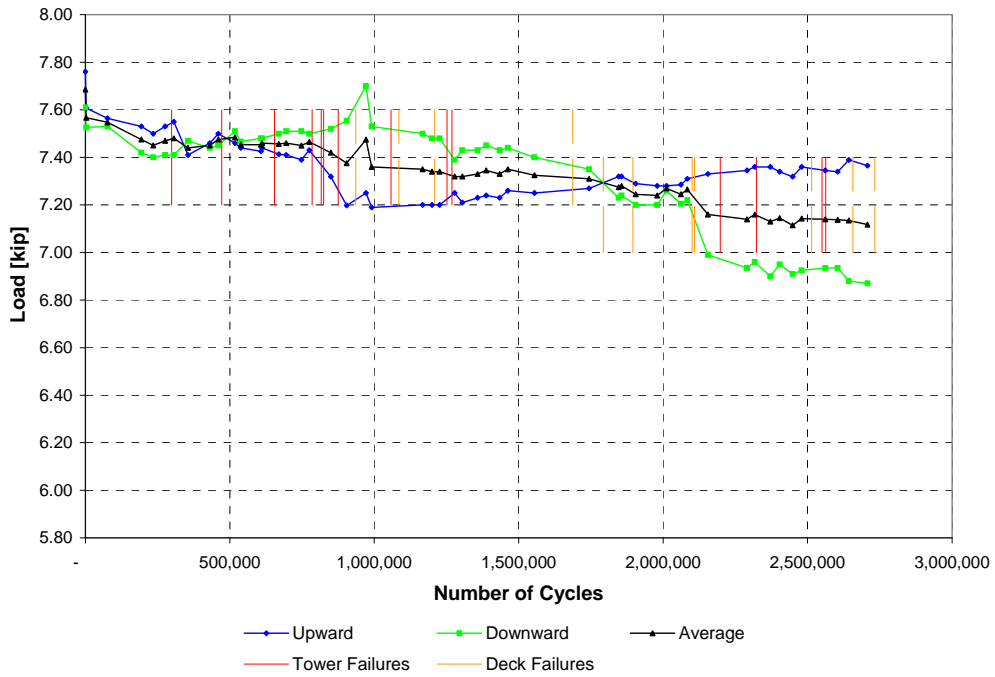
Figure 4-38 and Figure 4-39 show the peak loads to get to the required displacement versus number of cycles. The average of the forces for the upward and the downward forces can be reasonably approximated as a straight line for specimen #1 and a quadratic curve fit for specimen #2 as shown Figure 4-40 and Figure 4-41.

Note that specimen #1 has a larger drop in load at the beginning compared with specimen #2. This first reduction is believed to be because of possible grout cracking and possibility further wedge seating. The loads started to reduce continuously after wire breaks started to occur. It should be noted that it was not possible to detect a single wire breakage event based on the reduction in stiffness. This is because the change in load after a wire break occurred was generally too small to detect reliably. However, certain individual wire breaks lead to a very significant change in load. This might be because these particular breaks were the last wires of a particular strand.

**Figure 4-38: Number of Cycles vs. Load – Specimen #1**

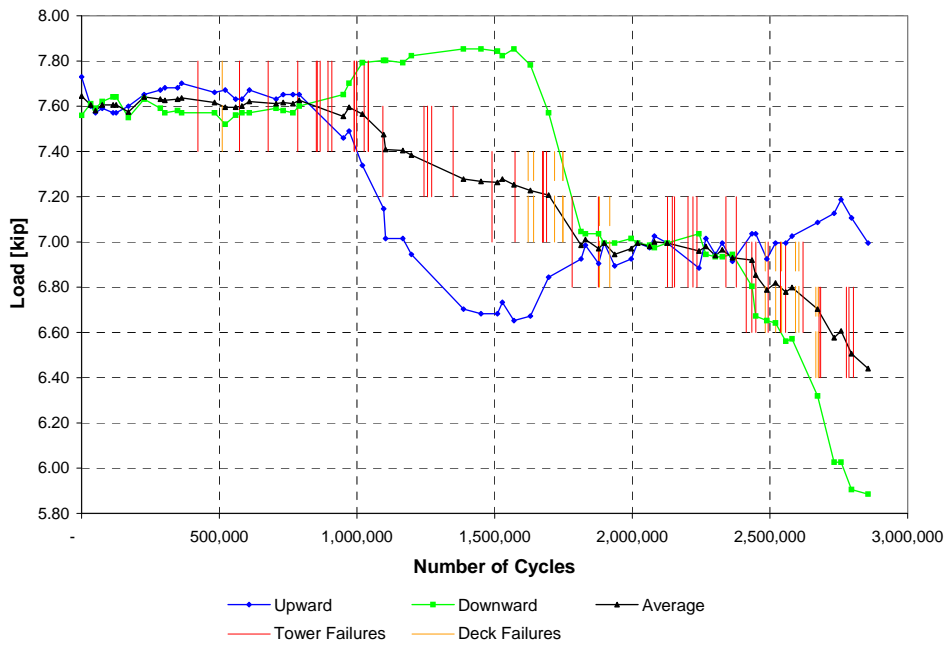
The accelerated reduction in stiffness observed on specimen #2 might be related to the larger number of failures that occurred during the test. It can be observed that the load to attain the displacement dropped significantly over the testing time, which indicates a reduction in stiffness. Both specimens showed a noticeable first drop in stiffness after the first couple of cycles.

**Figure 4-39: Number of Cycles vs. Load – Specimen #2**

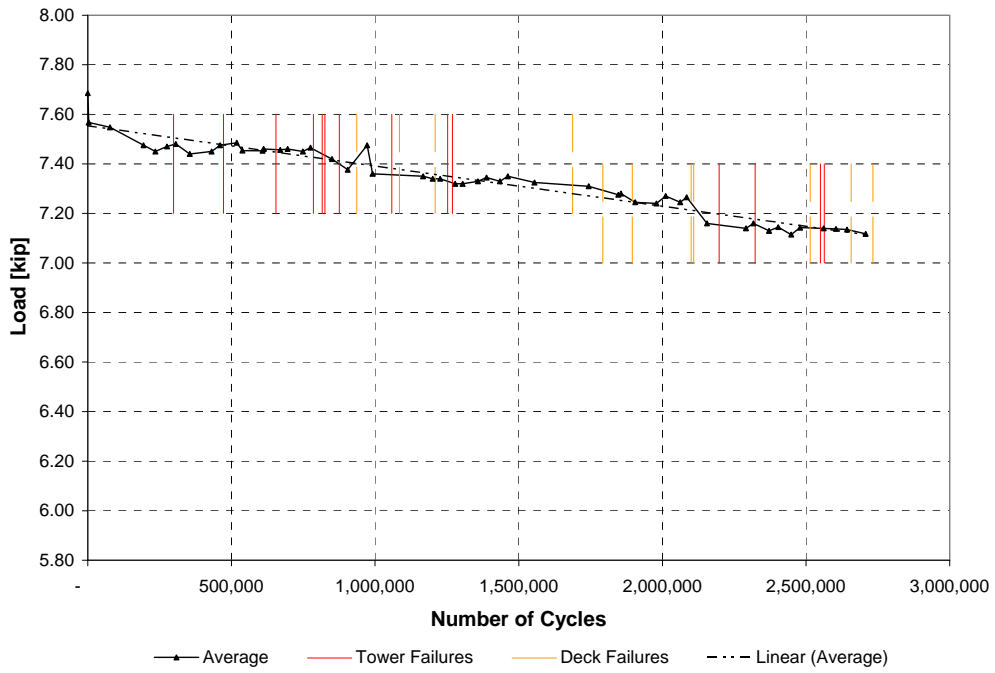
**Figure 4-40: Number of Cycles vs. Average Load – Specimen #1**

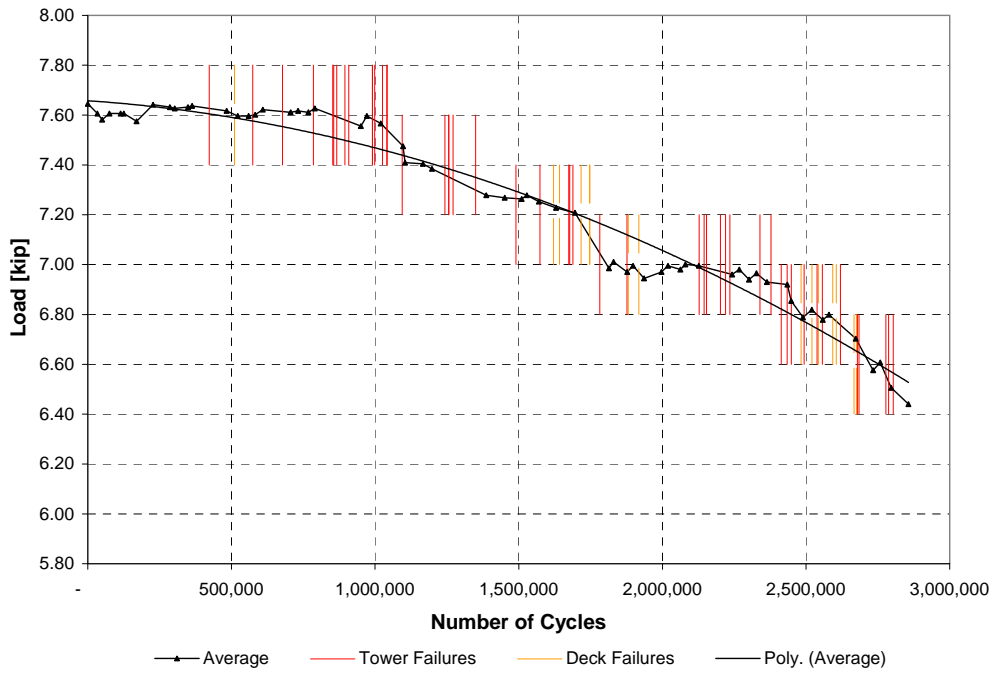
**Figure 4-41: Number of Cycles vs. Load – Specimen #2**

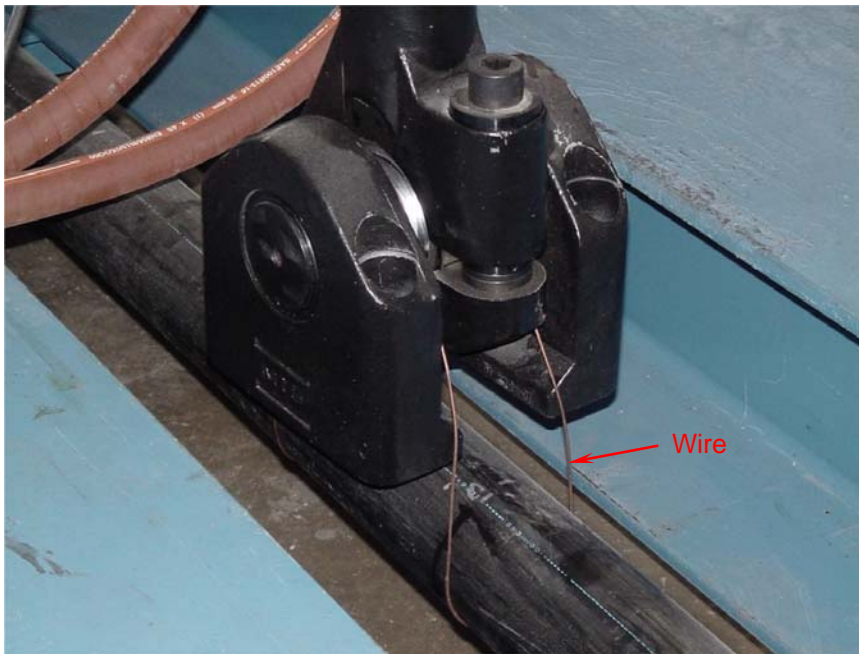
Pluck tests on the stay cable specimen were performed at the beginning and at the end of the fatigue test on specimen #2 and at the end of the fatigue test on specimen #1. They were used to determine the natural frequencies of the stay. The tests were performed by pulling up the specimen at mid-span with a weak link, a wire, which was attached to a pulling device – either the crane or the actuator used in the fatigue test (Figure 4-42). A sudden fracture in the link while the stay was continuously lifted led to free vibration. The estimated deflection of the cable specimen was roughly 0.75 in. (20 mm) just before fracture of the link occurred. The frequency data of the specimen were recorded using the 4 acoustic sensors provided by Soundprint. An FFT was performed to obtain the characteristic frequencies. The resulting natural frequencies for both specimens are given in Table 4-1. Based on the limited data, it is believed that the intact stay cable specimen has a natural frequency of roughly 12.5 Hz for the first mode.

**Figure 4-42: General Setup for a Pluck Test**

The natural frequencies determined at the end of the test are lower because of the wire fractures that occurred during test. Every wire fracture lowers the tension force in the stay and therefore the frequency of the specimen. The difference in the frequency at the end of the test between the two specimens is because a larger number of wire breaks occurred on specimen #2.

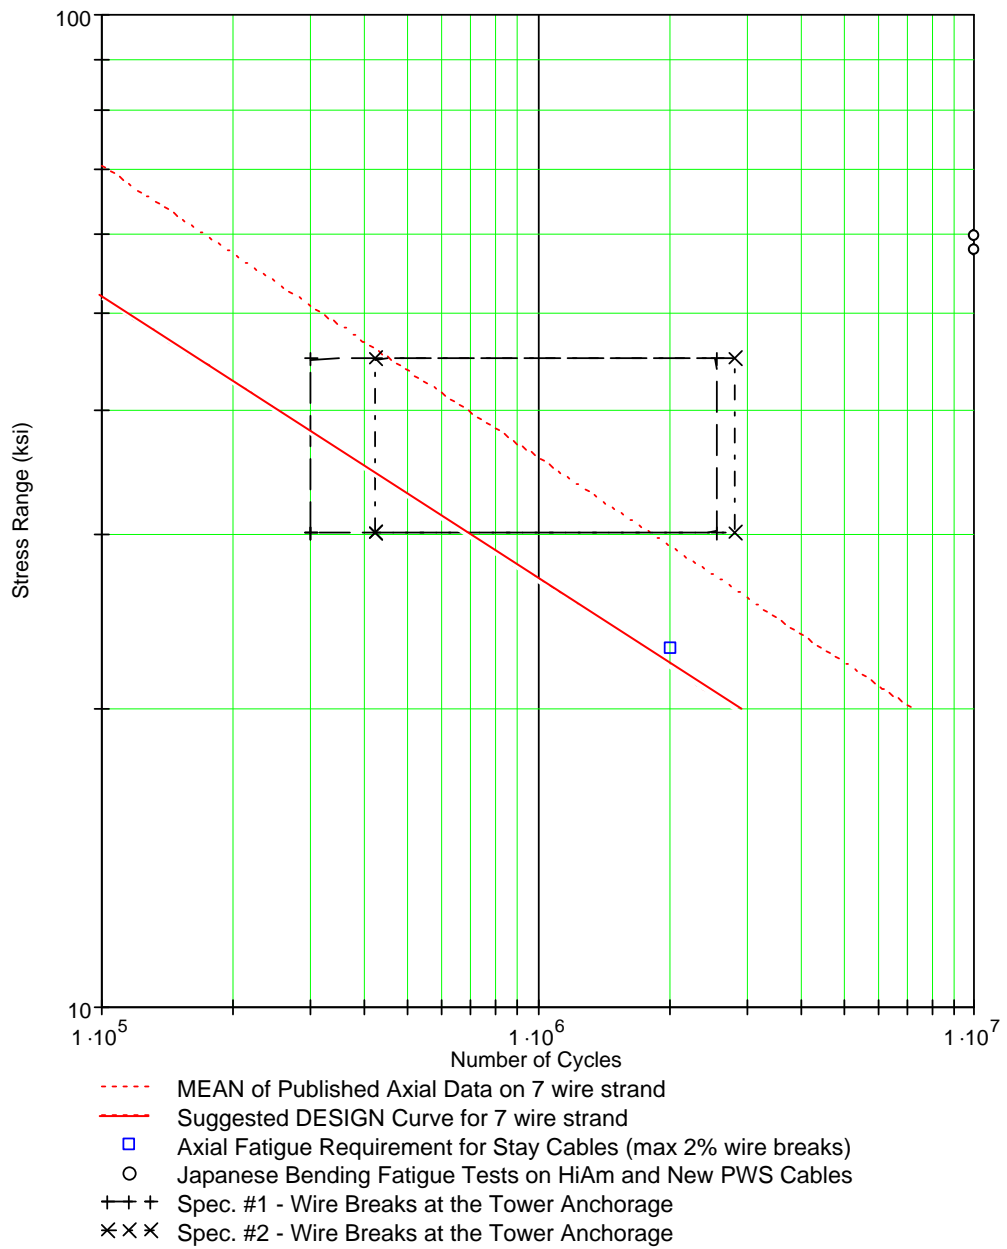
A comparison of the FEM estimated stresses and the number of cycles for which wire breaks occurred at the tower anchorage are shown in an S-N plot in Figure 5-1. The graph shows the mean value of published axial fatigue data, a suggested design equation for strand, the axial fatigue requirement for stay cables, the Japanese bending fatigue test (all discussed in Chapter 1), as well as the results from the two bending fatigue tests. As mentioned before, the lower and upper bound of the stress range from the FEM were between 30 and 45 ksi (200 N/mm<sup>2</sup> and 310 N/mm<sup>2</sup>). The first break at the tower anchorage of specimen #1 occurred after 300,000 cycles and the last (14<sup>th</sup>) after 2,550,000 cycles. The corresponding values for specimen #2 are 420,000 cycles for the first break and 2,800,000 cycles for the last (51<sup>st</sup>) break. Although the stress range cannot be defined as a single value at this point, the test results compare reasonably well with the existing axial fatigue data.

**Figure 5-1: Comparison with Existing Fatigue Data**
