**EVALUATION AND REPAIR OF IMPACT DAMAGED PRE-  
STRESSED CONCRETE BRIDGE GIRDERS**

**Dissertation**

**The University of Texas at Austin**

**May 1996**

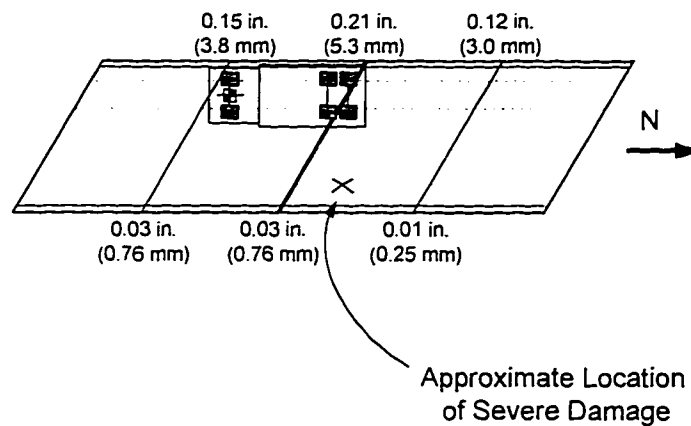
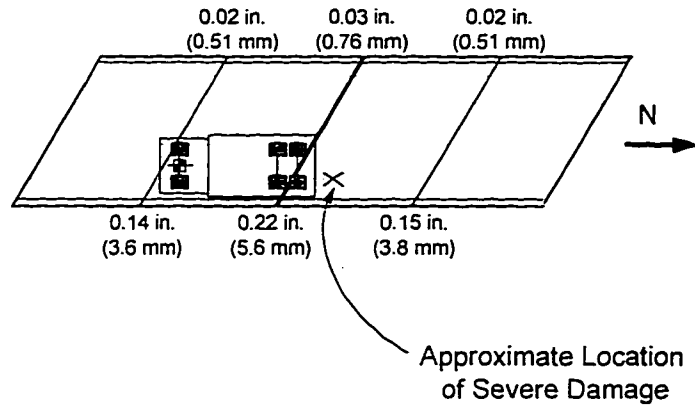
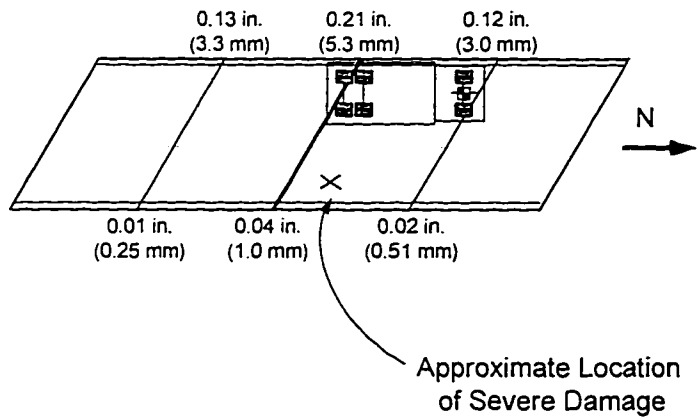
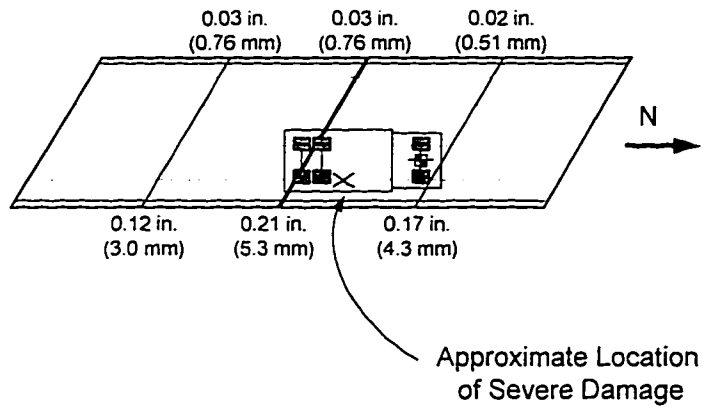
Concerning only the damaged span (north interior span), several observations can be made about the results of the in-situ load testing. The most interesting observation is that very little difference in centerspan displacement was observed for the different vehicle locations (load tests 1 through 4). The magnitude of this displacement ranges from 0.21 in. (5.3 mm) to 0.22 in. (5.6 mm). Since the most severe damage occurred for girder number 1 just north of midspan, it might be expected that the centerspan displacement would be largest for load tests 2 and 4. This is not the case, as is shown in Figures 2.32 and 2.34. There was little difference in the load-deflection response at midspan even though the damage was much more severe on the east side at girder 1. Comparing the displace-

ments at the north and south quarter points, again very little difference in response was measured when the load was placed at the northwest and southwest locations (load tests 1 and 3, Figures 2.31 and 2.33 respectively). However, when the vehicle was placed at the northeast and southeast locations (load tests 2 and 4, Figures 2.32 and 2.34 respectively), there does appear to be a slight unsymmetric response with respect to the quarter point displacements, a maximum difference of 0.02 in. (0.51 mm). When the load was placed at the southeast location (load test 2 Figure 2.32) the displacement at the northeast quarter point was observed to be larger than at the southeast quarter point where the load was located. It appears that the unsymmetric nature of the observed displacements is consistent with the unsymmetric nature and location of the damage; the girder that was most severely damaged was girder 1 and this damage occurred north of centerspan where the observed quarter point displacements were largest. It should be noted, however, that the measured displacements were on the order of  $1/5000^{\text{th}}$  of the span length, well within acceptable limits for serviceability and functionality of the structure even in the damaged state.

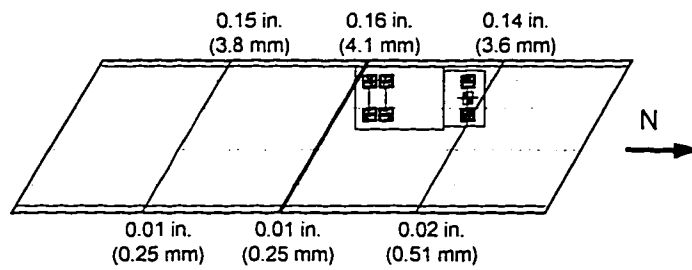
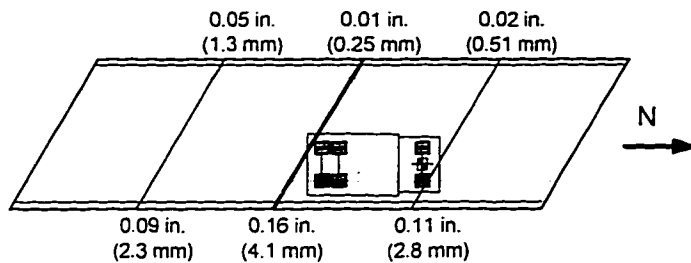
was 0.16 in. (4.1 mm), compared to the displacement of the damaged span of 0.22 in. (5.6 mm), a difference of approximately 1/16<sup>th</sup> of an inch (1.5 mm). To summarize the results of the in-situ load tests performed on the Waelder bridge, it is apparent that although severe damage occurred as a result of vehicle impact, the overall serviceability of the structure remained intact, and therefore repairs could be performed to extend the service life of the structure.

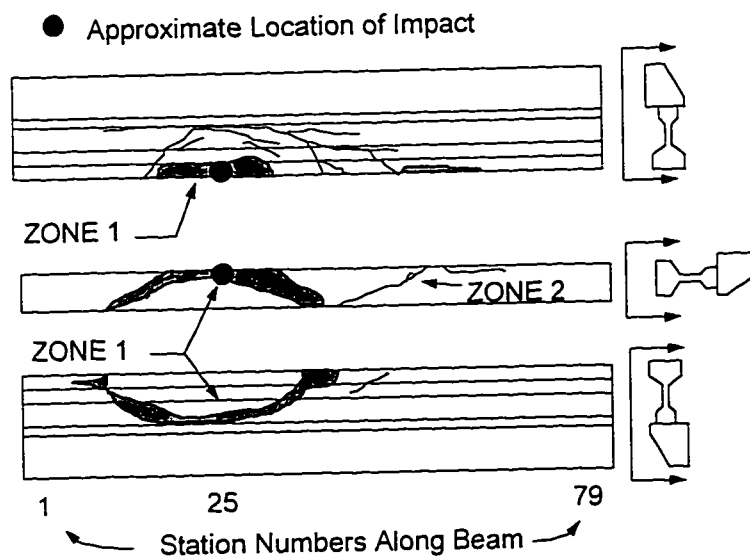
Figure 4.5 Schematic of Impact Damage of Steel Girder

For the purposes of this discussion, the damaged areas have been grouped into two distinct zones. Figure 4.5 shows a schematic of both sides and the bottom of the girder, illustrating the observable damage as well as the station numbering used for nondestructive tests. Severely damaged and spalled regions are indicated by hatching and the zone of direct impact is indicated by a large black dot.

The first damaged zone is located in the area of direct impact and consists of a group of concentric cracks extending from the lower flange up to the interface between the web and upper flange. There were several large spalled areas as well as several exposed prestressing tendons on both sides of the member on the bottom flange (refer to hatched zones in Figure 4.6). On the nonimpacted side a large delaminated zone of the web was located directly opposite the zone of impact. It appears that the impact resulted in a shear failure whereby a D-shaped region of the web and lower flange cracked completely through the member and the lower flange was horizontally offset approximately 1/2 to 1 in. (13 to 25 mm). The exposed

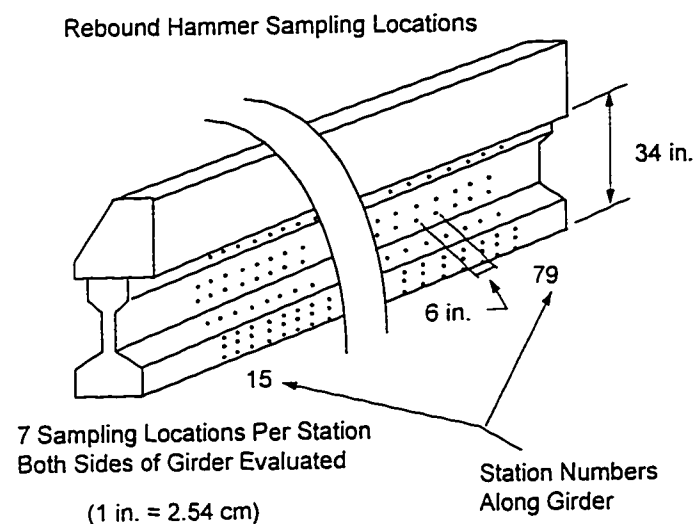
Figure 4.8 Schematic of Rebound Hammer Testing Locations for Damage Assessment of Steck Girder

hammer was not within specified calibration parameters, it was disassembled, cleaned, lubricated, reassembled, and the calibration checked again. Measurements were taken at stations spaced at 6-in. (15-cm) along the length of the girder. At each station eight locations were tested on each side of the girder as shown in Figure 4.8, for a total of sixteen locations per station as follows: one at mid-height of the top flange, one at mid-height of

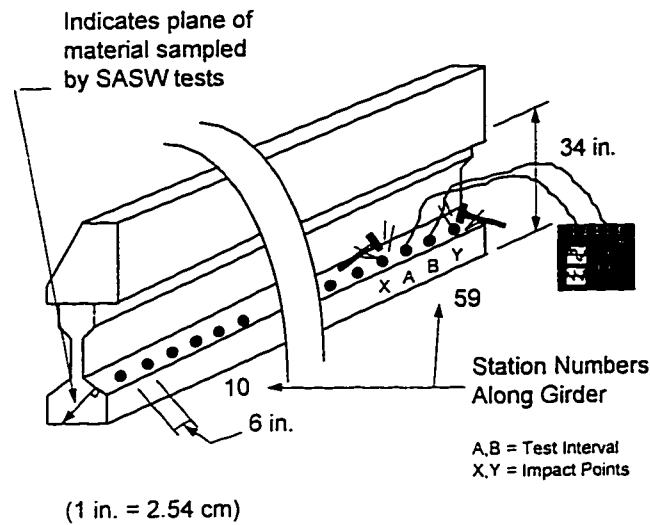
Figure 4.10 Schematic of SASW Testing Locations for Damage Assessment of Steel Girder

Measurements for the SASW method were recorded using each pair of adjacent station intervals as shown in Figure 4.10. Again, the same 6-in. (15-cm) stationing was used for SASW evaluation of the damaged girder. Only grid points located along the haunch of the bottom flange were used for SASW evaluation. Sampling was performed by placing accelerometers at adjacent stations (points A and B in Figure 4.10), and impacting the concrete surface at stations X and Y one interval from opposite ends of the A-B interval shown in Figure 4.10. Five acceleration records were taken at each location on each side of the test interval, and the results averaged.

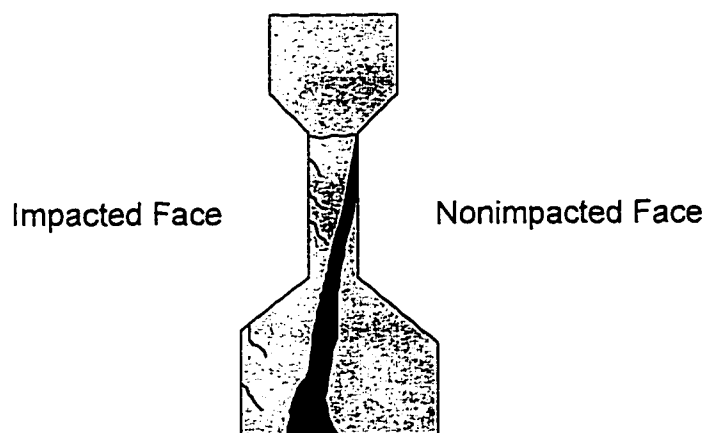
On both sides of the girder the zone of delaminated and fractured material is very clearly defined by rebound measurements; however, damage that occurs deeper in the member or on the opposite side cannot be detected (refer to zone 1 in Figure 4.6 and Figures 4.11 and 4.12). Comparing the rebound values with the photographs in Figures 4.2 through 4.5, it appears that with the rebound hammer it is possible to delineate between sound and unsound material. The cross section at station 26, for example, based on visual observation, is shown in Figure 4.13. However, detailed information about damage that was not visible from the surface of the member was not able to be clearly defined using the rebound hammer.

Figure 4.13 Cross Section at Sampling Station 26 -  
Based on Rebound Measurements and Visual Inspection

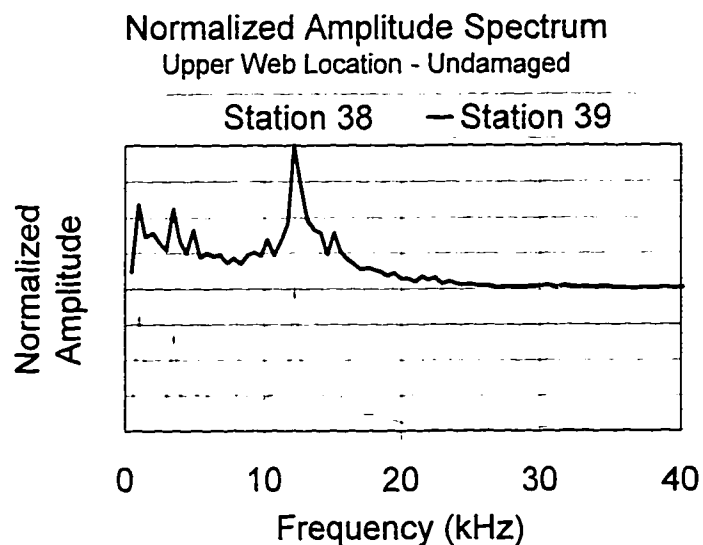
Figure 4.14 Damage Assessment by Impact Echo - Upper Web Undamaged Locations

Rather than discuss the detailed process of data reduction for the impact echo method, only the results of testing will be presented. Figure 4.14 shows the normalized amplitude spectra obtained from the impacted side of the girder at stations 38 and 39 generated from impact echo sampling along the web. The peak amplitude at these locations occurs at a frequency of 12.2 kHz. Based on the measured compression wave velocity of 15,800 ft/s (4820 m/s) and measured frequency at peak amplitude, the corresponding thickness of the web at stations 38 and 39 was determined to be 7.77-in. (20-cm). The actual thickness of the web at the ends and cen-

ter of the girder varied from 7.5 to 8.5-in. (19 to 22-cm).

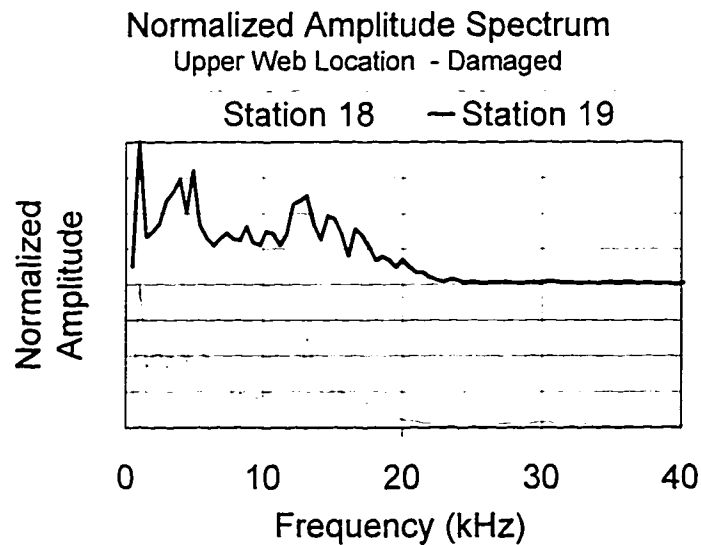
Figure 4.15 Damage Assessment by Impact Echo - Upper Web Damaged Location

It is obvious when comparing the spectra in Figure 4.14 and Figure 4.15 that damage is clearly indicated by a shift in the peak amplitude from a frequency of 12.2 kHz (the solid thickness response in Figure 4.14) to lower dominant frequencies (Figure 4.15). It should be noted that the most dominant frequency of 0.97 kHz in each case (the largest peak at the left end of each spectrum with an amplitude of 1.0) is the resonant frequency of the displacement transducer of the instrument, and, hence, is a false reading. However, the other high amplitude peaks that are evident in each normalized amplitude spectrum are meaningful and require further explanation. At

station 18 there are three other dominant peaks; one at a frequency of 4.88 kHz and a normalized amplitude of 0.63 which corresponds to a thickness of 19.4-in. (49.4-cm), a second peak at a frequency of 7.32 kHz and normalized amplitude of 0.32 corresponding to a thickness of 12.9-in. (32.9-cm), and a third peak at a frequency of 13.18 kHz and normalized amplitude of 0.63 corresponding to a thickness of 7.2-in. (18.3 mm). At station 19 there are three dominant peaks other than the one corresponding to the resonant frequency of the instrument: one at a frequency of 3.91 kHz and a normalized amplitude of 0.74 which corresponds to a thickness of 24.3-in. (67.1-cm); a second peak at a frequency of 4.88 kHz and normalized amplitude of 0.80 corresponding to a thickness of 19.4-in. (49.4-cm); and a third peak at a frequency of 13.18 kHz and a normalized amplitude of 0.63 corresponding to a thickness of 7.2-in. (18.3-cm). In comparison to the actual web thickness of 7.5 to 8.5-in. (19.1 to 21.6-cm), all of these peaks correspond to a thickness greater than the web with the exception of the peaks occurring at a frequency of 13.18 kHz, very close to the solid thickness frequency of the web (12.21 kHz). The lower frequency vibration responses are indicative of a delaminated concrete. The impact echo response of samples taken over a delamination behaves much like a plate restrained at its edges undergoing flexural vibration. The flexural vibrations are characterized by lower frequencies than the solid thickness mode of

vibration and ,hence, are an indication in some instances that a delamination is present at the sampling location (24,25).

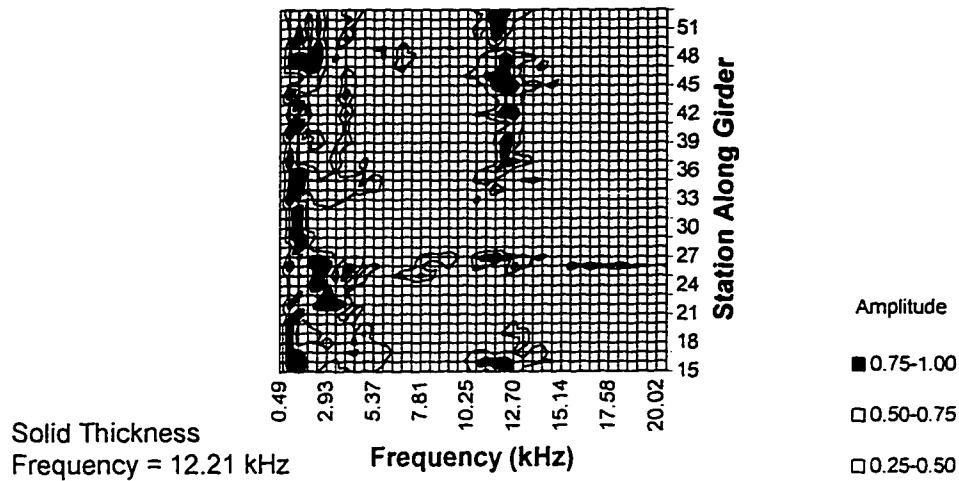
Figure 4.16 Global Damage Assessment Using Impact Echo - Upper Web Location

In order to assess the extent of damage on a global rather than local basis, a contour of the amplitude spectra along the length of the member for the upper web area on the impacted side of the girder is shown in Figure 4.16. The most evident observation is that the web of the entire beam is damaged from stations 15 to 42 and exhibits varying degrees of delamination as characterized by low frequency flexural modes of vibration.

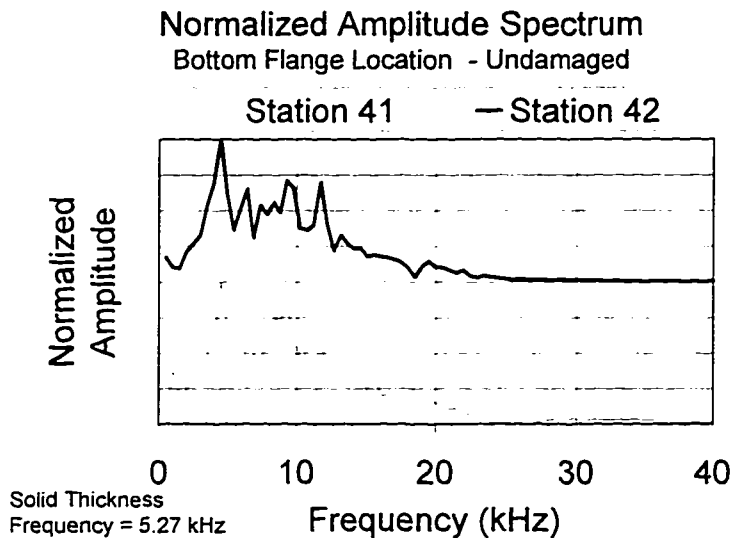
Figure 4.17 Damage Assessment by Impact Echo - Undamaged Bottom Flange Locations

Figure 4.17 shows the results of impact echo sampling at stations 41 and 42 on the impacted face of the member for a bottom flange sampling location. The frequency which corresponds to the solid thickness of the flange was calculated to be 5.27 kHz. As shown in Figure 4.17 the most

dominant peaks of each normalized amplitude spectrum appear very near this solid thickness frequency. The actual response at each of these locations results in a dominant peak at a frequency of 4.39 kHz which corresponds to a thickness of 21.6 in (54.9-cm). Although this is not exactly the solid thickness frequency, interpretation of these tests reveals that there is

relatively no damage in the bottom flange at this location which was also confirmed by visual inspection. It is possible that the geometry of the flange itself causes the response to contain some flexural modes of vibration which could account for the discrepancy between measured and expected frequencies.

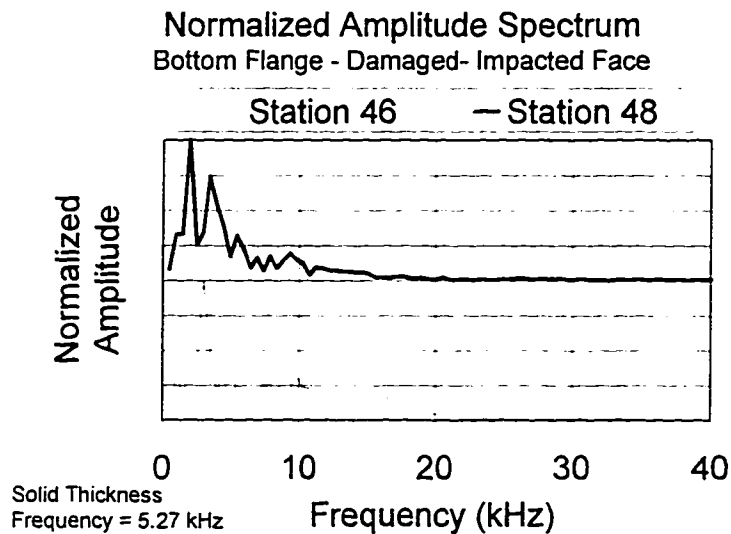
Figure 4.18 Damage Assessment by Impact Echo - Damaged Bottom Flange Locations

In contrast to the undamaged flange locations at stations 41 and 42, Figure 4.18 shows the results of impact echo sampling of the bottom flange at stations 46 and 48 on the impacted side of the girder. It was evident by visual inspection at these locations that there was a crack running through the bottom flange of the member; however, it was not known how deep into

the member the cracks extended. Between stations 46 and 48 this crack was very near the surface of the member. The response at these locations is dominated by low frequency flexural modes of vibration indicative of a delamination. In this instance, where the crack is near the surface, it is reasonable that the response is dominated by flexural frequencies indicating delaminated concrete. At station 46 the dominant frequency is 2.93 kHz and at station 48 the dominant frequency is 1.95 kHz, both of which are much less than the solid thickness frequency of 5.27 kHz, indicating near surface damage.

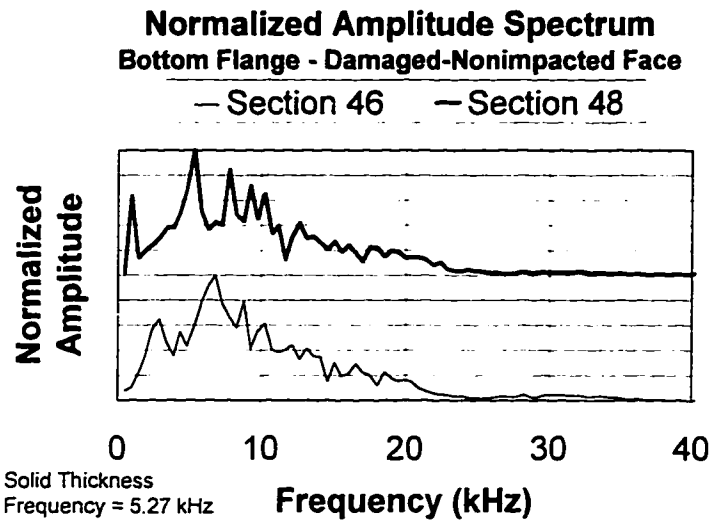
Figure 4.19 Damage Assessment by Impact Echo - Damaged Bottom Flange Location - Nonimpacted Face

The results of impact echo testing at stations 46 and 48 on the nonimpacted face of the girder were taken for comparison to the tests performed on the impacted side of the girder. On the impacted face the response was interpreted as a delamination; the crack was very near the surface. Visual observations revealed that the crack was closer to the side face of the flange at station 48 than at 46. Referring to Figure 4.6, zone 2, the crack propagated from the nonimpacted face to the impacted face across the bottom flange and also up the face of the flange on the impacted side of the member. Again, the extent of this crack was not clearly evident, but impact echo results will show that the damage is clearly detectable from either side; however, interpretation of the results is simpler from the nonimpacted face.

Figure 4.19 shows the results of impact echo testing at a bottom flange location for stations 46 and 48 on the nonimpacted side of girder. Again the frequency corresponding to the solid thickness of the flange was calculated to be 5.27 kHz. An interesting comparison to the solid thickness frequency can be made for the results at stations 46 and 48 on the nonimpacted face of the member. The dominant frequency response at station 46 was found to be 6.84 kHz with a corresponding calculated thickness of 13.89-in. (35.3-cm). The dominant frequency response at station 48 was found to be 5.37 kHz with a corresponding calculated thickness of 17.68-in.

(44.9-cm). Remembering that the actual thickness of the bottom flange of the girder was measured to be 18-in. (45.7-cm), several observations can be made regarding the results of impact echo tests on both the impacted and nonimpacted face of the member.

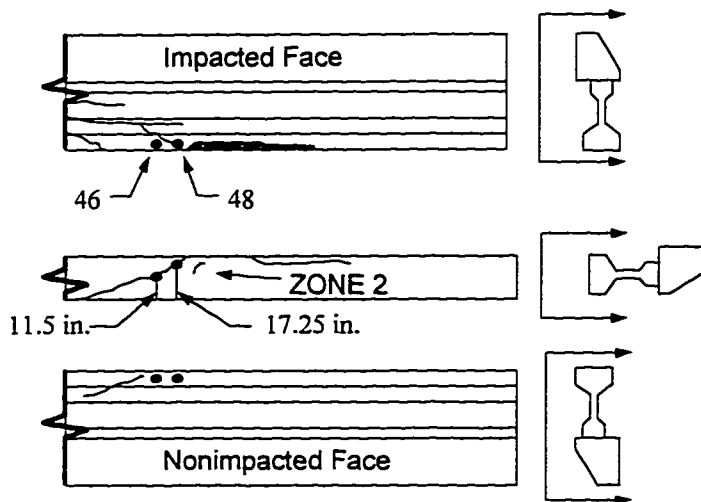
First, in order to lend perspective to the location of these measurements, a more detailed schematic of Figure 4.6, zone 2 is shown in Figure 4.20. This schematic shows that measurements locating the crack in the bottom flange at stations 46 and 48 were very close to the results obtained

Figure 4.20 Detailed Schematic of Zone 2 Damage of Steck Girder

station 46, the crack was measured to be approximately 11.5-in. (29.2-cm) from the nonimpacted face. Impact echo results indicated that the crack was 13.89-in. (35.3-cm) from the edge. It should be noted, however, that measurements for this sampling location were taken approximately 3-in. (7.6-cm) from the bottom of the member, while exact location of the crack was measured on the bottom surface of the girder. It is likely that the crack did not extend perpendicularly from the bottom surface, but rather at an angle, and may account for the discrepancy between impact echo results and actual measurements. At station 48, where the crack was very near the surface on the impacted face, measurements located this crack to be 17.25-in. (43.8-cm) from the nonimpacted face, while impact echo results located the crack at 17.68-in. (44.9-cm) from the nonimpacted face. The results in this instance were easily verified due to the proximity of the crack to the surface of the member. It is much easier to interpret the vibrational response when flexural modes are not present as is the case at stations 46 and 48 on the nonimpacted face of the member. Delaminations are not as easily or confidently identified using the impact echo method; however it is possible to detect both visible and hidden damage in concrete using the impact echo technique.

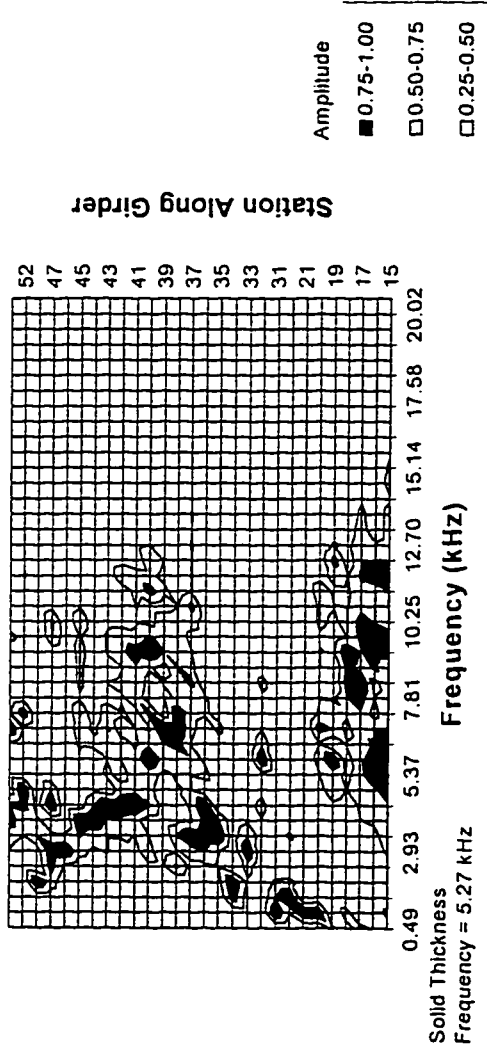
Figure 4.21 Global Damage Assessment Using Impact Echo - Bottom Flange Location - Impacted Side of Girder

For global assessment purposes a contour of the normalized amplitude spectra along the bottom flange on both sides of the member was constructed using the results from each individual sampling location. These contour plots shown in Figures 4.21 and 4.22 reveal the nature of the damage to the flange on a global basis. It should be noted that on the impacted face between stations 19 and 35 and on the nonimpacted face between station 33 and 43 there was such severe damage to the concrete in the bottom flange that no data were able to be recorded. This lack of data is evident in each the contour plot. No clear pattern of response exists in the contour plots for the bottom flange on each side of the girder which is an indication on a global level that there appears to be damage within the flange of the member throughout the entire sampling range with the exception of a few locations that exhibit peak amplitudes near the solid thickness frequency of 5.27 kHz as already discussed (Figure 4.17).

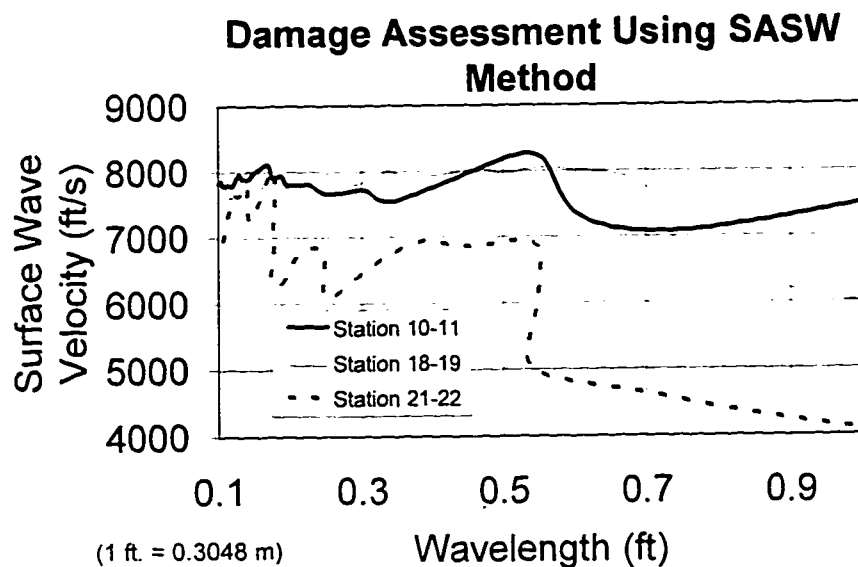
Figure 4.23 Damage Assessment Using SASW Method - Bottom Haunch Location - Impacted Side of Steck Girder

Figure 4.23 shows the dispersion curves generated from SASW testing between stations 10-11, 18-19, and 21-22. These three cross sections represent zones of varying degrees of visible damage on the impacted side of the girder. The dispersion curve over the station 10-11 interval corresponds to undamaged concrete. It shows relatively constant velocity as a function of wavelength varying from about 7,100 ft/s (2,150 m/s) to about 8,200 ft/s (2,500 m/s). Comparison of this dispersion curve with the cross section in Figure 4.24(a) shows that even though some

damage exists on the non-impacted side of the girder, it is not directly beneath the array axis, and therefore does not affect the observed surface wave velocities.

Dispersion curves over the 18-19 and 21-22 station intervals show reductions in surface wave velocity (Figure 4.23). These reductions in velocity occur at longer wavelengths (deeper in the member) for the 18-19 interval, but affect shorter wavelengths (shallower) for the 21-22 interval. Figure 4.24(b) and (c), based on visual observation, indicate deep damage between interval 18-19 and shallow damage between interval 21-22 respectively. Comparing visual observations with SASW results over these station intervals shows how the dispersion curves can be used qualitatively to evaluate the extent and relative depth of damage.

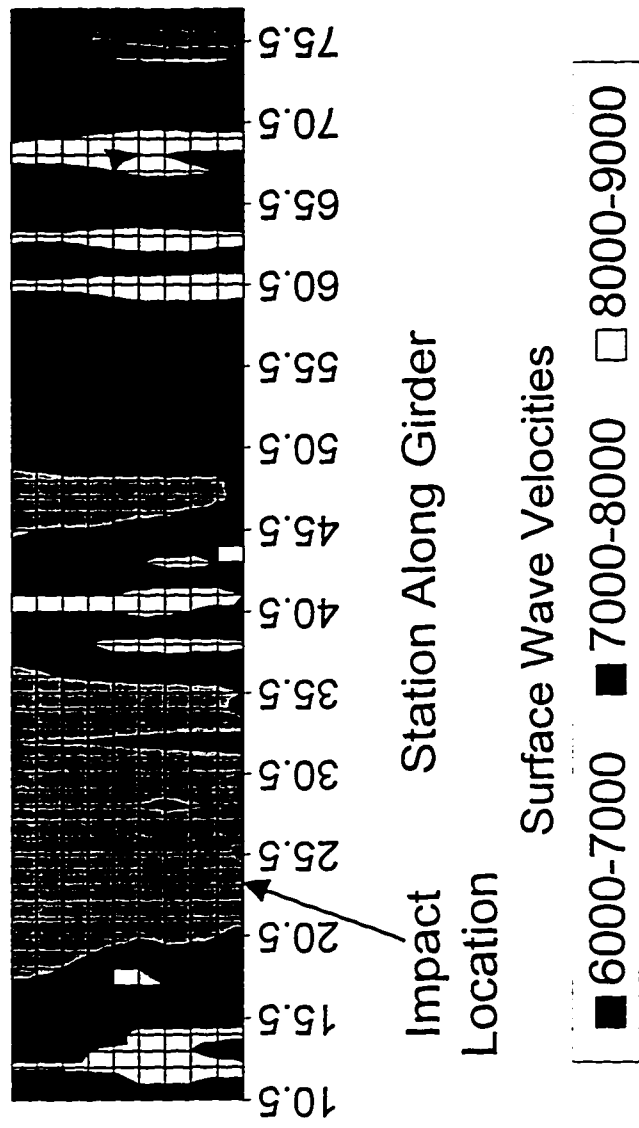
Figure 4.25 Global Damage Assessment Using SASW Method

The trends observed in the contour plot (Figure 4.25) reveal how the SASW method, like the impact echo method, is capable of delineating between sound and unsound material. The apparent decrease in surface wave velocities between stations 17 and 21 correspond to a transition from sound concrete to the beginning of severely fractured material. The low surface wave velocities present between stations 22 and 36 represent the severely damaged zone in the region nearest the impact, and another transition zone from damaged to more sound material exists from station 37 to 46. Between stations 46 and 48 another zone of low surface wave velocity exists, which correlates very closely with impact echo measurements taken in the same region (Figures 4.18 and 4.21)

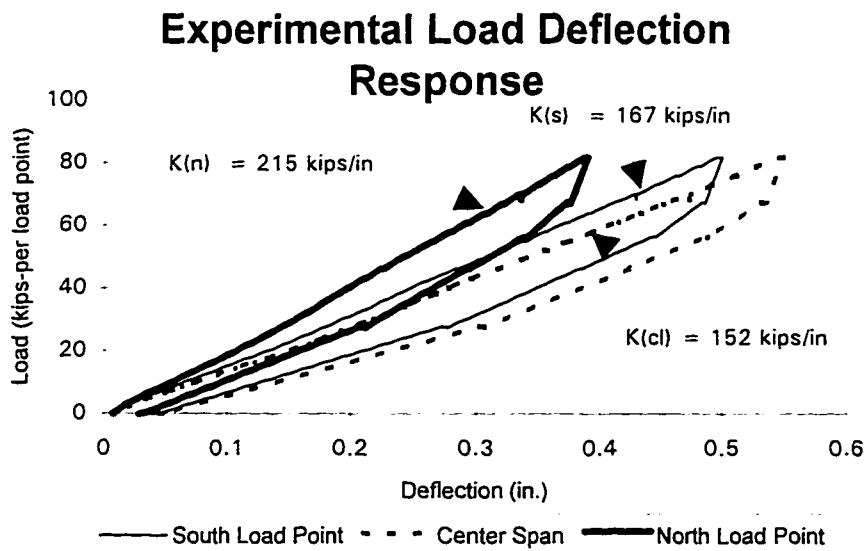
Figure 4.29 Experimentally Measured Load-Deflection Response of Damaged Steck Girder (1 kip = 4.45 kN)

The measured load-deflection response at the load application points and center span locations are shown in Figure 4.29. It should first be noted that the locations at the south load point and center span were both damaged, whereas the location at the north load point remained relatively undamaged. Several observations can be made regarding the experimentally measured load-deflection response at each of the instrumented cross sections.

south load point, based on least squares regression of experimental data was found to be 167 kips/in. (29,250 kN/m). The stiffness at the north load point was experimentally determined to be 215 kips/in. (37,650 kN/m), while at center span, the stiffness was measured to be 152 kips/in. (26,620 kN/m). It is evident when comparing the response at the north and south load application points that the difference in measured stiffness reflects the unsymmetrical nature of the damage to the girder; the south location was severely damaged resulting in a lower stiffness than the essentially undamaged north cross section. The stiffness at the center span location was less than that found at both north and south cross sections as expected. The center of the girder should experience more deflection than at either load point, and this was reflected in the experimental response. It should be noted, however, that the stiffness of a damaged girder does not appear to be an extremely important factor when assessing the extent of damage. In this instance comparison of stiffness is made to distinguish the unsymmetrical nature of the response. When in-situ nondestructive load testing was performed on the Waelder bridge, stiffness did not play a major role in the overall performance of the damaged structure. The measured displacements were on the order of  $1/5000^{\text{th}}$  of the span length, while for the Steck girder, after removal from the bridge, the displacements were on the order of  $1/1000^{\text{th}}$  of the span length, still within acceptable limits. While the

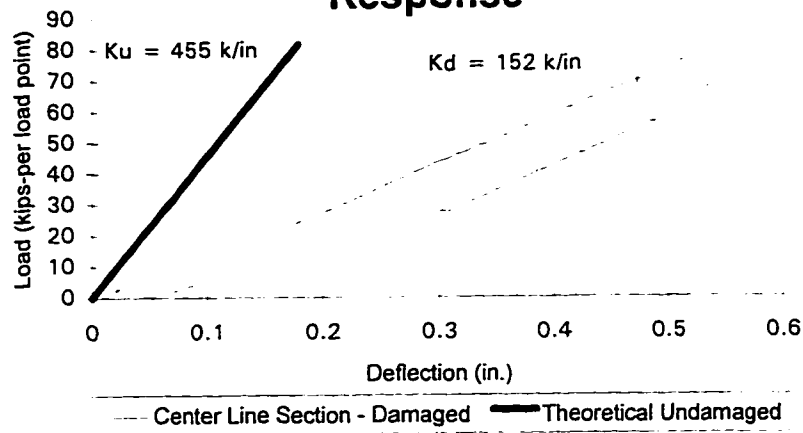
Figure 4.30 Comparison of Theoretical Load Deflection Response of Damaged Steel Girder at the Centerspan Location (1 kip = 4.45 kN)

Using an elastic analysis procedure, the theoretical load-deflection response at center span was determined and compared to the experimentally measured response at the same location in order to evaluate the reduction in stiffness due to impact damage. Figure 4.30 compares the theoretical and experimental behavior at the center span location. The theoretical stiffness of the center span section was determined by analysis to be 455 kips/in (79,680 kN/m), and, as previously shown, the experimentally observed stiffness at center span was only 152 kips/in (26,620 kN/m). It is obvious that the extent of impact damage incurred was quite severe and that the experimentally derived stiffness is only 33 % of the theoretical

value. Again, stiffness should not be considered as the deciding factor for repair or replacement of a damaged girder.

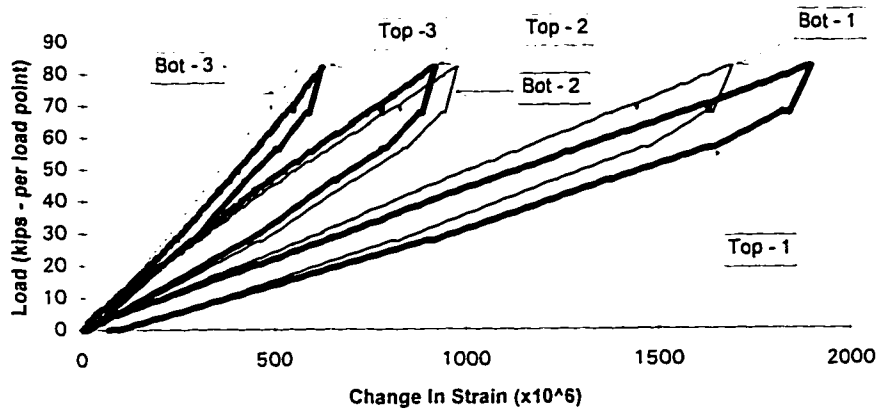
Figure 4.31 Experimentally Measured Deformations of Instrumented Tendons - Steck Girder - Damaged (1 kip = 4.45 kN)

Several observations can be made regarding the measured tendon deformations. First and foremost, the relative magnitudes of the tendon deformations at each cross section correlate closely with the extent of damage based on both visual observations as well as the measured girder displacements. Cross section one appeared visibly to have sustained the most severe damage, and this is reflected in the measured tendon deformations at this location; the maximum changes in elongation of the tendons were between 1600 and 1800 microstrain. Cross section two sustained less damage than cross section one, and cross section three sustained little

damage with the exception of cracking of the concrete near the bottom on the impacted side of the girder. Again, the magnitude of the tendon deformations at cross sections two and three correlate well with the observed visible damage of the girder.

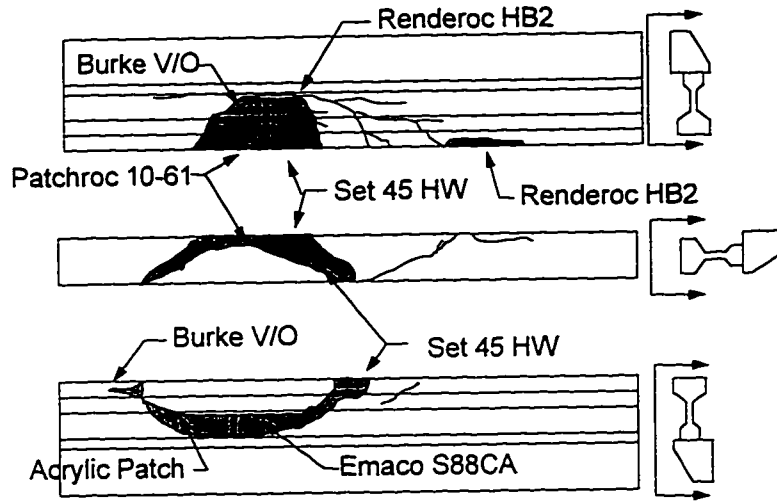
Figure 5.4 Placement of Patching Materials for Repair of Concrete in Steck Girder

Both of these materials were also used to repair portions of the lower flange where patch depth was in excess of 6-in. (15-cm) (Figure 5.4). The web repairs were hand-packed and then shaved smooth, while the flange repairs were performed with partial formwork in one location and without

The third type of V/O material that was chosen for the repair, EMACO S88CA, manufactured by Masterbuilders Incorporated, was a silica fume, fiber-reinforced, cementitious repair mortar. EMACO S88CA was used to complete the repair of the web on the nonimpacted face of the girder (Figure 5.4). The patch depth ranged from 1/2 to 4-in. (1.3 to 10.2-cm) and was approximately 60-in. by 8-in. (150-cm by 20-cm) in plan. In contrast to the two-component latex-modified mortars, this material did not

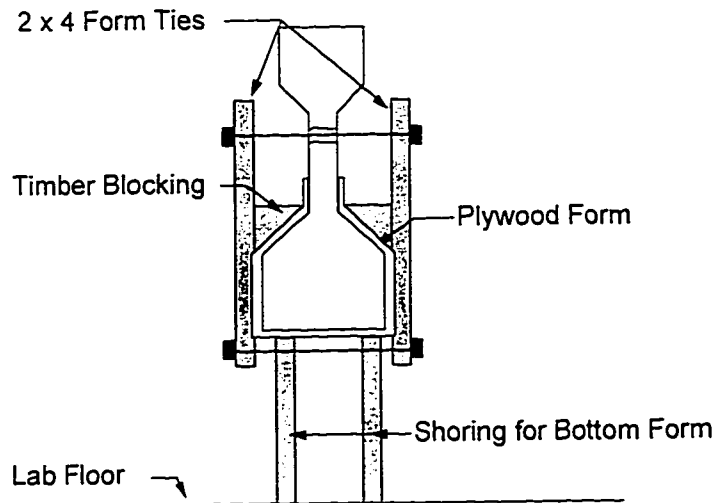
Figure 5.5 Schematic of Formwork for Cast-in-Place Concrete Repairs of Steck Girder

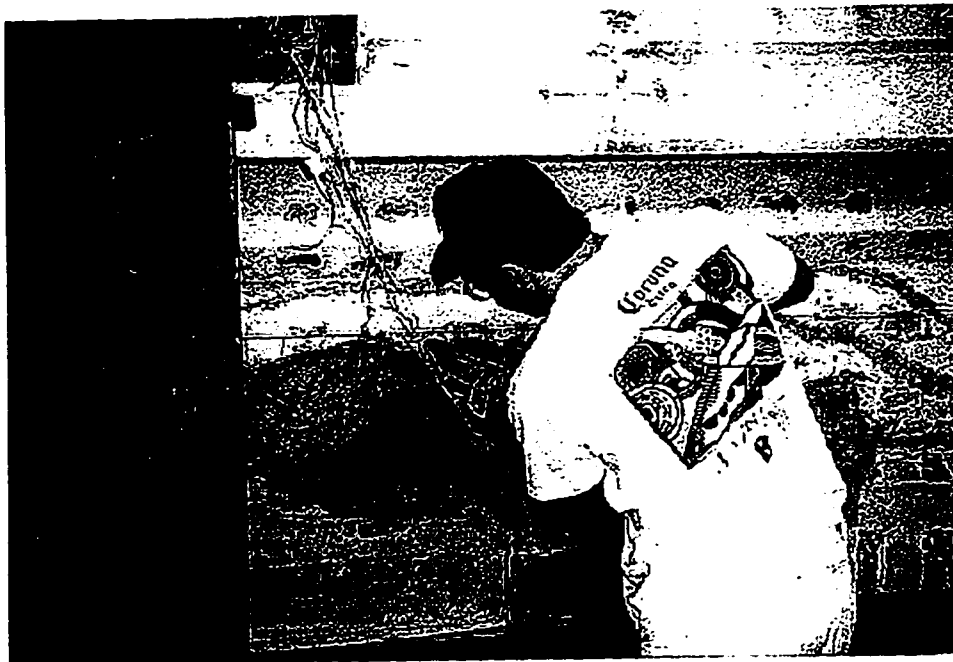
Figure 5.18 Repair of Web Damage on Impacted Side of Girder Using Burke V/O

deroc HB2 and Burke V/O was that the Renderoc HB2 tended to pull away from the surface more readily than the Burke V/O, resulting in slightly less build per lift. Even though each material seemed to be nearly identical in appearance and consistency, extensive shrinkage cracking was observed

in the thinner web patches using the Burke V/O whereas the Renderoc HB2 exhibited none.

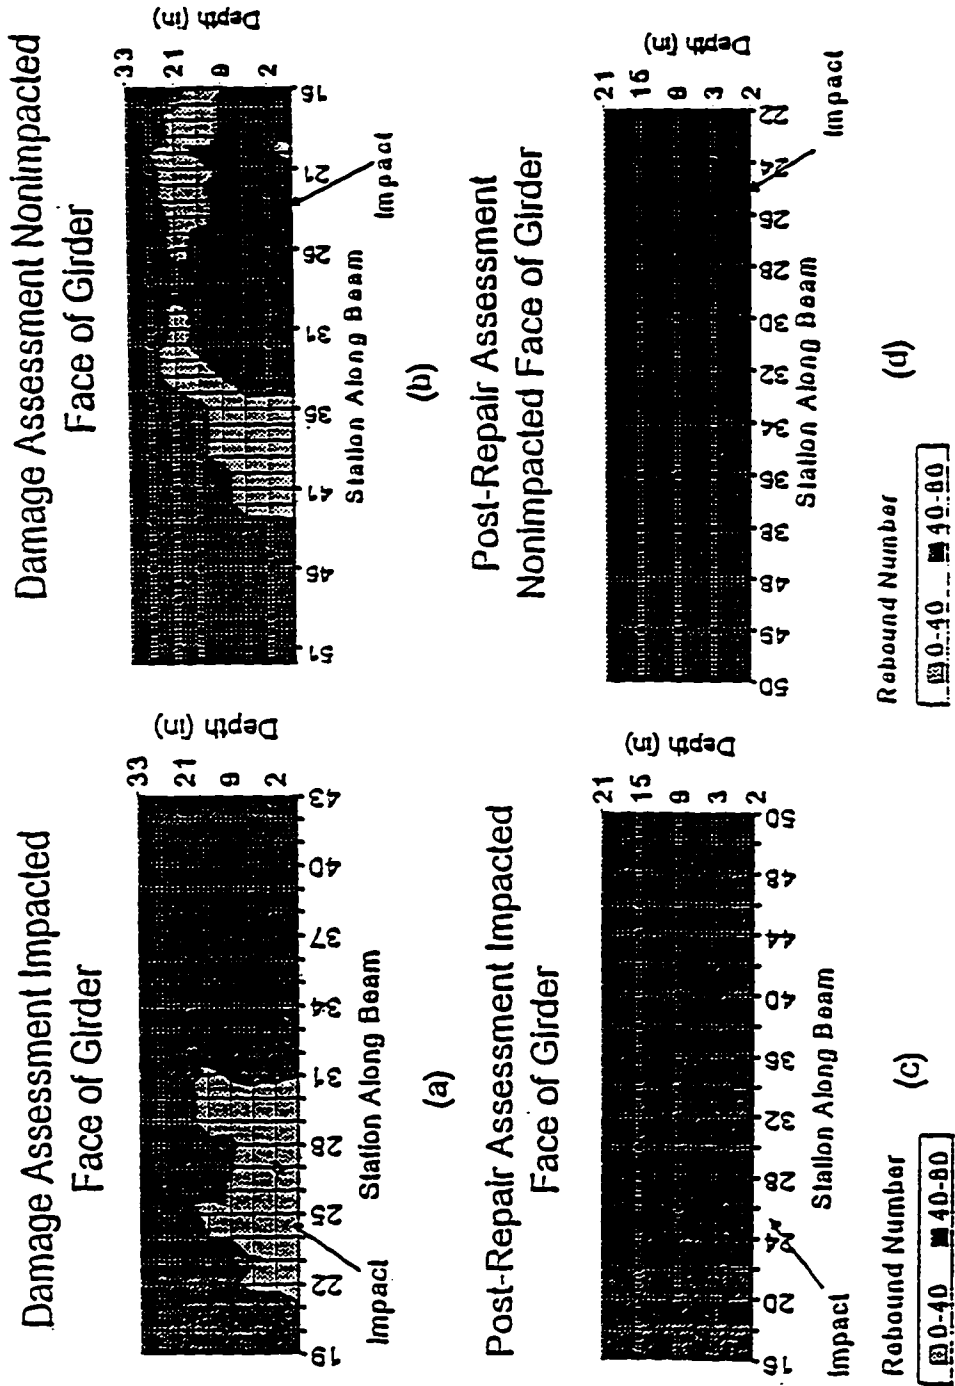
It was found that there was no difference in surface hardness measurements after each phase of the repair; therefore, only the final rebound hammer measurements will be presented for comparison with those taken for damage assessment purposes. A contour of post-repair rebound hammer results was plotted for each face of the girder showing the variation of surface hardness over the repaired zones. Results of damage assessment rebound measurements are repeated for comparison to post-repair results (Figure 5.24). Comparison of the measurements reveals that the surface hardness of the damaged girder clearly indicated the damaged zones; however, post-repair rebound numbers indicated a sound repair had been accomplished. It should be emphasized that the rebound hammer is not sensitive enough to distinguish internal flaws with any degree of accuracy, and therefore, as a means of providing quality assurance, the rebound hammer cannot detect areas where internal damage remains after the repair is complete. The rebound hammer should not be used for quality assessment of repaired concrete for this reason alone; however, it may be possible to detect patched areas that have not sufficiently adhered to the concrete substrate with the rebound hammer.

Figure 5.24 Comparison of Rebound Measurements Before and After Concrete Repair

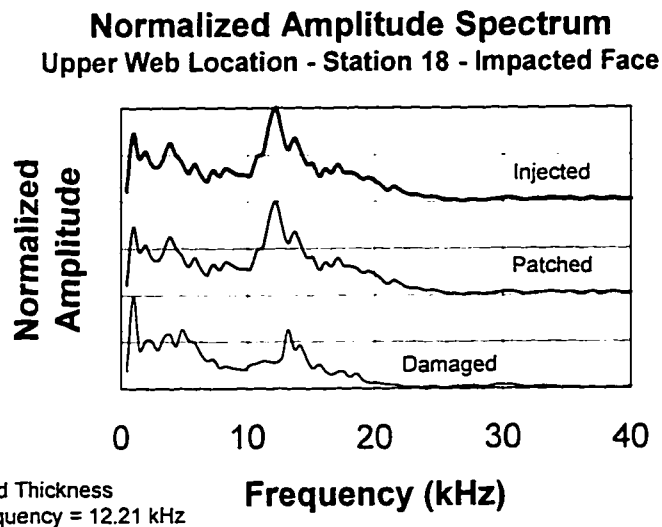
Impact echo measurements were taken during and after the repair. The normalized amplitude spectrum for each location was generated and used for qualitative comparison. As an example, Figure 5.25 shows a comparison of pre- and post-repair impact echo responses for a web location at station 18. The normalized amplitude spectrum for the upper web location on the impacted side is shown. In the damaged state delaminated concrete is detected at this location (refer to Figure 4.15 and discussion of damage assessment). After patching the damage, there was an evident shift in the response to a peak amplitude at a frequency of 12.21 kHz, the

Figure 5.25 Quality Assessment of Concrete Repairs Using Impact Echo - Web Location - Impacted Side of Girder

web solid thickness frequency. The response following injection at this location did not change significantly between the patched and injected phase; both reveal a peak amplitude at the solid thickness frequency.

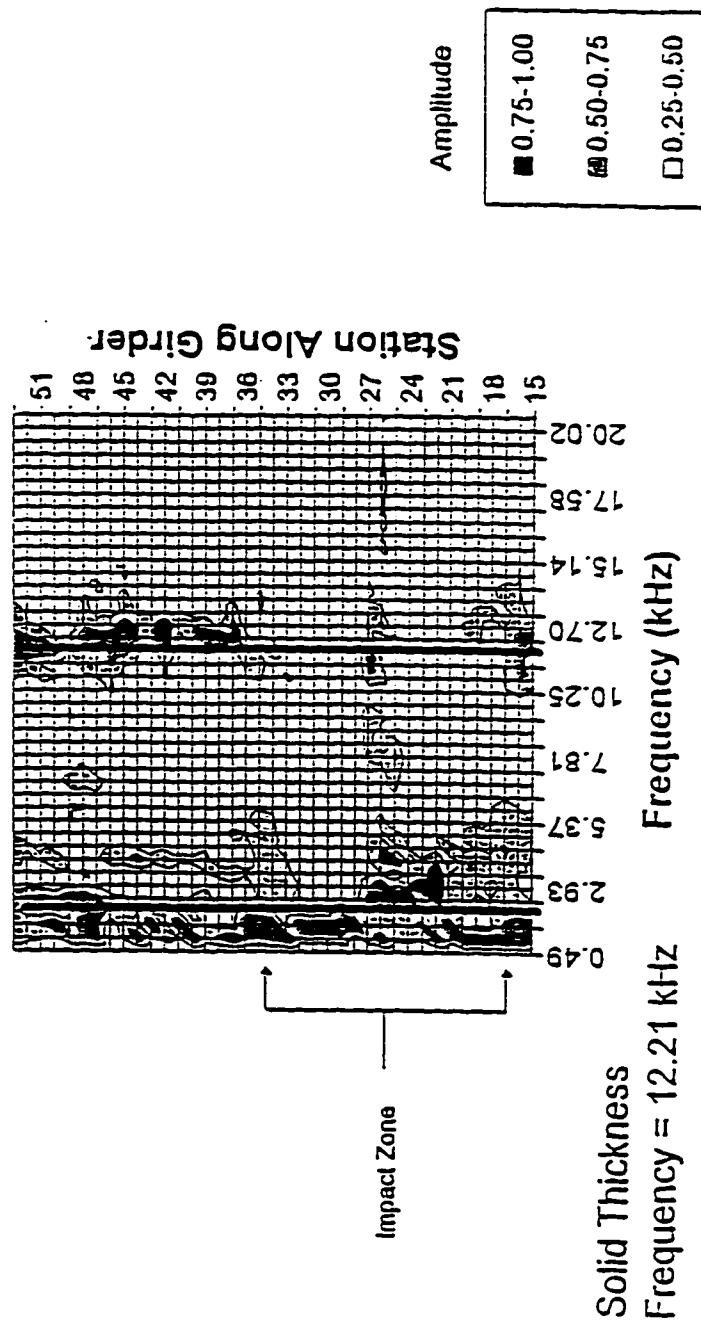
Figure 5.26 indicates that stations 15 through 42 are dominated by peak amplitudes composed of low frequency response or delaminated areas. The dark zones indicating frequency responses at amplitudes from 0.75 to 1.0 are observed at low frequencies which were interpreted as delaminated zones. The interpretation of the impact echo response was substantiated by visual inspection as discussed in Section 4.3.5. When the epoxy was injected after the concrete was patched using various materials, a shift towards a solid vibrational mode of response was indicated for the most dominant peaks in the 0.75 to 1.0 range (Figure 5.27). There is a dis-

Figure 5.26 Global Damage Assessment Using Impact Echo - Upper Web Location

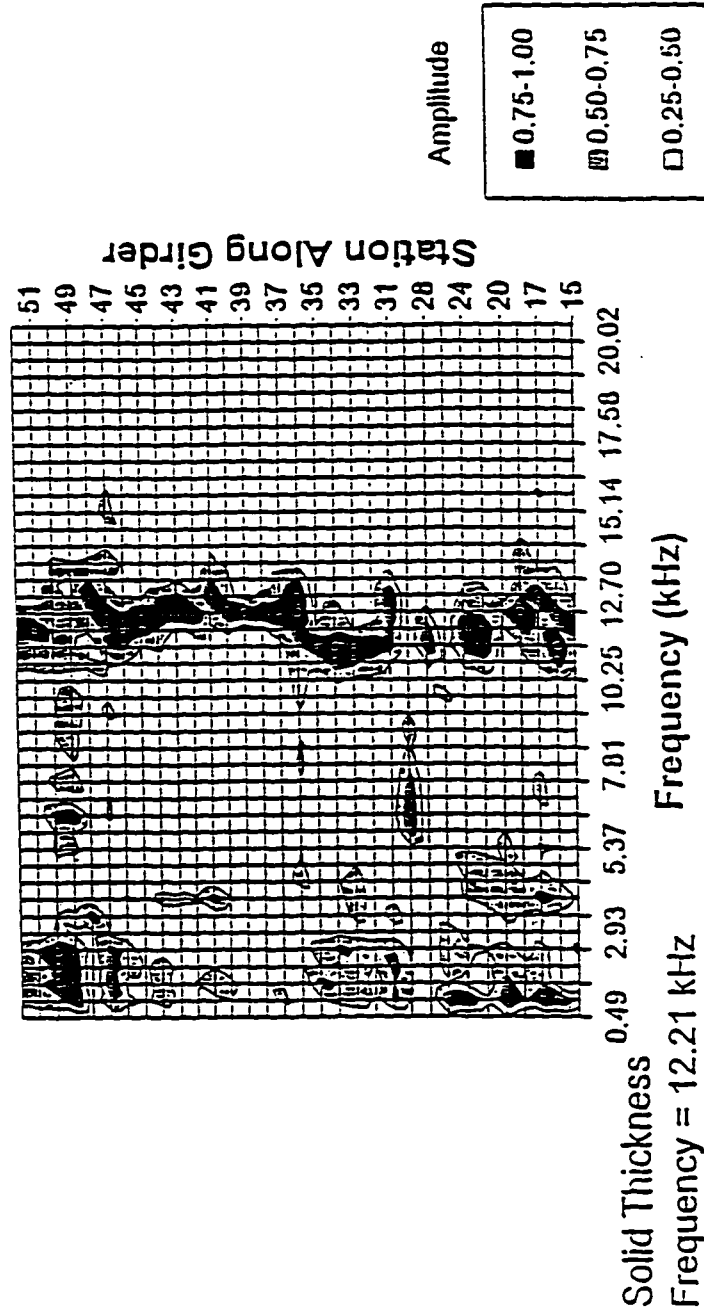
Figure 5.27 Global Assessment of Epoxy Injection Phase - Upper Web Area - Impacted Face

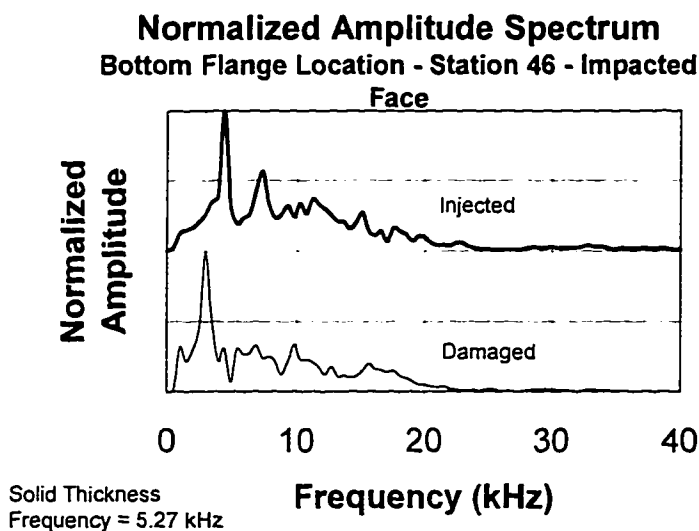
In terms of localized assessment of the repair, station 46 only required epoxy injection, not any patching of the concrete. Figure 5.28 shows the results from pre- and post-repair impact echo results for the bottom flange location at station 46. It is evident that the epoxy injection had a beneficial effect on the integrity of the member at this location as revealed by a shift in the peak amplitude towards the solid thickness frequency of 5.27 kHz. In the damaged state the maximum amplitude occurred at a frequency of 2.93 kHz and, once the girder was injected, the peak amplitude occurred at a frequency of 4.39 kHz. Again, as stated in the discussion of impact echo results for the bottom flange sampling locations (Section 4.3.5), there appears to be a discrepancy between the measured

Figure 5.28 Localized Assessment of Concrete Repair Using Impact Echo - Bottom Flange - Impacted Face

frequency and the calculated solid thickness frequency (5.27 kHz vs. 4.39 kHz). However, it is possible that the geometry of the flange itself causes the response to contain some amount of flexural vibration which could account for the discrepancy between measured and expected frequencies (refer to Figure 4.17 and the corresponding discussion of damage assessment results for stations 41 and 42 respectively).
