**EVALUATION AND REPAIR OF IMPACT DAMAGED PRE-  
STRESSED CONCRETE BRIDGE GIRDERS**

**Dissertation**

**The University of Texas at Austin**

**May 1996**

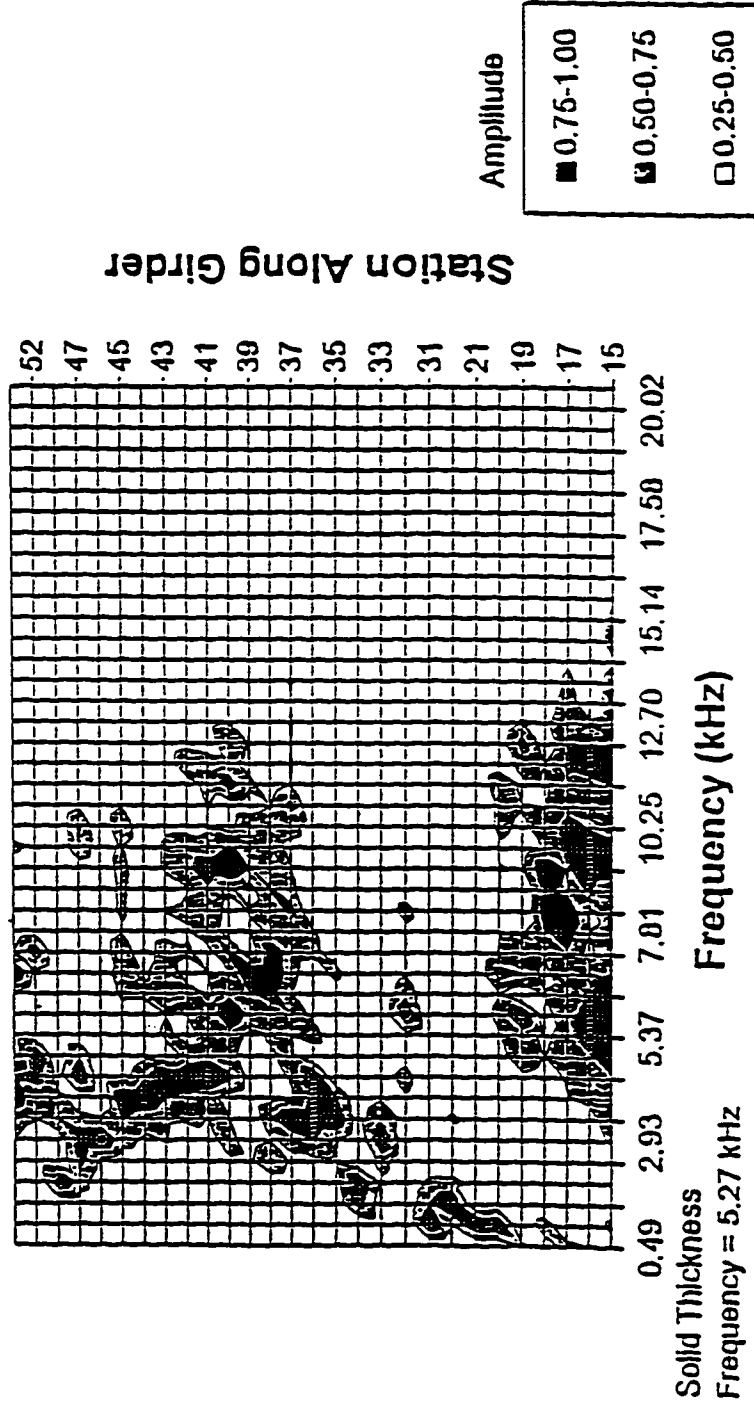
Again, the individual spectra for each location along the bottom flange were combined to form a spectral contour along the length of the member for the damaged state and after the girder was both patched and injected. These are shown in Figures 5.29 and 5.30. As discussed in Section 4.3.5, the results of global damage assessment using the impact echo method revealed that no clear pattern existed in the spectral contour, and that damage was indicated throughout the length of the girder. The range of maximum normalized amplitude, or most dominant peak of the frequency response, was very large with a minimum frequency of 0.98 kHz to a maximum of 9.28 kHz indicating damage throughout the length of the member (Figure 5.29). However, as the repair progressed, impact echo data indicated a shift towards a solid vibrational mode of 5.27 kHz (compare high amplitude regions in Figures 5.29 and 5.30). Following concrete repair by patching and epoxy injection, the range of frequency content was drastically reduced as compared to the damaged state. The

Figure 5.29 Global Damage Assessment Using Impact Echo - Bottom Flange Area - Impacted Face

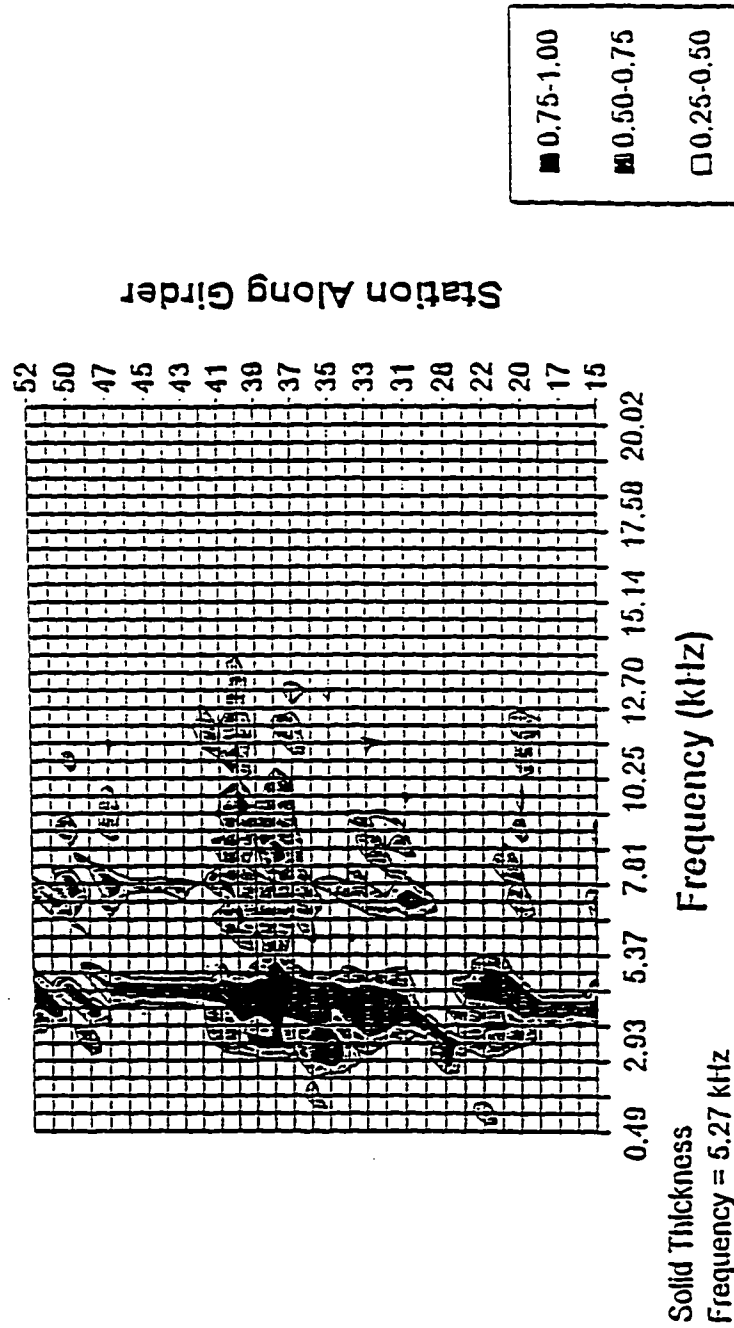
minimum dominant frequency measured 3.42 kHz and the maximum measured was 4.39, both of which are much closer to the solid mode vibrational frequency of 5.27 kHz (Figure 5.30). The shift in the peak amplitudes found from the injection assessment spectral contour indicated that along the length of the repaired girder integrity had for the most part been restored. The peak amplitudes for the bottom flange sampling locations along the length of the girder became much more uniform indicating a clear pattern of a solid vibrational mode of response.

Figure 5.30 Global Assessment of Epoxy Injection Phase - Bottom Flange Area - Impacted Face

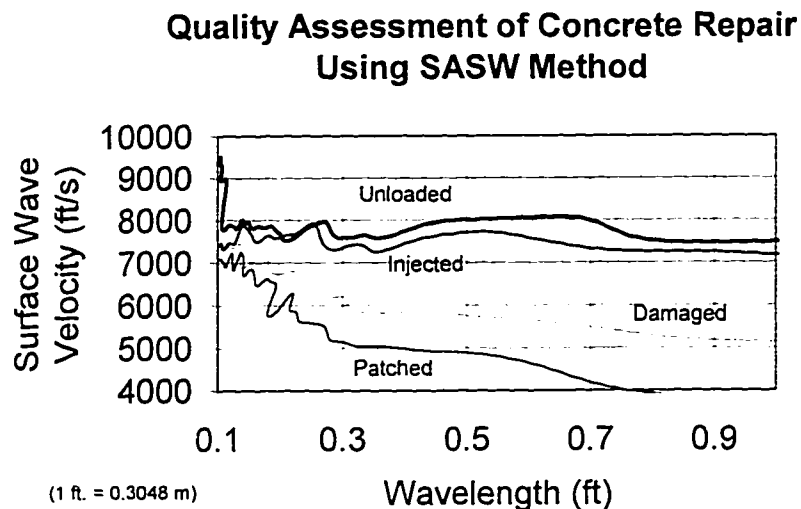
Figure 5.31 Localized Assessment of Concrete Repair Using SASW Method - Bottom Haunch Locations

rated. The deterioration was most likely due to the development of additional cracking upon application of preload. Note that no new concrete was placed at this location. After epoxy injection, surface wave velocities were greater than 7,000 ft/s (2,130 m/s) at all wavelengths indicating that integrity had been restored.

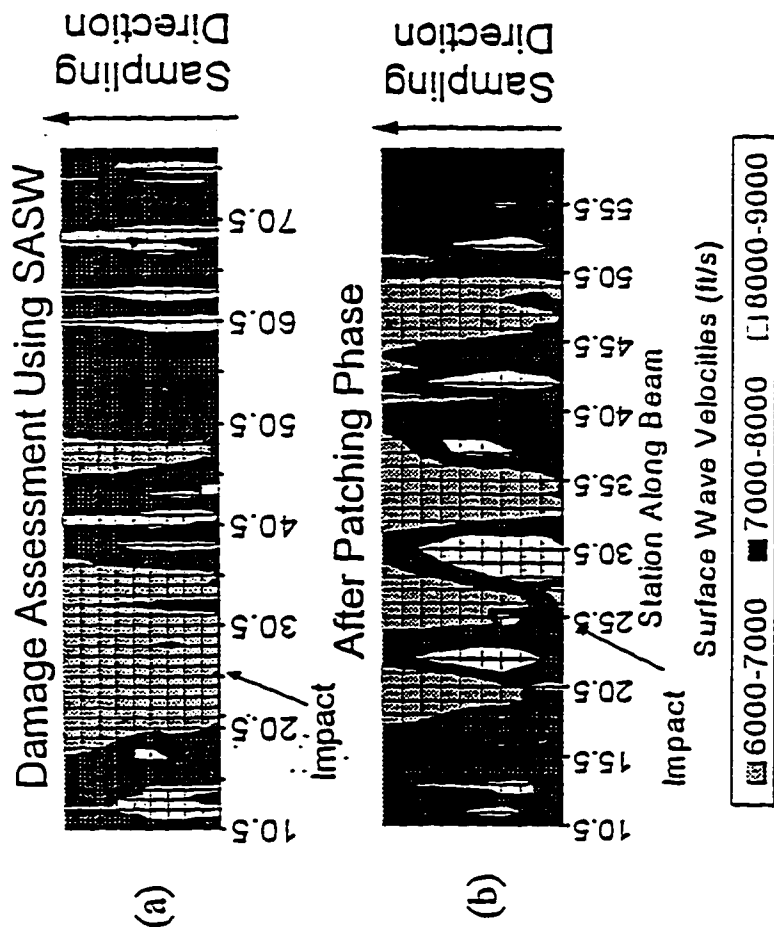
The dispersion curves were used to generate a contour of surface wave velocity versus wavelength along the length of the girder for each phase of repair as well as in the damaged state. A comparison of Figure 5.32 and Figure 5.33 shows the ability of the SASW technique to monitor the effectiveness of the patching and epoxy injection. In the damaged, state several zones of low surface wave velocities are present (Figure 5.32 (a)) from stations 18 through 37 and then again from stations 45 to 50. Once the patching phase was complete (Figure 5.32 (b)), there appeared to be a definite increase in surface wave velocities from stations 18 through 32 indicating the effectiveness of the repair in this region. However, between stations 33 to 37 the zone of low surface wave velocity appears to have increased in size, and between stations 45 and 50 surface wave velocities appear to have decreased. This is most likely due to the formation of additional cracking upon application of the preload. After epoxy injection was complete, zones of very low surface wave velocities increased in range from 4,000 to 5,000 ft/s (1,219 to 1,524 m/s) to 6,000 to 7,000 ft/s ( 1830 to

Figure 5.32 Global Assessment of Damaged and Patched Girder Using SASW - Lower Haunch Area - Impacted Face

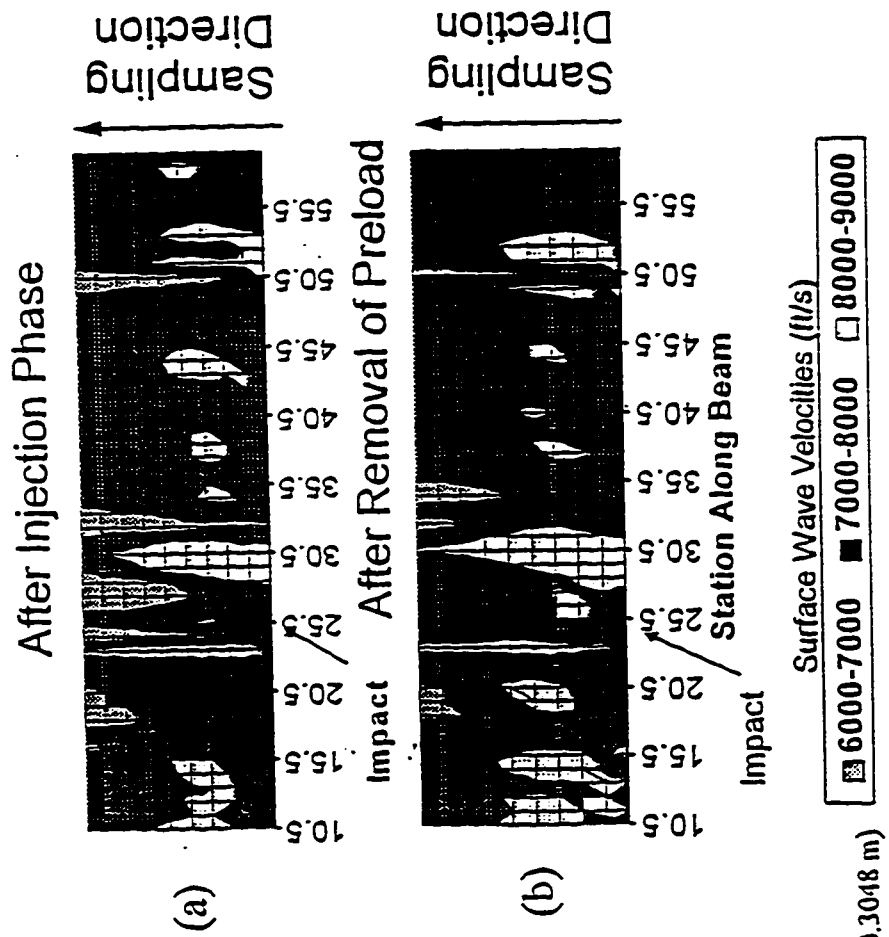
2130 m/s) in range (Figure 5.33-a) and upon removal of the preload the few zones below 7,000 ft/s (2130 m/s) surface wave velocity practically disappeared (Figure 5.33-b). This is more than likely due to the closing of any remaining cracks upon the removal of load.

Figure 5.33 Global Assessment of Damage and Patched Girder Using SASW- Haunch Area - Impacted Face

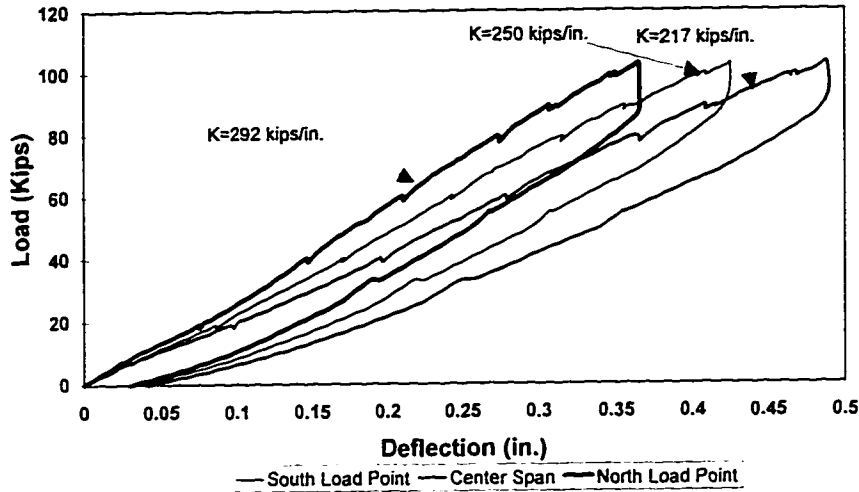
Figure 5.34 shows the experimental results obtained for the load-deflection response at each of the three instrumented cross sections. Linear regression of experimental measurements revealed that the slope of the load-deflection response, or member stiffness, at the south load point

Figure 5.34 Experimental Load Deflection Response of Steck Girder After Concrete Repair and Epoxy Injection

was 250 kips/in. (43,800 kN/m), an increase of 18 % from the damaged state. The center span stiffness was measured to be 217 kips/in. (37,950 kN/m), an increase of 14 % from the damaged state, and at the north load point the measured stiffness was 292 kips/in. (51,000 kN/m), an increase of 17 %.

It is still evident from these results that even though the girder was repaired, the nature of the damage still resulted in unsymmetric displacement of the girder. However, as previously discussed, the stiffness of the member is not extremely important to the overall performance of the girder in terms of functionality.

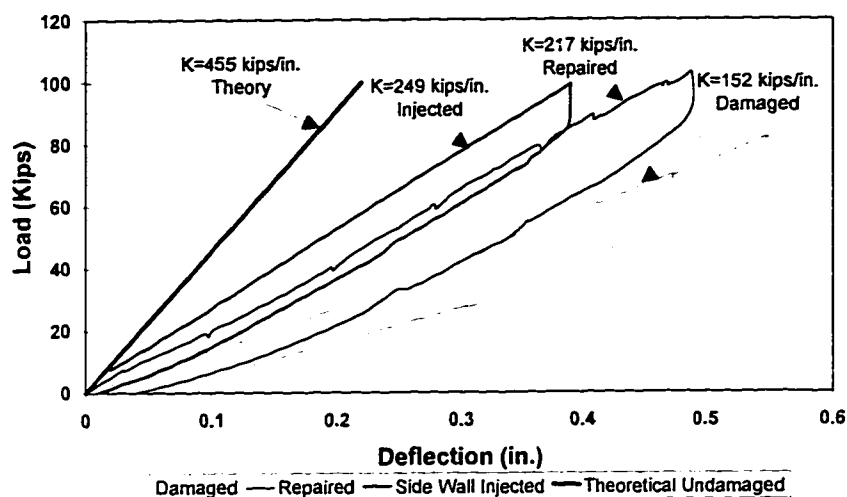
Figure 5.35 Experimental Load Deflection Response of Steck Girder After Concrete Repair and Epoxy Injection

Figure 5.35 shows the comparison of damaged, post-repair experimental and theoretical load-displacement response at the center span section. The theoretical center span displacement at an applied load of 82 kips (365 kN) per load point was 0.18 in. (5 mm) and the theoretical undamaged stiffness was found to be 455 kips/in. (79,700 kN/m). In the damaged state, a displacement of 0.55 in. (14 mm) was measured at 82 kips (365 kN), and the damaged stiffness based on linear regression of experimental results was found to be 152 kips/in. (26,600 kN/m), only 33% of the undamaged stiffness. Once the girder was repaired (patched and injected), the measured displacement was reduced to 0.38 in. (10 mm). The

repaired member stiffness was found to be 217 kips/in. (37,950 kN/m), 48% of the undamaged stiffness, an increase of 15% from the damaged state.

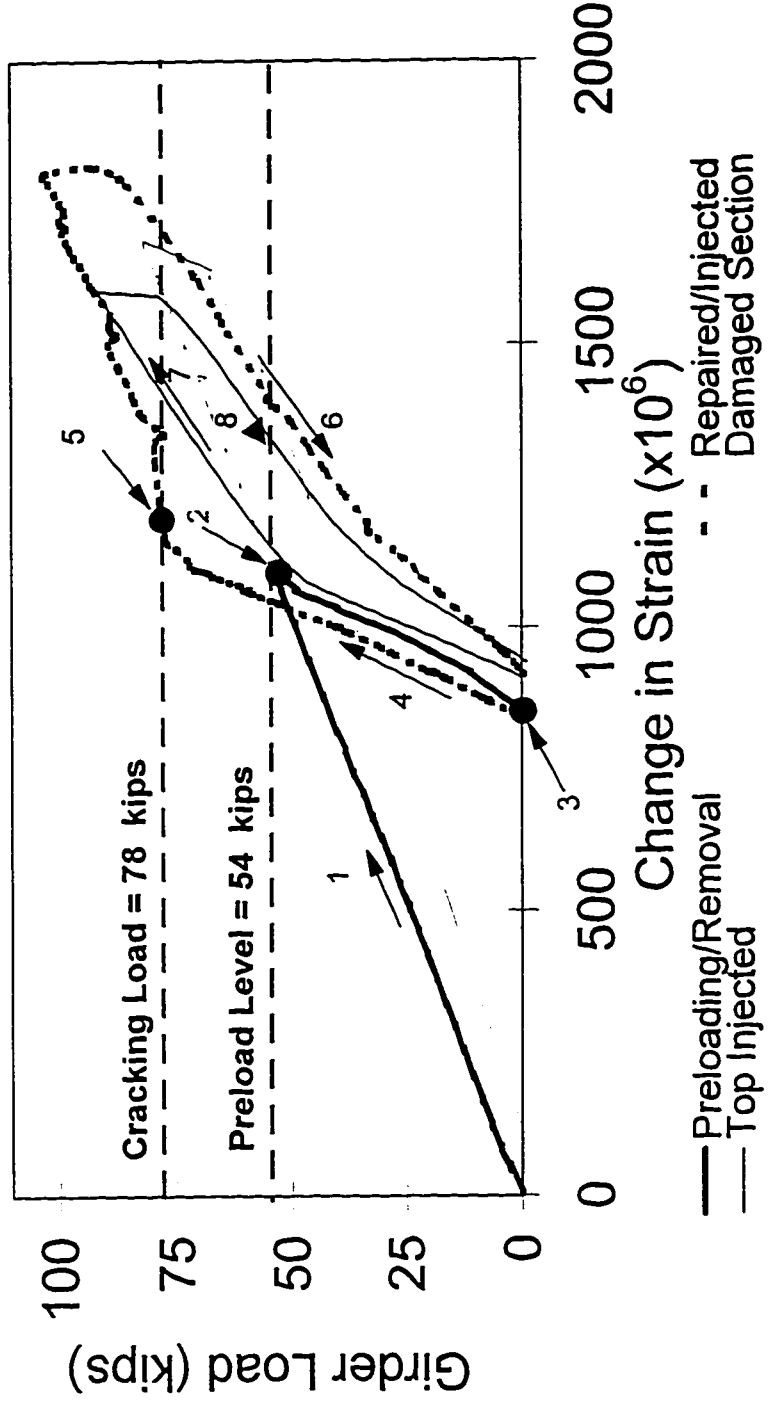
Figure 5.36 Experimental Load-Deformation Response of Tendon at south Cross Section Following Concrete Repair

First, it should be noted that the slope of the load-deformation response in the damaged state is much less than after the initial repair was complete. It is possible to follow the history of the tendon response from stage 1 (damaged state) up to a preload level of 54 kips (240 kN) per load point to stage 2 when the repair was performed. Once the concrete patching and epoxy injection were accomplished while maintaining the preload at stage 2, the preload was removed. The tendon strains then followed the unloading curve to stage 3 after removal of preload. Stage 3 identifies a very important effect of preloading the girder prior to repair. By applying preload it is shown here that the effective prestress in the tendon increases and, at the same time, the patch material in the bottom flange is compressed. Upon subsequent load application, the response of the tendon follows the loading curve beyond the level of applied preload (stage 4) until stage 5 is reached. Cracks form within the patch at stage 5 at an applied load of 78 kips (347 kN) per load point when both the precompression supplied by preloading as well as the tensile resistance of the patch material are eventually overcome. Following the loading history through stage 5, the response changes from uncracked behavior (prior to stage 5) through a transition to cracked response, and eventually unloading through stage 6. Once the siderail cracks were repaired and the girder again loaded, the load history of the tendon follows through stage 7 where the transition from

an uncracked to a cracked response is again experienced. However, it should be noted that this transition occurs very near the level of preload at approximately 54 kips (240 kN) rather than at the higher level of load when not only precompression needed to be overcome, but the tensile strength of the patch as well, which, after initial loading, had already experienced flexural cracking .

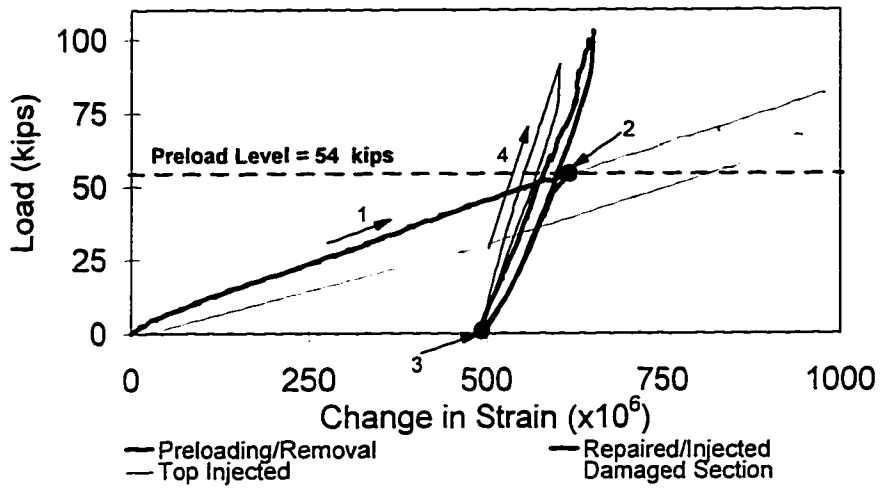
The behavior is very similar to the results shown for the south cross section. It is evident that the effects of preload lead to an obvious change in slope of the curve before and after the repair was performed. As the preload was applied deformations followed the same path as measured in the damaged state (refer to stage 1 in Figure 5.37). The repair was performed while the preload was sustained at 54 kips (240 kN) per load point (refer to stage 2 in Figure 5.37). After concrete patching and epoxy injection, the preload was removed and the unloading path defined between

stage 2 and stage 3. Again the effects of preload are evident: increased stiffness, higher effective prestress, and precompression of the patched zone. The difference between the response at the midspan and the south cross sections was that the centerspan section was not stressed as highly as the severely damaged south cross section and therefore did not crack upon subsequent loading.

Figure 5.37 Experimental Load-Deformation Response of Tendon at Center Span Cross Section Following Concrete Repair

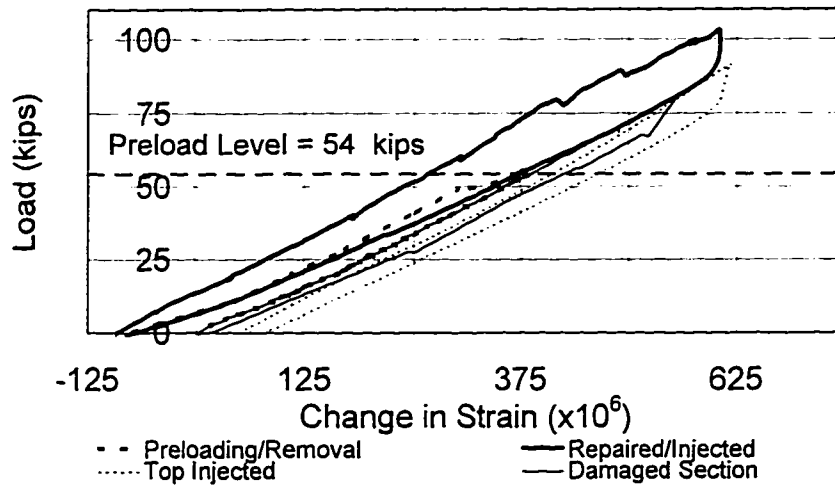
Figure 5.38 Experimental Load-Deformation Response of Tendon at north Cross Section Following Concrete Repair

In comparison to the south and center span locations, the tendon behavior at the north cross section changed very little (Figure 5.38). It was shown in Chapter 4 that the north cross section sustained very little concrete damage. As a result, the effects of preload and concrete repair are not as significant as was shown for the other two cross sections. However, there does appear to be a slight change in the behavior when comparing the damaged to the repaired state; the slope of the girder load versus change in tendon strain curve increases, signifying that the repair did have a beneficial effect.

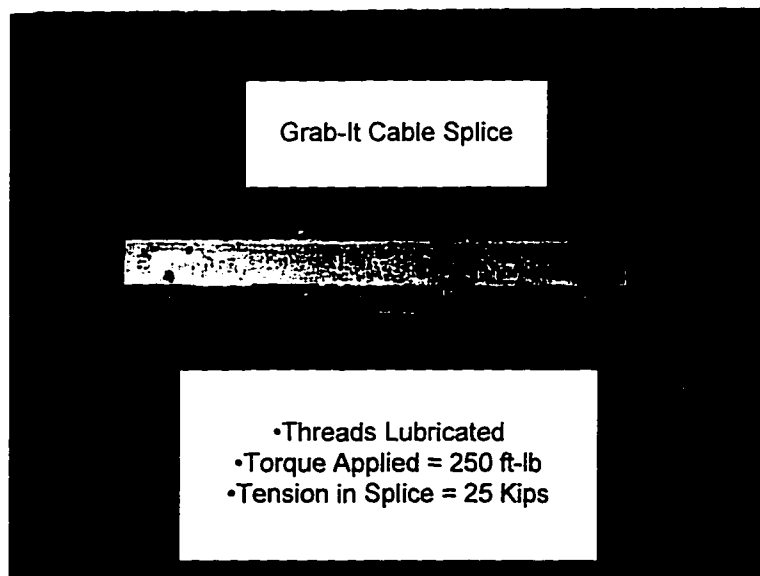
When the external threads were cleaned with a wire wheel and then lubricated, the required torque was closer to the expected value; tensioning of the splice was more reliable and much safer to install when the threads were lubricated. At an applied torque of 250 lb.-ft. (339 N-m) the induced tension was measured to be 25 kips (111 kN). Figure 6.12 shows the exterior of the turnbuckle after the test with lubricated threads. It is evident from the results that if the Grab-It™ splice assembly is to be used with any degree of safety and reliability, the threads must be thoroughly cleaned and lubricated prior to stressing.

Figure 6.12 Grab-It™ Cable Splice - Exterior of Turnbuckle - Lubricated Threads - Torque Proof Test

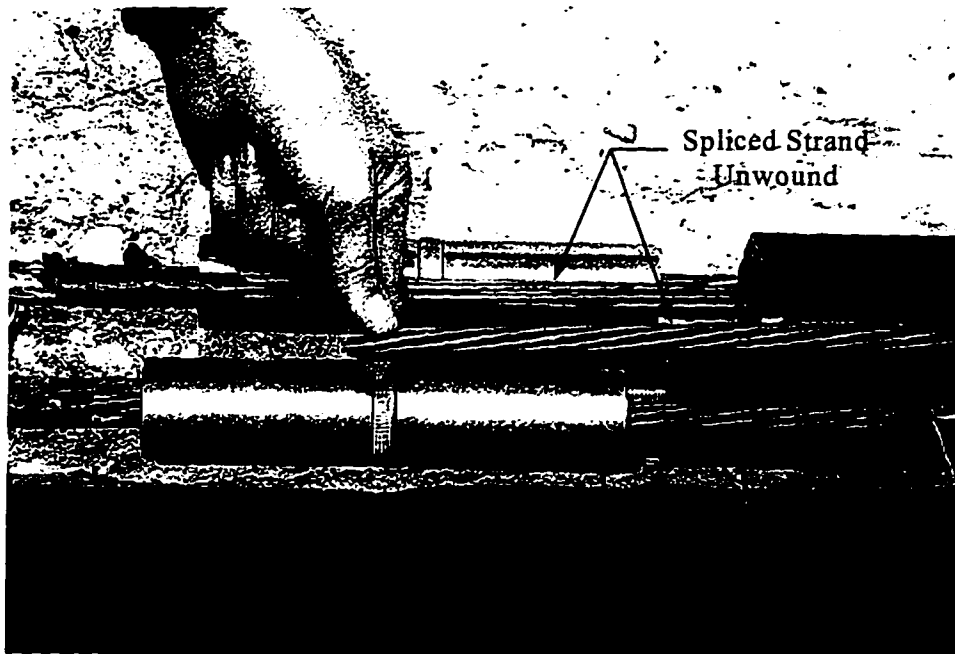
The thrust bearings that were intended to isolate the rotation of the splice from the strand did not work as intended. The bearings at each end of the splice sleeve did not work properly and therefore did not isolate rotation of the splice sleeve and bolt from rotation of the strand. As the bearing at the threaded end of the splice rotated, damage to the threads and the bearing resulted. As torque was applied to the assembly and the thrust bearings began to bind, the strand twisted such that it began to unravel. The only modification that was made to the original design of the splice more than likely caused this problem to worsen. The original design called for a buttress thread for the bolt and matching splice sleeve. Upon closer evaluation of the original design it appears that the intent of using the but-

Figure 6.16 Binding of Thrust Bearing Causing Extreme Twisting of Spliced Strand

During installation of the splice on strand number two it was observed that the thrust bearing began to bind up to such an extent that the twist angle of the strand became almost horizontal as shown in the photograph in Figure 6.17. At this stage stressing of this spliced strand was stopped. Figure 6.18 shows the completed repair of all four severed strands using the Alberta splice.

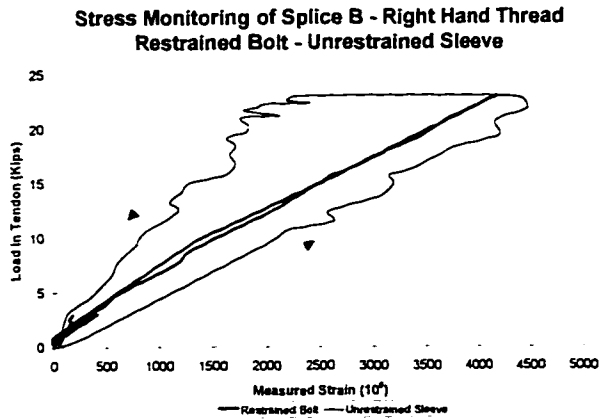
Figure 6.19 Test of Alberta Splice in Stress Bed - Bolt Restrained and Torque Applied to Unrestrained Sleeve

strand are observed in the measured deformation response of the tendon.(Figure 6.19 and Figure 6.21). When torque is applied to one side of the splice while the other side is restrained against twisting, rotational energy is stored in the strand on the unrestrained side. As the direction of the applied torque is reversed (the splice unloaded), this energy is immediately released as evidenced by the flat portion of the unrestrained curves in Figure 6.19 and Figure 6.21. It is also evident that when the splice is stressed hydraulically, this twisting behavior is not observed as shown in Figure 6.20. These tests reveal more detailed behavior than was possible for splices that were installed in the girder as the load in the tendon could be directly monitored with a load cell.

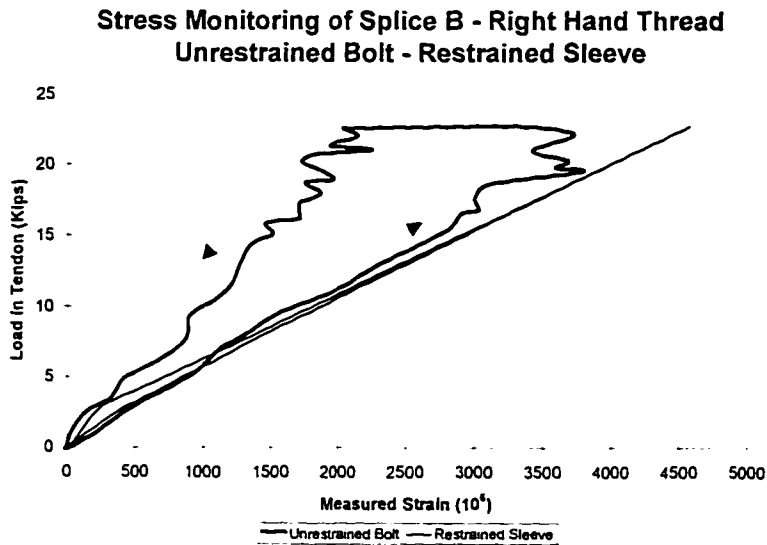
Figure 6.21 Test of Alberta Splice in Stress Bed - Sleeve Restrained and Torque Applied to Unrestrained Bolt

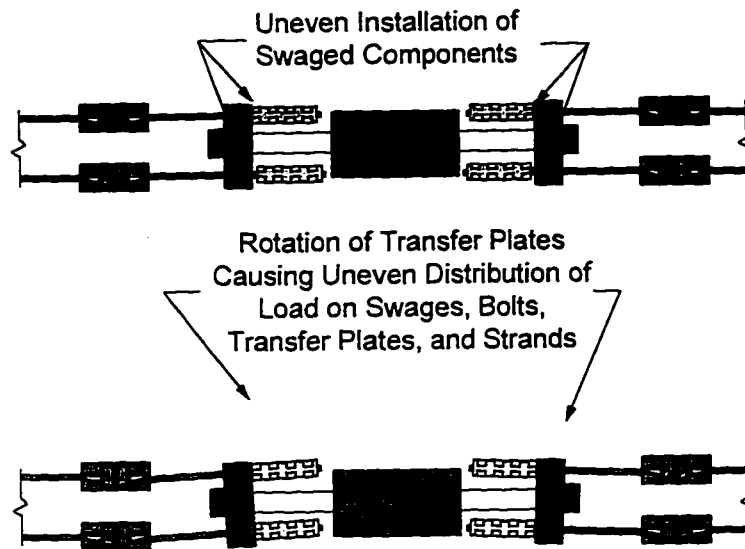
Figure 6.44 Schematic of Difficulties Encountered Installing Dual Tendon Splice - Unequal Distribution of Load Between Splice Components

plished by cutting the prefabricated swaged tendon sections to length as was done for the multi-bolt splices. Four strand couplers were used, one attached to the each end of the damaged strand. A schematic of the installation procedure is shown in Figure 6.42. The swaged tendons were placed through the 5/8-in.- (16-mm-) diameter outer holes in the transfer plates, the high strength bolts were then placed through the center holes of the transfer plates in the opposite direction as the strand (Figure 6.43). Once the swaged tendons and the bolts were in place through the holes in the transfer plate, the turnbuckle was engaged with approximately 1/2-in. (13-mm) of thread length for each bolt, and the swaged components were cut to the required length. After the swaged components were measured and cut to length, each side of the assembly was attached to the existing strands using couplers, the bolts slid backwards, the turnbuckle inserted, and the bolts engaged. Slack was removed by sliding the tendons further into the wedge anchorages of the couplers and then partially engaging the turnbuckle. Due to the weight and bulk of the assembly it was difficult to install the splice with all of the swaged components the exact same length, and spaces between the ends of the swages and the transfer plates resulted. As the turnbuckle was engaged, the transfer plates rotated until the ends of the swages came in contact with the surface of the plate (Figure 6.44) resulting in uneven load distribution between the splice components.

There were problems encountered while installing the dual strand splice. The most evident difficulty was to assure equal distribution of load to all of the components of the strand splice. As previously mentioned, it was not possible to install all four swaged tendons such that the bearing ends of the swages were equidistant. This caused rotation of the transfer plates and uneven load distribution throughout the splice components. It was also difficult to restrain the ends of the splice assembly. Rather than having a bolt or nut which could be rotated to facilitate gripping with a wrench, the transfer plates had to be gripped to provide restraint against rotation while applying torque to the turnbuckle. The transfer plates had a fixed vertical position which made gripping with a wrench difficult and slippage frequent.

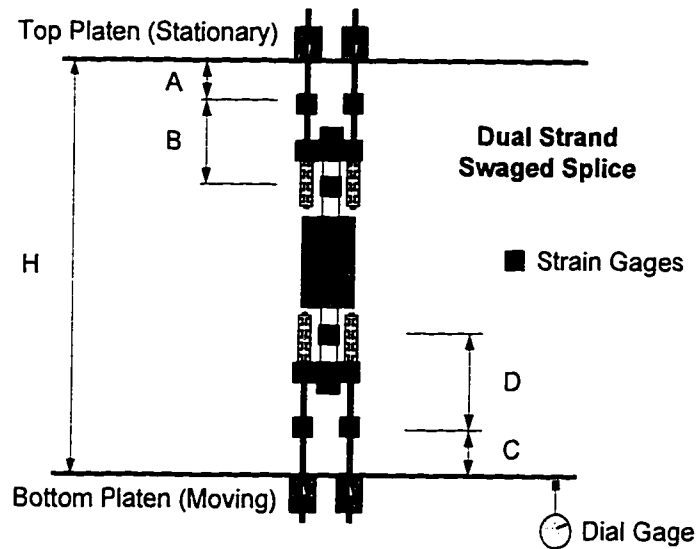
Figure 6.62 Tensile Test Setup for Dual Strand Swaged Splice Assemblies

Table 6.9 - Strand in Air Static Tensile Strength of Dual Strand Swaged Splice					
Test	A	B	H	Tu	Comments
1	7.125 in. (18 cm)	7.75 in. (19.7 cm)	54.63 in. (138 cm)	74.9 kips (333 kN)	Break of Strand Inside Swage
2	5.5 in. (14 cm)	4.5 in. (11.4 cm)	49.25 in. (125 cm)	66.7 kips (297 kN)	Failure of Threads on Bolt

The two tests performed on the dual strand swaged splice resulted in different modes of failure. One strand of the first specimen failed within the swage as expected. The failure occurred at 91 % of the ultimate strength of the strand; the manufacturer rates the swaged tendon for 90 % of the ultimate strength of the strand due to the swaging process. The second specimen, however, failed through the threads of the bolt. Some problems were encountered while fabricating the some of the turnbuckles for the dual strand splices. In some instances the threads within the turnbuckle were not cut to full depth through the entire length of the turnbuckle. With less than the full depth of threads there is less area to resist the load as it is transferred from the bolt to the turnbuckle and failure through the threads would be likely in this instance. It appeared that the second specimen failed through the threads due to fabrication errors. Although it was not immediately apparent upon inspection of the second specimen tested, two other assemblies were not tested due to improper thread depth. It is very likely that improper depth of the threads within the turnbuckle lead to premature failure of the second specimen which reached only 81 % of the ultimate strength of the strand. The expected mode of failure for this splice was substantiated by further tests of the swaged portion of the splice in

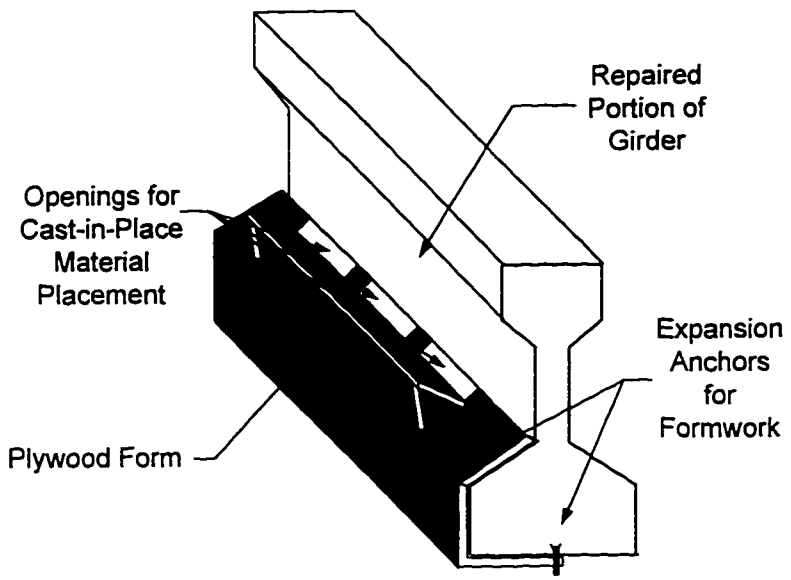
Figure 6.66 Schematic of Formwork for Cast-In-Place Repair of Steel Girder - Final Phase

A schematic of the forms used for the repair is shown in Figure 6.66. The patch material was placed into the forms through openings in the top as shown schematically. A photograph of the bottom portion of the forms in place along with installed splices is shown in Figure 6.67. Once the forms were in place, preload was applied to the girder using the hydraulic rams as before. After preloading, the patch material was placed, allowed to cure, and the forms were removed the next day; however the preload was maintained for three days after the patching was performed.

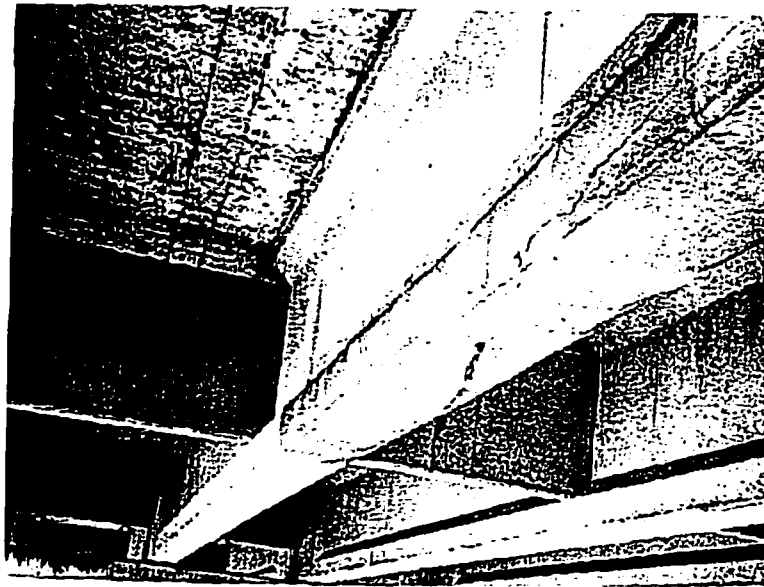
Diaphragm Reaction - occurs when the diaphragm acts as a reaction point for the transverse impact loading (Figure 7.6)

Figure 7.6 Photograph of Concrete Damage Where the Diaphragm Acts as a Reaction for Transverse Impact Loading

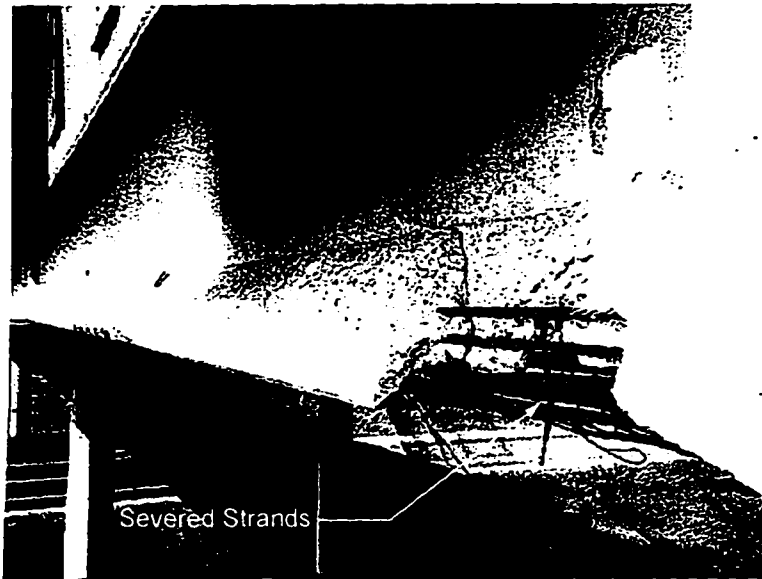
**Loss of Concrete Section** - occurs in extreme cases resulting in large volume loss of concrete in the precompressed tensile zone (bottom flange and lower portion of the web) (Figure 7.9)

Figure 7.9 Photograph Showing Large Volume Loss of Concrete Cross Section
