1. Report No. <b>REVISED PRELIMINARY REVIEW COPY</b>		2. Government Accession No.		3. Recipient's Catalog No.	
4. Title and Subtitle <b>CURRENT PRACTICE IN THE REPAIR OF PRESTRESSED BRIDGE GIRDERS</b>				5. Report Date (AUGUST 1993) <b>REVISED — March 1994</b>

6. Performing Organization Code	
7. Author(s) <b>Lisa R. Feldman, James O. Jirsa, and Ramon L. Carrasquillo</b>				8. Performing Organization Report No. <b>Research Report 1370-1</b>

**IN-SERVICE REPAIR OF PRESTRESSED BRIDGE GIRDERS —  
CURRENT PRACTICE**

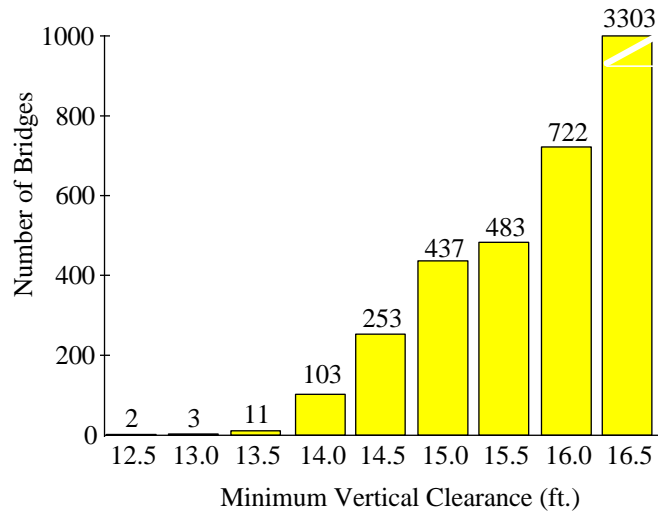
Figure 3-2 Distribution of bridge clearances (Interstates, U.S. and State Highways, Loops, and Spurs) in Texas.

tory, Inspection and Appraisal Database System. As shown in Figure 3.2, 38 percent of all prestressed concrete bridges on the Texas system of Interstates, U.S. and State Highways, Loops and Spurs, have vertical clearances less than the current suggested 16 ft. - 6 in. (5.03 m) minimum vertical clearance. Data shown in Figure 3.2 were limited to heavily traveled routes, such as state highways and loops, likely to have a high number of large vehicles traveling on them. As well, the TxDOT is responsible for maintaining all of the selected route types.

Specifications require that bridges built in the state of Texas in 1993 have a minimum vertical clearance of at least 14 ft. - 6 in. (4.42 m). However, recommended practice is to keep minimum vertical clearance above 16 ft. - 6 in. (5.03 m). Figure 3.2 shows a distribution of the number of bridges in 6-in. (152.4 mm) increments of minimum vertical clearance. All data shown in this figure were extracted from BRINSAP, the Texas Department of Transportation Bridge Inventory,

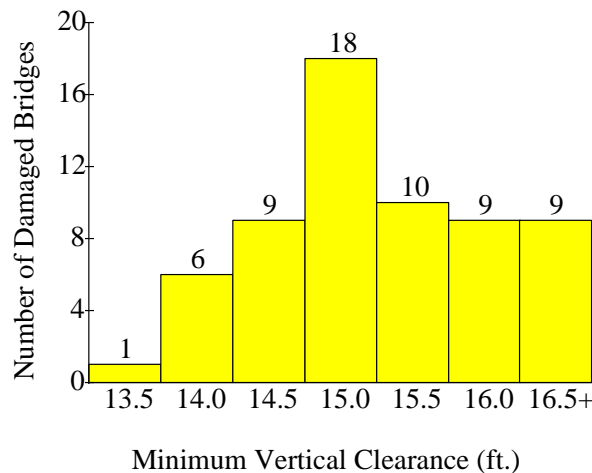
Figure 3-3 Bridge clearances versus the number of damaged bridges

The distribution of minimum vertical bridge clearances for the reported impact-damaged bridges is shown in Figure 3.3. As shown, 53 of the damaged bridges (some bridges had multiple damaged girders), or 85 percent of the total number of damaged bridges, had vertical clearances below 16 ft. - 6 in. (5.03 m). Note that the number of bridges damaged by over-height loads does not necessarily coincide with the number of girders damaged, since more than one girder on a given bridge can be damaged when the bridge is struck by an over-height vehicle.

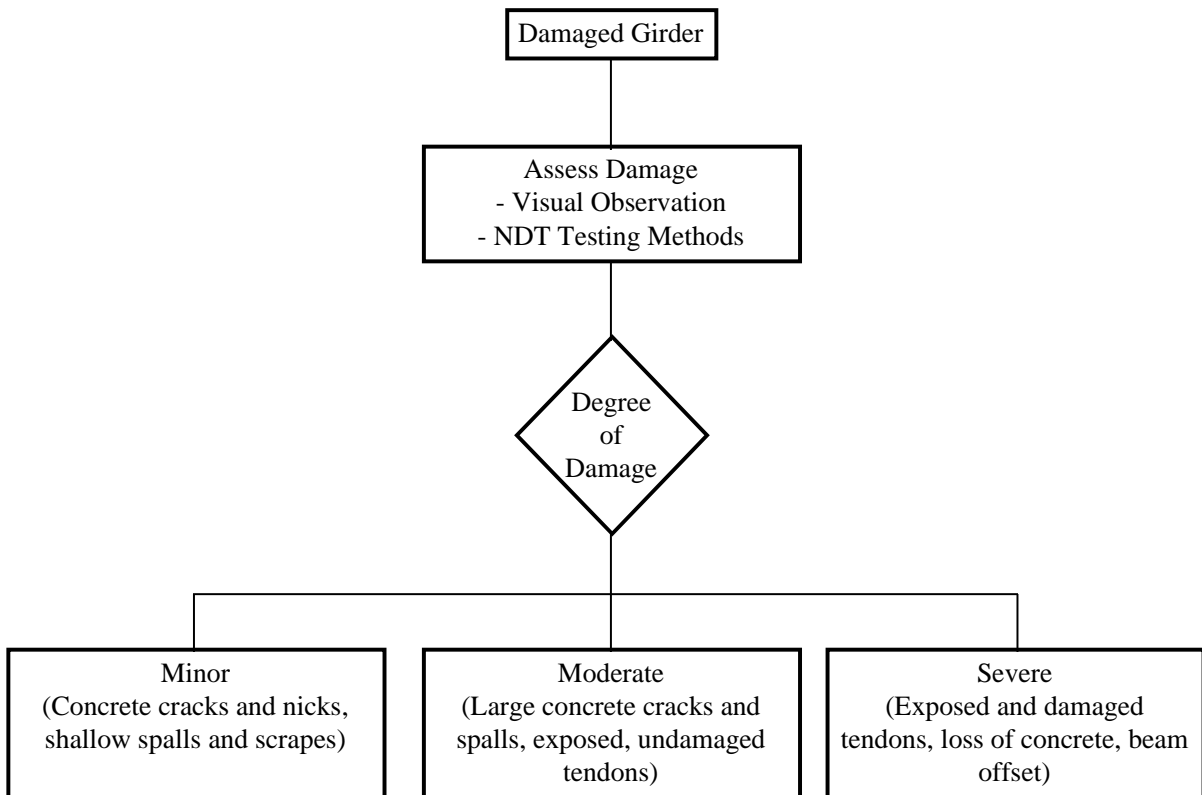
Figure 5- 1 Impact damage assessment

An outline of the procedure for assessing the impact damage of a girder is shown in Figure 5.1. The degree of damage follows the same categories established for the surveys discussed in Chapters 3 and 4.

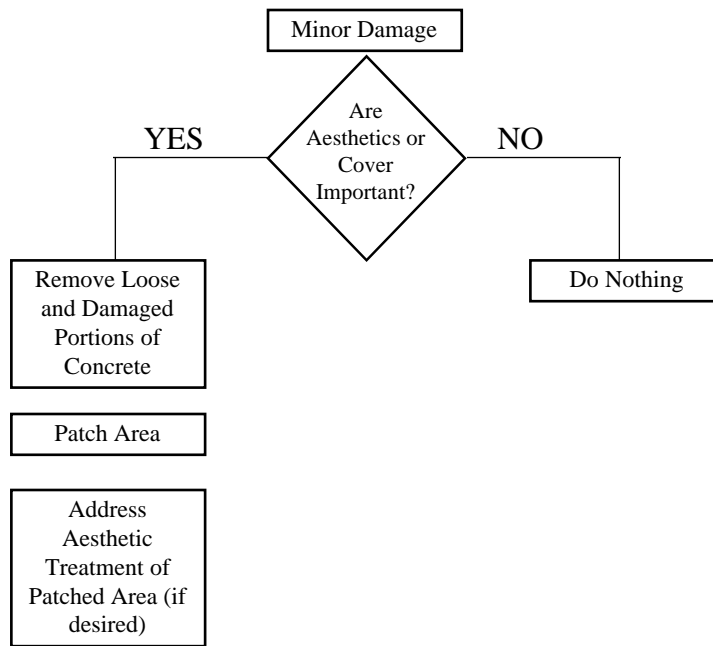
Figure 5- 8 Minor damage repair
