**REINFORCED CONCRETE FRAME CONNECTIONS
REHABILITATED BY JACKETING**

ABSTRACT

The program was part of the coordinated research effort between Mexican and American engineers implemented after the 1985 Mexico earthquake, and sponsored by the National Science Foundation (USA) and Consejo Nacional de Ciencia y Tecnologia (Mexico).

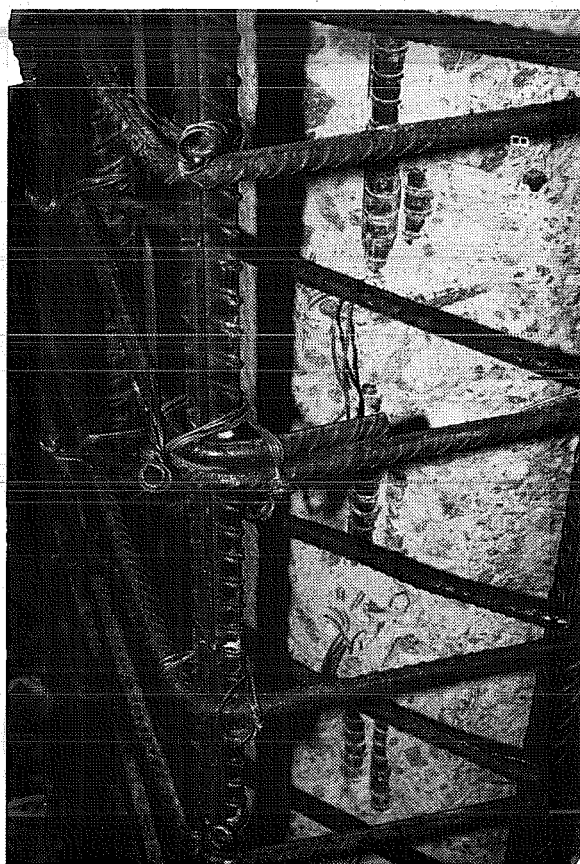
facilitate construction. However, the use of bundles might affect the structure's performance since bond along the bars could be damaged during large load reversals. Distributed reinforcement around the column was also used in many cases (Figure 1.5). There is no

Figure 1.5 Column Jacketing Using Distributed Reinforcement

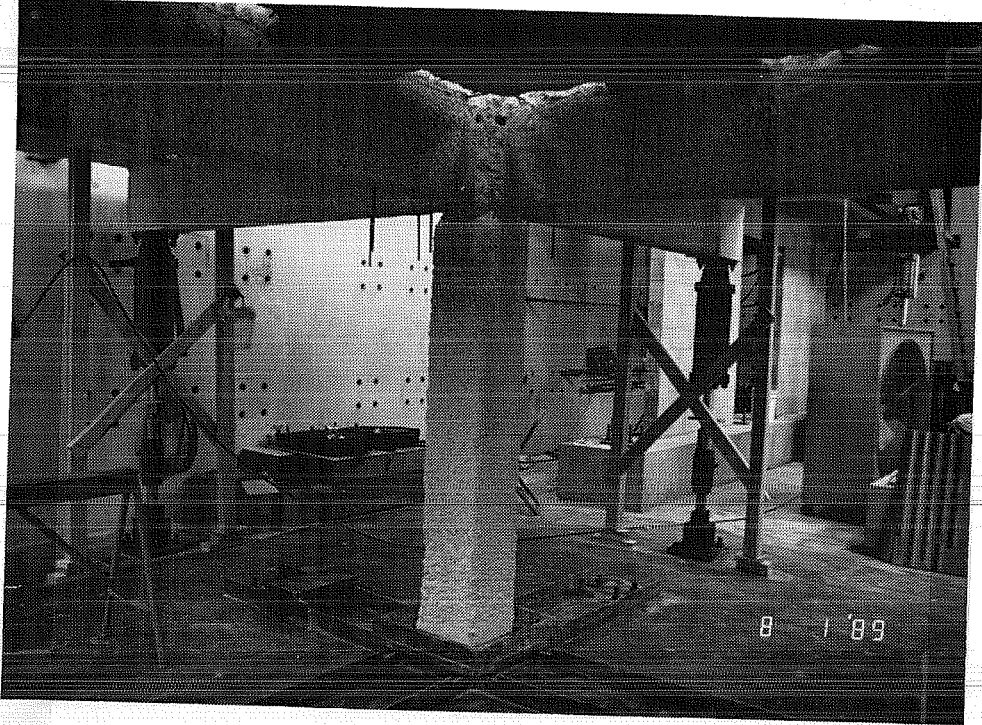
The slab was perforated in an alternate pattern along the edge of the beams as shown in Figures 2.13 and 2.14. Perforations were initiated with a series of holes along the boundaries of each perforation. To reduce concrete spalling from the slab lower surface, a piece of lumber was shored against the slab while the holes were drilled. The perforations were completed with an electric jackhammer. A transverse groove was cut into the beam top cover to place the inverted U-shaped ties in the beam. Concrete was placed and consolidated through the slab perforations. The time required for surface preparation and slab perforations for specimen SD-B was nine times that required for surface preparation for the specimens with jacketed columns only.

Figure 2.13 Specimen SD-B - Surface Preparation

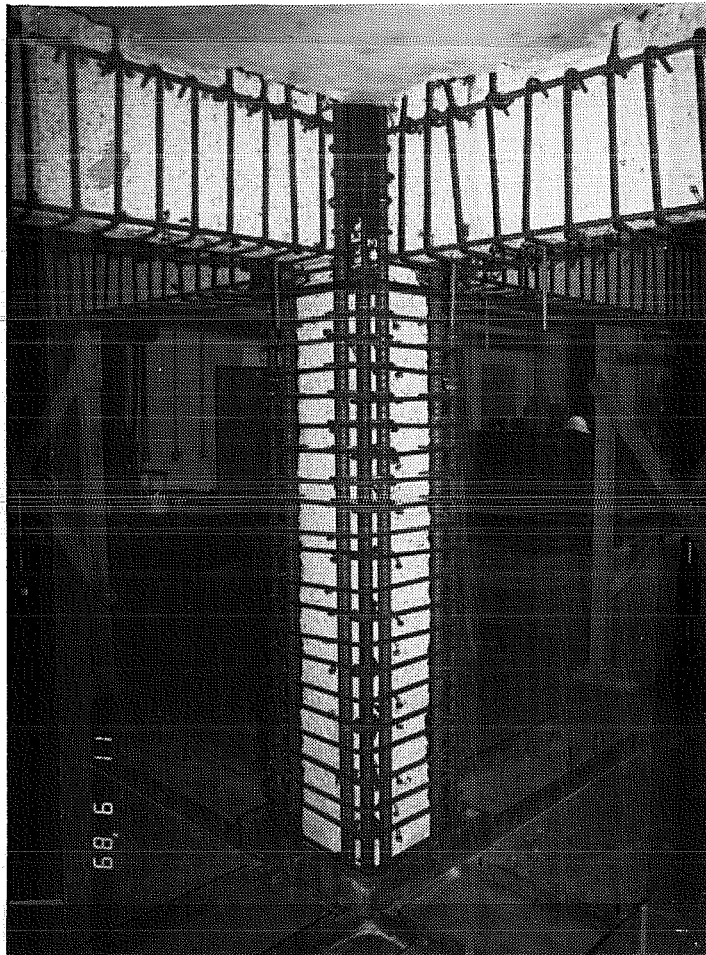
The final reinforcement cage of specimen SD-B is shown in Figure 2.15. Top reinforcement (2-#5 bars) in the beam jacket, passed through orthogonal beams in 1.25-inch diameter holes which were drilled several inches below the slab. Bottom reinforcement was placed in horizontal grooves in the existing column. The reinforcement for the column jacket was assembled first. Next, the inverted U-shaped ties were placed through the transverse slab grooves (Figure 2.16). The U-shaped ties were placed in groups of three along the beams as high as possible. Because the beam width was somewhat larger than the distance between hook extensions of the U-shaped ties, the hooks bore against the beam faces so that the ties hung due to friction. Afterward, the top bars were inserted, and the U-shaped ties were lowered to the final position and secured. Finally, the bottom bars (2-#4) were placed and secured.

Figure 2.15 Specimen SD-B - Reinforcement Cage

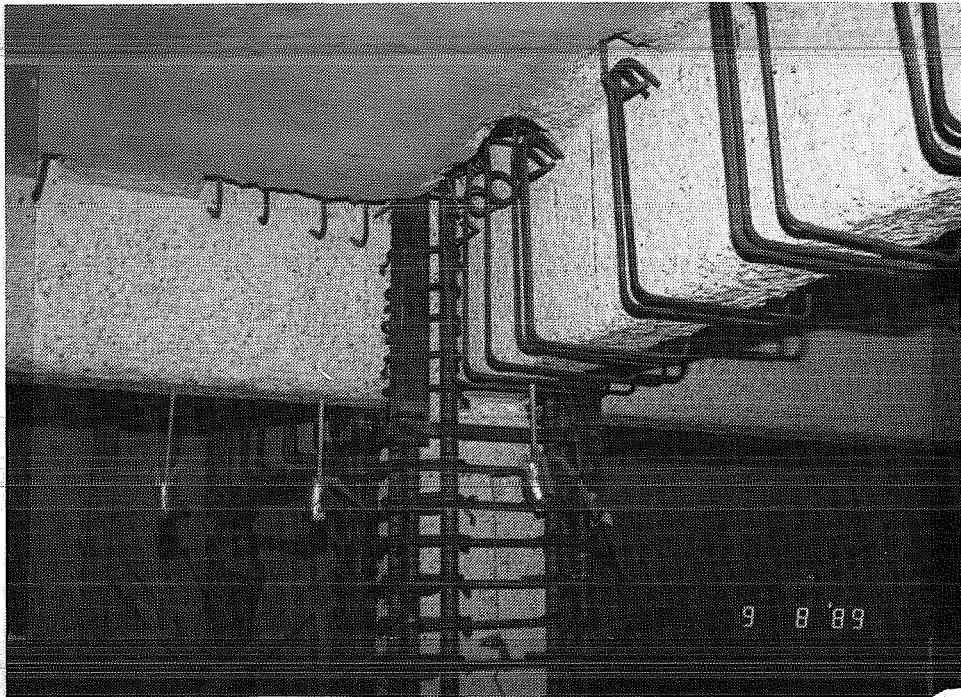
Figure 2.16 Specimen SD-B - Assemblage of Beam Jacket

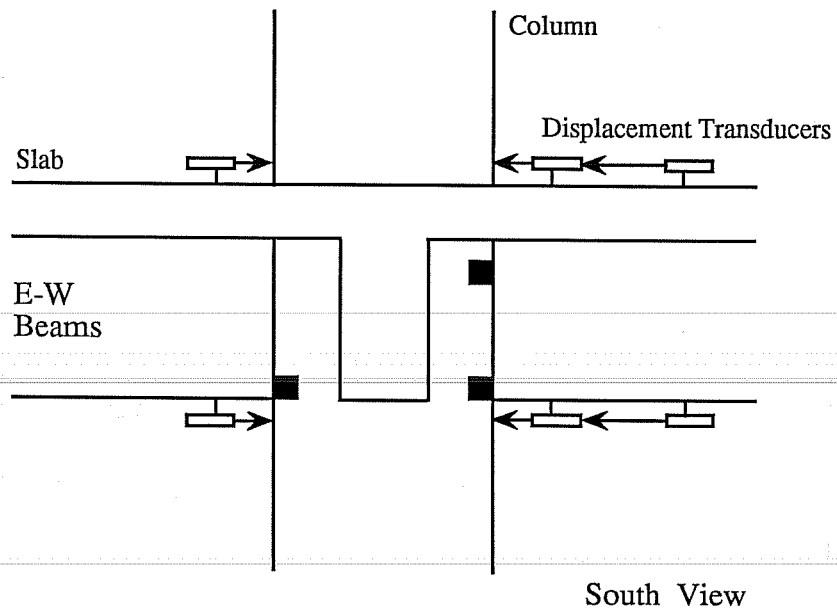
Figure 2.24 Instrumentation for Beam Rotation Measurements

Instrumentation used for beam rotations and column rotations is shown in Figure 2.24 and 2.25. Beam rotations were measured with linear potentiometers positioned 2 in. above the slab and below the beam soffit. Similarly, column rotations were measured with linear transducers mounted 2 in. from the column faces. The column and beam deformations included in the rotation measurements, as a result of the position of the potentiometers, were taken into account. In specimen O, since beam deformations were considerably smaller than column deformations, beam rotations were the most affected and therefore were corrected. Conversely, in the rehabilitated specimens, column rotations were corrected for the measured beam deformations. The linear potentiometers were positioned against small steel plates attached to the concrete surface. After several large loading cycles, typically at drifts to 4%, the concrete in the vicinity of the transducer mounting devices sometimes spalled and further measurements were unreliable. Average curvatures are presented up to cycles to 2% drift. Average beam and column curvatures were determined by dividing the measured relative rotation at one section by the length along the member over which they occurred.

3.2.2 Member Curvatures. Beam and column rotations were measured for all tests. Instrumentation used for measuring beam and column rotations is shown in Figure 2.24 and Figure 2.25, respectively. The measurements included elastic and inelastic deformations, as well as slip of beam and column longitudinal reinforcement within the joint. Beam rotations were measured over two regions along the beams (Figure 3.2). Region 1 covered the first 3 to 4 in. next to the column in all four beams. Region 2 included, approximately, the next 12 in. in the east and north beams. Average beam curvatures were calculated from the beam rotations by dividing the measured relative rotations by the length along the member over which the rotation occurred, i.e. the length of Regions 1 and 2. Column rotations were measured over the first 4 to 5 in. of the column above and below the joint in both loading directions. Average column curvatures over the gauge length were calculated. In all specimens, upper column curvatures were calculated over a shorter region than lower column curvatures.

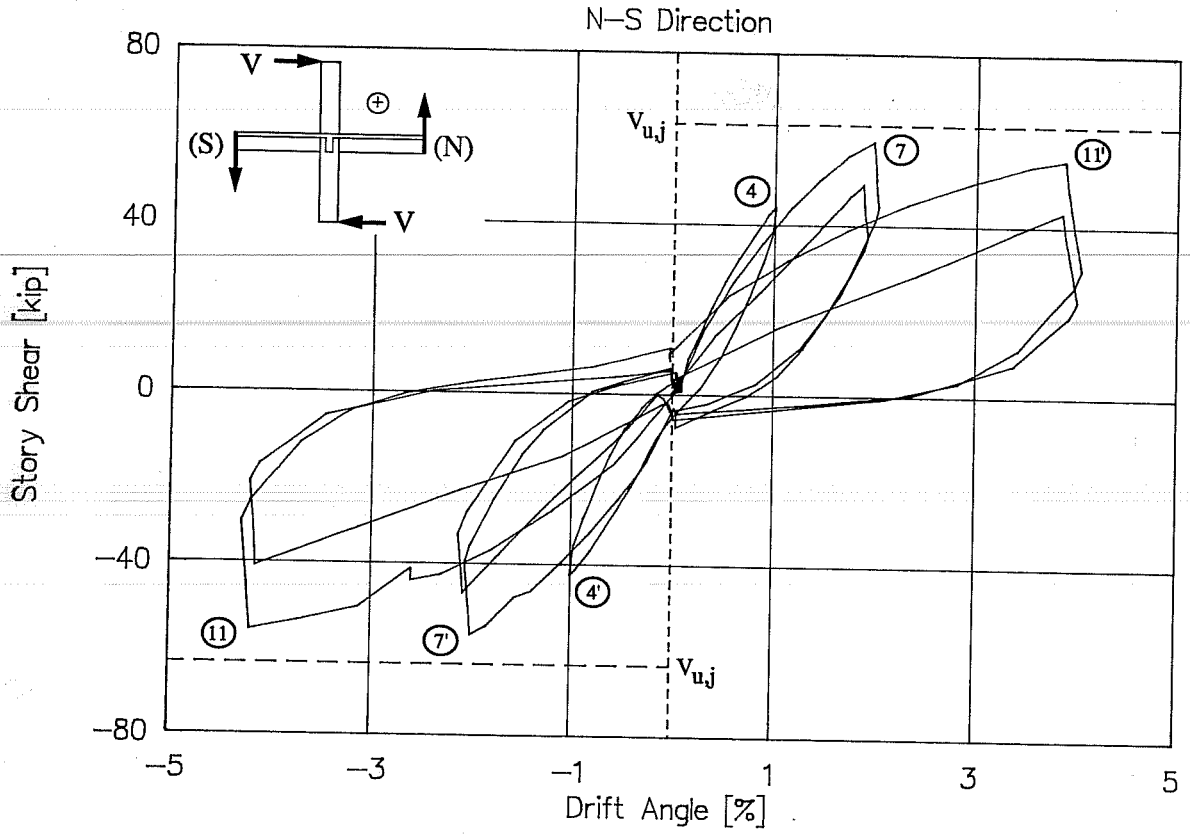
response of the subassembly in the N-S direction (Figure 3.46) showed similar behavior. It is interesting to note that in this direction, the specimen did not reach the calculated capacity $V_{u,j}$. The joint had failed in the E-W direction during cycle 9, so that cracking in the core and alternate loading affected the N-S strength in cycle 11. In this cycle, spalling of joint and the N-S beam cover probably accelerated the strength reduction.

Figure 3.46 Specimen SD-B - Story Shear vs. Drift angle (N-S Direction)

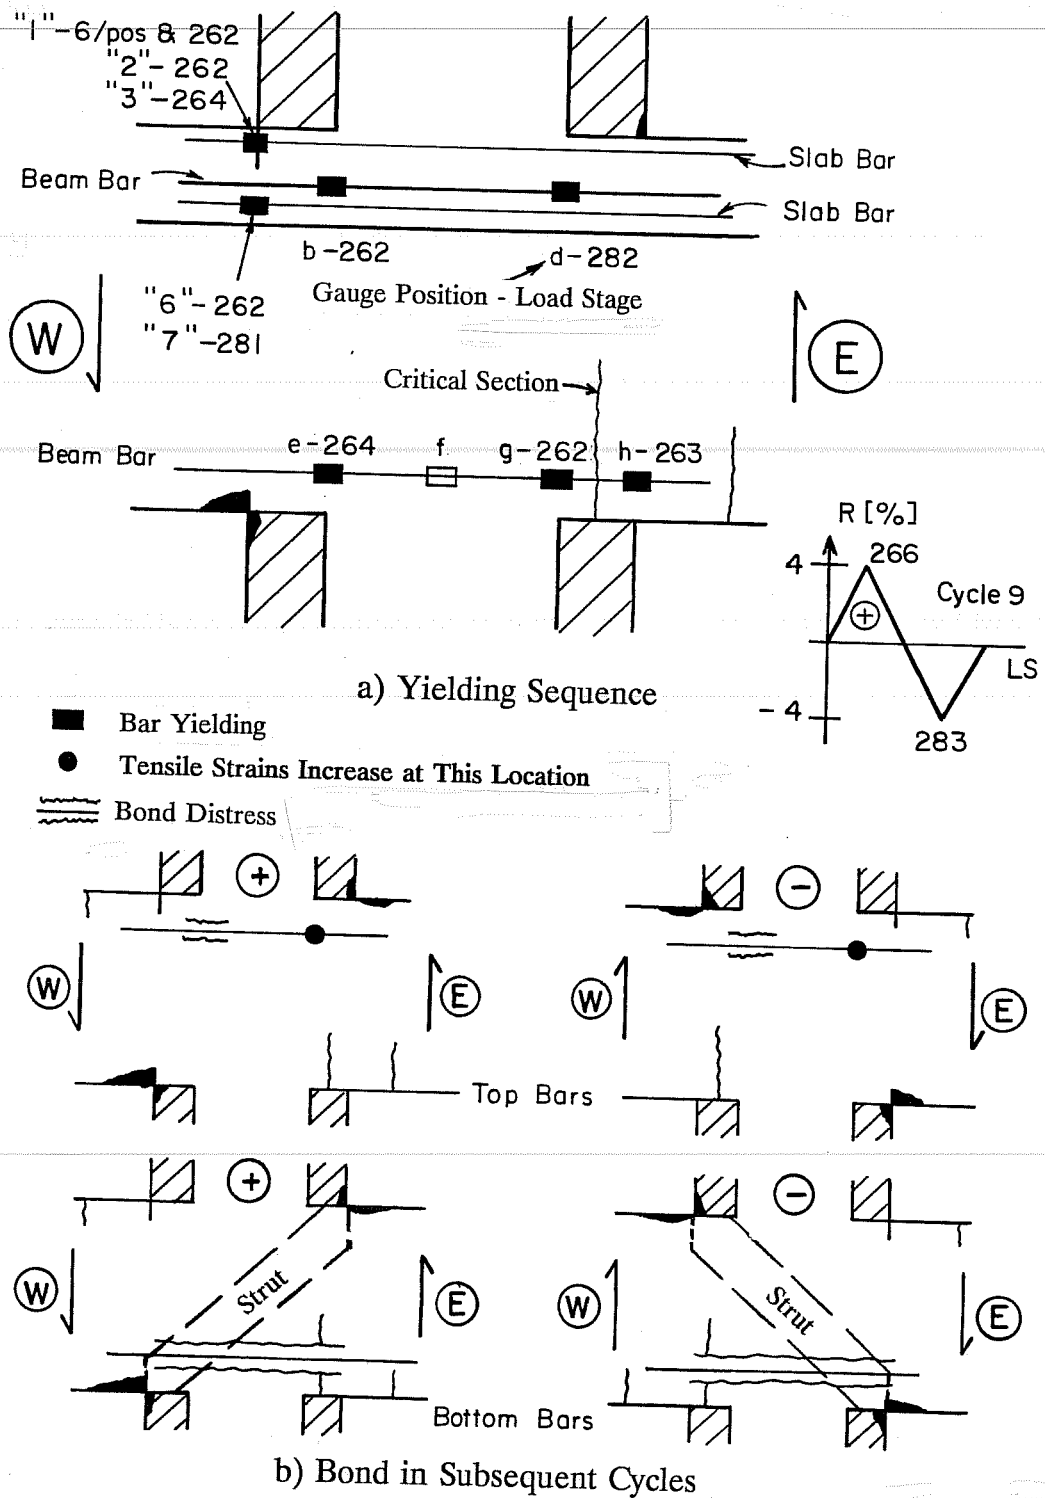
Figure 4.36 Specimen SB - Yielding Sequence (E-W Direction)

4.4.1 Beams. Beam bar strains in SB were much larger than in RB. The yielding sequence of the beam reinforcement and slab bars next to the column in the E-W direction, and the load stages in which the bars yielded are shown in Figure 4.36a. Only working gauges are shown. The progression of bond loss is also illustrated for cycles after yielding (Figure 4.36b). Bond along top bars was better than in RB because the tensile strength of the concrete of the existing structure was higher and because the beams were undamaged before the test. In Figure 4.37, the W beam shear versus strain at gauge location "b" is shown. During negative loading (beam upwards), tensile strains were measured because the neutral axis was above the bars. Top beam reinforcement was placed 3 in. below the top slab surface. After yielding, local bond was damaged and the bar slipped after which the strain decreased until reaching the load peak 9/pos. In subsequent cycles, strain remained practically constant because the bar was debonded at this location.

Bottom beam reinforcement first yielded at "g" (see Figure 4.36) thus suggesting that the critical section was located inside the jacket similarly to specimen RB. Bond

4.5.1 Beams. In Figure 4.47, the yielding sequence in the E-W slab and beam bars is presented. Only working beam gauges are shown. E-W beam yielding occurred in cycle 5. The yielding sequence and strains were somewhat different from those in SB (see Figure 4.36).

Forces on the joint were highest during cycle 9, and caused large joint distortion and severe joint damage which finally led to joint failure. At gauge position "h", the bar yielded during cycle 9/pos (Figure 4.47). In subsequent cycles, crushing in the bottom concrete caused large compression forces on the bottom bar which increased the bond distress. In cycle 9/neg (LS 286), during downward loading of the E beam, the W beam yielded at "a". After, the top bar was pulled through the joint losing bond. Splitting cracks were observed on top of the E beam and considerable crushing in the E beam was noted. Since the top bar lost anchorage in the tension side of the joint (E side) and through the joint, the bar was anchored in the compression face of the joint (W side), thus increasing the force to be resisted by the diagonal strut (see Figure 4.36b for SB, in which the same phenomenon is illustrated for bottom beam bars).

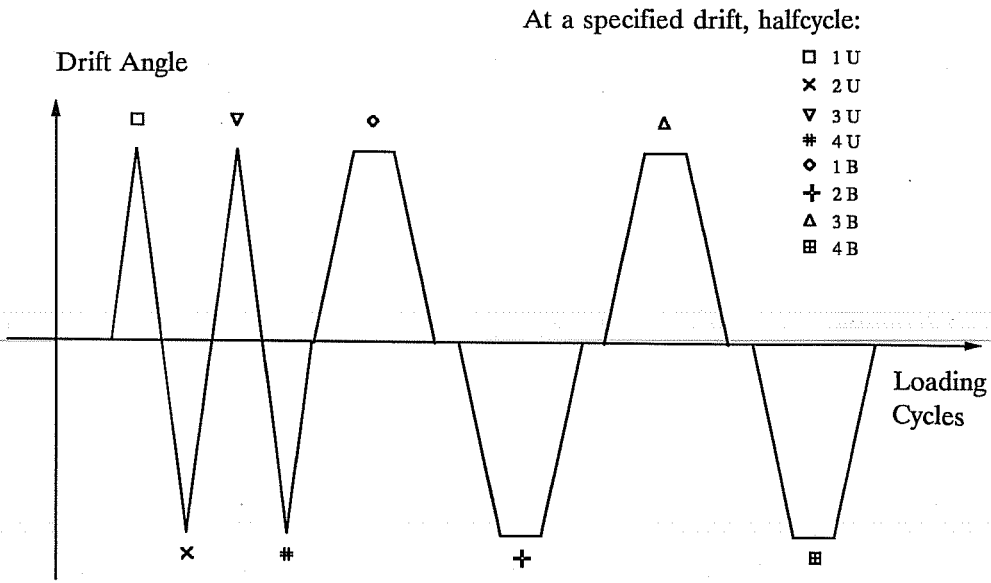
Figure 5.8 Notation for Figures 5.9, 5.10 and 5.12

Figure 5.8 shows the notation used in Figures 5.9 and 5.10. Equivalent stiffnesses for specimen SB in the E-W direction are presented in Figures 5.9 and 5.10. The values are comparable to those observed in the N-S direction. Similar diagrams were plotted for other specimens (not shown). Equivalent stiffness $K_{e, zero\ shear}$ is shown in Figure 5.9. The stiffness deteriorated more rapidly in early stages of loading. First positive half-cycles showed larger stiffness in all specimens for two reasons. First, the story shear reached during positive half-cycles was a little larger than the one measured in negative half-cycles. Damage caused in a positive half-cycle affected the strength in the subsequent half-cycle. Second, the residual drift angle was smaller at the beginning of the first cycle to a new deformation level. Most of the stiffness degradation at a given deformation occurred in the first unidirectional cycle. Equivalent stiffness values decreased in subsequent cycles and were generally associated with loss of strength. This was especially the case in cycles to 4% drift angle. When bidirectional cycles were applied, deterioration progressed with cycling. Specimens showed severe stiffness deterioration when a new deformation level was applied. The equivalent stiffness $K_{e, zero\ shear}$ for the first unidirectional half-cycle at a given drift level (label 1U in Figure 5.8a), is presented in Table 5.1.

a) Notation for Equivalent Stiffness

b) Notation for Peak-to-Peak Stiffness

Peak-to-peak stiffness versus E-W drift angle for specimen SB is found in Figure 5.12. Comparable values are observed in the other direction. Similar graphs were plotted for the other tests (not shown here). Data for peak-to-peak stiffness deterioration best follows a curve similar to that for equivalent stiffness. Guimaraes (Ref. 21), reported that the stiffness degradation of normal strength concrete specimens, i.e. less than 6000 psi., show a parabolic decay. The first cycles at a given deformation level showed slightly higher stiffnesses than subsequent cycles because the maximum values of story shear decayed progressively. Stiffness degradation was larger during cycles to 2% and 4% in which most of the joint softening, and crushing and spalling occurred. Peak-to-peak stiffness for the first unidirectional cycle at a given drift level (label 1U in Figure 5.8b), is given in Table 5.2.

The equivalent viscous damping ratio H_{eq} plotted against the story drift angle during E-W loading for specimen SB is shown in Figure 5.18. The energy dissipation capacity of specimen SB is used for illustration. Similar graphs were plotted for other tests in the two loading directions (not shown). The notation introduced in Figure 5.8 is applicable. In general, damping ratios increased with drift angle.
