REINFORCED CONCRETE FRAME CONNECTIONS
REHABILITATED BY JACKETING

Copyright
by
Sergio Manuel Alcocer
1991

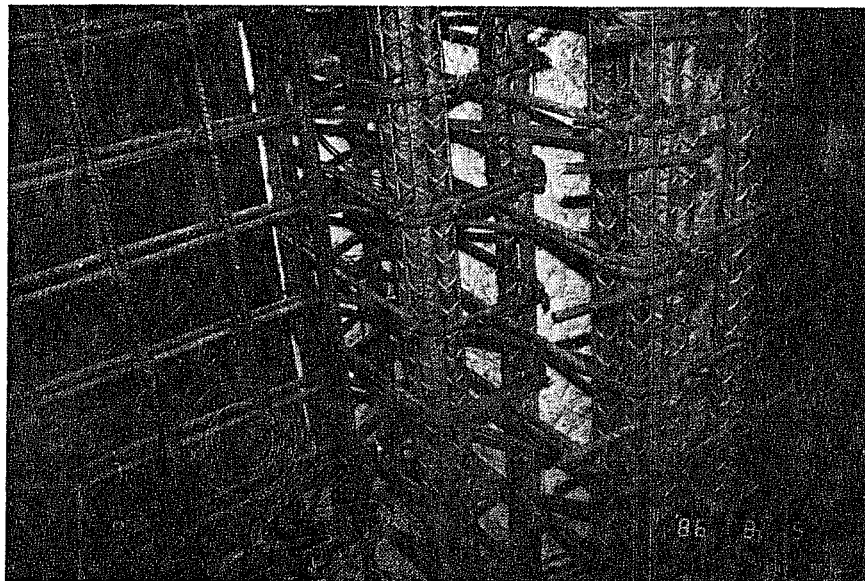
Figure 1.4 Column Jacketing Using Bundled Bars

One of the most common solutions for rehabilitation of concrete frame buildings in Mexico City after the 1985 earthquake, was concrete jacketing of the structural members (Refs. 5, 24). Jacketing of columns only and jacketing of columns and beams both was compatible with the structural system of the building. Jacket reinforcement was continuous to enhance the strength, stiffness and energy dissipation characteristics of the moment resisting frame. One of the advantages of jacketing was the reduced foundation strengthening required as compared with buildings in which shear walls were added. Many buildings had a box type foundation that helped distribute the forces transferred from the superstructure. In some cases, only strengthening of grade beams was necessary which was done generally by jacketing. In general, foundation rehabilitation was expensive and difficult. Different layouts of column longitudinal reinforcement were used. Figure 1.4 shows a jacketed column in which the bars were bundled

to reduce slab perforation and to facilitate construction. However, the use of bundles might affect the structure's performance since bond along the bars could be damaged during large load reversals. Distributed reinforcement around the column was also used in many cases (Figure 1.5). There is no experimental evidence regarding the comparative performance of bundles versus distributed reinforcement in jacketed frame columns subjected to earthquake loads.

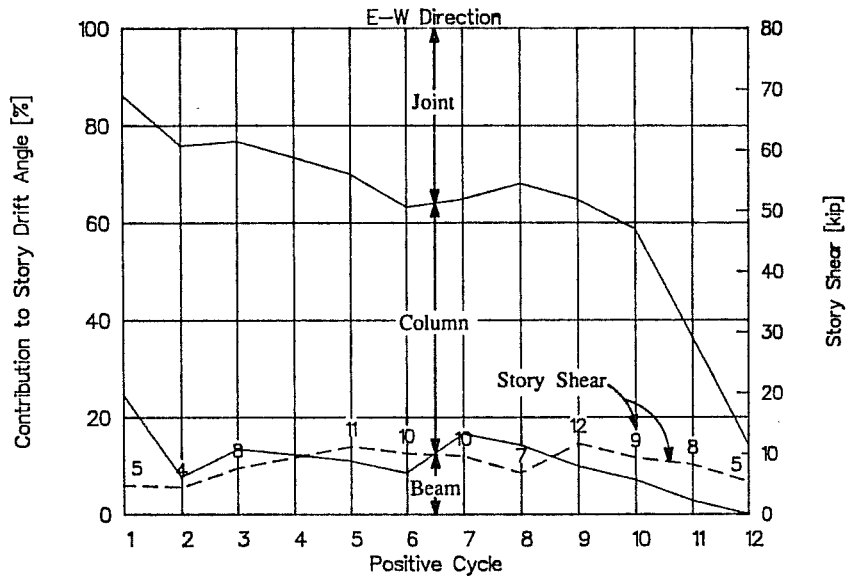
Figure 5.1 Specimen O - Member Contribution to Drift Angle (E-W Direction)

Member contribution to drift angle for specimens O and RB, during E-W positive cycles, are presented in Figures 5.1 and 5.2, respectively. Similar graphs were plotted for the other specimens (not shown here). Contributions in the N-S direction were similar (not shown). The variation of measured story shear is also shown in the figures (right edge vertical scale). The story shear helps to indicate the effect of the changes in a given portion of the structure on the strength of the specimen, and is particularly important to understand the mode of failure. In general, at large deformation levels, an increase in the participation of the most damaged element was accompanied with a severe loss of strength. For unidirectional cycles, the story shear shown is the same as the measured peak value. For bidirectional cycles, the story shear is the maximum value before the other direction was loaded. For specimen O (Figure 5.1), the beams contributed least to total deformation. The column contribution, which was largest at the first stages of the test, diminished by the end of the test when joint deformations contributed more to the total drift. After cycle 9, the joint contribution increased rapidly and accounted for 85% of the total drift by the end of the test. Specimen O can be considered to have failed in cycle 9 due to severe joint distress which was aggravated by hinging in the columns and bond degradation of column bars in the joint. From cycles 9 to 12, the story shear decreased 55%, while the joint

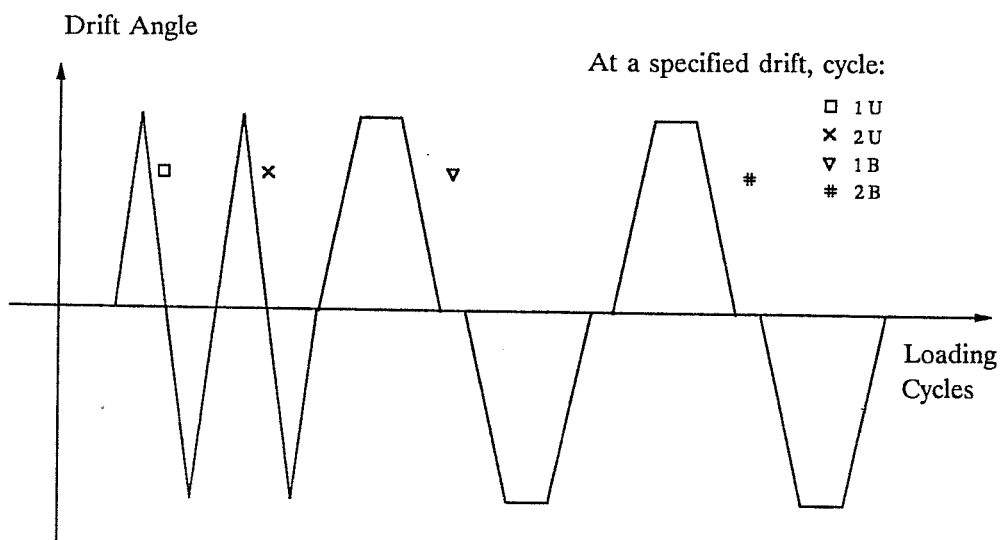
a) Notation for Equivalent Stiffness

b) Notation for Peak-to-Peak Stiffness

Figure 5.8 Notation for Figures 5.9, 5.10, and 5.12

Figure 5.8 shows the notation used in Figures 5.9 and 5.10. Equivalent stiffnesses for specimen SB in the E-W direction are presented in Figures 5.9 and 5.10. The values are comparable to those observed in the N-S direction. Similar diagrams were plotted for other specimens (not shown). Equivalent stiffness $K_{e, zero\ shear}$ is shown in Figure 5.9. The stiffness deteriorated more rapidly in early stages of loading. First positive half-cycles showed larger stiffness in all specimens for two reasons. First, the story shear reached during positive half-cycles was a little larger than the one measured in negative half-cycles. Damage caused in a positive half-cycle affected the strength in the subsequent half-cycle. Second, the residual drift angle was smaller at the beginning of the first cycle to

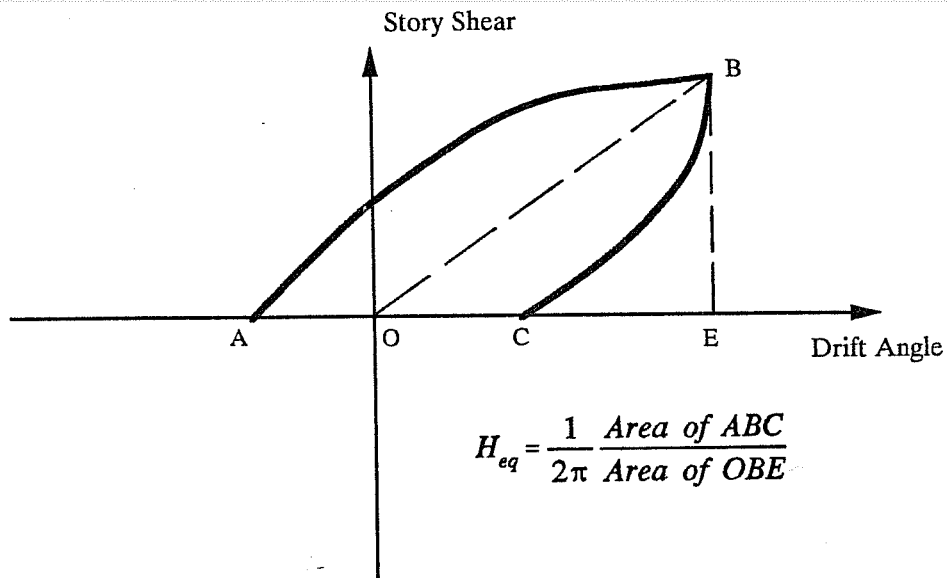
Figure 5.17 Definition of Equivalent Viscous Damping Ratio

The definition of equivalent viscous damping ratio H_{eq} is depicted in Figure 5.17. It was taken as the ratio of the dissipated energy within half a cycle to 2π times the strain energy measured at peak of an equivalent linearly elastic system. Values of the equivalent viscous damping ratio were used to compare the energy dissipation capacity of the specimens and to indirectly measure pinching of hysteresis loops.
