The Influence of Overhang Construction on Girder Design

Thesis

The University of Texas at Austin

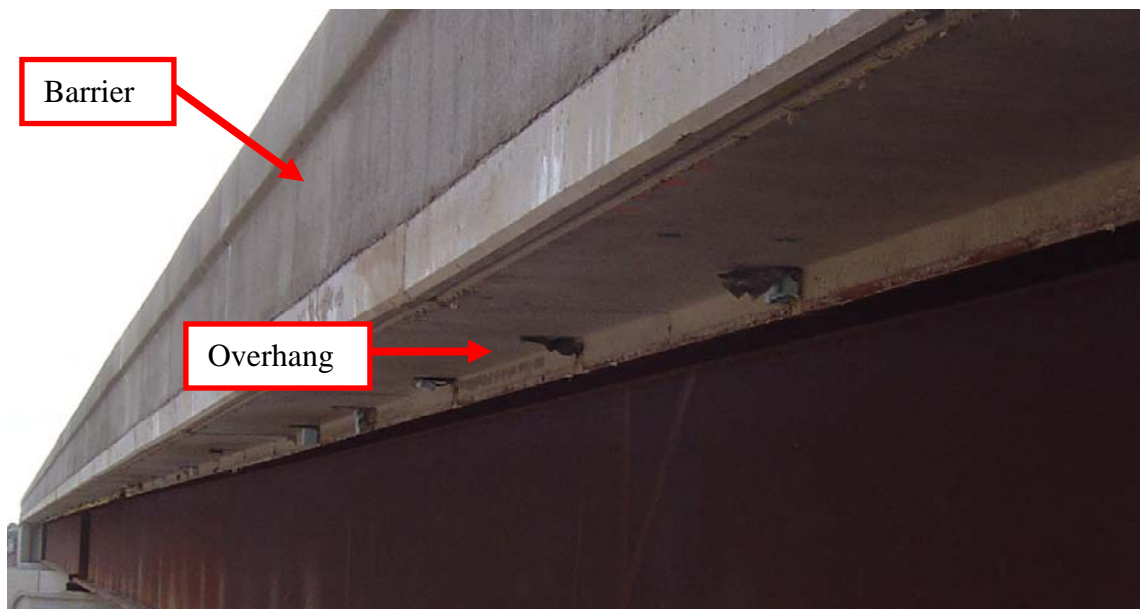
Overhangs on bridges result from economical constraints to use as few girders as possible across the bridge width. As seen in Figure 1-1, the overhang cantilevers out from the fascia girder, extending the roadway to support both traffic and the concrete barrier. Designers typically proportion overhangs so that the same girder sections are used for both interior and fascia girders. Most designers employ common rules of thumb with regard to the geometry; however, these rules of thumb usually lead to unbalanced torsional loading on the girder system that is not considered in the design. With no research justification for these rules of thumb, influences such as girder span or configuration of the overhang brackets relative to the girder geometry are not given proper consideration and have led to problems during bridge construction. In some cases excessive girder twist has resulted in bridges that were dangerously close to failure.

Figure 1-1 Bridge Deck Overhang

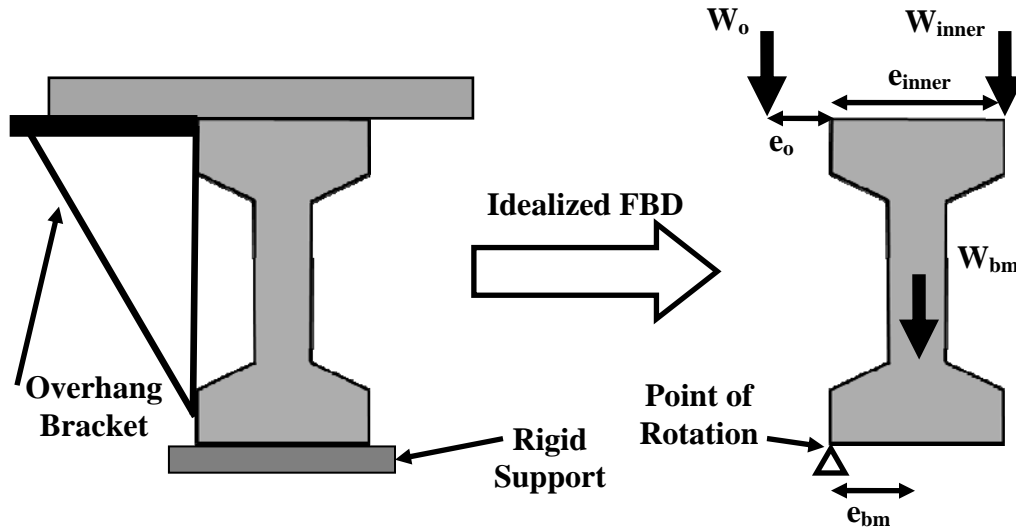
Overhangs influence the stability of the bridge system due to the induced torsion, which is a result of the technique for forming the concrete bridge deck. The torsional load is idealized by the free body diagram of the system in Figure 2-1. Once the concrete has cured, the concrete deck overhang has sufficient strength to cantilever from the edge of the fascia girder. However, while the concrete is still fluid, the overhang portion of the deck must be supported by overhang brackets. The resultant force from the overhang weight, W_o , acts at an eccentricity, e_o , from the edge of the fascia girder. If the overhang load and eccentricity are large enough, the system can become unstable and rotate about the point referred to as the “point of rotation.” For a beam with a rigid support, the point of rotation is the edge of the beam or end of the rigid support, whichever is closest to the centerline of the beam. The stability of the system can be evaluated by summing the moments about the point of rotation as given in Equation 2-1 and Equation 2-2.

Figure 2-1 Idealized Free Body Diagram of Bridge Overhang

For the system idealized in Figure 2-1, the self weight of the fascia girder as well as the reaction from the weight of the concrete deck on the inside of the fascia girder, W_{inner} (Equation 2-2), provide a stabilizing effect to the torsional load from the overhang. Thus, simple ways to have a stable system are to reduce the weight from the overhang or use a heavier girder. If a large overhang is required on a concrete girder system, bracing along the length of a girder can be added to prevent instability. A variety of different solutions are used, depending on the state's standard practices and guidelines.

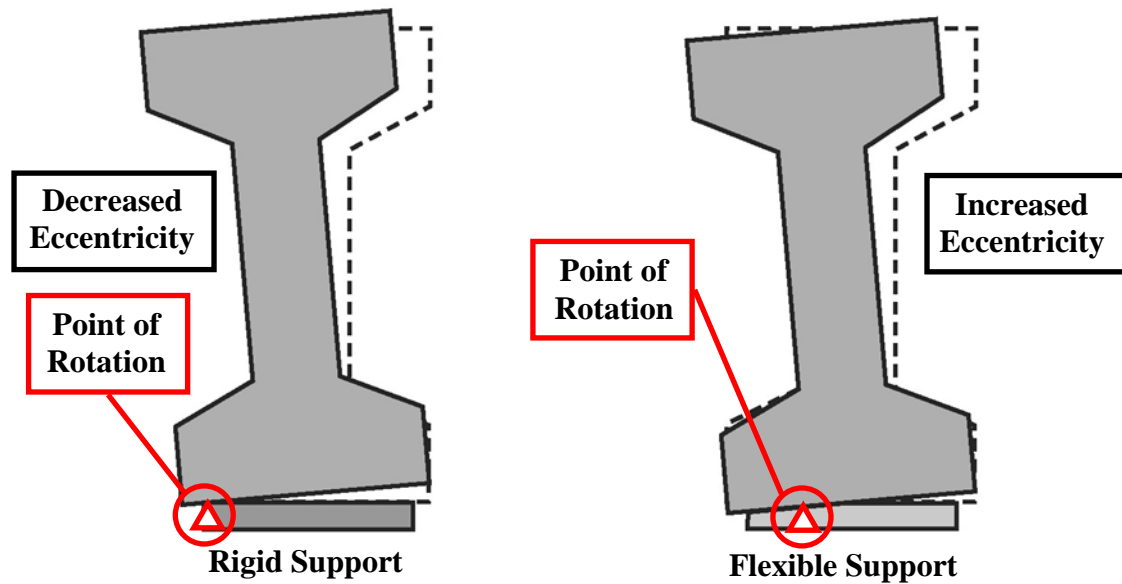
Two sources of deformations arise for prestressed concrete bridges loaded by overhangs: torsional deformations and rigid body rotation from flexible bearings. Due to the eccentricity of the overhang, torsion develops in the fascia girder that reduces the flexural capacity of the girder. Rather than specifically design for the torsion, many designers control the problem by limiting the overhang dimension based upon rules of thumb. The torsional rigidity of most prestressed concrete bridge girders is very large due to the thick flanges and web, making most torsional deformations small enough to neglect. Nonetheless, torsional deformations do contribute to the overall deformed shape of the girder. Flexible bearings, the other source of deformations, are important components of the structural system that allow the bridge to expand and contract due to changes in the thermal environment throughout the year. Although the flexibility of the bearing is helpful in accommodating the thermal expansion and contraction, the flexibility is detrimental to the torsional deformations from the overhang. The high compressibility of the bearings moves the point of rotation inward toward the center of the girder, which can lead to large rigid body rotations (Figure 2-2). Moving the point of rotation inward increases the eccentricity of the overhang load and thereby decreases the stability of the bridge. The torsional stiffness of the concrete girder system is sensitive to the details that are used to restrain girder twist. These details have changed dramatically over the past 20 years, as is discussed in the next subsection.

Figure 2-2 Effect of Rigid and Flexible Supports on Eccentricity

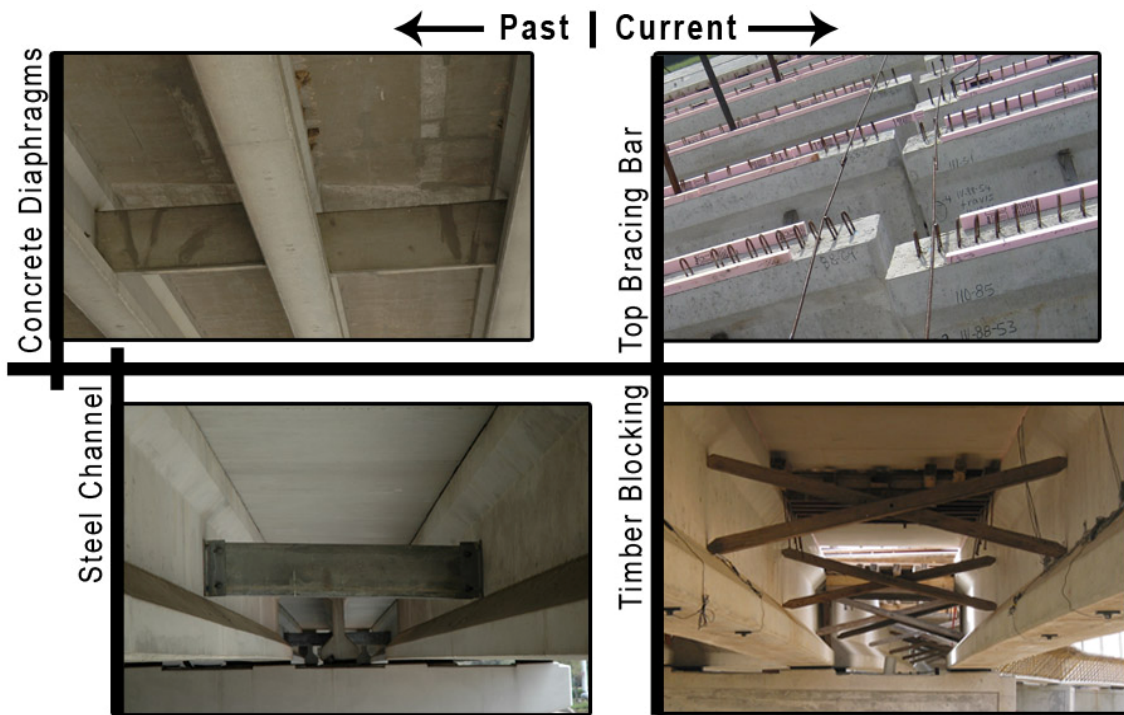
commonly used with steel girders to improve the torsional stiffness of the girder system. Similar details were used in the past with concrete bridges; however these braces were eliminated to improve the economy of the bridge system. Figure 2-3 shows pictures of concrete girder bridges constructed in the 1970's alongside a concrete bridge completed in 2006. In the 1970's, removable forms were commonly used for both the overhang and the interior bridge deck. A cast-in-place concrete diaphragm was used at the middle of the simply supported girders, while a smaller concrete diaphragm was employed at the support above the abutment. In addition to restraining girder twist, the concrete diaphragms also provided lateral bracing against wind loads during construction.

Figure 2-3 Progression of Bracing Details

In recent years, permanent diaphragms are rarely used on prestressed concrete bridges. In current Texas practice, the bracing requirements of prestressed concrete girders are governed by standard sheet MEBR(C)-1, “Minimum Erection and Bracing Requirements.” During construction, lateral bracing is mainly provided with the use of 4-inch square timbers. The lateral bracing from the timbers is achieved with the use of a combination of X’s and lateral struts positioned near the bottom flange. In addition, the top bracing bar shown in the top right picture of Figure 2-3 is used to provide additional restraint to twist of the fascia girder. This restraint is accomplished by welding the bracing bar directly to the R-bars that extend from the top of the precast girders. There are two different stages that the top bracing bar is used, one before and one after the precast concrete panels (PCP) are installed. Prior to PCP installation, #5 reinforcement are welded to adjacent bars and to the R-bar from one side of the bridge to the other. This detail requires a line of bars to be placed at each end and at mid-span of the bridge. The bracing bar shown in Figure 2-3 is the bar installed prior to PCP installation.

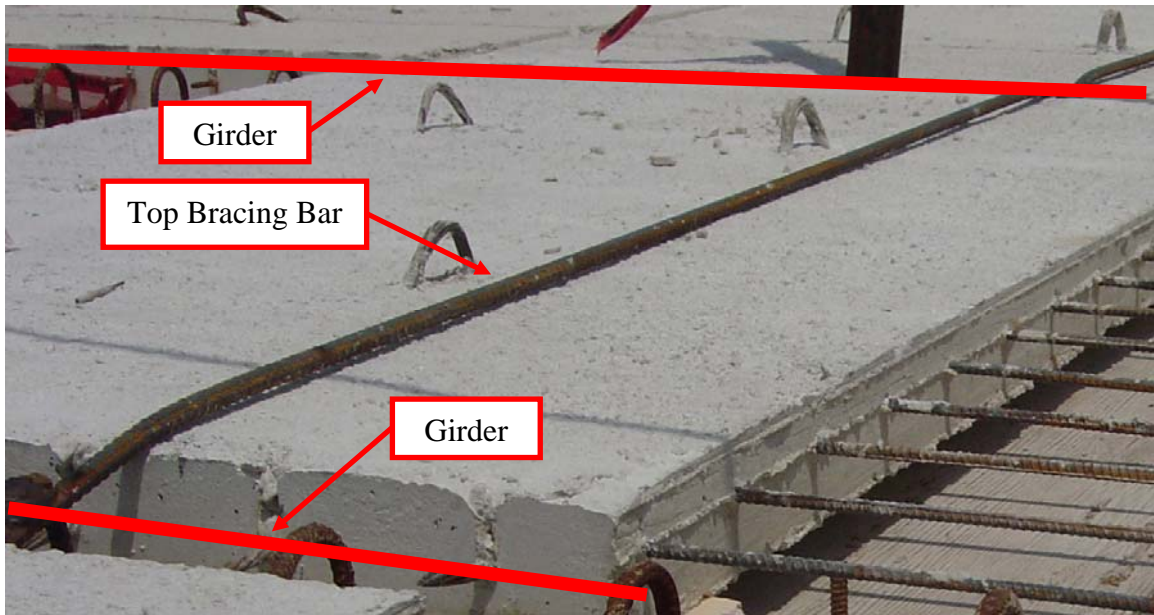
After the PCP are installed on the bridge, the detail of the top bracing bar changes. Instead of welding #5 bars in series, one #5 bar is used between each adjacent girder. Due to the height of the panels, the #5 bars are bent around the panels and welded to the R-bar (Figure 2-4). Whereas the bracing bars prior to PCP installation are usually only positioned at the ends and middle of the girders, after the deck panels are installed, the bracing bars are spaced at approximately 15 feet increments along the girder length.

Figure 2-4 Top Bracing Bar After Panel Installation

many of the timbers may become dislodged during deck construction as shown in Figure 2-5. In addition, as seen in Figure 2-4, the top bracing bar is very flexible and located above the top flange of the beam, making it inefficient.

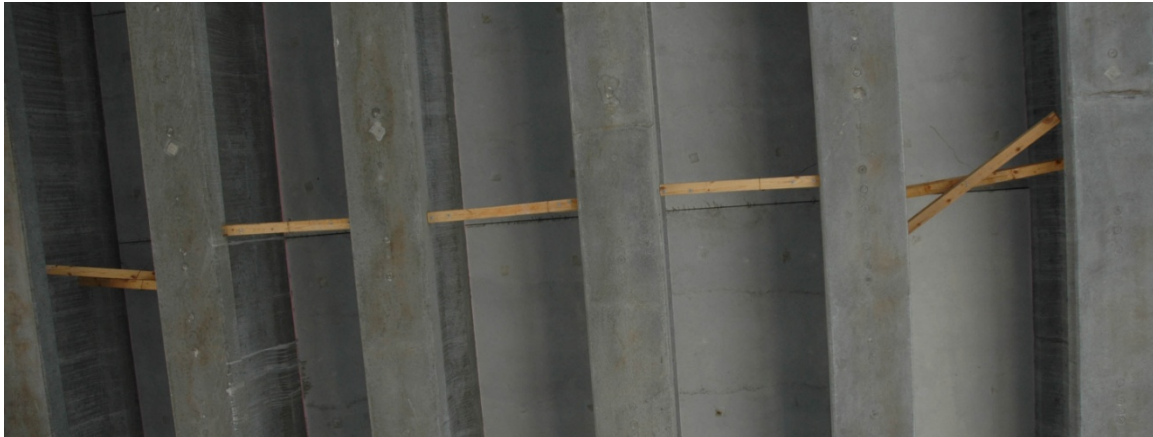
Figure 2-5 Effect of Twist on Timber Blocking

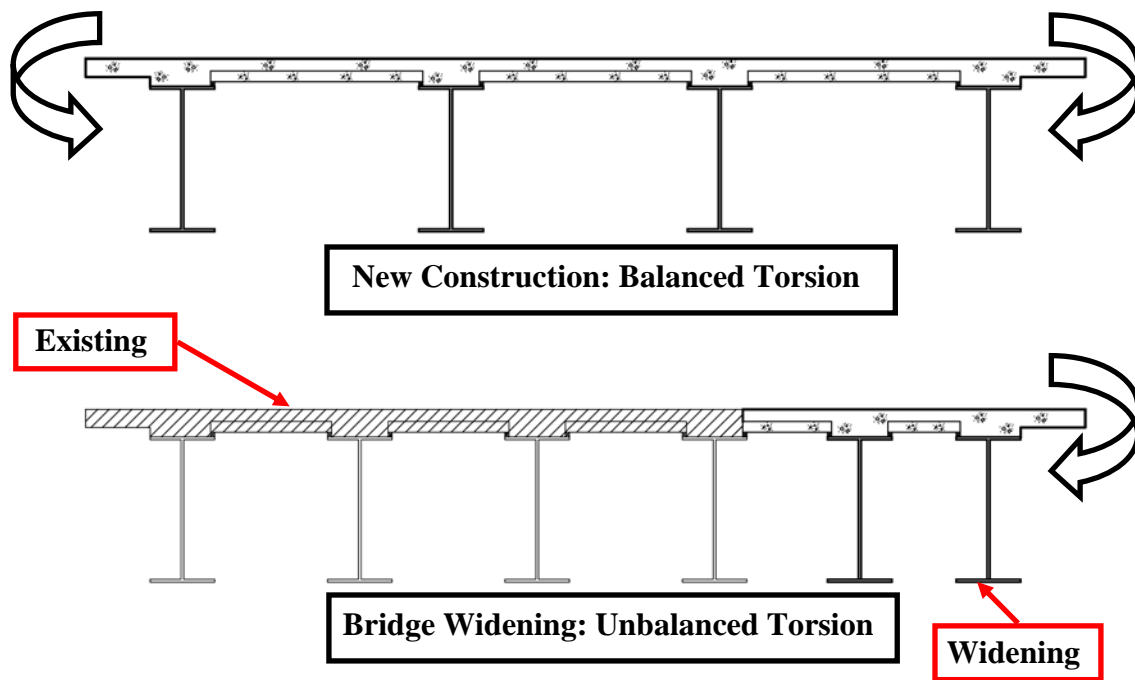
Before the specifics of the problematic bridge are outlined, the static differences of new construction versus a bridge widening should be discussed. In new construction, the overhangs on the two edges of the bridge are often similar in geometry such that the two overhangs counterbalance each other (Figure 2-6). In such a girder system, the overhang may cause local torsional distortions in the fascia girders. In a bridge widening, the overhang only exists on one side leading to an unbalanced load that must be fully resisted by the torsional stiffness of the girder system. Since many bridge widening projects only consist of a few girders, the combined torsional stiffness may be relatively low and such girder systems are highly susceptible to the system mode of buckling outlined above. In the case of the steel girder system used in the bridge widening, the torsional deformations were aggravated due to the unbalanced load from the overhang.

Figure 2-6 Differences in Torsion for New & Bridge Widening Projects

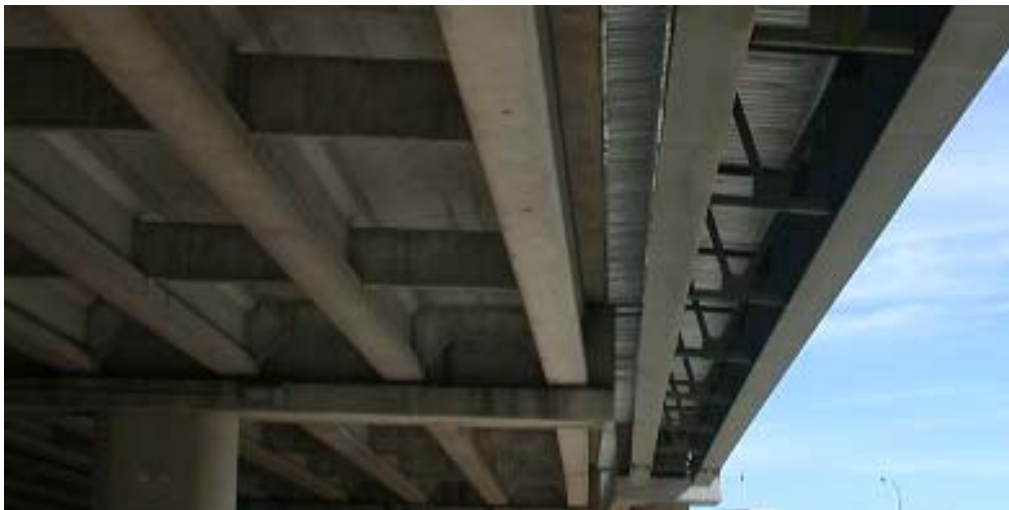
Figure 2-7 shows the twin girder system used in a bridge widening that had problems related to the system mode of buckling. Although several intermediate cross-frames were used, the system suffered a significant twist as shown in Figure 2-7. The twist of the girders is indicated in Figure 2-8 by the 10 inch offset of the bottom flange measured from a plumb line dropped from the top flange.

Figure 2-7 Twin Girder Widening with Excessive Girder Twist

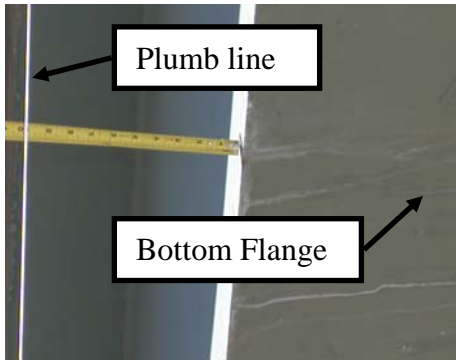
Figure 2-8 Girder Twist

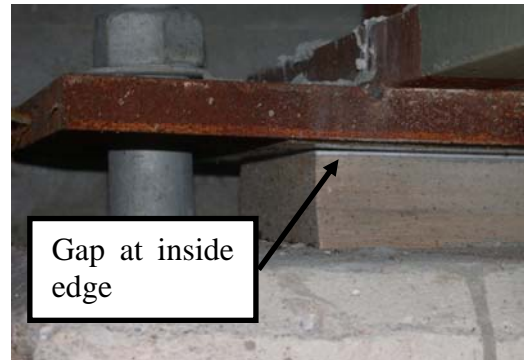
Figure 2-9 Fabric Pad Lift-Off

The system buckling mode was amplified by the torque from the overhang. Figure 2-9, shows a close up of the support deformations from the bridge. The overhang twisted the girder outwards causing a separation between the sole plate and the fabric pads at the interior edge. Though the (approximately) 1/16 inch gap does not seem too large in this case, the resulting rotation in the girder cross-section can be quite large. For example, assuming a rigid cross-section, if the 1/16 inch gap occurred over a 12 inch wide bottom flange, the lateral deformation at the top flange of a 60 inch deep girder would be on the order of 5/16 inches. This is a relatively large rigid body twist in the girder that can be intensified by a distributed twist along the bridge length.

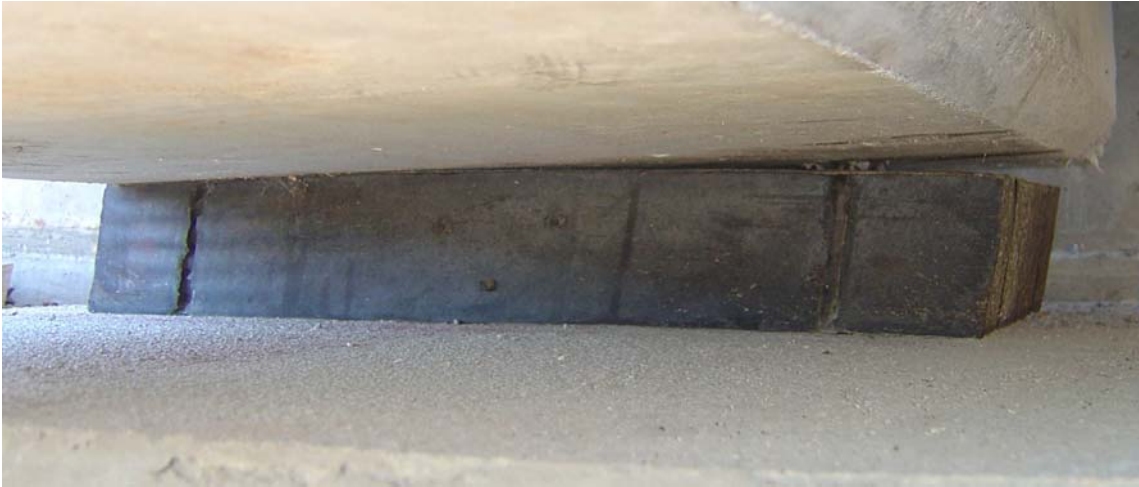
The two prestressed concrete bridges discussed in this section experienced excessive girder rotation during the casting of the concrete bridge deck. For the purposes of referencing, the two bridges are referred to as Bridge 1 and Bridge 2. Both bridges were constructed in accordance with typical Texas practices and feature Type B prestressed girders, 36 inches deep with 18 inch wide flanges. The overhang dimension was 30 inches, measured from the center line of the beam to the edge of the bridge. In terms of bracing, standard sheet MEBR(C)-1 was used. Both bridges were reported to have large rotations shortly after the deck pour, as noticed by the girder lifting off the bearing pad (Figure 2-10).

Figure 2-10 Girder Rotates off Bearing Pad

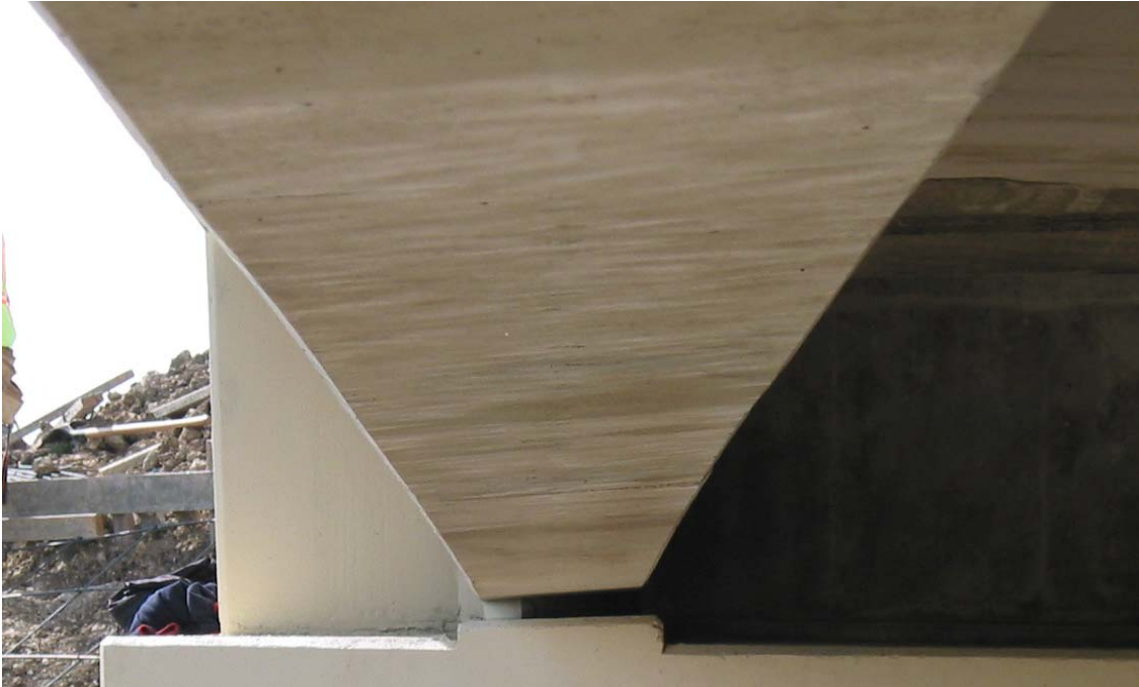
To determine the extent of rotations, a site visit was conducted in November 2006. Both bridges were investigated and found to have significant rotations, as evidenced in Figure 2-11. The rotation of the girders was determined by measuring the difference in elevation of the flange ends with a level and dial caliper. On Bridge 1, three measurements were made on the north fascia girder at approximately the mid span, quarter point, and support. As can be seen from Figure 2-12, the rotations are approximately the same along the length and ranged from 2° to 3°. On Bridge 2, the rotations of the two fascia girders at the supports were found to be 2.8° and 2.3°.

Figure 2-11 Large Rotations of Prestressed, Fascia Girder at Bridge 1

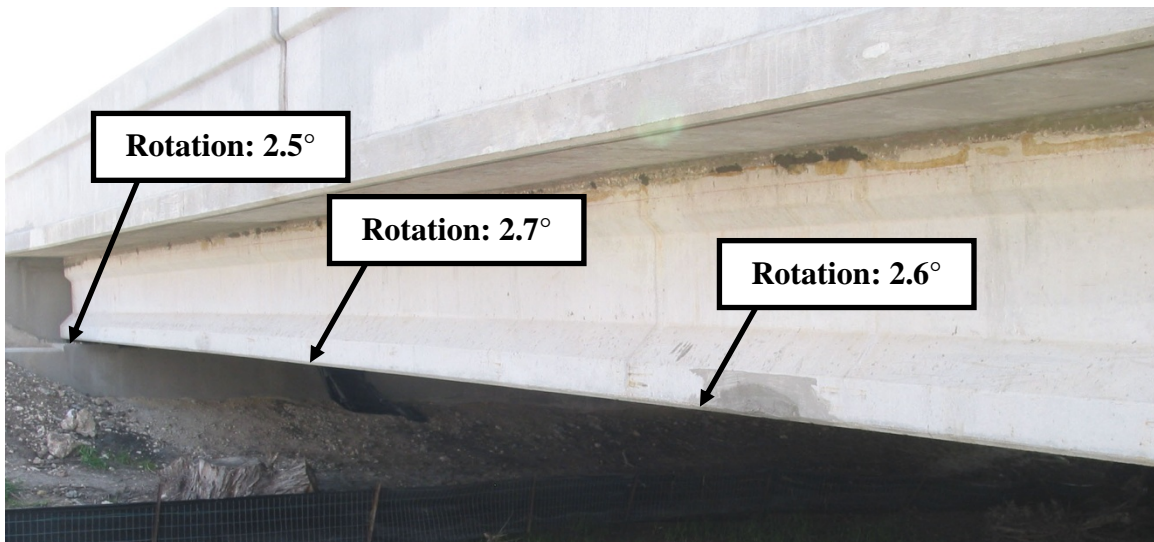
Figure 2-12 Measured Rotations of Bridge 1

A couple observations can be made from the data. First, the controlling deformation mode for the fascia girder was rigid body rotation due to flexible bearings. This deformation mode is evident from the similar rotations found across the length of

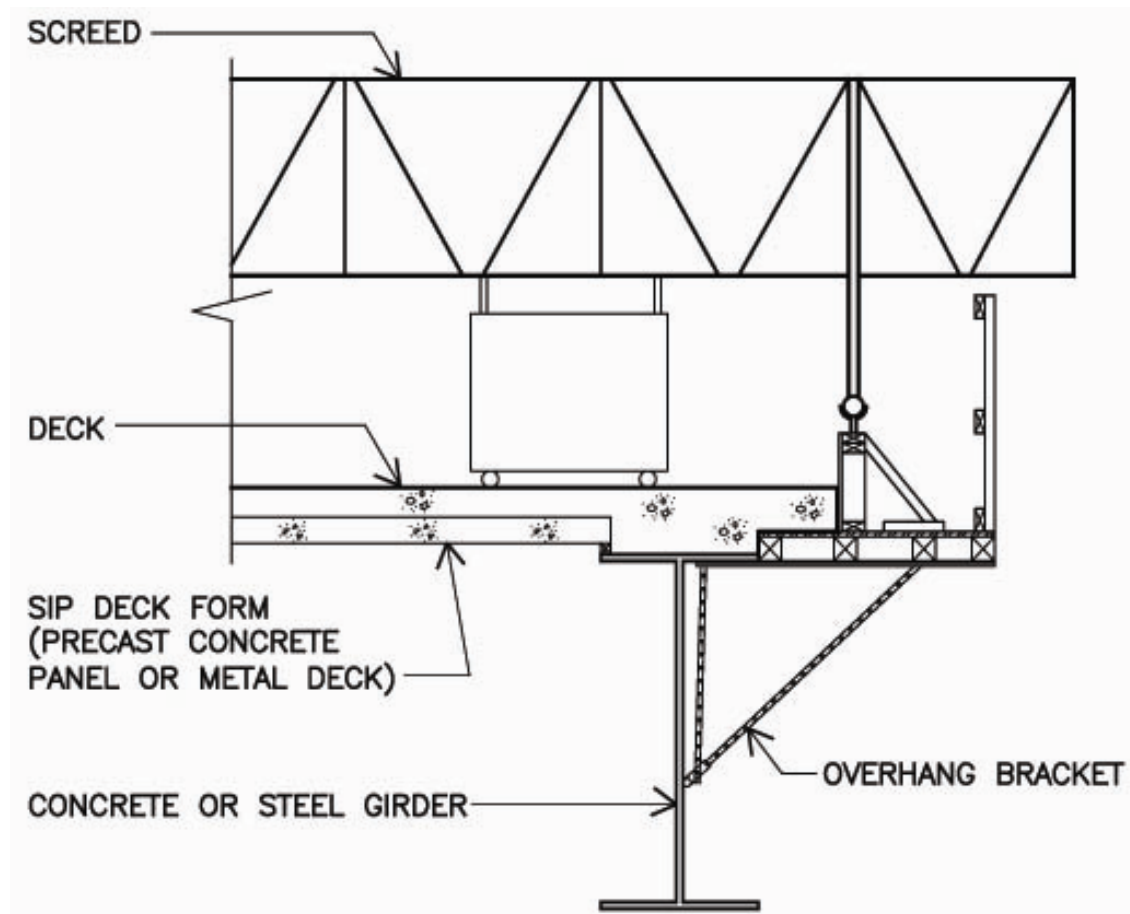
Many of the problems that develop with overhangs occur due to the bridge construction process. Thus, it is useful to look at this process. After the girders have been lifted into place, formwork is placed to shape the deck. Between interior girders, the deck is typically formed by a stay-in-place (SIP) deck form, such as precast concrete panels or metal decks. At the fascia girder, the overhang is formed by wooden forms, which are supported by the overhang brackets. The wooden forms extend to support a rail for the screed and walking path for construction workers. If deck steel is needed, it is placed before the concrete deck is poured. The concrete is properly vibrated by construction workers before the screed creates a level roadway. Figure 2-13 depicts the typical cross section during a deck pour.

Figure 2-13 Typical Deck Construction

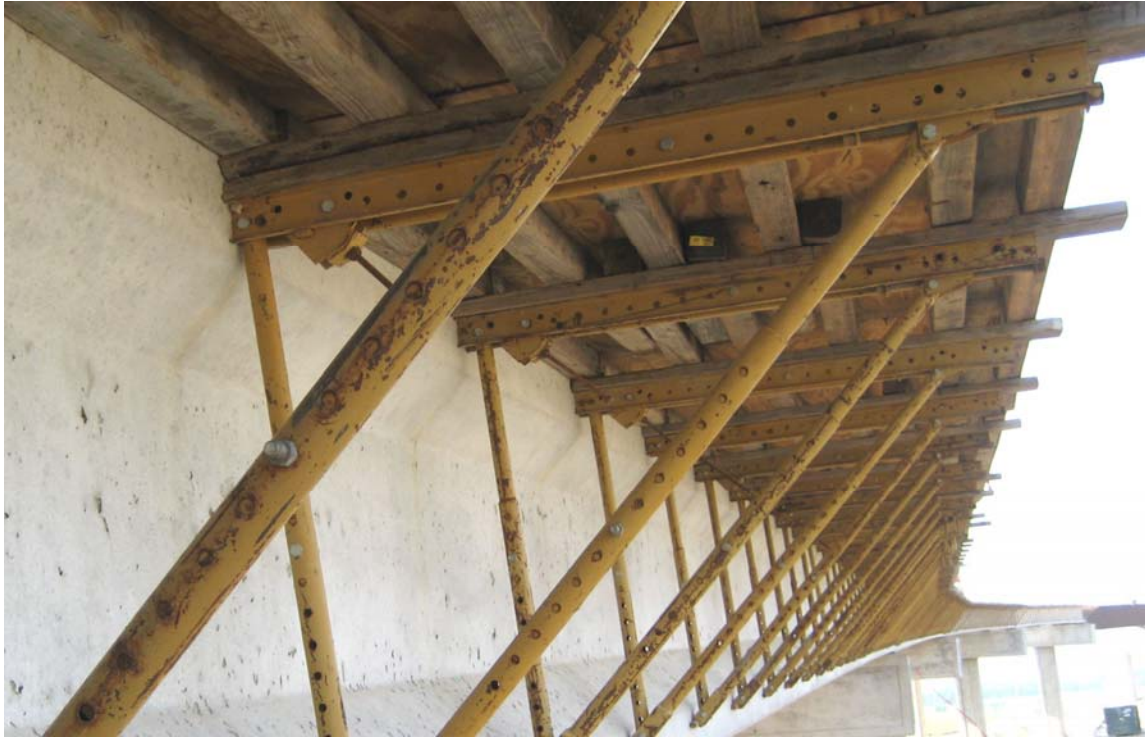
Texas limits the overhang, as measured from the centerline of the beam, to 3 feet-11 inches or 1.3 times the depth of the girder, whichever is the lesser of the two limits. Overhang brackets come in all shapes and sizes, as can be seen in Figure 2-14 and Figure 2-16. The heights of the overhang brackets can be altered at the jobsite to fit most girder configurations. For instance, some of the brackets listed on the Meadow Burke website can be fitted for bracket heights between 30 and 50 inches, while others fit heights between 50 and 70 inches. In addition, Meadow Burke's standard brackets could support up to a 3 feet overhang, while the heavy duty brackets could be custom made for overhang lengths of 14 feet. Figure 2-14 shows the typical overhang brackets used at the interchange between SH 71 and SH 130.

Figure 2-14 Overhang Brackets Used at SH 71-130 Bridge

A possible problem develops when the same overhang bracket is used interchangeably on both the steel and concrete girders, which is a very common practice. In Figure 2-14, the overhang bracket can be seen as bearing on the bottom flange of the concrete girder. However, when the same bracket is used on steel girders without adjustment, a different scenario arises: one in which the bracket can bear in the middle of the steel web, as seen in Figure 2-15. Ideally, the overhang brackets should be positioned to react close to the girder flanges where the web plate will be the stiffest. Yet, in many instances on steel girder applications, the brackets react near the mid depth of the web or may even react in the compression portion of the web. Both of these instances can cause lateral deformations in the web plate that can be locked into the web once the concrete deck cures and affect the local stability of the web plates.

Figure 2-16 shows the typical overhang brackets used at the 19th Street Bridge over US 82 in Lubbock, Texas. As can be seen, the brackets are much different from the girder and brackets shown in Figure 2-14. The brackets in Lubbock are the heavy-duty type and bear near the bottom flange. Two adjacent brackets are connected to create a platform to form the overhang, support the screed rail, and create a path for the construction workers.

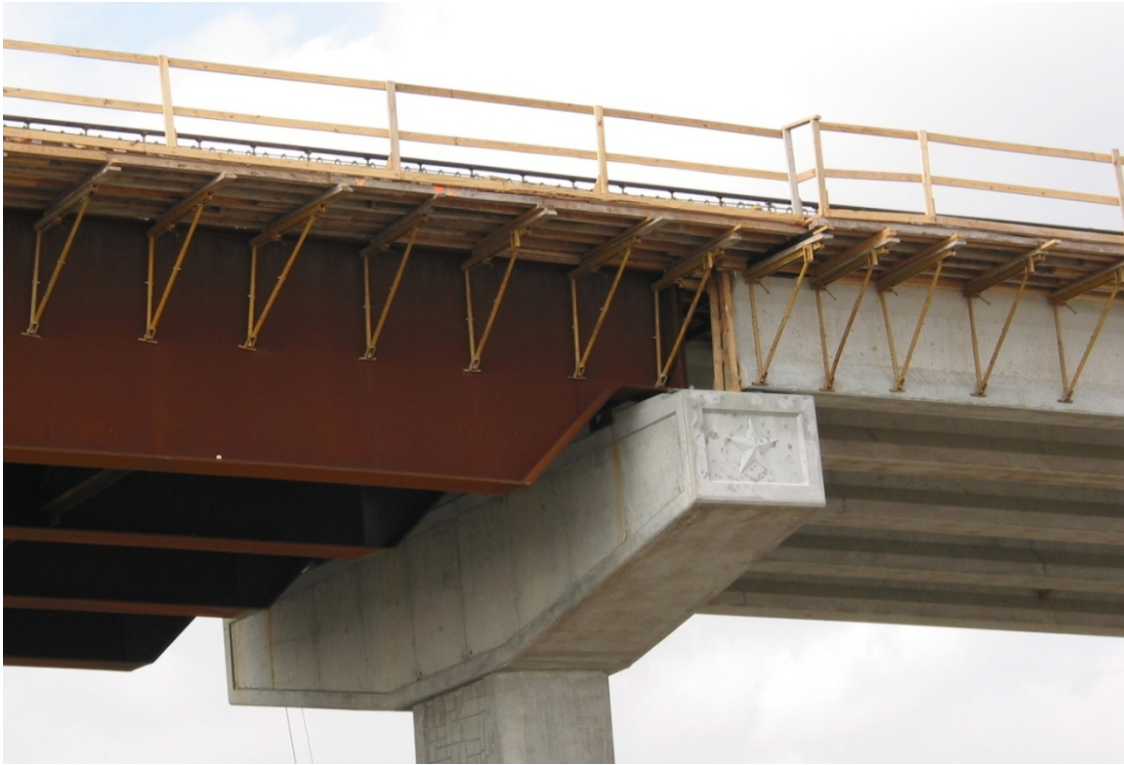
Figure 2-15 Overhang Brackets Transiting Between Concrete and Steel Girders

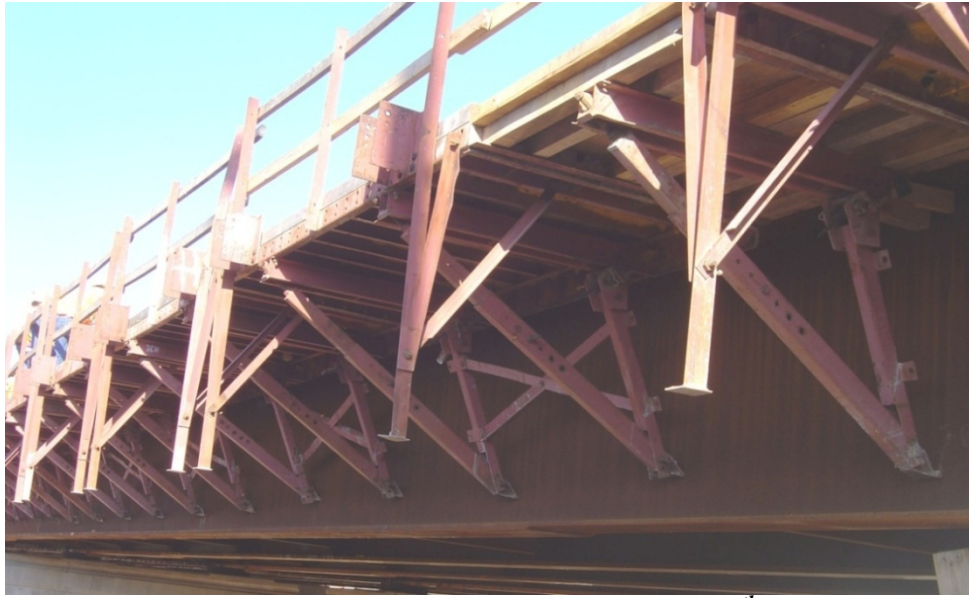
Figure 2-16 Overhang Bracket Geometry at US 82-19th Street Bridge

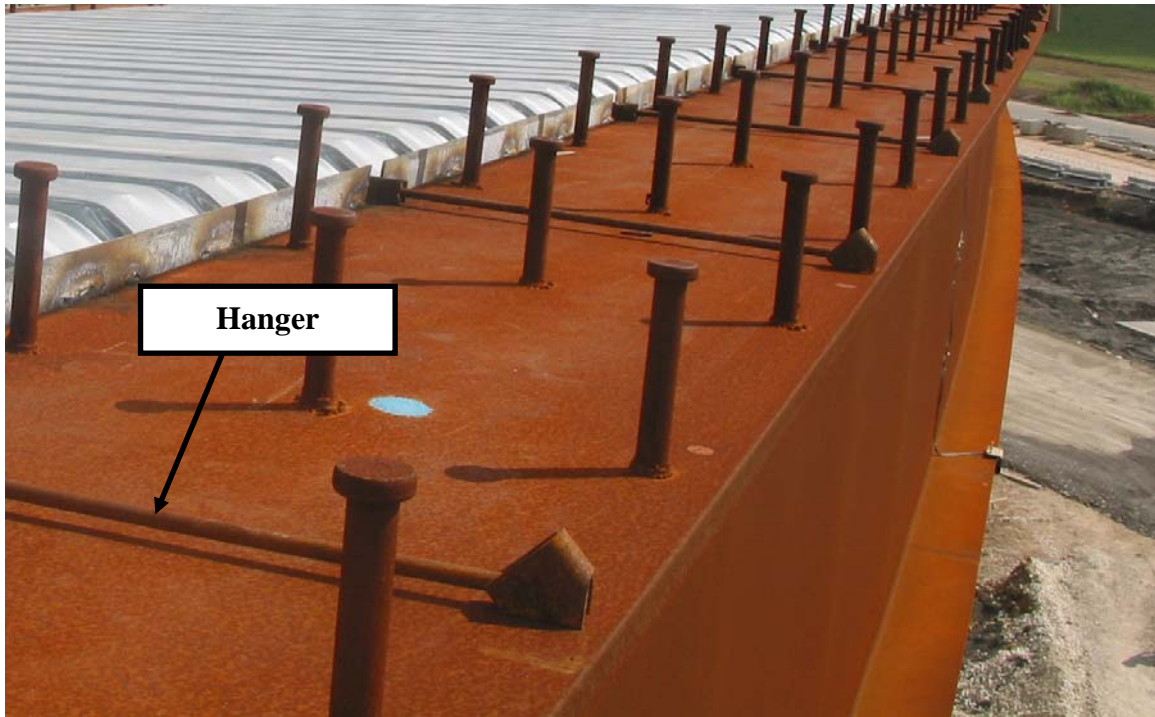
Overhang brackets are connected to the concrete or steel girder by a hanger. For concrete girders, the hanger is generally embedded into the top flange, during either the cast or as a post-process installation. For steel girders, the hanger is welded to both sides of the top flange of the beam, as seen in Figure 2-17.

Figure 2-17 Connection of Overhang Bracket to Steel Beam

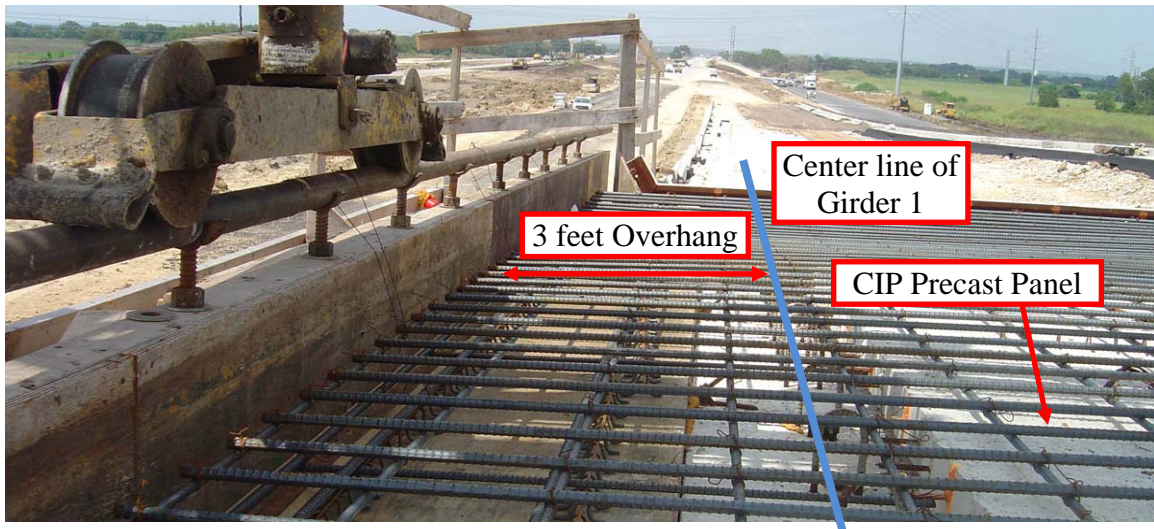
precast deck panels (approximately 4 inches thick) with 4 inches of cast in-place concrete. At the overhangs, standard plywood forms were used as shown in Figure 3-1. The overhang dimension is 3 feet from the center of the exterior beams. The total width of the bridge is 50 feet.

Figure 3-1 Slab Reinforcement at Overhang

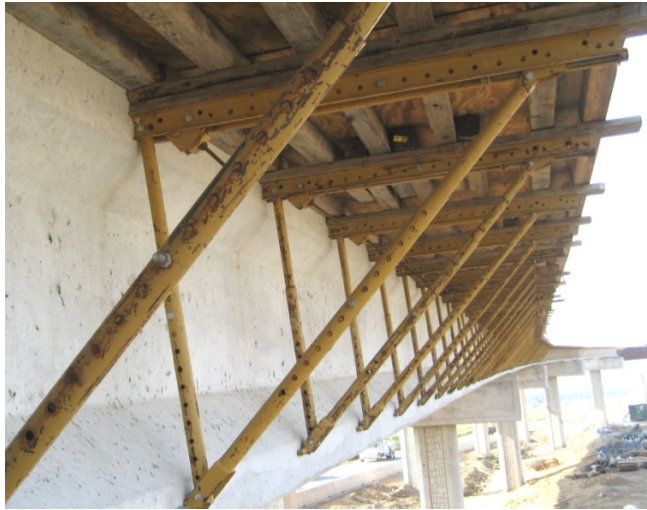
The weight of the wood forms, the fluid concrete of the deck overhang, and the finishing machine is supported using cantilever overhang brackets as shown in Figure 3-2. The brackets are supported at the top with a tension tie that is typically welded to an insert at the top of the girders. The bottom of the bracket reacts on the edge of the bottom girder flange.

Figure 3-2 Overhang Brackets Used at SH 71-SH 130 Bridge

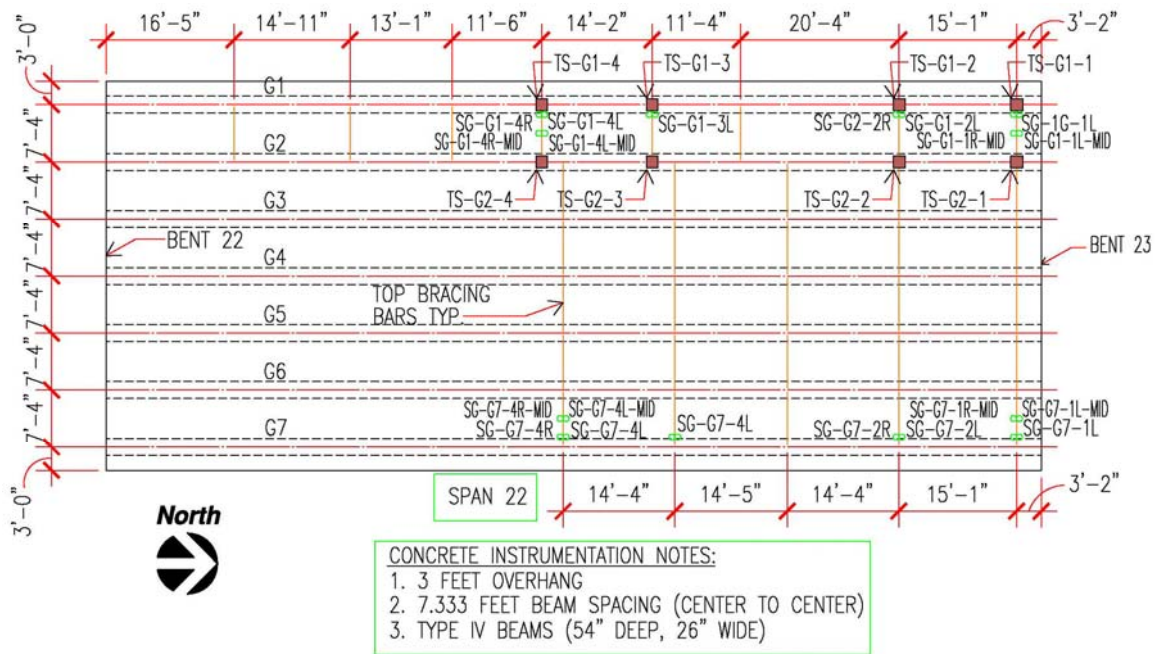
The type of data collected at each site is related to the anticipated deformations that were discussed in Section 2.1.2. For concrete girders, torsional deformations along the girder length can affect the global stability of the girders. Thus, the instrumentation of Span 22 focused on monitoring twist of the girders and the effectiveness of the top bracing bars during concrete placement. In addition vertical deflections of both exterior and interior girders were measured at stations along the girder length. An overall instrumentation plan is shown in Figure 3-3. The specifics of monitoring vertical deflections, torsional rotations, and strain in the top bracing bar at SH 71-SH 130 are discussed in the next three sections.

Figure 3-3 Instrumentation Plan for SH 71-SH 130 (Span 22)

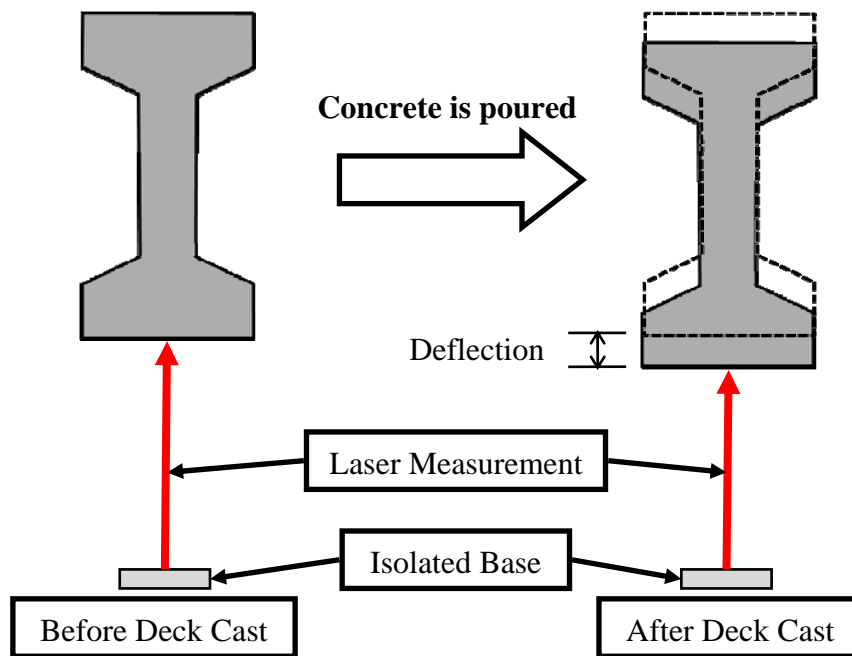
Vertical deflections were found using a laser distance meter to measure changes in girder elevations before and after construction activity. The Hilti® PD-32 was chosen as the laser distance meter to monitor vertical deformations during construction. The resolution of the instrument was 1/16th of an inch. Conceptually, the vertical deflection due to the deck pour was taken as the difference in elevation of the girders before and after the concrete deck was poured. Elevations were determined using a setup that is idealized in Figure 3-4.

Figure 3-4 Idealized Deflection Measurement Setup

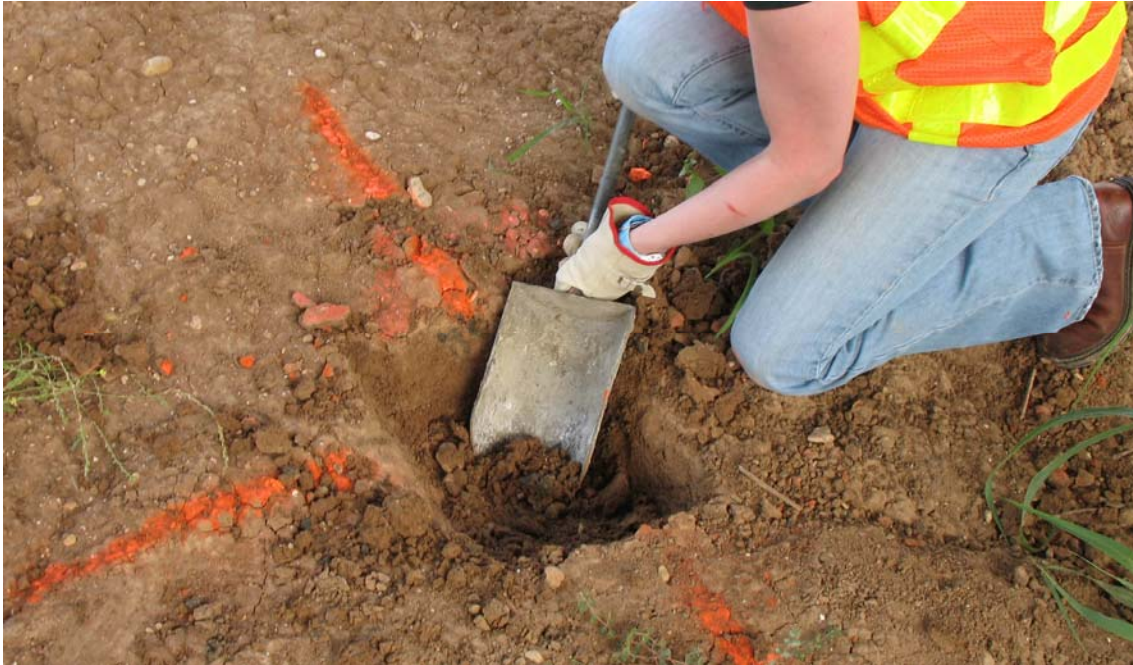
A concern for nearly any test setup is how to take measurements accurately and consistently. For this site, the concern was related to the reference point of the measurements. An important aspect of the accuracy of the measurements was to place the instrument in the same position and to have a solid foundation at the measurement locations. For instance, if the soil is used as the reference point, changes in the top soil conditions between the initial and final measurements from concrete trucks or other construction equipment in the area was a major concern. As such, an isolated base was created for each deflection measurement location to minimize local movements. Below each deflection location, a hole was dug 6 to 8 inches deep, as shown in Figure 3-5. Figure 3-6 shows the mixing process for the Hydro-Stone® that was used to fill the hole. The set time for Hydro-Stone is relatively short, thereby quickly providing an isolated base for the laser measurements (Figure 3-6). The laser distance meter was aimed at a target mark located on the bottom side of the girder, as shown in Figure 3-7. Figure 3-8 shows that a nail was placed in the Hydro-Stone base points to ensure that the distance meter was placed at the same location for each reading. The corner of the laser distance meter was placed over the nail each time to ensure that repeatable results could be

Figure 3-5 Hole for Isolated Base of Deflection Measurement

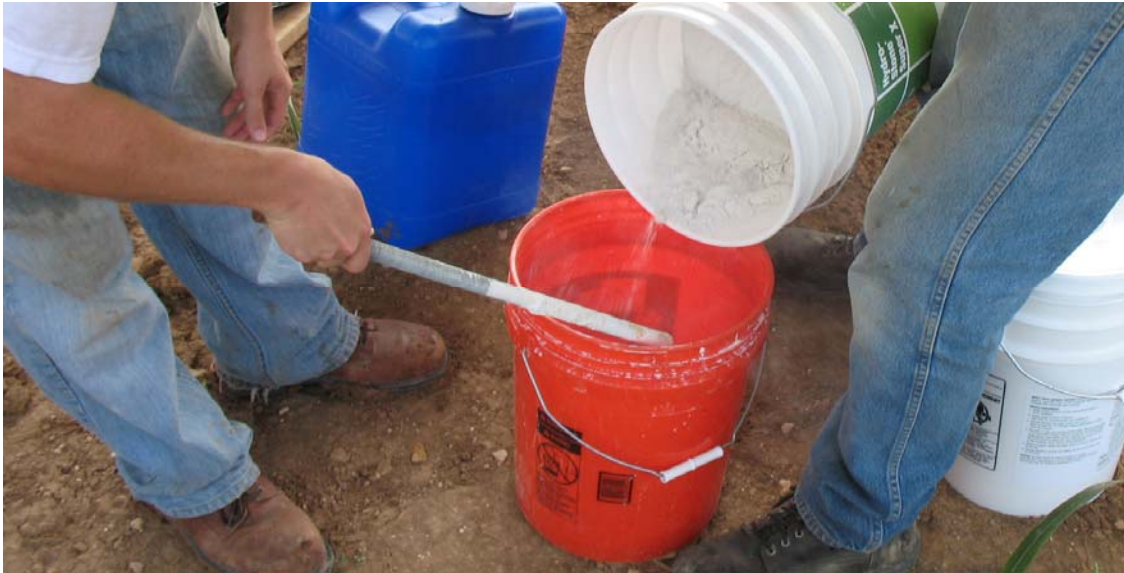
Figure 3-6 Mixing Hydro-Stone for Isolated Base

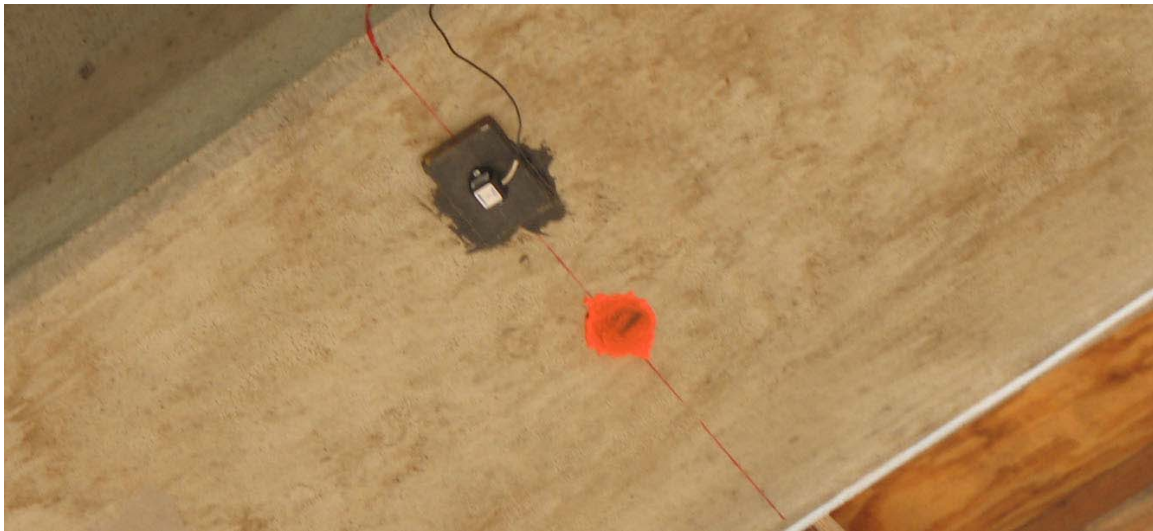
Figure 3-7 Spray-Painted Spot for Deflection Measurements

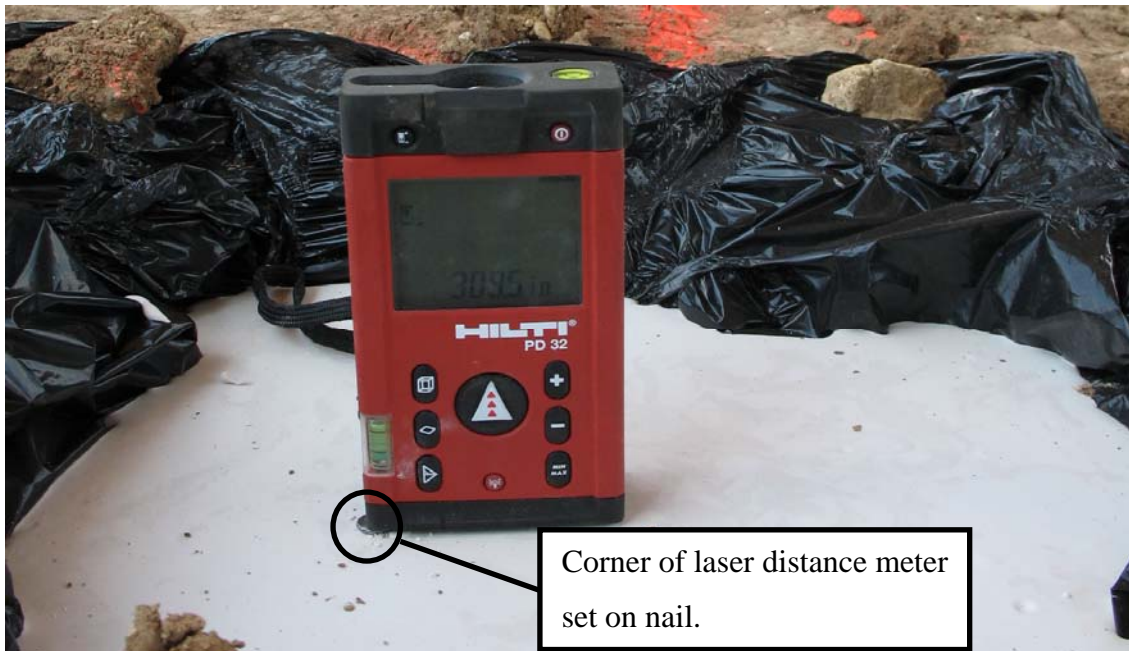
Figure 3-8 Deflection Laser Measurement from Isolated Base
