The Influence of Overhang Construction on Girder Design

Thesis

The University of Texas at Austin

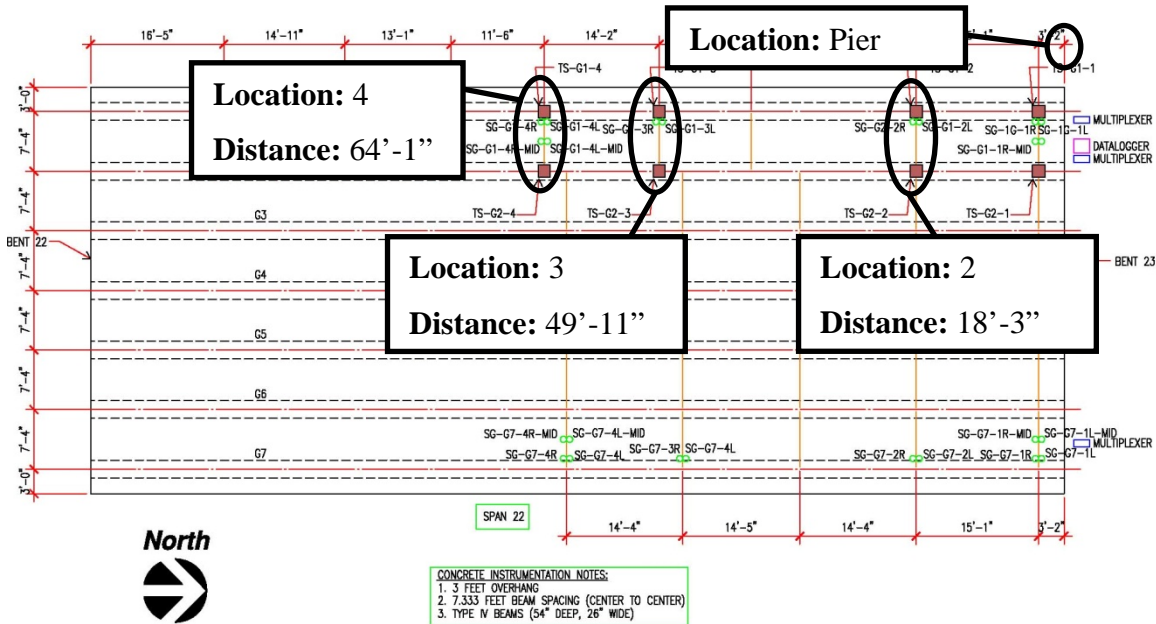
A total of seven locations were chosen for vertical deflection measurements. As can be seen in Figure 3-9, three readings were taken on the fascia girder (girder 1) and first interior girder (girder 2) at three stations along the girder length. The final location was a point on the pier to be used as a control measurement. Due to the stiffness of the pier and the symmetric loading, the deflection of the pier will not likely register on the laser distance meter. If significant deflection was recorded, it could be attributed to movement of the isolated base. Thus, the pier location was chosen to determine if the isolated bases moved, as well as to confirm that the pier did not deflect.

Figure 3-9 Vertical Deflection Measurement Locations at SH 71-SH 130

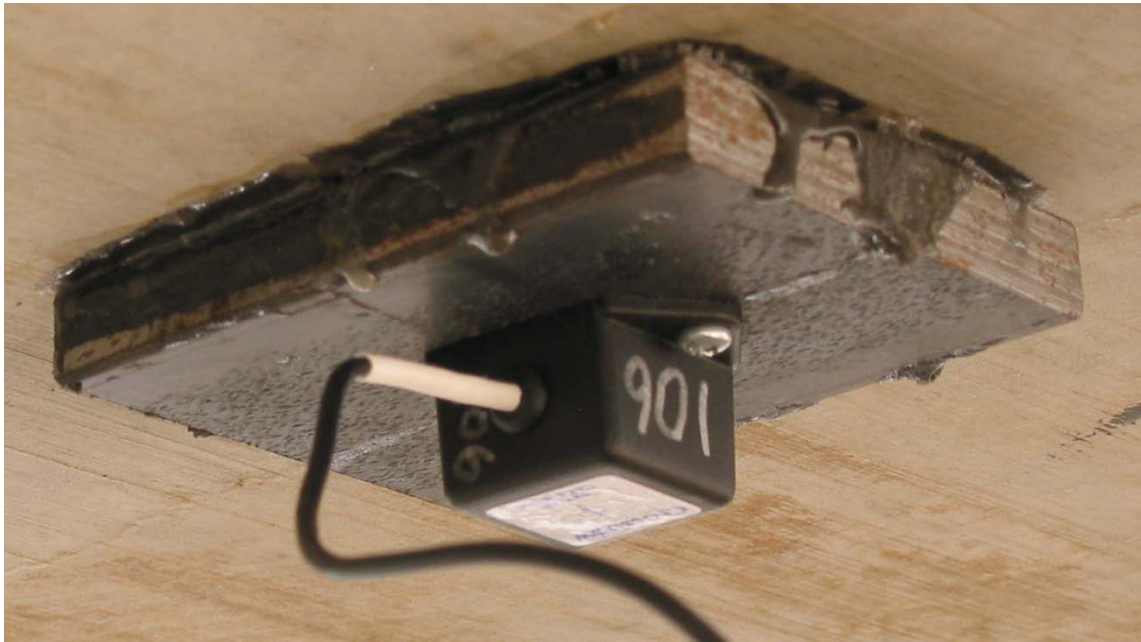
The twist of the girders was determined by tilt sensors (CXTLA-01-T) manufactured by Crossbow Technology, Inc. The electronic side of the tilt sensors is discussed in Section 3.4.2. In the field, the tilt sensors were attached to steel plates before being installed on the underside of the girders, as seen in Figure 3-10. The tilt sensors were planned to be used on multiple projects over a series of months. Thus, steel plates were used, as compared to wood, because long term stability was a concern. To install on the underside of the girder, a 5-minute metal/concrete epoxy from Loctite was used. Bar clamps were used to hold the steel plate to the concrete surface while the epoxy cured.

Figure 3-10 Tilt Sensor Attached to Steel Plate

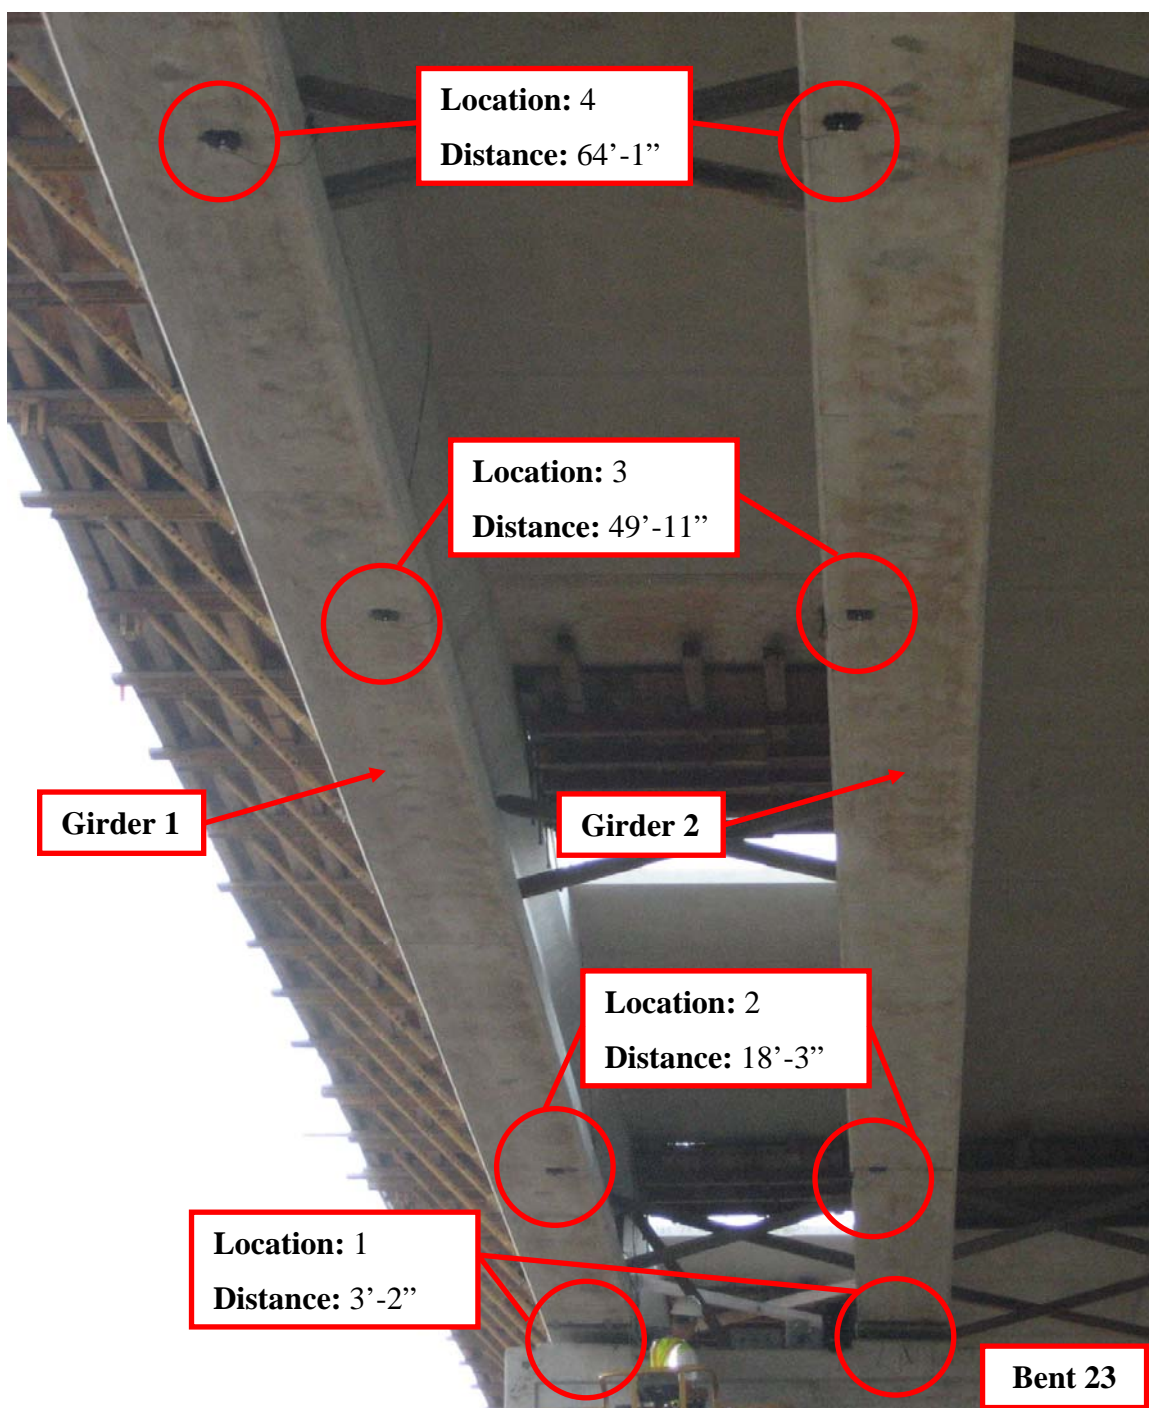
Four tilt sensors were placed along the lengths of both Girders 1 and 2. Girder 1 was denoted as the fascia girder on the west side of the bridge, while Girder 2 was denoted as the adjacent interior girder. Figure 3-11 details the locations of the tilt sensors along each girder. The distances were measured relative to the end of beam at Bent 23, which is located on the north end of the bridge. Tilt sensors are denoted by the abbreviation TS, girder number, and location number. Thus, the third tilt sensor on Girder 2 is labeled: TS-G2-3.

Figure 3-11 Locations of Tilt Sensors on SH 130-71 (Span 22)

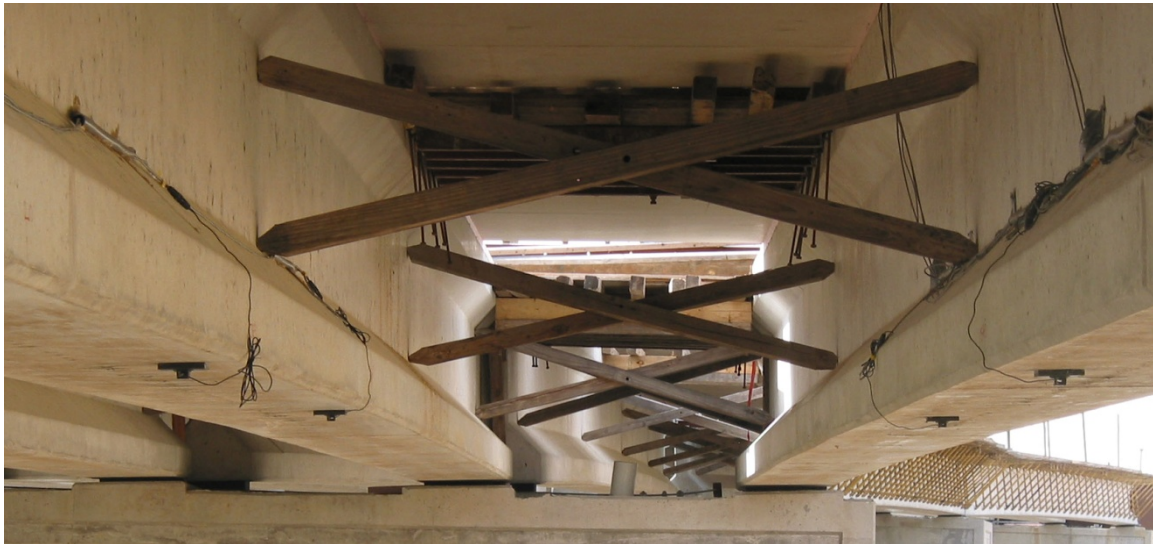
The bracing details for prestressed concrete girders have changed over the years. In the 1970's, cast-in-place concrete diaphragms were often used at the middle of the simply supported girders, while smaller concrete diaphragms were employed at the supports above the abutment. In addition to restraining girder twist, the concrete diaphragms provided lateral bracing against wind loads during construction. Due to the cost of forming the diaphragms, a steel channel was also employed to brace the girders. However, in recent years, permanent diaphragms are rarely utilized. Current practice often relies on lateral bracing by square timbers forming an X as shown in Figure 3-12. Another detail that is combined with the square timbers is the use of “top bracing bars.”

Figure 3-12 Timber Blocking of Concrete Girders

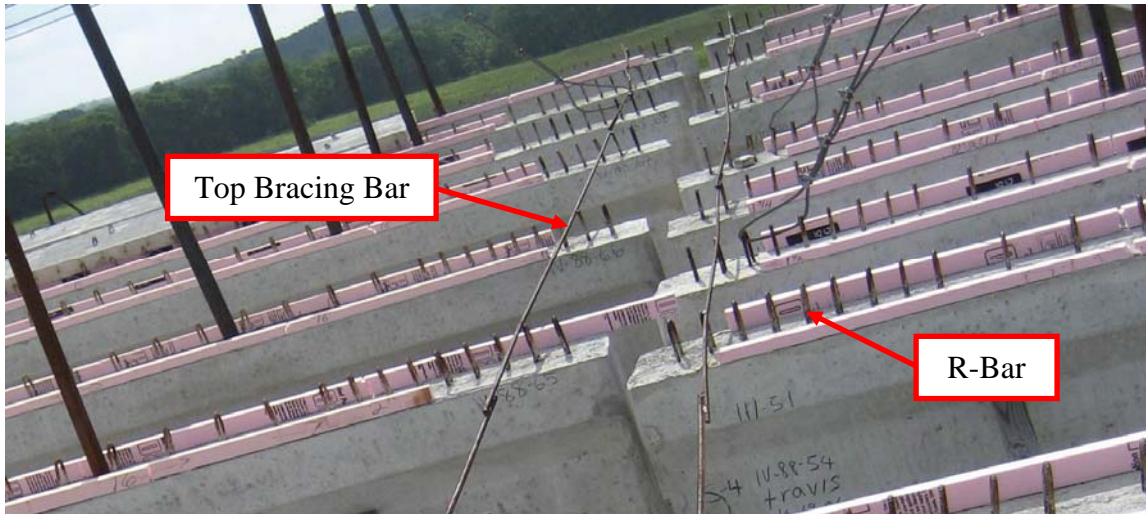
There are two different stages that the top bracing bar is used, one before and one after the precast concrete panels (PCP) are installed. Figure 3-13 shows the type of detail used before the panels are installed. The #5 reinforcement are welded to adjacent bars and to the R-bar—hoop coming out of the prestressed concrete girder—from one side of the bridge to the other. This detail requires a line of bars to be placed at each end and at mid-span of the bridge. As seen in Figure 3-13, the line of bars seems to be relatively flexible.

Figure 3-13 Top Bracing Bar Before PCP Installation

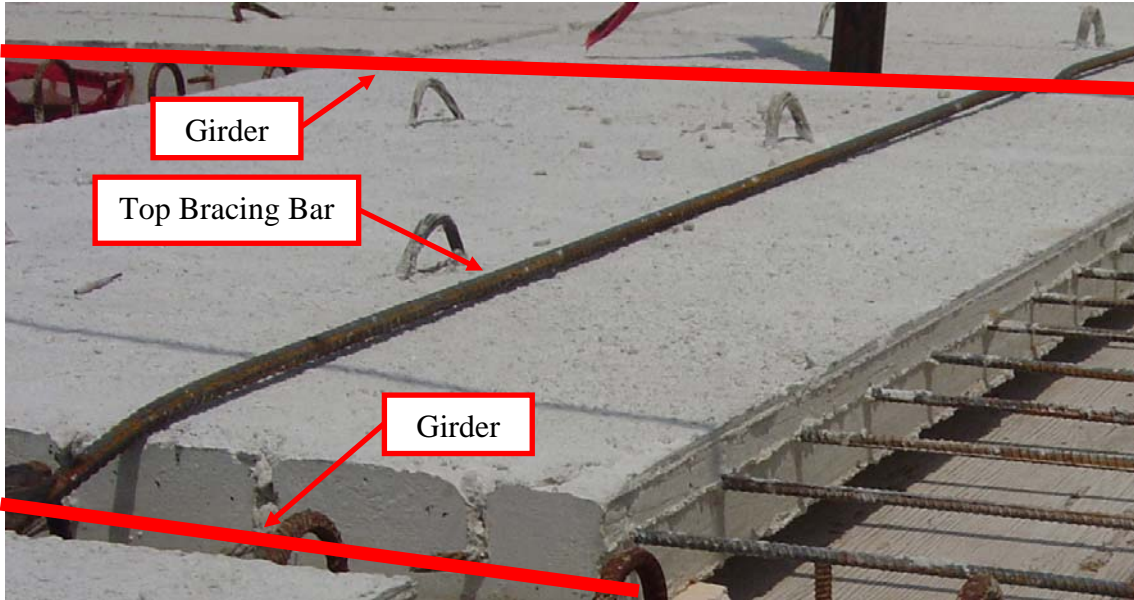
After the deck panels are installed on the bridge, the detail of the top bracing bar changes. Instead of welding #5 bars in series, one #5 bar is used between each adjacent girder, as seen in Figure 3-14. Due to the height of the panels, the #5 bars are bent around the panels and welded to the R-bar (Figure 3-15). It should be noted that the bracing bars come into contact with the edge of the panels. As such, friction can be transferred from the bars to the panels. Whereas the bracing bars prior to PCP installation are usually only positioned at the ends and middle of the girders, after the deck panels are installed, the bracing bars are spaced at approximately 15 feet increments along the girder length. Figure 3-16 details the frequency of bars across the north half of the bridge. Near the north end of the girder, the bars are in a continuous line from one end of the bridge to the other. However, after the second line of bars, the line becomes discontinuous at the west exterior girder (Girder 1). The bracing line is discontinuous due to the presence of a drain at approximately 31 feet from Bent 23. Since wooden forms were used to form the deck around the drain, rather than PCP, the top bracing bars were offset to the next PCP.

Figure 3-14 Top Bracing Bar After PCP Installation

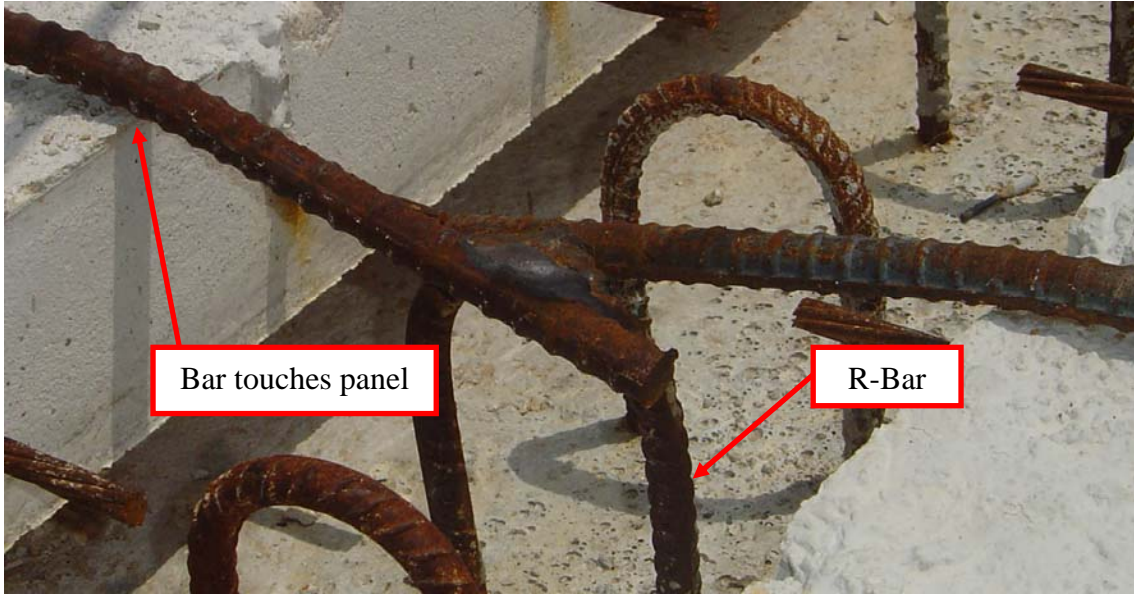
Figure 3-15 Weld of Top Bracing Bar to R-Bar of Girder

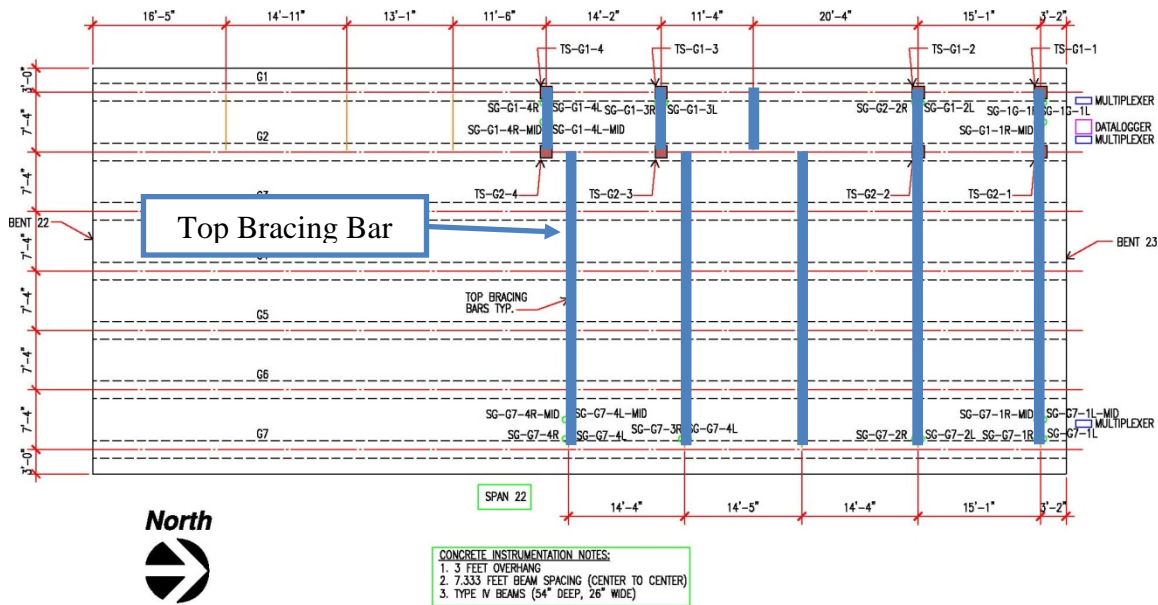
Figure 3-16 Location of Top Bracing Bars After PCP Installation

Strain gages are denoted by the abbreviation SG, girder number, location number, and orientation. Thus, the strain gage oriented on the left side of the bar at the third location on Girder 7 (east side) is labeled: SG-G7-3L. Left and right were defined from the orientation given in Figure 3-16. Therefore gages designated on the left were on the side of the bar closest to Bent 23, while gages designated right were on the side of the bar

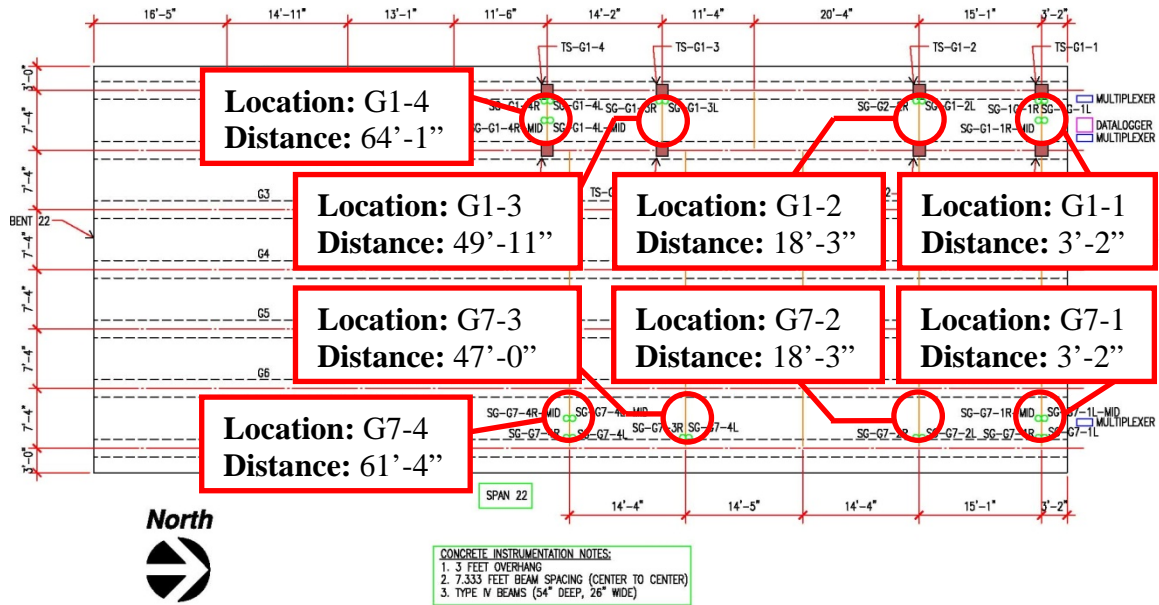
Strain gages were installed on some of the bracing bars to monitor the forces that developed in the bars during concrete placement. A total of 24 strain gages were applied along 8 bars throughout the north half of the bridge. As can be seen from Figure 3-17, the strain gages are installed on bars spanning between the exterior and interior girders on the east and west sides of the bridge. Two-thirds of the strain gages were applied at the ends of the bars, near the weld at the exterior beam. The remaining gages were installed at mid-length of the bars to determine if there was a different stress value between the ends and mid-length of the bars (Figure 3-18). The mid-length strain gages were placed on bars near the support (Location 1) and mid-span (Location 4) on both the east and west sides of the bridge. The distances were measured from the end of the beam at Bent 23. The locations of the individual bars are also sequentially numbered from Bent 23.

Figure 3-17 Location of Top Bracing Bar Strain Gages

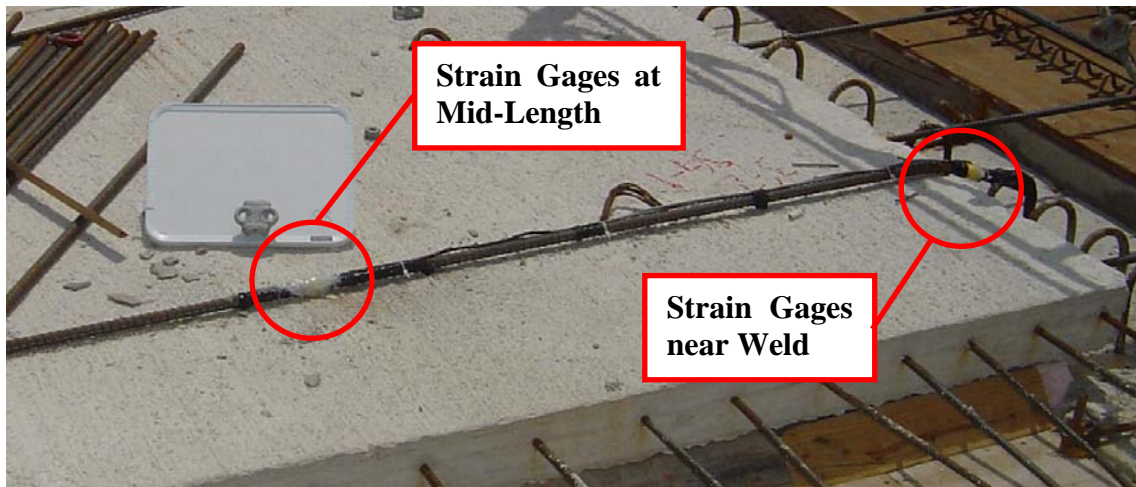
Figure 3-18 Strain Gages Installed at Mid-Length and at Ends of Bar

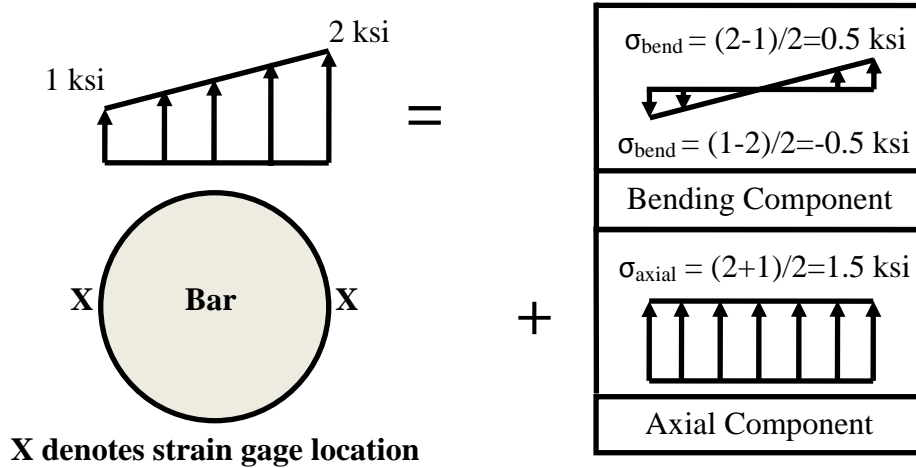
As noted above, strain gages were placed on both the right and left sides of each bar. Two gages were installed at each specific location to eliminate the error due to bending of the bars. This correction is highlighted in Figure 3-19. Assuming a

distribution of stress, which is derived from the strain readings, of 2 ksi on one end and 1 ksi on the other, the effective axial stress in the bar is 1.5 ksi. This value is calculated by subtracting off the bending component. Therefore, the axial stress is simply the average stress of the right and left strain gages.

Figure 3-19 Idealized Correction of Stress in Bar Due to Bending

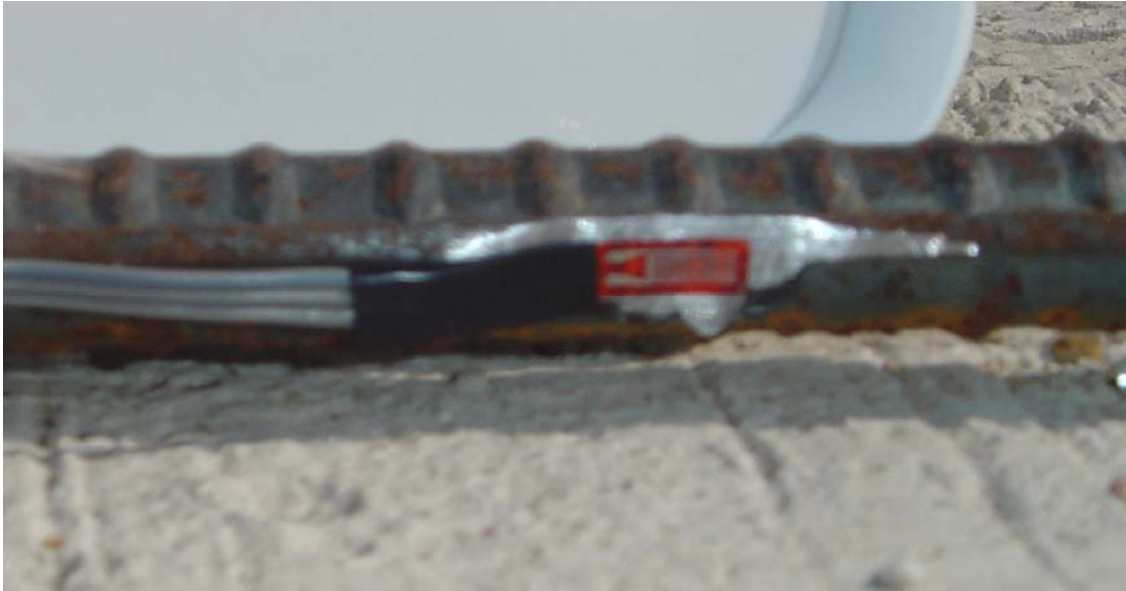
The installation of strain gages to the top bracing bars is discussed below. The strain gages were traditional foil backed gages obtained from Texas Measurement (Gage Factor = 2.12). Specific details on the strain gages are provided in Section 3.4.1. A strain gage installed on a top bracing bar is shown in Figure 3-20. The strain gages were placed on the bars by first sanding the surface smooth and then cleaning with acetone. A two-part adhesive was then used to bond the gage to the steel bars.

Figure 3-20 Installed Strain Gage on Top Bracing Bar

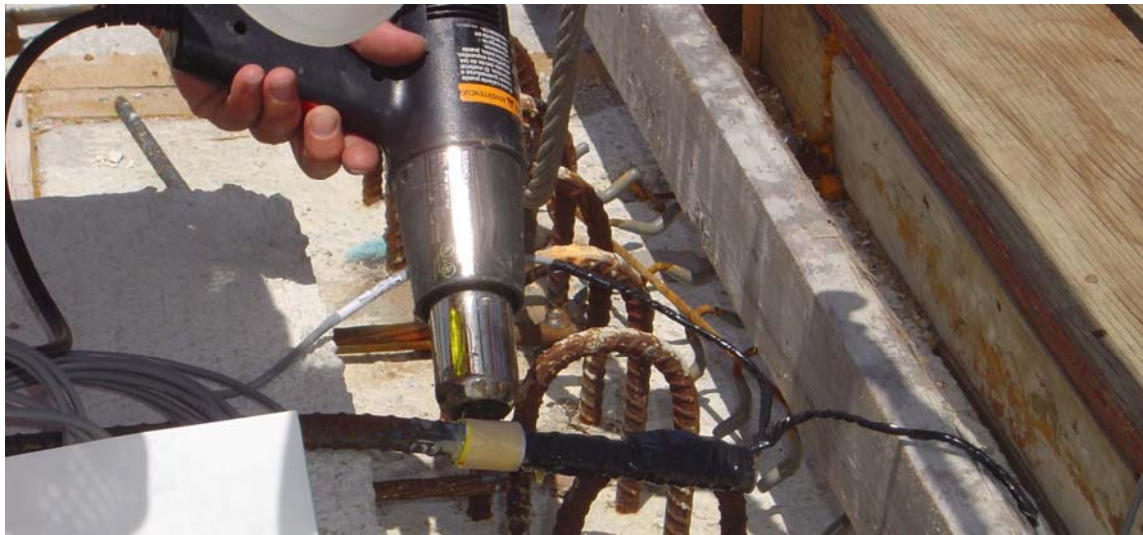
Field sites are harsh environments that create additional complications for instrumentation as compared to laboratory instrumentation. Thus, two levels of protection were used for to guard against moisture and mechanical damage. The first protection level consisted of a shrink-wrap coating tape from Texas Measurement, type CT-D10, as shown in Figure 3-21. After placing the tape over the strain gage, the tape was heated to shrink around the gage surface, thereby providing some moisture and mechanical protection. A second level of protection provided was from a silicone adhesive, which gave mechanical protection once it hardened (Figure 3-22). The silicone

Figure 3-21 Heating Protective Tape on Top Bracing Bar

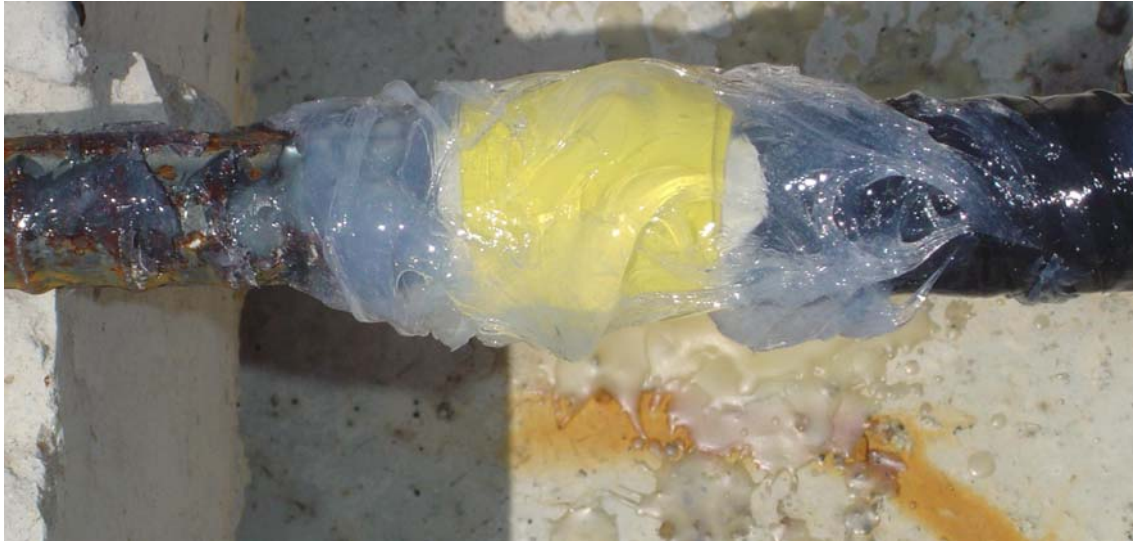
is a special formulation (Dow Corning® 3145) obtained from Vishay that will not react with the strain gage adhesive.

Figure 3-22 Silicone Applied as Moisture Protection to Top Bracing Bar

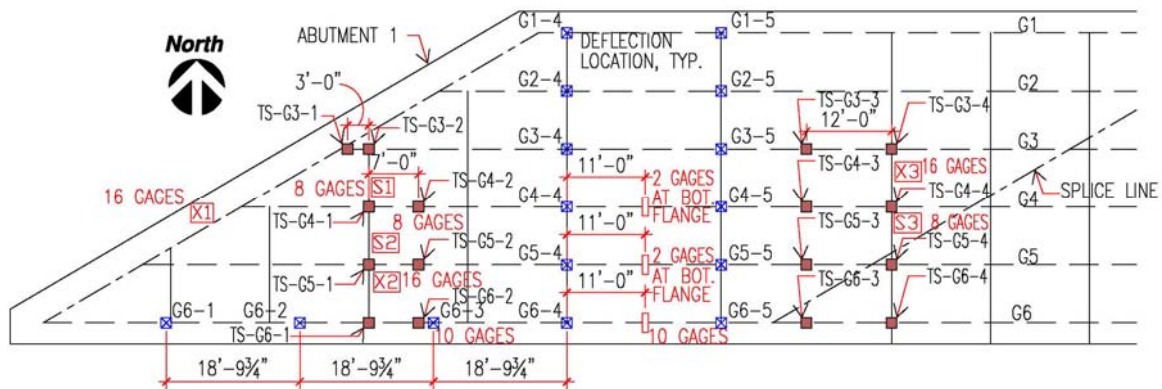
Due to the contractor's lifting sequence, the girders along Span 1 were the focus for the instrumentation at 19th Street Bridge. The instrumentation plan for the bridge is shown in Figure 3-23. The goal of the project was to monitor the local and global deformations of the bridge. The overhang brackets can cause large local forces in the webs of the girders and cause out-of-plane plate deformations. For local deformations, a method developed by Mercan (2005) was used to measure web imperfections. In addition to local deformations, the large skew angle can result in significant interaction between adjacent girders. In terms of global deformations, vertical deflection and torsional twist of the girders due to the deck pour were measured both across the width and along the length of the bridge. A live load test was also conducted at the bridge in conjunction with the other two projects. Yet, the results from the live load test are not presented in this thesis.

Figure 3-23 Instrumentation Plan for 19th Street Bridge over US 82

A total of fifteen locations were chosen for deflection measurement, as detailed in Figure 3-23. During the deck pour, only nine locations were chosen for deflection measurement (Figure 3-25). A series of live load tests were performed approximately a month later, in which the final six locations were used for deflection measurements. Of the nine measurements, four were taken at Girder 6 (exterior girder), while one measurement was taken at each of the other five girders. Location 4 is the reading at each of the girders, which corresponds to a bracing line that is measured 76.75 feet from

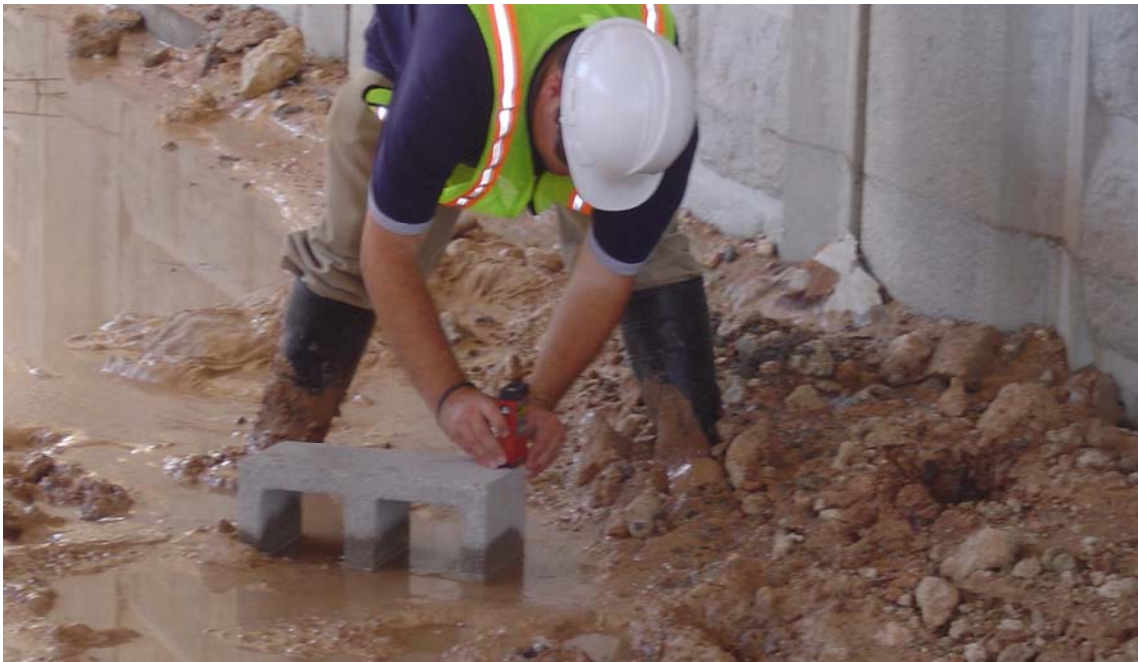
The same method as described in Section 3.1.1.1 for the prestressed concrete girder bridge in Austin was used in Lubbock to measure vertical deflections. Due to the soil and field conditions on the day of the deck pour, a different isolated base was used in Lubbock than in Austin. Before the deck pour, an isolated base was created using a cement paste. However, as shown in Figure 3-24, excessive rain water collected below

the bridge the week before the deck pour and an alternate base was necessary. The new isolated base took the form of CMU blocks embedded in the soil. Placing the CMU blocks directly on the ground provided a stable foundation for the readings because the soil below the bridge was very hard so that soil settlement due to vibration would be very small. To ensure uniformity and repeatability in readings at each location, the laser was placed along a corner of the CMU block and aligned in the same orientation each time. The CMU blocks were tested as the isolated bases before the deck pour and it was found that the girder elevations were very repeatable.

Figure 3-24 Vertical Deflection Measurement at 19th Street Bridge

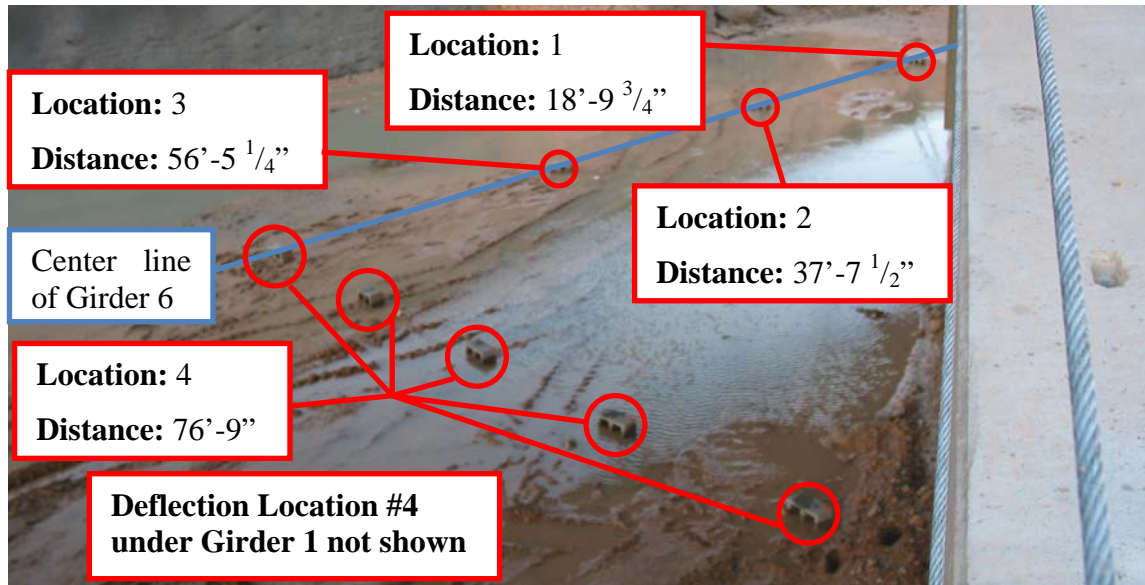
Figure 3-25 Vertical Deflection Measurement Locations at 19th Street Bridge

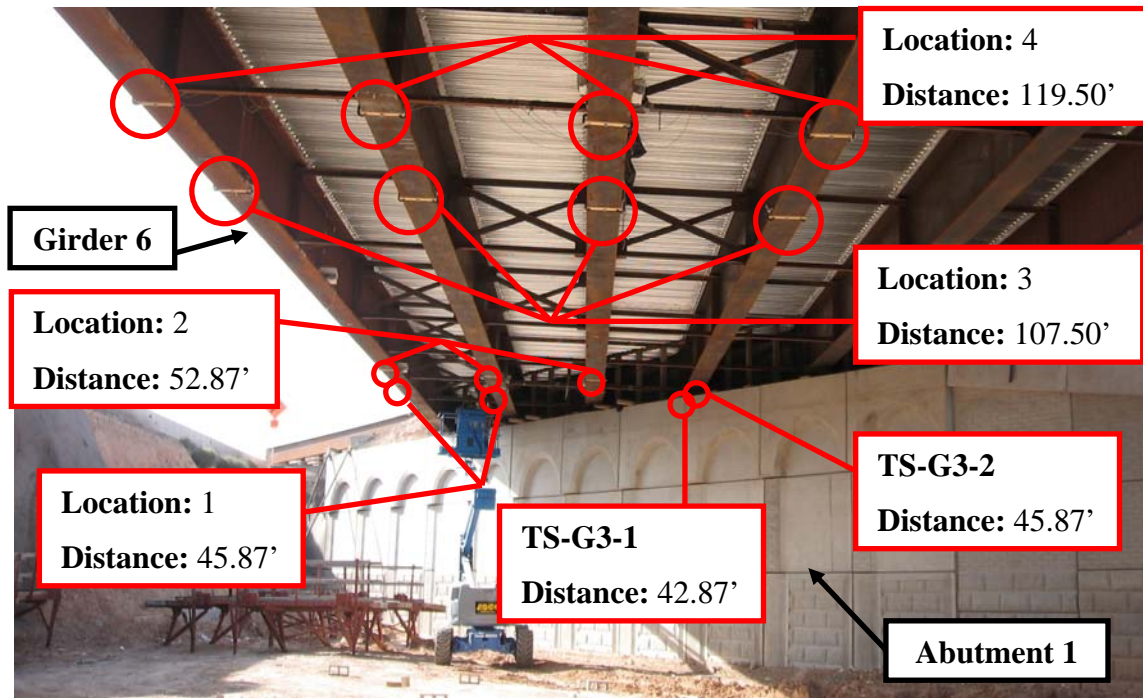
Sixteen tilt sensors were installed on the 19th Street Bridge. Twelve of the tilt sensors were placed along three interior girders and four along Girder 6, which was a fascia girder on the south side of the bridge. The three interior girders with tilt sensors were Girders 3, 4, and 5. The locations of the tilt sensors are indicated on Figure 3-26. The locations are numbered from Abutment 1 (east side of bridge), while the distances shown are referenced from the east end of Girder 6. The tilt sensor at location 1 on Girder 4 malfunctioned during the pour and is not shown. Also, the numbering scheme for locations 1 and 2 along Girder 3 is slightly different than along the other girders. The

difference is noted in Figure 3-26. Tilt sensors are denoted by the abbreviation TS, girder number, and location number. Thus, the third tilt sensor on Girder 5 is labeled: TS-G5-3.

Figure 3-26 Locations of Tilt Sensors at 19th Street Bridge

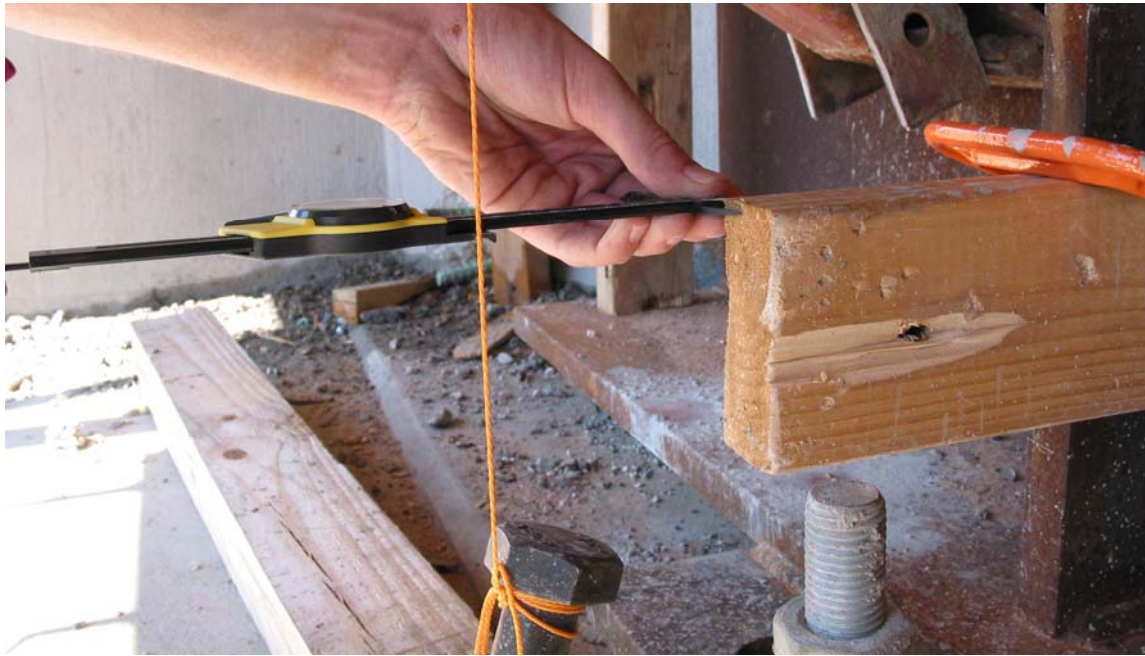
At the 19th Street Bridge, another method was used to measure rotations at the abutments on the east and west ends. This method was considered a control measurement and is demonstrated by Figure 3-27. A vertical plumb line was created by adding weight to a string. A block of wood was clamped to the bearing stiffener at the support to provide a reference point that could be measured before and after the concrete placement. Figure 3-27 shows the initial measurement being taken prior to the deck pour. A similar measurement was taken at another reference point near the top of the girder. The amount of girder twist was calculated by comparing the deformations that occurred at the two reference points during the concrete placement divided by the distance between the reference points. The control measurement was taken at an exterior (Girder 6) and interior girder (Girder 5) for both Abutment 1 (east end) and Abutment 3 (west end).

Figure 3-27 Control Rotation Measurement at Support of 19th Street Bridge

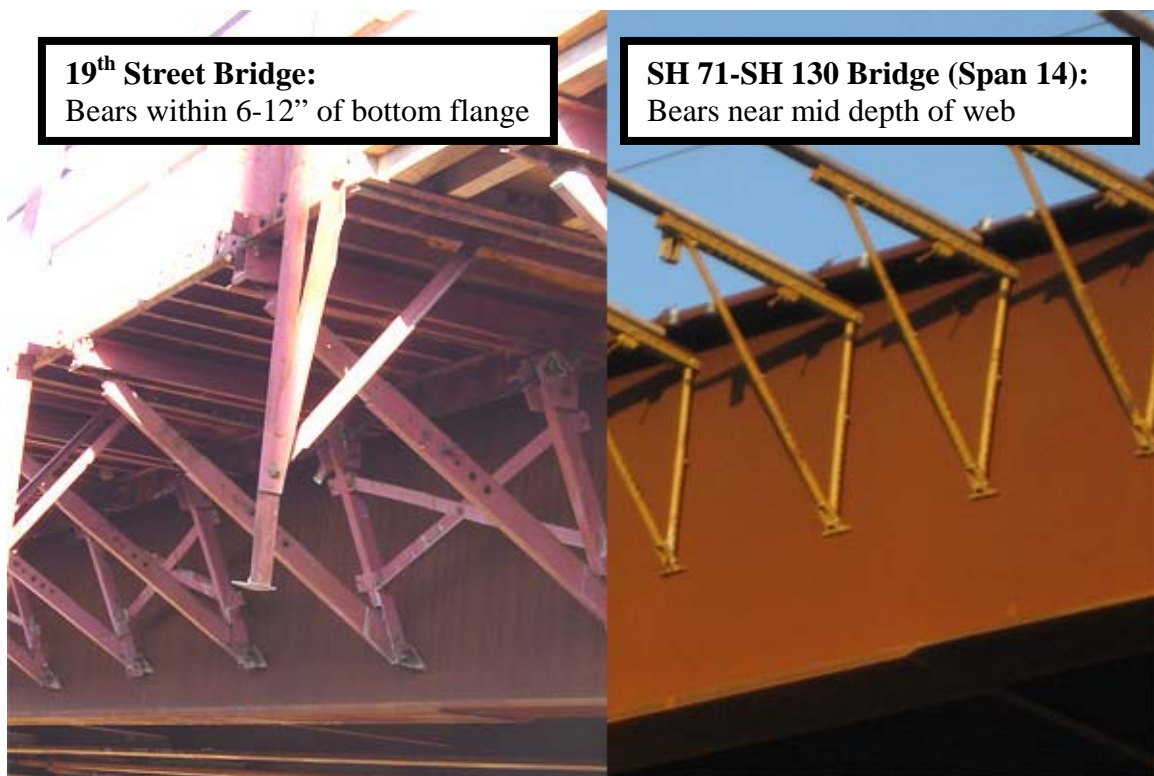
The final type of data obtained at the 19th Street Bridge were local plate deformations in steel girder webs due to loading from the overhang brackets. Overhang brackets typically react directly on the web resulting in a large concentrated force that bends the plate. Since steel plate girders typically have relatively thin webs, the forces can distort the web, thereby leading to local instabilities or large web imperfections that get locked into the girders once the deck cures. Since the brackets in Lubbock are the heavy-duty type, the brackets are spaced further apart and apply larger forces at the web. However, this force is compensated by the position of the brackets, which bear near the bottom of the web. The difference in position of the overhang brackets for the 19th Street Bridge and Span 14 of SH 71-SH 130 can be seen in Figure 3-28. For the 19th Street Bridge, the impact of plate bending in the web is expected to be less than at the Span 14 Bridge due to the position of the bracket.

Figure 3-28 Difference in Location of Overhang Bracket

overhang brackets at mid depth was expected to have a significant influence on deformations (Figure 3-28). The stations of measured web imperfections are indicated in the plan view of Span 14 shown in Figure 3-33. The measurements were taken along Girder 4 (fascia) and Girder 3 (interior). Following the information in Section 3.2.1.3, measurements were taken at three phases during construction. Panels of the webs were defined by the web stiffener locations. For the baseline imperfection readings, measurements were taken at panel ends and at three locations equally spaced at Panels 1, 2, 5, and 6. At Panels 3 and 4, measurements were taken at 2 foot intervals to better capture the variations in web deformations along the panel length (Figure 3-33). These panels were heavily investigated to track global deformation trends in the panels. However, due to the time constraints involved with traffic under the bridge, only 32 locations, at Panels 2, 3, and 6, were chosen for the “after the deck pour” measurement. After the overhang brackets had been removed, the number of locations was further reduced to six due to constraints from the contractor. In addition, as will be shown from the results presented in Section 4.3.2, the sample of the magnitudes of the deformations did not warrant extensive measurements. A total of three readings were taken at each station to ensure accurate measurements. If a potentiometer was noticed not to return to its original position, an additional reading was taken at the same location.

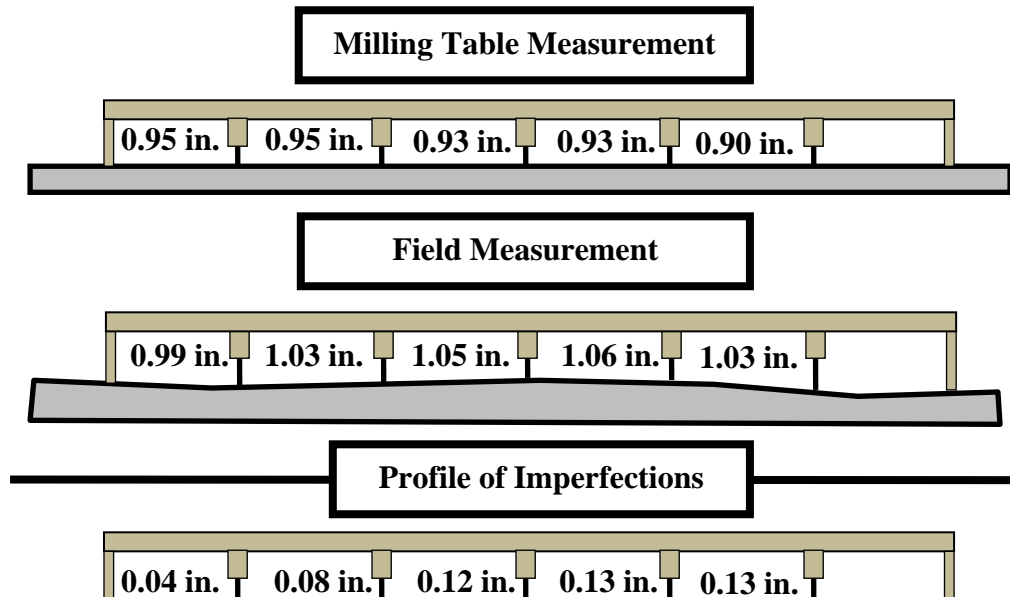
PDG between tests, the position of the potentiometers remained constant from one test to the next. Thus, the imperfection in the webs was found by subtracting the position of the potentiometers relative to the milling table from the field readings. An example of the correction is shown in Figure 3-29. Additional details of the web imperfection readings can be found in Mercan's (2005).

Figure 3-29 Example of Correcting Data from Potentiometer Displacement Gauge

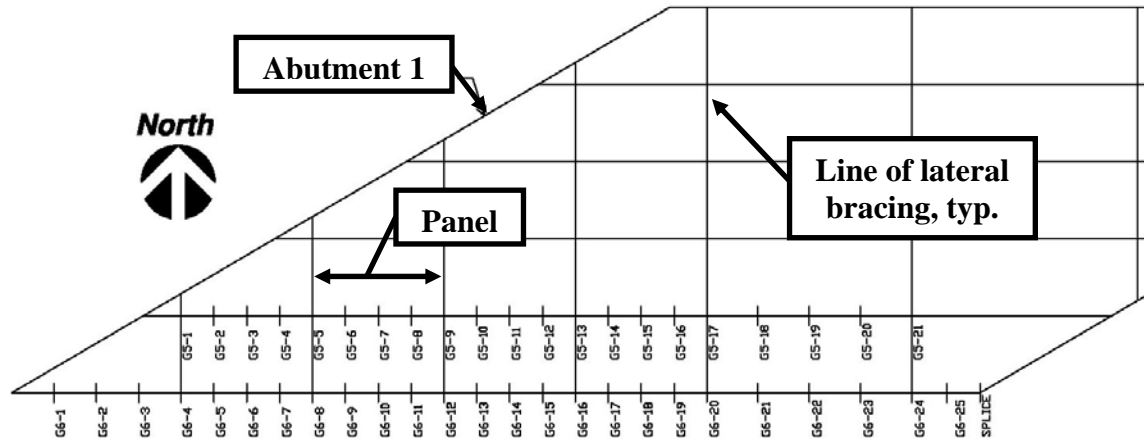
Figure 3-30 19th Street Bridge Web Imperfection Plan

The stations of measured web imperfections are indicated in the plan view shown in Figure 3-30. The measurements were taken along Girder 6 (exterior) and Girder 5 (interior). Defining the portion of the web between two adjacent lateral bracing lines (i.e. locations of cross frames or struts) as a panel, measurements were taken at three locations, equally spaced along the panel as well as at each panel end (Figure 3-30).

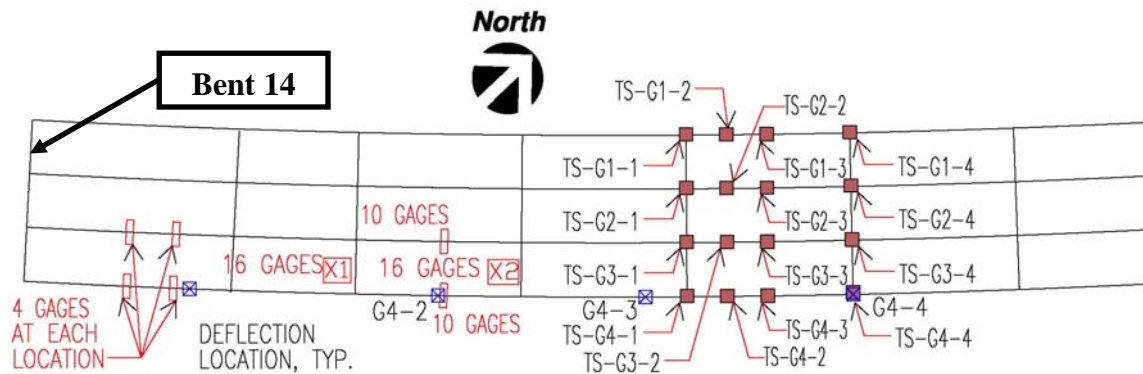
Figure 3-31 Instrumentation Plan for SH 71-SH 130 (Span 14)

Girder 3 and Girder 4 along Span 14 of the curved steel girder system were instrumented and monitored for local and global deformations from girder erection to the concrete deck pour. Strain gages were installed at three locations along each girder and two cross frames (Figure 3-31). Data from the strain gages during these periods were reported by Schuh (2008). The location of the overhang reaction was shown in Figure 3-28. Local deformations were monitored using the PDG method outlined in Section 3.2.1.3 that was developed by Mercan (2005). In addition, vertical and torsional deformations of the girders during the deck pour were measured at multiple locations across the width and along the length of the bridge. Though the girders and cross frames were instrumented and erected in March 2007, the concrete deck pour of Span 14 did not occur until April 2008 due to a delay in the construction schedule. Meanwhile, a frontage road under Span 14 was opened in September 2007 to allow operation of SH 130, which greatly reduced access to the equipment on the bridge.

As depicted in Figure 3-31, the tilt sensors were installed on each girder in the fifth panel measured from Bent 14. A panel is defined as the region between two adjacent cross frame lines. Tilt sensors were installed at each end (Location 1 and 4), near the panel's first quarter point (Location 2), and near the panel's midpoint (Location 3). A picture of the instrumented panels is shown in Figure 3-32. The locations are numbered from Bent 14, while the distances shown are referenced from the Bent 14 end of each girder. Tilt sensors are denoted by the abbreviation TS, girder number, and location number. Thus, the third tilt sensor on Girder 2 is labeled: TS-G2-3.

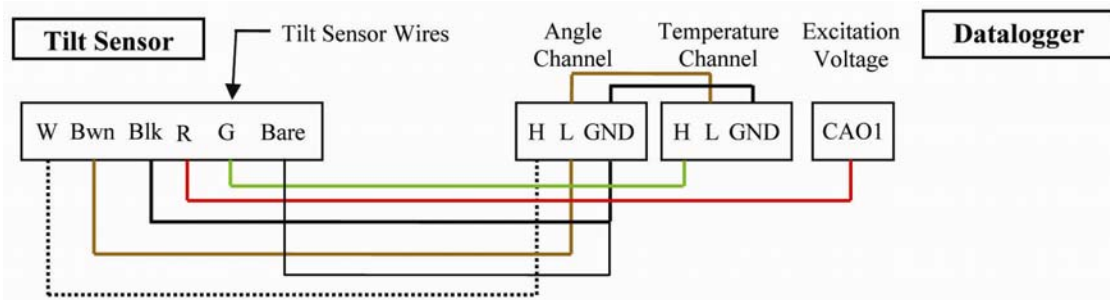
Figure 3-34 Tilt Sensor to Datalogger Wire Diagram

The requirements for wiring the tilt sensors to the CR5000 datalogger and/or AM416 multiplexer are discussed in the following two paragraphs. If the tilt sensor is connected directly to a CR5000 datalogger, the wiring is as follows (see Figure 3-34):

- Red wire goes to excitation channel (i.e., COA1 or COA2)
- White wire goes to H input on differential angle channel
- Brown wire goes L input on differential angle channel
- Black wire goes to GND input on differential angle channel
- Green wire goes to H differential temperature channel
- Add a wire that goes from L input on angle channel to L input on temperature channel
- Add a wire from GND input on angle channel to GND input on temperature channel
- Exposed bare wire goes to any ground channel on the datalogger

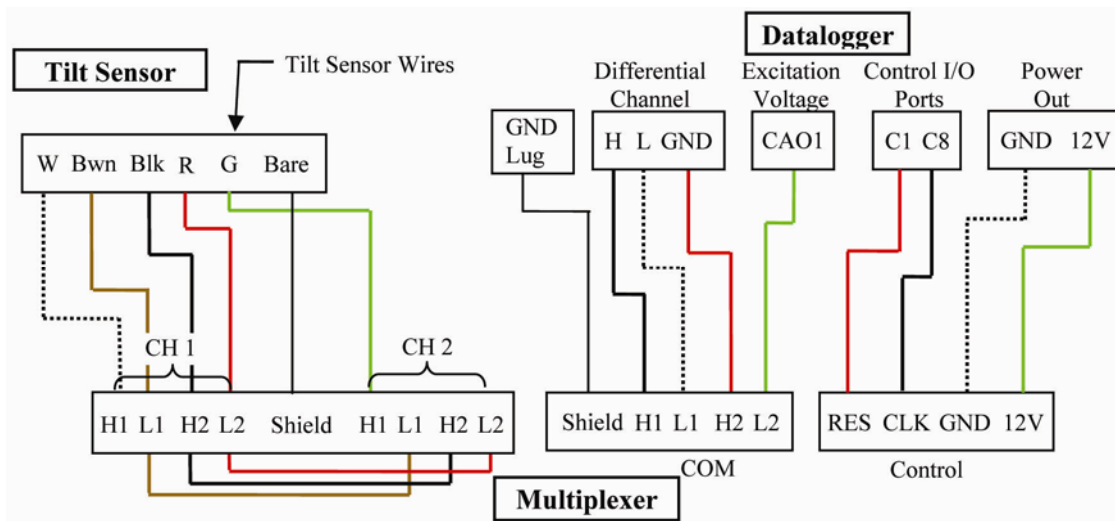
Figure 3-35 Tilt Sensor to Multiplexer to Datalogger Wire Diagram

If the tilt sensor is connected to an AM416 multiplexer, the wiring is as follows (see Figure 3-35):

- Red wire goes to L2 of angle (1st) channel of multiplexer
- Black wire goes to H2 of angle (1st) channel of multiplexer
- White wire (angle voltage) goes to H1 of angle (1st) channel of multiplexer
- Brown wire goes to L1 of angle (1st) channel of multiplexer

- Green wire (temperature voltage) goes to H1 of temperature (2nd) channel of multiplexer
- Add a wire that goes from L1 input on angle channel to L1 input on temperature channel
- Add a wire from H2 input on angle channel to H2 input on temperature channel
- Add a wire from L2 input on angle channel to L2 input on temperature channel
- The wiring from a multiplexer to a datalogger is shown below.
